**FOLLOW-UP COOPERATION STUDY  
ON  
THE PROJECT FOR CONSTRUCTION  
OF  
THE SUEZ CANAL BRIDGE  
(PAVEMENT on STEEL DECK)**

**FINAL REPORT**

**MARCH 2013**

**JAPAN INTERNATIONAL COOPERATION AGENCY**

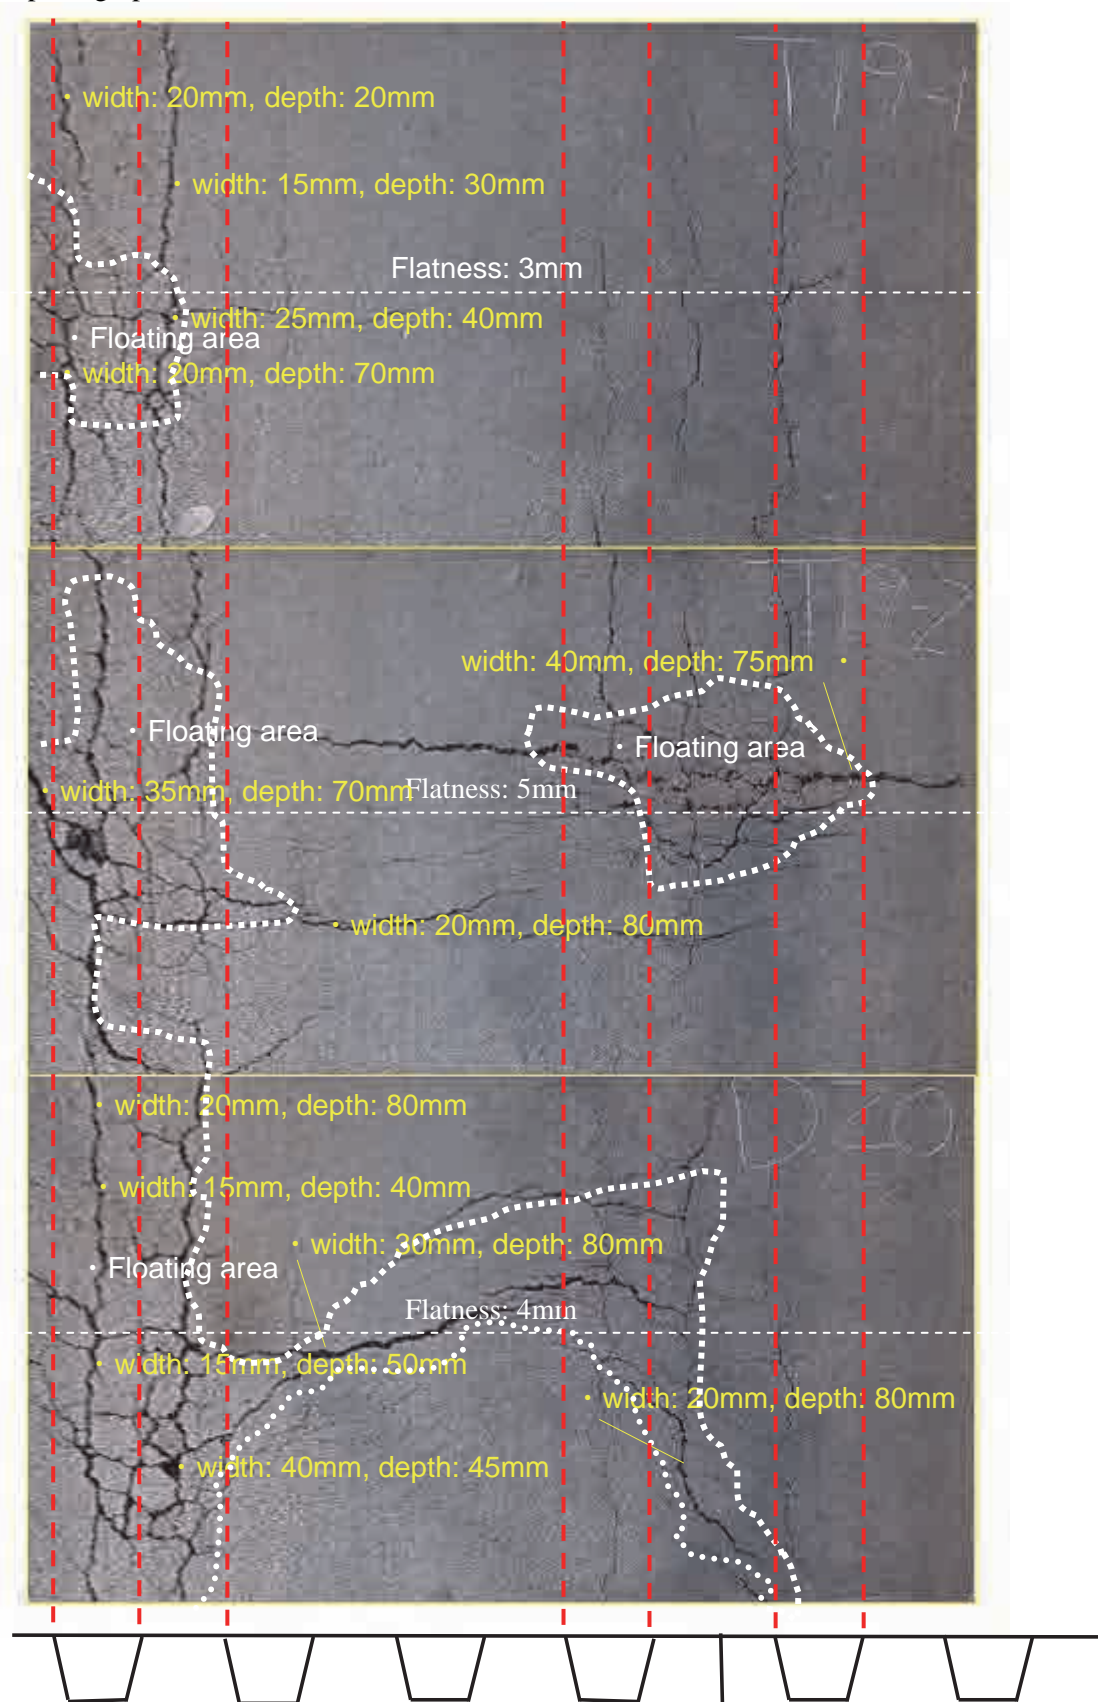
Figure 2.2.3 Results of Detailed Inspection (N1)

- The photograph shows the results of N1.

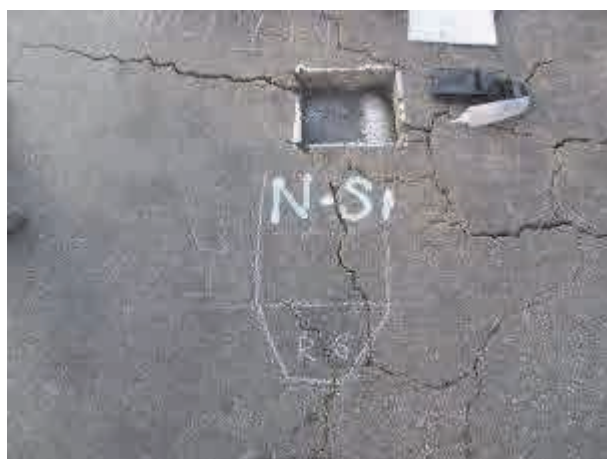
**Photo 2.3.2 Top Surface of Steel Deck (S1)**

A fter the Removal of Asphalt Layers

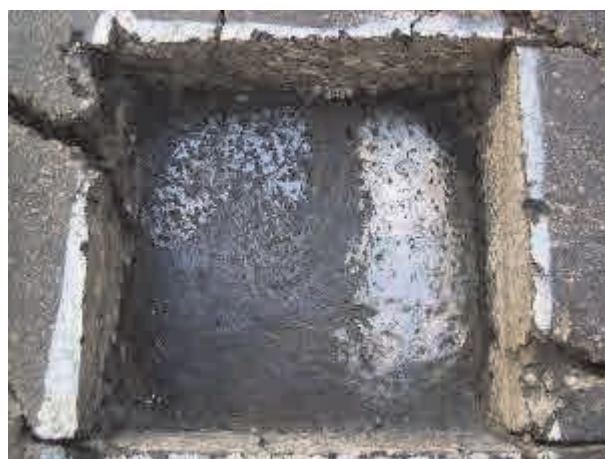
Ground Surface on the Rib

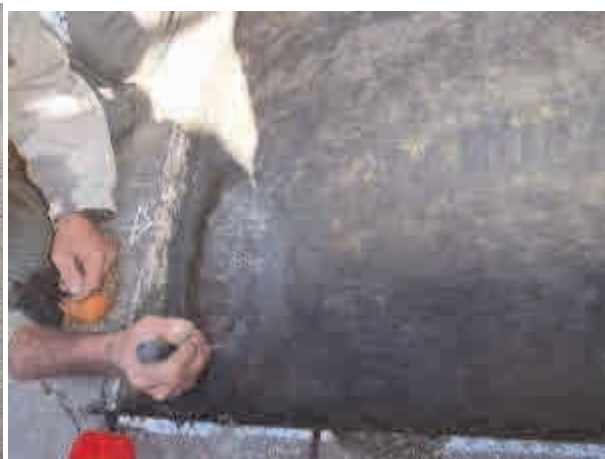
After the Removal of Asphalt Layers

- In L2 cutout: the stick layer was changed to a layer of steel rust and could not be removed easily even with power tools. The thickness of the rust layer was about 0.5 to 1 mm.
- In L1 cutout: after the removal of the asphalt, red material (possibly rust) stuck to the stick layer. The stick layer (adhesive layer) seemed to be sound in L1, but could be removed easily in some parts. (Photo 2.3.1)
- There were some thickness reductions due to corrosion in the west part of the L1 cutout.

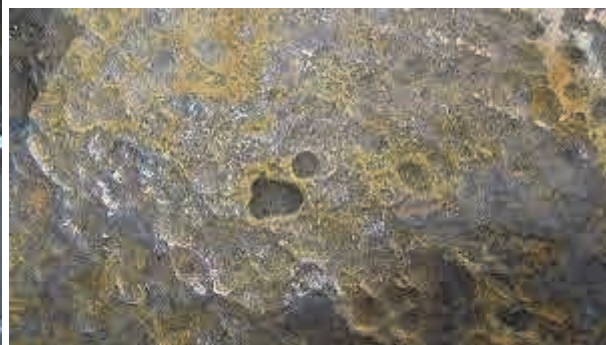
Surface Condition (Magnified)

**Photo 2.3.3 Top Surface of Steel Deck (L2)**

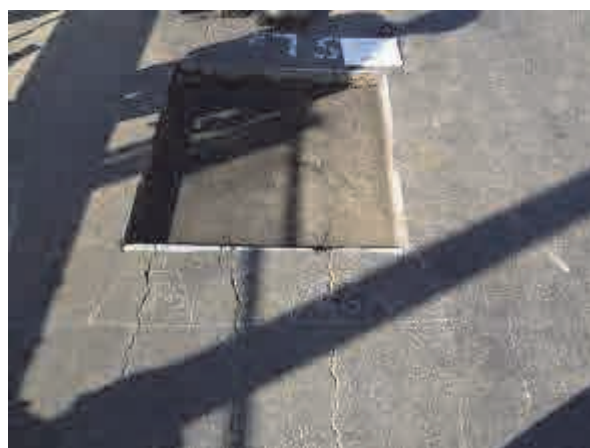
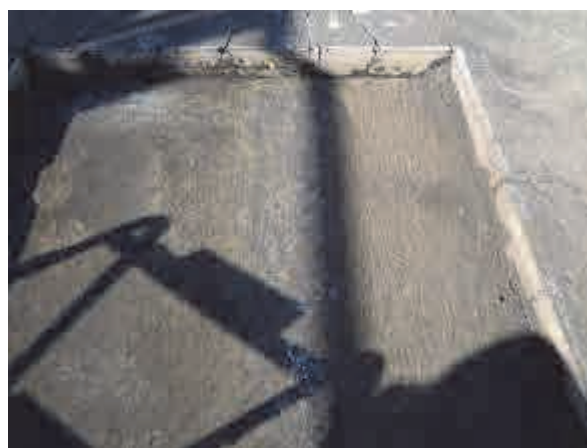
5) L3

**Photo 2.3.5 Top Surface of Steel Deck (L3)**

- Water invaded the area under the stick layer and the steel was corroded in every cutout.
- Corrosion conditions of the steel deck surface were different in each cutout.
- In the north side cutouts L1, there are sound steel surfaces in some areas but corrosion had propagated in part of the surface.
- In order to fix the corrosion, it is necessary to blast and remove the rust first, then apply a new asphalt layer with a waterproof layer.

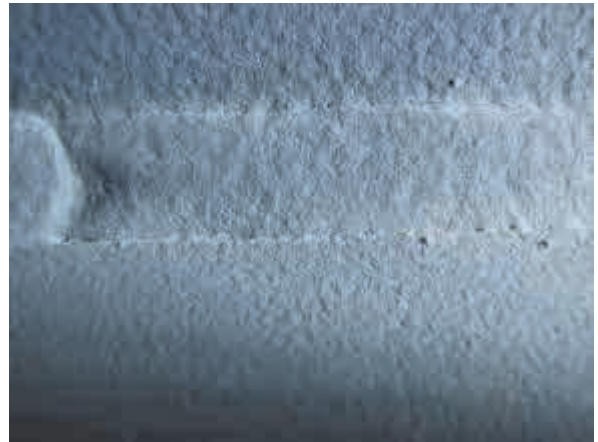
L1 WS-Tr20-1-R6\_R5 Side

- Some poor welds were found and are listed in the appendix.
- A few paint cracks were found as shown in Photo 2.3.8. Patterns of these paint cracks are different from those of fatigue cracks.

**Photo 2.3.8 Paint Cracks**

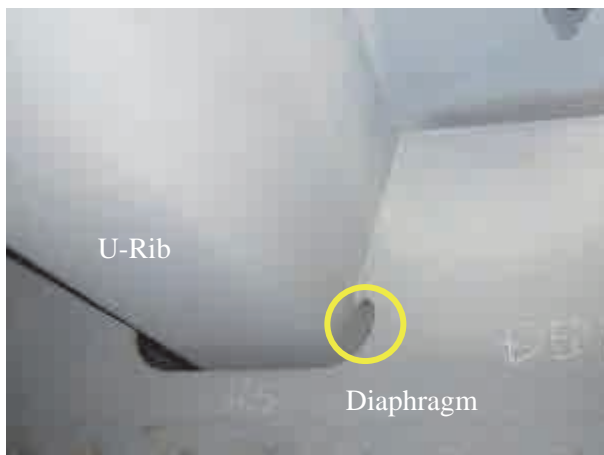
- No fatigue cracks were detected either in the closely inspected area under the pavement cutouts or No. 7, 8 U-rib in the bridge.
- Fatigue prone details and welding of unfavorable quality were found in some parts.
- These parts should be inspected again later in periodic inspections. Such details are as follows:
  - ✓ Scallop of U-rib in transverse member connection (Upper left in Photo 2.3.9)
  - ✓ Vertical rib welded to deck plate, especially under the wheel location (center left and bottom left in Photo 2.3.9)
  - ✓ Flange of transverse rib adjacent and very close to horizontal stiffener (upper right in Photo 2.3.9)
  - ✓ U-shape rib weld bead (depends on weld root condition)
  - ✓ Scallops in the intermediate web (bottom right in Photo 2.3.9).

Boxing Weld on Scallop End of U-Rib

**Photo 2.3.9 Parts that need Monitoring, Especially in the Steel Deck**

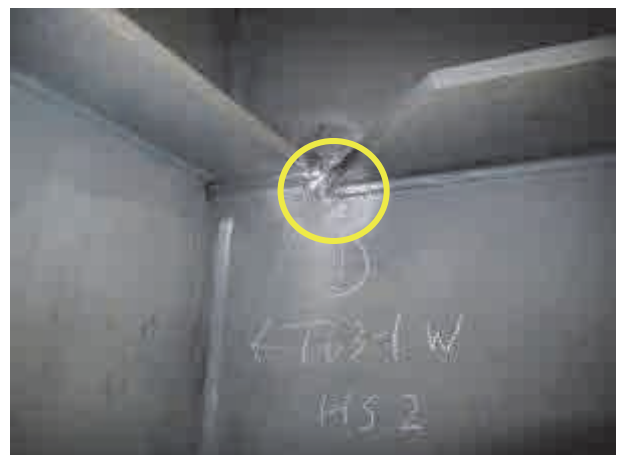
Butt Weld of T.Rib Flange, closely

Adjacent to HS Horizontal Rib

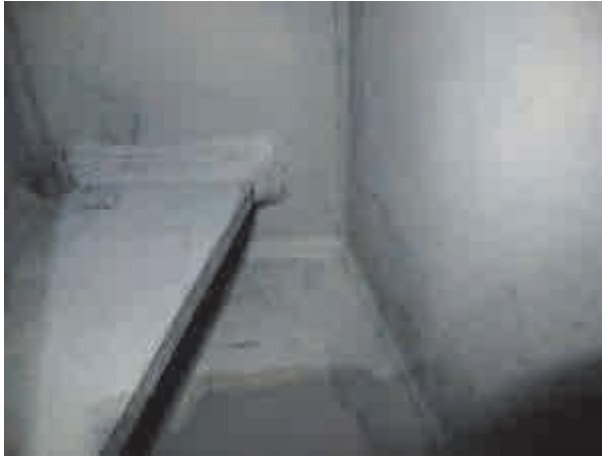
Vertical Rib Welded to Deck Plate,  
Especially Harmful under Wheel Position

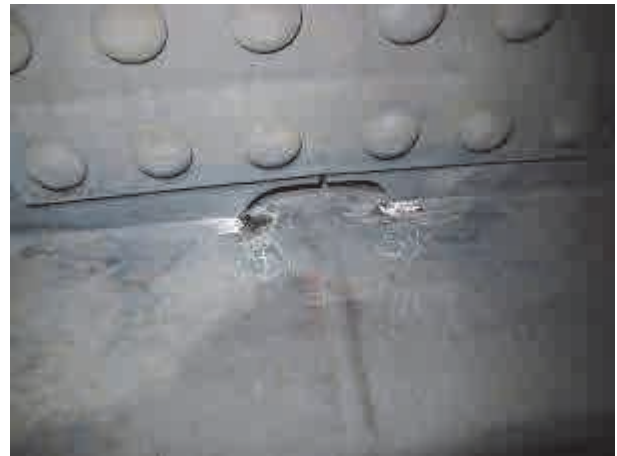
Web Scallop on L.Flange

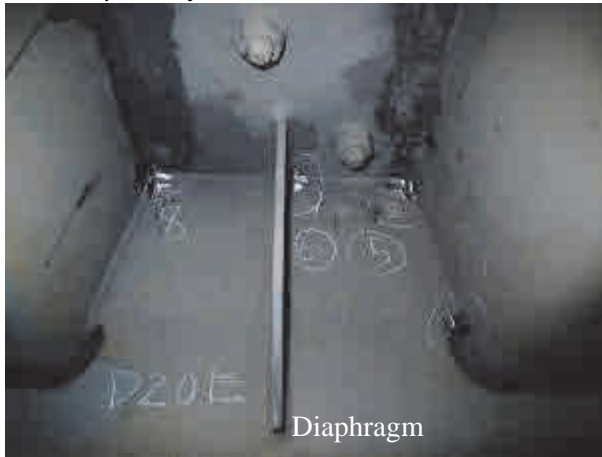
Rib for Erection, Boxing Weld on Deck Surface under Wheel Position

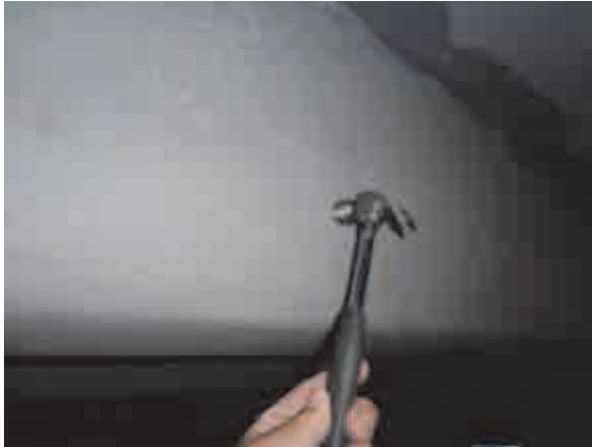
L1 (D20 to TR20-1: Rib 6)

The hammer testing results indicate that no waste deposit remains inside and the deck plates have no crack penetration.

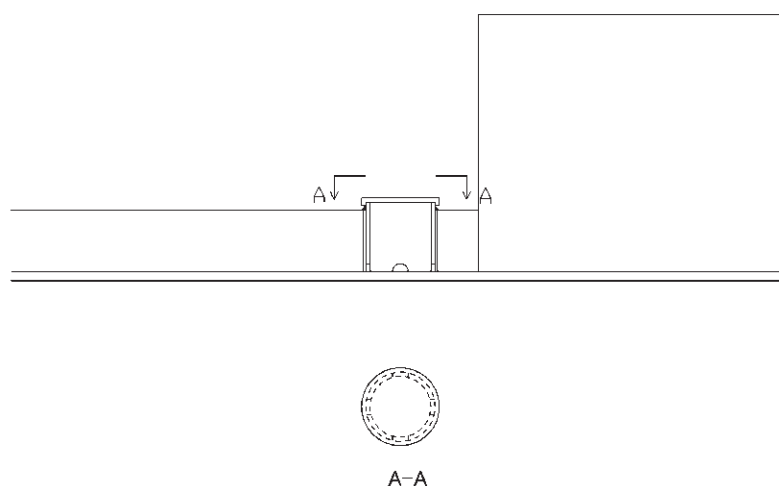
**Figure 3.4.1 Monitoring Device for Water Exposure on the Surface of Steel Deck Plate**

According to the results of an investigation on the soundness of pavement, the cracking problem has become serious on all the pavement on the steel deck plate. Boring into pavement to see the state of the interior has revealed water congestion and much corrosion on the steel deck plate. This indicates it is highly possible that the cracking problem may enable water to permeate into the pavement and further cause severe corrosive damage. So, it is necessary to figure out visually how much water comes into the pavement and stays on the surface of the steel deck plate by cutting open part of the pavement on which cars are usually not running.

- Do not scratch or damage the surface of the steel deck plate when drilling.
- Do scrapping on the surface of the steel deck plate exposed in the drilled hole and glue a waterproofing sheet or apply a waterproofing coat to form a waterproof layer.
- Insert a PVC (Polyvinyl Chloride) pipe, VP 100 mm, sized at 105 mm for outer diameter, and 100 mm in length, onto the waterproof layer after drilling four small holes — semicircle with approximately 10 mm in radius — to allow for water drainage at the bottom of the pipe.
- To prevent water intrusion, attach an end cap onto the top of the pipe. The cap can be opened and closed by screwing or a similar action.
- Seal up the gap around the top of the pipe and fill it with the sealant material to stop water intrusion due to rain.

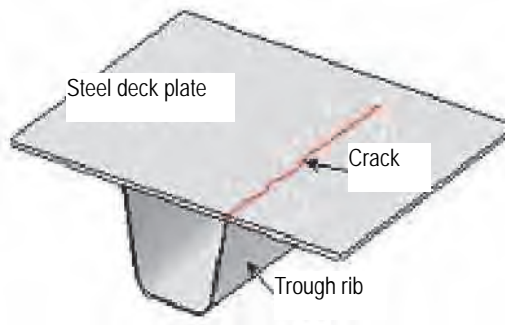
At the time the Suez Canal Bridge was completed, steel deck plate with 12 mm thickness was commonly used – currently changed to 16 mm – for orthotropic steel deck plate bridges in Japan. In recent years, it has been reported many fatigue cracks are occurring in the vicinity of welded joints between the steel deck plate and trough ribs subject to cyclic local deformation due to wheel loading as shown in Figure 4.3.1. To reinforce or repair it, development of a method that provides a sufficient composite strength for less than 80 mm thick pavement has been considered. Thus, SFRC and ECC have been developed in order to suppress fatigue crack initiation and propagation by improving composite strength gained from integrating them rigidly with the steel deck plate.

**Figure 5.1.1 Fatigue crack in steel deck plate**

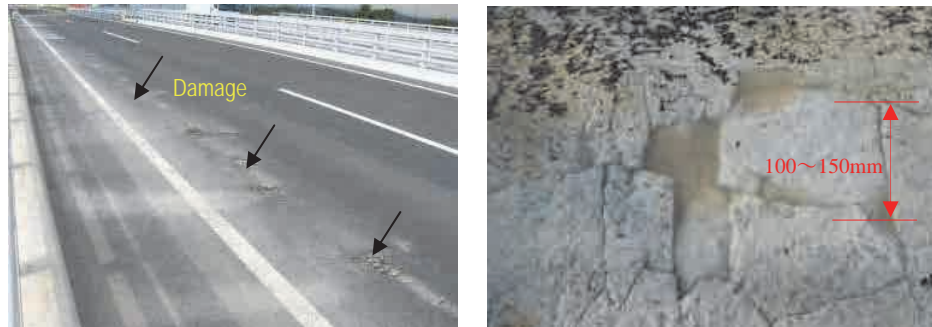
Mihara Bridge started its service in March 2005 and just six months later, pavement damage was found. Repair work was carried out soon after investigation. For micro-scale damage, 40 mm thick pavement was changed to 50 mm thickness by adding fine-graded gap-ascon; for small-scale damage, aramid fiber grid was laid over the grinded surface; and for large-scale damage, ECC replacement was applied. In July 2012, however, since no improvement was seen, all pavement was replaced with guss asphalt. Consequently, this shows that ECC application is not yet successful.

**Photo 5.1.7 Damage Occuring on Mihara Bridge**

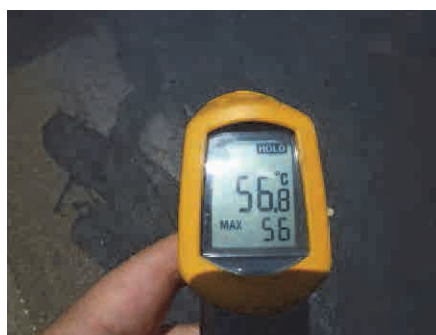
In June 2012, during the on-site investigation, the air temperature was 20°C at 10:00 AM and the temperature of the road surface was 56°C. Basically, SFRC pavement should be laid before the high-durability epoxy resin bond dries out, as described later in detail. On a road surface with a temperature of 56°C, SFRC pavement must be finished in just 30 minutes, which is logistically impossible.

**Photo 5.1.10 Temperature on Road Surface in the Suez Canal Bridge (Pictured at 10:00 AM on 4 June 2012)**
