CHAPTER 6 MAINTAINANCE MANAGEMENT PLAN

7.1 The Damaged Condition of Pavement and Soundness of Steel Deck Plate

Inspection Photo D/B in the Suezu Cannal Bridge

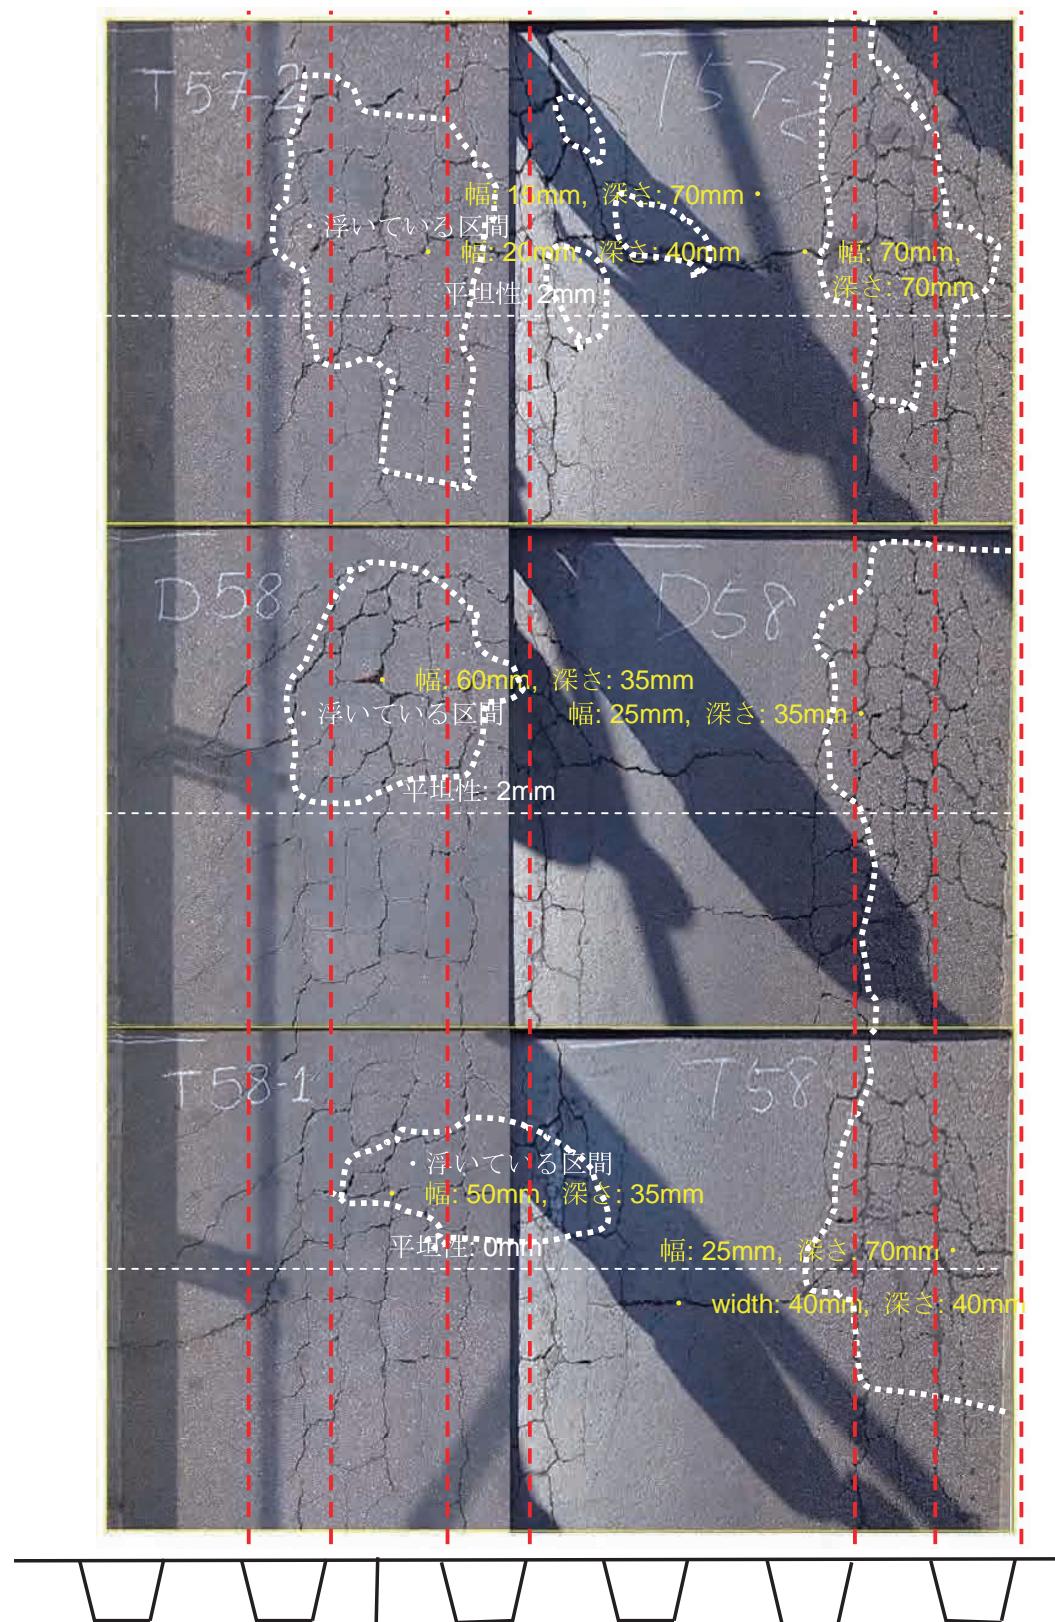
1) S-1 (Tr57-2/D58/Tr58-1)

Inspection date of South: 30th November 2011

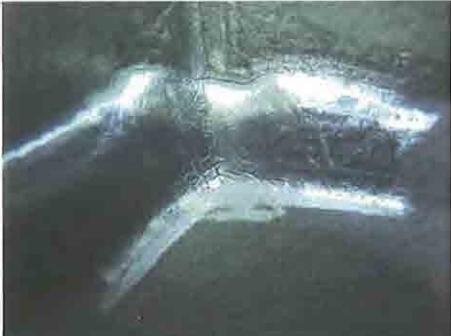
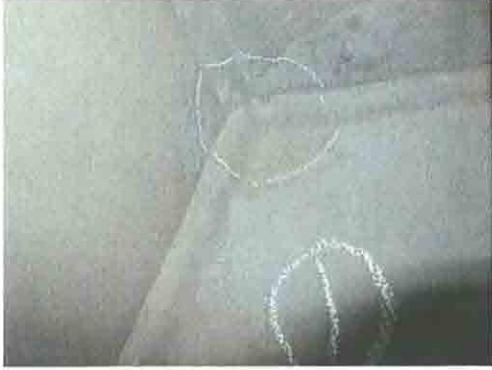
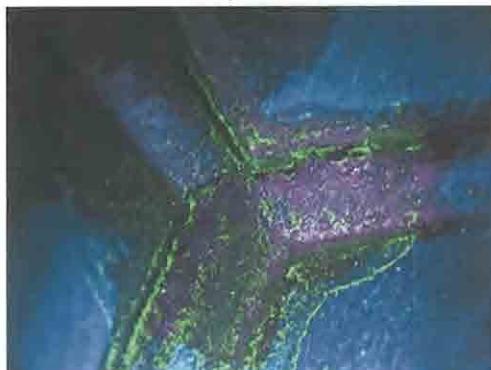
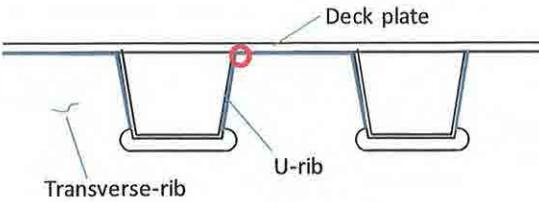
No	1	Date	2011/12/06
connection name	MT result		
junction of 3-weld line U-rib and T. rib			
paint crack	Risk of fatigue crack		
Location L1(1):WT20-1W,R6S(5)	Comment welding crack		
Location map

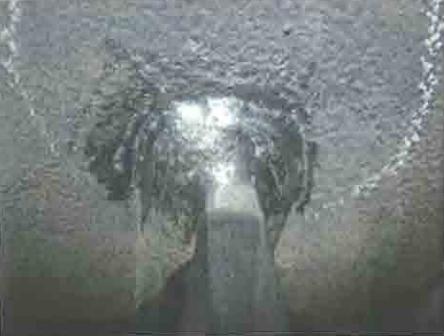
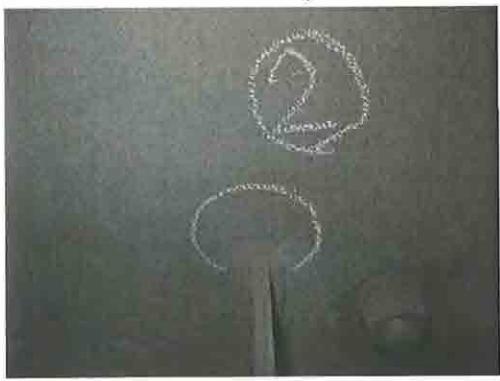
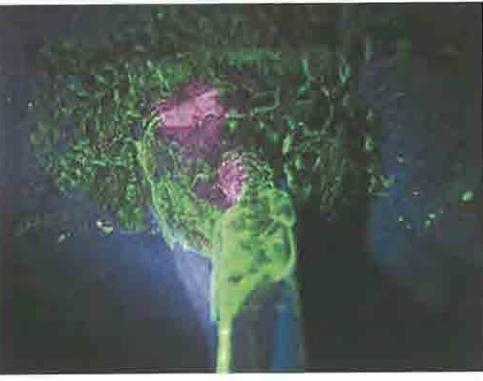
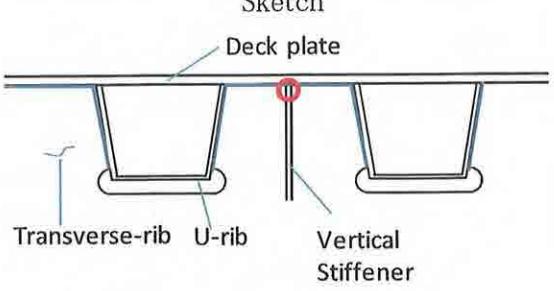
No	2	Date	2011/12/06
connection name	MT result		
junction of 3-weld line U-rib and T. rib			
paint crack mud cracking, very shallow, surface cracking	Risk of fatigue crack small		
Location L1 (2) :	Comment Weld crack, no clear reason		
Location map

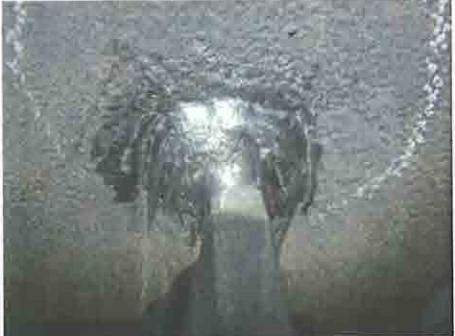
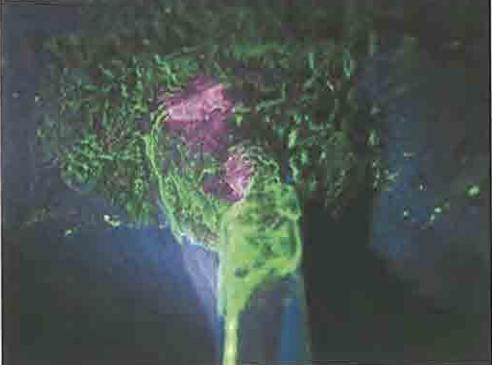
No	3	Date	2011/12/06
connection name	MT result		
paint crack	Risk of fatigue crack		
Location	Comment		
L1(3):			
Location map

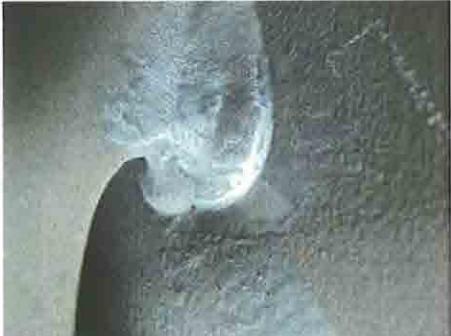
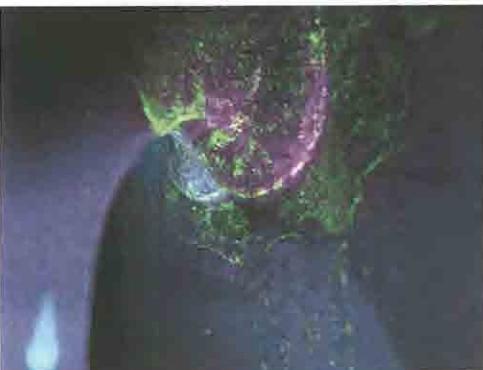
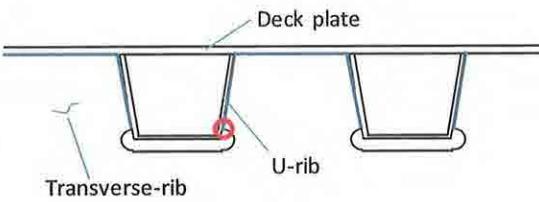
No	7	Date	2011/12/06
connection name		MT result	No crack
paint crack		Risk of fatigue crack	
L1(7): Location		Comment	
Location map

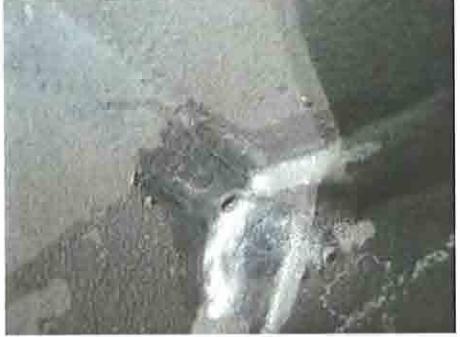
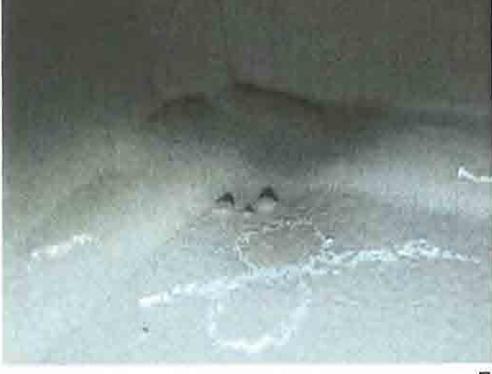
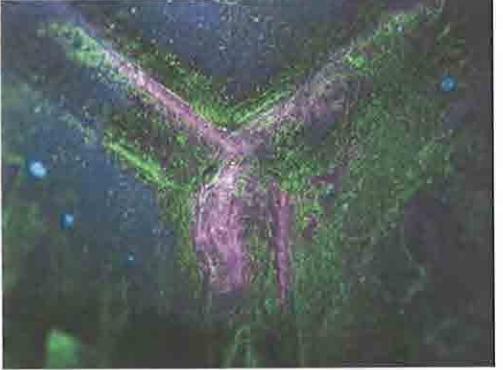
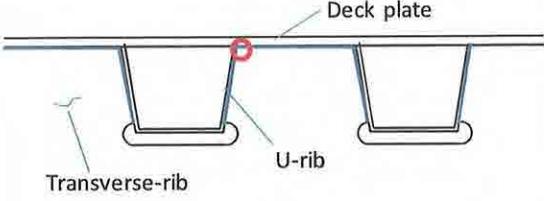
No	8	Date	2011/12/06
connection name	junction of 3-weld line U-rib and T. rib	MT result	
paint crack mud cracking, very shallow, surface cracking		Risk of fatigue crack small	
Location L1 (8) : D20E R6(5)		Comment	Weld crack, no clear reason
Location map

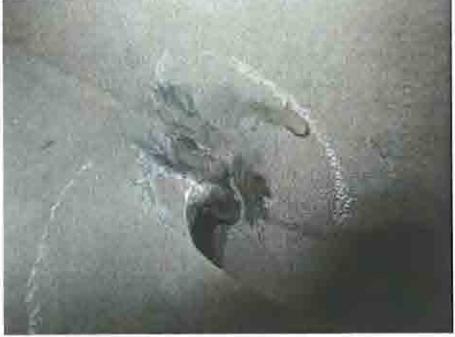
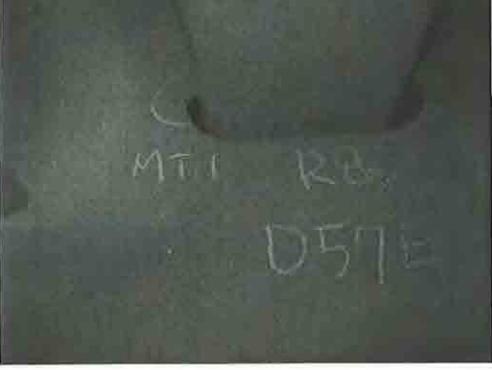
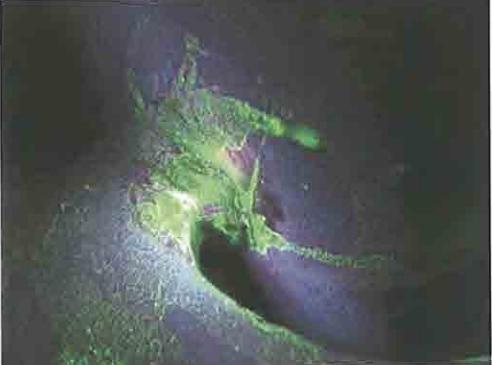
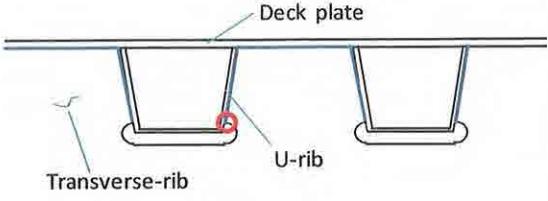
No	9	Date	2011/12/07
connection name		MT result	No crack
paint crack		Risk of fatigue crack	
Location	L2,S2(1):W D57E R8S_w	Comment	
Location map

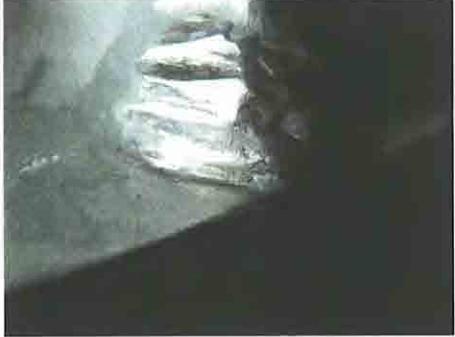
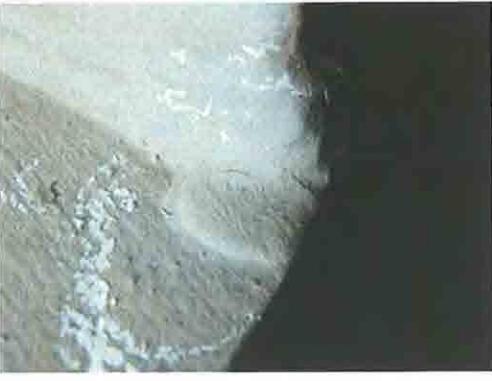
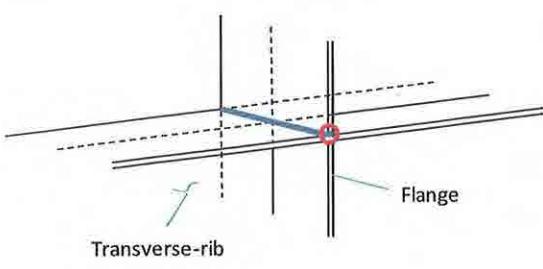
No	10	Date	2011/12/07
connection name	MT result		
paint crack	Risk of fatigue crack		
Location L2,S2(2):W T57-2	Comment		
Location map

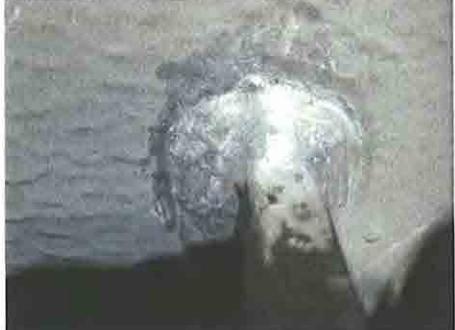
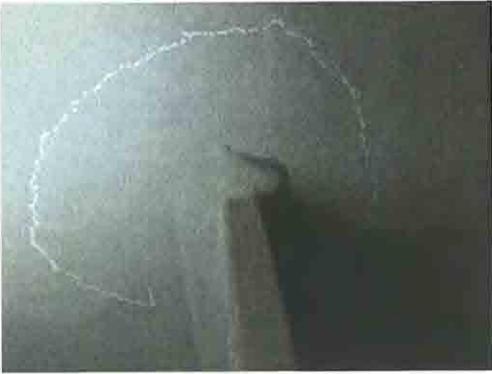
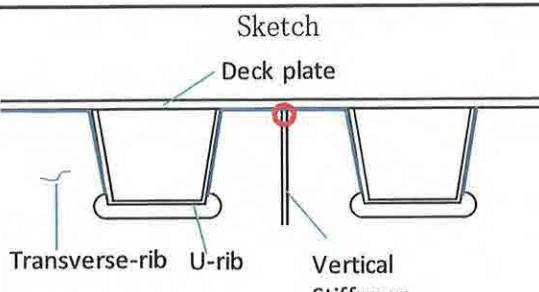
No	11	Date	2011/12/07
connection name		MT result	No crack
paint crack		Risk of fatigue crack	
Location	L2,S2(3):W 57E R8S-Web	Comment	
Location map

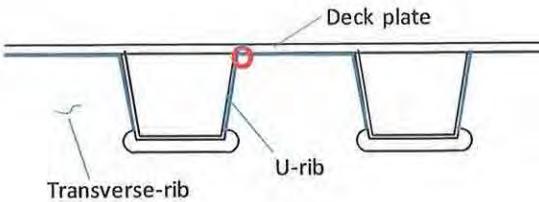
No	12	Date	2011/12/07
connection name	junction of 3-weld line U-rib and T. rib	MT result	No crack
paint crack		Risk of fatigue crack	
Location	L2,S2(4):W 58W R6S_5	Comment	
Location map

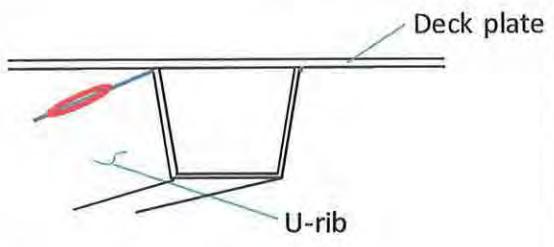
No	13	Date	2011/12/07
connection name	Weld between U-rib and Deck plate	MT result	No crack
paint crack		Risk of fatigue crack	
Location	L2,S2(5):W57(3) R5S_4	Comment	
Location map

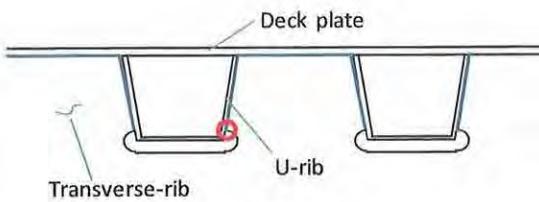
No	14	Date	2011/12/07
connection name		MT result	No crack
paint crack		Risk of fatigue crack	
Location	L2,S2(6):W T57-2E R5S_6	Comment	
Location map

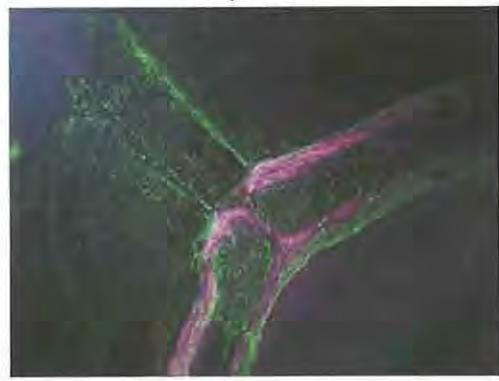
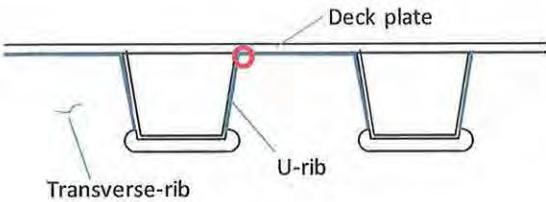
No	15	Date	2011/12/07
connection name	junction of 3-weld line U-rib and T. rib	MT result	No crack
paint crack		Risk of fatigue crack	
Location	L3(1):W 61E R5S_6	Comment	
Location map

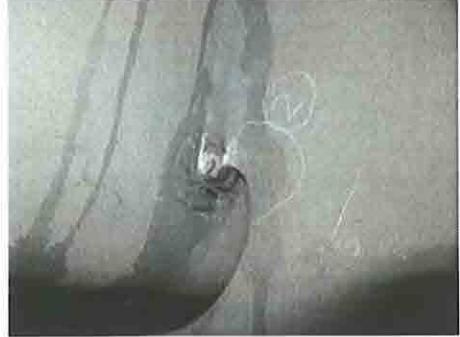
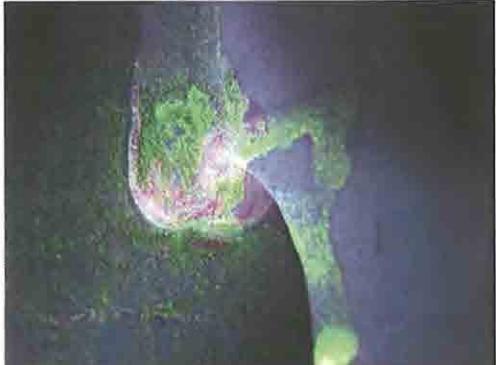
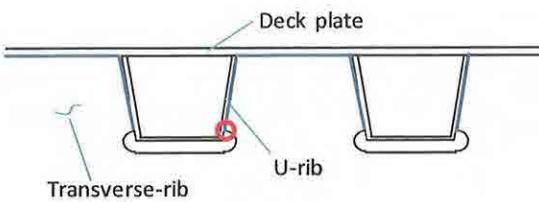
No	16	Date	2011/12/07
connection name		MT result	No crack
paint crack		Risk of fatigue crack	
Location	L3(2):W 61E R5S_6	Comment	
Location map

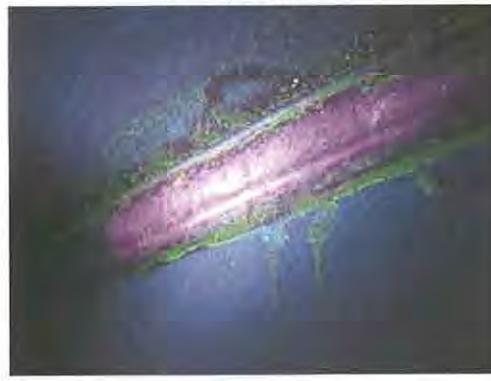
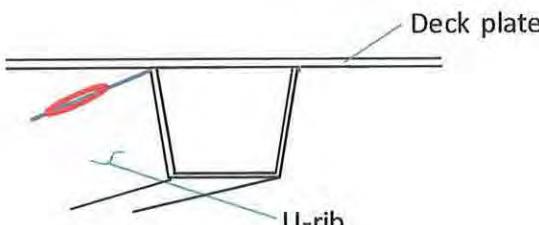
No	17	Date	2011/12/07
connection name		MT result	
Weld between U-rib and Deck plate		No crack	
paint crack		Risk of fatigue crack	
Location	L3(3):W61(1) R5S_6	Comment	
Location map

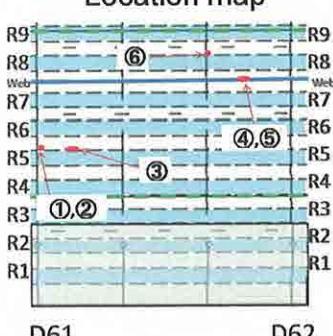
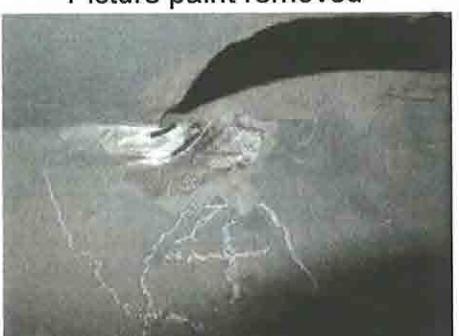
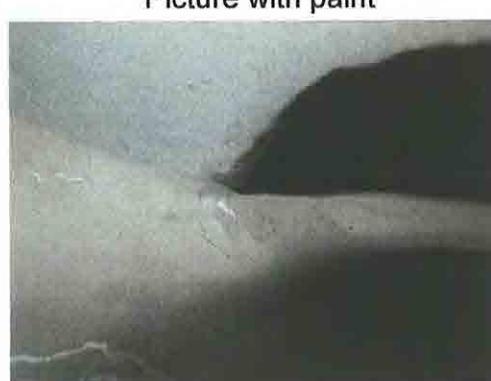
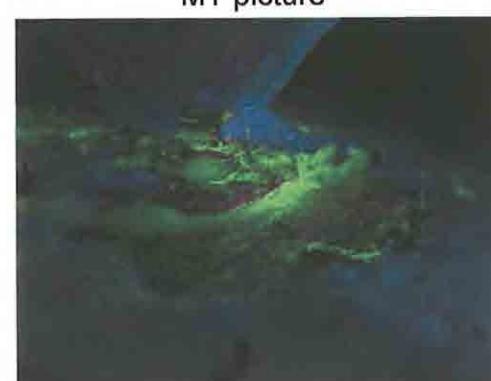
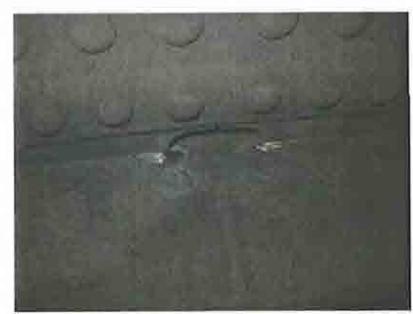
No	18	Date	2011/12/07
connection name		MT result	No crack
paint crack		Risk of fatigue crack	
Location L3(4):W61(3) Web_S		Comment	
Location map

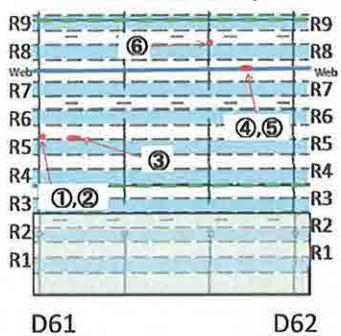
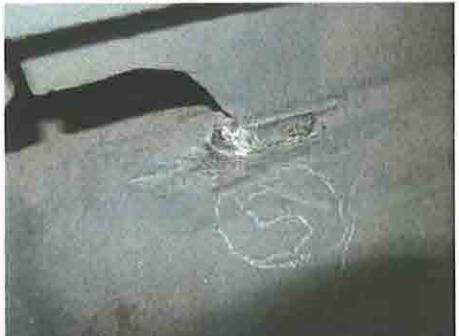
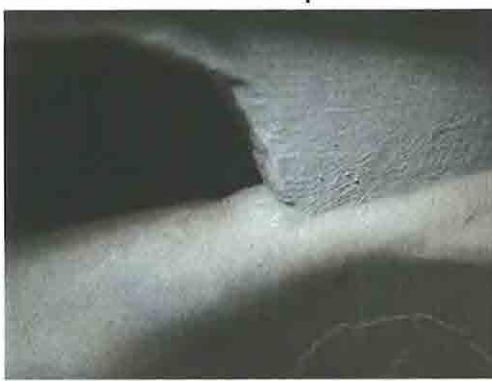
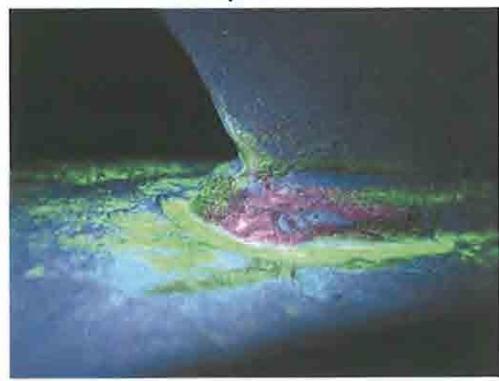
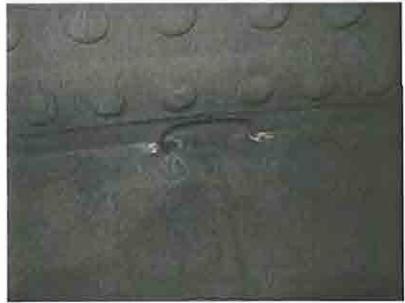
No	19	Date	2011/12/07
connection name		MT result	No crack
paint crack		Risk of fatigue crack	
Location	L3(5):W61(3) Web_S	Comment	
Location map

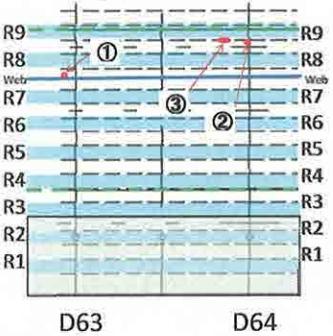
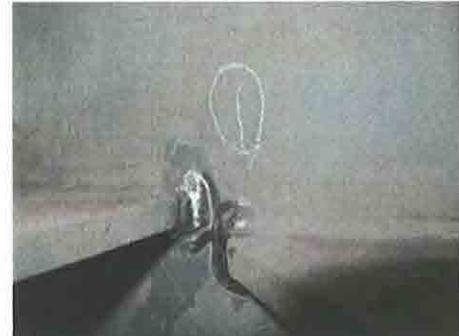
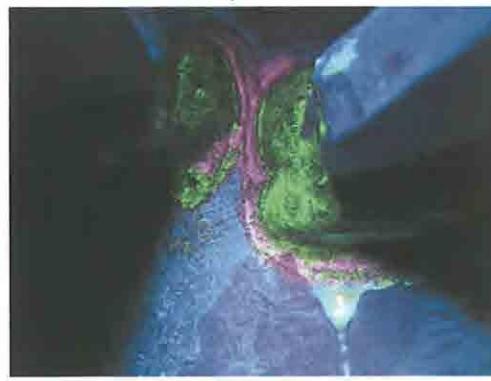
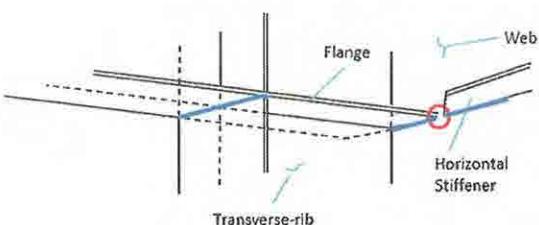
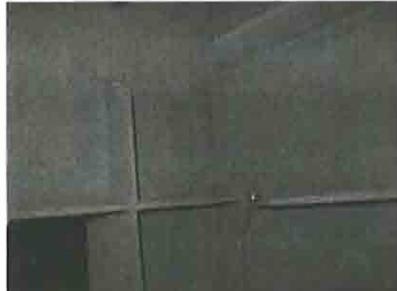
No	25	Date	2011/12/07
connection name		MT result	No crack
paint crack		Risk of fatigue crack	
Location L4(1):W 62(3) WebS		Comment	
Location map

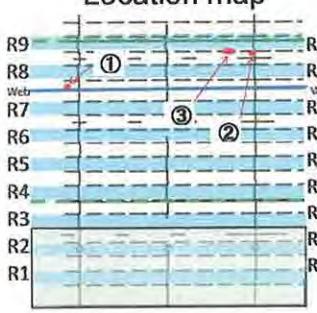
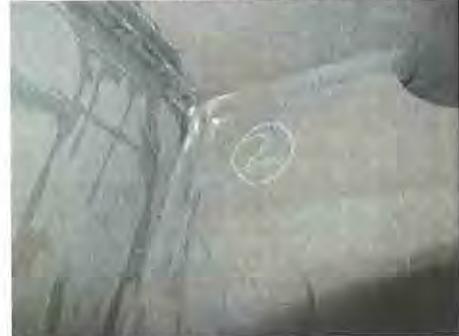
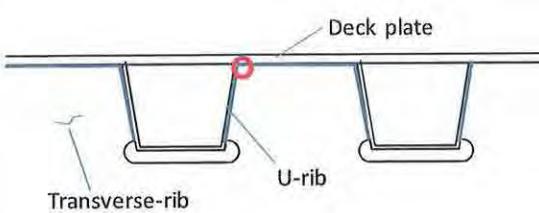
No	26	Date	2011/12/07
connection name	junction of 3-weld line U-rib and T. rib	MT result	No crack
paint crack		Risk of fatigue crack	
Location	L4(2):W D64W R9S_8	Comment	
Location map

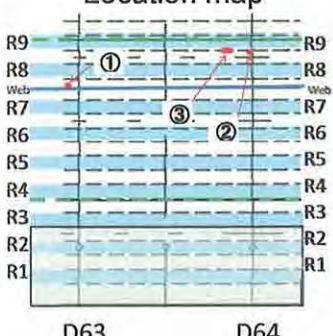
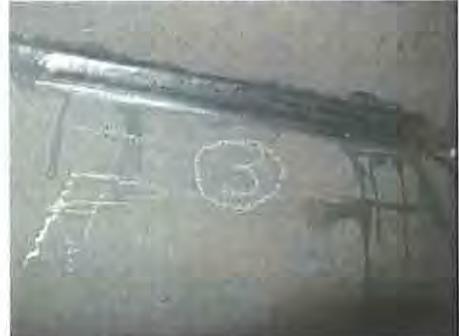
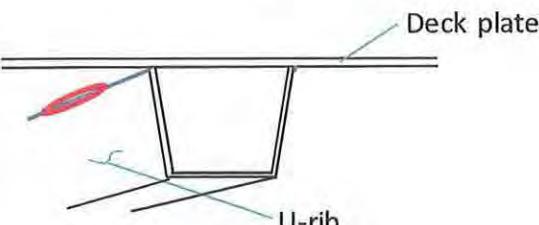
No	27	Date	2011/12/07
connection name	Weld between U-rib and Deck plate	MT result	No crack
paint crack		Risk of fatigue crack	
Location	L4(3):W 63(2) R9S_8	Comment	
Location map

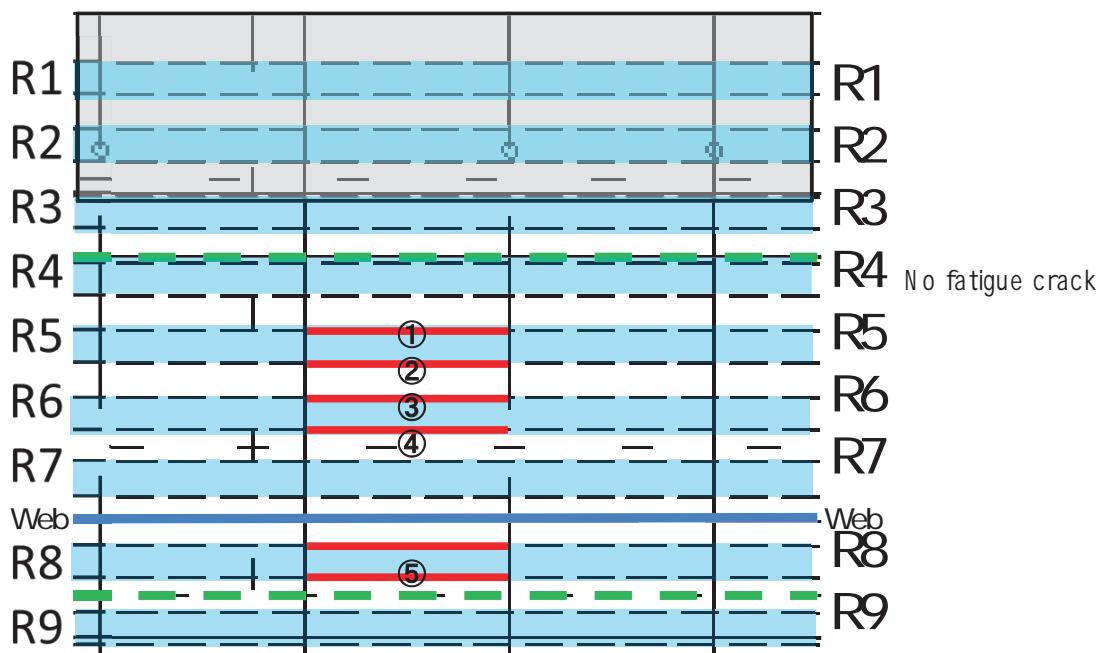
①N-W20(1)-R5_4

No fatigue crack

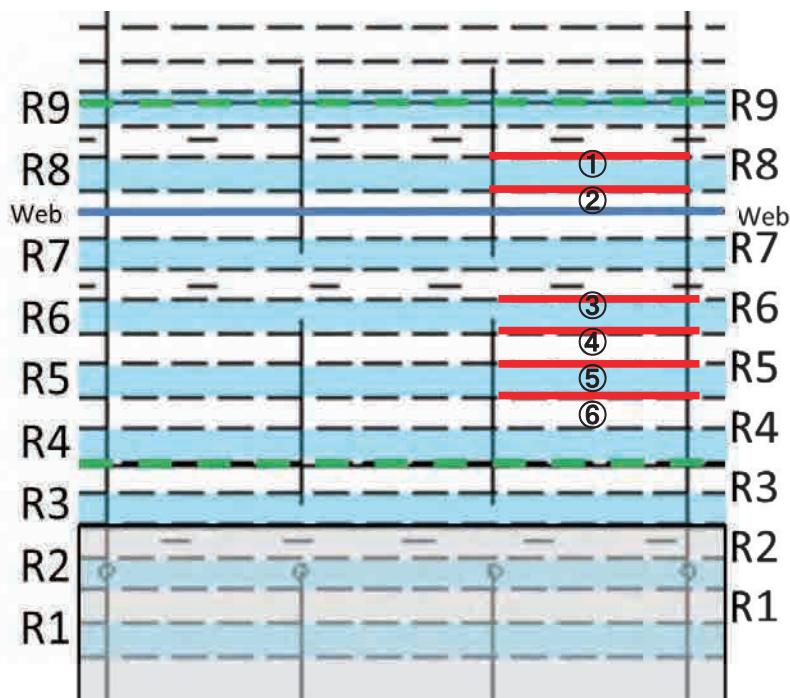
L2,S2 inside box gader

No fatigue crack,corrosions on the surface

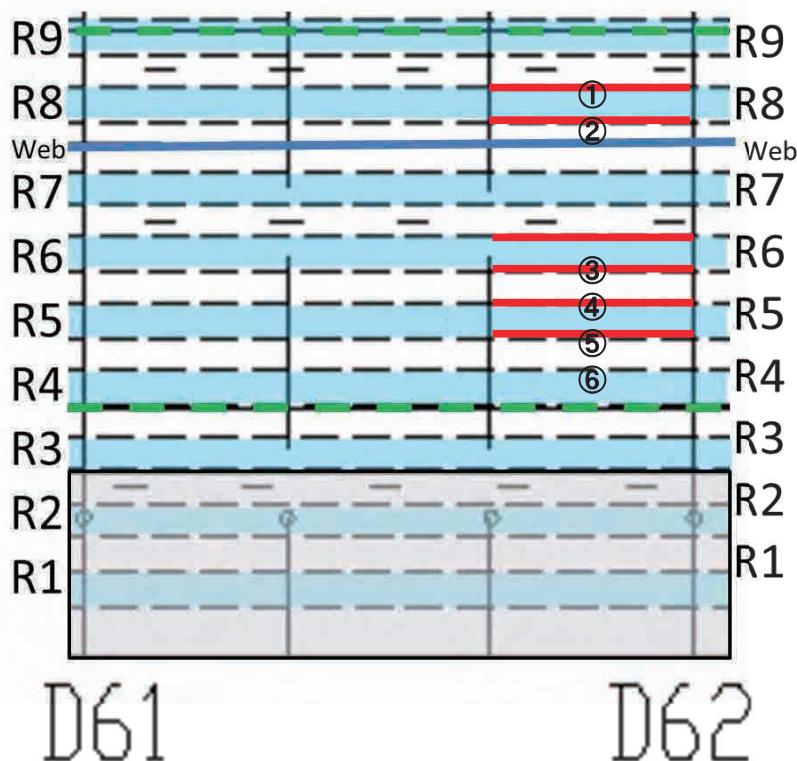
①N-W61(3)-R8_9

No fatigue crack,corrosions on the surface

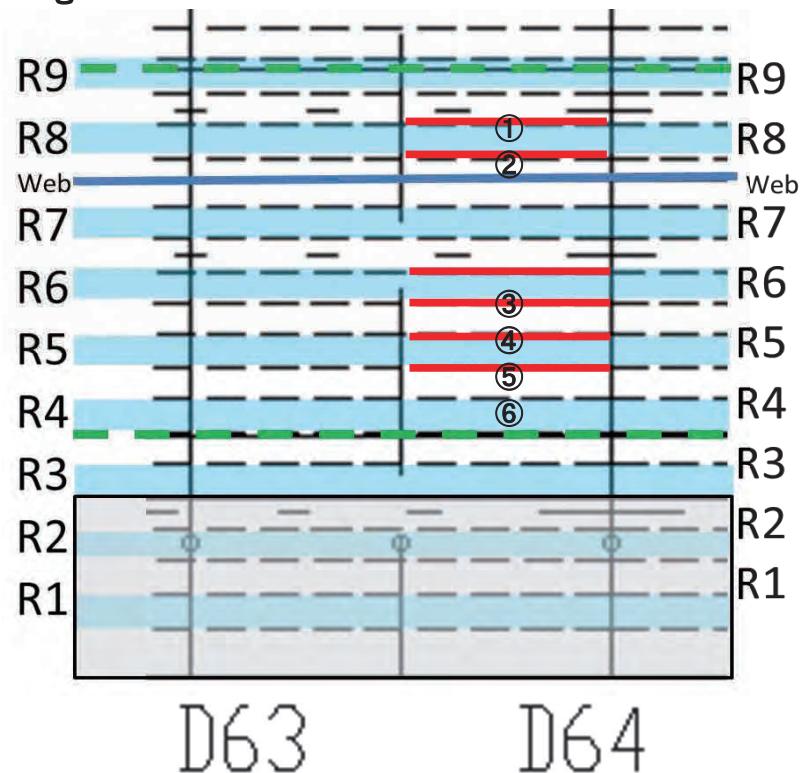
①N-W63(2)-R8_9

No fatigue crack,corrosions on the surface
