**FOLLOW-UP COOPERATION  
STUDY REPORT  
ON  
THE PROJECT FOR IMPROVEMENT  
OF  
FISHERY INFRASTRUCTURE  
IN  
ANSE LA RAYE, SAINT LUCIA**

**MARCH 2013**

**JAPAN INTERNATIONAL COOPERATION AGENCY**

**ECOH CORPORATION**

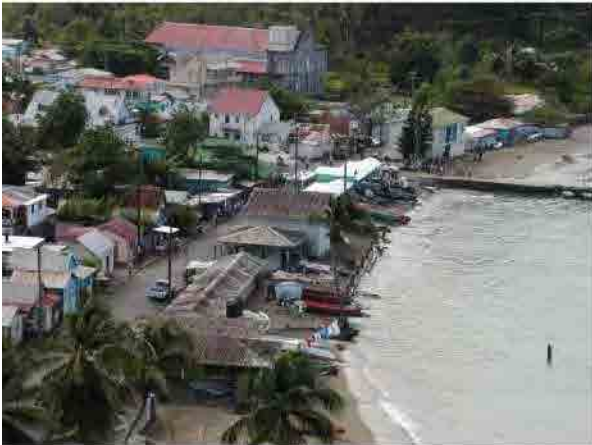
Photo-1 Panoramic view of Old Fishery Center at Basic Design Study (2006/10/20)

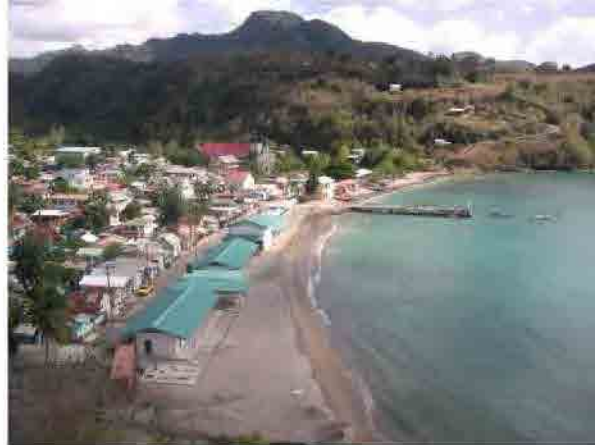
Photo-2 Panoramic view of New Fishery Center at the completion date (2010/02/19)

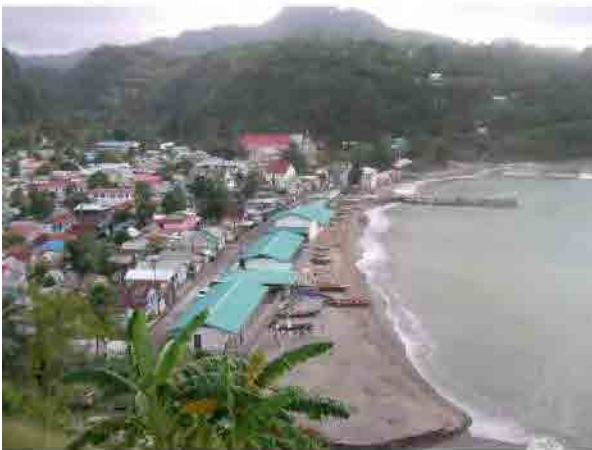
Photo-3 Panoramic view of one year inspection (2011/02/08)

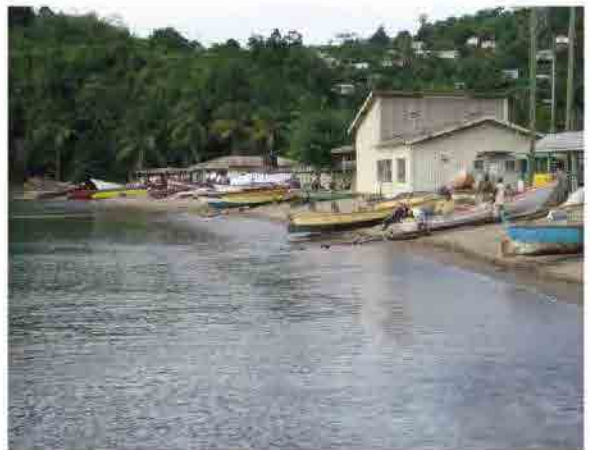
Photo-4 Foreshore condition of Fisheries Complex at Basic Design (2006/10/20)

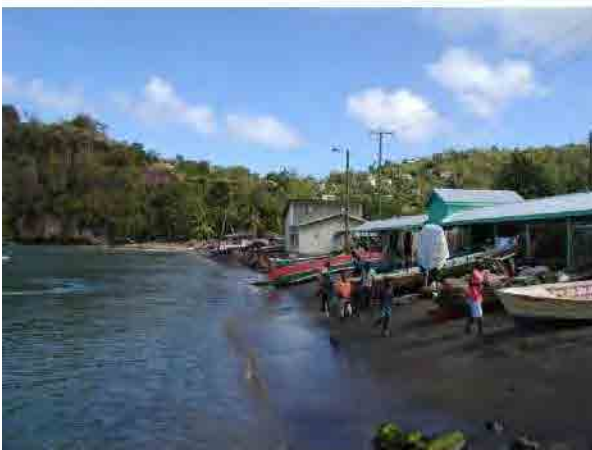
Photo-5 Foreshore condition of Vendors Arcade at Basic Design (2006/10/20)

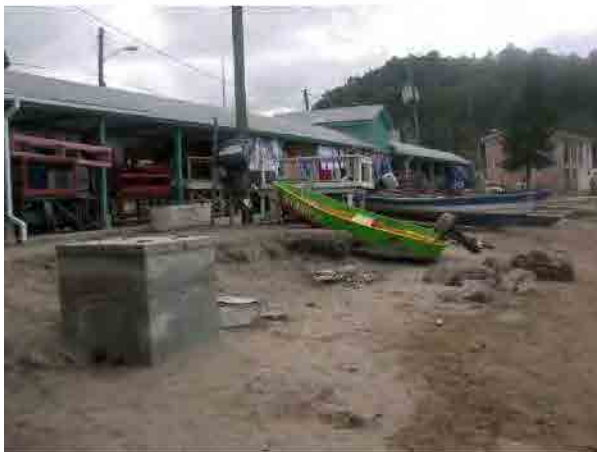
Photo-9 Foreshore condition of Vendors Arcade at one year inspection (2011/02/28)

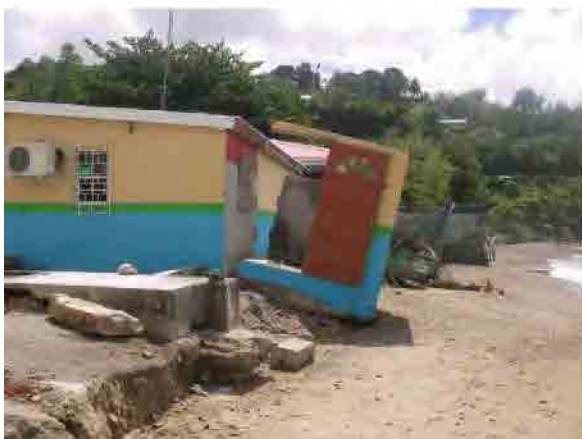
Photo-11 Storehouse of old office of Cooperative (2011/02/28)

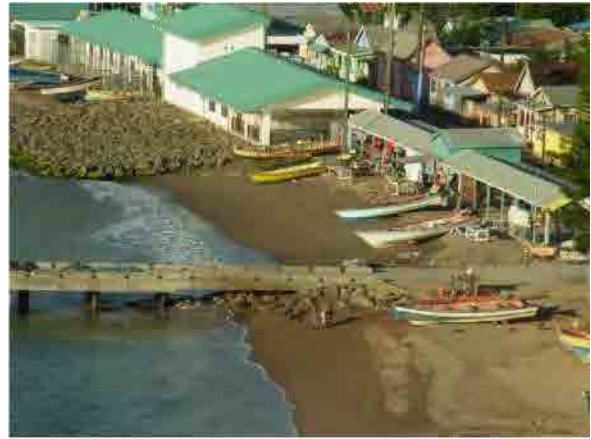
Photo-14 Clarification of recovery of beach at Additional Survey (2012/01/20)

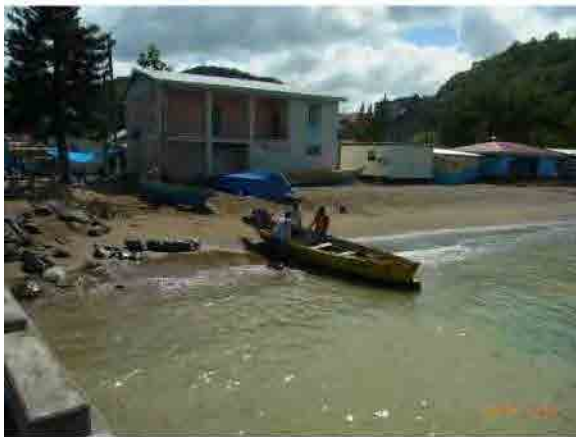
Photo-15 Recover condition of Community Center (2012/02/22)

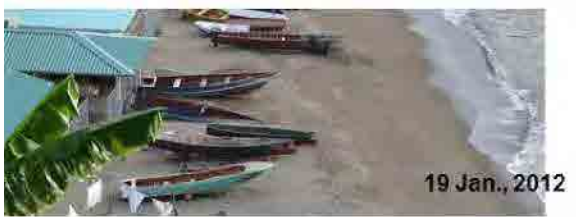
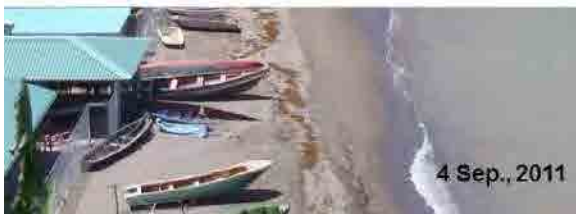
Photo-17 Comparison of foreshore condition before and after completion of short-term countermeasure

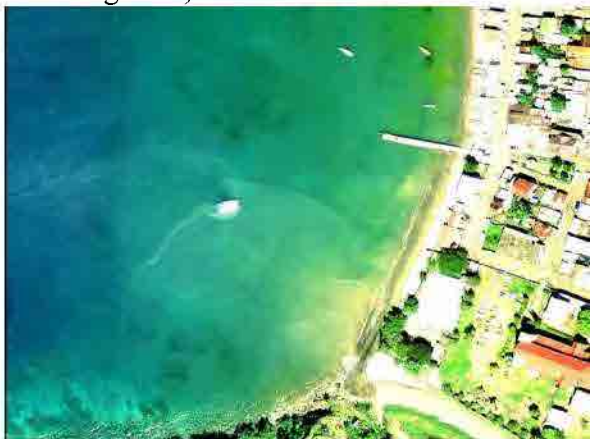
Photo-18 There is nothing deposit of sand at river mouth by air photo at February, 2009

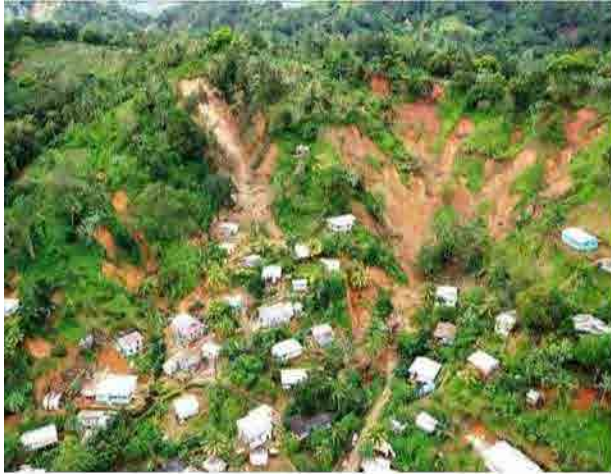
Photo-19 Large scale of hillside collapse by Hurricane Tomas

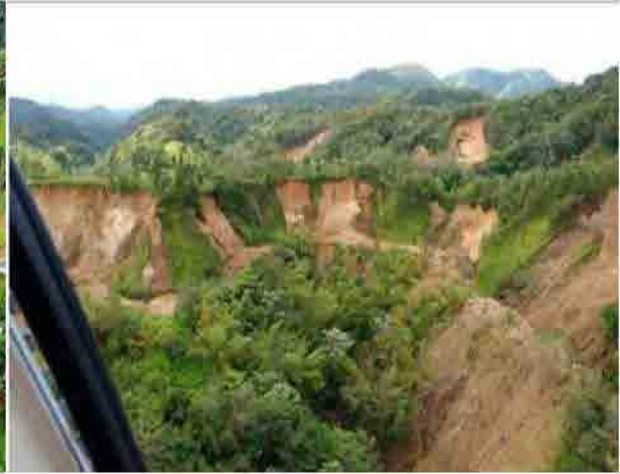
Large amount of sand was transported through the river

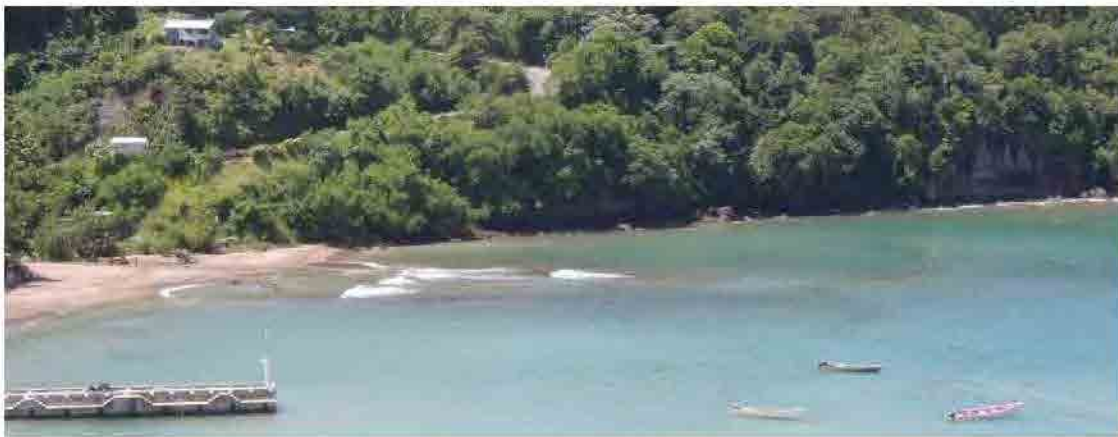
Phot-20 Deposited sand at the river mouth of South river in Anse La Raye Bay

Shoal at river mouth and breaking wave on the shoal (2011/09/04)

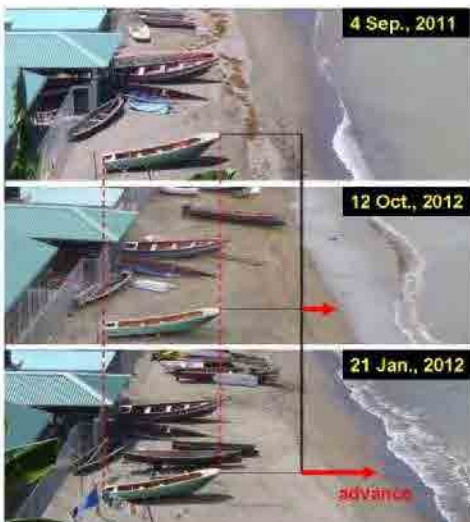
Photo-21 Beginning of setback of sand from the deposited sand to the North side beach

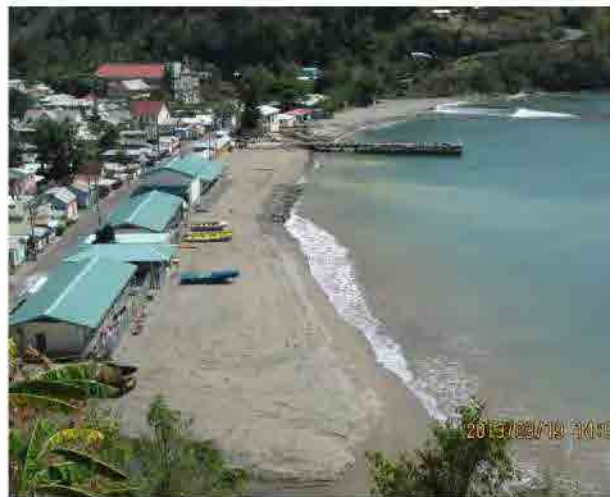
Photo-38 Panoramic view at completion (North side beach) (2013/3/19)

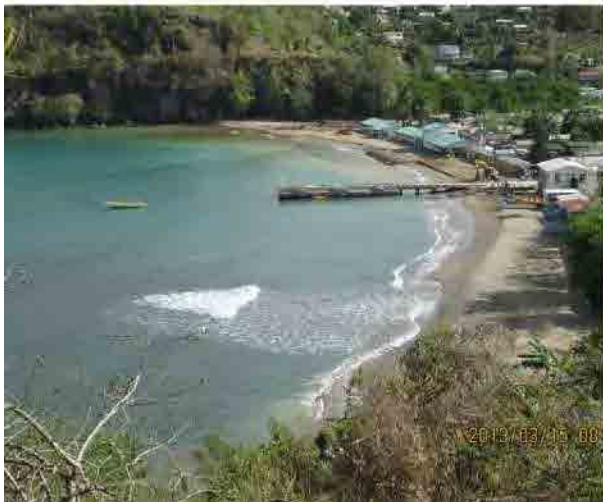
Photo-39 Panoramic view at completion (South side beach) (2013/3/15)

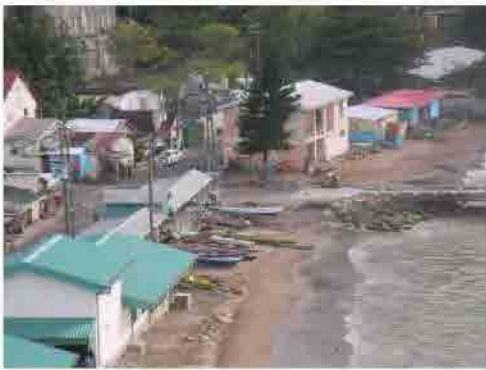
Subsidence and recession of shoreline in front of Vendors Arcade

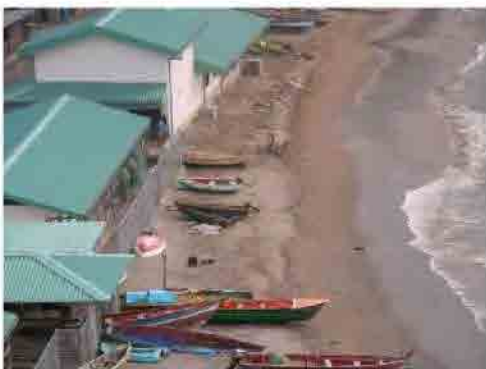
Subsidence and recession of shoreline between Fisheries Complex and the Jetty

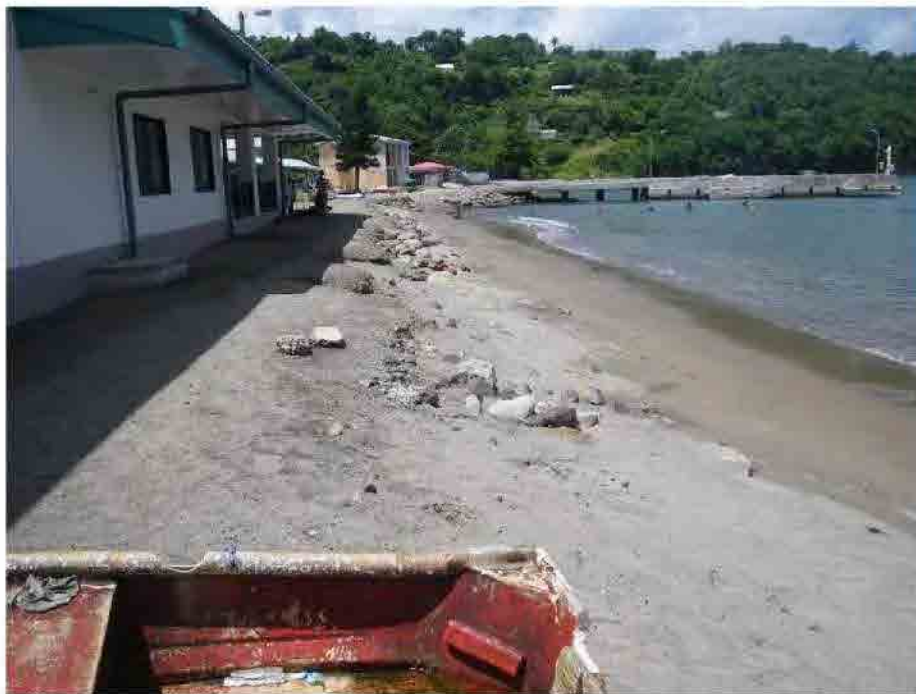
Sept. 23, 2010 Photo by Mr. Adachi of ECOH CORPORATION

1) In the picture taking a picture of the area in front of Fisheries Complex on July 23, 2010 that is 5 months later than the completion (February, 2010), the width of backshore has been backfilled by rubble stones that were used for temporary revetment at the time of completion, waves have been run-up near the back-filling portion and the backshore width becomes about 5 m. The picture of front face of Fisheries Complex taken by General manager of JICA ST. Lucian office on September 28, 2010 shows the beach further retreated and becomes 2 to 3 meters if backshore width. There is no big difference with the picture that hurricane “Thomas” passed on October 30, 2010. However, at the time of Defects Inspection (February 8, 2011) the backshore in front of Fisheries Complex was lost and ground subsidence with about 1m was generated and exposed the

part of power cable of foundation portion of distribution box. This beach retreat phenomena has been reached to south side from Fisheries Complex, Vendors Arcade, Community Center, Warehouse to Laundry.

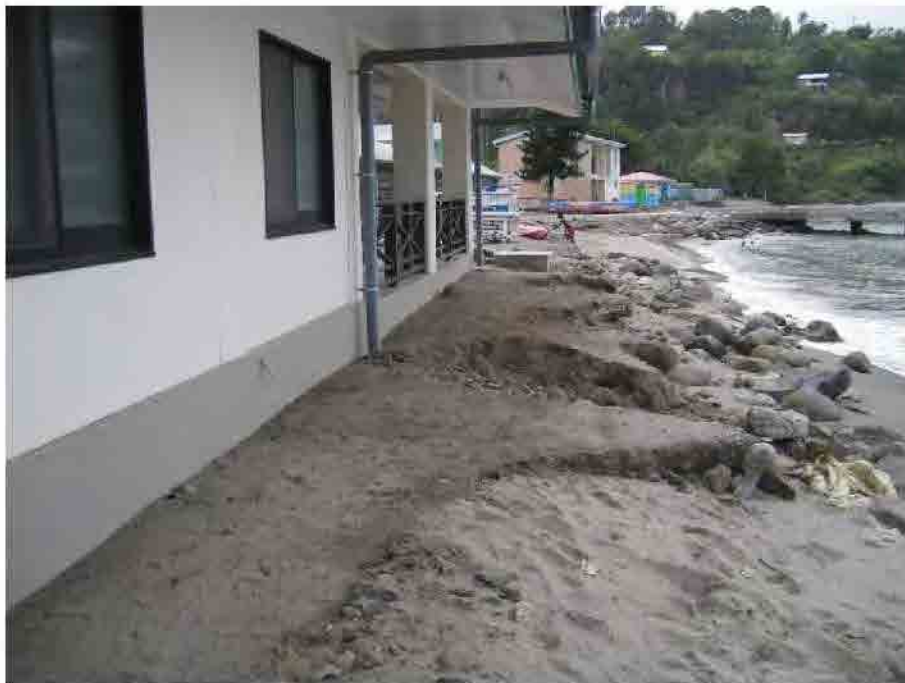
Nov. 02, 2010 After attacked Hurricane Tomas

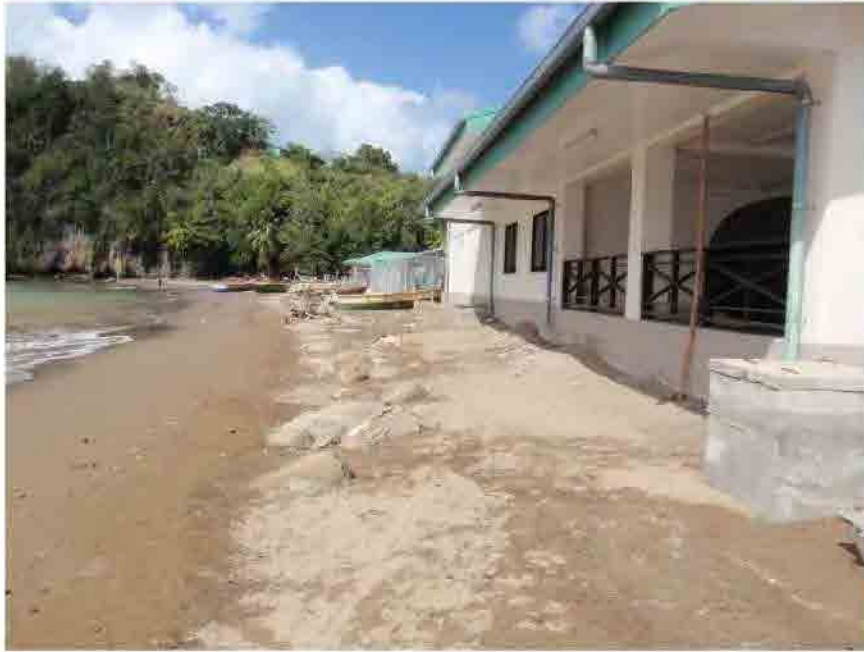
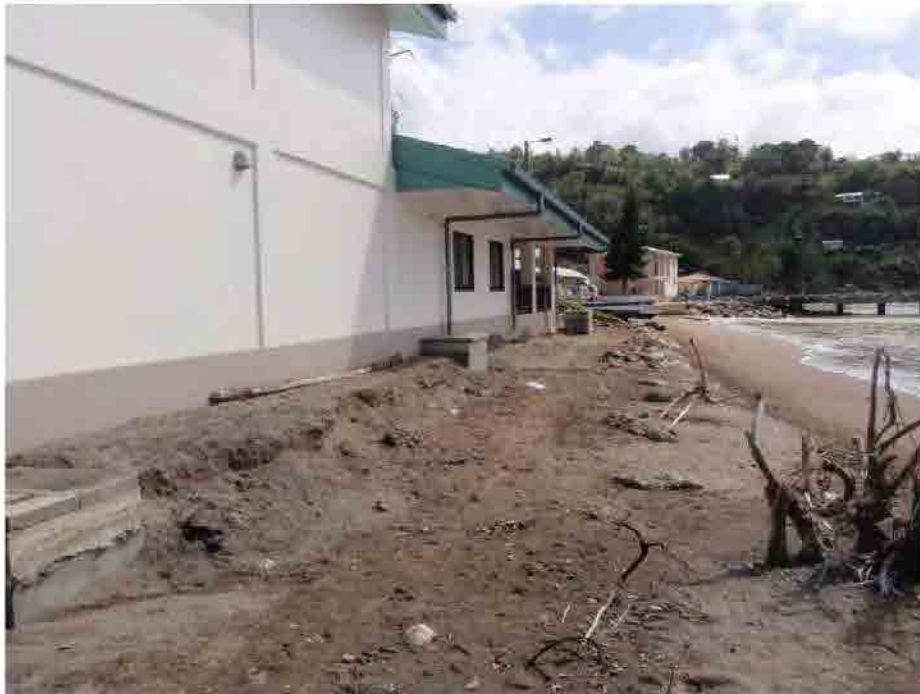
Feb. 08, 2011 at One year inspection

**Photo 2-1-1-6 Beach situation in front of Fisheries Complex at one year inspection**

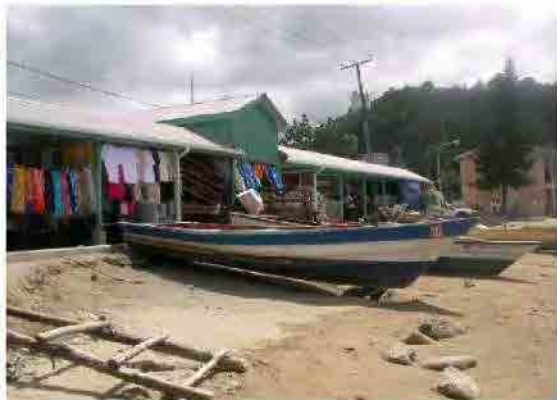
Beach situation in front of Vendors Arcade at one year inspection; Feb. 08, 2011

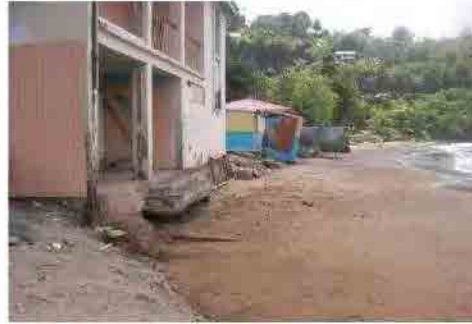
1) The south side of beach where is out of project site, beach retreat and the subsidence are apparent. The deepest part of beach arc circular faces to Community Center (the office of Village Council has removed during construction period and this center is not in use now) and adjoining warehouse. The jetty is not affected the influence of beach retreat by foundation of foot protection with rubble stone.

Beach situation in front of the Community Center at one year inspection (subsidence of 1m); Feb. 08, 2011

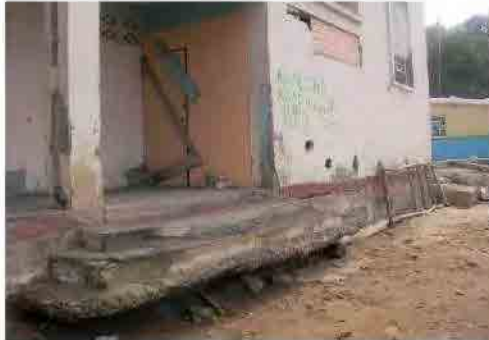
2) The sea side of foundation portion of Community Center is exposed situation and the entrance at the seaside in adjoining warehouse has been widely falling. The boarder block wall of common laundry where is in south side has been leant to seaside. With these, there are an elementary school and a church grave yard, this vicinity is in the deposited tendency where is beach is advanced.

Subsidence in front of the Community Center at one year inspection; Feb. 08, 2011

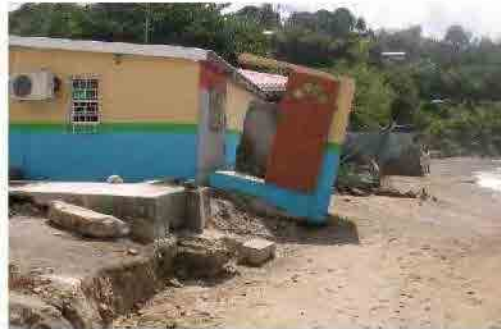
Old warehouse of the Fisheries Cooperative (partially collapse of building) at one year inspection; Feb. 08, 2011

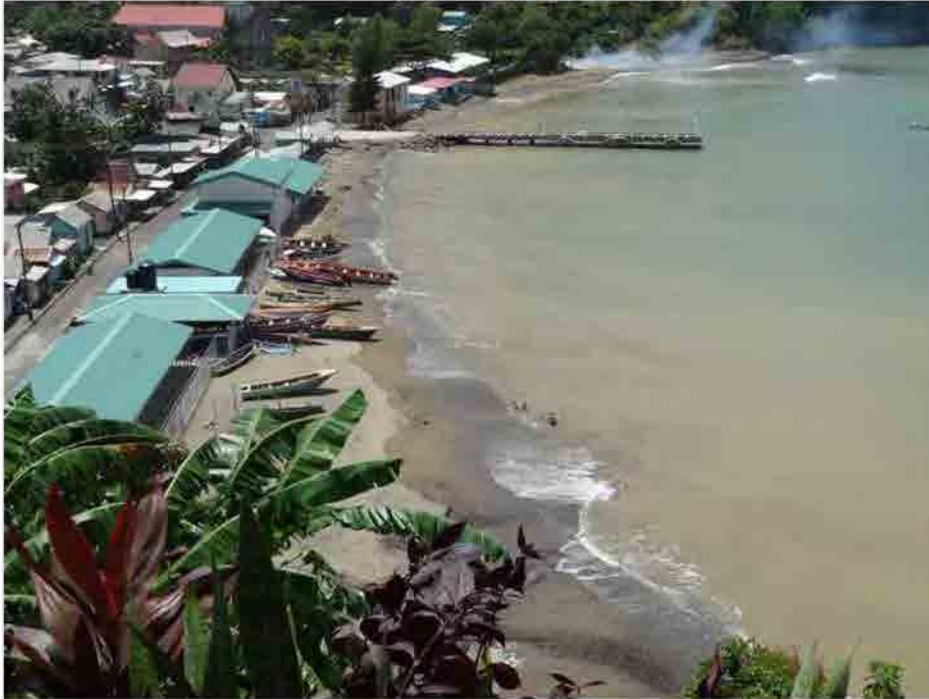
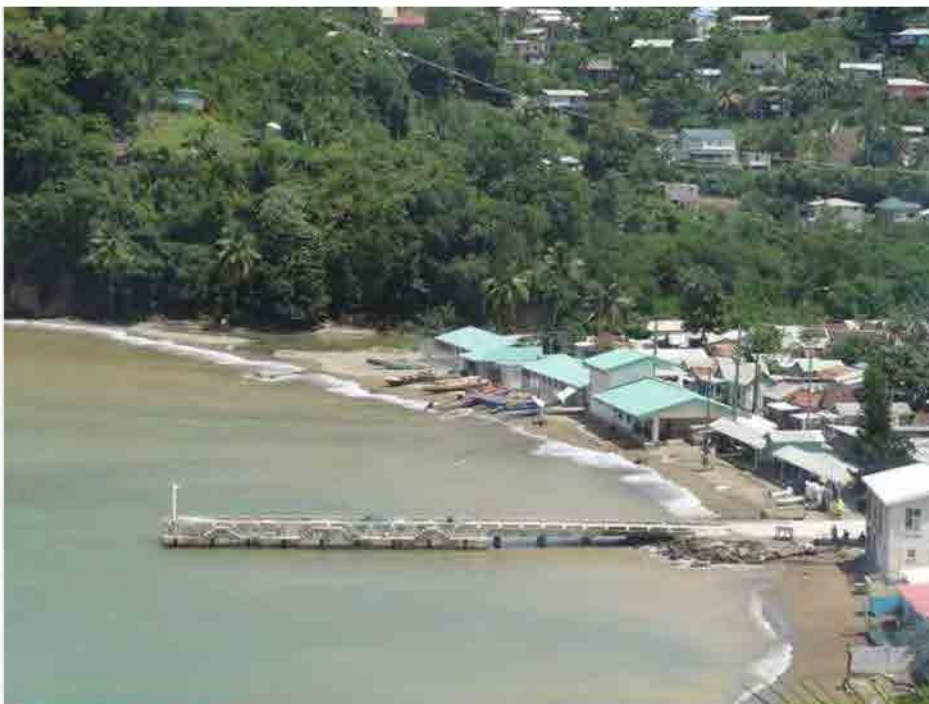
The following photos are total beach situation taken at the time of ebb tide in September, 2011. It is understood that pocket beach is formed but the run-up waves reached to facilities.

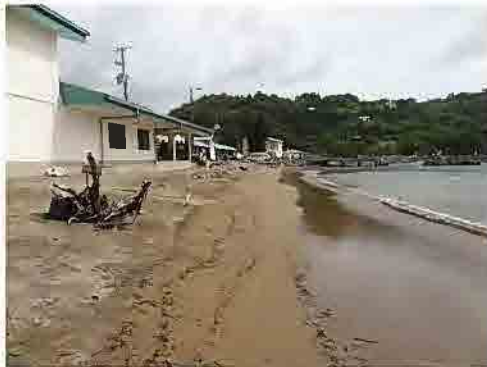
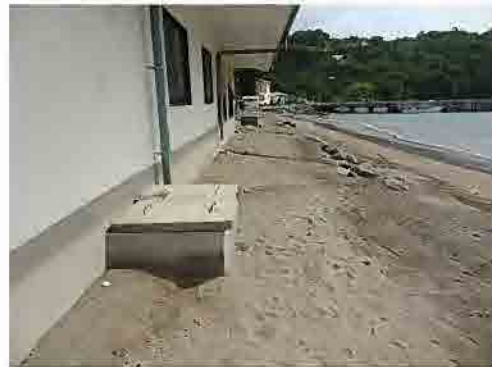
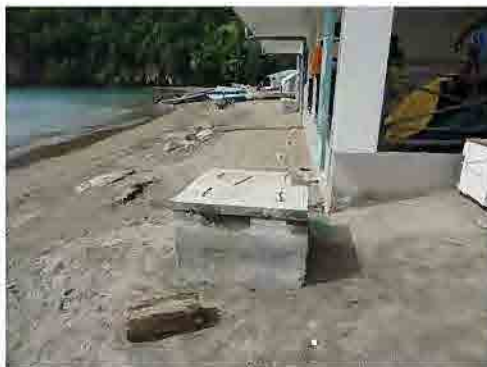
As shown in 2-1-1 beach has been recovered a little bit than the time of Defects Inspection (February, 2011). It is understood that foreshore slope becomes gradual although the backshore is lost.

Beach situation in front of Fisheries complex

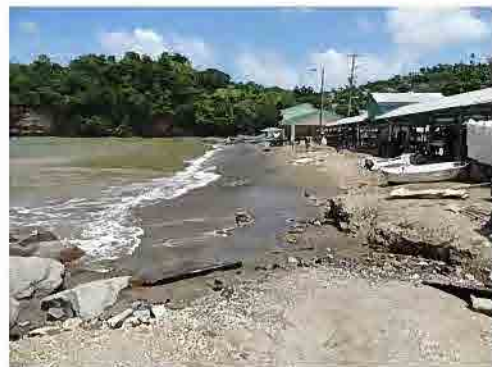
Beach situation in front of Venders' arcade

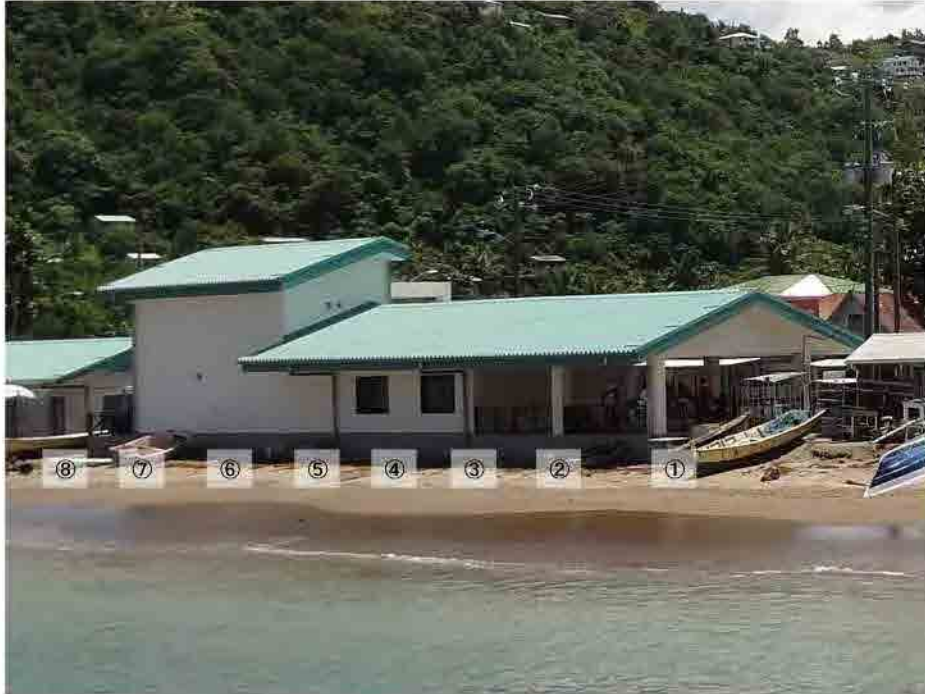
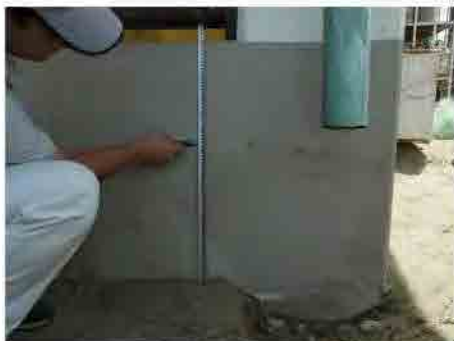
① Sea side 42cm

The following photos shows the actual surveying of the foreshore situation in front of Fisheries Complex and Vendors Arcade where show the significant ground subsidence. According to these, it is understood that the backshore height has been recovered than that of subsidence at the time of Defects Inspection. The ground subsidence height as a whole is from 40 cm to 50 cm.

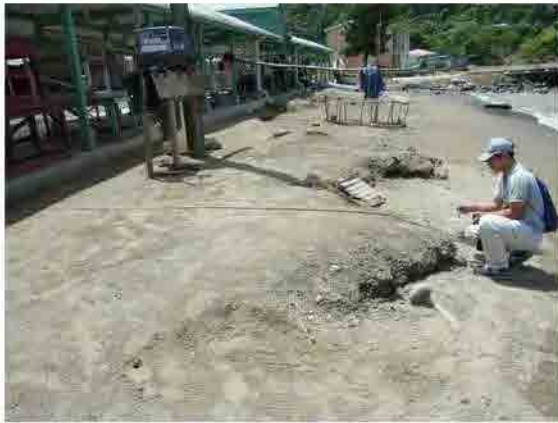
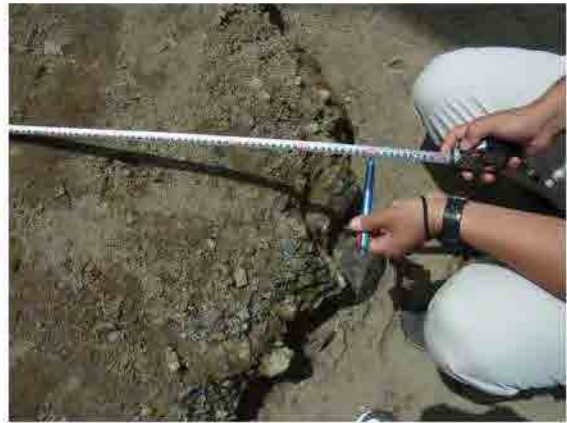
① 4.8m

Photo 2-1-2-7 Grand subsidence situation of Vendors Arcade

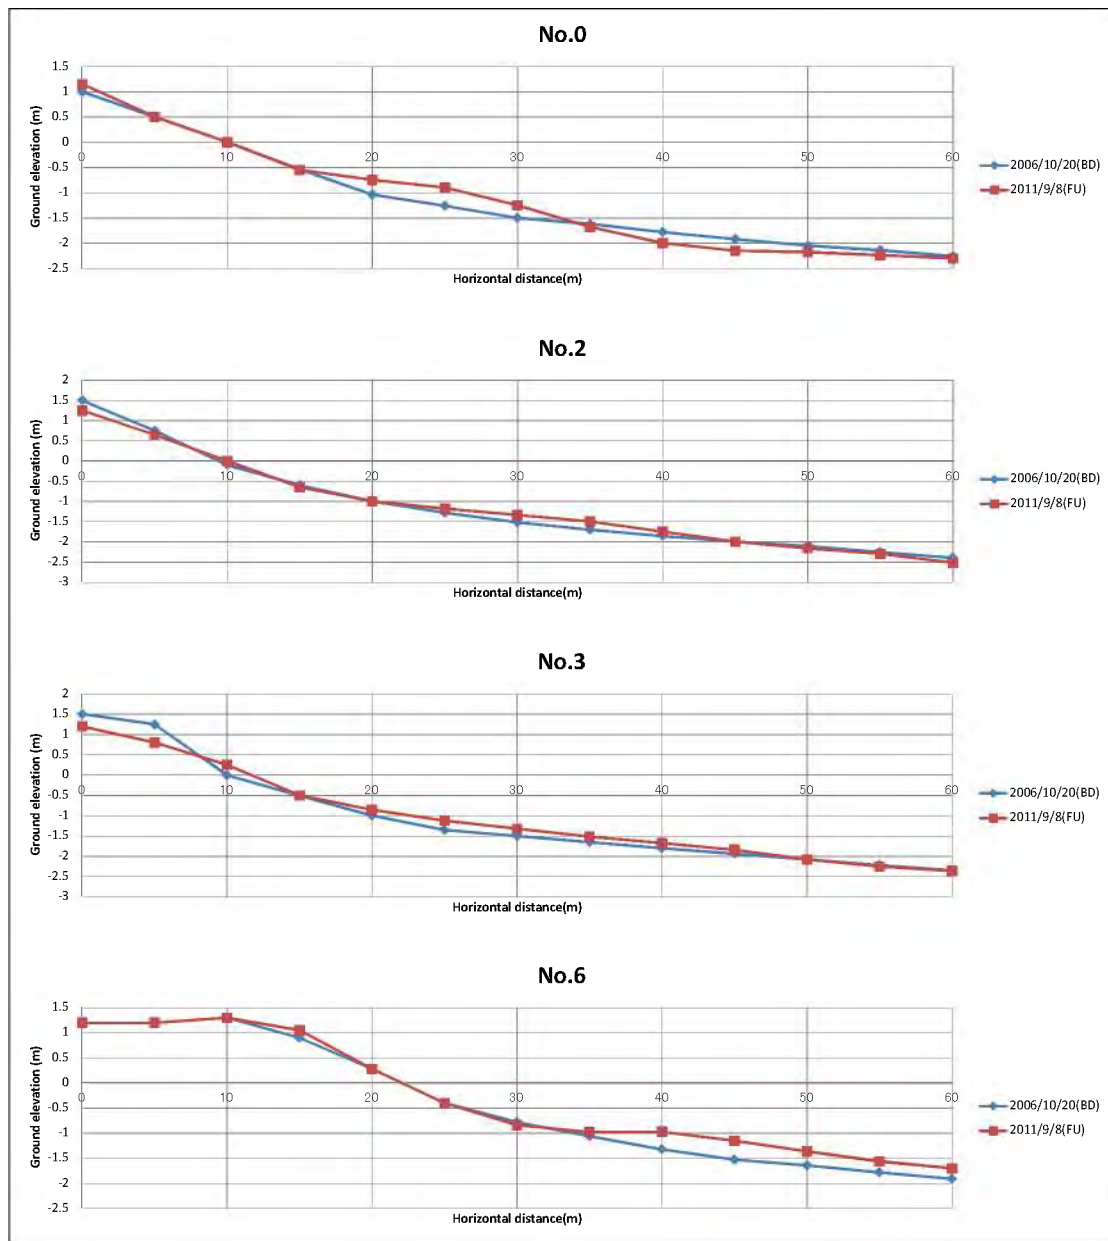
**Figure 2-2-2-2 Cross section comparison chart of representative survey lines**

In the cross section comparison on the north half side of Anse La Raye Bay beach, the beaches between the survey line 1 and the survey line 4 are sagged and the beach is gently sloped however, the area around 20-30m offshore has the tendency to be slightly deposited. The cross sectional changes are not generated at the beach and the offshore up to the survey line 5 and 6. The settlement measurement of beach between the survey line 1 and the survey line 4 was maximum about 1m at the time of one year inspection and it becomes gentle with maximum about 46 cm now. And also, the foreshore of Arcade at the survey line 0 to the survey line 2 is sagged as well as the foreshore of Fisheries Complex building and the width of backshore becomes narrower toward south side. The backshore of south end of Arcade was lost and the under part of floor concrete is scoured and the foundation is exposed.

There will be possible scouring of the foundation of facilities by further recession of shoreline if high wave is continued keeping the present situation. It is already in hurricane season therefore, the urgent countermeasure which is workable within short period is necessary. In order to prevent scouring at foreshore by wave run-up, the covering foreshore with rubble stones was made to execute within a period of this study. The construction area is in front of Fisheries Complex and Vendors Arcade. Floor Plan is shown in Figure 2-2-2-3 and the cross section is shown in Figure 2-2-2-4.

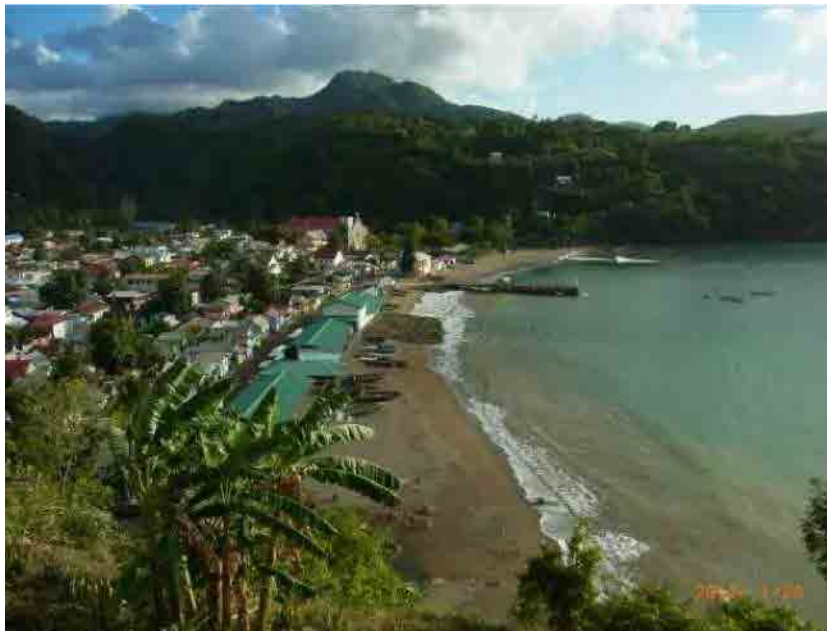
**Photo 2-2-3-1 Whole beach view from north side**

Photo 2-2-3-1 is a broad view from north side cliff toward south side. It can be understood that the area from river mouth of north side to Fishing Gear Lockers II area has been recovered. Photo 2-2-3-2 shows the site of short-term countermeasure works enlarged. With this, it is understood that the rubble stones in front of Fisheries Complex could have been worked for wave absorbing function. The recuperative power of foreshore in front of Vendors Arcade where forms pocket beach being wedged between these rubble stones and the one at the base part of the jetty is weak but it indicates stable foreshore slope.

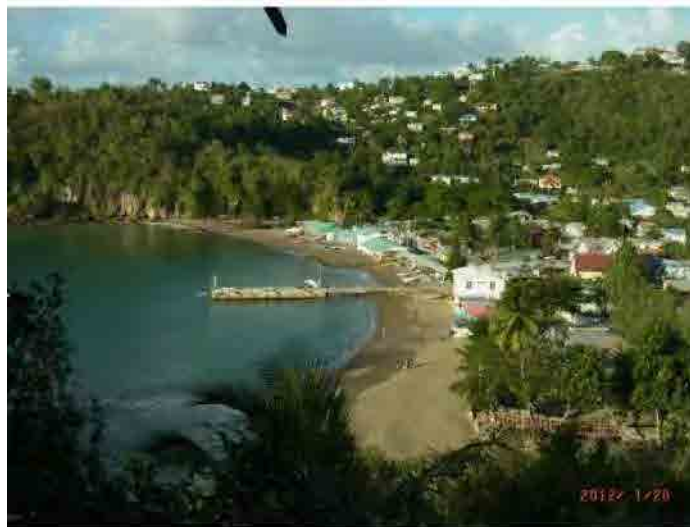
**Photo 2-2-3-3 Whole beach view from south side**

Photo 2-2-3-3 is the picture of beach from view point on south side cliff. It is understood that the south side beach from the jetty has been greatly recovered and the backshore width considerably advanced. Photo 2-2-3-4 enlarged an area around the jetty. With this, it is understood that the backshore has been formed at south side of access portion of the jetty and the shoreline has been advanced. It is expected that sediment transport shall run over the rubble stones at the base of the jetty of access portion.

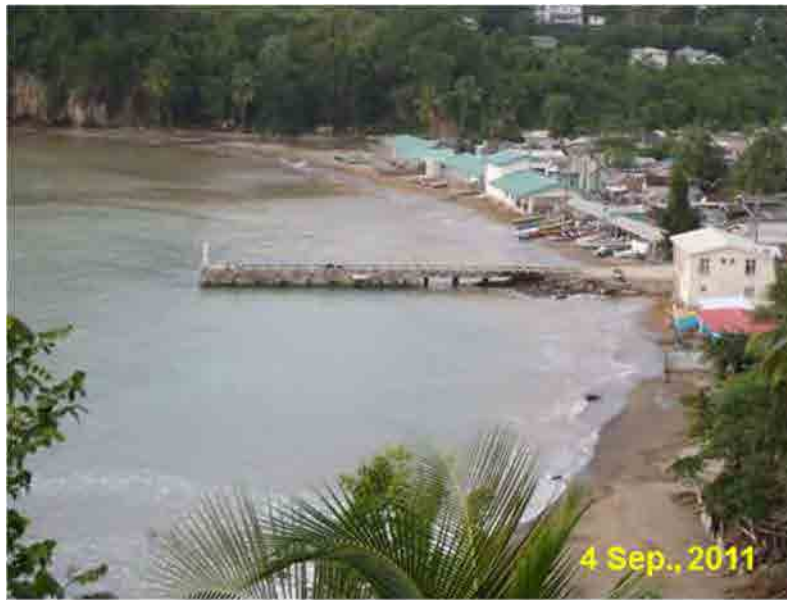
**Photo 2-2-3-5 Beach status before short-term countermeasure works**

Photo 2-2-3-5 and Photo 2-2-3-6 show the comparison of before and after short-term countermeasure works. It is understood that south side beach has been apparently recovered. Photo 2-2-3-7 and Photo 2-2-3-8 show the comparison of foreshore in front of Community Center. The rubble stones at the jetty base part are exposed in Photo 2-2-3-7. However, it is understood that the exposed portion becomes apparently small and the backshore has been recovered in Photo 2-2-3-8. Therefore, it can be predicted that the recovery of north side beach from the jetty shall take longer time although the south side of beach from the jetty has been shown a tendency to recover greatly at the time of last additional study.

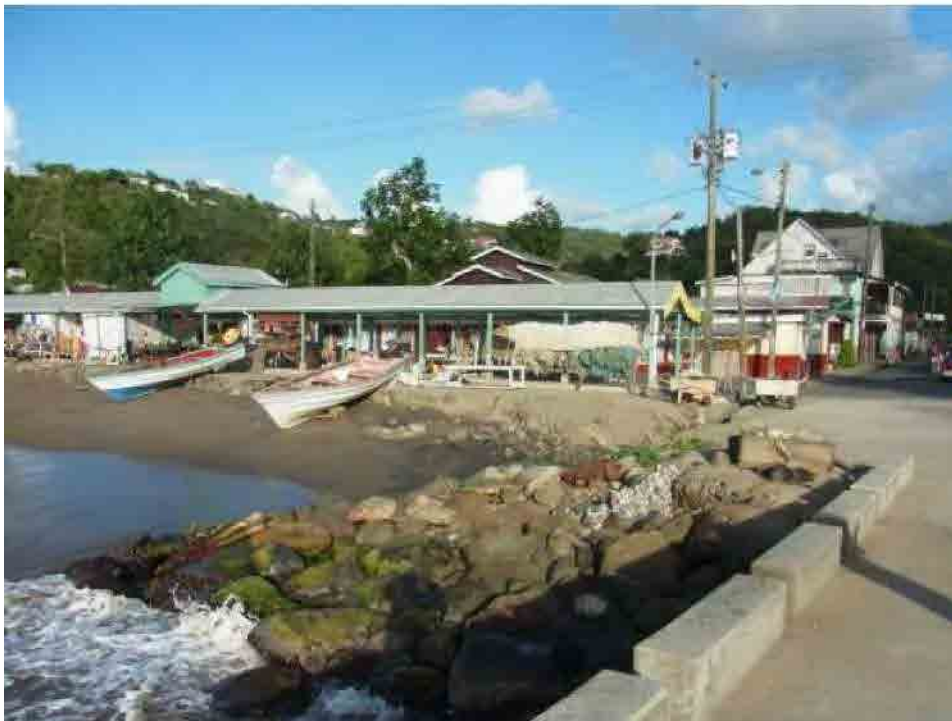
**Photo 2-2-3-11 Beach situation of rubble stones in base part of the jetty**

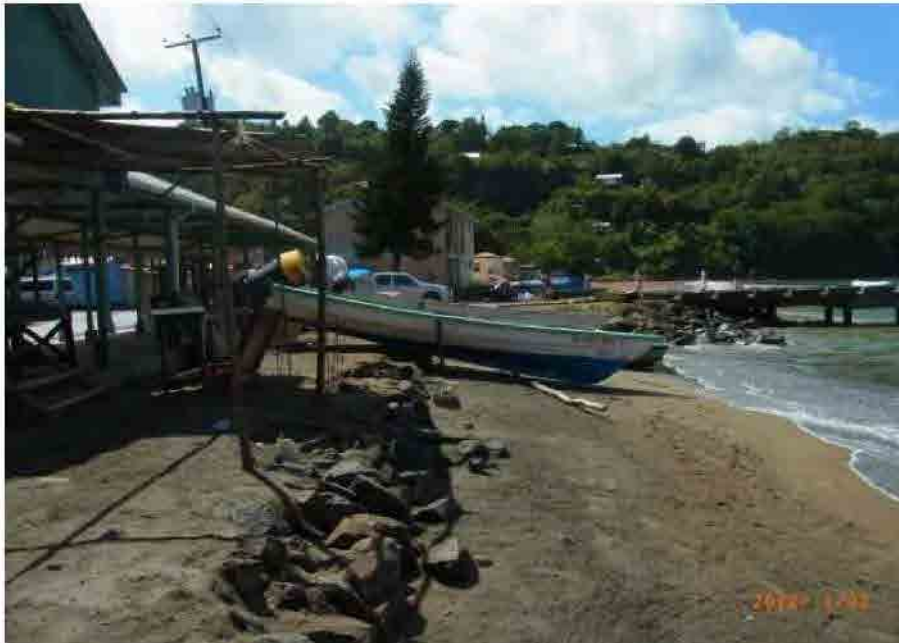
**Photo 2-2-3-13 Exposed situation of armor stones**

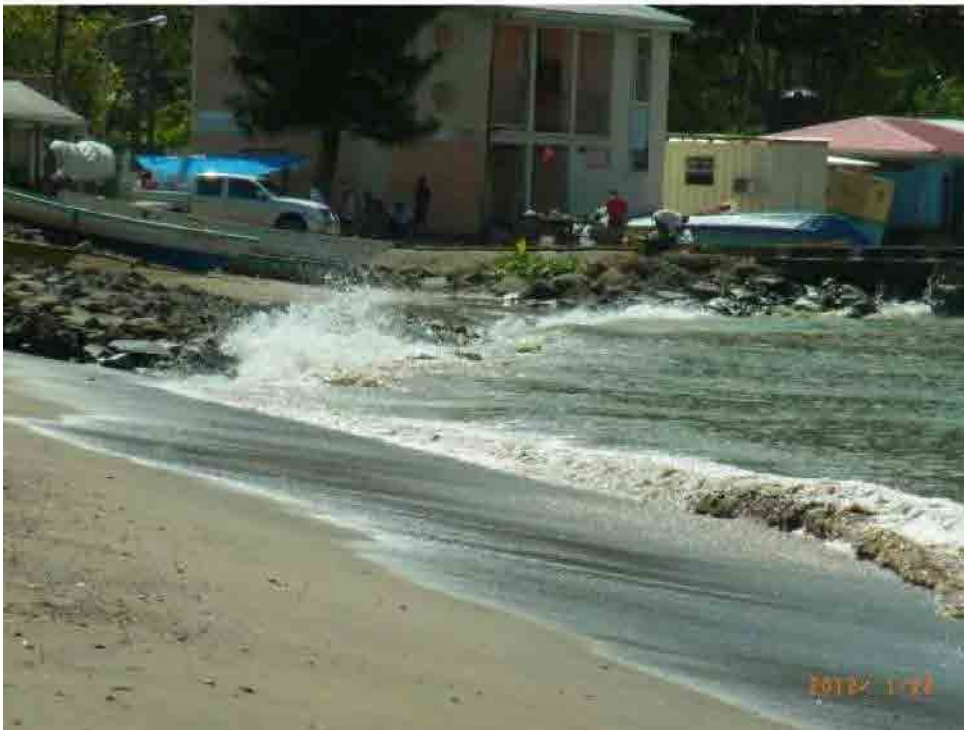
Photo 2-2-3-14 shows the rubble stones situation in front of Arcade. The rubble stones are installed on the level and the protective effect is worked but the head part is exposed and lead to uneven part with the foreshore. Photo 2-2-3-15 shows the exposed situation of rubble stones. Fishermen have indicated the possibility to make damage to boat bottom at the time of hauling them up.

**Photo 2-2-3-15 Armor stone part and foreshore slope in front of Fisheries Complex (2)**

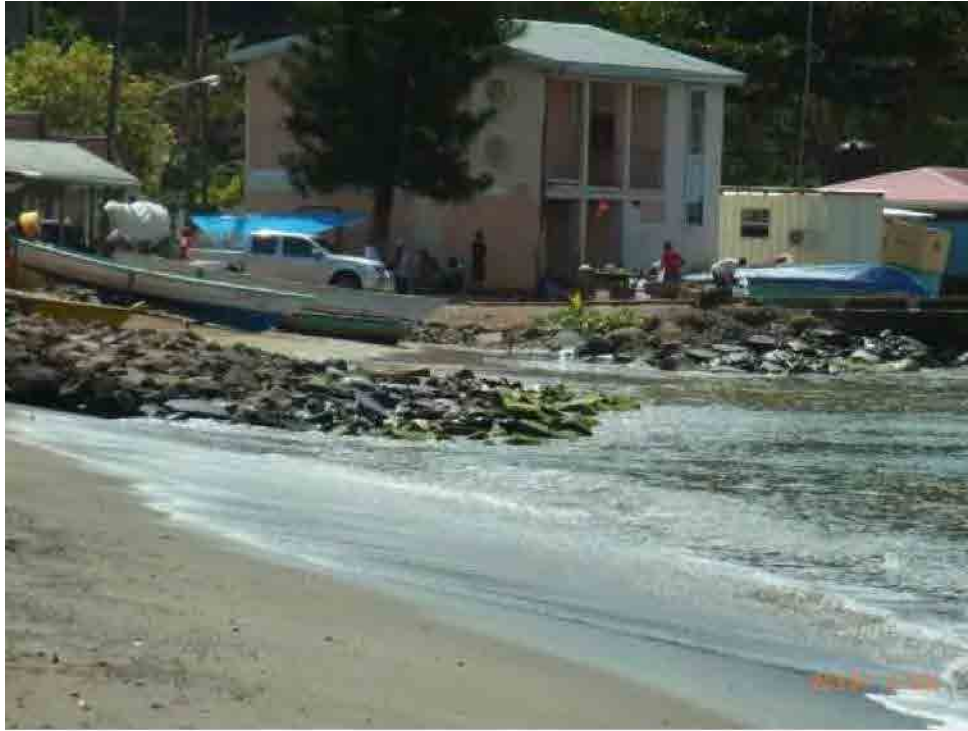
**Photo 2-2-3-16 Situation at head of rubble stones**

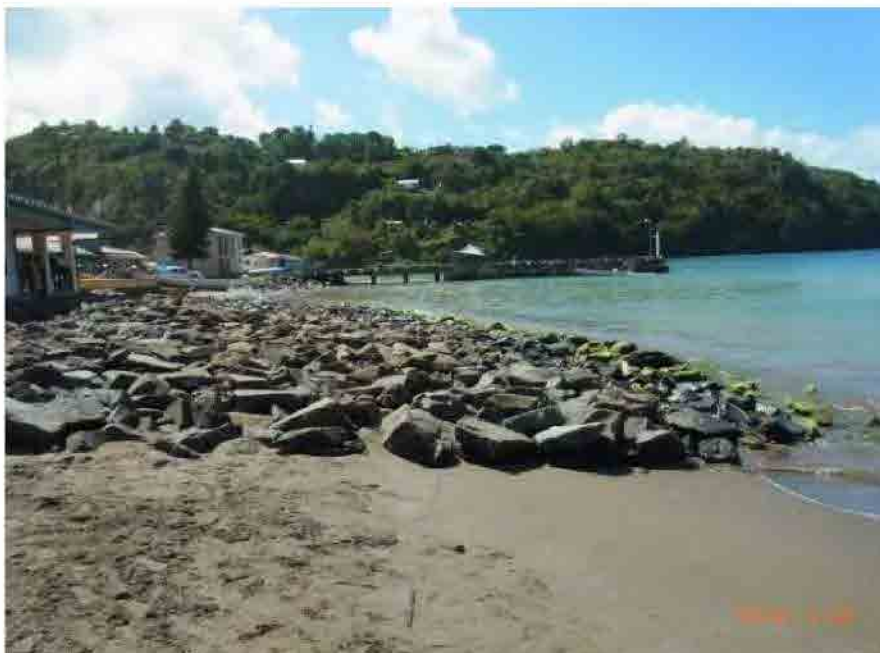
Photo 2-2-3-17 shows deposited situation of foreshore at north side of rubble stones. It can be understood that sand is about to supply into the inside of armor stones. Photo 2-2-3-18 shows the backshore situation of north side of armor stone part. Like this, it can be understood that backshore is going to be formed. Photo 2-2-3-19 shows the foreshore side situation in front of Arcade at south side of armor stone part. It is understood that waves are diffracted at the head of armor stones and supply sand.

**Photo 2-2-3-17 Deposited situation of foreshore at north side of armor stones**

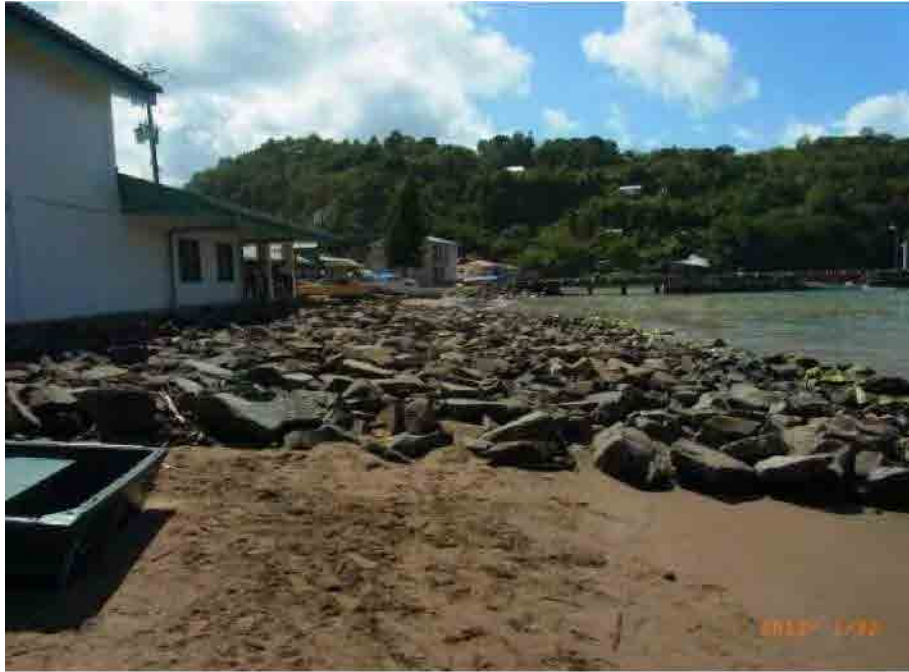
**Photo 2-2-3-18 Backshore situation at north side of armor stone part**

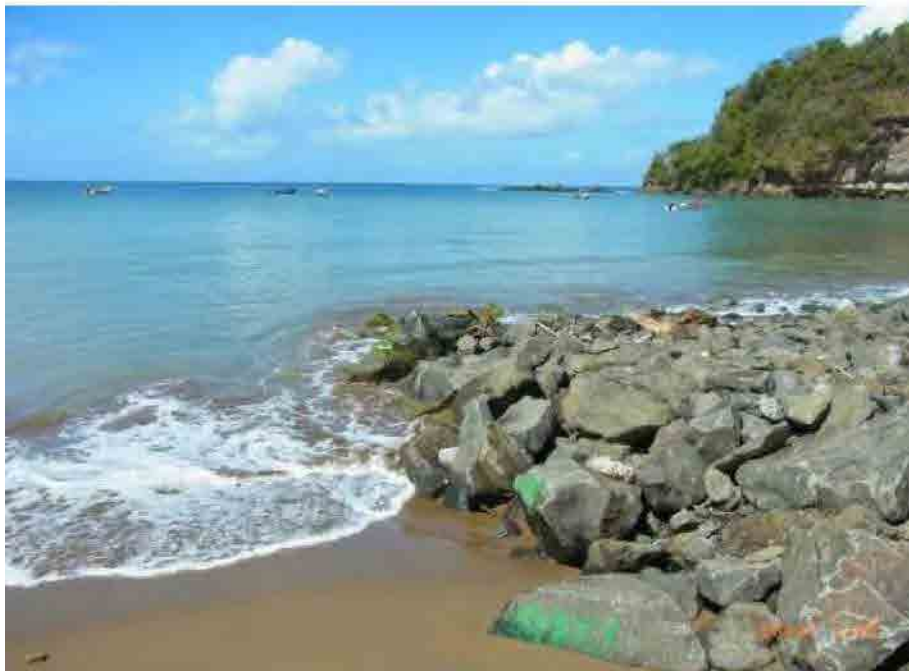
**Photo 2-2-3-19 Foreshore side situation in front of Arcade at south side of armor stone part**

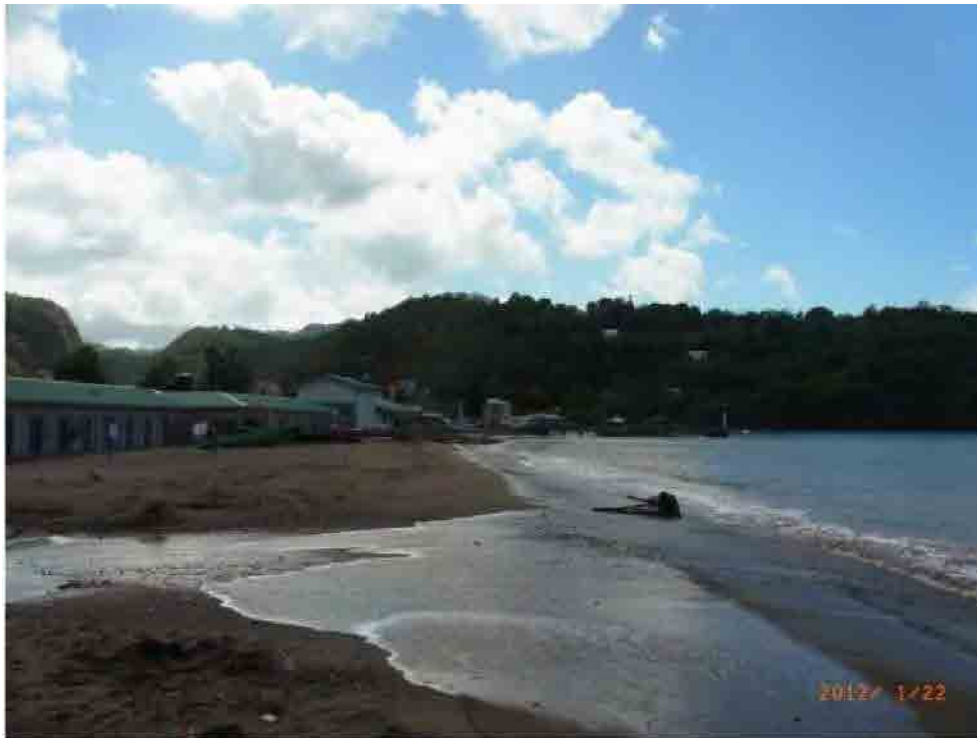
Photo 2-2-3-20 shows backshore situation in front of Work Shop from Fishing Gear Lockers. It can be understood that large scale backshore is formed from north side river mouth to Fishing Gear lockers. Photo 2-2-3-21 shows backshore and foreshore situation in front of Fishing Gear Lockers to Work Shop. Top height of backshore is not seen enough recovered yet but it can be confirmed that the backshore is apparently formed.

**Photo 2-2-3-20 Backshore situation in front of Fishing Gear Lockers to Work Shop**
