**FOLLOW-UP COOPERATION  
STUDY REPORT  
ON  
THE PROJECT FOR IMPROVEMENT  
OF  
FISHERY INFRASTRUCTURE  
IN  
ANSE LA RAYE, SAINT LUCIA**

**MARCH 2013**

**JAPAN INTERNATIONAL COOPERATION AGENCY**

**ECOH CORPORATION**

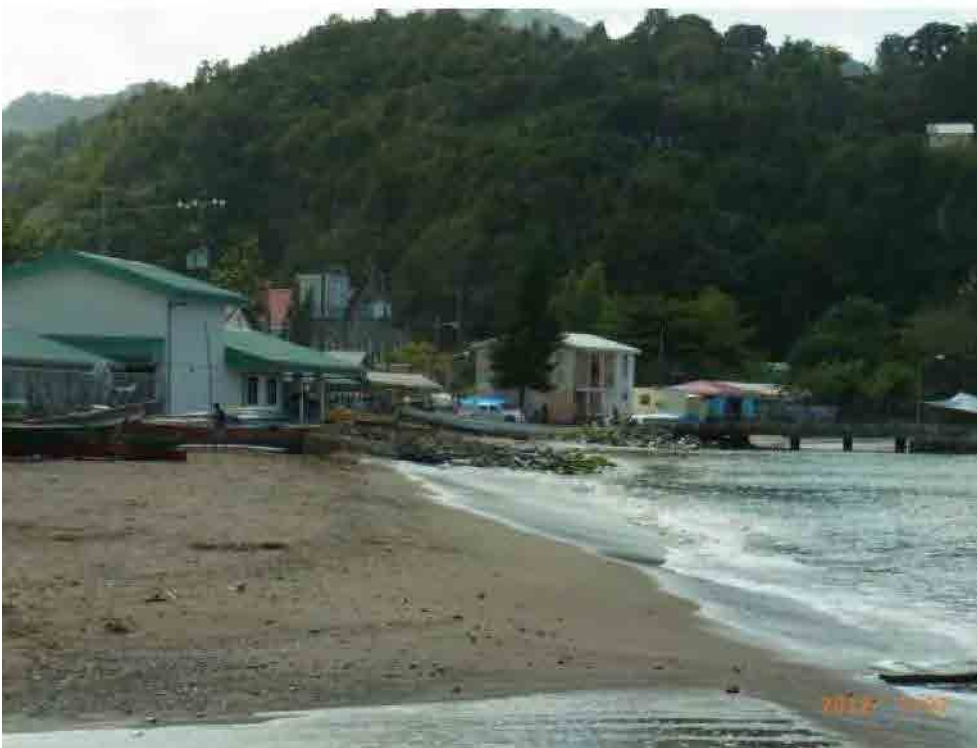
Photo 2-2-3-20 shows backshore situation in front of Work Shop from Fishing Gear Lockers. It can be understood that large scale backshore is formed from north side river mouth to Fishing Gear lockers. Photo 2-2-3-21 shows backshore and foreshore situation in front of Fishing Gear Lockers to Work Shop. Top height of backshore is not seen enough recovered yet but it can be confirmed that the backshore is apparently formed.

**Photo 2-2-3-21 Backshore and foreshore situation in front of Fishing Gear Lockers to Work Shop**

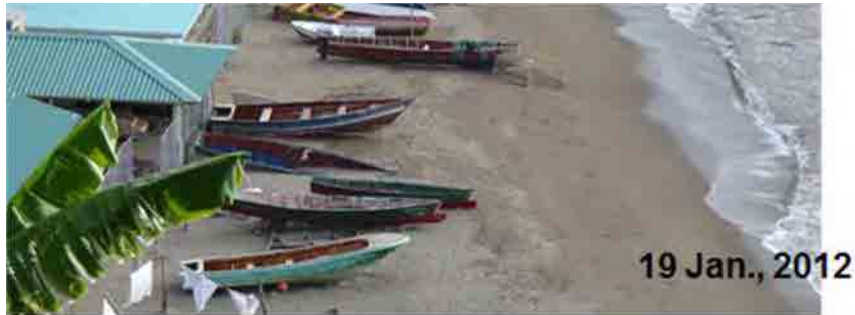
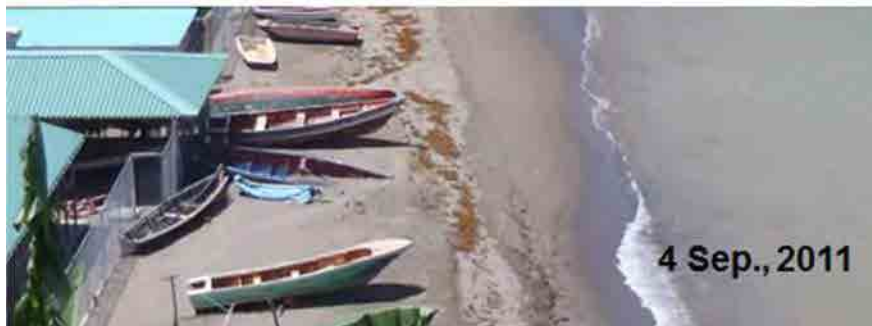
Photo 2-2-3-22 shows the comparison with the situation before short-term countermeasure works. Photo was taken to meet the scale with a light green boat and compare two photos and it is understood that the shoreline apparently advanced and the backshore width is extended.

**Photo 2-2-3-22 Comparison with the situation before short-term countermeasure**

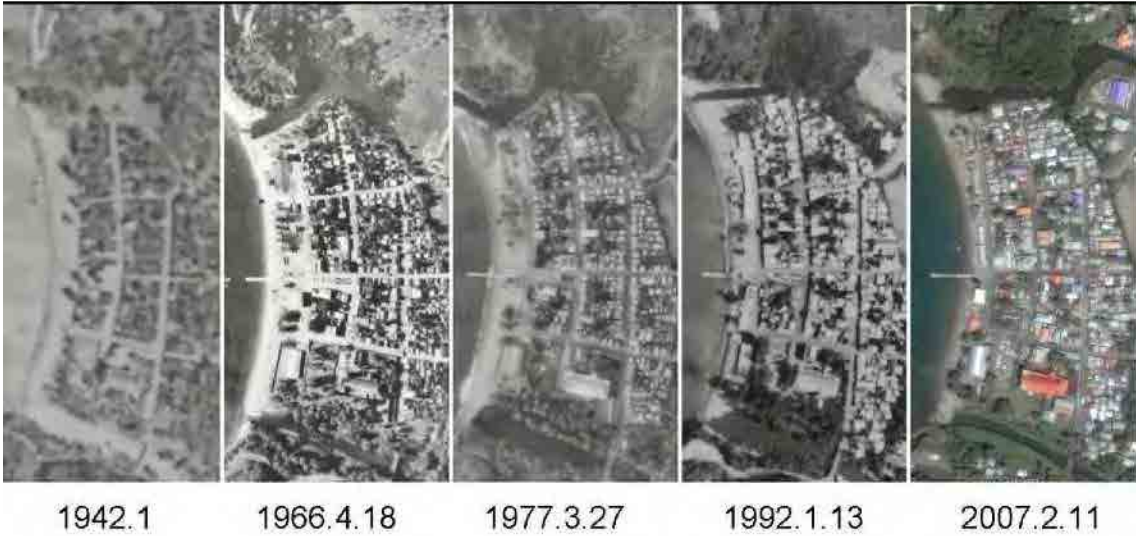
Shoreline changes in the Anse La Raye Beach and the Roseau Beach, which locations are shown in Figure 3-1-1-1, are analyzed by utilizing aerial photographs. Figure 3-1-1-2(a) and (b) are aerial photographs of Anse La Raye Beach. By comparing the spaces of three roads running parallel to the beach and a distance from the sea-side road to the shoreline, the shoreline changes can be roughly understood. The distance from the road to the shoreline was nearly the same as the road space in 1977, while it became apparently shorter in 2007 and 2009.

Figure 3-1-1-2(a) Aerial photographs of Anse La Raye

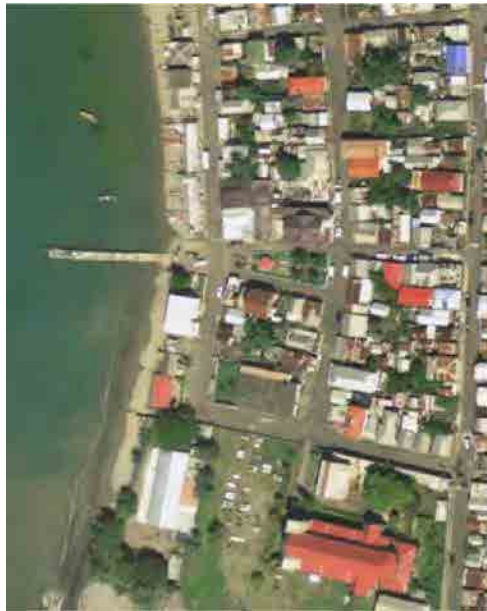
**Figure 3-1-1-2(b) Aerial photograph of Anse La Raye, taken in February 2009**

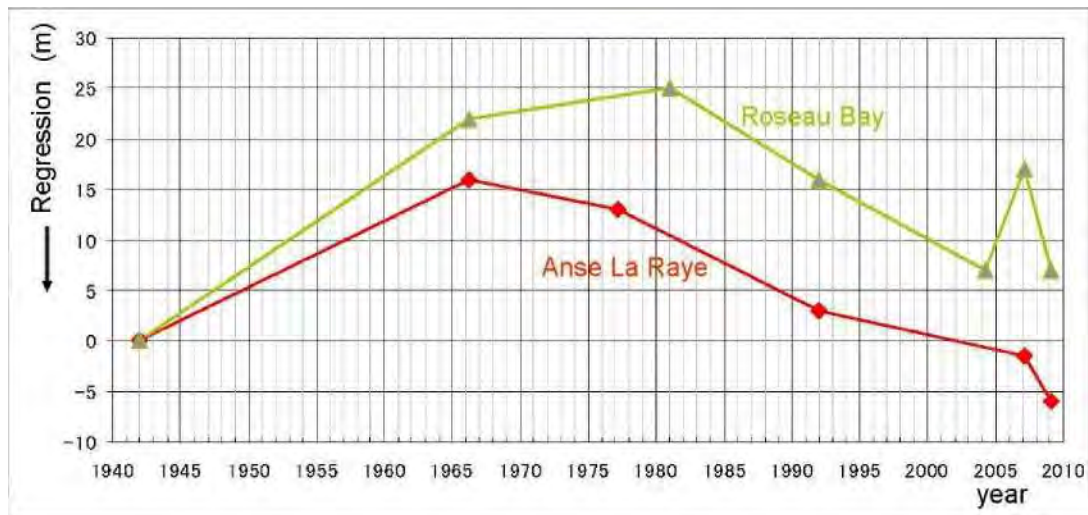
**Figure 3-1-1-4 Changes of shorelines**

- c) Since the similar shoreline recessions occurred in the different two beaches, it is inferred that the cause of recession is due to not the something related to the local and inherent in each beach, but the phenomena in wide area such as atmospheric and oceanographic ones.

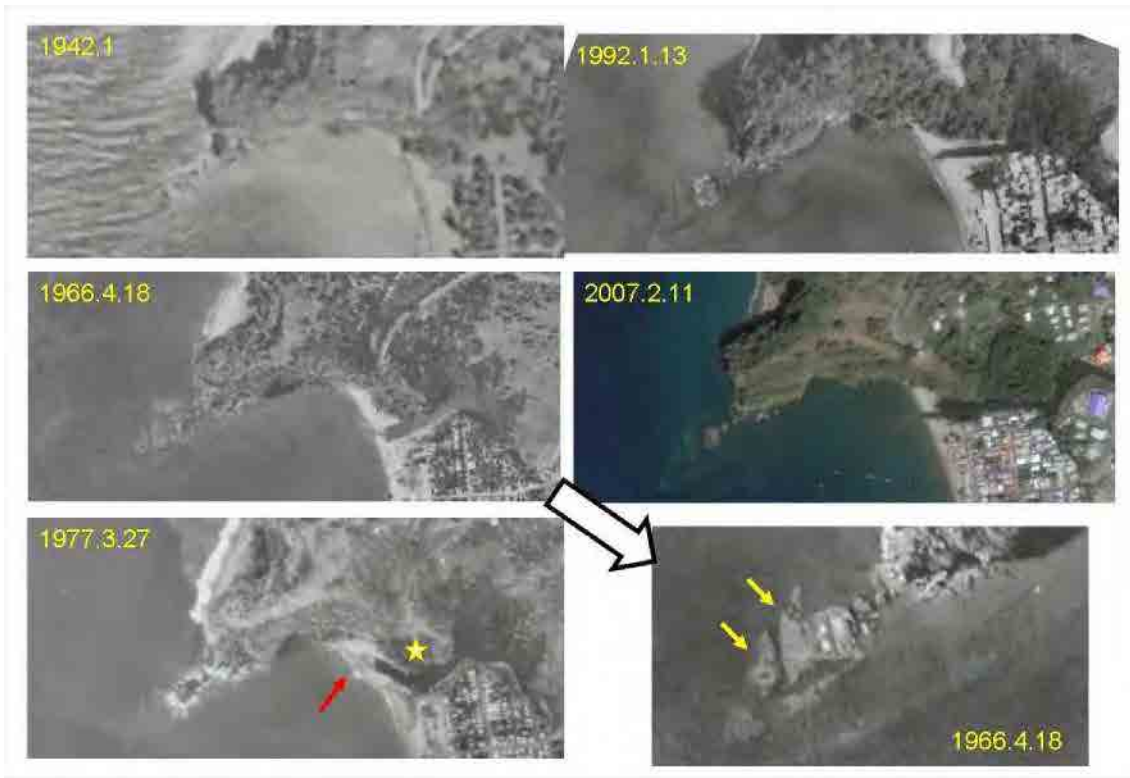
**Figure 3-1-1-6 Headland located at the north end of Anse La Raye Beach**

Checking the photos of cliff, taken from the sky, in chronological order (see Figure 3-1-1-6), the cliff configuration changed during a years from 1966 to 1977, that is a landslide. Furthermore, the shoreline in 1977, which is denoted by a red arrow, advanced remarkably in comparison with shorelines in other date. It is not contradictory to the landslide. There is a topography projected downward in 1977, which is denoted by a yellow star in Figure 3-1-1-6. As it disappeared in 1992, it is inferred that the landslide occurred also at this place after 1977.

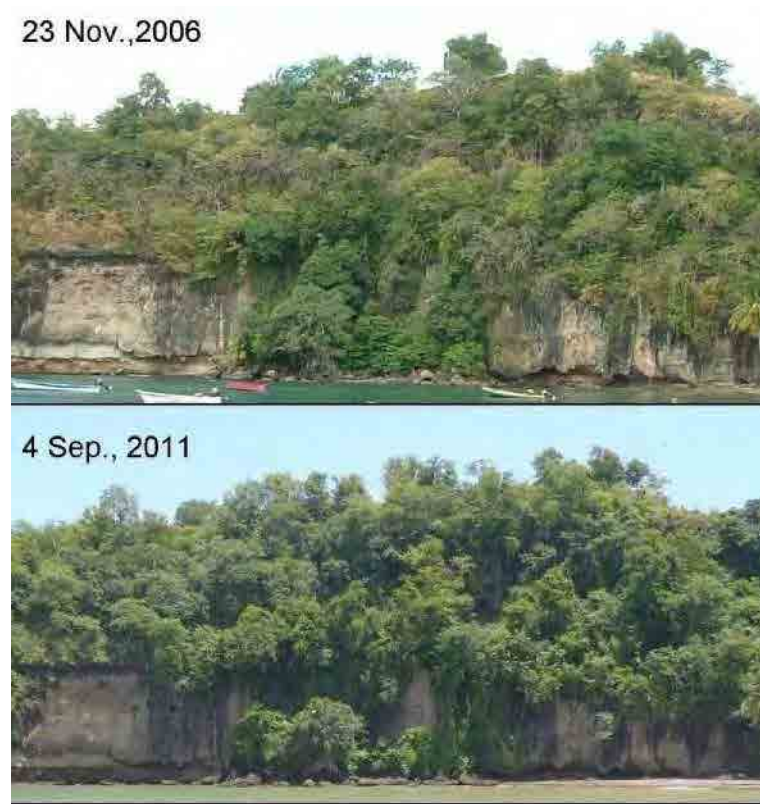
Possibility of temporal sand supply is examined. Figure 3-1-2-1 shows the coastal cliff at the north-side of the Anse La Raye Beach, which was taken from a tip of the jetty. Trees grew thick on both dates, at the base of coastal cliff. Why did the trees grow at such place near the sea surface?

**Figure 3-1-2-1 Coastal cliff, taken from a tip of the jetty**

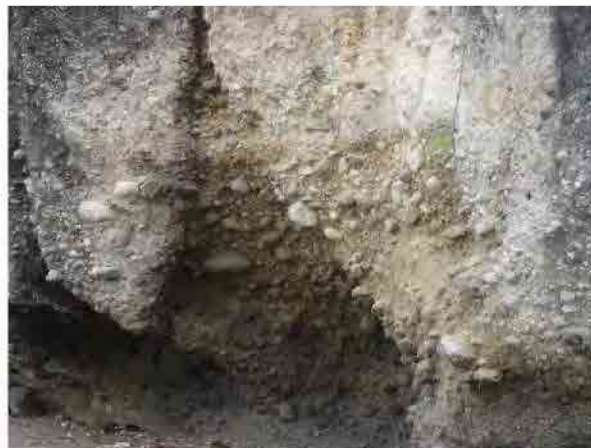
Figure 3-1-2-2 shows a condition of coastal cliff which is located at the right-side of the trees. The cliff over-hangs slightly over the sea, and a notch is formed due to erosion by waves at the base. The coastal cliff is sedimentary soft rock containing gravels, which seems to be not so strong. Taking these conditions into account, it is inferred that the trees on the cliff dropped to the base with the landslide before 2006, and they took root there.

**Figure 3-1-2-3 Enlarged photo of coastal cliff**

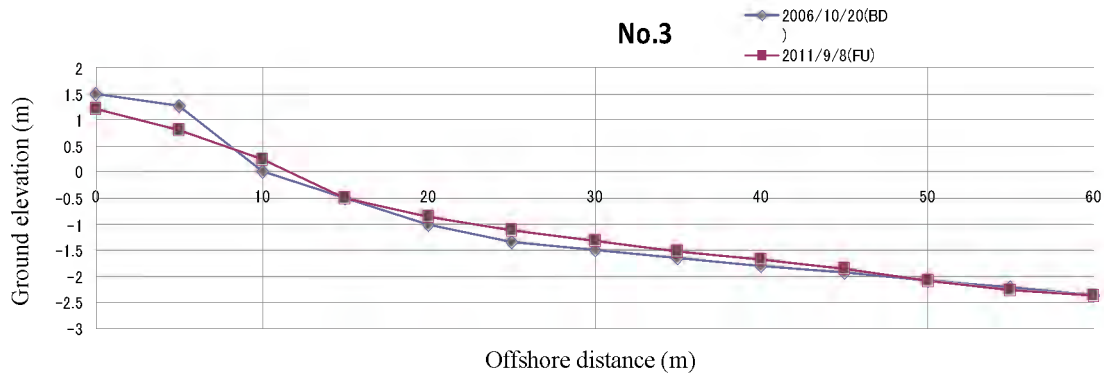
Figure 3-2-1-1 shows the comparison of beach profiles between in October 2006 and in September 2011, which are measured before and after the project respectively. The reference line No.3 is a line passing a center of Fisheries Complex (see Figure 3-2-1-2), and an origin is set at the base of Fisheries Complex, being positive in the seaward direction, in Figure 3-2-1-1. In the area from 0m to about 8m, the beach eroded about 0.5m thick.

Figure 3-2-1-1 Comparison of beach profiles in front of Fisheries Complex (Reference line No.3)

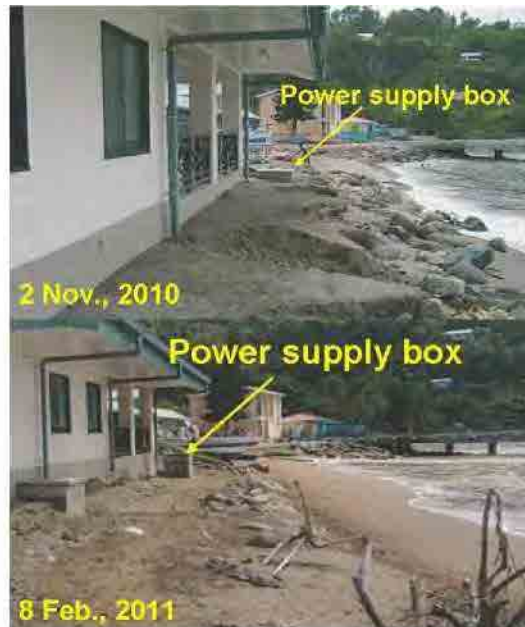
Figure 3-2-1-3 shows the beach topography in front of Fisheries Complex, one of which has been taken on the day just after the Hurricane Tomas(30 Oct., 2011) and another has been taken in about three months. Although the beach was eroded by the Hurricane Tomas, the erosion did not reach to the base of Fisheries Complex. The erosion reached up to the base by 8 Feb., 2011, and the power box was exposed. That is due to the duration of high wave conditions during about one month after the hurricane (see Figure 3-2-1-4).

**Figure 3-2-1-3 Comparison of beach topography in front of Fisheries Complex**

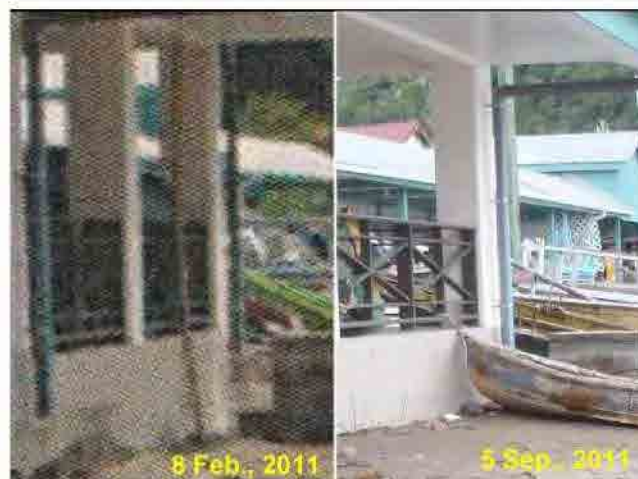
Figure 3-2-1-5 shows photos of beach in front of Fisheries Complex, taken on 8 Feb. and 5 Sep., 2011 respectively. Paying attention to rubble stones which are in existence at the place about 5 meters from the base, it is understood that the sand has accumulated there because the exposed part of stones became smaller on 5 Sep., 2011. Concerning to the area close to the base, the recovery of beach is not recognized because the distance from a handrail to the floor is nearly the same as that from the floor to the beach in both photos, which are enlarged in Figure 3-2-1-6.

**Figure 3-2-1-6 Enlarged photos (parts of Figure 3-2-1-5)**

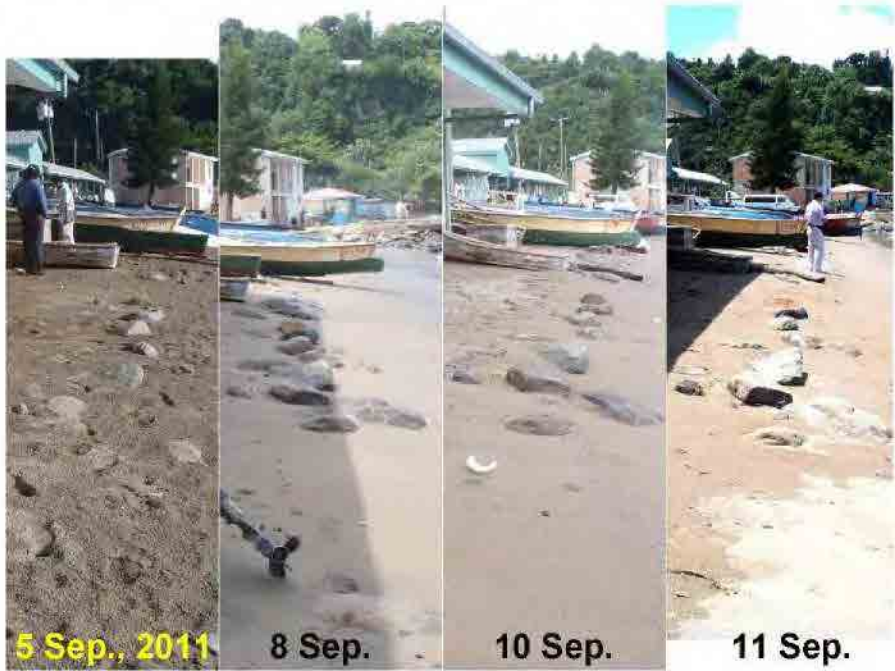
Figure 3-2-1-7 shows the conditions of rubble stones in front of Fisheries Complex on the days of 5, 8,10, and 11 September, 2011. Judging from the exposed conditions of rubble stones, the changes of beach are as followings. The sand accumulated well on 5 September. The beach eroded slightly by the day of 8 September. The sand deposited a little on 10 September. The beach eroded slightly again on 11 September. That is to say, the place, which is about 5 meters apart from the base of Fisheries Complex, changes daily.

The above considerations can be summed up as followings; The beach in front of Fisheries Complex, within about 8 meters of the base, eroded about 0.5 meter thick between the profiles before and after the project. The erosion occurred due to the Hurricane Tomas on 30 October 2011 and following large waves continuing about one month. During a last half year, the erosion at the base of building does not develop further. At the place about 5 meters from the base, the sand have

accumulated and the beach has been recovered a little, but the beach is not stable because erosion and deposition repeat daily.

Figure 3-2-1-7 Short-term changes of beach in front of Fisheries Complex

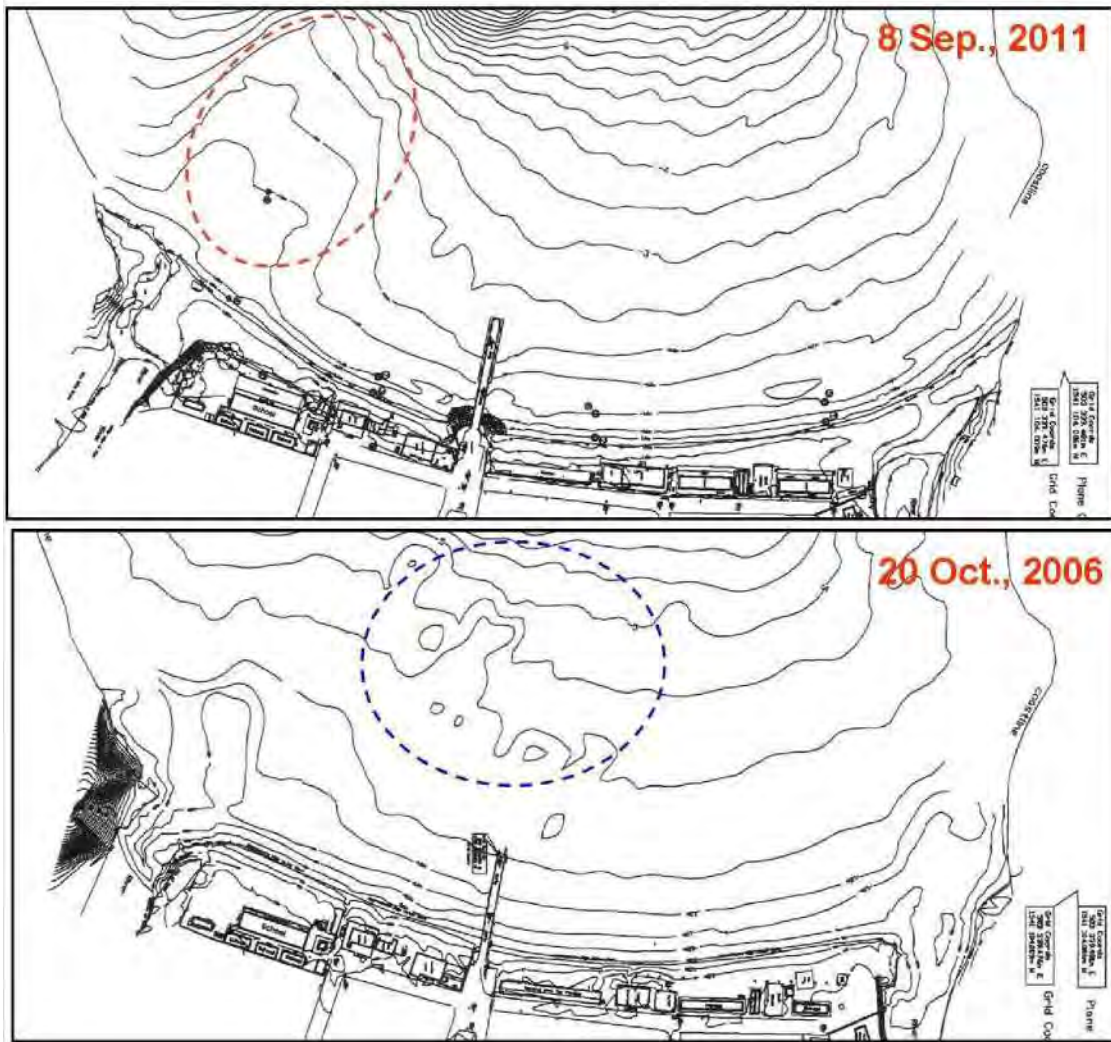
Figure 3-2-2-1 shows the contour maps surveyed in 2006 and in 2011. Please take notice that an interval of contour lines is 1m in 2006, while it is 0.5m in 2011. The distinctive feature of topography in 2006 exists in the area surrounded by a dotted blue line, where the contour lines are disarranged. In the case that the sea bottom material is sand, the contour lines should be smooth curves. The disarrangement of contour lines suggests the existence of rock reefs on the bottom.

**Figure 3-2-2-1 Comparison the contour maps surveyed in October 2006 and September 2011**

In 2011 (Figure 3-2-2-1), the contour lines in the corresponding area are curved smoothly, and the rock reefs is considered to be disappeared. It is propriety to interpret that the sand accumulated on the rock reefs.

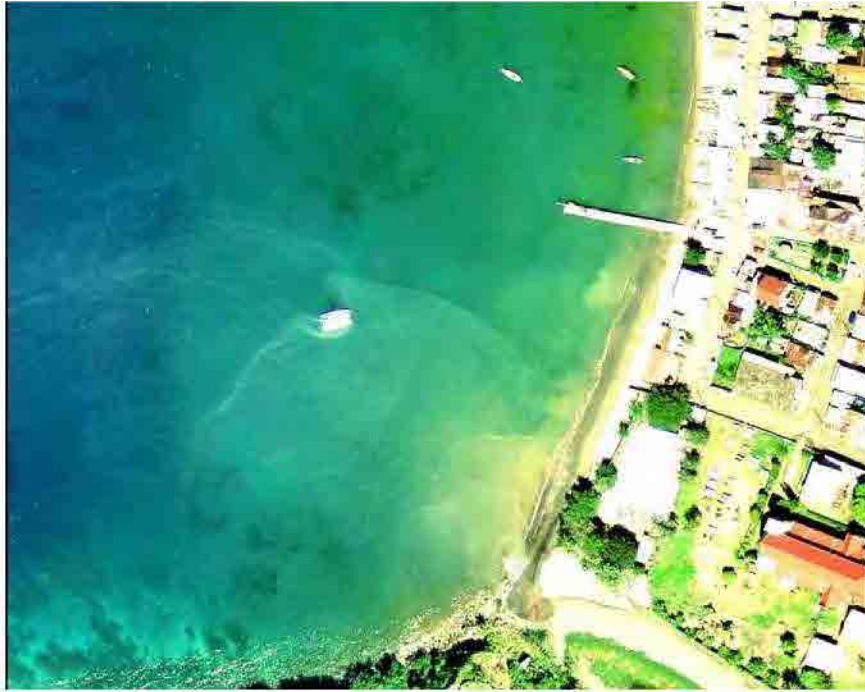
Figure 3-2-2-2 is the aerial photograph taken in February 2009, of which contrast and the tone of color have been slightly adjusted. By inspecting this photo carefully, the color of sea bottom can be detected black in the area surrounded by a dotted blue line. Also from this evidence, it can be inferred that there exist the rock reefs.

**Figure 3-2-2-2 Aerial photograph taken in February 2009**

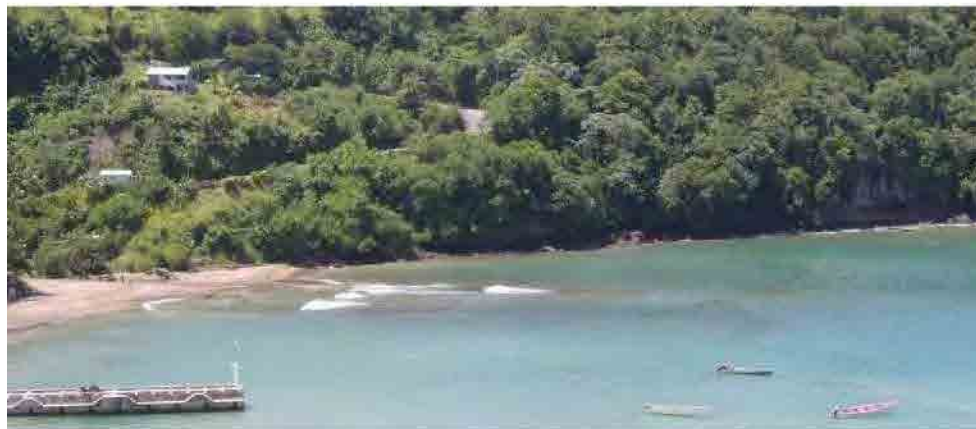
The distinctive feature of topography in 2011 exists in the area surrounded by a dotted red line, where the contour lines project remarkably offshore-ward. This accreting topography, or shoal, can be seen in Figure 3-2-2-3 which was taken in the almost same time as surveying, on which the waves break. However, the shoal is not recognized in front of river mouth both in the aerial photograph in February 2009 (Figure 3-2-2-2) and in the contour map in 2006.

**Figure 3-2-2-3 Shoal in front of river mouth and breaking waves (4 Sep., 2011)**

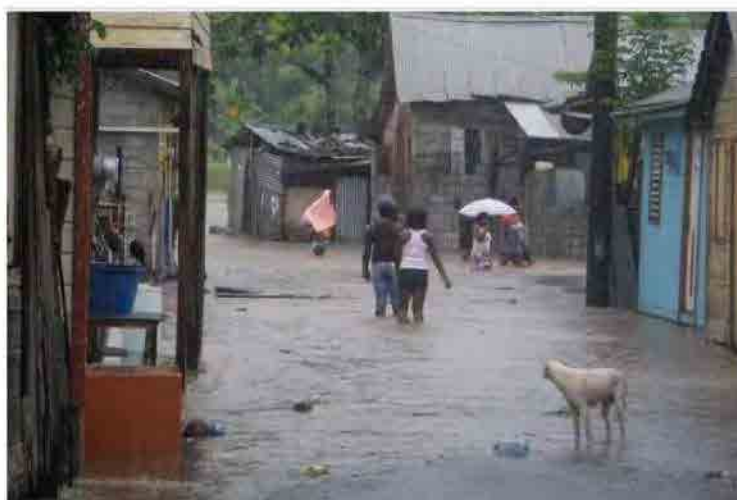
Concerning to the flood 1), there are two pictures, Figure 3-2-3-1 and 3-2-3-2, which were taken by Mr. Adachi, a resident engineer. Figure 3-2-3-1 shows a condition of flood with muddy water and Figure 3-2-3-2 shows a inundated village of Anse La Raye. Except these two pictures, there is no more quantitative information such as precipitation, duration time of rain or river discharge. But, it is no doubt that the large flood occurred.

**Figure 3-2-3-2 Inundated village on 5 May, 2009**

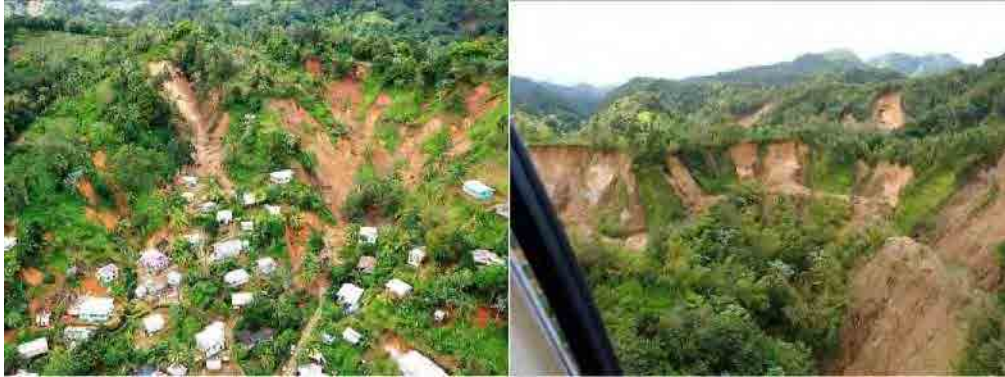
Owing to a large quantity of rainfall, large and small scale hillside landslides took place all over Saint Lucia (see Figure 3-2-3-3). It is inferred that the earth and sand run into the river, which were transported to the river mouth by the flood.

**Figure 3-2-3-3 Large scale hillside landslides (Hurricane Tomas)**

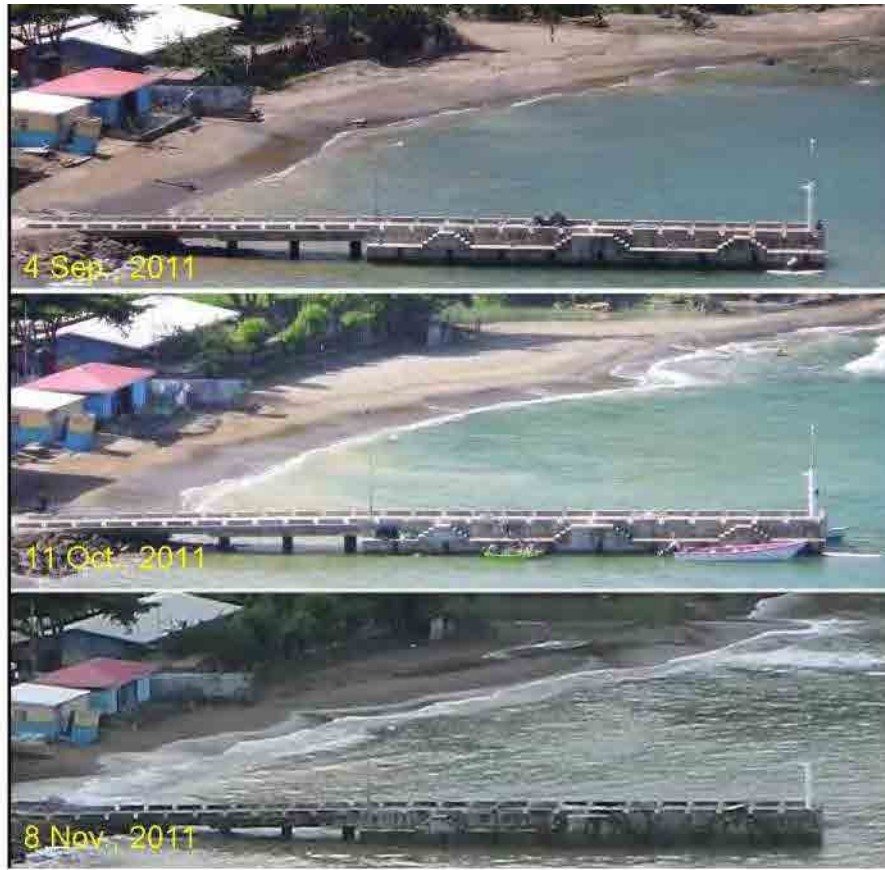
The sand deposited in the deep area is not transported to the beach, while the sand deposited in the shallow area is transported to the beach by the incident waves. As the jetty is a permeable structure, the sand is also transported in the longshore direction to the beach in front of Fisheries Complex. Figure 3-3-1-1 shows the south-side beach of the jetty, which pictures were taken at approximately one month interval. The volume of sand seems to be increasing on the beach.

Figure 3-3-1-1 Changes of south-side beach of the jetty

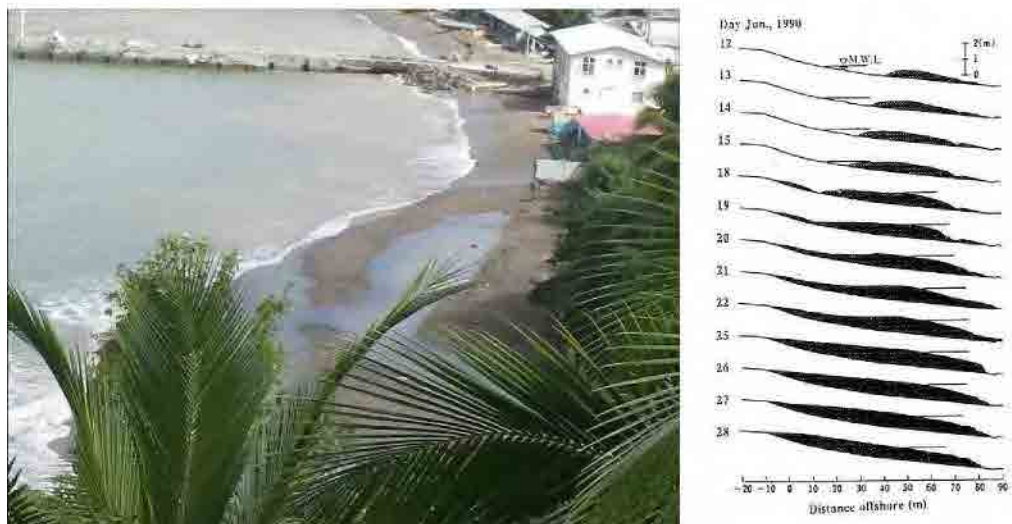
Figure 3-3-1-2 Sand accumulation on beach, 8 Nov., 2011

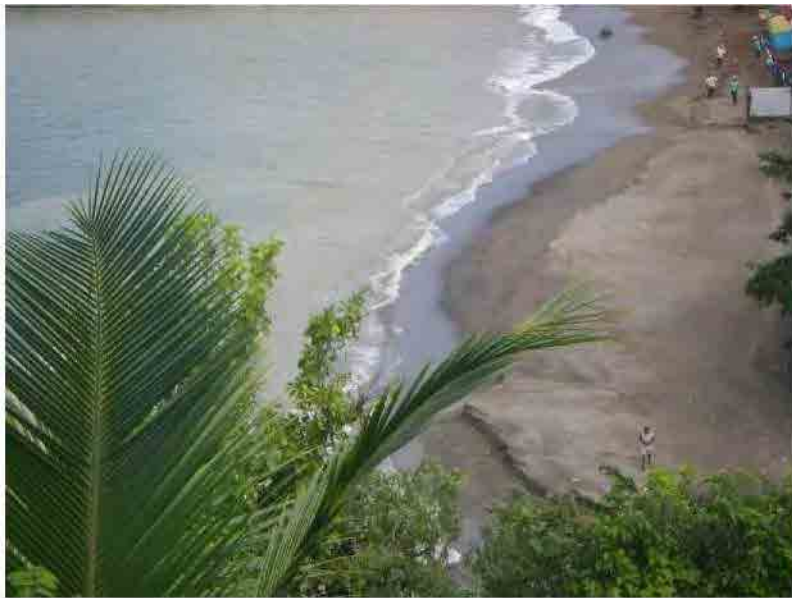
**Figure 3-3-1-3 Sand accumulation on beach, 30 Nov., 2011**

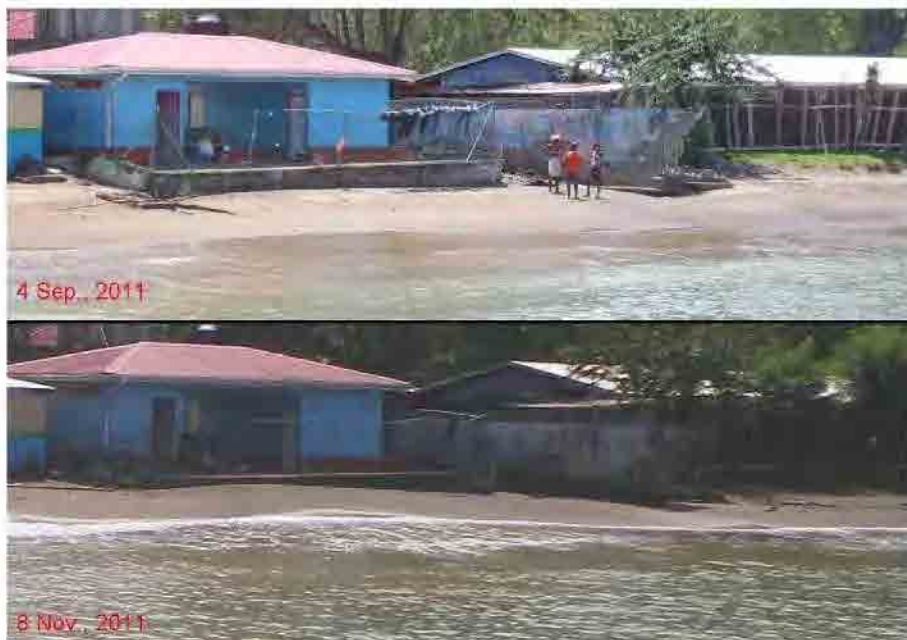
Figure 3-3-1-6 shows the beach in front of the washhouse. Paying attention to the concrete wall on the back shore, the sand accumulated about 0.5 meter during about two months from September to November, 2011, which is roughly estimated by comparing the height of person standing nearby. In short, the expected sand accumulation is now taking place on the south-side beach of the jetty.

**Figure 3-3-1-6 Beach in front of washhouse**

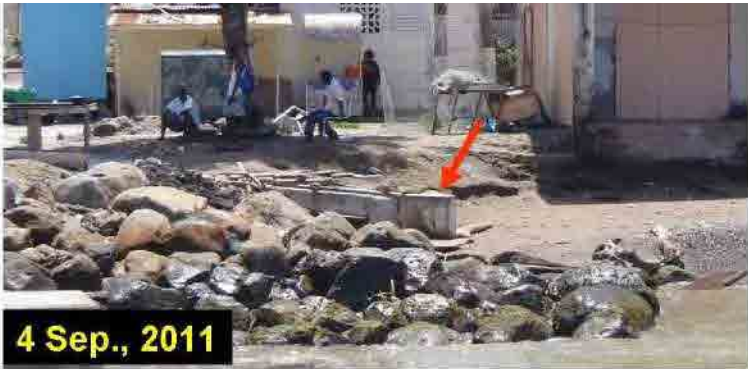
Next, let's confirm a beach recovery in front of the Community center, which is closed to the jetty. Figure 3-3-1-7 shows the situation on the day of 4 September, 2011, that is, the beach was eroded and concrete channel for drainage was exposed, which is denoted by a red arrow. The same situations are seen on 1st October in Figure 3-3-1-8 and 14 December, 2011 in Figure 3-3-1-9. Then

Figure 3-3-1-7 Situation in front of Community Center, 4 Sep., 2011

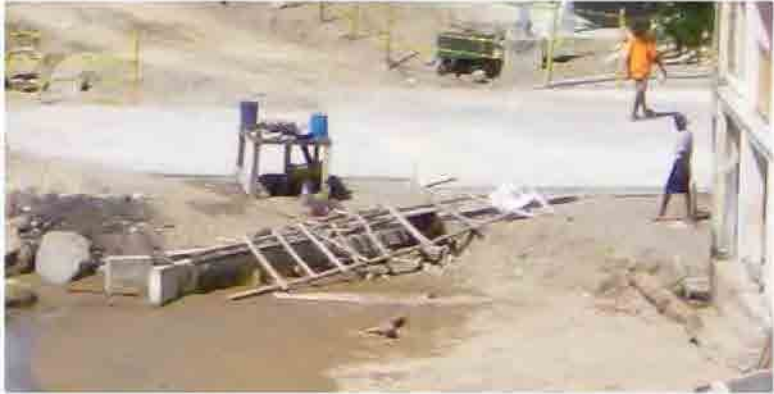
Figure 3-3-1-8 Situation in front of Community Center, 1st Oct., 2011

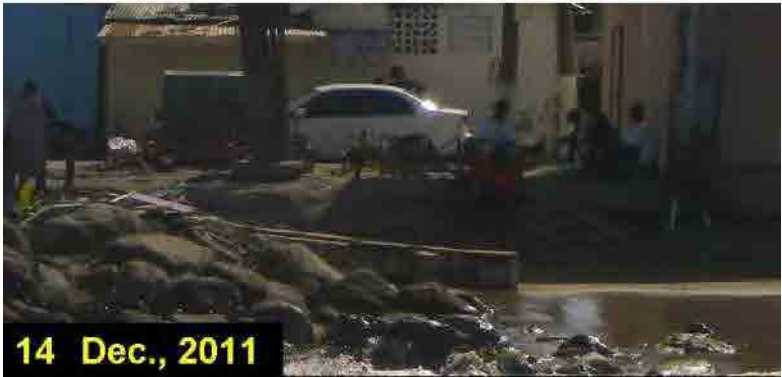
Figure 3-3-1-9 Situation in front of Community Center, 14 Dec., 2011

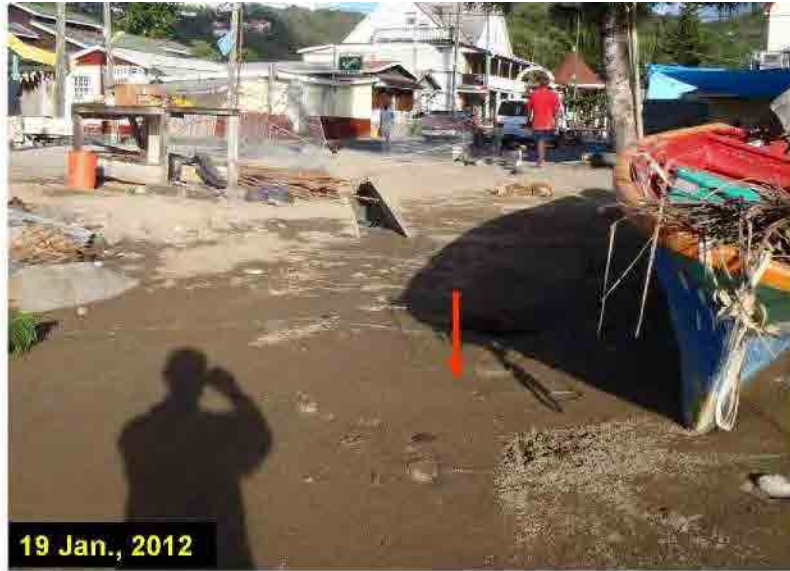
there was no beach recovery until the middle of December, 2011. Figure 3-3-1-10 shows a situation on the day of 19 January, 2012. The channel, which location is denoted by a red arrow, was completely buried under the recovered beach. The beach recovery in this area was delayed about two months compared with the areas in Figures 3-3-1-3 and 3-3-1-6.

**Figure 3-3-1-10 Situation in front of Community Center, 19 Jan., 2012**

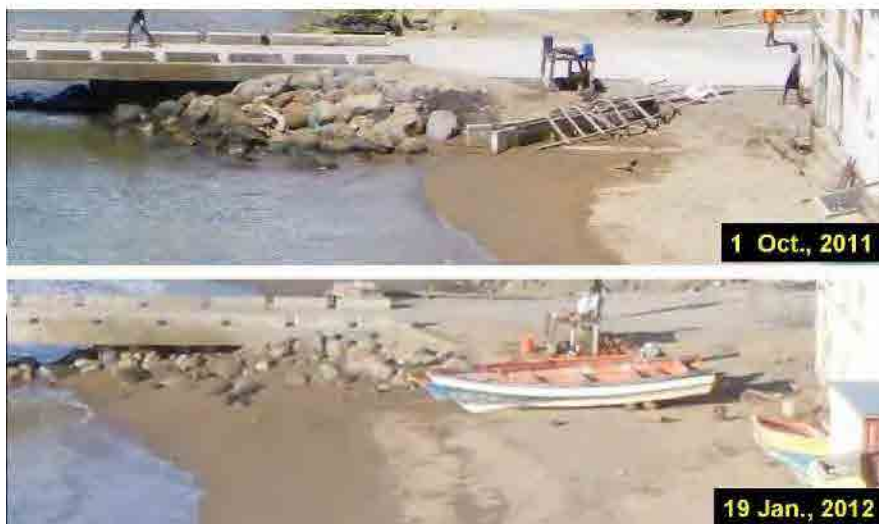
**Figure 3-3-1-11 Recovery of beach in front of Community Center**

Figure 3-3-1-11 shows a comparison between the situations on 1st Oct, 2011 and on 19 January, 2012, in which we can clearly observe the shoreline advancement.

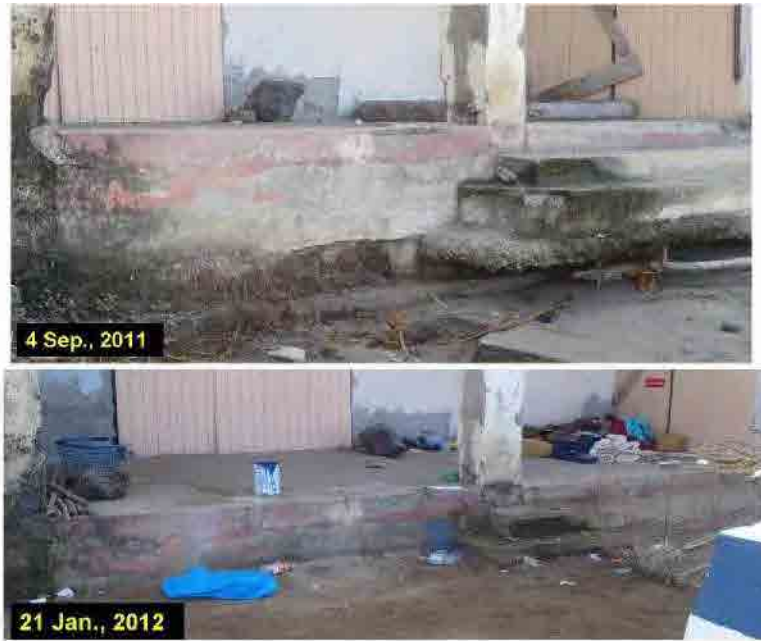
**Figure 3-3-1-12 Scour at the base of Community Center**

Figure 3-3-1-12 shows the base of Community Center. The base was scored and a stair was suspended on 4 September, 2011, while the sand has deposited in the scored area on 21 January, 2012 when the beach has been recovered.

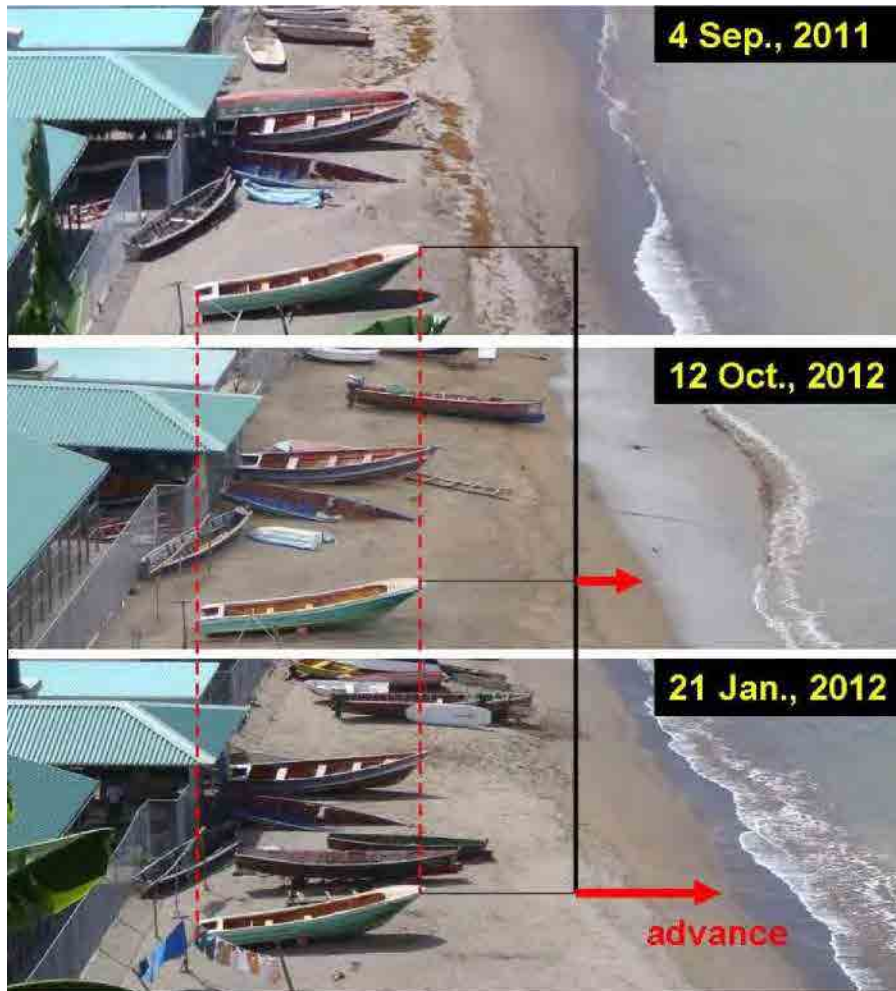
**Figure 3-3-1-14 Beach in front of Workshop**

Figure 3-3-1-14 shows the beach in front of Workshop on the days of 4 September, 2011, 12 October, 2011 and 21 January, 2012. In these pictures the small boat was set at the same place and in the same manner by chance. By referencing the boat, the scales of pictures have been adjusted. By comparing these pictures, it is understood that the shoreline, or the wet line, advanced with time.

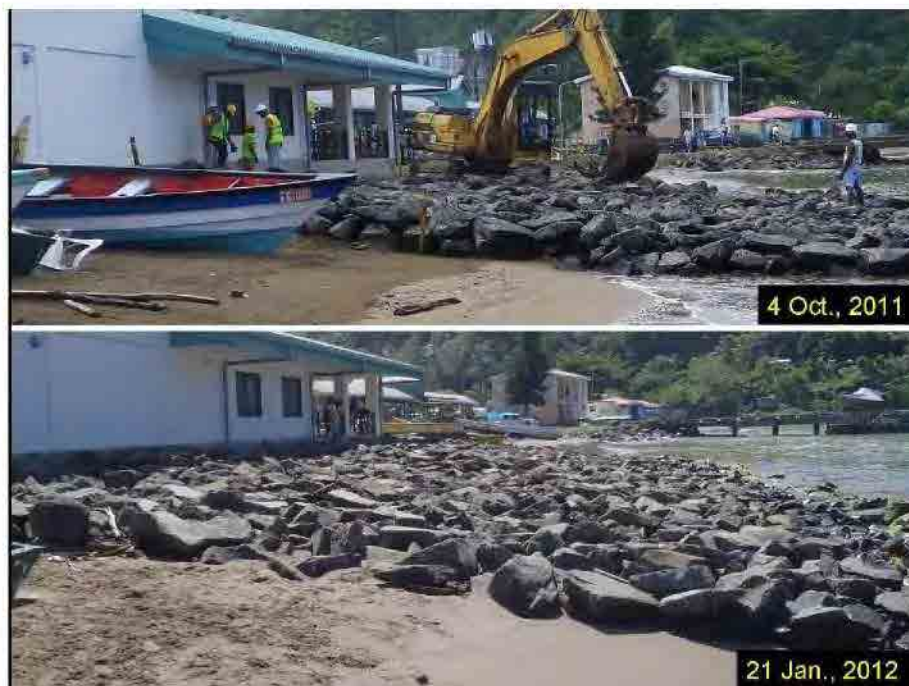
**Figure 3-3-1-16 Beach in the vicinity of the area armored with rubble stones**

Figure 3-3-1-16 shows the beach in the vicinity of the area armored with rubble stones, in front of Fisheries Complex. The upper picture was taken when the armoring works, which was 0.6 meter thick, was under construction on 4 October, 2011. In the lower picture, the thickness of armor layer became thin, being about half of initial one.

Figure 3-3-1-7 shows the changes of profile at the reference line No.4, which location is roughly corresponding to the beach in Figure 3-3-1-16, see Figure 3-3-1-5. The profile did not change during about five years from October, 2006 to September, 2011, while the sand accumulated on the beach during a successive period up to January, 2012. The extent of accumulation was about 0.3 meter thick at the offshore distance of 10 meters. Then, it can be considered that the decrease of thickness is not due to settlement of stones, but due to sand accumulation.

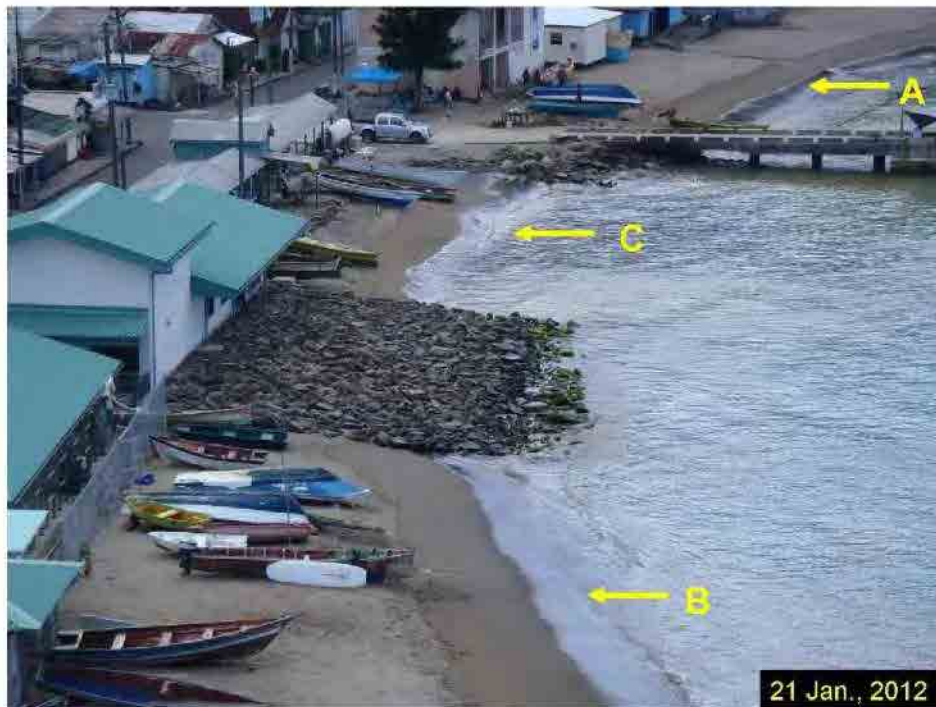
**Figure 3-3-1-18 Beach condition on 21 January, 2012**

Figure 3-3-1-18 shows the wide area of beach on 21 January, 2012. As already explained, the sand accumulated on the beaches over the jetty, denoted by an arrow with A, and on this side of armored area, by an arrow with B. However, the center beach bounded by the jetty and the rubble stones' work, that is the beach in front of Vendors Arcade, was formed relatively land-side compared with the beaches of A and B. There was no sand accumulation yet when this picture was taken.

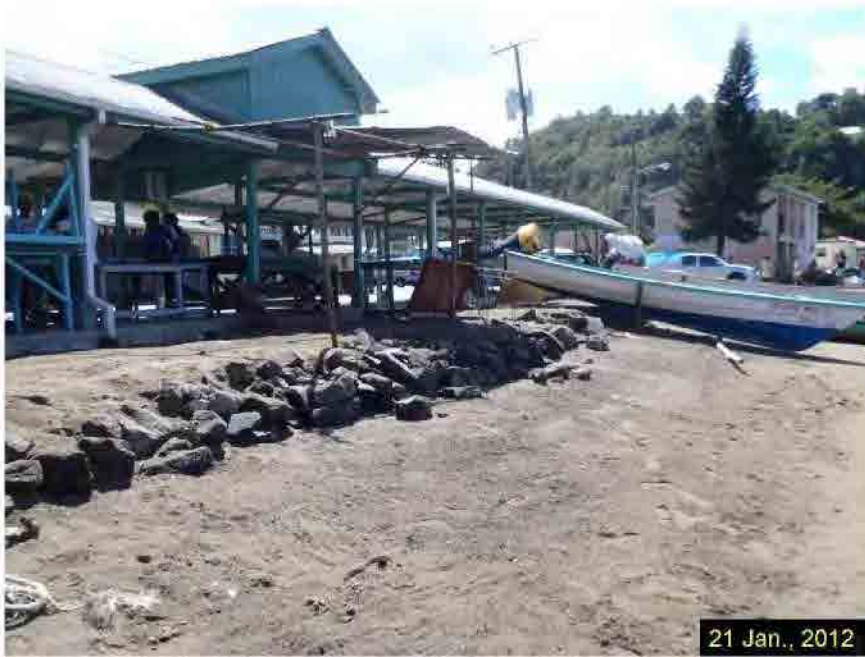
Figure 3-3-1-20 shows the beach in front of Vendors Arcade on 21 January, 2012. Although the profile did not change, the rubble stones are exposed at the boundary between the foreshore and the backshore because the crown height of rubble stone laid under the beach is a little bit high. Anyway, as the exposed rubble stones make the people away from the beach, it is desirable to improve this situation.

**Figure 3-3-1-20 Beach in front of Vendors Arcade**

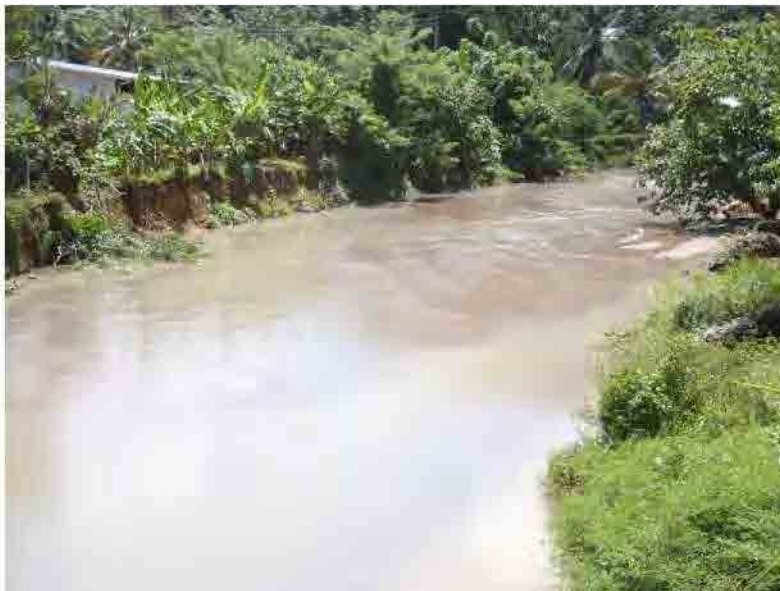
The reason why the sand increased in the recent period is because of sand supply from the river. Owing to a large quantity of rainfall due to the Hurricane Tomas, large and small scale hillside landslides took place all over Saint Lucia. At the time, large amount of sand was transported to the bay through the river by flood. However, it can be guessed that a large volume of sand is still remained in the upper reach of river. For example, Figure 3-3-1-24 shows the existence of sand on the bed in the river flowing into the bay at the south-end of the beach in the Anse La Raye. It is considered that such remaining sand was transported to the bay during the rainy season of four months from September, 2011 to January, 2012. It is expected that such remaining sand gradually transported to the bay from now on.

Figure 3-3-1-24 Deposition of sand in the river, 11 September, 2011
