APPENDIX 6

Result of Accessibility Survey in Rio de Janeiro

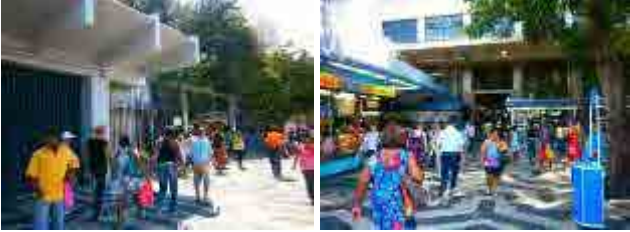
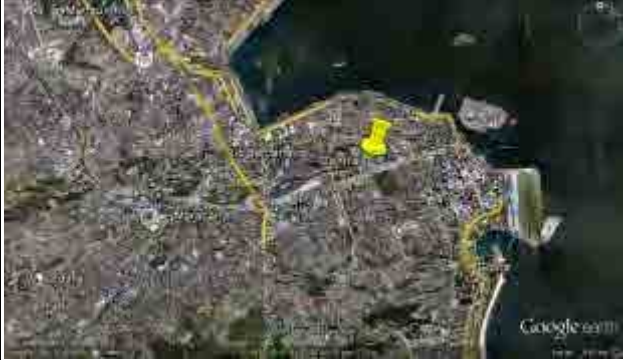
No.	01	Mode	Rail
Survey Date	17/09/12	Name of St.	Central
Area	Centro	Line Name	-
Current Condition			
Entrance/ Approach		Location

1. Condition		2. Issues	
Entrance/ Exit	No directions for entrance, no exit sign outside station.	<ul style="list-style-type: none"> > Safety hazard: level and the gap between the platform and the train; > Direction signs for entrance; > Lack of map or landmark information for exit; > No totem for self-service ticketing; > Add general route mapping and info at platform; > Accessibility for disabled people. 	
Ticketing	Crowded box office.		
Platform	No direction signs on the floor, no board, no map.		
Other	Almost no foreign language, Small character size. No travel time info.

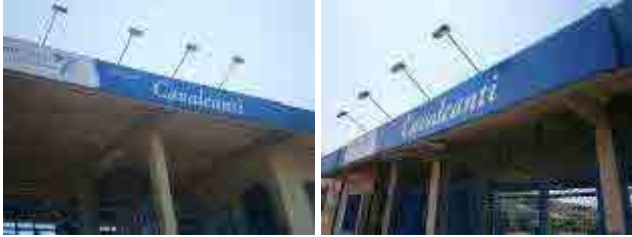
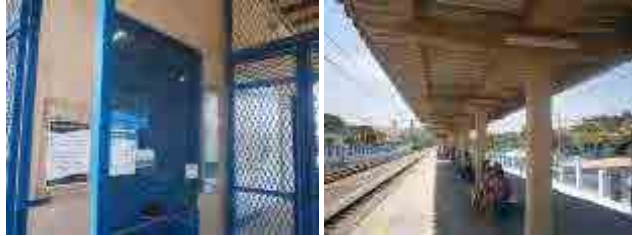
No.	03	Mode	Rail
Survey Date	11/10/12	Name of St.	Cavalcanti
Area	Cavalcanti	Line Name	Belford Roxo
Current Condition			
Entrance/ Approach		Location

Description			
5. Condition		6. Issues	
Entrance/ Exit	No directions for entrance, no exit sign outside station.	<ul style="list-style-type: none"> > Direction signs for entrance; > Lack of map or landmark information for exit; > Add general route mapping and info at platform; > Accessibility for disabled people. 	
Ticketing	Only one box office, Fare info with small letters.		
Platform	No direction signs on the floor, no board, no map.		
Other	No foreign language.

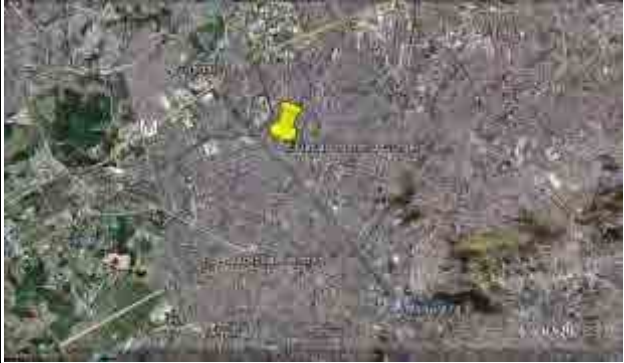
No.	06	Mode	Rail
Survey Date	15/10/12	Name of St.	Honorio Gurgel
Area	Honorio Gurgel	Line Name	Belford Roxo
Current Condition			
Entrance/ Approach		Location

Description			
11. Condition		12. Issues	
Entrance/ Exit	No directions for entrance, no exit sign outside station.	<ul style="list-style-type: none"> > Direction signs for entrance; > Lack of map or landmark information for exit; > Add general route mapping and info at platform; > Accessibility for disabled people. 	
Ticketing	No instruction for fare and ticket; Only one box office		
Platform	No direction signs on the floor, no board, no map.		
Other	No foreign language, Small character size.

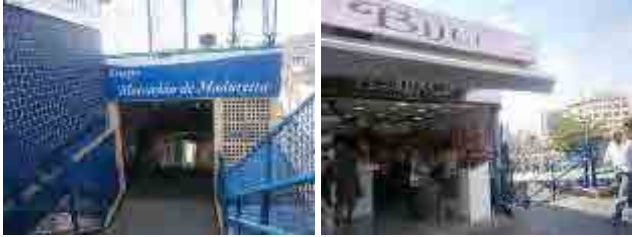
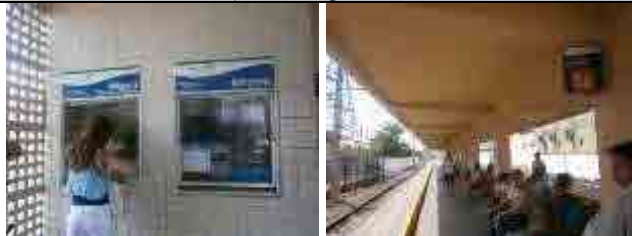
No.	07	Mode	Rail
Survey Date	11/10/12	Name of St.	Mercadao de Madureira
Area	Madureira	Line Name	Belford Roxo
Current Condition			
Entrance/ Approach		Location

Description			
13. Condition		14. Issues	
Entrance/ Exit	No directions for entrance, no exit sign outside station.	<ul style="list-style-type: none"> > Direction signs for entrance; > Lack of map or landmark information for exit; > Add general route mapping and info at platform; > Accessibility for disabled people. 	
Ticketing	Fare info with small letters.		
Platform	No direction signs on the floor, no board, no map.		
Other	No foreign language, small character size. No travel time info.

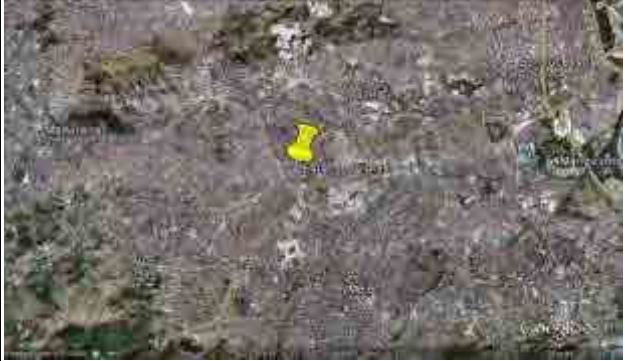
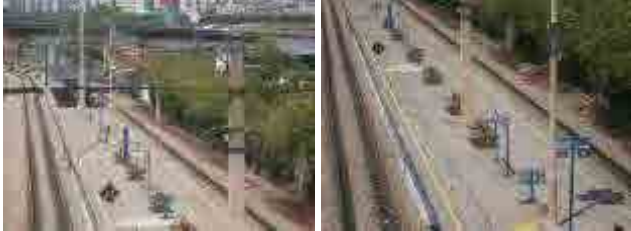
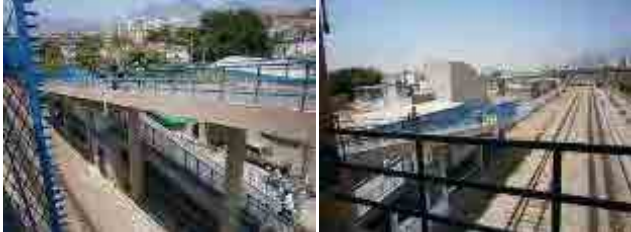
No.	09	Mode	Rail
Survey Date	11/10/12	Name of St.	Pilares
Area	Pilares	Line Name	Belford Roxo
Current Condition			
Entrance/ Approach		Location

Description			
17. Condition		18. Issues	
Entrance/ Exit	No directions for entrance, no exit sign outside station.	<ul style="list-style-type: none"> > Direction signs for entrance; > Lack of map or landmark information for exit; > Add general route mapping and info at platform and entrance; > Accessibility for disabled people. 	
Ticketing	Only one box office, Fare info with small letters.		
Platform	No direction signs on the floor, no board, no map.		
Other	No foreign language, small character size. No travel time info.

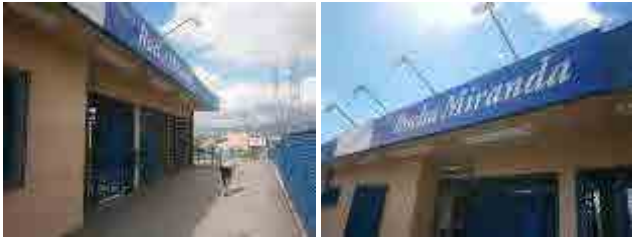
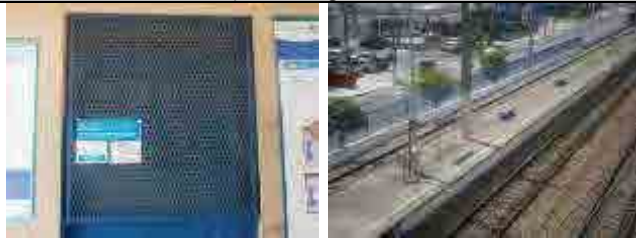
No.	10	Mode	Rail
Survey Date	15/10/12	Name of St.	Rocha Miranda
Area	Rocha Miranda	Line Name	Belford Roxo
Current Condition			
Entrance/ Approach		Location

Description			
19. Condition		20. Issues	
Entrance/ Exit	No directions for entrance, no exit sign outside station.	<ul style="list-style-type: none"> > Direction signs for entrance; > Lack of map or landmark information for exit; > Add general route mapping and info at platform; > Accessibility for disabled people. 	
Ticketing	No identification and no instruction for fare and ticket.		
Platform	No direction signs on the floor, no board, no map.		
Other	No foreign language, small character size.

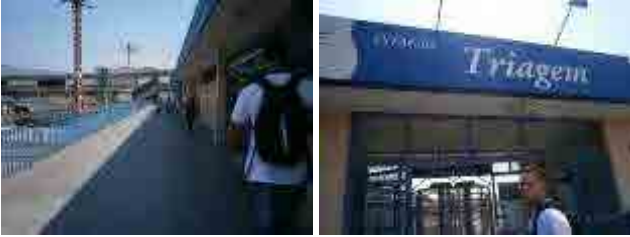
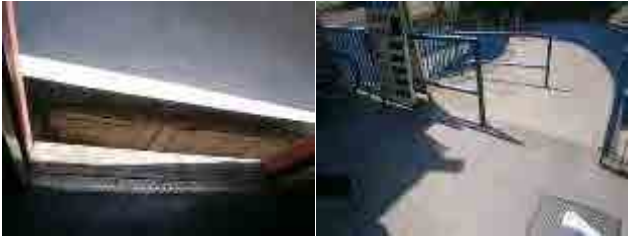
No.	12	Mode	Rail
Survey Date	19/09/12	Name of St.	Triagem
Area	Rocha	Line Name	Belford Roxo
Current Condition			
Entrance/ Approach		Location

Description			
23. Condition		24. Issues	
Entrance/ Exit	No directions for entrance, no exit sign outside station.	<ul style="list-style-type: none"> > Direction signs for entrance; > Lack of map or landmark information for exit; > Add general route mapping and info at platform; > Accessibility for disabled people. 	
Ticketing	Fare info with small letters.		
Platform	No direction signs on the floor, no board, no map, gap between rail and platform.		
Other	No foreign language.

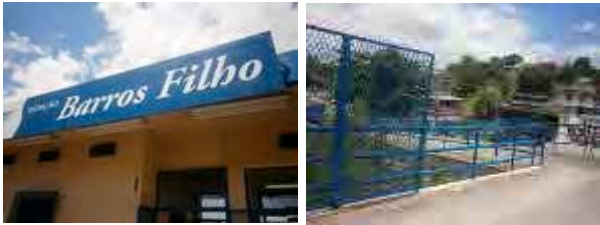
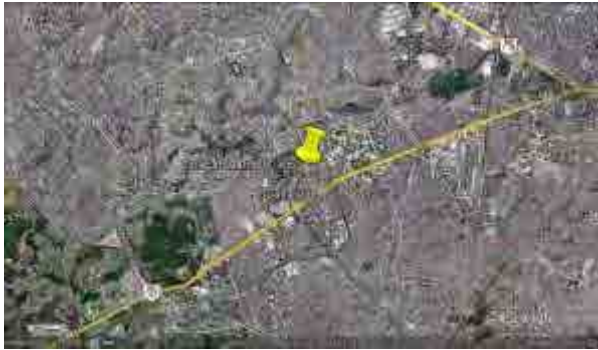
No.	13	Mode	Rail
Survey Date	15/10/12	Name of St.	Barros Filho
Area	Barros Filho	Line Name	Belford Roxo
Current Condition			
Entrance/ Approach		Location

25. Condition		26. Issues	
Entrance/ Exit	No directions for entrance no exit sign outside station.	<ul style="list-style-type: none"> > Lack of map or landmark information for exit > Direction signs for entrance and on the floor of platform > Approaching information or timetable at platform > Accessibility for disabled people. 	
Ticketing	Only one box office, Fare info with small letters		
Platform	No timetable and no approach info; Difficult access for disabled people No direction signs on the floor, no board.		
Other	No foreign language

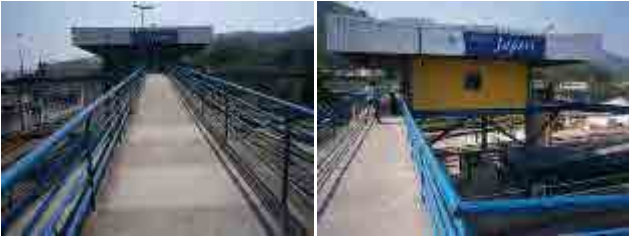
No.	16	Mode	Rail
Survey Date	18/09/12	Name of St.	Japeri
Area	Nova Belem	Line Name	Japeri
Current Condition			
Entrance/ Approach		Location

Description			
31. Condition		32. Issues	
Entrance/ Exit	No directions for entrance, no exit sign outside station.	<ul style="list-style-type: none"> > Direction signs for entrance; > Lack of map or landmark information for exit; > Put more seats on the platform for users; > Add general route mapping and info at platform. 	
Ticketing	Fare info with little letters.		
Platform	No direction signs on the floor, no board, no map, lack of seat.		
Other	No foreign language. No travel time info.

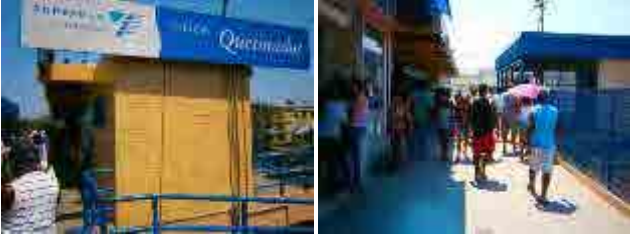
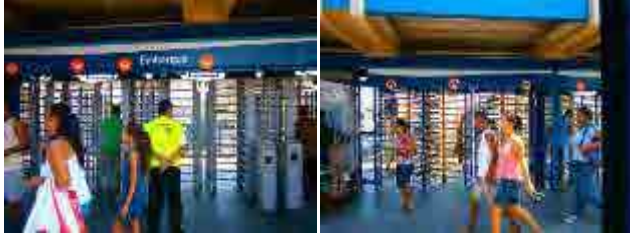
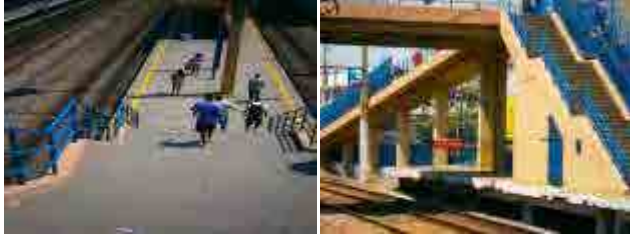
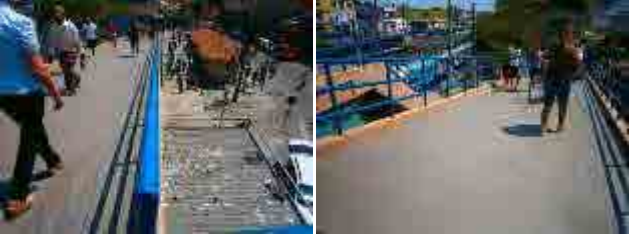
No.	18	Mode	Rail
Survey Date	18/09/12	Name of St.	Queimados
Area	Queimados	Line Name	Japeri
Current Condition			
Entrance/ Approach		Location

Description			
35. Condition		36. Issues	
Entrance/ Exit	No directions for entrance, no exit sign outside station.	<ul style="list-style-type: none"> > No maps; > Missing many Direction signs; > Direction signs for entrance; > Lack of map or landmark information for exit; > Add general route mapping and info at platform; > Accessibility for disabled people. 	
Ticketing	Fare info with small letters.		
Platform	No direction signs on the floor, no board, no map.		
Other	No foreign language. No travel time info and no timetable.

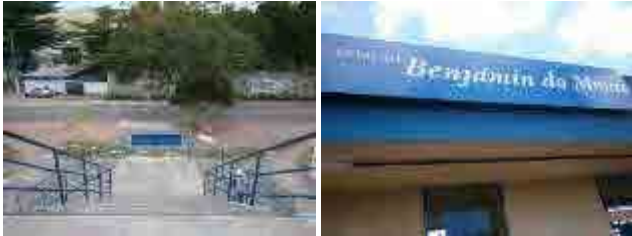
No.	21	Mode	Rail
Survey Date	08/10/12	Name of St.	Benjamin do Monte
Area	Inhoaiba	Line Name	Santa Cruz
Current Condition			
Entrance/ Approach		Location

Description			
41. Condition		42. Issues	
Entrance/ Exit	No directions for entrance, no exit sign outside station.	<ul style="list-style-type: none"> > Map location of difficult visibility; > Direction signs for entrance; > Lack of map or landmark information for exit; > Add general route mapping and info at platform; > Accessibility for disabled people. 	
Ticketing	Fare info with small letters.		
Platform	No direction signs on the floor, no board, no map.		
Other	No foreign language.

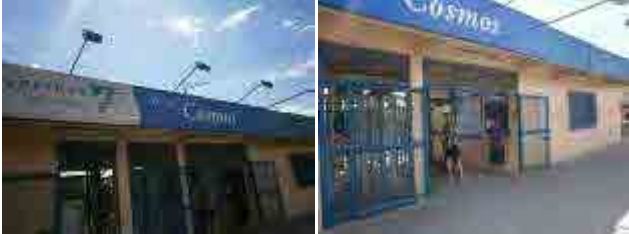
No.	22	Mode	Rail
Survey Date	08/10/12	Name of St.	Cosmos
Area	Cosmos	Line Name	Santa Cruz
Current Condition			
Entrance/ Approach		Location

43. Condition		44. Issues	
Entrance/ Exit	No directions for entrance, no exit sign outside station.	<ul style="list-style-type: none"> > Safety hazard: level and the gap between the platform and the train; > Direction signs for entrance; > Lack of map or landmark information for exit; > Add general route mapping and info at platform; > Accessibility for disabled people. 	
Ticketing	Fare info with small letters.		
Platform	No direction signs on the floor, no board, no map, safety hazard level and gap with train.		
Other	No foreign language.

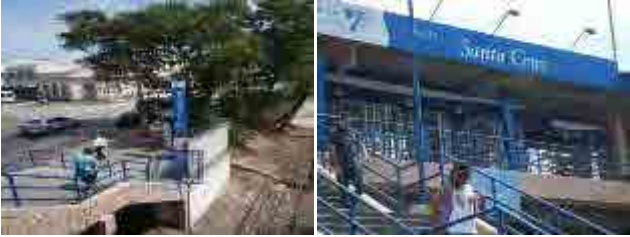
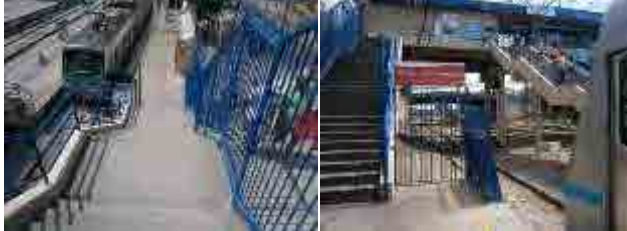
No.	25	Mode	Rail
Survey Date	24/09/12	Name of St.	Santa Cruz
Area	Santa Cruz	Line Name	Santa Cruz
Current Condition			
Entrance/ Approach		Location

49. Condition		50. Issues	
Entrance/ Exit	No exit sign outside station. Poor signalization at station. Accessibility of disable people.	<ul style="list-style-type: none"> > Safety hazard: level and the gap between the platform and the train; > Direction signs for entrance; > Lack of map or landmark information for exit; > Add general route mapping and info at platform; > Accessibility for disabled people. 	
Ticketing	Fare info with small letters.		
Platform	No direction signs on the floor, no board, no map, disable people waiting to be helped.		
Other	No foreign language.

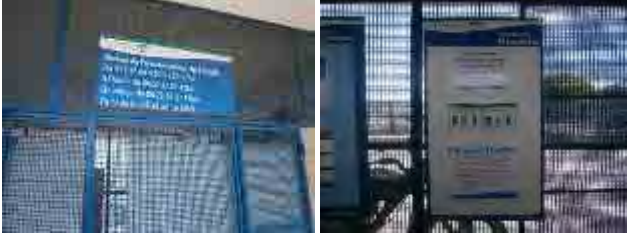
No.	26	Mode	Rail
Survey Date	08/10/12	Name of St.	Tancredo Neves
Area	Santa Cruz	Line Name	Santa Cruz
Current Condition			
Entrance/ Approach		Location

[Accessibility]			
Description			
51. Condition		52. Issues	
Entrance/ Exit	No directions for entrance, no exit sign outside station.	<ul style="list-style-type: none"> > Poor signalization at station; > Direction signs for entrance; > Lack of map or landmark information for exit; > Lack of security for users with police and cameras. No enforcement. 	
Ticketing	Fare info with small letters.		
Platform	No photo. No map.		
Other	No foreign language. No security, drug addict observed.

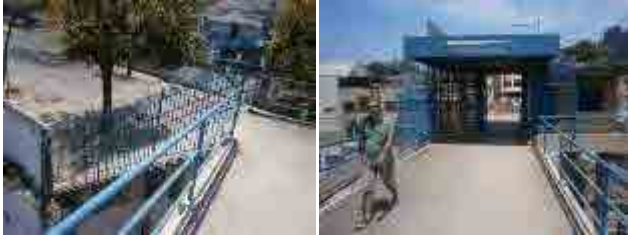
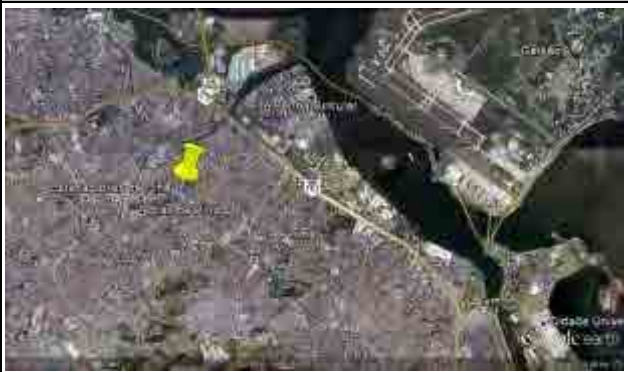
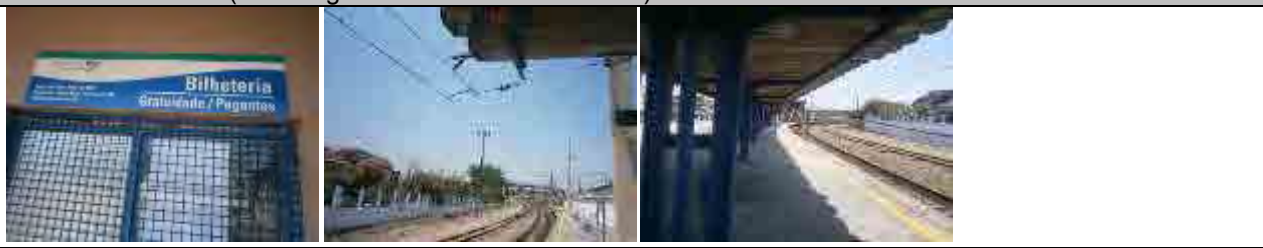
No.	28	Mode	Rail
Survey Date	11/10/12	Name of St.	Bras de Pina
Area	Bras de Pina	Line Name	Saracuruna
Current Condition			
Entrance/ Approach		Location

55. Condition		56. Issues	
Entrance/ Exit	No directions for entrance, no exit sign outside station.	<ul style="list-style-type: none"> > Safety hazard between the platform and the train; > Direction signs for entrance; > Lack of map or landmark information for exit; > Add general route mapping and info at platform; > Accessibility for disabled people. 	
Ticketing	No instruction for fare and ticket.		
Platform	No direction signs on the floor, no board, no map.		
Other	No foreign language.

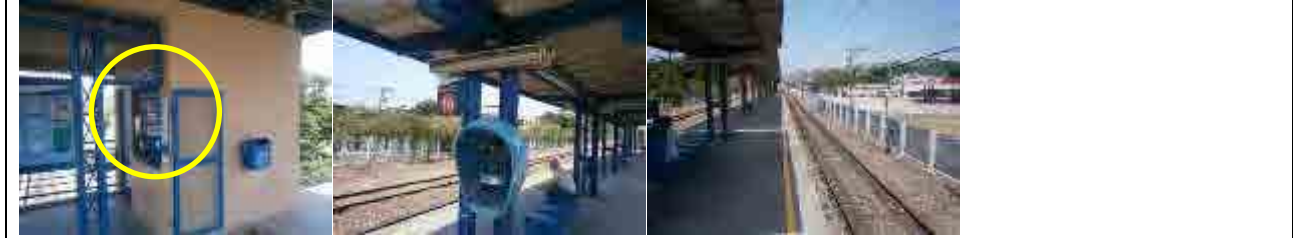
57. Condition		58. Issues
Entrance/ Exit	No directions for entrance, no exit sign outside station.	<ul style="list-style-type: none"> > Poor signalization at station; > No maps in entrance and platform; > Direction signs for entrance; > Lack of map or landmark information for exit; > Add general route mapping and info at platform; > Accessibility for disabled people.
Ticketing	Without directional info.	
Platform	No direction signs on the floor, no board, no map.	
Other	No foreign language.

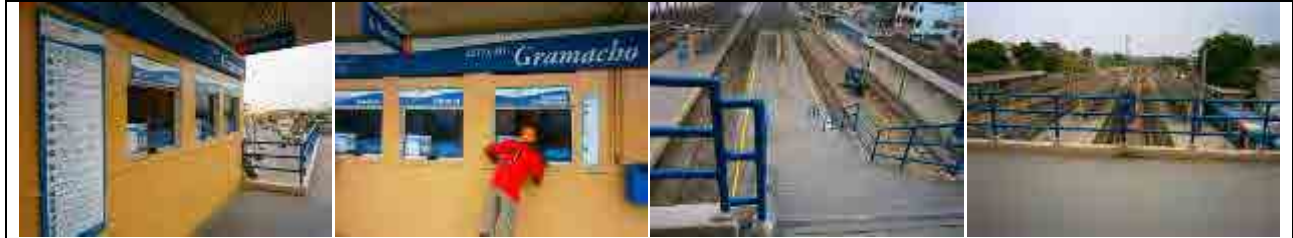
59. Condition		60. Issues
Entrance/ Exit	<No photo>	<ul style="list-style-type: none"> > Lack of map or landmark information for exit; > Add general route mapping and info at platform; > Accessibility for disabled people.
Ticketing	Fare info with small letters.	
Platform	No direction signs on the floor, no board, no map.	
Other	No foreign language.

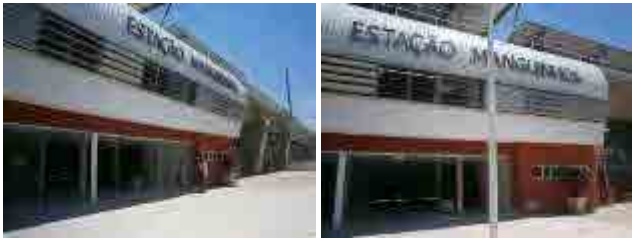
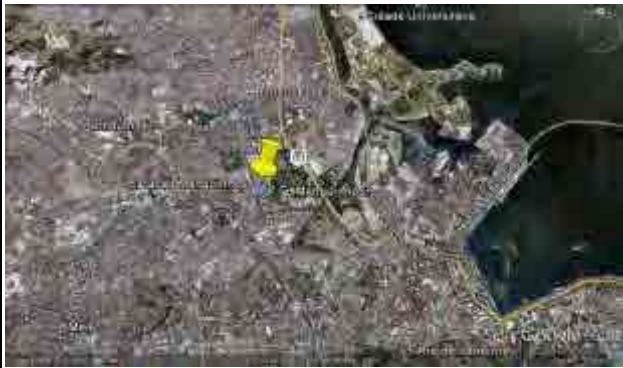
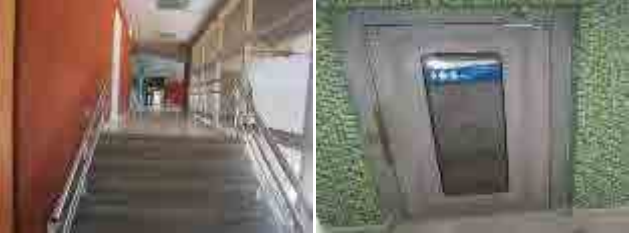
No.	31	Mode	Rail
Survey Date	10/10/12	Name of St.	Manguinhos
Area	Manguinhos	Line Name	Saracuruna
Current Condition			
Entrance/ Approach		Location

Description			
61. Condition		62. Issues	
Entrance/ Exit	No directions for entrance, no exit sign outside station.	> Lack of map or landmark information for exit; > Directional signs on the floor.	
Ticketing	Fare info with small letters.		
Platform	<No photo>		
Other

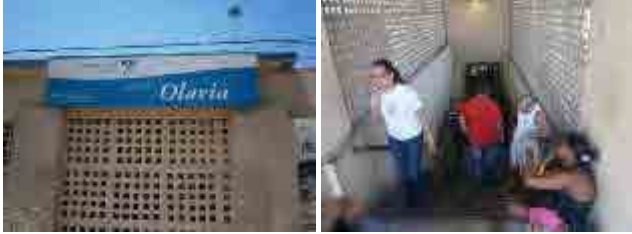
No.	32	Mode	Rail
Survey Date	10/10/12	Name of St.	Olaria
Area	Olaria	Line Name	Saracuruna
Current Condition			
Entrance/ Approach		Location

Description			
63. Condition		64. Issues	
Entrance/ Exit	No directions for entrance, no exit sign outside station.	<ul style="list-style-type: none"> > Safety hazard: gap between the platform and the train; > Direction signs for entrance; > Lack of map or landmark information for exit; > Add general route mapping and info at platform; > Accessibility for disabled people. 	
Ticketing	No instruction for fare and ticket.		
Platform	No direction signs on the floor, no board.		
Other	No foreign language.

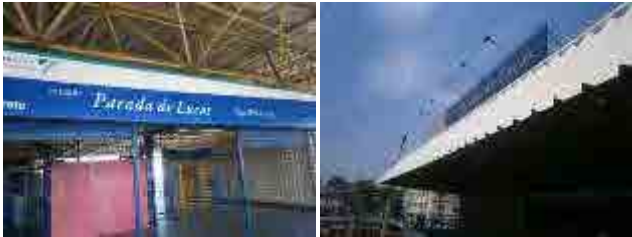
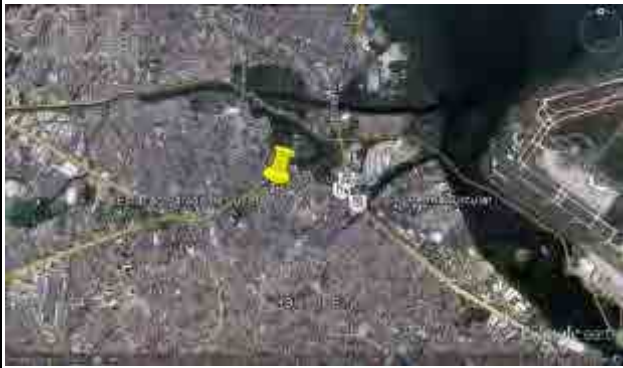
No.	33	Mode	Rail
Survey Date	11/10/12	Name of St.	Parada de Lucas
Area	Parada de Lucas	Line Name	Saracuruna
Current Condition			
Entrance/ Approach		Location

Description			
65. Condition		66. Issues	
Entrance/ Exit	No exit sign outside station.	> Poor signalization at station; > Direction signs for entrance; > Lack of map or landmark information for exit; > Add general route mapping and info in entrance; > Accessibility for disabled people.	
Ticketing	<No photo>		
Platform	<No photo>		
Other	No foreign language.

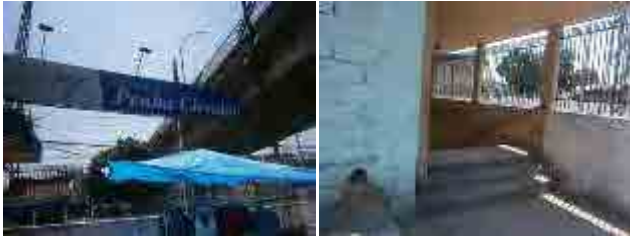
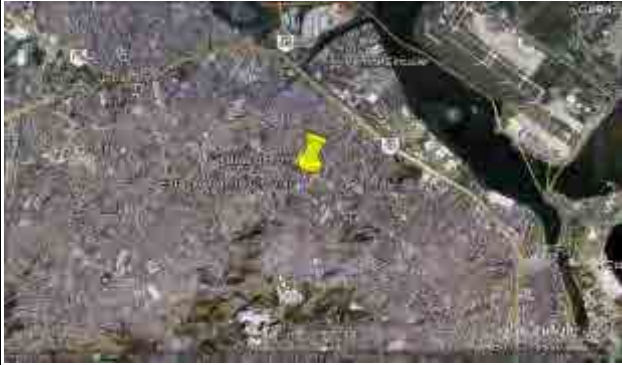
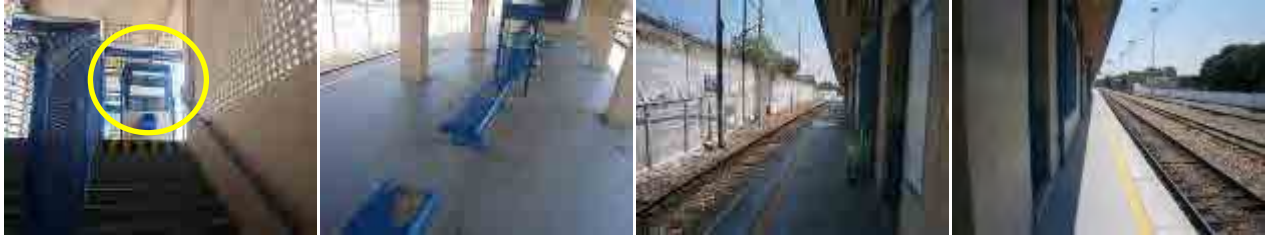
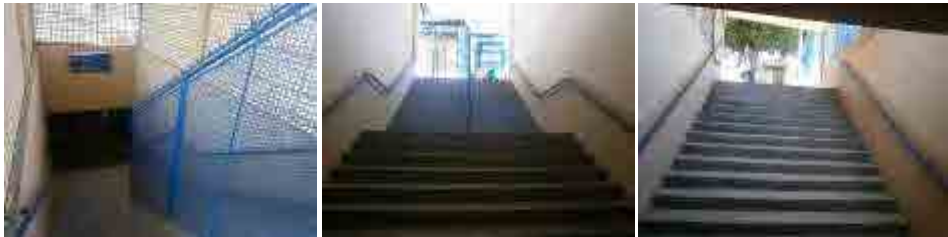
No.	34	Mode	Rail
Survey Date	11/10/12	Name of St.	Penha Circular
Area	Penha	Line Name	Saracuruna
Current Condition			
Entrance/ Approach		Location

Description			
67. Condition		68. Issues	
Entrance/ Exit	No directions for entrance, no exit sign outside station.	<ul style="list-style-type: none"> > Poor signalization at station; > Direction signs for entrance; > Lack of map or landmark information for exit; > Add general route mapping and info at platform; > Accessibility for disabled people. 	
Ticketing	Photo distant.		
Platform	No direction signs on the floor, no board, narrow passage for users.		
Other	No foreign language.

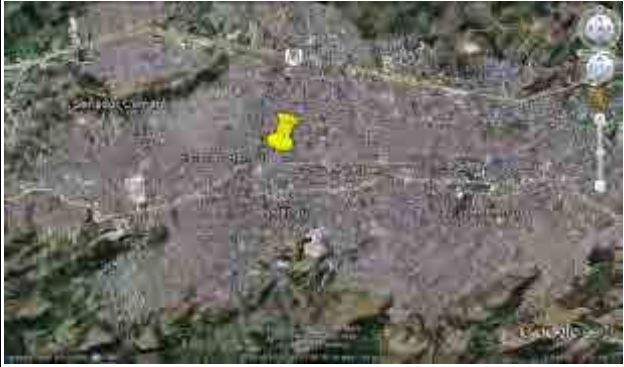
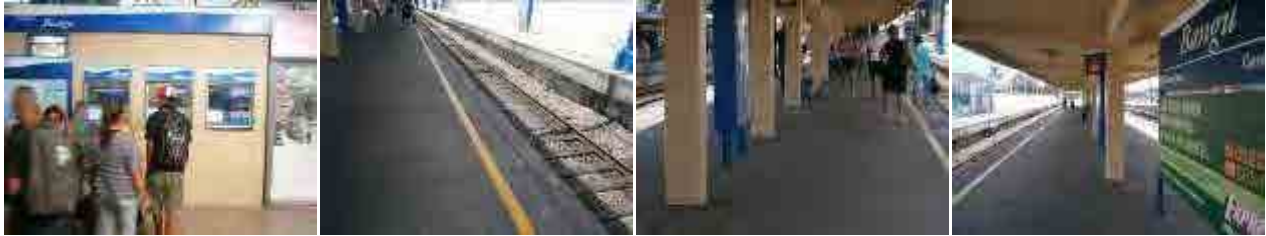
No.	39	Mode	Rail
Survey Date	24/09/12	Name of St.	Bangu
Area	Bangu	Line Name	Deodoro
Current Condition			
Entrance/ Approach		Location

Description			
77. Condition		78. Issues	
Entrance/ Exit	No photo in the entrance. Need a map or directions for exit.	<ul style="list-style-type: none"> > Direction signs for entrance; > Lack of map or landmark information for exit; > Add general route mapping and info at platform. 	
Ticketing	Fare info with small letters.		
Platform	No direction signs on the floor, no board, no map.		
Other	No foreign language.

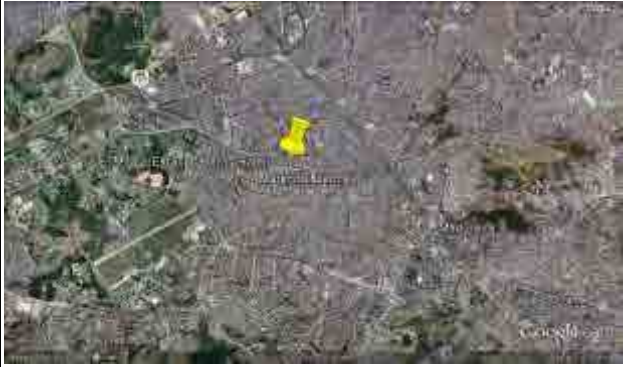
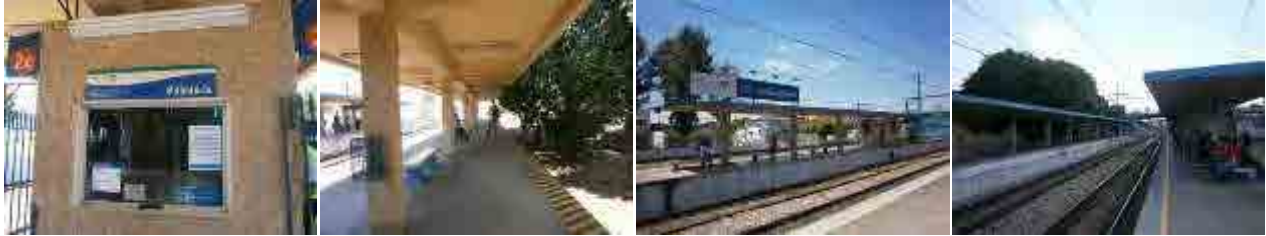
No.	40	Mode	Rail
Survey Date	09/10/12	Name of St.	Bento Ribeiro
Area	Bento Ribeiro	Line Name	Deodoro
Current Condition			
Entrance/ Approach		Location

79. Condition		80. Issues	
Entrance/ Exit	No directions for entrance, no exit sign outside station.	<ul style="list-style-type: none"> > Poor signalization at station identification on direction, > Wire spiral next at gate for access of users; > Direction signs for entrance; > Lack of map or landmark information for exit; > Add general route mapping and info at platform; > No accessibility for disabled people. 	
Ticketing	Fare info small letters.		
Platform	No direction signs on the floor, no board, no map.		
Other	No foreign language, warning signs only in Portuguese.

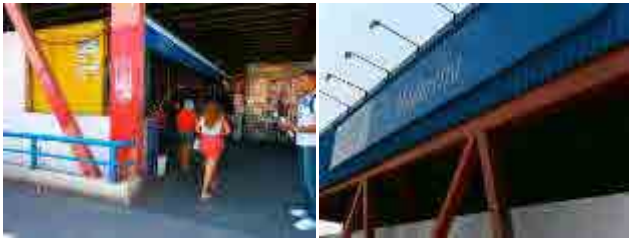
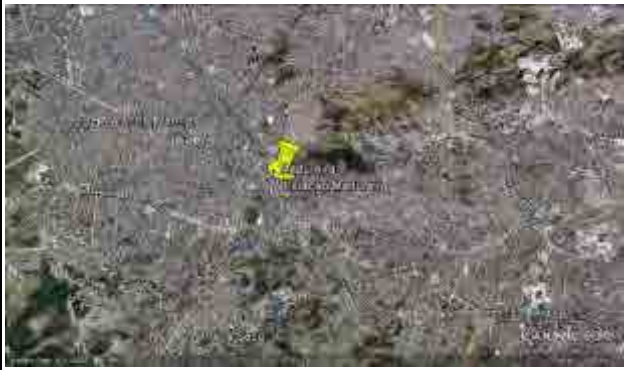
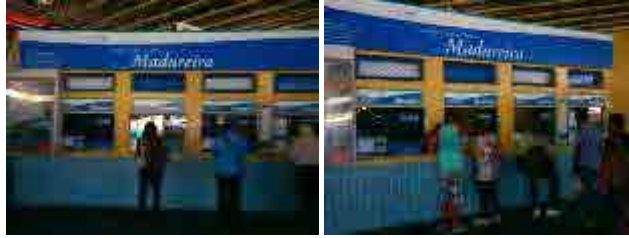
No.	46	Mode	Rail
Survey Date	17/09/12	Name of St.	Madureira
Area	Madureira	Line Name	Deodoro
Current Condition			
Entrance/ Approach		Location

Description			
91. Condition		92. Issues	
Entrance/ Exit	No directions for entrance, no exit sign outside station.	> Add general route mapping and info in foreign language; > Direction signs for entrance; > Lack of map or landmark information for exit.	
Ticketing	Fare info small letters.		
Platform	<No photo>		
Other	No foreign language. Lift out of order.

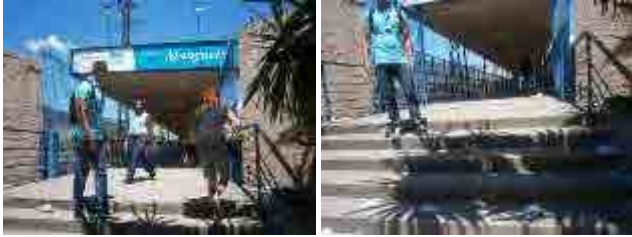
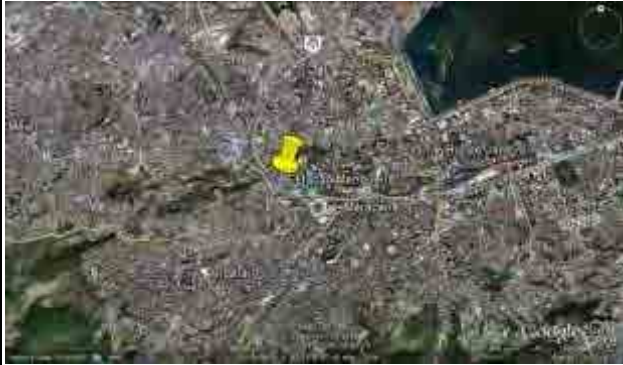
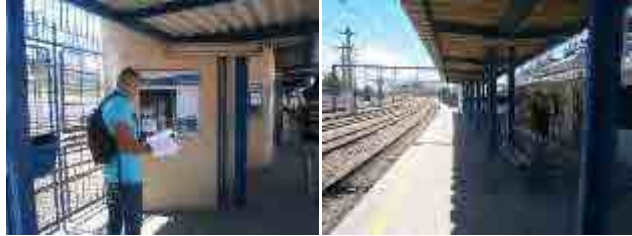
No.	48	Mode	Rail
Survey Date	08/10/12	Name of St.	Mangueira
Area	São Cristóvão	Line Name	Deodoro
Current Condition			
Entrance/ Approach		Location

Description			
95. Condition		96. Issues	
Entrance/ Exit	No exit sign outside station.	<ul style="list-style-type: none"> > Lack of map or landmark information for exit; > Add general route mapping and info at platform; > Accessibility for disabled people. 	
Ticketing	Fare info small letters.		
Platform	No direction signs on the floor, no board, no map.		
Other	No foreign language. No ramps for disabled people.

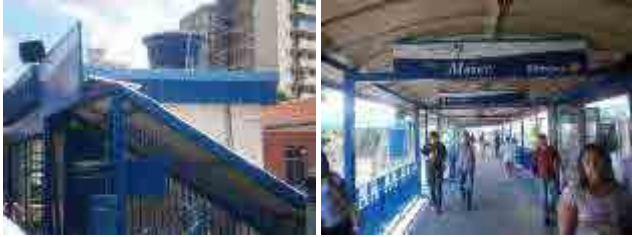
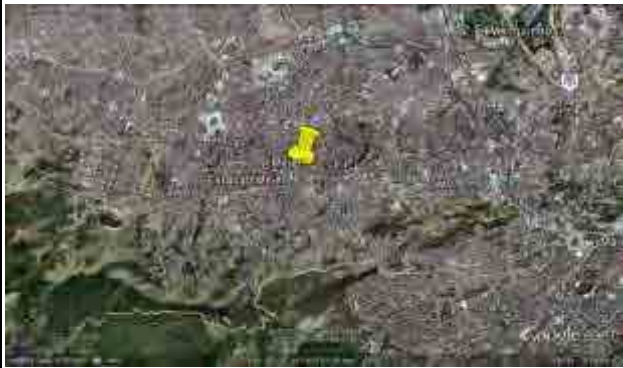
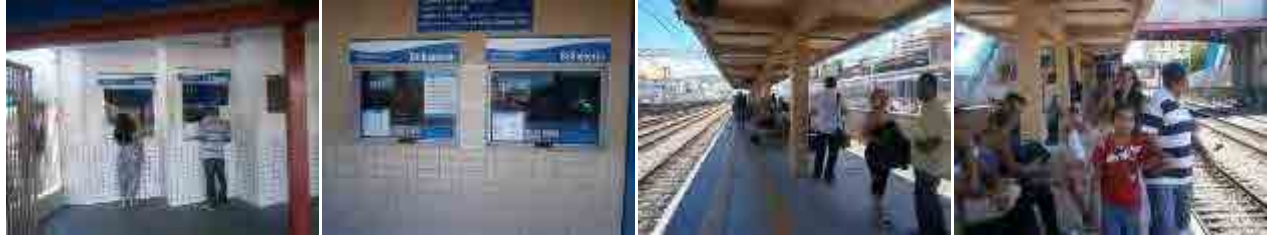
No.	51	Mode	Rail
Survey Date	08/10/12	Name of St.	Méier
Area	Méier	Line Name	Deodoro
Current Condition			
Entrance/ Approach		Location

Description			
101. Condition		102. Issues	
Entrance/ Exit	No directions for entrance, no exit sign outside station.	<ul style="list-style-type: none"> > Direction signs for entrance; > Lack of map or landmark information for exit; > Add general route mapping and info at platform; > Accessibility for disabled people. 	
Ticketing	Fare info with small letters.		
Platform	No direction signs on the floor, no board.		
Other	No foreign language. No travel time info.

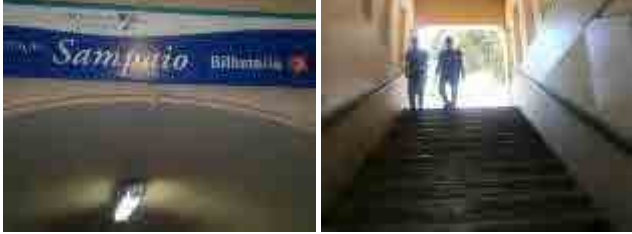
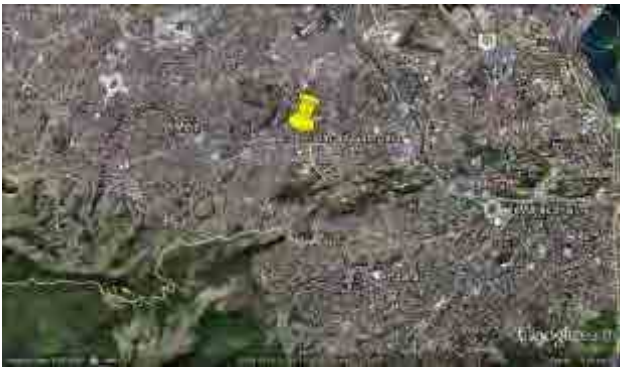
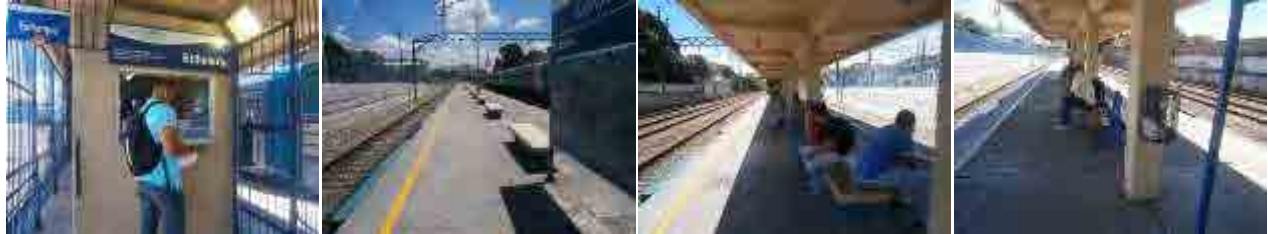
No.	60	Mode	Rail
Survey Date	08/10/12	Name of St.	Sampaio
Area	Sampaio	Line Name	Deodoro
Current Condition			
Entrance/ Approach		Location

119. Condition		120. Issues	
Entrance/ Exit	No directions for entrance, need a map or direction for exit.	<ul style="list-style-type: none"> > Safety hazard: level between the platform and the train; > Unsafe underground pathway for pedestrians; > Direction signs for entrance; > Lack of map or landmark information for exit; > Add general route mapping and info at platform; > Accessibility for disabled people. 	
Ticketing	Fare info with small letters.		
Platform	No direction signs on the floor, no board, no map.		
Other	No foreign language, no safety for users.

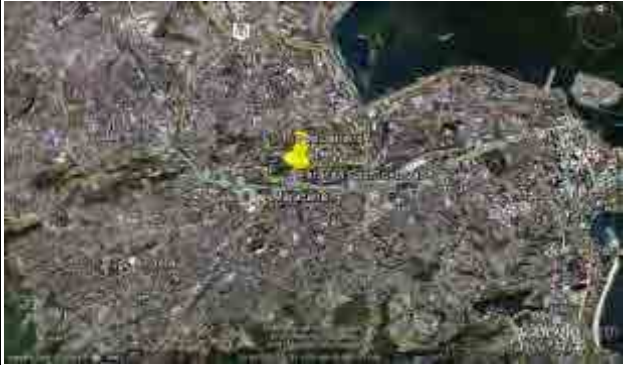
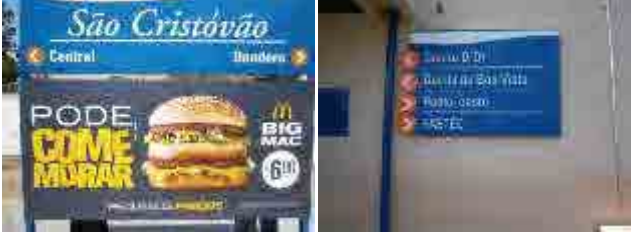
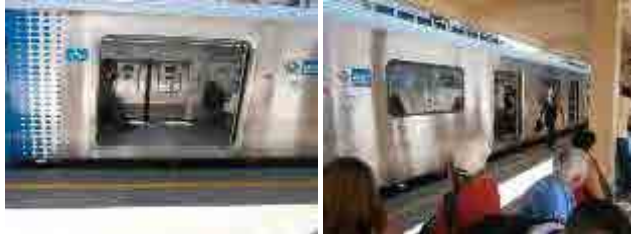
No.	62	Mode	Rail
Survey Date	17/09/12	Name of St.	São Cristóvão
Area	São Cristóvão	Line Name	Deodoro
Current Condition			
Entrance/ Approach		Location

123. Condition		124. Issues	
Entrance/ Exit	No directions for entrance, no exit sign outside station.	<ul style="list-style-type: none"> > Safety hazard: level between the platform and the train; > Direction signs for entrance; > Lack of map or landmark information for exit; > Add general route mapping and info at platform; > Accessibility for disabled people. 	
Ticketing	Fare info with small letters.		
Platform	No direction signs on the floor, no board, no map.		
Other	No foreign language. No ramps for disabled people.

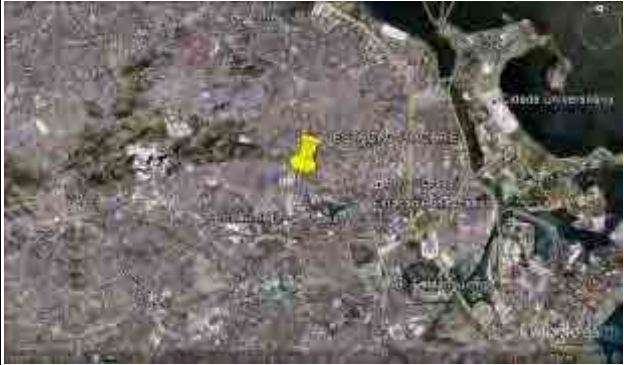
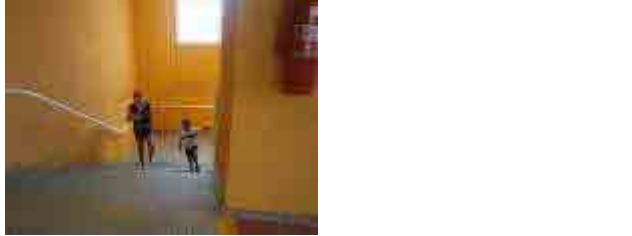
No.	69	Mode	Cable Car
Survey Date	19/09/12	Name of St.	Itacaré
Area		Line Name	
Current Condition			
Entrance/ Approach		Location

Description			
137. Condition		138. Issues	
Entrance/ Exit	Guided pathway.	> Add general route mapping and info at platform.	
Ticketing	<No photo>		
Platform	No map.		
Other	Almost no foreign language, Small character size. No fare info outside box office.

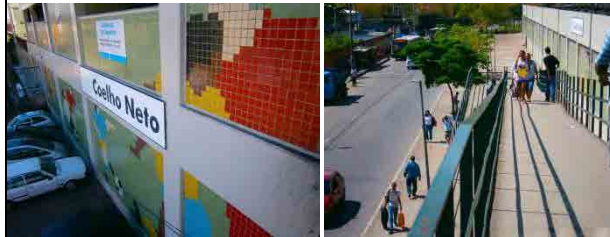
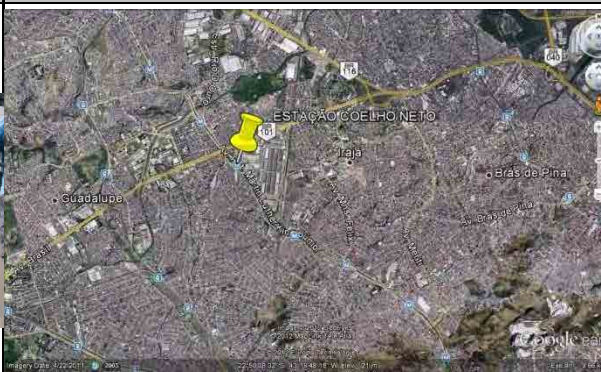
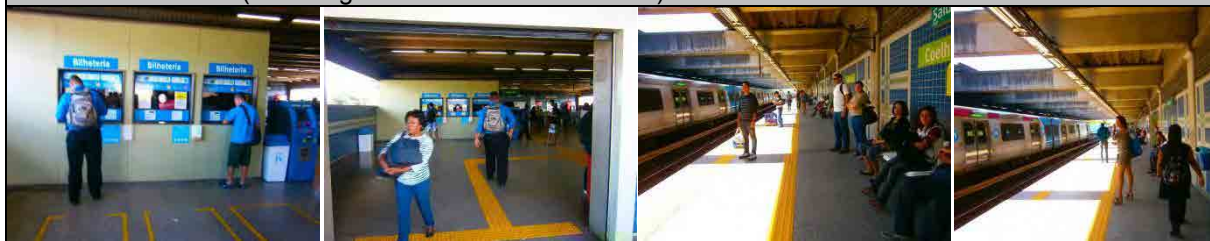
1. Condition		2. Issues
Entrance/ Exit	No directions for entrance, no exit sign outside station.	<ul style="list-style-type: none"> > Direction signs for entrance; > Few direction signs and no for lift; > Add general route mapping, info and train arrival time at platform. > Small size signs and poor visualization.
Ticketing	Totem for card recharge. Lack of general route/system info.	
Platform	Lack of maps and direction information.	
Other	Almost no foreign language, Small character size. No travel time info. No fare info outside box office.

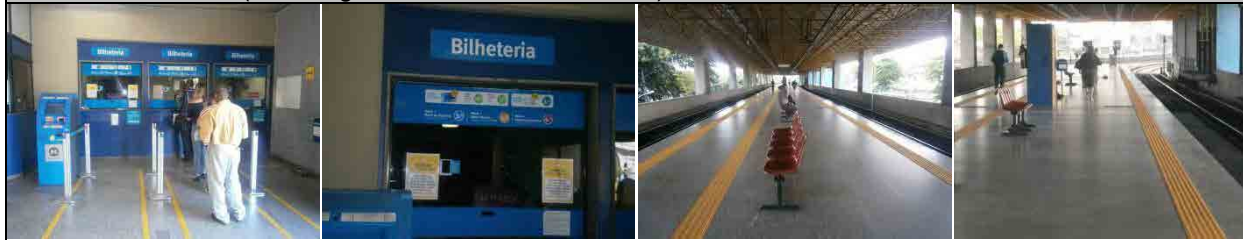
1. Condition		2. Issues
Entrance/ Exit	No directions for entrance, no exit sign outside station.	<ul style="list-style-type: none"> > Direction signs for entrance; > Add general route mapping, info and train arrival time at platform. > Add more seats for users.
Ticketing	Totem for card recharge. Lack of general route/system info.	
Platform	Lack of maps and direction information. Few seat for users.	
Other	Almost no foreign language, Small character size. No travel time info. No fare info outside box office.

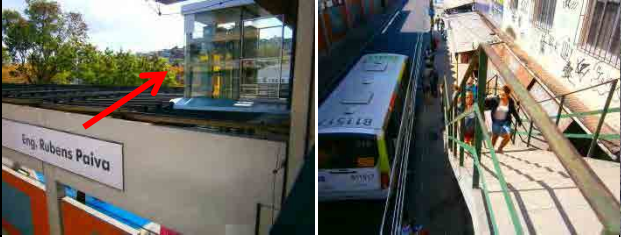
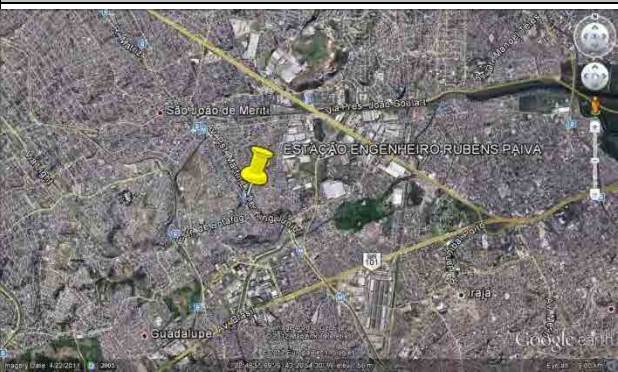
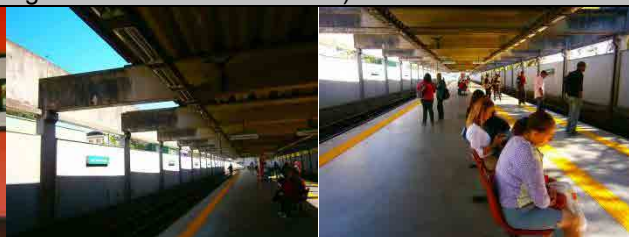
No.	04	Mode	Metro
Survey Date	28/09/12	Name of St.	Engenheiro Rubens Paiva
Area	Pavuna	Line Name	Green
Current Condition			
Entrance/ Approach		Location

1. Condition		2. Issues	
Entrance/ Exit	No directions for entrance, no exit sign outside station. Old access ladder.	<ul style="list-style-type: none"> > Reforming ladder; > Direction signs for entrance; > Lack of map or landmark information for exit; > Add general route mapping, info and train arrival time at platform. > Small size signs. 	
Ticketing	Totem for card recharge. Lack of general route/system info.		
Platform	Lack of maps and direction information. Few seat for users.		
Other	Almost no foreign language, Small character size. No travel time info. No fare info outside box office.

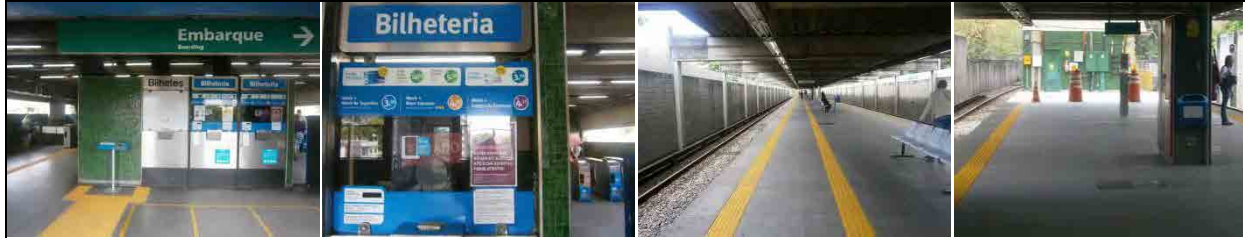
1. Condition		2. Issues
Entrance/ Exit	Poor entrance identification, no naming of the exit.	<ul style="list-style-type: none"> > Improve entrance/exit identification; > Direction signs for entrance; > Improve sign visualization at platform; > Lack of map or landmark information for exit; > Add general route mapping, info and train arrival time at platform.
Ticketing	Totem for card recharge. Lack of general route/system info.	
Platform	Lack of maps and direction information. Poor sign visualization.	
Other	Almost no foreign language, Small character size. No travel time info. No fare info outside box office.

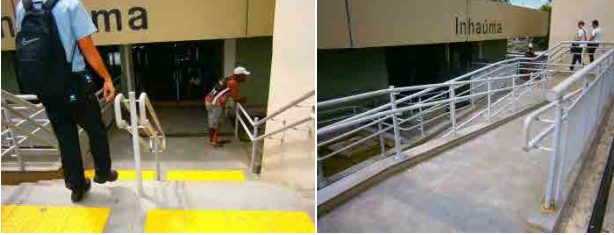
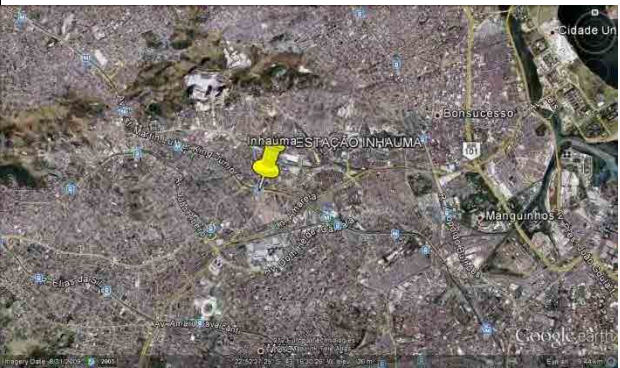
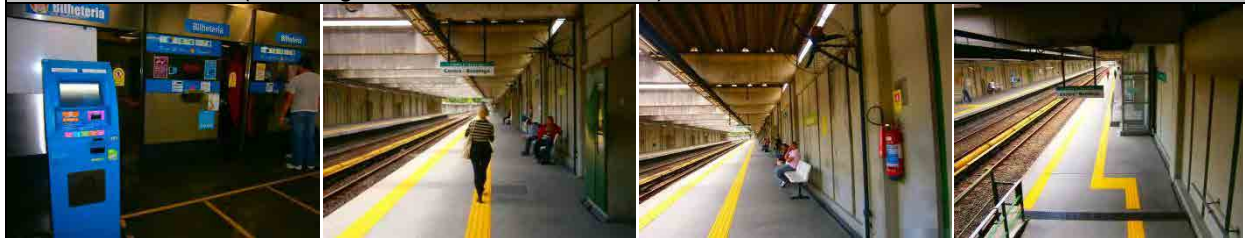
1. Condition		2. Issues
Entrance/ Exit	No directions for entrance, no exit sign outside station.	<ul style="list-style-type: none"> > Direction signs for entrance; > Improve sign visualization at platform; > Lack of map or landmark information for exit; > Add general route mapping, info and train arrival time at platform.
Ticketing	Totem for card recharge. Lack of general route/system info.	
Platform	Lack of maps and direction information.	
Other	Almost no foreign language, Small character size. No travel time info. No fare info outside box office.

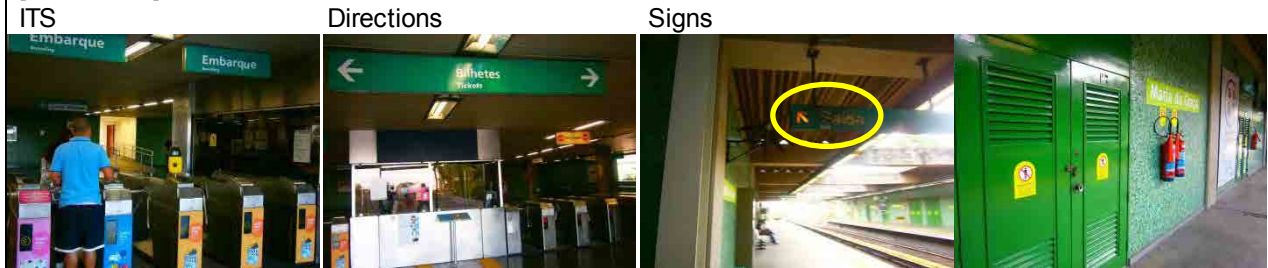
1. Condition		2. Issues
Entrance/ Exit	No directions for entrance, no exit sign outside station.	<ul style="list-style-type: none"> > Direction signs for entrance; > Improve sign visualization at platform; > Lack of map or landmark information for exit; > Add general route mapping, info and train arrival time at platform.
Ticketing	Totem for card recharge. Lack of general route/system info.	
Platform	Lack of maps and direction information. Poor visualization sign.	
Other	Almost no foreign language, Small character size. No travel time info. No fare info outside box office.

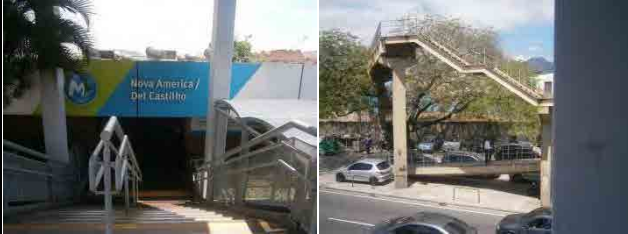
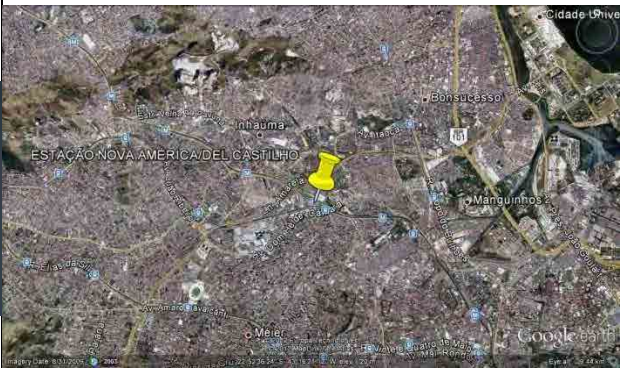
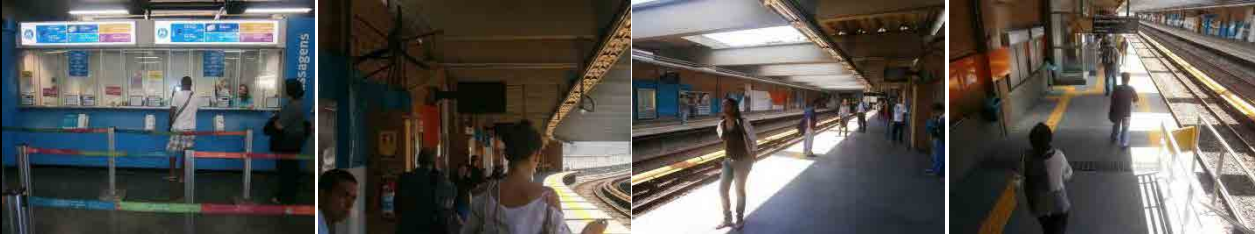
No.	09	Mode	Metro
Survey Date	28/09/12	Name of St.	Nova America_Del Castilho
Area	Del Castilho	Line Name	Green
Current Condition			
Entrance/ Approach		Location

1. Condition		2. Issues	
Entrance/ Exit	No directions for entrance, no exit sign outside station.	<ul style="list-style-type: none"> > Direction signs for entrance; > Improve sign visualization at platform; > Lack of map or landmark information for exit; > Add general route mapping, info and train arrival time at platform. 	
Ticketing	Totem for card recharge. Lack of general route/system info.		
Platform	Lack of maps and direction information.		
Other	Almost no foreign language, Small character size. No travel time info. No fare info outside box office.

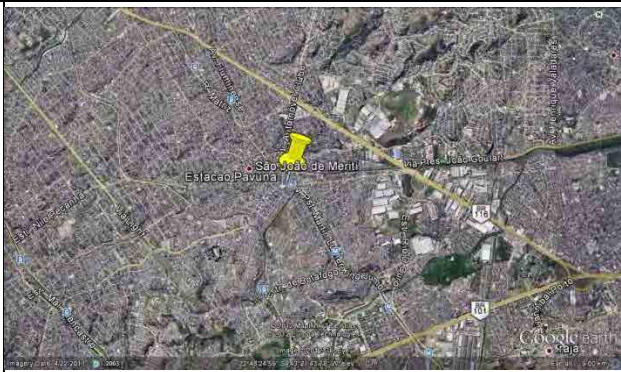
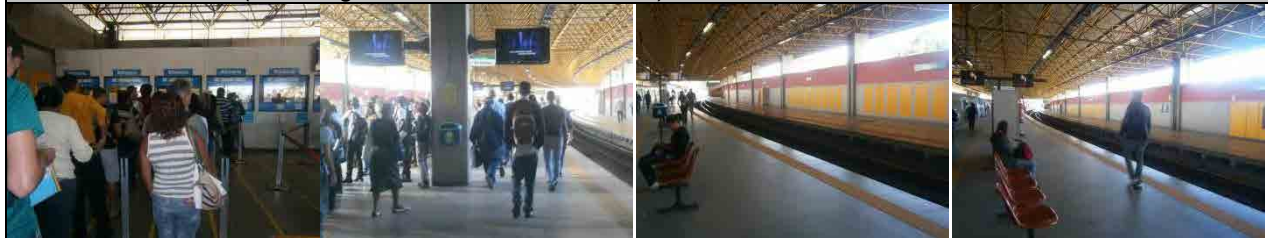
1. Condition		2. Issues
Entrance/ Exit	No directions for entrance, no exit sign outside station.	<ul style="list-style-type: none"> > Direction signs for entrance; > Improve sign visualization at platform; > Lack of map or landmark information for exit; > Add general route mapping, info and train arrival time at platform.
Ticketing	Totem for card recharge. Lack of general route/system info. Line formation.	
Platform	Lack of maps and direction information.	
Other	Almost no foreign language, Small character size. No travel time info. No fare info outside box office.

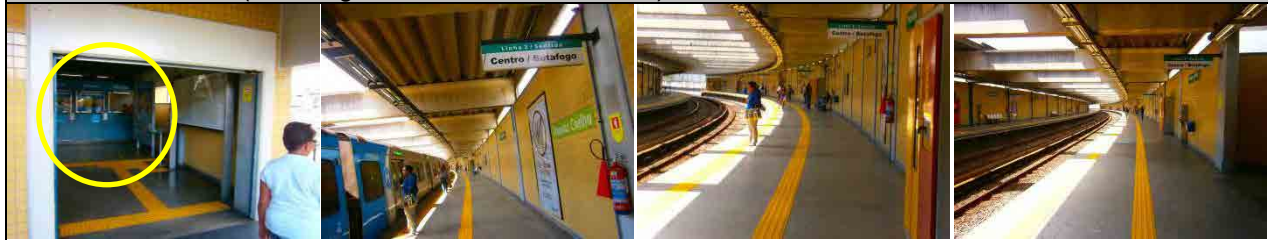
1. Condition		2. Issues
Entrance/ Exit	No directions for entrance, no exit sign outside station.	<ul style="list-style-type: none"> > Improve entrance/exit identification; > Direction signs for entrance; > Lack of map or landmark information for exit; > Add general route mapping, info and train arrival time at platform.
Ticketing	Totem for card recharge. Lack of general route/system info.	
Platform	Lack of maps and direction information.	
Other	Almost no foreign language, Small character size. No travel time info. No fare info outside box office.
