APPENDIX 6

Result of Accessibility Survey in Rio de Janeiro

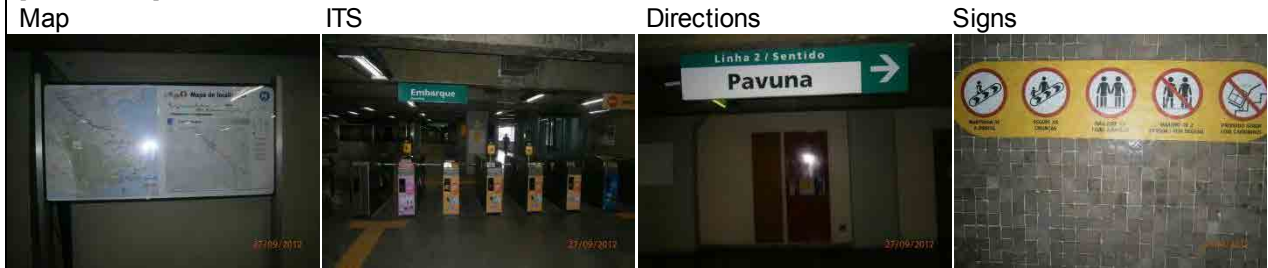
1. Condition		2. Issues
Entrance/ Exit	No directions for entrance, no exit sign outside station.	<ul style="list-style-type: none"> > Improve entrance/exit identification; > Direction signs for entrance; > Improve sign visualization at platform; > Lack of map or landmark information for exit; > Add general route mapping, info and train arrival time at platform.
Ticketing	Totem for card recharge. Lack of general route/system info.	
Platform	Lack of maps and direction information.	
Other	Almost no foreign language, Small character size. No travel time info. No fare info outside box office.

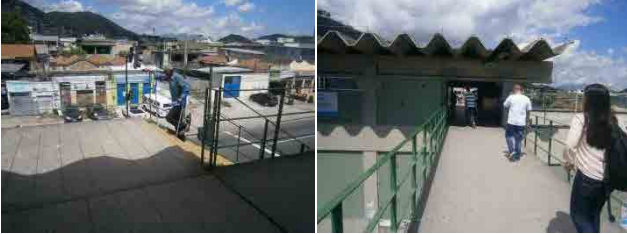
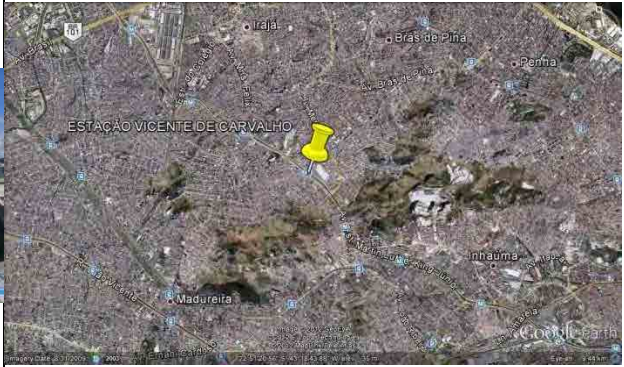
No.	13	Mode	Metro
Survey Date	28/09/12	Name of St.	Vicente de Carvalho
Area	Vicente de Carvalho	Line Name	Green
Current Condition			
Entrance/ Approach		Location

Description			
1. Condition		2. Issues	
Entrance/ Exit	No directions for entrance, no exit sign outside station.	<ul style="list-style-type: none"> > Improve entrance/exit identification; > Direction signs for entrance; > Improve sign visualization at platform; > Lack of map or landmark information for exit; > Add general route mapping, info and train arrival time at platform. 	
Ticketing	Totem for card recharge. Lack of general route/system info.		
Platform	Lack of maps and direction information.		
Other	Almost no foreign language, Small character size. No travel time info. No fare info outside box office.

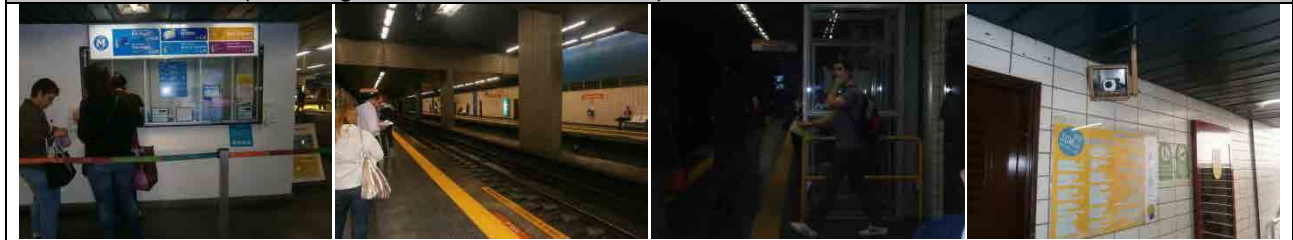
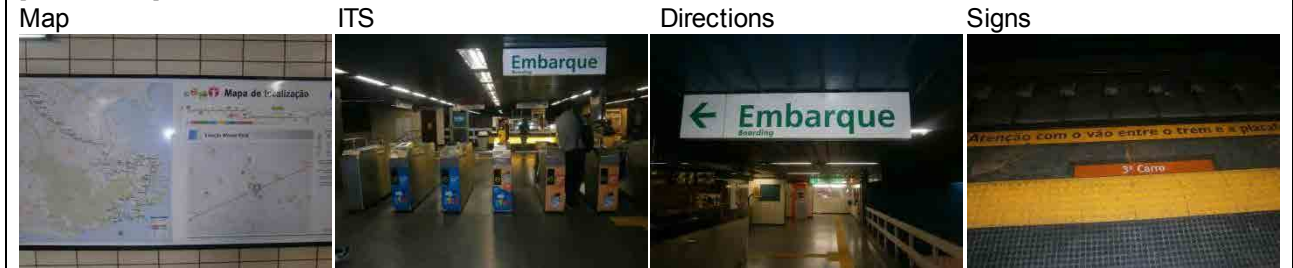
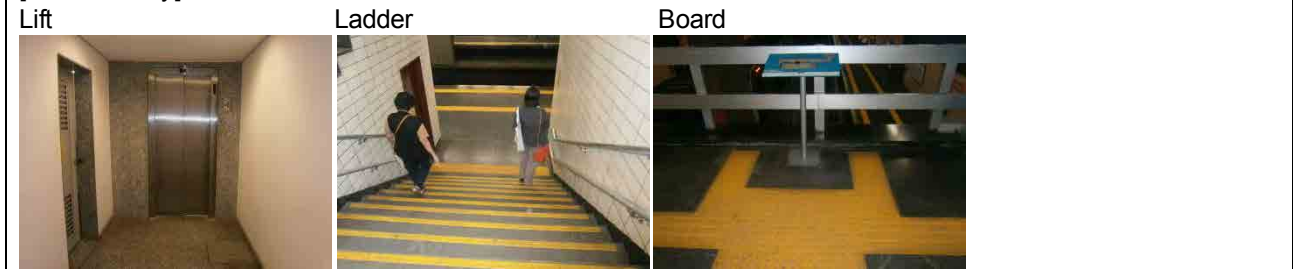
1. Condition		2. Issues
Entrance/ Exit	No directions for entrance.	<ul style="list-style-type: none"> > Direction signs for entrance; > Lack of map or landmark information for exit; > Add general route mapping, info and train arrival time at platform.
Ticketing	Totem for card recharge. Lack of general route/system info.	
Platform	Some maps and direction information.	
Other	Almost no foreign language, Small character size. No travel time info. No fare info outside box office.

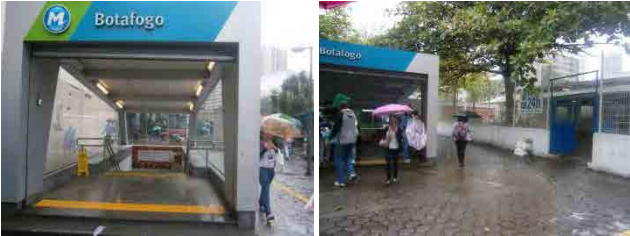
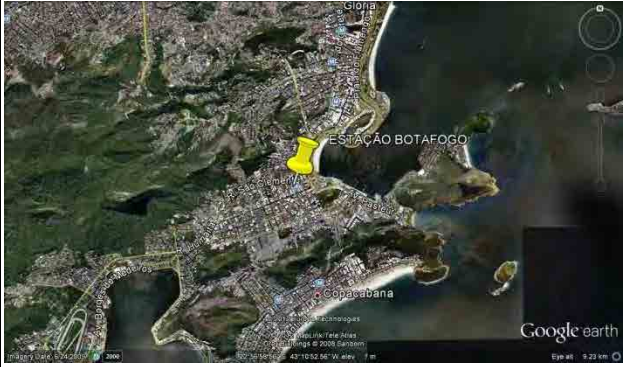
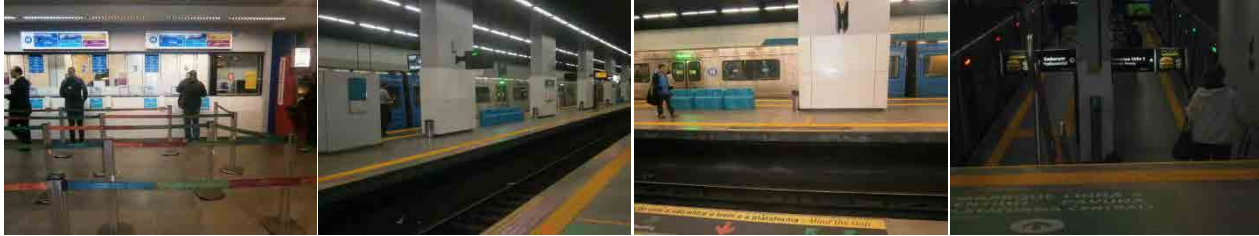
No.	15	Mode	Metro
Survey Date	26/09/12	Name of St.	Botafogo
Area	Botafogo	Line Name	Orange
Current Condition			
Entrance/ Approach		Location

Description			
1. Condition		2. Issues	
Entrance/ Exit	No directions for entrance, no exit sign outside station.	<ul style="list-style-type: none"> > Direction signs for entrance; > Lack of map or landmark information for exit; > Improve entrance and exit accessibility for disabled users. 	
Ticketing	Totem for card recharge. Lack of general route/system info.		
Platform	Good direction information and map.		
Other	No travel time info. No fare info outside box office.

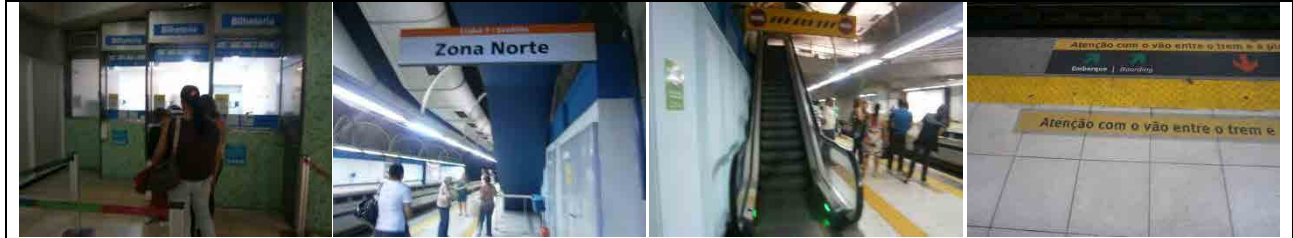
1. Condition		2. Issues
Entrance/ Exit	Good signalization.	<ul style="list-style-type: none"> > Add general route mapping, info and train arrival time at platform. > Good entrance, exit and embankment accessibility.
Ticketing	Totem for card recharge. Lack of general route/system info.	
Platform	Lack of maps, but good direction information.	
Other	No travel time info. No fare info outside box office.

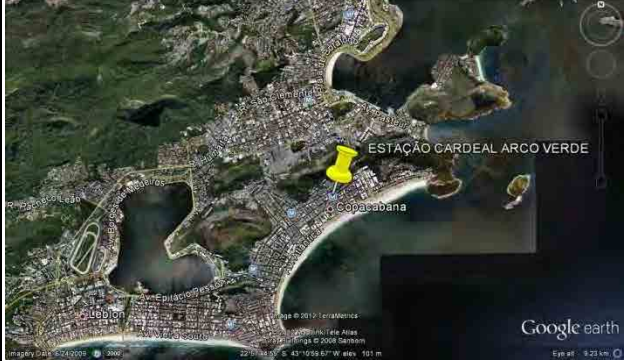
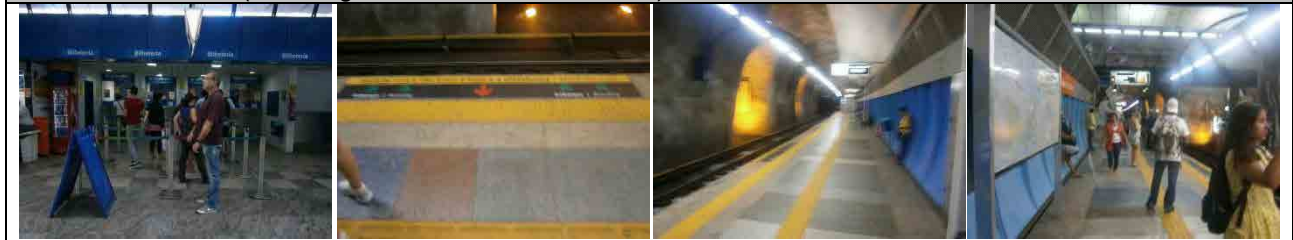
1. Condition		2. Issues
Entrance/ Exit	Good signalization.	<ul style="list-style-type: none"> > Lack of map or landmark information for exit; > Add general route mapping, info and train arrival time at platform. > Good accessibility for disabled users.
Ticketing	Totem for card recharge. Lack of general route/system info.	
Platform	Lack of maps and direction information.	
Other	Almost no foreign language, Small character size. No travel time info. No fare info outside box office.
