No.	18	Mode	Metro
Survey Date	26/09/12	Name of St.	Carioca
Area	Centro	Line Name	Orange

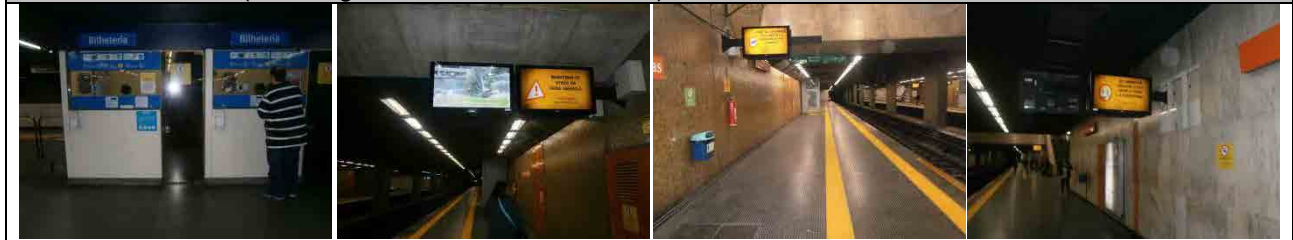
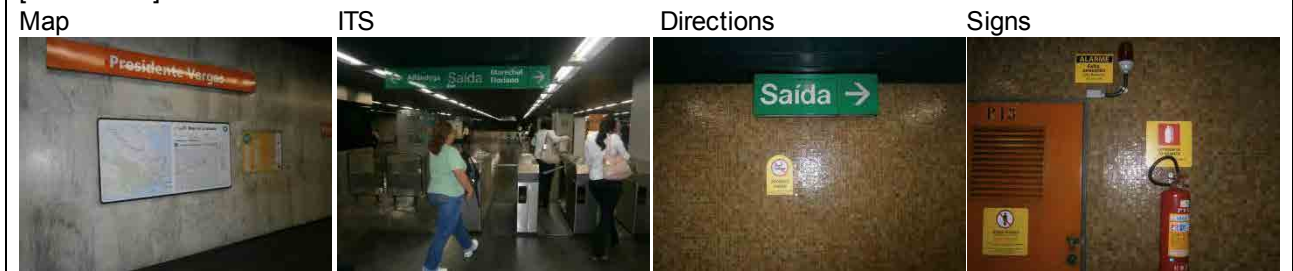
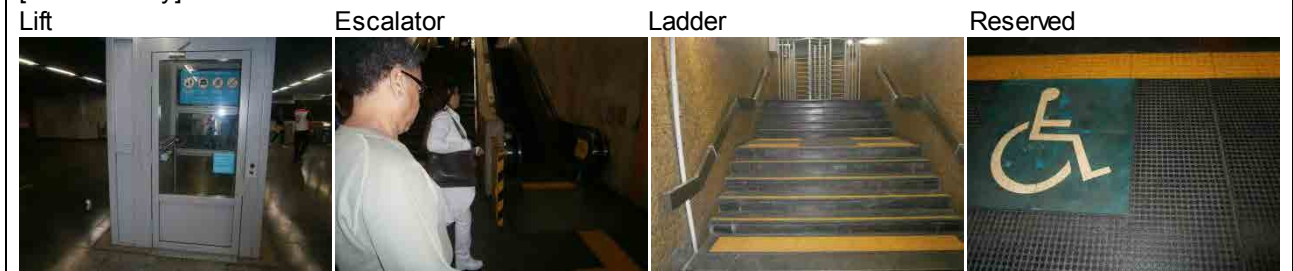
1. Condition		2. Issues
Entrance/ Exit	No directions for entrance, no exit sign outside station.	<ul style="list-style-type: none"> > Direction signs for entrance; > Lack of map or landmark information for exit; > Add general route mapping, info and train arrival time at platform.
Ticketing	Totem for card recharge. Lack of general route/system info.	
Platform	Lack of maps and direction information.	
Other	Almost no foreign language, Small character size. No travel time info. No fare info outside box office.

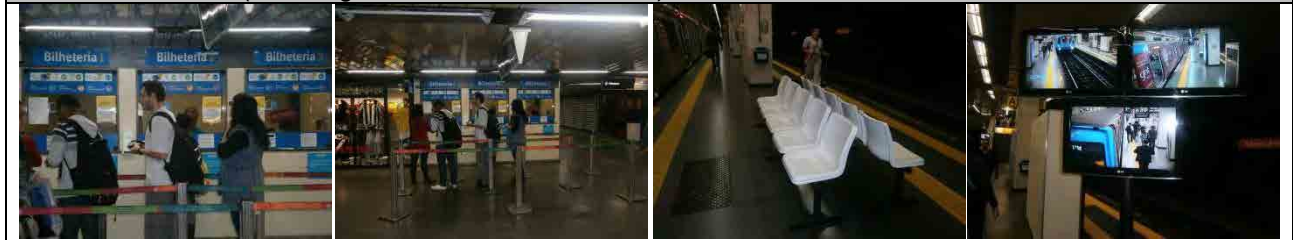
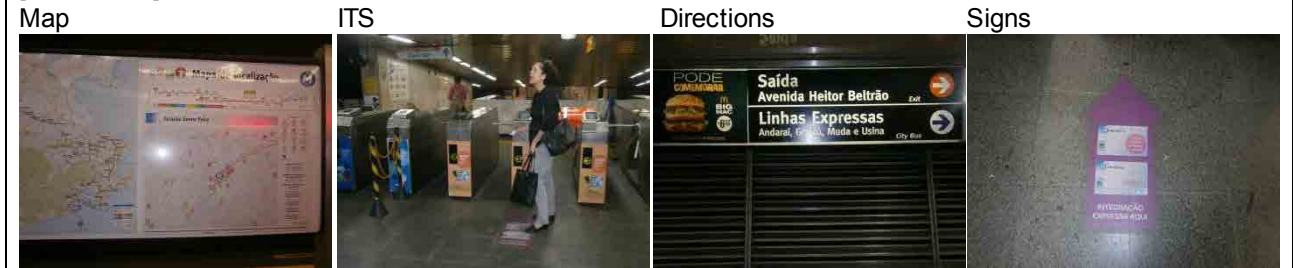
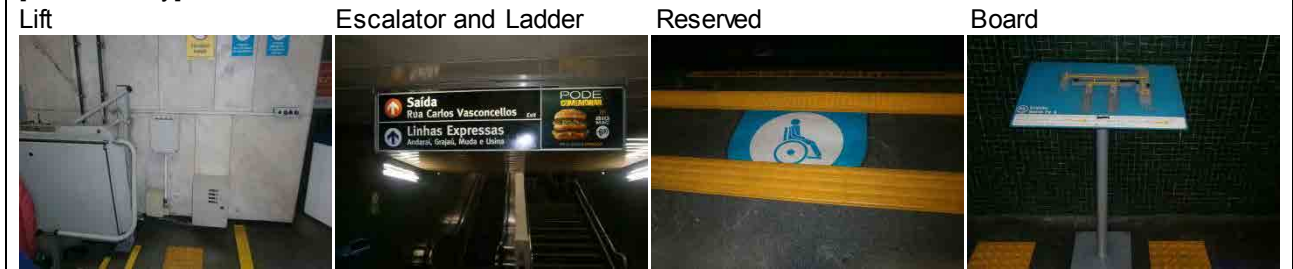
1. Condition		2. Issues
Entrance/ Exit	No directions for entrance, no exit sign outside station.	<ul style="list-style-type: none"> > Improve entrance/exit identification; > Direction signs for entrance; > Lack of map or landmark information for exit; > Add general route mapping, info and train arrival time at platform.
Ticketing	Totem for card recharge. Lack of general route/system info.	
Platform	Lack of maps and direction information.	
Other	Almost no foreign language, Small character size. No travel time info. No fare info outside box office.

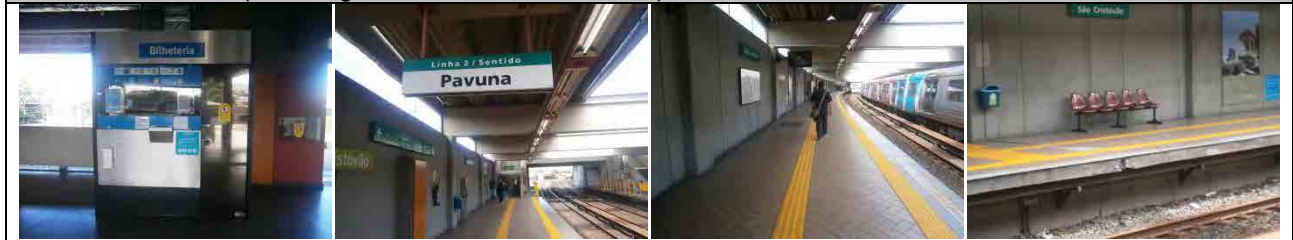
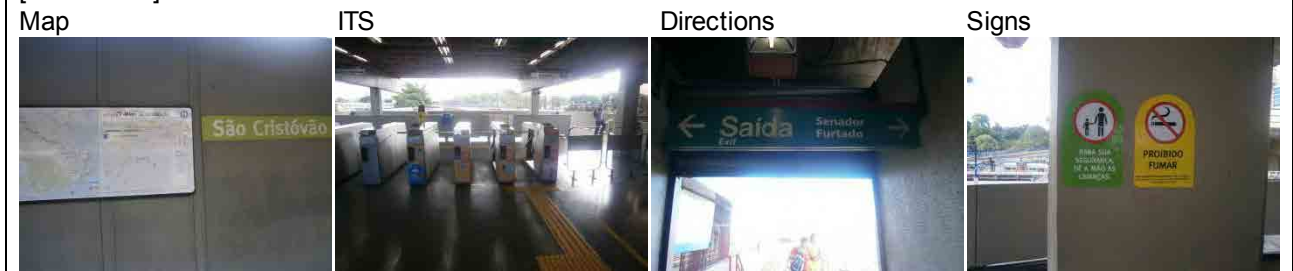
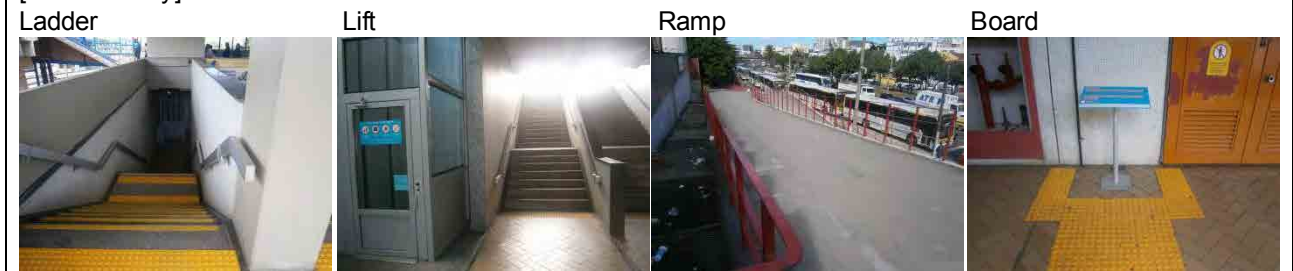
1. Condition		2. Issues
Entrance/ Exit	No directions for entrance, no exit sign outside station.	<ul style="list-style-type: none"> > Direction signs for entrance; > Add general route mapping, info and train arrival time at platform.
Ticketing	Totem for card recharge. Lack of general route/system info.	
Platform	Lack of maps and direction information.	
Other	Almost no foreign language, Small character size. No travel time info. No fare info outside box office.

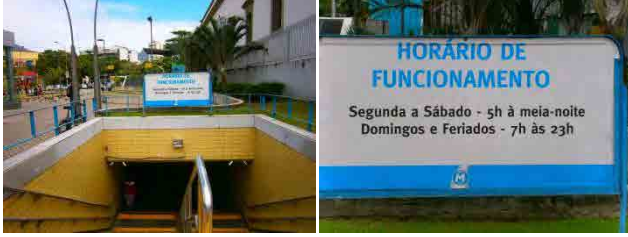
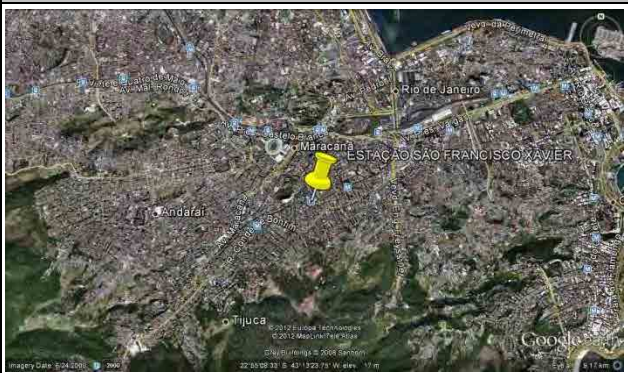
Description			
1. Condition		2. Issues	
Entrance/ Exit	No directions and name for entrance, no exit sign outside station.	<ul style="list-style-type: none"> > Improve identification in the entrance; > Direction signs for entrance; > Lack of map or landmark information for exit. 	
Ticketing	Totem for card recharge. Lack of general route/system info.		
Platform	<No photo>		
Other	Almost no foreign language, Small character size. No travel time info. No fare info outside box office.

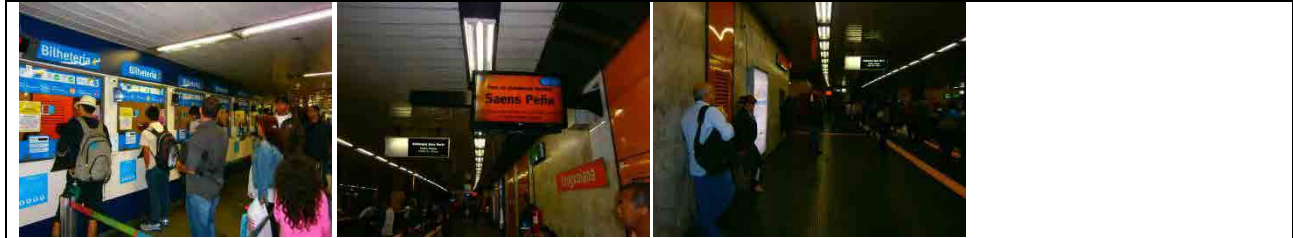
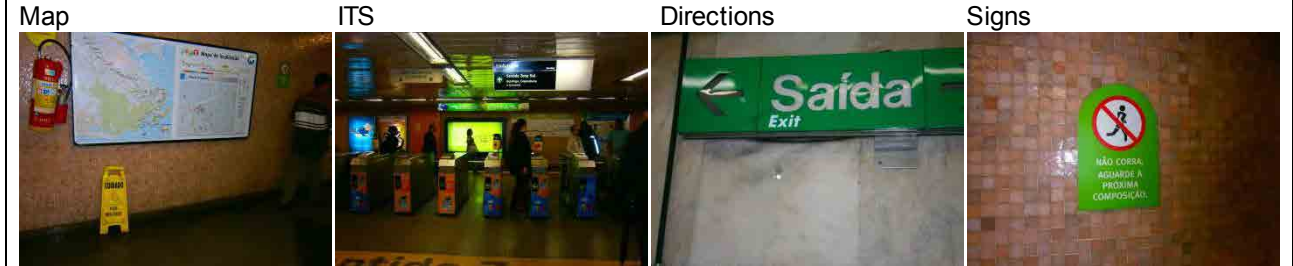
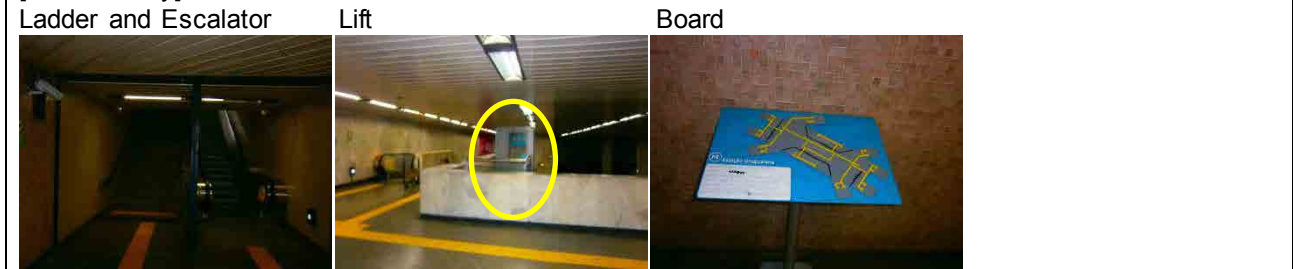
1. Condition		2. Issues
Entrance/ Exit	No directions for entrance, no exit sign outside station.	<ul style="list-style-type: none"> > Improve entrance/exit identification; > Direction signs for entrance; > Lack of map or landmark information for exit; > Add general route mapping, info and train arrival time at platform.
Ticketing	Totem for card recharge. Lack of general route/system info.	
Platform	Lack of maps and direction information.	
Other	Almost no foreign language, Small character size. No travel time info. No fare info outside box office.

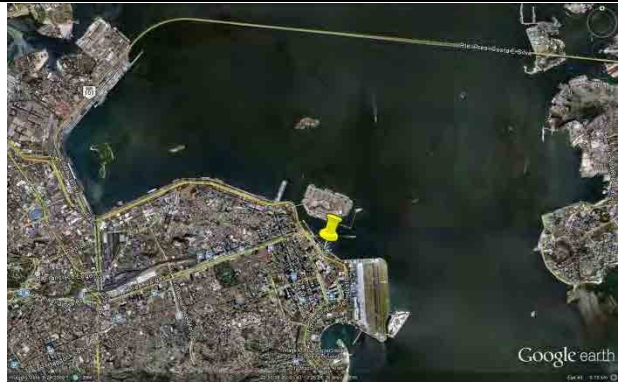
Equipment (Information and Accessibility)			
[Information]			
<p>Message</p>  		<p>Info Boards</p>  	
[Accessibility]			
<p>Signs</p>  		<p>Signs</p>  	
Description			
5. Condition		6. Issues	
Entrance/ Exit	Station under construction.	<p>> Local with great number of users, however with no signs in foreign language.</p> <p>> Good accessibility for users to move around the station. Place apparently clean and toilets for users.</p> <p>> No route map and time table available.</p>	
Ticketing	No messages in foreign language.		
Platform			
Other

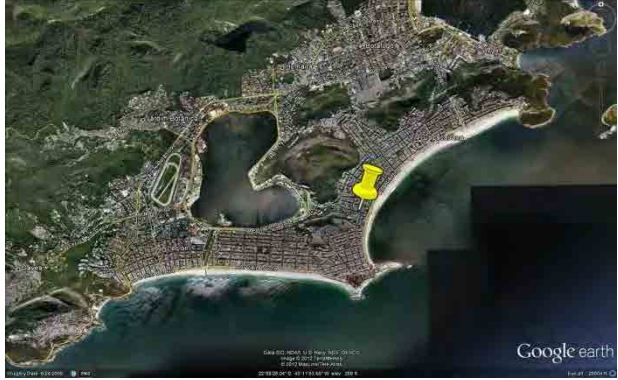
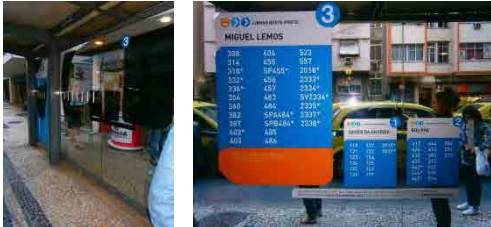
1. Condition	2. Issues
<p>Approach</p> <p>Damaged bus stop and/or info board.</p>	<p>> Dirty Bus Stop; Dirty and Ripped Boards; Bus Stop Without shelter; > Segregation of buses is confusing. No specific route and/or timetable info; > In general, vandalism and damaged of bus stops.</p>
<p>Ticketing</p> <p>Fare info not available/not visible at bus stop.</p>	
<p>Platform</p> <p>Lack of maintenance. Available route direction info.</p>	
<p>Other</p> <p>Bus stop with unsafe conditions for disabled people and/or general users. No messages/signs in foreign language.</p>

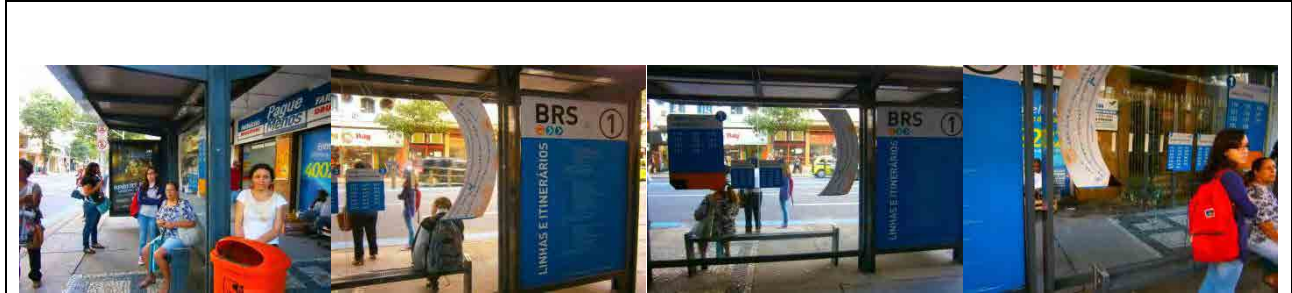
1. Condition		2. Issues
Approach	Damaged bus stop and/or info board.	<ul style="list-style-type: none"> > Dirty Bus Stop; Dirty Boards; > Bus Stop Boards Ripped; > Segregation of buses is confusing. No information availability.
Ticketing	No messages/signs in foreign language.	
Platform	Lack of maintenance. Available route direction info.	
Other	Safety hazard for some users.

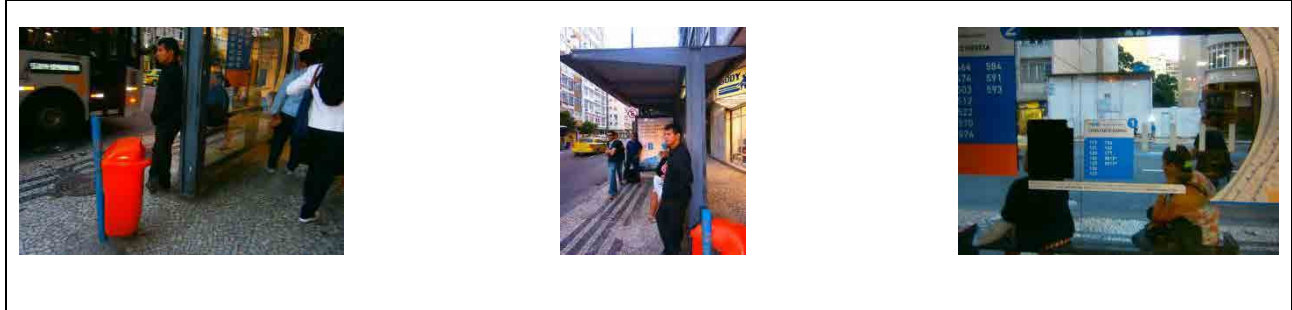
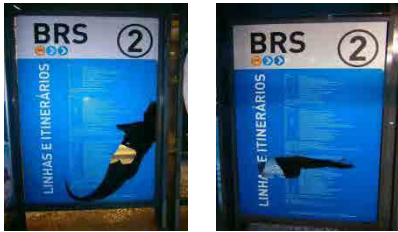
1. Condition		2. Issues	
Approach	Damaged bus stop and/or info board.	> Dirty and Ripped Bus Stop; Dirty Boards; Bus Stop Without seats; > Segregation of buses is confusing. No information availability.	
Ticketing	No messages/signs in foreign language.		
Platform	Lack of maintenance. Available route direction info.		
Other

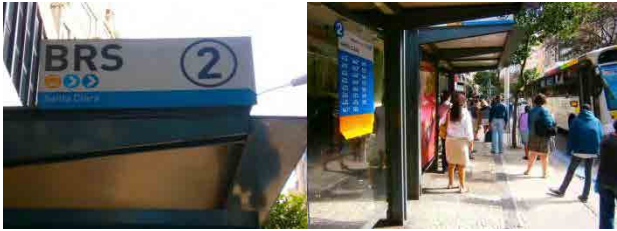
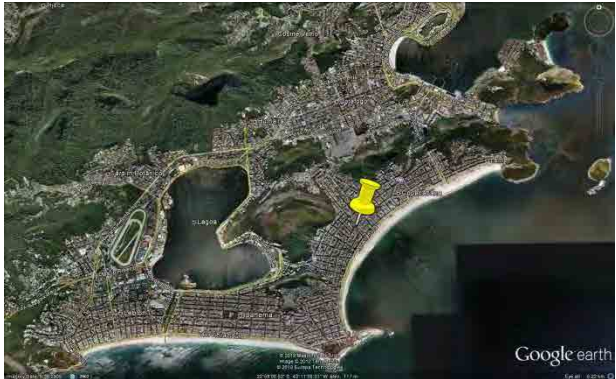
1. Condition		2. Issues
Approach	Damaged bus stop and/or info board.	<ul style="list-style-type: none"> > Dirty Bus Stop; Dirty and Ripped Boards; > Segregation of buses is confusing; > In general, vandalism and damaged of bus stops.
Ticketing	No messages/signs in foreign language.	
Platform	Lack of maintenance. Available route direction info.	
Other

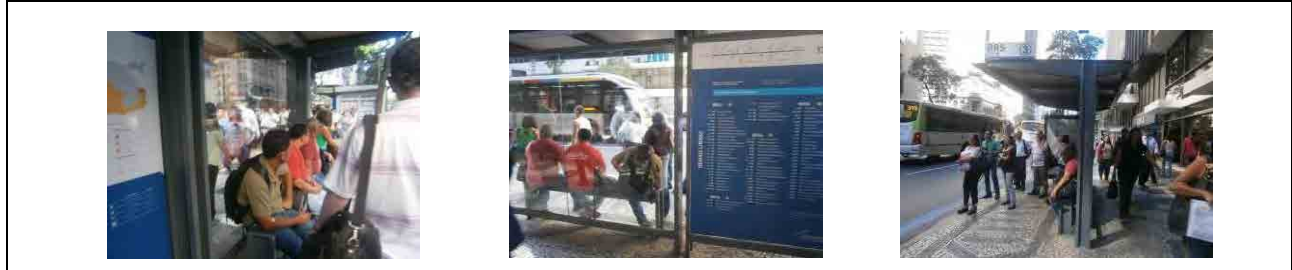
1. Condition		2. Issues
Approach	Damaged bus stop and/or info board.	<ul style="list-style-type: none"> > Dirty Bus Stop; Dirty Boards; > Segregation of buses is confusing. No specific route and/or timetable info; > In general, vandalism and damaged of bus stops; > No assistance for disabled people.
Ticketing	Fare info not available/not visible at bus stop.	
Platform	Lack of maintenance. Available route direction info.	
Other	No messages/signs in foreign language.

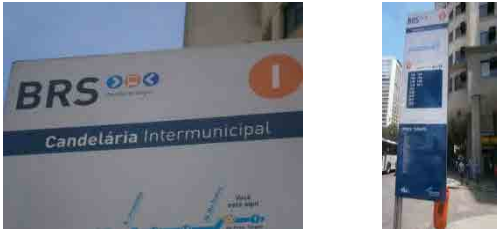
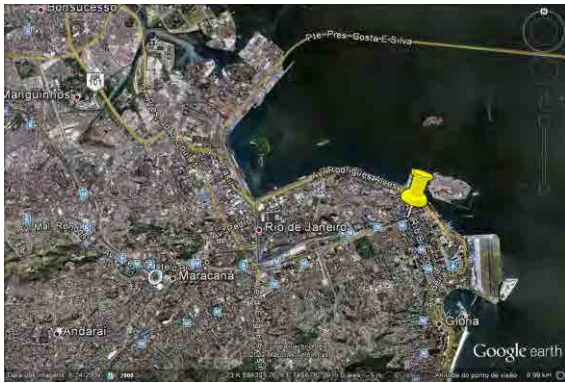
1. Condition		2. Issues	
Approach	Damaged bus stop and/or info board.	> Dirty Bus Stop; Dirty Boards; Bus Stop Without shelter; Boards ripped;	
Ticketing	Fare info not available/not visible at bus stop. Unsafe condition for disabled people and/or general users.	> Segregation of buses is confusing. No specific route and/or timetable info;	
Platform	Lack of maintenance. Bus Stop Without shelter; Without Seats.	> In general, vandalism and damaged of bus stops.	
Other	No messages/signs in foreign language. Bus stop with unsafe conditions for disabled people and/or general users.

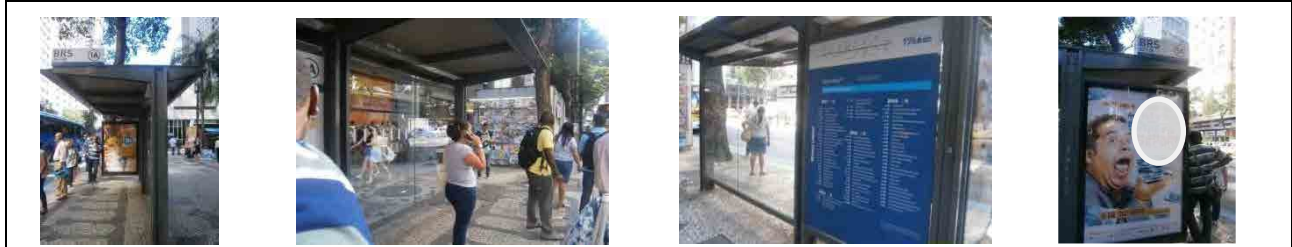
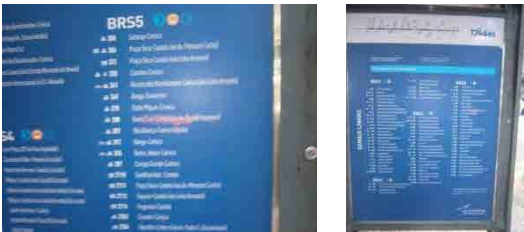
1. Condition	2. Issues
Approach	<ul style="list-style-type: none"> > Dirty Bus Stop; Dirty Boards; No seats; > Segregation of buses is confusing; > In general, vandalism and damaged of bus stops.
Ticketing	
Platform	
Other

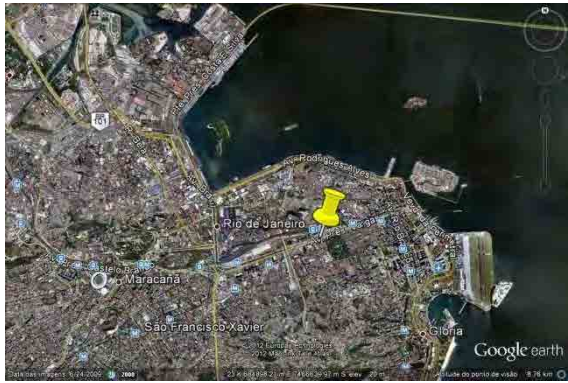
Description	
1. Condition	2. Issues
Approach	<ul style="list-style-type: none"> > Dirty Bus Stop; Dirty Boards; > Segregation of buses is confusing; > In general, vandalism and damaged of bus stops; > Bus Stop Without Seat.
Ticketing	
Platform	
Other

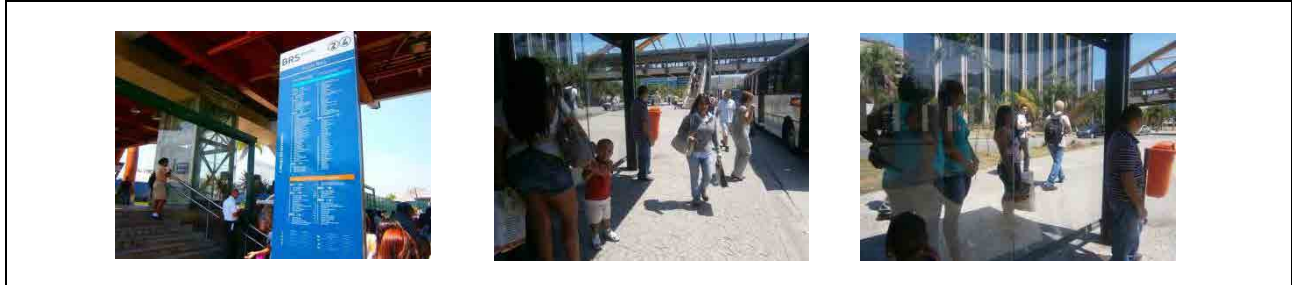
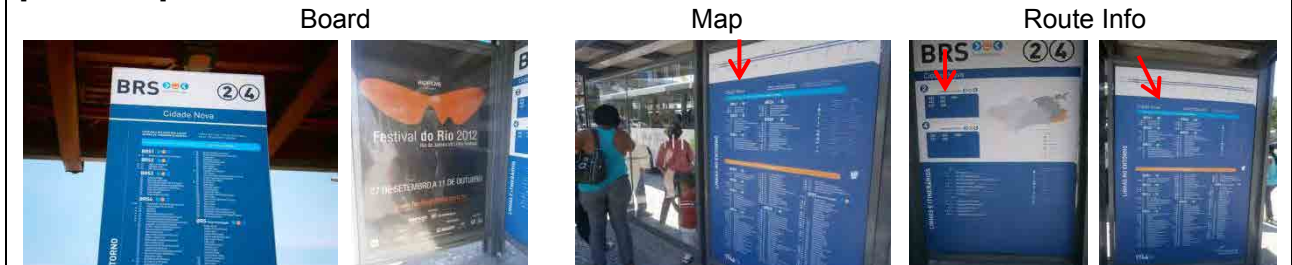
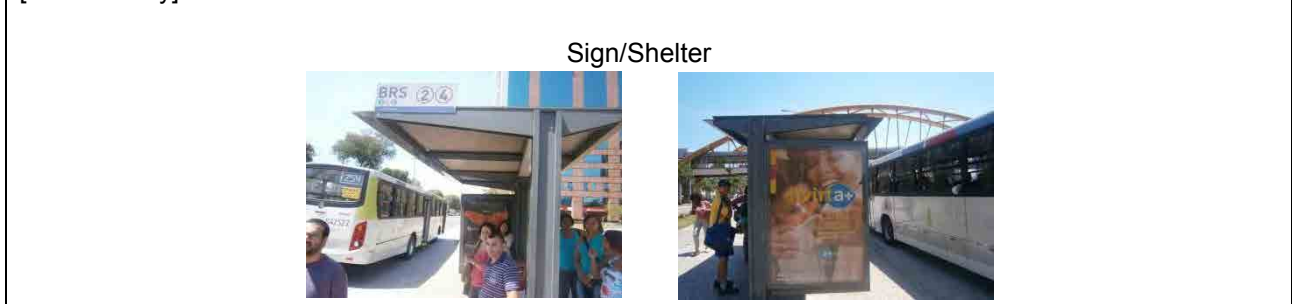
1. Condition		2. Issues
Approach	Damaged bus stop and/or info board.	<ul style="list-style-type: none"> > Dirty Bus Stop; Dirty Boards; > Segregation of buses is confusing; > In general, vandalism and damaged of bus stops; > No seats.
Ticketing	Fare info not available/not visible at bus stop. Unsafe condition for disabled people and/or general users.	
Platform	Lack of maintenance.	
Other	No messages/signs in foreign language.

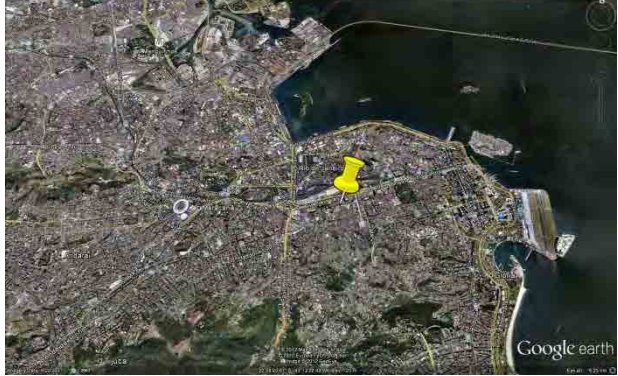
Entrance/ Approach	Location

Description	
1. Condition	2. Issues
Approach	Damaged bus stop and/or info board.
Ticketing	No messages/signs in foreign language.
Platform	Lack of maintenance.
Other	
	<ul style="list-style-type: none"> > Dirty Bus Stop; Dirty Boards; Bus Stop Without shelter and seats; > Segregation of buses is confusing. No information availability; > Safety hazard for some users.

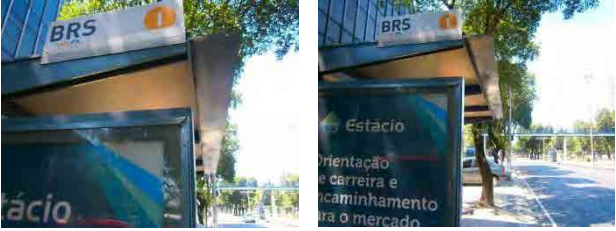
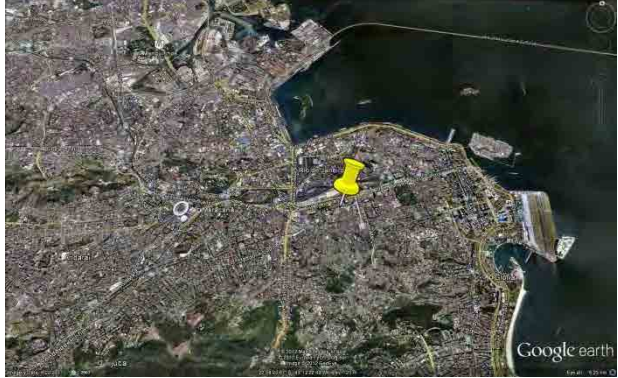
Entrance/ Approach	Location

1. Condition		2. Issues	
Approach	Damaged bus stop and/or info board.	> Dirty Bus Stop; Dirty Boards; Bus Stop Without seats; > Segregation of buses is confusing. No information availability.	
Ticketing	No messages/signs in foreign language.		
Platform	Lack of maintenance.		
Other
