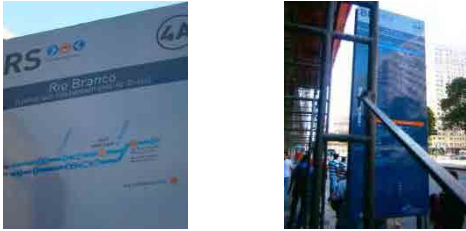
No.	26	Mode	BRS
Survey Date	02/10/2012	Name of St.	Rio Branco
Area	Centro (Downtown)	Line Name	4 A
Current Condition			
Entrance/ Approach		Location

Description			
1. Condition		2. Issues	
Approach	Damaged bus stop and/or info board.	<ul style="list-style-type: none"> > Bus Stop without seats and shelter; > Segregation of buses is confusing. No information availability; > Safety hazard for some users; Construction zone around bus stop. No protection for pedestrian. 	
Ticketing	No messages/signs in foreign language.		
Platform	Lack of maintenance.		
Other	No timetable.

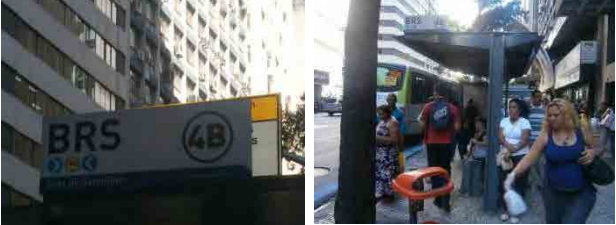
1. Condition		2. Issues
Approach	Damaged bus stop and/or info board.	<ul style="list-style-type: none"> > Dirty Bus Stop; Dirty and Ripped Boards; > Segregation of buses is confusing; > In general, damaged of bus stops.
Ticketing	No messages/signs in foreign language.	
Platform	Lack of maintenance.	
Other

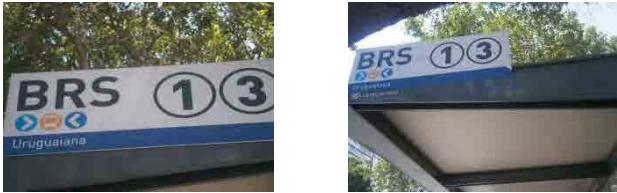
1. Condition		2. Issues	
Approach	Damaged bus stop and/or info board.	<ul style="list-style-type: none"> > Dirty Bus Stop; Dirty and Ripped Boards; > Segregation of buses is confusing. No specific route and/or timetable info; > In general, vandalism and damaged of bus stops. 	
Ticketing	No messages/signs in foreign language.		
Platform	Lack of maintenance. Bus Stop Without Seats.		
Other	Bus stop with unsafe conditions for disabled people and/or general users.

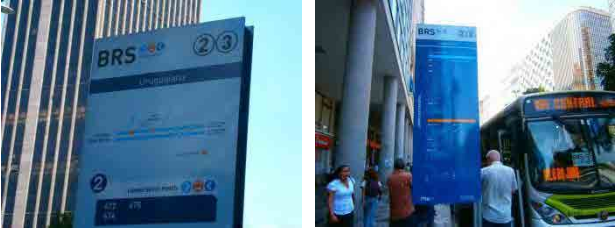
No.	34	Mode	BRS
Survey Date	02/10/2012	Name of St.	Uruguaiana
Area	Centro (Downtown)	Line Name	2 - 3
Current Condition			
Entrance/ Approach		Location

Description			
1. Condition		2. Issues	
Approach	Poor visualization.	<ul style="list-style-type: none"> > Segregation of buses is confusing. No specific route and/or timetable info; > Bus Stop Without shelter. 	
Ticketing	No messages/signs in foreign language.		
Platform	Lack of maintenance. Bus Stop Without Seats.		
Other	Bus stop with unsafe conditions for disabled people and/or general users.

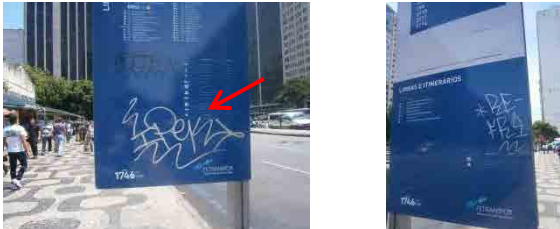
[Information]	
<p>Route Info/Vandalism</p>

1. Condition		2. Issues
Approach	Damaged bus stop and/or info board.	<ul style="list-style-type: none"> > Segregation of buses is confusing. No specific route and/or timetable info; > In general, vandalism and damaged of bus stops.
Ticketing	No messages/signs in foreign language.	
Platform	Lack of maintenance. Bus Stop Without Shelter.	
Other	Bus stop with unsafe conditions for disabled people and/or general users.

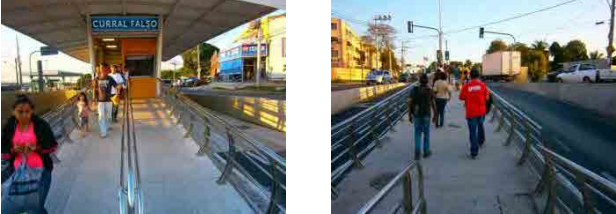
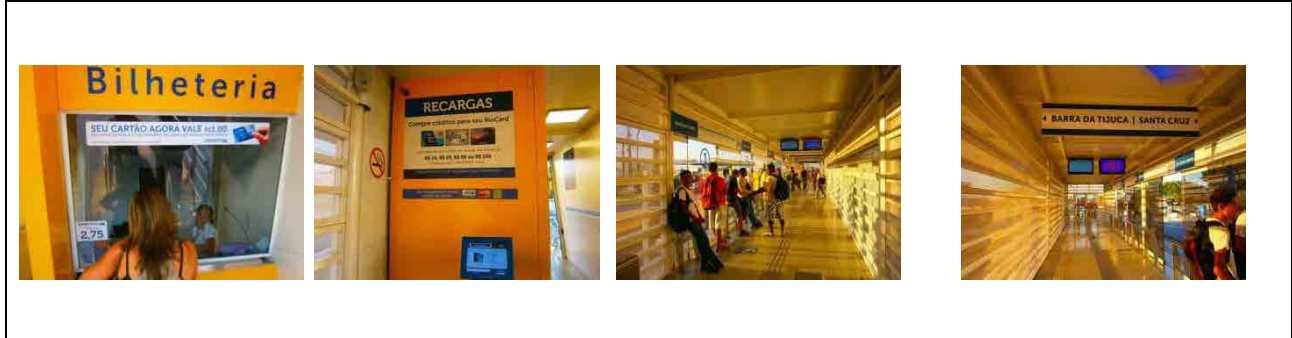
1. Condition		2. Issues	
Approach	Few direction signs and no maps outside platform.	>No BRT station signs on vicinity area; > No messages/signs in foreign language.	
Ticketing			
Platform	Few Seats.		
Other

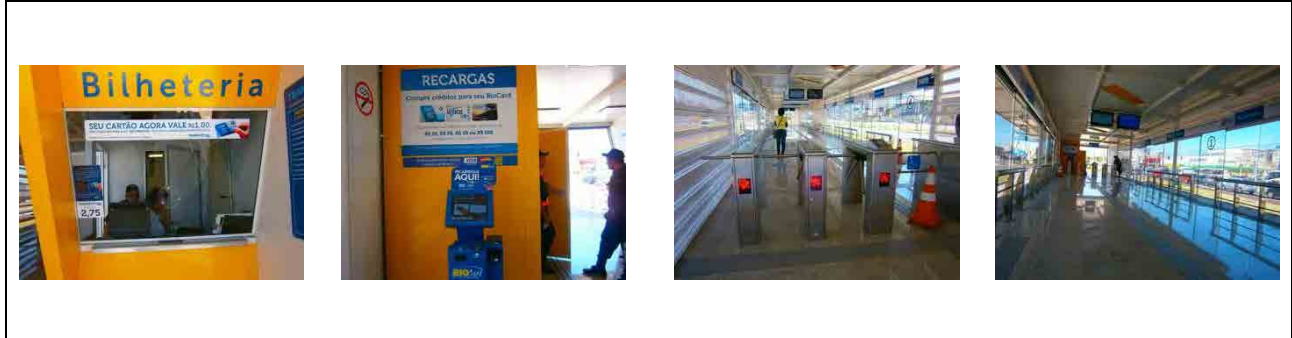
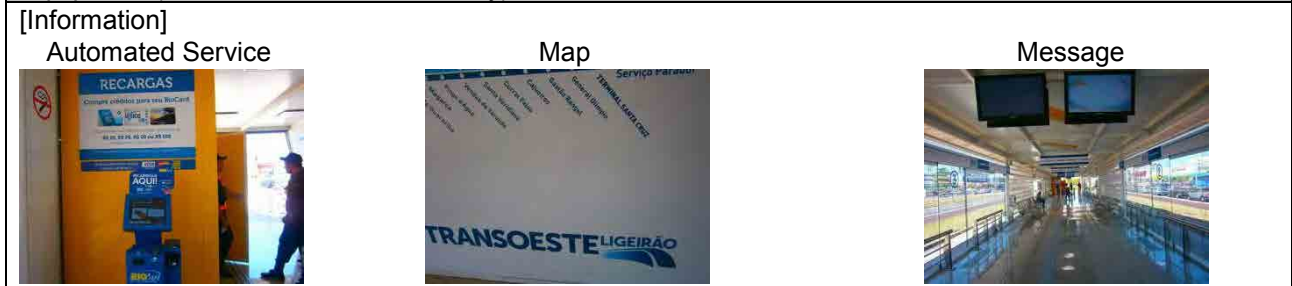
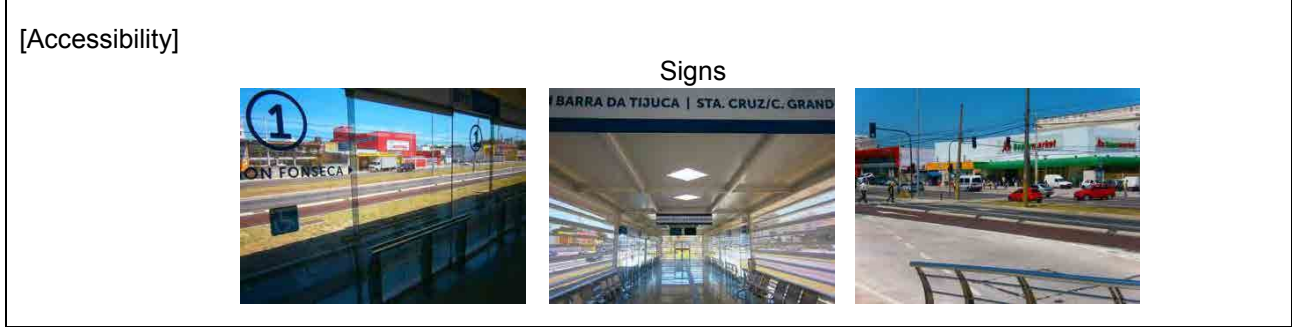
1. Condition	2. Issues	
Approach	>No BRT station signs on vicinity area; >Few signs and no maps; >Improve Intermodal connectivity info for users.	
Ticketing		
Platform		Few Seats.
Other		No messages/signs in foreign language.

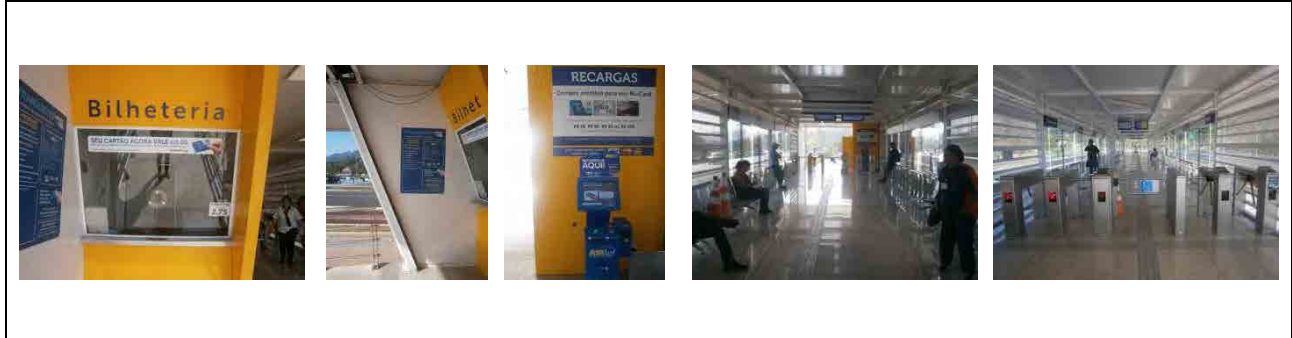
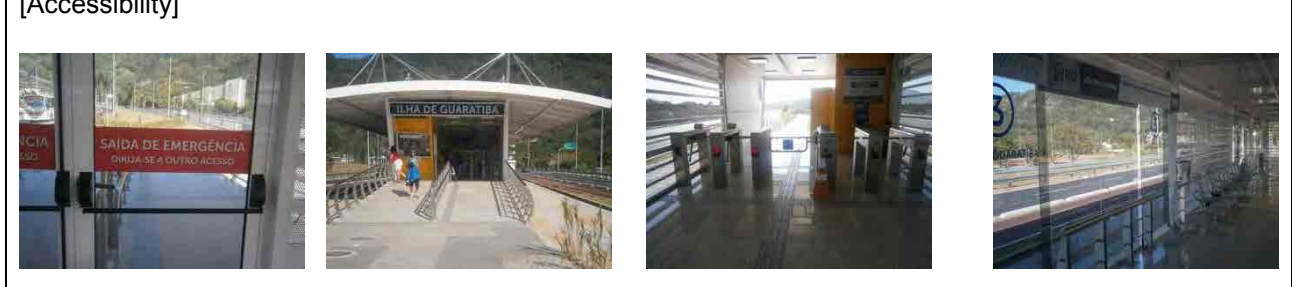
1. Condition	2. Issues
Approach	>No BRT station signs on vicinity area; >Few signs and no maps; >Improve Intermodal connectivity info for users.
Ticketing	
Platform	
Other

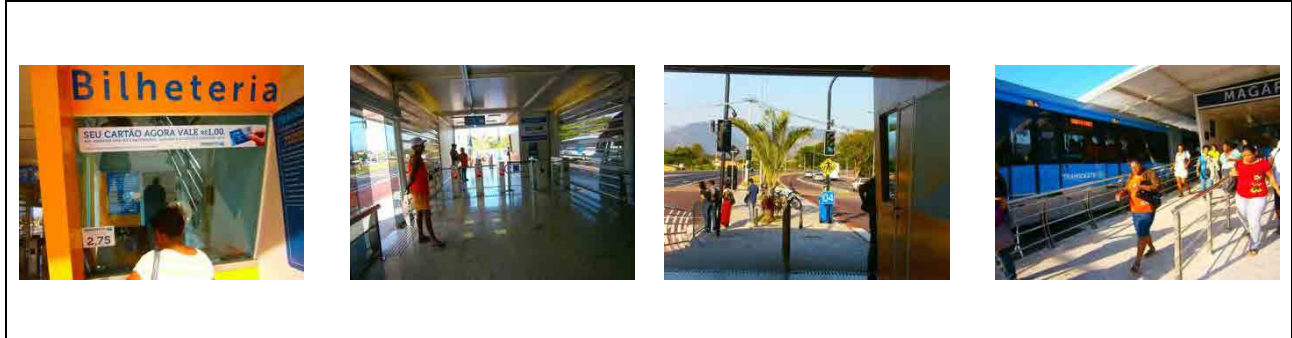
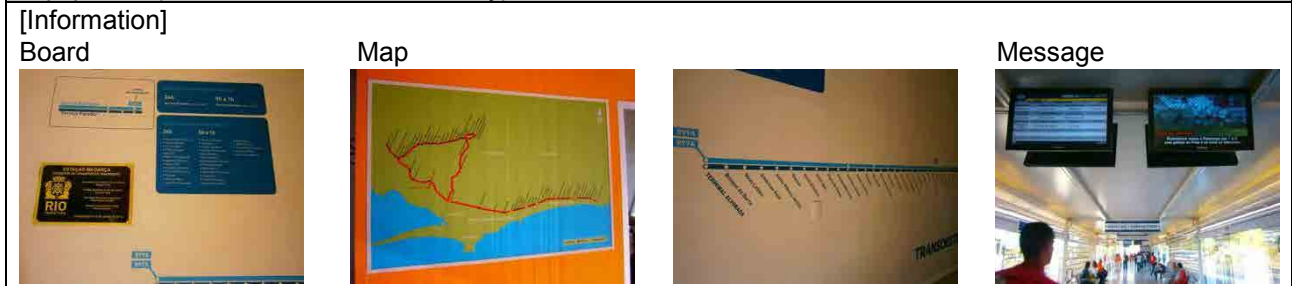
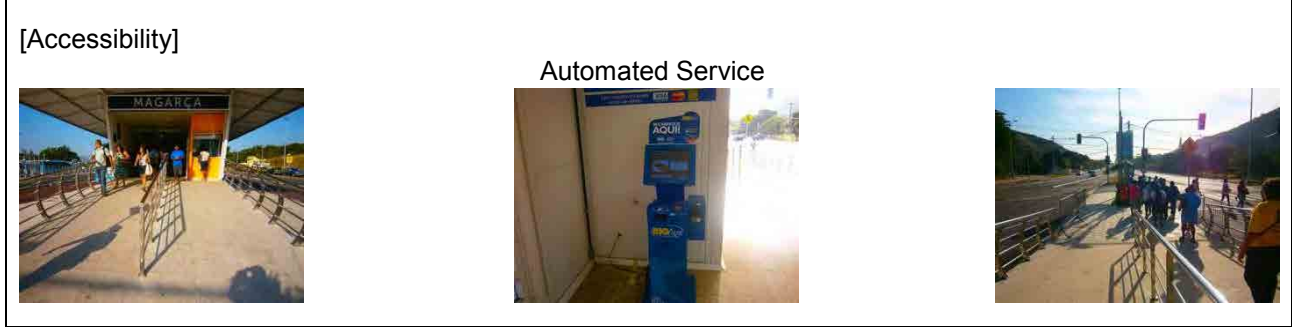
1. Condition	2. Issues
Approach	>No BRT station signs on vicinity area; >Few signs and no maps; >Improve Intermodal connectivity info for users.
Ticketing	
Platform	
Other

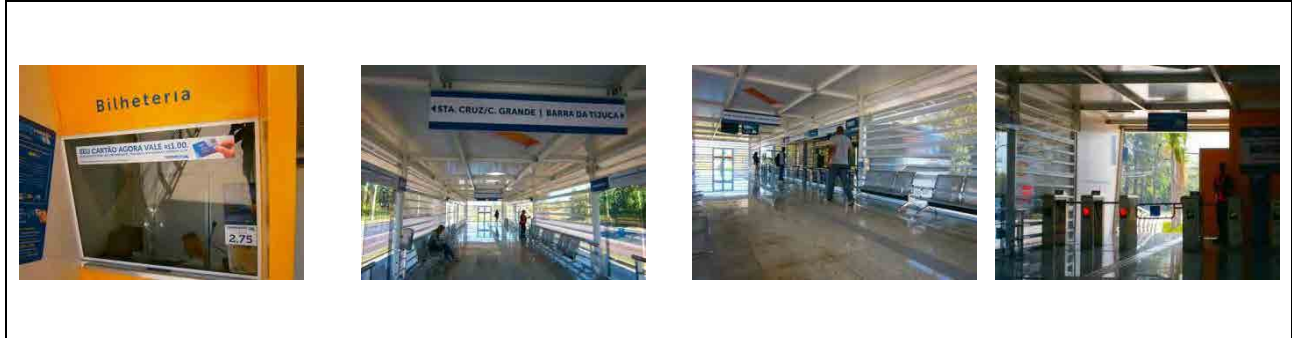
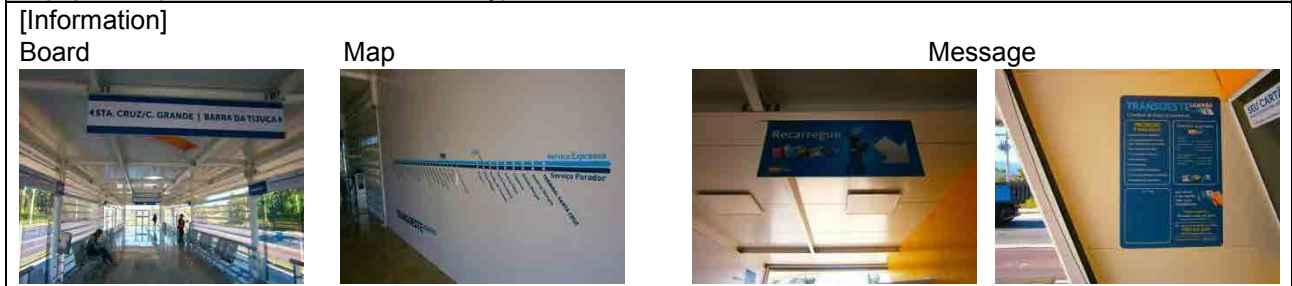
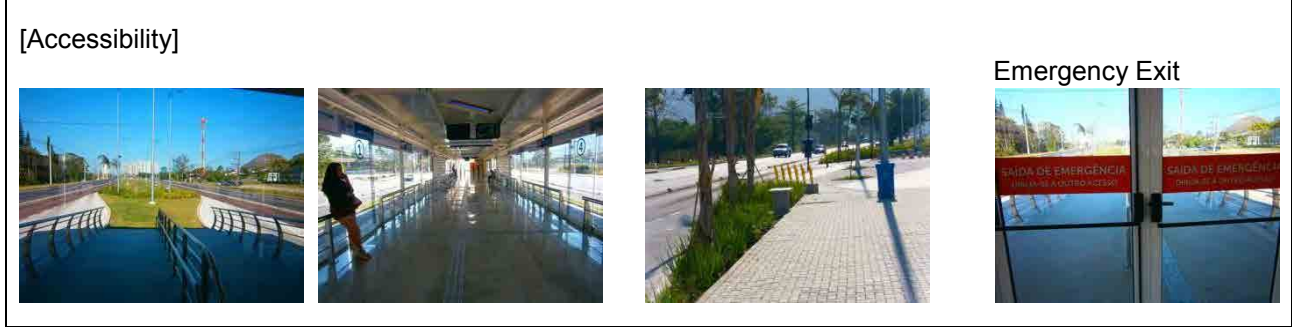
1. Condition		2. Issues	
Approach	Bus arrival/travel time info for users.	>No BRT station signs on vicinity area;	
Ticketing		>Few plates of signaling;	
Platform	Few Seats.	>Improve Intermodal connectivity info for users.	
Other	No messages/signs in foreign language.

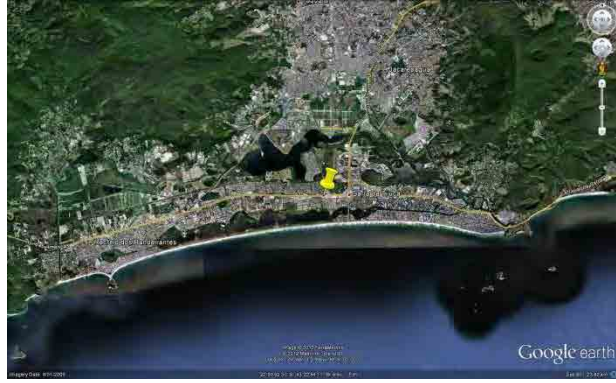
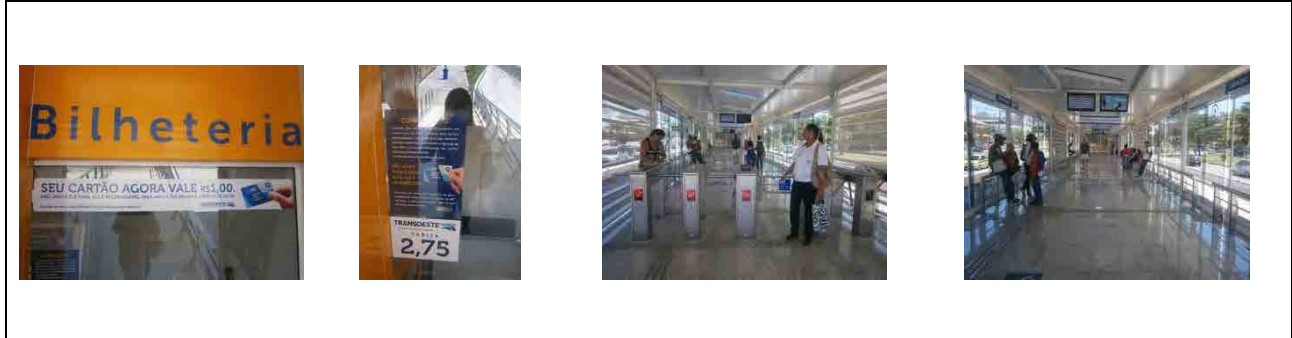
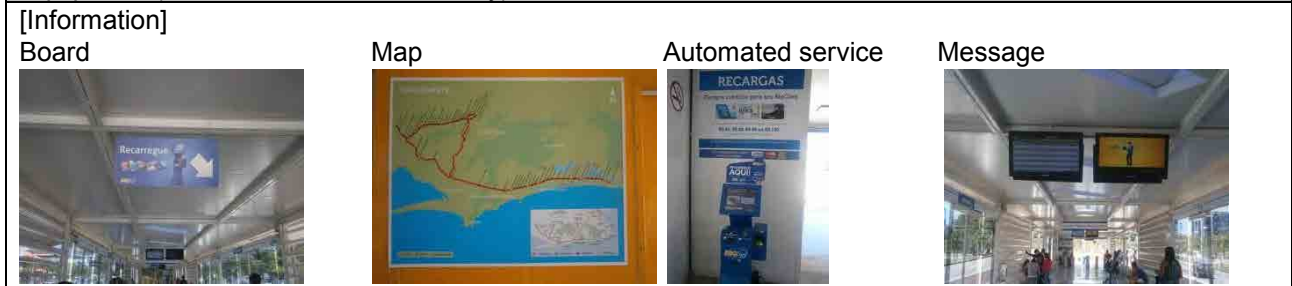
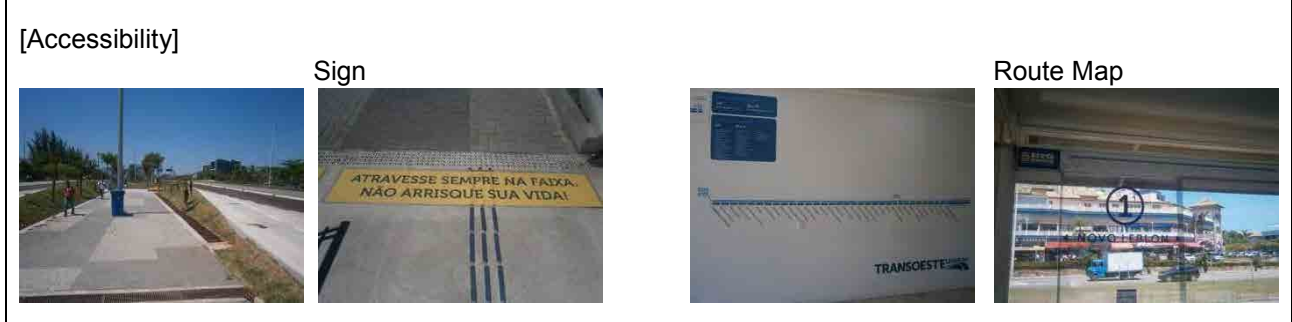
1. Condition	2. Issues
Approach	<ul style="list-style-type: none"> > Few plates of signaling; > Improve Intermodal connectivity info for users; > Lack of maintenance.
Ticketing	
Platform	
Other

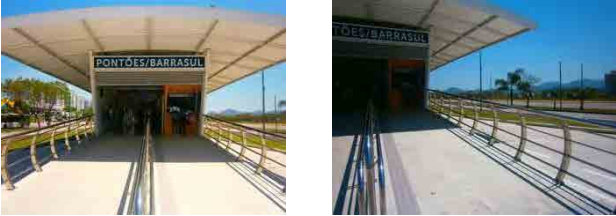
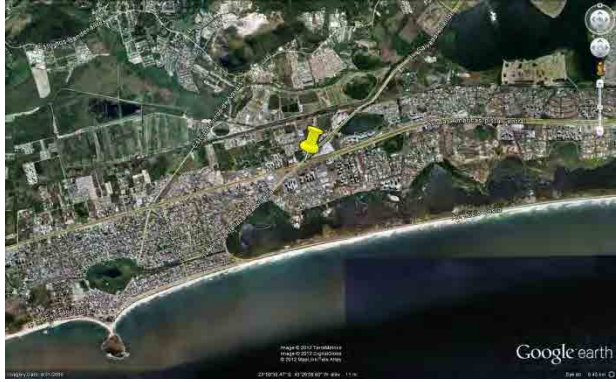
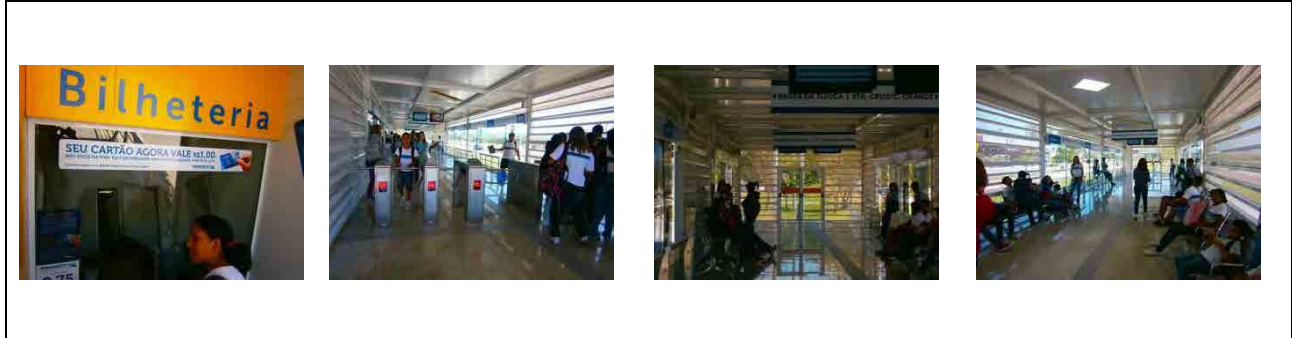
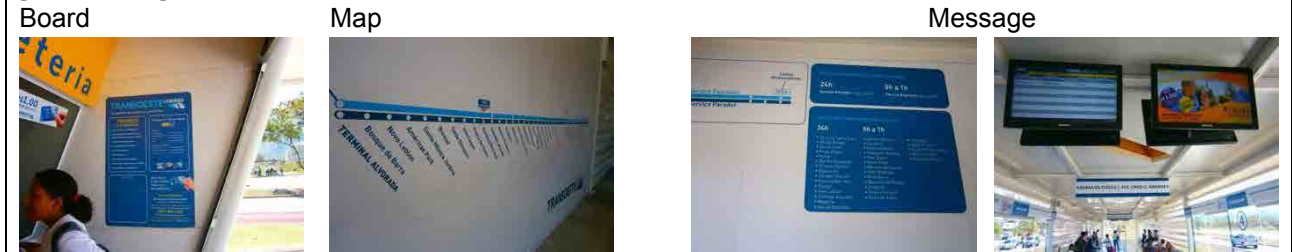
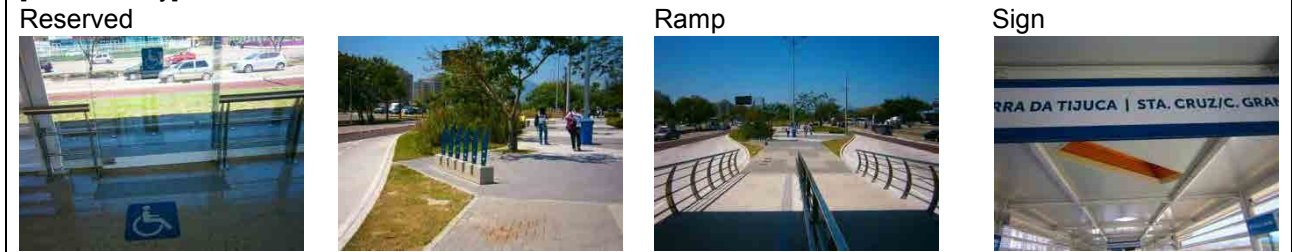
1. Condition	2. Issues
Approach	<ul style="list-style-type: none"> >Few direction signs; >Improve Intermodal connectivity info for users; >Lack of maintenance.
Ticketing	
Platform	
Other

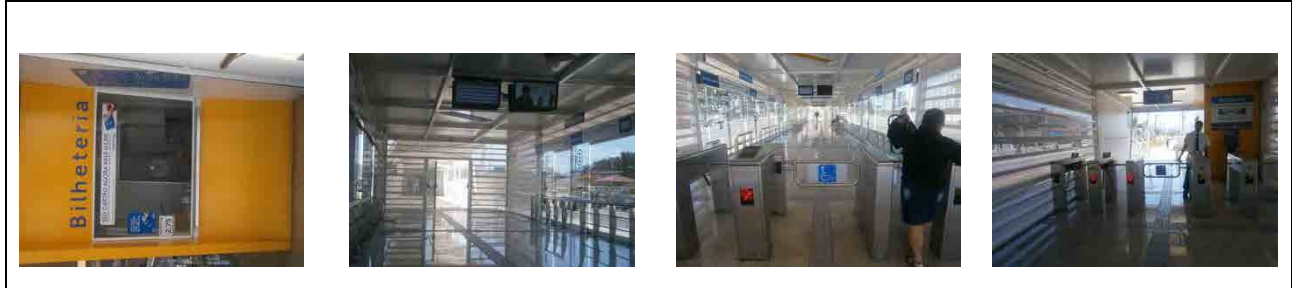
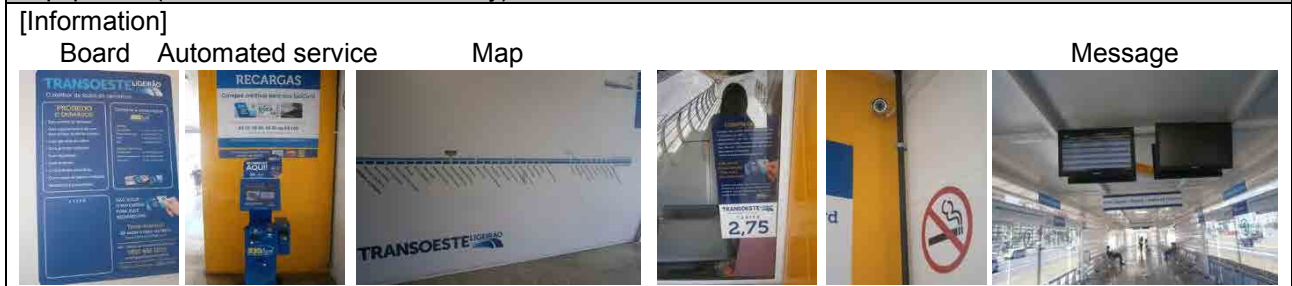
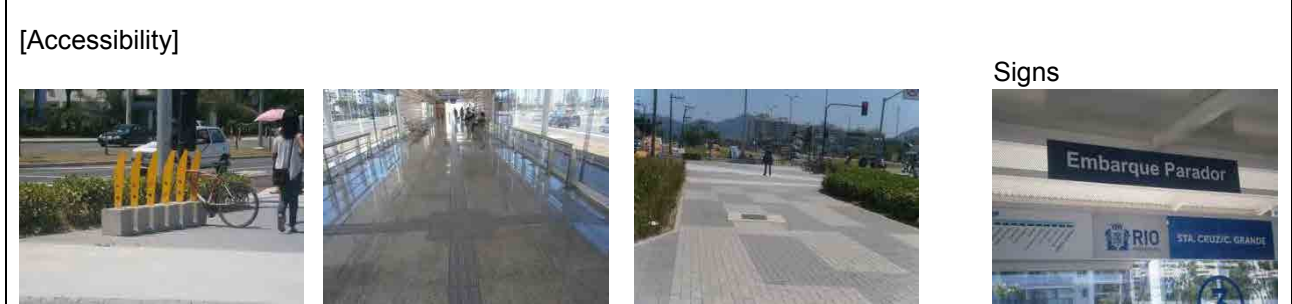
1. Condition		2. Issues
Approach	No adequate access for pedestrians and cyclists.	<ul style="list-style-type: none"> >No BRT station signs on vicinity area; >Few signs and no maps; >Improve Intermodal connectivity info for users.
Ticketing		
Platform	Few Seats.	
Other	Lack of maintenance. No messages/signs in foreign language.

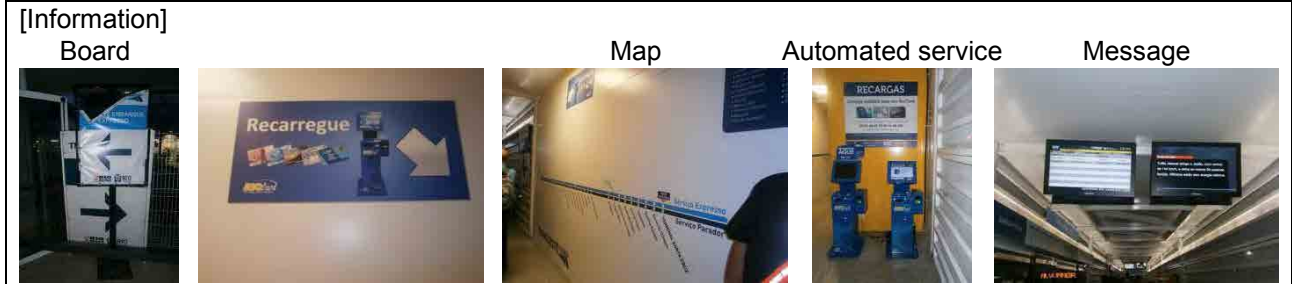
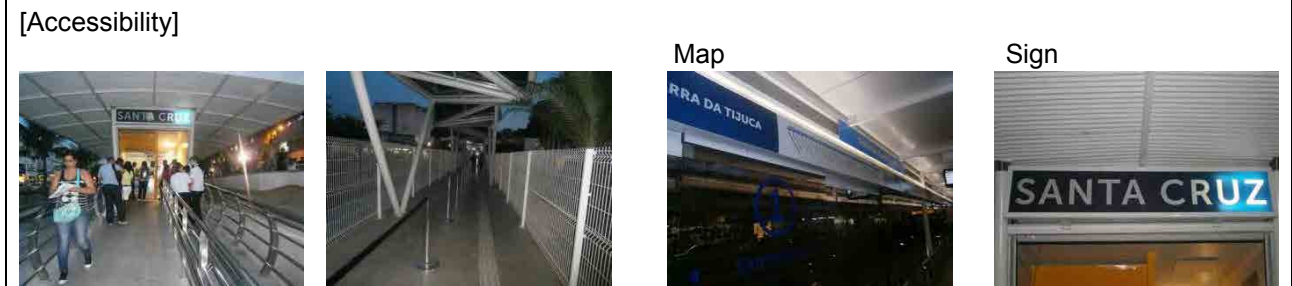
Equipment (Information and Accessibility)

1. Condition		2. Issues
Approach	No adequate access for pedestrians and cyclists. Narrow pathway. Few Seats. Lack maintenance / organization. No messages/signs in foreign language.	<ul style="list-style-type: none"> >No BRT station signs on vicinity area; >Few signs and no maps; >Improve Intermodal connectivity info for users.
Ticketing		
Platform		
Other

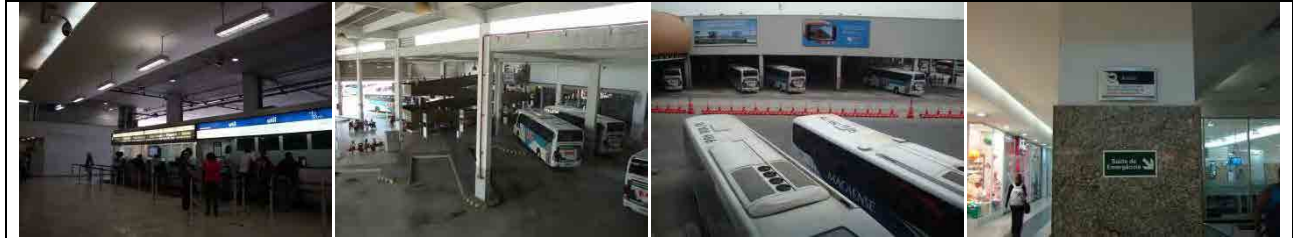
General Condition (Ticketing / Platform / Embankment)

1. Condition		2. Issues
Entrance/ Exit	Good accessibility.	> Lack of map or landmark information for exit.
Ticketing	Some crowded lines observed.	
Platform	No rumble strips/guided pathway.	
Other	No fare info outside box office; > Info in English available; > Good accessibility and direction signs; > Surveillance Control Center.

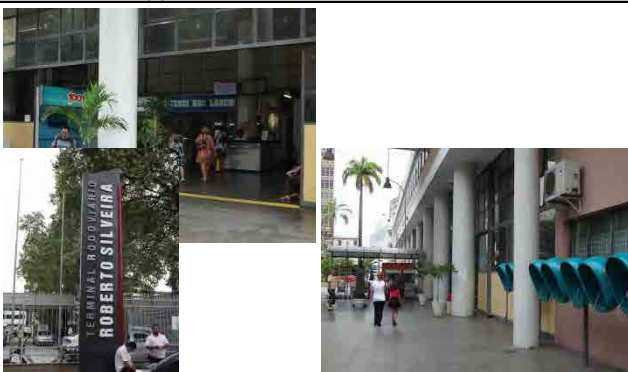
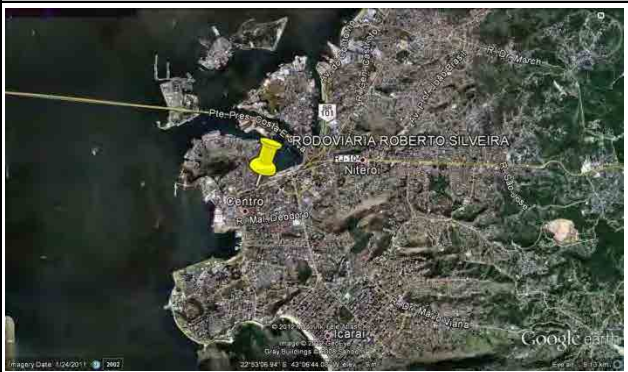
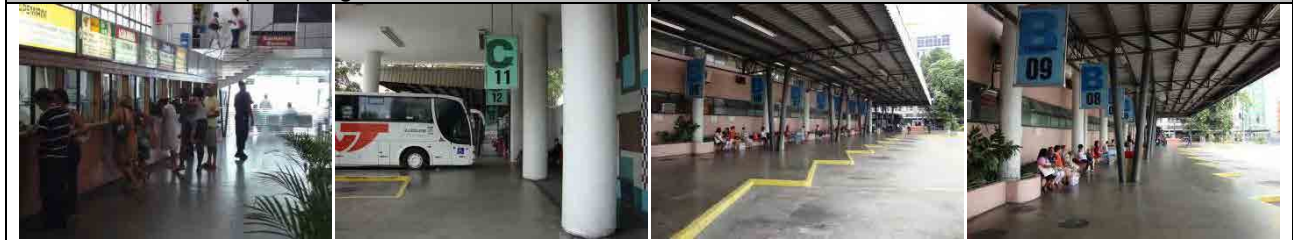
1. Condition		2. Issues
Entrance/ Exit		<ul style="list-style-type: none"> > Lack of map or landmark information for exit; > Add general route mapping, info and bus arrival time at platform; > Improvement needed for disabled users.
Ticketing	Lack of general route/system info.	
Platform	No rumble strips/guided pathway.	
Other	No foreign language. No fare info outside box office.

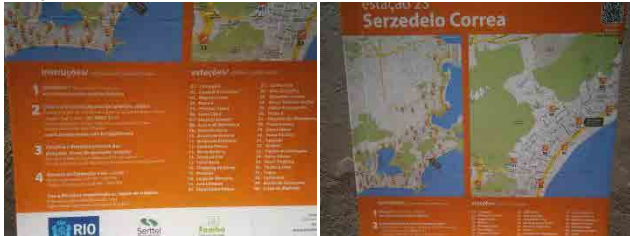
Equipment (Information and Accessibility)			
[Information]			
Map		Directions

Description			
1. Condition		2. Issues	
<ul style="list-style-type: none"> > Ped signal and ramps; > Station map; > Info in English/Portuguese; > Solar Panel. 		<ul style="list-style-type: none"> > Need cell phone/mobile app to unlock bikes; > Bike liberation malfunction sometimes; > Nearby high speed avenue.
