**REPORT**  
**FOR**  
**THE FOLLOW-UP PROGRAMME**  
**ON**  
**THE PROJECT FOR**  
**IMPROVEMENT OF WATER**  
**QUALITY IN LOCAL AREAS**  
**IN**  
**THE REPUBLIC OF THE**  
**PHILIPPINES**

**SEPTEMBER 2011**

**Japan International Cooperation Agency**

**Japan Techno Co., Ltd.**

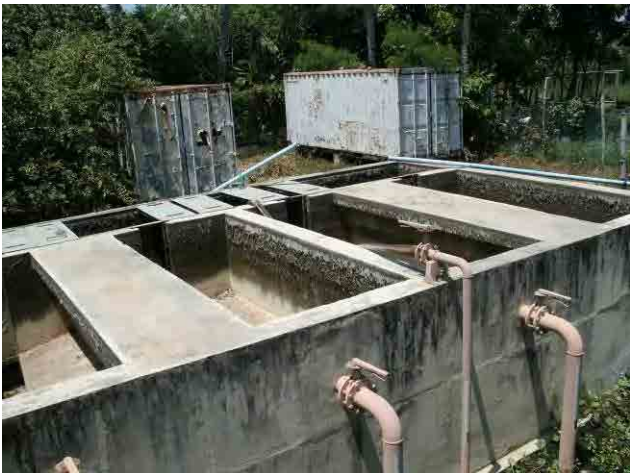
Sludge drying bed: Bed sand has been removed due to clogging after being used for five times.

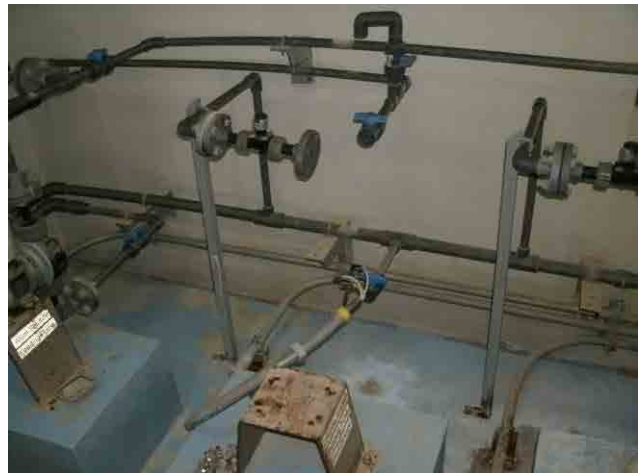
Post chlorination pump: It has been removed due to a breakdown.

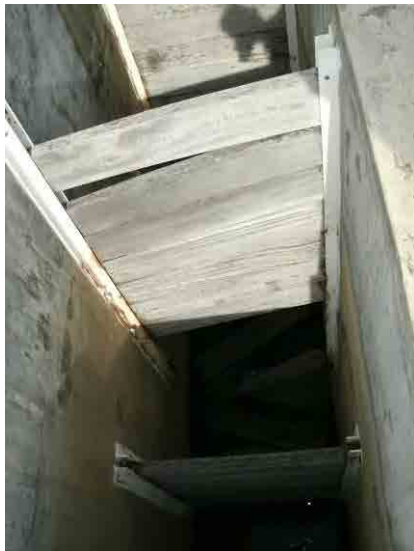
Flocculator: Some baffle plates fell off due to breakage of holding bolts caused by corrosion.

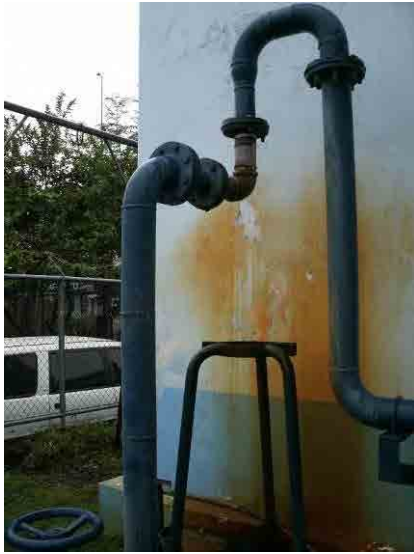
Sand separator: It was changed two times and finally removed because of holes.

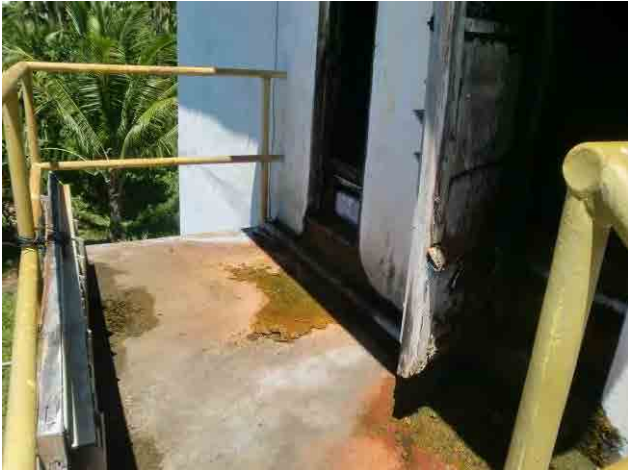
Aeration tower: The doors are decrepit; one of doors is already removed.

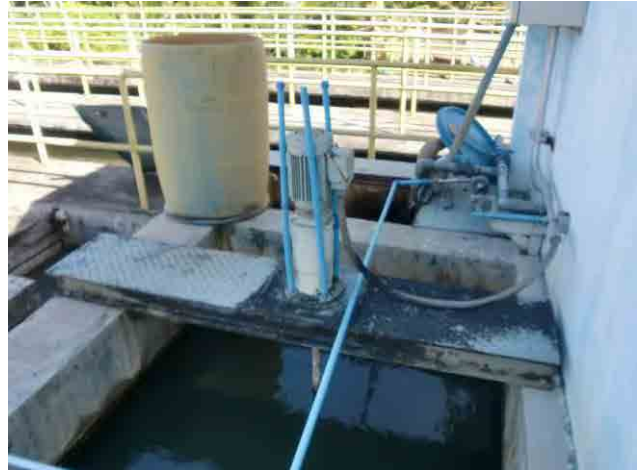
Rapid mixer: Not in use due to breakdown. It was covered not to hit rain and it was decomposed and greased once.

Currently the operation of WTP is only chlorination; coagulant is not dosed due to the technical failure of the chemical feeding pump and the rapid mixer. The test operation was conducted with a manual mixing to confirm the operational status using coagulant PAC 80mg/l. The current chlorine dosage is 1.0mg/l, and as the result of breakpoint chlorination, the rate was found appropriate. Therefore current chlorine dosage is left unchanged. The status of floc in sedimentation was confirmed. The floc after 4 hours operation with injecting coagulant was floating thus the growth of floc is considered to be not well. However, the floc was sedimented in flocculation basin and sedimentation basin after 2 hours of stopping the operation, and the water in the basin became clear. It is thought to be preferable to improve the flocculator and increase the intensity of agitation because the floc will be settled in the sedimentation basin once the formulation of the big floc with coagulant injection occurs.

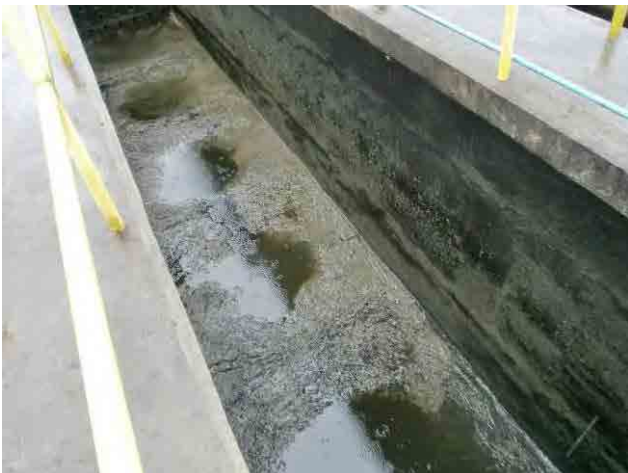
Sedimentation basin: Sludge is removed only three times since the operation started. Therefore, the sludge is accumulated considerably.

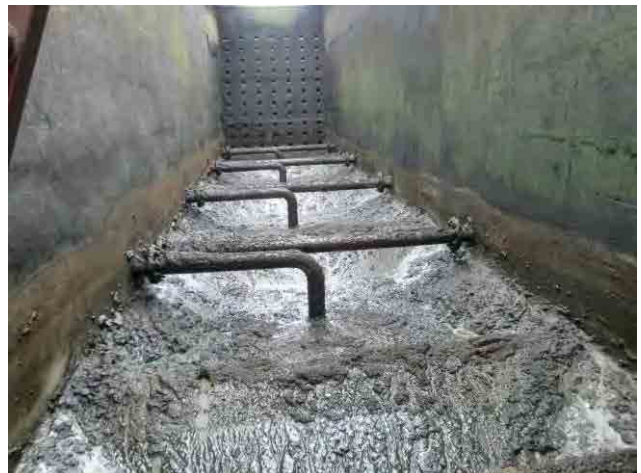
Sedimentation basin: Sludge is black, it might be manganese.

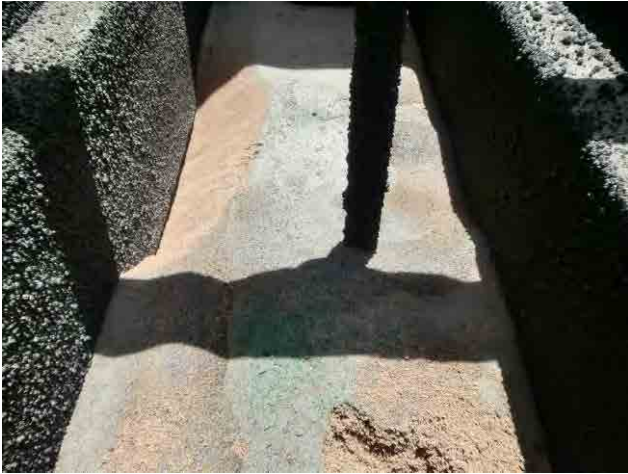
There is the problem that filter sand becomes mud ball because the raw water contains high hardness. However, current operation is not done the surface-wash due to using the surface-wash pump for transmission pump. This makes the rapid sand filter not to function properly and there is a need for a replacement of the filter sand. Humic substances need to be removed by sedimentation after pH adjustment. For this, laboratory water quality analysis needs to be conducted on the possibilities of the trihalomethane formation as there is a possibility that the cancer causing trihalomethane can be generated by a reaction of the chlorination with the humic substance. The sedimentation basin and the filtration rate of the rapid sand filter also need an adjustment to the actual volume of water treatment.

Rapid sand filter: A sand layer thickness is 60cm by the plan, but currently 90cm; thus the surface-wash pipes are covered and filtration area has decreased due to no space between sand and trough.

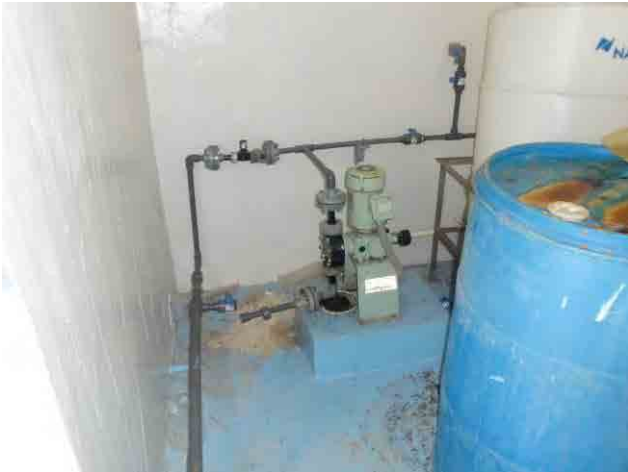
Chemical feeding pump: broken down and not being used.

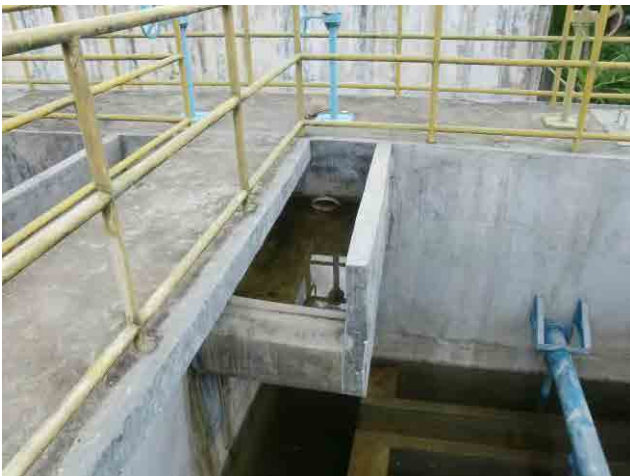
Rapid sand filter, inlet trough: Improvement is required to prevent the destruction of the floc.

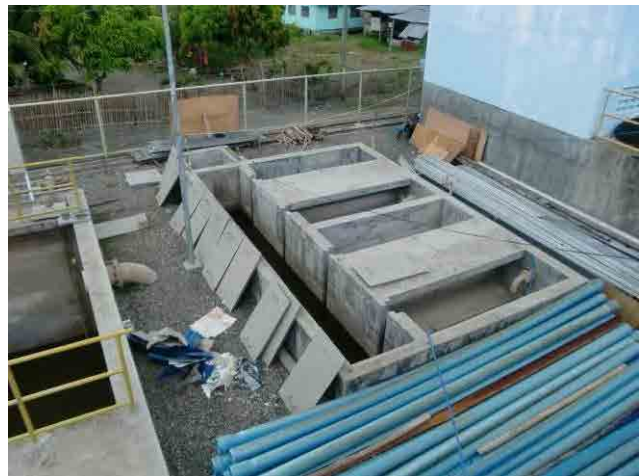
Sludge drying bed: Installation of bed sand is required due to accommodate the change in Philippines effluent standard..

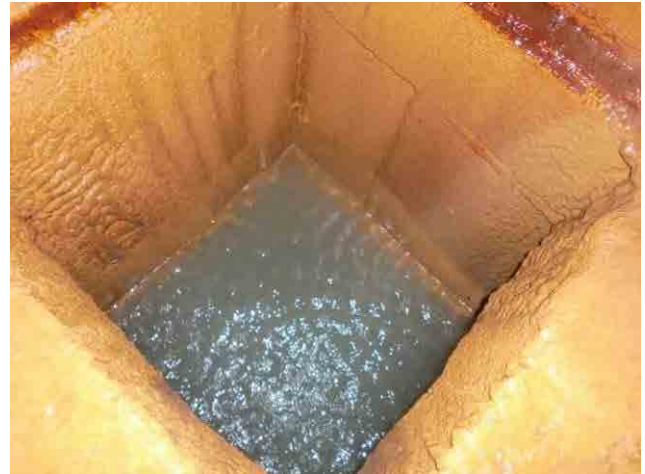
Aeration tower: There are no steps for existing manholes. New manholes will be opened for effective maintenance.

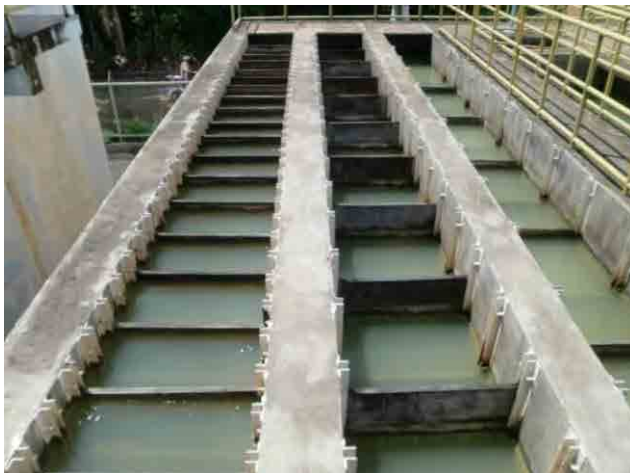
Hydraulic Flocculator: Adjustment of vertical baffles is required.

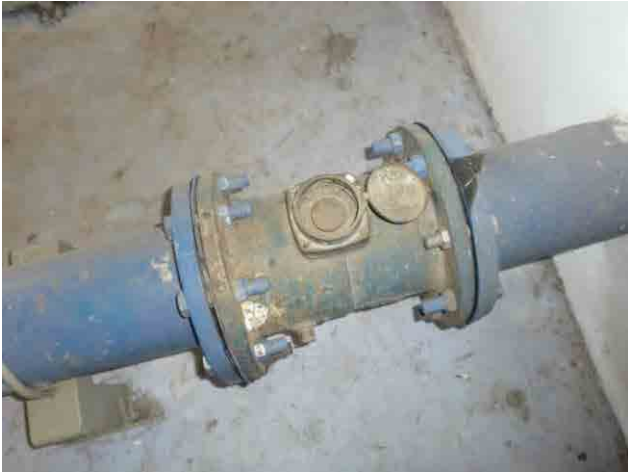
Flow meter for surface-wash pipe: Flow meter has been removed.

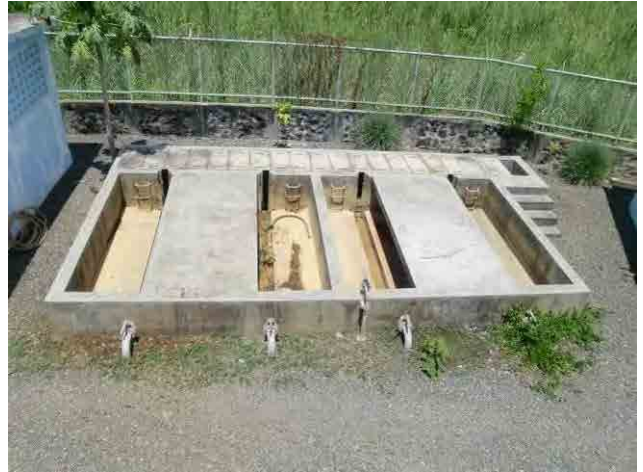
Sludge drying bed: Installation of bed sand is required due to accommodate the change in Philippines effluent standard..

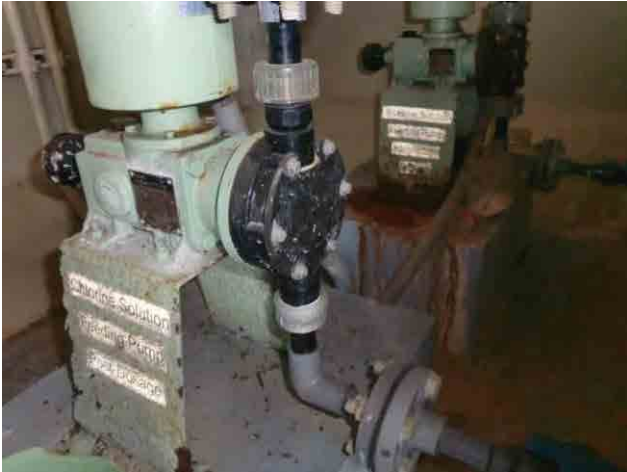
Post chlorination, injection pump: Not in use due to the breakdown.

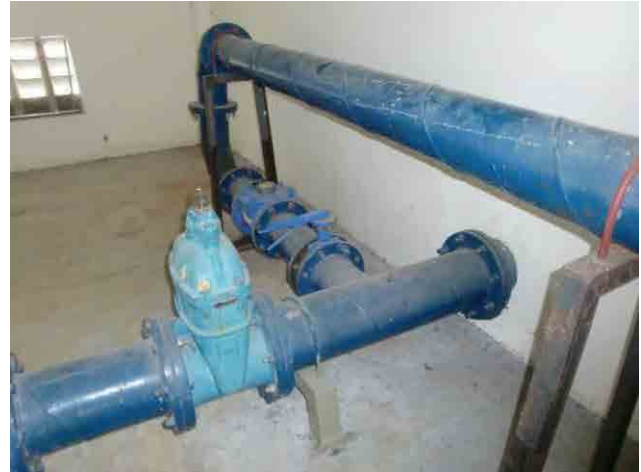
Transmission pipe: A bypass line is connected from another water source to dilute the saline water in the reservoir.

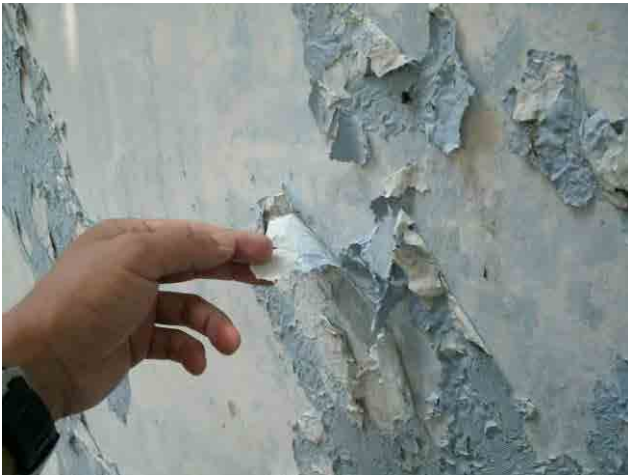
Aeration tower: Paint of exterior wall is peeling off. WD requested to remove all.

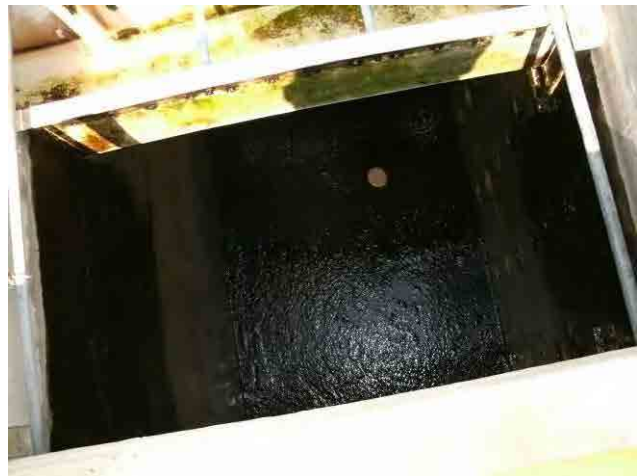
Sedimentation basin: Due to insufficient settlement of flocs, sludge is accumulated at the end of the basin.

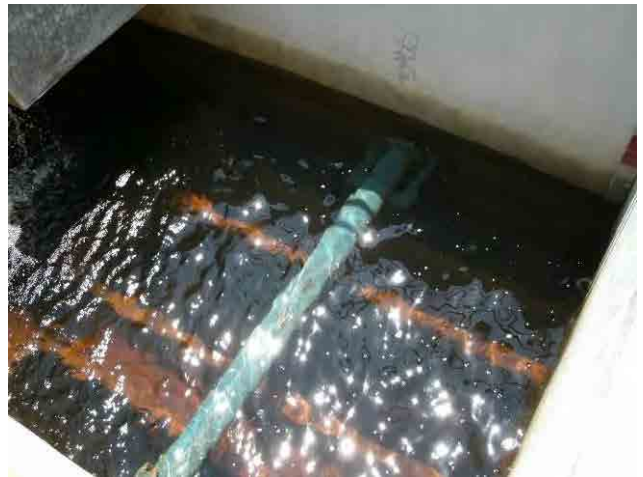
Rapid sand filter: Colored particles are not removed in the sedimentation basin, thus the influent water is colored.

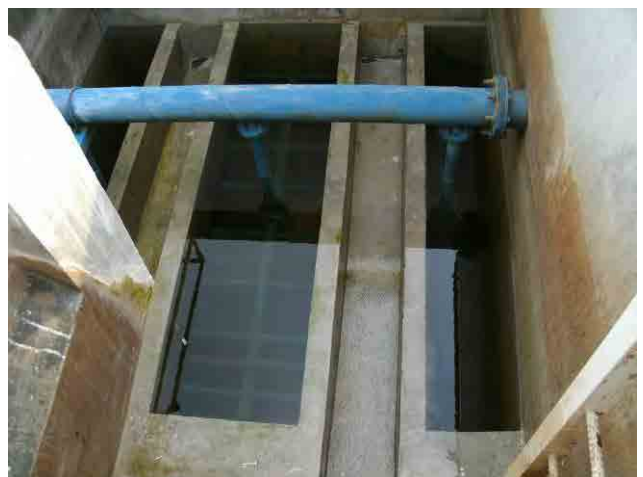
Rapid sand filter: After backwash the water is relatively clear.

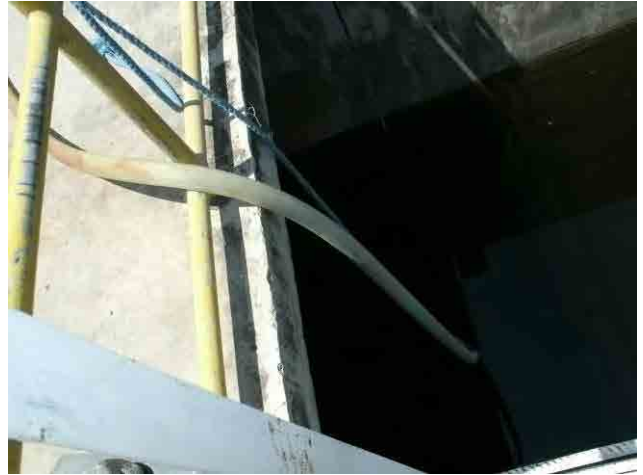
Drainage basin: The single phase pump installed by WD.

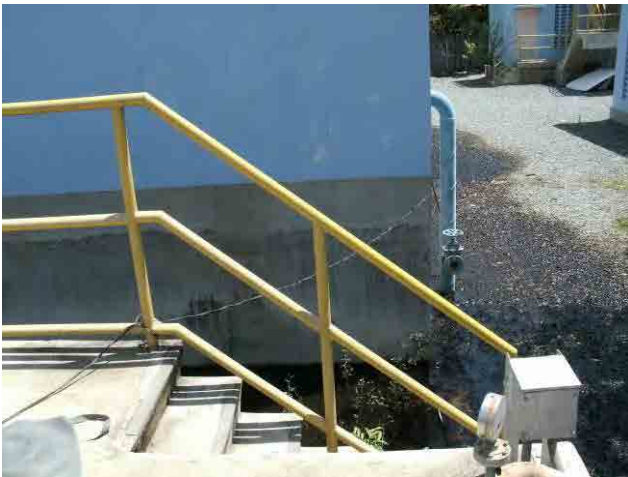
Drainage basin: The single phase power is provided from the distribution pump room using an extension cord.

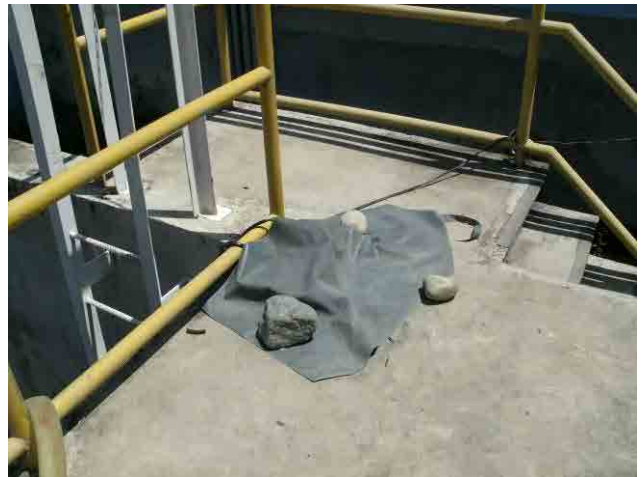
Drainage basin: The single phase socket is covered by a sheet for insulation.

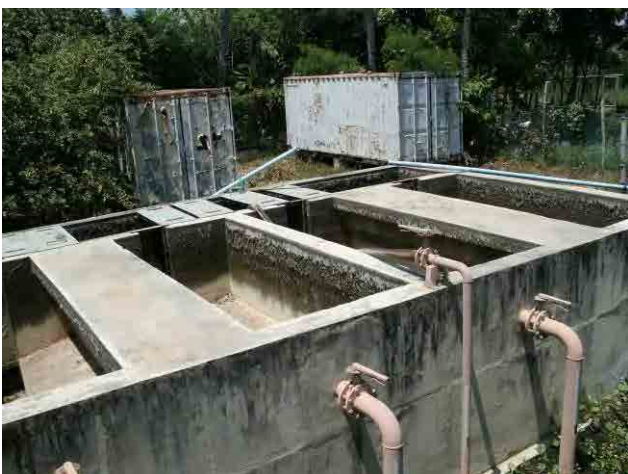
Sludge drying bed: Bed sand has been removed due to causing clog after using five times.

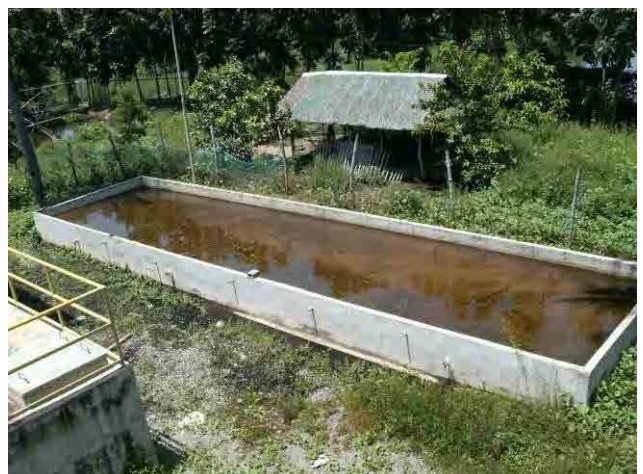
Sludge Storage basin: A sludge storage basin was constructed by WD for receiving the excess sludge.

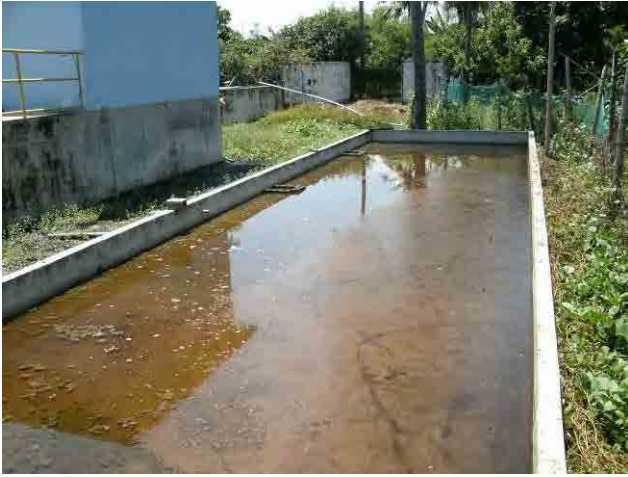
Sludge Storage basin: It takes about 3-4 weeks for drying sludge by natural evaporation in the sludge storage basin.

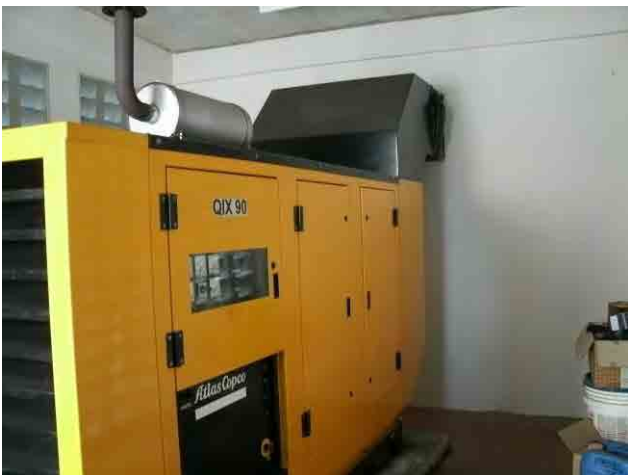
Generator: Maintenance of generator is so favorable that it looks as good as new.

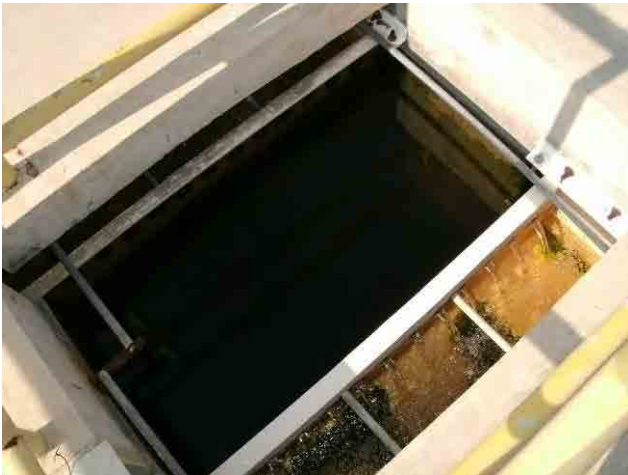
Sedimentation basin: Flocs are carried over from the effluent trough.

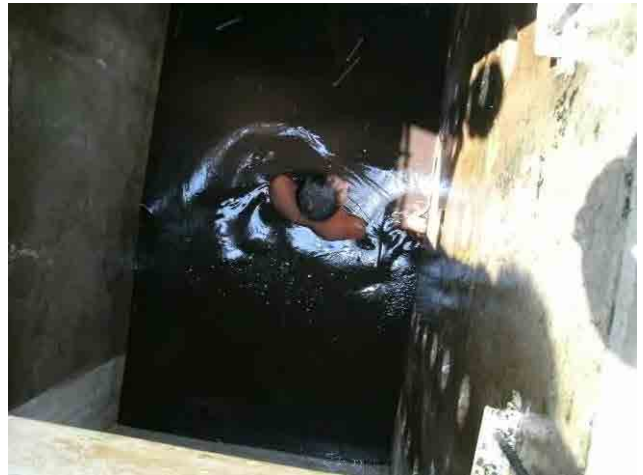
Sedimentation basin: Sludge is accumulated at the end of the basin.

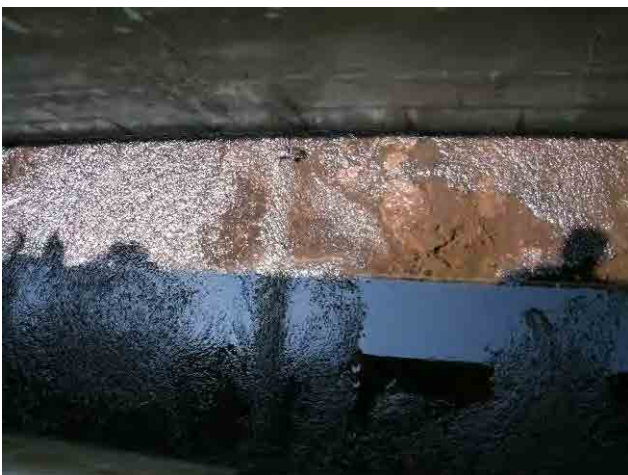
Sedimentation basin: A large amount of blown sludge is accumulated.

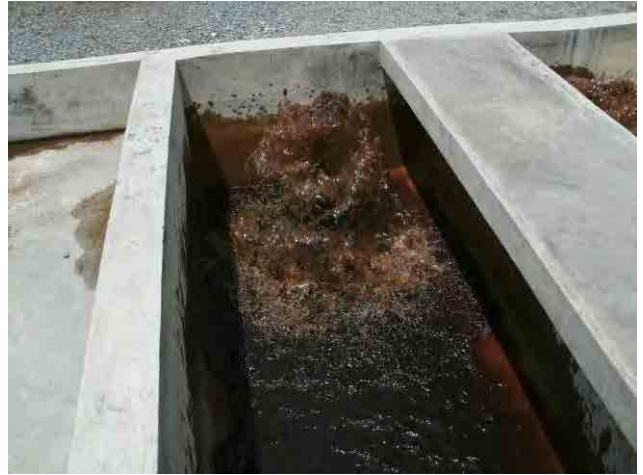
Sludge Drying bed: Drained sludge is being discharged into the drying bed.

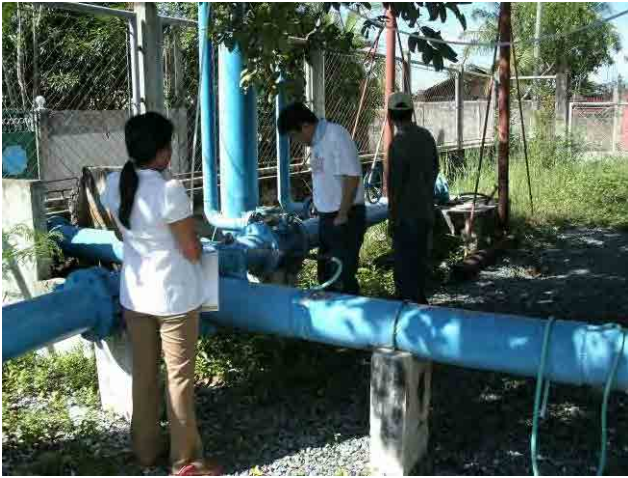
No.4 Well: Quantity of water intake is 11l/s, which is less than planned value, 28l/s.

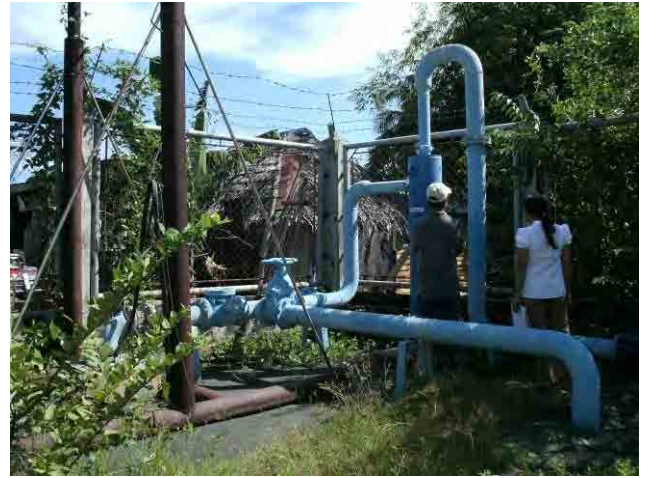
No.7 Well: Quantity of water intake is 10.5l/s which is less than planned value, 28l/s.

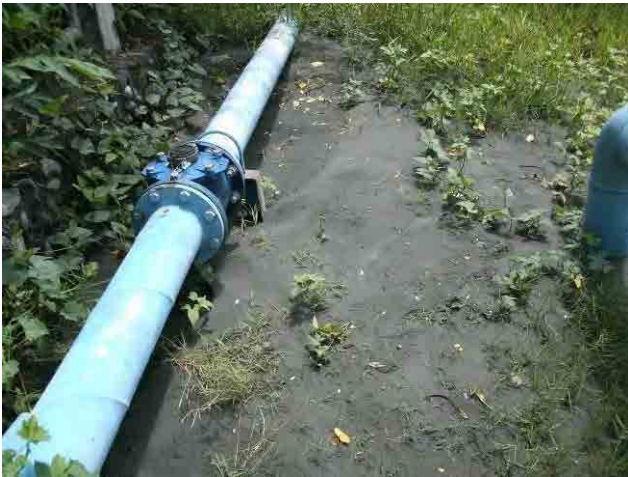
No.7 Well: Excess sand is pumped up.

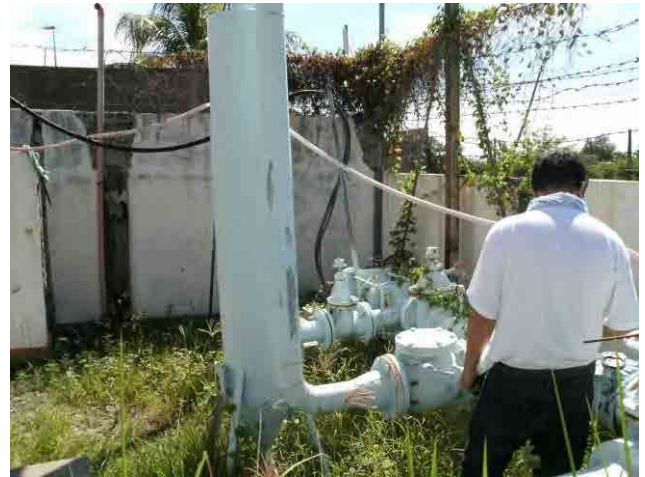
No.6 well: Quantity of water intake is 24.4l/s which is close to planned value, 28l/s.

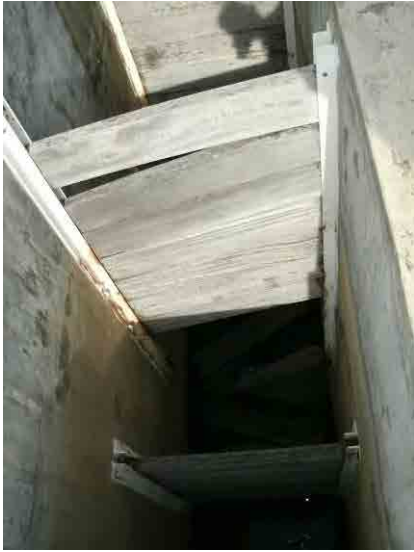
Flocculator: Some baffle plates fell off due to breakage of holding bolts caused by corrosion.

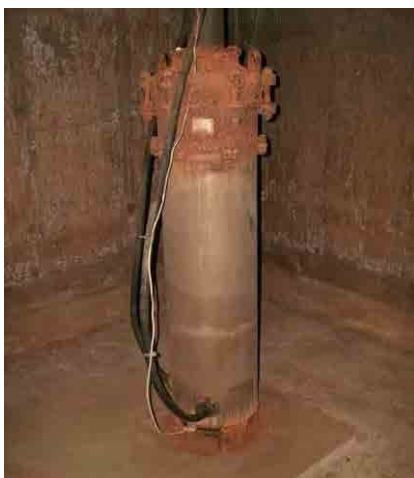
Distribution pump: Rusting but no problem for operation.

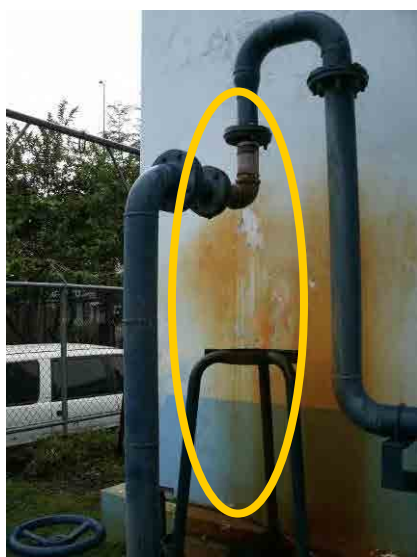
Sand separator: It was changed two times and finally removed because of holes.

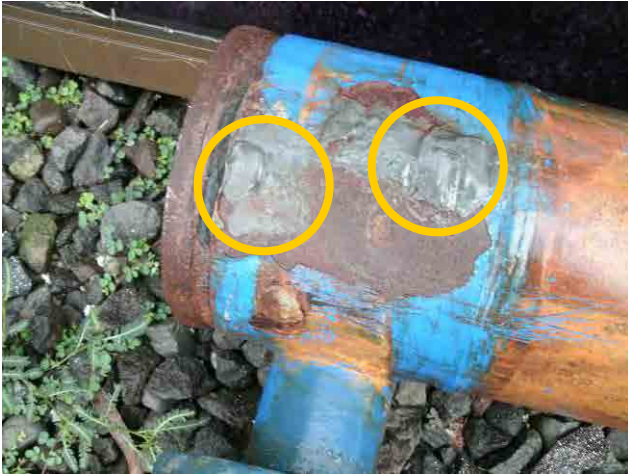
Sand separator: Holes have been filled with pate.

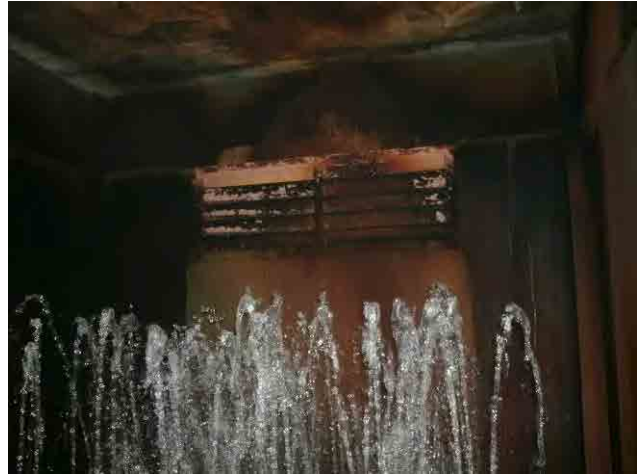
Aeration tower: Water pressure decreased so the jet does not reach to the ceiling. DO in the water is sufficient.

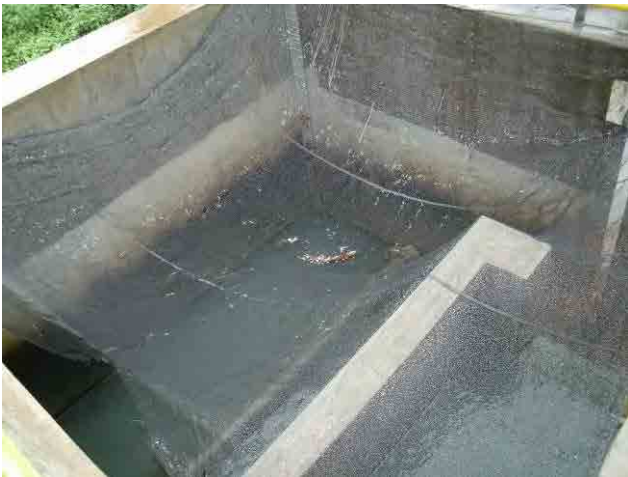
Rapid sand filter: Filter basins are covered by the net to prevent the leaves dropping in.

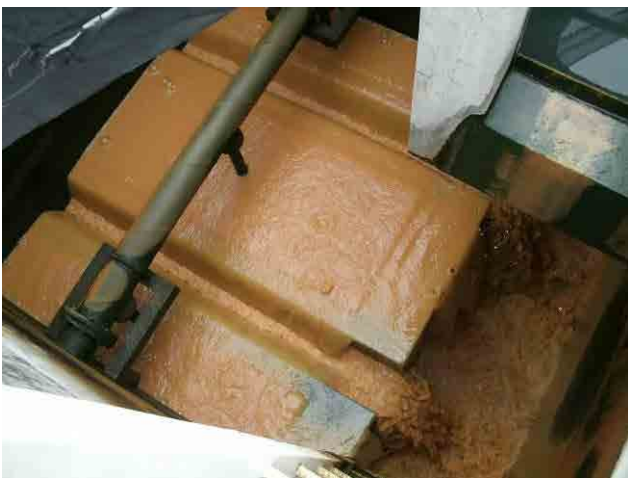
Rapid sand filter: Under back washing.

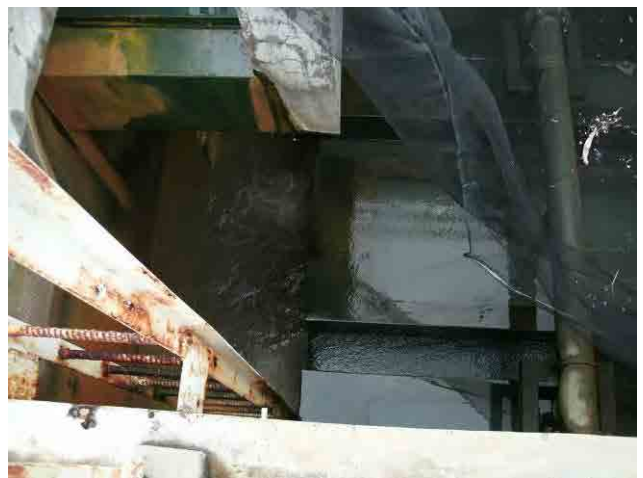
Rapid sand filter: After the back wash.

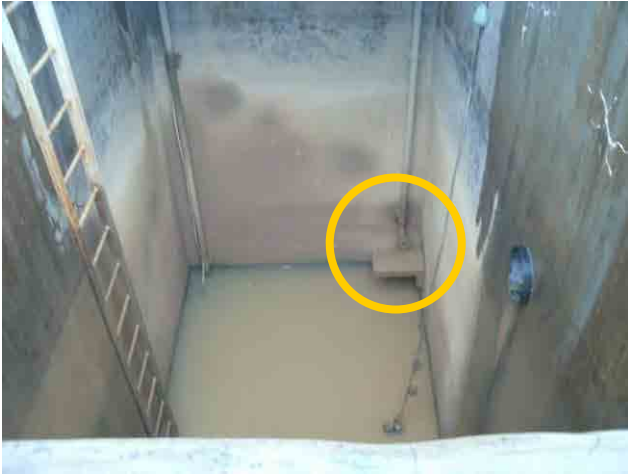
Drainage basin: Recycle pump has been removed due to breakdown.

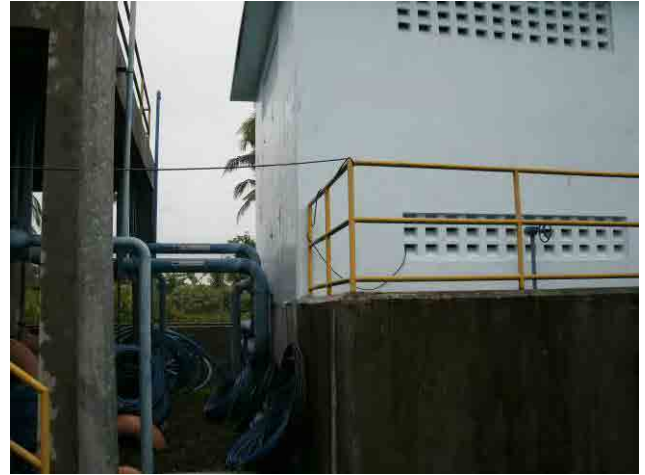
Chlorination pump: Single phase power is supplied by using the extension electric cord.

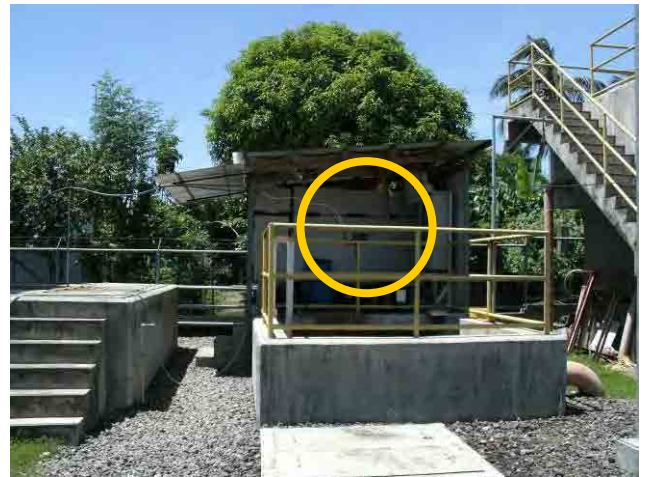
Intermediate Chlorination pump: installed by the WD

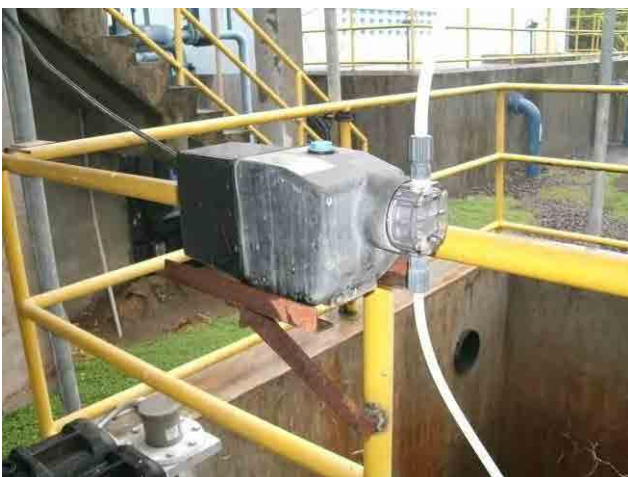
Intermediate Chlorination pump: installed by the WD
