**DATA COLLECTION SURVEY  
ON  
ROAD FRAGILITY  
IN  
TIMOR-LESTE**

**FINAL REPORT**

**AUGUST 2013**

**JAPAN INTERNATIONAL COOPERATION AGENCY  
INGEROSEC CORPORATION**

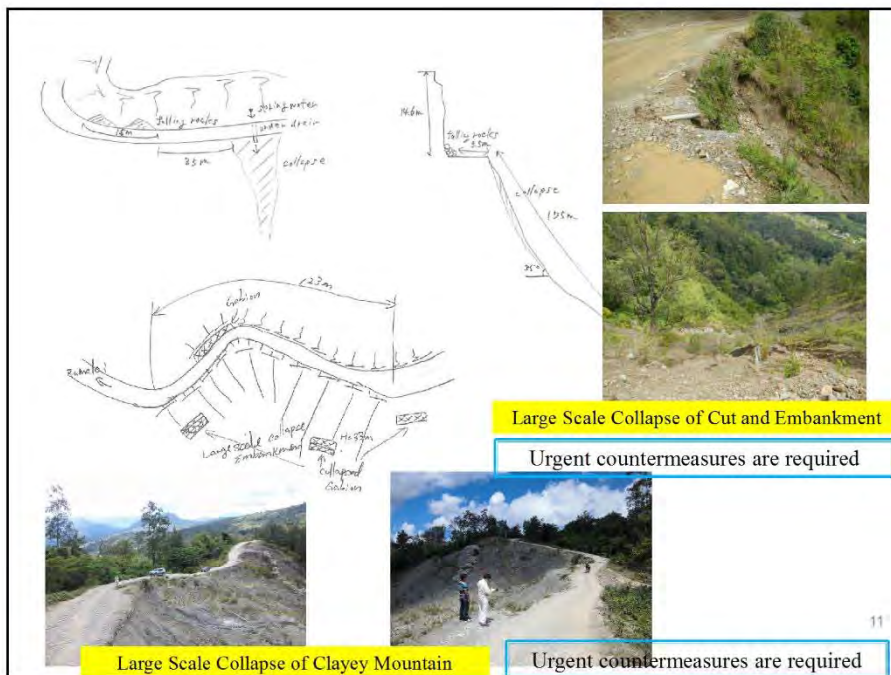
**Road Body Condition**

1. Requiring over the whole mountainous section to take countermeasures for A02, A05, A12
2. Not requiring whole section comparatively to take countermeasures for A06, A11
3. Although countermeasures are not required for road body, but road pavement are deteriorated

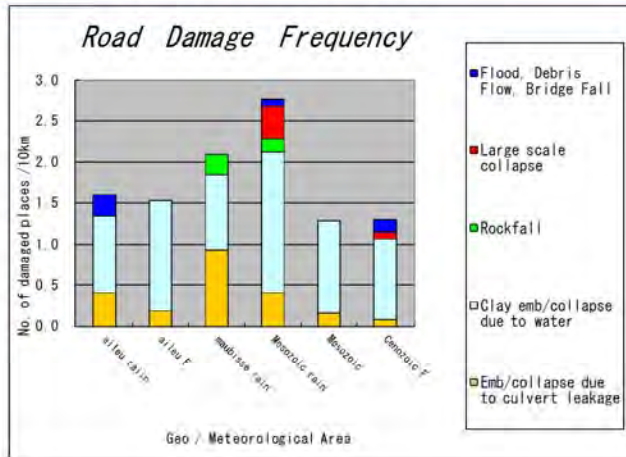
#### 4.4 Road Damage Frequency by Type and Zone

1. Most Frequent Road Damages with variety types occurred at Mesozoic Foundation at Central Mountains with high rainfall.
2. On other geological sections, almost same frequency of road damages occurred if the embankment collapse by Culvert Leakage was settled.

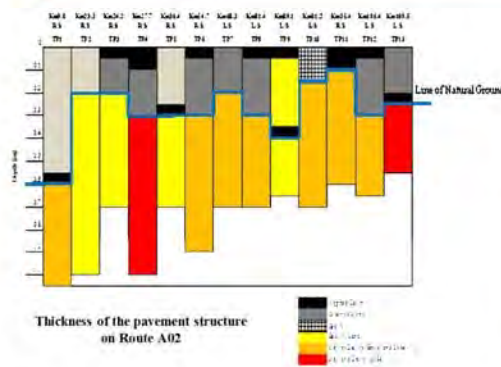
#### 4.5 Pavement Damage due to Pavement Structure

1. Pavement deteriorated at **weak Silty and Clayey subgrade** sections.
2. Pavement deteriorated where **no Base Course constructed**.
3. Pavement deteriorated at high underground water even on Gravel and Sand Subgrade.

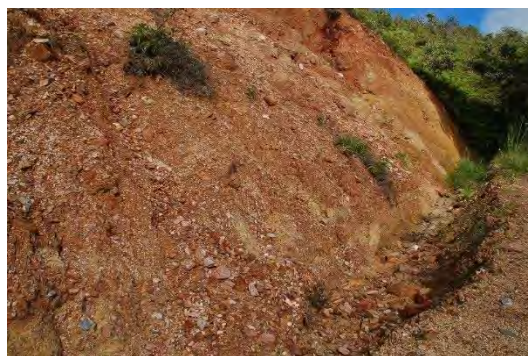
Photo 2.1 Lateritic shale (16.1 km)

The coastal area, in which the capital Dili is located, is covered with alluvium consisting mainly of loose gravel. In the steep mountainous section between the 2km point and the 20km point, the ground surface is covered with lateritic shale, and schist that has been made fragile and susceptible to exfoliation by weathering and erosion. (See Photos 2.1 and 2.2.)

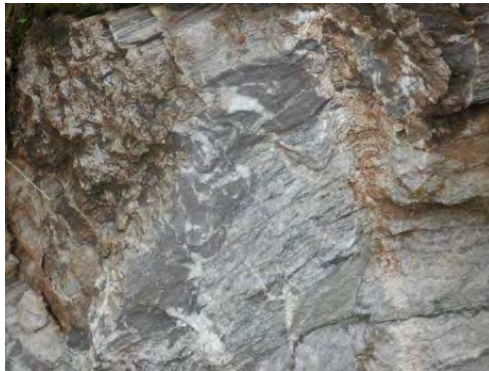
**Photo 2.3 Limestone (59.1 km)**

Schist is also predominant in the section between the 55km point and 60km point. The schist in this section has been made fragile and susceptible to exfoliation by weathering with erosion of the section between the 2km point and 20km point as mentioned above. Limestone ground and boulders are found at the 59.1km point and 66km point. However, schist and sandstone are also found. (See Photos 2.3 and 2.4.)

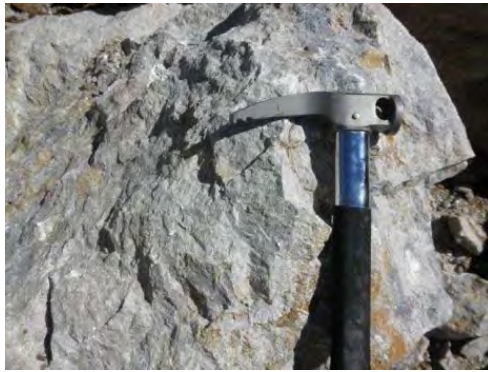
**Photo 2.5 Limestone (103.6 km)**

Terrain as a result of landslides of limestone boulders is identified at the 91.2km point. An outcrop of fluvial terrace riser is found at the 103.6km point. The upper part of the riser contains boulders with a grain size of approximately 30 cm and the lower part contains a number of pieces of limestone with a diameter of approximately 1.5 meters. (See Photo 2.5.)

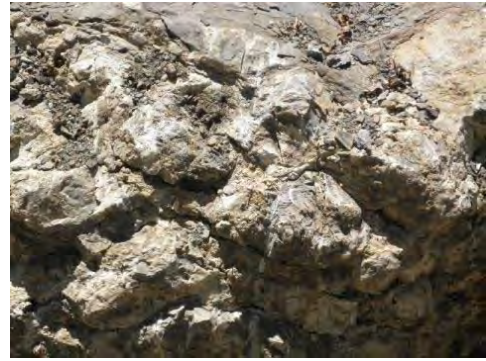
**Photo 2.6 Conglomerate (106.4 km)**

A trace of debris flow was identified at the 106.4km point. Pieces of sandstone and conglomerate, in addition to limestone, were found on the streambed. (See Photo 2.6.)

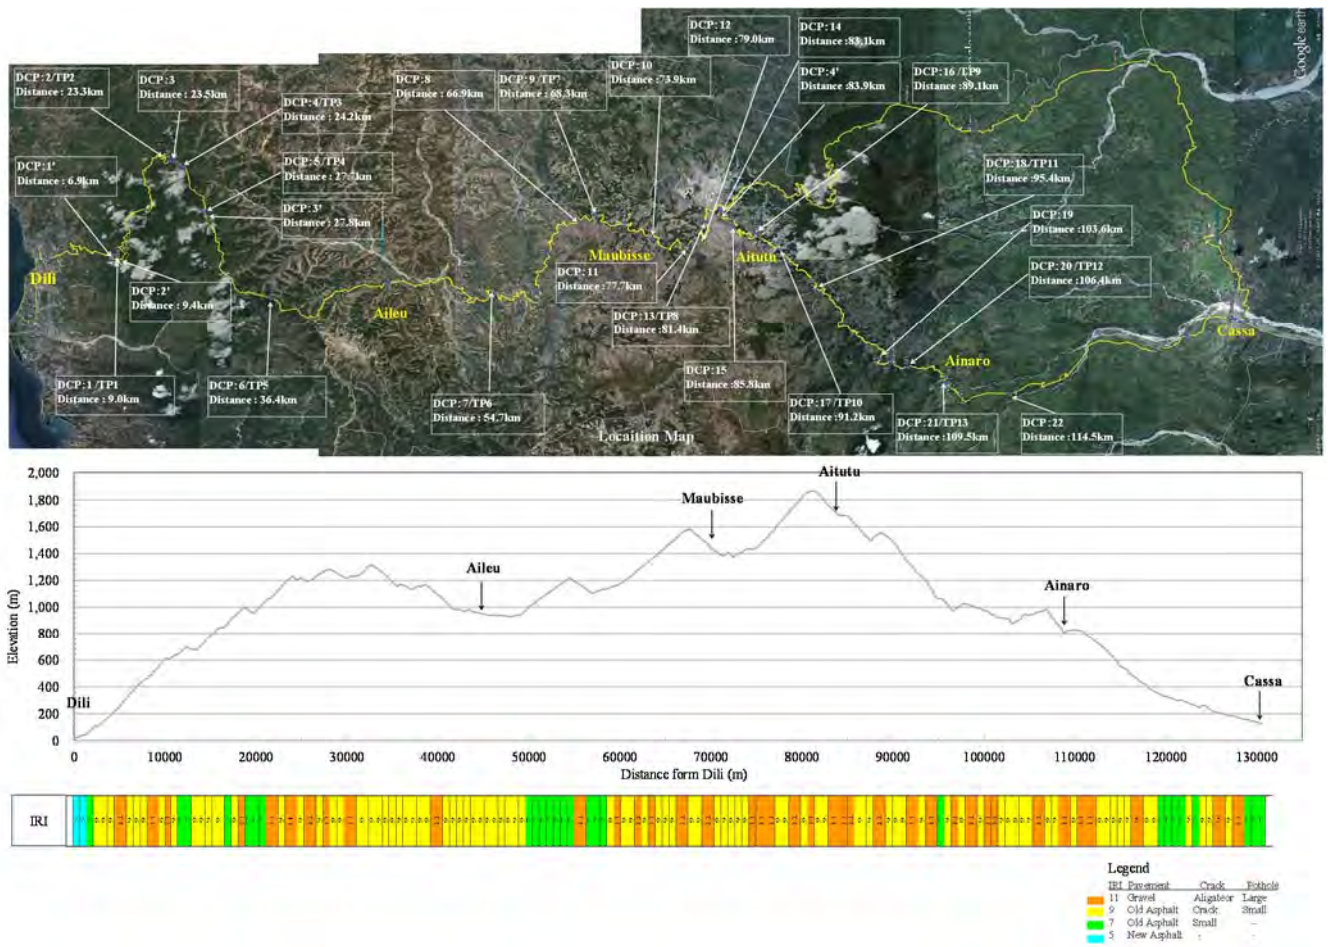
Figure 2.4 Condition of the pavement on Route A02 (between Dili and Cassa)

More specifically, along the pavement sections between the starting point and the 3.0km point and between the 50km point and 60 km point around the city of Aileu, the road is maintained at level 7 (in a fair state) as per the International Roughness Index (IRI). However, a lot of potholes and alligator cracks can be found in various locations in the pavement sections at the 3km point, 50km point and 60km point as well as the 79km point. Since the natural ground along these sections, with clayey soil derived from weathered shale and mudstone as mentioned above, subsidence natural sub grade landslides have been brought by torrential rain, and road locations in this section have been destroyed by landslides and gradual sinking to a lower level. At all of these locations, the road has also been degraded to earth and road (above IRI level 10) with complete destruction of the pavement. Under these circumstances, the pavement section in the mountains has IRI level 9 or 11.

The pavement along the entire length of the section between the 79 km point and the 131km point was repaired with grant aid from the Government of Japan. The pavement in the flat section between the 120 km point and the 131 km point has been maintained in a good condition at IRI level 7. As the natural ground along this section is also clayey soil derived from weathered shale and mudstone, like the other sections mentioned above, in several places the pavement has been completely damaged, and the road has also been degraded to an earth and gravel road (IRI level 10 or above) where torrential rain has caused subsidence of the natural sub grade or landslides, and the subsidence and landslides have caused total road destruction. Under such circumstances, the pavement in the section between the 79km point and the 120km point in the upland area which is connected to the central mountains has IRI level 9 or 11. Pavement at this level requires immediate repair work.

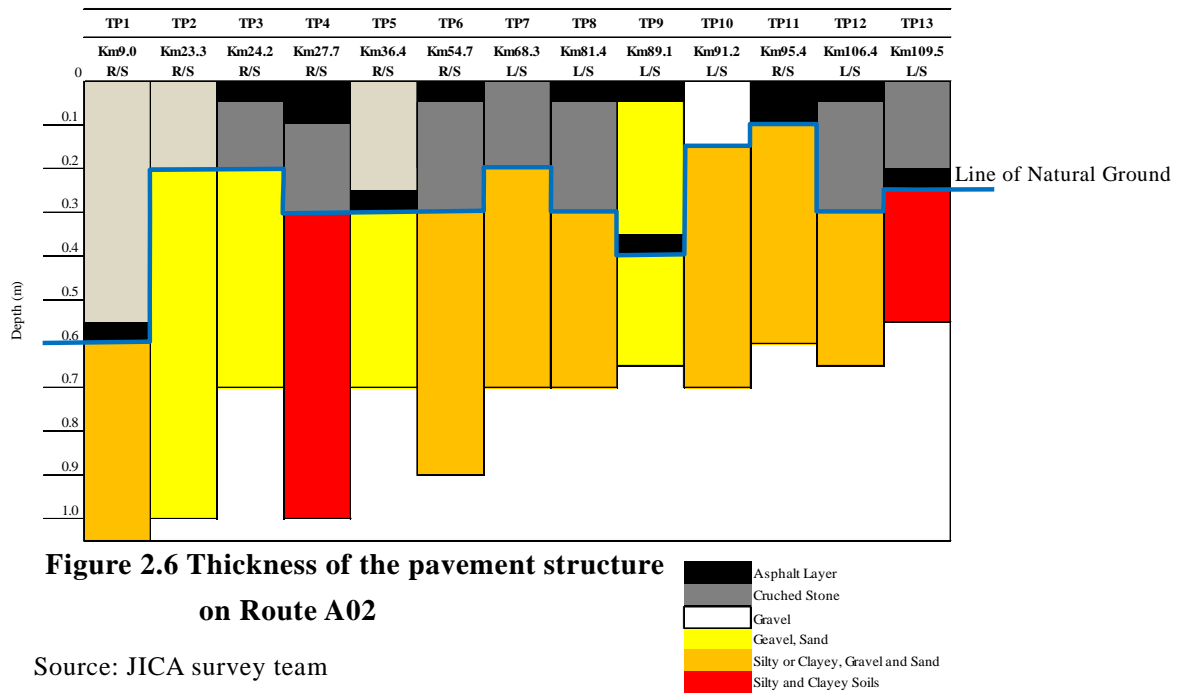
- The test pitting was conducted in Talus terrain at all the sites except TP9, TP10, TP12 and TP13. The existing road was constructed on the embankment on the Talus.

- The pavement thickness on Route A02 is not uniform along its length.
- Natural ground, instead of compacted subgrade made of borrow material, is found below the base course (TP4, TP6, TP7, TP8, TP12).

- The material used in the existing base course does not have the necessary bearing capacity for base course material. In addition, the base course does not have sufficient thickness (refer to figure 2.6).

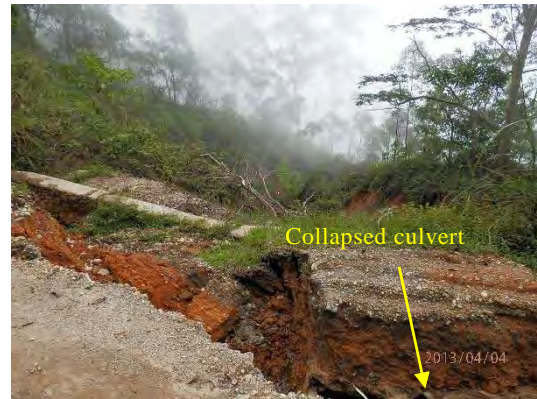
**Photo 2.9 Condition at 27.8 km**

Water leaked from the cross culvert under the road caused by the collapse of the embankment slope on the valley side (Photo 2.9). While the embankment is reinforced with gabions, the slope below the gabions is deep valley terrain. The surface characteristics of the soil are the same as at the 27.7 km point.

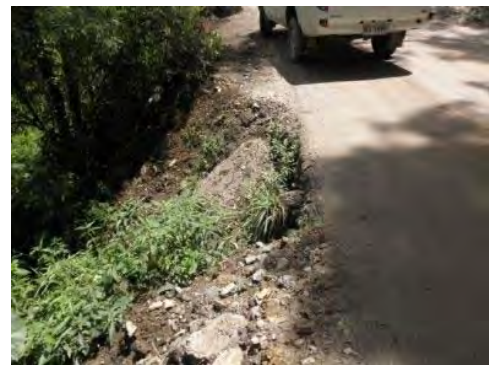
**Photo 2.14 Condition at 85.8 km point**

The condition of this site is similar to the 83.1km point mentioned above. Improper drainage of water from the mountain side led to collapse of the embankment on the valley side (Photo 2.14).

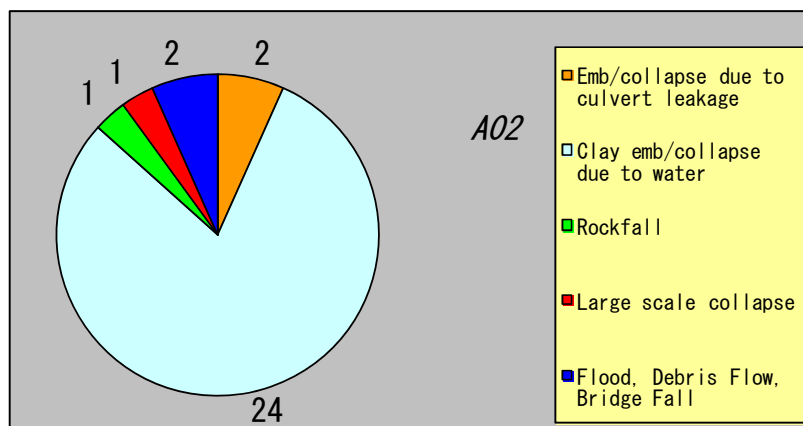
**Figure 2.8 Classification of the causes of damage to the road embankment**

Figure 2.8 shows the large number of causes of damage to the pavement by type of cause. The results were obtained from the results of field reconnaissance and evaluation of the existing road conditions on Route A02.

Slope collapse was observed at a total of 30 sites.

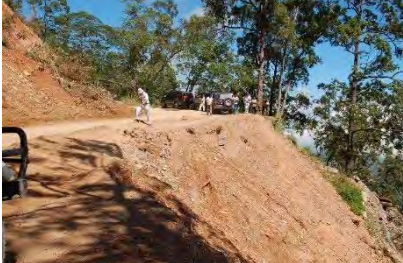
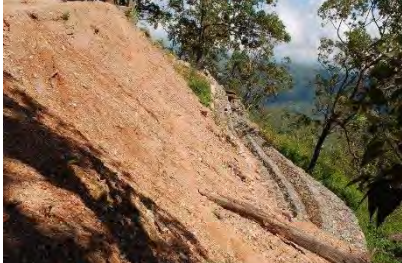
<p>Rockfall</p>

- (a) basically recommend the cutting of dangerous rock and consider the following measure as Schotcrete, Rock net and gabion wall (see photo 2).

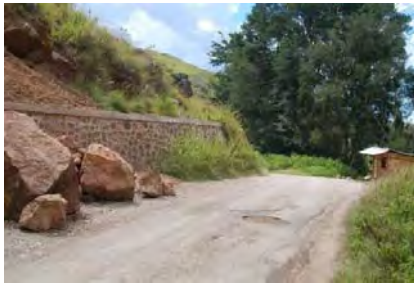
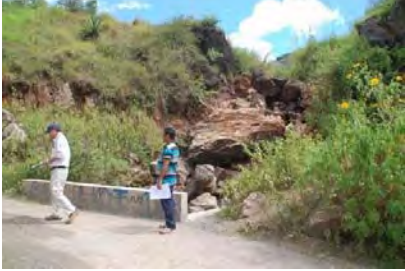
<p>Large Scale Collapse</p>

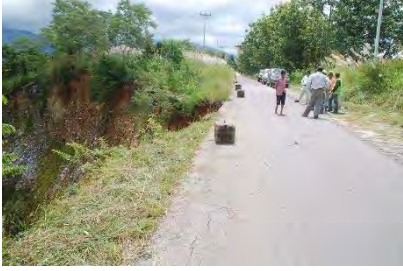
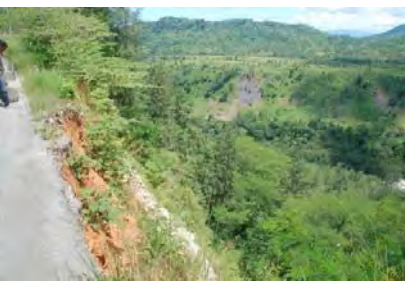
<p>Flood, Debris Flow, Bridge Fall</p>

- (a) Construction of large capacity Bridge for the main cause of damage of Low discharge capacity.

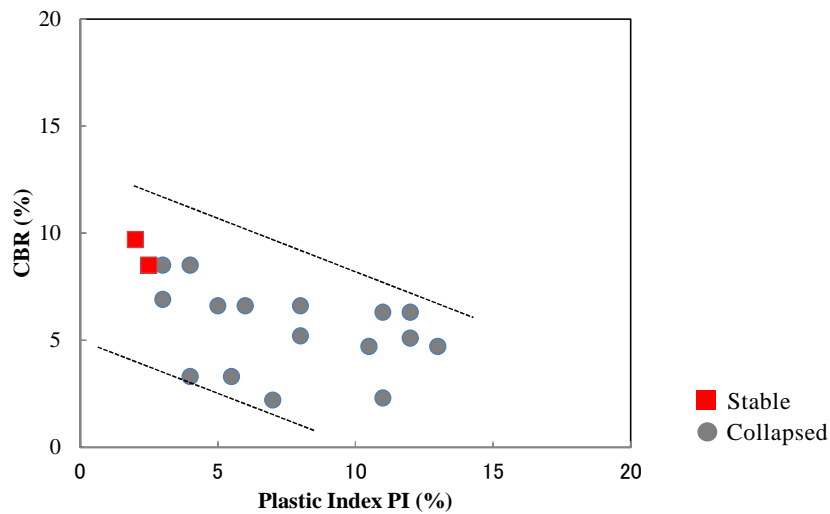
**Figure 2.9 Correlation between plasticity index and CBR of the subgrade**

Figure 2.9 shows the correlation between the plasticity index and the CBR of the subgrade, the natural ground material, with data taken at the locations of stable and collapsed slopes shown in different shapes and colors. The CBR value of the subgrade materials is seven (7) or lower and the plasticity indices of the subgrade materials are within the range of those for clayey soil at the locations where the roadside embankments have collapsed. These figures reveal the difficulty of maintaining the necessary bearing capacity of the subgrade with the materials used as subgrade materials at the locations where the embankments collapsed, and therefore, these materials are inappropriate subgrade materials.

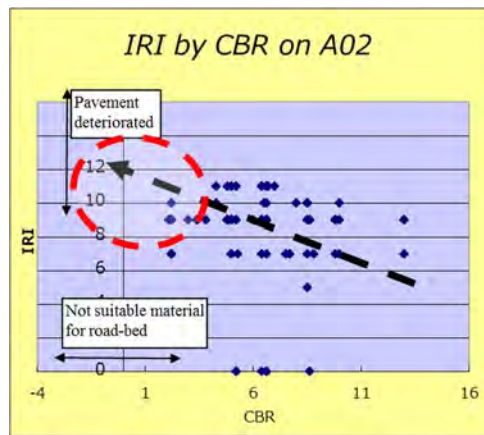
**Figure 2.10 Relationship between damage to the pavement and fragility of the compacted/natural subgrade**

The road embankment collapsed on Route A02 because of the reasons mentioned in 2.2.5 (2). Figure 2.4 shows that the pavement was also damaged in locations other than the above-mentioned. Refer to Figure 2.10 which shows that the IRI and CBR for the whole route of A02 are correlative. In addition, it appears that pavement damage has a tendency to deteriorate in locations where the subgrade is weak, as shown in Table 2.7. It can be inferred that the road embankment collapsed due to similar causes of deterioration of the bearing capacity of the subgrade. It can be stated that damage to the road embankment is most often caused by the fragility of the natural conditions in Timor-Leste.

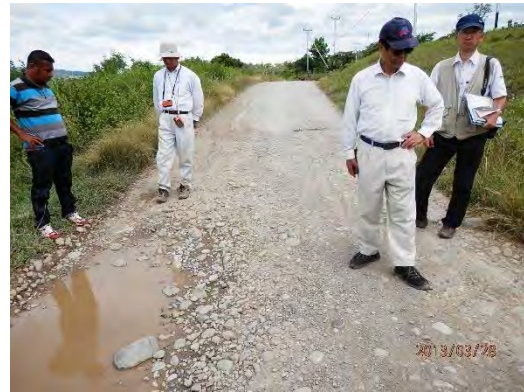
- Weakening of the base course and subgrade by water in the concave parts of the road over which the water flows down as a result of lack of an adequate drainage system contributed to the occurrence of damage to the surface course (see the photo below). Despite fair surface conditions between the 110km point and the 130km point, the pavement collapsed due to water in the concave parts of the road.

Water in the concave parts of the road

The issues to be considered with regard to repair work for damage to the pavement are as follows:

- The base course materials should be installed before installing the surface course in sections where there is no base course material.
- Pavement design including the required thickness and materials of each course should be prepared taking into consideration the bearing capacity of the subgrade and the traffic load.

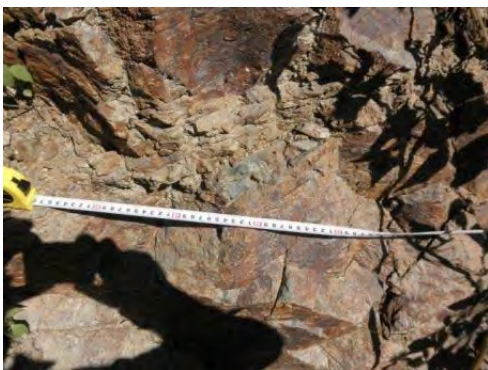
Replacing the Paleozoic formation, a Mesozoic formation covers the ground surface around Manatuto in the central region. A Cenozoic formation covers the top layer of the eastern region instead of a Mesozoic formation and raised coral reefs are observed along the northern coast of the eastern region. The geology at the 45.0km point of Route A04 from Tibar on the northern coast of Ermera belongs to the Paleozoic Aileu formation and it is very similar to the section of Route A02 from Dili to Aileu. The top layer is covered with schist and it is very fragile and susceptible to exfoliation due to weathering and erosion. (See Photo 3.1.)

**Photo 3.1 Schist (6.9km point on A04)**

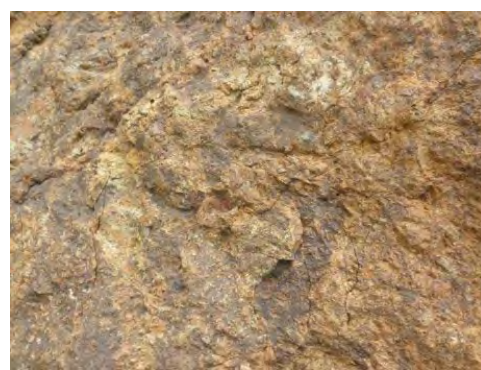
Looking at the 53.6km point of Route A02 from Aituto to Betano on the southern coast, the geology from Same to the mountain region is noteworthy for its disaster-prone geology. It belongs to the Mesozoic formation from the Triassic to the Jurassic period and mainly consists of schist, shale and mudstone. (See Photo 3.1, 3.2.)

**Photo 3.2 Shale (9.4km point on A05)**

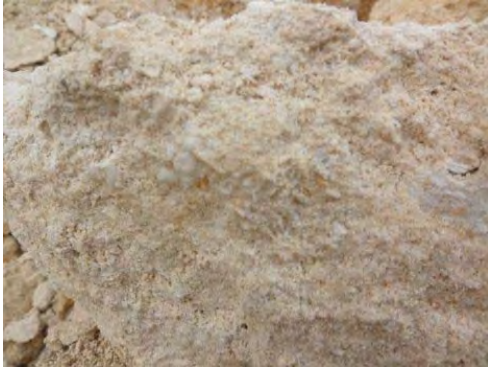
it is slightly more fragile than ordinary limestone. (See Photo 3.3.)

**Photo 3.3 Coral limestone (29.1km point on A06)**

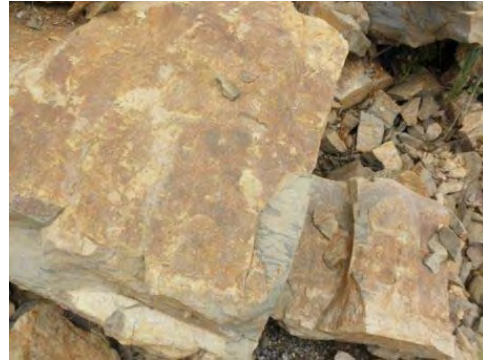
This 85.2km point section starts from Manatuto to Natarbora. It mostly consists of Mesozoic formation from the Triassic to the Jurassic period which is typically comprised of schist, shale and mudstone. They form alternate layers of dip slopes that are liable to rockfall. (See Photo 3.4.)

**Photo 3.4 Shale (31.1km point on A09)**

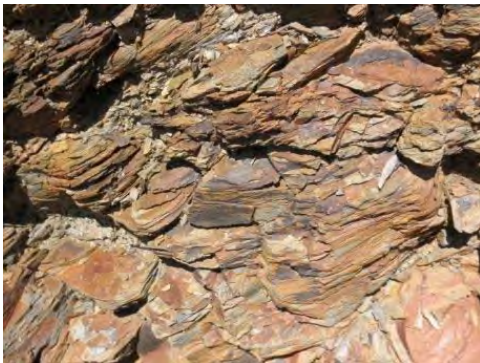
This 68.5km point section of Route A12 starts from Ermera to Hauba. It is geologically similar to the section of Route A02 from Dili to Aileu and mostly consists of a Paleozoic Aileu formation with lateritic schist covering the top layer. It is very fragile and susceptible to exfoliation due to weathering and erosion. (See Photo 3.5.)

**Photo 3.5 Schist (50.5km point on A10)**

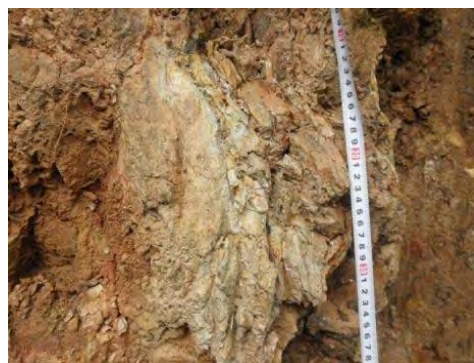
This 62.5km point section starts from Ermera to Maliana. Geologically, it is classified into a mountain part and river part. The mountain part consists of a Paleozoic Aileu formation, which is mainly comprised of lateritic schist, like the above mentioned Route A10. (See Photo 3.6.)

**Photo 3.6 Schist (8.0km point on A11)**

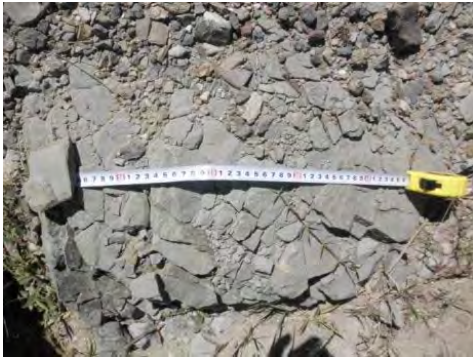
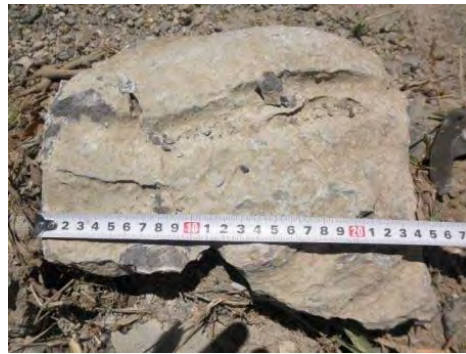
This 50.9km point section links Maliana and Zumalai. Its geographical features are shown in the table below. While this section is Paleozoic and Cenozoic formations, it mostly consists of Mesozoic formations from the Triassic to the Jurassic period and is mainly comprised of schist, shale and mudstone. (See Photos 3.7 and 3.8.)

**Photo 3.7 Schist (22.5km point on A12)    Photo 3.8 Shale (25.9km point on A12)**

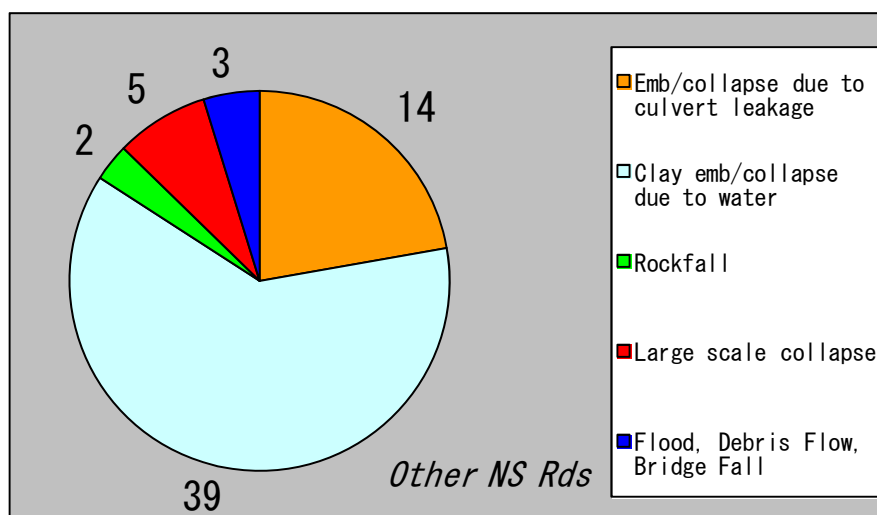
**Figure 3.2 Classification of the cases of damage to the road pavement by cause**

With regards to the north-south national road network, the survey was carried out of damage on Routes A04, A05, A06, A09, A10, A11 and A12. Figure 3.2 shows the classification of the causes of damage.

The causes of damage were classified into five (5) types in accordance with the classification survey of Route A02.

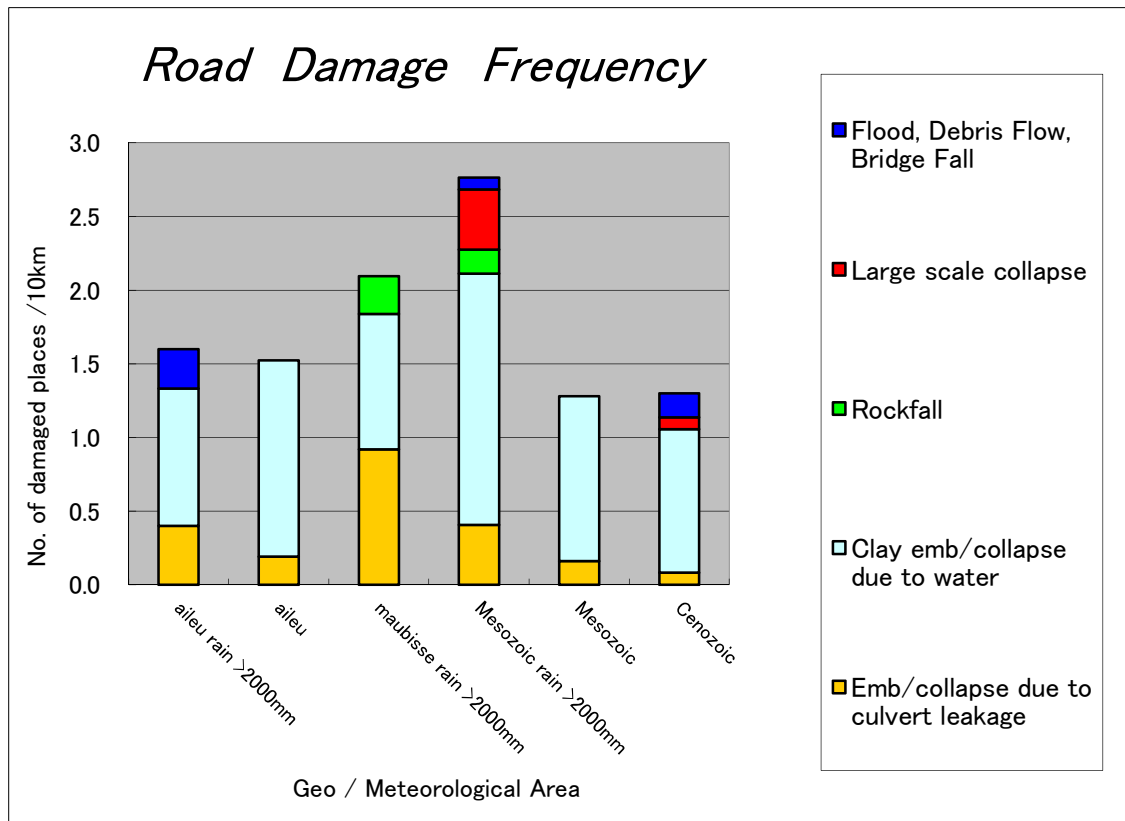
**Figure 3.3 Road damage frequency by area classification**

The frequency of pavement damage is highest in the area where the geological debilitation is Mesozoic and the annual precipitation exceeds 2,000mm. “Clayey Embankment Collapse because of Water” is far by the most common cause of pavement damage. This is also the most common cause of pavement damage in the other areas. Damage caused by “Large Scale Collapse” frequently occurs in the Mesozoic formation area with an annual precipitation exceeding 2,000mm. This suggests that ground comprised of Mesozoic formation with high precipitation is fragile. Damage caused by “Embankment Collapse due to Culvert Leakage” has occurred in all the areas covered by the survey, but the frequency is marked in areas with an annual precipitation of over 2,000mm.

“Flood, Debris Flow and Bridge Fall” is the second major cause in the Cenozoic formation area. In view of this, it might be ground comprised of Cenozoic formation that has not yet consolidated.
