**IMPLEMENTATION REVIEW STUDY REPORT  
ON  
THE PROJECT FOR THE REHABILITATION OF  
THE EAST DEMERARA WATER  
CONSERVANCY( II )  
IN  
THE REPUBLIC OF GUYANA**

**October 2013**

**JAPAN INTERNATIONAL COOPERATION AGENCY**

**SANYU CONSULTANTS INC.**

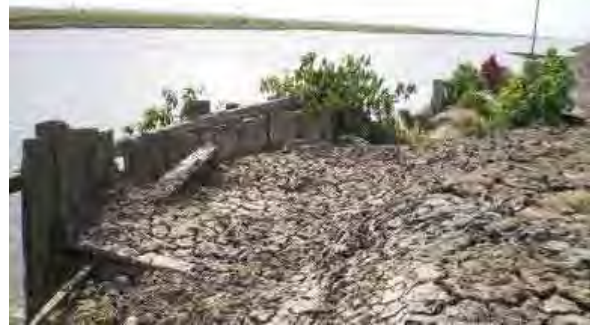
Part	Conditions
Main body	At present, normally functioning without problems (PH2 -1-5, PH 2-1-7)
Wooden pile revetment	Almost normal at the both upstream and downstream sides (The disordered row of piles does not mean necessarily the aging condition because of the piles being not driven straight into the hard ground.) (PH 2-1-7, PH 2-1-8)
Surrounding embankment	Complementary filling on the crest has quite recently completed. The portion provided with the wooden pile revetment is limited and filled slopes at the upstream side are steep.(PH 2-1-5, PH 2-1-6)
Operation	The downstream side is in marshy condition, and the canal extends from there. (PH 2-1-9) The Gate is operated 4 times a year by the staff of the Flagstaff Office (at the beginning of the dry season and the wet season) .

PH2-1-6 Wooden pile revetment at the inlet mouth

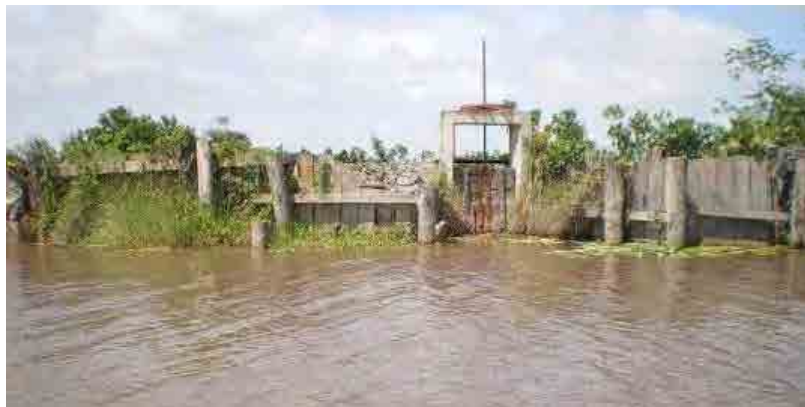
PH 2-1-7 Wooden pile revetment at the upstream side

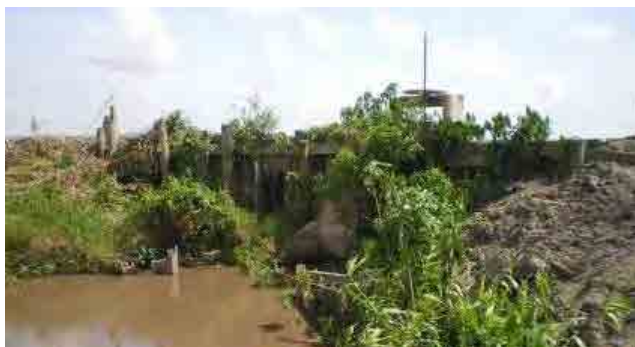
PH 2-1-8 Wooden pile revetment

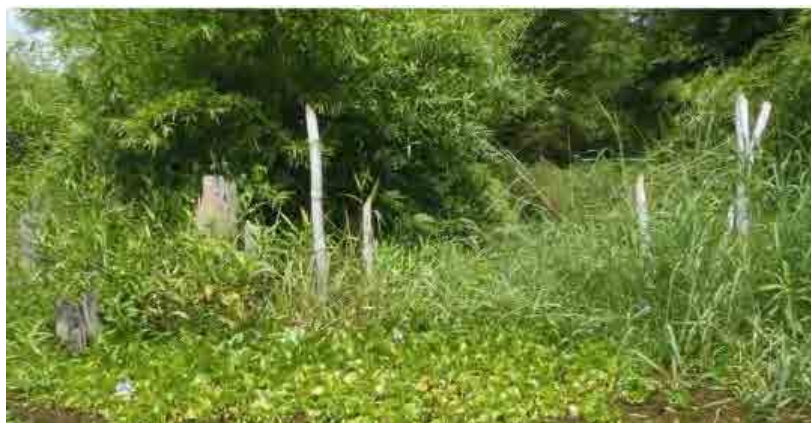
Part	Conditions
Main body	At present, normally functioning without problems (see PH 2-1-14)
Wooden pile revetment	Concrete retaining walls are installed at the surrounding portions of the inlet mouth. Wooden pile revetments were once installed on the tail portions, but now leave almost no trace of existence (see PH 2-1-15).
Surrounding embankment	No symptom of sliding is seen on the slopes of embankments/grounds (see PH 2-1-15).
Operation	The gate is daily operated by the staff of the Flagstaff Office. Water is conveyed to the waterworks for the tap-water of Georgetown.

PH2-1-15 Debris of the revetment and vegetation on the slope

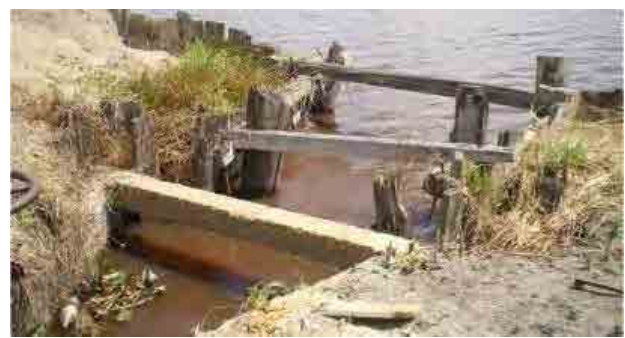
Part	Conditions
Main body	At present, functioning almost normally without problems, though there is a doubt in future operation due to the inclined spindle. (see PH 2-1-16)
Wooden pile revetment	Revetment works at the upstream side are rather irregular with having only temporary treatments (see PH 2-1-17). Disturbed condition is not seen in the downstream side revetment, but the range of revetment coverage is quite limited (see PH 2-1-19).
Surrounding embankment	Crest of the embankment has narrow width because it has been dwindled (see PH 2-1-18). At the right hand point of about 20m distant from the inlet, a terrace was formed as a result of sliding over the slope of upstream side (see PH 2-1-20).
Operation	The gate is operated by the staff of Flagstaff Office four times a year. This facility is the most important headwork in northern irrigation network, and downstream canal is of a large scale (see PH 2-1-21).

PH2-1-17 Revetment at the inlet mouth

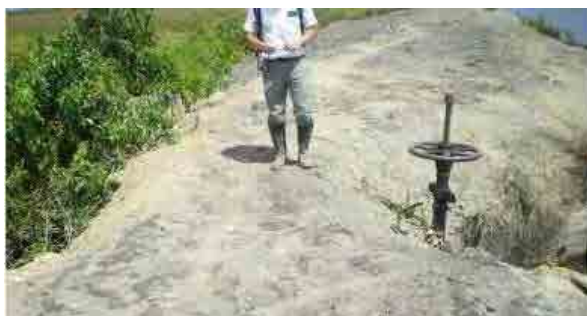
PH2-1-18 Lean and narrow embankment crest

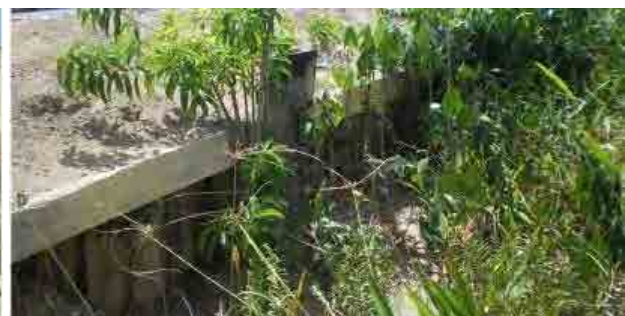
PH2-1-19 Revetment at the outlet mouth

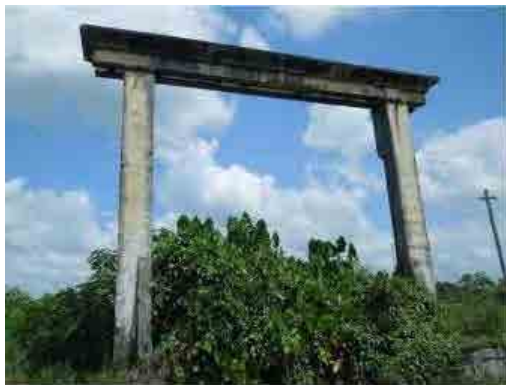
PH2-1-22' Piers for winching the Cuhnia regulation gate

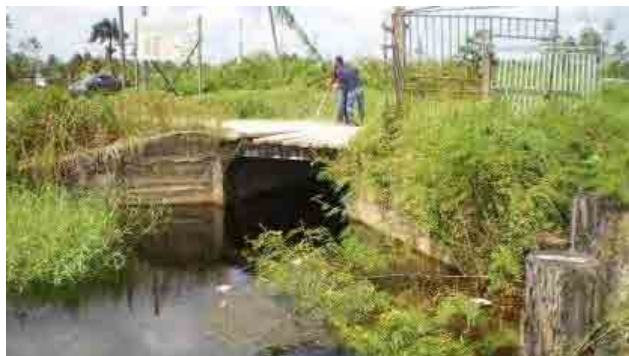
PH2-1-25 Wooden bridge  
and the narrow concrete flume

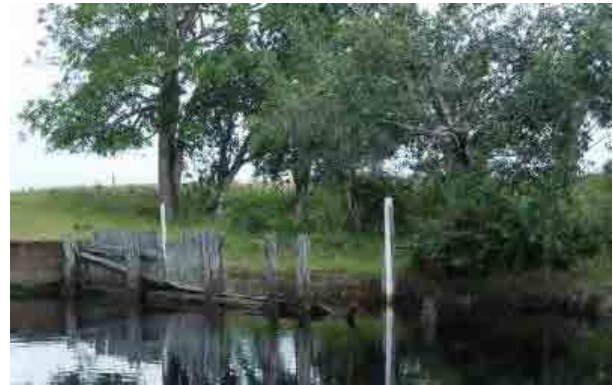
PH2-1-30 Rotten wooden sheet piles and the stable ground surface

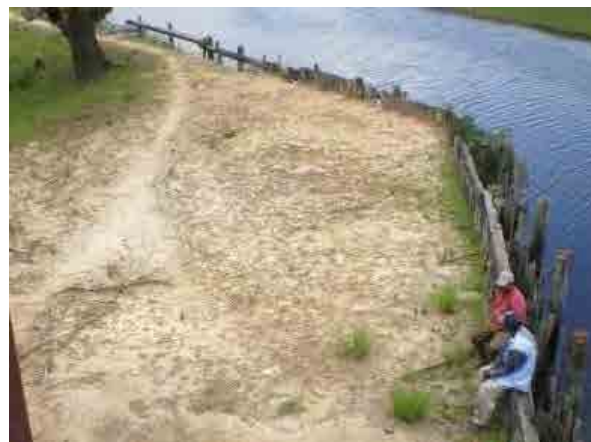
PH2-1-31 Embankment surface composed of well-compacted clayey soil

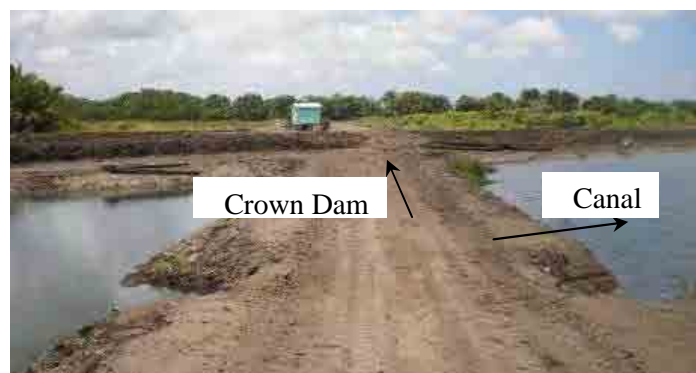
In Guyana, all the old roads in rural area are not called “road” but called “dam” or “trail”. The Crown Dam is confirmed as the road and its surface elevation is lower than the crest elevation of the conservancy dam and the Hope/Dochfour Drainage Channel. The conclusion is that the Crown Dam can not function as the conservancy dam in place of the existing one.

PH 2-1-38 Crossing point of the Crown Dam and the Hope/Dochfour canal
