PART 3

SELECTION OF BRIDGES FOR SEISMIC CAPACITY IMPROVEMENT (PACKAGE B AND C)

CHAPTER 11 PROCEDURES FOR SELECTION OF BRIDGES FOR OUTLINE DESIGN

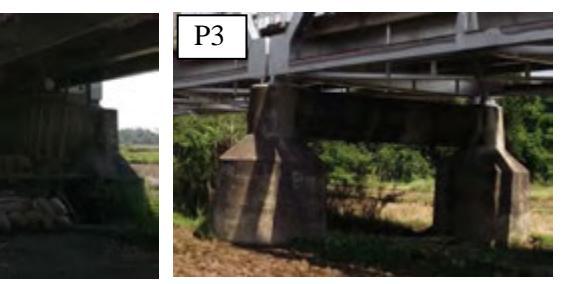
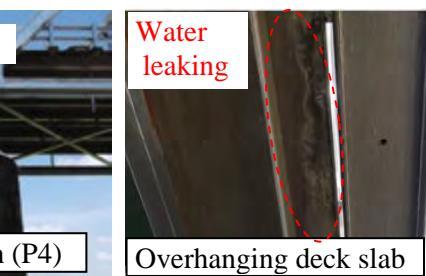
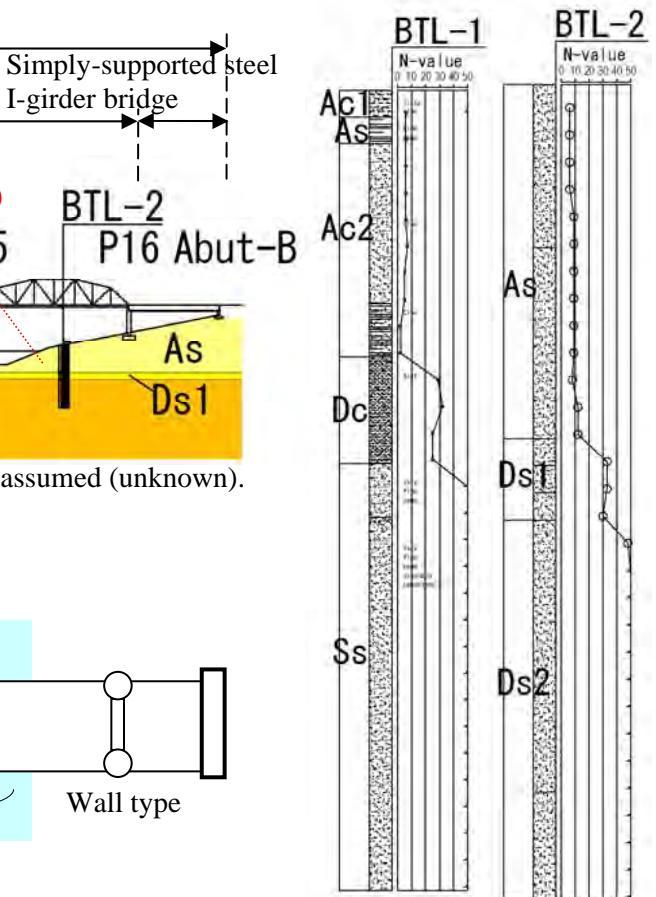
Figure 13.2.1-1 Structural and Geological Outline of Buntun Bridge

Seismic Vulnerability				Structural Soundness				
	Items Results of Surveys Analyses/Comments				Items Results of Surveys Analyses/Comments			
	1. Differenceinsoiltypesbetweenadjacent piers2. Continuous orSimplySupportedBridge	Soil Type is consistent along with the entire bridge1. Main Spans: Simply supported 2. Approach Spans: Simply supported	<ul> <li>No soil type difference between adjacent piers</li> <li>All spans are simply supported.</li> <li>High possibility of unseating due to simply supported structures</li> </ul>		1. Primary Members	Steel Truss	<ul> <li>All superstructure members were recently repainted and they are in good condition.</li> <li>Overall damage degree: Good</li> </ul>	
Earthquake Resisting System	<ul> <li>3. Eccentric Loads (longitudinal and transverse dir.)</li> <li>4. Pier Type (single column/wall or multiple columns)</li> </ul>	Maximum span ratio: (2 nd span length): (3 rd span length) = 1.0:1.7 1. Wall type 2. Rigid frame type 3. Rigid frame type with shear walls	<ul> <li>The span ratio is over 1.5</li> <li>Possibility of eccentric loads only in the transverse direction: simply supported</li> <li>13 out of 16 piers are rigid frame type</li> <li>Multiple column type is more advantageous than single column/wall type against earthquakes in terms of structural redundancy.</li> </ul>	Superstructures	2. Secondary Members	2. Secondary Members	Steel Truss	<ul> <li>All superstructure members were recently repainted and they are in good condition.</li> <li>Overall damage degree: Good</li> </ul>

12. Soil Type	Soil type (JRA): 1	- Firm ground condition				COME, LANSING PROPAGATION SUBJECTS ARE ADMITTED (MARATIME).	
	13. Liquefaction Potential	- N-Value range of the layer: 6 – 9	- very high inqueraction potential				River	
Seismic Hazard	14. Distance from Active Faults	- Distance: 15.9km - Active Fault Name: Taboan River Fault	- The distance is over 10km. - Small effect of the active fault movement		Wall type Rig	id frame type Rigid frame t	Wall type

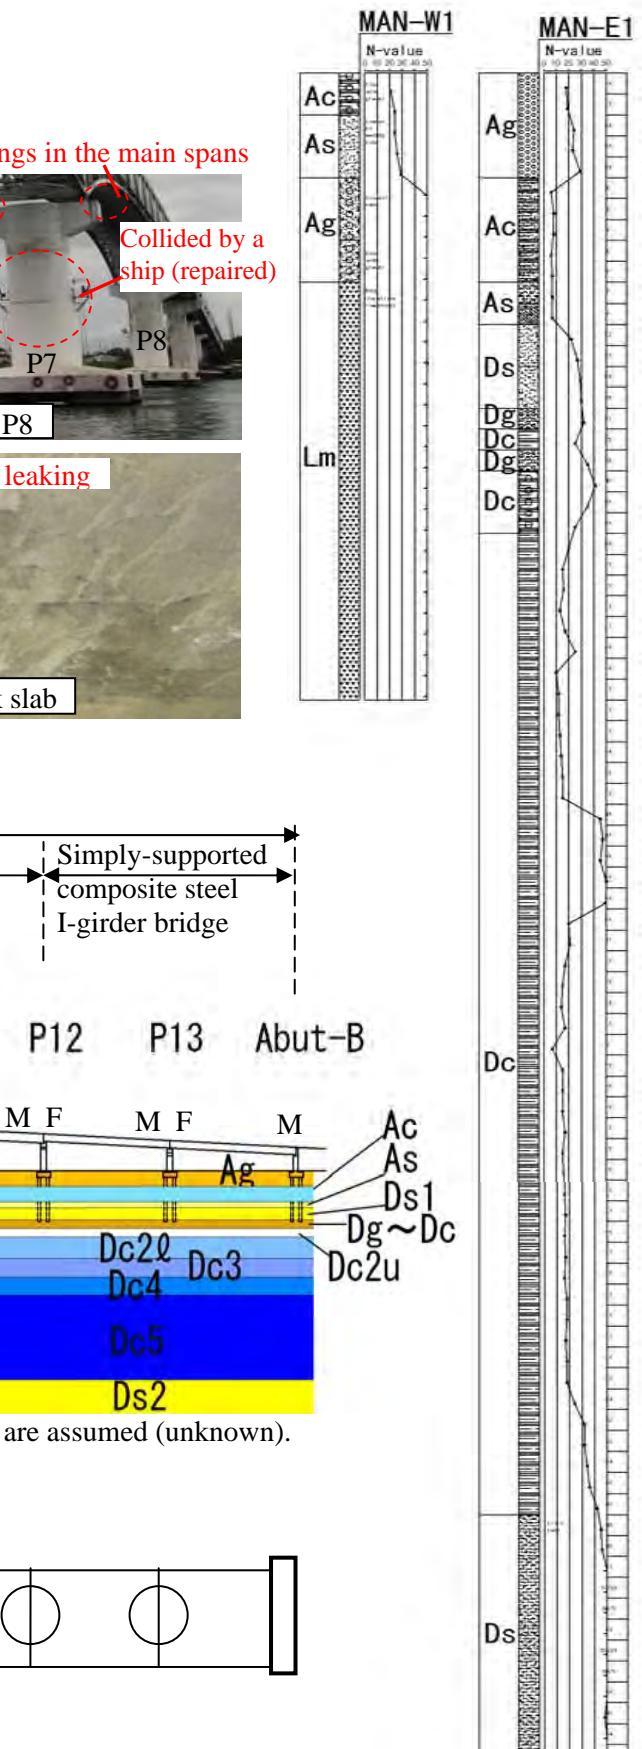
Figure 13.2.1-4 Structural and Geological of 1st Mandaue Mactan Bridge

Seismic Vulnerability	
	Items	Results of Surveys	Analyses/Comments
	1. Difference in soil types between adjacent piers	Soil Types are considered to be different among Pier-6, Pier-7, and Pier-8. (Soil type: I or II)	- Soil type difference among Pier-6, Pier-7, and Pier-8 (Soil type: I or II)

2. Continuous or Simply Supported Bridge	<ol> <li>Main Spans: Continuous</li> <li>Approach Spans: Continuous or Simply supported</li> </ol>	<ul><li>A few side spans are simply supported.</li><li>High possibility of unseating at side spans due to simply supported structures</li></ul>
Earthquake	3. Eccentric Loads (longitudinal and transverse dir.)	Maximum span ratio: ( $6^{th}$ span length): ( $7^{th}$ span length) = 1.0:2.2	<ul> <li>The span ratio is over 1.5</li> <li>Possibility of eccentric loads in both the longitudinal &amp; transverse dir.: continuous</li> </ul>
System	4. Pier Type (single column/wall or multiple columns)	Single column type	- Single column/wall type is less advantageous than multiple column type against earthquakes in terms of structural redundancy.

7. Unseating/Fall-down Prevention Devices (both longitudinal and transverse dir.)	<ul> <li>Longitudinal dir.: No restrainer</li> <li>Transverse dir.: No restrainer</li> </ul>	- High possibility of unseating under earthquake due to non-existence of seismic restrainers
Unseating/ Fall-down	8. Bearing	<ol> <li>Linear type (Movable or Fixed)</li> <li>Corroded</li> <li>Pivot type (Fixed hinge)</li> <li>Corroded</li> <li>Corroded</li> <li>Corroded</li> <li>Corroded</li> </ol>	<ol> <li>Steel bearings (linear type) at abutments &amp; piers of I-girder bridges         <ul> <li>Condition: Corroded, paint deterioration</li> <li>Steel bearings (roller type) at piers of the steel truss bridge             <ul> <li>Condition: Good</li> <li>Steel bearings (pivot type) at piers                     <ul> <li>Condition: Good</li></ul></li></ul></li></ul></li></ol>
System			<ul> <li>Types of existing bearing are not vulnerable to earthquakes</li> <li>Possibility of unseating at piers of simply supported steel I-girder bridges due to corroded bearings</li> <li>Overall vulnerability: Serious</li> </ul>

10. Foundation Type (known or unknown)	No available drawings	- Unknown structure
	11. Scouring	Moderate scouring at Pier-10	- Stability reduction of Pier-10 under earthquake due to the scouring
Foundation	12. Soil Type	Soil type (JRA): I & II	- Firm ground and moderate ground mix (Moderate)

13. Liquefaction Potential	<ul> <li>Liquefiable layer type: Silty sand</li> <li>N-Value range of the layer: 7</li> </ul>	- Very high liquefaction potential
Seismic Hazard	14.DistancefromActive Faults	- Distance: 15.8km - Active Fault Name: Cebu Lineament	<ul><li>The distance is over 10km.</li><li>Small effect of the active fault movement</li></ul>

Soundness	
VS	Analyses/Comments
	- Primary steel members are apparently in good condition.
	<ul> <li>The load capacity is considered to be reduced by the damage even though</li> </ul>
	the damage was repaired. - Overall damage degree: Moderate
cion loss	<ul> <li>Heavy corrosion at most of secondary steel members</li> <li>Section loss at some of the secondary steel members</li> <li>Overall damage degree: Serious</li> </ul>
ar exposure	<ul> <li>Minor cracking at the bottom face of deck slab through the entire bridge (Crack width range: 0.1-0.4mm)</li> <li>Rebar exposure at the overhanging deck slabs</li> <li>Overall damage degree: Moderate</li> </ul>
ed by a ship ed) P7	<ul> <li>Severe rebar exposure at the bottom face of piers in the water</li> <li>Pier-7 was collided by a ship in the past.</li> <li>Overall damage degree: Serious</li> </ul>
ctural Deficien	cies
uakes (confine akes (liquefact	ment loss, deterioration) ion potential, unknown structure,

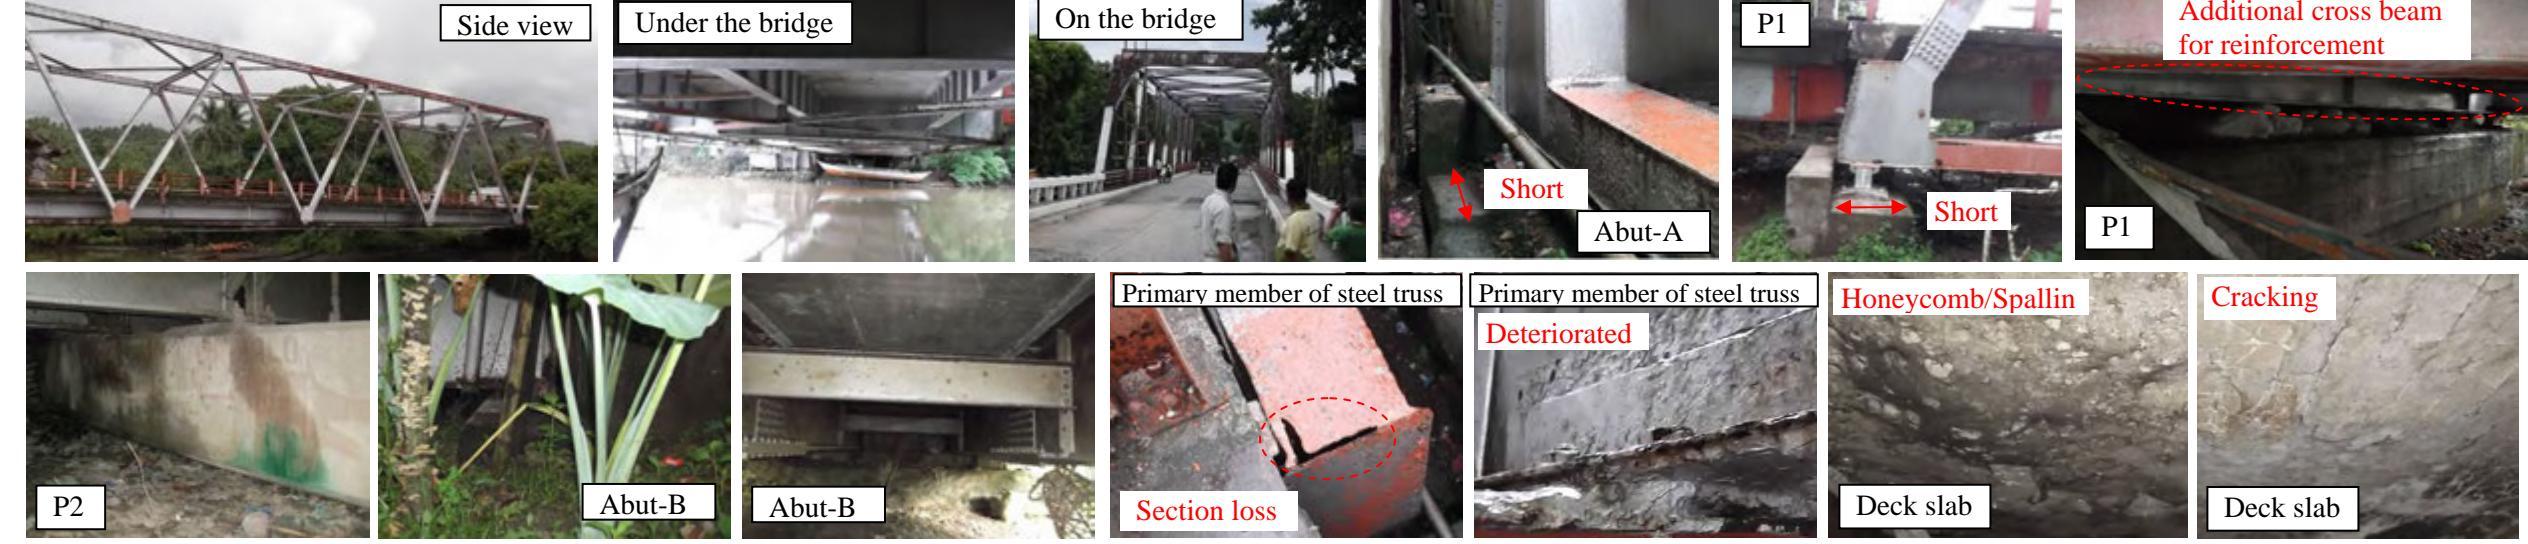
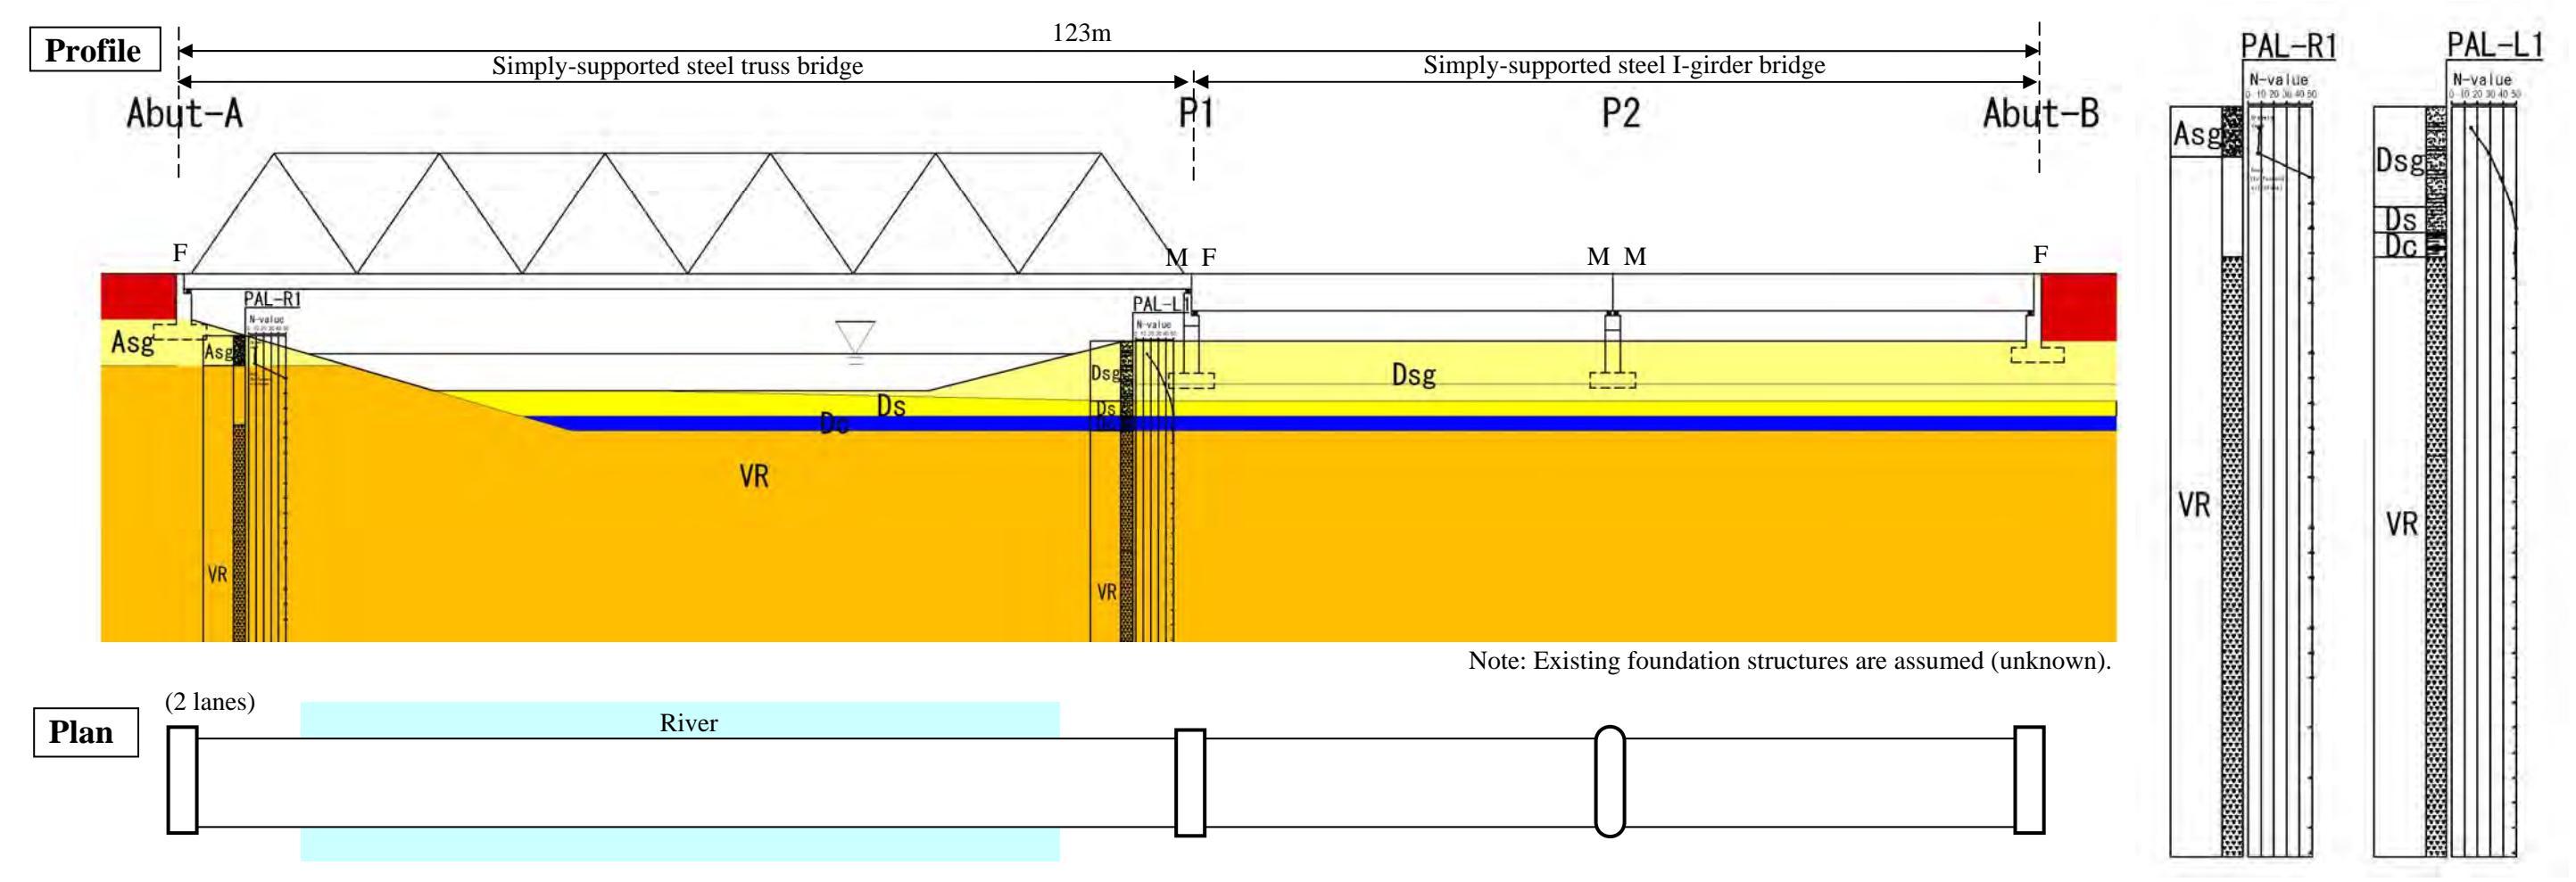
Figure 13.2.1-7 Structural and Geological of Palanit Bridge

Seismic Vulnerability				Structural Soundne	ess		
	Items	Results of Surveys	Analyses/Comments		Items	Results of Surveys	f Surveys Analyses/Comments		
	1. Difference in soiltypesbetweenadjacent piers	Soil Type is consistent along with the entire bridge	- No soil type difference between adjacent piers		1. Primary	Steel Truss Section loss	<ul> <li>Severe painting deterioration and corrosion on steel members</li> <li>Section loss at some part of primary steel members</li> </ul>

2. Continuous or Simply Supported Bridge	<ol> <li>Main Spans: Simply supported</li> <li>Approach Spans: Simply supported</li> </ol>	<ul> <li>All spans are simply supported.</li> <li>High possibility of unseating due to simply supported structures</li> </ul>		Members	Deteriorated	<ul> <li>Low load capacity (load limit: 7t)</li> <li>Overall damage degree: Serious</li> </ul>		
Earthquake Resisting System	<ol> <li>Eccentric Loads (longitudinal and transverse dir.)</li> <li>Pier Type (single</li> </ol>	Maximum span ratio: $(1^{st} \text{ span length}): (2^{nd} \text{ span length})$ = 2.7:1.0 Wall type	<ul> <li>The span ratio is over 1.5</li> <li>Possibility of eccentric loads only in the transverse direction: simply supported</li> <li>Single column/wall type is less advantageous</li> </ul>	structures	2. Secondary Members	Steel Truss Corroded Corroded	<ul> <li>Severe painting deterioration and corrosion on steel members</li> <li>Overall damage degree: Serious</li> </ul>

5. Height of Abutment (Embankment)	- Abut-A: 3m - Abut-B: 3m 1972 (Constructed before 1992)	<ul> <li>Lower risk of abutments' collapse under earthquake</li> <li>Possibility of confinement loss of pier</li> </ul>			Cracking & Honeycomb/ water leaking Spalling	- Major cracking & water leaking at the bottom face of deck slab through the entire bridge (Crack width range: 0.3-0.7mm)

7. Unseating/Fail-down Prevention Devices (both longitudinal and transverse dir.)	- Transverse dir.: No restrainer	existence of seismic restrainers	res	4. Deterioration		- Overall damage degree: Serious     - Rebar exposure & cracking at the bearing     base of Pier-1

1. Abut-A: 55cm Minimum Required Seat Length	- The seat lengths of abutments and piers don't satisfy JRA's minimum required seat length.	- ]	Rebar exposure & o	cracking at the bearing base of Pier-1

- JRA: 104cm, AASHTO: 51cm	short seat length						
	10. Foundation Type (known or unknown)	No available drawings	- Unknown structure		Asg		Dsg E-3		
Foundation	11. Scouring	None	- No scouring effect			Do Ds Ps VR

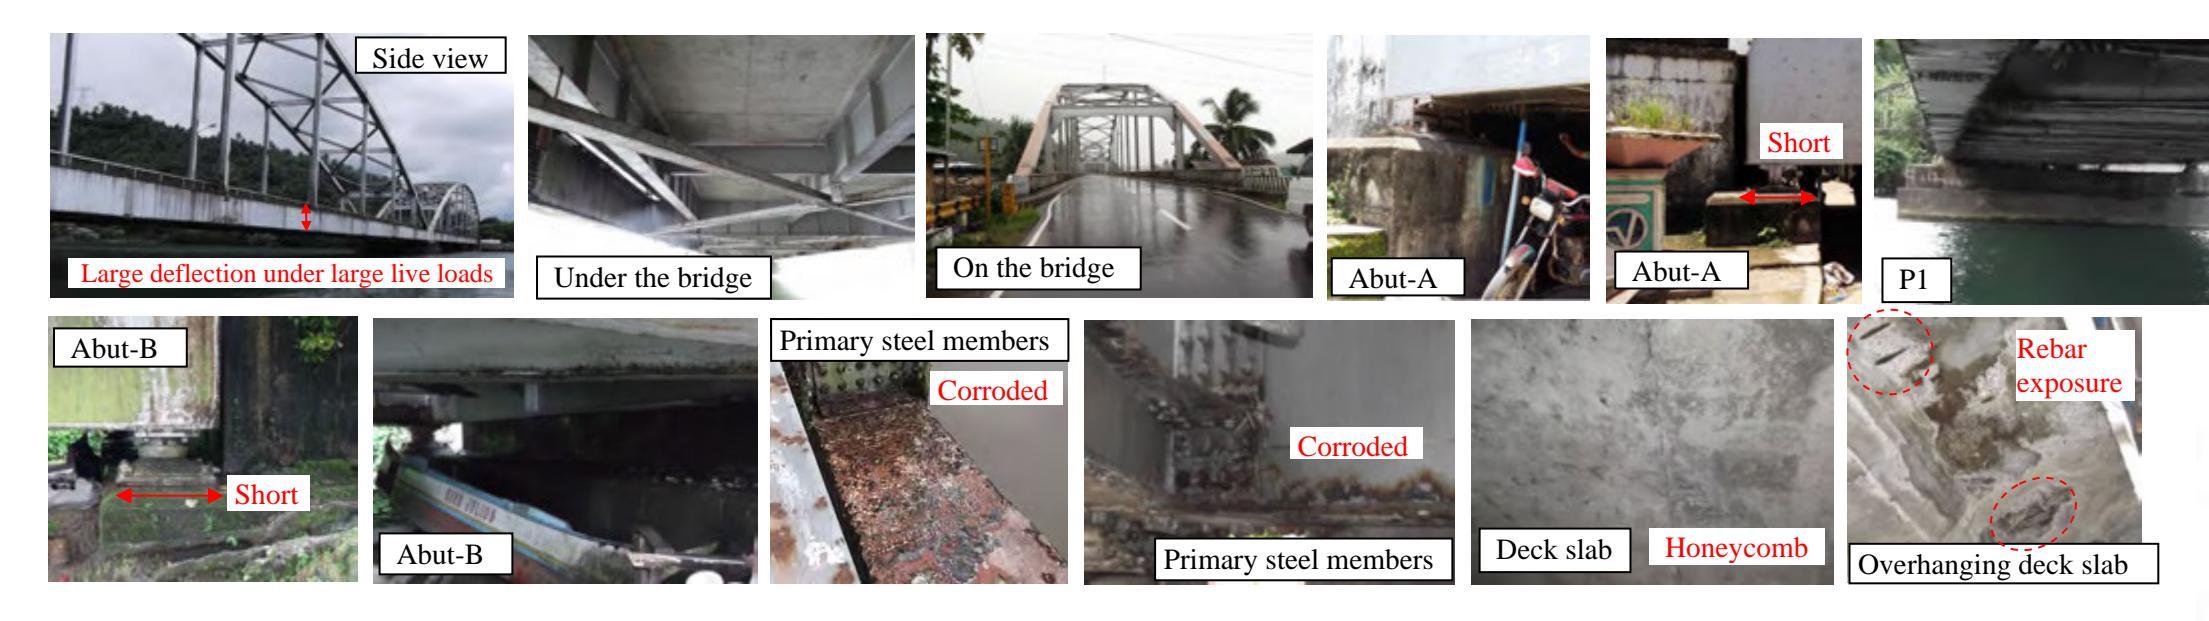
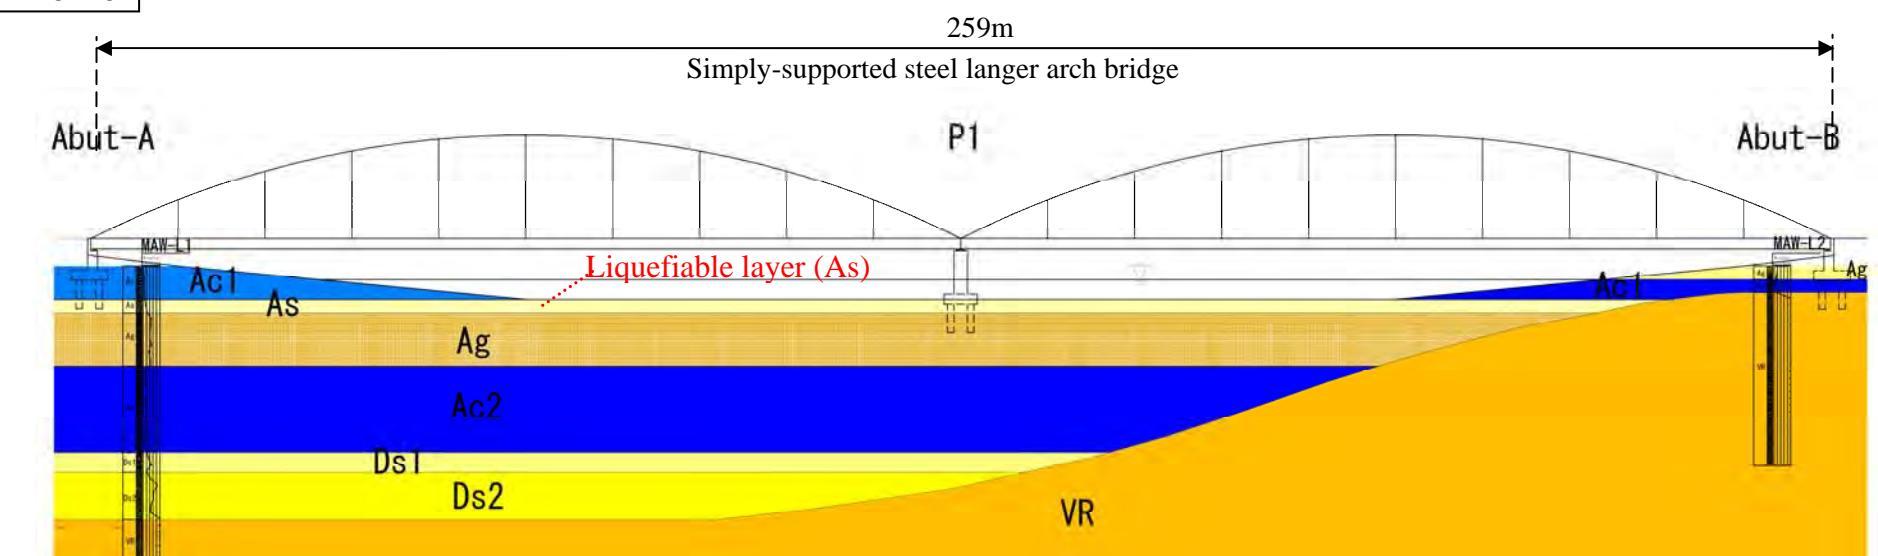
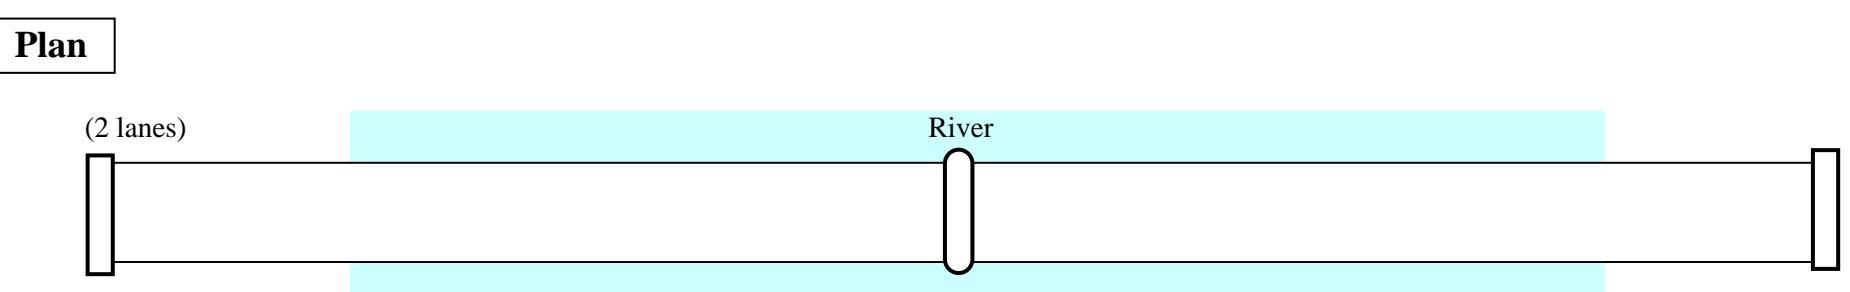
Figure 13.2.1-10 Structural and Geological Outline of Mawo Bridge

Seismic Vulnerability			Structural Soundness				
	Items	Results of Surveys	Analyses/Comments		Items	Results of Surveys	Analyses/Comments
	1. Difference in soiltypesbetweenadjacent piers2. Continuous orSimplySupportedBridge	Soil Types are considered to be different between Pier-1 and Abut-B. (Soil type: I or III) Simply supported	<ul> <li>Soil type difference between Pier-1 and Abut- B (Soil type: I or III)</li> <li>All spans are simply supported.</li> <li>High possibility of unseating due to simply supported structures</li> </ul>		1. Primary Members	Steel langer arch Corroded	<ul> <li>Painting deterioration and corrosion on steel members</li> <li>Low load capacity (load limit: 7t)</li> <li>Overall damage degree: Moderate</li> </ul>
Earthquake Resisting System	<ul> <li>3. Eccentric Loads</li> <li>(longitudinal and transverse dir.)</li> <li>4. Pier Type (single column/wall or multiple columns)</li> </ul>	Maximum span ratio: (1 st span length): (2 nd span length) =1.0:1.0 Wall type	<ul> <li>The span ratio is 1.0.</li> <li>Little possibility of eccentric loads</li> <li>Single column/wall type is less advantageous than multiple column type against earthquakes in terms of structural redundancy.</li> </ul>	erstructures	2. Secondary Members	Steel langer arch	<ul> <li>Painting deterioration and corrosion on steel members</li> <li>Overall damage degree: Moderate</li> </ul>

<ul><li>5. Height of Abutment (Embankment)</li><li>6. Built Year</li></ul>	- Abut-A: 2m - Abut-B: 2m 1976 (Constructed before 1992)	<ul> <li>- Heights of embankments are below 5m.</li> <li>- Lower risk of abutments' collapse under earthquake</li> <li>- Possibility of confinement loss of pier columns/walls</li> <li>- Lack of seismic capacities of all the members</li> </ul>	Supe	3. Deck Slab	Rebar exposure Honeycomb/Spalling	<ul> <li>Cracking &amp; water leaking at the bottom face of deck slab through the entire bridge (Crack width range: 0.3-0.7mm)</li> <li>Honeycomb/Spalling at the bottom face of deck slab in Span 1 &amp; 2</li> </ul>

7. Unseating/Fall-down Prevention Devices (both longitudinal and transverse dir.)	<ul> <li>Longitudinal dir.: No restrainer</li> <li>Transverse dir.: No restrainer</li> </ul>	- High possibility of unseating due to non- existence of seismic restrainers			Cracking & water leaking	<ul> <li>Rebar exposure at the overhanging deck slab</li> <li>Overall damage degree: Serious</li> </ul>

9. Seat Length	<ol> <li>Abut-B: 90cm</li> <li>Minimum Required Seat Length</li> <li>JRA: 135cm, AASHTO: 66cm</li> <li>Pier-2: 90cm</li> <li>Minimum Required Seat Length</li> <li>JRA: 135cm, AASHTO: 66cm</li> </ol>	<ul> <li>The seat lengths of abutments and Pier-1 don't satisfy JRA's minimum required</li> <li>Possibility of unseating due to the short seat length</li> </ul>	- L - L - D - S 3. Stu - N	ow load capacity (I arge deflection und Deterioration at steel evere deterioration ructural Soundness Jone	oad limit: 7t), abnormal vibration of the su ler large live loads l truss members of the deck slab (cracking, honeycomb/sp. (Substructures)	iperstructure alling, water leaking, rebar exposure)

10. Foundation Type (known or unknown)	No available drawings	- Unknown structure		Abut	259m Simply-supported steel ranger arch bridge -A P1	Abut-B
	11. Scouring	Condition of Pier-1 is unknown.	- Unknown		-		
Foundation	12. Soil Type 13. Liquefaction	Soil type (JRA): I & III - Liquefiable layer type: Sand - N-Value range of the layer: 8-12	<ul><li>Firm ground and soft ground mix (Soft)</li><li>Very high liquefaction potential</li></ul>			As Ag Dist	isting foundation structures are assumed (unknown)
Seismic Hazard	Potential 14. Distance from Active Faults	- Distance: 1.4km - Active Fault Name: Northern Samar Lineament	<ul><li>The distance is less than 2km.</li><li>Fatal effect of the active fault movement</li></ul>			anest River

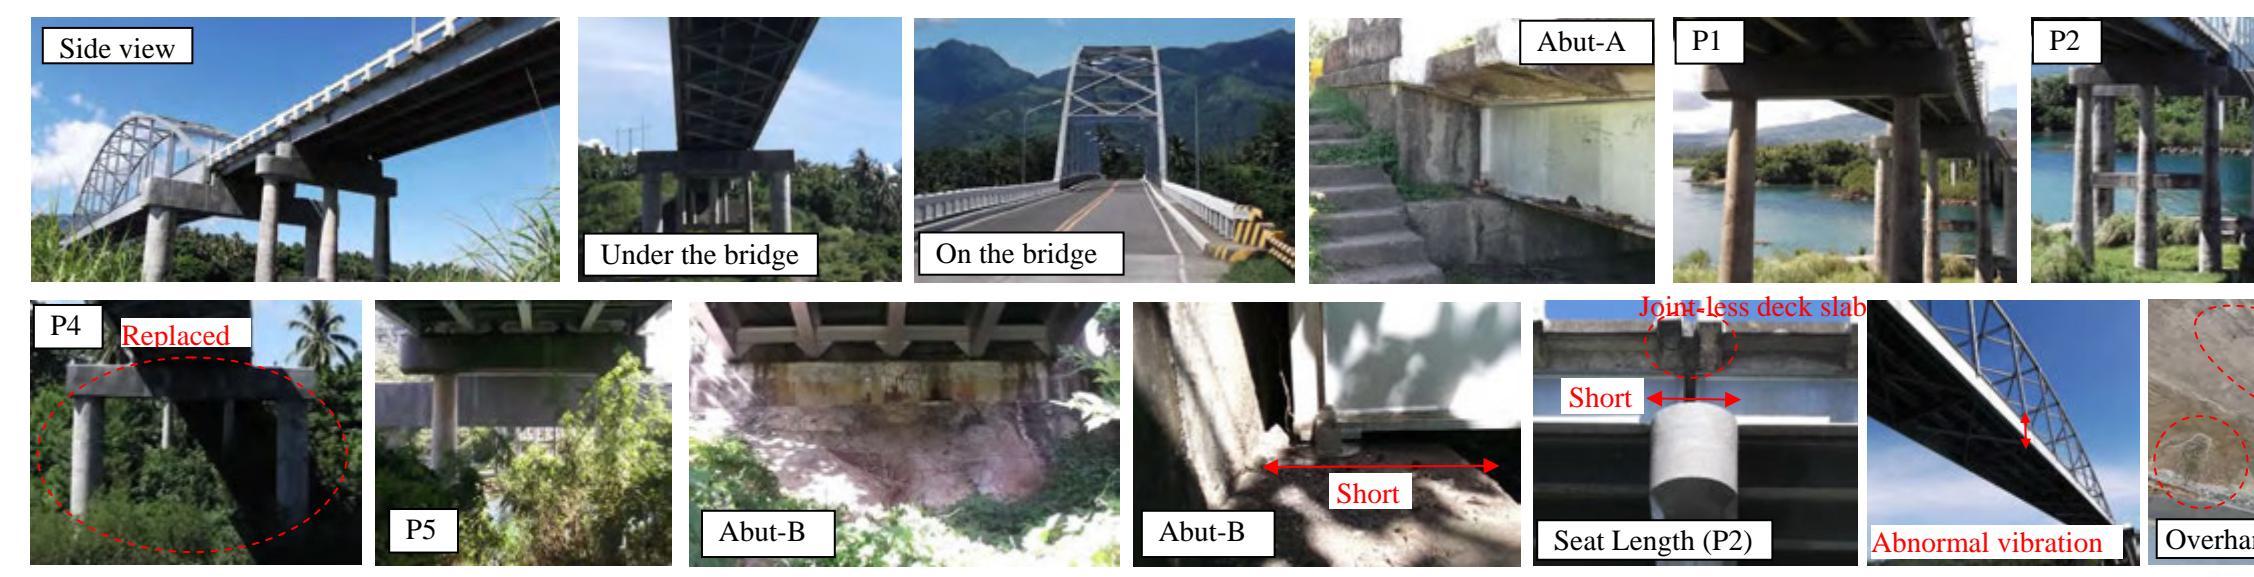
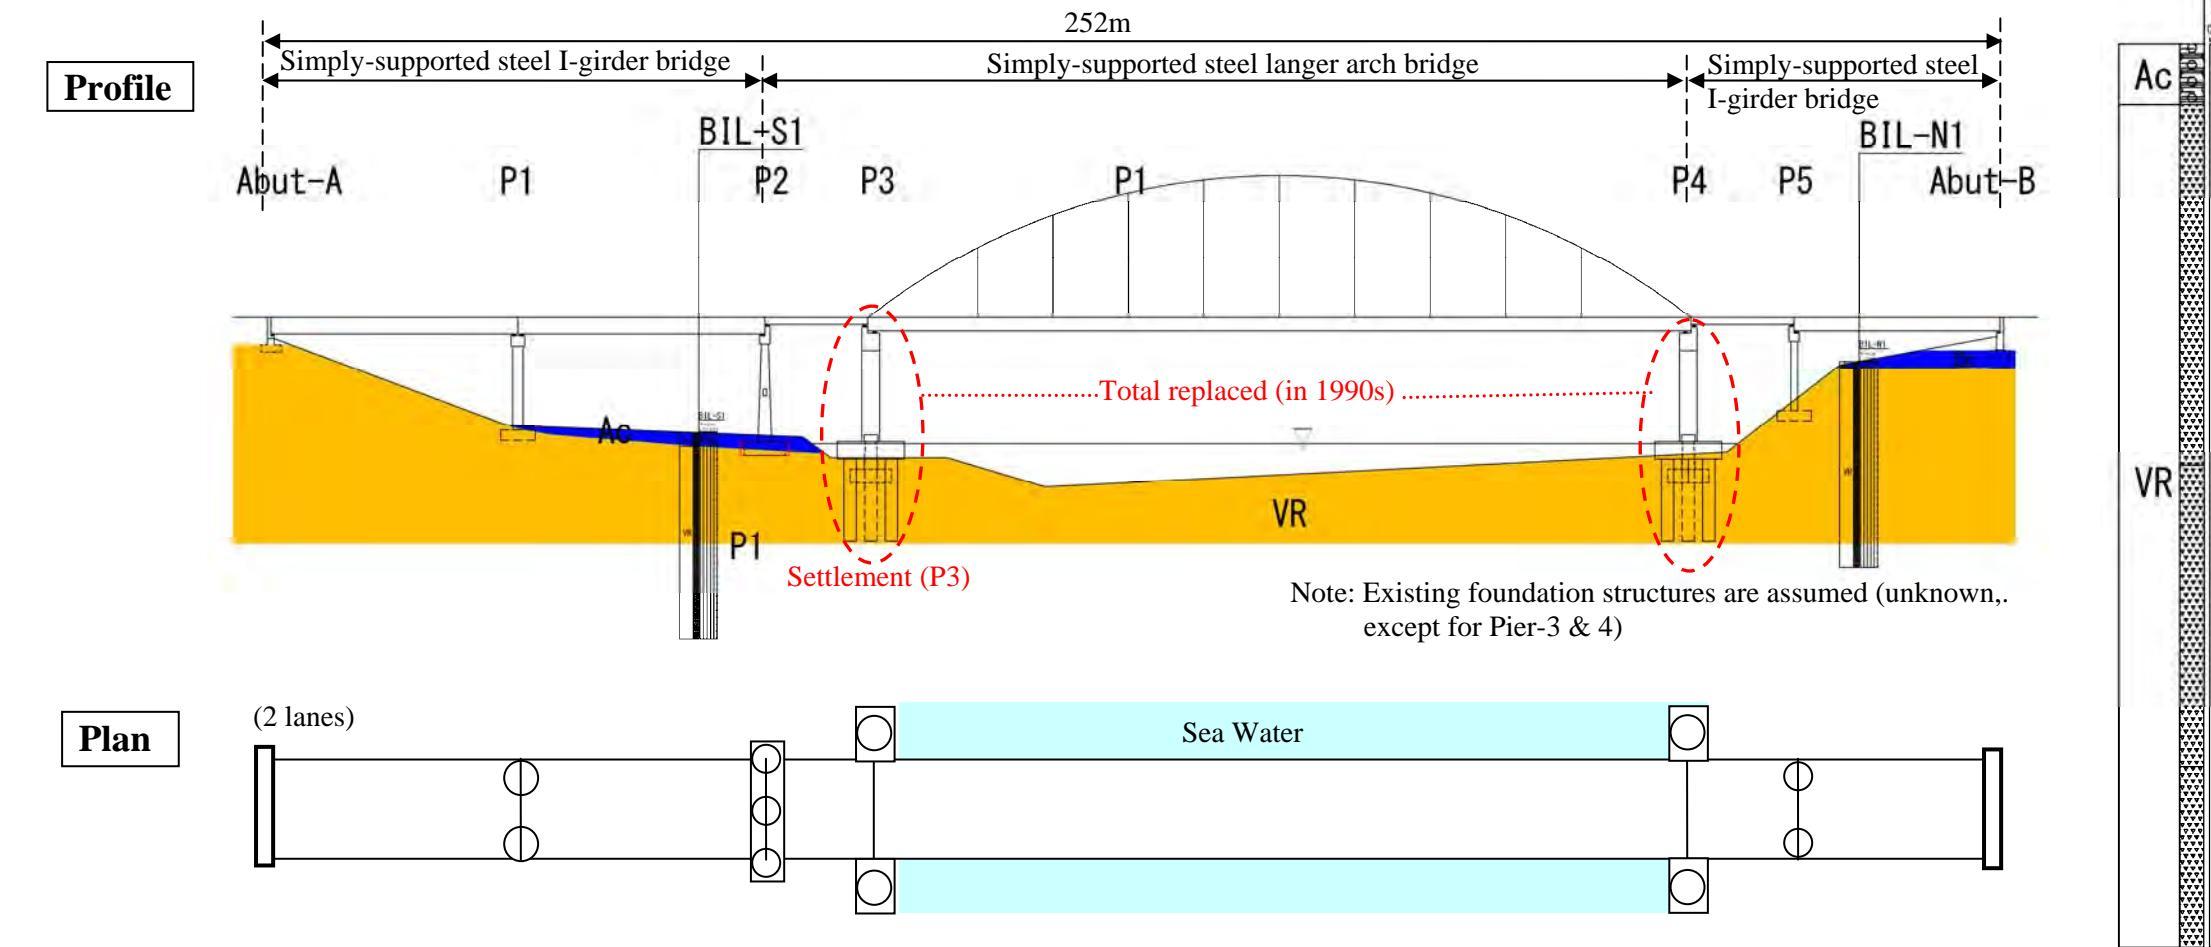
Figure 13.2.1-13 Structural and Geological Outline of Biliran Bridge

Seismic Vulnerability				Structural Soundness		
	Items	Results of Surveys	Analyses/Comments	Items	Results of Surveys	Analyses/Comments
Earthquake Resisting System	1. Difference in soiltypesbetweenadjacent piers2. Continuous orSimplySupported	Soil Type is consistent along with the entire bridge 1. Main Spans: Simply supported 2. Approach Spans: Simply supported	<ul> <li>No soil type difference between adjacent piers</li> <li>All spans are simply supported.</li> <li>High possibility of unseating due to simply</li> </ul>	1. Primary Members 2. Secondary Members	Steel I-girder	<ul> <li>Corrosion on steel I-girder members</li> <li>Primary members of steel langer arch are in good condition.</li> <li>Overall damage degree: Moderate</li> </ul>
	Bridge 3. Eccentric Loads	Note: Joint-less deck slab Maximum span ratio:	supported structures - The span ratio is over 1.5		Steel langer arch	- Secondary members are in good

(longitudinal and transverse dir.)	(5 span length): (4 span length) =1.0:8.5	- Possibility of eccentric loads only in the transverse direction: simply supported			- Overall damage degree: Good
	column/wall or multiple columns)		than single column/wall type against earthquakes in terms of structural redundancy.

12. Soil Type 13. Liquefaction	Soil type (JRA): I - The ground at the site consists of	- Firm ground condition     - No liquefaction potential		Settlemont (P3)	Note: Existing foundation structures are assumed (unknown except for Pier-3 & 4)
Seismic Hazard	Potential 14. Distance from Active Faults	nonliquefiable layers - Distance: 4.3km - Active Fault Name: PFZ Central Leyte Fault	<ul> <li>The distance is between 2 and 5km.</li> <li>Serious effect of the active fault movement</li> </ul>	Plan (2 lanes)		Sea Water

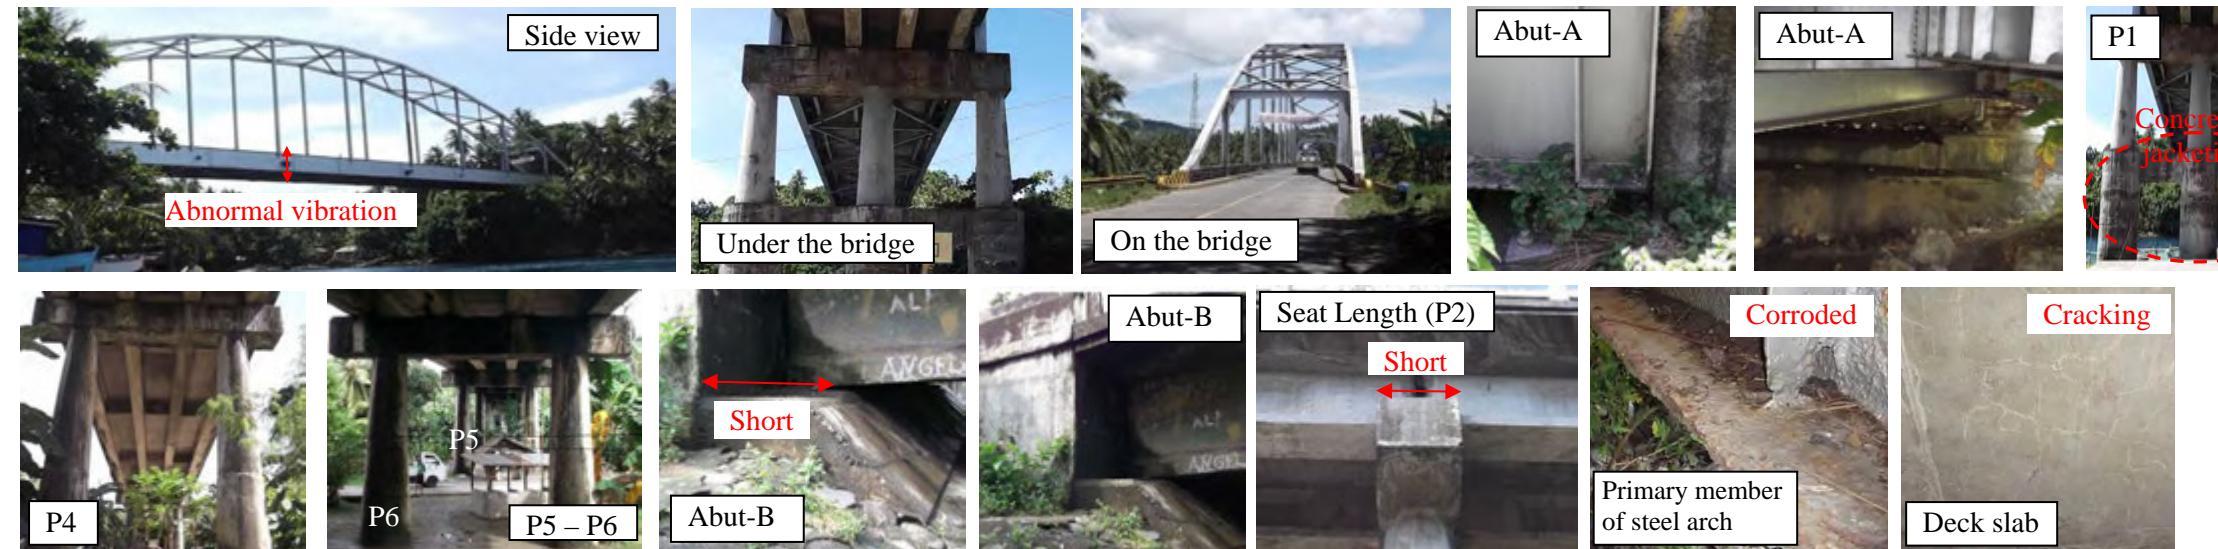
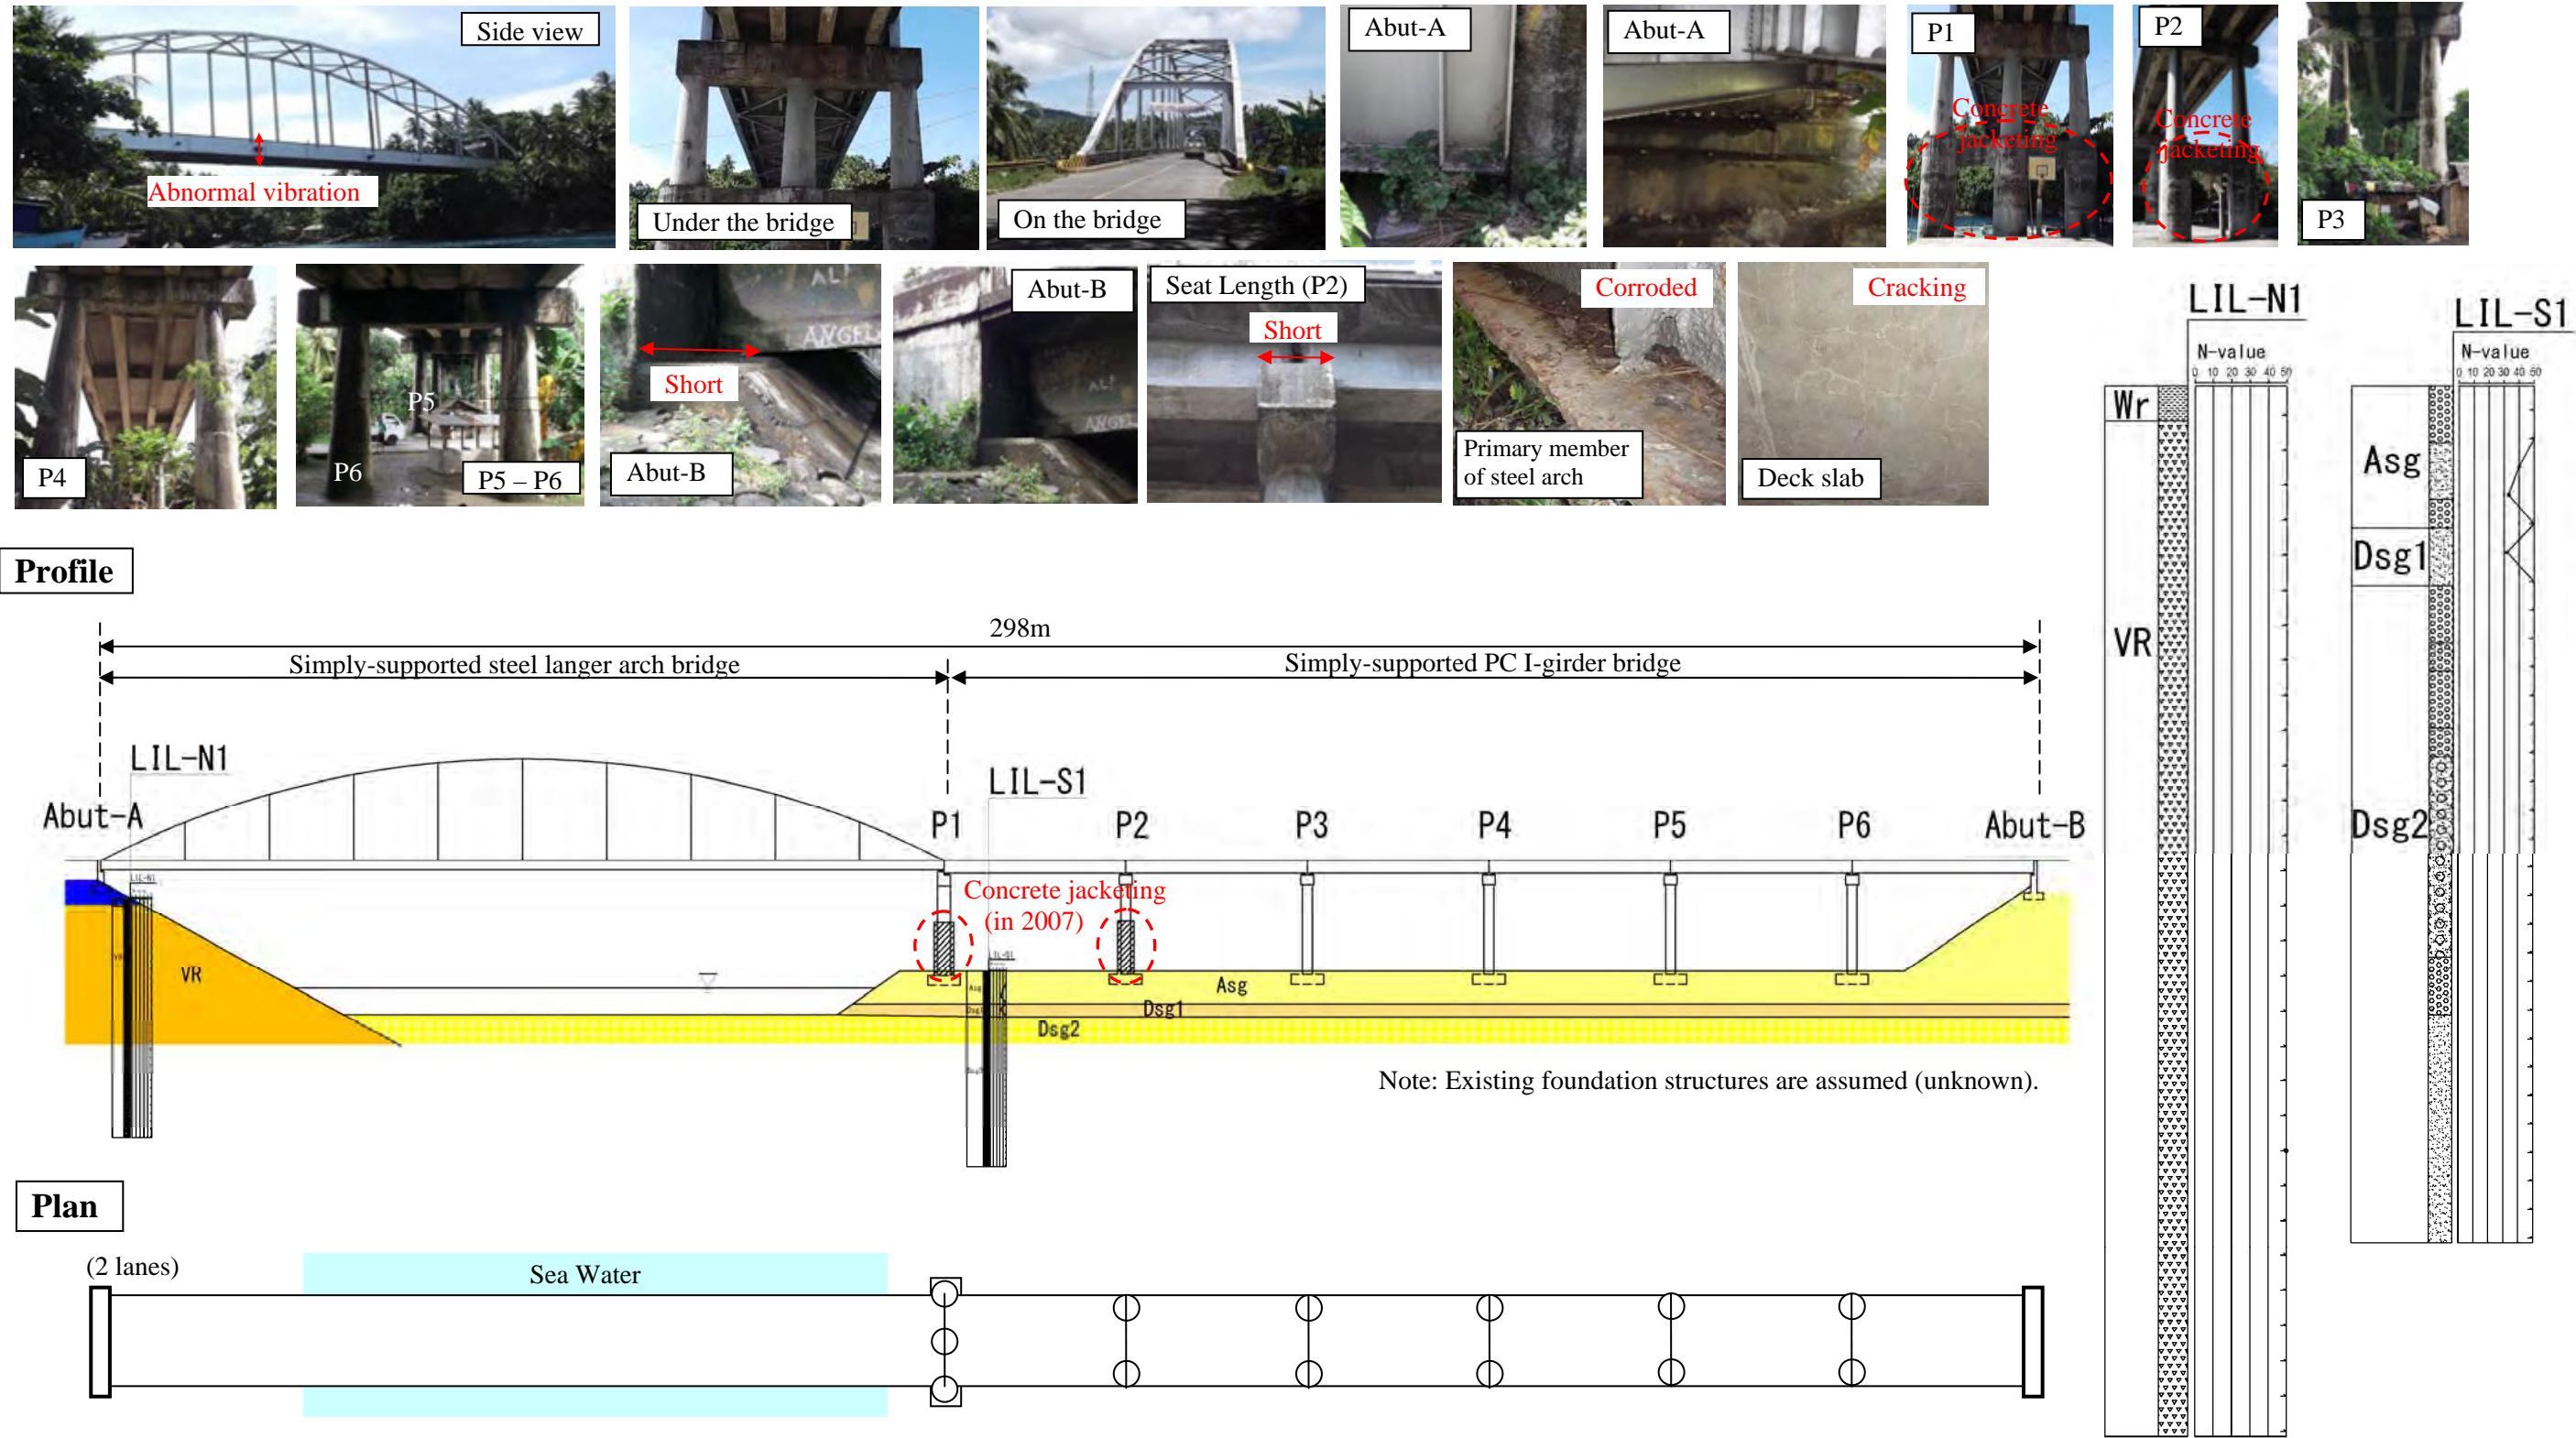
Figure 13.2.1-16 Structural and Geological Outline of Lilo-an Bridge

Seismic Vulnerability					Structural Soundness				
	Items	Results of Surveys	Analyses/Comments			Items	Results of	of Surveys	Analyses/Comments
	<ol> <li>Difference in soil types between adjacent piers</li> <li>Continuous or Simply Supported Bridge</li> <li>Eccentria Loada</li> </ol>	Soil Type is consistent along with the entire bridge 1. Main Spans: Simply supported 2. Approach Spans: Simply supported	<ul> <li>No soil type difference between adjacent piers</li> <li>All spans are simply supported.</li> <li>High possibility of unseating due to simply supported structures</li> </ul>			1. Primary Members	Steel langer arch	PC I-girder	<ul> <li>Corrosion on steel langer arch members</li> <li>Water leaking on PC I-girders</li> <li>Overall damage degree: Moderate</li> </ul>
Earthquake Resisting System	<ul> <li>3. Eccentric Loads</li> <li>(longitudinal and transverse dir.)</li> <li>4. Pier Type (single column/wall or multiple columns)</li> <li>5. Height of Abutment (Embankment)</li> </ul>	Maximum span ratio.         (1 st span length): (2 nd span length)         =3.9:1.0         Multiple column type         Height of Embankments         - Abut-A: 4m         - Abut-B: 4m	<ul> <li>- The span ratio is over 1.5</li> <li>- Possibility of eccentric loads only in the transverse direction: simply supported</li> <li>- Multiple column type is more advantageous than single column/wall type against earthquakes in terms of structural redundancy.</li> <li>- Heights of embankments are below 5m.</li> <li>- Lower risk of abutments' collapse under earthquake</li> </ul>		Superstructures	2. Secondary Members	Steel langer arch Corroded	Loose connection	<ul> <li>Corrosion at bracing connections</li> <li>Loose connection due to lack of bolts at splices of steel members</li> <li>Overall damage degree: Moderate</li> </ul>
