PART 3

SELECTION OF BRIDGES FOR SEISMIC CAPACITY IMPROVEMENT (PACKAGE B AND C)

CHAPTER 11 PROCEDURES FOR SELECTION OF BRIDGES FOR OUTLINE DESIGN

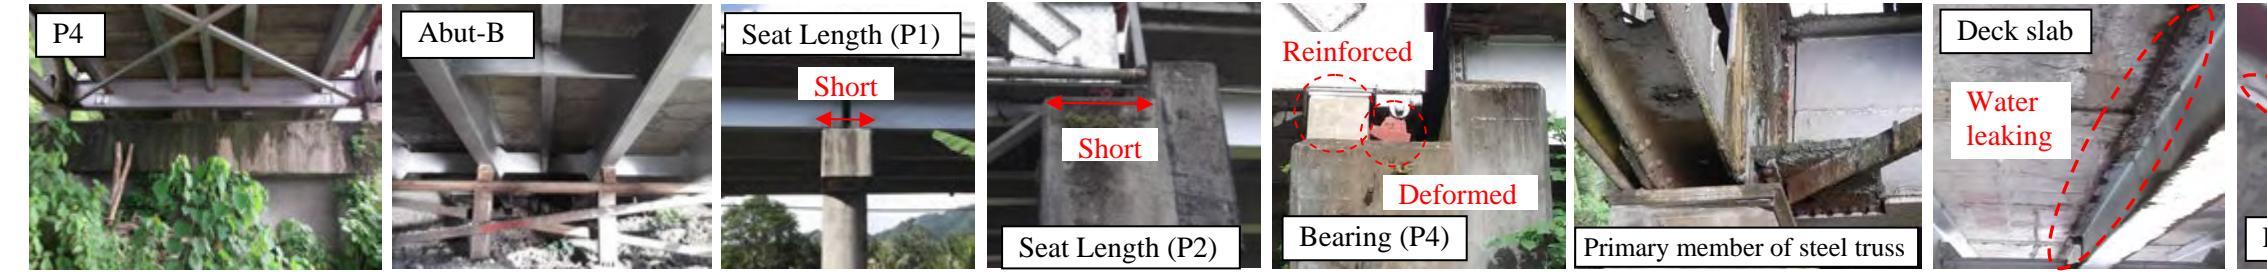
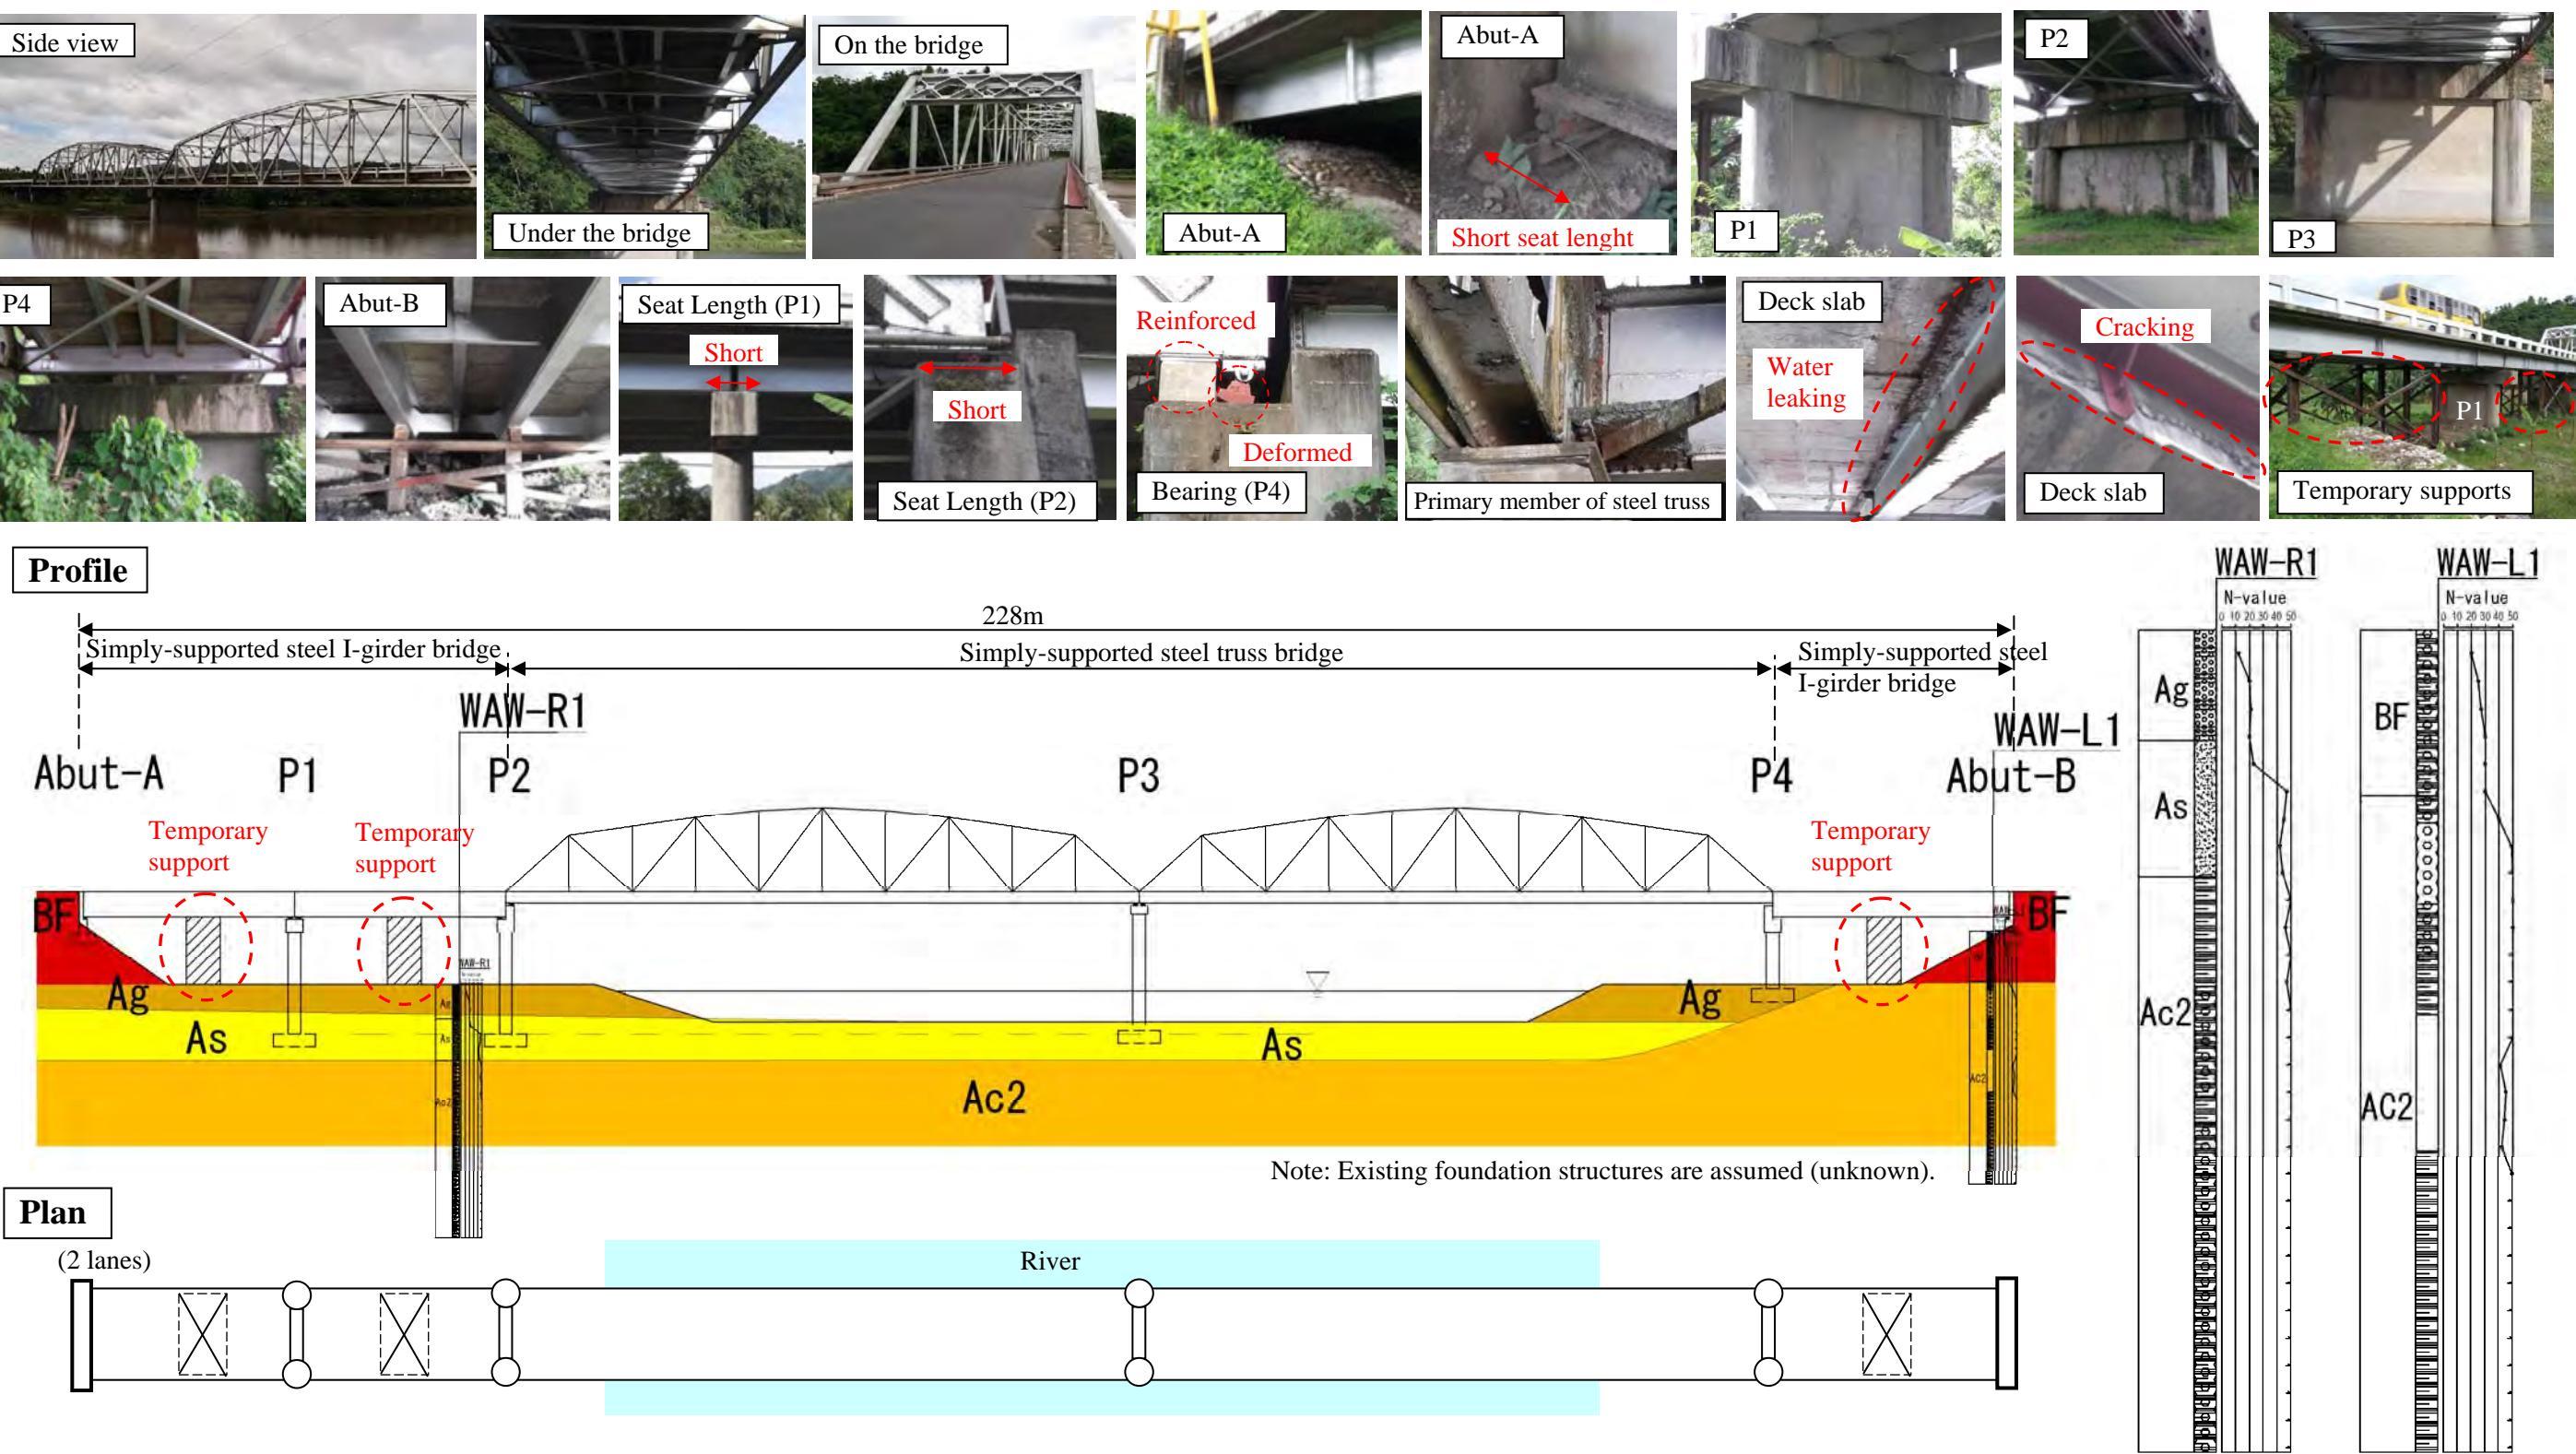
Figure 13.2.1-19 Structural and Geological of Wawa Bridge

Bridge length/width	L=228m, W=8.9m	1	Traffic Load Regulation	10t	]		
Year Built	1967	ļ	Soil Profile Type	I (JRA)			
Bridge Type	- Main Spans: Simply supported steel truss bridge	ļ	Liquefaction Potential	None			
	- Approach Spans: Simply supported steel I-girder bridge	1	As-built drawing	None			
Side view	On the bridge Under the bridge		Abut-A	Abut-A Abut-A Short seat I	lenght	P1	
P4	Abut-B Seat Length (P1)	1	Reinforced			Deck slab	-

Seismic Vulnerability			
	Items	Results of Surveys	Analyses/Comments		
	1. Difference in soil types between adjacent piers	Soil Type is consistent along with the entire bridge	- No soil type difference between adjacent piers		
Earthquake	2. Continuous or Simply1. Main Spans: Simply supported 2. Approach Spans: Simply suppBridge		<ul><li>All spans are simply supported.</li><li>High possibility of unseating due to simply supported structures</li></ul>
