**REPUBLIC OF THE PHILIPPINES
SPECIAL ASSISTANCE FOR PROJECT
SUSTAINABILITY (SAPS)
FOR
KAMANAVA AREA FLOOD CONTROL AND
DRAINAGE SYSTEM IMPROVEMENT
PROJECT
FINAL REPORT**

FEBRUARY 2014

**ORIENTAL CONSULTANTS CO., LTD. (OC)
PACIFIC CONSULTANTS CO., LTD.**

FINAL REPORT

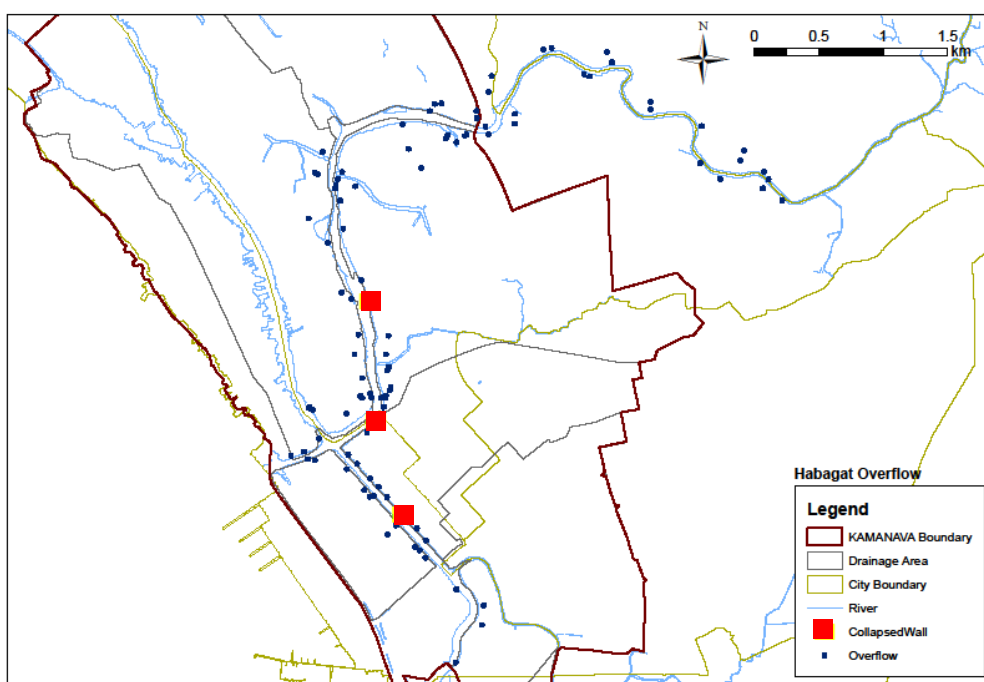
Figure 4.2.9 Locations at which People Said that River Water Overflowed and Reported Collapsed River Walls during 2012 Monsoon (Habagat)

Many respondents said that river water did not overflow from Malabon river between Lambingan bridge and Tonsuya bridge during Habagat. On the other hand, the respondents who live near Manila bay said that the river water overflowed during Habagat rather than during “Ondoy”.

Furthermore, three walls reportedly collapsed during Habagat to accelerate the inundation.

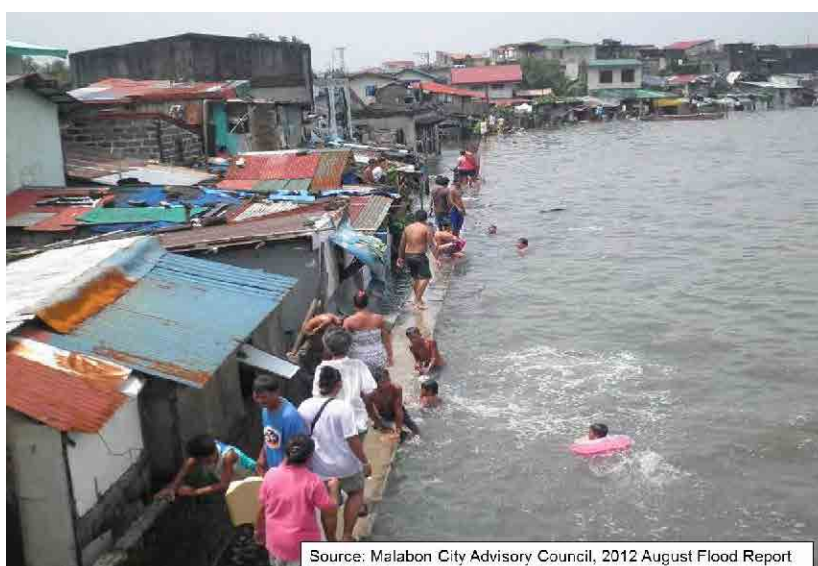
Figure 5.4.2 High Tide on August 2, 2012 at C-4 Bridge of Malabon River Left Bank

Figure 5.4.1 (Photo) shows a picture of the high tide condition taken on August 2, 2012 by Malabon City Engineer. The location is the right bank downstream of C-4 Bridge, whose distance from the river mouth is 1 km. The top elevation of the submerged river wall was 12.60 m (DPWH Datum). It is understood that the highest tide level exceeded the 12.60 m (DPWH Datum).

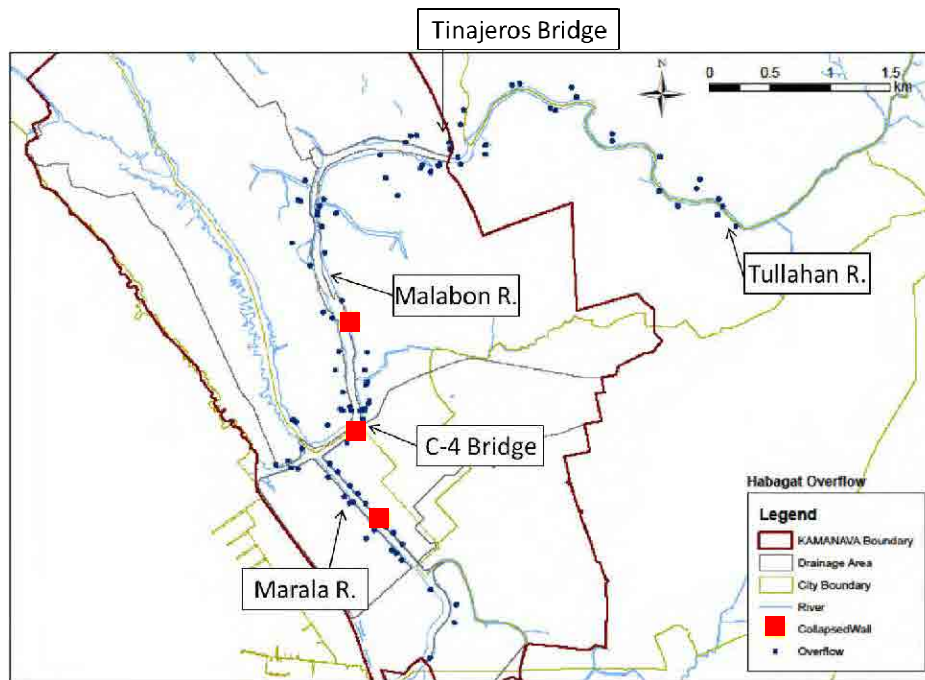
Figure 5.4.3 Locations at which People Reported that River Water Overflowed and of Collapsed River Walls during 2012 Monsoon (Habagat)

The Figure below shows the location in which local people informed the JICA Study Team that the flood water came from the river according to the Flood Mark survey. It is understood that the overflow from the Marala river as well as the Malabon river stretch took place.

Also it should be pointed out that the Tullahan river, which is upstream of the Tinajeros Bridge as shown in the Figure below, was flooded during the 2012 monsoon (Habagat).

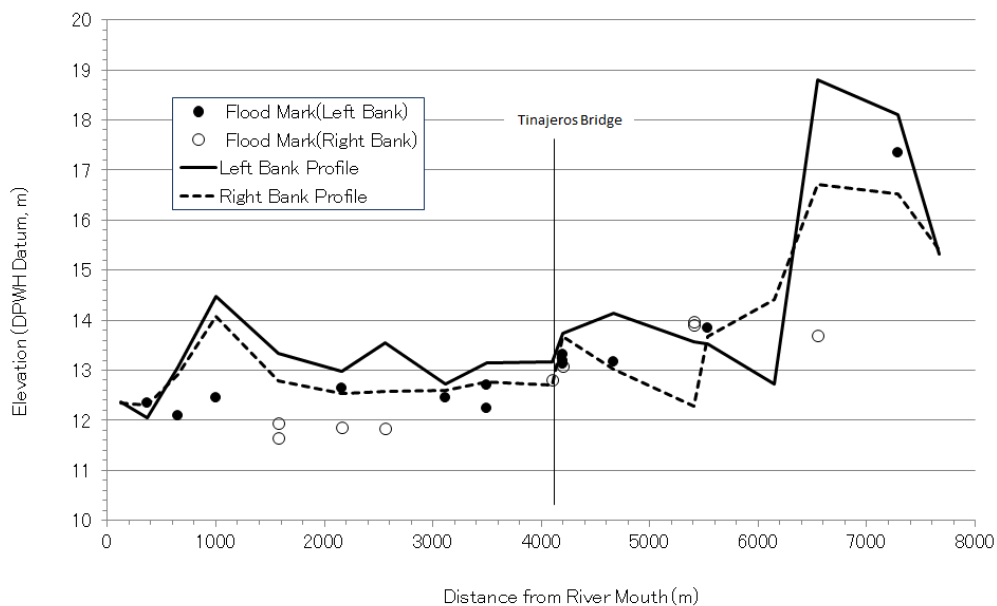
Figure 5.4.4 Flood Marks along the Tullahan-Tenejeros-Malabon River during 2012 Monsoon (Habagat)

Figure 5.4.4 is the longitudinal profile of the flood mark elevations along the Tullahan-Tenejeros-Malabon River based on the topographic survey in this SAPS Study¹. The design top (crown) level of the river wall at Tinajeros Bridge is 13.2 m (DPWH Datum) (DFL=12.4m (DPWH Datum)). The

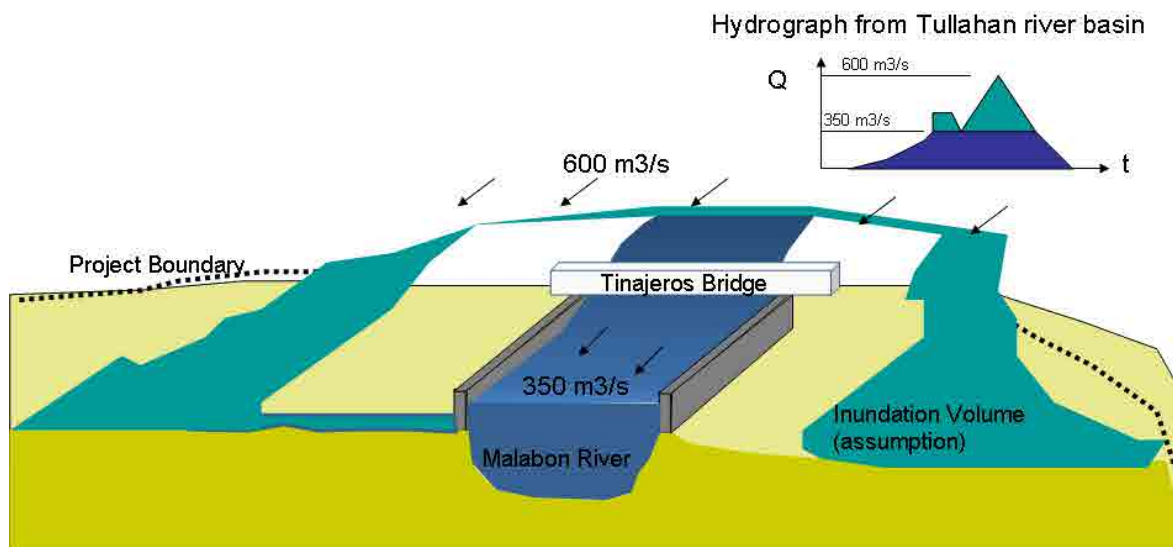
Figure 5.4.5 Flooding Situation at KAMANAVA Project Boundary

The flooding at the Tullahan River section arrived at the KAMANAVA project area boundary, the Tinajeros Bridge on the Malabon river as illustrated in overflow in 2012 Habagat as shown in Figure 5.4.5.

The flood discharge which could enter the Malabon river channel is limited to the channel flow capacity. The discharge over the channel capacity could drain out of the Project area as well as the overland flow in the Project area.

The flood water entered the sub-drainage area. In the KAMANAVA Project design, such flood water entering in the sub-drainage area, if it is equal to or less than design scale, was not assumed.

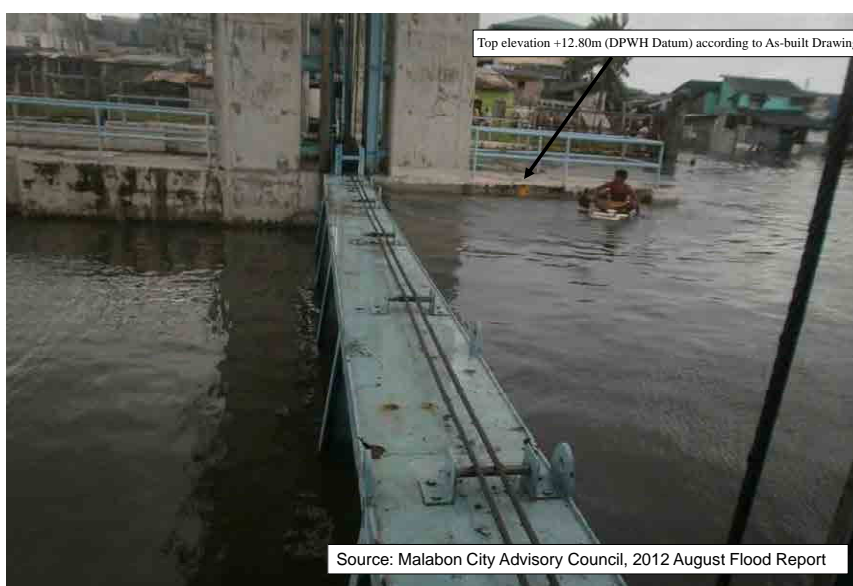
Figure 5.9.1 Navotas Floodgate in August 1, 2012

At the time of the 2012 monsoon (Habagat), the floodgates such as South Pinagkabalian, Muzon, Navotas, Longos, Kailugan and Pinagkabalian floodgates were operated and closed during the flood.

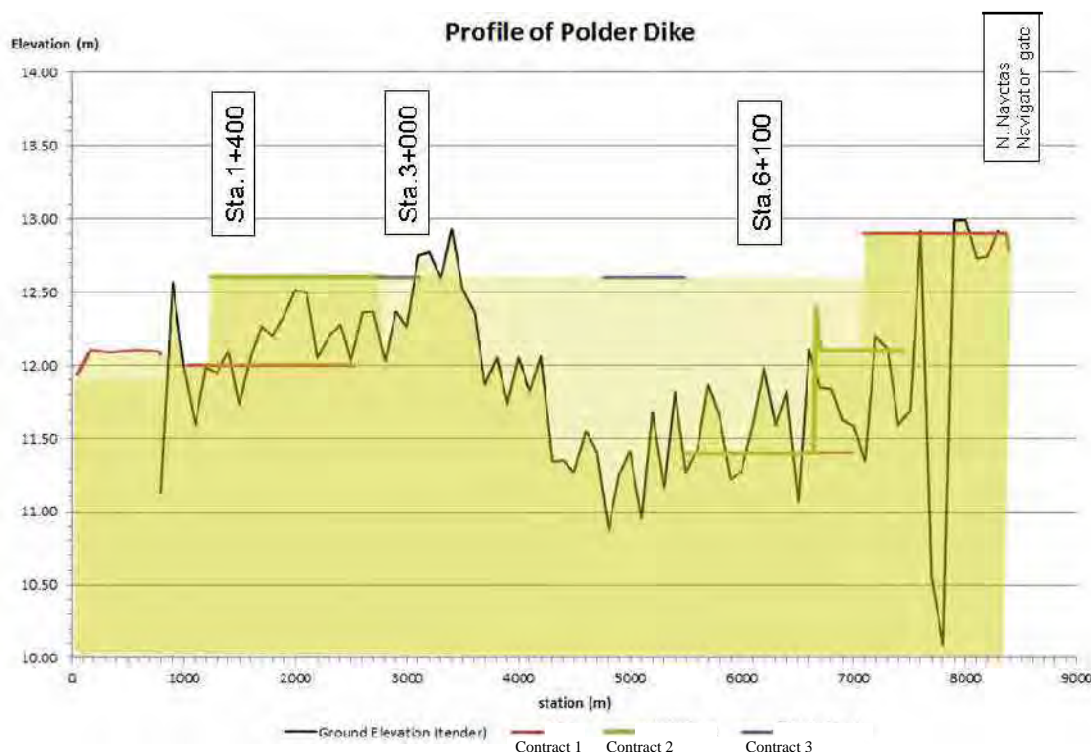
Figure 5.10.1 Profile of Polder Dike Section during 2012 Monsoon (Habagat)

At the time of the 2012 monsoon (Habagat), the polder dike was completed as per design, however, as shown in Figure 5.10.1 and Figure 5.10.2, there were 3 sections of overflow from outside of the Project Area. The maximum tide level was +12.65 m (DPWH Datum) in the Bangkulasi Pumping Station, while the top elevation of the polder dike was +12.60 m (DPWH Datum). It is understood that a locally low portion due to dike settlement and erosion allowed the overflow.

Such overflow from outside of the project area was not considered in the KAMANAVA Project design, especially for the inland flood protection area. Therefore, the flooding extent in the project area was made worse.

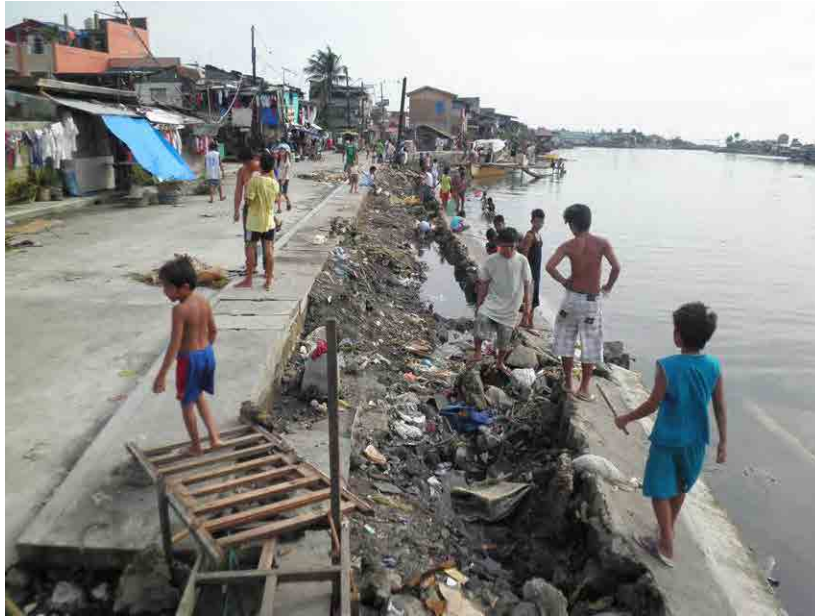
Figure 5.10.4 Photo of Collapsed River Wall at Left Bank of Marala River

At the time of the 2012 monsoon (Habagat), the river wall was completed as per design, however, as shown in Figure 5.10.3 and Figure 5.10.4, there were 3 sections of collapsed river wall that resulted in overflow from the river side into the protected Area. The maximum tide level was +12.65 m (DPWH Datum) in the Bangkulasi Pumping Station, while the top elevation of the river wall was +12.60 m (DPWH Datum) along the Malabon and Marala rivers. It is understood that weak foundation of the river wall allowed the collapse.

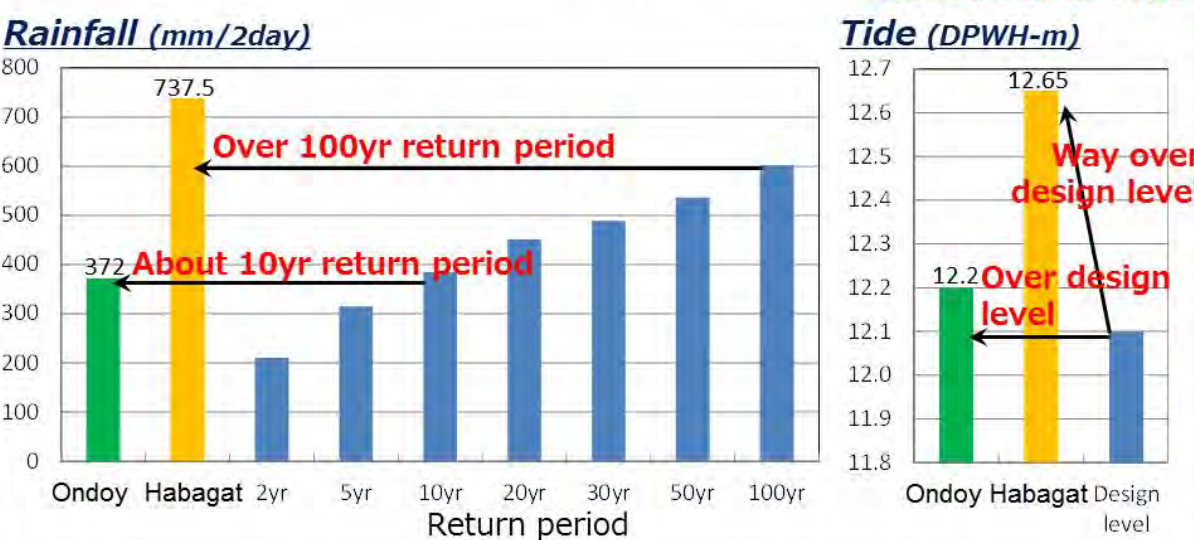
2 Reasons for the occurrence of floods during Ondoy/Habagat – Rainfall and Tide

- ◆ The rain and high tide were strong during Ondoy while way extreme during Habagat.
- ◆ These extreme conditions caused serious flooding in KAMANAVA area.

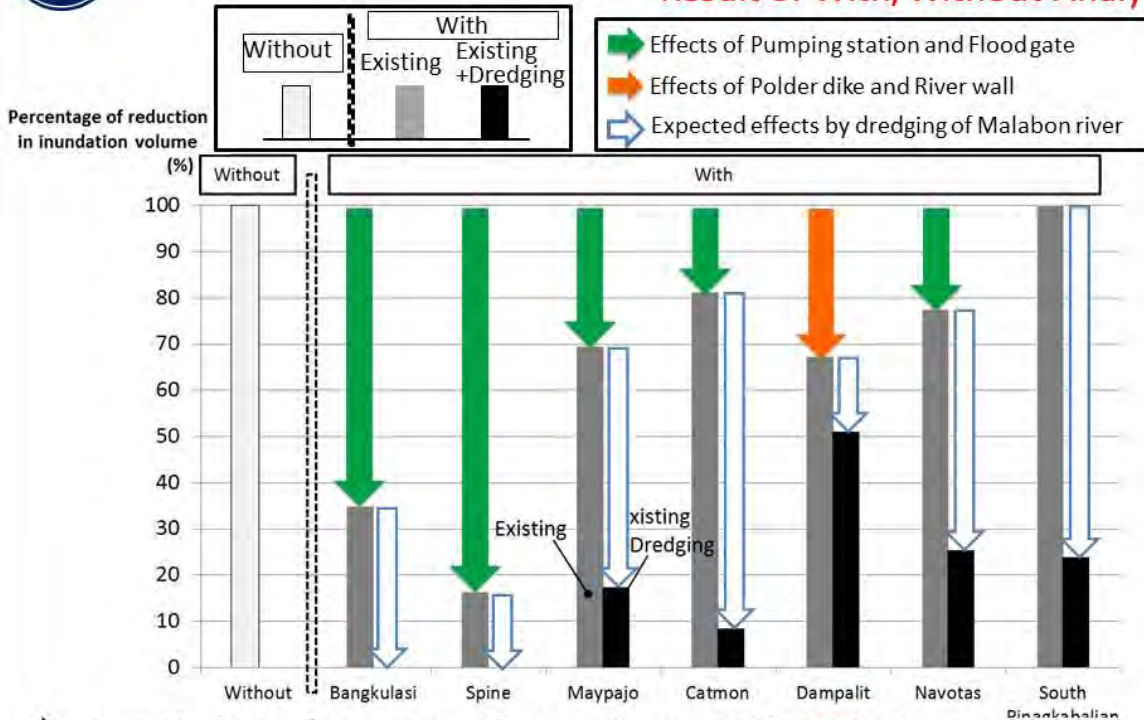
Result of With/Without Analysis

➔ Inundation volume per unit area decreased by **26%** on average. It can be further decreased to **75%** on average by Project with dredging.¹¹

1. If there were no Project, the average inundation volume would result to more than 1m depth, especially Dampalit, South Pinagkabalian and Catmon.
2. With the Project, the inundation volume in Project area decreased by 26% on average, mainly due to the pumps.
3. At the time of "Ondoy", the channel capacity at upper reach of Malabon river is estimated to be 100 m³/s only, so flood water had been overflowed into Catmon and South Pinagkabalian as well as Dampalit and caused inundation.
4. In Dampalit, the polder dike was not completed, so sea water entered in the Project area.
5. By dredging of Malabon river, the effects (reduction of inundation volume) would further be enhanced to 75% on average.

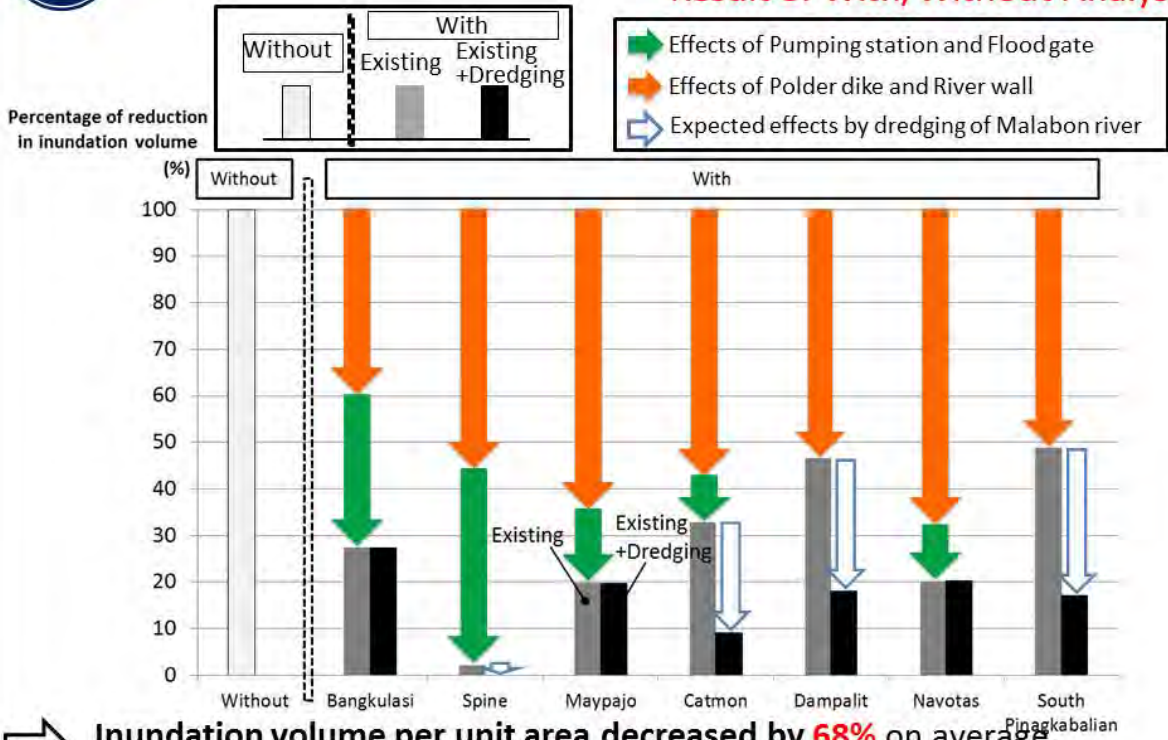
3 Effects of the Project during Habagat Result of With/Without Analysis

➔ Inundation volume per unit area decreased by **68%** on average.
It can be further decreased to **85%** on average by Project with dredging.

2. With the Project, the inundation volume in Project area decreased by 68% on average, especially Spine, Maypajo and Navotas.
3. At the time of Habagat, the channel capacity at upper reach of Malabon river is estimated to be 350 m³/s which is still less than design capacity, so flood water had been overflowed into Catmon and South Pinagkabalian as well as Dampalit and caused inundation. But with the Project, the inundation volume was decreased by 50% or more in all areas.

4. In Dampalit, the polder dike was completed, so no sea water entered in the Project area and only a very few polder dike sections allowed inflow.
5. By dredging of Malabon river, the effects (reduction of inundation volume) would be further enhanced to 85% on average. However, the overflow of Malabon and Marala rivers due to high tide resulted into remaining inland inundation condition in Bangkulasi and Maypajo.

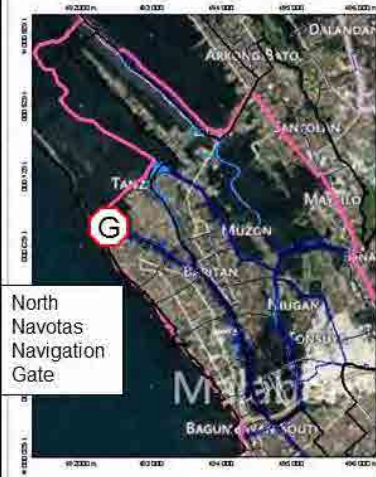
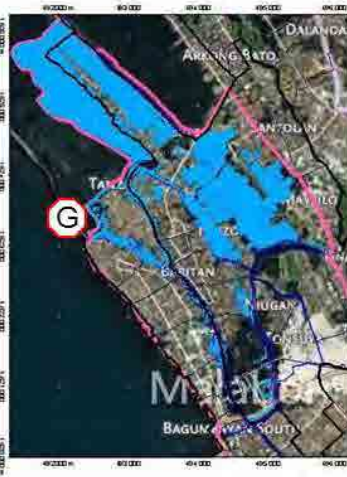
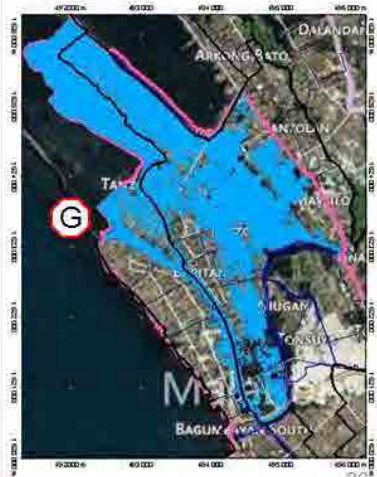
LGU	Conflict of Interests in terms of gate closure elevation
Navotas	Due to the shallow water depth at EL.10.5m and livelihood of the residents, Navotas prefers higher gate closure elevation such as EL.11.5m.
Malabon	Due to many low elevation areas in the city, Malabon prefers lower gate closure elevation such as 10.5m as per Design.

- In Malabon, during high tide, the reverse flow from river to inland areas thru drainage channel causes inundation. So the gate closure level should be lower than the present EL.11.0m to avoid such situation. According to Malabon City, the gate closure level should be 10.5m as per design.
- One of the solutions discussed was dredging of Navotas river to lower the riverbed so that the ships can still pass through with the closure level at 10.5m.
- Another consideration in the gate closure level of is the livelihood of fisher folks (e.g. longer closure time of the gate will shorten the access time)

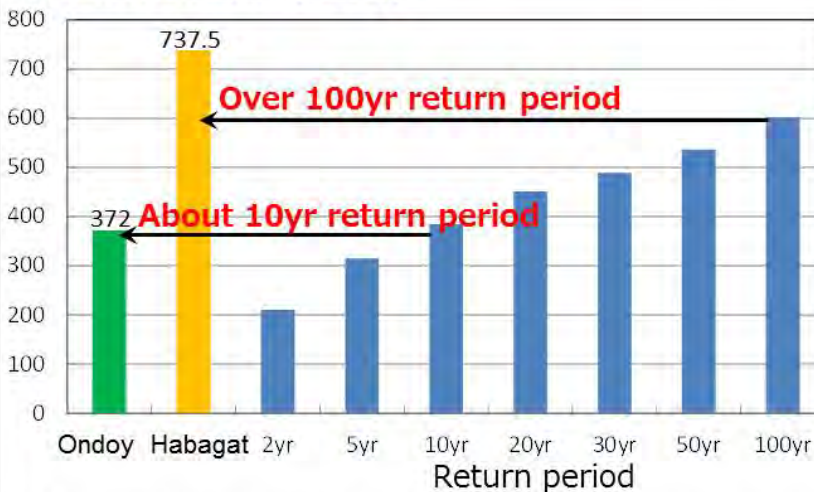
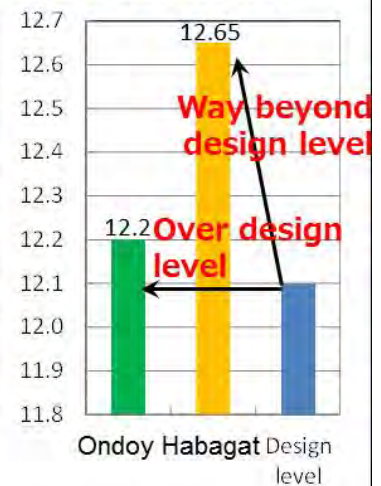
- ◆ The rain and high tide were strong during Ondoy while way extreme during Habagat.
- ◆ These extreme conditions caused serious flooding in KAMANAVA area.
