**フィリピン共和国
パナイ島エスタンシアにおける
重油流出事故に対する
国際緊急援助隊(専門家チーム)派遣
活動報告書**

独立行政法人国際協力機構
国際緊急援助隊事務局

緊 援
J R
13-001

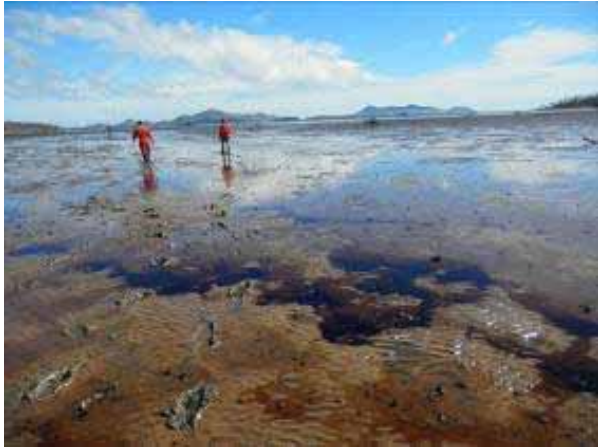
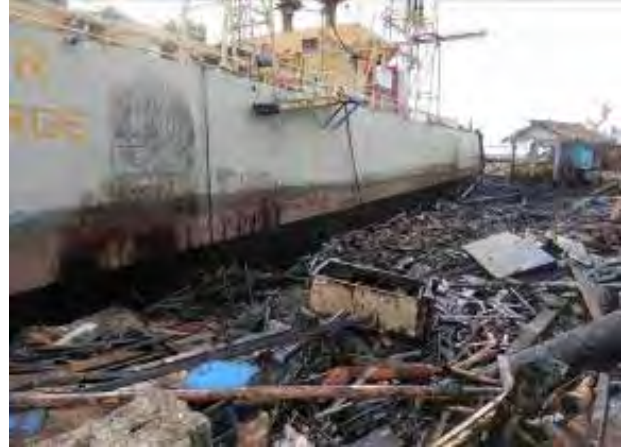
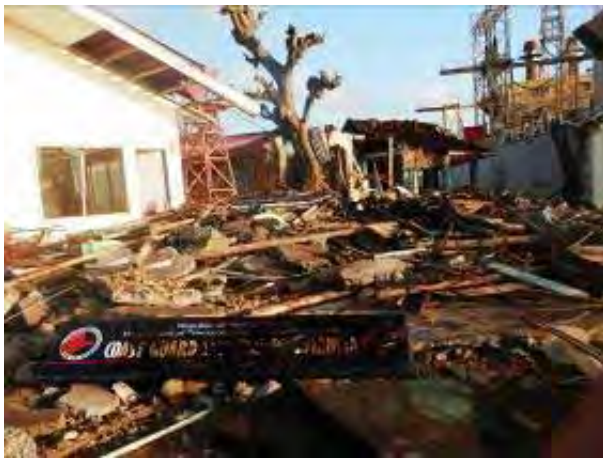
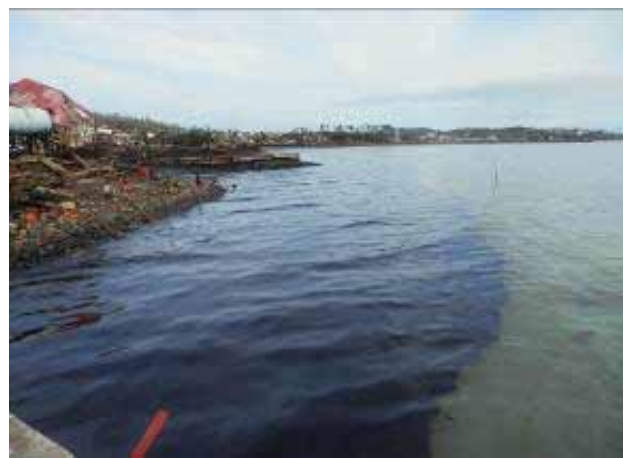
PCGが撮影した事故直後の現場の様子

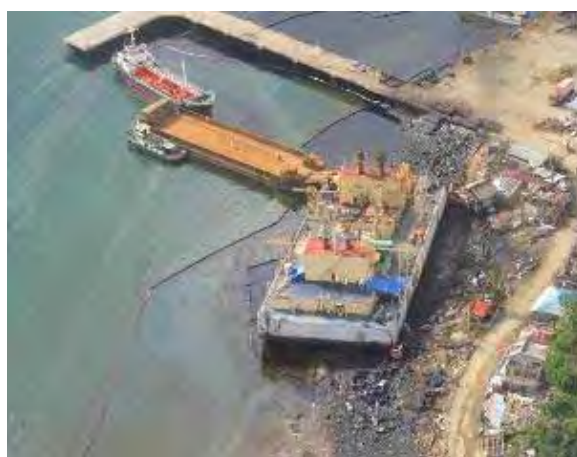
PB103の座礁状況

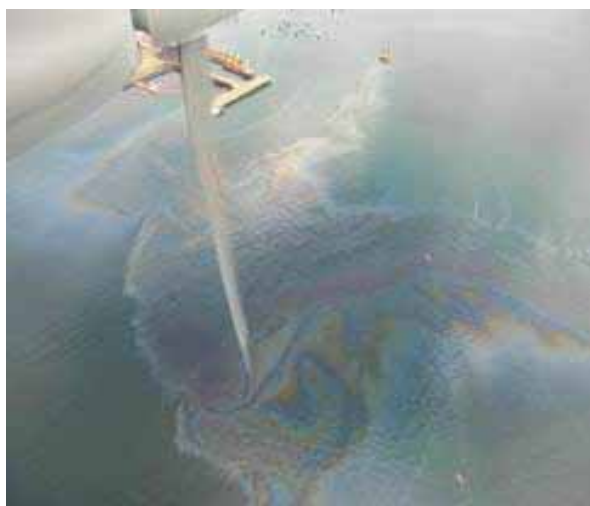
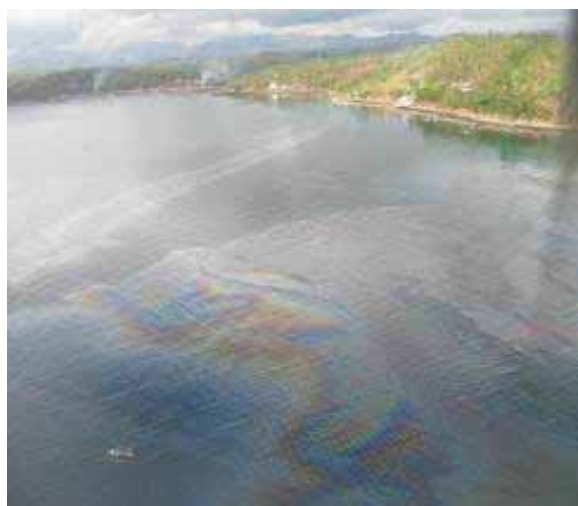
事故現場から同現場南方（「Tanza」の沖合海域）にかけて、油膜の色が黒ずんで見える状態（油膜色調A）から油膜の色が銀白色に続いて明るい虹色の色帯に見える状態（油膜色調D）の数筋の帯状油膜を認めた（色調の区分については後述）。その他の沖合海域には顕著な浮流油を認めず。

エスタンシア港の沖合の浮流油の状況

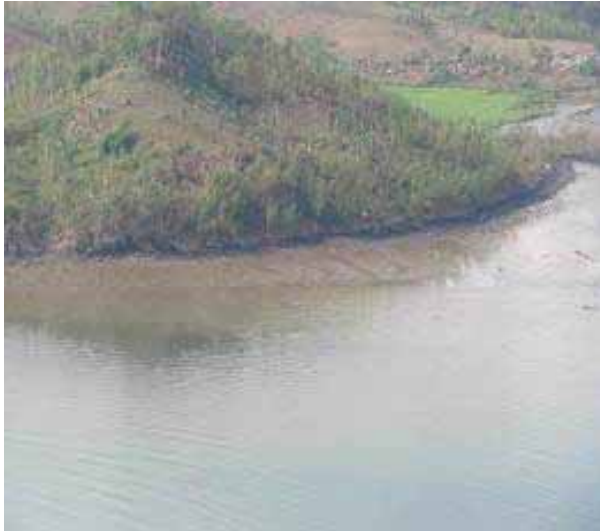
海岸に漂着した油の状況
(海岸線が油で黒く見えている)

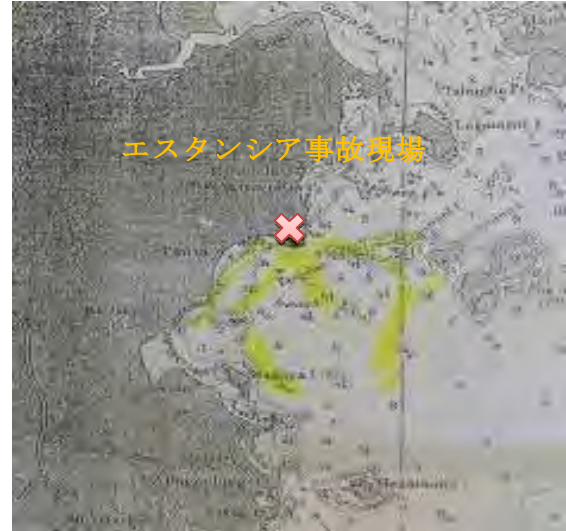
沖合への油の流出状況
(黄色の着色部分。隊員によるマッピング)

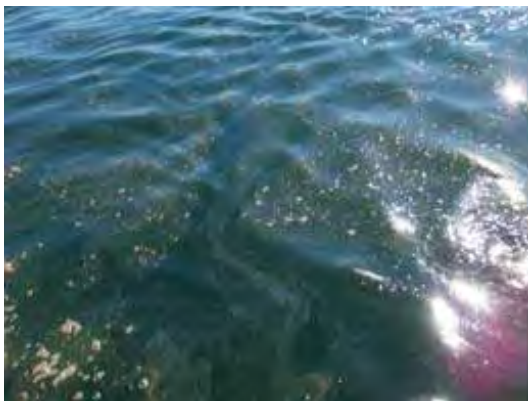
物理的な回収が必要な浮流油の様子（色調A） ひしゃくによる物理的油回収の例（イメージ）

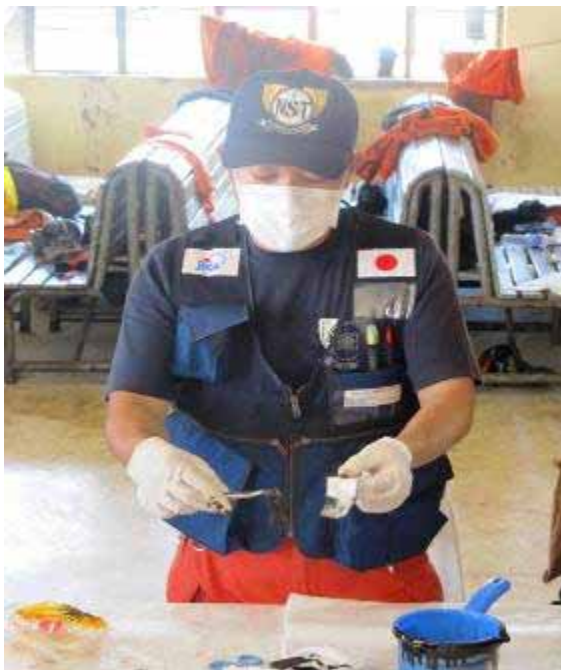
- 1) Aについては表面への付着により一様の有効性が確認されたが、1分間のテストでは十分な内部浸透量が少ない結果となった。
- 2) Bについては、表面から内部への浸透が十分に認められ有効性が確認された。
- 3) Cについては、表面への多くの付着及び有効な捕獲性が確認された。
- 4) Dについては、表面への付着が確認されたが、油面より引き上げると滴下して、有効な捕獲性は認められない結果であった。

資器材Aの試験の様子

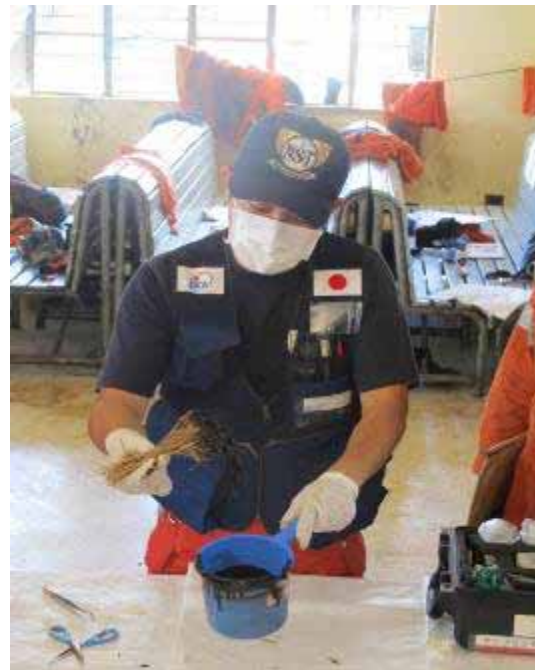
資器材Dの試験の様子

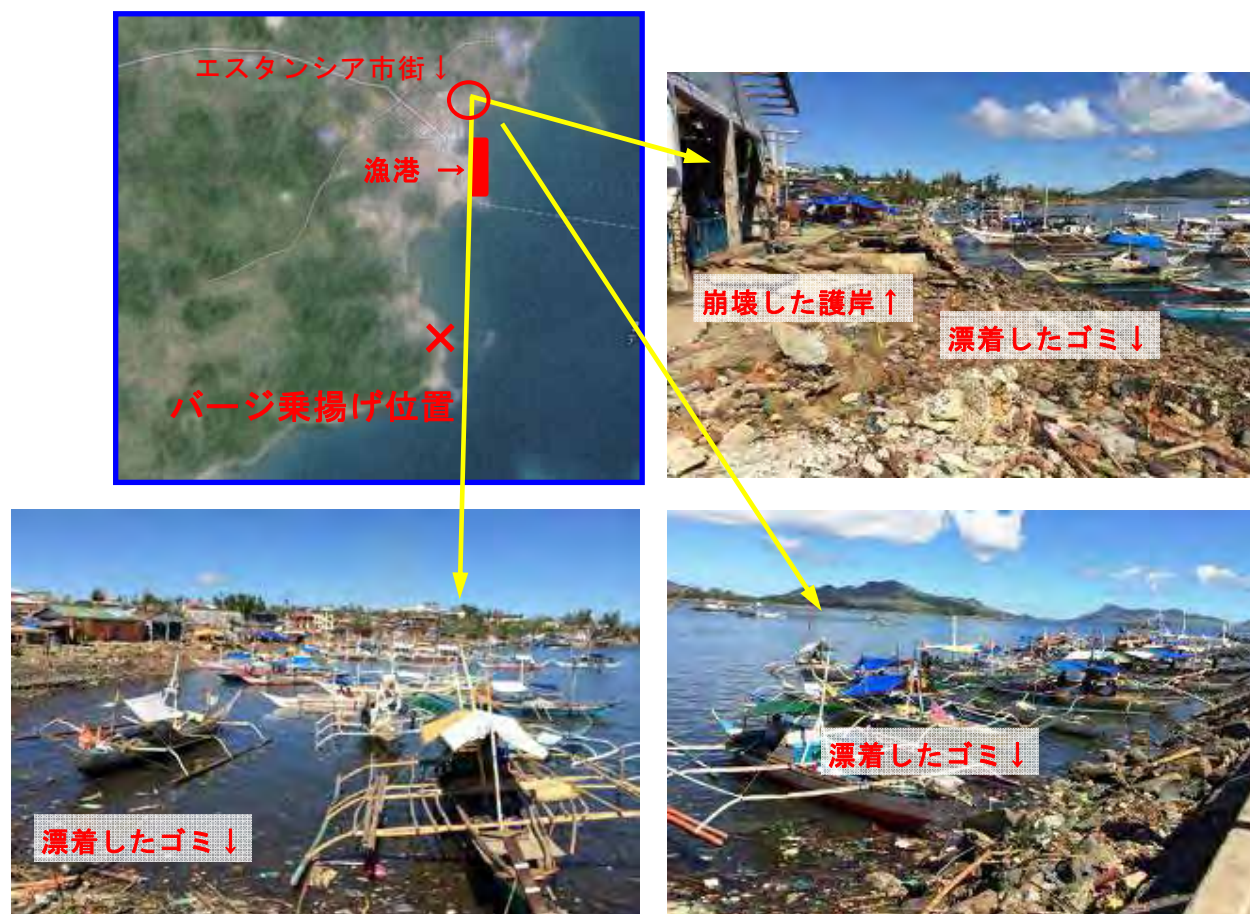
事故現場の北方約1,200mに位置する漁港のうち北側の領域においては、海面に浮流する油、陸岸に漂着した油及び油の臭いはいずれも認められなかった。同行したPCG職員を介して付近にいた漁民へ「事故に伴い流出した油の有無」について質問したところ、「流出した油はここには到達しなかった」とのことであった。

なお、石積みの護岸は、広範囲で崩壊しており、台風に伴う高波と高潮による被害と見受けられ、また、陸岸には大量のゴミが漂着していた。

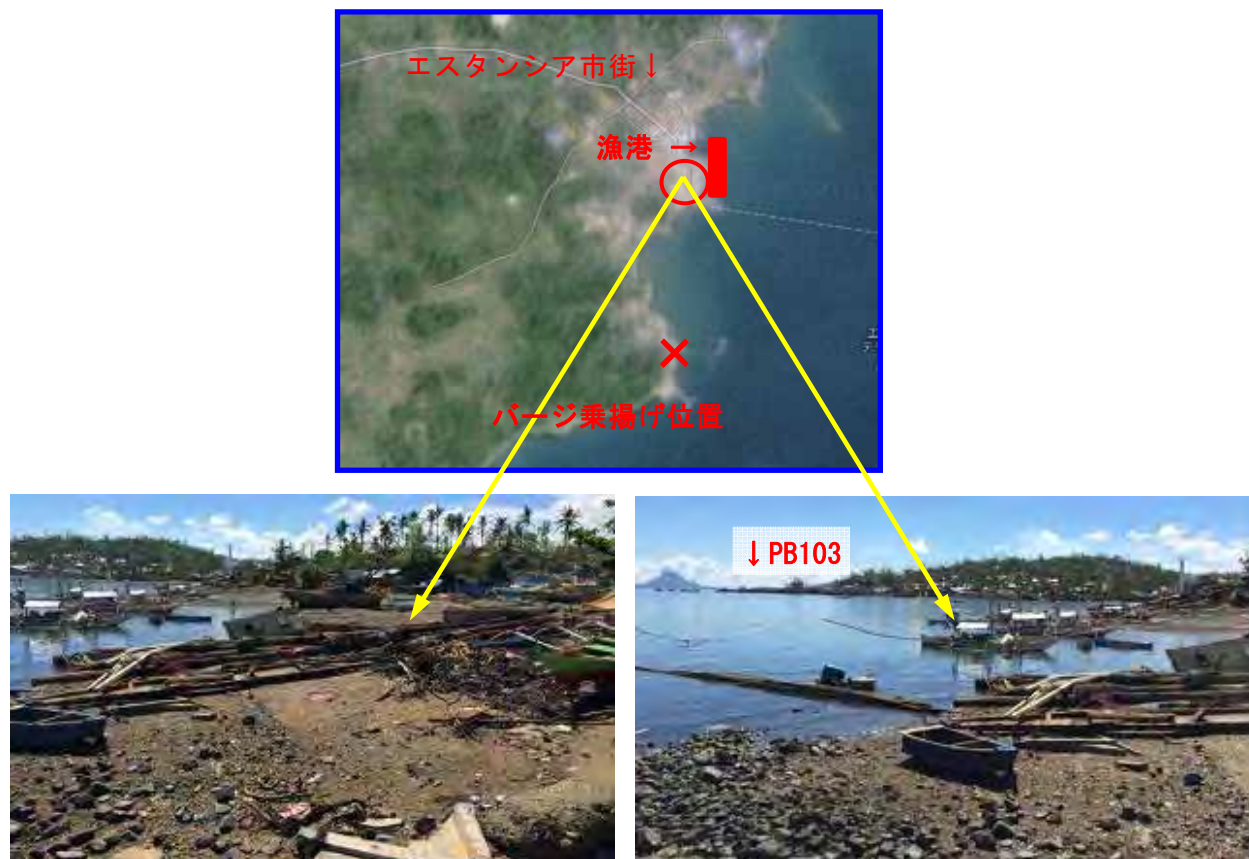
2) 漁港（南側）

油流出現場の北方約800mに位置する漁港のうち南側の領域においても同様に、海面に浮流する油、陸岸に漂着した油及び油の臭いはいずれも認められなかった。

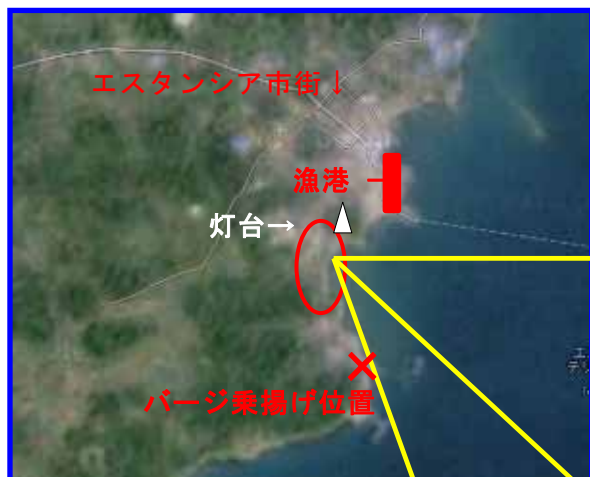
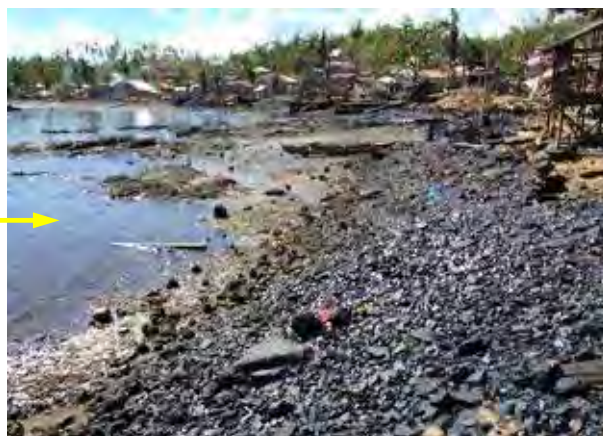
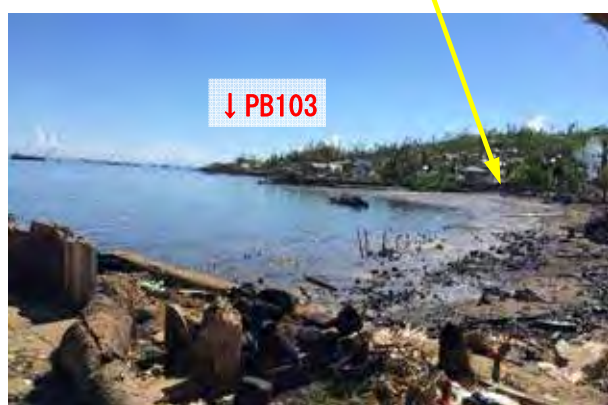
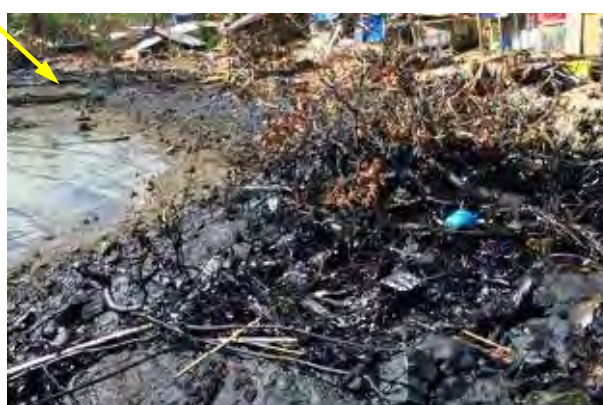
3) 現場北側の入り江

事故現場の北方約500mに位置する灯台から南方に広がる入り江において、陸岸に漂着した黒い油と油の臭いを認めた。陸岸上の岩石に付着した油は、一部で乾燥した状態を呈しており、一方で、ムース化（乳化）した油は全く認められなかった。また、付近の海上に浮流する油を認めないことから、流出事故当日に北側へ漂流した油が漂着したものと推定される。

この入り江から南方の事故現場にかけて、油の漂着が認められるが、崩壊した家屋の瓦礫等により徒歩による調査が困難となったため、本地点で調査を打ち切った。

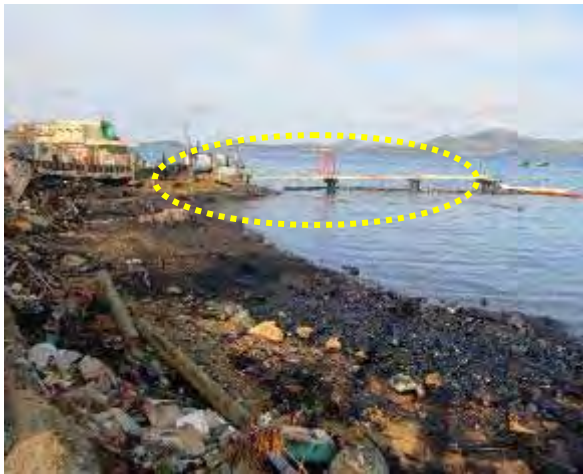
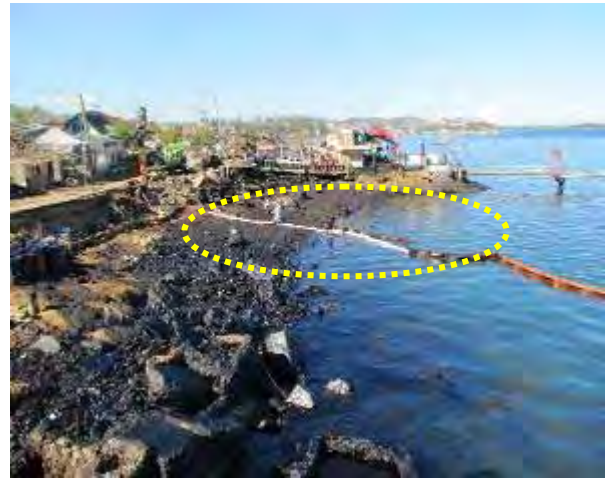
改善前（左）と改善後（右）の様子

- a. オイルフェンスの不足分について、追加の調達を考慮すること。
- b. 現状の改善策として、拡散防止範囲を狭め、十分に囲い込める範囲で拡散防止策をとること。
- c. オイルフェンス型吸着材のみを拡散防止策の資器材として使用しないこと。
- d. 1次オイルフェンスは十分な数量もなく、損傷して汚染が著しいため撤去すること。

アドバイスbに対し、オイルフェンスの拡散防止範囲を狭め、十分に囲い込める範囲に修

正された。改善前と改善後の様子を比べると改善後は1本のオイルフェンスで無理のない範囲で展張されていることが分かる。

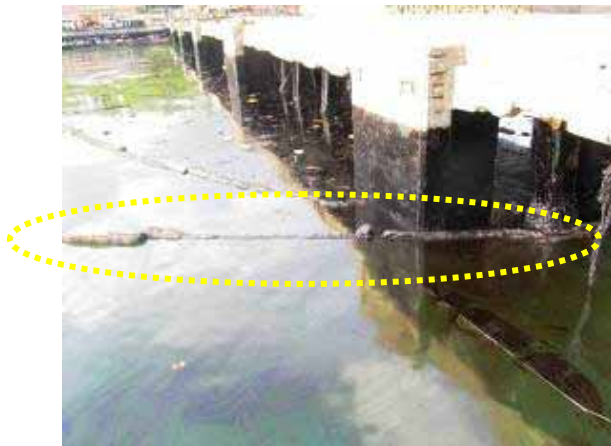
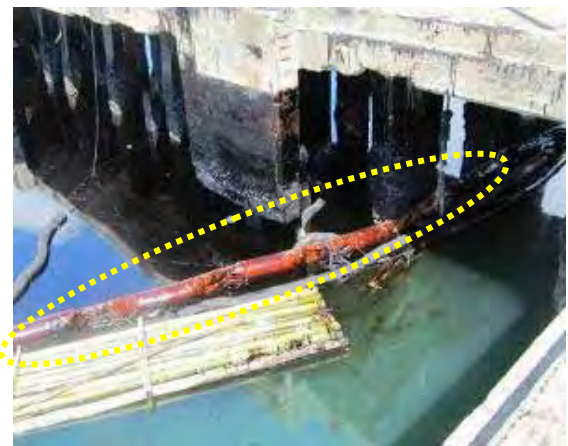
改善前（左）と改善後（右）の様子

アドバイスcに対し、オイルフェンス型吸着材にオイルフェンスが加えられ修正された。改善前（左）と改善後（右）の様子を比べると改善後はオイルフェンス型吸着材に代わり、オイルフェンスが使用されていることが分かる。

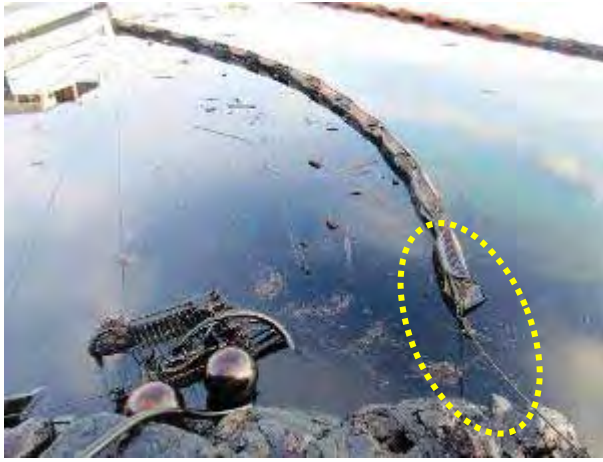
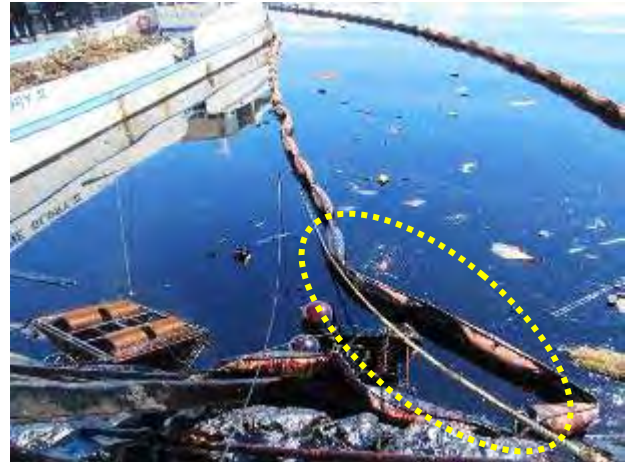
端末部分から油が漏れ出ていることが認められ拡散防止策が効果をなしていない。

改善前（左）と改善後（右）の様子

アドバイスeに対し、オイルフェンスの先端部と岸壁の接続点にオイルフェンスを折り返して隙間をなくすよう修正された。改善前（左）と改善後（右）の様子を比べると改善後はオイルフェンスの先端部からの更なる油流出を防いでいることが分かる。

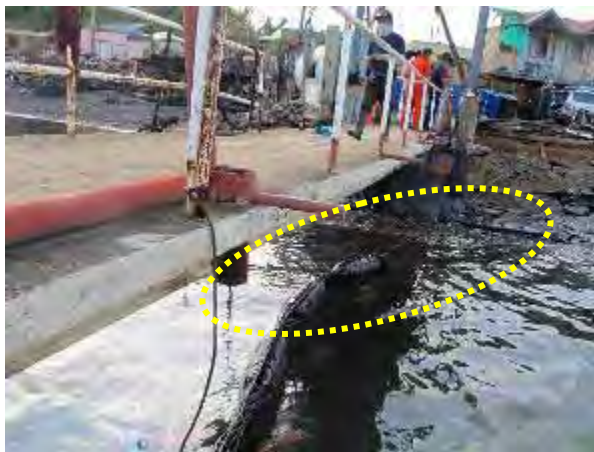
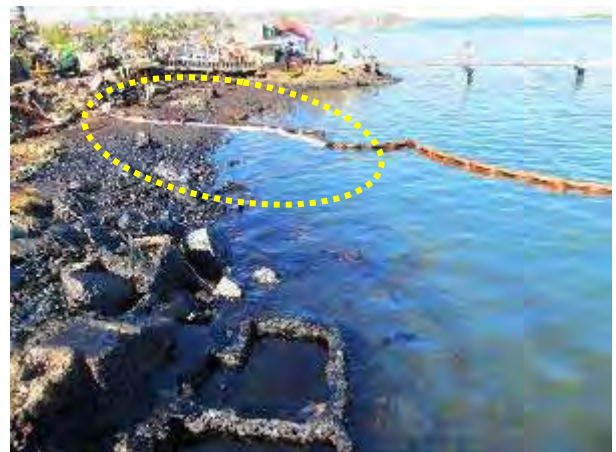
改善前（左）と改善後（右）の様子

アドバイスfに対し、陸側に引き込み、吸着材を併用した修正がなされた。改善前（左）と改善後（右）の様子を比べるとオイルフェンスの末端が十分に陸側（砂浜）へ引き込まれるとともに、オイルフェンスの片側にオイルフェンス型吸着材が併用され、更なる油流出を防いでいることが分かる。

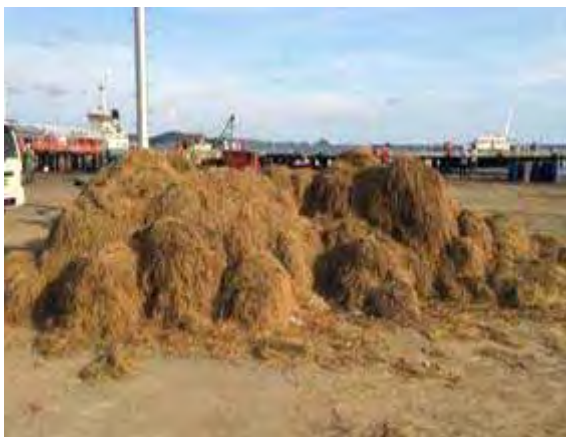
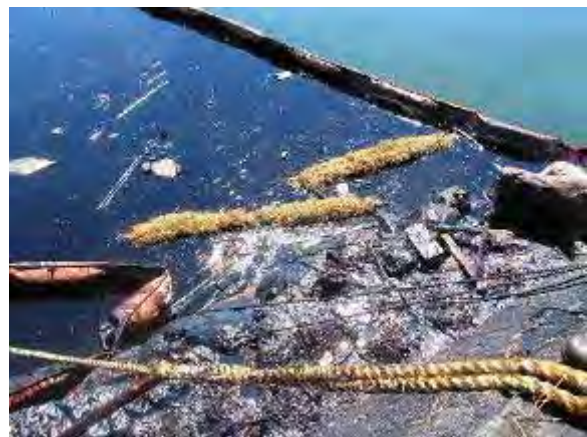
稲わら（左）と抱き枕状に工夫した稲わら製の捕獲材（右）

隊員の助言に基づき、大量に集められた稲わら（右）を抱き枕状にまとめて海上に投入するよう改善が図られた（右）。

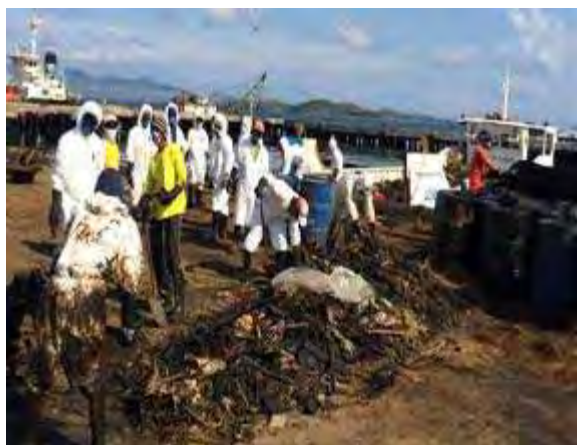
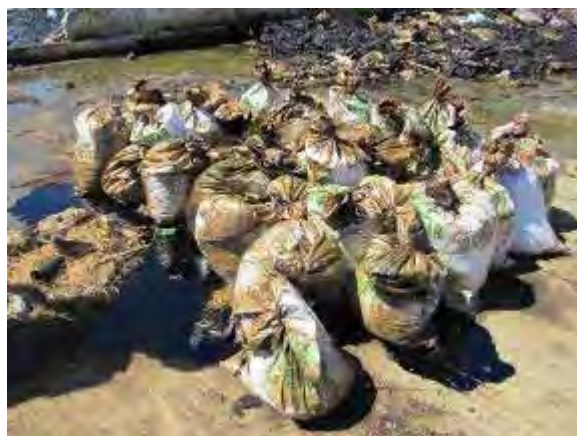
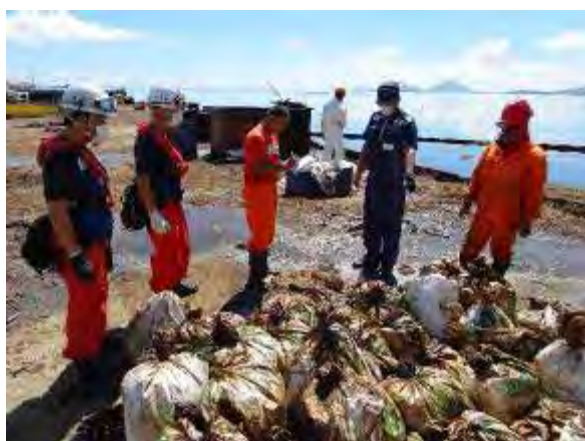
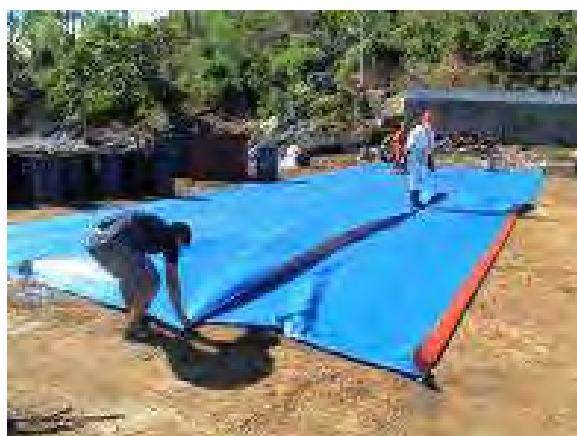
回収した油汚染ゴミを栈橋に一時的に集めたうえで作業船へ積み込んでいるが、栈橋に直接油汚染ゴミが置かれているため、栈橋上に油が漏れ、二次汚染を引き起こしている。

油汚染ゴミの処理方法に関する指導状況

（左上）指導前の状況、無造作に汚染ゴミが山積みされている。

油が漏れることを防ぐために細かなゴミは土のう袋に必ず入れるよう指示するとともに、一時的なゴミ置き場にビニールシートを敷き、栈橋上での二次汚染を防ぐよう指導した。

隊員の指導に基づき、土のう袋の利用が徹底されたほか、栈橋にビニールシートが敷かれ、二次汚染の防止策が図られた（写真参照）。

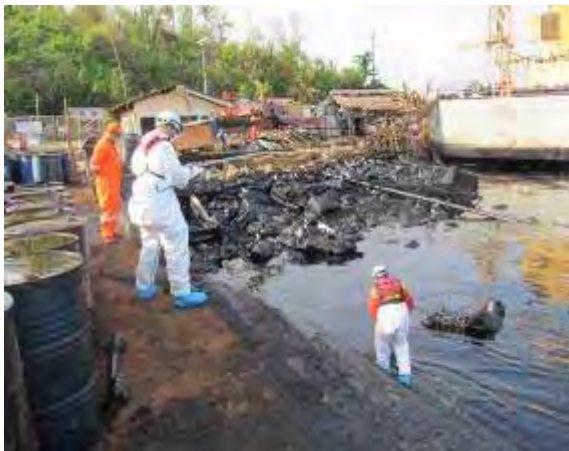
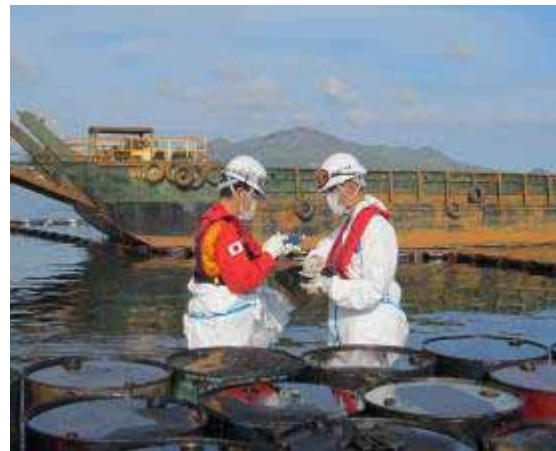
隊員によるガス（ベンゼン）検知の様子

JDRが有する資器材でガス検知を行い、ガス検知の手法を理解させるとともに、現場職員の安全確保のために、PCGによるガス検知を今後、適時適切に実施し、組織として現場職員の安全を確保する体制を確立するべきであると提言した。

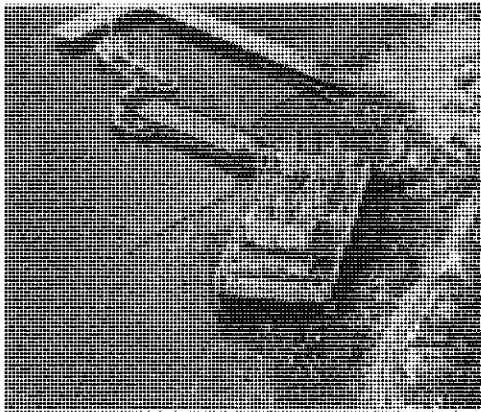
Accident site

- 1) It is necessary to surround the accident barge with oil boom without any gap/opening, prevent further spread of oil to the off-shore area and minimize the marine pollution. There was gap/opening between oil fences surrounded the accident barge causing leak and connecting point and spilt oil has spread out from there.

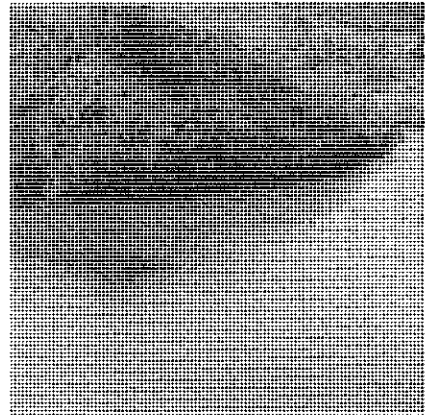
oil reached ashore

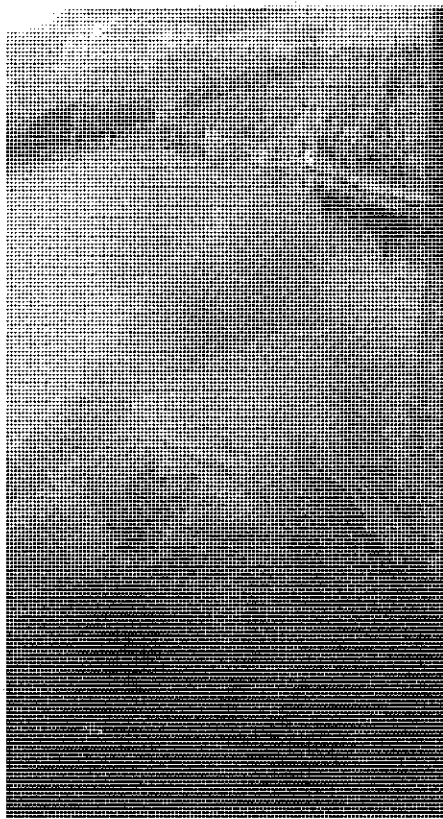
Floating oil spill (oil sheen)

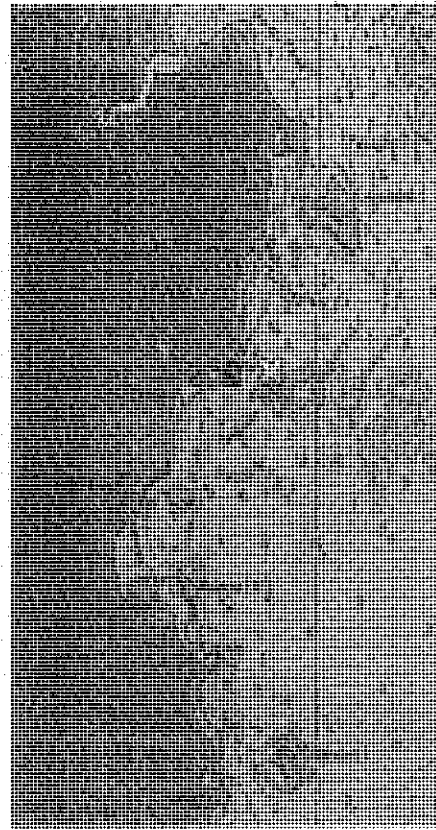
Floating oil spill (oil sheen)

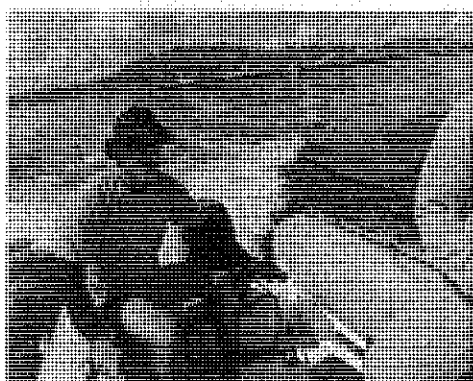
We conducted oil treatment mission by using RB in accordance with its concentrated level. In thin oil area, we adopted the mixture of oil and sea water by using RB, and in thick area colored black or brown, adopted physical measures to scoop or adsorb.

(Mixture in thin oil area)

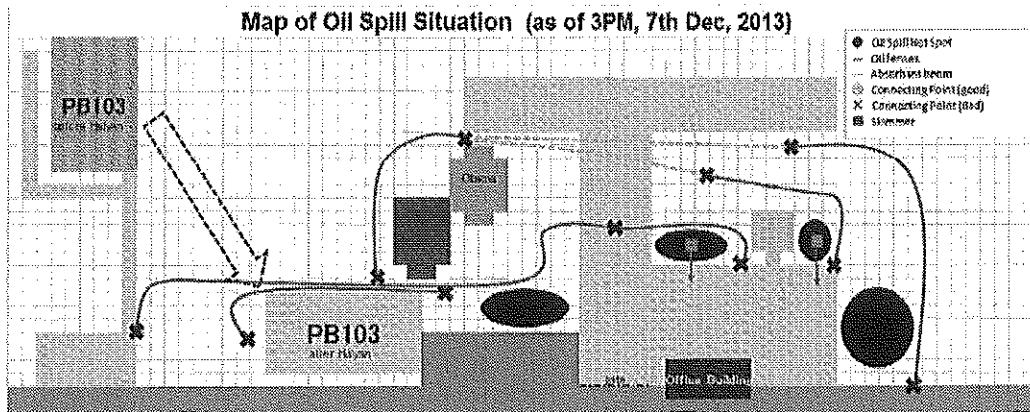
(As of 7 Dec.)

The Oil containment booms were arranged in proper manner as follows:

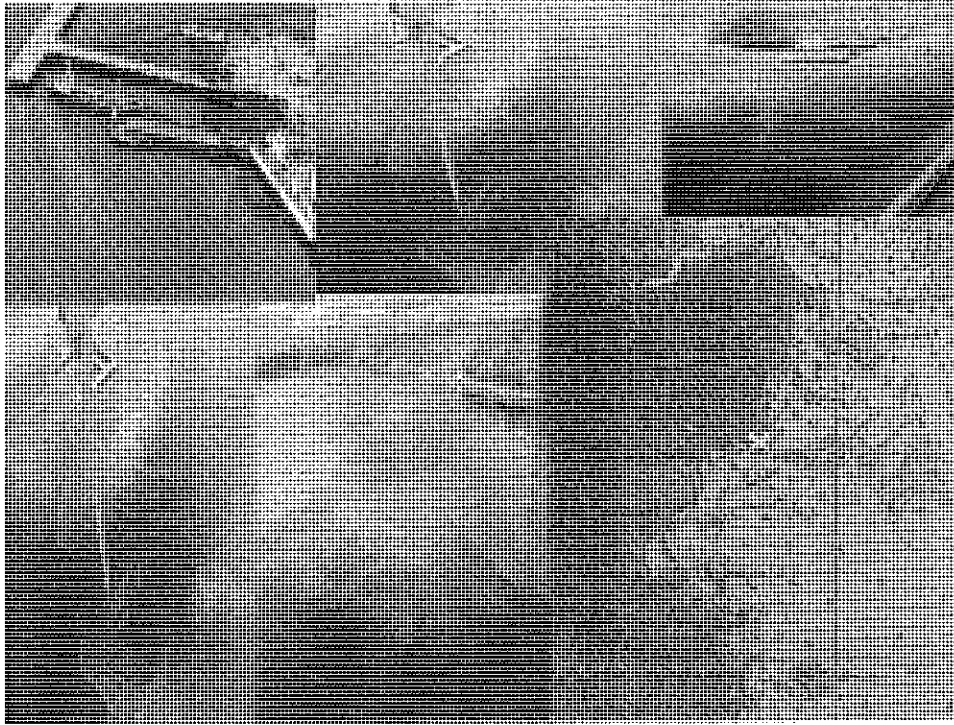
In the sea areas within 10Km to the south and south-east of the accident ship (near offshore sea area of Tanza), we saw a few lines of oil-film belts whose color ranged from dark (oil-film color A) to silver white and then bright rainbow color (oil-film color D)

③ We did not see any major floating oil in other off-shore sea areas we surveyed.

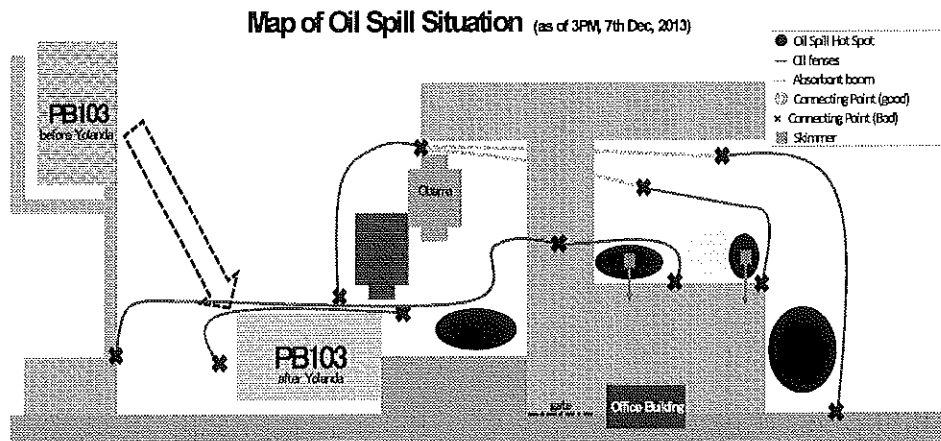
Map of Oil Spill Situation (as of 3PM, 8th Dec, 2013)

- Aerial survey on Dec 8, 2013 observed dark colored floating oil up to 10Km off shore of the accident site, despite multiple layers of oil containment booms extended around the accident site, in an attempt to prevent spreading of floating spilt oil.
- On the same day, JDR (oil defense and removal) expert team gave advices based on the findings from aerial survey and the situation of oil containment boom extension in the concerned area. Specific advices given by the experts are discussed in the following pages. Appropriate modifications were made based on these advices.
