Supporting Report
Appendix D
Assessment on Existing
Flood Mitigation Facilities

PREPARATORY SURVEY
FOR
FLOOD RISK MANAGEMENT PROJECT
FOR
CAGAYAN DE ORO RIVER (FRIMP-CDOR)
IN
THE REPUBLIC OF THE PHILIPPINES

FINAL REPORT

Appendix D
ASSESSMENT ON EXISTING FLOOD MITIGATION FACILITIES

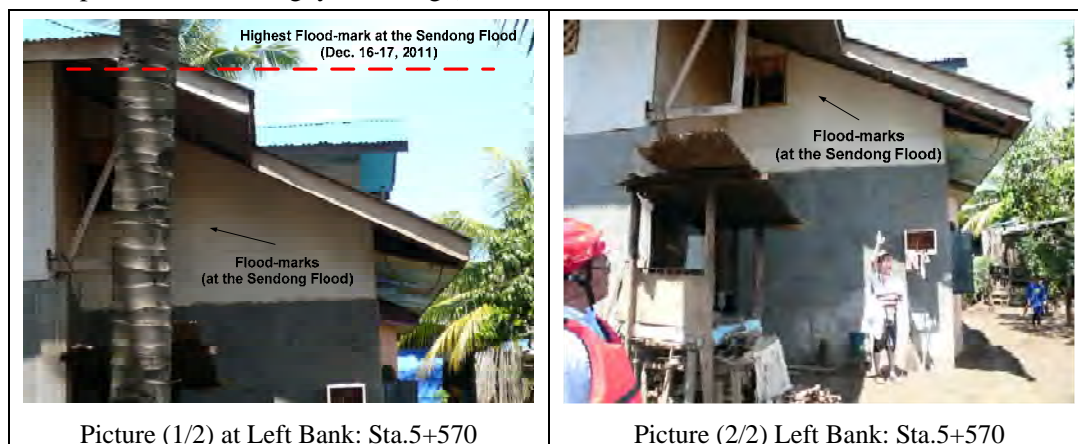
- Flood discharge over topped the Ysalina Bridge located just upstream of the City Hall of CDO (4.2 km upstream from the river mouth);
- Flood inundation depth was more than 5 m from ground level along the river bank;
- Flood water level reached the roof of houses (flood inundation depth about 6 to 7m at upstream of the Kagay-an Bridge)

Figure 1.2.1 Picture of Flood-Mark on House (Left Bank: Sta.5+570)

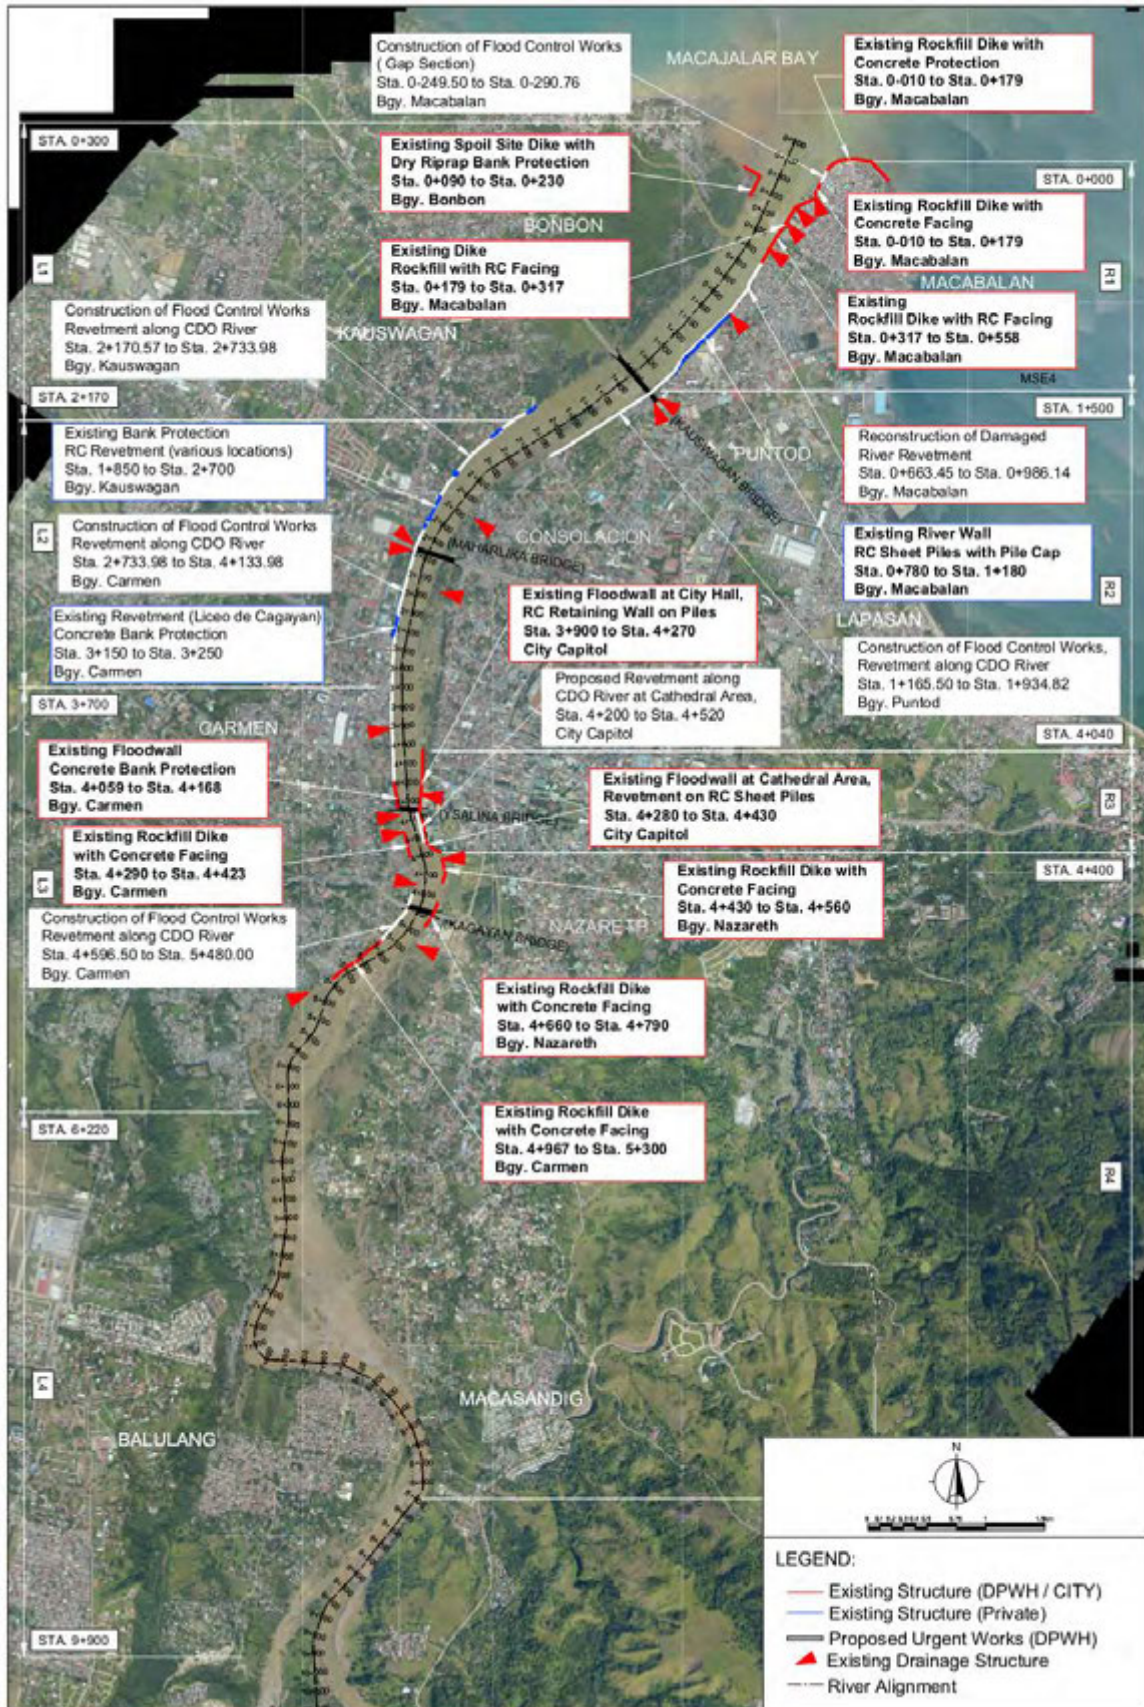
Figure 1.2.2 Location of Existing River Bank Revetment and Urgent Rehabilitation of River Dike

The Table 1.2.2 to 2.2.4 is shown in Figure 1.2.2.

DPWH is making efforts to accelerate progress of the construction / rehabilitation works mentioned above and to complete before the rain season in the CDO river basin.

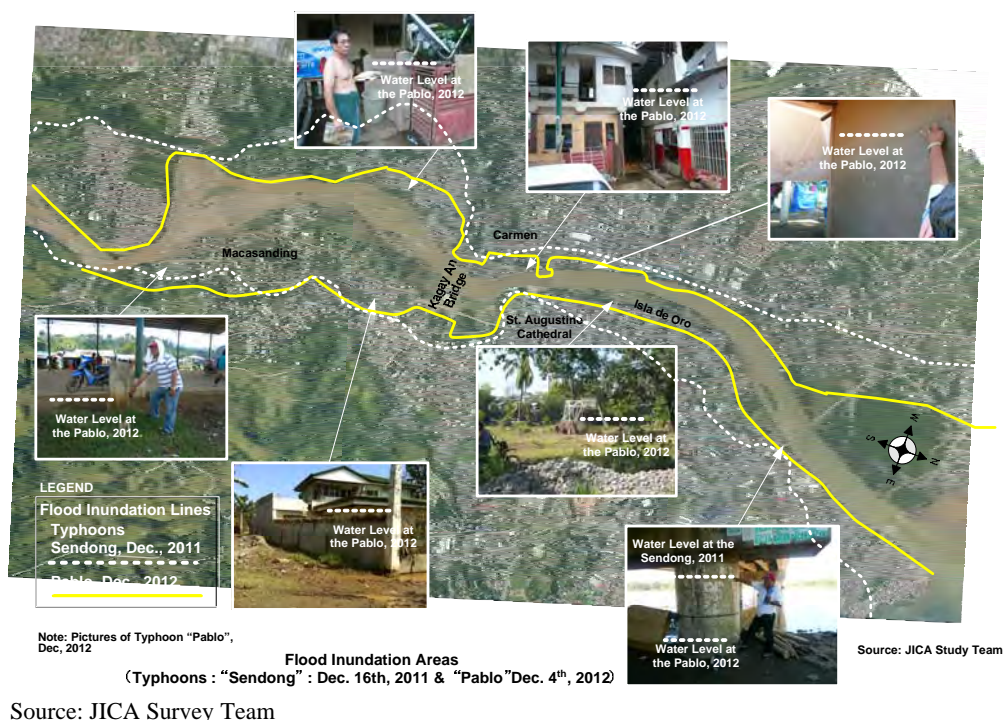
Figure 1.3.1 Flood Inundation Map (TS "Sendong" and TY "Pablo")

The following figure shows flood inundation lines caused by typhoons Pablo and Sendong for the purpose of comparing of extent between the two flood inundation areas.

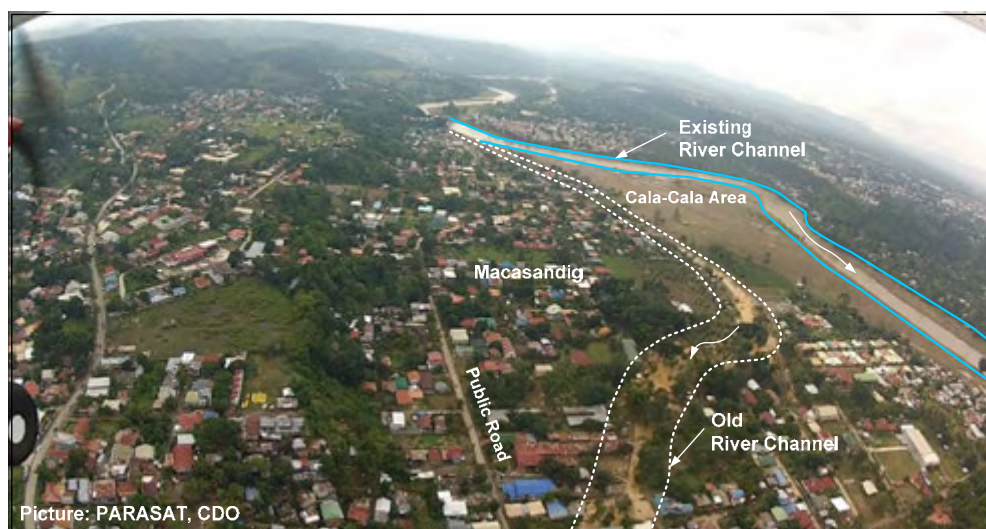
Figure 1.3.2 Location of Existing River and Old River at Macasandig (Dec. 7th, 2012)

(i) In the low lying portions of land that extends in this area, the followings are confirmed; river channel is still unstable, and trace of old-river is found at the right bank (See Figure 1.3.2). It is noted that the area is in fragile condition against flood inundation due to the following view points; Back water affect caused by the river narrow section between the Ysalina Bridge and the Kagay-an Bridge, and there is no river protection works such as dike.

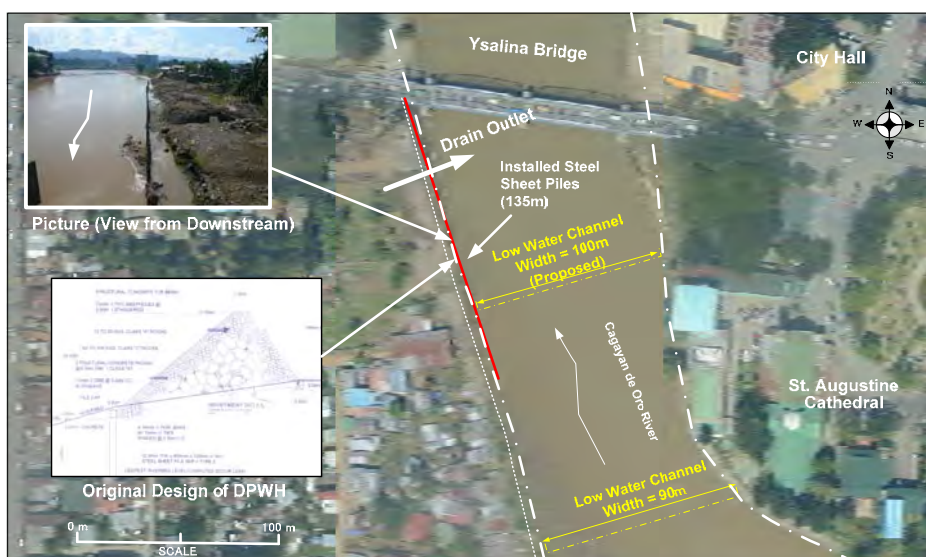
- Installation of steel sheet pile under construction based on the original design of DPWH Region- X is shown below. However, during the technical meeting with the Region- X, the Survey Team suggested the design might create adverse condition of river narrowing section or reducing river width.
- The alternative design of this section is discussed in detail in Chapter 8.

Figure 1.3.5 Location of Installed Steel Sheet Pile and Design of Dike (prepared by DPWH)

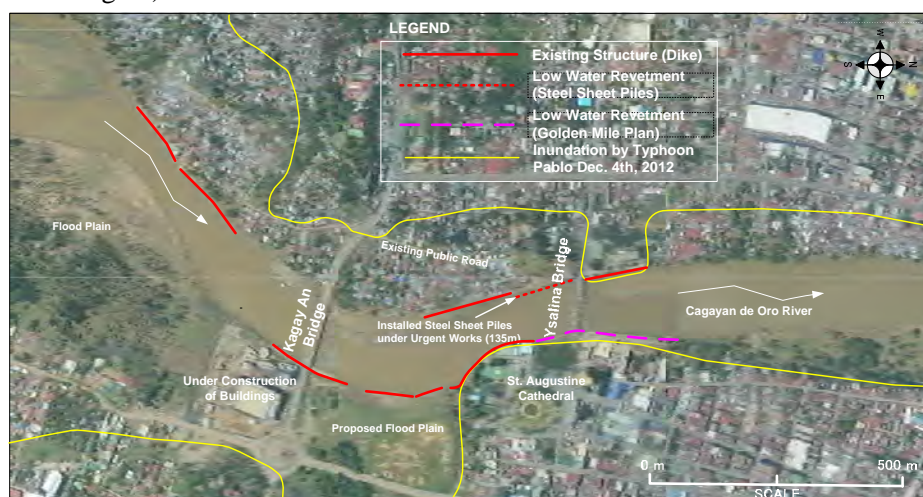
- No flood inundation damages has occurred at right bank (low swamp area) located upstream of the St. Augustine Cathedral between the Ysalina Bridge and the Kagay-an Bridge because no houses / people are living in the area. In addition, the area has a function of retarding basin, therefore it is considered that construction of dike along the river bank is not required to protect or to close the area urgently.
- Building facilities of hotel/mall and shopping store are under construction at right river bank located at upstream of the Kagay-an Bridge.
- To install additional sheet pile at right river bank toward upstream from the existing revetment to maintain low water channel; and
- To provide earth dike as high water channel structures at right flood plain located upstream of the buildings with smooth lines (approach angle of more 11 degree).

Figure 1.3.6 Location of Existing Structures around the River Narrow Area (Downstream of the Ysalina Bridge – Upstream of Kagay An Bridge)

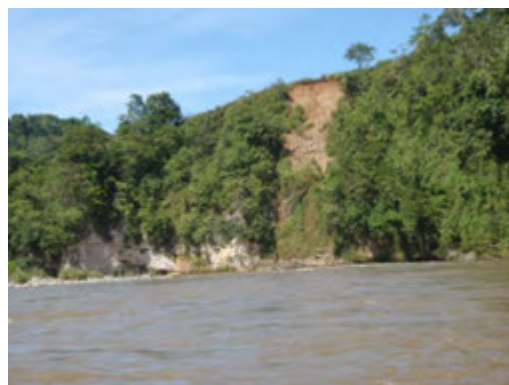
Surface Failure (CDO River 2012)

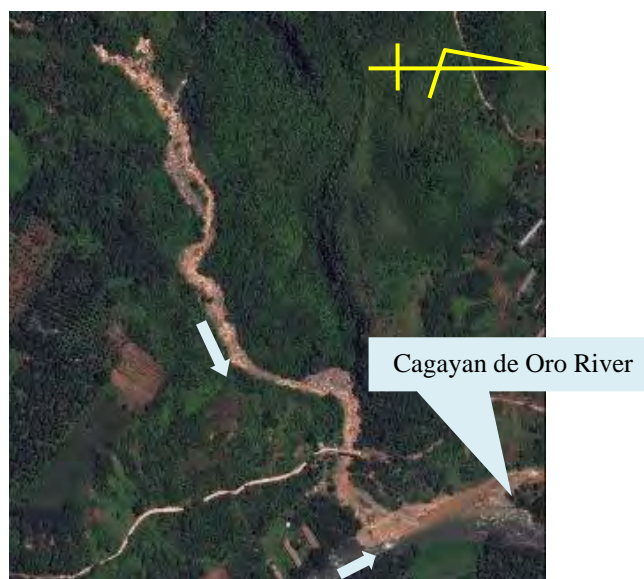
Photo 2.2.1 Debris Flow occurred in Bitanog River (A)

The trace of this debris flow is confirmed at the left tributary (Bitanog River) which is located at the upstream approximately 1km from Uguiaban Bridge. This debris flow site is the only site that is confirmed by photographic interpretation.

A debris flow which occurred in the middle of valley was flowed out with eroding the riverbed, and stopped at the confluence. The condition which was flowed out to the confluence spot is observed on the photo. The real condition of debris flow is explained in chapter 9.3 (See Photo 2.2.1).

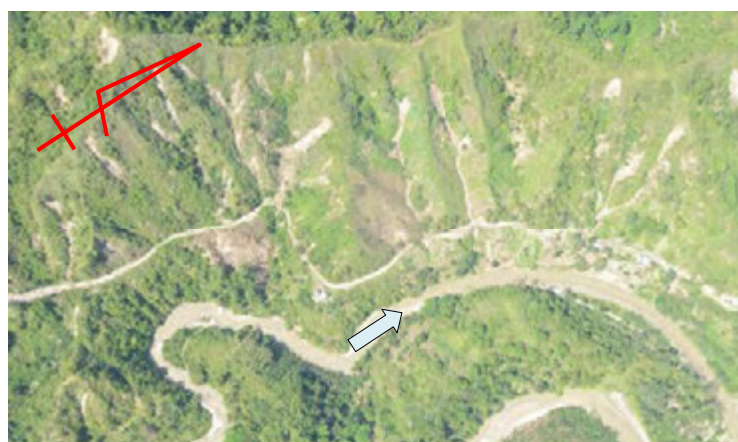
Photo 2.2.2 Slope failures distributing along the tributary of Iponan River (B)

Photo 2.2.2 shows the conditions of the slope failures taken in a part of Iponan River watershed, and is shown as the comparison of Cagayan de Oro watershed.

According to this photo, the sediments due to the slope failures have flowed into the tributary of Iponan River. If there are many slope failures like this, the influence to the downstream is presumed to be great. But slope failures like Iponan watershed are not observed in Cagayan de Oro watershed (Iponan River is shown in Figure 3.1.1).

The geology of Iponan River watershed consists of limestone of the Tertiary, unlike the geology of Cagayan de Oro River watershed that consists of the volcanic deposit. In comparison to the topography of Cagayan de Oro River watershed, that of Iponan River watershed consists of the undulating topography due to erosion.

The weathered Limestone is not resistance to erosion, therefore the slope failures are presumed to tend to be occurred under such environments.

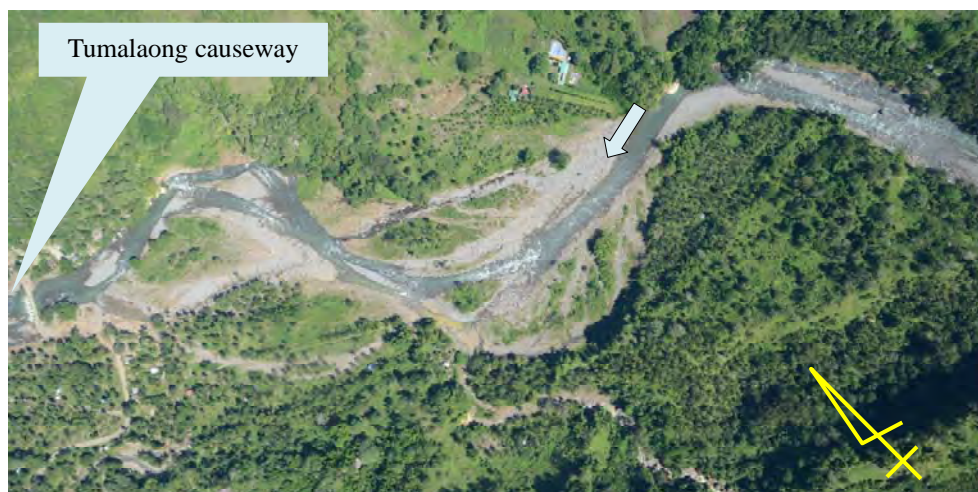
Photo 2.2.3 Riverbed inundation observed along Tumalaong River (C)

Photo 2.2.3 shows the typical place of immediately the upstream of the Tumalaong causeway. The riverbank and towhead which are eroded widely by the meandering are observed.

These sediment movements are due to the bed load transport, and are considered to be the sediment movement form which transports bed materials to downstream gradually (See Figure 2.2.2). In this interpretation, the marked movement which affects facilities or downstream are not confirmed.

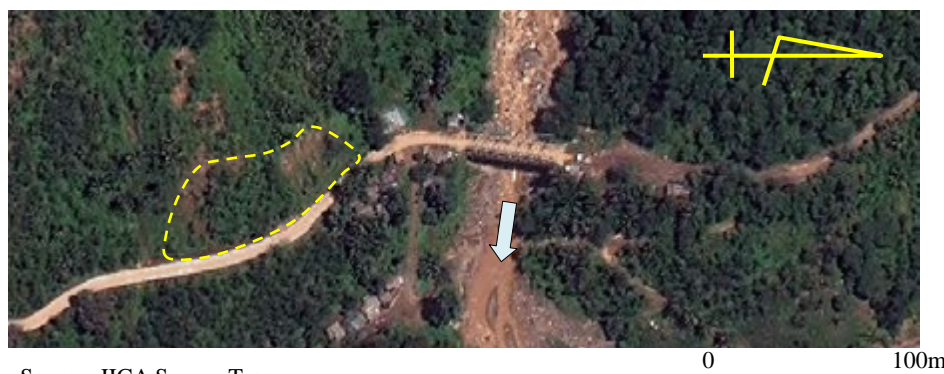
Photo 2.2.4 Landslide along the Road (D:dashed line)

Photo 2.2.4 shows the landslide which was found by chance along the road near Bitanog River (See Figure 3.1.1). The landslide (50m width, 30m height), which is located at the margin of higher terrace, has not affected the sediment production to the downstream. The condition of site is as shown in Photo 2.2.5.

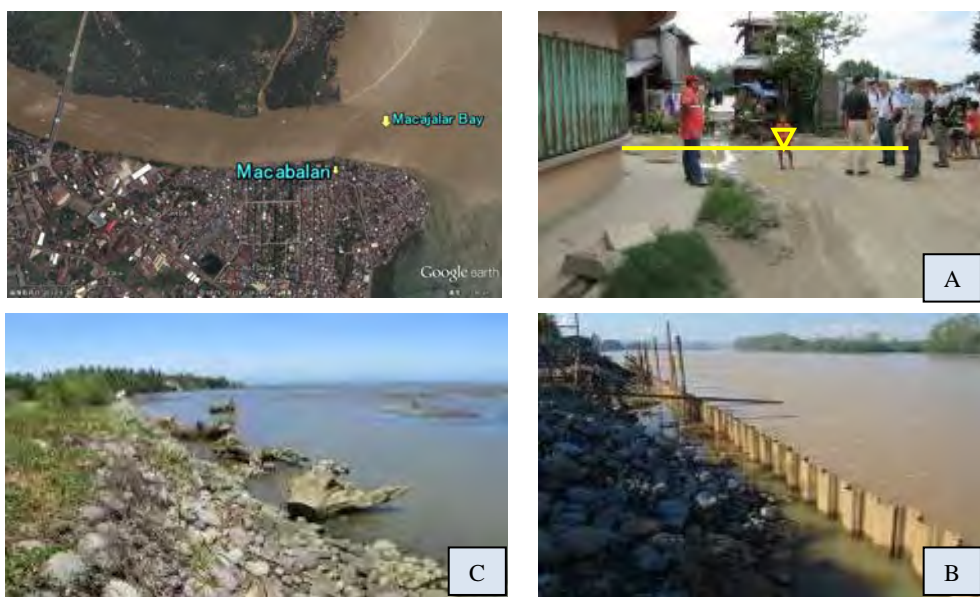
Photo 3.2.1 Around Estuary

The width of river estuary at Macabalan is about 250m (See Figure 3.1.1). A large amount of sediments flowed out from the upstream. The water depth of the inundation at Sendong was confirmed to have been about 60cm (See Photo 3.2.1 A). No flood deposit with gravels was observed at this zone.

Almost all sediments which consists of fine materials that flowed from upstream is presumed to be deposited on the riverbed, or to have flowed as wash load toward the sea (See Photos 3.1 B, C).

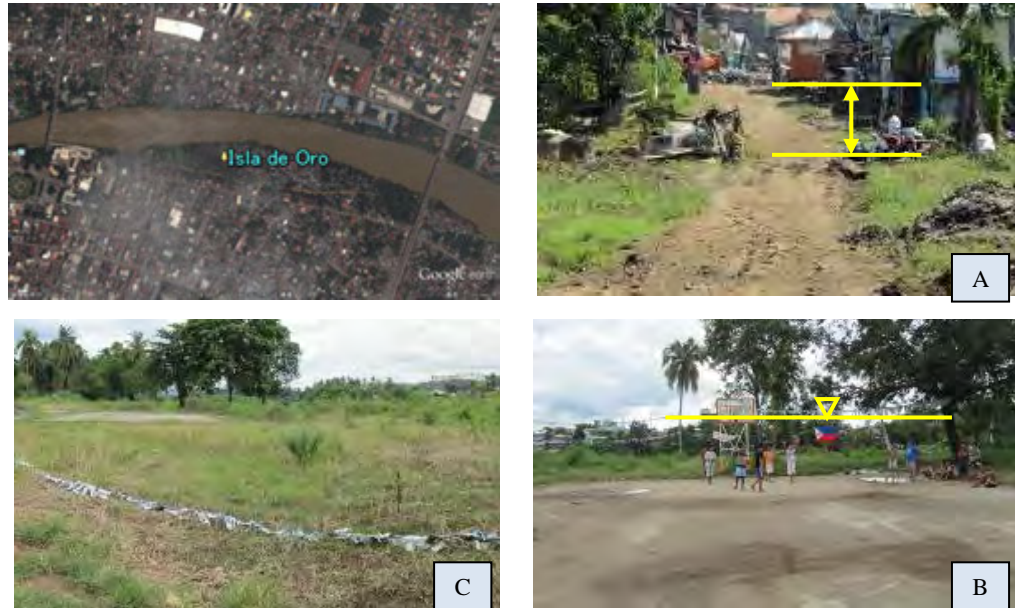
Photo 3.2.2 Isla de Oro

Isla de Oro is an area of delta formed from sediment deposits with ground elevation of about 3m lower than the surface elevation of the public road (See Photo 3.2.2 A and Figure 3.1.1). Many houses in this area were washed away during TS Sendong. Due to curve shape of the river channel at immediately upstream of the Isla de Oro, the flood is presumed to have had a straight flow. The height of flood was about 2.5m above the ground level at the basketball court (See Photo 3.2.2 B), no flood deposit was observed at this zone (See Photo 3.2.2 C).

As no flood deposit with gravels was observed at this zone, fine materials in the flood are presumed to be flowed out toward sea as wash load (See Photo 3.2.2 C).

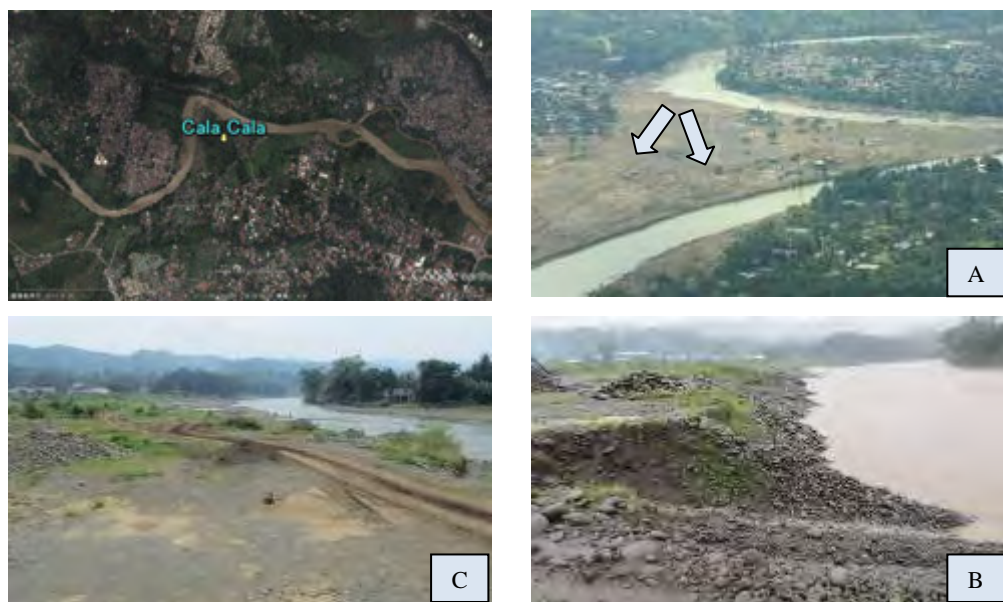
Photo 3.2.3 Cala Cala

This area is considered as the lower terrace (See Figure 3.1.1). As the river immediately upstream is in meandering shape, the flood of this area was presumed to have had a straight flow like Isla de Oro.

Photo 3.2.3 A is the aerial photo taken immediately after Sendong. At the present, the remarkable trace of flood deposits were not observed on this terrace, fine materials in the flood was presumed to have flowed out toward the sea as wash load, but fine materials and the boulders which consist of old terrace deposits were observed (See Photos 3.3 B, C).

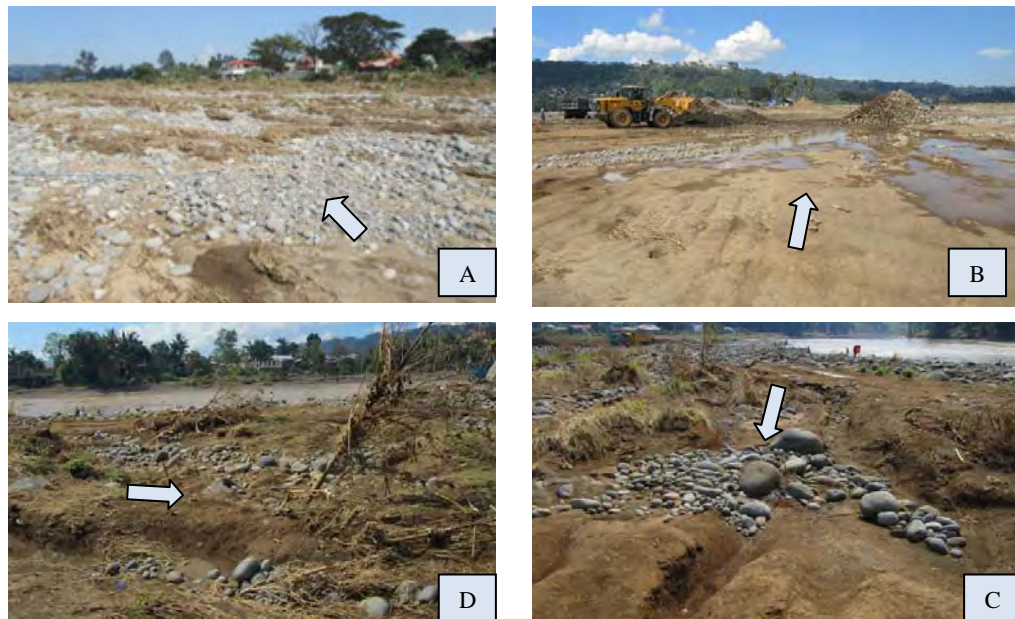
Photo 3.2.4 Terrace Surface after Pablo

Photo 3.2.4 shows the condition of terrace surface after Pablo. A lot of boulders were observed on the terrace, but these boulders are old terrace deposits (See Photo 3.2.4

A). As the terrace surfaces are eroded as shown Photos 3.4 B to D, the flood energy was considered to have had an enormous large energy.

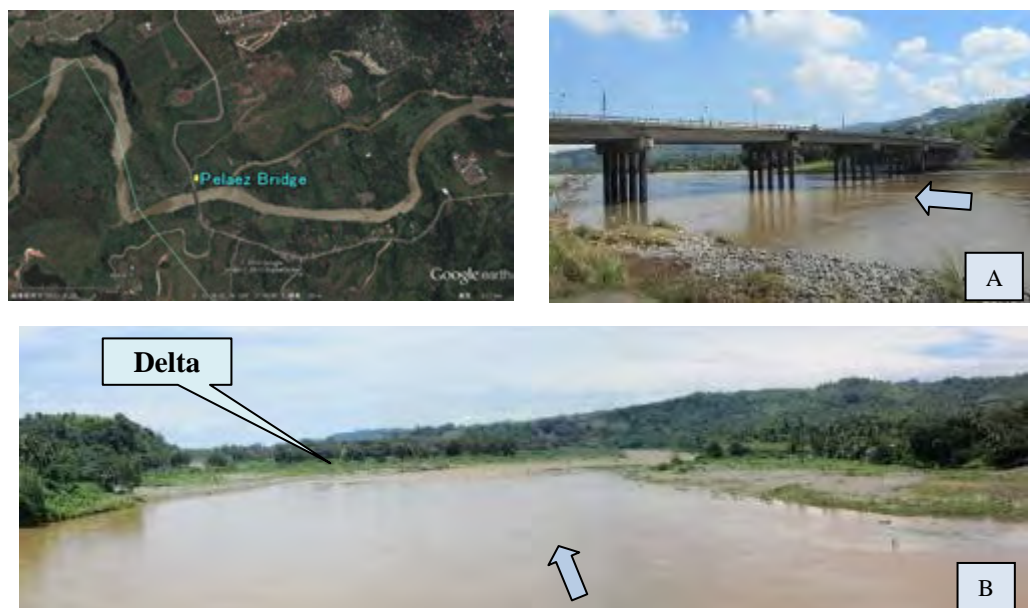
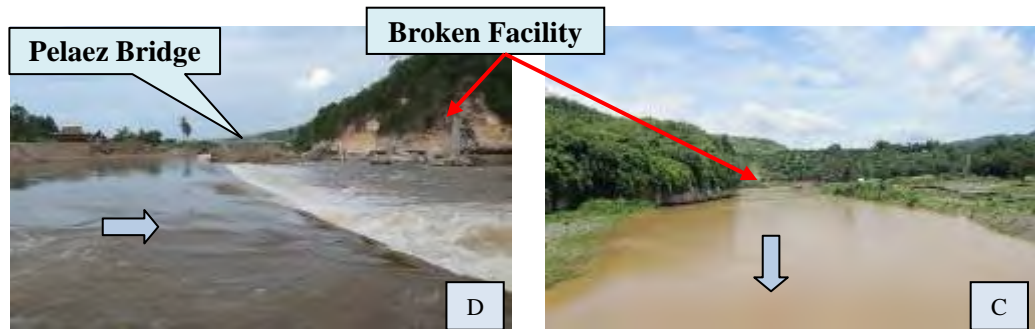
Photo 3.2.5 Pelaez Bridge (1/2)

The large delta is located immediately downstream of Pelaez Bridge (See Photo 3.2.5B and Figure 3.1.1). This bridge and facilities in the delta are not damaged by Sendong, but the facility (water pipe bridge) of upstream of this bridge was damaged by Sendong floodwaters (See Photo 3.2.5 C).

As flood deposits were not observed around the bridge, fine materials carried by floodwaters are presumed to have flowed out toward downstream as wash load.

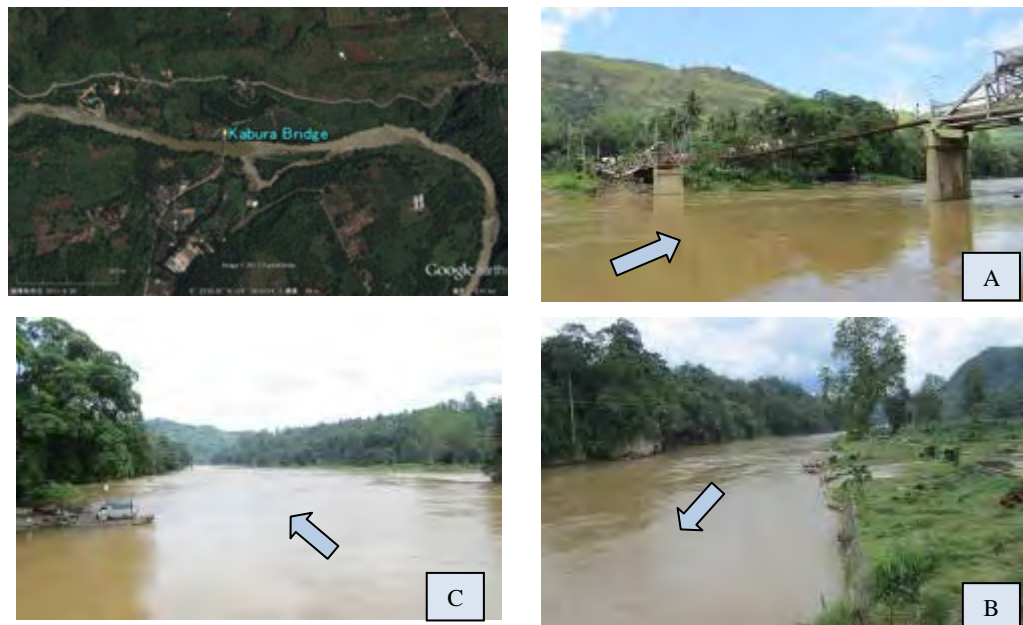
Photo 3.2.6 Cabula Bridge

Cabula Bridge was damaged by storm Sendong floodwaters.

At the present, flood deposits were not observed around the bridge, fine materials carried by floodwaters is presumed to have flowed out toward downstream as wash load (See Photos 3.6 B, C and Figure 3.1.1).

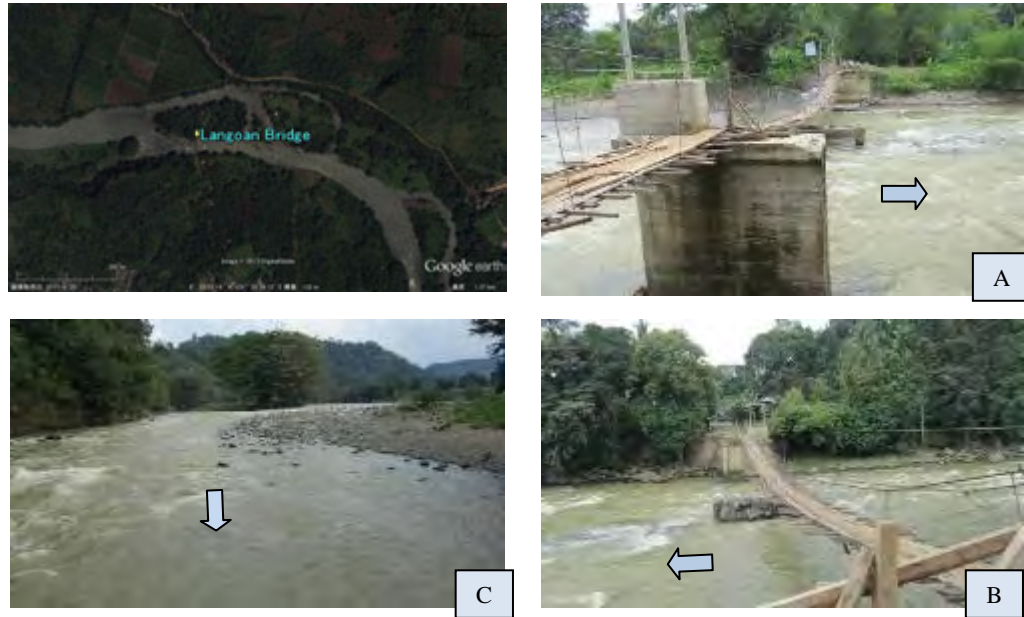
Photo 3.2.7 Langoan Bridge

This bridge area is in a delta and Langoan Bridge is one of the bridges which span between the delta and river bank. This bridge spanning between the delta and the right bank was damaged by Sendong (See Photos 3.7 A, B and Figure 3.1.1).

The flood deposits were not observed around the bridge (See Photo 3.2.7 C).

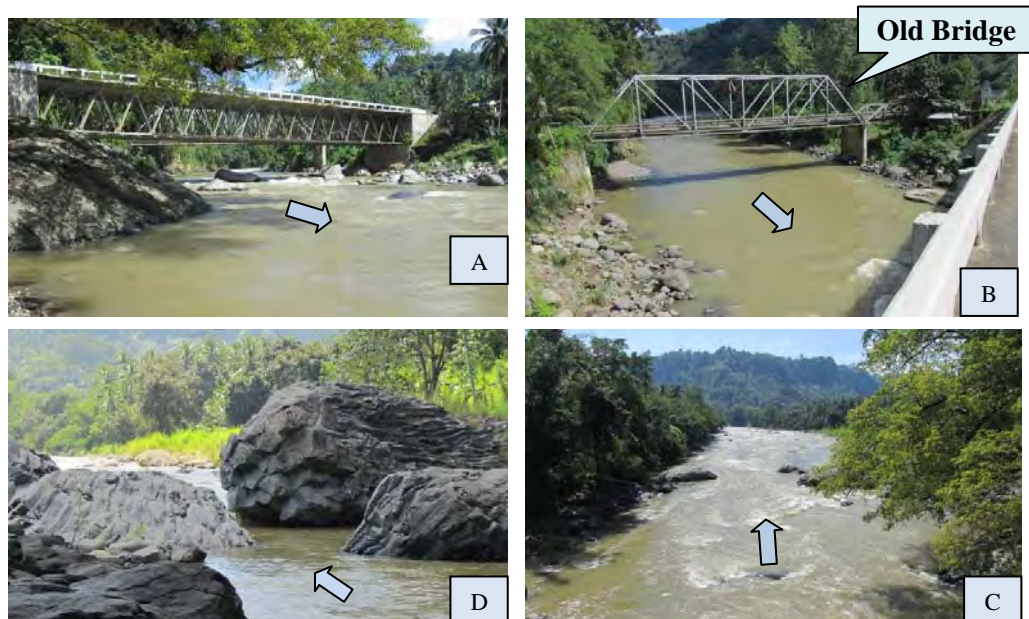
Photo 3.2.8 Uguiaban Bridge

In this spot, the width of the river is narrower compared to the downstream of the bridge, therefore the river stream has little rapids (See Photos 3.8 B, C).

Flood deposits were not observed around the bridge, but the volcanic boulders which seemed to have been fallen from slope failure occurred in the immediate slope were observed in the riverbed on the right bank (See Photo 3.2.7 D).

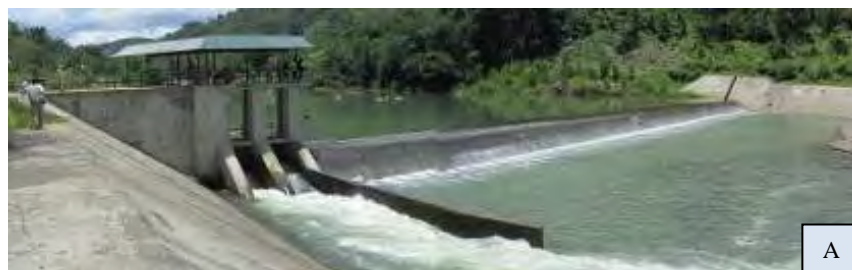
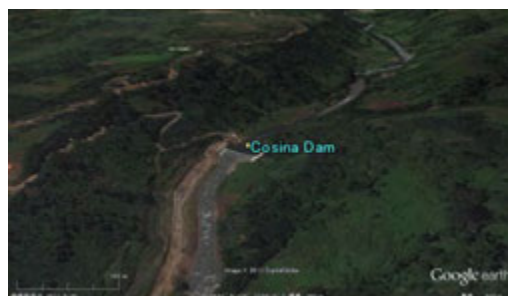
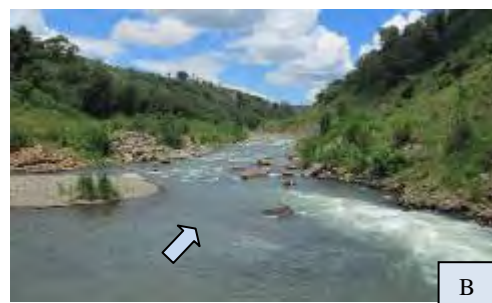
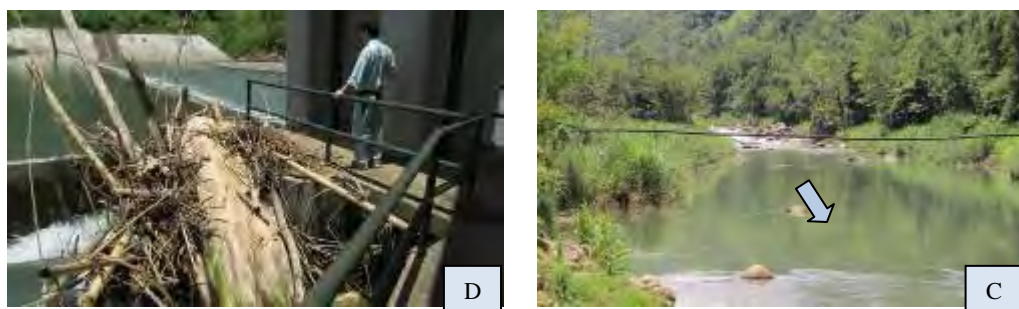
Photo 3.2.10 Cosina Dam (1/2)

The dam is about 2 meters height, and the condition of full capacity is observed. The obvious flood deposit is not observed around the dam including dam reservoir (See Photos 3.10 B, C).

The driftwoods which are considered to have been flowed out at Sendong are observed at the intake (See Photo 3.2.10 D).

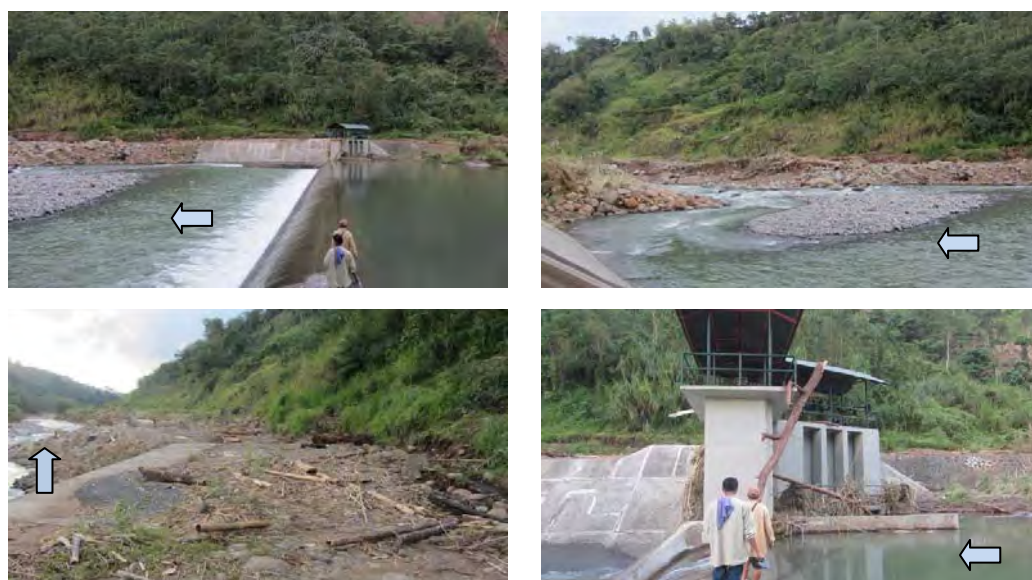
Photo 3.2.11 Condition after Pablo

Photo 3.2.11 shows the condition after Pablo. According to these photos, new driftwoods are observed at the intake, and the new flood traces are observed around the dam. But the dam reservoir is not filled up with sediment, and the marks of the sediment movements are not observed around the dam.

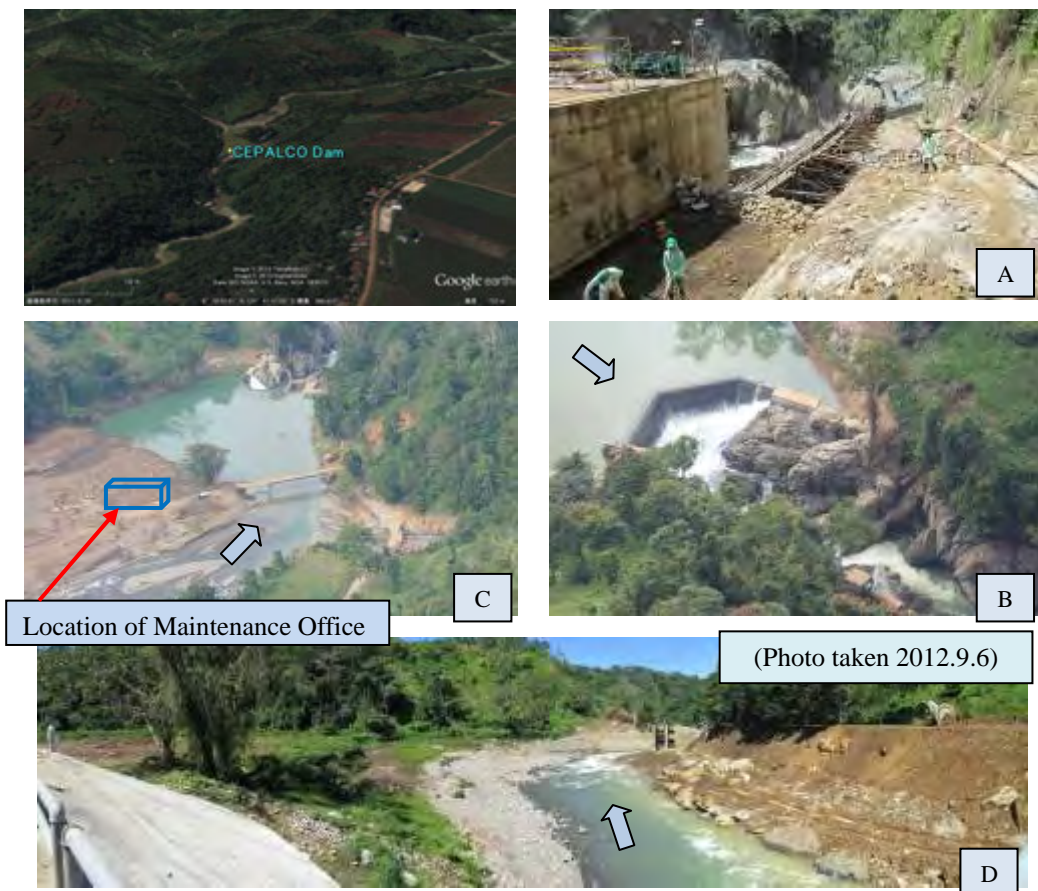
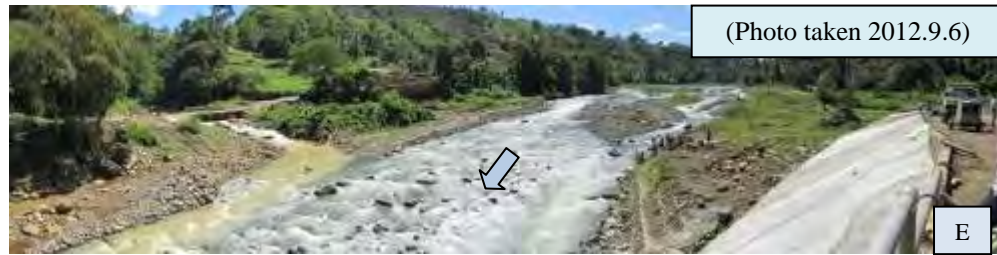
Photo 3.2.12 CEPALCO Dam (1/2)

This dam is being repaired at present (See Photo 3.2.12 A). Photo 3.2.12 B and C show the condition immediately after Sendong (photos taken from Helicopter).

According to the photos, there are thin brownish deposits observed on the left bank terrace where the maintenance office had been built. But the reservoir was not filled up with the flood deposit.

Photos 3.12 D and E show the present riverbed condition. As shown in photos, the flood deposit is scarcely observed.

Photo 3.2.12 E shows the immediate upstream of the dam, in spite of the fine weather, the muddy water which flows into Bubunawan River from right tributary was observed.

From this observation, the sediment which consists of the fine materials is presumed to have flowed out constantly from the plateau.

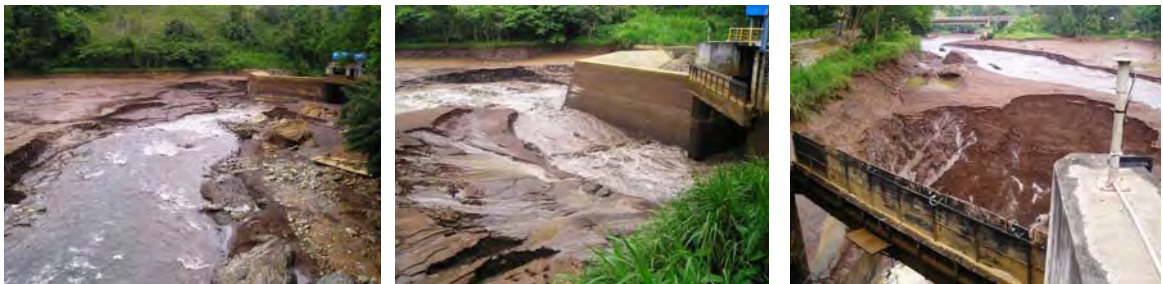
Photo 3.2.13 The Fine Materials flowed into the Reservoir every year (before Sendong)

Meanwhile, according to the dam management of the company, deposits of fine materials like clay, silt and fine sand is observed every year in the CEPALCO dam reservoir (See Photo 3.2.13 ; by MINDANAO ENERGY).

These fine materials were presumed to have flowed out from the plateau where the cultivated fields (Bananas, Pineapples, etc.) are located, and the fine materials which were trapped within the dam are removed from the terrace etc. of the upstream every year.

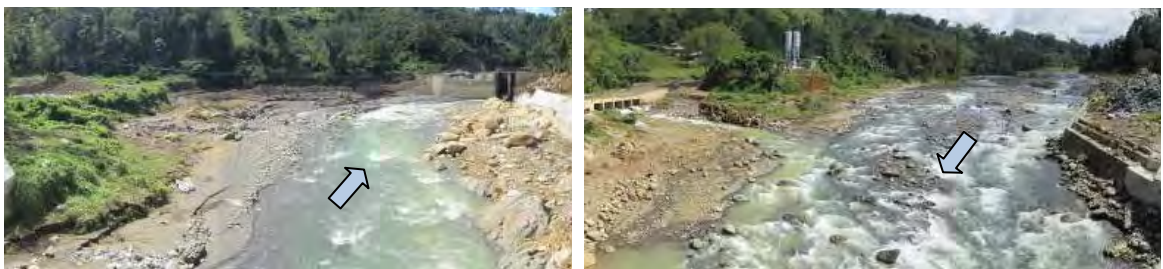
Photo 3.2.14 Condition of around the CEPALCO Dam after Pablo (10 Dec. 2012)

Photo 3.2.14 shows the upstream condition of the CEPALCO dam after Pablo. The traces of movement of the riverbed materials are observed. But the remarkable deposits in the CEPALCO dam were not observed.

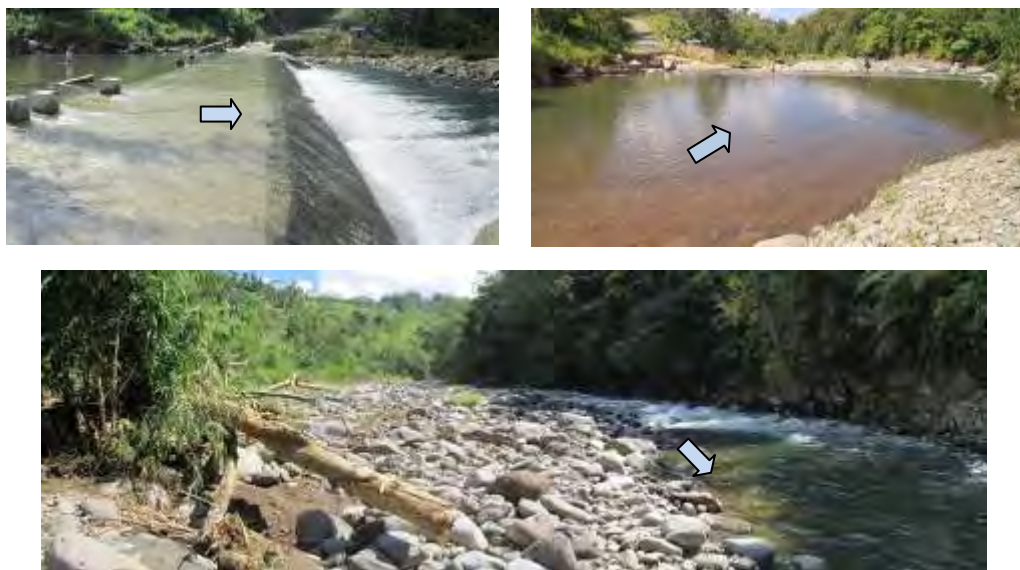
Photo 3.2.16 Condition of around Causeway After Pablo

In fact, according to observation after Pablo, the river water flows over the road surface of the causeway due to obstruction of the drainage pipes as shown in Photo 3.2.16, therefore the riverbed fluctuation is considered to be caused every severe flooding.

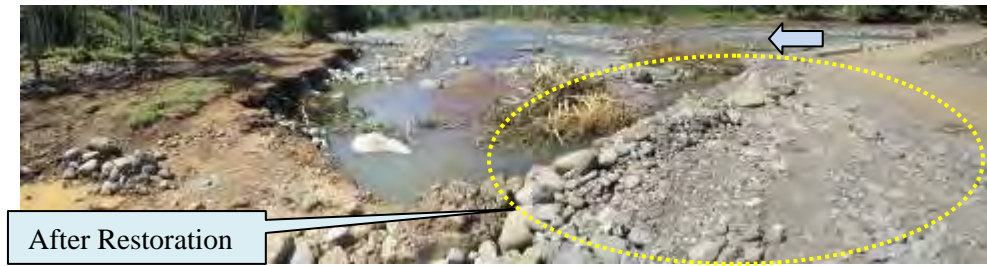
Photo 3.2.18 Condition of after Pablo (2/2)

In fact, according to the observation after Pablo, the outflow and the restoration of the left bank abutment are observed, the condition exemplifies what is mentioned above (See Photo 3.2.18).

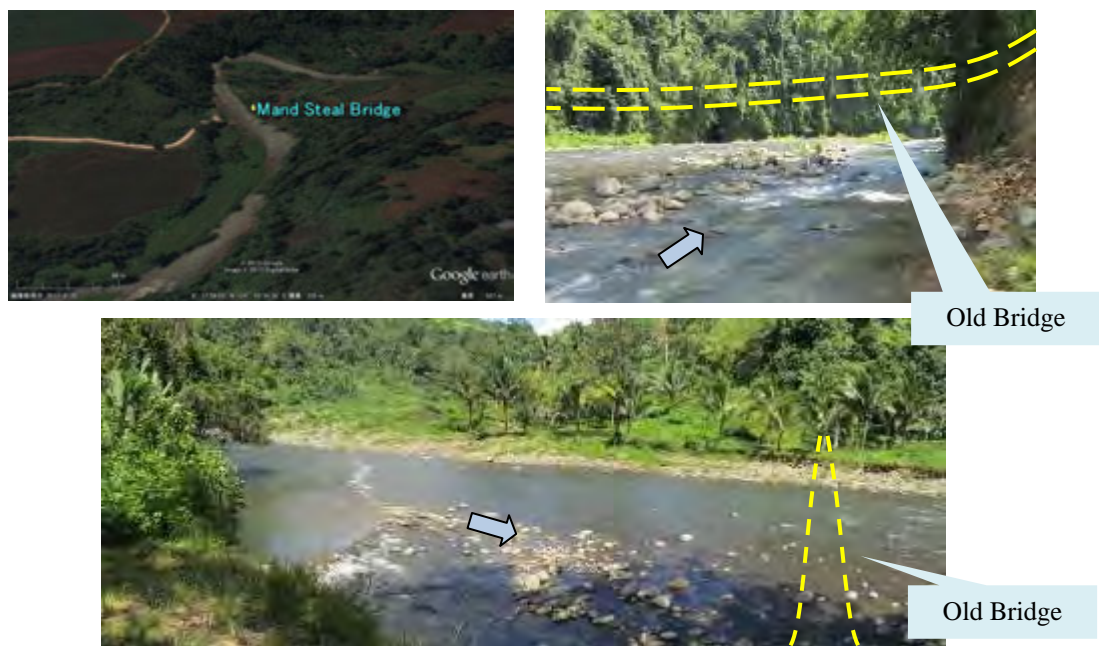
Photo 3.2.19 Old Mand Steel Bridge

The observed characteristics of flood deposits on the riverbed, consists of gravels and cobbles.

These deposits on the riverbed are presumed to be transported by “bed load” similar to the condition of Tumalaong causeway (See Photo 3.2.19).

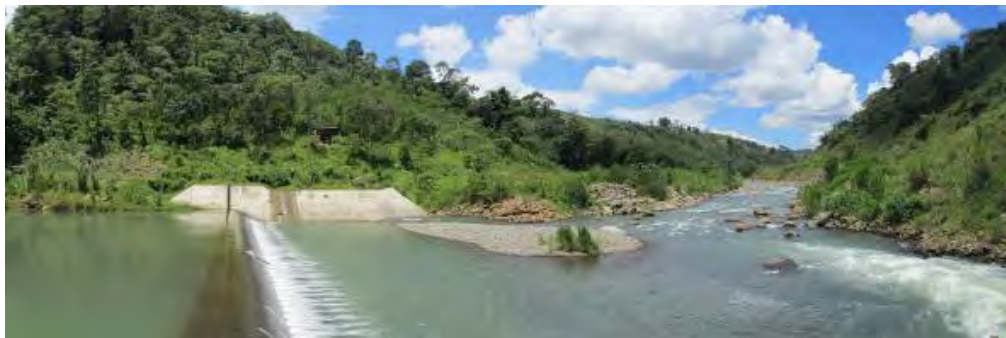
Photo 4.3.1 No Debris Flow Deposits around Cosina Dam

The traces of the debris flow deposits which are the factor of the sediment disaster, namely debris flow deposit, are not observed around the Cosina dam (See Photo 4.3.1 and Figure 4.3.1).

As shown in Figure 4.3.1, the riverbed gradient around the Cosina dam is $1/94$, so most debris flow deposits are considered to be already deposited in the upstream area.

The sediment movement form is presumed to be “bed load”.

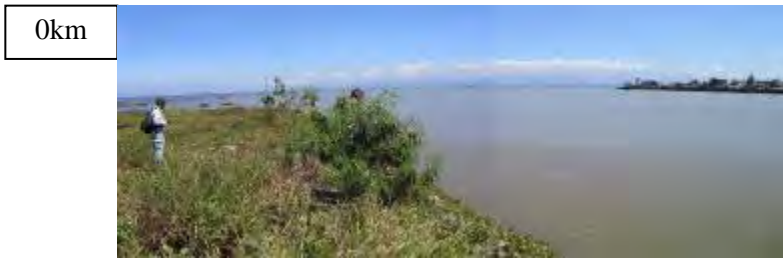
0km
Estuary (Sand Deposits are observed)

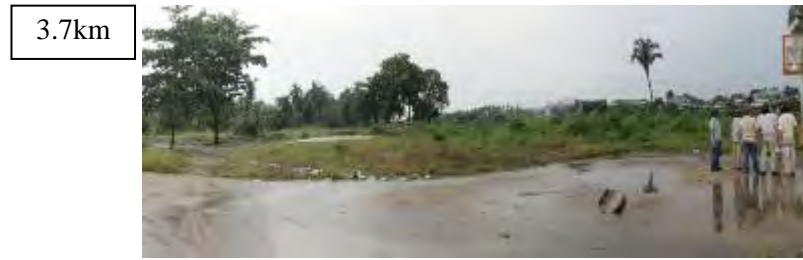
3.7km
Isla De Oro (Flood Deposit is not almost observed)

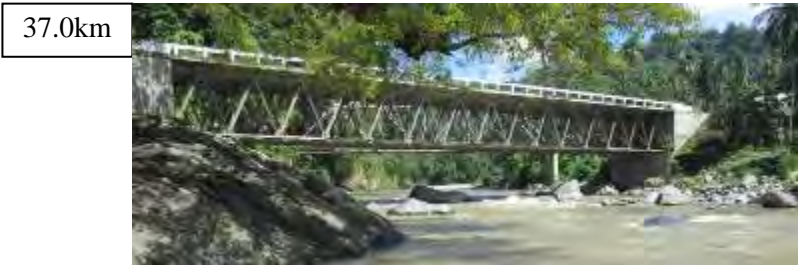
37.0km
Uguiaban Bridge (Flood Deposit is not almost observed)

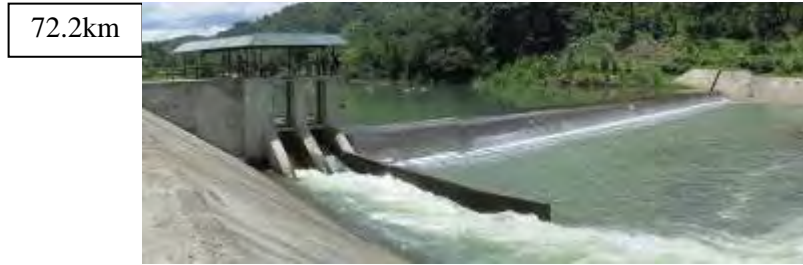
72.2km
Cosina dam (Flood Deposit is not almost observed)

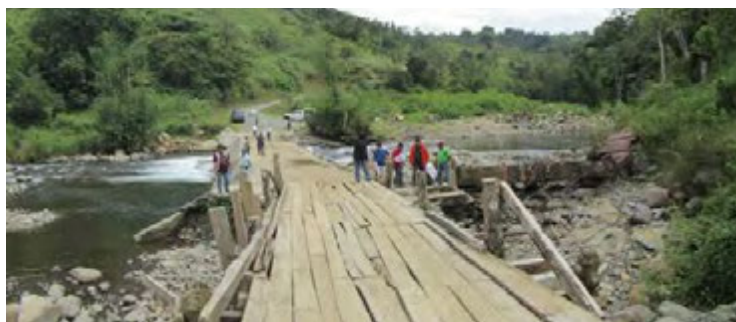
Photo 4.3.2 No Debris Flow Deposits around Kalasuyan Causeway

The trace of the debris flow is not observed in the downstream from Kalasyan causeway (See Photo 4.3.2 and Figure 4.3.2).

As shown in Figure 4.3.2, the riverbed gradient around Kalasyan causeway is 1/33, so most debris flow deposits are considered to be already deposited in the upstream area.

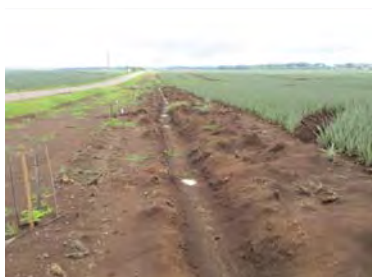
Cultivated Land covered with the Fine Materials

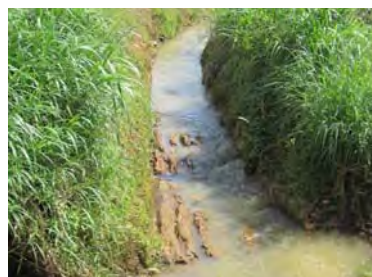
The Mud Flow in the Cultivated Land

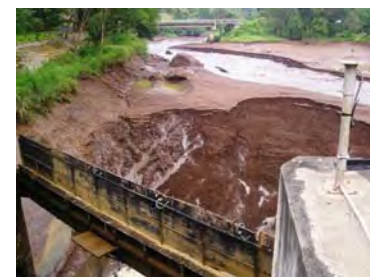
Photo 4.3.3 Outflow of the Fine Materials

One of the characteristics of the Bubunawan River is the outflow of a large amount of the fine materials from the plateau as shown in the CEPALCO dam.

The fine materials, which are not directly the factor of sediment disaster themselves, are considered to have a influence on the aggradation of riverbed of downstream (See Photo 4.3.3).

The Fine Materials deposited in the CEPALCO

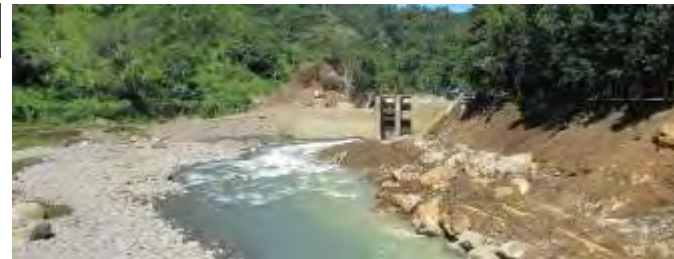
CEPALCO Dam (No Debris flow Deposits)

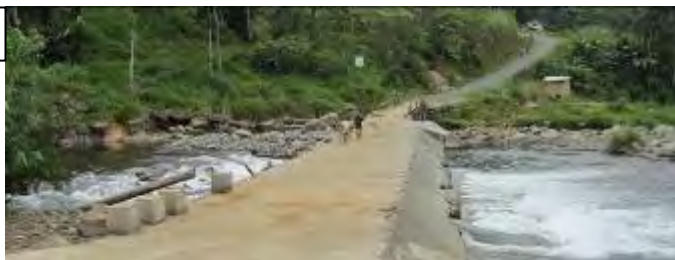
Kalasugan causeway (No Debris Flow Deposits)
