Supporting Report
Appendix D
Assessment on Existing
Flood Mitigation Facilities

PREPARATORY SURVEY
FOR
FLOOD RISK MANAGEMENT PROJECT
FOR
CAGAYAN DE ORO RIVER (FRIMP-CDOR)
IN
THE REPUBLIC OF THE PHILIPPINES

FINAL REPORT

Appendix D
ASSESSMENT ON EXISTING FLOOD MITIGATION FACILITIES

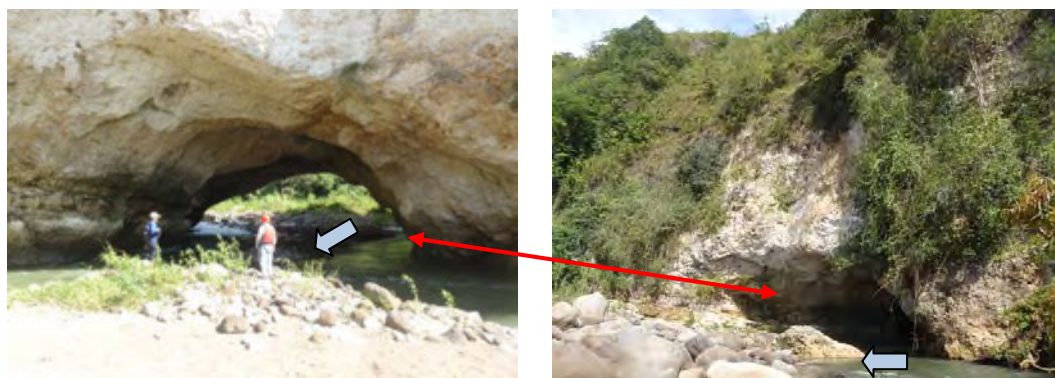
Photo 4.3.4 Tunnel Structure at the Confluence

One of the characteristics of Tumalaong River is that the structure of confluence forms tunnel shape which is 10m high and 20m wide (See Photo 4.3.4).

The geology is Limestone in the Pliocene age. The factor which forms the tunnel structure is unknown.

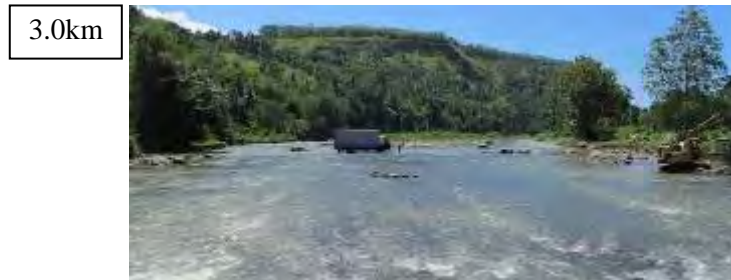
According to the condition of flood deposit in the riverbed, the deposit consists of mainly gravel and cobble. The movement form is presumed to be “bed load”.

Tumalaong Causeway (Riverbed Covered with Gravel)

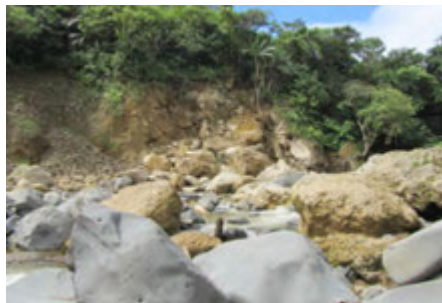
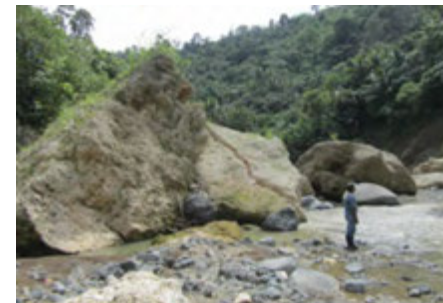
The debris flow flooded down continuously with bank erosion and slope failure.

The rainfall near this area is observed at Talakag. According to the rainfall data, the daily rainfall, which is 48.8mm, is the rainfall which is not considered to have been caused the debris flow.

Perhaps the local heavy rain is presumed to have been occurred. The debris flow is considered to be occurred in the future depending on the heavy rain.

Condition of Debris Flow

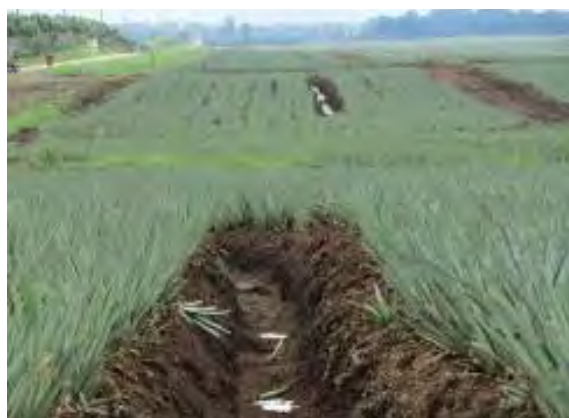
Photo 4.4.1 Pineapple Field on the Plateau

- iv) Probably the cultivated lands on the plateau are assumed to be the source area of the fine materials (See Figure 4.4.1 and Photo 4.4.1). This issue is considered to be the important sediment management issue.

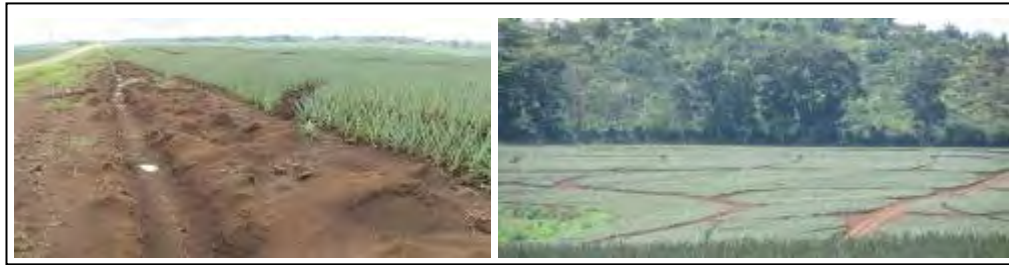
**Photo 4.6.1 The Vast Cultivated Land (Pineapple Fields of Del Monte Philippines)
Channels and Maintenance Roads are spread in a Matrix-like**

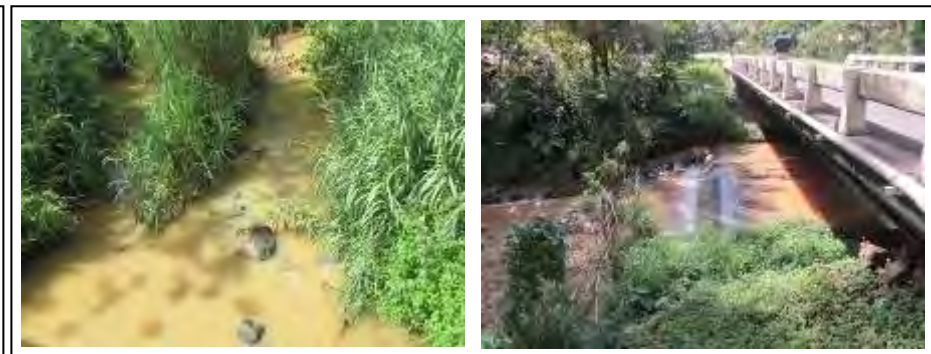
The fine materials (wash load) will be mostly deposited around the estuary, which can cause not only riverbed aggradation but also impact to the sea's ecosystem.

**Photo 4.6.5 Cloudy River water
River water in the downstream is much cloudy
due to accumulation of the fine materials.**

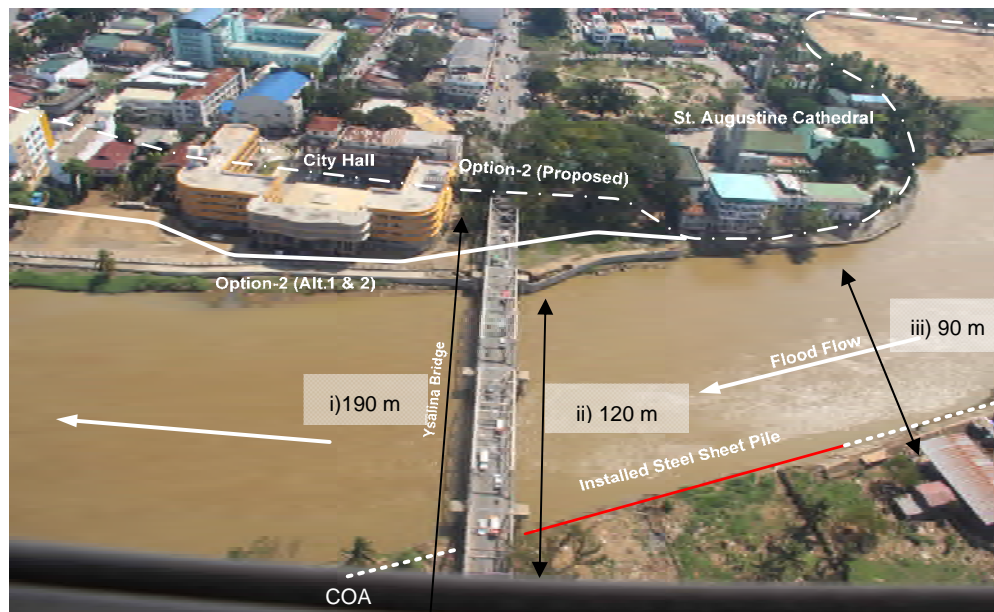
Photo 1.4.2 Present Condition of Bottleneck Section at Ysalina Bridge

- iv) At present, rehabilitation of damaged revetments by the TS Sendong is undertaking in the immediately upstream of left bank of the Ysalin Bridge. Steel sheet piles of about 100m long were already drive for foundation of the dike. If new dike will be constructed at this section the river width will be made narrower up to 90 m artificially.

The potential flood risk in the upstream is increased due to narrowing the river channel.
