Chapter 8 Summary of the Direction of Japan's Future Cooperation

8-1. Summary by Assistance Scheme

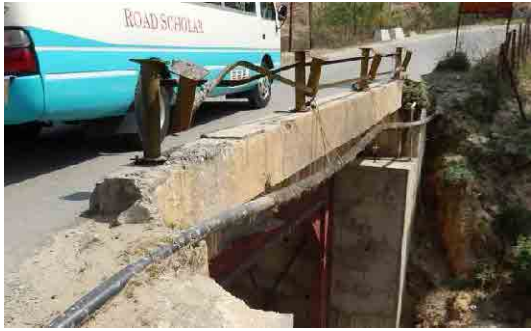
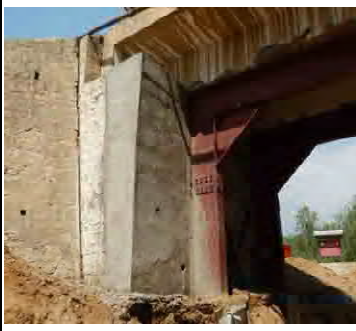
Bridge Name		A-1.Semtokha Flyover		PNH		No.1		Date	2014/4/19
Member	Railing			Member	Abutment				
Type of damage	Deformation	Damage level	c	Type of damage	Other	Damage level	-		
Condition	Damaged by vehicles			Condition	Improved

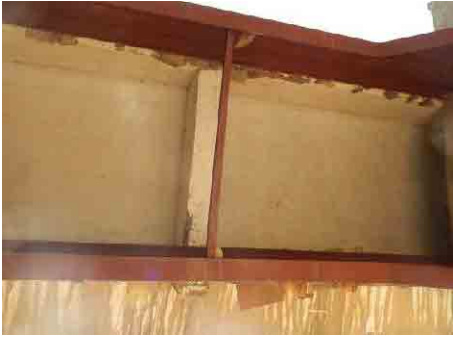
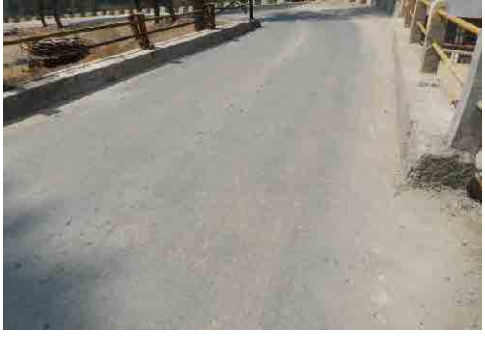
Member	Deck slab			Member	Pavement surface				
Type of damage	-	Damage level	a	Type of damage	-	Damage level	a		
Condition	soundness			Condition	soundness

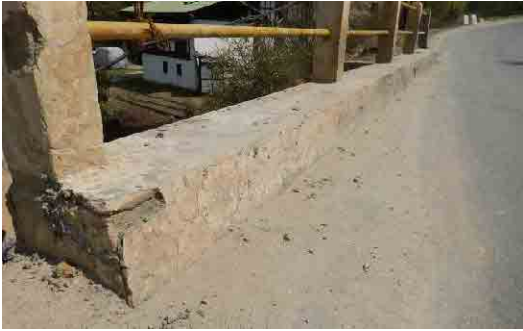
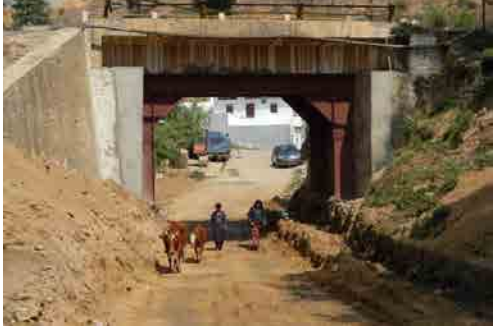
Member	Railing			Member	Entire bridge				
Type of damage	Damaged	Damage level	c	Type of damage	Other	Damage level	-		
Condition	Crack and peeling off			Condition	桁の補強及び交差道路掘削工事中である。

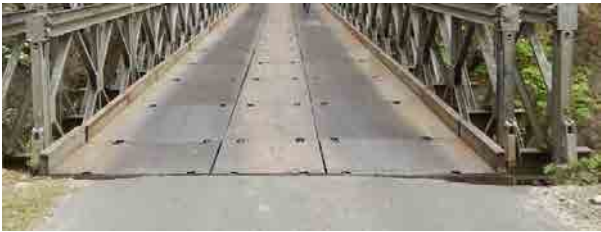
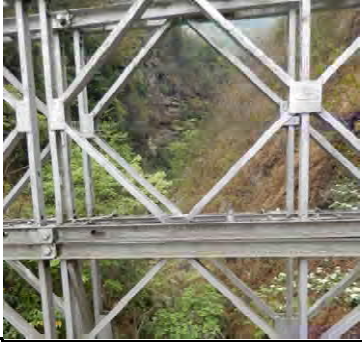
Bridge Name		A-2.Prakhadrang II		PNH	No.1	Date	2014/4/17	
Damage photo	Member	Pavement		Member	Truss			
	Type of damage	Unevenness	Damage level	e	Type of damage	-	Damage level	a
	Condition	Restriction (use former road) of heavy vehicles		Condition	Soundness

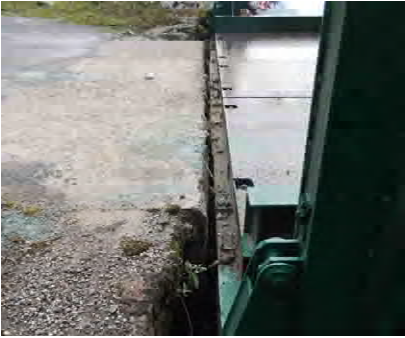
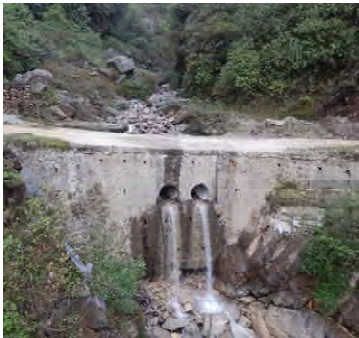
Bridge Name	A-3.Namling zam			PNH	No.1	Date	2014/4/16
Member	Pavement of approach section			Member	Upstream side of Sabo dam		
Type of damage	Unevenness	Damage level	e	Type of damage	Other	Damage level	-
Condition	Space/damage at joint section			Condition	Bailey bridge improved at existing location after past flooding

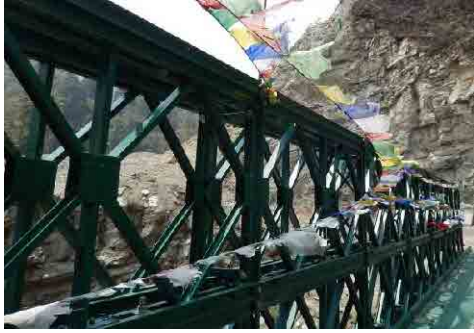
Bridge Name		A-4.Gektong zam		PNH	No.1 Nangar-Ura bypass	Date	2014/4/16	
Damage photo	Member	Surface		Member	Truss			
	Type of damage	-	Damage level	a	Type of damage	-	Damage level	a
	Condition	Soundness		Condition	Soundness

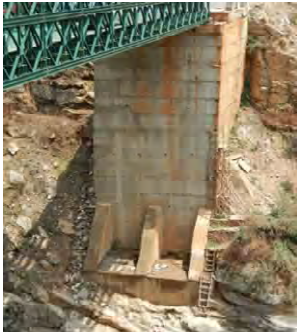
Member	Abutment		Member				
	Type of damage	-	Damage level	a	Type of damage		Damage level	
	Condition	Soundness		Condition

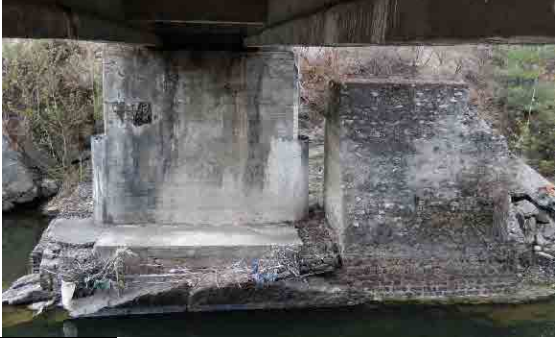
Bridge Name		A-5.Tangchu zam			PNH	No.1	Date	2014/4/17
Damage photo	Member	Railing			Member	Abutment wall		
	Type of damage	Loss of concrete	Damage level	c	Type of damage	Peeling off	Damage level	d
	Condition	Peeling off/rebar exposure			Condition	Partly rebar exposure

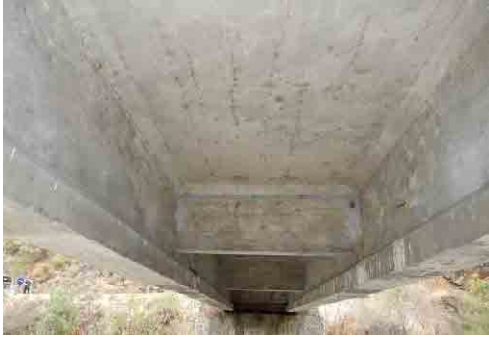
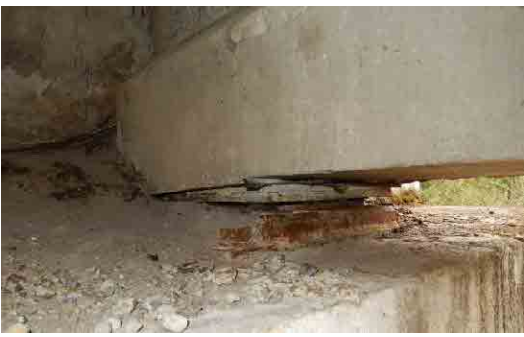
Member	Deck slab			Member	Bearing shoe		
	Type of damage	-	Damage level	a	Type of damage	Clogging	Damage level	e
	Condition	Soundness			Condition	Clogging surrounding shoe

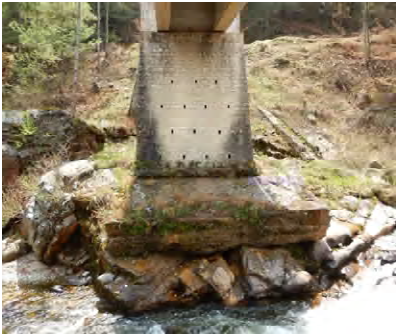
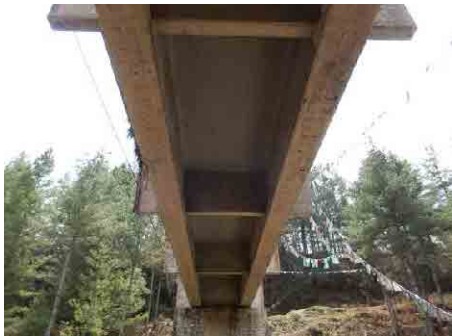
Bridge Name		A-6.Rabten Zam		PNH	No.1	Date	2014/4/16	
Damage photo	Member	Body		Member	Deck slab			
	Type of damage	-	Damage level	a	Type of damage	-	Damage level	a
	Condition	Soundness		Condition	Soundness

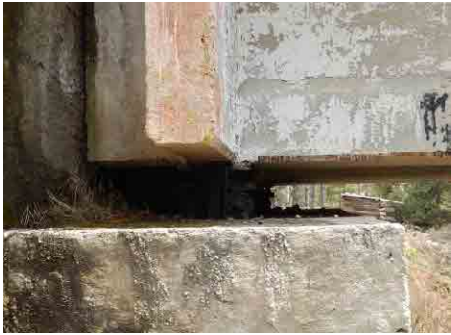
Member	Bearinmg shoe		Member	Pavement			
	Type of damage	-	Damage level	a	Type of damage	-	Damage level	a
	Condition	Soundness		Condition	Soundness

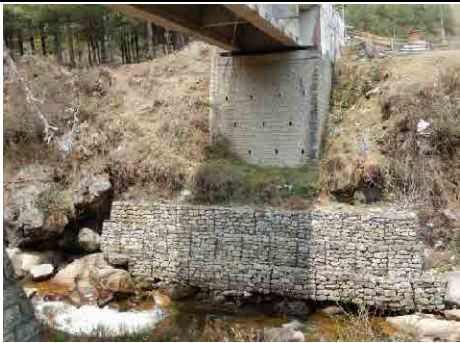
Member	Entire Bridge		Member				
	Type of damage	Scouring	Damage level	a	Type of damage		Damage level	
Condition	Scouring measurement has been carried out		Condition

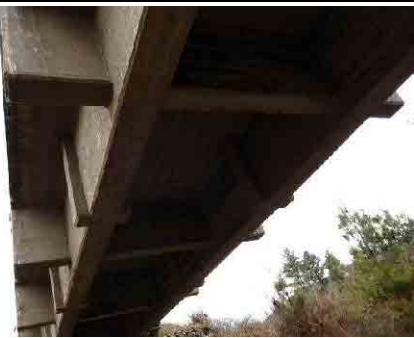
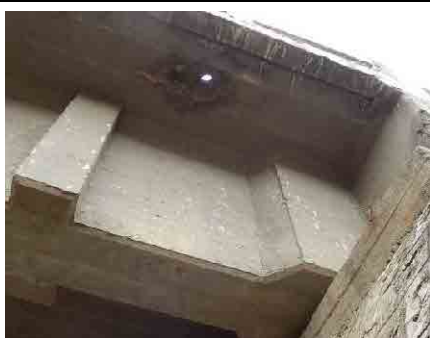
Bridge Name		A-7.Gaytsa Zam			PNH	No.1	Date	2014/4/16		
Damage photo	Member	Girder			Member	Drainage facilities				
	Type of damage	-	Damage level	a	Type of damage	-	Damage level	a		
	Condition	Soundness			Condition	Soundness

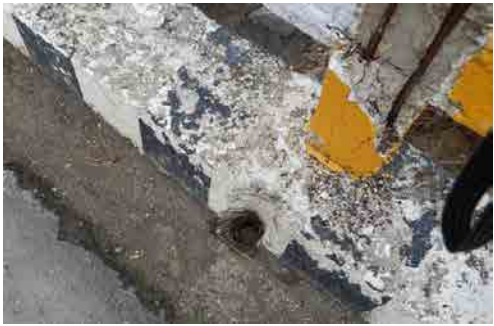
Member	Railing			Member	Expansion joint				
	Type of damage	Rebar exposure	Damage level	c	Type of damage	-	Damage level	a		
	Condition	Partly rebar exposure			Condition	Soundness

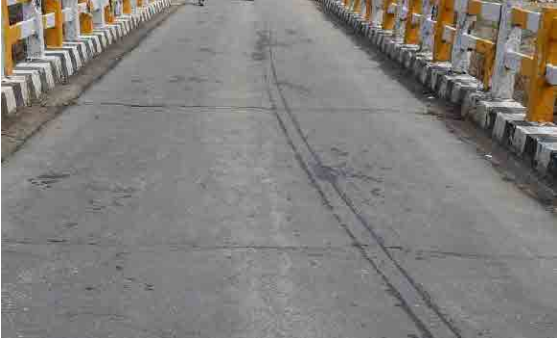
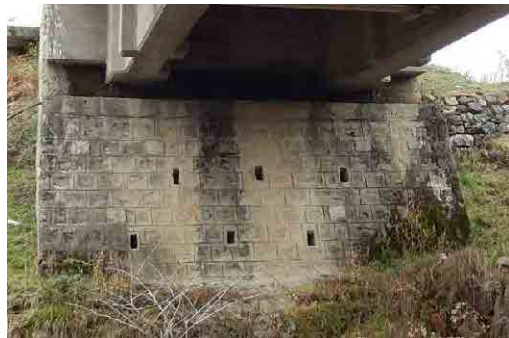
Member	Surface			Member	Body				
	Type of damage	-	Damage level	a	Type of damage	-	Damage level	a		
Condition	Soundness			Condition	Soundness

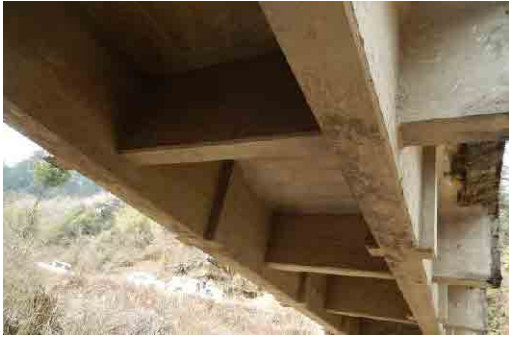
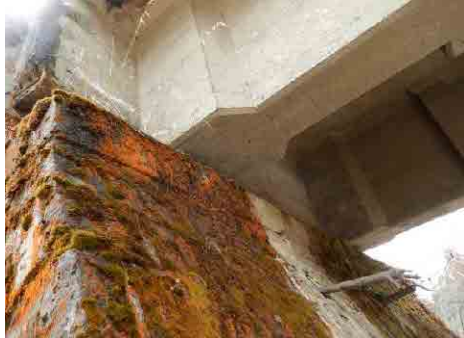
Bridge Name		A-8.Bong Zam			PNH	No.1	Date	2014/4/16
Damage photo	Member	Deck slab			Member	Girder		
	Type of damage	-	Damage level	a	Type of damage	-	Damage level	a
	Condition	Soundness			Condition	Soundness

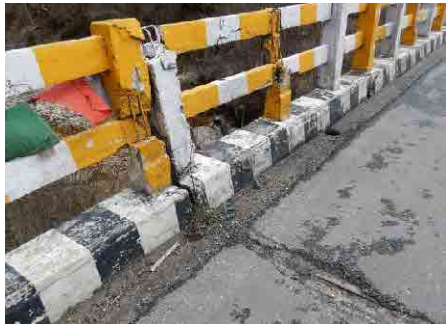
Member	Railing			Member	Abutment		
	Type of damage	Rebar exposure	Damage level	c	Type of damage	Water leakage	Damage level	c
Condition	Partly rebar exposure			Condition	Water leakage but almost soundness

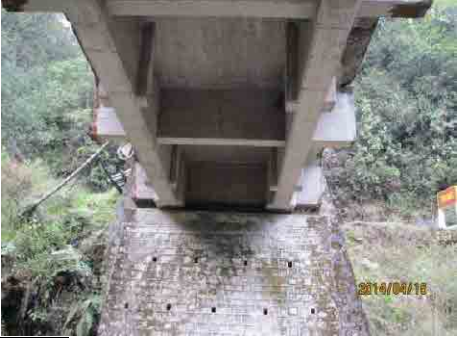
Bridge Name		A-9.Nangni zam			PNH	No.1	Date	2014/4/15
Damage photo	Member	Deck slab/girder			Member	Bearing shoe/mortar		
	Type of damage	-	Damage level	a	Type of damage	Dysfunction	Damage level	e
	Condition	Soundness			Condition	Dysfunction after water leakage

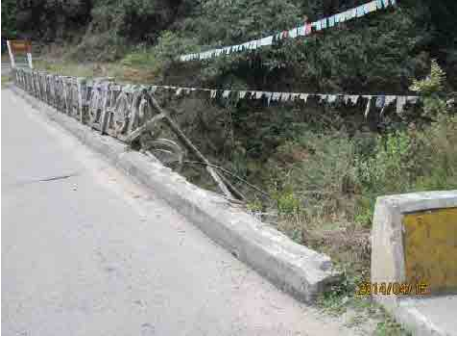
Member	Railing			Member	Drainage facilities		
	Type of damage	Deformation	Damage level	e	Type of damage	Water leakage	Damage level	e
	Condition	-			Condition	Splash to the girder due to no drain pipe

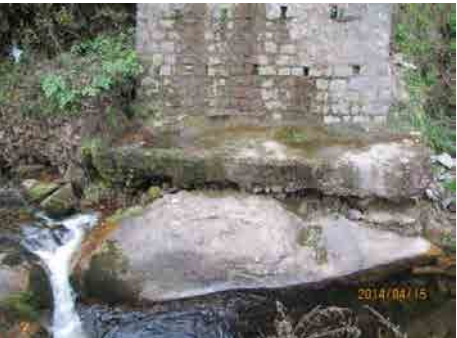
Member	Foundation			Member			
	Type of damage	Scouring	Damage level	e	Type of damage		Damage level	
Condition	Collapse of sounding foundation			Condition

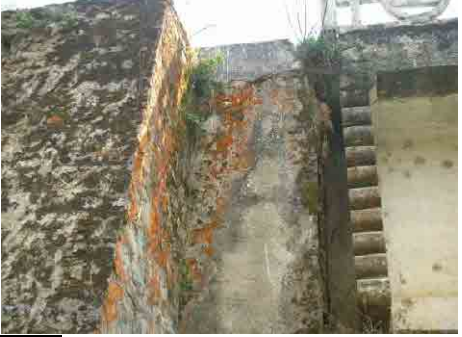
Member	Parapet wall			Member	Bearing shoe				
	Type of damage	Crack	Damage level	d	Type of damage	-	Damage level	-		
	Condition	Large crack width			Condition	Different elevation of opposite side

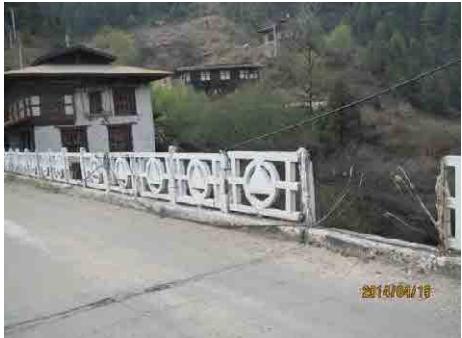
Member	Railing			Member	Pavement/Expansion joint				
	Type of damage	Deformation	Damage level	e	Type of damage	Unevenness	Damage level	c		
	Condition	-			Condition	-

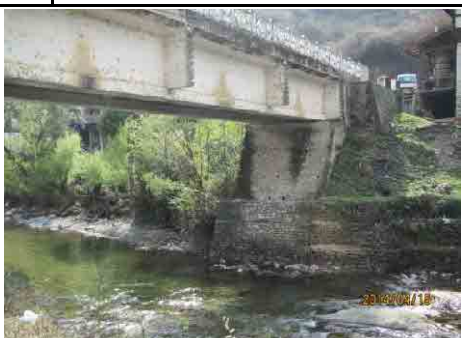
Member	Drainage facilities			Member					
	Type of damage	Water leakage	Damage level	e	Type of damage		Damage level			
	Condition	Splash to the girder due to no drain pipe			Condition

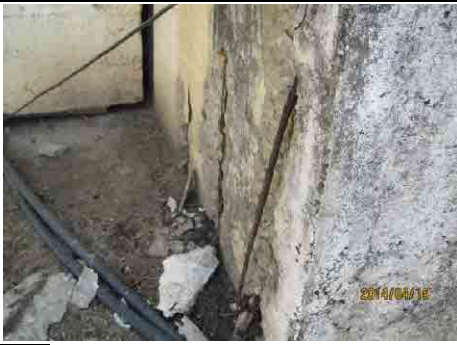
Bridge Name		A-11.Chuzomsa zam		PNH	No.1	Date	2014/4/15	
Damage photo	Member	Deck slab/girder			Member	Body wall		
	Type of damage	-	Damage level	a	Type of damage	Peeling off/exposure	Damage level	d
	Condition	Soundness			Condition	Parapet wall of Trongsa side

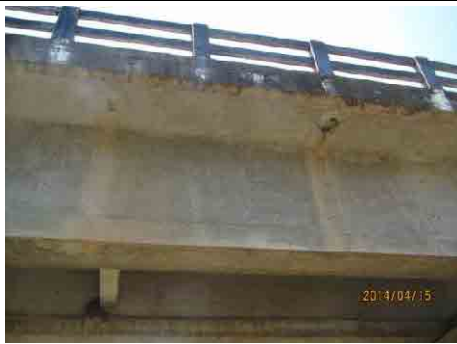
Member	Pavement/ Expansion joint			Member	Drainage facilities		
	Type of damage	Unevenness	Damage level	c	Type of damage	Water leakage	Damage level	e
	Condition	-			Condition	Splash to the girder due to no drain pipe

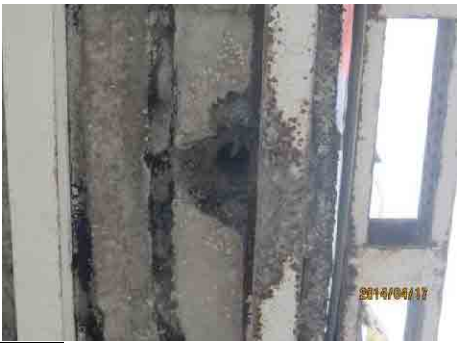
Bridge Name	B-1.Passang zam			PNH	No.4	Date	2014/4/17
Member	Deck slab			Member	Deck slab		
Type of damage	Peeling off	Damage level	c	Type of damage	Crack	Damage level	b
Condition	Cause by water leakage from drain			Condition	Necessity of detailed design

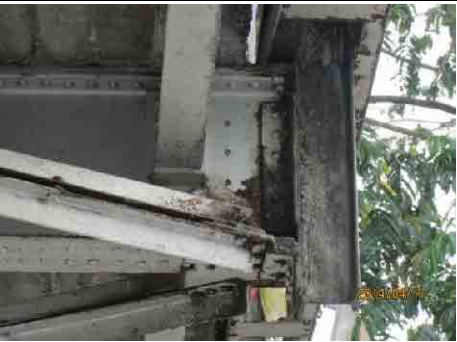
Member	Main girder (steel)			Member	Abutment		
Type of damage		Damage level	c	Type of damage	Deformation	Damage level	e
Condition	Necessity of detailed design			Condition	Spalling

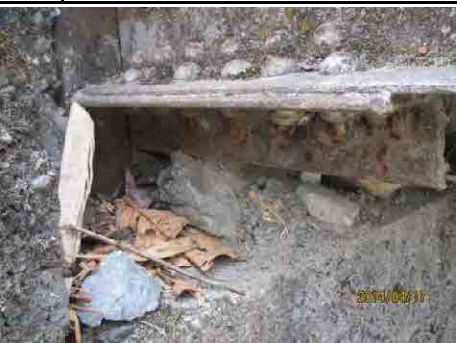
Member	Bearing shoe			Member	Pavement		
Type of damage	Clogging soil	Damage level	e	Type of damage	Deformation	Damage level	e
Condition	Soil surrounding shoe			Condition	Crack on cold joint

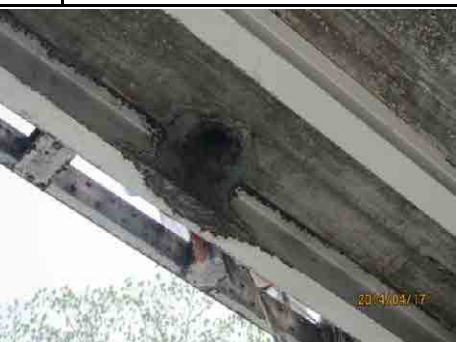
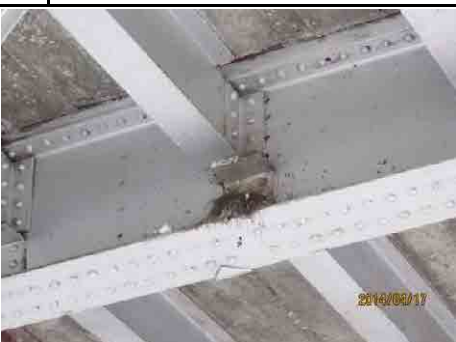
Member	Drainage facilities			Member	Entire bridge		
Type of damage	Peeling off	Damage level	e	Type of damage	Other	Damage level	
Condition	Splash to the girder due to no drain pipe			Condition	Bird nest

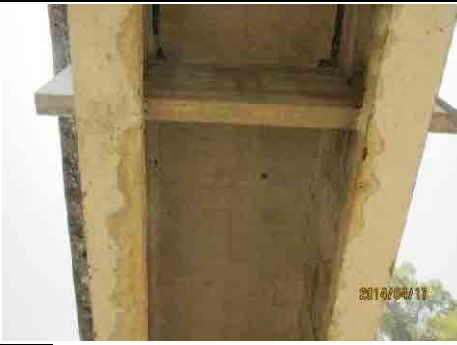
Bridge Name		B-2.Beteni zam			PNH	No.4	Date	2014/4/17
Damage photo	Member	Deck slab			Member	Abutment		
	Type of damage	-	Damage level	a	Type of damage	Crack	Damage level	d
	Condition	Soundness			Condition	Crack on cold joint

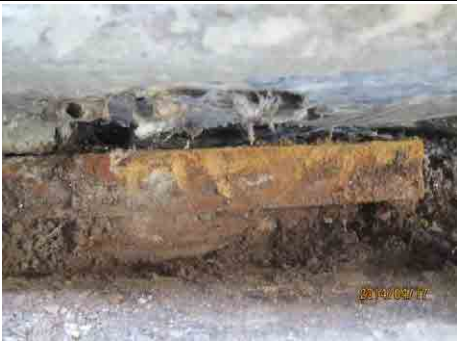
Member	Bearing shoe			Member	Pavement		
	Type of damage	Soil surrounding shoe	Damage level	e	Type of damage	Unevenness	Damage level	e
	Condition	Soil surrounding shoe			Condition	Dents on surface

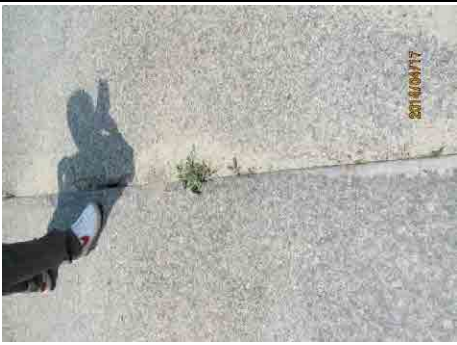
Member	Expansion joint			Member			
	Type of damage	Abnormal of joint	Damage level	e	Type of damage		Damage level	
	Condition	No space			Condition

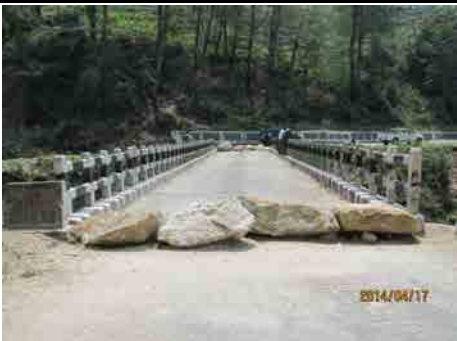
Member	Entire bridge			Member			
	Type of damage	-	Damage level		Type of damage		Damage level	
	Condition	Unused			Condition

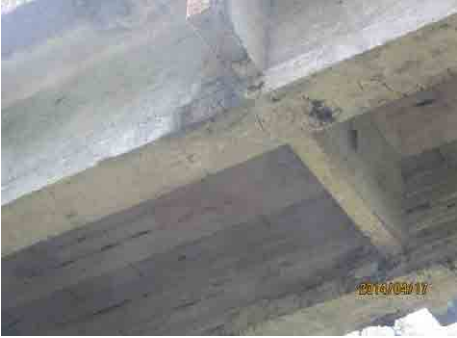
Bridge Name		B-3.Katley III			PNH	No.4	Date	2014/4/17
Damage photo	Member	Deck slab			Member	Abutment		
	Type of damage	-	Damage level	a	Type of damage	-	Damage level	e
	Condition	Soundness			Condition	Large space of joint (necessity of detailed survey)

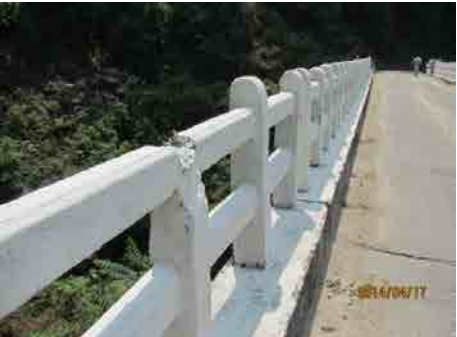
Member	Railing			Member	Expansion joint		
	Type of damage	Deformation	Damage level	c	Type of damage	Deformation	Damage level	c
	Condition	-			Condition	-

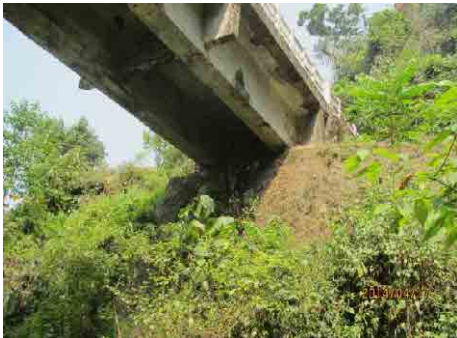
Member	Drainage facilities			Member			
	Type of damage	Water leakage	Damage level	e	Type of damage		Damage level	
Condition	Splash to the girder due to no drain pipe			Condition

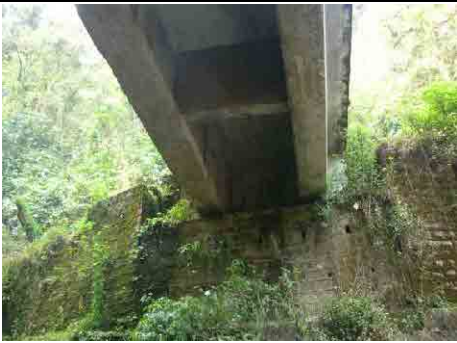
Bridge Name	B-4.Chaplekhola			PNH	No.4	Date	2014/4/16
Member	Undersurface of deck slab			Member	Uppersurface of deck slab		
Type of damage	-	Damage level	a	Type of damage	Crack	Damage level	c
Condition	Soundness			Condition	Necessity of detailed survey

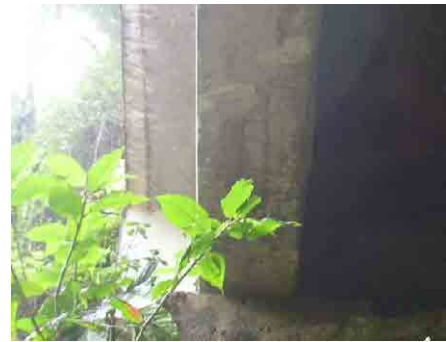
Member	Girder			Member	Lateral		
Type of damage	Peeling off	Damage level	d	Type of damage	Crack	Damage level	-
Condition	Peeling off/rebar exposur			Condition	Damage on latral member

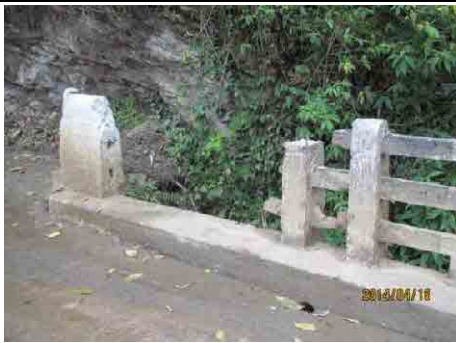
Member	Bering shoe			Member	railing		
Type of damage	Dysfunction	Damage level	e	Type of damage	Deformation	Damage level	e
Condition	Corrosion			Condition	-

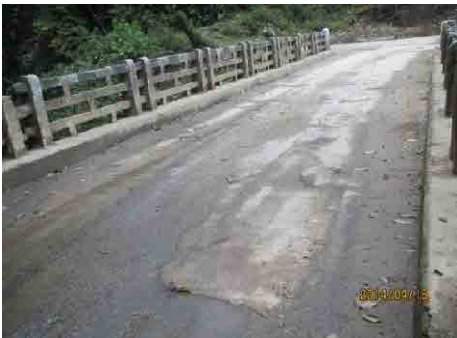
Member	Pavement			Member	Drainage facilities		
Type of damage	Unevenness	Damage level	c	Type of damage	Clogging soil	Damage level	e
Condition	-			Condition	-

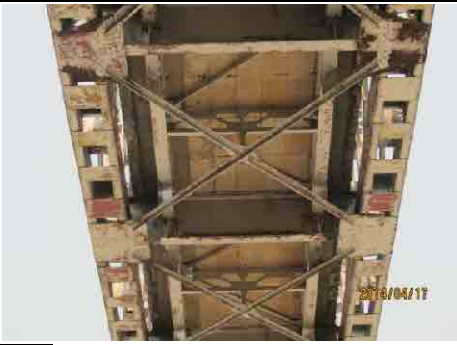
Bridge Name		B-5.Geleg(Aie) zam		PNH	No.4	Date	2014/4/17	
Damage photo	Member	Deck slab		Member	Main girder			
	Type of damage	-	Damage level	a	Type of damage	Deterioration of protection against corrosion	Damage level	e
	Condition	Soundness		Condition	Entirely peeling of paint on main girder

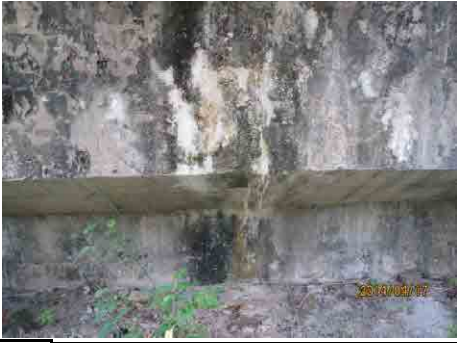
Member	Abutment		Member	Bearing shoe			
	Type of damage	Crack/free lime	Damage level	e	Type of damage	Deformation	Damage level	e
	Condition	Free lime on abutment wall		Condition	Deformation/moss

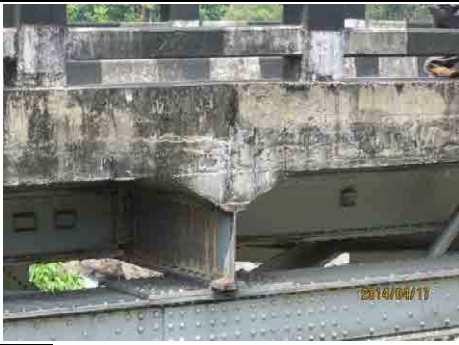
Bridge Name		B-6.Samkhara zam			PNH	No.4	Date	2014/4/17		
Damage photo	Member	Side of deck slab			Member	Undersurface of deck slab				
	Type of damage	Free lime	Damage level	d	Type of damage	Crack	Damage level	d		
	Condition	Free lime has occurred			Condition	Thin cover

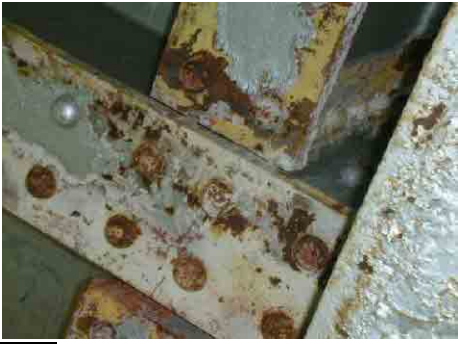
Member	Main girder			Member	Bearing shoe				
	Type of damage	Deterioration of protection against corrosion	Damage level	e	Type of damage	clogging soil	Damage level	e		
	Condition	Peeling of paint			Condition	-

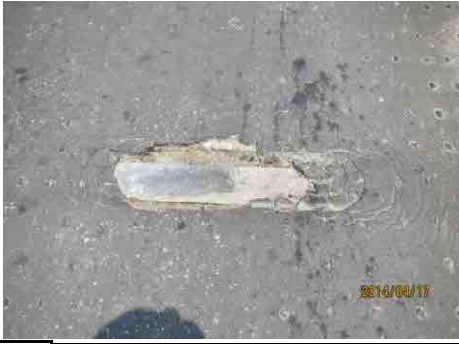
Member	Pavement			Member					
	Type of damage	Unevenness	Damage level	e	Type of damage		Damage level			
	Condition	-			Condition

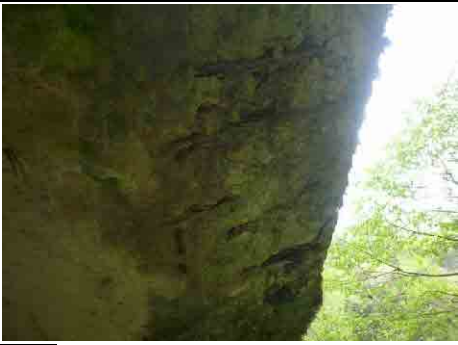
Bridge Name		B-7.Telegangchu zam			PNH	No.4	Date	2014/4/16
Damage photo	Member	Deck slab			Member	Main girder		
	Type of damage	Repar exposure	Damage level	e	Type of damage	Repar exposure	Damage level	d
	Condition	Peeling off/rebar exposure at edge of deck slab			Condition	Caused by poor constructio

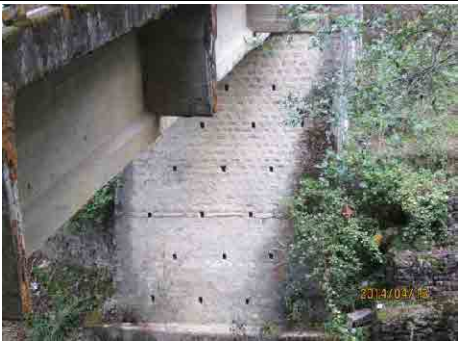
Member	Abutmnt			Member	Bearing shoe		
	Type of damage	-	Damage level	a	Type of damage	Dysfunction	Damage level	e
	Condition	Soundness			Condition	Dysfunction after water leakage

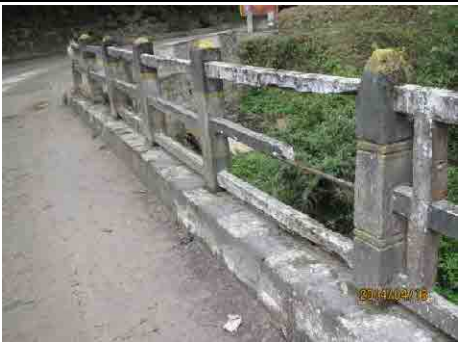
Member	Railing			Member	Pavement/Expansion joint		
	Type of damage	Deformation	Damage level	c	Type of damage	Unevenness	Damage level	c
Condition	-			Condition	Unevenness on pavement surface

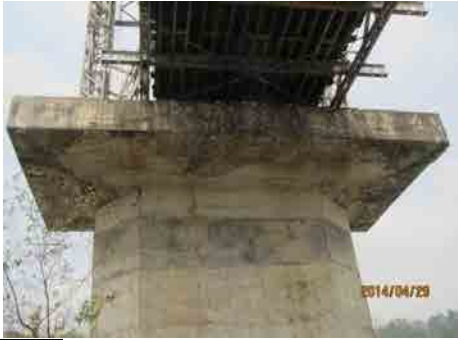
Bridge Name	C-1.Diana Kuephen zam			PNH	Samtse-Sipsu	Date	2014/4/29
Member	Deck slab/main girder			Member	Substructure (Main tower)		
Type of damage	-	Damage level	-	Type of damage	Crack	Damage level	c
Condition	Soundness			Condition	Crack on undersurface of over hung part

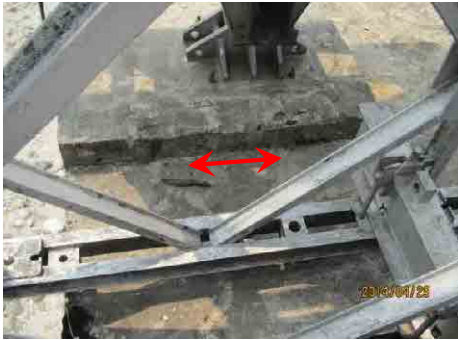
Member	Substructure (upper surface of tower)			Member	Substructure (Anchorage)		
Type of damage	Crack	Damage level	c	Type of damage	Crack	Damage level	c
Condition	Crack such as arrow direction			Condition	Crack on the circle mark

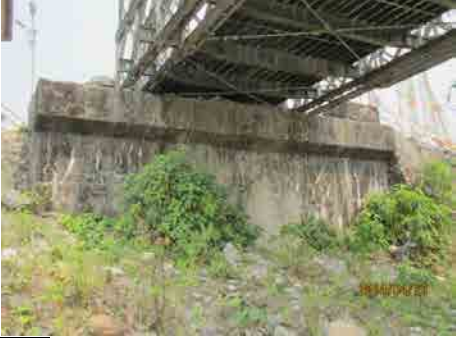
Bridge Name		C-2.Dramzang zam		PNH	Samtse-Sipsu	Date	2014/4/29	
Damage photo	Member	Deck slab/main girder		Member	Abutment			
	Type of damage	-	Damage level	-	Type of damage	Crack/free lime	Damage level	d
	Condition	Soundness		Condition	-

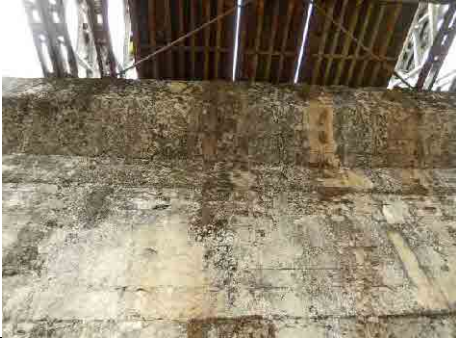
Bridge Name		C-3.Jitti zam		PNH	Samtse-Sipsu	Date	2014/4/29	
Damage photo	Member	Main girder			Member	Abutment		
	Type of damage	-	Damage level	a	Type of damage	Peeling off	Damage level	c
	Condition	Soundness			Condition	Peeling off on the surface

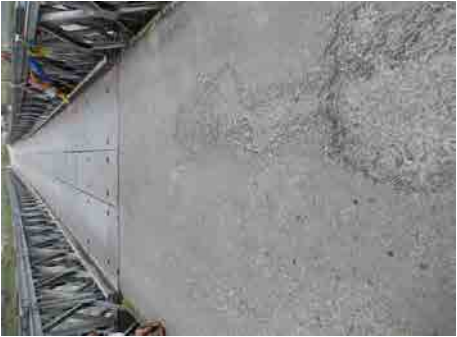
Member	Pavement			Member	Carrageway Surface		
	Type of damage	Unevenness	Damage level	c	Type of damage	-	Damage level	a
	Condition	Unevenness at road side			Condition	Soundness

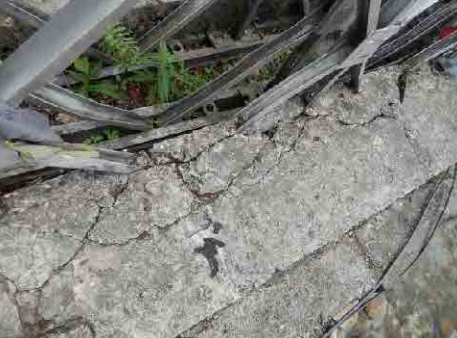
Member	Railing			Member	Pier column		
	Type of damage	Crack	Damage level	c	Type of damage	Crack	Damage level	c
	Condition	Partly crack			Condition	Crack/peeling off on the surface

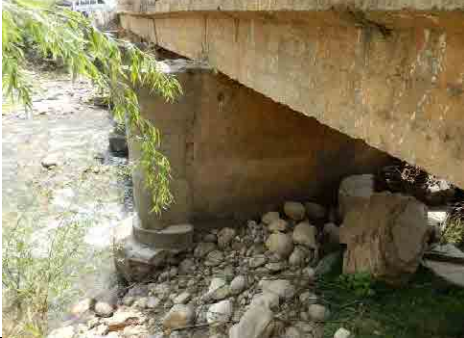
Bridge Name		E-1.Dopshari zam			PNH	Paro pref.	Date	2014/4/19
Damage photo	Member	Abutment			Member	Pier		
	Type of damage	-	Damage level	a	Type of damage	Damage	Damage level	
	Condition	Soundness			Condition	Damaged by debris flow

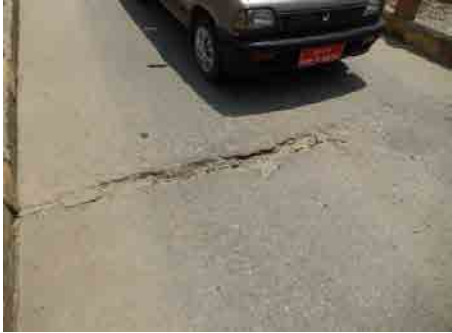
Member	Joint			Member	Deck slab/girder		
	Type of damage	Unevenness	Damage level	e	Type of damage	-	Damage level	a
	Condition	Different elevation on road surface			Condition	Soundness

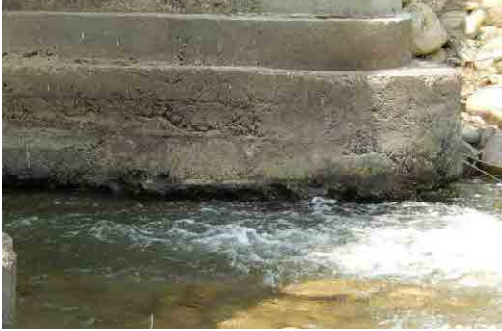
Member	Pier			Member	Railing		
	Type of damage	Scouring	Damage level	c	Type of damage	Rebar exposure	Damage level	c
Condition	Scouring			Condition	Partly rebar exposure

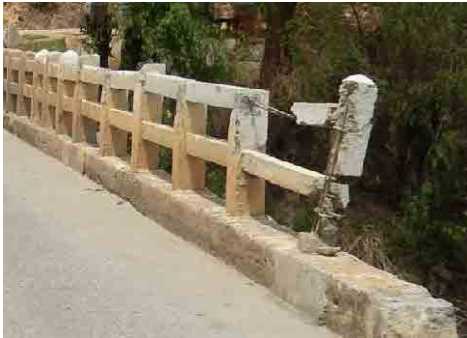
Member	Guardrail			Member	Drainage facilities			
Type of damage	Damage	Damage level	c	Type of damage	-	Damage level	a	
Condition	Partly damaged			Condition	Soundness
