APPENDICIES

APPENDIX 2-1

Number of Freight Train of Myanmar Railways

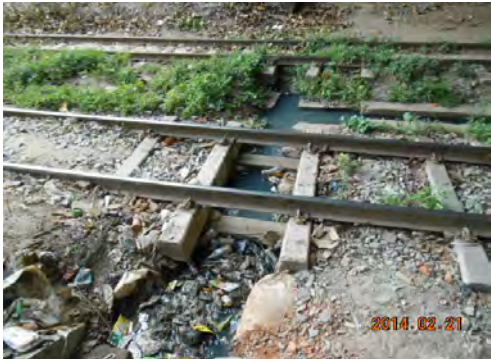
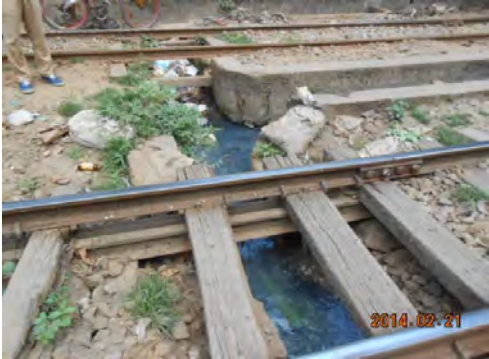
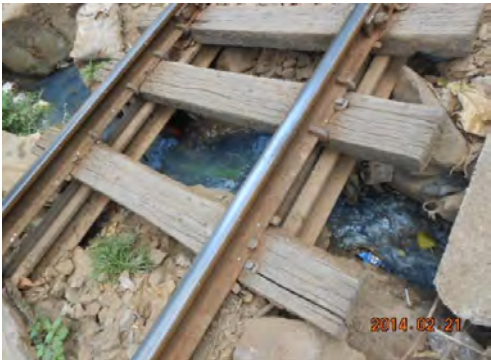
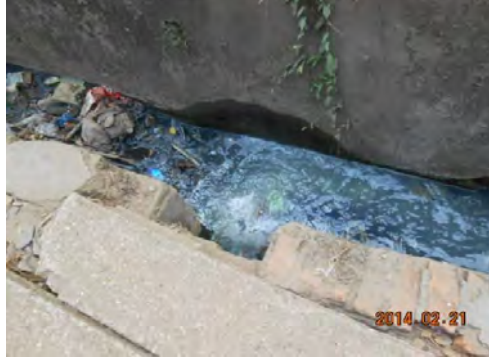
DATA SHEET for SIDE DRAINAGE

Side Drainage No. : Side Drainage Name :		
Identification No.:		Survey Date: 2014/2/21
Between Hanthawaddy station and Hletan station		
Mile Post (distance from Yanngon RS.)	MR's official data	Measured by YUTRA※
clockwise:	-	
anti-clockwise(if any):		
equivalent KM Post (distance from Yangon RS.)		
clockwise:	-	7.06
anti-clockwise(if any):		
Type of Bridge : Steel I girder	Year of Built :	
Bridge Length : 1 Span @ 0.67 m = 0.67 m	Skew :degree	
Bridge Width : 1.25 m		
Bridge Conditions: Extent and Degree: (A: Sound condition, B: Need Major Repair, C: Serious condition)		
<u>Superstructure:</u> _____		
<u>Abutment/Pier:</u> _____		
<u>Shoe:</u> _____		
Utility line <u>None</u> / Electric / Water / Gas / Telecommunication / Optical fiber / Others(.....)		
Photos (General view, Side view(Left and Right), Defects, Damages, etc..)

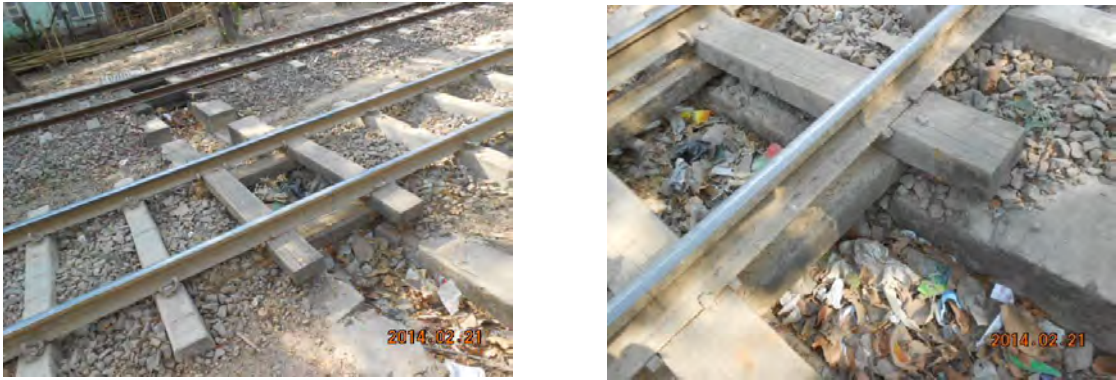
DATA SHEET for SIDE DRAINAGE

Side Drainage No. : Side Drainage Name :		
Identification No.:		Survey Date: 2014/2/21
Between Hanthawaddy station and Hletan station		
Mile Post (distance from Yanngon RS.)	MR's official data	Measured by YUTRA※
clockwise:	-	
anti-clockwise(if any):		
equivalent KM Post (distance from Yangon RS.)		
clockwise:	-	7.50
anti-clockwise(if any):		
Type of Bridge : Steel I girder	Year of Built :	
Bridge Length : 1 Span @ 0.56 m = 0.56 m	Skew :degree	
Bridge Width : 1.25 m		
Bridge Conditions: Extent and Degree: (A: Sound condition, B: Need Major Repair, C: Serious condition)		
<u>Superstructure:</u> C		
<u>Abutment/Pier:</u> B		
<u>Shoe:</u>		
Utility line <u>None</u> / Electric / Water / Gas / Telecommunication / Optical fiber / Others(.....		
Photos (General view, Side view(Left and Right), Defects, Damages, etc..)

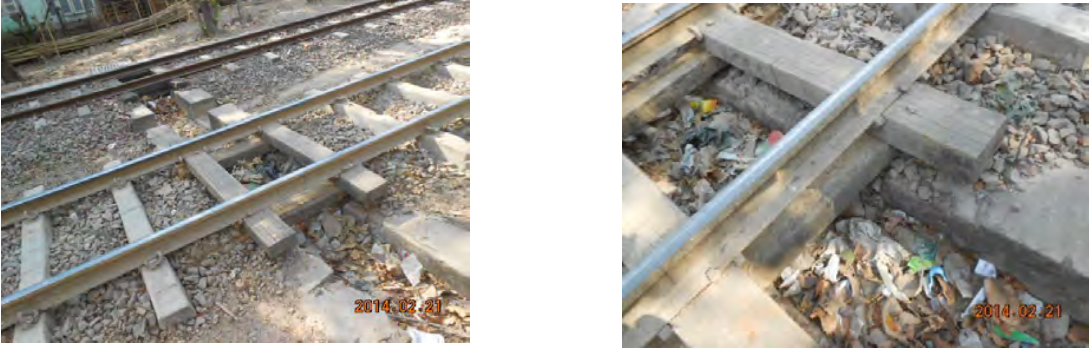
DATA SHEET for SIDE DRAINAGE

Side Drainage No. : Side Drainage Name :		
Identification No.:		Survey Date: 2014/2/21
Between	Hletan	station and
Kamauyut	station	
Mile Post (distance from Yanngon RS.)	MR's official data	Measured by YUTRA※
clockwise:	-	
anti-clockwise(if any):		
equivalent KM Post (distance from Yangon RS.)		
clockwise:	-	8.57
anti-clockwise(if any):		
Type of Bridge : Steel I girder	Year of Built :	
Bridge Length : 1 Span @ 0.52 m = 0.52 m	Skew :degree	
Bridge Width : 1.25 m		
Bridge Conditions: Extent and Degree: (A: Sound condition, B: Need Major Repair, C: Serious condition)		
<u>Superstructure: C</u>		
<u>Abutment/Pier: A</u>		
<u>Shoe:</u>		
Utility line <u>None</u> / Electric / Water / Gas / Telecommunication / Optical fiber / Others(.....)		
Photos (General view, Side view(Left and Right), Defects, Damages, etc..)

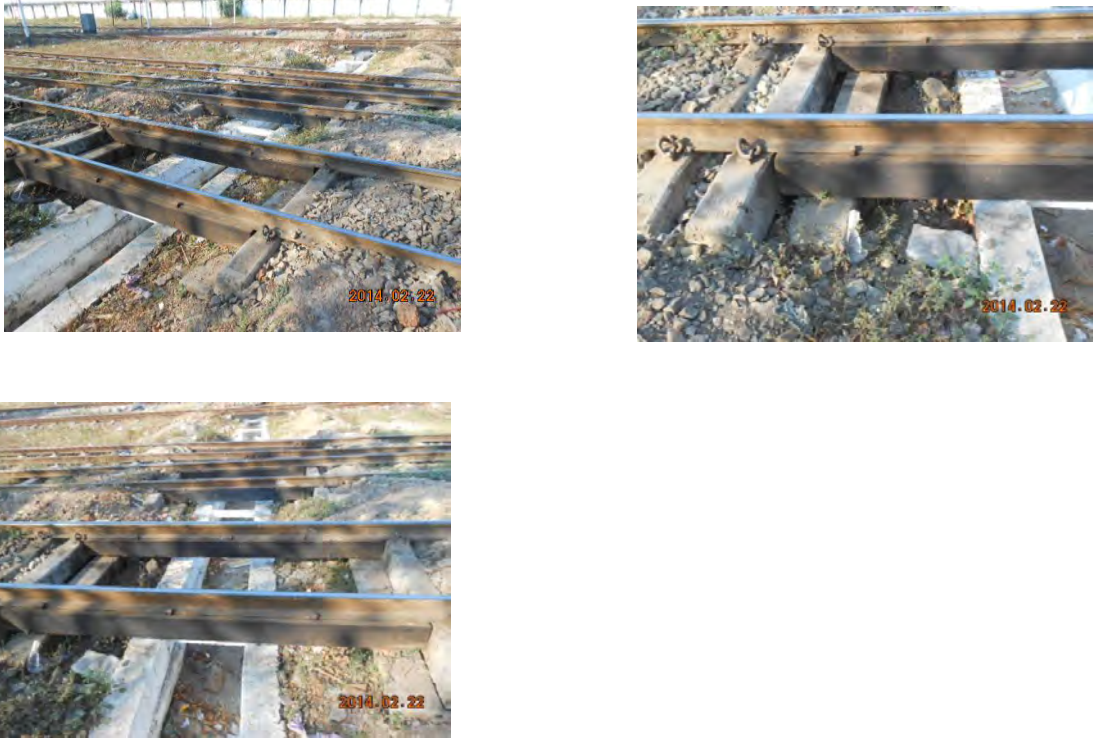
DATA SHEET for SIDE DRAINAGE

Side Drainage No. : Side Drainage Name :		
Identification No.:		Survey Date: 2014/2/21
Between	Kyuntkon	station and
		Insein station
Mile Post (distance from Yanngon RS.)	MR's official data	Measured by YUTRA※
clockwise:	-	
anti-clockwise(if any):		
equivalent KM Post (distance from Yangon RS.)		
clockwise:	-	14.39
anti-clockwise(if any):		
Type of Bridge :	Steel I girder	Year of Built :
Bridge Length :	1 Span @ 0.53 m = 0.53 m	Skew :degree
Bridge Width :	1.25 m	
Bridge Conditions: Extent and Degree: (A: Sound condition, B: Need Major Repair, C: Serious condition)		
Superstructure: C		
Abutment/Pier: C		
Shoe:		
Utility line (None) / Electric / Water / Gas / Telecommunication / Optical fiber / Others(.....)		
Photos (General view, Side view(Left and Right), Defects, Damages, etc..)

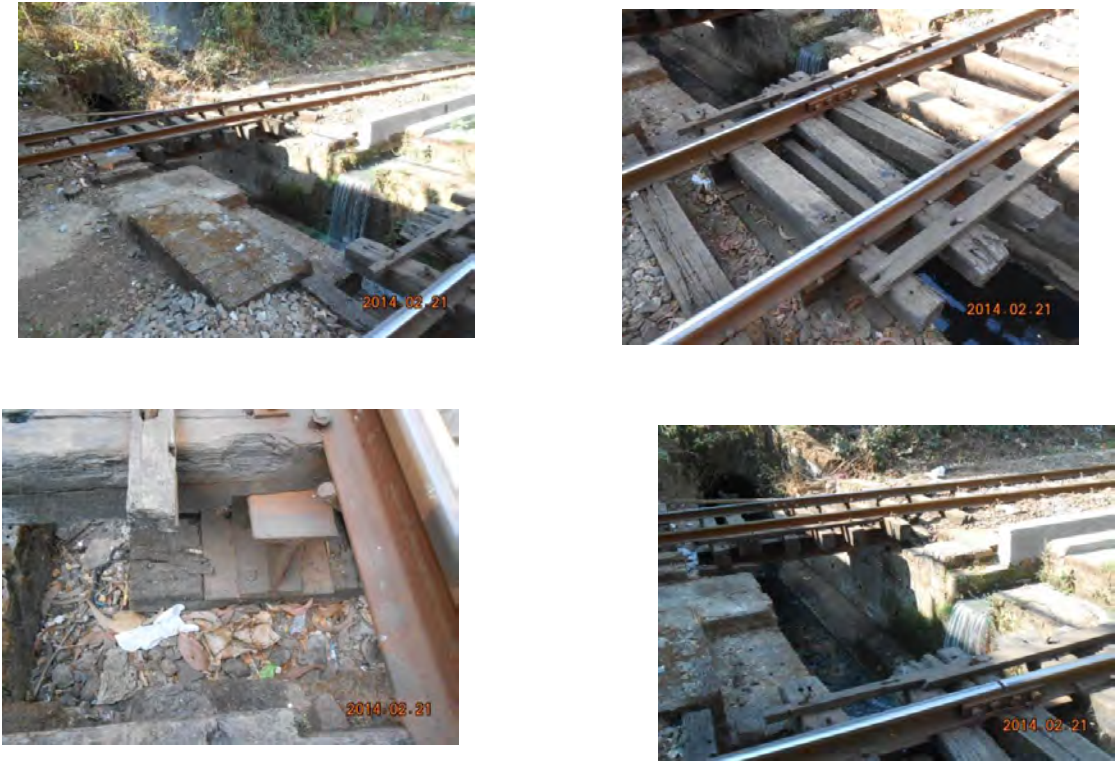
DATA SHEET for BRIDGE

Bridge No. : B01		Bridge Name : 6		(<u>Bridge</u>) or Culvert	
Identification No.: C6				Survey Date: 2014/2/21	
Between Lanmataw station and		Pyay Rd. station			
Mile Post (distance from Yanngon RS.)		MR's official data		Measured by YUTRA※	
clockwise:		1/1-1/2			
anti-clockwise(if any):					
equivalent KM Post (distance from Yangon RS.)					
clockwise:		1.71		1.55	
anti-clockwise(if any):					
Type of Bridge : Steel I girder		Year of Built :			
Bridge Length : 1 Span @ 2.73 m = 2.73 m		Skew :degree			
Bridge Width : 1.3 m					
Bridge Conditions: Extent and Degree: (A: Sound condition, B: Need Major Repair, C: Serious condition)					
Superstructure: C partially no rivet					
Abutment/Pier: A					
Shoe: C Adjust height by wood					
Utility line (<u>None</u>) / Electric / Water / Gas / Telecommunication / Optical fiber / Others(.....)					
Photos (General view, Side view(Left and Right), Defects, Damages, etc..)

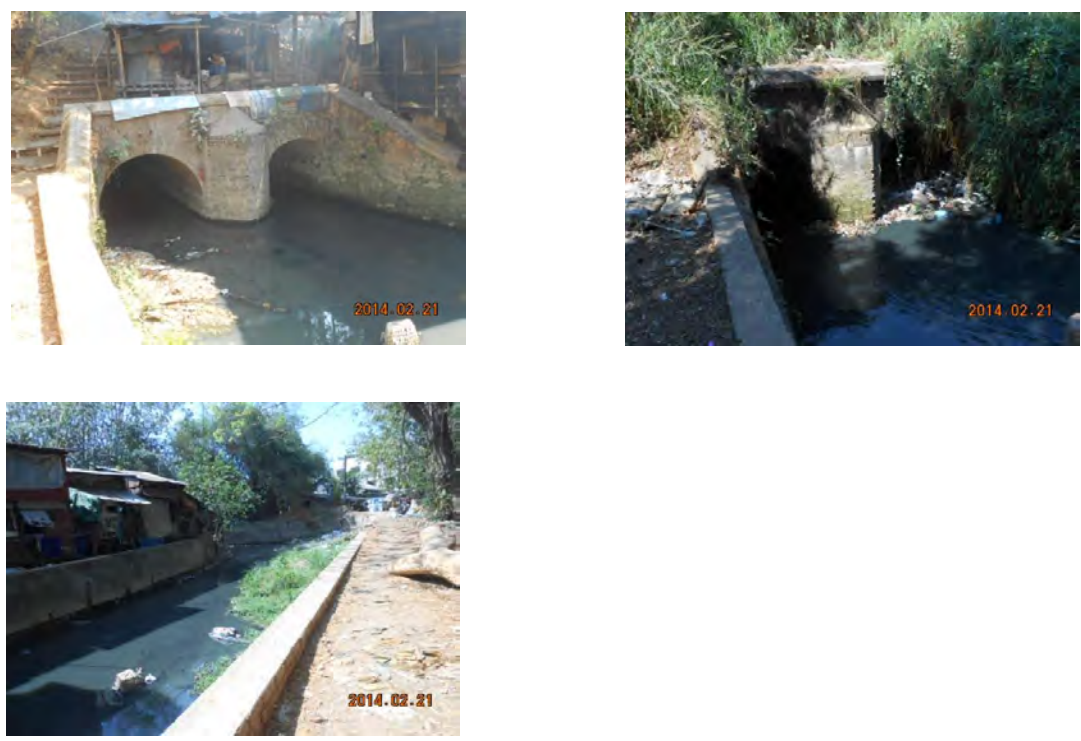
DATA SHEET for BRIDGE

Bridge No. :	B02	Bridge Name :	-	Bridge or Culvert
Identification No.:	C11	Survey Date:	2014/2/21	
Between		station	and	station
Mile Post (distance from Yanngon RS.)		MR's official data	Measured by YUTRA※	
clockwise:		-		
anti-clockwise(if any):				
equivalent KM Post (distance from Yangon RS.)				
clockwise:		-	4.25	
anti-clockwise(if any):				
Type of Culvert :	Box / Pipe / Other (.....)		Year of Built :	
Number of Cell :		Skew :degree	
Size of Culvert :	Inner : 2.4m xm			
Inlet / Outlet size:	width(m):	7	thickness (m):	0.6
Length :	from inlet to outlet m			
Culvert Conditions: Extent and Degree: (A: Sound condition, B: Need Major Repair, C: Serious condition)				
Inlet/Outlet: _____				
Pipe/Box: _____				
Photos (General view, Side view(Left and Right), Defects, Damages, etc..)

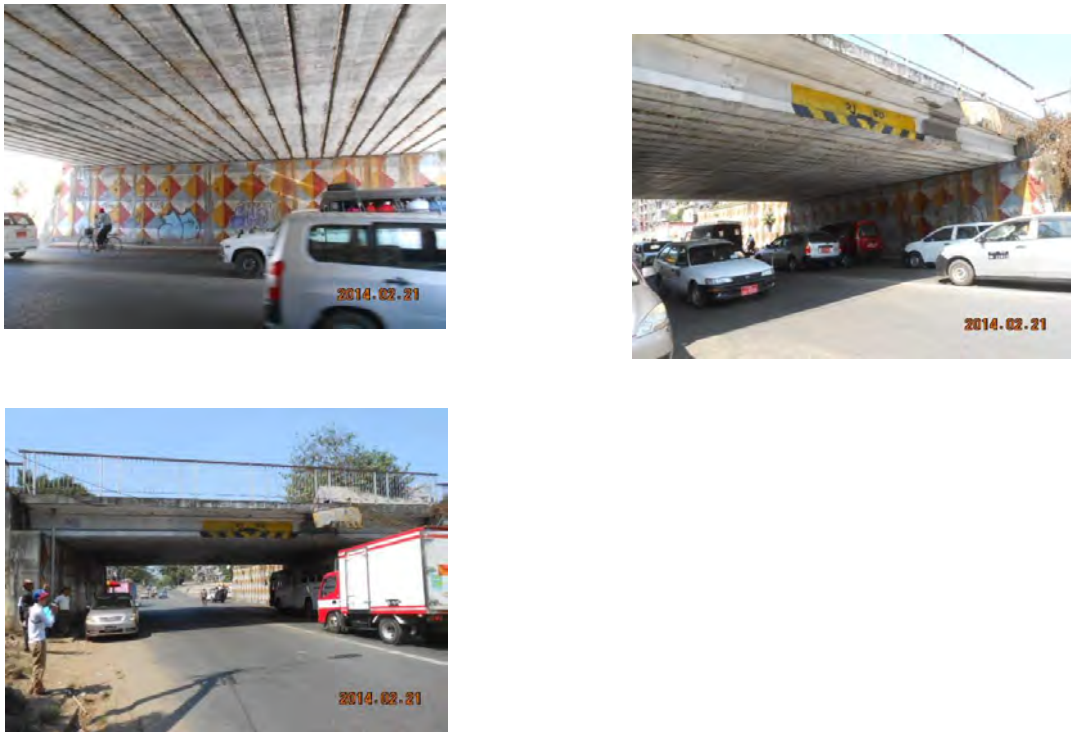
DATA SHEET for BRIDGE

Bridge No. :	B03	Bridge Name :	-	(Bridge) or Culvert
Identification No.:	C13	Survey Date:	2014/2/21	
Between PanhlaingRd. station and Kyeemyndaing station				
Mile Post (distance from Yanngon RS.)	MR's official data		Measured by YUTRA※	
clockwise:	-			
anti-clockwise(if any):				
equivalent KM Post (distance from Yangon RS.)				
clockwise:	-		5.25	
anti-clockwise(if any):				
Type of Bridge :	RC I girder	Year of Built :	
Bridge Length :	1 Span @ 16.8 m =	16.8 m	Skew :degree
Bridge Width :	17.12 m			
Bridge Conditions: Extent and Degree: (A: Sound condition, B: Need Major Repair, C: Serious condition)				
Superstructure:	A	<u>peel off the paint</u>		
Abutment/Pier:	A			
Shoe:	C	<u>None</u>		
Utility line (None) Electric / Water / Gas / Telecommunication / Optical fiber / Others(.....)				
Photos (General view, Side view(Left and Right), Defects, Damages, etc..)

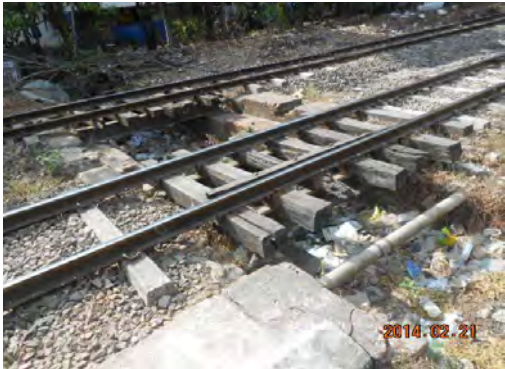
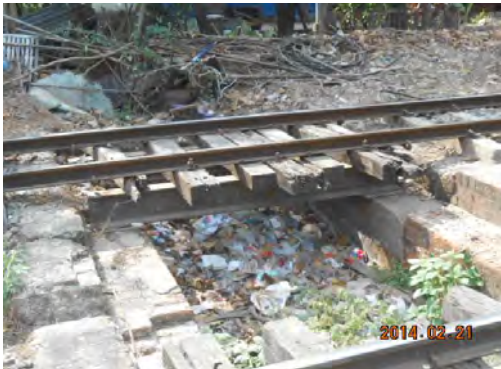
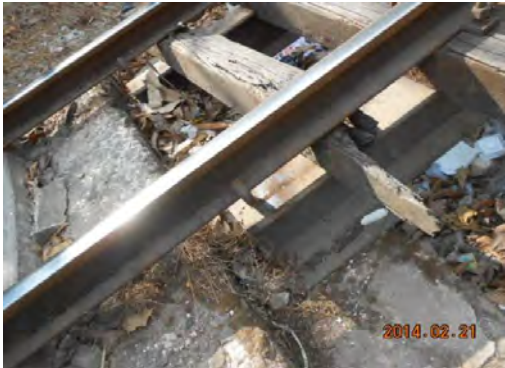
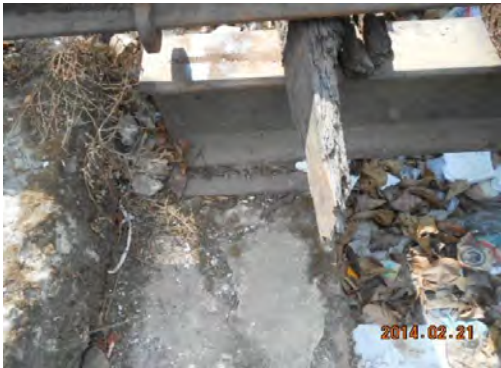
DATA SHEET for BRIDGE

Bridge No. : B04	Bridge Name : 17	(Bridge) or Culvert
Identification No.: C17		Survey Date: 2014/2/21
Between Hletaqn station and Kamayut station		
Mile Post (distance from Yanngon RS.)	MR's official data	Measured by YUTRA※
clockwise:	5/4-5/5	
anti-clockwise(if any):		
equivalent KM Post (distance from Yangon RS.)		
clockwise:	8.33	8.29
anti-clockwise(if any):		
Type of Bridge : Steel I girder	Year of Built :	
Bridge Length : 1 Span @ 2.9 m = 2.9 m	Skew :degree	
Bridge Width : 1.25 m 1.7m		
Bridge Conditions: Extent and Degree: (A: Sound condition, B: Need Major Repair, C: Serious condition) Superstructure: B Abutment/Pier: B Shoe: C None		
Utility line (None) / Electric / Water / Gas / Telecommunication / Optical fiber / Others(.....		
Photos (General view, Side view(Left and Right), Defects, Damages, etc..)

Remarks		
Two types of gauge is applied

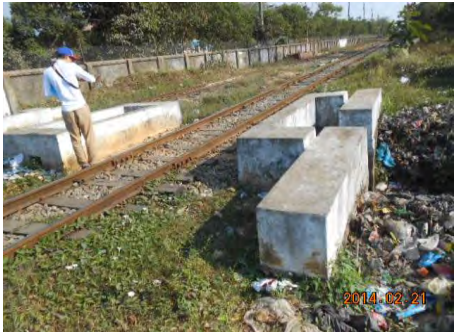
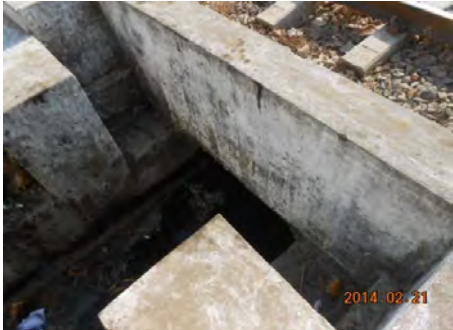
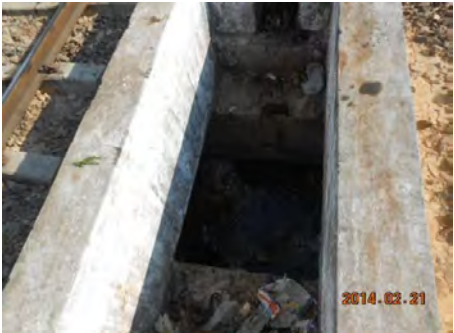
DATA SHEET for BRIDGE

Bridge No. :	B06	Bridge Name :	Bridge or <u>Culvert</u>
Identification No.:	C19BX	Survey Date:	2014/2/21
Between		Kamayut station	and Thiri Myine station
Mile Post (distance from Yanngon RS.)		MR's official data	Measured by YUTRA※
clockwise:			
anti-clockwise(if any):			
equivalent KM Post (distance from Yangon RS.)			
clockwise:			9.71
anti-clockwise(if any):			
Type of Culvert :	<u>Box</u> / Pipe / Other (.....)		Year of Built :
Number of Cell :		Skew :degree
Size of Culvert :	Inner :m xm		
Inlet / Outlet size:	width(m): 3.3	thickness (m):	0.5
Length :	from inlet to outlet 6.8m		
Culvert Conditions: Extent and Degree: (A: Sound condition, B: Need Major Repair, C: Serious condition)			
Inlet/Outlet:	A		
Pipe/Box:	A		
Photos (General view, Side view(Left and Right), Defects, Damages, etc..)

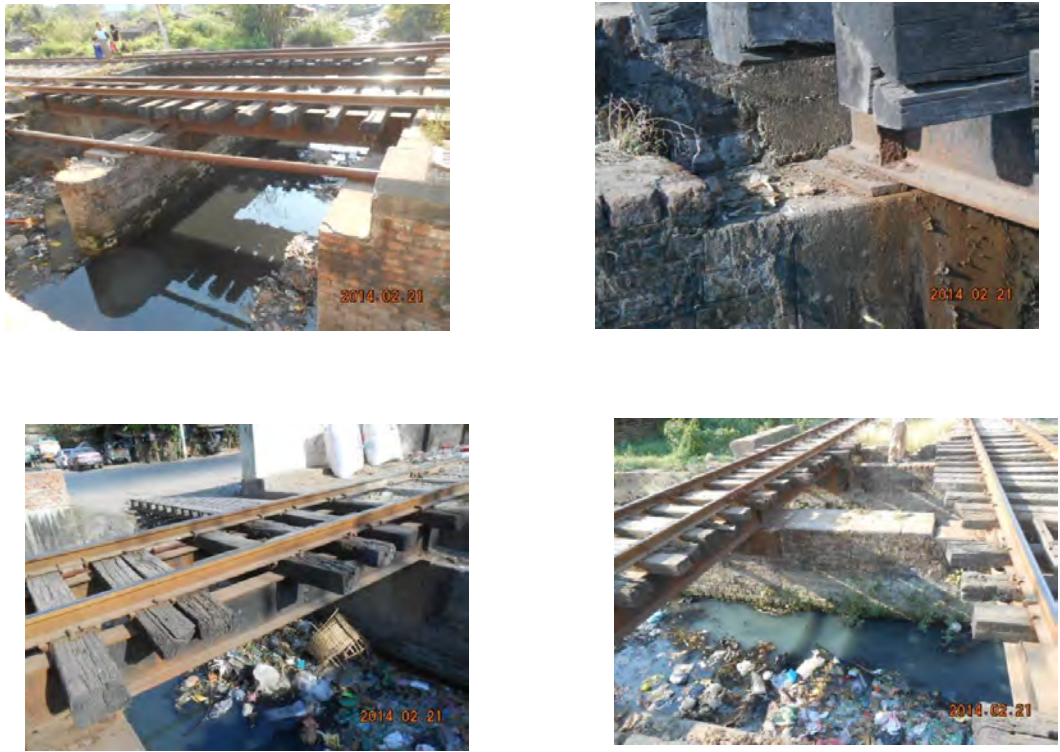
DATA SHEET for BRIDGE

Bridge No. : B07	Bridge Name : 20	(Bridge) or Culvert
Identification No.: C20		Survey Date: 2014/2/21
Between Kamayut station and Thirimine station		
Mile Post (distance from Yanngon RS.)	MR's official data	Measured by YUTRA※
clockwise:	6/10-6/11	
anti-clockwise(if any):		
equivalent KM Post (distance from Yangon RS.)		
clockwise:	10.35	10.29
anti-clockwise(if any):		
Type of Bridge : Steel I girder	Year of Built :	
Bridge Length : 2 Span @ 3.9+3.9 m = 7.8 m	Skew :degree	
Bridge Width : 1.25 m		
Bridge Conditions: Extent and Degree: (A: Sound condition, B: Need Major Repair, C: Serious condition) Superstructure: <u>A</u> Abutment/Pier: <u>B</u> deteriorated by aging Shoe: <u>B</u>		
Utility line (None) / Electric / Water / Gas / Telecommunication / Optical fiber / Others(.....		
Photos (General view, Side view(Left and Right), Defects, Damages, etc..)

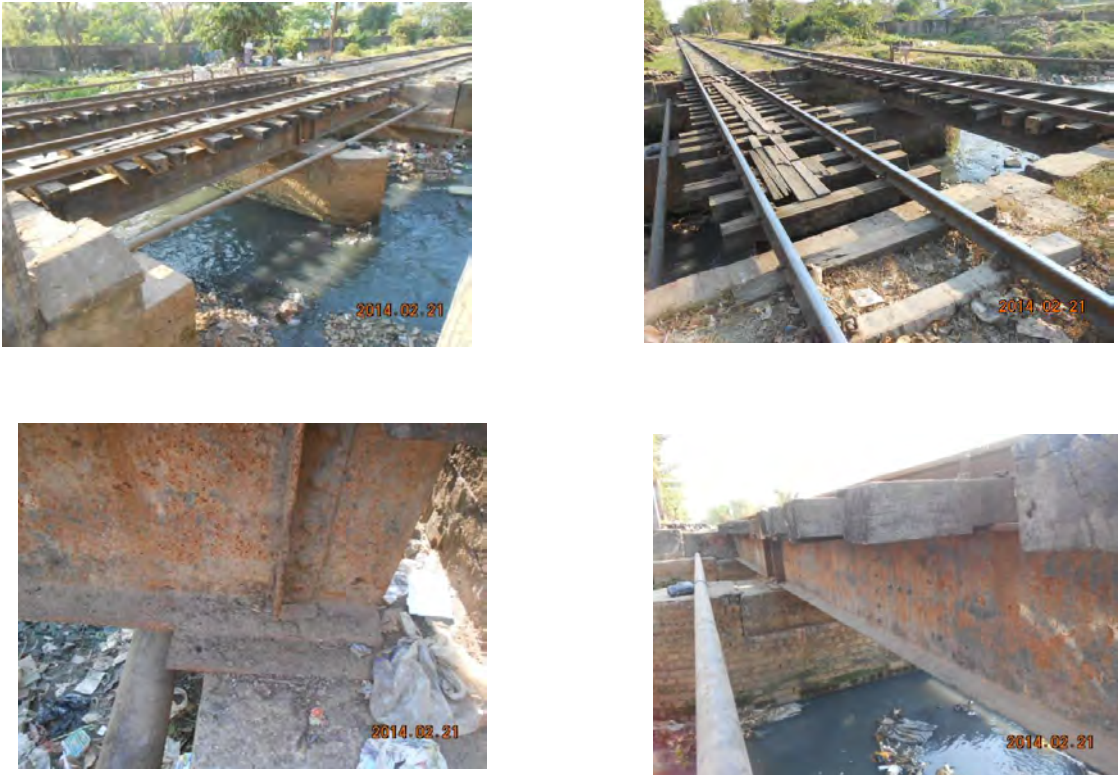
DATA SHEET for BRIDGE

Bridge No. : B08		Bridge Name : 21		Bridge or Culvert
Identification No.: C21			Survey Date: 2014/2/21	
Between Oakkyin station and		Thamine station		
Mile Post (distance from Yanngon RS.)	MR's official data		Measured by YUTRA※	
clockwise:	7/3-7/4			
anti-clockwise(if any):				
equivalent KM Post (distance from Yangon RS.)				
clockwise:	11.49		11.59	
anti-clockwise(if any):				
Type of Bridge : Steel I girder	Year of Built :			
Bridge Length : 2 Span @ 5.4+5.4 m = 10.8 m	Skew :degree			
Bridge Width : - m				
Bridge Conditions: Extent and Degree: (A: Sound condition, B: Need Major Repair, C: Serious condition)				
Superstructure: A				
Abutment/Pier: B deteriorated by aging				
Shoe: B				
Utility line None / Electric / Water / Gas / Telecommunication / Optical fiber / Others(.....				
Photos (General view, Side view(Left and Right), Defects, Damages, etc..)

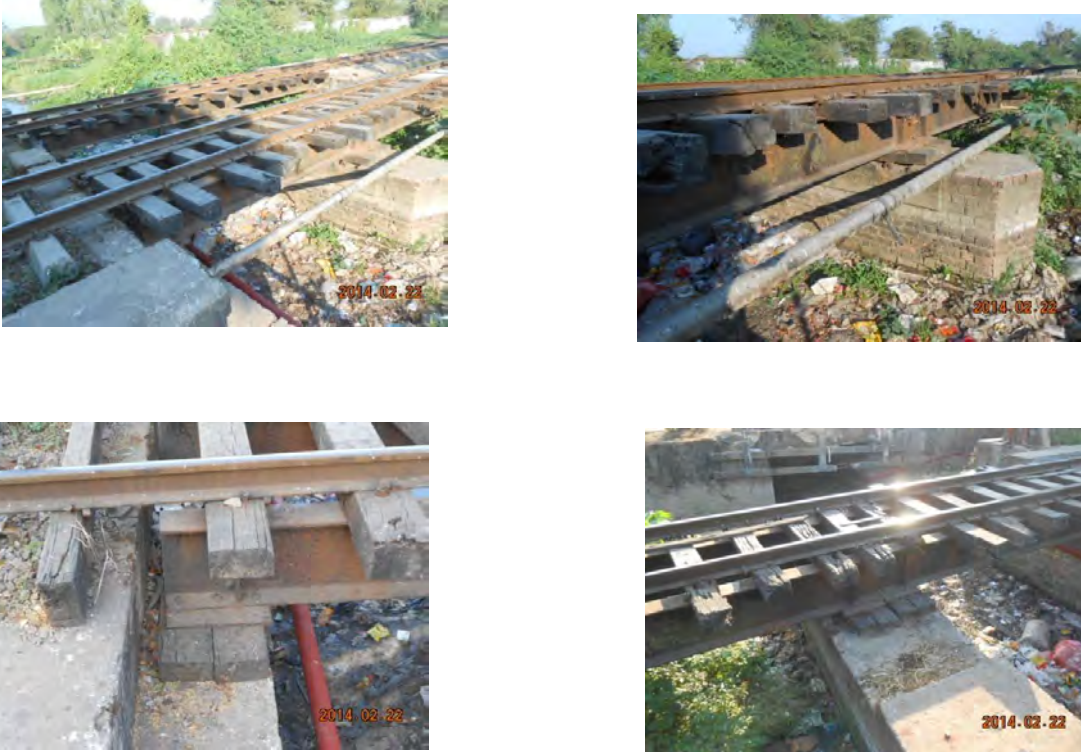
DATA SHEET for BRIDGE

Bridge No. :	B09	Bridge Name :	22	(Bridge) or Culvert
Identification No.:	C22	Survey Date:	2014/2/22	
Between <u>Thamine Myothit</u> station and <u>Kyunkon</u> station				
Mile Post (distance from Yanngon RS.)	MR's official data		Measured by YUTRA※	
clockwise:	7/22-7/23			
anti-clockwise(if any):				
equivalent KM Post (distance from Yangon RS.)				
clockwise:	12.76		12.72	
anti-clockwise(if any):				
Type of Bridge :	Steel I girder	Year of Built :	
Bridge Length :	1 Span @ 3.85+3.85 m = 7.7 m		Skew :degree	
Bridge Width :	1.25 m			
Bridge Conditions: Extent and Degree: (A: Sound condition, B: Need Major Repair, C: Serious condition)				
Superstructure:	B	rust		
Abutment/Pier:	B-C	deteriorated by aging		
Shoe:	C	Adjust height by wood		
Utility line (None) / Electric / Water / Gas / Telecommunication / Optical fiber / Others(.....)				
Photos (General view, Side view(Left and Right), Defects, Damages, etc..)

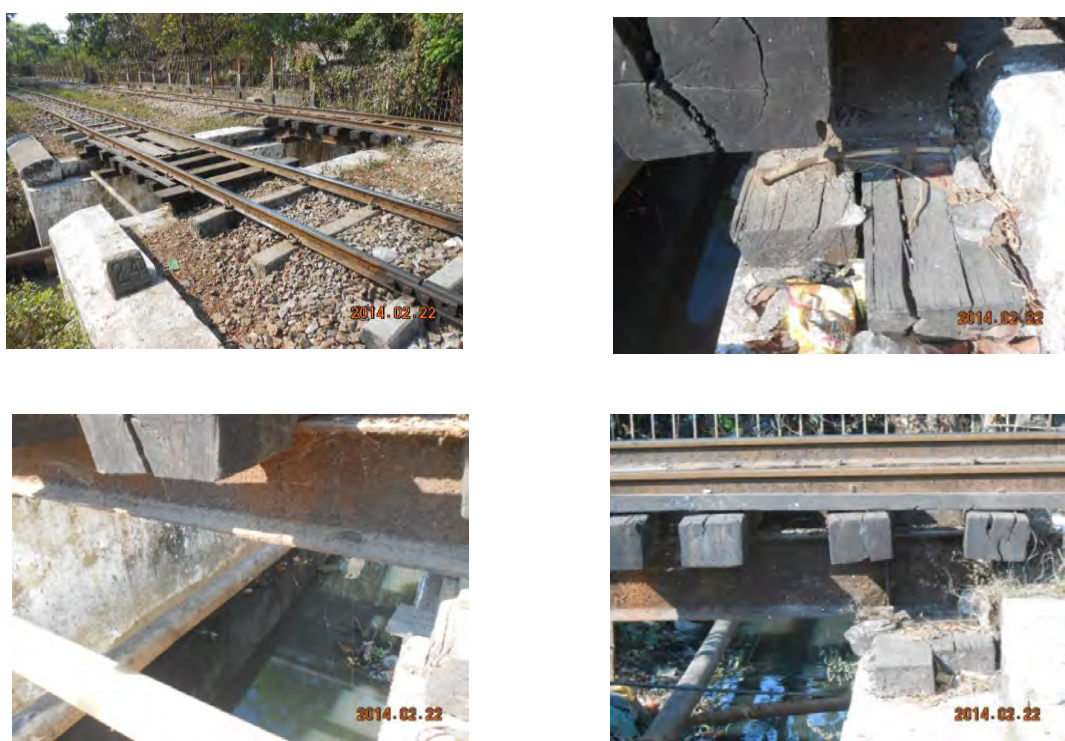
DATA SHEET for BRIDGE

Bridge No. : B10	Bridge Name : 24	(Bridge) or Culvert
Identification No.: C24		Survey Date: 2014/2/22
Between Insein station and Ywama station		
Mile Post (distance from Yanngon RS.)	MR's official data	Measured by YUTRA※
clockwise:	9/8-9/9	
anti-clockwise(if any):		
equivalent KM Post (distance from Yangon RS.)		
clockwise:	15.04	15.06
anti-clockwise(if any):		
Type of Bridge : Steel I girder	Year of Built :	
Bridge Length : 1 Span @ 2.85 m = 2.85 m	Skew :degree	
Bridge Width : 1.25 m	m	
Bridge Conditions: Extent and Degree: (A: Sound condition, B: Need Major Repair, C: Serious condition) Superstructure: B-C rust Abutment/Pier: A Shoe: C Adjust height by wood		
Utility line None / Electric / Water / Gas / Telecommunication / Optical fiber / Others(.....		
Photos (General view, Side view(Left and Right), Defects, Damages, etc..)

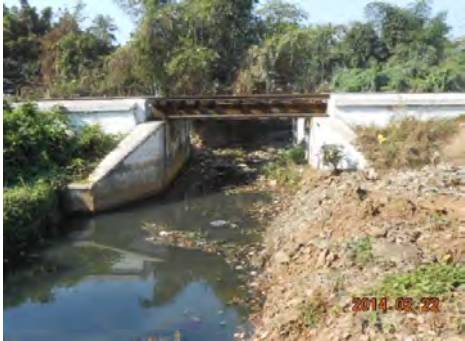
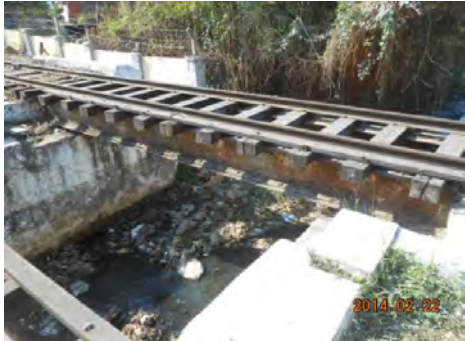
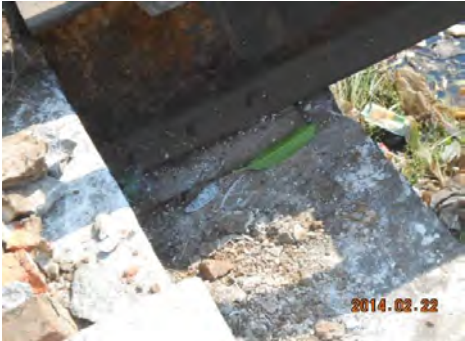
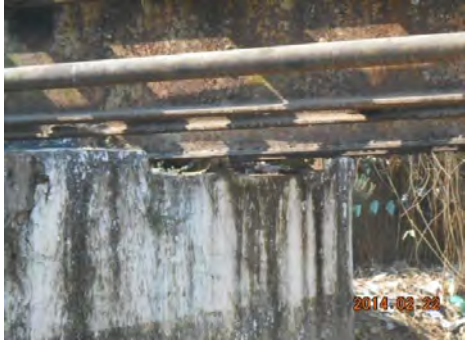
DATA SHEET for BRIDGE

Bridge No. :	B11	Bridge Name :	25	(Bridge) or Culvert
Identification No.:	C25	Survey Date:		2014/2/22
Between		Insein	station and	Ywama station
Mile Post (distance from Yanngon RS.)	MR's official data		Measured by YUTRA※	
clockwise:	9/15-6/16			
anti-clockwise(if any):				
equivalent KM Post (distance from Yangon RS.)				
clockwise:	15.51		15.51	
anti-clockwise(if any):				
Type of Bridge :	Steel I girder	Year of Built :		
Bridge Length :	1 Span @	5.8 m =	5.8 m	Skew :degree
Bridge Width :	1.25 m			
Bridge Conditions: Extent and Degree: (A: Sound condition, B: Need Major Repair, C: Serious condition)				
Superstructure:	B	blasting		
Abutment/Pier:	B	deteriorated by aging		
Shoe:	B			
Utility line (None) / Electric / Water / Gas / Telecommunication / Optical fiber / Others(.....				
Photos (General view, Side view(Left and Right), Defects, Damages, etc..)

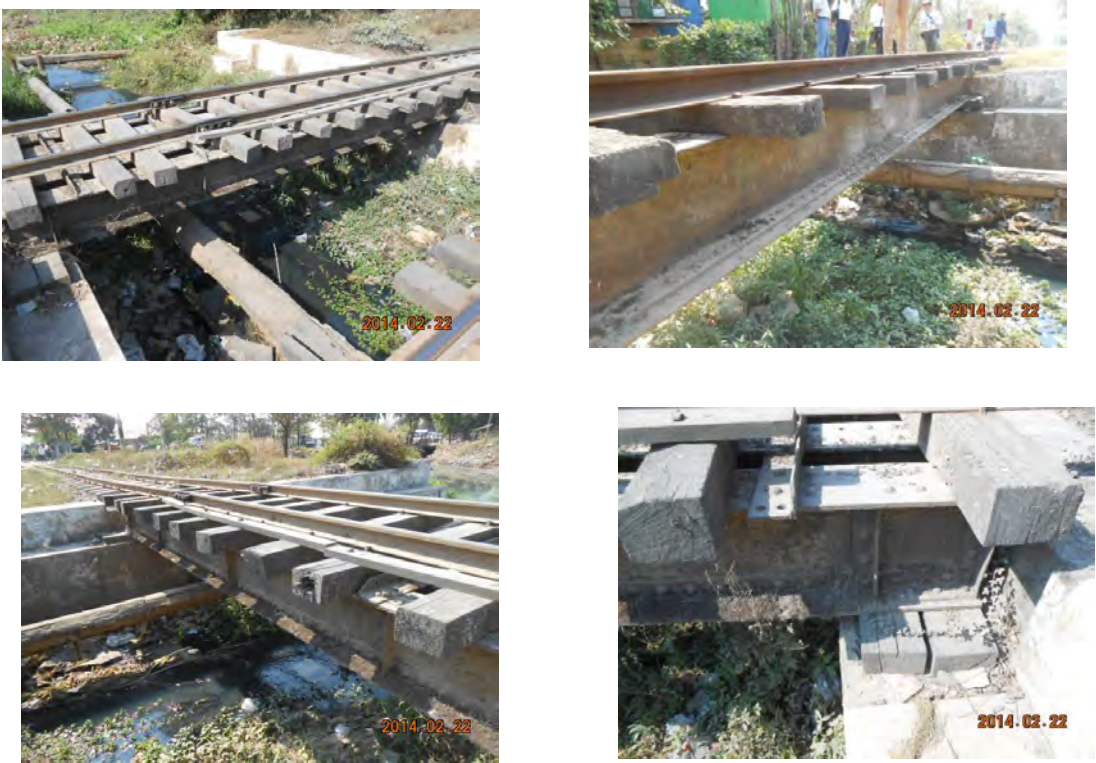
DATA SHEET for BRIDGE

Bridge No. : B12		Bridge Name : 26		Bridge or Culvert
Identification No.: C26			Survey Date: 2014/2/22	
Between Ywama station		and Phawkan station		
Mile Post (distance from Yanngon RS.)		MR's official data		Measured by YUTRA※
clockwise:		101/10-10/11		
anti-clockwise(if any):				
equivalent KM Post (distance from Yangon RS.)				
clockwise:		16.78		16.81
anti-clockwise(if any):				
Type of Bridge : Steel I girder		Year of Built :		
Bridge Length : 1 Span @ 7.1 m = 7.1 m		Skew :degree		
Bridge Width : 1.4 m		1.77 m		
Bridge Conditions: Extent and Degree: (A: Sound condition, B: Need Major Repair, C: Serious condition)				
Superstructure: A-B				
Abutment/Pier: A				
Shoe: C Adjust height by wood				
Utility line None / Electric / Water / Gas / Telecommunication / Optical fiber / Others(.....				
Photos (General view, Side view(Left and Right), Defects, Damages, etc..)

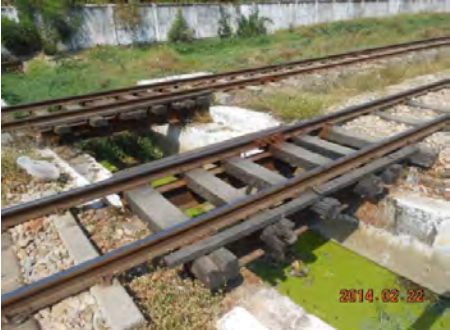
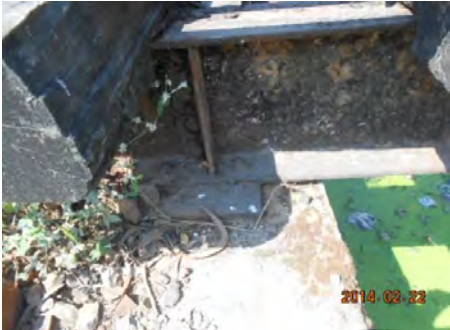
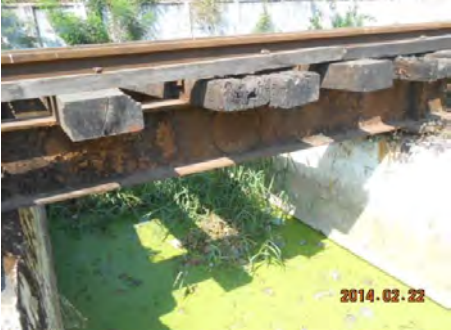
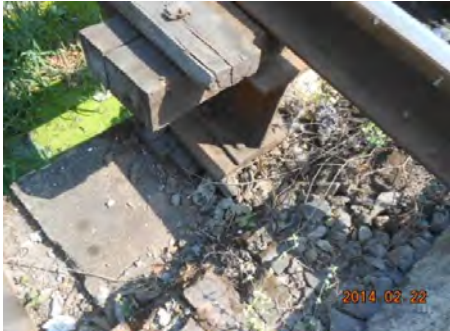
DATA SHEET for BRIDGE

Bridge No. :	B13	Bridge Name :	27	(Bridge) or Culvert
Identification No.:	C27	Survey Date: 2014/2/22		
Between		Phawkan	station and	Aungsanmyo station
Mile Post (distance from Yanngon RS.)	MR's official data		Measured by YUTRA※	
clockwise:	11/1-11/2			
anti-clockwise(if any):				
equivalent KM Post (distance from Yangon RS.)				
clockwise:	17.80		17.78	
anti-clockwise(if any):				
Type of Bridge :	Steel I girder	Year of Built :		
Bridge Length :	1 Span @ 2.9 m =	2.9 m	Skew :degree	
Bridge Width :	1.25 m			
Bridge Conditions: Extent and Degree: (A: Sound condition, B: Need Major Repair, C: Serious condition)				
Superstructure: A-B				
Abutment/Pier: B peel off mortar, crack				
Shoe: B-C				
Utility line (None) / Electric / Water / Gas / Telecommunication / Optical fiber / Others(.....				
Photos (General view, Side view(Left and Right), Defects, Damages, etc..)

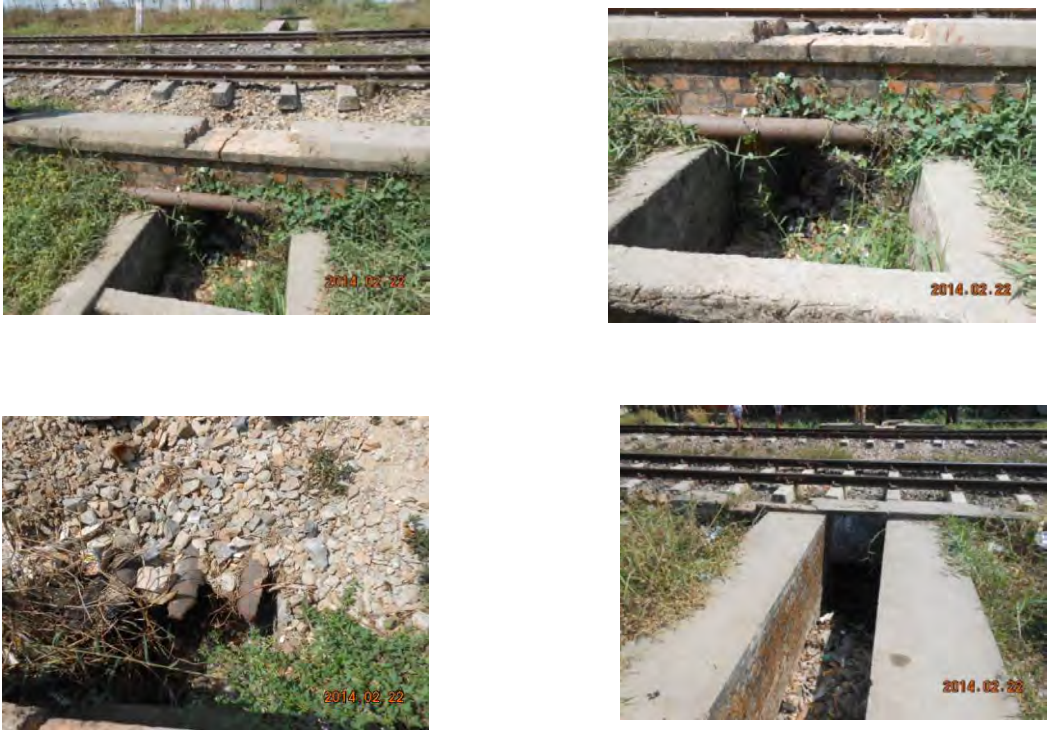
DATA SHEET for BRIDGE

Bridge No. :	B14	Bridge Name :	26	Bridge or Culvert
Identification No.:	C28	Survey Date:	2014/2/22	
Between	Kamayut	station	and	Thiri Myine station
Mile Post (distance from Yanngon RS.)	MR's official data		Measured by YUTRA※	
clockwise:	11/14-11/15			
anti-clockwise(if any):				
equivalent KM Post (distance from Yangon RS.)				
clockwise:	18.66		18.65	
anti-clockwise(if any):				
Type of Culvert :	Box / Pipe / Other (.....)		Year of Built :	
Number of Cell :		Skew :degree	
Size of Culvert :	Inner : 0.6m xm			
Inlet / Outlet size:	width(m):	0.6	thickness (m):	0.6
Length :	from inlet to outlet 7.4m			
Culvert Conditions: Extent and Degree: (A: Sound condition, B: Need Major Repair, C: Serious condition)				
Inlet/Outlet: B-C				
Pipe/Box:				
Photos (General view, Side view(Left and Right), Defects, Damages, etc..)

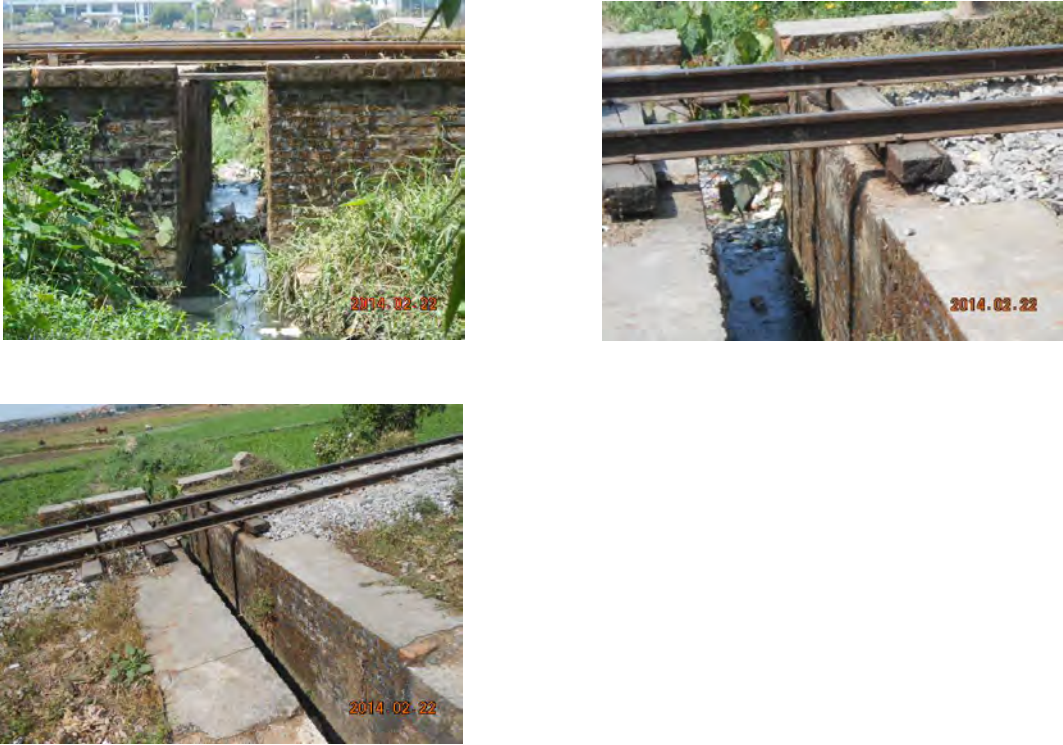
DATA SHEET for BRIDGE

Bridge No. : B15	Bridge Name : 29	(Bridge) or Culvert
Identification No.: C29		Survey Date: 2014/2/22
Between Aungsanmyo station and Danyingone station		
Mile Post (distance from Yanngon RS.)	MR's official data	Measured by YUTRA※
clockwise:	12/1-12/2	
anti-clockwise(if any):		
equivalent KM Post (distance from Yangon RS.)		
clockwise:	19.40	19.46
anti-clockwise(if any):		
Type of Bridge :	Year of Built :	
Bridge Length :	1 Span @ 0.6 m = 0.6 m	Skew :degree
Bridge Width :	7.85 m	
Bridge Conditions: Extent and Degree: (A: Sound condition, B: Need Major Repair, C: Serious condition) Superstructure: - Abutment/Pier: B Shoe: -		
Utility line (None) / Electric / Water / Gas / Telecommunication / Optical fiber / Others(.....)		
Photos (General view, Side view(Left and Right), Defects, Damages, etc..)

Remarks	Culvert

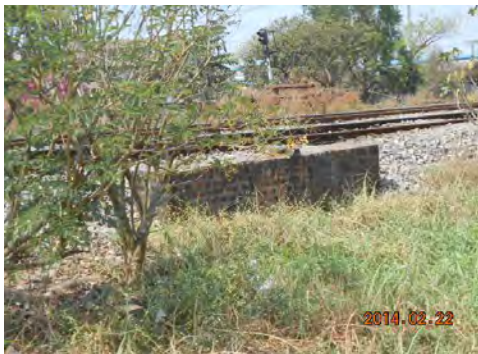
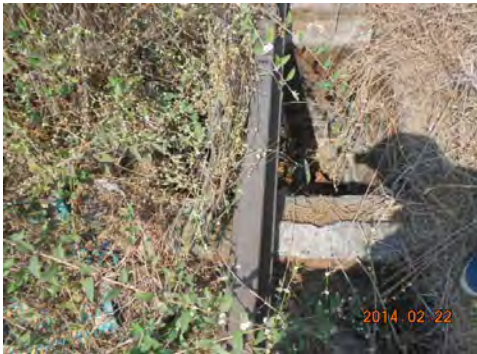
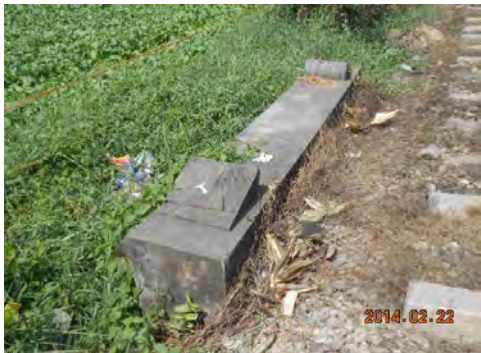
Remarks				
No water flow due to rubbish

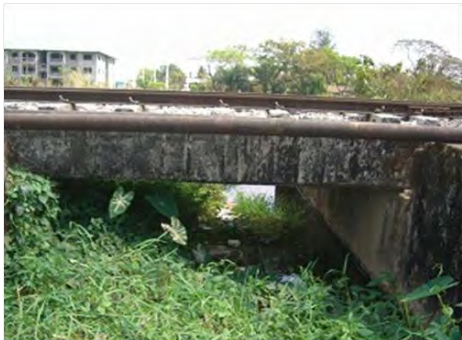
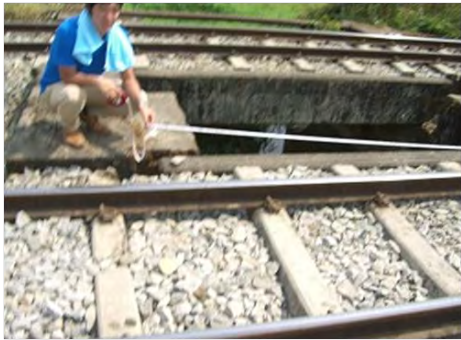
</div>			
Remarks			
Not listed from MR, but existed

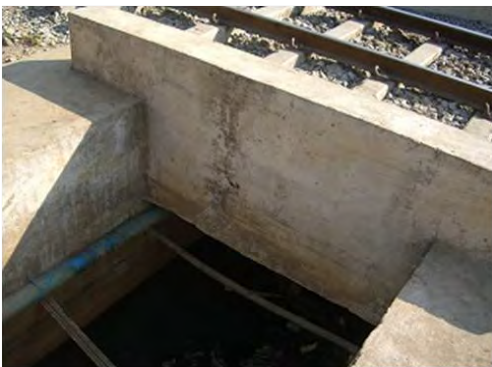
Remarks			
Not listed from MR, but excited

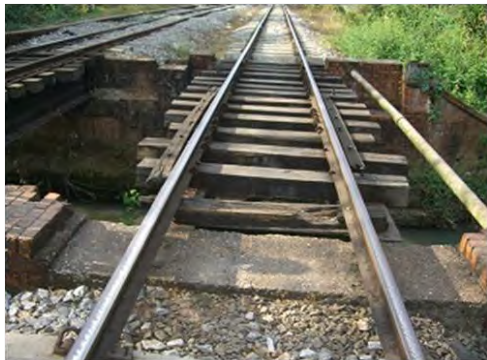
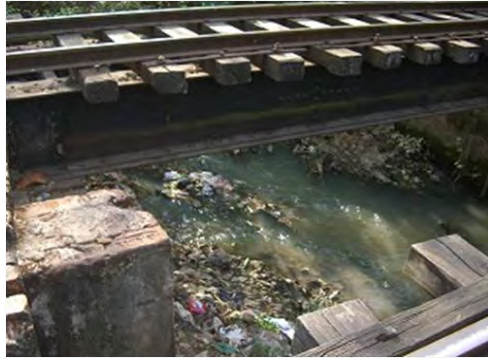
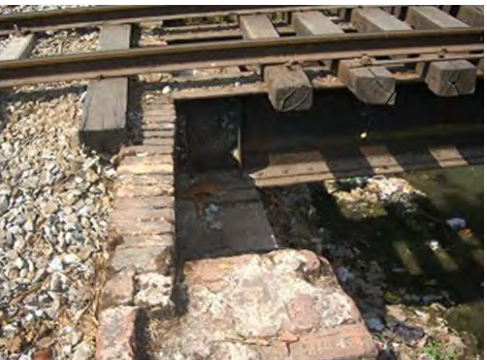
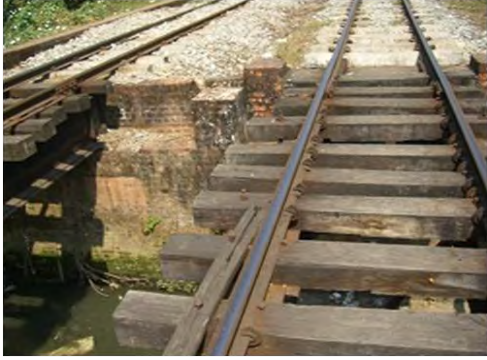
Remarks Not listed from MR, but excited

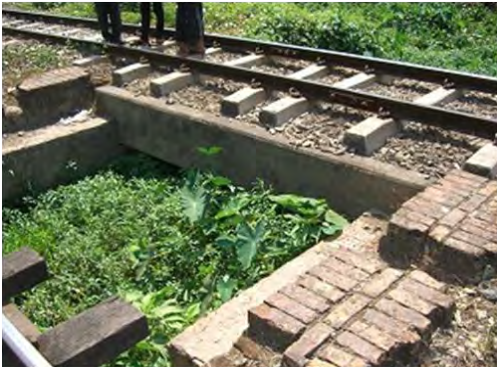
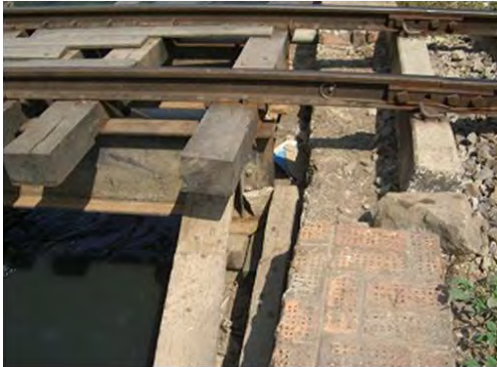
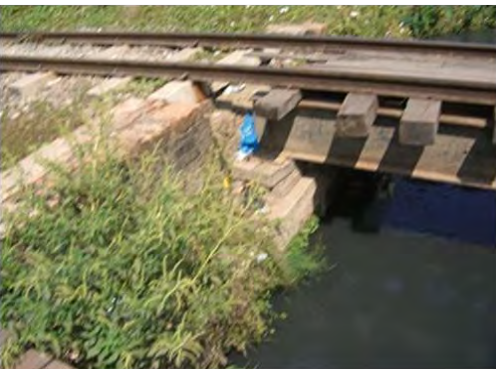
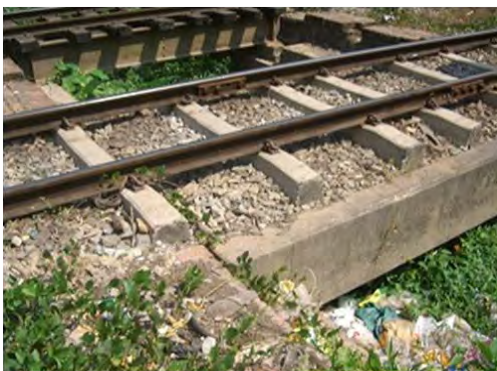
Bridge No. :	B45	Bridge Name :	3	<u>Bridge</u> or Culvert
Identification No.:	A3	Survey Date: 2013/2/21		
Between		Baukhtaw	station and	Tarmwe station
Mile Post (distance from Yanngon RS.)	MR's official data		Measured by YUTRA※	
clockwise:				
anti-clockwise(if any):	4/2-4/3			
equivalent KM Post (distance from Yangon RS.)				
clockwise:	38.97		40.10	
anti-clockwise(if any):				
Type of Bridge :	Steel, RC	Year of Built :		
Bridge Length :	1 Span @ 3.82 m =	3.82 m	Skew :degree	
Bridge Width :	2.46 m	1.39m		
Bridge Conditions: Extent and Degree: (A: Sound condition, B: Need Major Repair, C: Serious condition) Superstructure: <u>B</u> Abutment/Pier: <u>B</u> Shoe:				
Utility line <u>None</u> / Electric / Water / Gas / Telecommunication / Optical fiber / Others(.....)				
Photos (General view, Side view(Left and Right), Defects, Damages, etc..)

Remarks There are RC type and steel type bridge

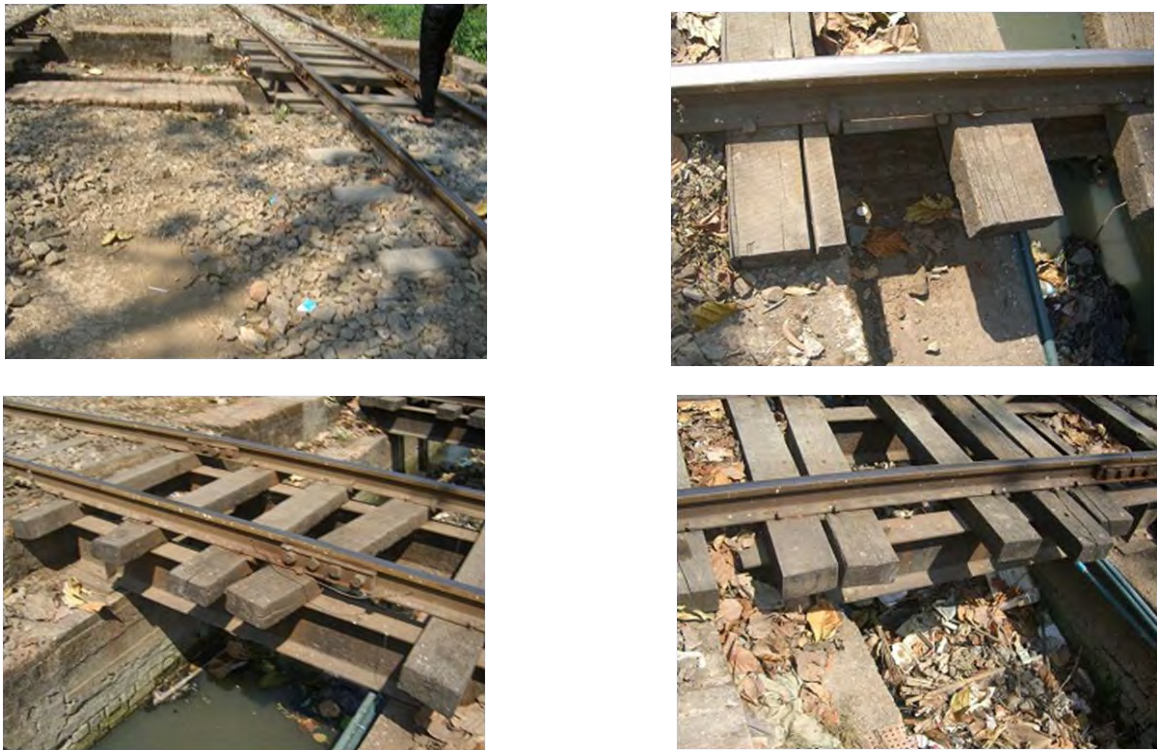
Bridge No. :	B47	Bridge Name :	1	<u>Bridge</u> or Culvert
Identification No.:	A1	Survey Date: 2013/2/21		
Between		Tarmwe	station and	Myittanyunt station
Mile Post (distance from Yanngon RS.)	MR's official data		Measured by YUTRA※	
clockwise:				
anti-clockwise(if any):	3/5-3/6			
equivalent KM Post (distance from Yangon RS.)				
clockwise:	40.37		41.29	
anti-clockwise(if any):				
Type of Bridge :	Steel I girder	Year of Built :		
Bridge Length :	1 Span @ 2.7 m =	2.7 m	Skew :degree	
Bridge Width :	1.42 m			
Bridge Conditions: Extent and Degree: (A: Sound condition, B: Need Major Repair, C: Serious condition) Superstructure: <u>B</u> Abutment/Pier: <u>B</u> Shoe:				
Utility line <u>None</u> / Electric / Water / Gas / Telecommunication / Optical fiber / Others(.....)				
Photos (General view, Side view(Left and Right), Defects, Damages, etc..)

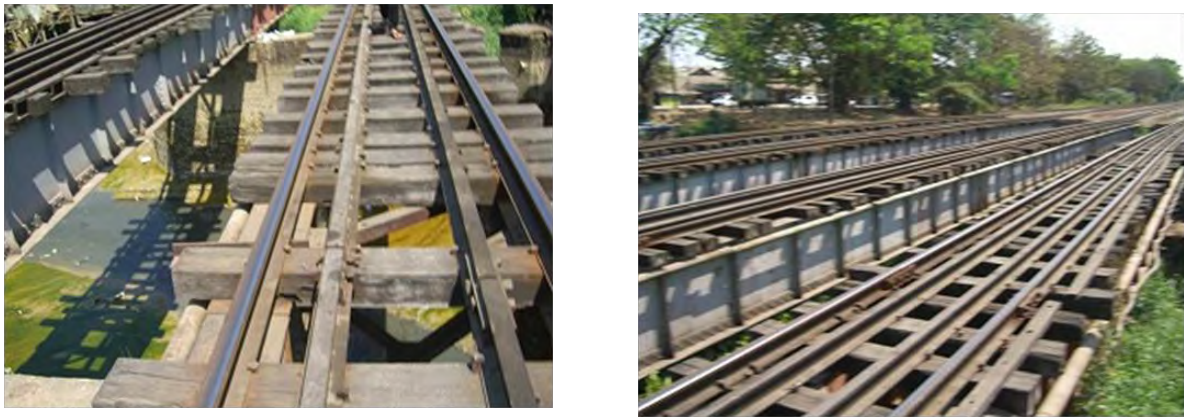
Bridge No. : B48	Bridge Name : 9	(Bridge) or Culvert
Identification No.: YM9		Survey Date: 2013/2/21
Between Myittanyunt station and Mahlwagone station		
Mile Post (distance from Yanngon RS.)	MR's official data	Measured by YUTRA※
clockwise:		
anti-clockwise(if any):	2/18-2/19	
equivalent KM Post (distance from Yangon RS.)		
clockwise:	41.11	41.89
anti-clockwise(if any):		
Type of Bridge : Steel I girder	Year of Built :	
Bridge Length : 3 Span @ 41.5 m =	41.5 m	Skew :degree
Bridge Width : 1.47 m		
Bridge Conditions: Extent and Degree: (A: Sound condition, B: Need Major Repair, C: Serious condition) Superstructure: <u> B </u> Abutment/Pier: <u> B </u> Shoe: <u> can't see </u>		
Utility line <u>None</u> / Electric / Water / Gas / Telecommunication / Optical fiber / Others(.....)		
Photos (General view, Side view(Left and Right), Defects, Damages, etc..)
