APPENDICIES

APPENDIX 2-1

Number of Freight Train of Myanmar Railways

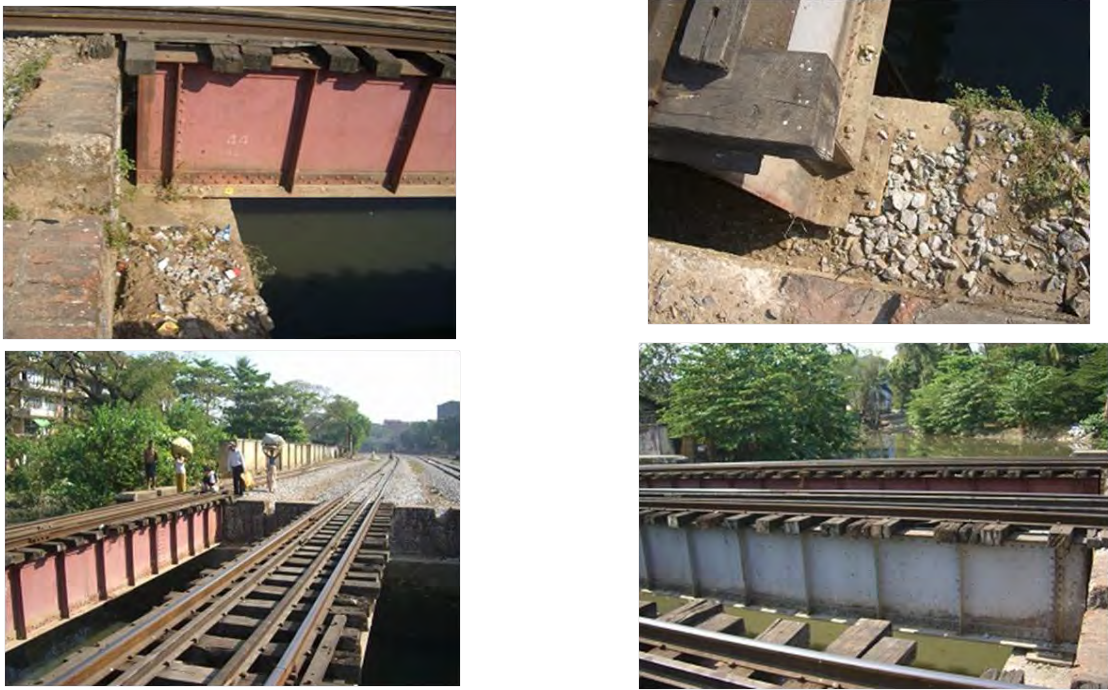
Bridge No. :	B52	Bridge Name :	3	<u>Bridge</u> or Culvert
Identification No.:	YM3	Survey Date: 2013/2/21		
Between Pazundaung station and		Yangon Central station		
Mile Post (distance from Yanngon RS.)	MR's official data		Measured by YUTRA※	
clockwise:				
anti-clockwise(if any):	0/13-0/14			
equivalent KM Post (distance from Yangon RS.)				
clockwise:	44.67		45.24	
anti-clockwise(if any):				
Type of Bridge :	Steel I girder	Year of Built :		
Bridge Length :	1 Span @ 14 m =	14 m	Skew :degree	
Bridge Width :	1.4 m			
Bridge Conditions: Extent and Degree: (A: Sound condition, B: Need Major Repair, C: Serious condition) Superstructure: <u>B</u> Abutment/Pier: <u>B</u> Shoe: <u>-</u>				
Utility line <u>None</u> / Electric / Water / Gas / Telecommunication / Optical fiber / Others(.....				
Photos (General view, Side view(Left and Right), Defects, Damages, etc..)

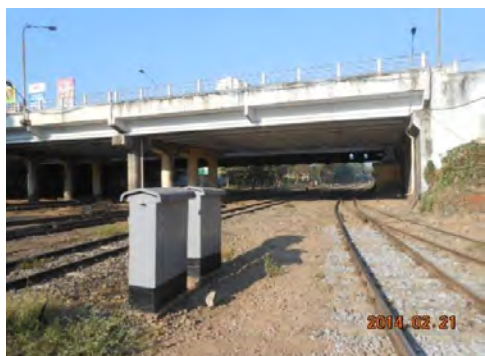
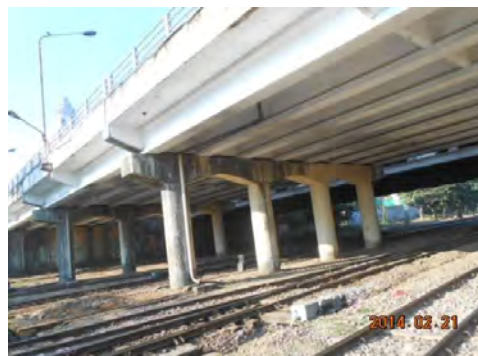
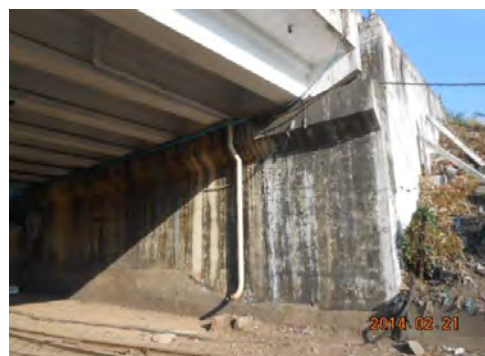
ROB No. R01		ROB Name : Sule	
Identification No.: C2		Survey Date: 2014/2/21	
Yangon Central station		and Phaya Rd. station	
Mile Post (distance from Yanngon RS.)	MR's official data	Measured by YUTRA※	
clockwise:	0/4-0/5		
anti-clockwise(if any):			
equivalent KM Post (distance from Yangon RS.)			
clockwise:	0.29	0.33	
anti-clockwise(if any):			
Type of ROB :	RC I girder(8)	Year of Built :	
ROB Length :	3 Span @	m =	m
		Skew :	degree
ROB Lane No. :	1+4 lanes with sidewalk		
Clearance from RL to under girder (m):	4.59	Design Load (ton):	
Width(m):			
ROB Conditions: Extent and Degree: (A: Sound condition, B: Need Major Repair, C: Serious condition)			
Superstructure:	A	mold	
Abutment/Pier:	A	mold	
Shoe:	-	can't see

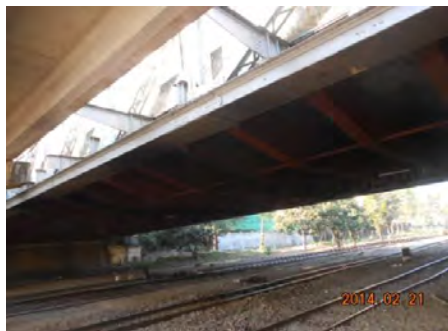
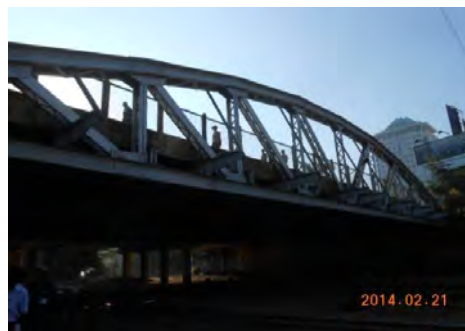
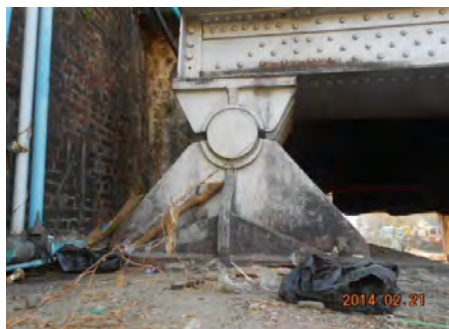
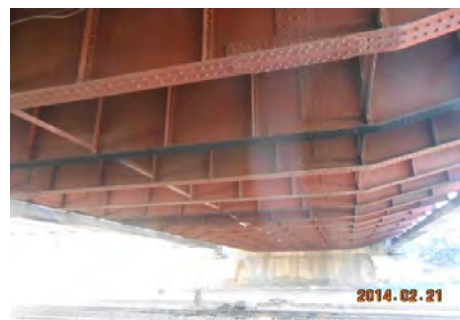
ROB No. R02		ROB Name : Sule	
Identification No.: C2A		Survey Date: 2014/2/21	
Between Yangon Central station		and Phaya Rd. station	
Mile Post (distance from Yanngon RS.)	MR's official data	Measured by YUTRA*	
clockwise:	04/-05		
anti-clockwise(if any):			
equivalent KM Post (distance from Yangon RS.)			
clockwise:	0.29	0.35	
anti-clockwise(if any):			
Type of ROB :	Steel arch truss	Year of Built :	
ROB Length :	1 Span @	m =	m
ROB Lane No. :		1+4 lanes with sidewalk	
Clearance from RL to under girder (m):	3.94	Design Load (ton):	
Width(m):			
ROB Conditions: Extent and Degree: (A: Sound condition, B: Need Major Repair, C: Serious condition)			
Superstructure:	A		
Abutment/Pier:	A break brick		
Shoe:	A

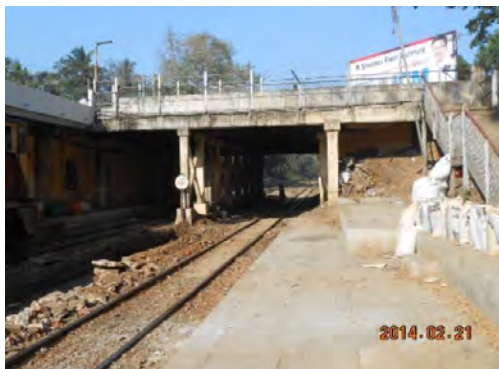
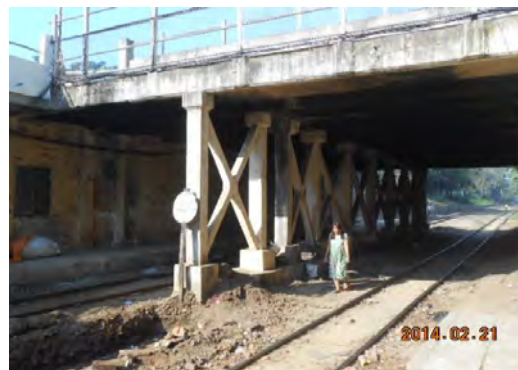
ROB No. R03		ROB Name : Pha Ya Toad	
Identification No.: C5		Survey Date: 2014/2/21	
Between		Phaya Ro station	and Lanmataw station
Mile Post (distance from Yanngon RS.)		MR's official data	Measured by YUTRA*
clockwise:		0/15-0/16	
anti-clockwise(if any):			
equivalent KM Post (distance from Yangon RS.)			
clockwise:		1.03	0.93
anti-clockwise(if any):			
Type of ROB :	RC girder(10)	Year of Built :	
ROB Length :	2 Span @	m =	m
			Skew : degree
ROB Lane No. :	2+2 lanes with sidewalk		
Clearance from RL to under girder (m):	3.92	Design Load (ton):	
Width(m):	20.25		
ROB Conditions: Extent and Degree: (A: Sound condition, B: Need Major Repair, C: Serious condition)			
Superstructure:	B	mold	
Abutment/Pier:	B	mold,peeling	
Shoe:	None

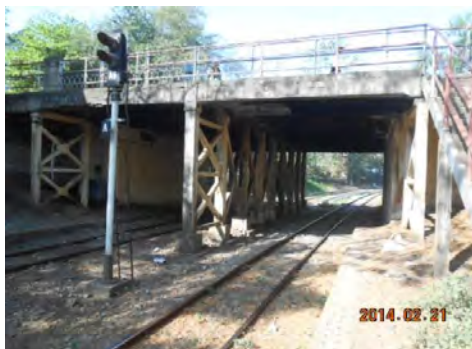
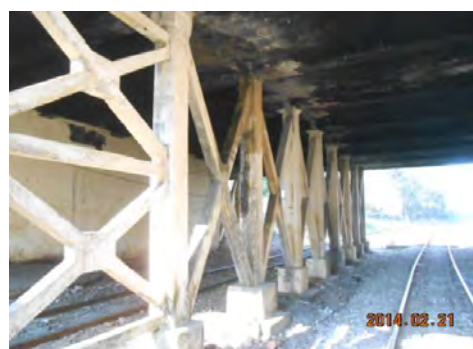
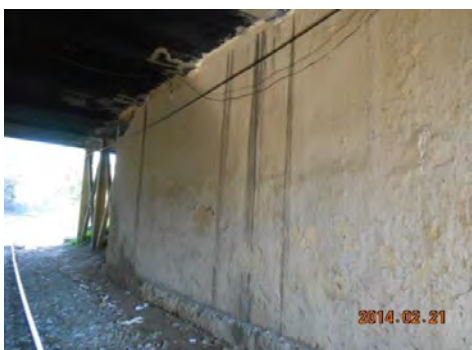
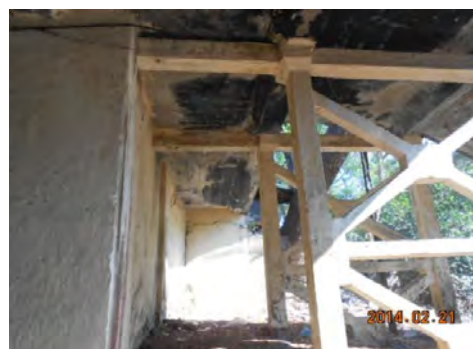
Abutment/Pier: B crack

Shoe: B

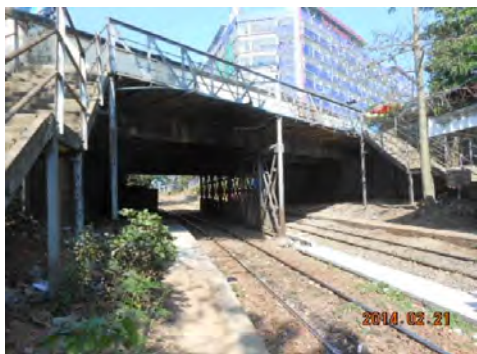
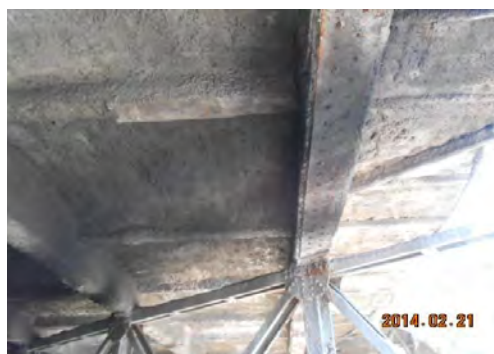
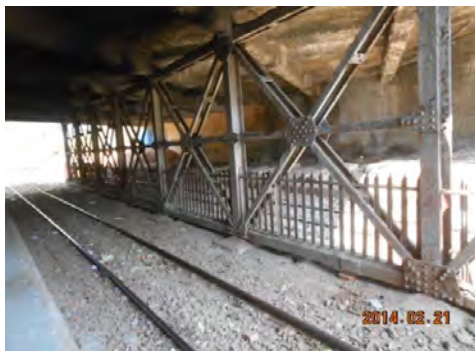
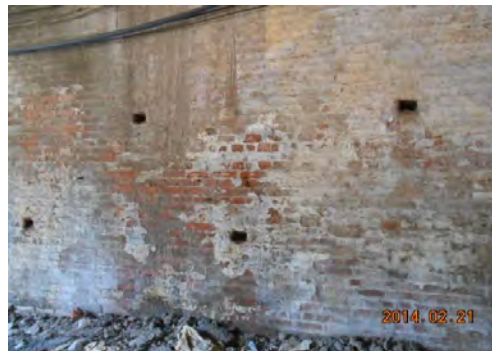
ROB No. R05		ROB Name : Pyay Road	
Identification No.: C7		Survey Date: 2014/2/21	
Between		Pyay Rd station	and Shan Rd. station
Mile Post (distance from Yanngon RS.)	MR's official data		Measured by YUTRA*
clockwise:	1/11-1/12		
anti-clockwise(if any):			
equivalent KM Post (distance from Yangon RS.)			
clockwise:	2.37	2.13	
anti-clockwise(if any):			
Type of ROB :	RC I girder(7)	Year of Built :	
ROB Length :	2 Span @	m =	m
		Skew :	30 degree
ROB Lane No. :	3+3 lanes with sidewalk		
Clearance from RL to under girder (m):	3.83	Design Load (ton):	
Width(m):	24.75		
ROB Conditions: Extent and Degree: (A: Sound condition, B: Need Major Repair, C: Serious condition)			
Superstructure:	B		
Abutment/Pier:	A crack		
Shoe:	None

Pierbis steel

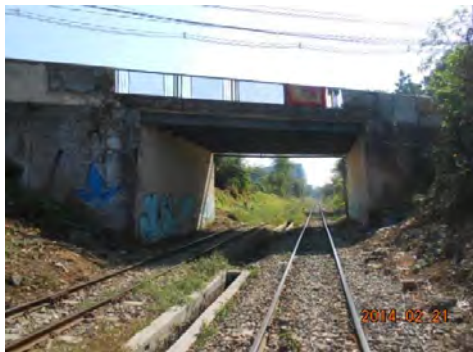
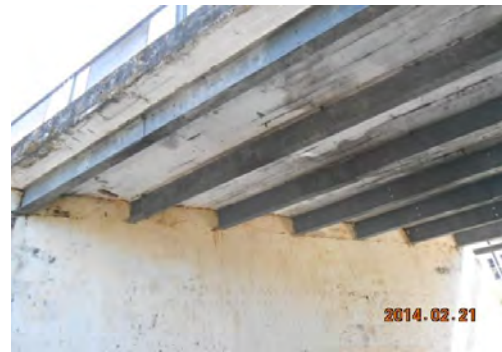
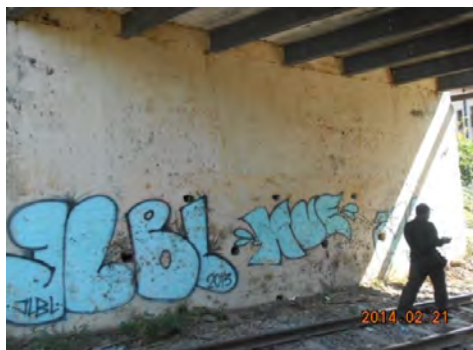
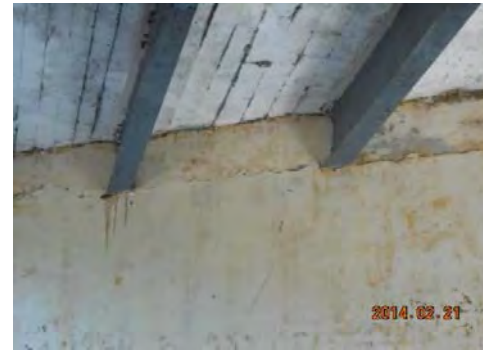
ROB No. R06		ROB Name : Kha Yae Pin	
Identification No.: C8		Survey Date: 2014/2/21	
Between		Pyay Rd station	and Shan Rd. station
Mile Post (distance from Yanngon RS.)	MR's official data		Measured by YUTRA*
clockwise:	1/21-1/22		
anti-clockwise(if any):			
equivalent KM Post (distance from Yangon RS.)			
clockwise:	3.04	2.68	
anti-clockwise(if any):			
Type of ROB :	Steel I girder(7)	Year of Built :	
ROB Length :	1 Span @	m =	m Skew : 20 degree
ROB Lane No. :	1+1 lanes		
Clearance from RL to under girder (m):	4.26	Design Load (ton):	
Width(m):	8		
ROB Conditions: Extent and Degree: (A: Sound condition, B: Need Major Repair, C: Serious condition)			
Superstructure:	A mold		
Abutment/Pier:	A		
Shoe:	None

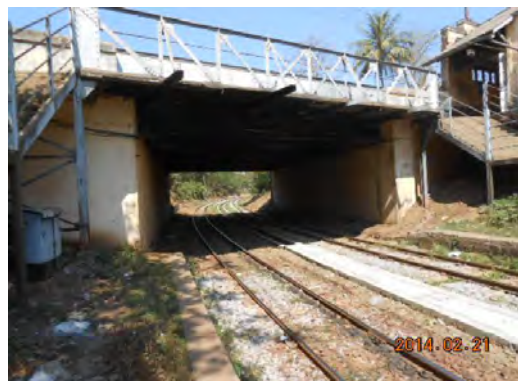
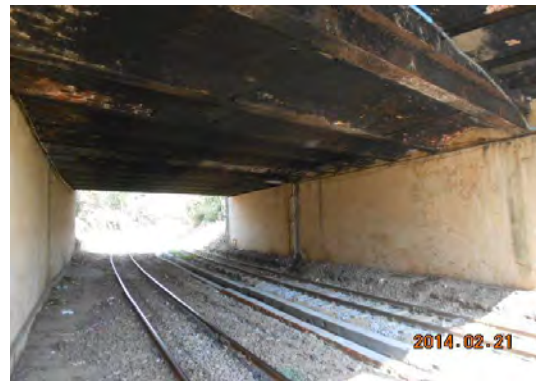
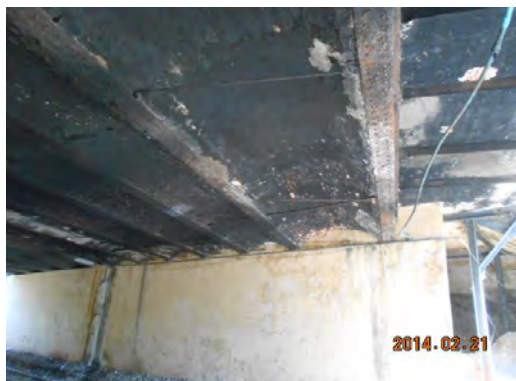
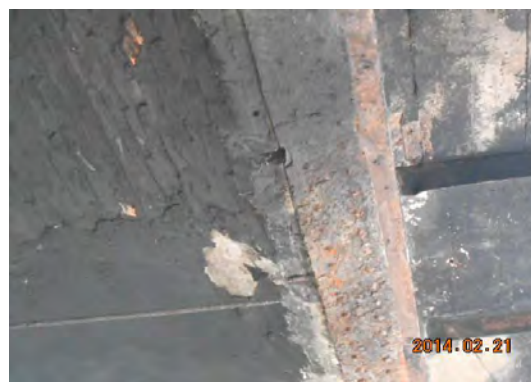
ROB No. R07		ROB Name : Shan Road	
Identification No.: C10		Survey Date: 2014/2/21	
Between		Shan Rc station	and Ahlone Rd. station
Mile Post (distance from Yanngon RS.)		MR's official data	Measured by YUTRA*
clockwise:		2/10-2/11	
anti-clockwise(if any):			
equivalent KM Post (distance from Yangon RS.)			
clockwise:		3.91	3.13
anti-clockwise(if any):			
Type of ROB :	Steel I girder(12)	Year of Built :	
ROB Length :	1 Span @ 9.55 m =	9.55 m	Skew : 20 degree
ROB Lane No. :	2+2 lanes with median		
Clearance from RL to under girder (m):	3.85	Design Load (ton):	
Width(m):	24		
ROB Conditions: Extent and Degree: (A: Sound condition, B: Need Major Repair, C: Serious condition)			
Superstructure:	C	a lot of rust	
Abutment/Pier:	A		
Shoe:	None

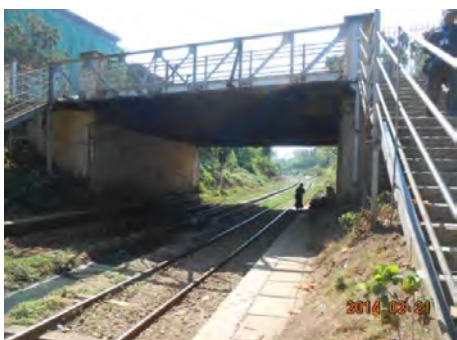
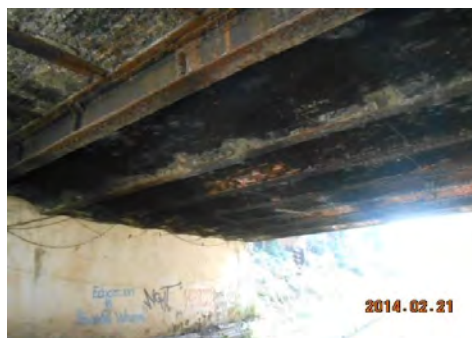
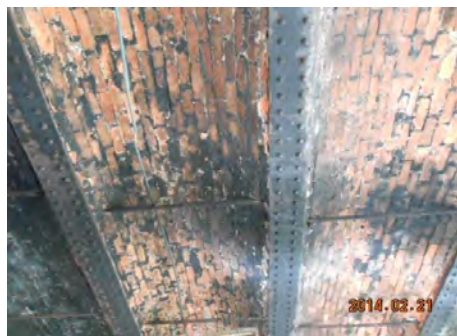
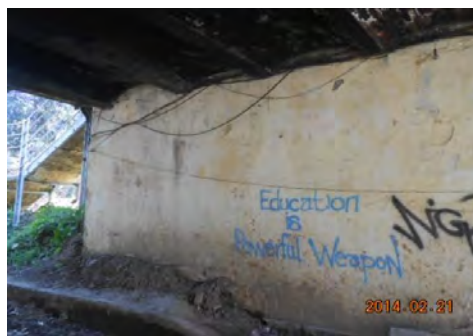
ROB No. R08		ROB Name : Ahlone	
Identification No.: C10A		Survey Date: 2014/2/21	
Between		Shan Rc station	and
		Ahlone Rd. station	
Mile Post (distance from Yanngon RS.)		MR's official data	Measured by YUTRA*
clockwise:		2/12-	
anti-clockwise(if any):			
equivalent KM Post (distance from Yangon RS.)			
clockwise:		4.02	3.63
anti-clockwise(if any):			
Type of ROB :	Steel I girder(8)	Year of Built :	
ROB Length :	1 Span @	m =	m
			Skew : degree
ROB Lane No. :	1+1 lanes with sidewalk (one side)		
Clearance from RL to under girder (m):	3.87	Design Load (ton):	
Width(m):	9.44		
ROB Conditions: Extent and Degree: (A: Sound condition, B: Need Major Repair, C: Serious condition)			
Superstructure:	B-C	rot	
Abutment/Pier:	A		
Shoe:	None

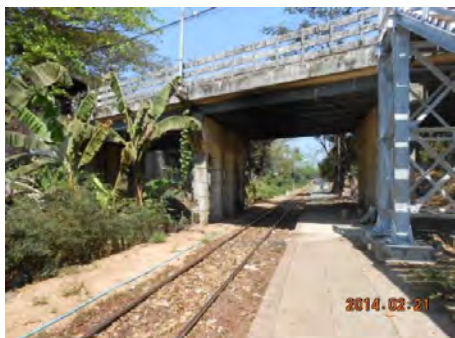
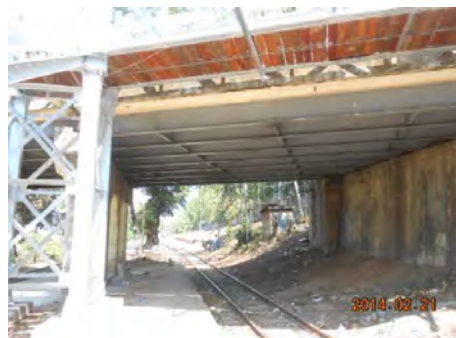
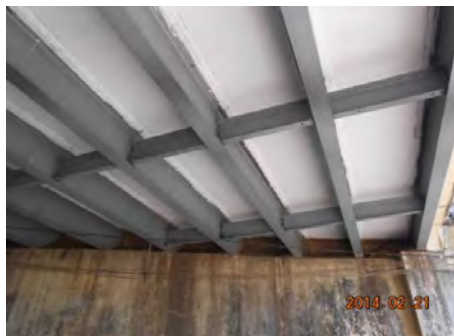
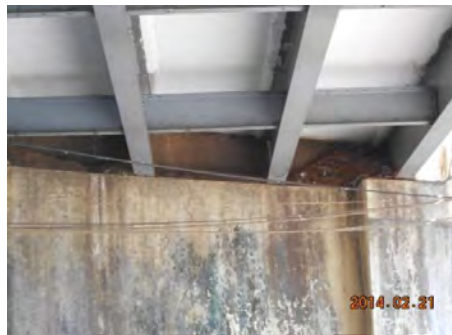
ROB No. R09		ROB Name : Pan Hlaing	
Identification No.: C12		Survey Date: 2014/2/21	
Between		Panhlaing R station	and
		Kyeemyindair station	
Mile Post (distance from Yangon RS.)		MR's official data	Measured by YUTRA*
clockwise:		2/23-2/24	
anti-clockwise(if any):			
equivalent KM Post (distance from Yangon RS.)			
clockwise:		4.78	4.56
anti-clockwise(if any):			
Type of ROB :	Steel I girder(8)	Year of Built :
ROB Length :	3 Span @ 8.68+0.68+6.72+0.68+8.97= 25.73 m		Skew :
ROB Lane No. :	2+1 lanes		
Clearance from RL to under girder (m):	4.21	Design Load (ton):	
Width(m):	9.75		
ROB Conditions:	Extent and Degree: (A: Sound condition, B: Need Major Repair, C: Serious condition)		
Superstructure:	A		
Abutment/Pier:	B	peel off, mold	
Shoe:	-	can't see

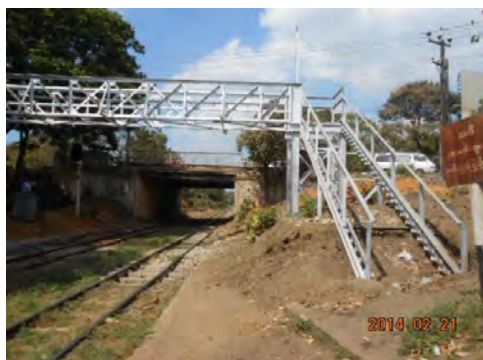
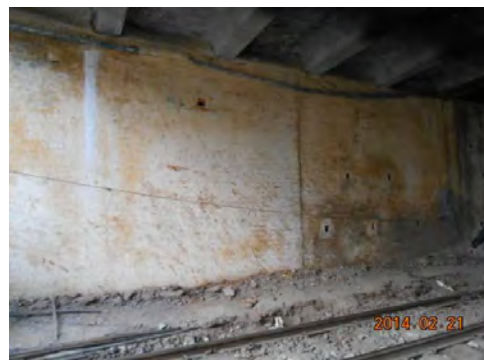
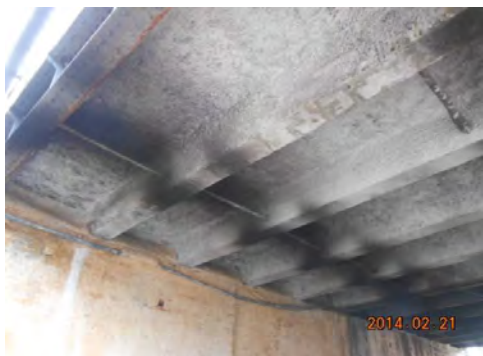
Abutment/Pier: B Crack

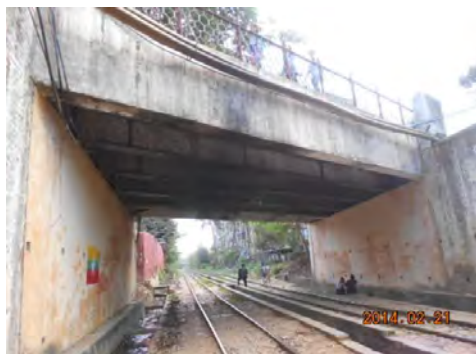
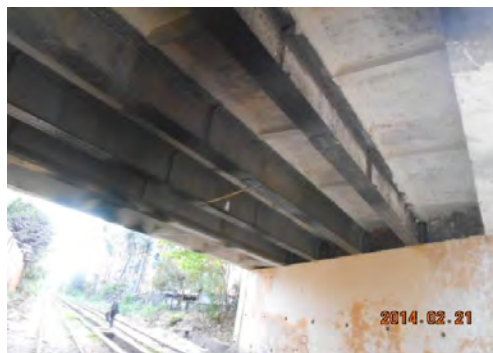
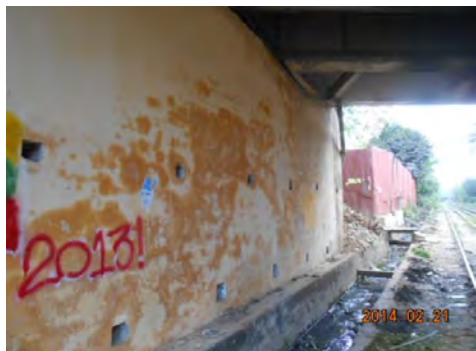
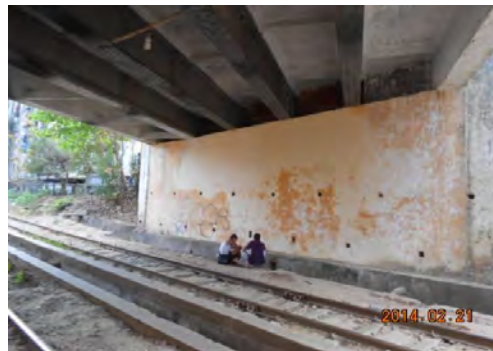
only measured the 1 span over the railway line

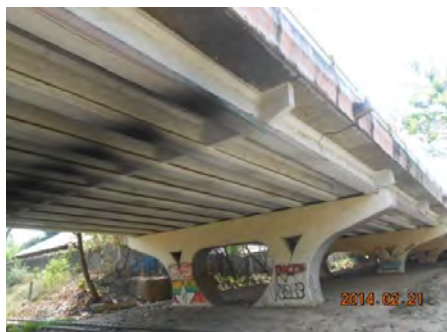
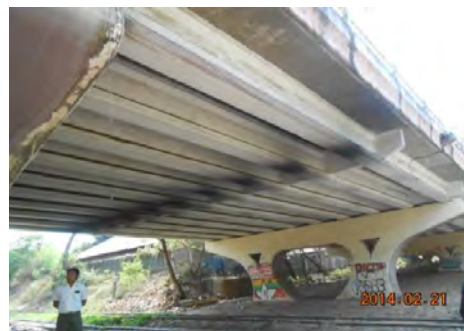
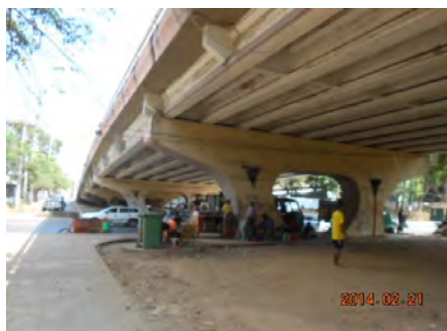
only measured the 1span over the railway line

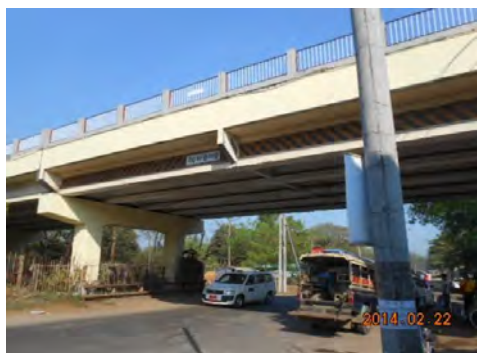
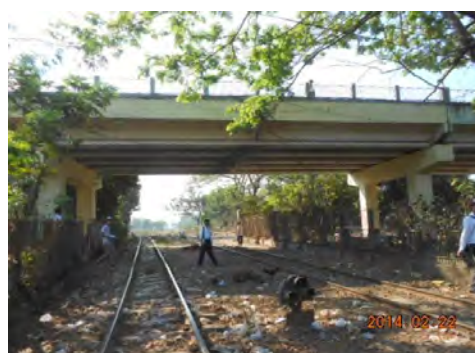
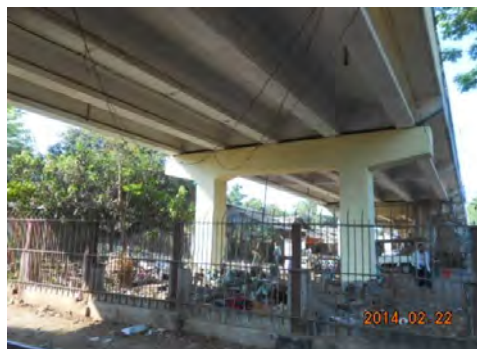
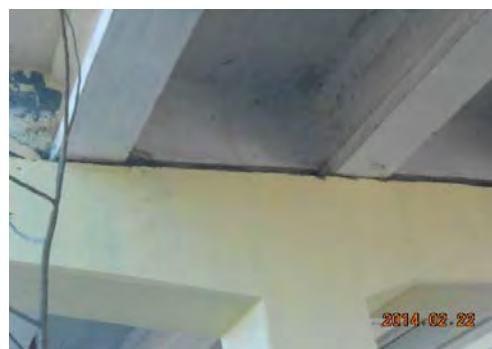
a lot of rubbish under ROB
only measured the 1span over the railway line

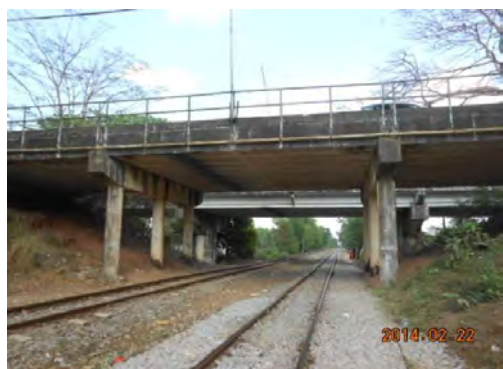
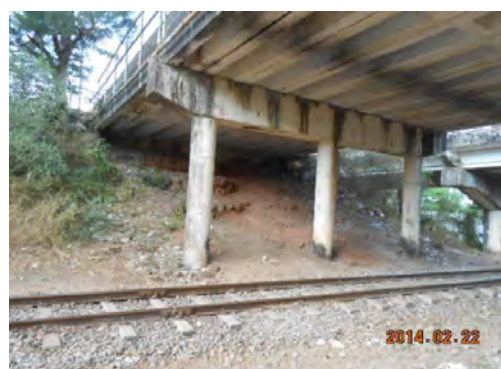
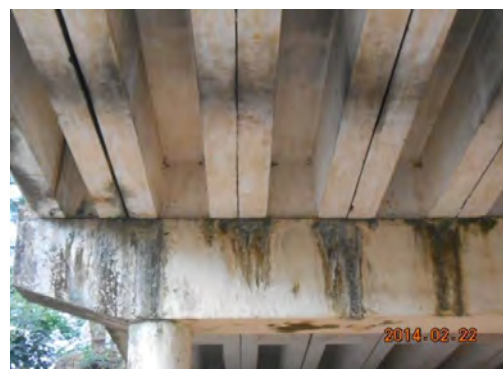
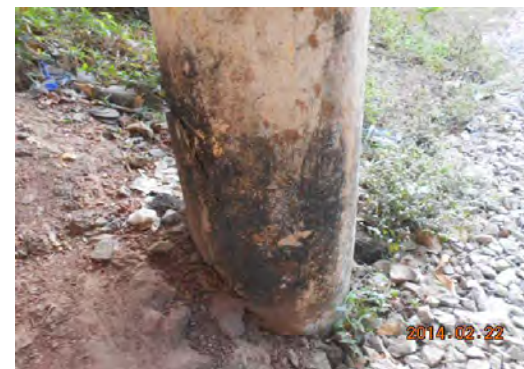
only measured the 1span over the railway line

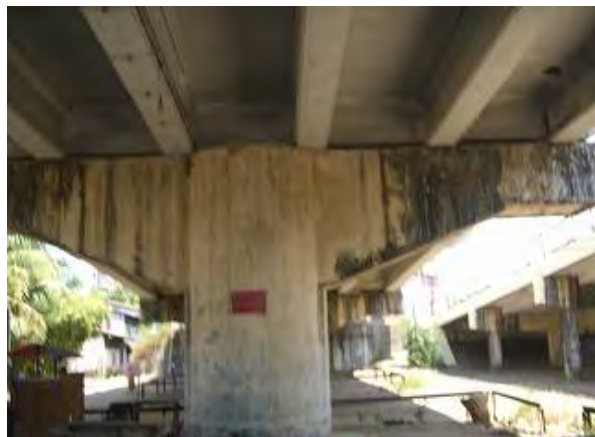
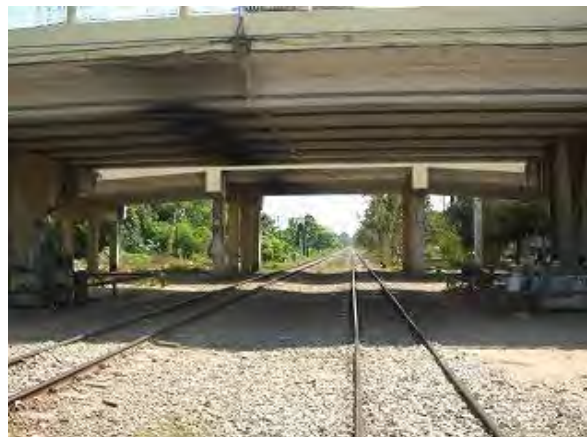
same as R20

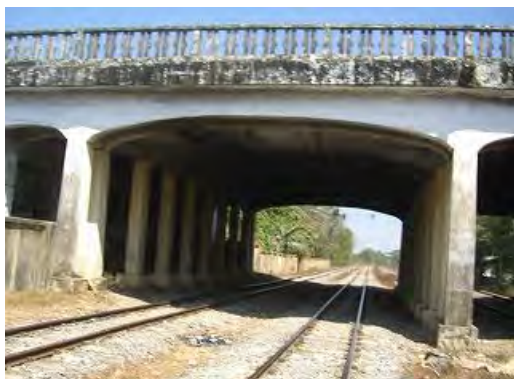
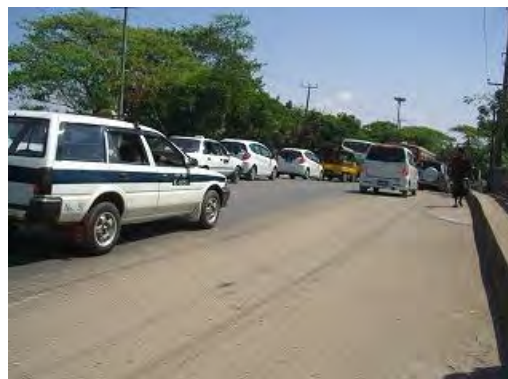
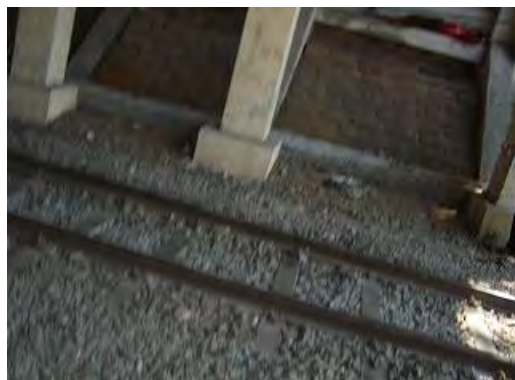
ROB No. R22		ROB Name : La Gun Eain	
Identification No.: YMBA		Survey Date: 2014/2/21	
Between		Myittanyur station	and
		Mahlwago station	
Mile Post (distance from Yanngon RS.)		MR's official data	Measured by YUTRA*
clockwise:		2/17-2/18	
anti-clockwise(if any):			
equivalent KM Post (distance from Yangon RS.)			
clockwise:		41.17	42.11
anti-clockwise(if any):			
Type of ROB :	RC I girder	Year of Built :	
ROB Length :	4 Span @	m =	m
			Skew : degree
ROB Lane No. :	3+3 lanes		
Clearance from RL to under girder (m):	4.63	Design Load (ton):	
Width(m):			
ROB Conditions: Extent and Degree: (A: Sound condition, B: Need Major Repair, C: Serious condition)			
Superstructure:	B		
Abutment/Pier:	B		
Shoe:	-

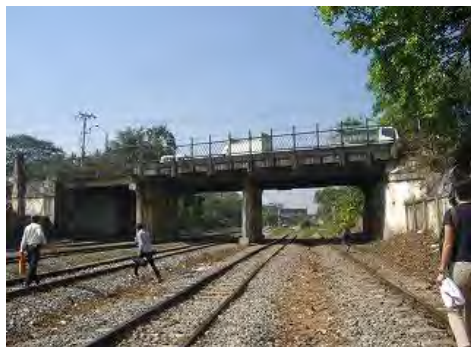
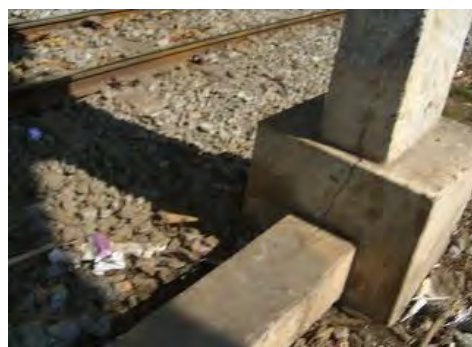
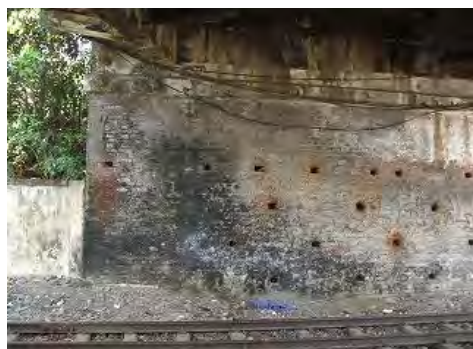
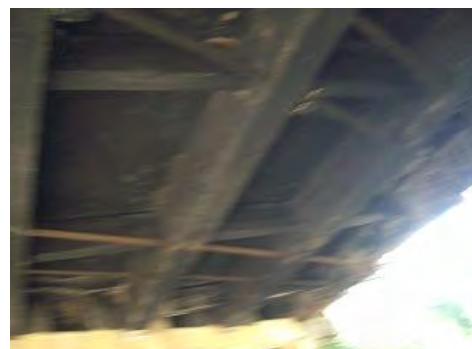
ROB No. R23		ROB Name : Set Yone	
Identification No.: YM5		Survey Date: 2014/2/21	
Between		Mahlwagon station	and
		Pazundau station	
Mile Post (distance from Yanngon RS.)		MR's official data	Measured by YUTRA*
clockwise:		1/2-1/3	
anti-clockwise(if any):			
equivalent KM Post (distance from Yangon RS.)			
clockwise:		43.80	44.33
anti-clockwise(if any):			
Type of ROB :	RC I girder	Year of Built :	
ROB Length :	3 Span @	m =	m
ROB Lane No. :	1+1	lanes	
Clearance from RL to under girder (m):	4.22	Design Load (ton):	
Width(m):			
ROB Conditions: Extent and Degree: (A: Sound condition, B: Need Major Repair, C: Serious condition)			
Superstructure:	B		
Abutment/Pier:	B		
Shoe:	-

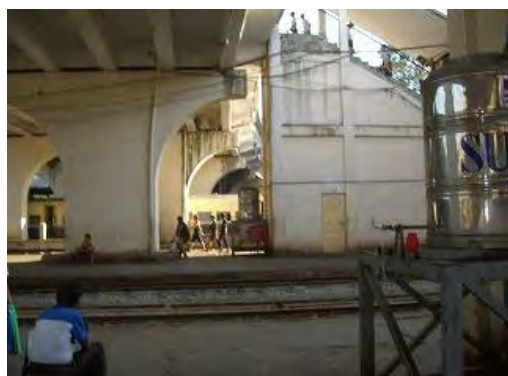
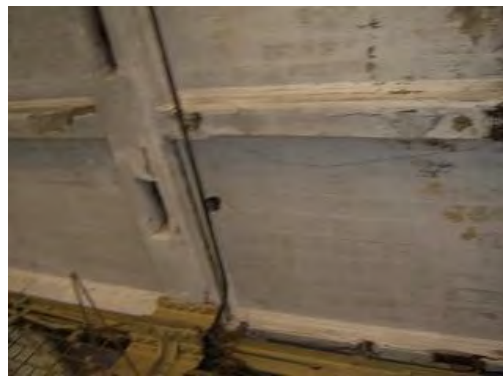
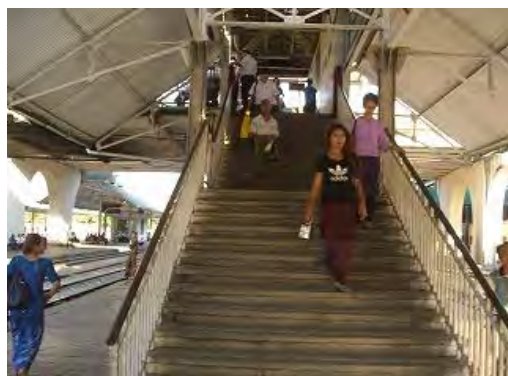
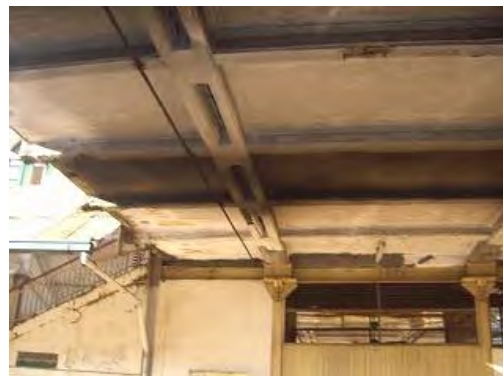
ROB No. R25		ROB Name : Pan Soe Dan	
Identification No.: C1		Survey Date: 2014/2/21	
Between Pazundaur station		and Yangon Cenl station	
Mile Post (distance from Yanngon RS.)	MR's official data	Measured by YUTRA*	
clockwise:	0/0-0/1		
anti-clockwise(if any):			
equivalent KM Post (distance from Yangon RS.)			
clockwise:	43.93	46.10	
anti-clockwise(if any):			
Type of ROB : PC I girder	Year of Built :		
ROB Length :	5 Span @	m =	m
ROB Lane No. :	2+2 lanes		
Clearance from RL to under girder (m):	6.96	Design Load (ton):	
Width(m):			
ROB Conditions: Extent and Degree: (A: Sound condition, B: Need Major Repair, C: Serious condition)			
Superstructure:	B		
Abutment/Pier:	B		
Shoe:	B

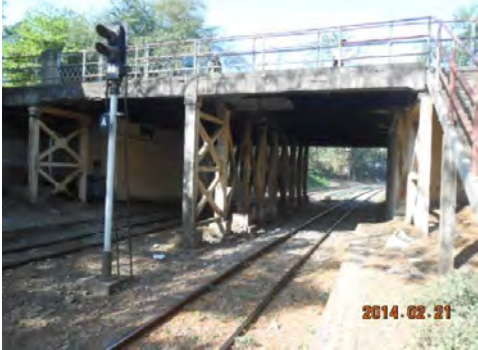
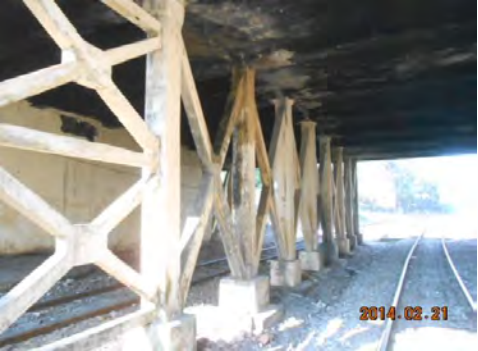
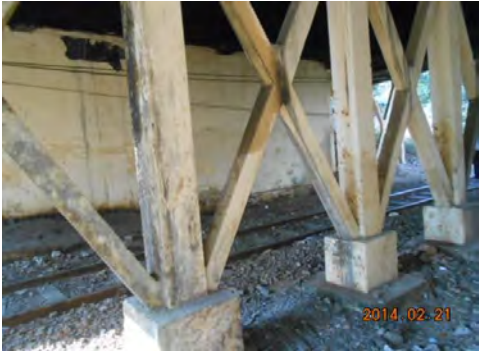
FOB No. : F03		FOB Name : Lamataw	
Identification No.: C5AX		Survey Date 2014/2/21	
Between Lamataw station		and Phaya Rd. station	
Mile Post (distance from Yanngon RS.)	MR's official data	Measured by YUTRA※	
clockwise:	1/1-1/24		
anti-clockwise(if any):			
equivalent KM Post (distance from Yangon RS.)			
clockwise:	2.41	1.48	
anti-clockwise(if any):			
Type of FOB :	Year of Built :		
FOB Length :	Span @	m =	m
Clearance from RL to under girder (m):			
Location (inside station or not) not			
FOB Condition Extent and Degree: (A: Sound condition, B: Need Major Repair, C: Serious condition)			
Superstructure: _____			
Under girder _____			
Abutment/Pier: _____			
Photos (General view, Side view(Left and Right), Defects, Damages, etc..)

Remarks			
Same as RO4

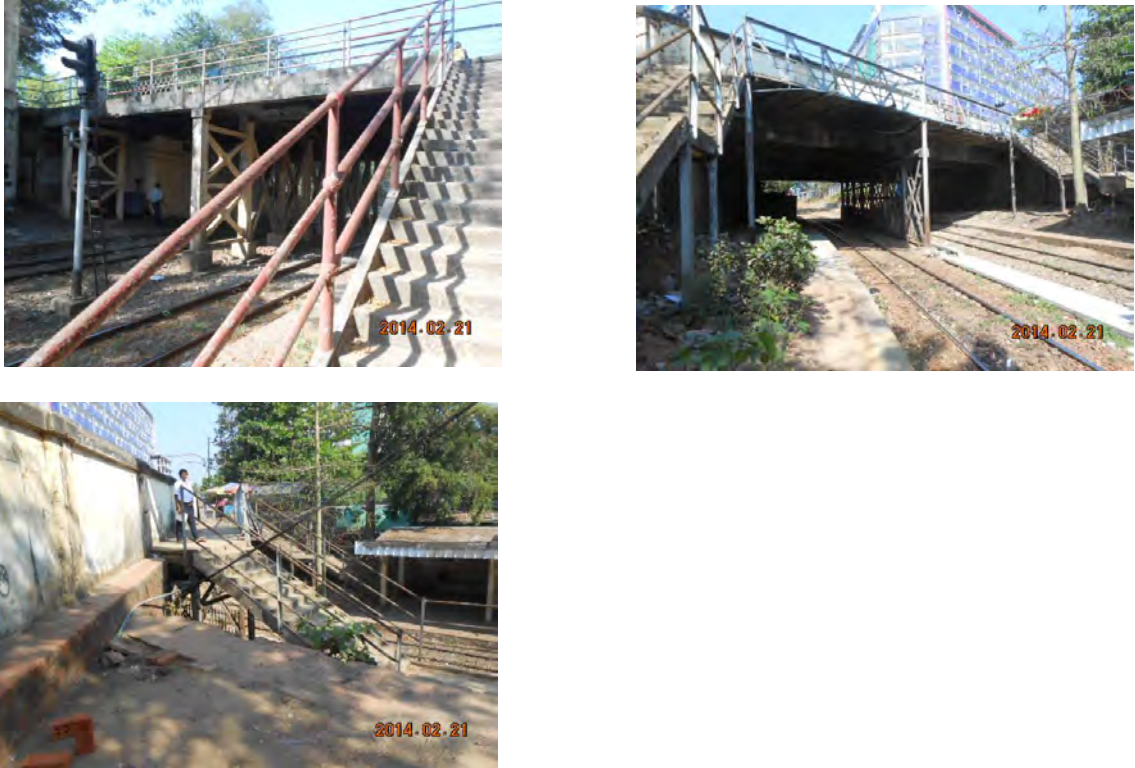
FOB No. : F04		FOB Name : Sayama Road	
Identification No.: C9		Survey Date 2014/2/21	
Between Pyay Rd station		and Shan Rd station	
Mile Post (distance from Yanngon RS.)	MR's official data	Measured by YUTRA※	
clockwise:	1/6-1/7		
anti-clockwise(if any):			
equivalent KM Post (distance from Yangon RS.)			
clockwise:	2.04	2.10	
anti-clockwise(if any):			
Type of FOB :	Year of Built :		
FOB Length :	1 Span @	m =	m
clearance from RL to under girder (m):	4.32		
Location (inside station or not)	not		
FOB Condition Extent and Degree: (A: Sound condition, B: Need Major Repair, C: Serious condition)			
Superstructure: _____			
Under girder _____			
Abutment/Pier: _____			
Photos (General view, Side view(Left and Right), Defects, Damages, etc..)

Remarks			
Same as RO5

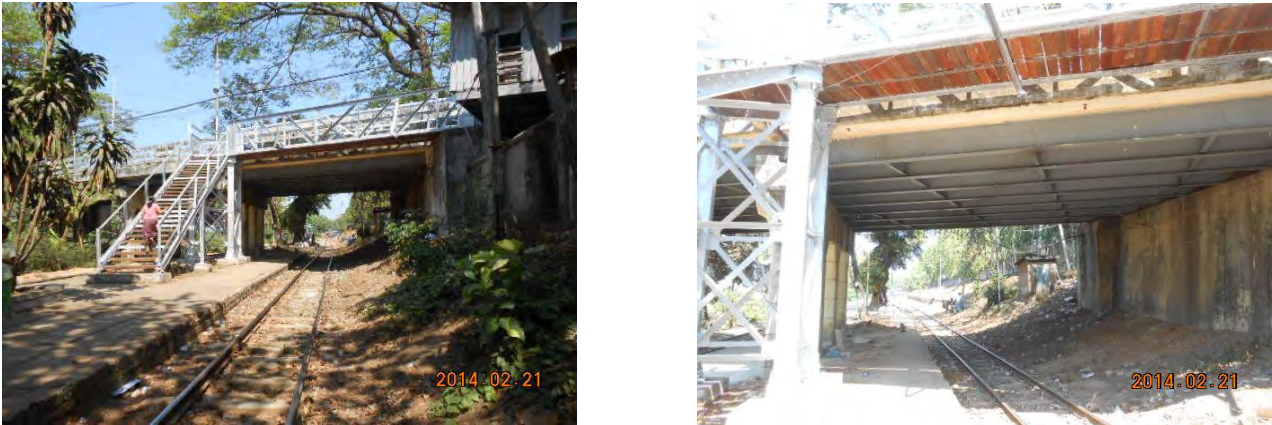
FOB No. : F05		FOB Name : Sayama Road	
Identification No.: C9		Survey Date 2014/2/21	
Between Pyay Rd station		and Shan Rd station	
Mile Post (distance from Yanngon RS.)	MR's official data	Measured by YUTRA※	
clockwise:	1/23-1/24		
anti-clockwise(if any):			
equivalent KM Post (distance from Yangon RS.)			
clockwise:	3.17	2.80	
anti-clockwise(if any):			
Type of FOB : Steel truss	Year of Built :		
FOB Length :	1 Span @	m =	m
clearance from RL to under girder (m):	4.18		
Location (inside station or not)	not		
FOB Condition Extent and Degree: (A: Sound condition, B: Need Major Repair, C: Serious condition)			
Superstructure:	A	Painted	
Under girder	A	Repaired	
Abutment/Pier:	A	Painted	
Photos (General view, Side view(Left and Right), Defects, Damages, etc..)

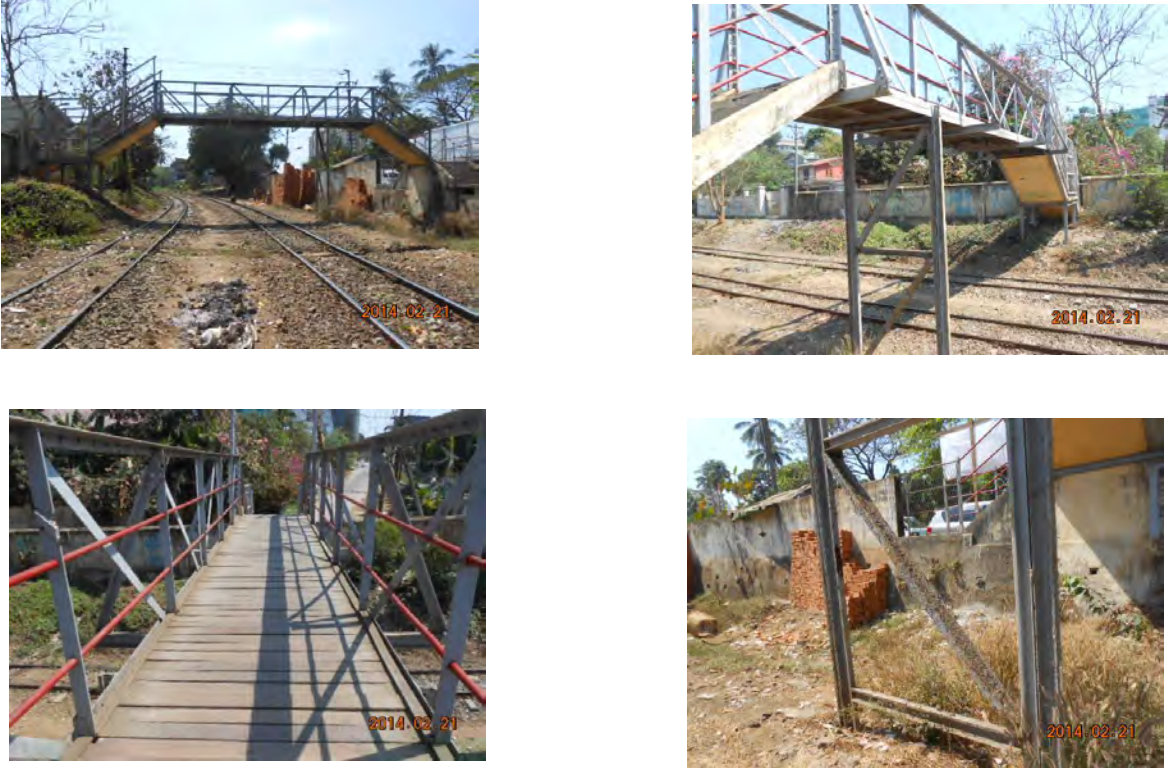
FOB No. : F06		FOB Name : Shan Rd.	
Identification No.: C10BX		Survey Date 2014/2/21	
Between Shan Rd.		station and	Ahlong Rd. station
Mile Post (distance from Yanngon RS.)	MR's official data		Measured by YUTRA※
clockwise:	2/1-2/2		
anti-clockwise(if any):			
equivalent KM Post (distance from Yangon RS.)			
clockwise:	3.31		3.10
anti-clockwise(if any):			
Type of FOB :	Year of Built :		
FOB Length :	Span @	m =	m
Clearance from RL to under girder (m):			
Location (inside station or not)			
FOB Condition Extent and Degree: (A: Sound condition, B: Need Major Repair, C: Serious condition)			
Superstructure: _____			
Under girder _____			
Abutment/Pier: _____			
Photos (General view, Side view(Left and Right), Defects, Damages, etc..)

Remarks			
Same as RO7

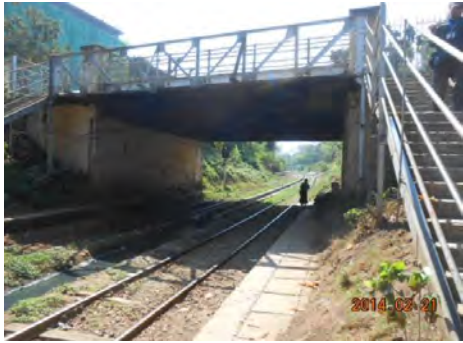
FOB No. : F07			FOB Name : Ahlone		
Identification No.: C10CX			Survey Date 2014/2/21		
Between Shan Rd. station			and Ahlone Rd. station		
Mile Post (distance from Yanngon RS.)		MR's official data		Measured by YUTRA※	
clockwise:		2/5-2/6			
anti-clockwise(if any):					
equivalent KM Post (distance from Yangon RS.)					
clockwise:		3.59		3.66	
anti-clockwise(if any):					
Type of FOB :			Year of Built :		
FOB Length : 1 Span @			m = m		
Clearance from RL to under girder (m): 4.32					
Location (inside station or not)					
FOB Condition Extent and Degree: (A: Sound condition, B: Need Major Repair, C: Serious condition)					
Superstructure: _____					
Under girder _____					
Abutment/Pier: _____					
Photos (General view, Side view(Left and Right), Defects, Damages, etc..)

Remarks					
Same as RO8

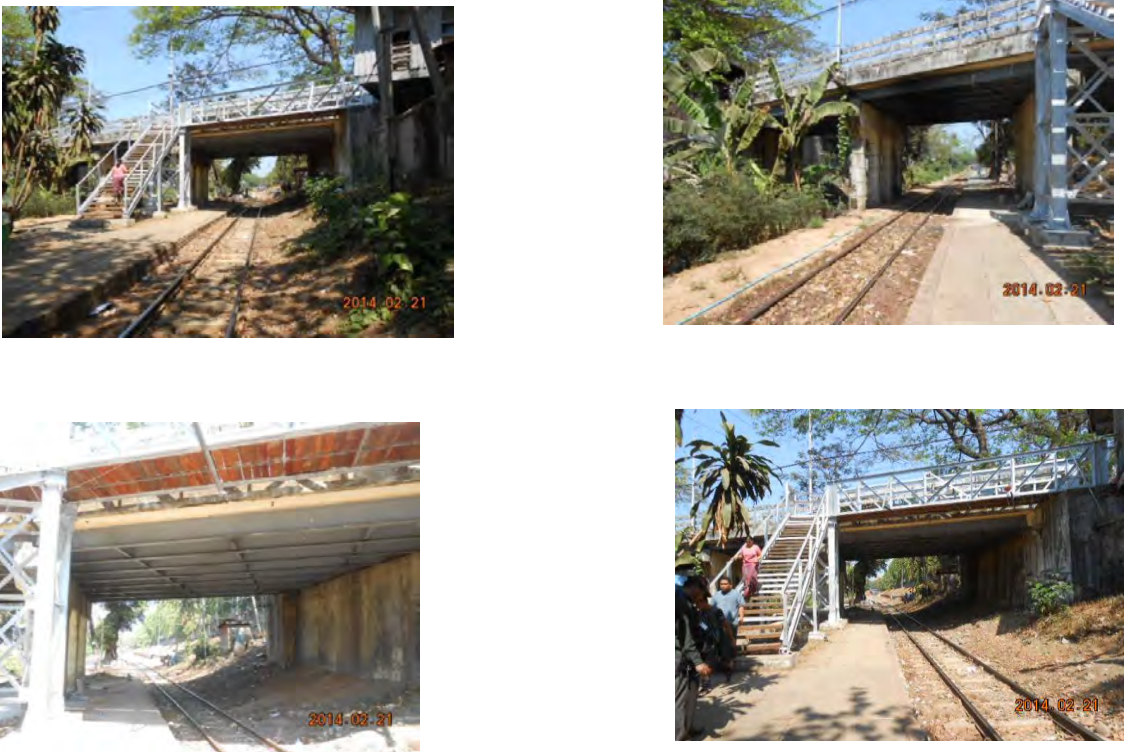
FOB No. : F08		FOB Name : Pan Hlaing	
Identification No.: C12AX		Survey Date 2014/2/21	
Between Panhlaing Rd. station		and Kyeemyindaing station	
Mile Post (distance from Yanngon RS.)	MR's official data	Measured by YUTRA※	
clockwise:	3/1-3/2		
anti-clockwise(if any):			
equivalent KM Post (distance from Yangon RS.)			
clockwise:	4.92	4.55	
anti-clockwise(if any):			
Type of FOB : Steel truss	Year of Built :		
FOB Length :	1 Span @	m =	m
clearance from RL to under girder (m):	4.99		
Location (inside station or not)	Inside		
FOB Condition Extent and Degree: (A: Sound condition, B: Need Major Repair, C: Serious condition)			
Superstructure:	A	Painted	
Under girder	A	Repaired	
Abutment/Pier:	A	Painted	
Photos (General view, Side view(Left and Right), Defects, Damages, etc..)

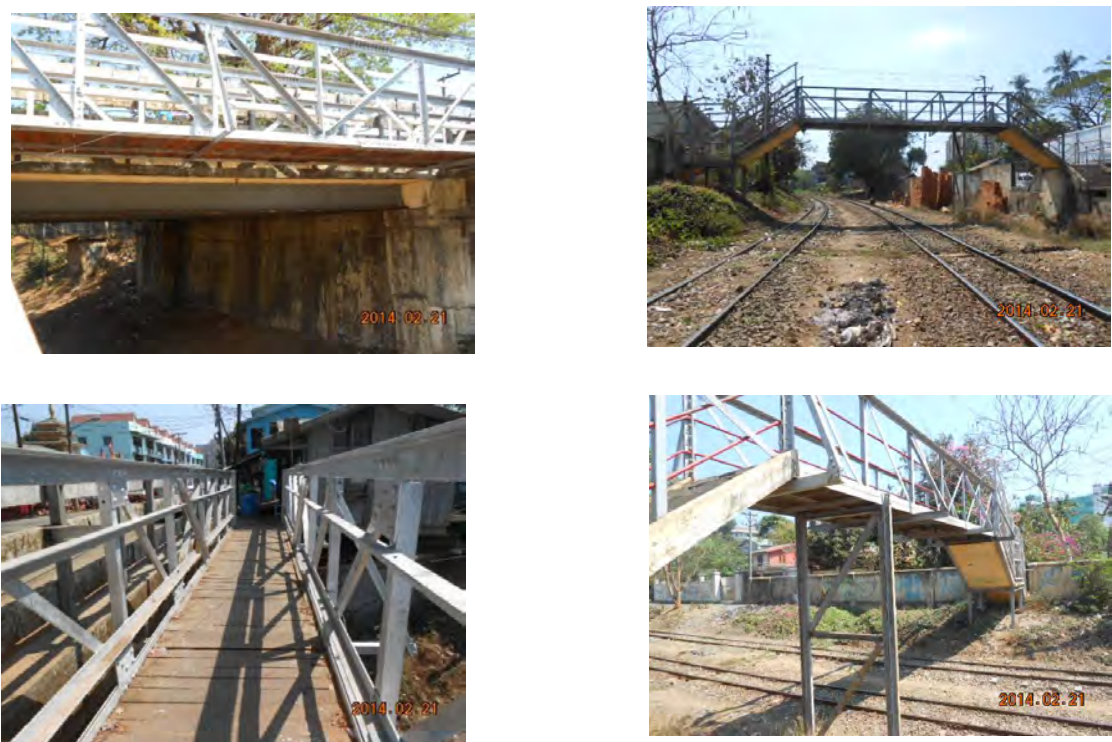
FOB No. : F09		FOB Name : Taw Lan Shaw Lan	
Identification No.: C12BX		Survey Date 2014/2/21	
Between Panhlaing Rd. station		and Kyeemyindaing station	
Mile Post (distance from Yanngon RS.)	MR's official data	Measured by YUTRA※	
clockwise:	3/8-3/9		
anti-clockwise(if any):			
equivalent KM Post (distance from Yangon RS.)			
clockwise:	5.39	4.90	
anti-clockwise(if any):			
Type of FOB : Steel truss	Year of Built :		
FOB Length :	2 Span @	m =	m
clearance from RL to under girder (m):	4.07		
Location (inside station or not)	not		
FOB Condition Extent and Degree: (A: Sound condition, B: Need Major Repair, C: Serious condition)			
Superstructure:	A		
Under girder	A		
Abutment/Pier:	B rust		
Photos (General view, Side view(Left and Right), Defects, Damages, etc..)

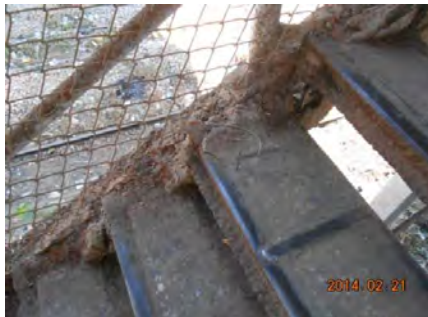
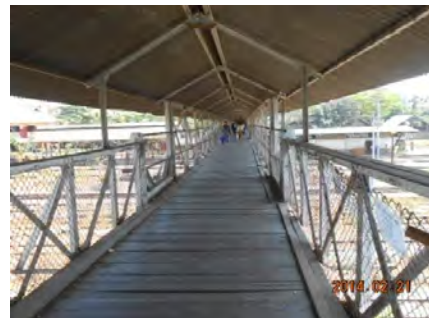
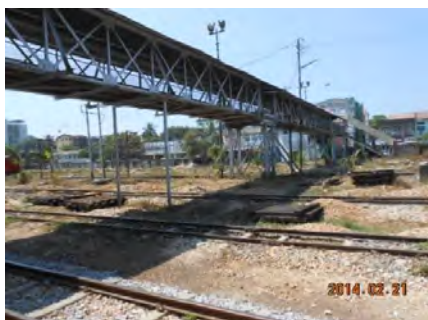
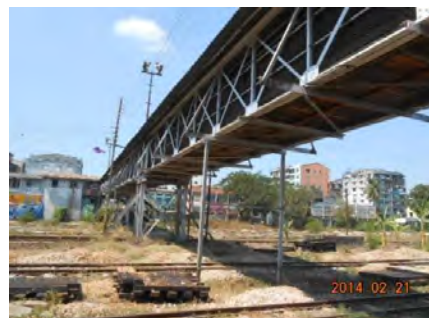
FOB No. : F10		FOB Name : Kyeemyindaing	
Identification No.: C13A		Survey Date 2014/2/21	
Between Panhlaing Rd. station		and Kyeemyindaing station	
Mile Post (distance from Yanngon RS.)	MR's official data	Measured by YUTRA※	
clockwise:	3/12-3/13		
anti-clockwise(if any):			
equivalent KM Post (distance from Yangon RS.)			
clockwise:	5.66	5.50	
anti-clockwise(if any):			
Type of FOB : Steel truss	Year of Built :		
FOB Length :	7 Span @	m =	83.5 m
clearance from RL to under girder (m):	3.88		
Location (inside station or not)	inside		
FOB Condition Extent and Degree: (A: Sound condition, B: Need Major Repair, C: Serious condition)			
Superstructure:	B		
Under girder	A		
Abutment/Pier:	B rust

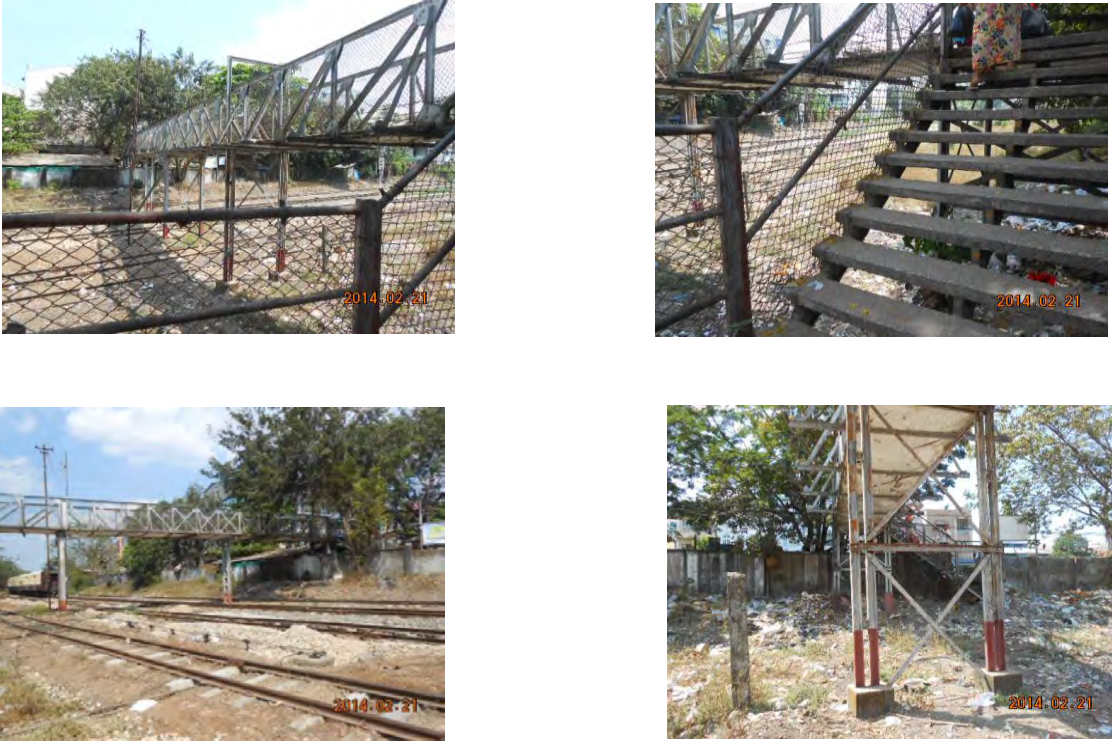
FOB No. : F11		FOB Name : Than Ta Dar	
Identification No.: C13B		Survey Date 2014/2/21	
Between Kyeemyindaing station		and Hanthawaddy station	
Mile Post (distance from Yanngon RS.)	MR's official data	Measured by YUTRA※	
clockwise:	3/17-3/18		
anti-clockwise(if any):			
equivalent KM Post (distance from Yangon RS.)			
clockwise:	6.00	5.90	
anti-clockwise(if any):			
Type of FOB : Steel truss	Year of Built :		
FOB Length :	4 Span @	m =	m
clearance from RL to under girder (m):	4.23		
Location (inside station or not)	Not		
FOB Condition Extent and Degree: (A: Sound condition, B: Need Major Repair, C: Serious condition)			
Superstructure:	B		
Under girder	B-C		
Abutment/Pier:	B		
Photos (General view, Side view(Left and Right), Defects, Damages, etc..)

Remarks	Railway flyover Span

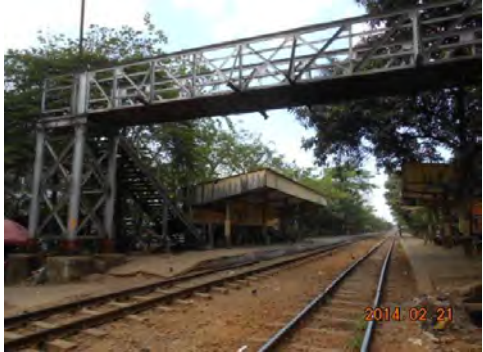
FOB No. : F14		FOB Name : Han Tha Waddy	
Identification No.: C16CX		Survey Date 2014/2/21	
Between Hanthawaddy station		and Hledan station	
Mile Post (distance from Yanngon RS.)	MR's official data	Measured by YUTRA※	
clockwise:	4/19-4/20		
anti-clockwise(if any):			
equivalent KM Post (distance from Yangon RS.)			
clockwise:	7.74	7.50	
anti-clockwise(if any):			
Type of FOB : Steel truss	Year of Built :		
FOB Length :	1 Span @	m =	m
clearance from RL to under girder (m):	4.98		
Location (inside station or not)	inside		
FOB Condition Extent and Degree: (A: Sound condition, B: Need Major Repair, C: Serious condition)			
Superstructure:	B		
Under girder	B		
Abutment/Pier:	A		
Photos (General view, Side view(Left and Right), Defects, Damages, etc..)
