APPENDICIES

APPENDIX 2-1

Number of Freight Train of Myanmar Railways

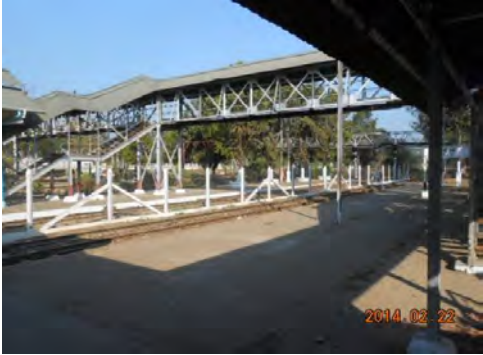
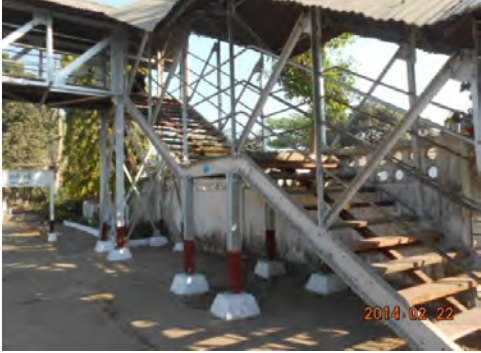
FOB No. : F18			FOB Name : Insein		
Identification No.: C23A			Survey Date 2014/2/22		
Between Insein station and Ywama station					
Mile Post (distance from Yanngon RS.)		MR's official data		Measured by YUTRA※	
clockwise:		9/1-9/2			
anti-clockwise(if any):					
equivalent KM Post (distance from Yangon RS.)					
clockwise:		14.58		14.60	
anti-clockwise(if any):					
Type of FOB : Steel truss			Year of Built :		
FOB Length : 2 Span @			m =		m
Clearance from RL to under girder (m): 4.21					
Location (inside station or not) inside					
FOB Condition Extent and Degree: (A: Sound condition, B: Need Major Repair, C: Serious condition)					
Superstructure:		A			
Under girder		A			
Abutment/Pier:		A			
Photos (General view, Side view(Left and Right), Defects, Damages, etc..)

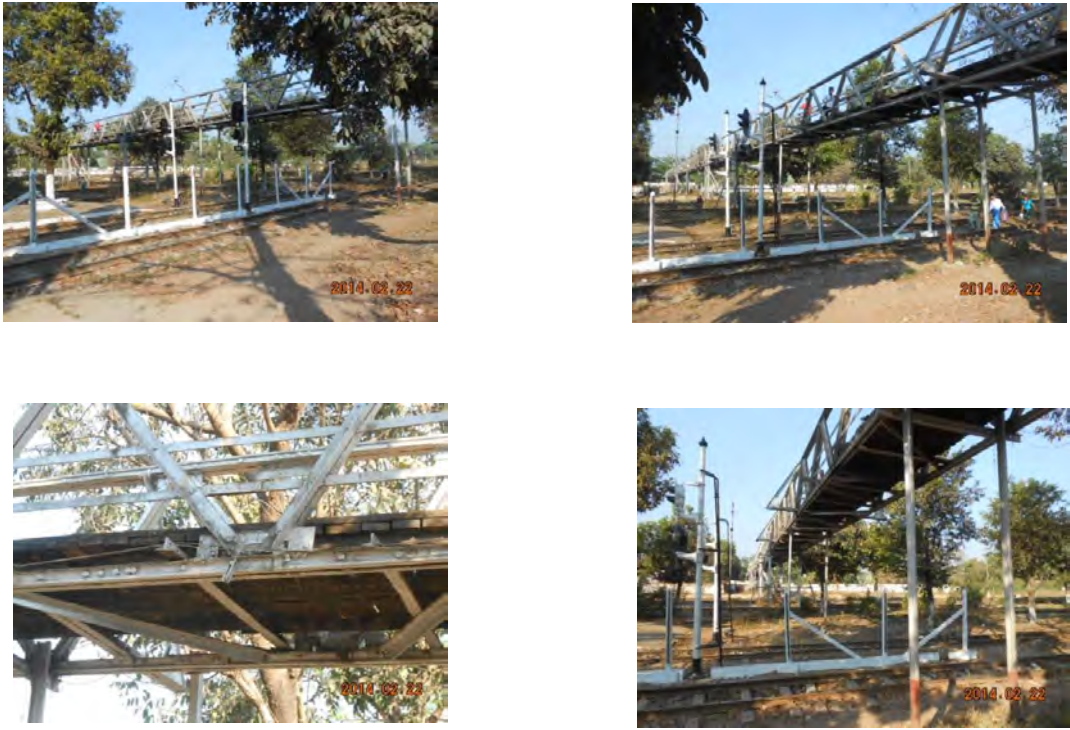
FOB No. : F19		FOB Name : Insein Factory	
Identification No.: C23B		Survey Date 2014/2/22	
Between Insein station		and Ywama station	
Mile Post (distance from Yanngon RS.)	MR's official data	Measured by YUTRA※	
clockwise:	9/2-9/3		
anti-clockwise(if any):			
equivalent KM Post (distance from Yangon RS.)			
clockwise:	14.64	14.64	
anti-clockwise(if any):			
Type of FOB : Steel truss	Year of Built :		
FOB Length :	10 Span @	m =	m
clearance from RL to under girder (m):	3.89		
Location (inside station or not)	inside		
FOB Condition Extent and Degree: (A: Sound condition, B: Need Major Repair, C: Serious condition)			
Superstructure:	B	Need paint	
Under girder	B		
Abutment/Pier:	B		
Photos (General view, Side view(Left and Right), Defects, Damages, etc..)

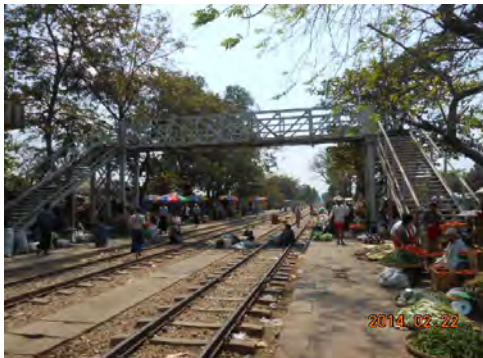
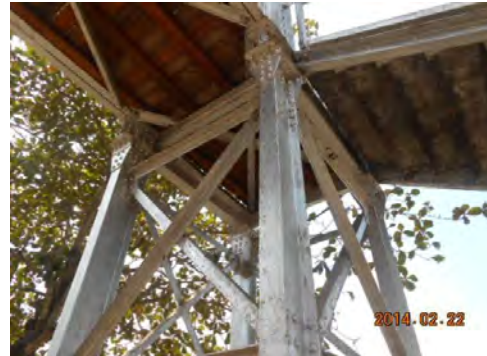
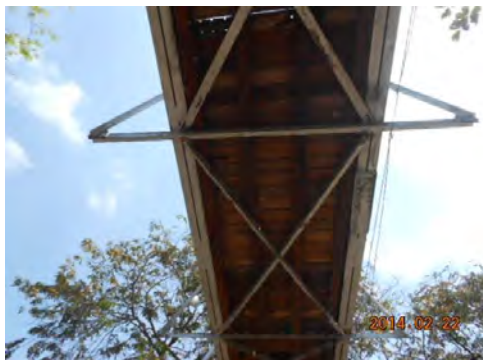
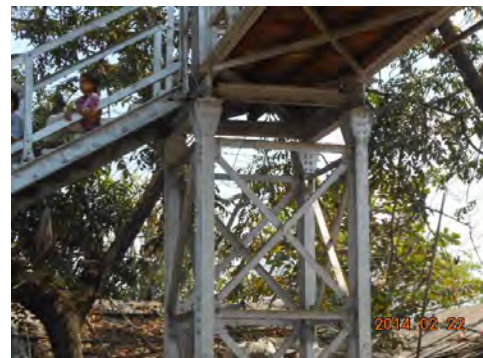
FOB No. : F22		FOB Name : Da Nyin Gone	
Identification No.: C30A		Survey Date 2014/2/22	
Between Danyingone station		and Gauk Kwin station	
Mile Post (distance from Yanngon RS.)	MR's official data	Measured by YUTRA※	
clockwise:	12/14-12/15		
anti-clockwise(if any):			
equivalent KM Post (distance from Yangon RS.)			
clockwise:	20.27	20.33	
anti-clockwise(if any):			
Type of FOB : Steel truss	Year of Built :		
FOB Length :	1 Span @	m =	m
clearance from RL to under girder (m):	4.82		
Location (inside station or not)	inside		
FOB Condition Extent and Degree: (A: Sound condition, B: Need Major Repair, C: Serious condition)			
Superstructure:	A		
Under girder	A		
Abutment/Pier:	A

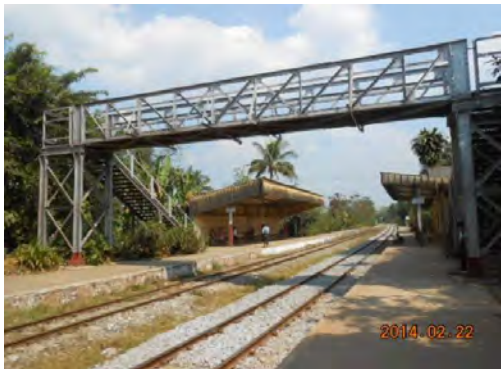
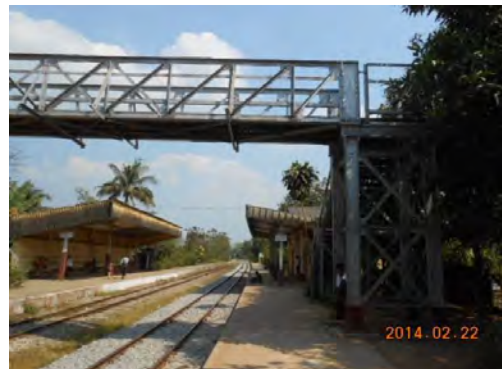
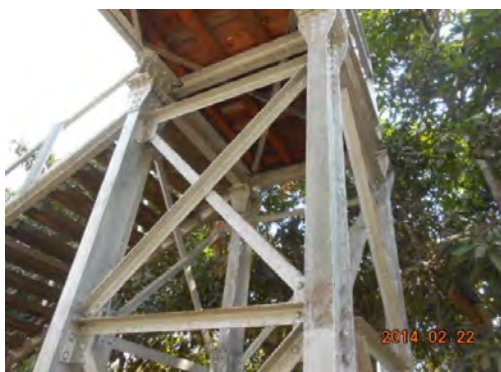
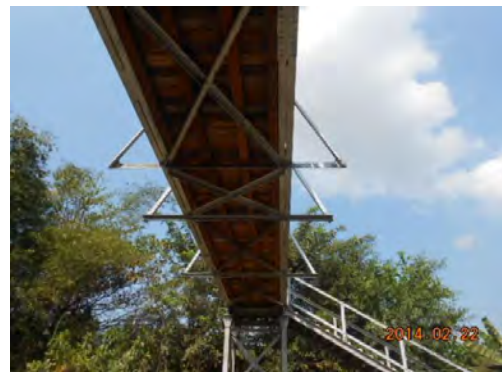
FOB No. : F23		FOB Name : Gout Kwin	
Identification No.: A43AX		Survey Date 2014/2/22	
Between Danyingone station		and Gauk Kwin station	
Mile Post (distance from Yanngon RS.)	MR's official data	Measured by YUTRA※	
clockwise:			
anti-clockwise(if any):	15/4-15/5		
equivalent KM Post (distance from Yangon RS.)			
clockwise:	21.14	21.89	
anti-clockwise(if any):			
Type of FOB : Steel truss	Year of Built :		
FOB Length :	1 Span @	m =	m
clearance from RL to under girder (m):	4.96		
Location (inside station or not)	inside		
FOB Condition Extent and Degree: (A: Sound condition, B: Need Major Repair, C: Serious condition)			
Superstructure:	A		
Under girder	A		
Abutment/Pier:	A

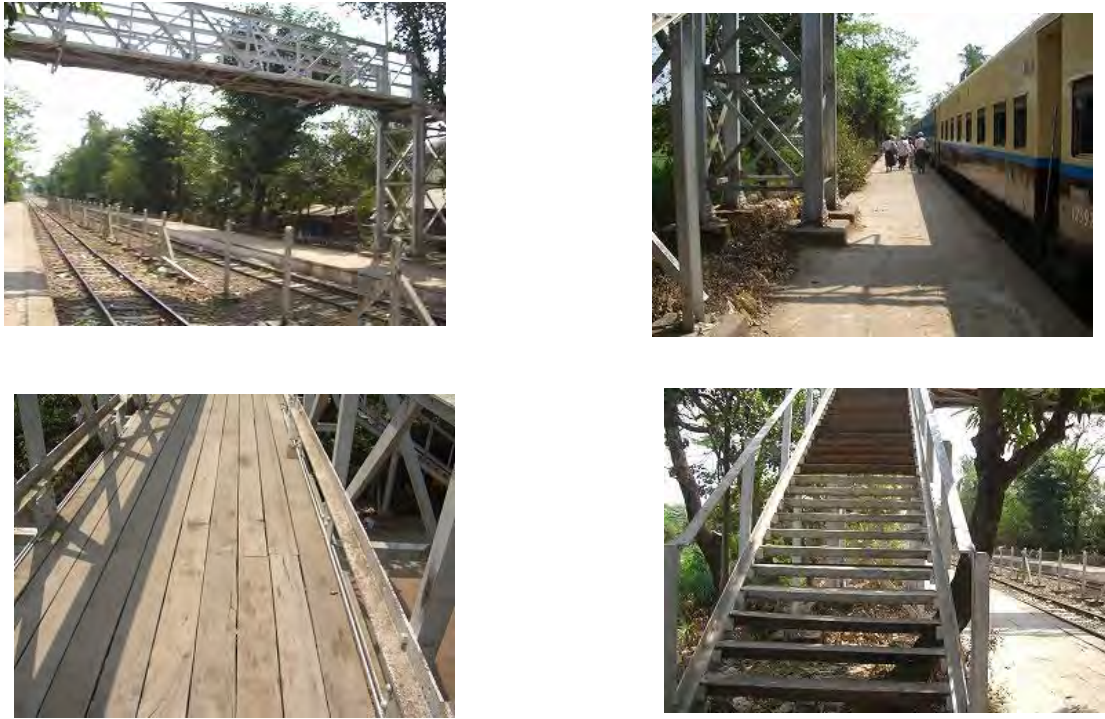
FOB No. : F24		FOB Name : Oakkalapa	
Identification No.: A21DX		Survey Date 2014/2/22	
Between Oakkalapa		station and Paywetseikkor station	
Mile Post (distance from Yanngon RS.)	MR's official data	Measured by YUTRA※	
clockwise:			
anti-clockwise(if any):	10/3-10/4		
equivalent KM Post (distance from Yangon RS.)			
clockwise:	29.25	30.26	
anti-clockwise(if any):			
Type of FOB : Steel truss	Year of Built :		
FOB Length :	1 Span @	m =	m
clearance from RL to under girder (m):	4.94		
Location (inside station or not)	inside		
FOB Condition Extent and Degree: (A: Sound condition, B: Need Major Repair, C: Serious condition)			
Superstructure:	B		
Under girder	B		
Abutment/Pier:	B		
Photos (General view, Side view(Left and Right), Defects, Damages, etc..)

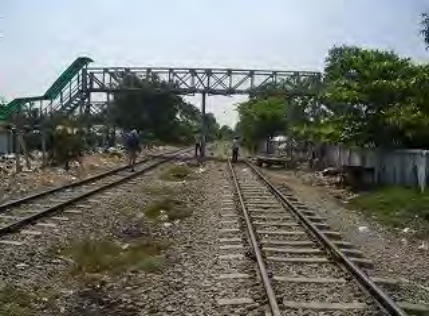
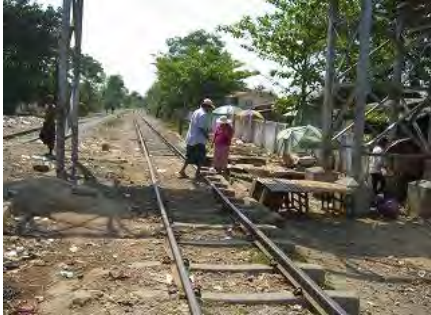
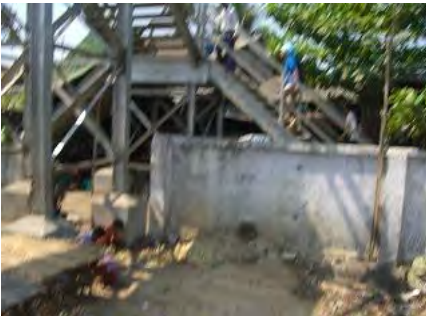
FOB No. : F26		FOB Name : Paywetseikkon Zay	
Identification No.: A21AX		Survey Date 2014/2/22	
Between Paywetseikkon station		and Kyaukyetwin station	
Mile Post (distance from Yanngon RS.)	MR's official data	Measured by YUTRA※	
clockwise:			
anti-clockwise(if any):	9/11-9/12		
equivalent KM Post (distance from Yangon RS.)			
clockwise:	30.33	31.26	
anti-clockwise(if any):			
Type of FOB : Steel truss	Year of Built :		
FOB Length :	1 Span @	m =	m
clearance from RL to under girder (m):	4.48		
Location (inside station or not)	not		
FOB Condition Extent and Degree: (A: Sound condition, B: Need Major Repair, C: Serious condition)			
Superstructure:	A		
Under girder	A		
Abutment/Pier:	A		
Photos (General view, Side view(Left and Right), Defects, Damages, etc..)

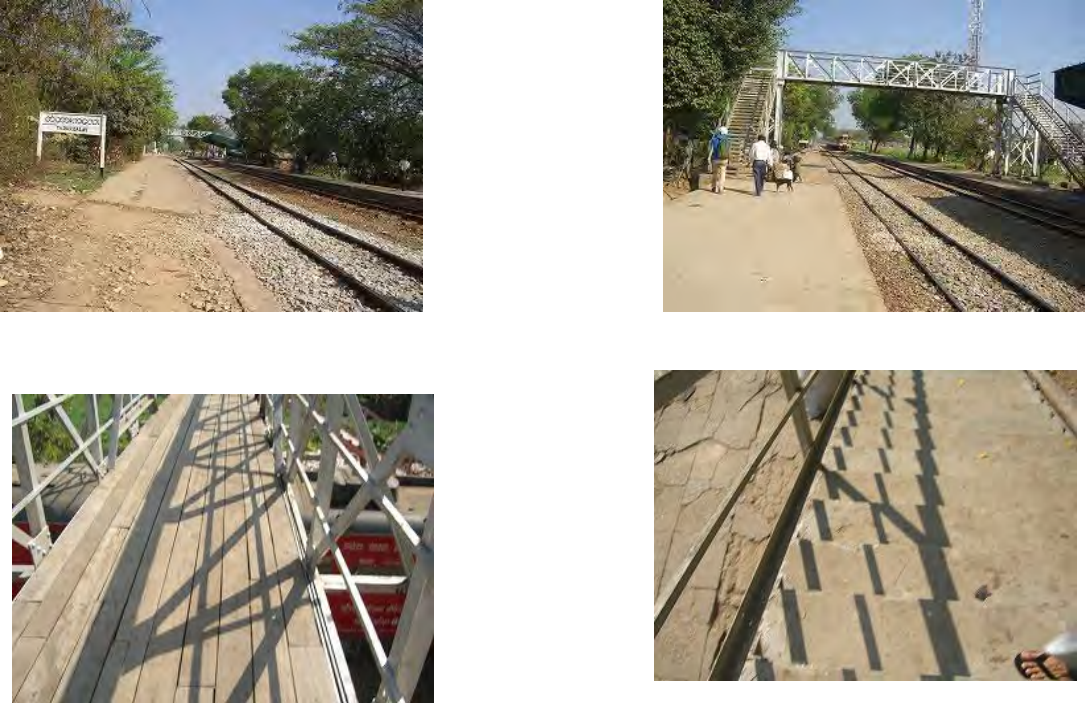
FOB No. : F27		FOB Name : Tadakalay	
Identification No.: A15AX		Survey Date 2014/2/22	
Between Kyaukyetwin station		and Tadakalay station	
Mile Post (distance from Yanngon RS.)	MR's official data	Measured by YUTRA※	
clockwise:			
anti-clockwise(if any):	8/4-8/5		
equivalent KM Post (distance from Yangon RS.)			
clockwise:	32.40	33.46	
anti-clockwise(if any):			
Type of FOB : Steel truss	Year of Built :		
FOB Length :	1 Span @	m =	m
clearance from RL to under girder (m):	4.96		
Location (inside station or not)	inside		
FOB Condition Extent and Degree: (A: Sound condition, B: Need Major Repair, C: Serious condition)			
Superstructure:	B		
Under girder	B		
Abutment/Pier:	B		
Photos (General view, Side view(Left and Right), Defects, Damages, etc..)

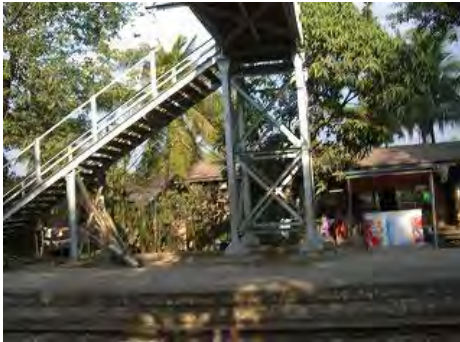
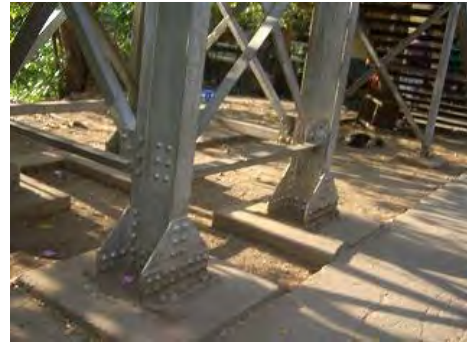
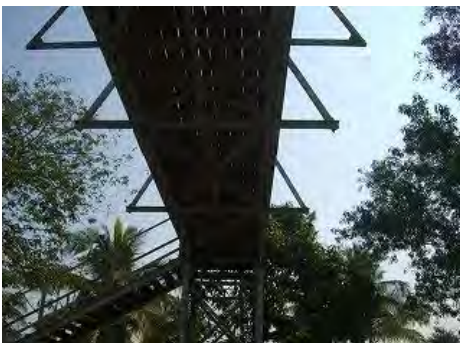
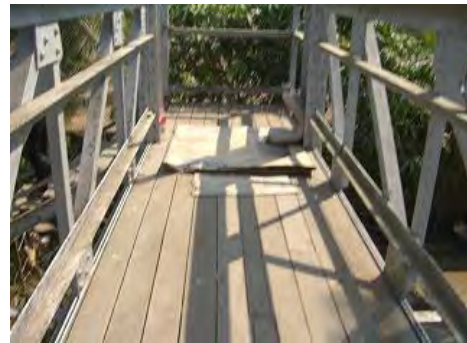
FOB No. : F28		FOB Name : Ye Ku	
Identification No.: A12AX		Survey Date 2014/2/22	
Between Yegu station		and Parame station	
Mile Post (distance from Yanngon RS.)	MR's official data	Measured by YUTRA※	
clockwise:			
anti-clockwise(if any):	7/2-7/3		
equivalent KM Post (distance from Yangon RS.)			
clockwise:	34.14	35.17	
anti-clockwise(if any):			
Type of FOB : Steel truss	Year of Built :		
FOB Length :	1 Span @	m =	m
clearance from RL to under girder (m):	4.95		
Location (inside station or not)	inside		
FOB Condition Extent and Degree: (A: Sound condition, B: Need Major Repair, C: Serious condition)			
Superstructure:	B		
Under girder	B		
Abutment/Pier:	B

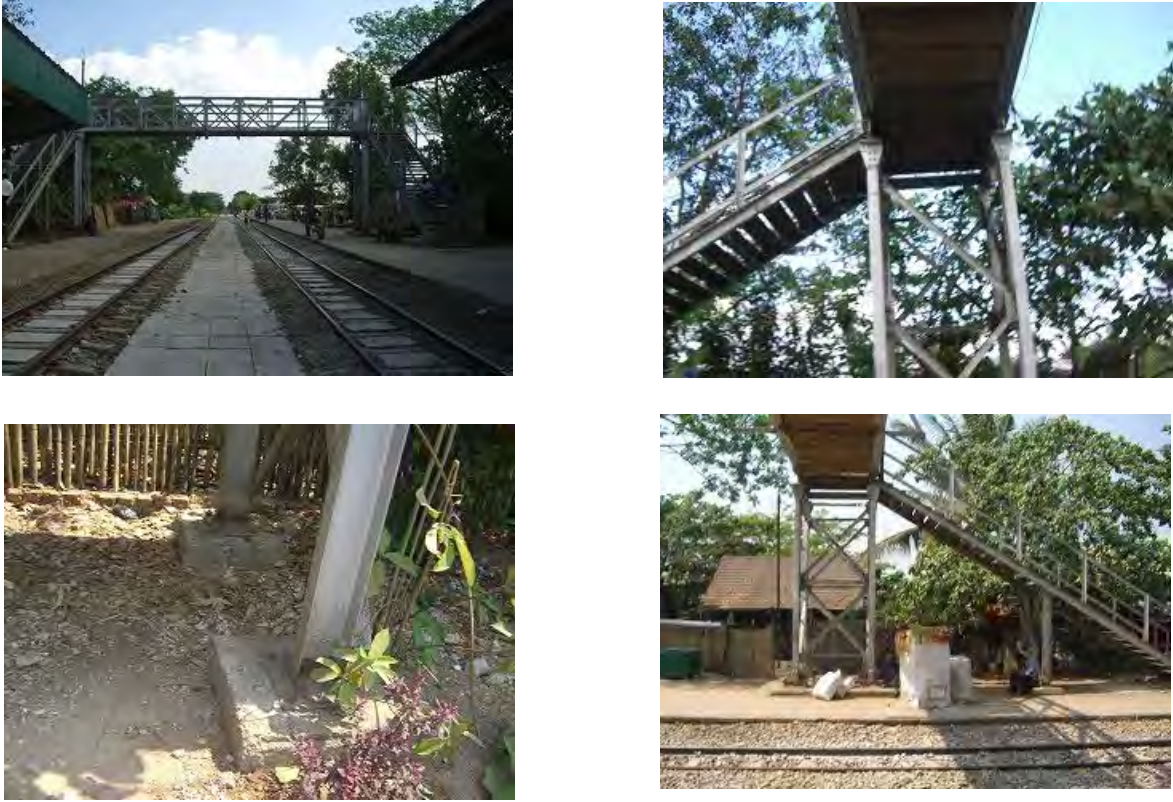
FOB No. : F29		FOB Name : Kanbe	
Identification No.: A7BX		Survey Date 2014/2/22	
Between Kanbe station		and Baukhtaw station	
Mile Post (distance from Yanngon RS.)	MR's official data	Measured by YUTRA※	
clockwise:			
anti-clockwise(if any):	5/13-5/14		
equivalent KM Post (distance from Yangon RS.)			
clockwise:	36.62	37.70	
anti-clockwise(if any):			
Type of FOB : Steel truss	Year of Built :		
FOB Length :	1 Span @	m =	m
clearance from RL to under girder (m):	4.81		
Location (inside station or not)	inside		
FOB Condition Extent and Degree: (A: Sound condition, B: Need Major Repair, C: Serious condition)			
Superstructure:	B		
Under girder	A		
Abutment/Pier:	A		
Photos (General view, Side view(Left and Right), Defects, Damages, etc..)

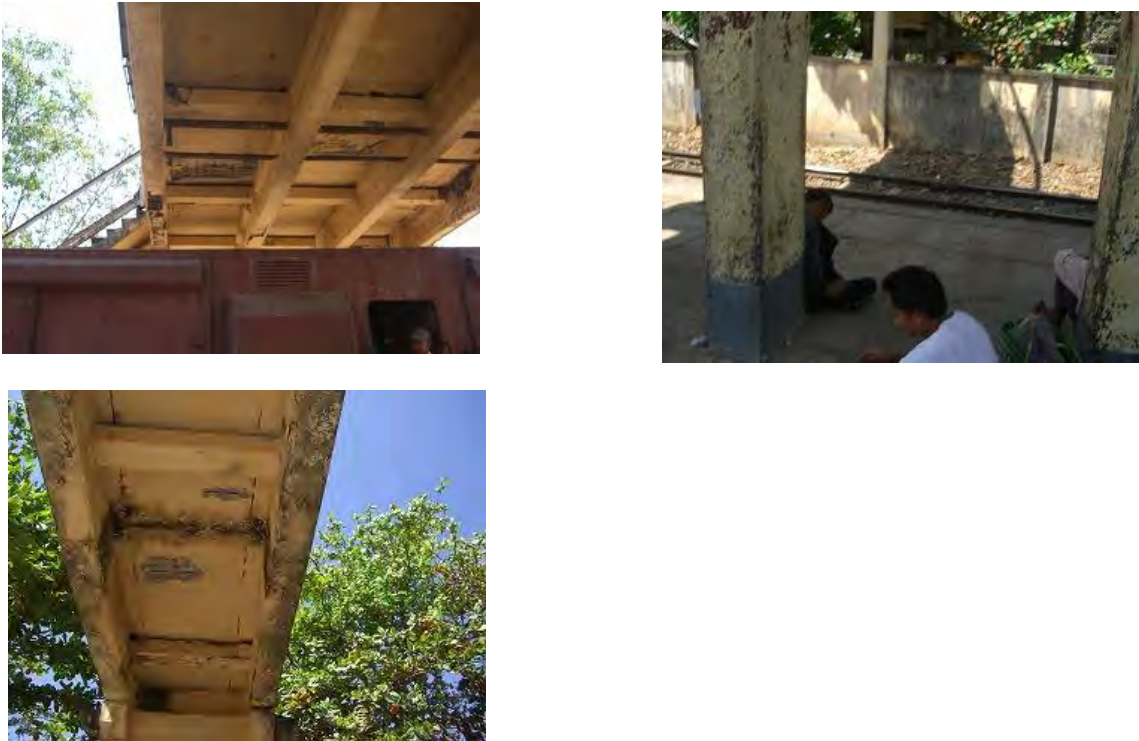
FOB No. : F32		FOB Name :	
Identification No.: YM7		Survey Date 2014/2/22	
Between Malwagone station		and Pazundaung station	
Mile Post (distance from Yanngon RS.)	MR's official data	Measured by YUTRA※	
clockwise:			
anti-clockwise(if any):	2/5-2/8		
equivalent KM Post (distance from Yangon RS.)			
clockwise:	41.91	42.57	
anti-clockwise(if any):			
Type of FOB : RC truss	Year of Built :		
FOB Length :	2 Span @	m =	m
clearance from RL to under girder (m):	4.78		
Location (inside station or not)	inside		
FOB Condition Extent and Degree: (A: Sound condition, B: Need Major Repair, C: Serious condition)			
Superstructure:	B		
Under girder	B		
Abutment/Pier:	B		
Photos (General view, Side view(Left and Right), Defects, Damages, etc..)

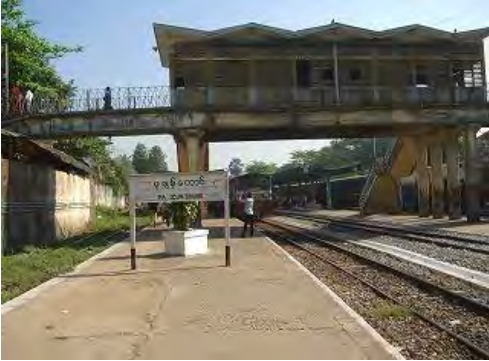
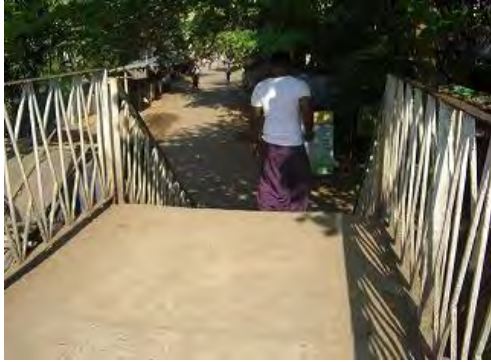
FOB No. : F33			FOB Name :		
Identification No.: YM4			Survey Date 2014/2/22		
Between Pazundaung station			and Yangon Central station		
Mile Post (distance from Yanngon RS.)		MR's official data		Measured by YUTRA※	
clockwise:					
anti-clockwise(if any):		0/21-1/1			
equivalent KM Post (distance from Yangon RS.)					
clockwise:		42.93		44.58	
anti-clockwise(if any):					
Type of FOB : Steel truss			Year of Built :		
FOB Length : 2 Span @			m = m		
Clearance from RL to under girder (m): 4.62					
Location (inside station or not) inside					
FOB Condition Extent and Degree: (A: Sound condition, B: Need Major Repair, C: Serious condition)					
Superstructure:		B			
Under girder		B			
Abutment/Pier:		B			
Photos (General view, Side view(Left and Right), Defects, Damages, etc..)

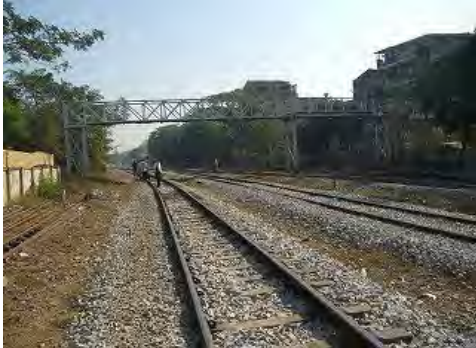
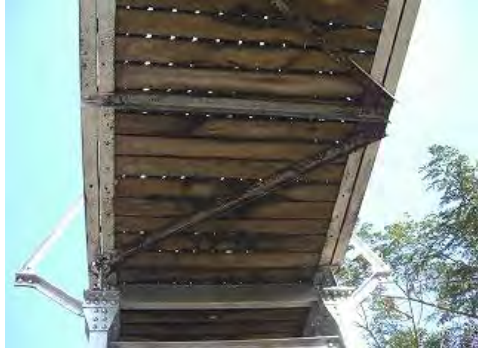
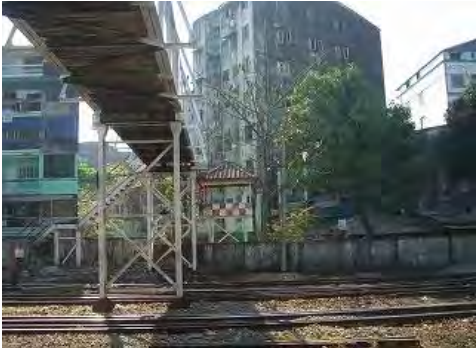
FOB No. : F34			FOB Name :		
Identification No.: YM3A			Survey Date 2014/2/22		
Between Pazundaung station			and Yangon Central station		
Mile Post (distance from Yanngon RS.)		MR's official data		Measured by YUTRA※	
clockwise:					
anti-clockwise(if any):		0/15-0/16			
equivalent KM Post (distance from Yangon RS.)					
clockwise:		43.96		44.96	
anti-clockwise(if any):					
Type of FOB : Steel truss			Year of Built :		
FOB Length : 2 Span @			m =		m
Clearance from RL to under girder (m):			4.78		
Location (inside station or not)			not		
FOB Condition Extent and Degree: (A: Sound condition, B: Need Major Repair, C: Serious condition)					
Superstructure:		B			
Under girder		B			
Abutment/Pier:		A			
Photos (General view, Side view(Left and Right), Defects, Damages, etc..)

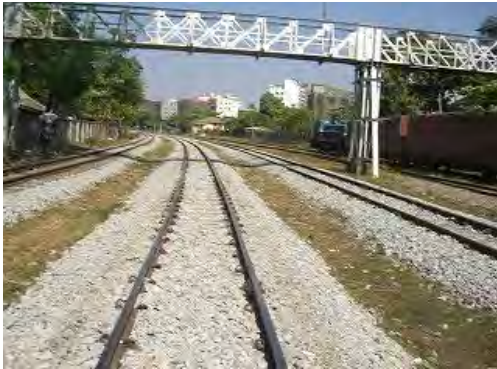
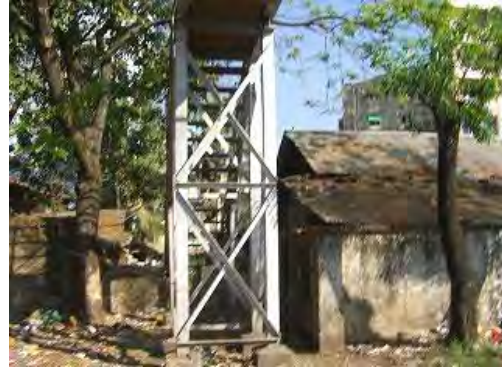
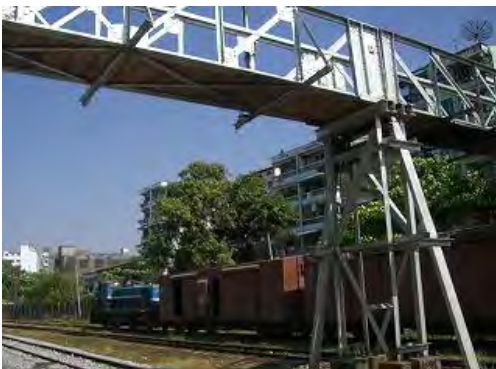
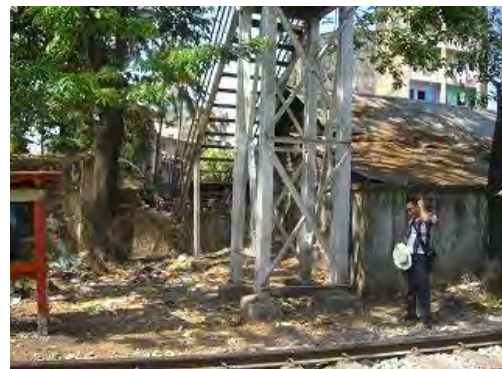
FOB No. : F35		FOB Name :	
Identification No.: YM2B		Survey Date 2014/2/22	
Between Pazundaung station		and Yangon Central station	
Mile Post (distance from Yanngon RS.)	MR's official data	Measured by YUTRA※	
clockwise:			
anti-clockwise(if any):	0/10-0/11		
equivalent KM Post (distance from Yangon RS.)			
clockwise:	44.87	45.34	
anti-clockwise(if any):			
Type of FOB : Steel truss	Year of Built :		
FOB Length :	2 Span @	m =	m
clearance from RL to under girder (m):	4.73		
Location (inside station or not)	not		
FOB Condition Extent and Degree: (A: Sound condition, B: Need Major Repair, C: Serious condition)			
Superstructure:	A		
Under girder	A		
Abutment/Pier:	A

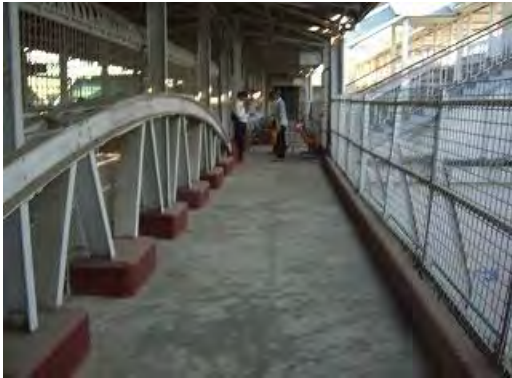
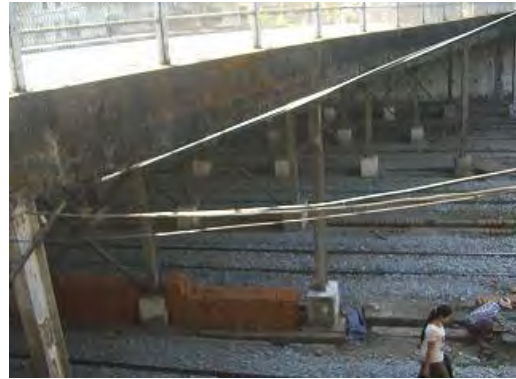
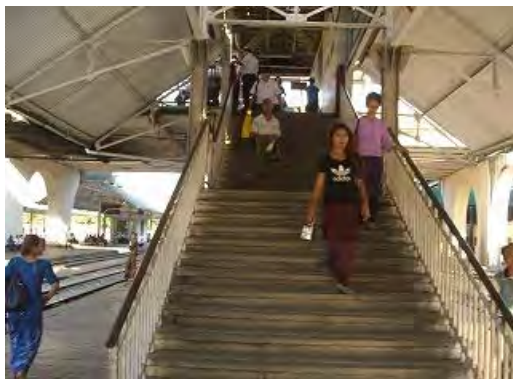
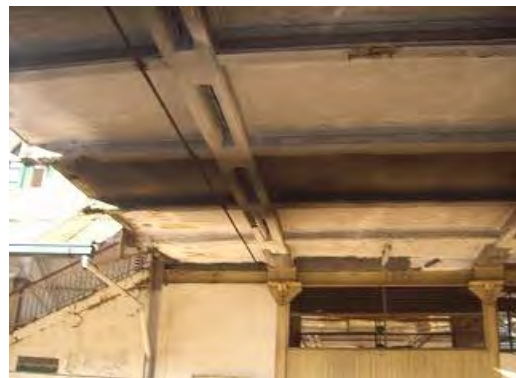
FOB No. : F36		FOB Name :	
Identification No.: C1AX		Survey Date 2014/2/22	
Between Pazundaung station		and Yangon Central station	
Mile Post (distance from Yanngon RS.)	MR's official data	Measured by YUTRA※	
clockwise:			
anti-clockwise(if any):	0/1		
equivalent KM Post (distance from Yangon RS.)			
clockwise:	45.53	46.11	
anti-clockwise(if any):			
Type of FOB : RC truss	Year of Built :		
FOB Length :	3 Span @	m =	m
clearance from RL to under girder (m):	4.74		
Location (inside station or not)	inside		
FOB Condition Extent and Degree: (A: Sound condition, B: Need Major Repair, C: Serious condition)			
Superstructure:	B		
Under girder	B		
Abutment/Pier:	B
