APPENDIX 2

橋梁検査台帳

INVESTIGATION RECORD SHEET FOR BRIDGE

Line Name		Western Line		Date of Survey		03/10/2012			
Bridge No.		1		Mileage		1 1/4 + 1208'			
Chief Civil Engineer		William Acken		Inspector		GRCL: Mr.Amissah JICA Study Team: Osamu Ohkawa			
Type of Superstructure (Bridge Length & Number of Spans)		Steel deck plate girder 66' 00" × 1(span) = 66' 00"							
Type of Substructure		Plain concrete abutment							
Photograph

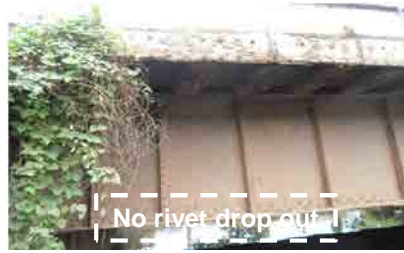
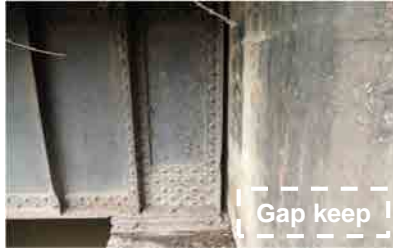
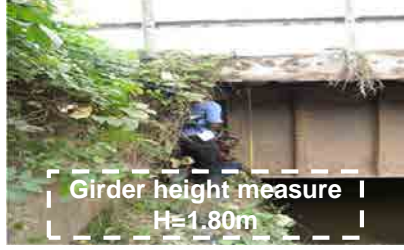
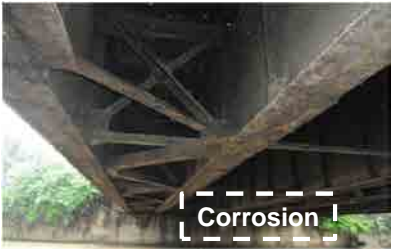
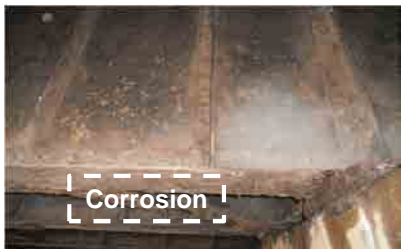
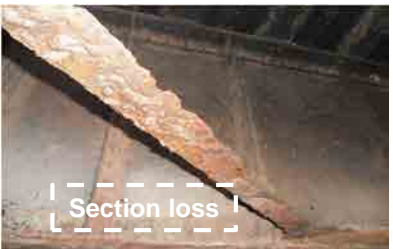
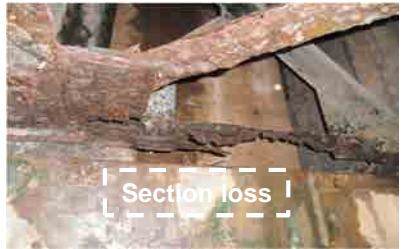
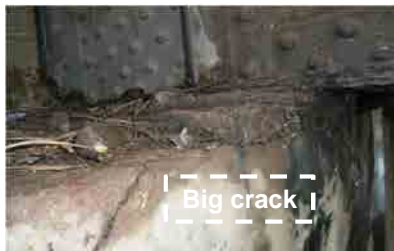
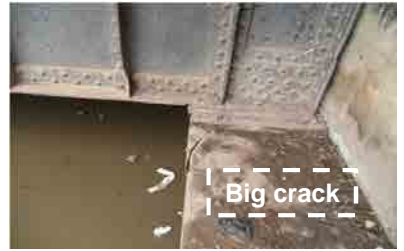
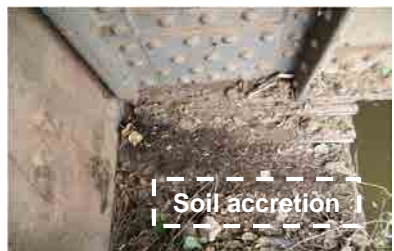
Comment		<p>鋼橋全体が錆びている。桁下空間が低い為の下フランジの腐食が激しく、断面欠損が見られる。 リベットの欠落は見られない。 下部工は錆汁が見られない。 パラペットのひび割れに対して、幅および長さを継続的に観察して、記録をとる必要がある。 基礎の洗掘に対してフトン籠により基礎を保護すべきである。</p>							
Overall Evaluation		Level-1 (Ordinary)		Level-2 (Notice)		Level-3 (Small Emergency)		Level-4 (Large Emergency)

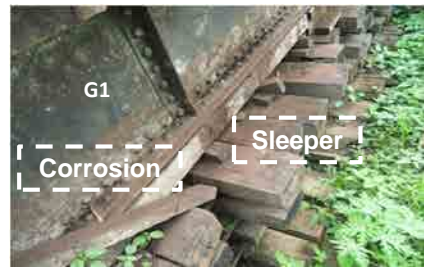
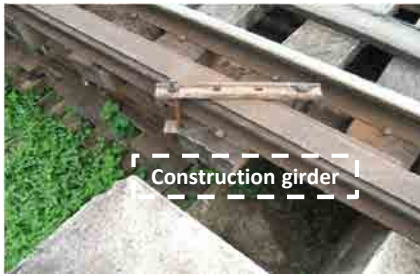
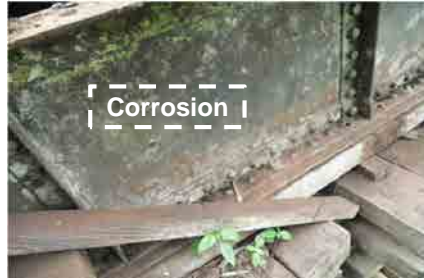
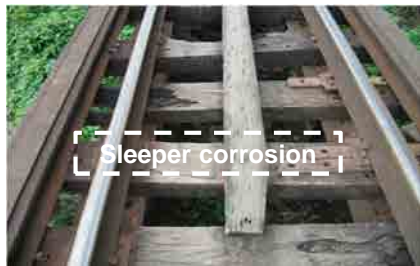
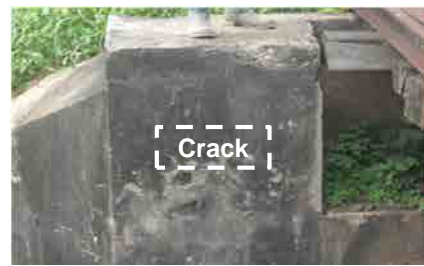
Comment		<p>洗掘によりTakoradi方の橋台(A1)が倒壊している。 上部工は、木枕木を使用して盛り替え、レール桁により軌道を保護している。 鋼橋全体が錆びている。リベットの欠落は見られない。 下部工は錆汁が見られない。 河川の切り回しはすでに完了していることから、早急に桁を撤去し、盛土により復旧することが望ましい。</p>							
Overall Evaluation		Level-1 (Ordinary)		Level-2 (Notice)		Level-3(Small Emergency)		Level-4(Large Emergency)

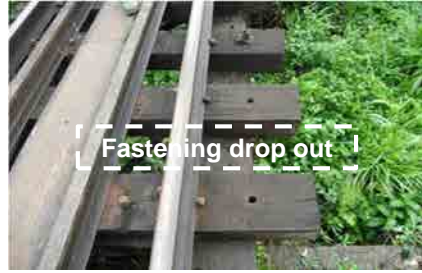
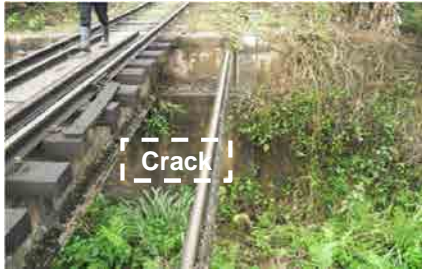
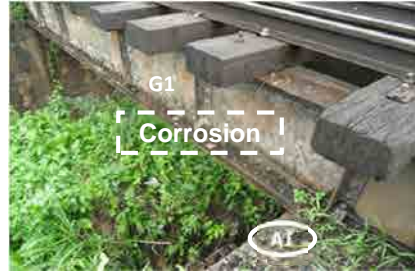
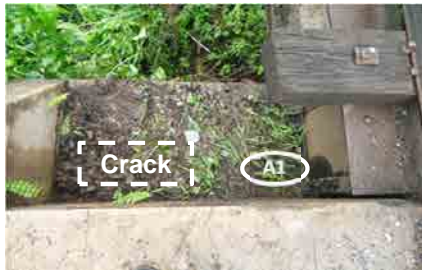
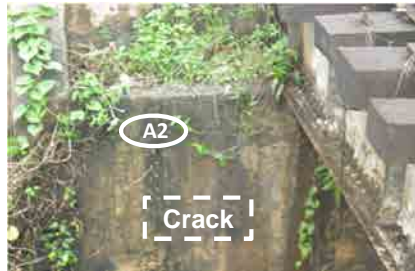
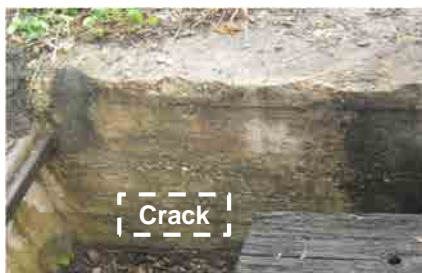
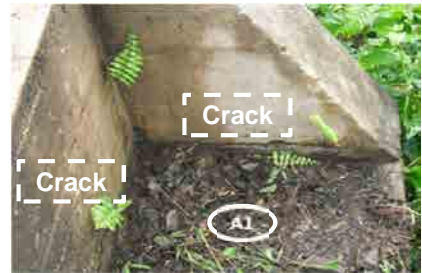
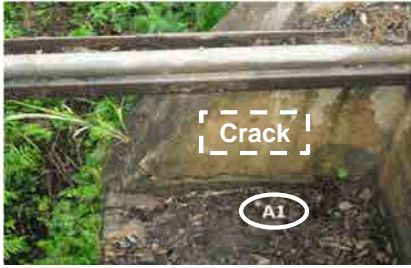
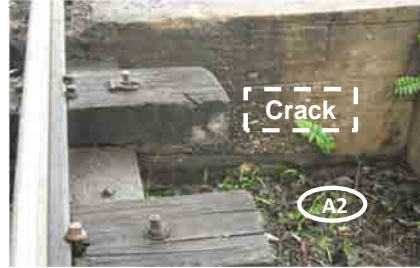
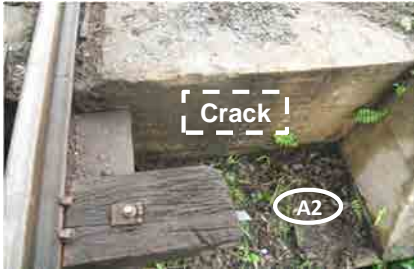
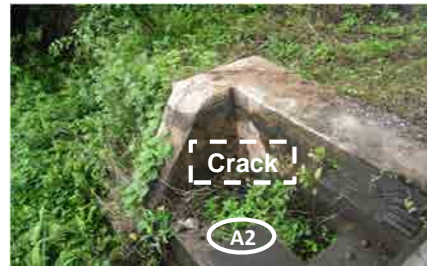
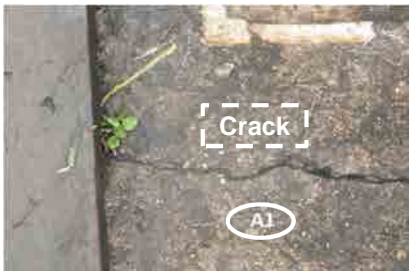
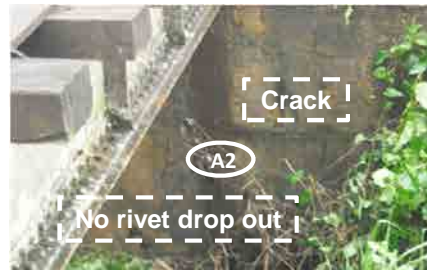
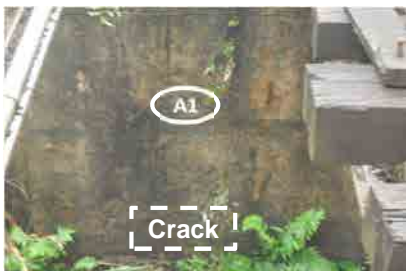
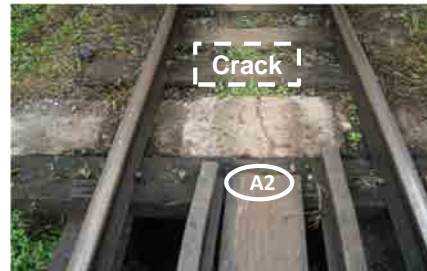
Comment		<p>鋼橋全体が錆びている。 リベットの欠落は見られない。 A1,A2橋台ともにパラペット前面、躯体前面に乾燥収縮と思われる大きな水平のクラックが見られる。 下部工は錆汁が見られない。</p>							
Overall Evaluation		Level-1 (Ordinary)		Level-2 (Notice)		Level-3 (Small Emergency)		Level-4 (Large Emergency)

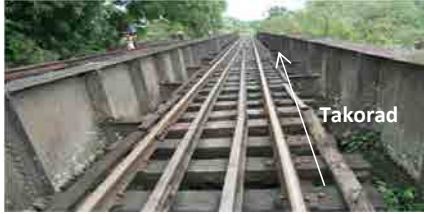
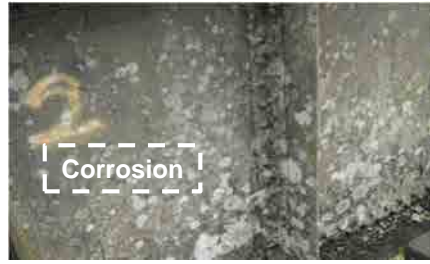
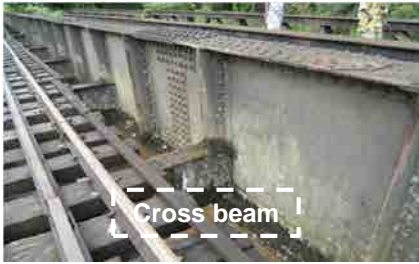
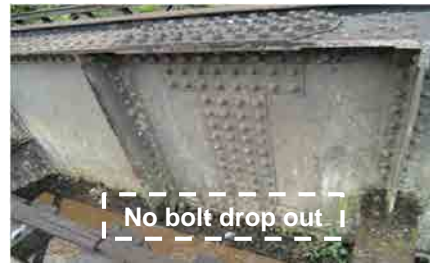
Comment		<p>鋼橋全体が錆びている。 リベット、添接板のボルトの欠落は見られない。 A1,A2橋台ともにパラペット前面、躯体前面に乾燥収縮と思われる大きな水平のクラックが見られる。 P1,P2橋脚には水平力が微小であり、部材寸法が比較的大きいので特に問題は無い。 下部工は錆汁が見られない。</p>							
Overall Evaluation		Level-1 (Ordinary)		Level-2 (Notice)		Level-3(Small Emergency)		Level-4(Large Emergency)

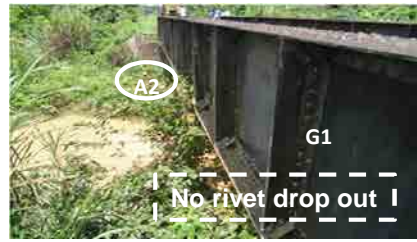
(Photo1)

Comment		<p>鋼桁全体が錆びている。 リベットの欠落は見られない。 A1,A2橋台ともにパラペット前面、躯体前面に乾燥収縮と思われる大きな水平のクラックが見られる。 沓の移動によりパラペット前面側で、コンクリートの破壊が見られる。ボルトの緩みを改善する必要がある。 下部工は錆汁が見られない。</p>							
Overall Evaluation		Level-1 (Ordinary)		Level-2 (Notice)		Level-3 (Small Emergency)		Level-4 (Large Emergency)

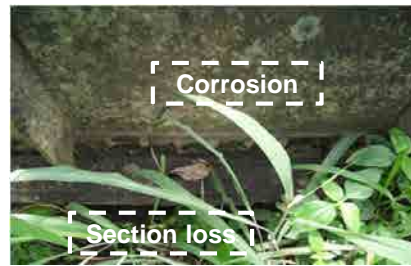
(Photo1)

Comment		<p>鋼橋全体が錆びている。 リベットの欠落は見られない。 A1,A2橋台ともにパラペット前面、躯体前面に乾燥収縮と思われる大きな水平のクラックが見られる。 P1橋脚には水平力が微小であり、部材寸法が比較的大きいので特に問題は無い。 下部工は錆汁が見られない。</p>							
Overall Evaluation		Level-1 (Ordinary)		Level-2 (Notice)		Level-3 (Small Emergency)		Level-4 (Large Emergency)

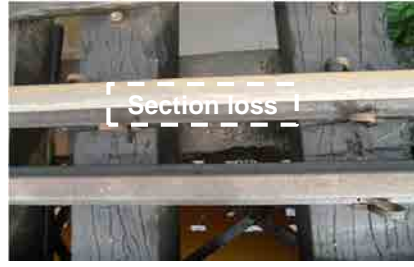
(Photo1)

Comment		<p>桁下空間が低い為、洪水時に桁下面が水に浸かっている可能性がある。</p> <p>鋼橋全体が錆びている。</p> <p>リベットの欠落は見られない。</p> <p>A1,A2橋台ともにパラベット前面、躯体前面に乾燥収縮と思われる大きな水平のクラックが見られる。</p> <p>下部工は錆汁が見られない。</p>							
Overall Evaluation		Level-1 (Ordinary)		Level-2 (Notice)		Level-3 (Small Emergency)		Level-4 (Large Emergency)

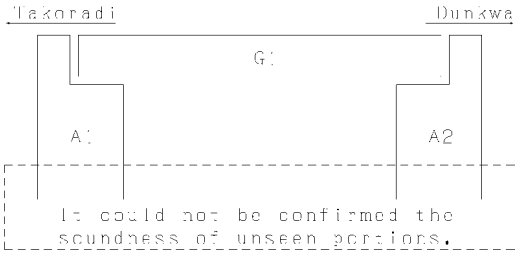
Diagram

<p>It could not be confirmed the soundness of unseen portions.</p>							
Evaluation of Superstructure	Condition	Girder 1		/	/	/	/		
		Usual							
		Rusty							
		Corroded							
		Cracked							
		Unstable							
Handling	Nothing								
Evaluation of Substructure	Condition	Abut 1		/	/	/	/		
		Usual							
		Exposed Bar							
		Cracked							
		Flaked							
		Scoured							
		Unstable							
	Handling	Nothing						Abut 2	
		Usual							
		Exposed Bar							
		Cracked							
		Flaked							
		Scoured							
		Unstable

Nothing							
Comment		<p>鋼橋全体が錆びている。 リベットの欠落は見られない。 A1,A2橋台ともにパラペット前面、躯体前面に乾燥収縮と思われる大きな水平のクラックが見られる。 下部工は錆汁が見られない。</p>							
Overall Evaluation		Level-1 (Ordinary)		Level-2 (Notice)		Level-3(Small Emergency)		Level-4(Large Emergency)

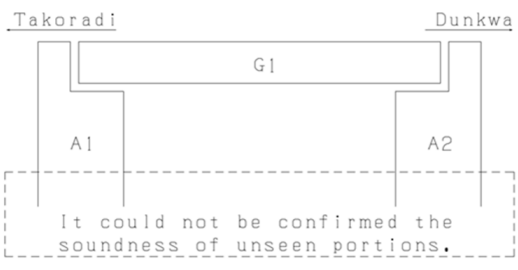
Diagram

<p>It could not be confirmed the soundness of unseen portions.</p>							
Evaluation of Superstructure	Condition	Girder 1		/	/	/	/		
		Usual							
		Rusty							
		Corroded							
		Cracked							
		Unstable							
Handling	Nothing								
Evaluation of Substructure	Condition	Abut 1		/	/	Abut 2			
		Usual				Usual			
		Exposed Bar				Exposed Bar			
		Cracked				Cracked			
		Flaked				Flaked			
		Scoured				Scoured			
		Unstable				Unstable			
	Handling	Nothing		Nothing

Comment		<p>鋼橋全体が錆びている。 リベットの欠落は見られない。 A1,A2橋台ともにパラペット前面、躯体前面に乾燥収縮と思われる大きな水平のクラックが見られる。 下部工は錆汁が見られない。</p>							
Overall Evaluation		Level-1 (Ordinary)		Level-2 (Notice)		Level-3 (Small Emergency)		Level-4 (Large Emergency)

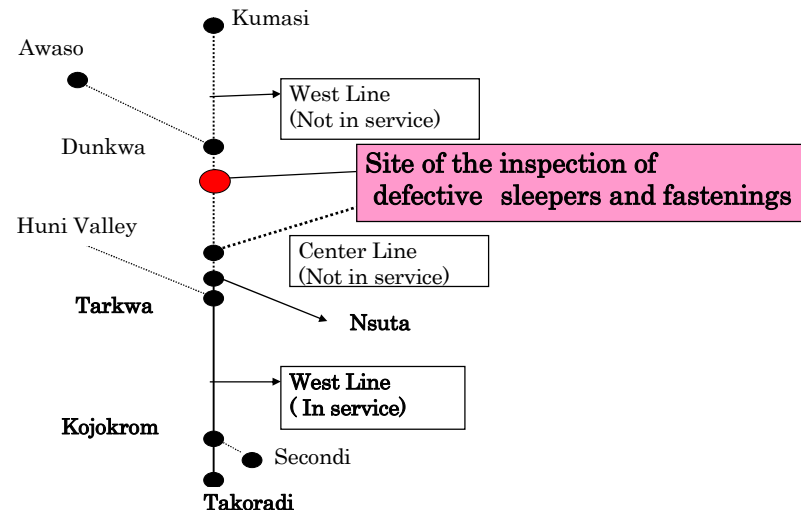
Drawing of defective sleepers and fastenings (1)

Result Example of the Inspection of Defective Sleepers and Fastenings (Imbraim~Buabin Section)

Ratio of defective sleepers=43%
(26/60)

Ratio of defective fastenings=59%
(141/(60 × 4))

- Establishment of standard for defective sleeper and fastening
- Periodical inspection (Once a year- Japanese Standard)
- Make drawings for controlling defective materials.
- This action should be carried out as soon as possible Between Takoradi and Nsuta .

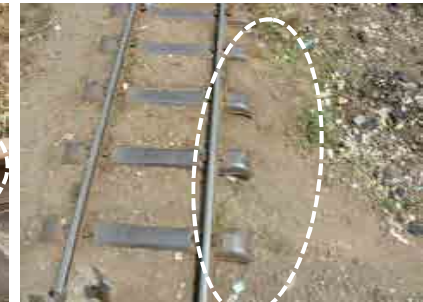
Ballast under the sleeper is too short and width of formation does not measure to standard (Takoradi ~ Kojokrom section)

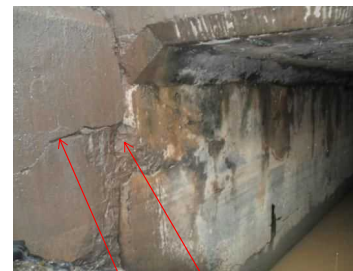
Crack

- Watch flaking of concrete and progression of crack.
- Hit the surface of the concrete with a hammer and determine the degree of floating.
- Strengthen visual checks on the abutment (collapse) of Manso.

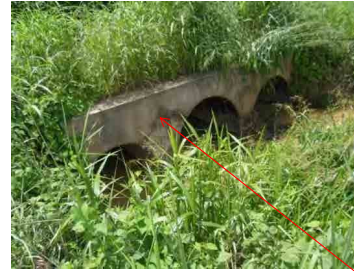
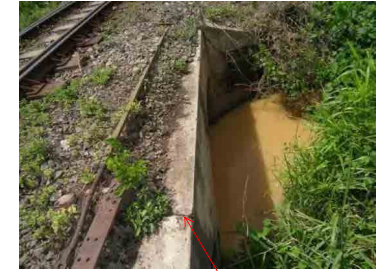
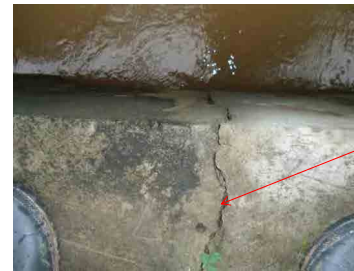
Flaking

Crack

- For the abutment of Manso, construct a temporary support and pile sand bags to prevents the inflow of water.
- For cracks and flaking of the concrete, carry out the injection method.

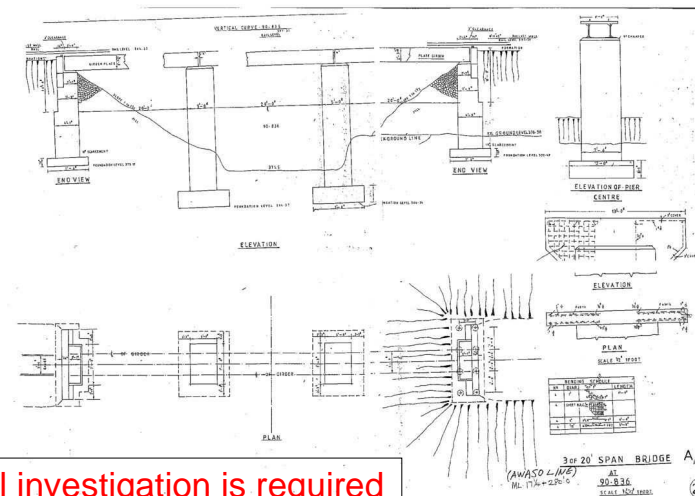
Soil investigation is required for bridge design

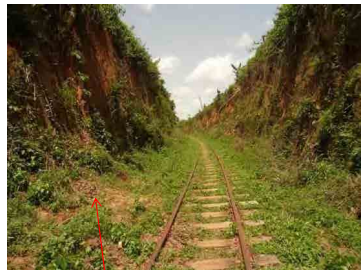
Landslide soil

- Watch for defects in the banking and cutting and signs of collapse regularly.
- Watch for defects in the banking and cutting immediately after heavy rain.
- When there is a risk of the collapse, the train service must be limited.

- In the banking area, infiltrated water must be prevented from entering the banking.
- In the cutting area, remove the risk of the collapse beforehand.

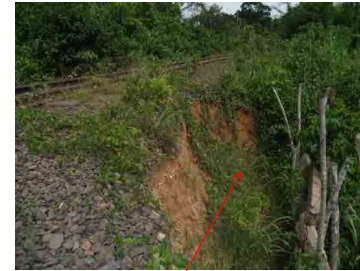
Deep landslide collapse
