**STUDY FOR  
SAFETY OPERATION AND MANAGEMENT  
OF  
RAILWAY IN GHANA

FINAL REPORT**

**JULY 2014**

**JAPAN INTERNATIONAL COOPERATION AGENCY**

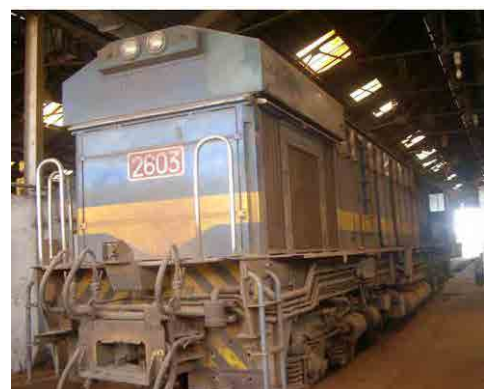
One of the main reasons for which 52% of the freight cars/locomotives were not operated in 2008 is the lack of signalling, train control system & station facilities, defective rolling stock (locomotives/passenger coaches/freight cars), and the lack of appropriate maintenance for track structure. The old-fashioned rolling stocks which have been used for more than 45 years could not have been kept in sufficiently good conditions because of the spare parts, i.e. wheel axles, the parts relating to the engine systems and brake systems were not available. Therefore, almost all the rolling stocks are left in the depot.

**Figure 3 Derelict Locomotive**

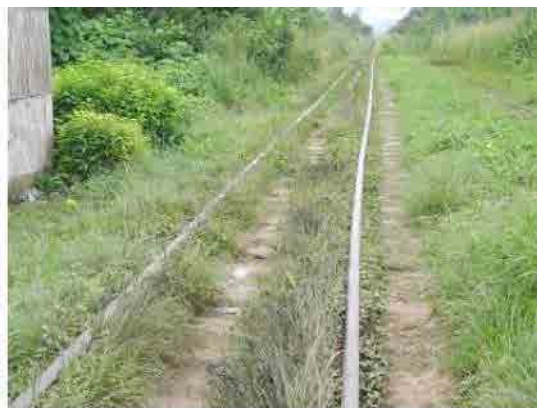
The insufficient track maintenance: the levels of left and right rails were not being adjusted, resulting in gauge irregularities, which have resulted in causing the heavy rolling when the rolling stocks are passing through such locations.

- Worn rails.
- Sleepers (wooden, some parts are steel) have been used beyond their estimated service life.
- Ballast under the sleepers is missing mostly from bottom of outer rails.

**Figure 4 Waving Track**

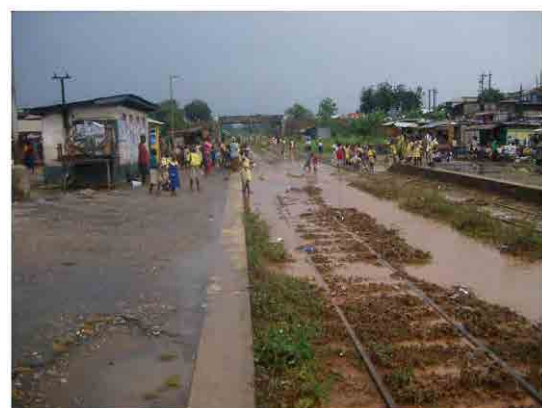
In addition, almost all drainage systems along the track are not functional due to the lack of maintenance and aging. Therefore, when the water flows into the station yard from surrounding areas during/after a slight rain, the track becomes submerged easily. This problem often leads to the shutdown or suspension of daily train operation.

**Figure 5 Water Covered Track**

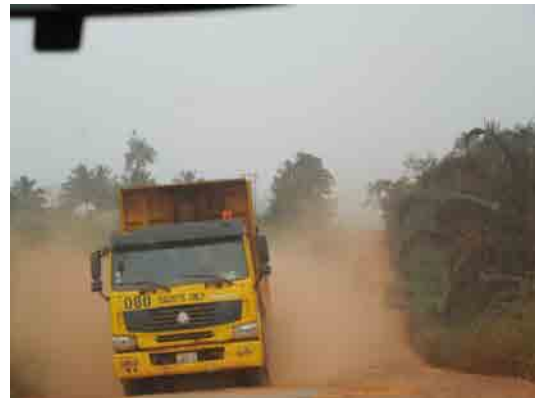
Since bauxite produced in Awaso is transported by trucks instead of the railway on this route, damage to the pavement is progressing further due to heavy trucks passing.

**Photo 1.4.2 Truck for Bauxite Transportation**

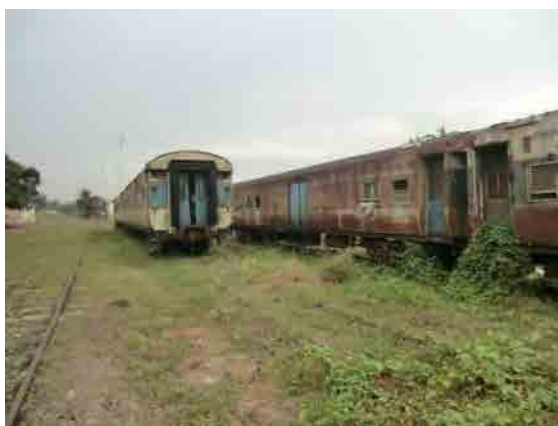
27 passenger cars out of 151 cars are available and those are used for passenger trains on the Eastern line. 4 cars for workers' trains and one standby car in Takoradi are also available. Other passenger cars are neglected in the stations or in the workshop, and the corrosion of the car bodies is significantly proceeding as shown in the Photo 2.1.25.

**Photo 2.1.28 Passenger Cars Left Neglected at Takoradi Station**

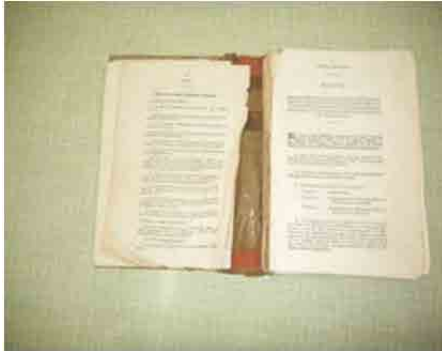
Current train operations are subject to rules and regulations as published in the following manuals. Rule Book, Traffic Manual, Staff manual and Working Time table. Those are all outdated and not suitable with current conditions including the facilities and equipment. And the management of documents is sloppy, like the years of publication are different or loosing pages.

(c) Manual with Missing Pages

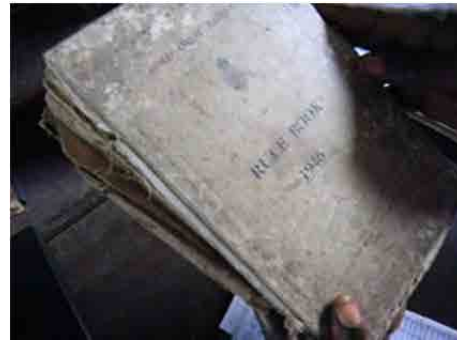
(d) Old Edition Manual

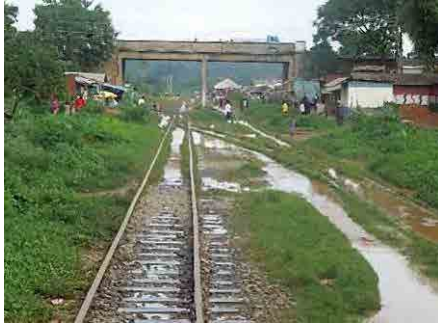
**Photo 2.2.7 Station Yard in which Effluent Flows through the Track Areas like a River (Kojokrom Station area on the Western Line)**

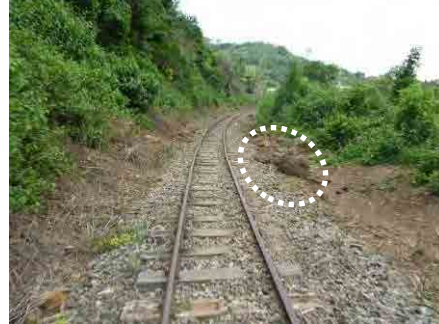
**Photo 2.2.8 Site with Rock Fall by the Side of the Track (Dunkwa-Buabin on the Western Line)**

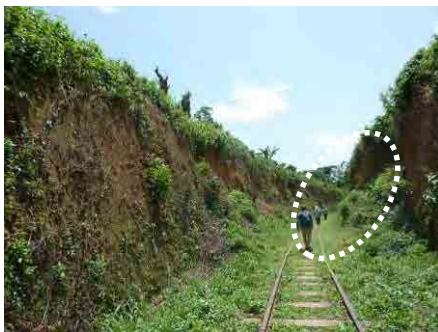
**Photo 2.2.9 Partial Failure of Nearly Vertical Slope (Maudaso-Ankwaso on the Awaso Branch line)**

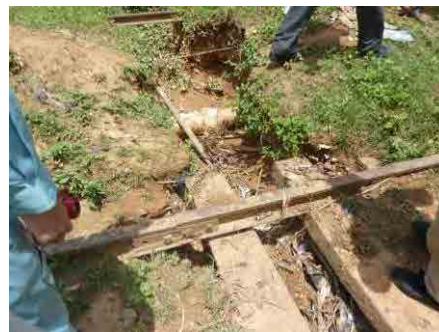
**Photo 2.2.10 Ballast and Roadbed Eroded by Water Flowing from a Residential Area (Maudaso-Ankwaso on the Awaso Branch line)**

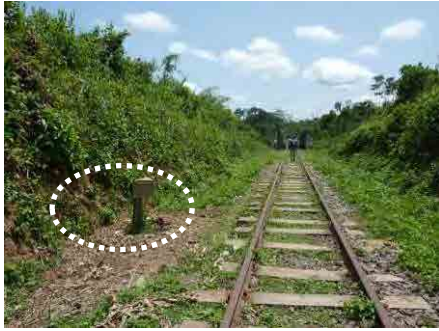
However, there are locations where mileage posts have deteriorated so much as to make the letters illegible, the post is lost, or overgrown grass covers the letters. Operators are often unable to identify the mileage posts with ease. Illegible letters must be repainted in white to ensure easy identification by those concerned with the railway (especially, the operator).

**Photo 2.2.11 Mileage Post Provided  
along the Track (four types  
of 0, 1/4, 1/2, and 3/4)**

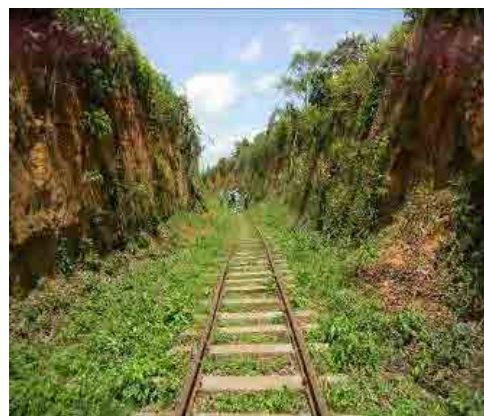
**Photo 2.3.4 Dangerous Cut**

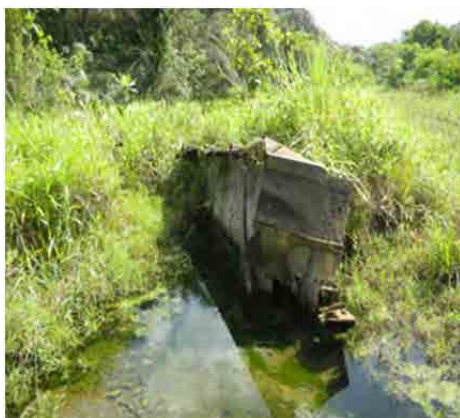
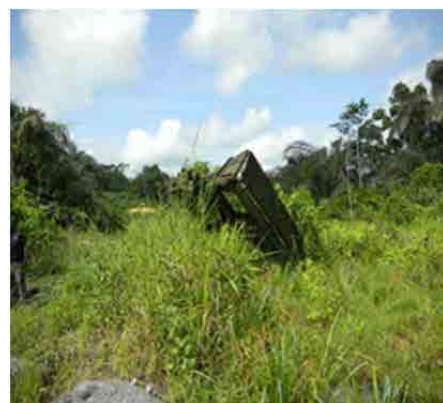
The points where derailments had occurred are near the start point of a left curve heading towards Takoradi. The roadbed collapsed just below the edge of the sleepers. The left sides of the tracks are wetlands and flood is a danger in heavy rain.

The wreckage of the rolling stock still remains crushed into the bank on the left side of the track. The traces of the derailment show that the right wheel ran out. All around the site the condition of sleepers and rail fasteners are poor. The rail joints in particular are extremely poor, the rolling stocks tend to experience rolling whenever they pass such bad sections. The accident sites are mended temporarily. And the manganese train operations still continue. It is necessary to pay close attention when passing the section because the roadbed has collapsed just below the edge of the sleepers, so they are half way to failure.

**Photo 2.3.5 Trace of Derailment (1)**

**Photo 2.3.6 Trace of Derailment (2)**

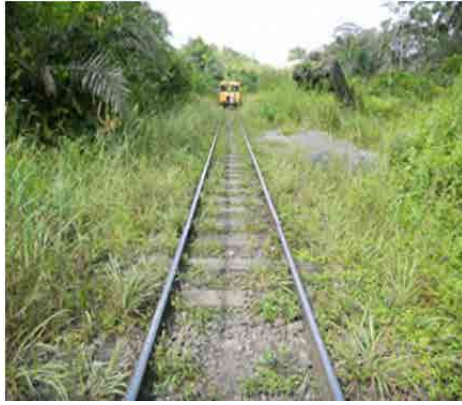
**Photo 2.3.7 Trace of Recovery Work**

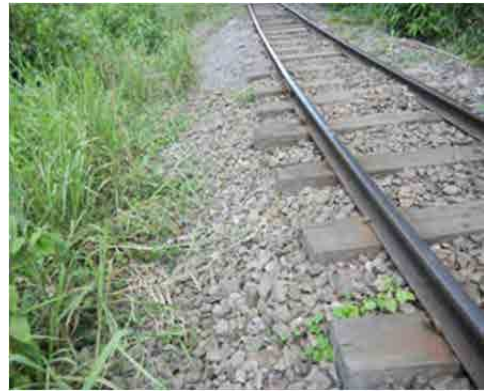
**Photo 2.3.8 Ballast beside Sleepers**

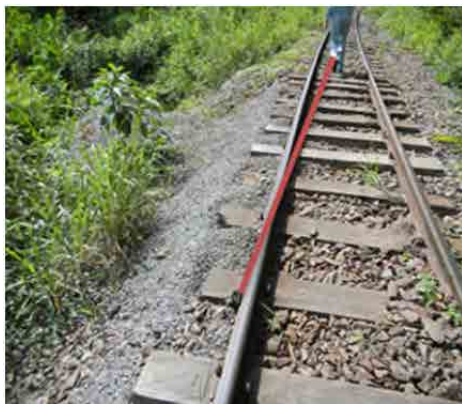
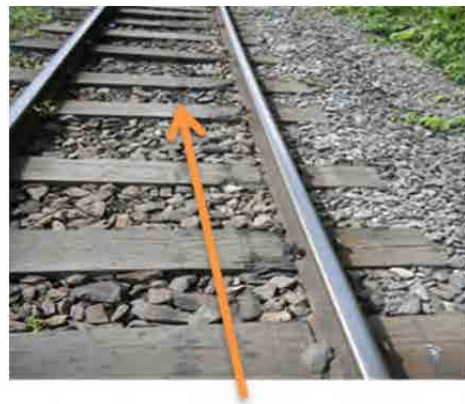
**Photo 2.3.9 Trace of Derailment (1)**

**Photo 2.3.10 Trace of Derailment (2)**

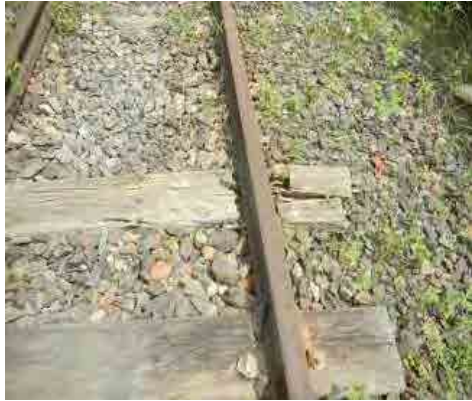
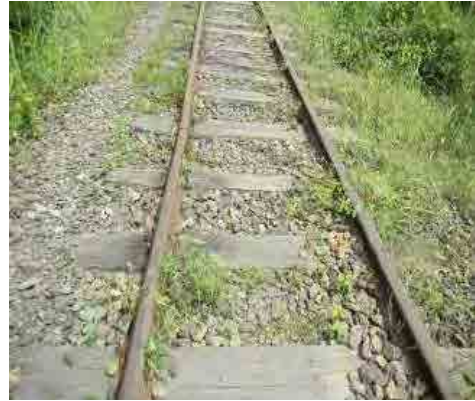
On this site trains operations are stopped. The points where derailments had occurred are the middle point of a left curve heading towards Takoradi. The bauxite ore that fell out of the wagons by running impact is scattered around there. It seems that the point where a huge amount of the bauxite ore had accumulated is the derailment place. All around that site the conditions of sleepers and rail fasteners are poor. The rail joints in particular are extremely poor, the joints are set in different place on each tracks, and the rolling stocks tend to experience irregular rolling whenever they pass such bad sections. And the roadbeds are poor too. It is easy to see that the sleepers are unstable. The situations are similar to the site near Nsuta. The track heads towards the left side and that is same direction as the Nsuta site.

**Photo 2.3.11 Edge of Sleepers (1)**

**Photo 2.3.12 Edge of Sleepers (2)**

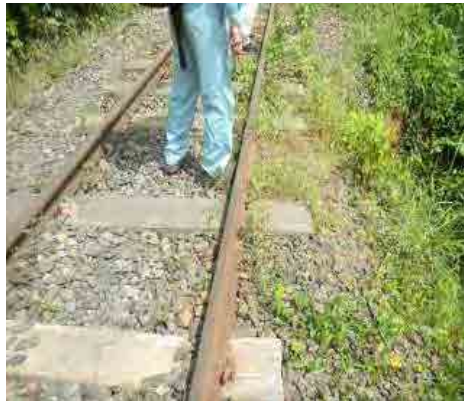
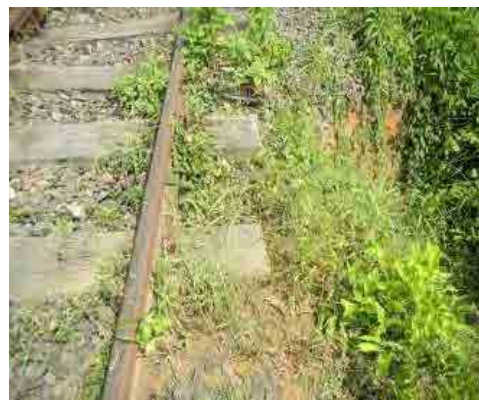
**Photo 2.3.13 Collapsed Roadbed (1)**

**Photo 2.3.14 Collapsed Roadbed (2)**

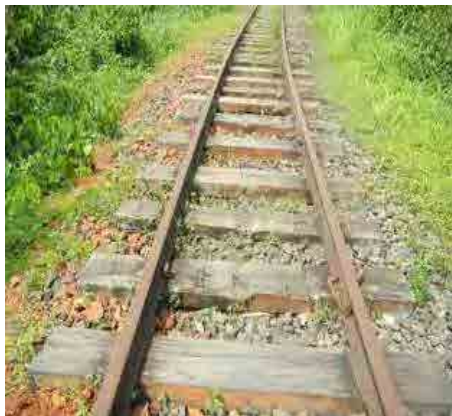
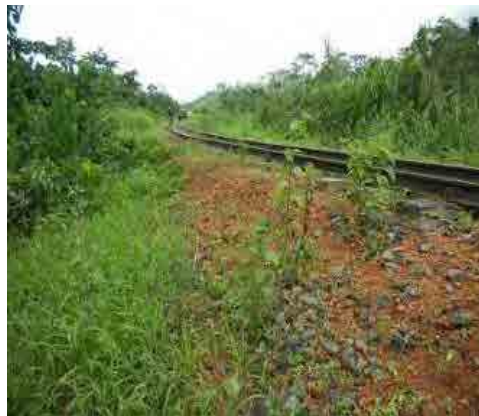
**Photo 2.3.15 Scattered Bauxite (1)**

**Photo 2.3.16 Scattered Bauxite (2)**

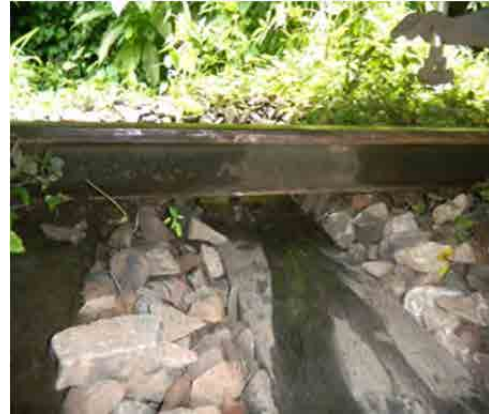
The points where derailments had occurred are near the end point of a right curve heading towards Takoradi with a down gradient. The condition of the sleepers is poor and the trace of the wheel that flew off was recognized at the point where the sleepers are unstable. The point is similar to the other sites.

**Photo 2.3.20 Trace of Derailment**

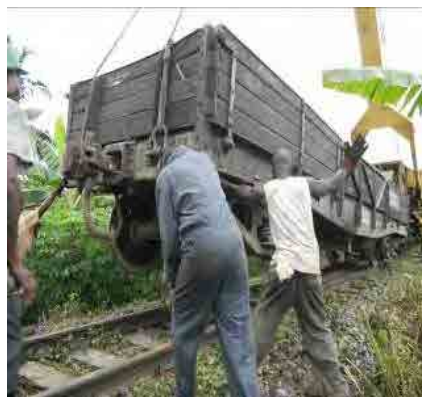
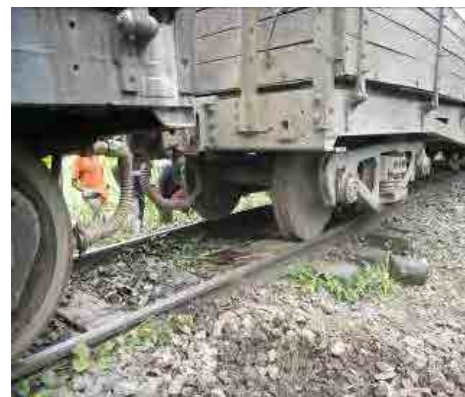
**Photo 2.3.21 Recovery Work (1)**

**Photo 2.3.22 Recovery Work (2)**

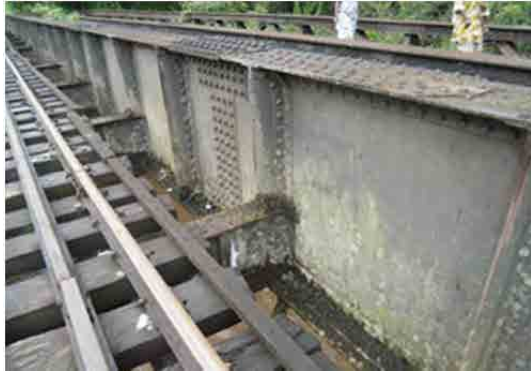
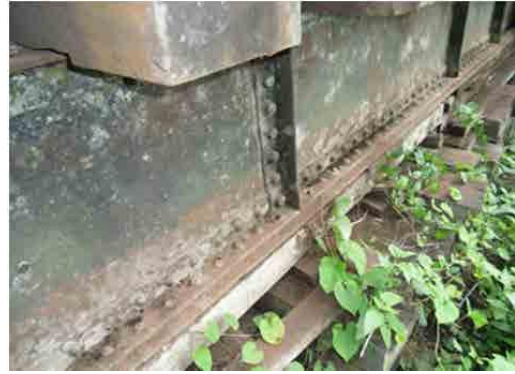
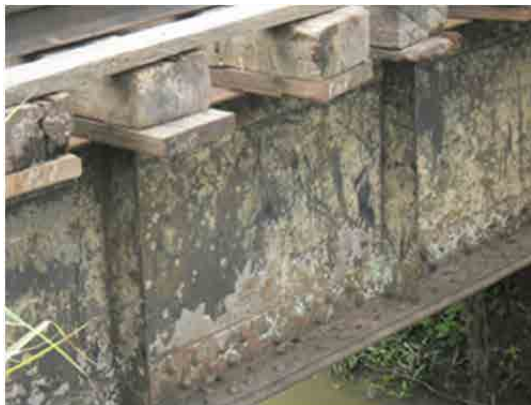
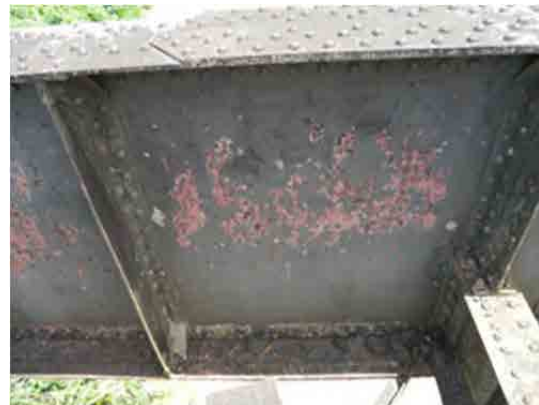
- All of the steel girders showed time-dependent deterioration, rust and corrosion due to high temperature and humidity. Also, cross sectional loss of members other than principal members has occurred in the course of the 60 to 110 years after construction.

**Photo 2.3.23 Corrosion of Steel Girders**

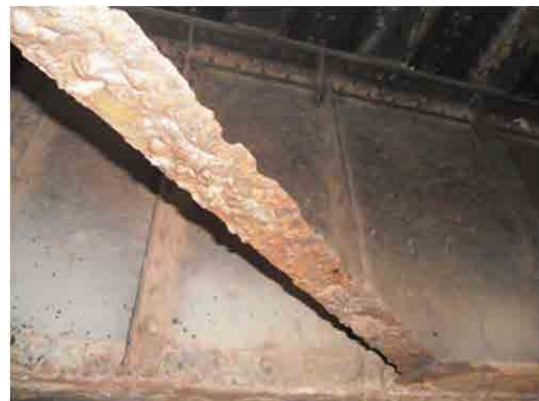
(Bridge No.1)

**Photo 2.3.24 Sectional Loss Observed in Stiffeners between Bridge Main Girders**

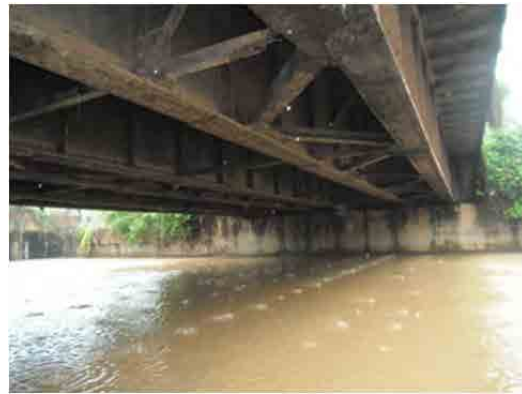
(Bridge No.1)

- In particular, Bridges No.1 and No.7 have insufficient clearance over the rivers. Main girders are submerged when the level of flood waters is high.
- No specific cracks could be detected in the steel girders. Only corrosion and rust are problems.

**Photo 2.3.25 Insufficient Overhead Clearance**

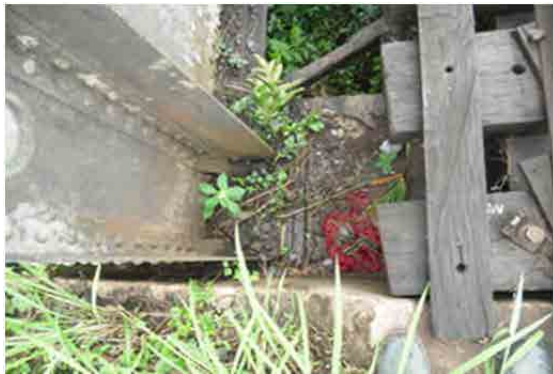
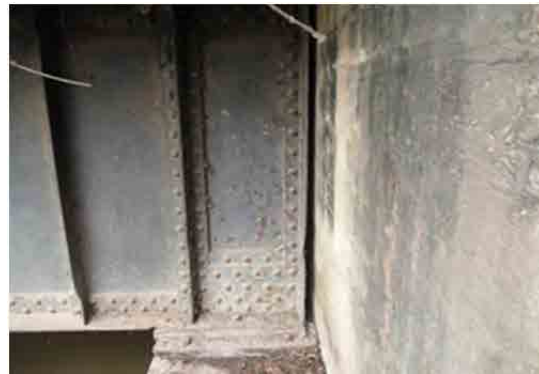
- Loss of rivets and bolts are limited. Therefore this is not particularly a problem.
- In some bridges, the distance between the steel girder end and abutment is not secured, resulting in collapse of the parapet in certain locations.

**Photo 2.3.26 Distance between the Bridge and Abutment**

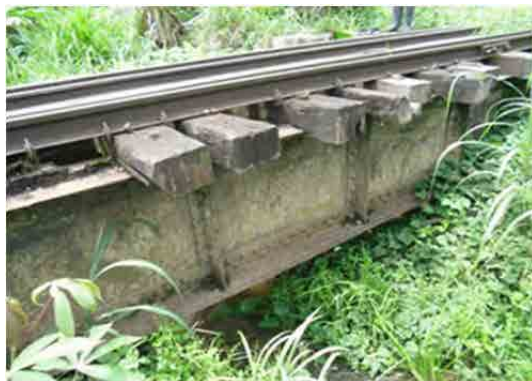
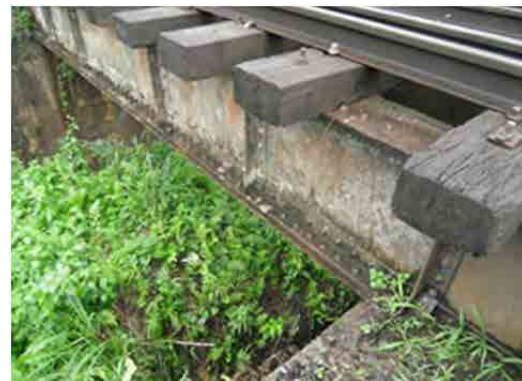
- Considerable rotting of sleepers on the bridges was apparent, and the sleepers are not arranged at even distances. In addition, fasteners are lost in certain locations.

**Photo 2.3.27 Condition of Track (Rails/Sleepers)**

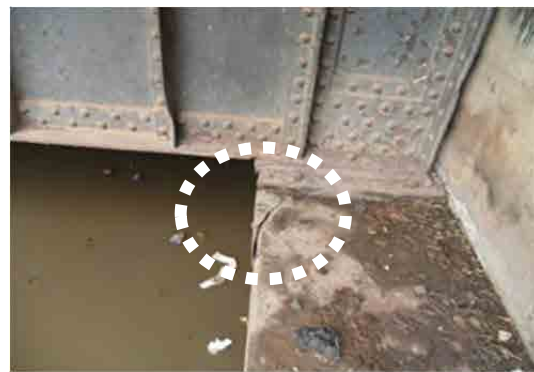
(b) Collapse due to Lack of Edge Distance  
(Bridge No.1)

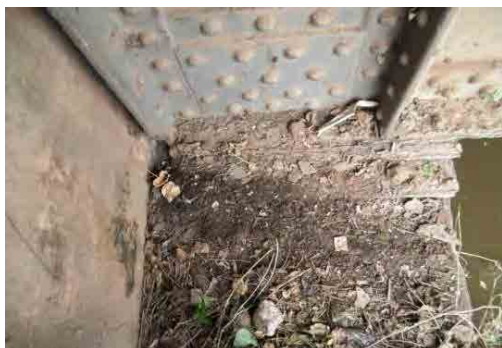
- The parapet front and the widely exposed surface showed major horizontal cracks, which are considered to be due to dry shrinkage.
- Soil was found to have accumulated around the girder supports. This promotes corrosion and hinders proper functioning.
- The girder seat surfaces were narrow in certain locations. Though the initial design standard at the time of design is not known, provision of necessary equipment (jacks, etc.) is difficult during repair work.
- Honeycomb has developed in portions of the concrete surfaces. This is an indication of faulty concrete placement.

(c) Accumulated Soil around Bearing  
(Bridge No.1)

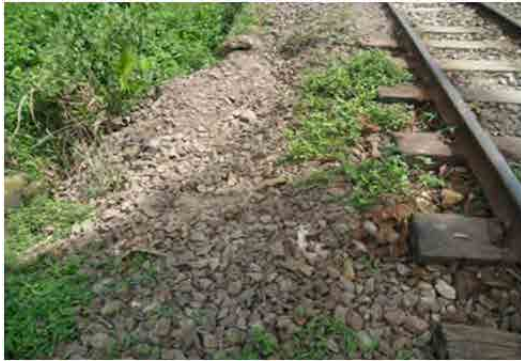
(a) Embankment Section (railway subgrade not clear)

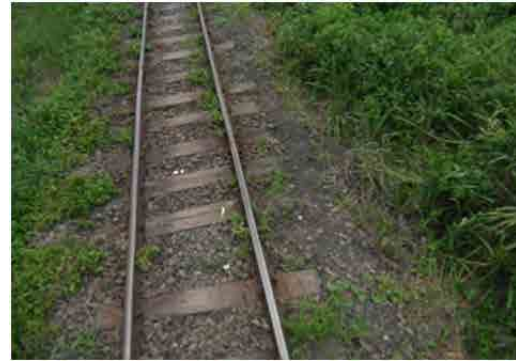
covered by soil and waste. Actually, even minor rainfall causes flooding of the track, which hinders train operation. Along part of the route, simplified earth-retaining work was provided as a minimum emergency measure.

(b) Emergency Earth-retaining Work

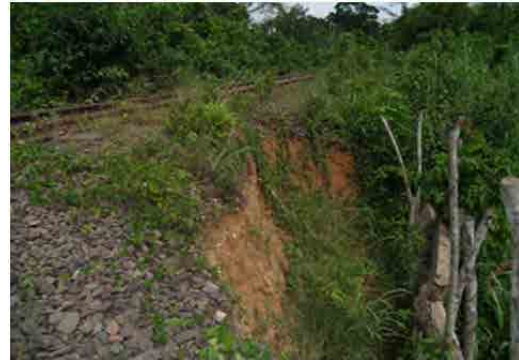
(c) Embankment Collapse on the Track Side

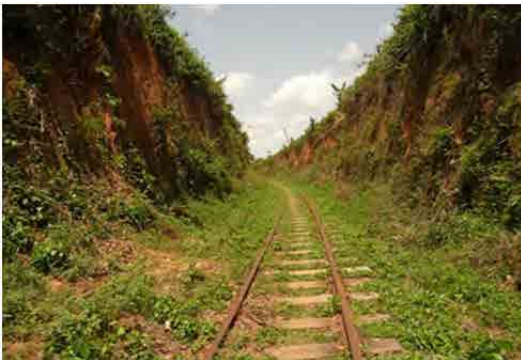
(d) Cut section (laterite soil cut and left as is)

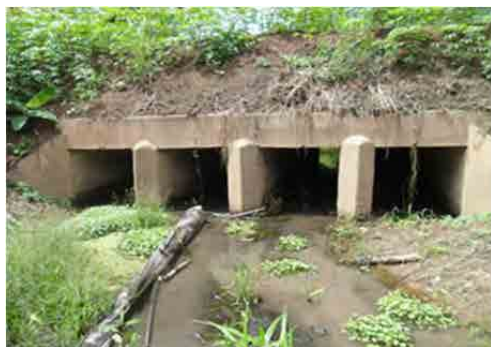
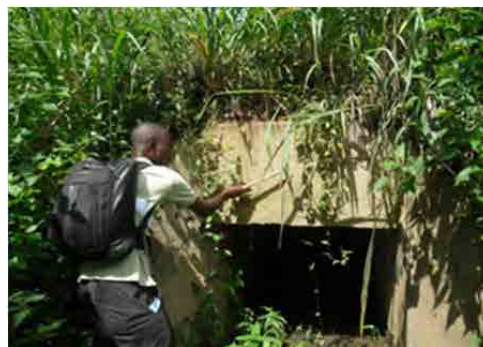
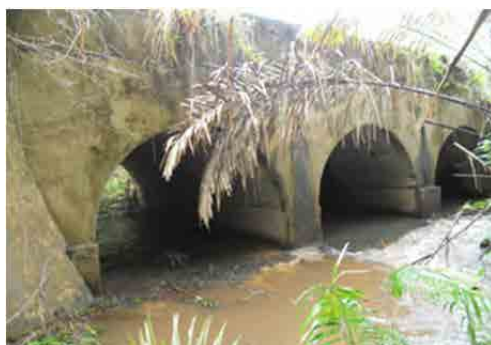
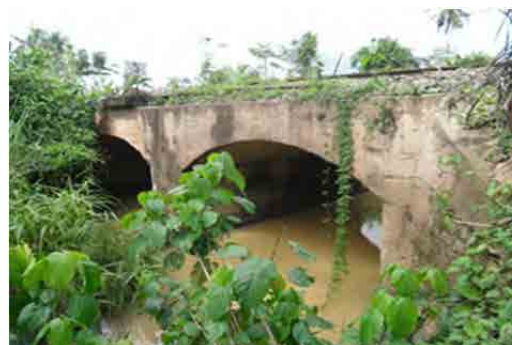
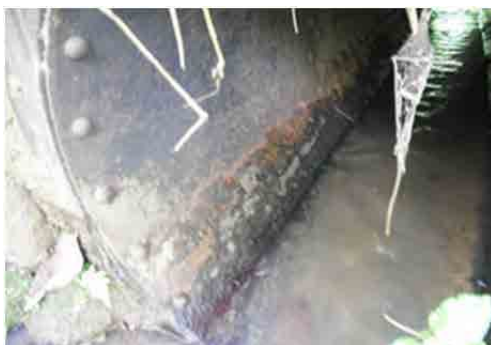
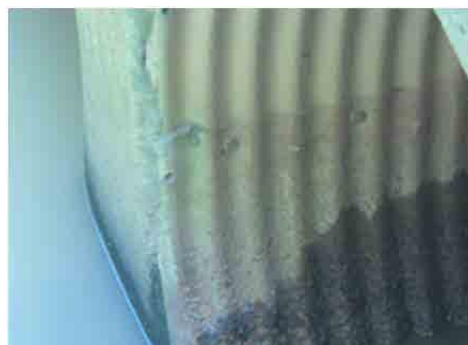
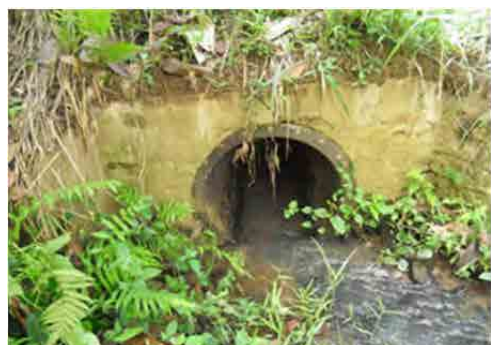
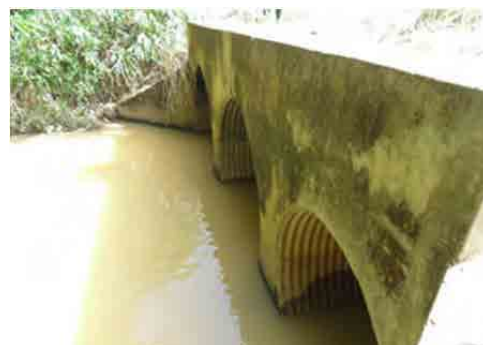
**Photo 2.3.31 Current Status of Culverts**

Takoradi-Nsuta section. However, some of these could not be actually seen on-site since they are covered with sediment, for example.

In the places where they are covered with sediment and their function as culverts or ditches is insufficient, water flows onto the track after heavy rain (Photo 2.3.33).

(a) Box Culvert

(b) Arch Culvert

(c) Pipe Culvert (Armco Pipe)

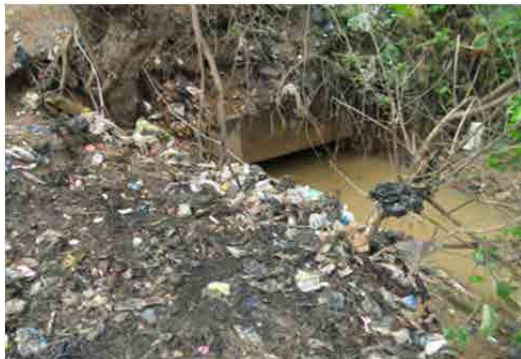
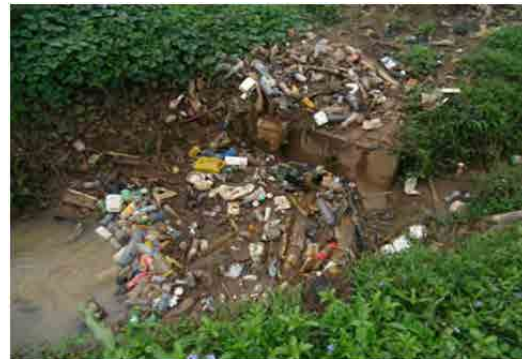
**Photo 2.3.32 Culvert Filled with Garbage in Kojokrom Station**

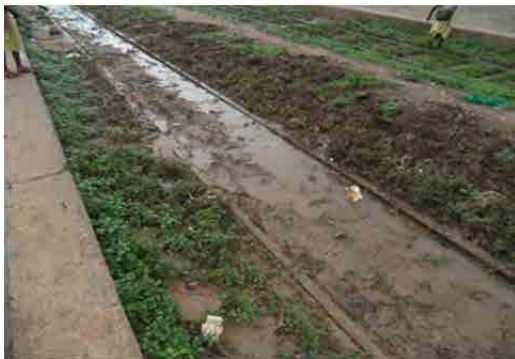
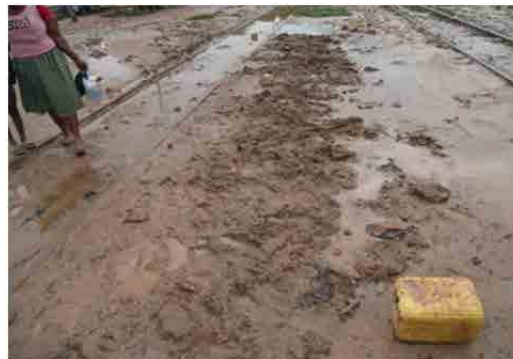
**Photo 2.3.33 Water and Soil Flowed onto the Track in Kojokrom Station**

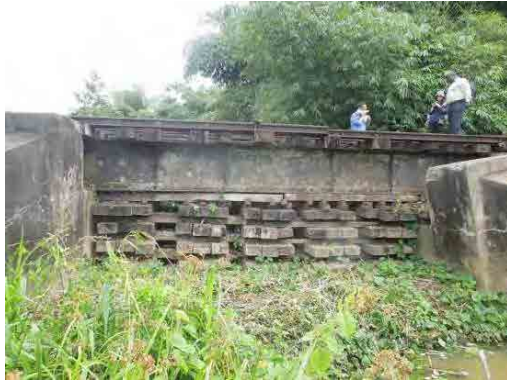
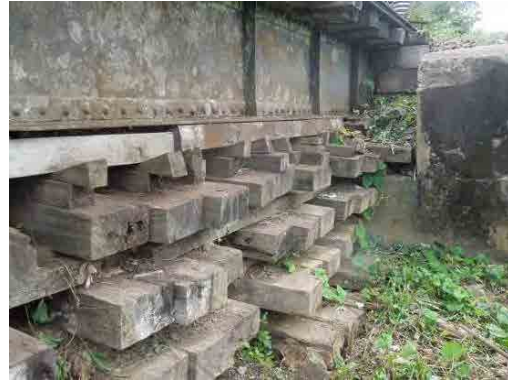
Emergency work was conducted for a steel upper-deck girder, No.2, because the Takoradi-side abutments to support girders had collapsed due to scour. The details of the work are shown below as an example of emergency repairs on-site.

**Photo 2.3.34 Steel Girder Bridge Temporarily Supported by Sleepers**

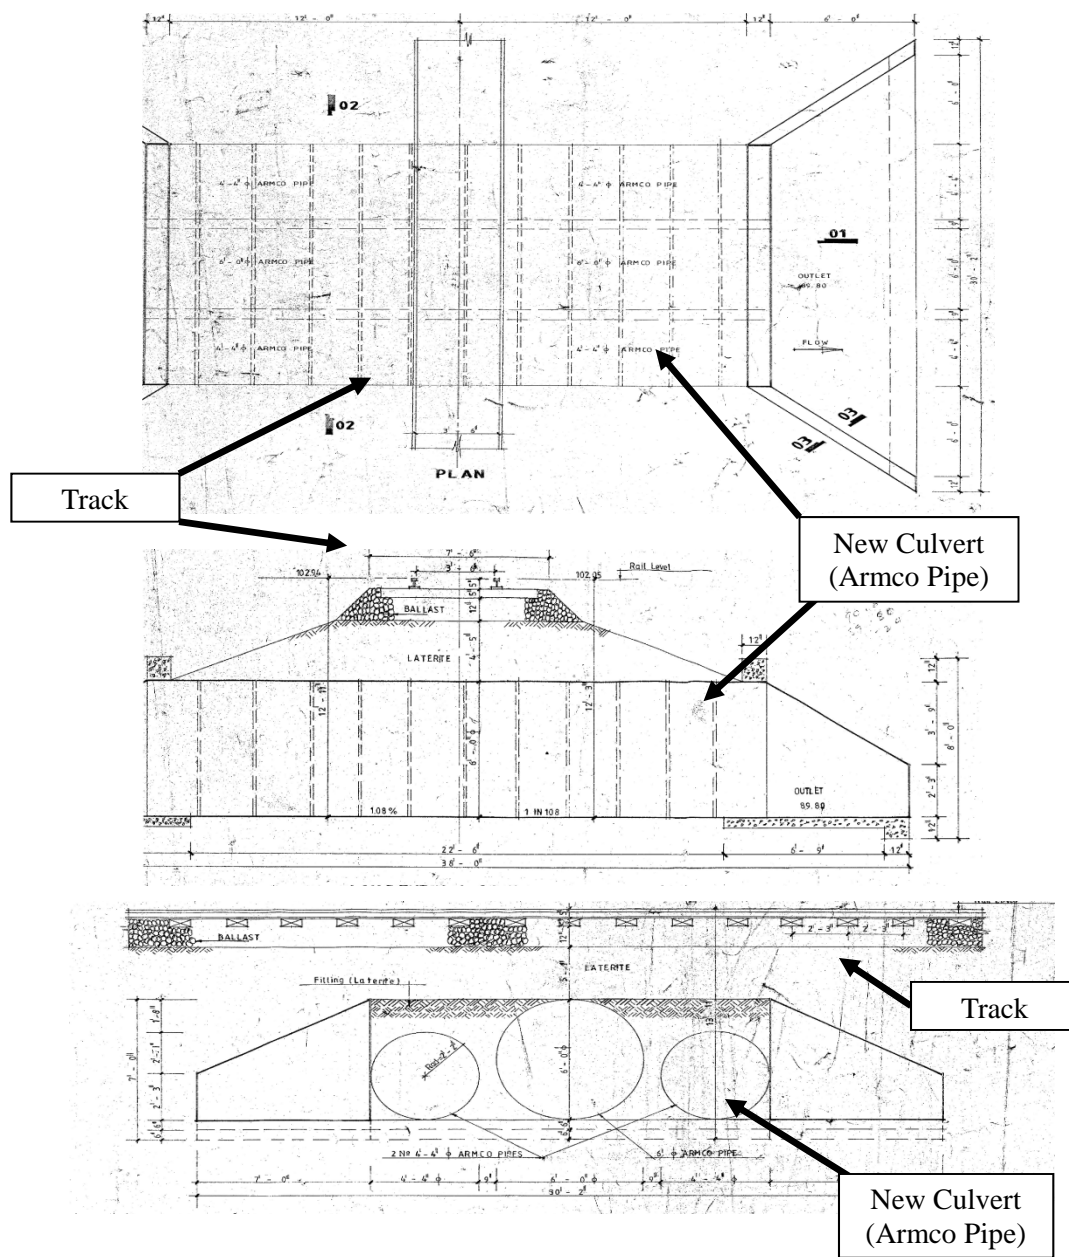
**Figure 2.3.2 New Culvert (Armco Pipe)**

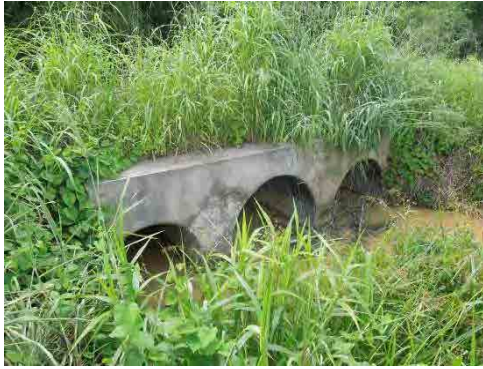
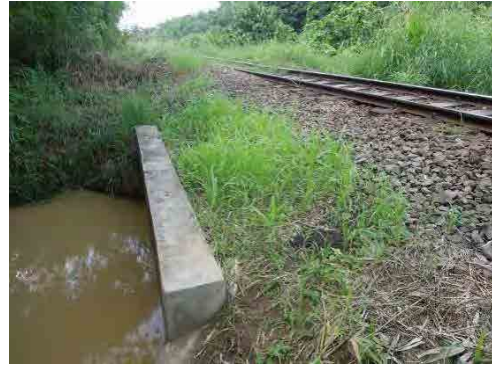
**Photo 2.3.35 Diverted River and New Culvert**

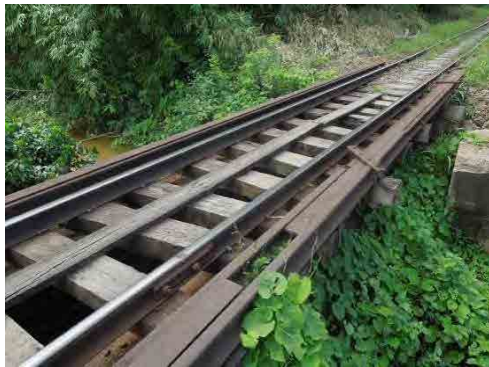
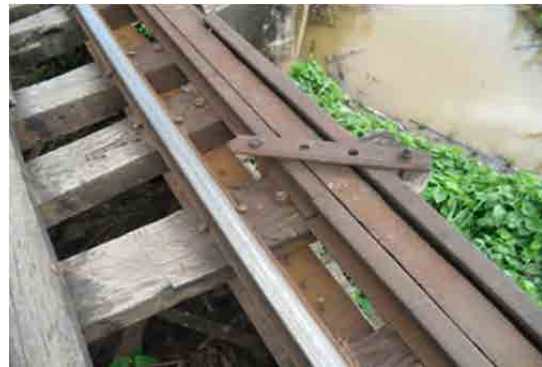
**Photo 2.3.36 Track Protection by Rail Girder**

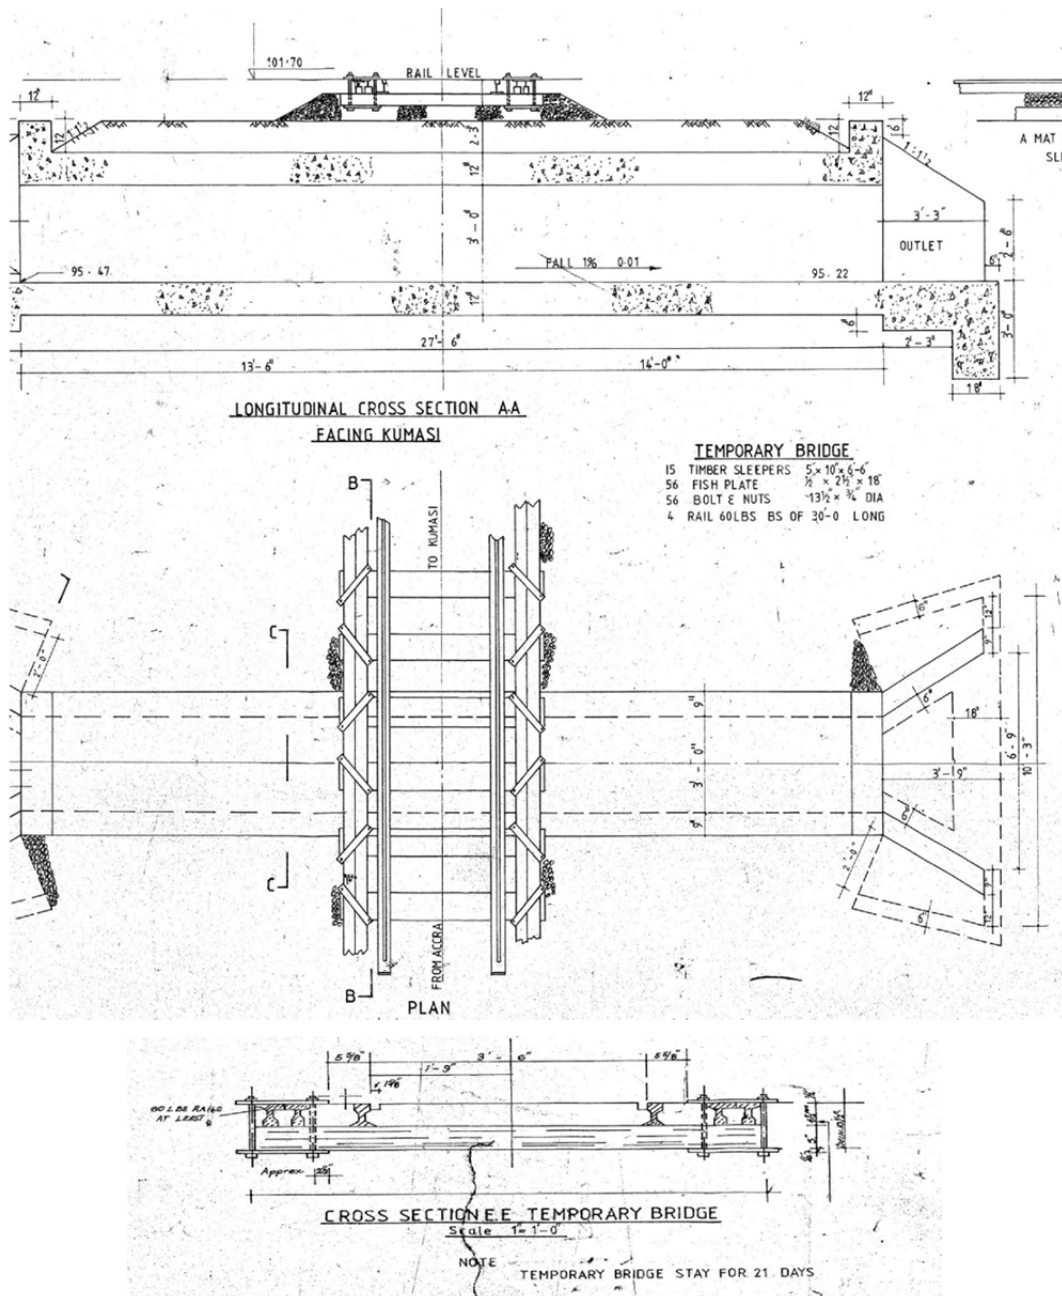
Figure 2.3.3 shows a drawing of track protection work used in the Western Line. And, this drawing describes the expiration date of the temporary bridge, “TEMPORARY BRIDGE STAY FOR 21 DAYS”. The use of these temporary bridges involves speed restriction, and a week limit for expiration date. The removal of this by urgent repair work is desirable as soon as possible.

**Figure 2.3.3 Track Protection Work by Rail Girder in the Western Line**

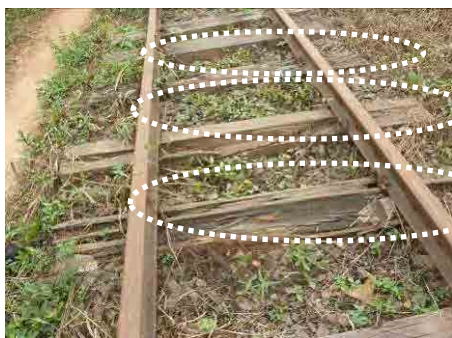
- It was observed that there are some sections where more than 3 sleepers in succession were damaged or broken (Photo 2.3.16 and 2.3.17)
- Figure 2.3.5 shows the status of sleepers, and 37 of 83 sleepers were damaged or broken.
- As shown in Table 2.3.4, the rates of defective sleepers range between 6% and 45%, which implies that the maintenance works might most probably have not been carried out thoroughly throughout the section.
- Japanese Standard regulates the rate of defective sleepers to be less than 7 %.

**Photo 2.3.37 Successive Sleepers Damaged**

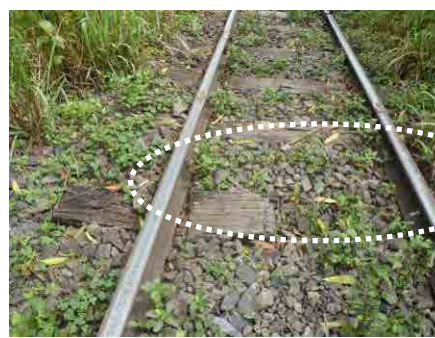
**Photo 2.3.38 Broken Sleeper  
(Due to Derailment)**

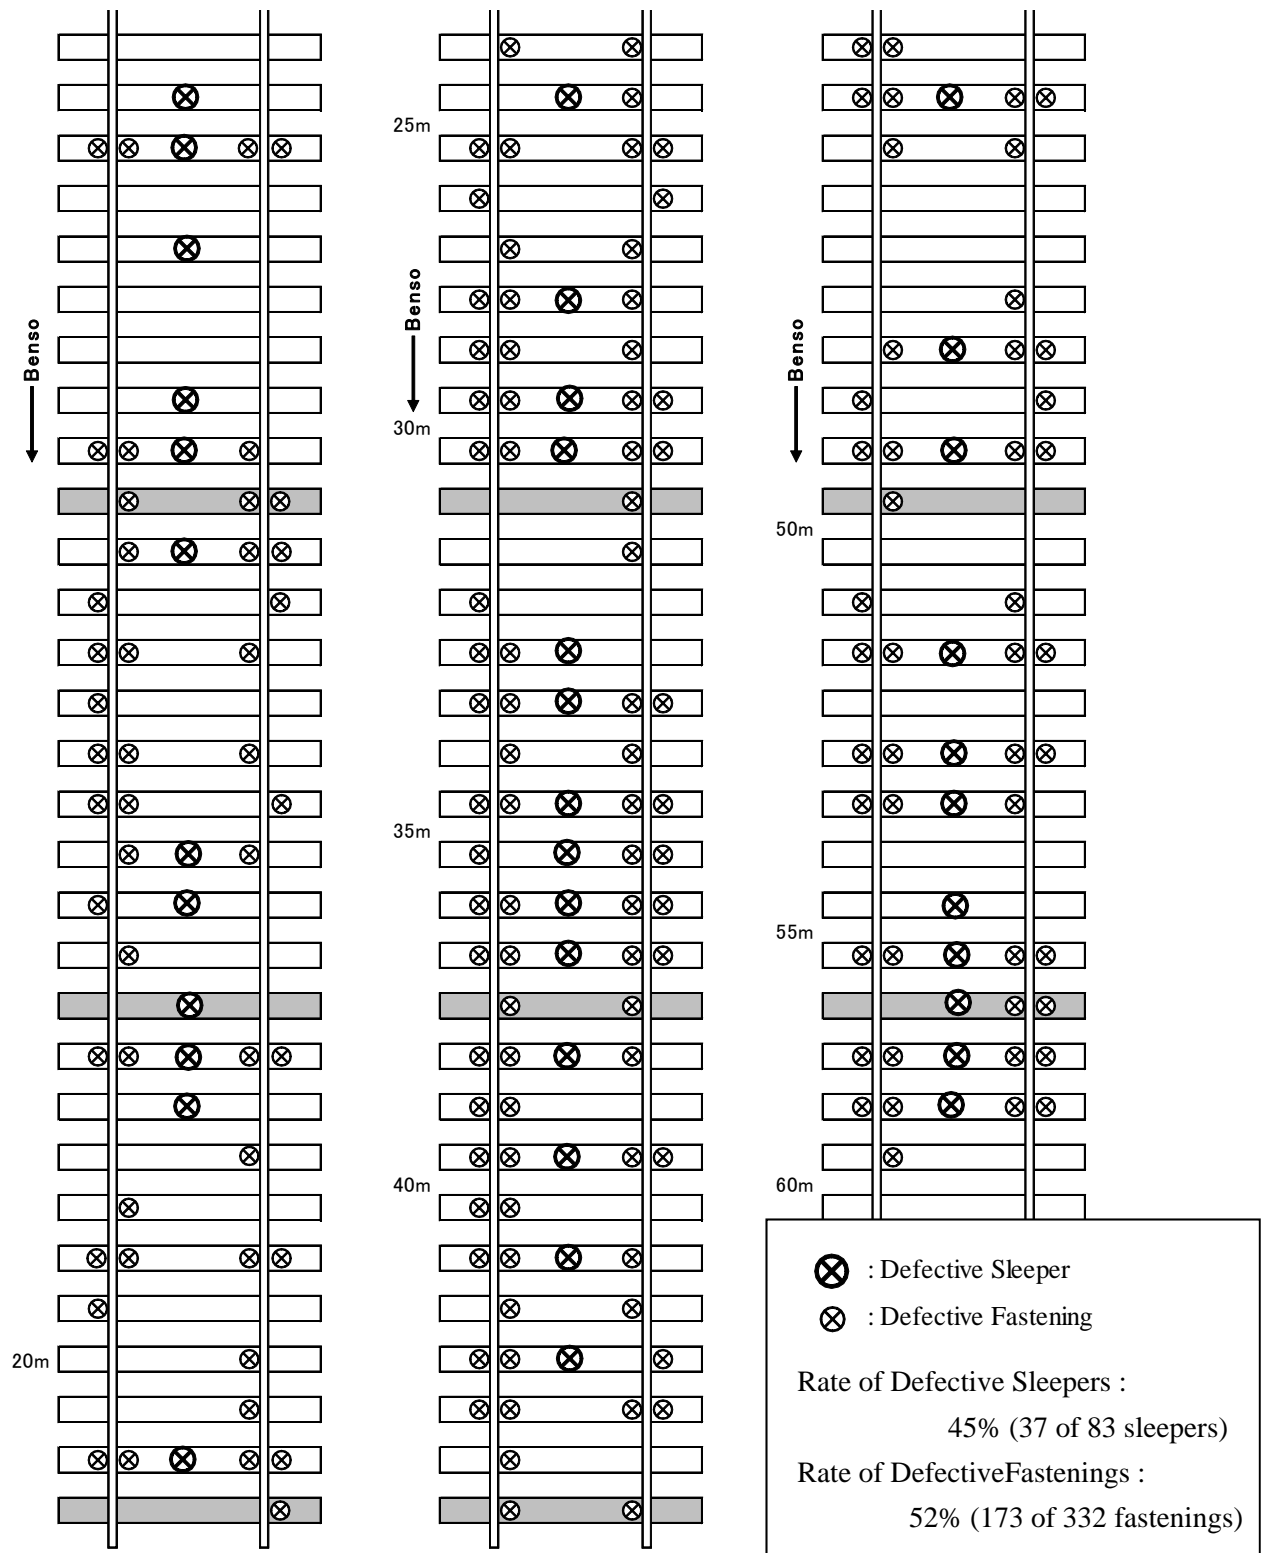
**Figure 2.3.5 The Status of Sleepers and Fastenings (Benso – Esuaso (No.2))**

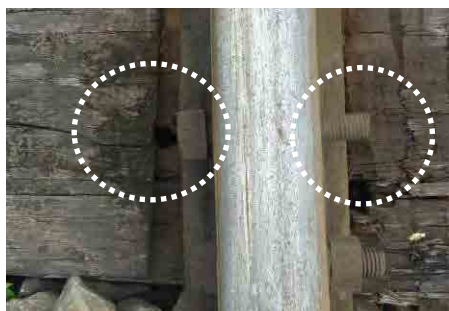
- There are many locations where fastening devices are missing (Photo 2.3.18).
- There are many locations with more than 3 successive defective fastenings.

**Photo 2.3.39 Missing Fastening Devices**

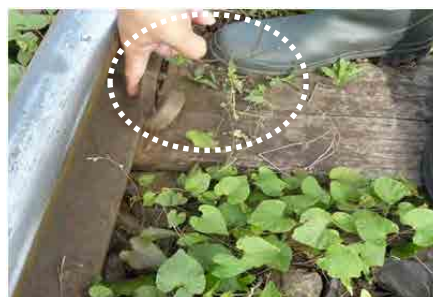
- Japanese Standard regulates the rate of defective fastening devices to be less than 5 %.
- As shown in Photo 2.3.19, more than half of the defective devices are under the condition that the shank spike was uplifted from the sleeper and thus not properly functioning.

**Photo 2.3.40 Uplifted Shank Spike**

- Uplifted shank spikes have to be hammered down to the normal positions. However, hammering down the uplifted shank spikes cannot be done at the locations where the depth of the spike hole in the sleeper is not adequate and thus the shape of the bottom of the shank spike became rounded (Photo 2.3.20). In such a case, it is required to make the spike hole deep enough by auguring, and then hammer down the shank spike, or use dog spikes instead.

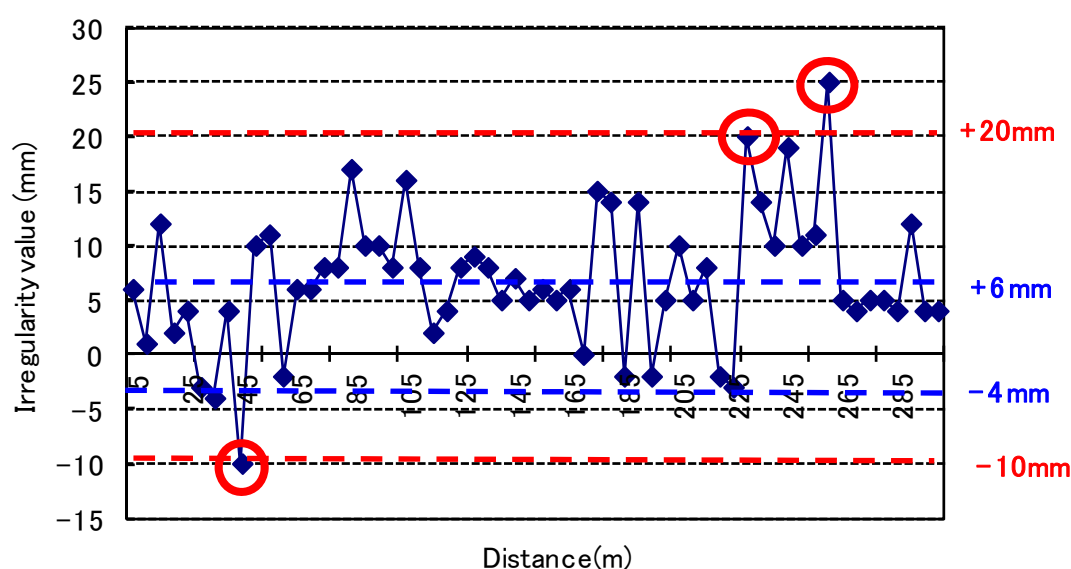
- Figure 2.3.6 shows the result of the investigation of gauge irregularity in the section Bonsawire – Nsuta, and that indicates that gauge tends to expand on the whole. This is a similar tendency in the other sections measured. Then, there are many points that exceed the normal maintenance limit, +6mm or -4mm and there are three points that exceed the urgent maintenance limit, +20mm or -10mm.

- Table 2.3.6 shows locations of measured gauge irregularity beyond the urgent maintenance limit, +20mm or -10mm.
- When the track gauge is reduced, it will reduce the tolerance relative to the wheel spacing of the rolling stock. When the track gauge is expanded, it will increase oscillation of the rolling stock. Because both cases increase the risk of derailment, track maintenance must be done with care.

**Figure 2.3.7 The Result of Gauge Irregularity Investigation (Bonsawire - Nsuta)**

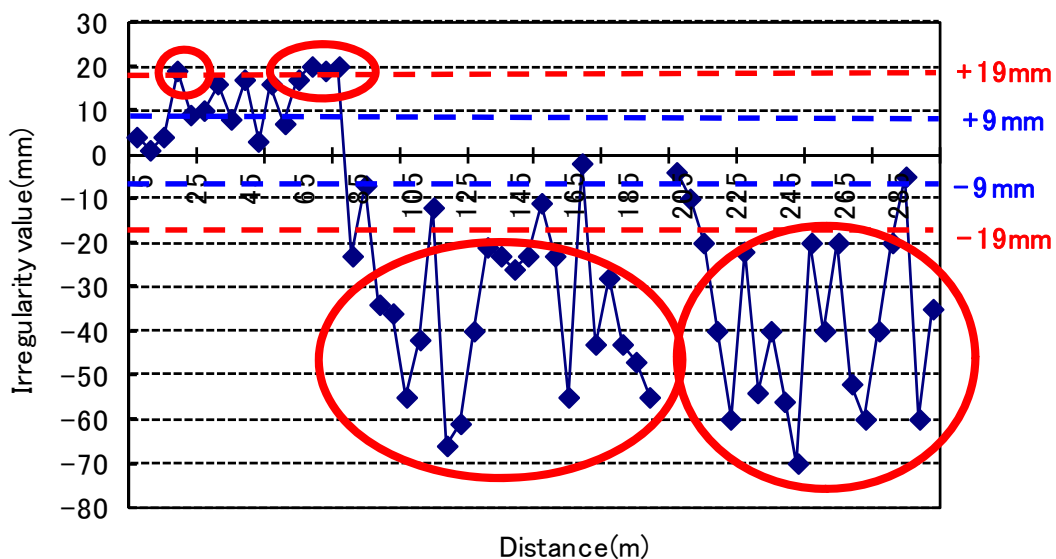
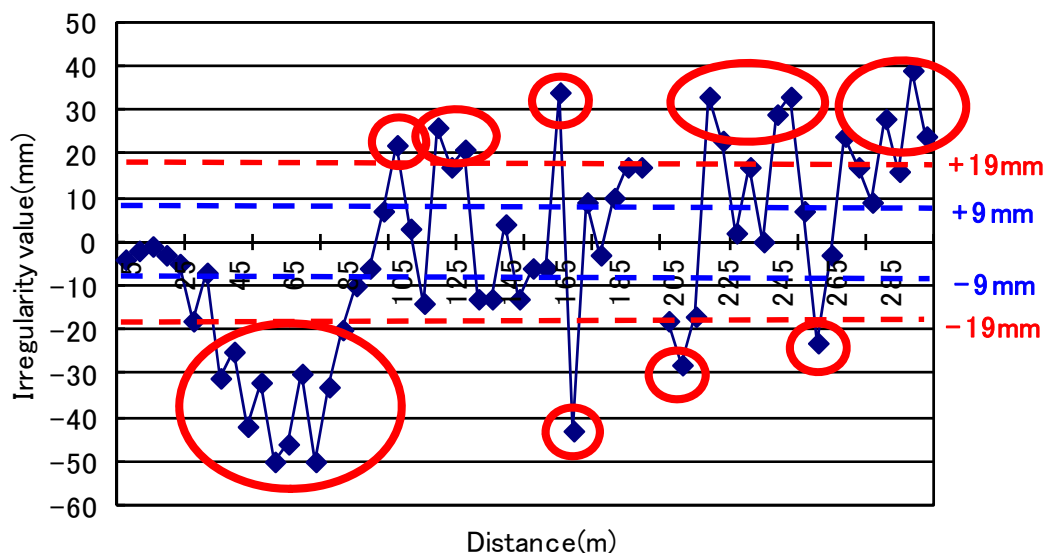
- Figure 2.3.8 shows the result of the track irregularity investigation in the section Bonsawire – Nsuta, and there are many points that exceed the urgent maintenance limit, +19mm or -19mm.
- The numbers of the points which exceed the urgent maintenance limit are shown in the Table 2.3.7. Many points exceed the urgent maintenance limit in all the sections measured. The track repair work should be implemented immediately, considering the high possibility of accidents such as derailment.

(a) Rail Level Irregularity (Right-side Rail)

(b) Line Irregularity (Right-side Rail)

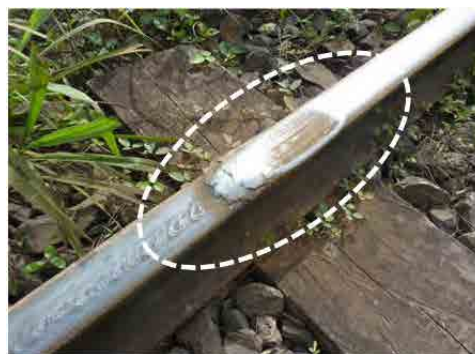
Wheel burns have occurred everywhere, and in certain locations, wheel burns were so large that the depression in the rail level was as much as about 3 mm as is shown in the photo. (See Photo 2.3.21.)

If left unattended, large wheel burns with a substantial dip in the rail, may soon develop into rail damage that could cause train derailment.

**Photo 2.3.42 Wheel Burn(Kojokrom - Angu)**
