**STUDY FOR  
SAFETY OPERATION AND MANAGEMENT  
OF  
RAILWAY IN GHANA

FINAL REPORT**

**JULY 2014**

**JAPAN INTERNATIONAL COOPERATION AGENCY**

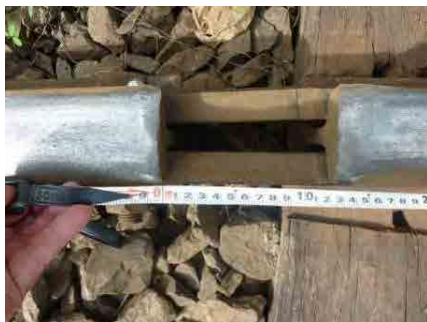
When a train runs and stops, the frictional force between the rails and sleepers and between the rails and rail fastenings resists the frictional force between the wheels and the rails. If excessive frictional force occurs between the wheels and the rails, the rails move in the direction, of motion which is called “Rail Creep.” This will always occur as long as the train is operated. Cumulative rail movement creates excessive joint gaps as shown in 2.3.22 and 2.3.23.

If left unattended, excessive joint gaps contribute to increased impacts due to wheels dropping. This leads to rail damage and finally to derailment. It is therefore essential to restore rail joints to specified levels.

**Photo 2.3.43 Excessive Joint Gap beyond 130mm (Kojokrom - Angu)**

The damage to the rails occurring during the test is considered to have been due to the following: At points where the rail gap was excessive, as shown in Photos 2.3.22 and 2.3.23, the wheels run down into the rail gaps directly with such impact as to damage the rail edges. Since the capacity of the sleepers and roadbed is satisfactory, the problem of damage to the rails may be removed if the rail gaps can be returned to the specified level (about 10 to 20 mm).

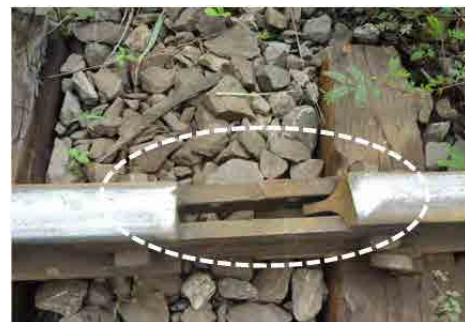
**Photo 2.3.44 Broken Rail End at the Joint (Kojokrom - Angu)**

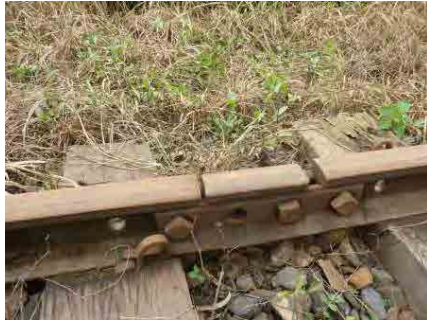
The method shown in Photo 2.3.24 worsens the situation by further weakening the already weak joint structures. This can lead to damage to the rail or fish plate at the joints. It is essential to restore the normal joint structure as soon as possible.

**Photo 2.3.45 Extremely Short Rail in the Joint Gap  
(Dunkwa - Awaso)**

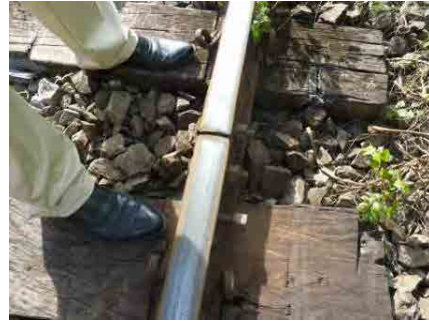
As shown in Photo 2.3.25, one fish bolt was missing from the outside rail and the nut for the fish bolt for the inside rail was loose. Similar defects were observed in many places and should be corrected to the normal joint structure as soon as possible.

**Photo 2.3.46 Lack of Fish Bolt and Loosening Nut  
(Kojokrom - Angu)**

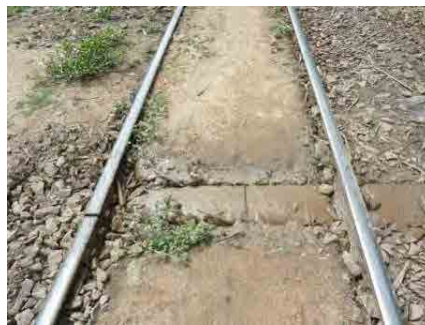
Where drainage is poor in the station yard, a phenomenon (called the mud pumping phenomenon) occurs in which roadbed soil is blown together with muddy water. This was observed in a few places.

**Photo 2.3.47 Mud Pumping (Manso Station)**

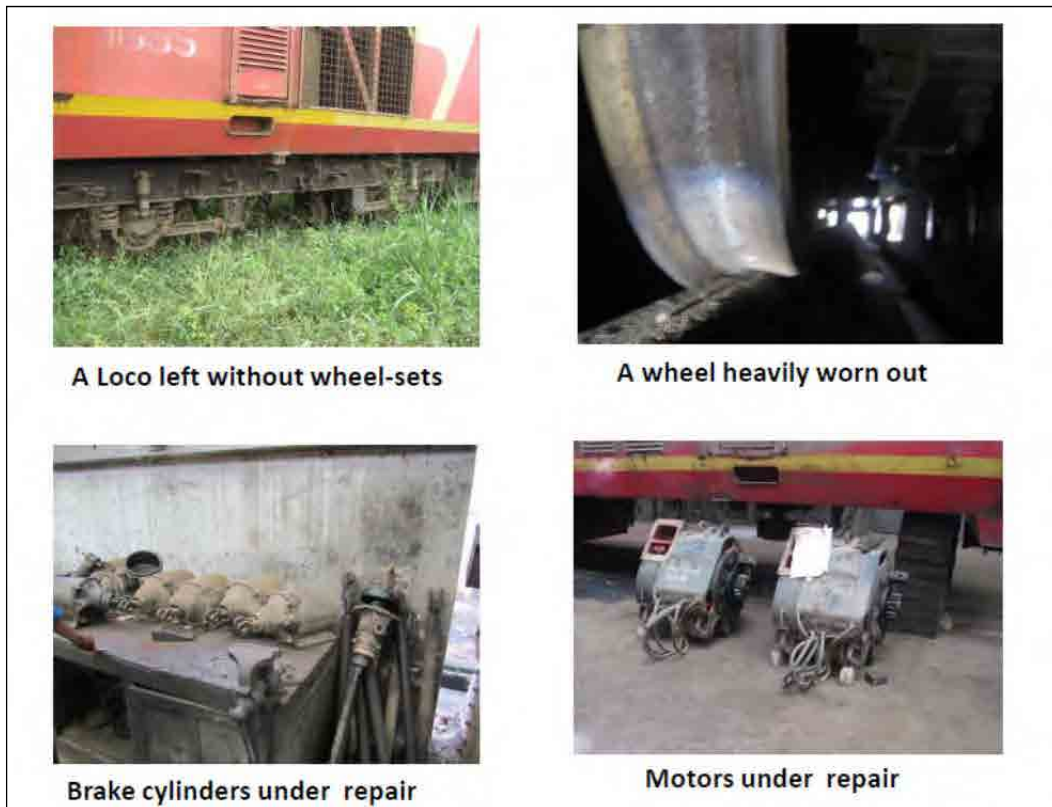
The reasons for the deterioration in rolling stock, which are out of operation, are classified into 5 types below. Most types under D) are due to A), B) & C)

- A) Consumable supplies not replaced
- B) Parts worn out and torn
- C) Breakage by an accident
- D) Corrosion, rust and ruin by long-time neglect without usage
- E) Incompatibility with track condition

The cases such as C), D) and E) are caused by external factors. 2601 class locomotives are in the case of E) due to their heavy axle load. Freight cars, except mineral wagons and almost all passenger cars are in the case of D). Some rolling stocks are abandoned due to accident. They are in the case of C).

**Photo 2.3.50 Defective of Locomotives**

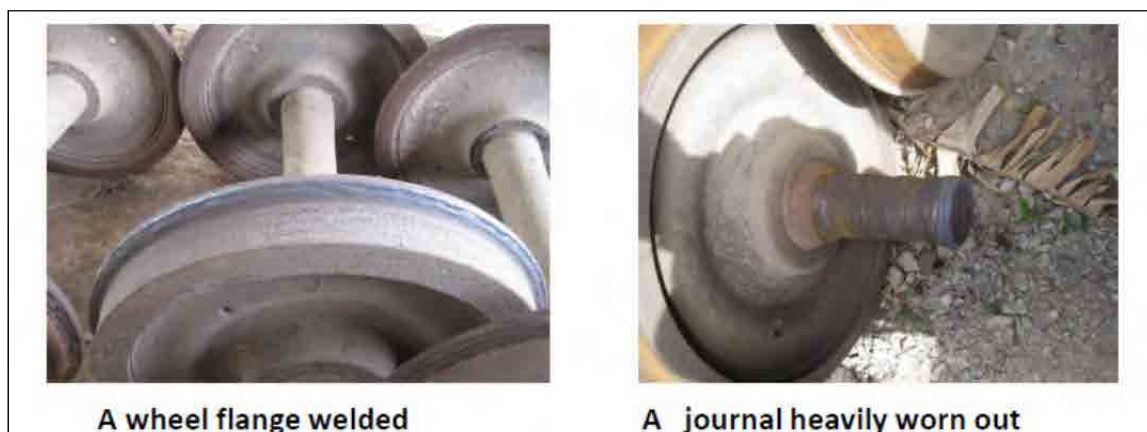
In the current situation of Ghana railway, wheels are key items for the operation of locomotives and break system, wheels and axles are those for freight wagons.

**Photo 2.3.51 Defective of Wagons**

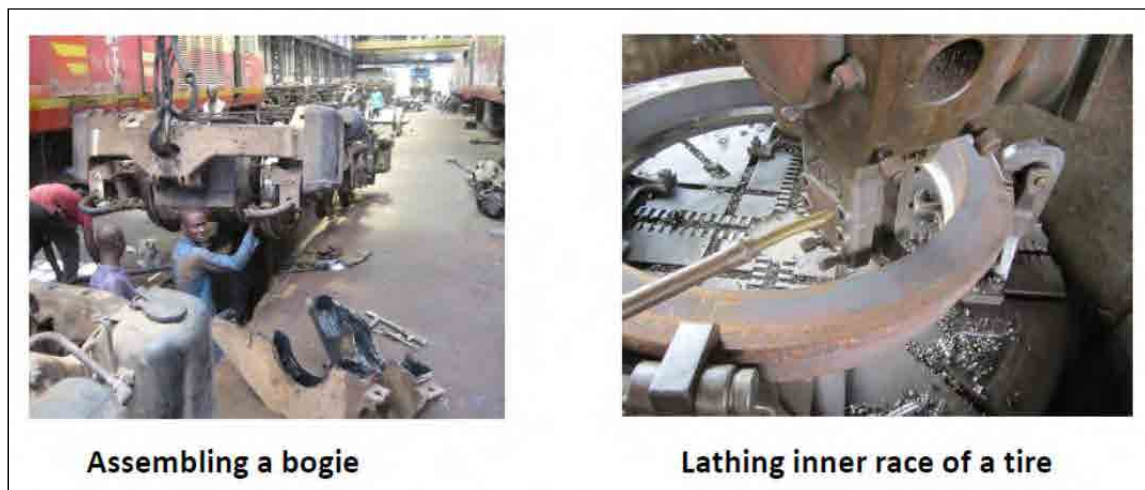
There are no definite rules in GRCL which prescribe requirements, skill capacity, or training & education system of employees concerned. It was not noticed that any training was practiced. It may be because the lack of budget makes the training impossible. As far as appearances go, the employees have enough skill to provide proper maintenance work at this stage. However, aging of the employees is proceeding and the lack of budget and spare parts is reducing maintenance work. Skill retention will be a serious problem in the long term.

**Photo 2.3.52 Maintenance Work at Location W.S**

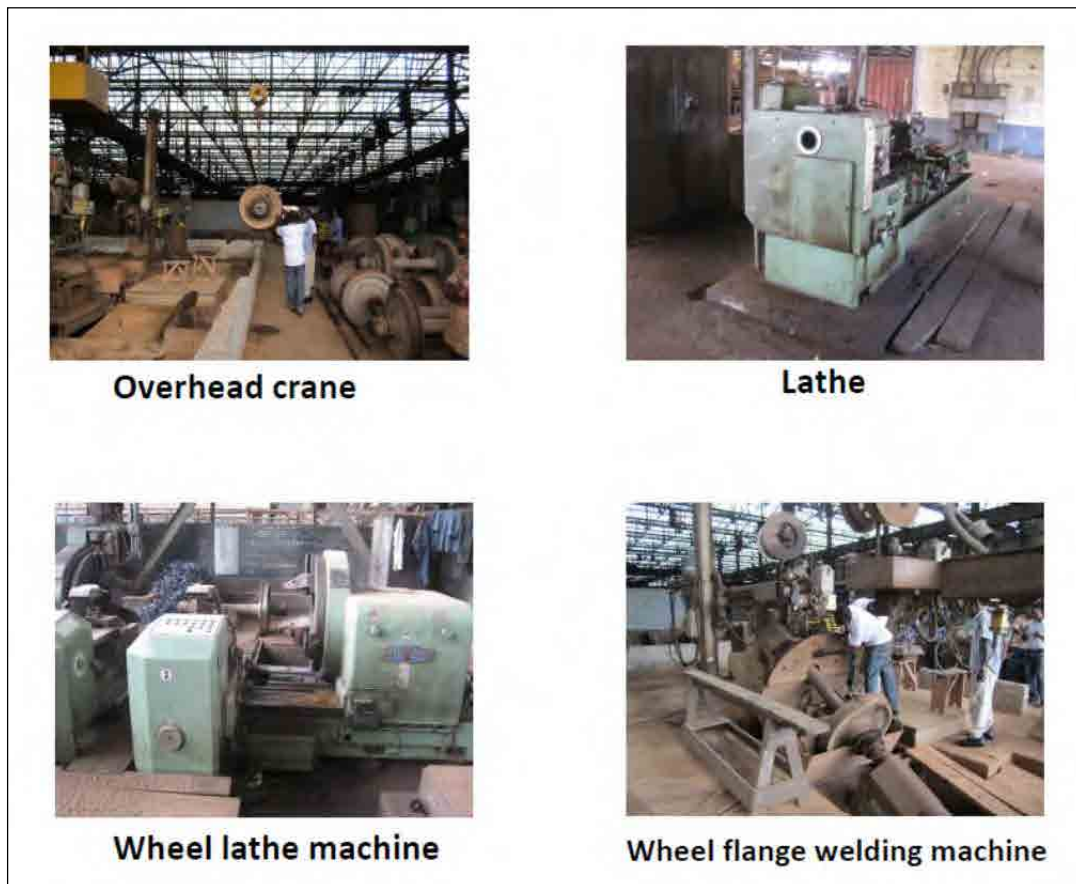
There used to be a variety of maintenance equipment, including sophisticated machines. Most of the maintenance machines have been abandoned and only indispensable ones such as cranes, lathe and wheel lathe are maintained for use, but they are in bad condition.

**Overhead crane**

**Lathe**

Maintenance facilities should be kept in good condition so that they can be used whenever they need to be used. That is the reason preventive maintenance and daily maintenance systems should be adopted. However maintenance of the machines has rarely been practiced due to the lack of maintenance budget and severe shortage of consumable goods, even oil and grease. They are only just kept in operation.

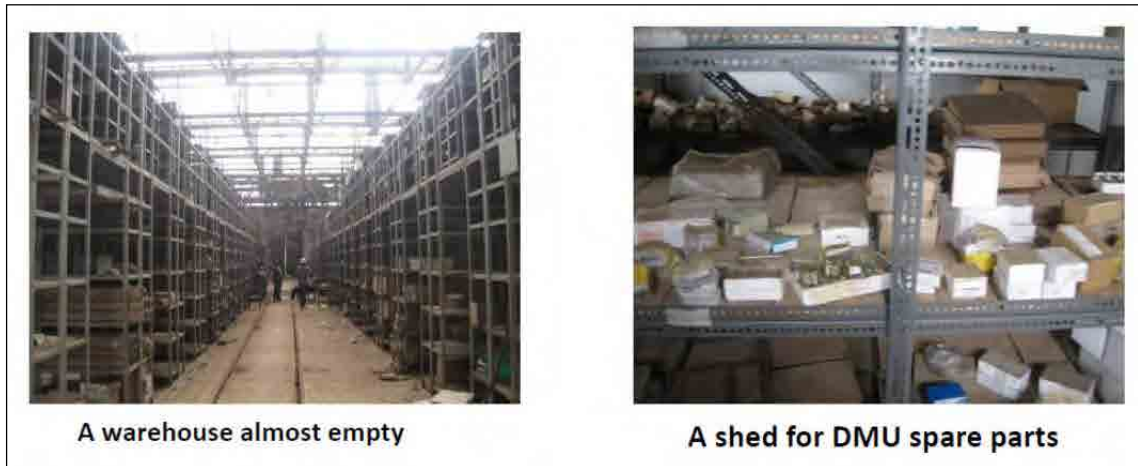
Material management has not only a quantity control function but also a quality control function. It is one of the important roles to keep stocks in good condition. As far as observing the shed of Tema line, quality control is poor and spare parts are placed on a dusty shelf.

**Photo 2.3.54 Current Status of Stock Parts**

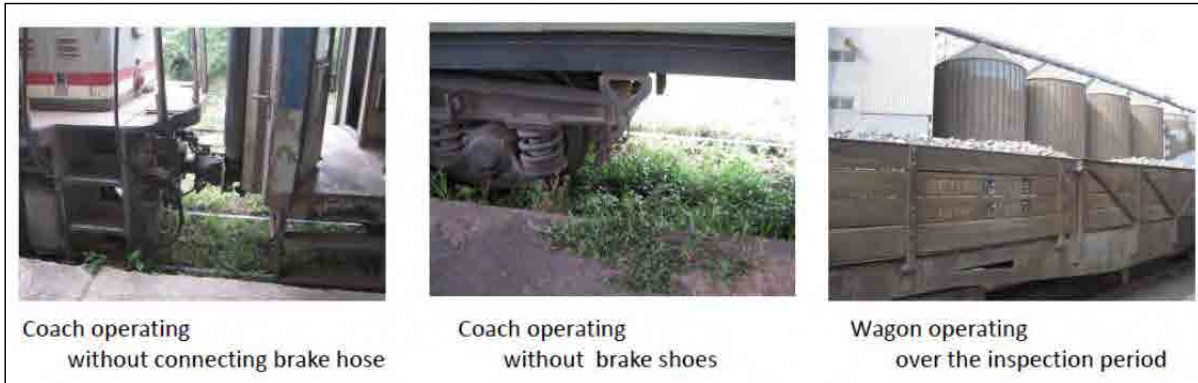
However implementation of PM is not sufficient due to the lack of budget and spare parts. Sometimes rolling stock and trains without brake hoses or brake shoes are operating beyond the maintenance period. In actual fact GRCL is obliged to accept break down maintenance against the rules.

**Photo 2.3.56 Examples against the Rule**

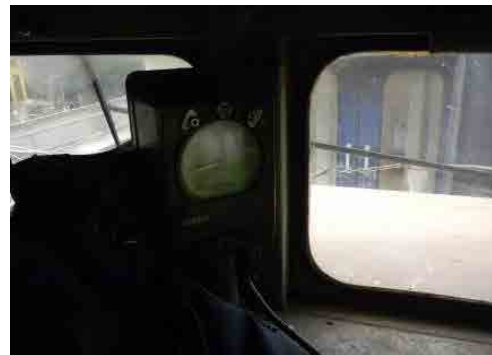
**Photo 3.1.2 Broken Speedometer (2)**

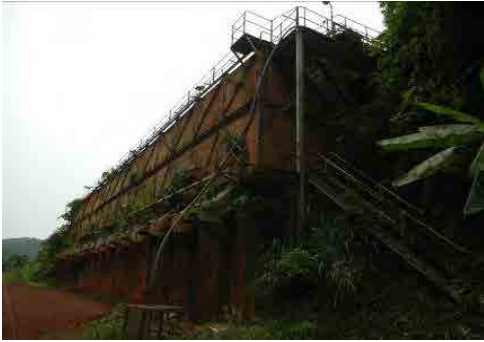
The JICA Study Team implemented site surveys at the bauxite loading site at Awaso and the manganese loading site at Nsuta. There is a weighting bridge at Awaso, but it has been out of order for many years (Photo 3.1.3 and 3.1.4). There is no weighting bridge/equipment at the manganese loading site in Nsuta. The operation of loading and offloading of the manganese ore are done by manganese company's staff. GRCL does not manage the weight of the loaded wagons (Photo 3.1.5). The loading conditions on the wagons are different (Photo 3.1.6 to 3.1.8). This increases the danger of derailment due to the tilting of wagons in the curves.

**Photo 3.1.3 Bauxite Hopper (Awaso)**

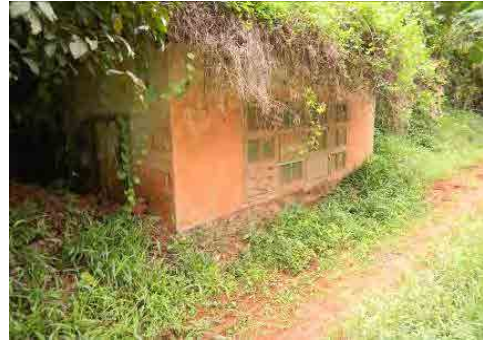
**Photo 3.1.4 Old Weigh Bridge (Awaso)**

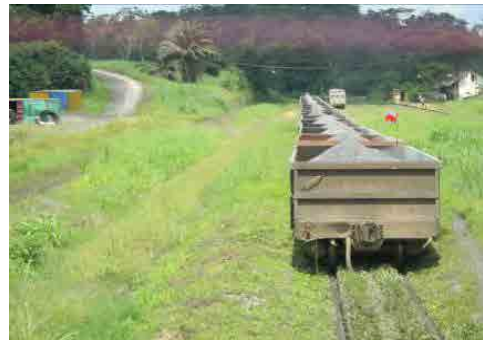
**Photo 3.1.6 Loading Manganese (Nsuta) (2)**

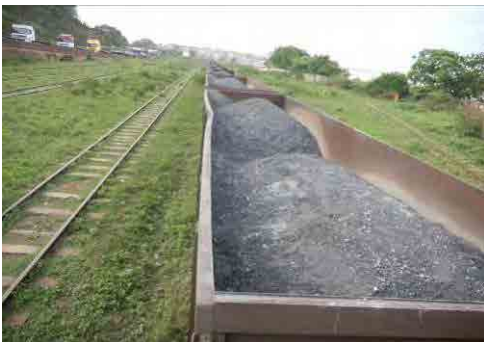
**Photo 3.1.7 Loading Manganese (3)**

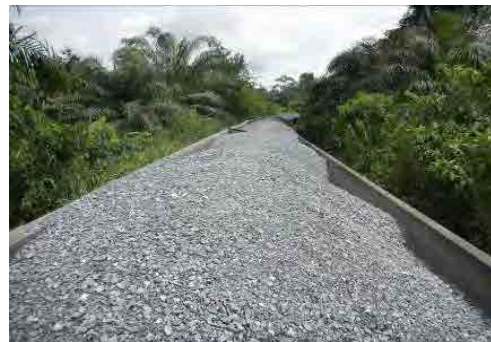
**Photo 3.1.8 Loading Manganese (4)**

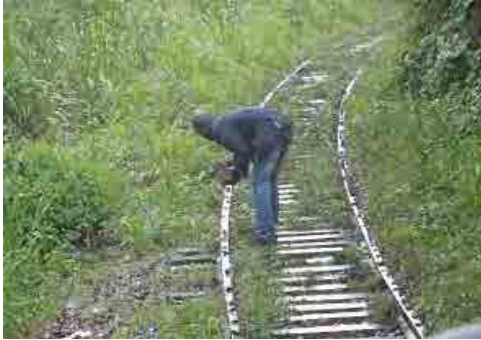
but they were damaged. So, the drivers put many pebbles on the rail to generate the required frictional force (Photo 3.1.9). This causes an increase in the degradation of the tracks and the wheels and also reduces the friction force. It becomes a vicious spiral. The device that heats the sand in the running shed are left damaged as well as the sand box with the loco (Photo 3.1.14).

**Photo 3.1.9      Using Pebbles  
for Wheel Slips**

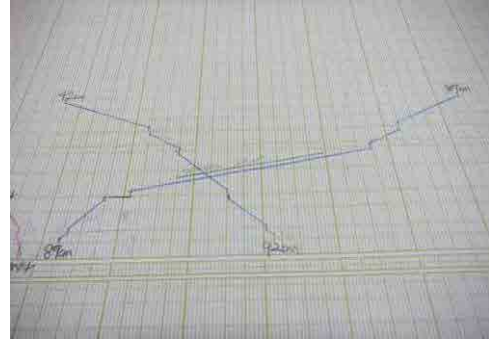
We were once on board a manganese train from Nsuta. We experienced wheel slips of the train as it had rained. And we saw many traces of the wheel slips during site surveys. Many wheel slips are caused by bad conditions of the track and the rolling stocks that reduce the frictional force that is ordinarily expected. When the Drivers experience wheel slips they try to recover for the delay by increasing speed and violating existing speed restrictions. And they operate the brakes excessively to decelerate. These operations increase the danger of derailment by irregular movement of the wagons and cause brake trouble too. The locos are provided with sand boxes,

**Photo 3.1.10      The Wheel Slip Record  
on the Actual Diagram**

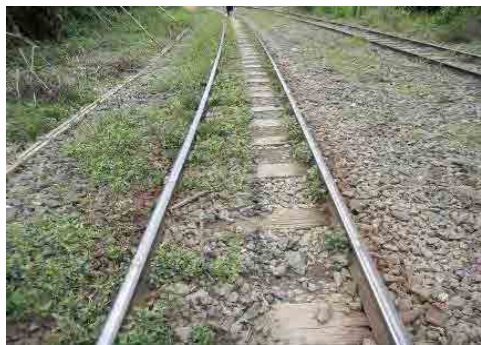
**Photo 3.1.11      Trace of the Wheel Slips  
on the Rail (1)**

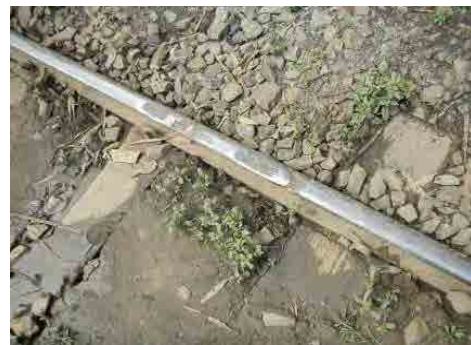
**Photo 3.1.12      Trace of the Wheel Slips  
on the Rail (2)**

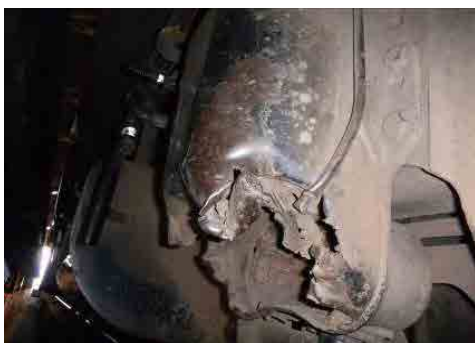
**Photo 3.1.13      Broken Sand Box**

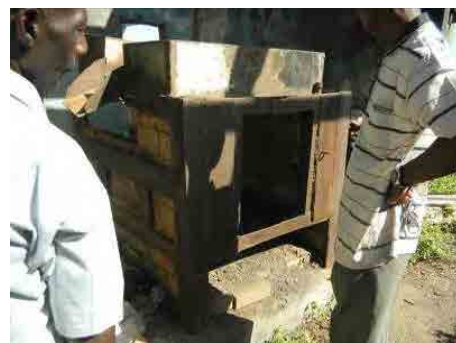
**Photo 3.1.14      Broken sand Heating Device**

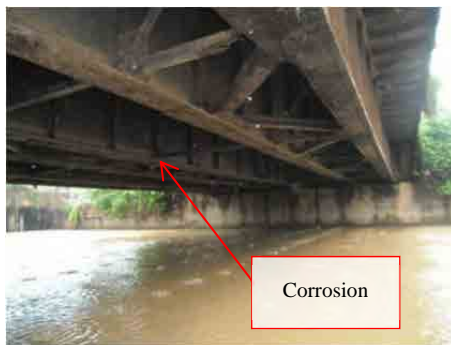
**Photo 4.2.31 Steel Beam of Busua Bridge**

In Ghana, progression of corrosion of steel bridge has been a serious situation due to lack of maintenance for a long period.

- Condition is very bad because of insufficient maintenance. Painting should be done at span center where bending moment is the largest.
- Due to lack of maintenance budget, the bridges could not be painted and that led to the corrosion.
- Portions at span center should be painted by use of ladder and wood plate.

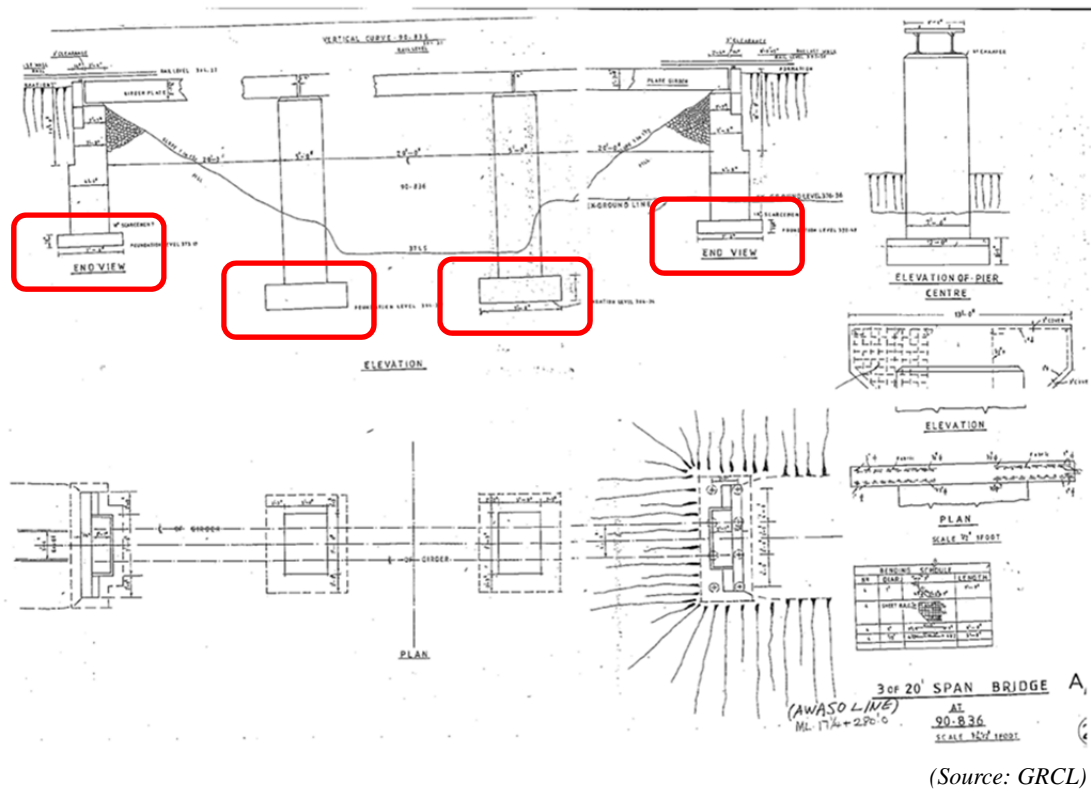
**Figure 4.2.2 Design of Bridge in Ghana**

Japanese steel bridges are regularly painted, which results in maintaining healthy condition. This implies how important regular inspection and continuous maintenance is. It was found out from design drawings of bridge structures in Ghana that the width of foundations tends to be narrow compared to the height of structure, which could be considered unstable for fall, sliding and subsidence.

- We learned that the foundation width is narrow compared to the height of abutment and pier , thus the structure is unstable. Width of the foundation should be widened.
- The width of the foundation should be widened because it becomes unstable by scouring.

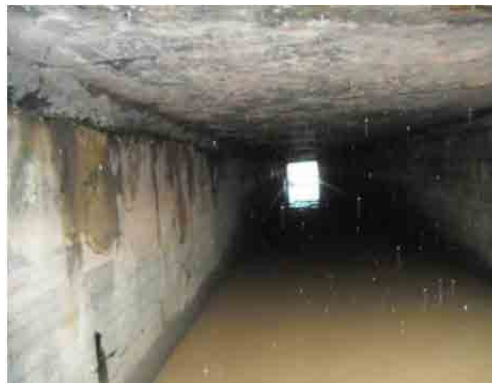
Taking an example of the box culvert nearby Busua Station, explanation was made regarding the relation of positions of tension side and compression side. It is necessary to arrange many steel bars at tension side because concrete is weaker in tension but steel bars are stronger in tension. It was also explained that substructure consisted of plane concrete and structurally weak.

**Photo 4.2.34 Box Culvert in the Suburbs of Busua**

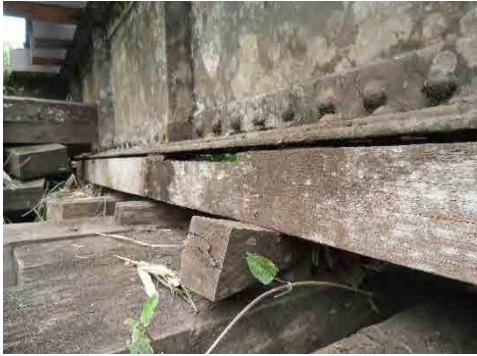
As a result of the inspection at Manso Bridge, it was confirmed that sleepers piled up to support the superstructure was subsided and thus not actually supporting it. The substructure that was built by plain concrete has collapsed due to narrow foundation width and has lost stability by scouring, etc. As trainees could not understand the reason of collapse, explanation was made about working load (train load, earth pressure, water pressure, earthquake load) and strut method as an appropriate measure.

**Photo 4.2.40** The state of the sleeper were piled up don't support upper structure (1)

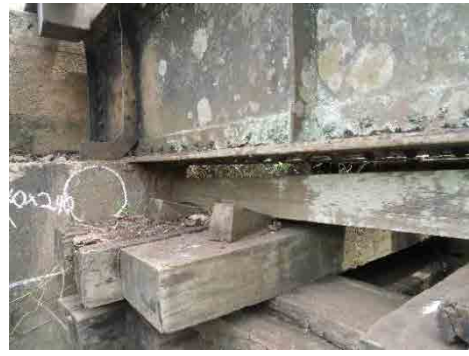
**Photo 4.2.41** The state of the sleeper were piled up don't support upper structure (2)

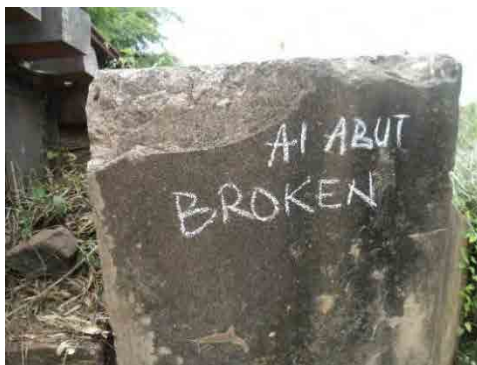
**Photo 4.2.42** The State of the Collapsed A1 abutment (1)

- A1 abutment has collapsed because of soil pressure, water pressure, train load, scouring and narrow foundation width as well as no regular maintenance.
- We confirmed that the subsidence of piled up sleepers that supported superstructure has occurred and thus sleepers did not support it.
- Substructure that was built by plain concrete and the foundation width was narrow. As concrete is weak for tension, it must be changed to reinforced concrete.
- It is considered effective to use H-steel as strut to prevent collapse of A1 abutment.

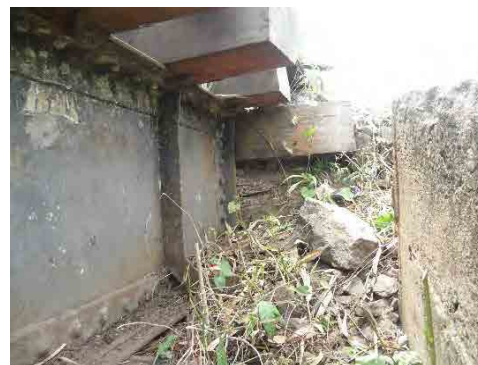
**Photo 4.2.43** The State of the Collapsed A1 abutment (2)

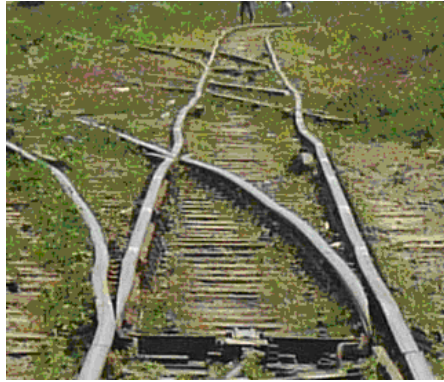
**Photo 4.2.56** There are many big track irregularity spots (Butuah St. Yard)

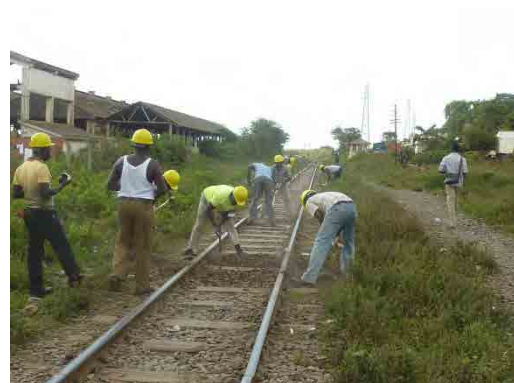
**Photo 4.2.61** Every group tried to change rotten sleepers

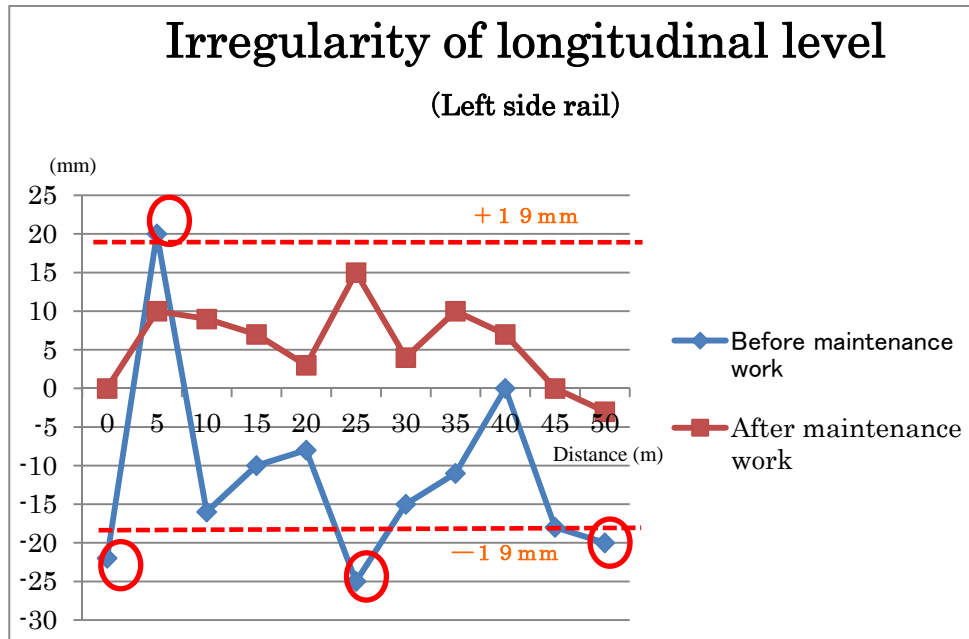
Each group has shown in graph the results of the track irregularity before and after the repair of tracks, then compared among groups. All groups have confirmed that the track condition was improved after the repair works. Following shows the result of inspections of track irregularity.

(Note: As at initial maintenance work, there were 4 spots were over the tolerable limit for urgency. However, irregularity values of whole of section including the of these over limit spots have become within the limit for urgency after the maintenance work.)

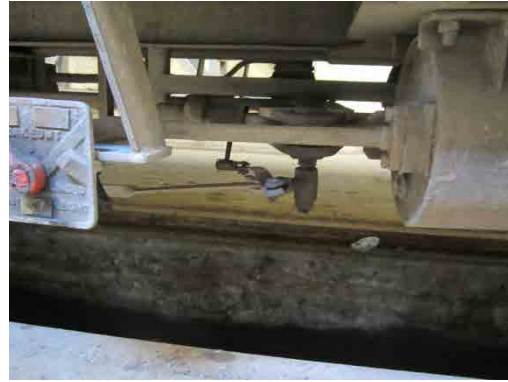
Using a freight car purchased from India, functions of the assembled brake test equipment were checked and confirmed. Though it was only a year and a half old, the brakes did not properly work due to insufficient daily cleaning and lubrication, which has resulted in air leakage from the brake pipe and sticking of the foundation brake system. Therefore, the freight car was repaired in advance jointly with GRCL employees.

**Photo 4.2.96 Non-movable Brake System which does not Move due to Sticking**

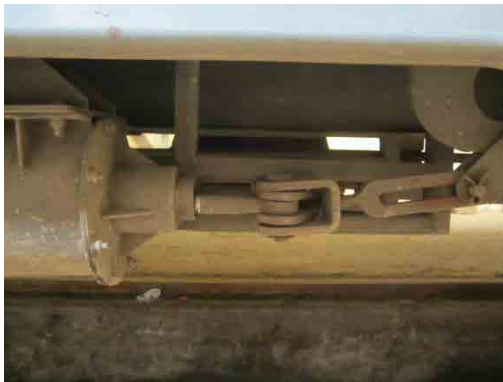
**Photo 4.2.97 Check of Functionality under Brake Cylinder Released Status**

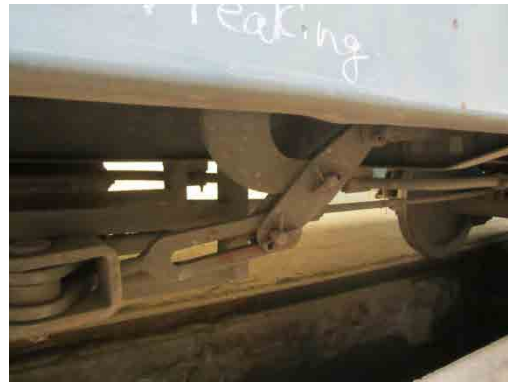
**Photo 4.2.98 Check of Functionality of Brake Cylinder Lever**

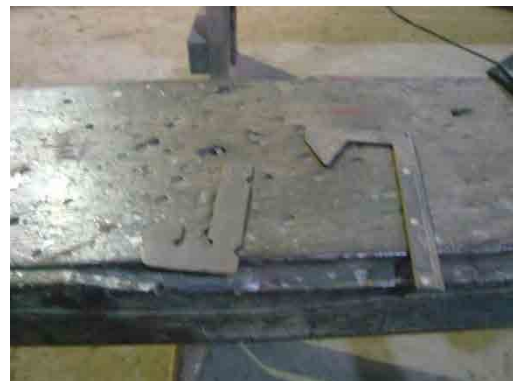
**Photo 4.2.110 Old-type Flange Measurement Device Used in Ghana**

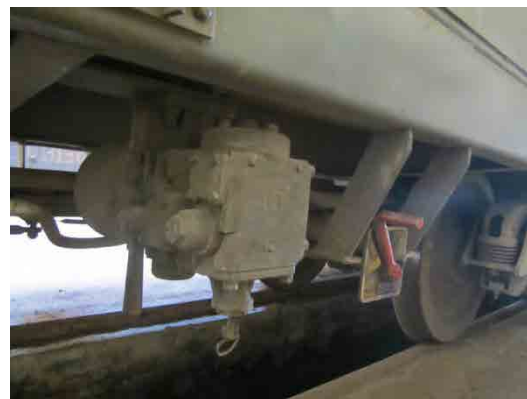
**Photo 4.2.132** Brake Valve Covered with Dust

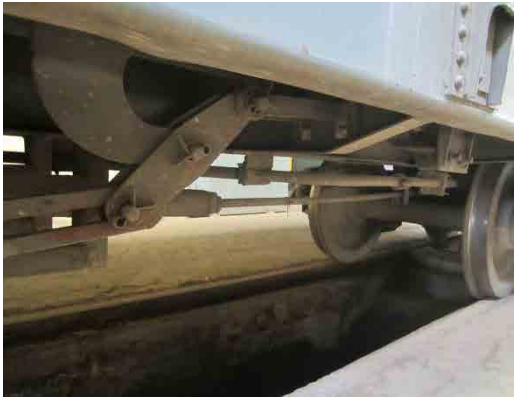
**Photo 4.2.133 Unlubricated Brake Lever**

- For the time being, Ghana railways shall strive to secure the minimum budget required, and, with efforts of all staffs, to maintain the train operations by the implementation of minimum maintenance, e.g. cleaning, lubrication (oil and grease), fastening of loosened bolts, and replacement of consumables.

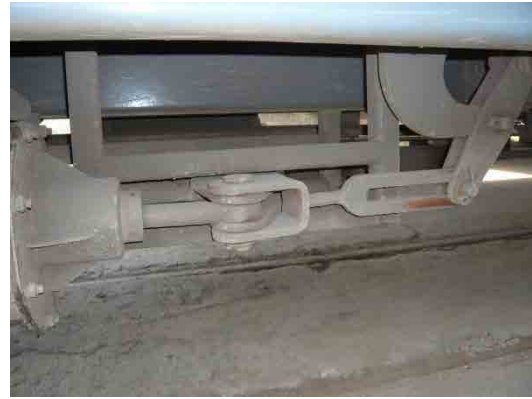
**Photo 4.2.134 Brake Cylinder and Lever  
(with scoring traits)**

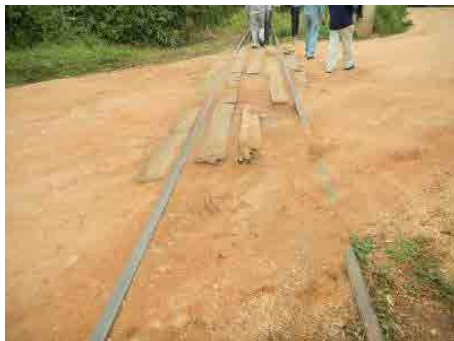
There are many rotten sleepers, unstable rails and fasteners everywhere. And it is notable that the conditions of the rail joints and roadbed are extremely poor. At a level crossing the tracks are buried under the ground.

**Photo 1 Track at level crossing**

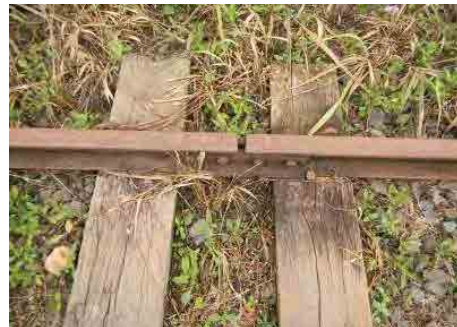
**Photo 2 Track condition in the section where Train operations are stopped**

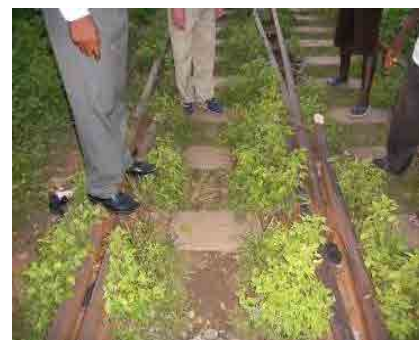
**Photo 10 Trace of derailment (Dunkwa)**

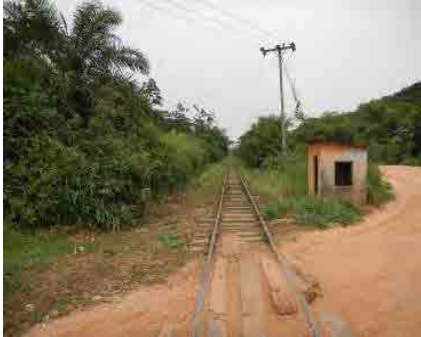
There are some boxes for guards at level crossing on the main road. But no crossing bars, security alarms or roadblocks are provided.

**Photo 11 Level crossing at Main road**

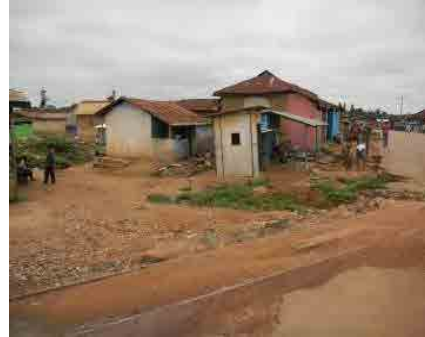
**Photo 12 Level crossing at Dominasi station**

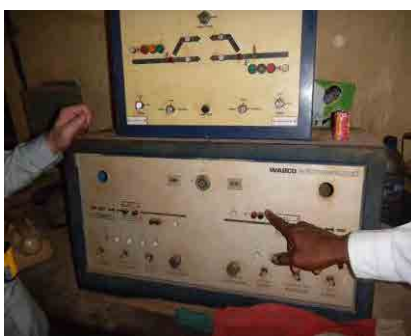
There are old semi-automatic block systems that were introduced in 1983. But they are out of order now. The points at the stations are controlled by mechanical devices.

**Photo 15 Old Blocking system**

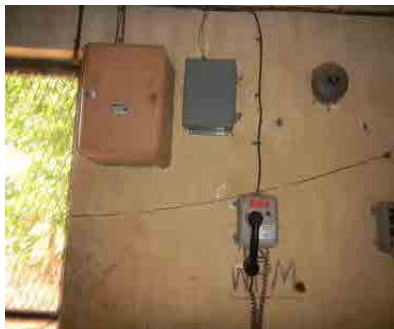
There is an old type of telecommunication system using a fixed line, but it is out of order now. The communication devices are mobile phones for officials now. The mobile phones are used for the blocking.

**Photo 21 Old telecommunication device (1)**

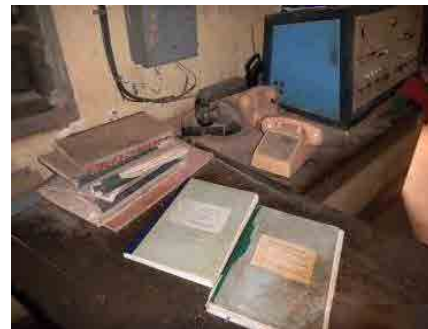
**Photo 22 Old telecommunication device (2)**

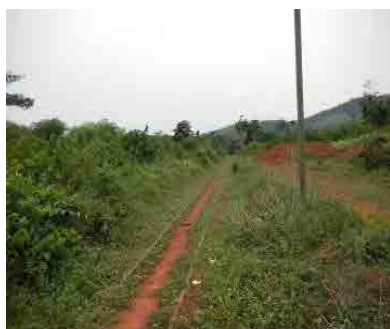
There is a sub-depot in the Awaso station too. The tracks that lead to the bauxite mine and in the mine are buried under the ground. There is a weight bridge in the bauxite loading site, but that has been out of order for many years.

**Photo 27** Track condition leading to Bauxite mine

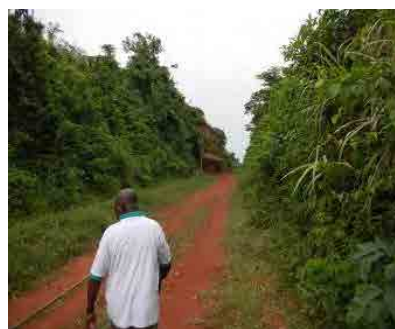
**Photo 28** Track condition at loading site

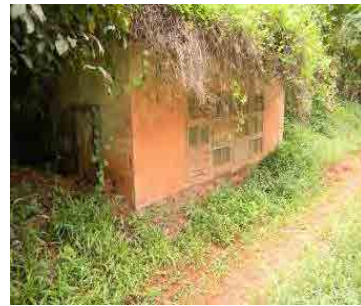
**Photo 32 Old weigh bridge**

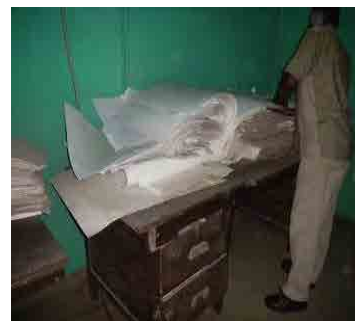
**Photo 40 Condition of management Documents**

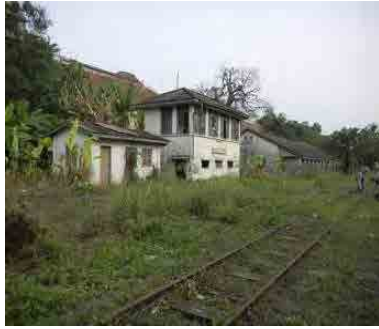
We made an inspection of the signal cabins at Takoradi station and Tarkwa station. The points at both stations are controlled by mechanical devices. There are the old blocking system and the old telecommunication devices, but they are out of order. The mobile phones are used for the blocking.

**Photo 41 Takoradi signal cabin**

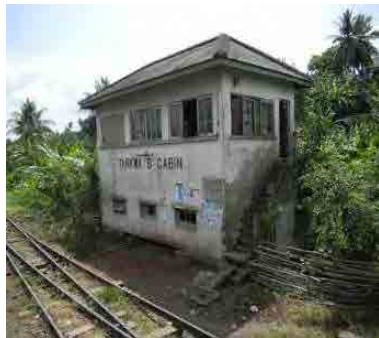
**Photo 43 Tarkwa signal cabin**

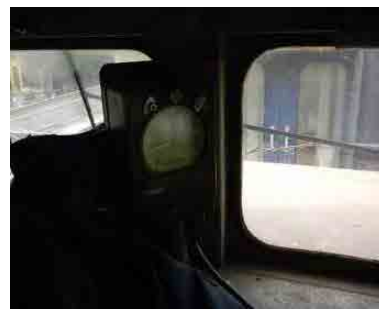
**Photo 46 Broken speedometer**

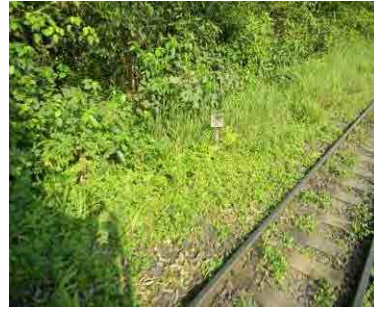
Generally the track conditions are very poor, so the driver is ordered to keep the running speed under

25km/h by the stationmaster. When the train runs into an extremely poor section with an up gradient which causes the train to run at a very low speed, the driver uses a blower to protect the motor from overheating.

**Photo 61** Extremely bad track (1)

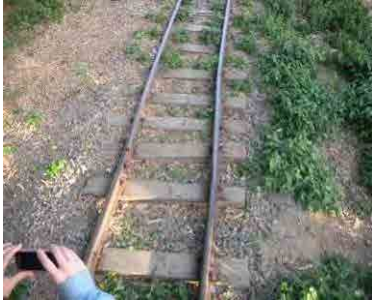
**Photo 62** Extremely bad track (2)

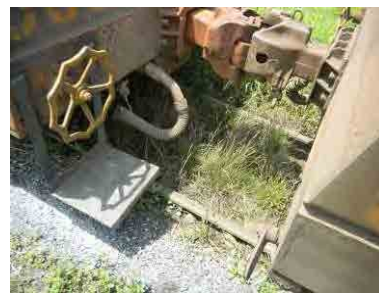
The shunter, the driver and the wagon inspector inspected the condition of the train. The certificate of inspection was delivered from the inspector to the driver after inspection. The composition of the train is 25 wagons, and the brakes of two wagons in the rear are out of order.

**Photo 66** Defective brake hose

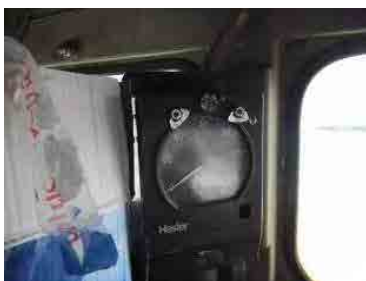
From Manso, there are many straight lines and the driver tried to recover the lost time, so the train ran at high speed, but the running speed is unknown because speedometer is broken. The wagon's rolling movement is recognized on the straight line because track conditions are very poor here too.

**Photo 73 Broken speedometer**

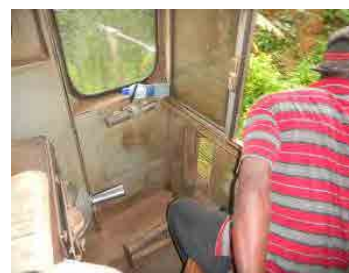
The section between Esuasoo and Benso is dangerous because of poor visibility due to being overgrown with weeds beside the tracks in the jungle. The driver checked the condition of the edge of the sleepers when the train passed through the dangerous section where the conditions of the roadbed and sleepers are extreme poor. When the train ran between Benso and Amantin, wheel slip occurred because of rain at the start of the curve with an up gradient. The driver and assistant driver tried to start on the steep grade by using pebbles, but it was impossible. So finally a relief locomotive was connected at the rear and the train advanced to Amantin by being pushed.

**Photo 74 Checking the track condition**

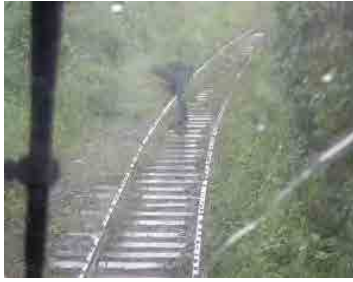
**Photo 75 Wheel slip (1)**

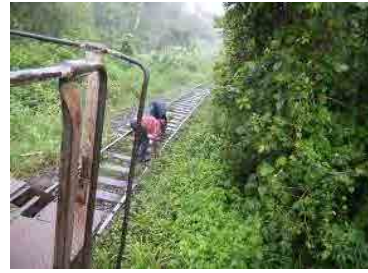
**Photo 76 Wheel slip (2)**

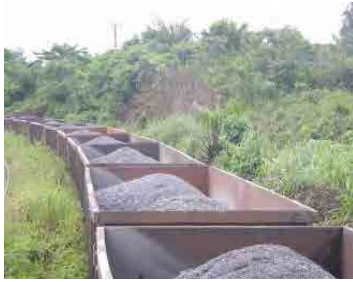
**Photo 77 Wagon condition at curve**

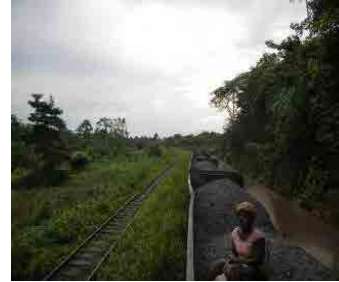
**Photo 78 Wagon condition at straight**
