APPENDIX 2

Bride Inspection Ledger

INVESTIGATION RECORD SHEET FOR BRIDGE

Study for Safety Operation and Management of Railway in the Republic of Ghana 2012 to 2013

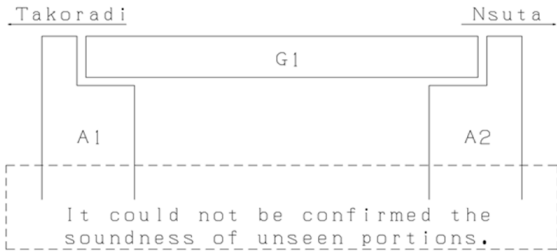
| Comment | | <p>The whole bridge gets rusty.</p> <p>The corrosion of the lower flange is severe, and a section loss is seen because clearance under girder is</p> <p>No loss of rivet are seen.</p> <p>No rust fluid is not seen in the superstructures.</p> | | | | | | | |

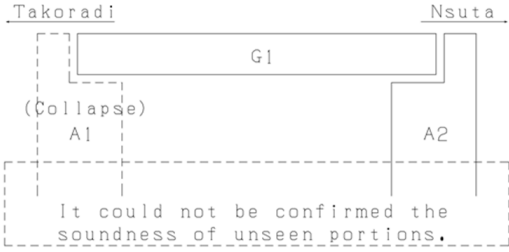
| Comment | | <p>Abutment of Takoradi side (A1) is collapsed by scouring. Superstructure was modified by using wood sleepers as substructure. The whole bridge gets rusty. No loss of rivet are seen. No rust fluid is not seen in the superstructures. It is desirable to to remove the girder and to restore the roadbed as the embankment as soon as possible.</p> | | | | |

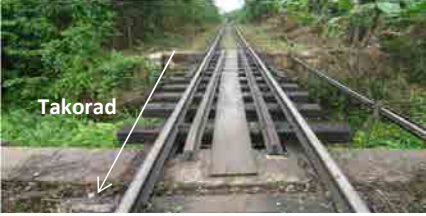
| Comment | | <p>The whole bridge gets rusty. No loss of rivet are seen.</p> <p>Big horizontal cracks thought to be the dry shrinkage is seen on the front of para-pet and the skeleton of the A1 and A2 abutment.</p> <p>No rust fluid is not seen in the superstructures.</p> | | | | | | | |

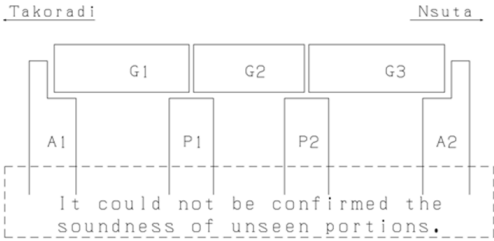
| Comment | | <p>The whole bridge gets rusty.</p> <p>No loss of rovet and splice plate is seen.</p> <p>Big horizontal cracks thought to be the dry shrinkage is seen on the front of para-pet and the skeleton of the A1 and A2 abutment.</p> <p>No rust fluid is not seen in the superstructures.</p> | | | | | |

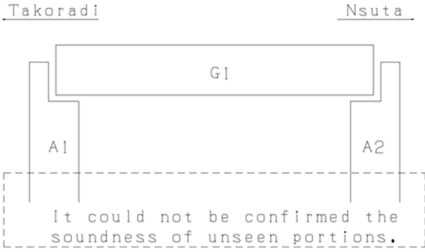
| Comment | | <p>The whole bridge gets rusty. No loss of rivet are seen.</p> <p>Big horizontal cracks thought to be the dry shrinkage is seen on the front of para-pet and the skeleton of the A1 and A2 abutment.</p> <p>Concrete in the front of para-pet by moving shoe is broken.</p> <p>No rust fluid is not seen in the superstructures.</p> | | | | | | | |

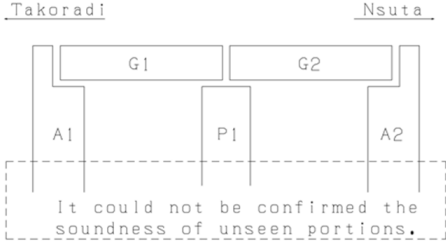
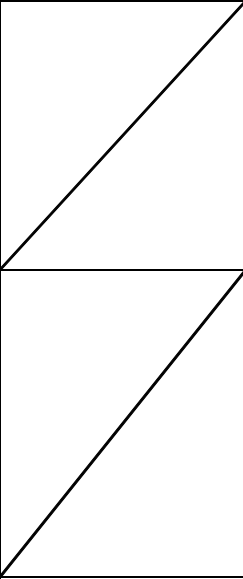
| Comment | | <p>The whole bridge gets rusty. No loss of rivet are seen.</p> <p>Big horizontal cracks thought to be the dry shrinkage is seen on the front of para-pet and the skeleton of the A1 and A2 abutment.</p> <p>No rust fluid is not seen in the superstructures.</p> | | | | | |

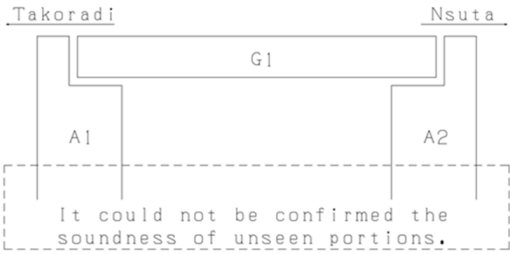
| Comment | | <p>Since clearance under girder is small, there is a possibility that the girder lower surface is immersed in water during the flood.</p> <p>The whole bridge gets rusty.</p> <p>No loss of rivet are seen.</p> <p>Big horizontal cracks thought to be the dry shrinkage is seen on the front of para-pet and the skeleton of the A1 and A2 abutment.</p> <p>No rust fluid is not seen in the superstructures.</p> | | | | | | | |

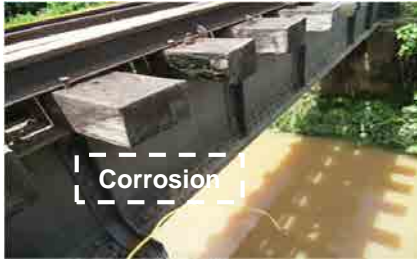
(Photo1)

| Comment | | <p>The whole bridge gets rusty.</p> <p>No loss of rivet are seen.</p> <p>Big horizontal cracks thought to be the dry shrinkage is seen on the front of para-pet and the skeleton of the A1 and A2 abutment.</p> <p>No rust fluid is not seen in the superstructures.</p> | | | | | | | |

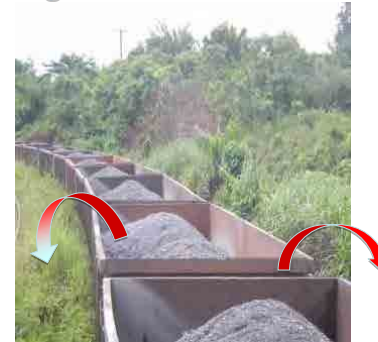
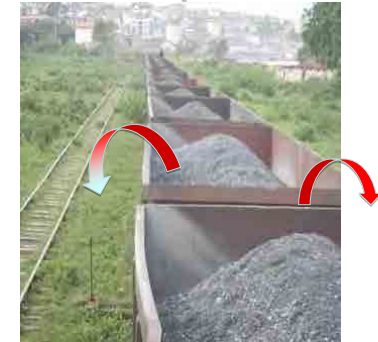
Rolling Stock's movement at derailment points

Irregular rolling happens wagon's right and left side case derailment easily. Especially curves with severe cant is most dangerous.

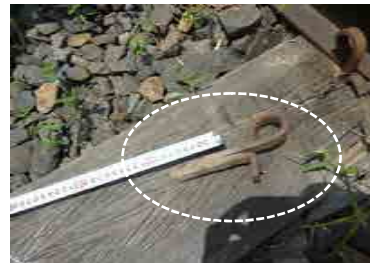
- Fastenings that can be pulled up easily by hand

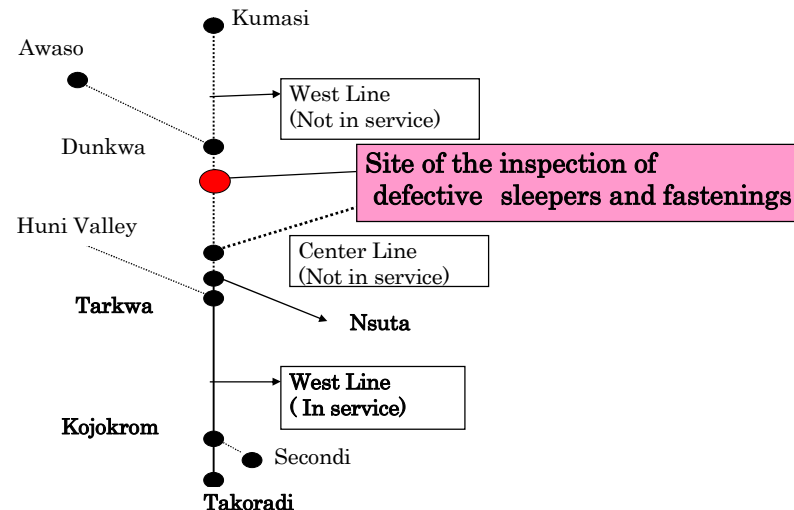
Drawing of defective sleepers and fastenings (1)

Ratio of defective sleepers=43%
(26/60)

Ratio of defective fastenings=59%
(141/(60 × 4))

Japanese standard
Defective sleeper : ≤7%
Defective fastening: ≤5%

- Establishment of standard for defective sleeper and fastening
- Periodical inspection (Once a year- Japanese Standard)
- Make drawings for controlling defective materials.
- This action should be carried out as soon as possible Between Takoradi and Nsuta .

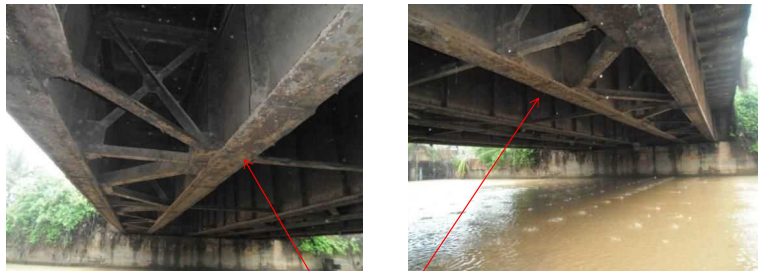
Steel Bridge in the Suburbs of Butuah

Corrosion

- Watch the progress of the rust and the situation of encrustation and deposits regularly.
- Remove the rust and repainting with durable materials.
- Remove the soil and garbage deposits in the shoes.
- Remove the loose rivets and replace them with high tensile bolts.

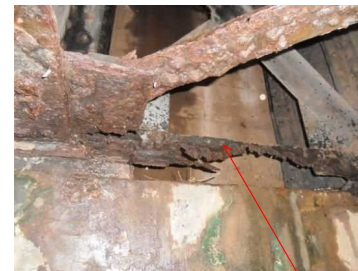
Section loss

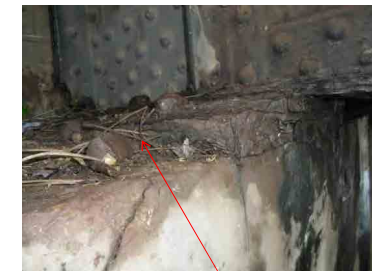
Soil deposits

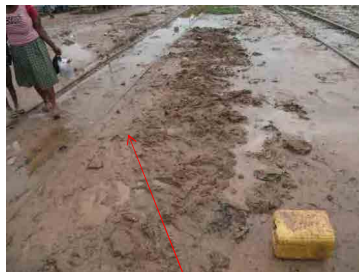
Situation of Problems with Drainage due to Accumulated Soil and Garbage Deposits

Accumulated soil

- Remove of accumulating soil in the station yard outside.
- Repair of the broken drainage system and improve water flow.
- Dig out the drains filled with soil and revive the function of the drainage system.
- Remove garbage in the drainage system regularly.

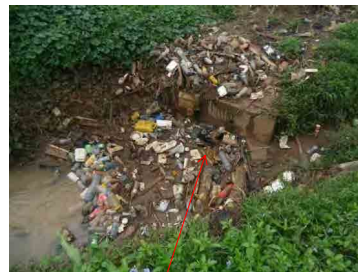
Deposit of garbage

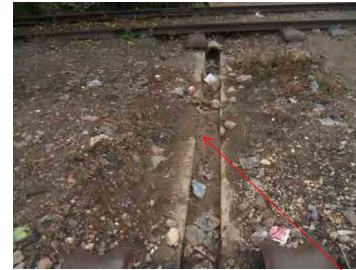
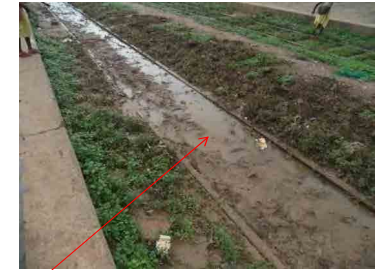
Situation of Problems with Drainage due to Accumulated Soil and Garbage Deposits

Accumulated soil

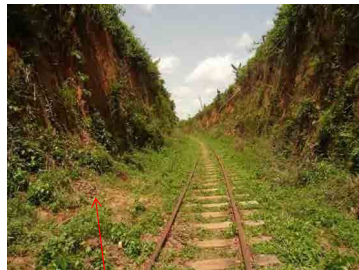
Landslide soil

- Watch for defects in the banking and cutting and signs of collapse regularly.
- Watch for defects in the banking and cutting immediately after heavy rain.
- When there is a risk of the collapse, the train service must be limited.

- In the banking area, infiltrated water must be prevented from entering the banking.
- In the cutting area, remove the risk of the collapse beforehand.

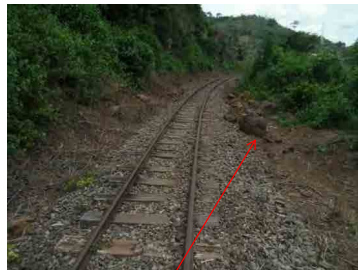
Landslide rock
