**The Urgent Project
for
Rehabilitation of Yangon Port
and
Main Inland Water Transport
in
The Republic of The Union of Myanmar**

FINAL REPORT

MAIN REPORT

January 2015

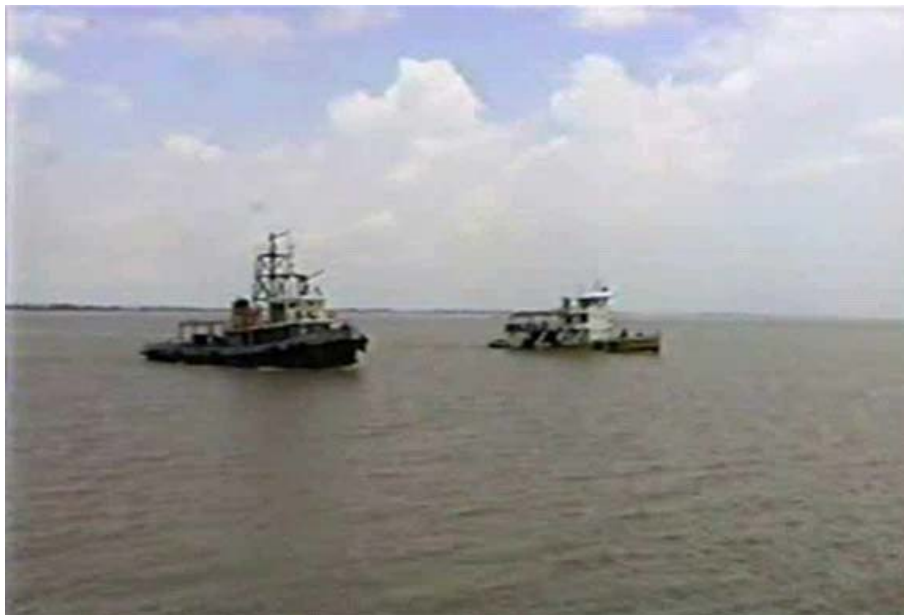
Photo 4.2.4 Sweeping Survey Ships

In order to confirm the existence of riverbed obstacles, a sounding survey was performed to search location and size of sunken obstacles. After some suspected obstacles are found, a sweeping survey at the suspected area was carried out by toeing wire rope on the riverbed by two boats as shown in Figure 4.2.1 and Photo 4.2.4.

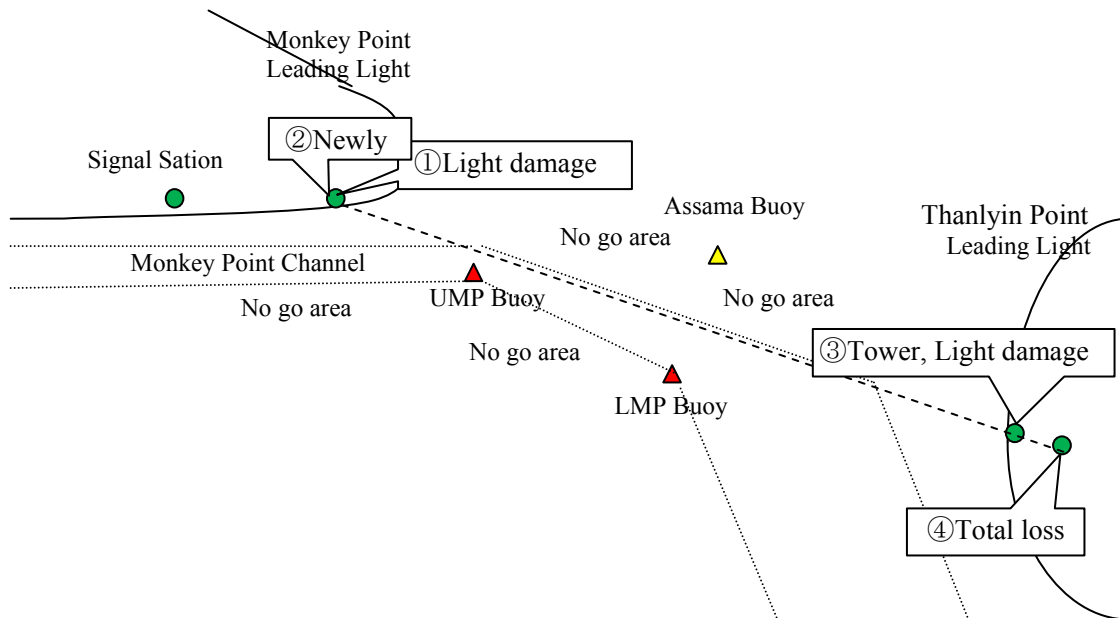
Figure 4.2.2 Location of Buoys and Leading Lights at Monkey Point Channel

Ships entering Yangon Port must pass the narrow Monkey Point Channel. In order to maintain safe navigation at the channel, MPA had installed leading lights at 6 places along a 35 mile stretch from the pilot station to the Monkey Point Channel as shown in Figure 4.2.2. However all leading lights were damaged by Nargis (See Photo 4.2.9), and this makes it difficult for ships to enter Yangon Port safely.

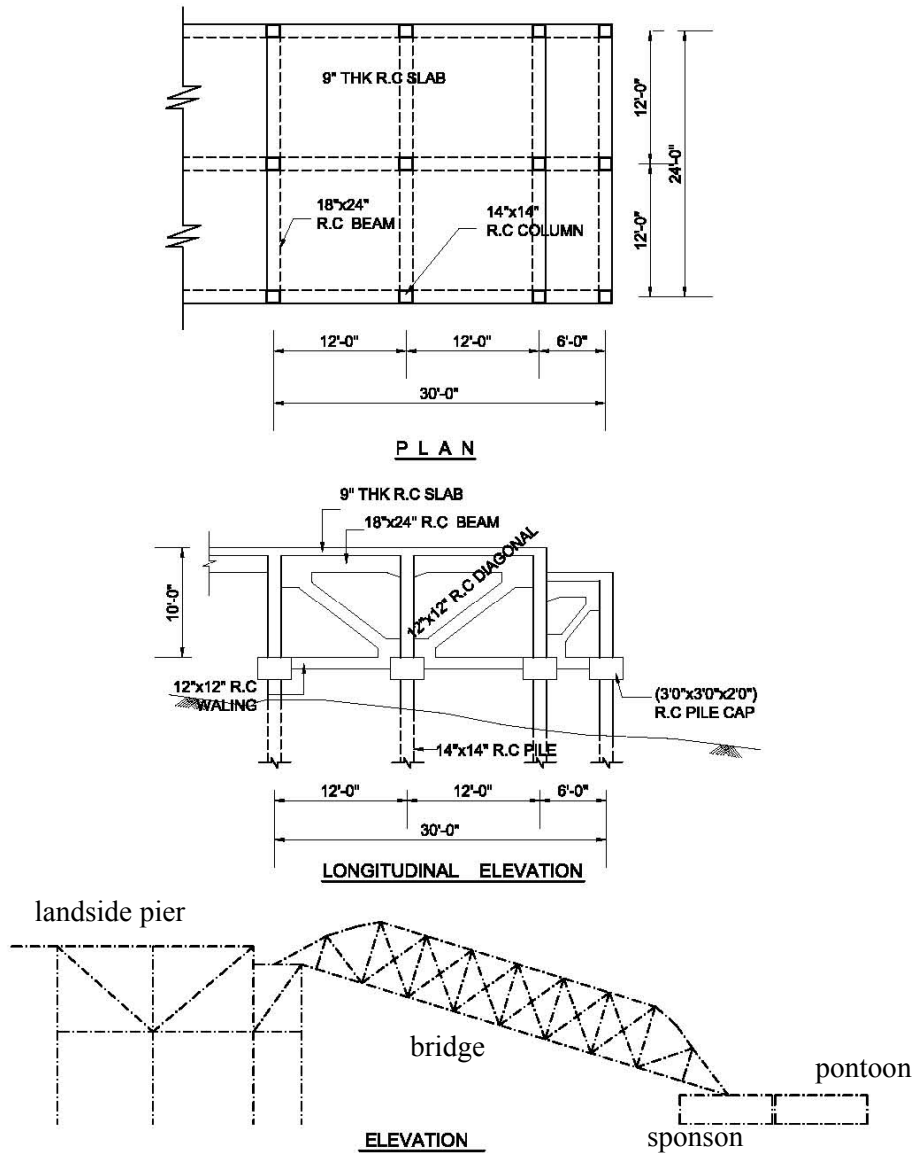
Figure 5.1.1 Standard Structure of Jetty Pier

A typical MPA jetty is composed of a landside concrete pier, a metal truss bridge, a steel sponson, a steel pontoon and a tank pontoon as illustrated in Figure 5.1.1.
