**The Urgent Project
for
Rehabilitation of Yangon Port
and
Main Inland Water Transport
in
The Republic of The Union of Myanmar**

FINAL REPORT

APPENDICES

YANGON PORT FACILITY

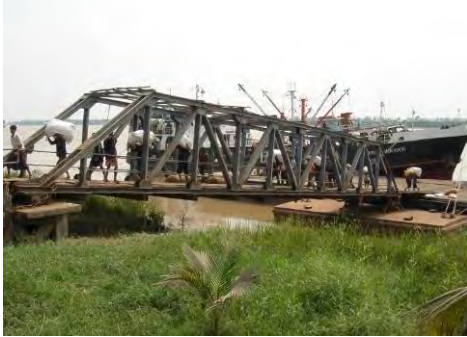
Photo 1 - General

<i>No.1</i>	<i>Name of Jetty</i>	Chungwa Jetty		
<i>Dimension</i>	Pontoon: Length 200' × Width 40' (before Nargis)	<i>Date of Inspection</i>	12 June, 2009	
Result of Inspection and Evaluation of Port Facilities				
<i>Facility</i>	<i>General Evaluation</i>	<i>Condition of Damage and/or Deterioration</i>	<i>Measures to be taken</i>	<i>Reference Photo</i>
Pontoon	Bad	Beam is partly rusted	It is needed to be replaced the heavy rusted member immediately	Photo 3, 4
Bridge	Good	Roller, support of Bridge, is shifted		Photo 1, 2
Pier	Fair	The roller is shifted to unnormal position	Reset the Roller to normal position	Photo-2
Sponson	Good	Have repaired last year		Photo 5

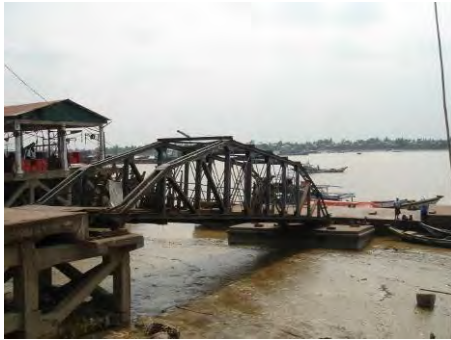
Photo 1 - General

<i>No.2</i>	<i>Name of Jetty</i>	Kyeemyindine No. 3 Jetty		
<i>Dimension</i>	Pontoon: Length 120' × Width 20' (before Nargis)	<i>Date of Inspection</i>	12 June, 2009	
Result of Inspection and Evaluation of Port Facilities				
<i>Facility</i>	<i>General Evaluation</i>	<i>Condition of Damage and/or Deterioration</i>	<i>Measures to be taken</i>	<i>Reference Photo</i>
Pontoon	Good	Rust, deficit		Photo 1
Bridge	Good	It has getting deteriorated	It is required to change the roller	Photo 1, 2, 4
Pier	Good	It has no remarkable deterioration		Photo 4
Sponson	Fair	Partially, holes are corroded	Set the plate and welding	Photo 3

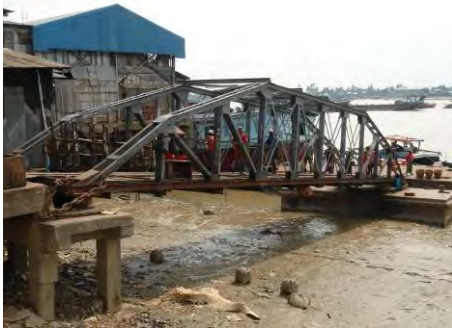
No.3	<i>Name of Jetty</i>	Kyeemyindine No. 5 Jetty		
<i>Dimension</i>	Pontoon: Length 80' × Width 20' (before Nargis)	<i>Date of Inspection</i>	12 June, 2009	
Result of Inspection and Evaluation of Port Facilities				
<i>Facility</i>	<i>General Evaluation</i>	<i>Condition of Damage and/or Deterioration</i>	<i>Measures to be taken</i>	<i>Reference Photo</i>
Pontoon	Good	No damage		Photo 1
Bridge	Good	Member is bent at Support position	It should be repaired	Photo 1, 2, 3, 4
Pier	Good	No special deterioration		Photo 5
Sponson	Good	Have repaired last year		Photo 1

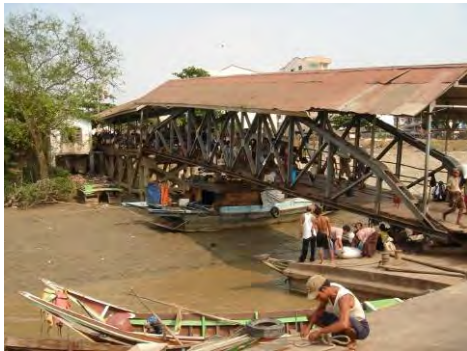
Photo 1

No.4	<i>Name of Jetty</i>	Kyeemyindine Bazar Road Jetty		
<i>Dimension</i>	Pontoon: Length 120' × Width 20' (before Nargis)	<i>Date of Inspection</i>	12 June, 2009	
Result of Inspection and Evaluation of Port Facilities				
<i>Facility</i>	<i>General Evaluation</i>	<i>Condition of Damage and/or Deterioration</i>	<i>Measures to be taken</i>	<i>Reference Photo</i>
Pontoon	Bad	Rust, hole	Repair the hole immediately	Photo 3
Bridge	Good	No damage		Photo 1, 2
Pier	Good	No damage		Photo 4
Sponson	Good	No damage		Photo 5

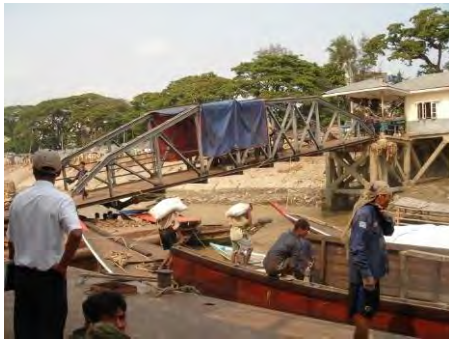
Photo 1

<i>No.5</i>	<i>Name of Jetty</i>	Bagaya No. 1 Jetty		
<i>Dimension</i>	Pontoon: Length 120' × Width 20' (before Nargis)	<i>Date of Inspection</i>	12 June, 2009	
Result of Inspection and Evaluation of Port Facilities				
<i>Facility</i>	<i>General Evaluation</i>	<i>Condition of Damage and/or Deterioration</i>	<i>Measures to be taken</i>	<i>Reference Photo</i>
Pontoon	Good	No damage		Photo 3
Bridge	Good	No damage		Photo 1, 2
Pier	Fair	Delamination of concrete	Set the flame and pour the concrete	Photo 4
Sponson	Good	No damage		Photo 5

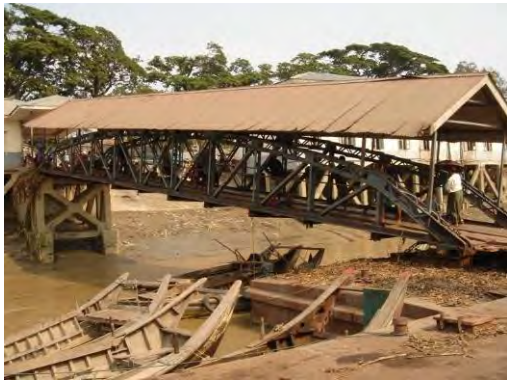
No.6	<i>Name of Jetty</i>	Bagaya No. 2 Jetty		
<i>Dimension</i>	Pontoon: Length 120' × Width 20' (before Nargis)	<i>Date of Inspection</i>	12 June, 2009	
Result of Inspection and Evaluation of Port Facilities				
<i>Facility</i>	<i>General Evaluation</i>	<i>Condition of Damage and/or Deterioration</i>	<i>Measures to be taken</i>	<i>Reference Photo</i>
Pontoon	Good	No damage		
Bridge	Good	No damage		Photo 1
Pier	Good	No damage		Photo 1, 2
Sponson	Good	No damage		Photo 1

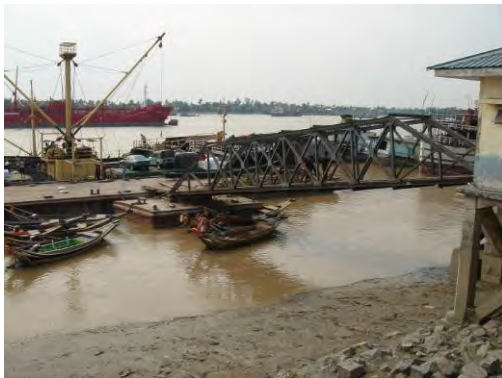
<i>No.7</i>	<i>Name of Jetty</i>	Bagaya No. 3 Jetty		
<i>Dimension</i>	Pontoon: Length 120' × Width 20' (before Nargis)	<i>Date of Inspection</i>	12 June, 2009	
Result of Inspection and Evaluation of Port Facilities				
<i>Facility</i>	<i>General Evaluation</i>	<i>Condition of Damage and/or Deterioration</i>	<i>Measures to be taken</i>	<i>Reference Photo</i>
Pontoon	Good	No damage		Photo 2
Bridge	Good	No damage		Photo 1, 2, 3
Pier	Good	Roller is deteriorated	Repair the roller	Photo 2
Sponson	Good	No damage		Photo 1

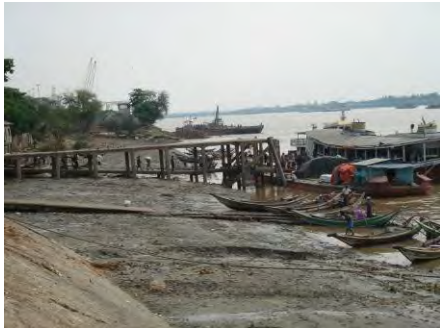
No.8	<i>Name of Jetty</i>	Bagaya Concrete short Jetty		
<i>Dimension</i>	Pontoon: Length 120' × Width 20' (before Nargis)	<i>Date of Inspection</i>	12 June, 2009	
Result of Inspection and Evaluation of Port Facilities				
<i>Facility</i>	<i>General Evaluation</i>	<i>Condition of Damage and/or Deterioration</i>	<i>Measures to be taken</i>	<i>Reference Photo</i>
Pontoon	Good	Rust, deficit		Photo 1
Bridge	-			
Pier	Bad	Reinforcing bar is exposed and trace of crack by delaminated Concrete	Pour the Concrete into the flaking parts	Photo 4
Sponson	-

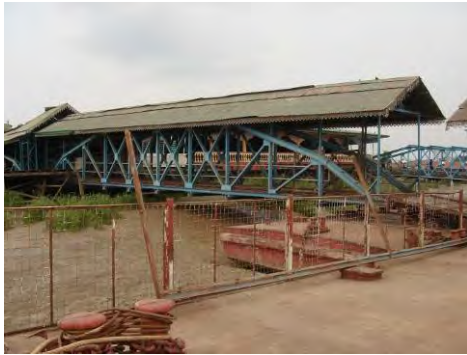
No.9-1	<i>Name of Jetty</i>	Wardan No. 1 Jetty		
<i>Dimension</i>	Pontoon: Length 120m × Width 20m (before Nargis)	<i>Date of Inspection</i>	12 June, 2009	
Result of Inspection and Evaluation of Port Facilities				
Facility	General Evaluation	Condition of Damage and/or Deterioration	Measures to be taken	Reference Photo
Pontoon	Good	No damage	Repair the hole immediately	Photo 1
Bridge	Good	No Deterioration		Photo 2, 3
Pier	Good	No damage		Photo 1
Sponson	Good	No damage		Photo 4

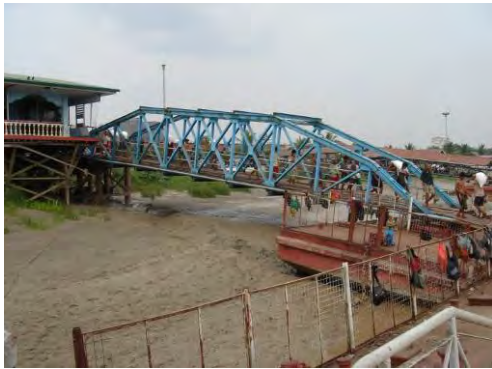
Photo 1

No.9-2	<i>Name of Jetty</i>	Wardan No. 2 Jetty		
<i>Dimension</i>	<i>Pontoon: Length 120' × Width 20' (before Nargis)</i>	<i>Date of Inspection</i>	12 June, 2009	
Result of Inspection and Evaluation of Port Facilities				
Facility	General Evaluation	Condition of Damage and/or Deterioration	Measures to be taken	Reference Photo
Pontoon	Good	No damage		Photo 1, 6
Bridge	Good	No damage		Photo 1, 2, 3
Pier	Good	No damage		Photo 4
Sponson	Good	No damage		Photo 5

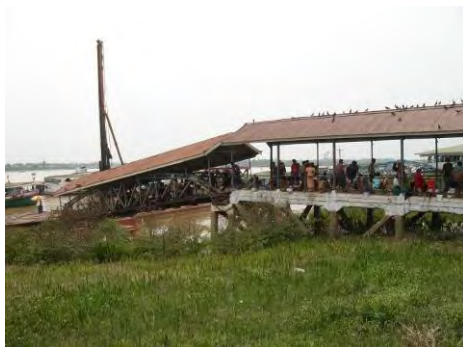
No.10-1	<i>Name of Jetty</i>	Wardan No. 3 Jetty		
<i>Dimension</i>	Pontoon: Length 240' × Width 20' (before Nargis)	<i>Date of Inspection</i>	12 June, 2009	
Result of Inspection and Evaluation of Port Facilities				
<i>Facility</i>	<i>General Evaluation</i>	<i>Condition of Damage and/or Deterioration</i>	<i>Measures to be taken</i>	<i>Reference Photo</i>
Pontoon	Good	Rust, deficit		Photo-7,8
Bridge	Good	Concrete crack		Photo 1
Pier	Bad	Shoe is placed tentatively	Reset shoe	Photo 2, 3, 4, 5
Sponson	Good			Photo-1

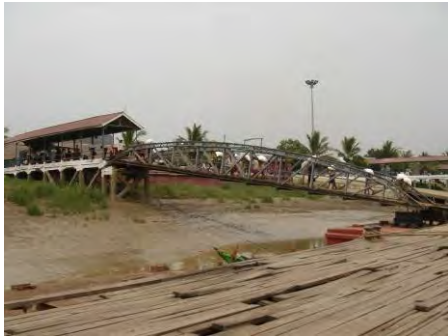
Photo 1

No.10-2	<i>Name of Jetty</i>	Bagaya No. 4 Jetty		
<i>Dimension</i>	Pontoon: Length 240' × Width 20' (before Nargis)	<i>Date of Inspection</i>	12 June, 2009	
Result of Inspection and Evaluation of Port Facilities				
<i>Facility</i>	<i>General Evaluation</i>	<i>Condition of Damage and/or Deterioration</i>	<i>Measures to be taken</i>	<i>Reference Photo</i>
Pontoon	Fair	Degradation of upper side timber	Replace timber	Photo 1,5
Bridge	Good	No damage	n.a.	Photo 1,4
Pier	Bad	Delamination of Concrete	Pour the concrete in the delaminated parts	Photo 2,3
Sponson	Good	No damage	n.a.	Photo-6

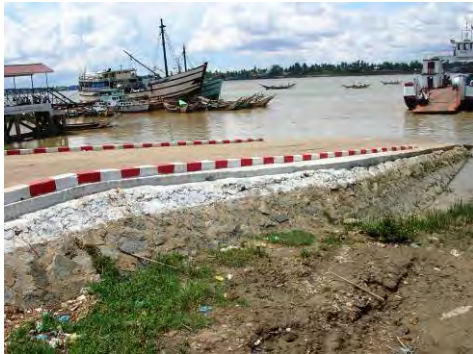
No.11	<i>Name of Jetty</i>	Wardan Ro/Ro Jetty		
<i>Dimension</i>		<i>Date of Inspection</i>	12 June, 2009	
Result of Inspection and Evaluation of Port Facilities				
Facility	General Evaluation	Condition of Damage and/or Deterioration	Measures to be taken	Reference Photo
Pontoon	-			
Bridge	-			
Pier	-			
Sponson	Good	No damage		Photo 1

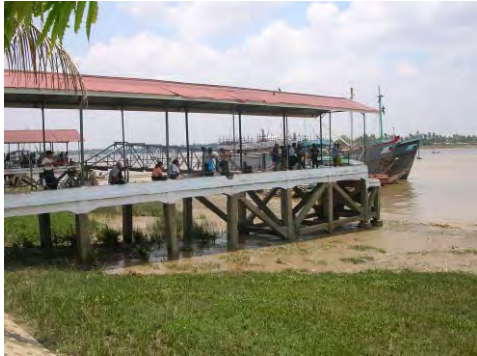
Photo 1

No.12	<i>Name of Jetty</i>	Wardan No. 5 Jetty		
<i>Dimension</i>		<i>Date of Inspection</i>	12 June, 2009	
Result of Inspection and Evaluation of Port Facilities				
Facility	General Evaluation	Condition of Damage and/or Deterioration	Measures to be taken	Reference Photo
Pontoon	-			
Bridge	-			
Pier	Good	No damage		Photo 1, 2
Sponson	-	-	-

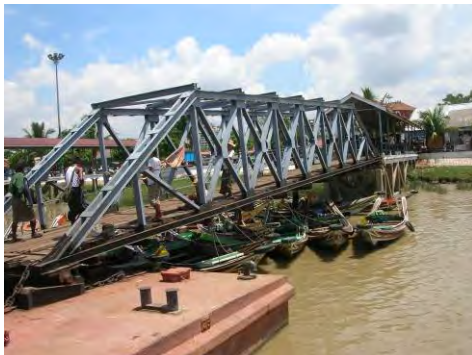
No.13	<i>Name of Jetty</i>	Wardan No. 6 Jetty		
<i>Dimension</i>	Pontoon: Length 120m × Width 20m (before Nargis)	<i>Date of Inspection</i>	12 June, 2009	
Result of Inspection and Evaluation of Port Facilities				
Facility	General Evaluation	Condition of Damage and/or Deterioration	Measures to be taken	Reference Photo
Pontoon	Good			Photo 4
Bridge	Good			Photo 2
Pier	Fair	Delamination of Concrete	Pour the concrete in faked parts	Photo 3, 6
Sponson	Good	No damage		Photo 5

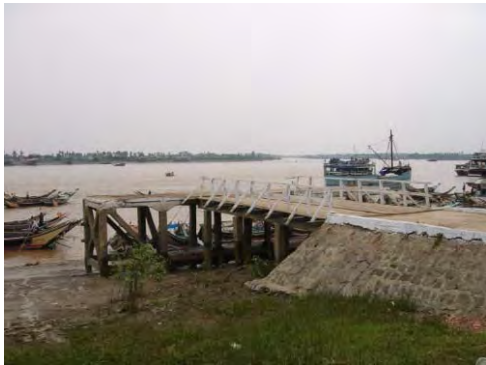
No.14	<i>Name of Jetty</i>	Concrete Jetty No.1		
<i>Dimension</i>	—	<i>Date of Inspection</i>		12 June, 2009
Result of Inspection and Evaluation of Port Facilities				
Facility	General Evaluation	Condition of Damage and/or Deterioration	Measures to be taken	Reference Photo
Pontoon	-			
Bridge	-			
Pier	Bad	Hole, Delamination	Reset the reinforcing bar and pour the concrete	Photo 1, 2, 3, 4, 5
Sponson	-

Photo 1 - General

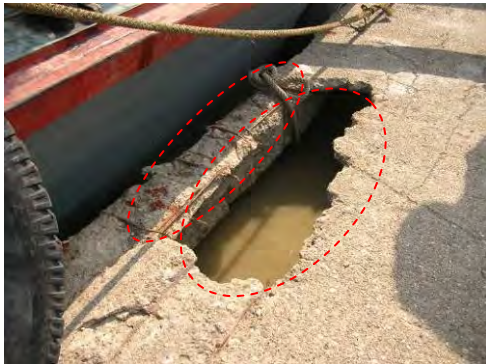
Photo 2 - Slab

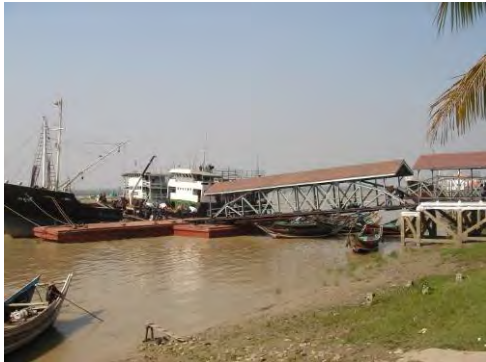
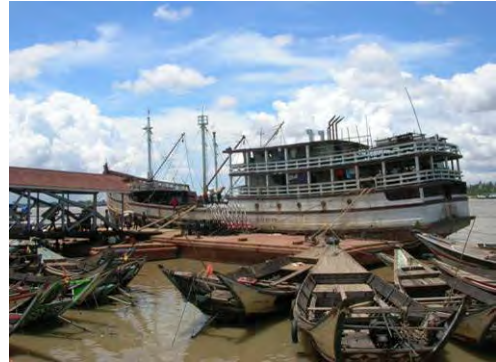
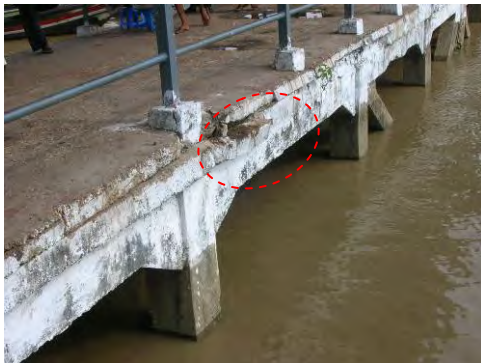
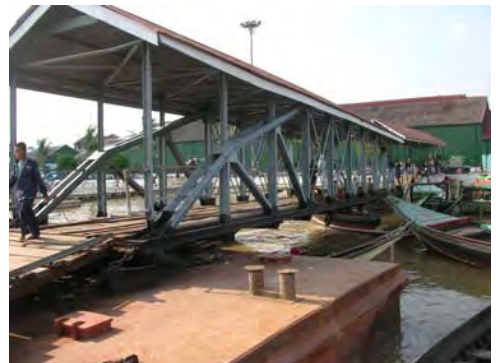
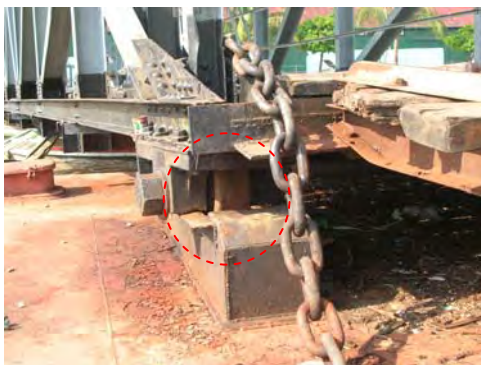
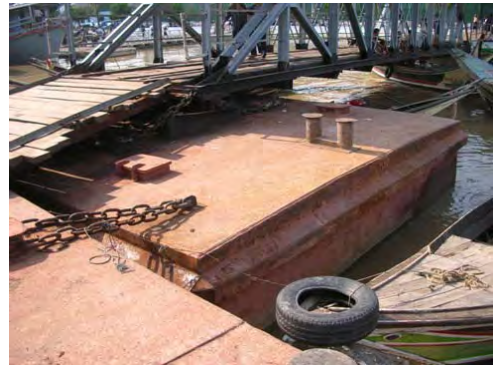
No.15	<i>Name of Jetty</i>	Kaingdan No. 1		
<i>Dimension</i>	Pontoon: Length 120m × Width 20m (before Nargis)	<i>Date of Inspection</i>	12 June, 2009	
Result of Inspection and Evaluation of Port Facilities				
<i>Facility</i>	<i>General Evaluation</i>	<i>Condition of Damage and/or Deterioration</i>	<i>Measures to be taken</i>	<i>Reference Photo</i>
Pontoon	Good	No damage		Photo 1, 4
Bridge	Good	No damage		Photo 3, 5
Pier	Fair	Delaminated concrete	Pour the concrete	Photo 2
Sponson	Good	No damage		Photo 6

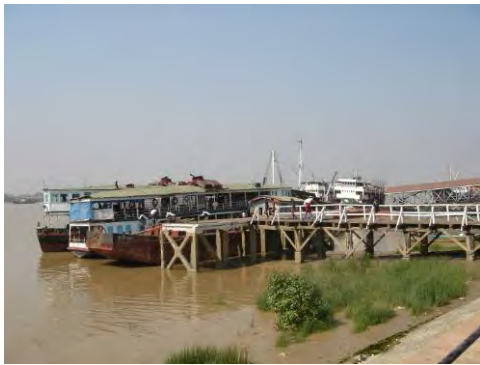
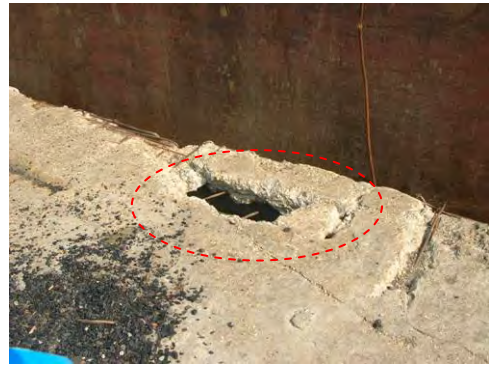
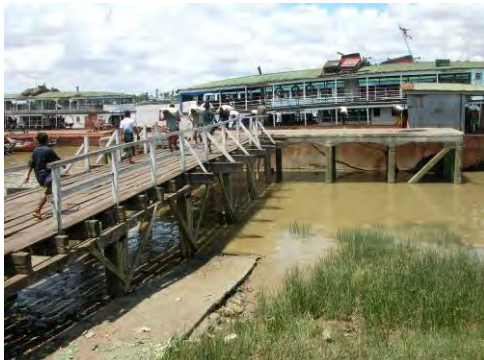
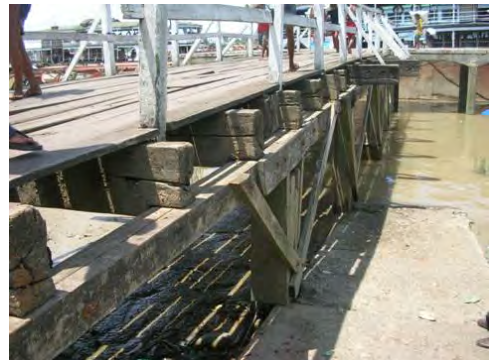
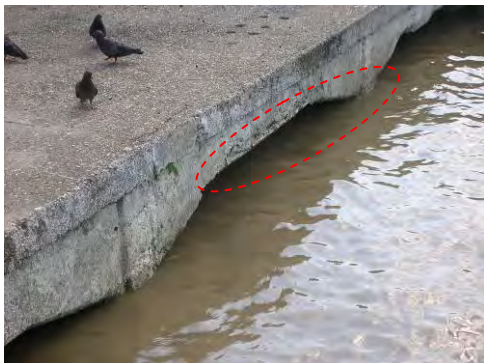
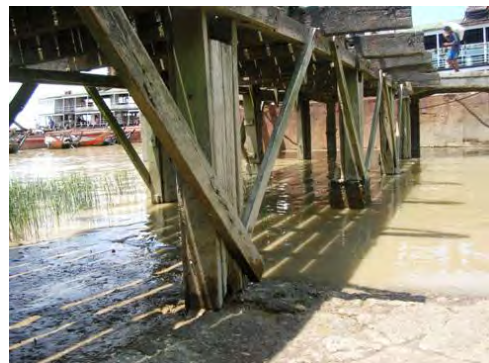
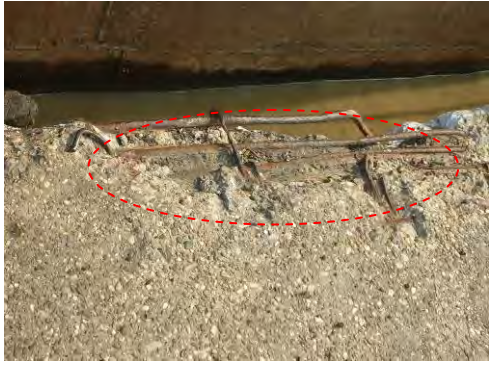
No.16	<i>Name of Jetty</i>	Concrete Jetty No. 2	
<i>Dimension</i>		<i>Date of Inspection</i>	12 June, 2009
Result of Inspection and Evaluation of Port Facilities			
<i>Facility</i>	<i>General Evaluation</i>	<i>Condition of Damage and/or Deterioration</i>	<i>Measures to be taken</i>
Pontoon	-		
Bridge	-		
Pier	Fair	Delaminated concrete, hole	Pour the concrete in flaked parts
Sponson	-		
			Photo 1, 2, 3, 4, 5, 6, 7

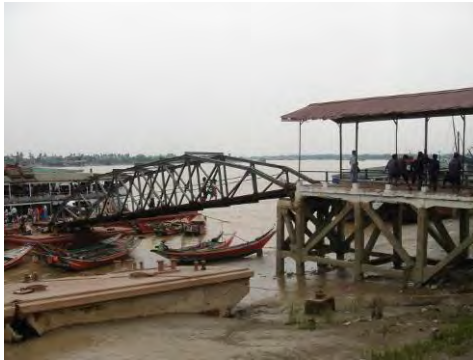
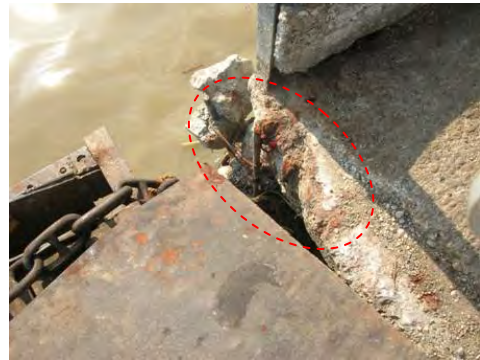
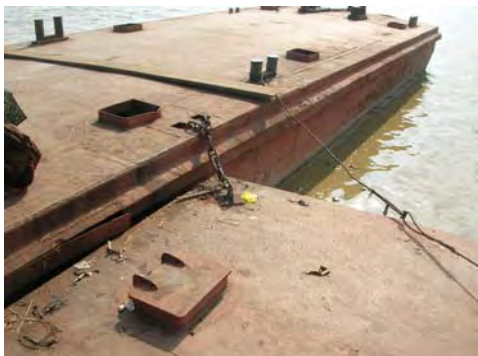
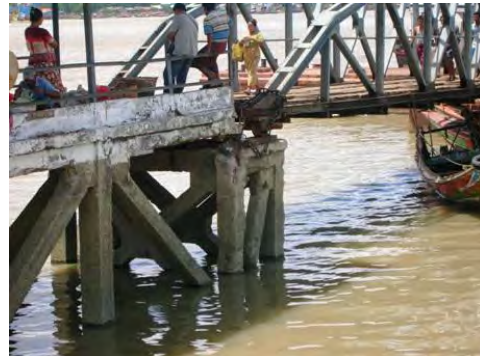
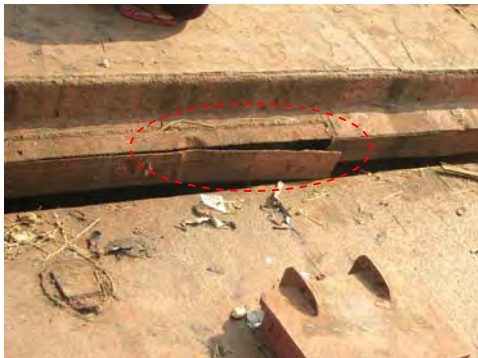
No.17	<i>Name of Jetty</i>	Kaingdan No. 2		
<i>Dimension</i>	Pontoon: Length 120m × Width 20m (before Nargis)	<i>Date of Inspection</i>	12 June, 2009	
Result of Inspection and Evaluation of Port Facilities				
Facility	General Evaluation	Condition of Damage and/or Deterioration	Measures to be taken	Reference Photo
Pontoon	Fair	Break of side steel	Reset the steel plate	Photo 3
Bridge	Good	No damage		Photo 1
Pier	Fair	Delaminated concrete	Pour the concrete in flaked parts	Photo 4, 5
Sponson	Good	No damage		Photo 2

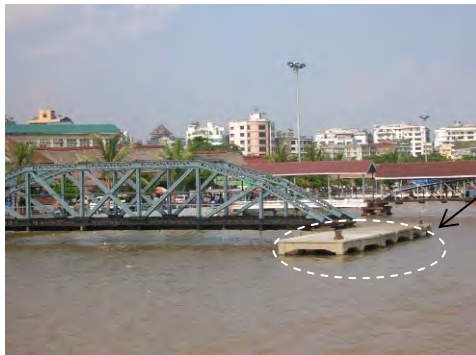
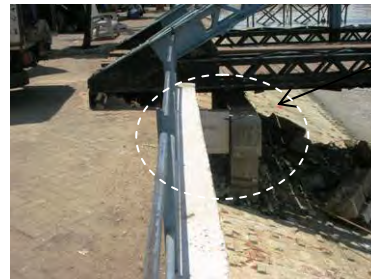
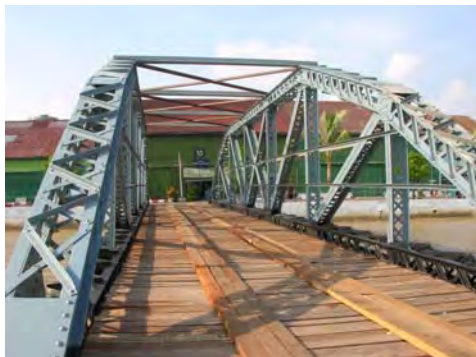
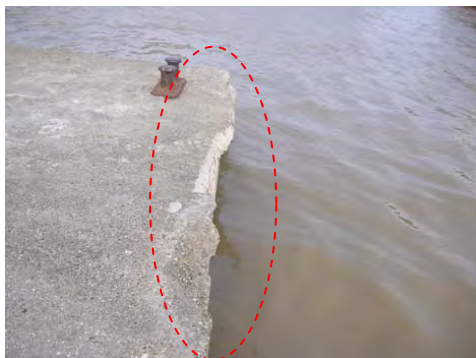
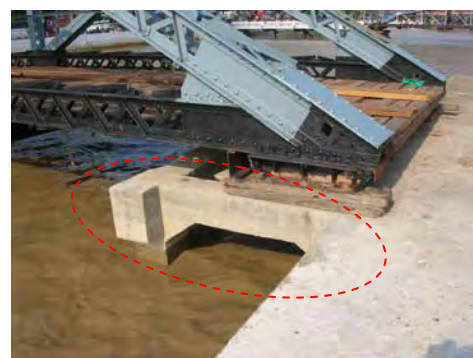
No.18	<i>Name of Jetty</i>	Concrete Jetty (Bagaya No. 4)		
<i>Dimension</i>	Bridge 100feet , Pier 72 feet	<i>Date of Inspection</i>	10 July, 2009	
Result of Inspection and Evaluation of Port Facilities				
Facility	General Evaluation	Condition of Damage and/or Deterioration	Measures to be taken	Reference Photo
Pontoon	-	Rust, deficit		
Bridge	Good	No damage		Photo 2
Pier	Good	No damage		Photo 4
Sponson	Fair	Delaminated concrete	Pour the concrete in the flaked parts	Photo 3, 4, 6

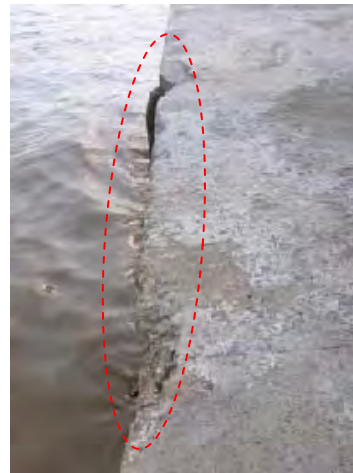
Photo 5 - Flaking of concrete

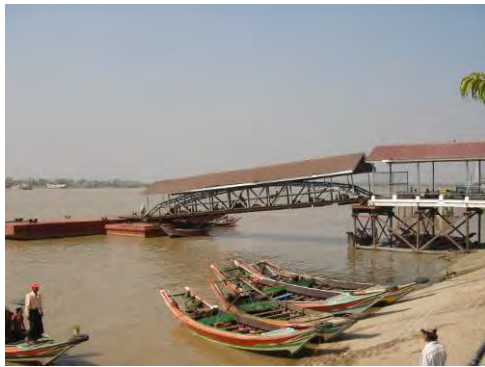
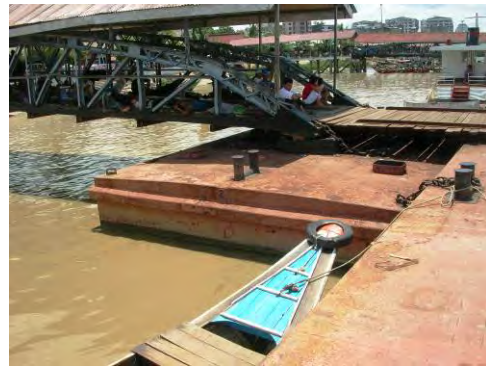
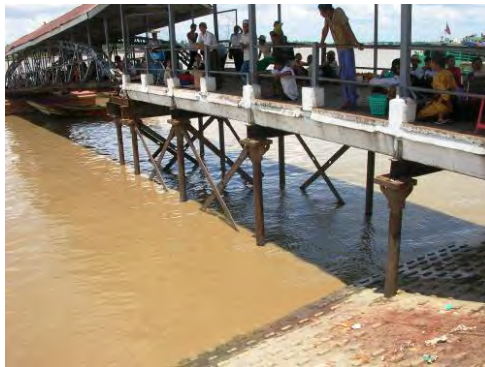
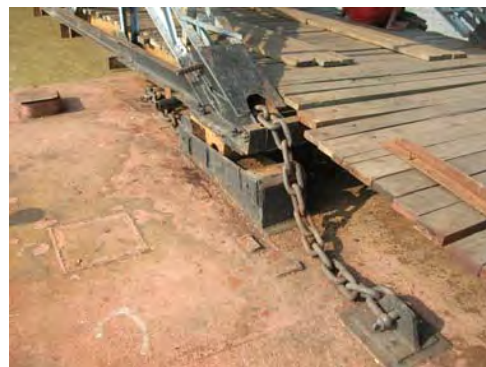
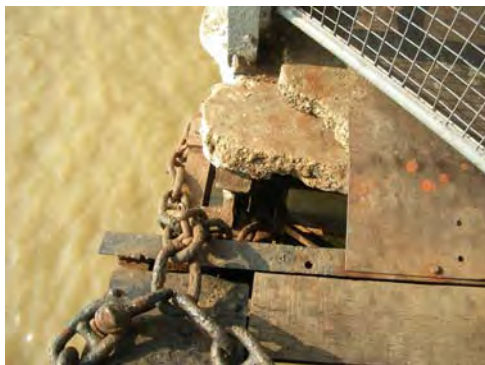
No.19	<i>Name of Jetty</i>	Lan Thit Street Jetty		
<i>Dimension</i>	Pontoon: Length 120m × Width 20m (before Nargis)	<i>Date of Inspection</i>	12 June, 2009	
Result of Inspection and Evaluation of Port Facilities				
<i>Facility</i>	<i>General Evaluation</i>	<i>Condition of Damage and/or Deterioration</i>	<i>Measures to be taken</i>	<i>Reference Photo</i>
Pontoon	Good	No damage		Photo 1
Bridge	Good	No damage		Photo 2
Pier	Fair	Lack of Concrete	Pour the Concrete in delaminated parts	Photo 3
Sponson	Fair	No Roller	Set the Roller	Photo 1,4,5

Roller is ordered, it is prepare to set the that one.

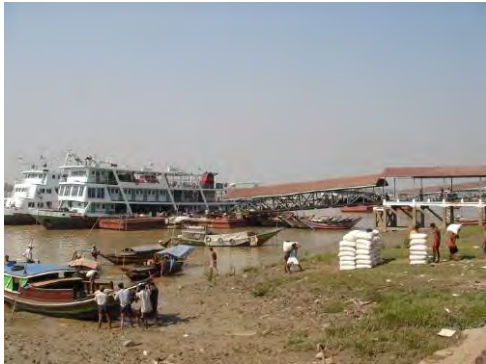
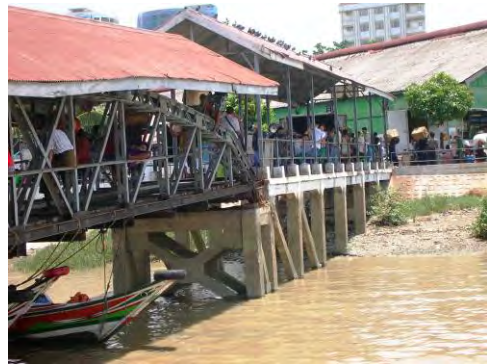
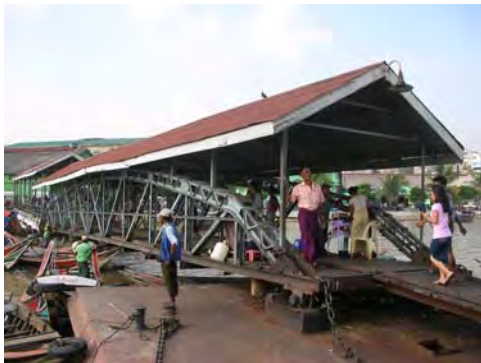
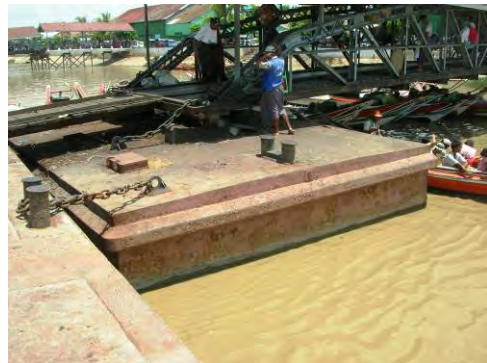
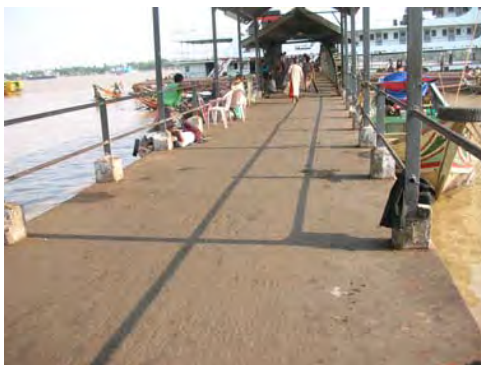
<i>No.20</i>	<i>Name of Jetty</i>	Hledan No. 1 Jetty		
<i>Dimension</i>	Pontoon: Length 120m × Width 20m (before Nargis)	<i>Date of Inspection</i>	12 June, 2009	
Result of Inspection and Evaluation of Port Facilities				
<i>Facility</i>	<i>General Evaluation</i>	<i>Condition of Damage and/or Deterioration</i>	<i>Measures to be taken</i>	<i>Reference Photo</i>
Pontoon	Good	No damage		
Bridge	Good	No damage		Photo 2
Pier	Fair	Lack of Edge concrete	Pour the concrete	Photo 3, 4
Sponson	Good	No damage		Photo 2,5

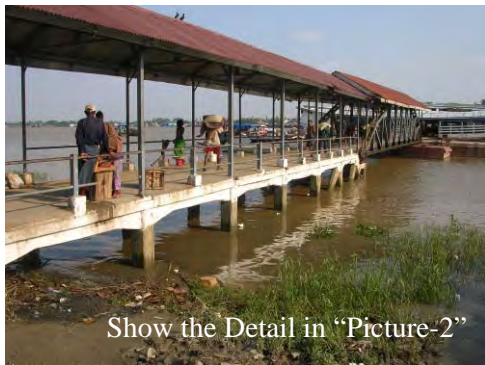
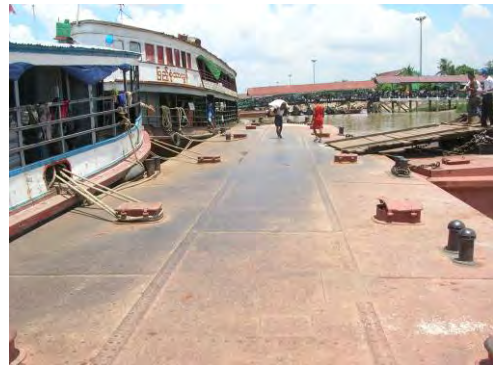
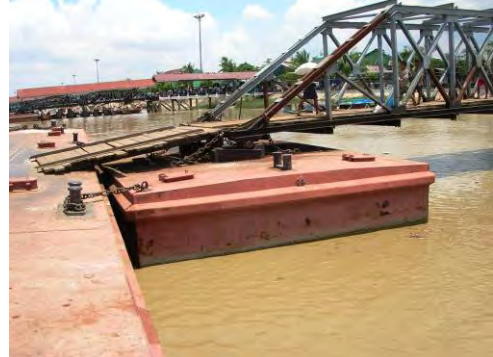
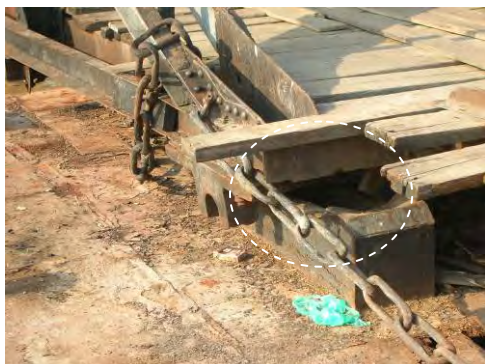
<i>No.21</i>	<i>Name of Jetty</i>	Hledan No.2 Jetty		
<i>Dimension</i>	Pontoon: Length 120m × Width 20m (before Nargis)	<i>Date of Inspection</i>	12 June, 2009	
Result of Inspection and Evaluation of Port Facilities				
<i>Facility</i>	<i>General Evaluation</i>	<i>Condition of Damage and/or Deterioration</i>	<i>Measures to be taken</i>	<i>Reference Photo</i>
Pontoon	Good	No roller	Set roller	Photo-4
Bridge	Fair	Rust, deficit	Check the rust	Photo 3,6
Pier	Fair	Big Trace of Crack Beem inside	Check the rust of Reinforcing – bar and pour the concrete	Photo 1, 2,7
Sponson	Good	No damage		Photo-5

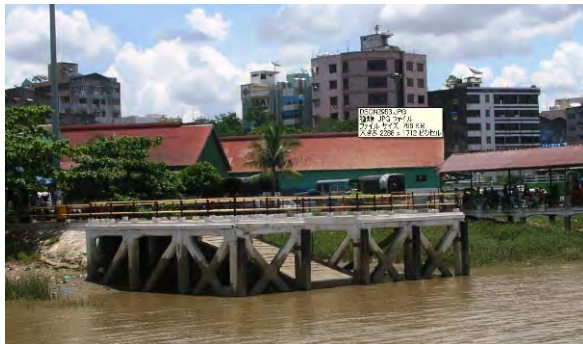
Photo 1- General

No.22	<i>Name of Jetty</i>	Concrete Jetty No.4		
<i>Dimension</i>		<i>Date of Inspection</i>	12 June, 2009	
Result of Inspection and Evaluation of Port Facilities				
<i>Facility</i>	<i>General Evaluation</i>	<i>Condition of Damage and/or Deterioration</i>	<i>Measures to be taken</i>	<i>Reference Photo</i>
Pontoon	Non			
Bridge	Non			
Pier	Non	No damage		Photo 1
Sponson	Non

This is private Jetty, so this Jetty is out of scope.

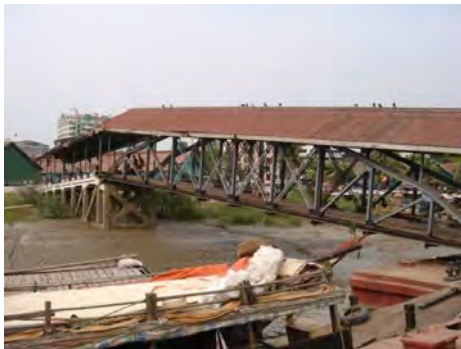
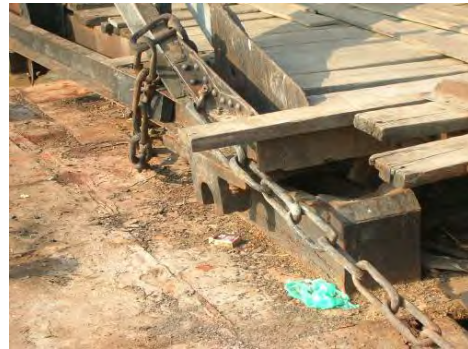
No.23	<i>Name of Jetty</i>	Phogylian 1		
<i>Dimension</i>	<i>Pontoon: Length 120'*Width20'</i>		<i>Date of Inspection</i>	12 June, 2009
Result of Inspection and Evaluation of Port Facilities				
<i>Facility</i>	<i>General Evaluation</i>	<i>Condition of Damage and/or Deterioration</i>	<i>Measures to be taken</i>	<i>Reference Photo</i>
Pontoon	Good	No damage		Photo-6
Bridge	Good	No damage		Photo-1
Pier	Fair	Delaminated concrete	Pour the Concrete in delaminated parts	Photo-1,4
Sponson	Good	No damage		Photo-5

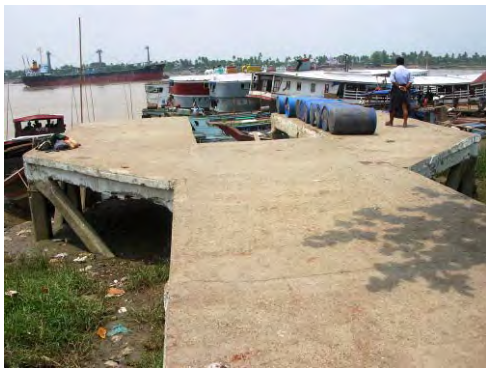
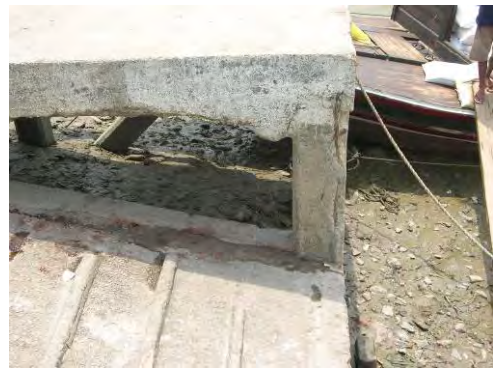
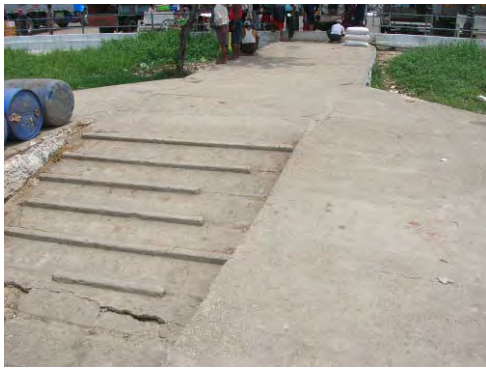
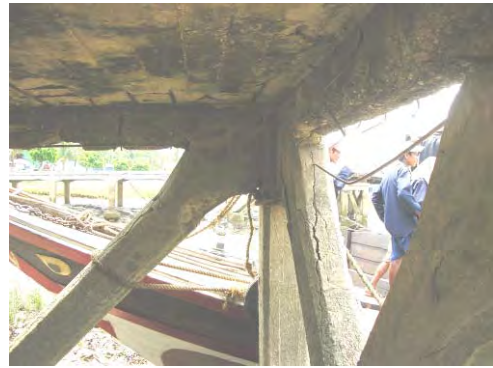
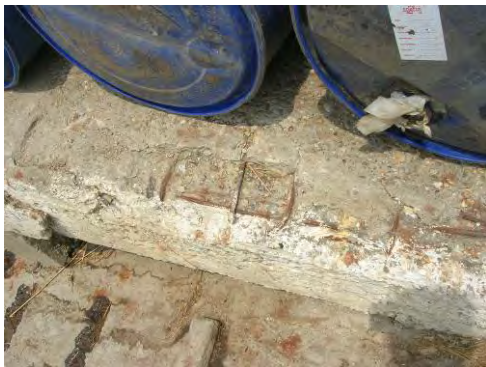
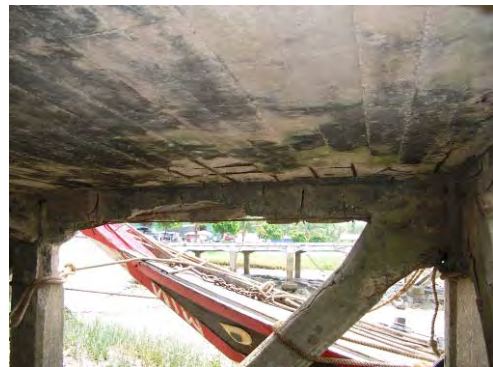
No.24	<i>Name of Jetty</i>	Concrete Jetty 5		
<i>Dimension</i>	-	<i>Date of Inspection</i>	12 June, 2009	
Result of Inspection and Evaluation of Port Facilities				
<i>Facility</i>	<i>General Evaluation</i>	<i>Condition of Damage and/or Deterioration</i>	<i>Measures to be taken</i>	<i>Reference Photo</i>
Pontoon	-			
Bridge	-			
Pier	Bad	Rust, deficit	Remove the Rust of Reinforcing-bar and pour the concrete	Photo 1-6
Sponson	-

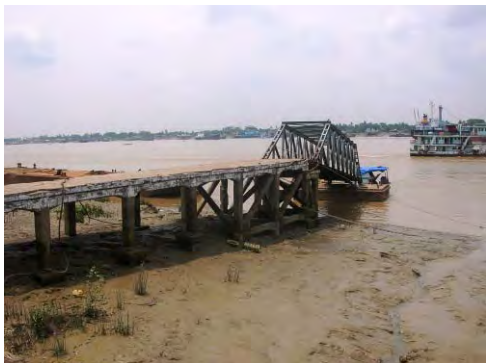
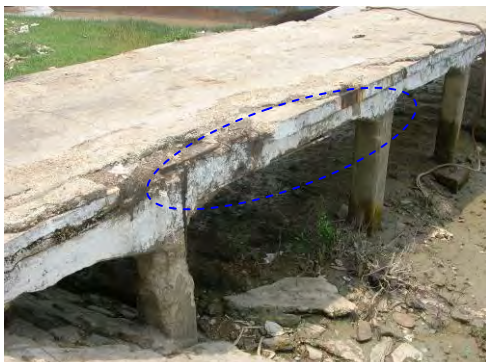
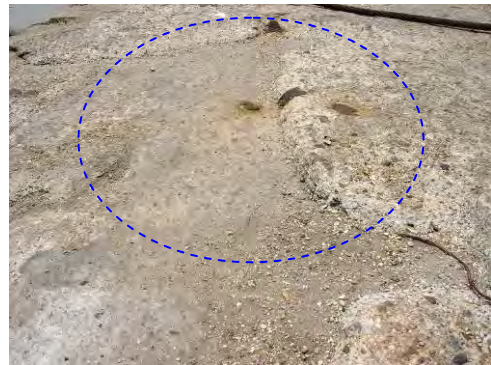
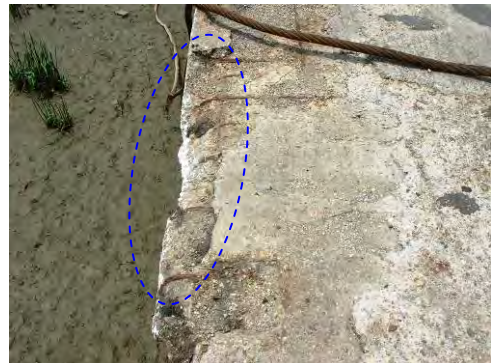
No.25	<i>Name of Jetty</i>	Phoegyilan 2		
<i>Dimension</i>	Pontoon: Length 120 * Width 20'	<i>Date of Inspection</i>	12 June, 2009	
Result of Inspection and Evaluation of Port Facilities				
Facility	General Evaluation	Condition of Damage and/or Deterioration	Measures to be taken	Reference Photo
Pontoon	-			
Bridge	Fair	No roller	Set the roller	Photo 1, 7, 8
Pier	Bad	Delamination of concrete	Pour the concrete	Photo 2, 3, 4, 5
Sponson	Good			Photo 1

Photo 4 - Surface of concrete

Photo 2 - Pier side-view

Photo 5 - Edge of concrete

Photo 3

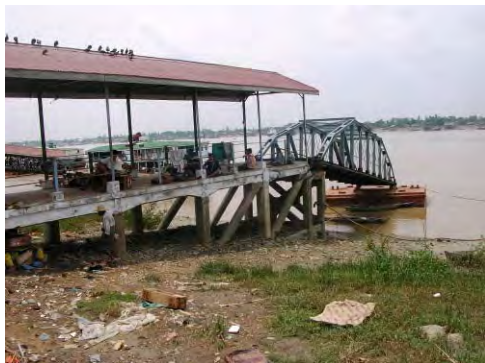
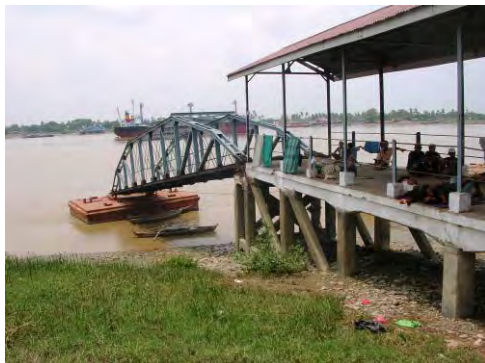
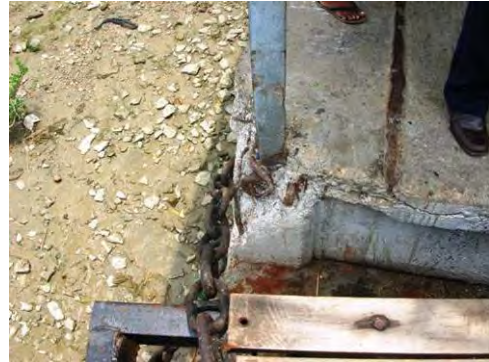
No.26	<i>Name of Jetty</i>	Shwee Taung Dan 1		
<i>Dimension</i>	Pontoon: Length 120 x Width 20'	<i>Date of Inspection</i>	10 July, 2009	
Result of Inspection and Evaluation of Port Facilities				
<i>Facility</i>	<i>General Evaluation</i>	<i>Condition of Damage and/or Deterioration</i>	<i>Measures to be taken</i>	<i>Reference Photo</i>
Pontoon	—			
Bridge	Good	No Roller	Set the roller	Photo 1, 5, 6
Pier	Fair	Delaminated concrete	Pour the concrete	Photo 2, 3, 4
Sponson	Good	No damage		Photo 2, 3

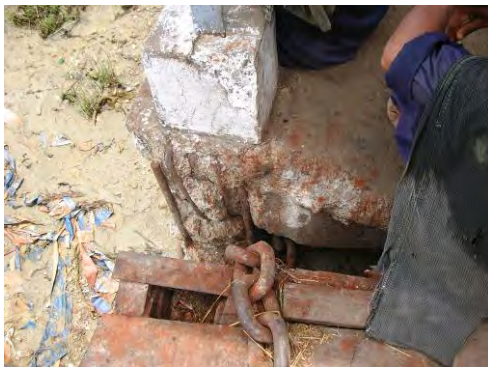
No.27	<i>Name of Jetty</i>	Shwee Taung Dan2		
<i>Dimension</i>	Pontoon: Length 120 x Width 20'	<i>Date of Inspection</i>	12 June, 2009	
Result of Inspection and Evaluation of Port Facilities				
<i>Facility</i>	<i>General Evaluation</i>	<i>Condition of Damage and/or Deterioration</i>	<i>Measures to be taken</i>	<i>Reference Photo</i>
Pontoon	Good	Rust, deficit		Photo 1
Bridge	Good	No		Photo 1, 5, 6
Pier	Fair	Delaminated concrete	Pour the concrete	Photo 2
Sponson	Good			Photo 4

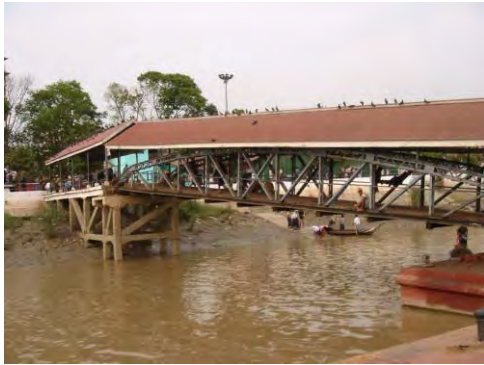
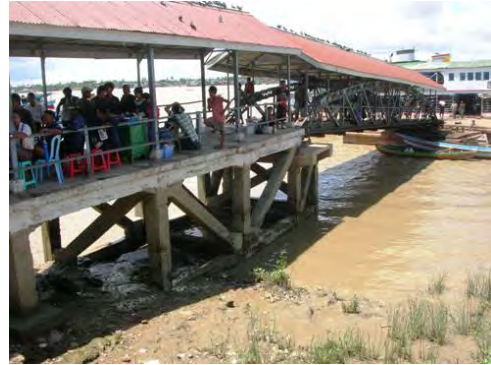
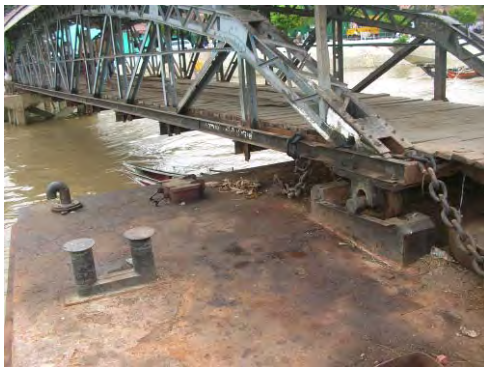
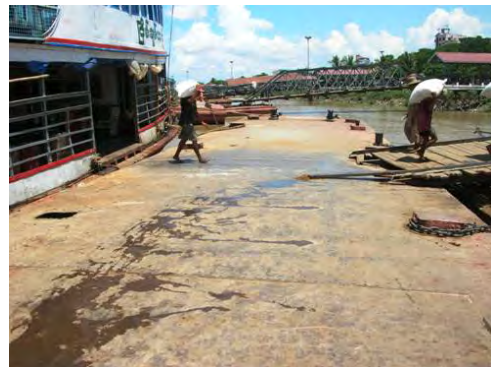
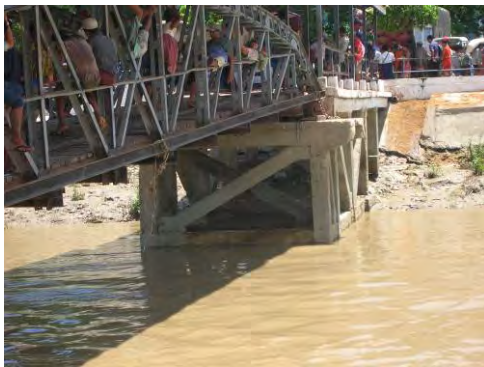
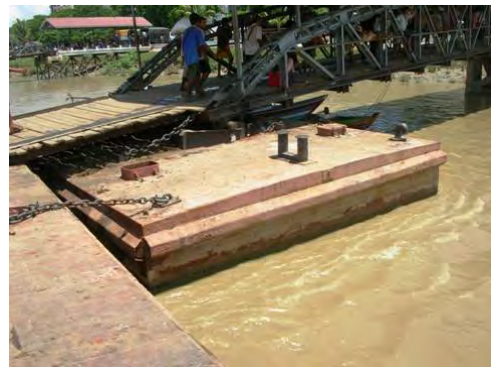
No.29	<i>Name of Jetty</i>	Lanmadaw 2		
<i>Dimension</i>	Pontoon: Length 120 x Width 20'	<i>Date of Inspection</i>	12 June, 2009	
Result of Inspection and Evaluation of Port Facilities				
Facility	General Evaluation	Condition of Damage and/or Deterioration	Measures to be taken	Reference Photo
Pontoon	Good	No damage		Photo 5
Bridge	Good	No damage		Photo 1, 2
Pier	Good	No damage		Photo 3, 4
Sponson	Good	No damage		Photo 6

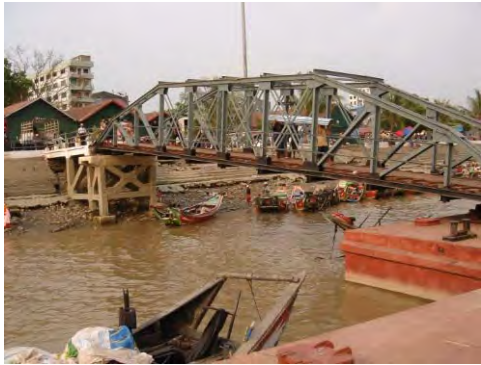
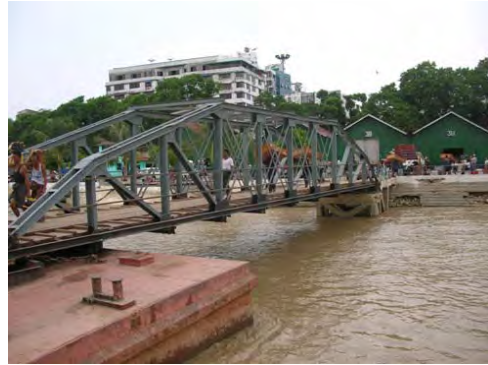
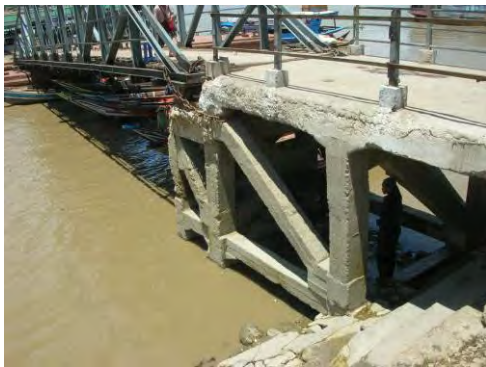
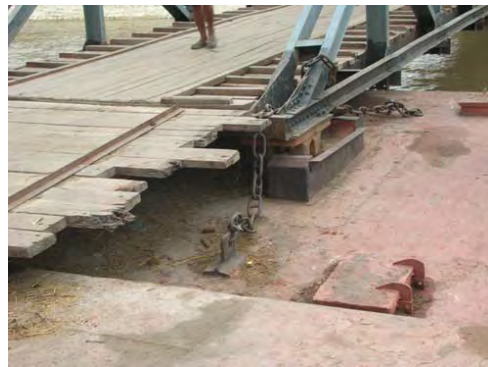
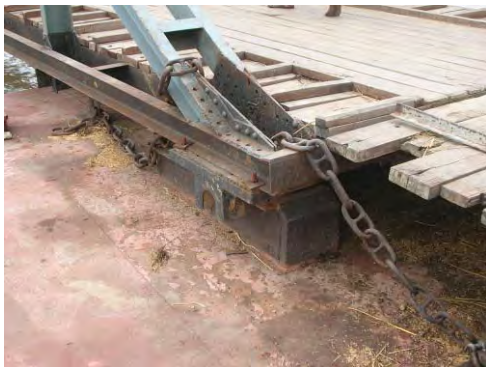
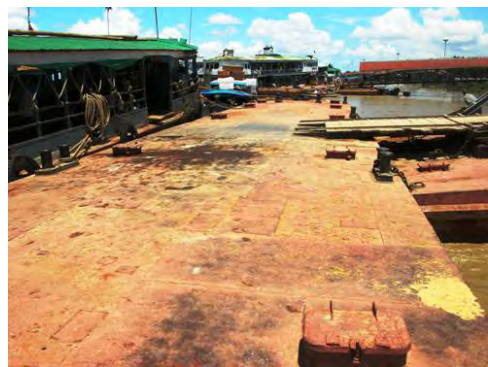
No.30	<i>Name of Jetty</i>	Shi Oh Dan No.1 Jetty		
<i>Dimension</i>	Pontoon: Length 120 x Width 20'	<i>Date of Inspection</i>	12 June, 2009	
Result of Inspection and Evaluation of Port Facilities				
Facility	General Evaluation	Condition of Damage and/or Deterioration	Measures to be taken	Reference Photo
Pontoon	Good	No damage		Photo 6
Bridge	Good	No damage		Photo 1, 3, 4, 5
Pier	Good	No damage		Photo 2, 6
Sponson	Good	No damage		Photo 1

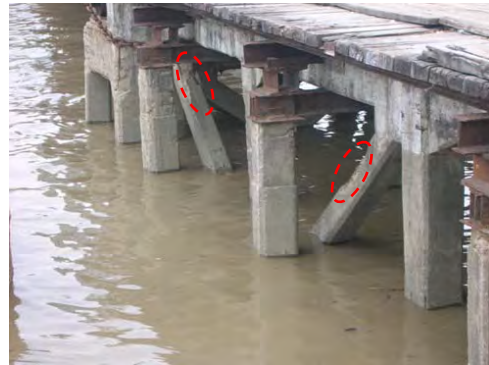
No.31	<i>Name of Jetty</i>	Sin Oh Dan 2		
<i>Dimension</i>	Pontoon: Length 120 x Width 20'	<i>Date of Inspection</i>	10 July, 2009	
Result of Inspection and Evaluation of Port Facilities				
Facility	General Evaluation	Condition of Damage and/or Deterioration	Measures to be taken	Reference Photo
Pontoon	Fair	Hole	Patch the plate	Photo 2,4
Bridge	Good	No damage		Photo 1
Pier	Fair	Delaminated concrete	Pour the concrete	Photo 3
Sponson	Good	No damage		Photo 1,5

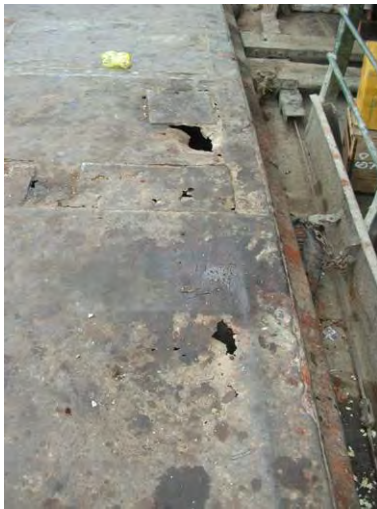
Photo 2 (Hole of upper plate at Pontoon)

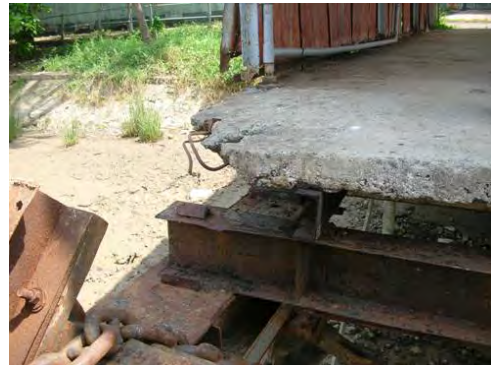
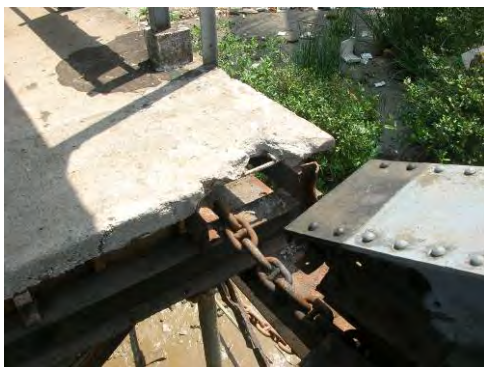
No.32	<i>Name of Jetty</i>	Port Heath Jetty 2		
<i>Dimension</i>	-	<i>Date of Inspection</i>	12 June, 2009	
Result of Inspection and Evaluation of Port Facilities				
Facility	General Evaluation	Condition of Damage and/or Deterioration	Measures to be taken	Reference Photo
Pontoon	-			
Bridge	Bad	Support of Bridge is destroyed		Photo 2
Pier	Fair	Lack of concrete	Pour the concrete	Photo 3,4
Sponson	Good	No damage		Photo 1

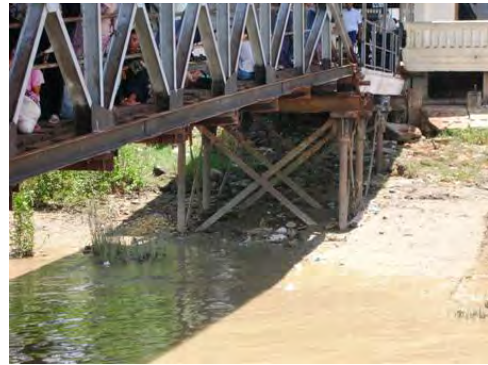
No.34	<i>Name of Jetty</i>	Pansondan Jetty		
<i>Dimension</i>	Pontoon: Length 120 x Width 20'	<i>Date of Inspection</i>	12 June, 2009	
Result of Inspection and Evaluation of Port Facilities				
<i>Facility</i>	<i>General Evaluation</i>	<i>Condition of Damage and/or Deterioration</i>	<i>Measures to be taken</i>	<i>Reference Photo</i>
Pontoon	Good	No damage		Photo 2
Bridge	Good	No damage		Photo 1
Pier	Fair	Delaminated concrete	Pour the concrete	Photo 4
Sponson	Good	No damage		Photo 3

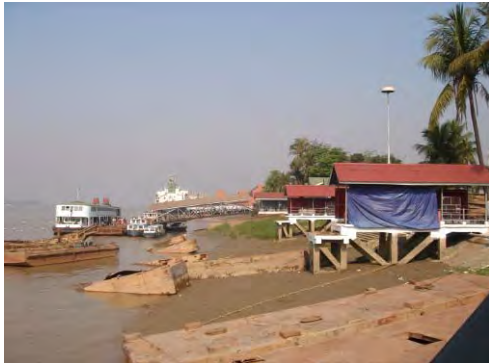
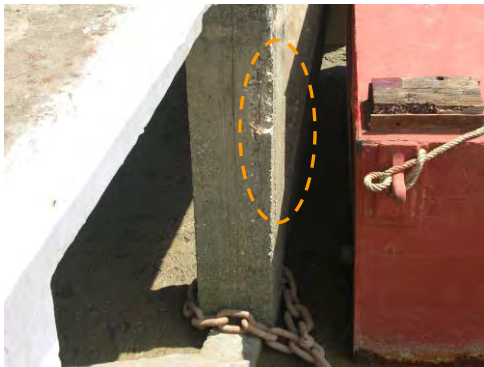
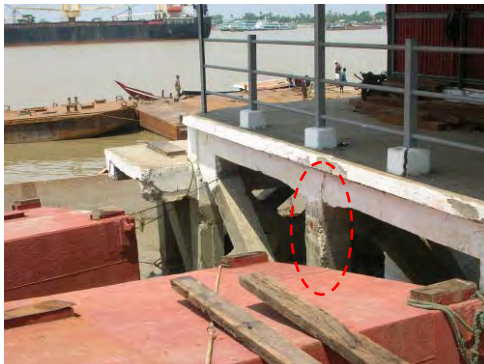
No.35-2	<i>Name of Jetty</i>	Nan Thi Da 1 (Lower)		
<i>Dimension</i>	Share the N.35-1 Jetty		<i>Date of Inspection</i>	12 June, 2009
Result of Inspection and Evaluation of Port Facilities				
<i>Facility</i>	<i>General Evaluation</i>	<i>Condition of Damage and/or Deterioration</i>	<i>Measures to be taken</i>	<i>Reference Photo</i>
Pontoon	-			
Bridge	-			
Pier	Fair	Delaminated concrete	Pour the concrete	Photo 1, 2, 3
Sponson	-

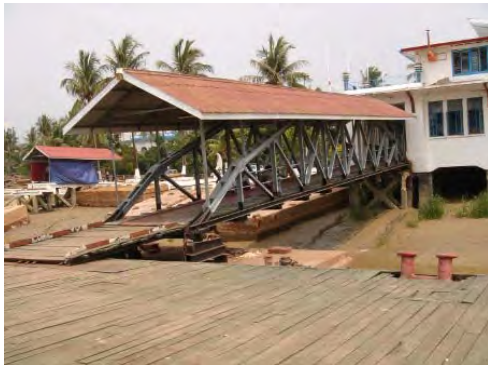
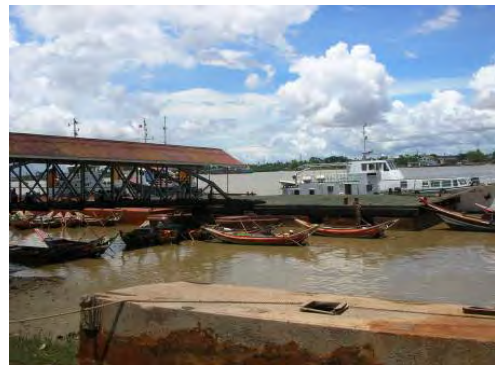
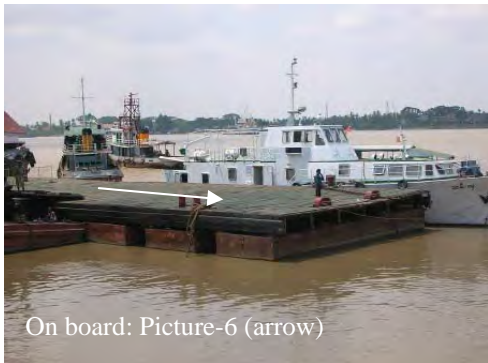
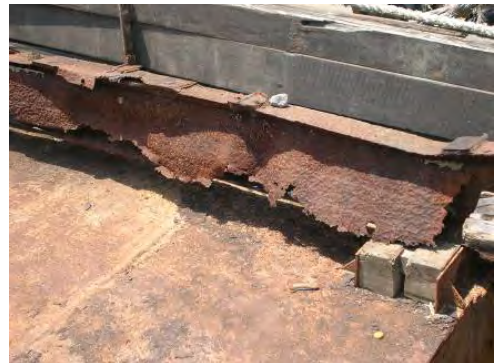
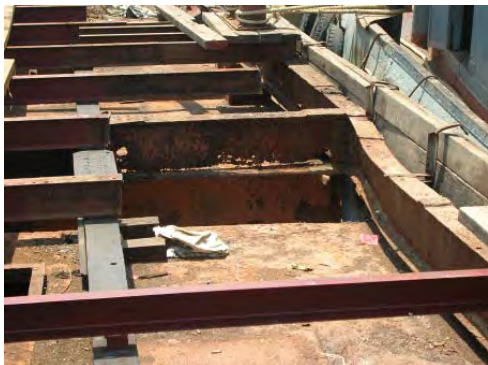
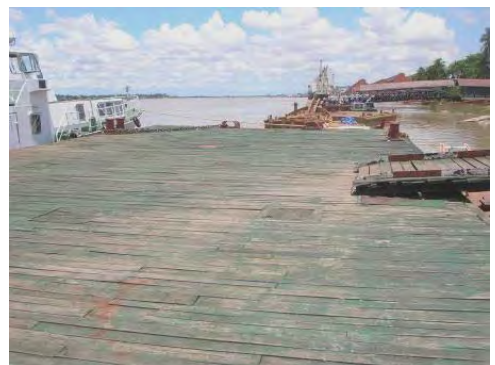
No.36-1	<i>Name of Jetty</i>	Nan Thi Da 2 No.3(upper ,)		
<i>Dimension</i>	Pontoon : Length 240'xWidth 20'	<i>Date of Inspection</i>		12 June, 2009
Result of Inspection and Evaluation of Port Facilities				
Facility	General Evaluation	Condition of Damage and/or Deterioration	Measures to be taken	Reference Photo
Pontoon	Bad	Rust, deficit	Change the beam	Photo 2, 3, 4, 5, 6
Bridge	Good	No damage		Photo 1
Pier	Good	No damage		Photo 1
Sponson	Good	No damage		Photo 1

On board: Picture-6 (arrow)

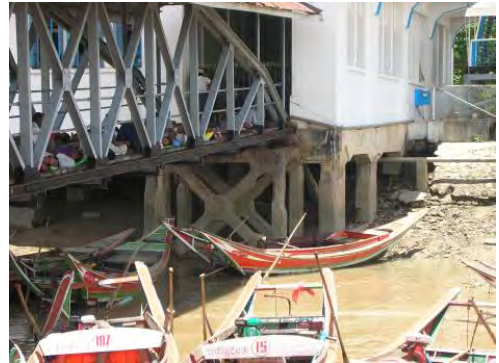
No.36-2	<i>Name of Jetty</i>	Nan Thi Da 2 No.4 (lower)		
<i>Dimension</i>	Share the No.36-1 Jetty		<i>Date of Inspection</i>	12 June, 2009
Result of Inspection and Evaluation of Port Facilities				
<i>Facility</i>	<i>General Evaluation</i>	<i>Condition of Damage and/or Deterioration</i>	<i>Measures to be taken</i>	<i>Reference Photo</i>
Pontoon	Good	No damage		Photo 3
Bridge	Good	No damage		Photo 1
Pier	Fair	Delaminated concrete	Pour the concrete	Photo 4
Sponson	Good	No damage		Photo 3
