**The Urgent Project
for
Rehabilitation of Yangon Port
and
Main Inland Water Transport
in
The Republic of The Union of Myanmar**

FINAL REPORT

APPENDICES

YANGON PORT FACILITY

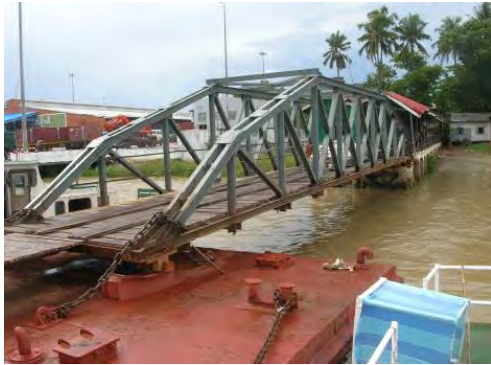
<i>No.37</i>	<i>Name of Jetty</i>	Thein Byu Jetty		
<i>Dimension</i>	Pontoon: Length 100' x Width 20'	<i>Date of Inspection</i>	12 June, 2009	
Result of Inspection and Evaluation of Port Facilities				
<i>Facility</i>	<i>General Evaluation</i>	<i>Condition of Damage and/or Deterioration</i>	<i>Measures to be taken</i>	<i>Reference Photo</i>
Pontoon	Good	No damage	Repaied	Photo 3
Bridge	Good	No damage	Repaied	Photo 1
Pier	Fair	Delaminated concrete	Pour the concrete	Photo 4, 5
Sponson	Good	No damage	Repaied	Photo 2

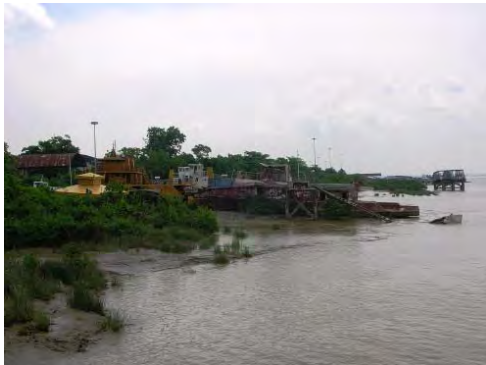
Photo 1

No.38	<i>Name of Jetty</i>	Workshop Pontoon Jetty		
<i>Dimension</i>	Pontoon: Length 100' x Width 20'	<i>Date of Inspection</i>		12 June, 2009
Result of Inspection and Evaluation of Port Facilities				
<i>Facility</i>	<i>General Evaluation</i>	<i>Condition of Damage and/or Deterioration</i>	<i>Measures to be taken</i>	<i>Reference Photo</i>
Pontoon	-			
Bridge	-			
Pier	Bad	Rust, deficit	Replace the reinforcing-bar and pour the concrete	Photo 1, 2
Sponson	-

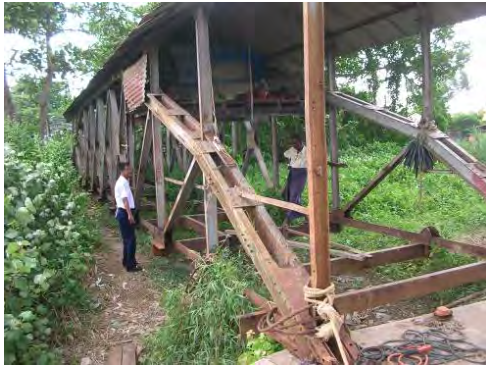
No.39	<i>Name of Jetty</i>	Botahtaung 2		
<i>Dimension</i>	Pontoon:		<i>Date of Inspection</i>	12 June, 2009
Result of Inspection and Evaluation of Port Facilities				
Facility	General Evaluation	Condition of Damage and/or Deterioration	Measures to be taken	Reference Photo
Pontoon	-			
Bridge	Fair	Rust	Under construction	Photo 1
Pier	-			
Sponson	-

Photo 1 - Old Bridge

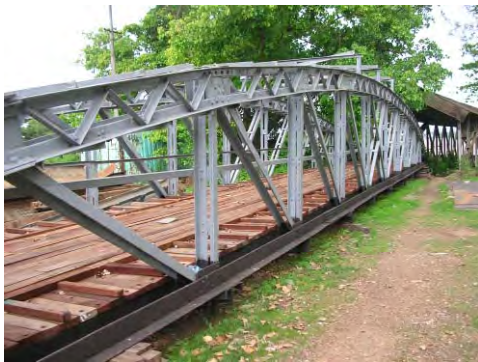
Photo 2 - New Bridge under construction

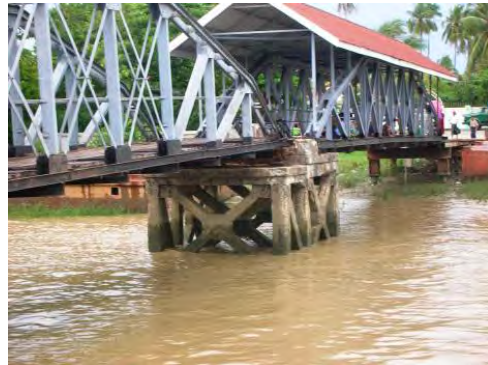
Photo 4

No.40-1	<i>Name of Jetty</i>	Botahtaung 3 (upper)		
<i>Dimension</i>	Pontoon: Length 120' x Width 20' (Upper & Lower)	<i>Date of Inspection</i>	12 June, 2009	
Result of Inspection and Evaluation of Port Facilities				
<i>Facility</i>	<i>General Evaluation</i>	<i>Condition of Damage and/or Deterioration</i>	<i>Measures to be taken</i>	<i>Reference Photo</i>
Pontoon	Good	No damage		Photo 3
Bridge	Good	No damage		Photo 1
Pier	Fair	Rust, deficit	Pour the concrete	Photo 4, 5, 6
Sponson	Good	No damage		Photo 2

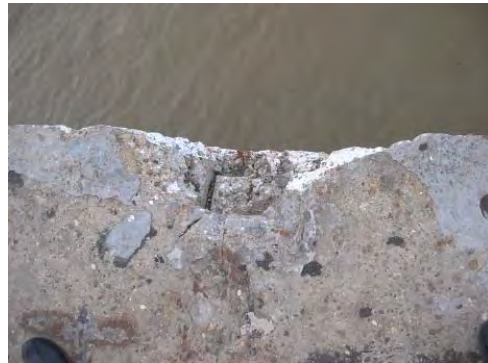
Photo 4

No.40-2	<i>Name of Jetty</i>	Botahtaung 3 (lower)		
<i>Dimension</i>	Pontoon: Length 120' x Width 20'	<i>Date of Inspection</i>	12 June, 2009	
Result of Inspection and Evaluation of Port Facilities				
<i>Facility</i>	<i>General Evaluation</i>	<i>Condition of Damage and/or Deterioration</i>	<i>Measures to be taken</i>	<i>Reference Photo</i>
Pontoon	Good	No damage		Photo 3
Bridge	Good	No damage		Photo 2
Pier	Fair	Rust, deficit	Pour the concrete	Photo 4, 5
Sponson	Good	No damage		Photo 2

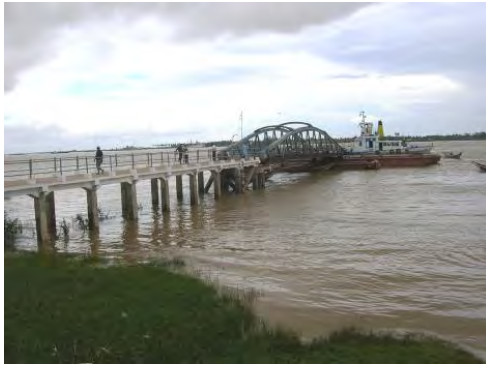
Photo 1

No.41-1	<i>Name of Jetty</i>	Botahtaung 4 (Upper)		
<i>Dimension</i>	Pontoon; Length 100'xWidth 20'	<i>Date of Inspection</i>	12 June, 2009	
Result of Inspection and Evaluation of Port Facilities				
Facility	General Evaluation	Condition of Damage and/or Deterioration	Measures to be taken	Reference Photo
Pontoon	Good	No damage		Photo 5
Bridge	Good	No damage		Photo 3
Pier	Fair	Delaminated concrete	Pour the concrete	Photo 1, 2, 4
Sponson	Good	No damage		Photo 3

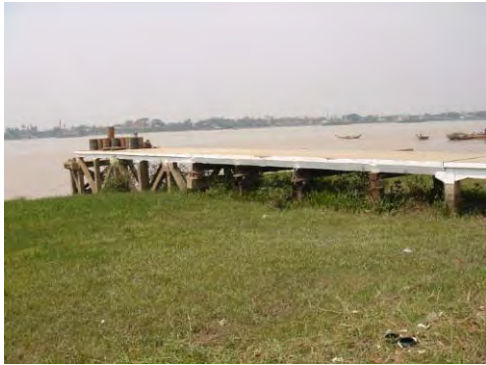
Photo 1

No.42-1	<i>Name of Jetty</i>	Botahtaung 5 (upper)		
<i>Dimension</i>	-	<i>Date of Inspection</i>	12 June, 2009	
Result of Inspection and Evaluation of Port Facilities				
Facility	General Evaluation	Condition of Damage and/or Deterioration	Measures to be taken	Reference Photo
Pontoon	-			
Bridge	-			
Pier	Fair	Rust, deficit	Pour the concrete	Photo 1, 2
Sponson	-

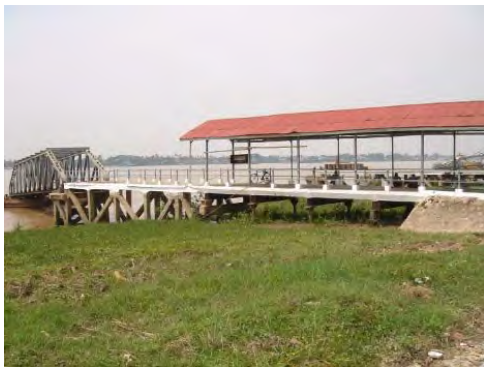
Photo 1

No.42-2	<i>Name of Jetty</i>	Botahtaung 5 (lower)		
<i>Dimension</i>	Pontoon; Length 100'xWidth 20'	<i>Date of Inspection</i>		12 June, 2009
Result of Inspection and Evaluation of Port Facilities				
Facility	General Evaluation	Condition of Damage and/or Deterioration	Measures to be taken	Reference Photo
Pontoon	Good	No damage		Photo 5
Bridge	Good	No damage		Photo 2, 3
Pier	Fair	Rust, deficit		Photo 1, 2, 3
Sponson	Good	No damage		Photo 4
Block	Bad	Stripped block	Repair the block	Photo 3

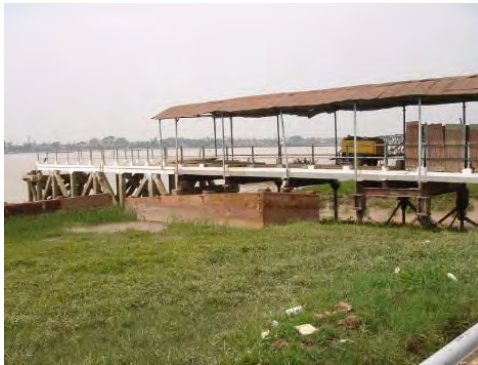
Photo 1

No.43-1	<i>Name of Jetty</i>	Botahtaung 6 (upper)		
<i>Dimension</i>	Pontoon; Length 200' x Width 20' (11 nos). Before Nargis	<i>Date of Inspection</i>	10 July, 2009	
Result of Inspection and Evaluation of Port Facilities				
<i>Facility</i>	<i>General Evaluation</i>	<i>Condition of Damage and/or Deterioration</i>	<i>Measures to be taken</i>	<i>Reference Photo</i>
Pontoon	-			
Bridge	-			
Pier	Bad	Rust, deficit		Photo 1, 2, 3
Sponson	-

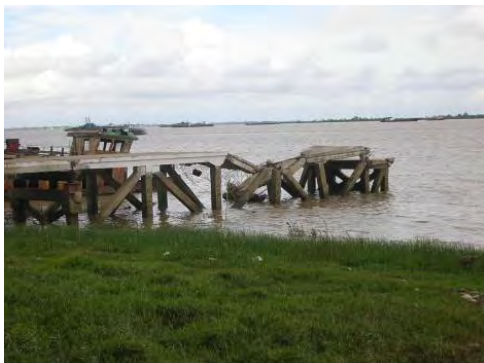
Photo 2

No.43-2	<i>Name of Jetty</i>	Botahtaung 6 (lower)		
<i>Dimension</i>	Pontoon; Length 200' x Width 20' (11 nos). Before Nargis	<i>Date of Inspection</i>	12 June, 2009	
Result of Inspection and Evaluation of Port Facilities				
<i>Facility</i>	<i>General Evaluation</i>	<i>Condition of Damage and/or Deterioration</i>	<i>Measures to be taken</i>	<i>Reference Photo</i>
Pontoon	-			
Bridge	-			
Pier	Bad	Collapse	Remove & reconstruct	Photo 1, 2, 3
Sponson	-

The concrete pier was Collapsed.
It should be taken away the concrete pier
and re-construct.

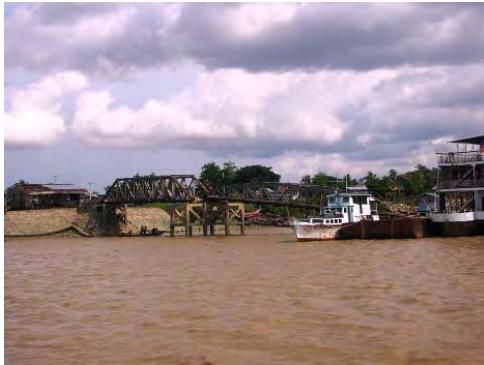
Photo 1

No.44	<i>Name of Jetty</i>	Min Ye Kyaw Thu Jetty		
<i>Dimension</i>	Pontoon; Length 120'xWidth 20'	<i>Date of Inspection</i>	30 May, 2009	
Result of Inspection and Evaluation of Port Facilities				
Facility	General Evaluation	Condition of Damage and/or Deterioration	Measures to be taken	Reference Photo
Pontoon	Fair	Hole	Patch the plate	
Bridge	Good	No Damage		Photo 1,2
Pier	Fair	Delaminated concrete	Pour the concrete	Photo 3,4,5
Sponson	Good	No Damage		Photo 6

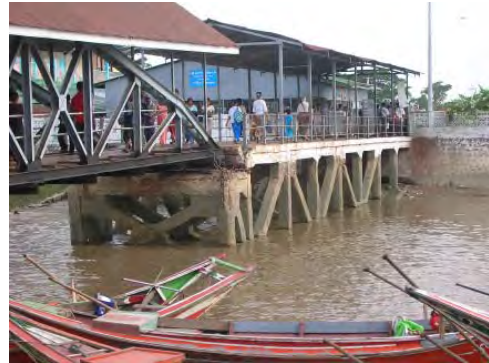
Photo 4

No.45	<i>Name of Jetty</i>	Dala Port Jetty		
<i>Dimension</i>	Pontoon: Length 120' x Width 20'	<i>Date of Inspection</i>	30 May, 2009	
Result of Inspection and Evaluation of Port Facilities				
<i>Facility</i>	<i>General Evaluation</i>	<i>Condition of Damage and/or Deterioration</i>	<i>Measures to be taken</i>	<i>Reference Photo</i>
Pontoon	Good	Rust, deficit		Photo 3
Bridge	Good			Photo 1, 2, 7
Pier	Fair	Delaminated concrete	Pour the concrete	Photo 4, 5
Sponson	Good			Photo 3

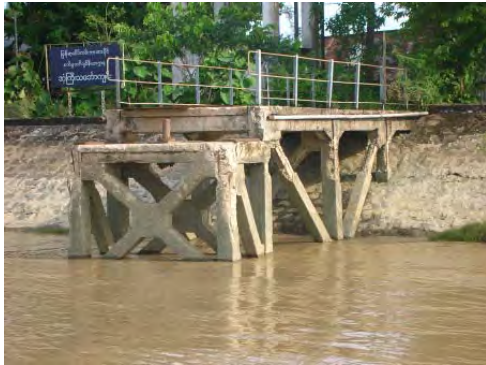
Photo 1

No.46	<i>Name of Jetty</i>	Ant Gyi Jetty		
<i>Dimension</i>	Pontoon; Length 100'x Width 20' (Before Nargis)		<i>Date of Inspection</i>	10 July, 2009
Result of Inspection and Evaluation of Port Facilities				
<i>Facility</i>	<i>General Evaluation</i>	<i>Condition of Damage and/or Deterioration</i>	<i>Measures to be taken</i>	<i>Reference Photo</i>
Pontoon	Good			Photo 4
Bridge	Good			Photo 4
Pier	Fair	Rust, deficit	Pour the concrete	Photo 1, 2, 3
Sponson	-

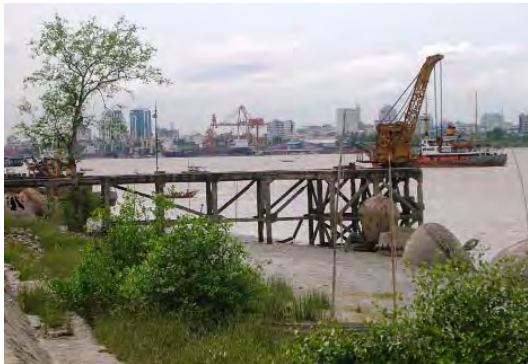
Photo 1

No.47	<i>Name of Jetty</i>	Crane Jetty in King's Bank		
<i>Dimension</i>	-	<i>Date of Inspection</i>	30 May, 2009	
Result of Inspection and Evaluation of Port Facilities				
<i>Facility</i>	<i>General Evaluation</i>	<i>Condition of Damage and/or Deterioration</i>	<i>Measures to be taken</i>	<i>Reference Photo</i>
Pontoon	-			
Bridge	-			
Pier	Bad	Flaking of concrete	Replace the reinforcing-bar and pour the concrete	Photo 1, 2, 3, 4,
Sponson	-

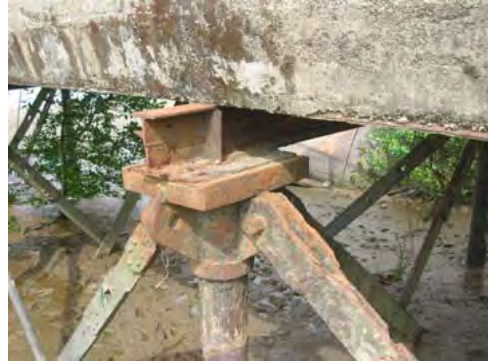
Photo 3

No.48	<i>Name of Jetty</i>	King's Bank Jetty		
<i>Dimension</i>	Sponson: Length 30' x Width 20'	<i>Date of Inspection</i>		10 July, 2009
Result of Inspection and Evaluation of Port Facilities				
<i>Facility</i>	<i>General Evaluation</i>	<i>Condition of Damage and/or Deterioration</i>	<i>Measures to be taken</i>	<i>Reference Photo</i>
Pontoon	Good	No Damage		Photo 5
Bridge	Good	No Damage		Photo 5
Pier	Fair	Rust, deficit	Reinforce the Steel	Photo 2, 3
Sponson	-			Photo 5

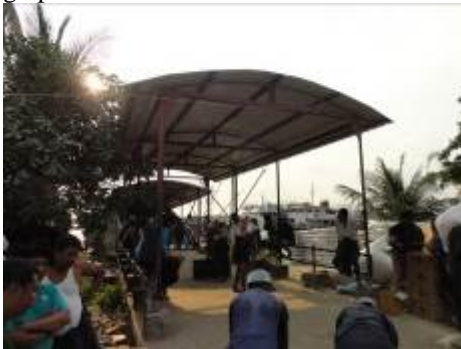
Photo 1 - New pier Added roof

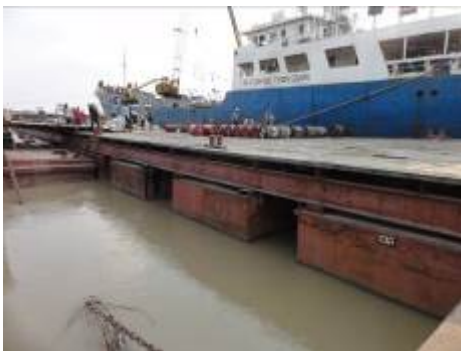
Photo 2 - Pontoon replaced

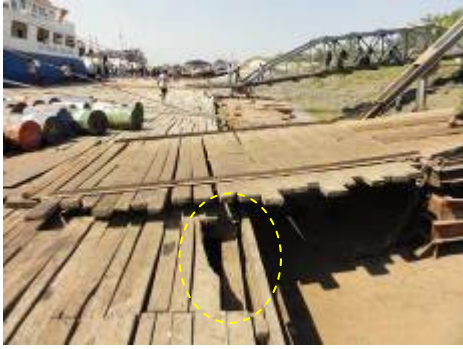
No.1	<i>Name of Jetty</i>	Chaung Wa Jetty (1&2)			
<i>Dimension</i>	Pontoon: Length 200' x Width 40' (after Nargis)	<i>Date of Inspection</i>			9 Dec 2014
Result of Inspection and Evaluation of Port Facilities					
<i>Facility</i>	<i>General Evaluation</i>	<i>Condition of Damage And/or Deterioration</i>	<i>Measures to be taken</i>	<i>Change from Last survey in 2011</i>	<i>Reference Photo</i>
Pontoon	Bad	Beam is partly rusted	-Rusted pontoon, steel deck need to be replaced the new -Need to repair deck timber lost		Photo 2,3,5,6
Bridge	Good	N	N		Photo 1,4
Pier	Pier No.1(Good) Pier No.2(Fair)	N	N	New R.C Approach (13'x36')	Photo 1
Sponson	Fair	Rust, deficit	N		Photo 3

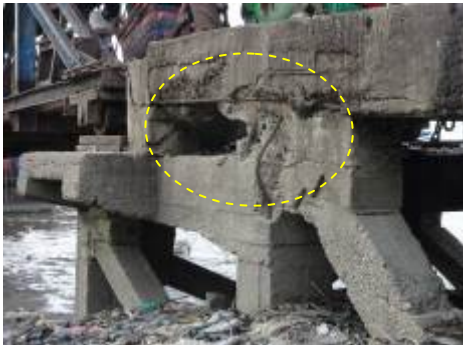
No.2	<i>Name of Jetty</i>	Kyeemyindine No.3 Jetty			
<i>Dimension</i>	Pontoon: Length 80' x Width 20' (after Nargis)		<i>Date of Inspection</i>	9 Dec ,2014	
Result of Inspection and Evaluation of Port Facilities					
<i>Facility</i>	<i>General Evaluation</i>	<i>Condition of Damage And/or Deterioration</i>	<i>Measures to be taken</i>	<i>Change from Last survey in 2011</i>	<i>Reference Photo</i>
Pontoon	N	N	N	No	
Bridge	N	N	N	No	
Pier	Fair	crack at top of Slab, Corner of concrete slab damage	Corner slab need to repair	No	Photo 1,2,3,4
Sponson	Fair	N	N	No

Photo 2 - Pier concrete damaged

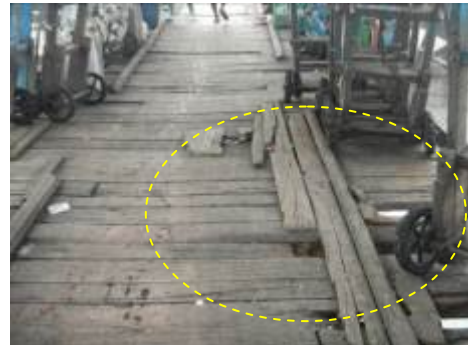
Photo 5 - Timber decking damage

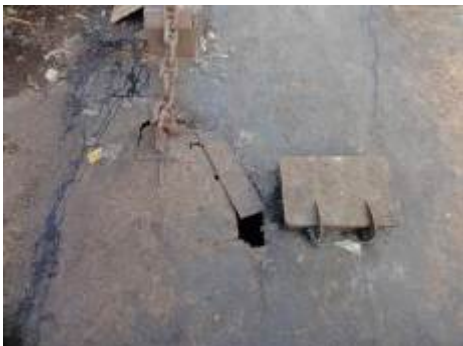
Photo 3 - Pontoon Top cover damage

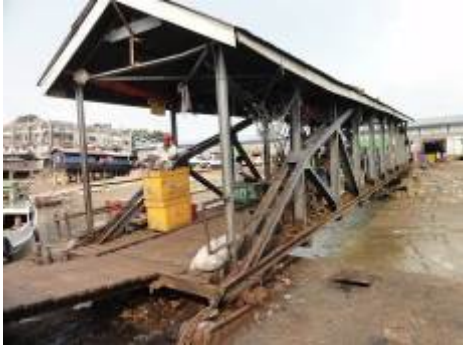
Photo 7 - Steel bridge

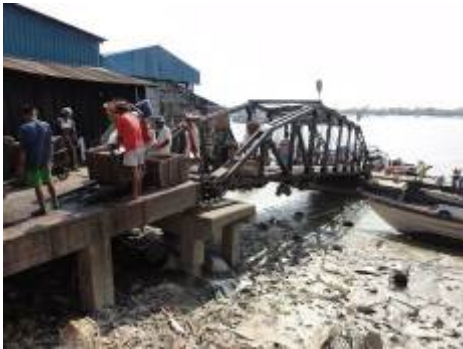
Photo 1 - General

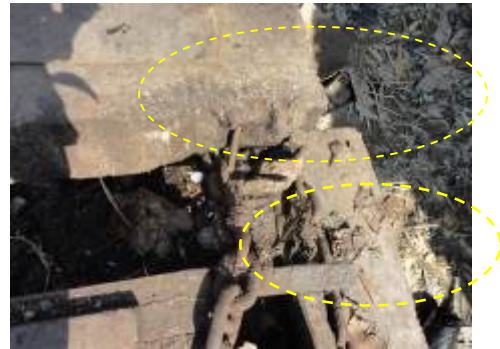
Photo 6 - Connection of steel bridge & abutment

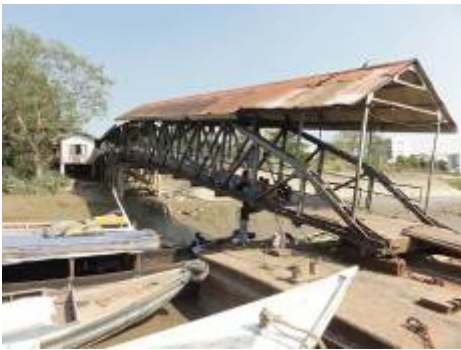
Photo 1 - General

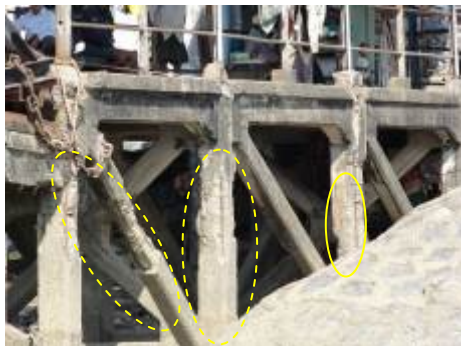
No.4	<i>Name of Jetty</i>	Kyeemyindine Bazar Road Jetty			
<i>Dimension</i>	Pontoon: Length 120' x Width 20' (after Nargis)	<i>Date of Inspection</i>		9 Dec,2014	
Result of Inspection and Evaluation of Port Facilities					
<i>Facility</i>	<i>General Evaluation</i>	<i>Condition of Damage And/or Deterioration</i>	<i>Measures to be taken</i>	<i>Change from Last survey in 2011</i>	<i>Reference Photo</i>
Pontoon	Good	No damage	N	No	Photo 4
Bridge	Fair	Timber deck is broken	Need to repair the bridge deck timber lost.	No	Photo 1,3,6
Pier	Bad	Reinforced bar is exposed and trace of crack by delaminated concrete.	To repair the column and bracing is Immediately required.	No	Photo 2,5,7,8
Sponson	Good	No damage		No	Photo 1,3

Photo 2 - Bracing & Colum damage

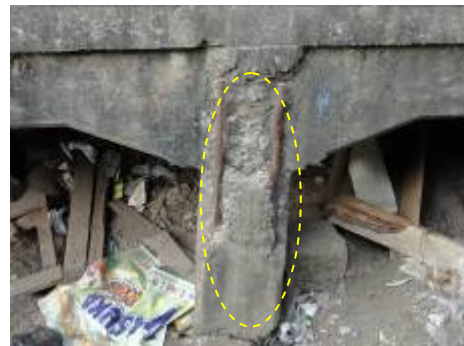
Photo 5 - Column damage

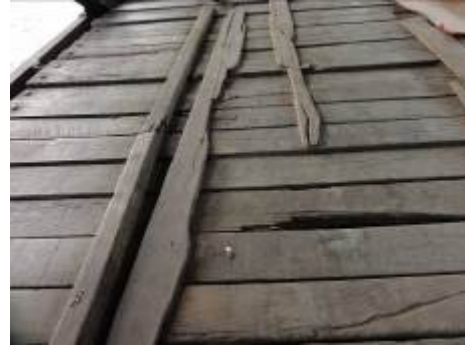
Photo 6 - Decking Timber loss & damage

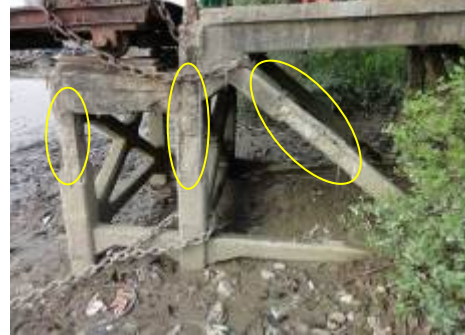
Photo 8 - Bracing & Colum damage

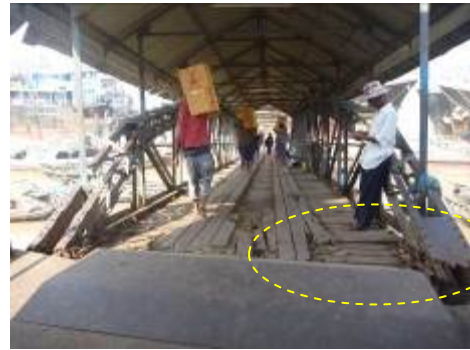
Photo 4 - Decking timber lost

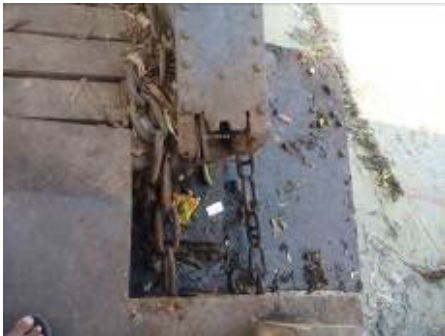
Photo 2 - Bridge roller connection rusted

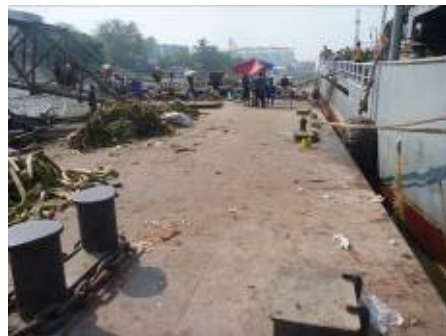
Photo 6 - Debris on the pontoon (reason of damage)

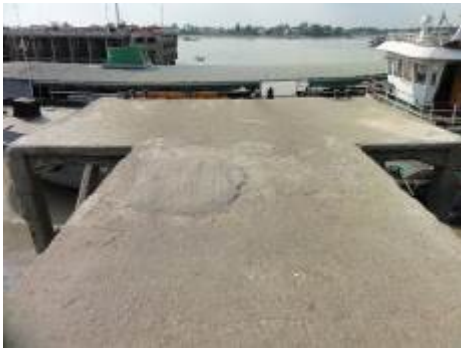
Photo 1 - General

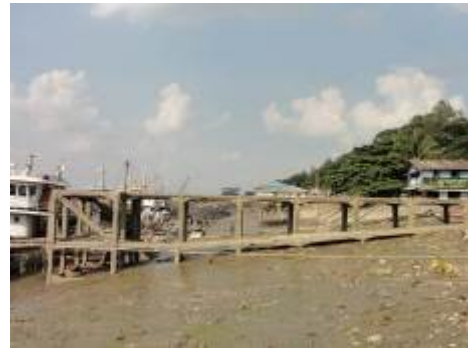
Photo 4 - General

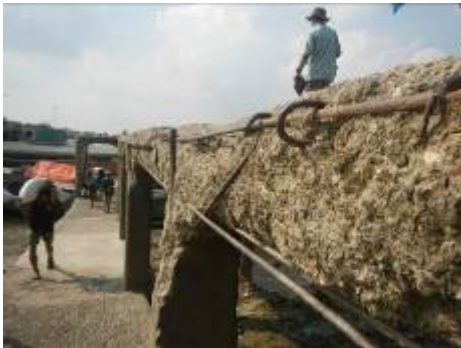
No.8	<i>Name of Jetty</i>	Bagaya Concrete Jetty			
<i>Dimension</i>	N/A	<i>Date of Inspection</i>			9 Dec,2014
Result of Inspection and Evaluation of Port Facilities					
<i>Facility</i>	<i>General Evaluation</i>	<i>Condition of Damage And/or Deterioration</i>	<i>Measures to be taken</i>	<i>Change from Last survey in 2011</i>	<i>Reference Photo</i>
Pontoon	N	N	N	No	
Bridge	N	N	N	No	
Pier	Very Bad	Reinforced bar is exposed	Need to repair	No	Photo 1~ 6
Sponson	N	N		No

Photo 2 - Concrete column and slab damage

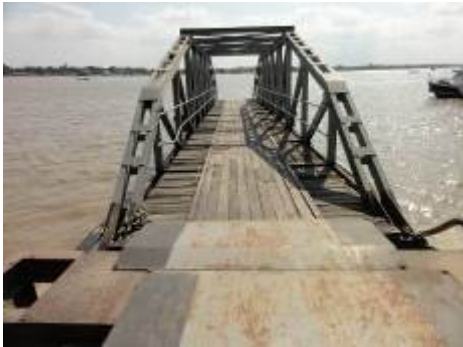
Photo 5 - Roller Wheel Missing

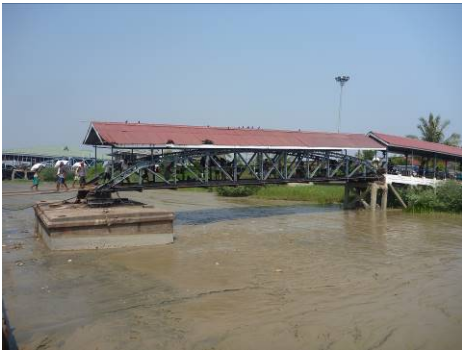
Photo 1 - General

No.11	<i>Name of Jetty</i>	Wardan No.3 Jetty			
<i>Dimension</i>	Pontoon: Length 120' x Width 20' (after Nargis)		<i>Date of Inspection</i>	9 Dec,2014	
Result of Inspection and Evaluation of Port Facilities					
<i>Facility</i>	<i>General Evaluation</i>	<i>Condition of Damage And/or Deterioration</i>	<i>Measures to be taken</i>	<i>Change from Last survey in 2009</i>	<i>Reference Photo</i>
Pontoon	Fair	N	Decking timber loose	No	Photo 4,5,6
Bridge	Fair	N	Roller wheel is required	No	Photo 1,2,3
Pier	Fair	N	N	No	Photo 1, 5
Sponson	Good	No damage		No	Photo 1,3

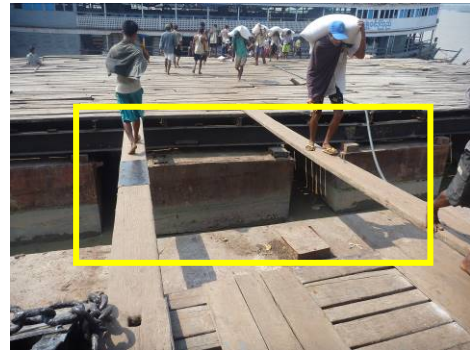
Photo 4 - Need proper porter way

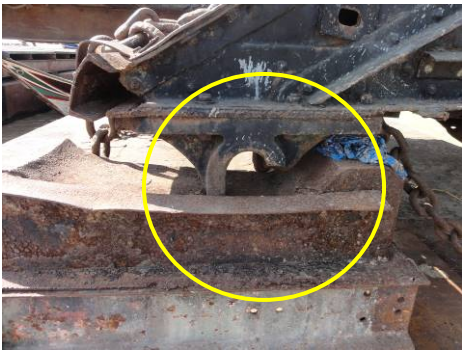
Photo 2 - Roller wheel is missing

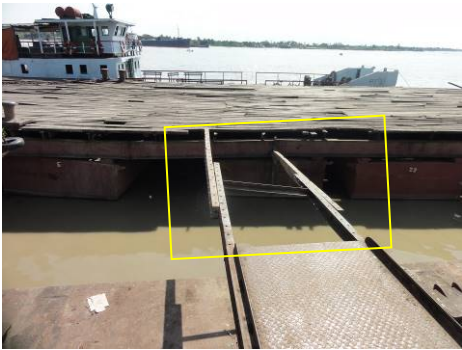
Photo 2 - No connection with Pontoon

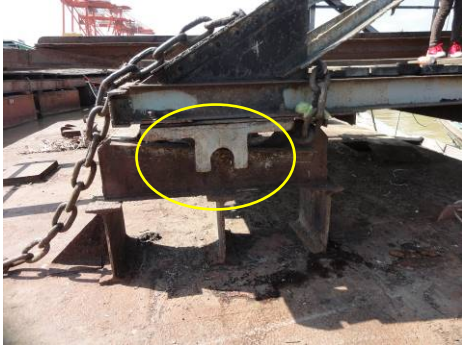
Photo 4 - Roller wheel missing

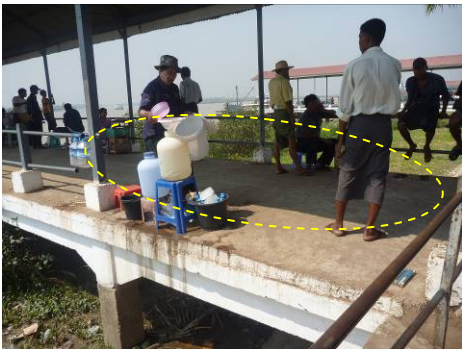
Photo 2 - Handrail missing

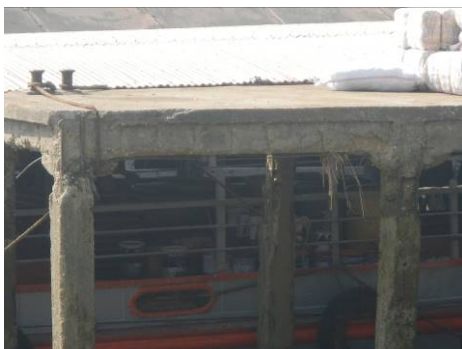
No.16	<i>Name of Jetty</i>	Concrete Jetty (Bagaya No.4)			
<i>Dimension</i>	Pontoon: Length 120' x Width 20' (before Nargis)		<i>Date of Inspection</i>	9 Dec, 2014	
Result of Inspection and Evaluation of Port Facilities					
<i>Facility</i>	<i>General Evaluation</i>	<i>Condition of Damage And/or Deterioration</i>	<i>Measures to be taken</i>	<i>Change from Last survey in 2009</i>	<i>Reference Photo</i>
Pontoon	N	N	N	N	N
Bridge	Fair	Deck timber loose	Need to be repair bridge deck timber loosening	N	Photo 1,2
Pier	Bad	Concrete Beam, slab & column damage	Immediately repair the column, bracing & slab	N	Photo 3, 6
Sponson	N	N	N	N	N

Photo 3 - Beam, column & slab damage
