Inspection and Evaluation of Port Facilities

<i>No.17</i>	<i>Name of Jetty</i>	Kaingdan No.1			
<i>Dimension</i>	Pontoon: Length 120' x Width 20' (before Nargis)		<i>Date of Inspection</i>	9 Dec,2014	
Result of Inspection and Evaluation of Port Facilities					
<i>Facility</i>	<i>General Evaluation</i>	<i>Condition of Damage And/or Deterioration</i>	<i>Measures to be taken</i>	<i>Change from Last survey in 2011</i>	<i>Reference Photo</i>
Pontoon	Good	No damage		No	Photo 2
Bridge	Fair	Timber deck is broken	Need to be repair bridge decking timber lost	No	Photo 1,4
Pier	Fair	N	N	No	Photo 1,6
Sponson	Good	No damage		No	Photo 2

APPENDIX B NAVIGATION SAFETY	B-3
B.1 On board Inspection Report of Navigation Safety of Yangon Port and Channels	B-3
B.1.1 Outline of the On Board Survey	B-3
B.1.2 Result of Inspection	B-3
B.1.3 Natural Condition	B-4
B.1.4 Current Condition of the Yangon Port and Channel.....	B-5
B.2 Evaluation for Navigation Aids	B-22
B.3 Comment for the Rating	B-23
B.4 Interview of Captain of M.S.T. Mhan Aung and Harbor Master	B-24
B.5 The Obstructions in Fairways Act Amending Law 1963	B-26

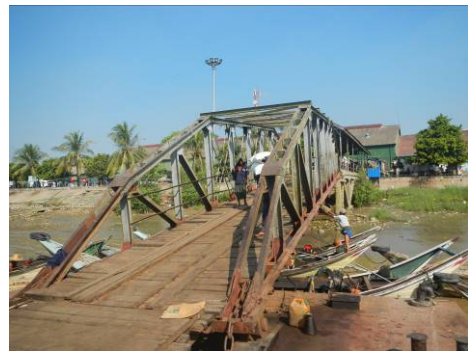
Photo 4 - Decking timbers lost

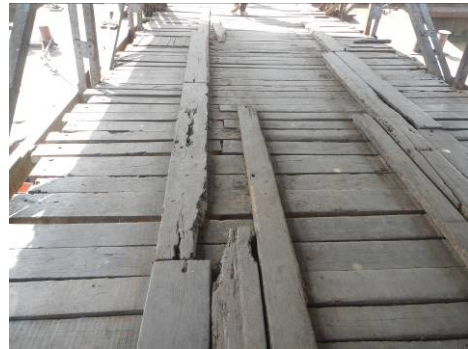
Photo 5 - Timber decking loss

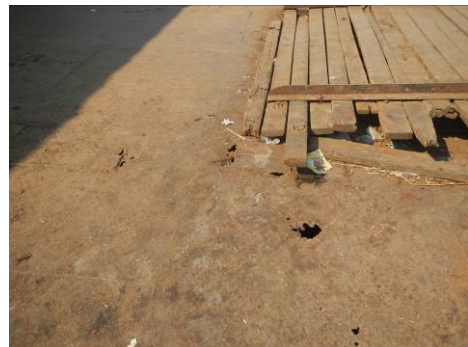
Photo 6 - Hole at Pontoon surface

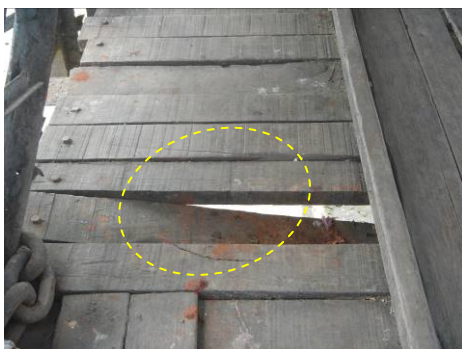
Photo 3 - Decking timber loose

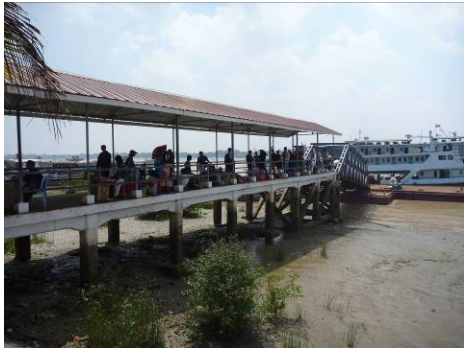
Photo 1 - Porter way C.G.I roofing is added

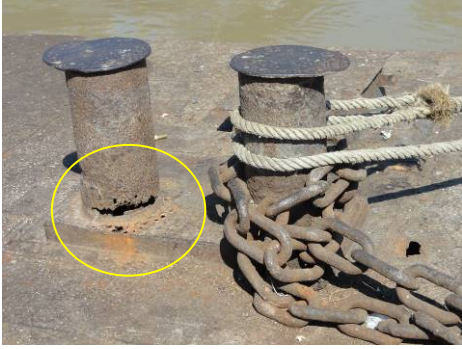
Photo 7 - Bollard base damage

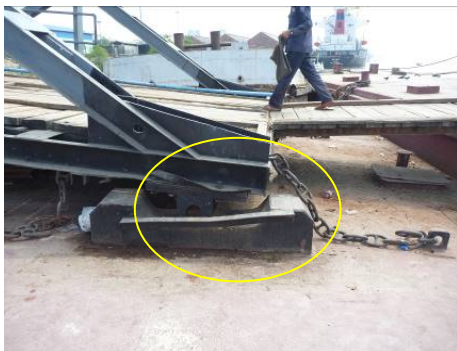
Photo 3 - Roller wheel is missing

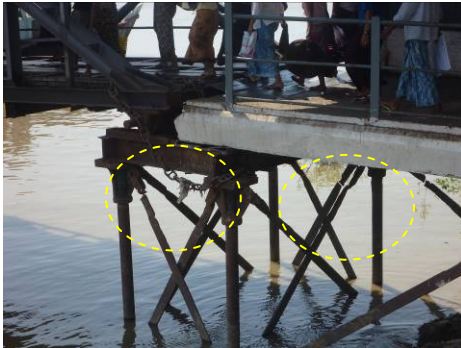
No.34	<i>Name of Jetty</i>	Pansodan Jetty			
<i>Dimension</i>	Pontoon: Length 120'x Width 20' (after Nargis)	<i>Date of Inspection</i>	4 December 2014		
Result of Inspection and Evaluation of Port Facilities					
<i>Facility</i>	<i>General Evaluation</i>	<i>Condition of Damage And/or Deterioration</i>	<i>Measures to be taken</i>	<i>Change from Last survey in 2011</i>	<i>Reference Photo</i>
Pontoon	Good	N	Rusted pontoon, steel deck need to be replaced the new	N	Photo 3,6
Bridge	Good	N	N	N	Photo 1,3,5
Pier	Fair	passenger way is damage, support is broken	Need to repair, Immediately	N	Photo 2,4
Sponson	Fair	N		N	Photo 3

Photo 2 - Support is rusted & broken

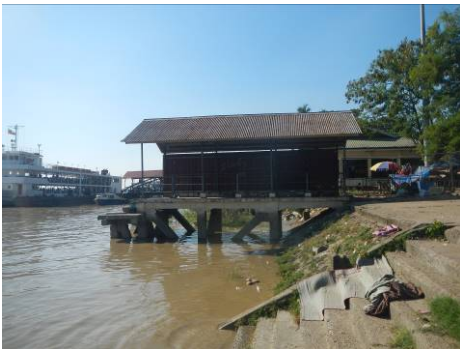
Photo 2 - Abutment slab corner damage

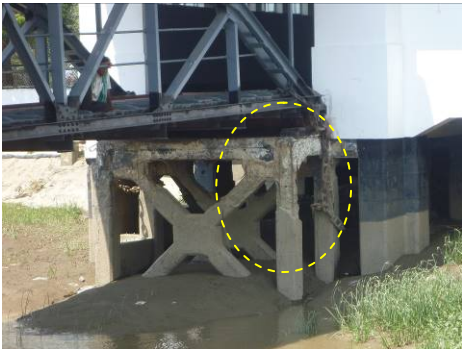
No.37	<i>Name of Jetty</i>	Nan Thi Da (4) Upper			
<i>Dimension</i>	Pontoon : Length 240'xWidth 20'	<i>Date of Inspection</i>		4 December 2014	
Result of Inspection and Evaluation of Port Facilities					
<i>Facility</i>	<i>General Evaluation</i>	<i>Condition of Damage And/or Deterioration</i>	<i>Measures to be taken</i>	<i>Change from Last survey in 2011</i>	<i>Reference Photo</i>
Pontoon	Fair		N	N	Photo-3 & 6
Bridge	Good	N	N	N	Photo 1,4
Pier	Bad	Abutment column damage,	Need to repair	N	Photo 2
Sponson	Fair	N	N	N	Photo 5

Photo 2 - Abutment column damage

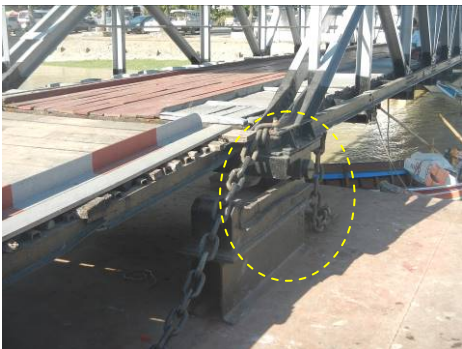
Photo 2 - Roller wheel is missing

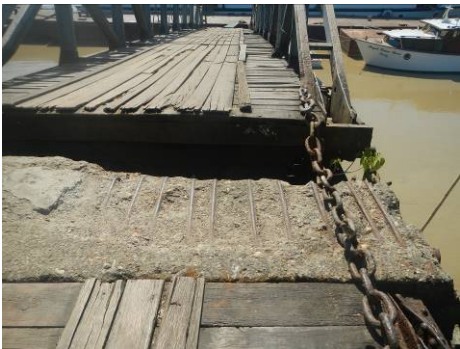
No.42	<i>Name of Jetty</i>	Botahtaung 3 (upper)			
<i>Dimension</i>	Share the No.36-1 Jetty		<i>Date of Inspection</i>	28 February,2011	
Result of Inspection and Evaluation of Port Facilities					
<i>Facility</i>	<i>General Evaluation</i>	<i>Condition of Damage And/or Deterioration</i>	<i>Measures to be taken</i>	<i>Change from Last survey in 2009</i>	<i>Reference Photo</i>
Pontoon	Good	N	N	No	Photo -6
Bridge	Good	N	N	No	Photo 1,6
Pier	Bad	Abutment slab damage	Need to repair	No	Photo 2,3,4,5
Sponson	Fair	Rust, deficit		No	Photo 6

Photo 2 - Abutment Slab concrete damage

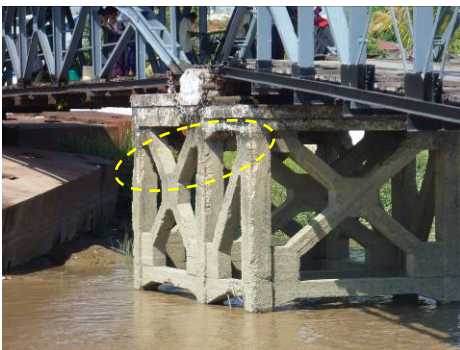
Photo 3- Abutment column damage

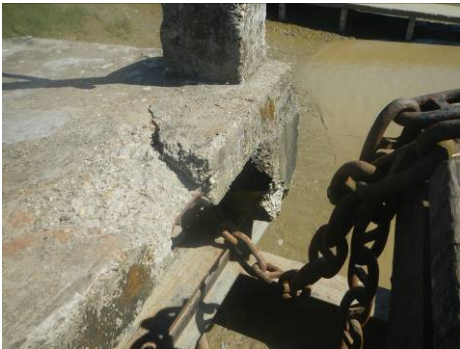
Photo 2 - Slab corner damage

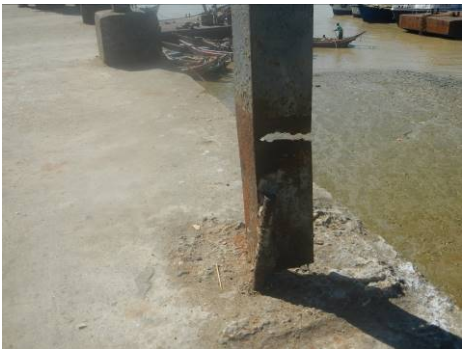
Photo 2 - Hand rail Post damage

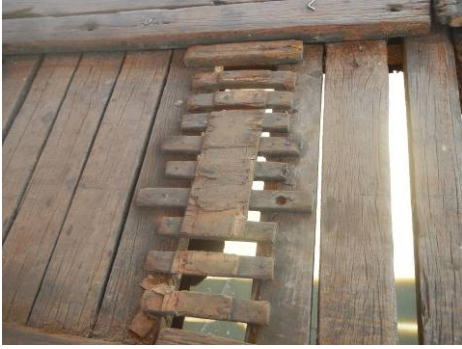
Photo 7 - Timber decking damage

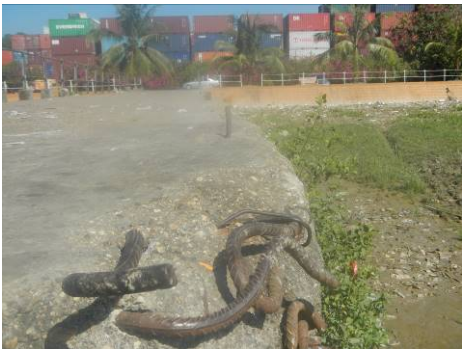
Photo 2 - Edge of Concrete Slab damage

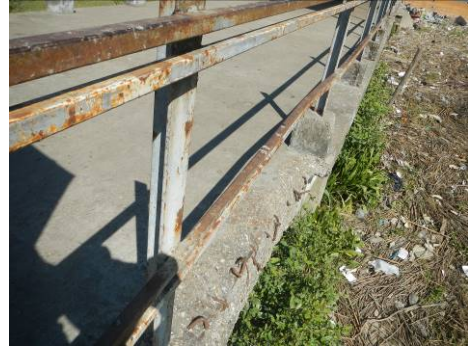
Photo 4 - Corner rebar expose

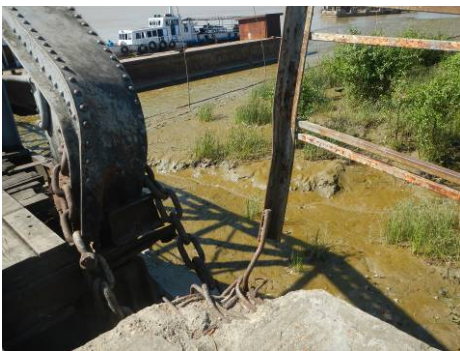
Photo 3 - Corner damage, Rebar expose

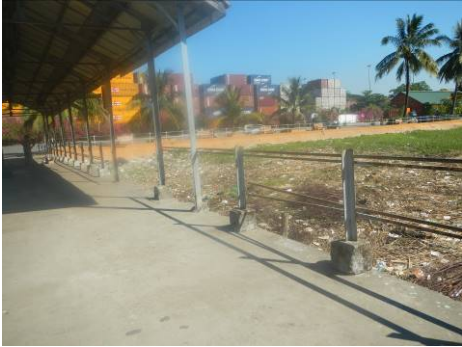
Photo 9 - Hand rail missing

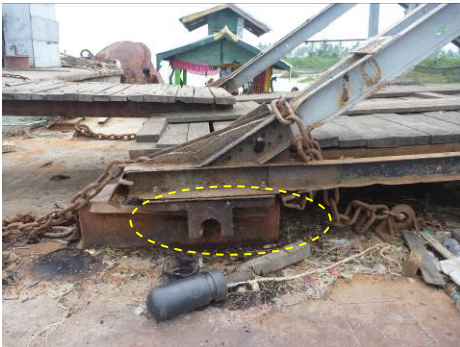
Photo 2 - Roller wheel is missing,

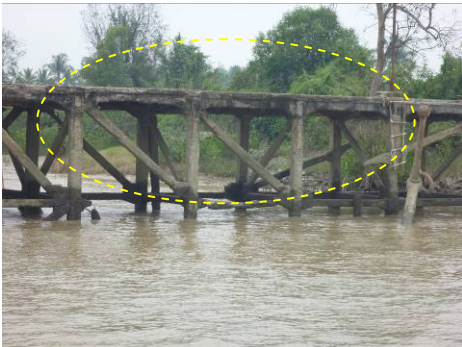
Photo 2 - Beams and bracings are totally damage

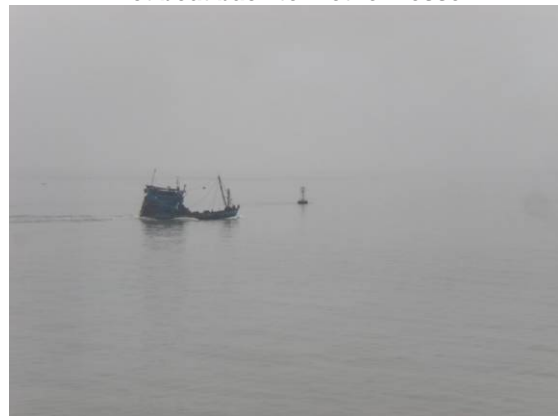
Photo B.4.42
Passed fishing boat and Upper Float Buoy
on Her starb’ dside 0.15’ off

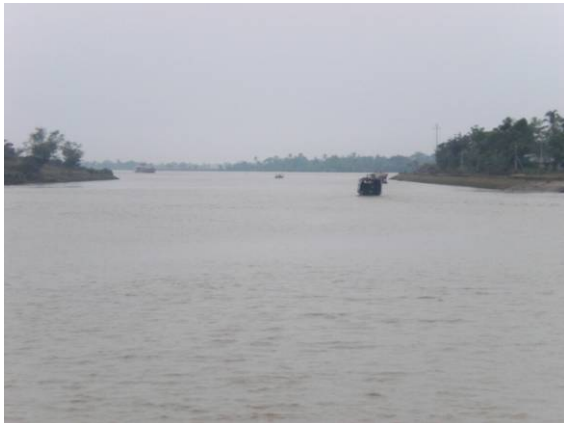
Photo C.1.10
Signal Station of Canal
Signal Station is operated by IWIR

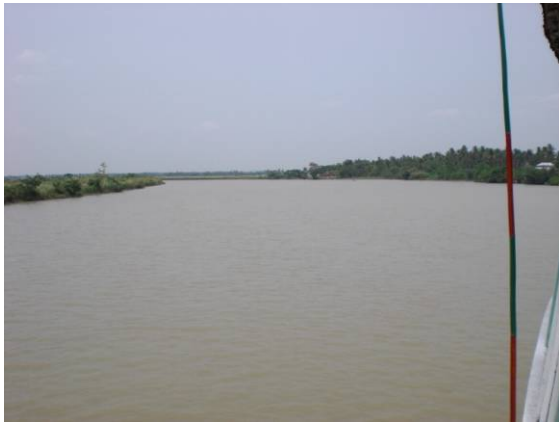
Photo C.1.31
Photoke Creek DWIR order to stop large size
of ships traffic in case dangerous situation
such as low water and strong current

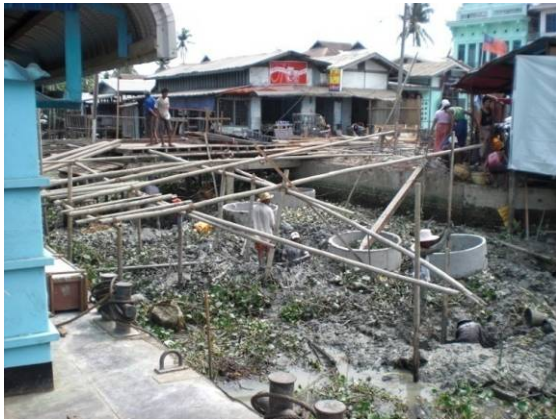
Photo C.1.39
Terminal building and Bridge are under construction

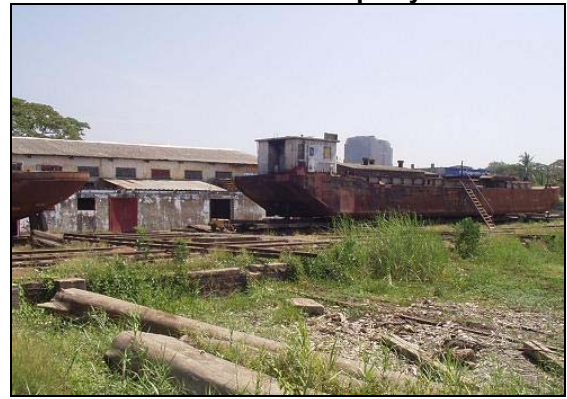
**Photo C.2.18
No.6 Side Slipway**

No. 6 Slipway			
Component	Particulars	Present Condition	Evaluation
Slipway	6 vsls, Traverse System	In operation, Age of winch is over 40 years, Made in Japan	Winch pull capacity be increased for larger vessels docking.
Hauling Winch	150 DWT		
Cradle	Steel(main) and Wooden(side)

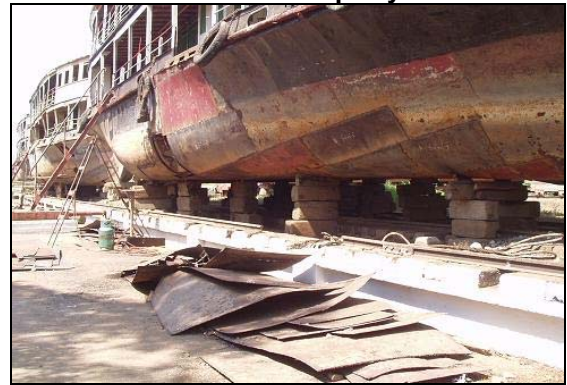
**Photo C.2.20
Renewed Bottom Shell Plates**
