**Ex-Post Situation Survey
for the Project for the Improvement of
Dusty-Nizhniy Pyandzh Road**

Ex-Post Situation Survey Report

March 2015

CTI Engineering International Co., Ltd.

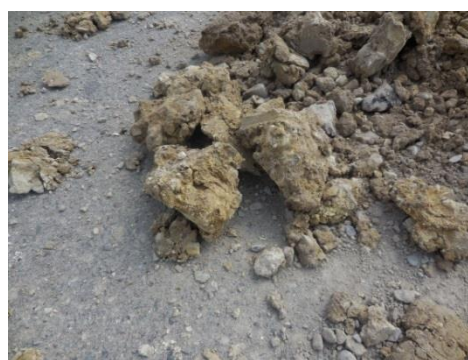
Cement Stabilized Sub-base of Clay

The base course is completely sandy soil. The PL, the moisture contents of the sub-base course are 32.7%, 12.5% each, which is comparatively high. Silt contents is 22.6%, which is also comparatively high.

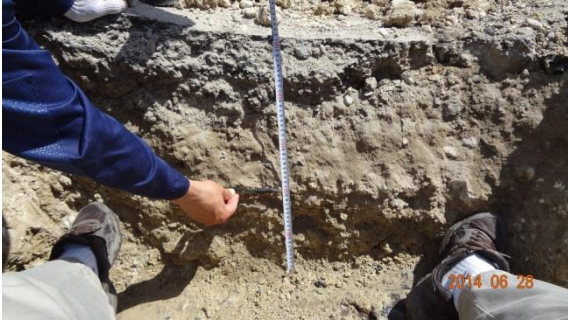
③ Excavation Cross Section
(Depth of 30cm, clay thickness 20cm)

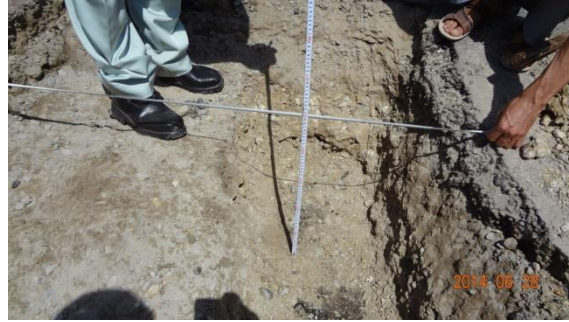
④ Excavation Cross Section
(Depth of 30cm, clay thickness 20cm)

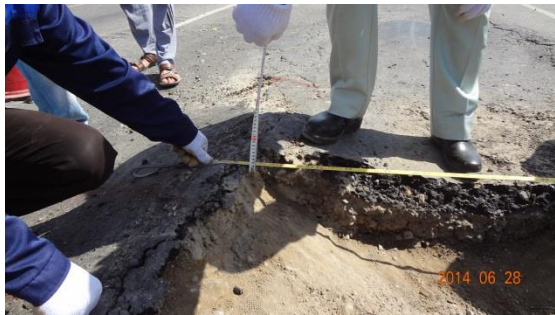
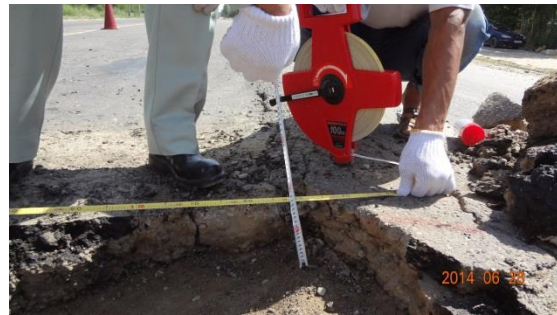
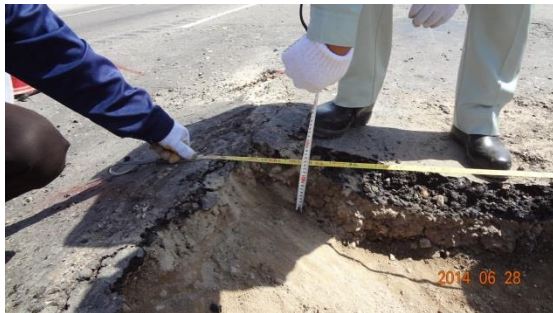
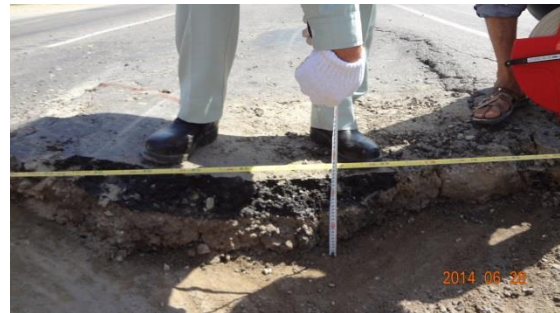
Photos of excavation survey are shown in Figure 2.19-2. Photo ⑤ to ⑧ show the irrigator cracks and deformation of AC pavement.

⑤ Pavement Thickness 2cm

⑥ Pavement Thickness 10mm

⑦ Pavement Thickness 13cm

⑧ Pavement Thickness 22cm

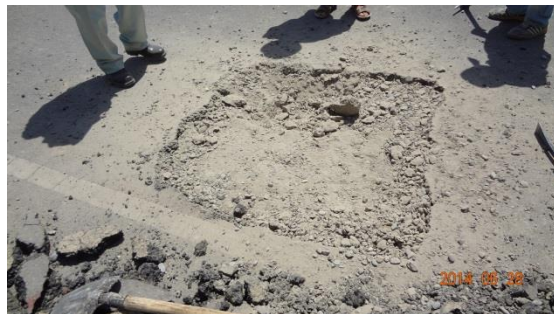
AC Pavement (5cm)

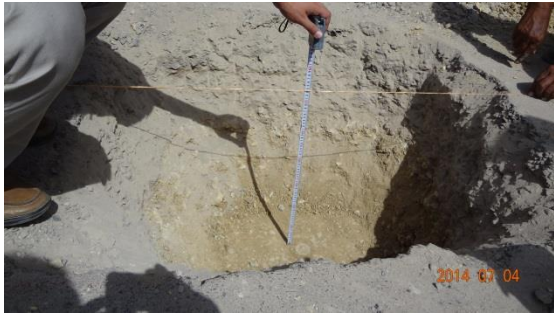
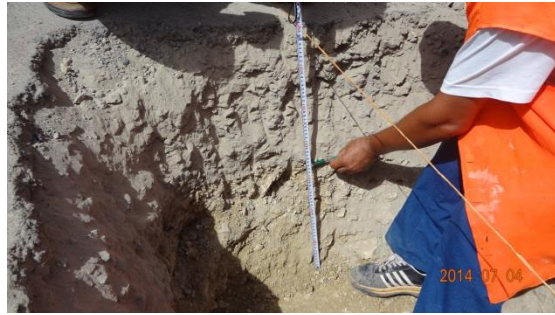
Excavation Cross Section(Depth 63cm, Subgrade thickness 33cm)

Excavation Cross Section(Depth 63cm, subgrade thickness 33cm)

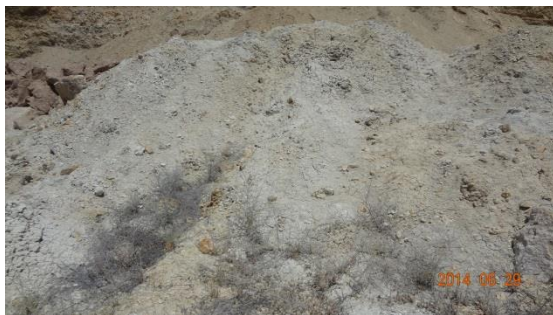
At the borrow pit for subgrade fill close to the Sta.22, three kinds of materials which are ① white soil with rock ② light brown soil with lots of fine particles ③ reddish brown soft rock have been confirmed. Since the ③ reddish brown soft rock was not found in the fill material, only ① and ② were collected. It is considered that ② material was mainly used for the construction because there have much ②soil in the borrow pit. ②soil was also collected at the first survey in Tajikistan. And the fine sand was also collected from the borrow pit close to Sta.13.

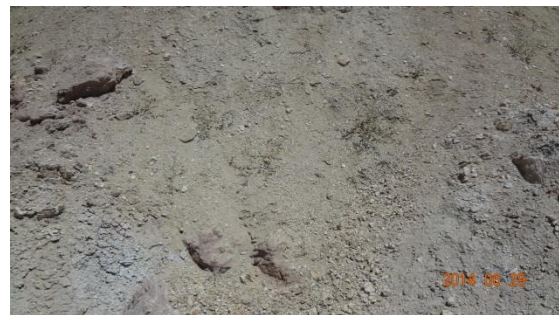
② (Sand at the slope, having large amounts of sandy soil)

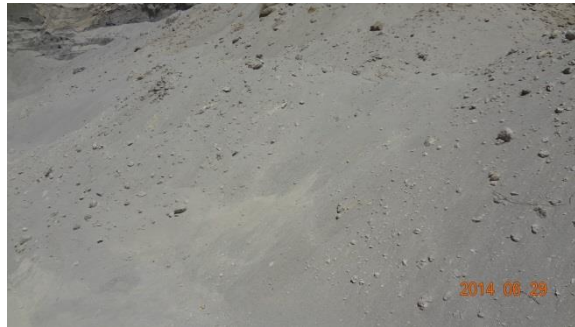
Figure 2.20-2 Borrow Pit Close to Sta.13 (Fine Sand)

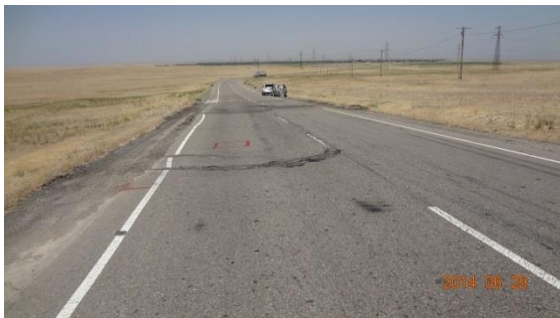
Steep Location-1

No.	Start	End	Section	Pavement Structure	Condition
Steep Section	1	14+420	14+460	6	AC : 10cm Base course : 30cm	Asphalt pavement is sliding significantly though the condition under the sub-base is firm.
	2	15+448	15+463			
Flat Section	1	4+475	4+508	4	AC : 5cm Base course : 25cm	The surface is drastically deforming along with the alligator crack. Cement stabilized sub-base is spouting out which interrupts the traffic.
	2	5+023	5+036			
	3	6+895	6+912			
	4	9+204	9+216	5	AC : 5cm Base course : 35cm	Surface is deformed along with the alligator crack which is interrupting the traffic. The deformations are expected to be progress in future.
	5	10+610	10+620			
	6	11+860	11+870			
	7	12+050	12+060

Field inspection for the repair location has been conducted, and the extent of repair works has been marked. There were locations where the defects were progressed compared to the first survey (in early May). It is required to determine the final repair locations when the repair works start.
