**THE PROJECT OF LANDSLIDE
MANAGEMENT IN THE REPUBLIC OF
MAURITIUS**

FINAL REPORT

SUMMARY REPORT

March 2015

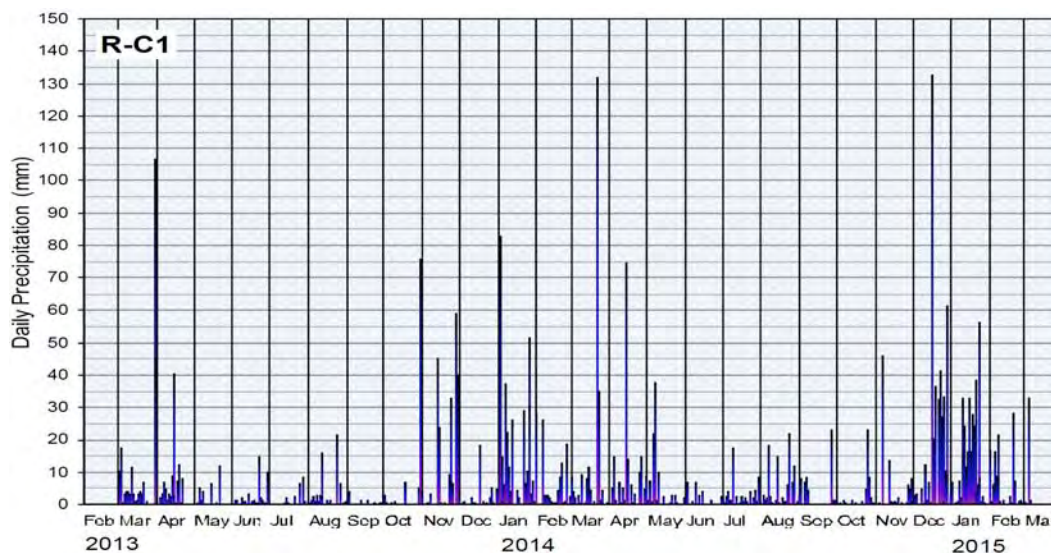
Figure 3.4.4 Result of Rain Gauge (source: JET)

During the monitoring period (26th February 2013 to 4th March 2015), much precipitation was recorded in rainy season (November to April). 450.0mm/month as the maximum monthly rainfall in the monitoring period was recorded in December 2014, and the minimum monthly rainfall in the monitoring period was 8.5mm/month recorded in September 2013. There were ten days when daily precipitation exceeded 50mm in the monitoring period.

There were three days when daily precipitation exceeded 100mm/day in the monitoring period, 30th March 2013, 21st March 2014 and 16th December 2014. On 16th December 2014, 133.0mm of rainfall within six hours and 77mm of maximum hourly precipitation were recorded. On 21st March 2014, 132.0mm/day and 50.0mm/hour were recorded. The daily precipitation on 20th March 2013 was 106.5mm, and total precipitation of 30th and 31st March was 152.5mm. The maximum hourly precipitation in 30th to 31st was 25.5mm.

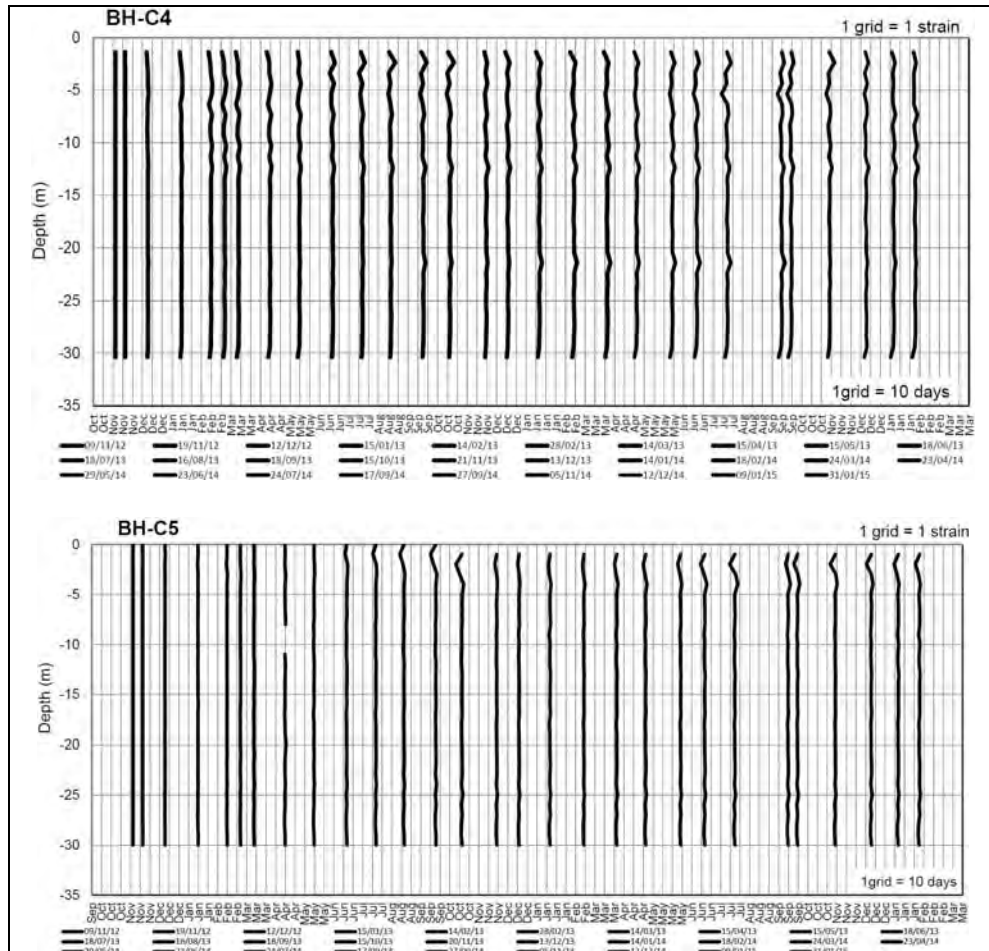
Figure 3.4.7 Results of Strain Gauges (source: JET)

BH-C4 is installed at left of center of Chitrakoot landslide area. Small deformations can be seen at 13m, 21m and above 6m deep. These small deformations may not be caused by landslide movement. It must be continued to be watched carefully.

BH-C5 is installed at the foot of Chitrakoot landslide area. There is nothing worthy of special mention in this monitoring.

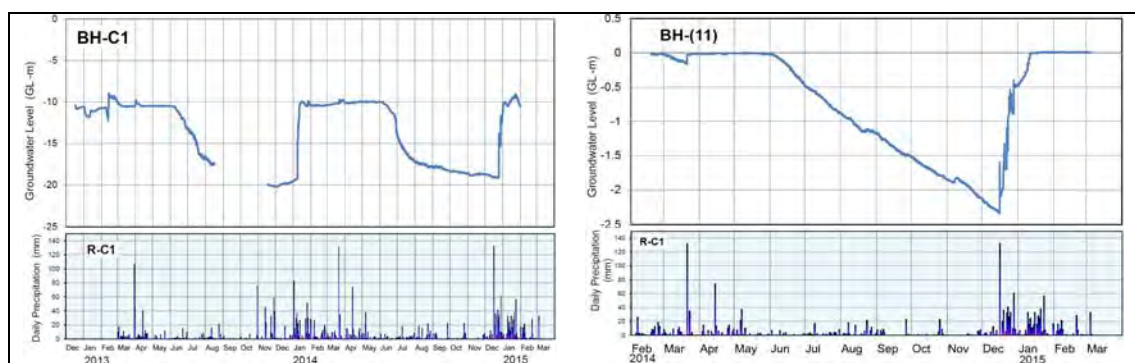
Figure 3.4.8 Results of Piezometer (source: JET)

Similarly, there are some other boreholes of which the groundwater level is very high in rainy season in Chitrakoot landslide area.

The groundwater level at BH-C3 was confirmed at about 40m deep in November 2012.

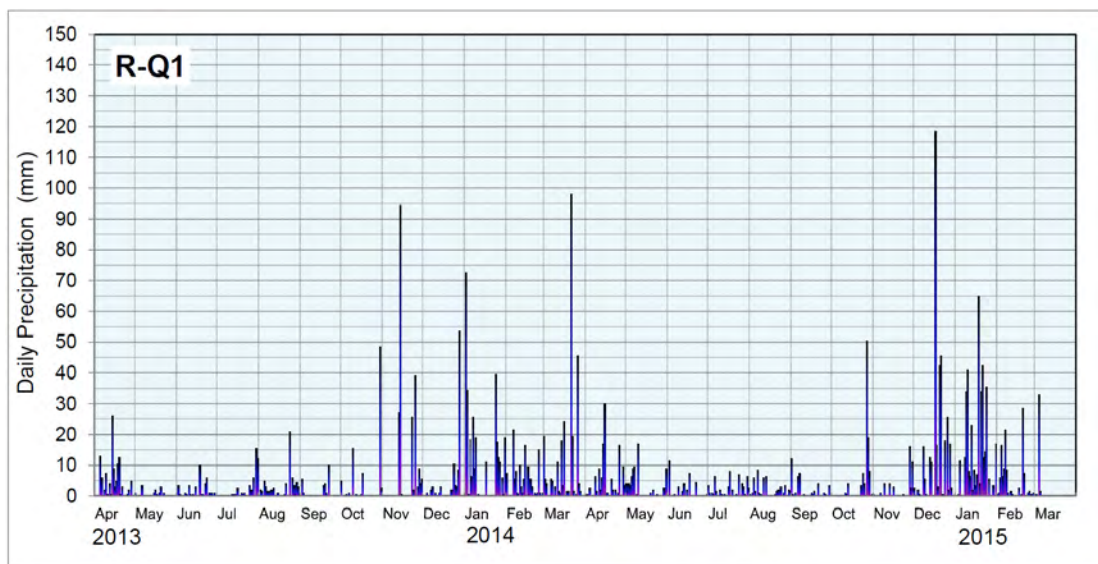
Figure 3.4.9 Result of Rain Gauge (source: JET)

precipitation was 117.5mm including the precipitation on 22nd March. It was high intensity rainfall recording 39.0mm of hourly precipitation.

94.5mm of daily precipitation were recorded on 14th November 2013. It is second heaviest precipitation in the monitoring period. The rainfall was started on 13th November, and total continuous precipitation was 121.5mm. However it was not so high intensity rainfall recording an hourly precipitation of 19.0mm.

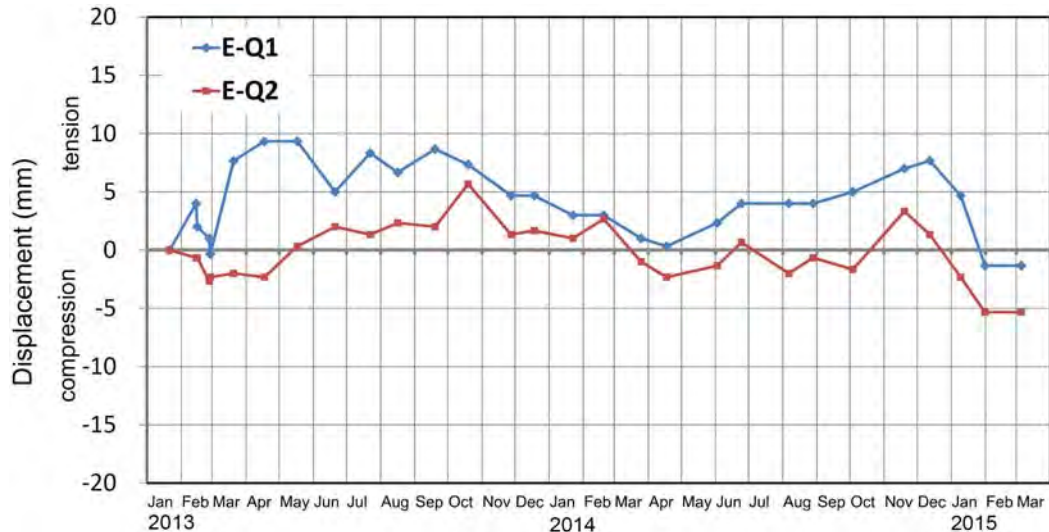
Figure 3.4.10 Result of Laser Distance Meter (source: JET)

Both E-Q1 and E-Q2 of which variations were within 10mm do not show remarkable movement. E-Q1 shows tendency of tension in winter and compression in summer. E-Q2 shows similar tendencies but behind E-Q1. These tendencies may be due to deformation of the ground or structures by the variation in temperature.

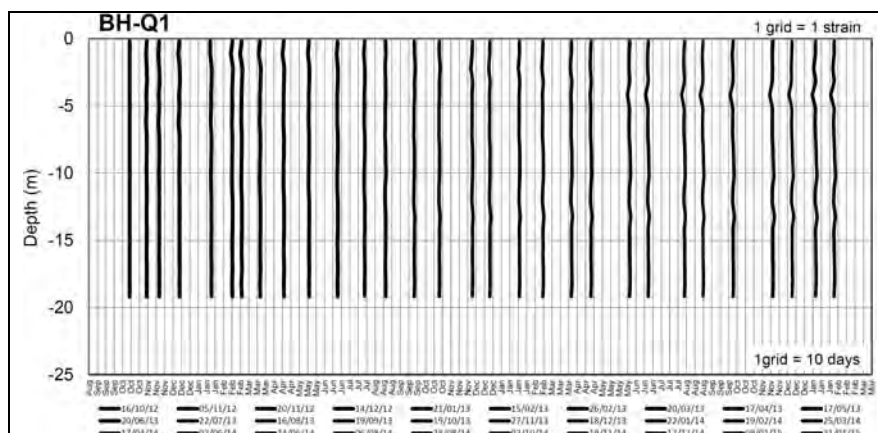
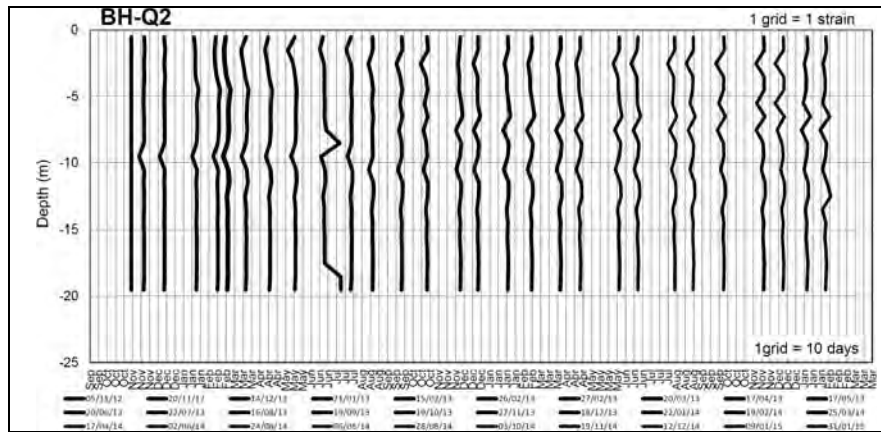
Figure 3.4.11 Results of Strain Gauges (source: JET)

BH-Q1 is installed in upper landslide block (Block B). There is nothing worthy of special mention on this monitoring.

BH-Q2 is installed in upper landslide block (Block A). Small deformation can be seen at 2m, 7m and 11m deep. These deformations are not big enough to be determined to be due to landslide activities.

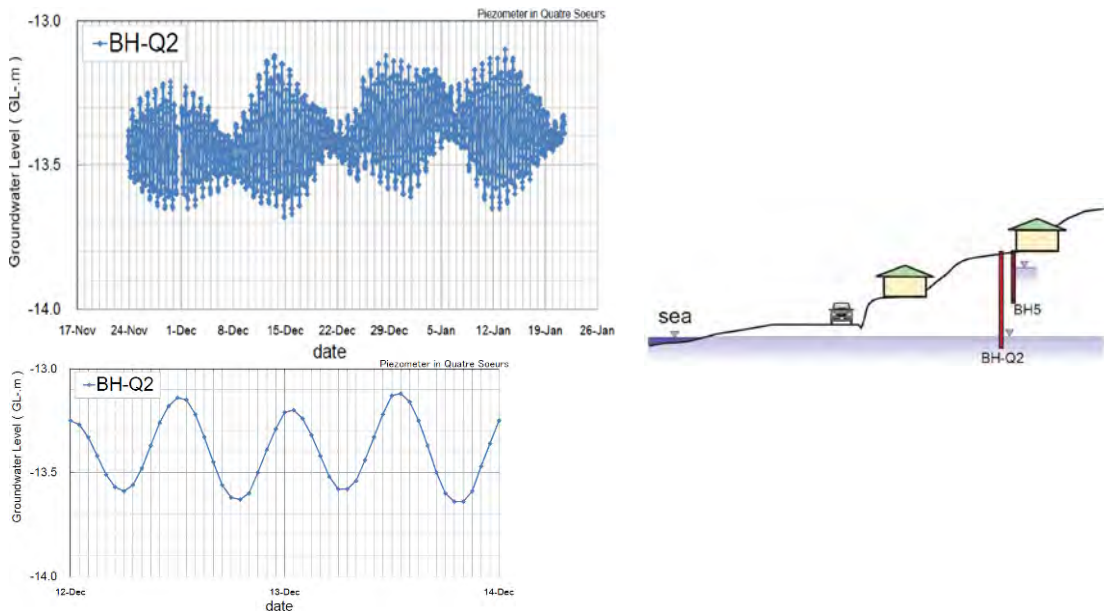
Figure 3.4.12 Groundwater at BH-Q2 (source: JET)

Piezometer at BH-Q2 which is the center of Block A was shifted to BH5 since the groundwater level is almost equal to the sea level following the tide level and over 13 m deep of the groundwater level at BH-Q2 cannot affect the landslide.

8m deep BH5 which was drilled before the project is located beside BH-Q2 (3m away from BH-Q2). The groundwater level follows the amount of the precipitation. In a day with much precipitation, the groundwater level rises to 0.5m below the ground surface. The base level of the groundwater was around 3.5m deep in rainy season, around 4.0m deep in non-rainy season. The groundwater level recorded by the piezometer at BH-Q2 must be shallow groundwater flowing in shallow permeable layer.

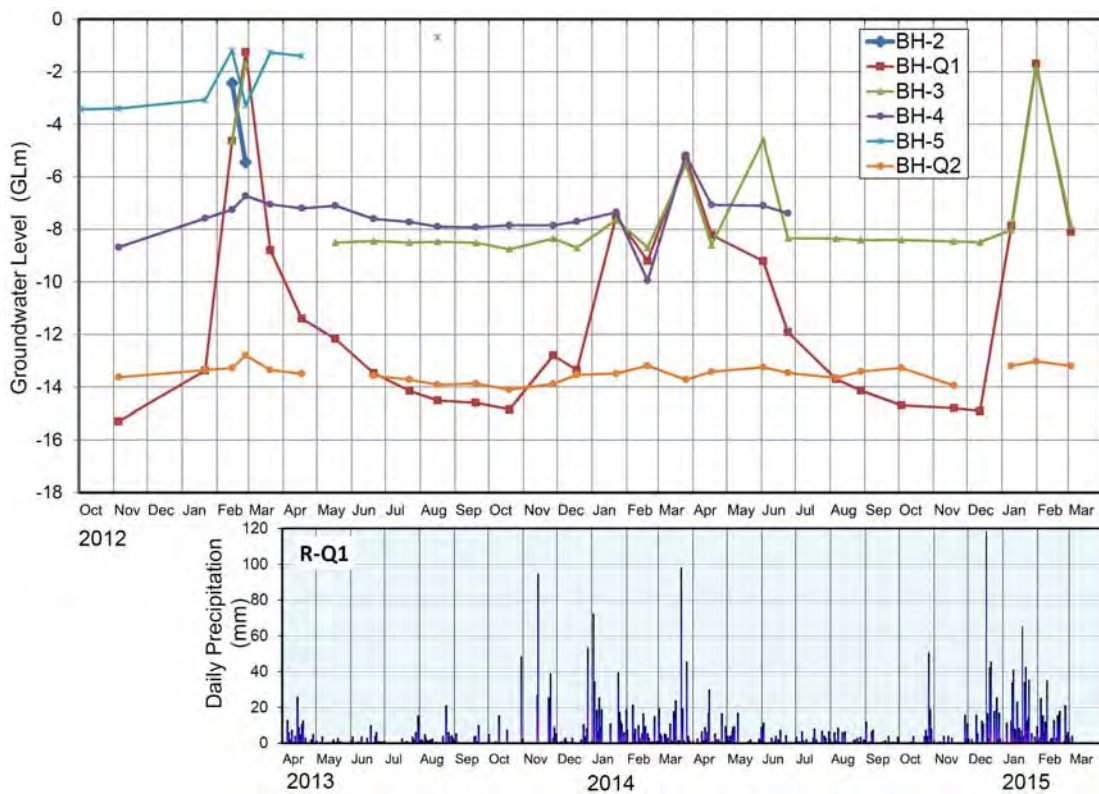
Figure 3.4.14 Water Level in the Boreholes (source: JET)

The groundwater levels are stable at all boreholes except BH-Q1 and BH-3. The water in the boreholes except BH-Q1 and BH3 may be isolated from the groundwater because strainers in the boreholes might be choked with soil. The water level in the borehole of BH-Q1 which may follows actual groundwater level, rose to about 1m deep in February 2013 from 14m deep in dry season.

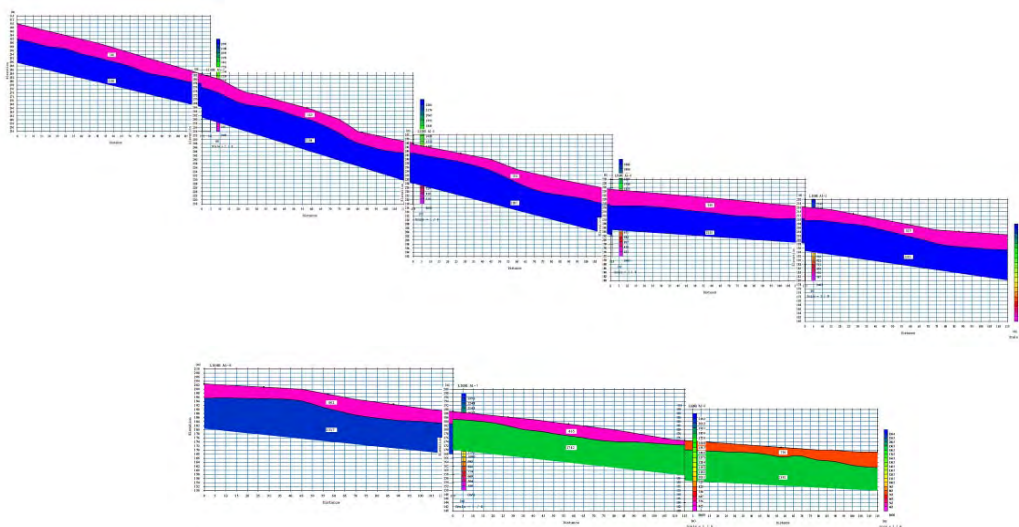
Figure 3.5.2 Seismic Velocity Section (A1-line) (source: JET)

The velocity structure is generally categorized into 2~3 strata, and the surface stratum is presumed to be colluvium with an elastic wave velocity of less than about 500m/s. The

The elastic wave velocity of the base rock shows a value of 1700m/s~3900m/s, more than three times the surface stratum velocity. The variation in velocity in hard base rock composed of basalt is attributed to the prevalence of fractures and cracks inherent in basalt.

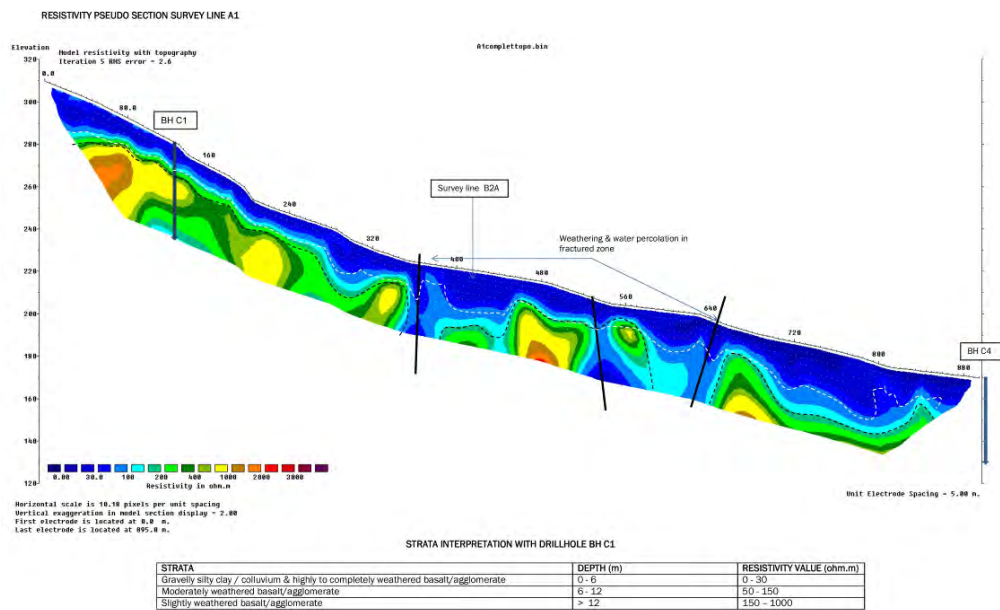
Figure 3.5.4 Resistivity Pseudosection (A1-line) according to Inverse Analysis (source: JET)

The resistivity distribution is generally divided over 2~3 strata, and the surface layer is estimated to be colluvium of less than about 50ohm.m. The stratum thickness is less than about 20m and distributed uniformly over the entire survey area. Also, a fall in resistivity is observed in 3 places on the A1-line, indicating a weathered zone or groundwater flow.
