7. Landslide Recording Sheet

# General Information Sheet (Other)

Management number	000000001	Reporter's name:	Tomoharu IWASAKI	Date of report :	June 14, 2012
Address	Temple Road, Creve Coeur	Type*	Damage of wall	latitude	-20.149417
			longitude	57.582472

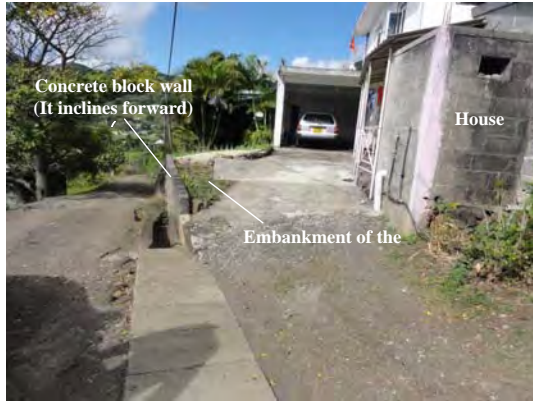
Deformation on the concrete block wall and house caused by embankment deformation at the front yard (parking area) was confirmed. Another problem was inadequate surface drainage causing surface water from mountains to flow directly at houses during heavy rain.

Ph-1 Full view of concrete block wall

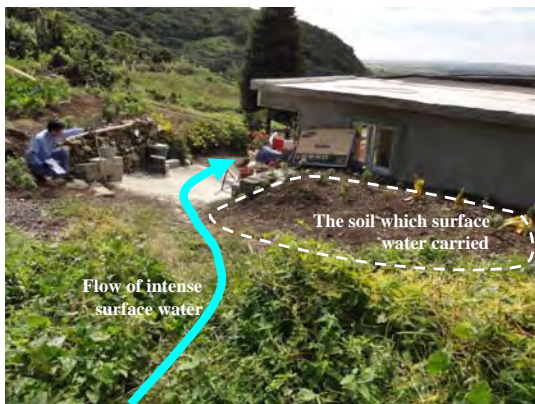
A large amount of water flows down from the mountain and hit the house which is located at the waterway during heavy rain.

Ph-3 The course that the surface water flows through (1)

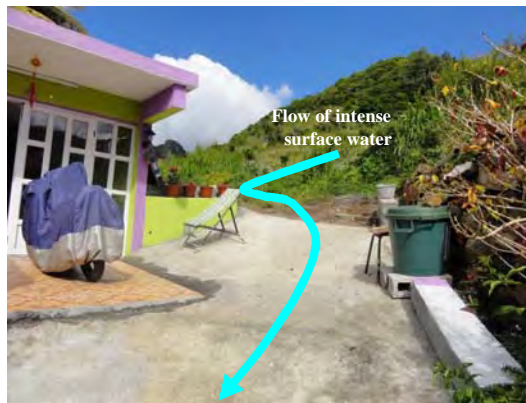
Ph-4 The course that the surface water flows through (2)

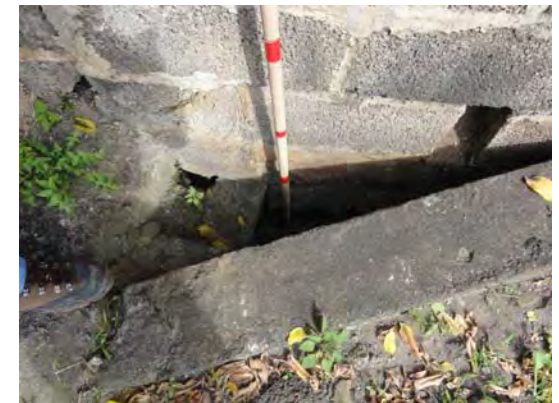
Ph-5 Damage of the drainage of the roadside

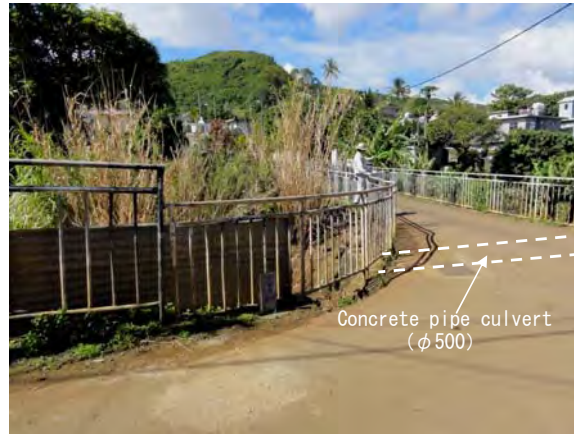
A small stream flows under the road through a concrete pipe culvert, however, because it is too small it causes flooding and bank erosion during heavy rain. The stone masonry wall built at the both side of riverbanks was destroyed by erosion. Therefore, it is necessary to build a retaining wall for both side of riverbanks and increase the diameter of the pipe culvert.

Ph-2 Full view (Down stream)

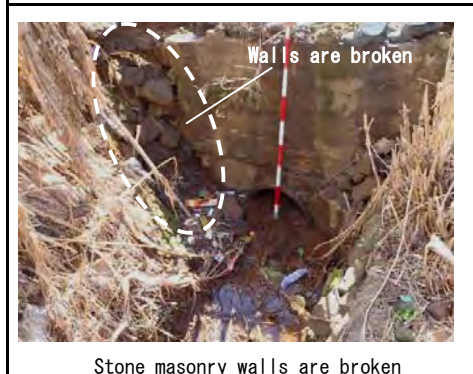
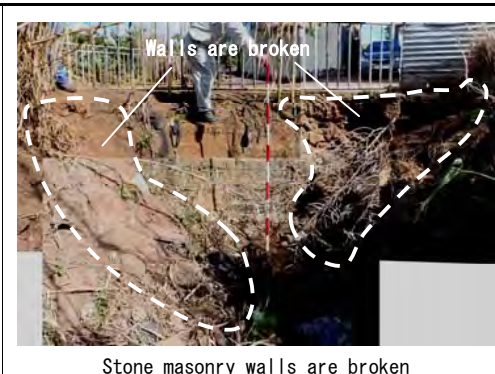
Stone masonry walls are broken

[Description]  
 A concrete pipe culvert is installed under the road crossing the small river. However, the size of the pipe culvert is small which causing the flood during heavy rain and bank erosion.  
 The stone masonry wall built at the both side of riverbanks was destroyed by erosion. Therefore, it is necessary to build a retaining wall for both side of riverbanks and increase the diameter of the pipe culvert.

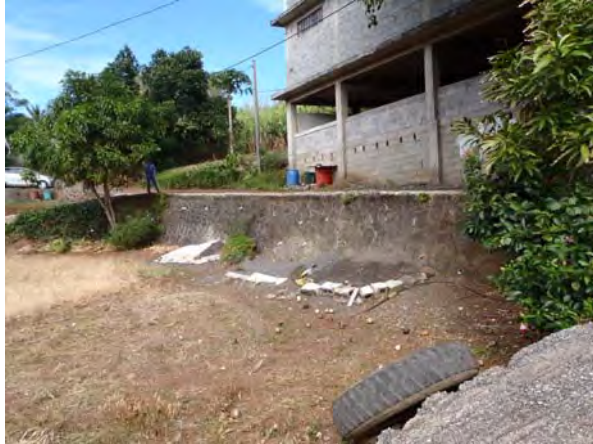
A 1m high retaining wall that was constructed to build the road was reported to be leaning but it was found to be stable and no slope failure was observed. Therefore, It is not necessary to investigate in detail.

Ph-1 Full view (Retaining wall)

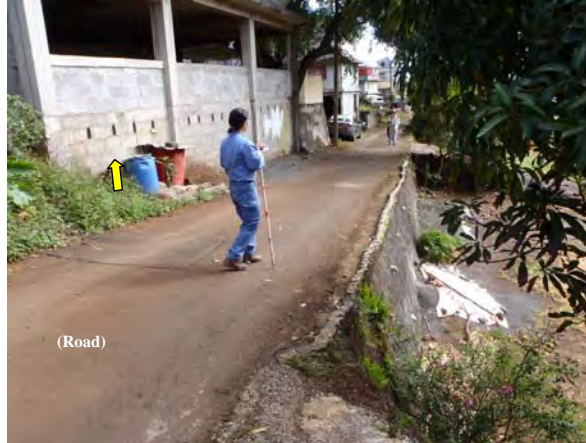
Ph-2 Retaining wall

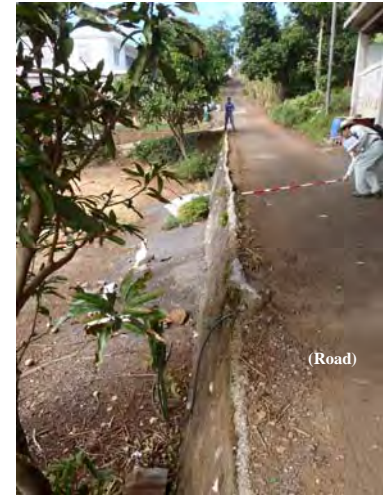
Ph-3 Retaining wall

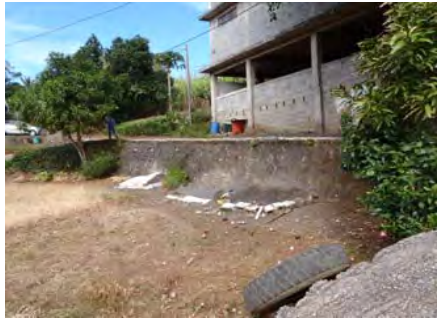
Ph-1 The retaining wall

[Description]  
A 1m height retaining wall that has been constructed to build the road was reported leaning but it was stable and no slope failure has been observed. Therefore, It is not necessary to investigate in detail.

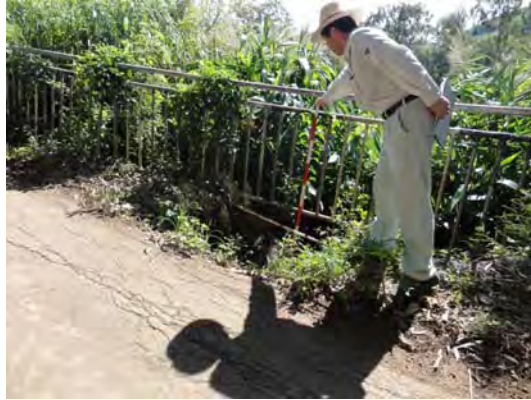
A slope failure was confirmed on the side of the road.  
 Slope failure is characterized as follows; W=2m, L=2m.  
 There is a possibility of slope failure in future.  
 It is necessary to undertake works regarding this road. And, it will be necessary to construct a retaining wall.  
 Also, there is slope failure in another site. But, the road has been already repaired.

Ph-2 slope failure

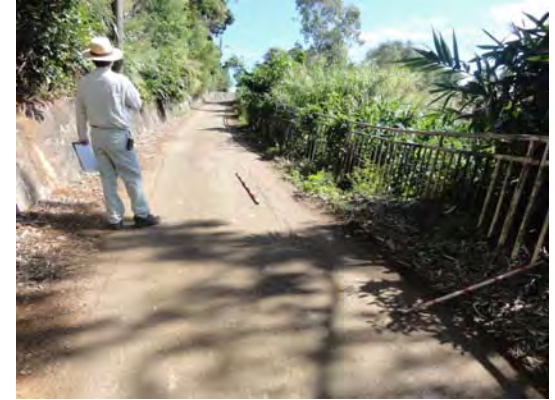
Ph-3 Transverse Cracks

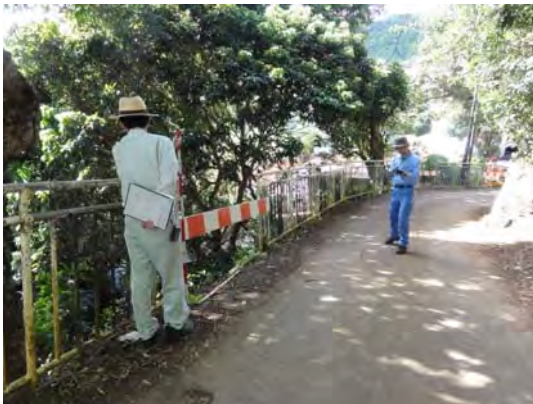
Ph-3 repaired road of another site

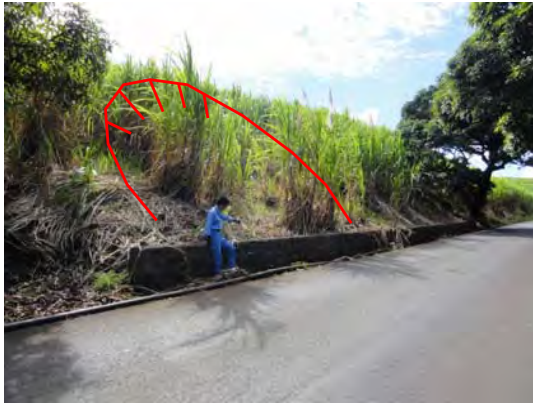
There are a few slope failures and a landslide in this site. The slope at the roadside collapsed during heavy rain in 2010 and a section of road was washed away. Since then, a retaining wall has been constructed and the site is currently stable.

Ph-1 Full view of landslide

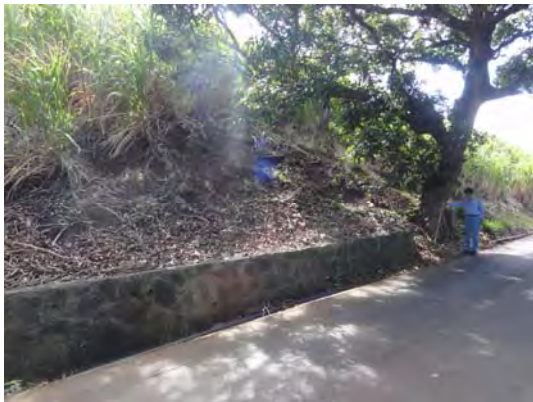
Ph-4 slope failure

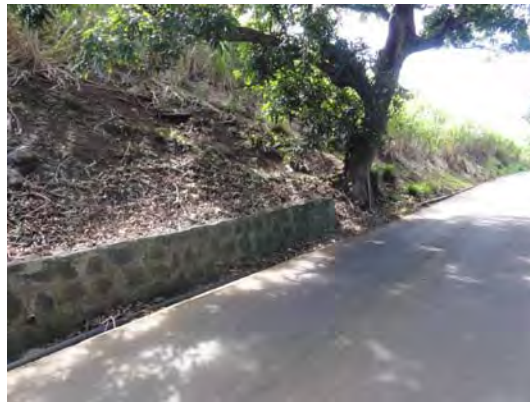
Ph-5 slope failure

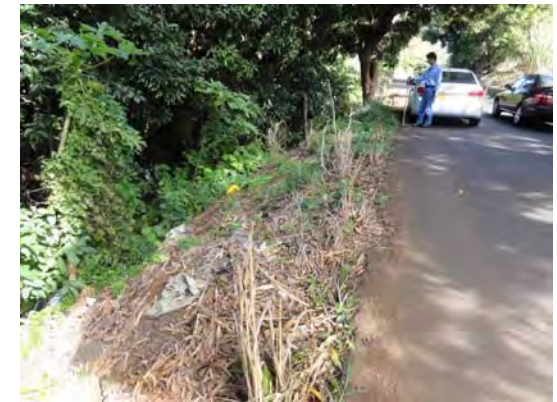
Ph-6 rocks and gravel by slope failure

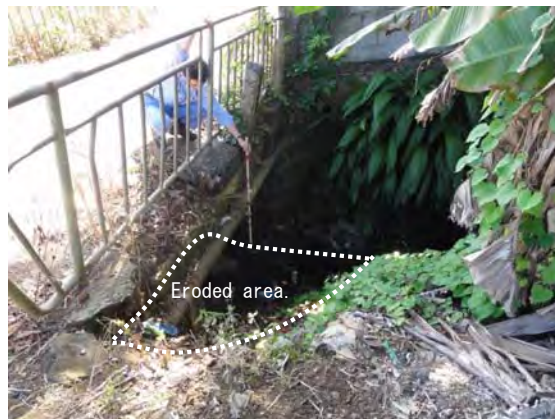
There appeared to be bank erosion on the left bank above the bridge. The upper bank has not been covered by anything while the retaining wall was constructed at the lower bank. In addition, the water level rises in the wet season causing the bank erosion.

Ph-2 Eroded area

[Description]  
It is necessary to carry out the countermeasures in the left bank of the upper side of the bridge.

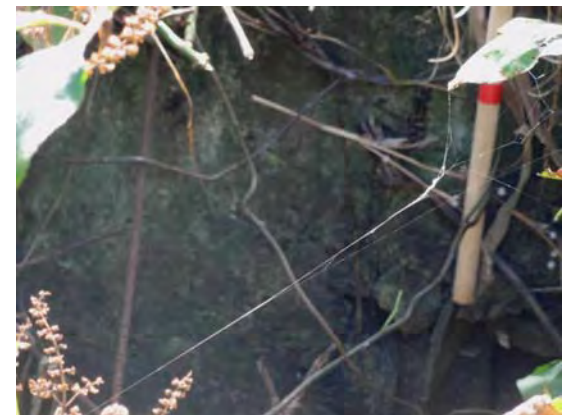
Ph-3 Concrete wall

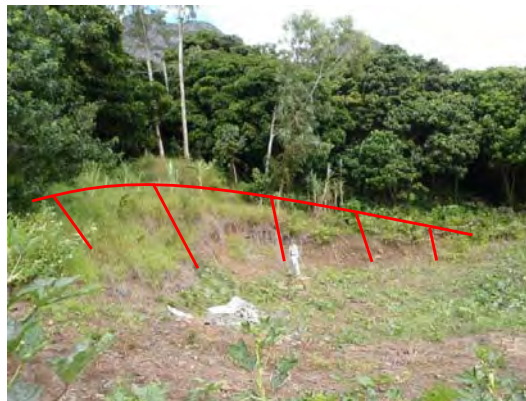
Ph-2 Minor Scarp

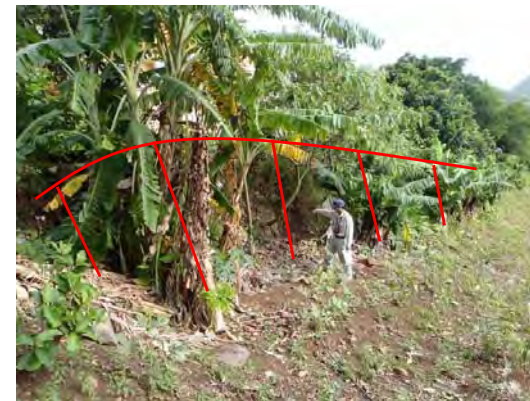
Ph-3 Minor Scarp

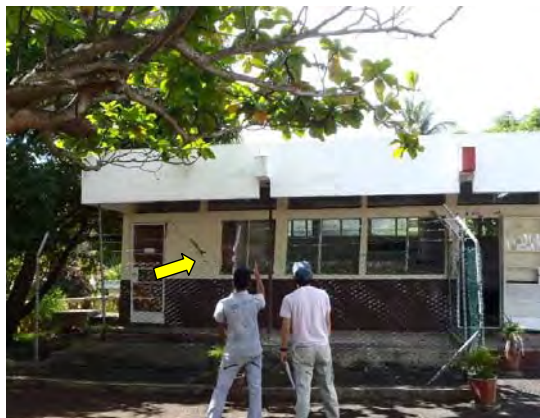
Ph-4 Damage on school  
(By the damage of the landslide, a part of the school cannot use)

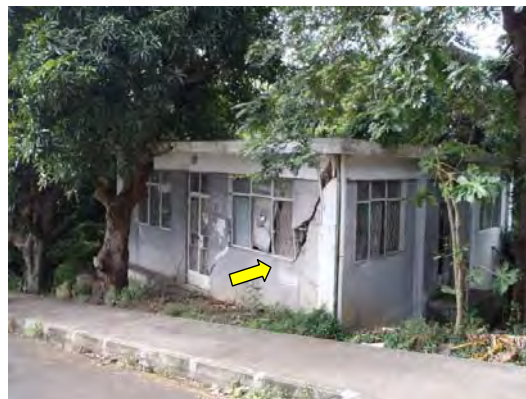
Ph-5 Damage on house  
(It's relocated)

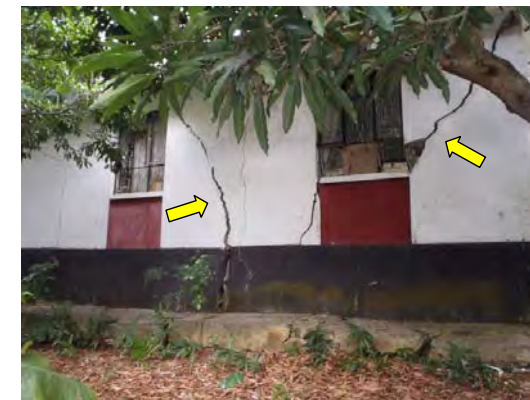
Ph-6 Damage on house  
(It's relocated)

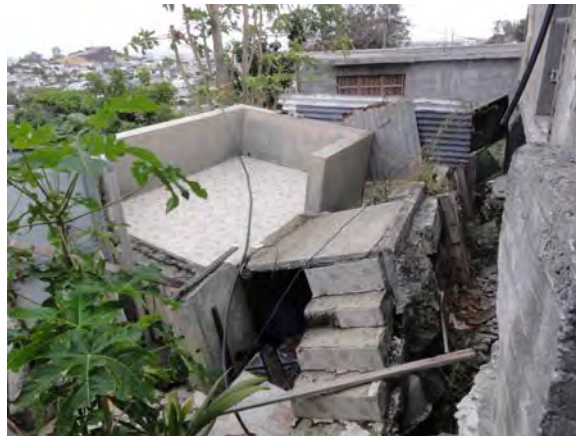
Ph-1 Main scarp

<p>[Resident's awareness and relocation]</p> <p>[Land use restrictions in hazard areas]</p> <p>[Description]</p> <p>The landslide is not stable. A landslide investigation and monitoring are necessary.</p>
--	--

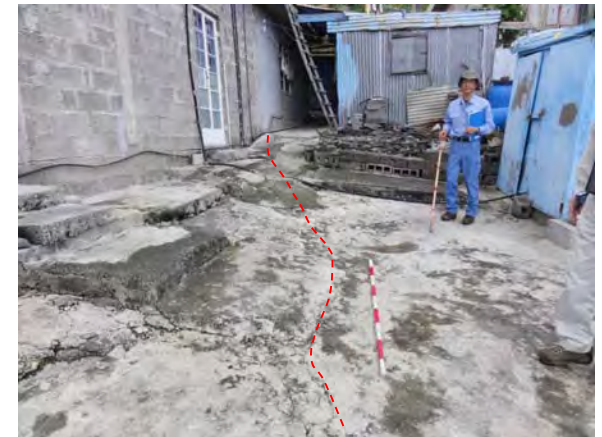
Ph-2 The broken steps

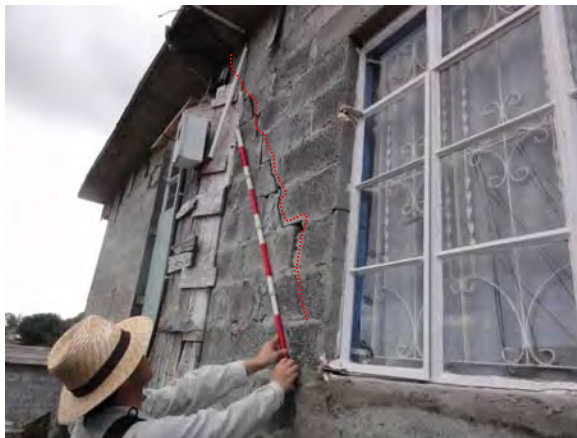
Ph-3 Observed cracks

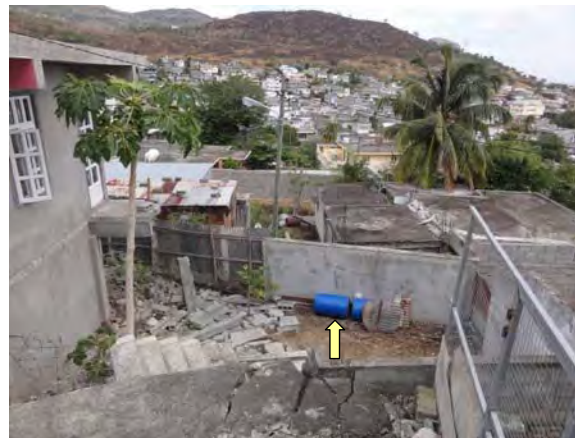
Ph-4 Damage on house  
(Caused by landslide)

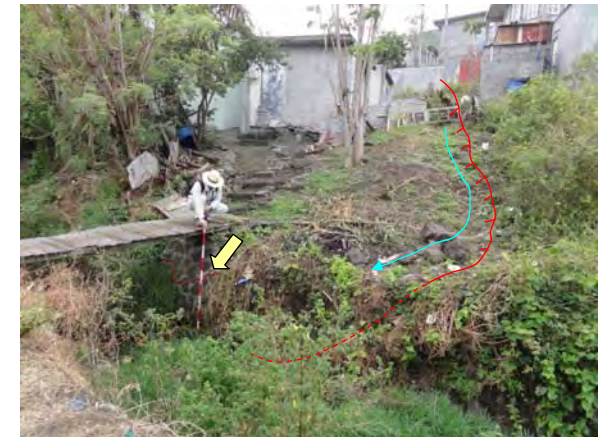
Ph-5 Direction of landslide movement

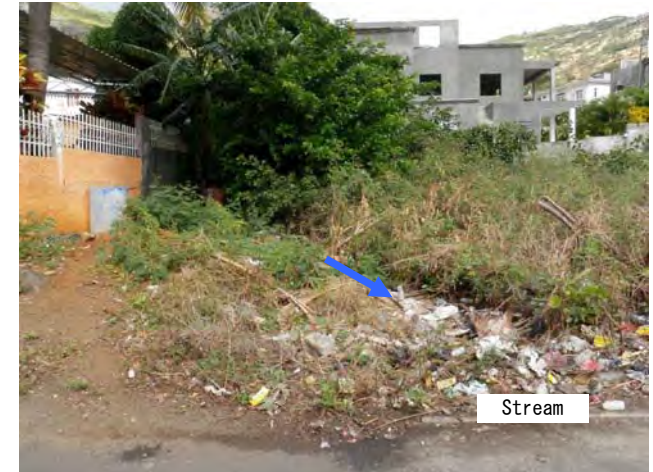
Ph-3 Channel of the depressions (upstream)

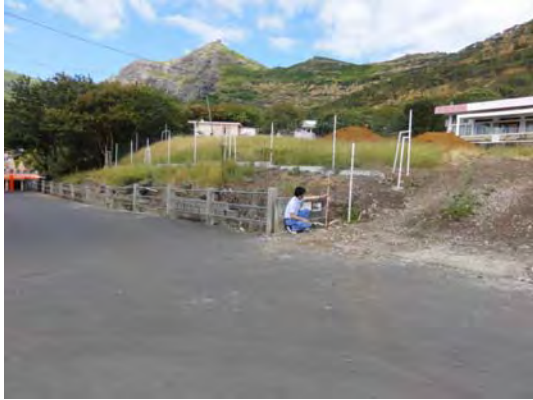
An embankment has been constructed to build up the road, which caused an adjacent retaining wall to be pushed out and deformed. Insufficient surface drainage causing accumulation of groundwater could also be a factor causing this deformation. It is necessary to reconsider the construction of the retaining wall and drainage.

Ph-1 Full view of Embankments

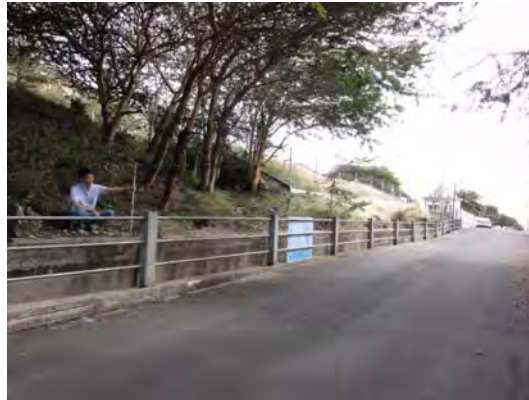
Ph-2 Slope in the retaining wall upper part

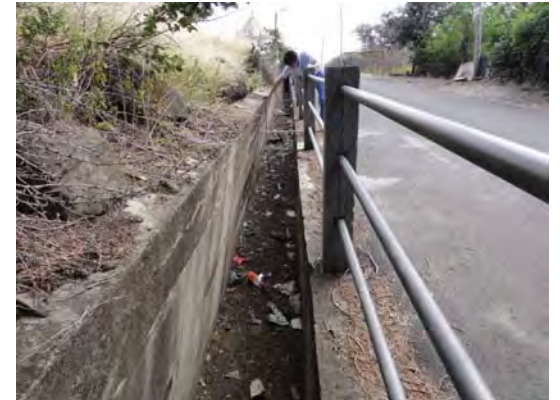
Ph-3 Inclined the retaining wall

[Description]  
 The Structural Measure (Hard-Component) was carried out.  
 The imperfection of the surface drainage is one of the factor that causing the accumulation of groundwater at the rear bank and pressurize the retaining wall.  
 It is necessary to reconsider the construction of the retaining wall and drainage.

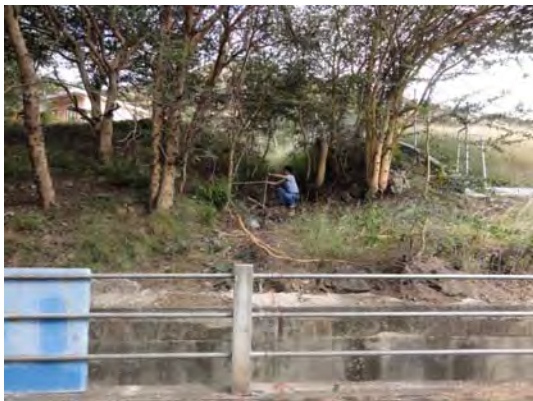
Ph-4 The Gully by flow of surface water

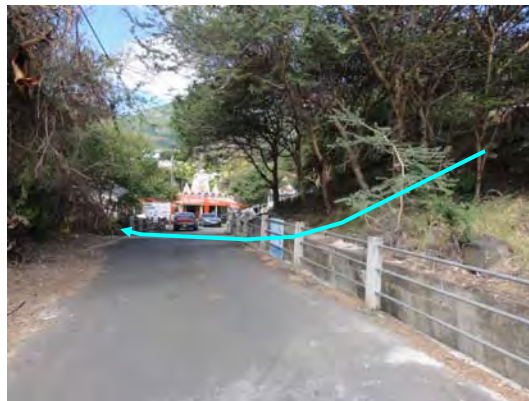
Ph-5 Flow of surface water

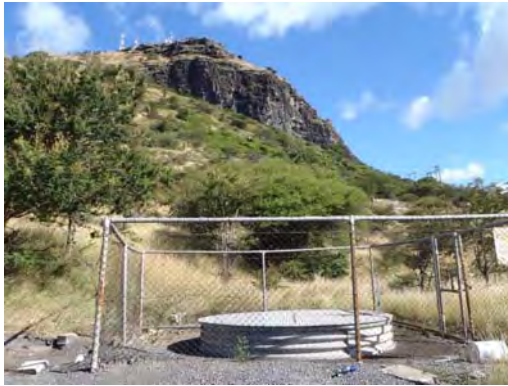
Ph-1 Drainage Well (W-2)

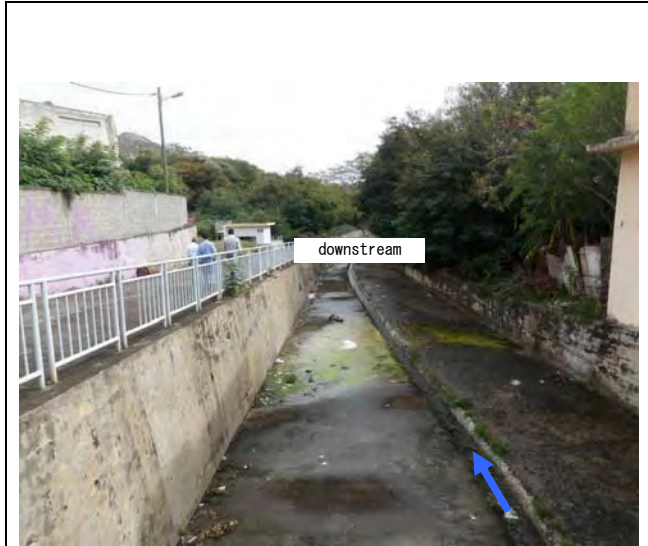
Every side of the channel is covered by concrete. The water level rises until the upper edge of the channel and erode beyond this point in the rainy season. The gabion has been set up at the lower part of slope at the channel and no damage has been reported yet. However, the deterioration of the concrete wall is remarkable and the extension of the wall height will be necessary. Therefore, further investigation and countermeasures are advisable.

Ph-1 Full view of the channel consolidation works

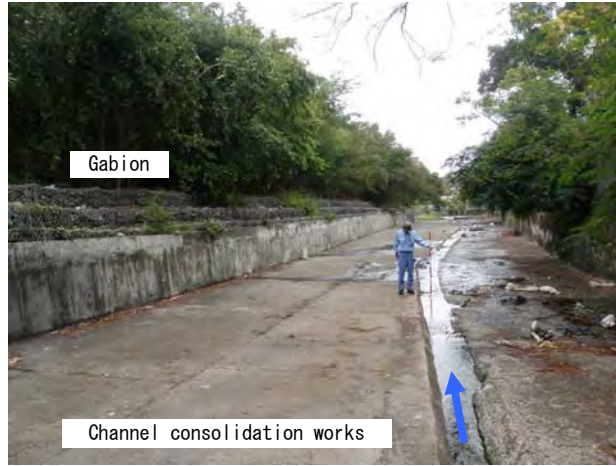
Ph-2 Stream of the channel consolidation works

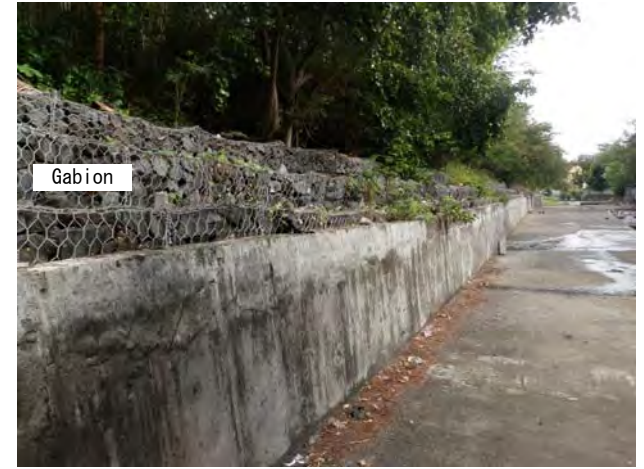
Ph-3 Gabion set up in channel consolidation works left bank

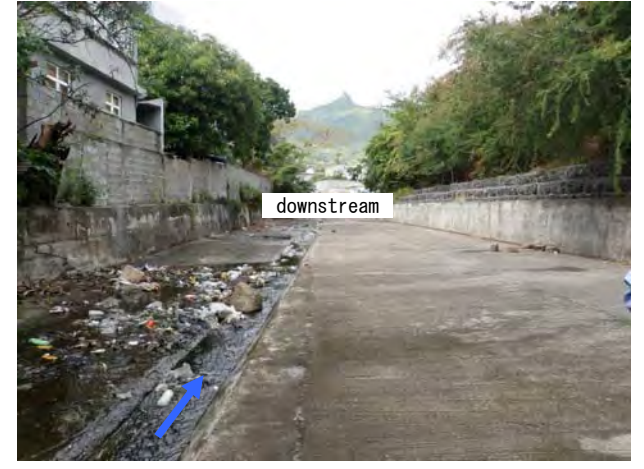
Ph-6 The channel works downstream

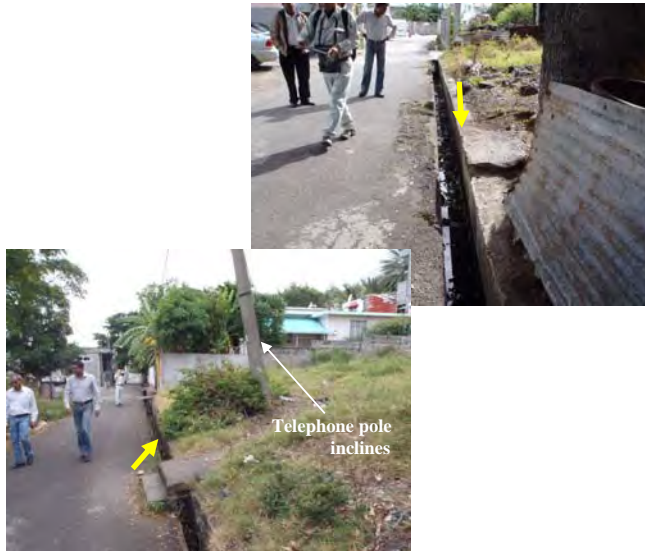
Ph-2 Retaining walls incline

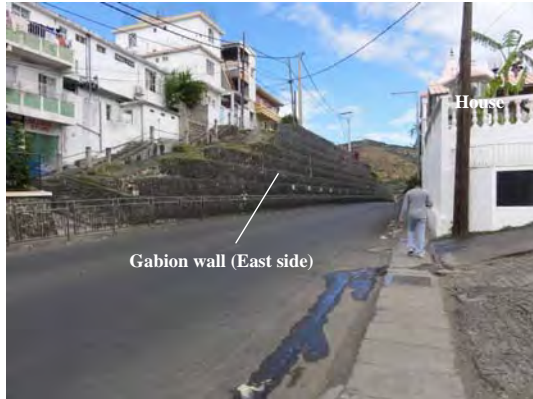
The gabion was installed on the cut-slope when the road was constructed. The height of the each gabion is 1m with a total height on the east side of 8m, and 7m on the west side. There is no record of damage for this site but the angle of the wall is steep. Therefore, the observation of this wall is advisable.

Ph-1 Full view of Gabion wall (East side)

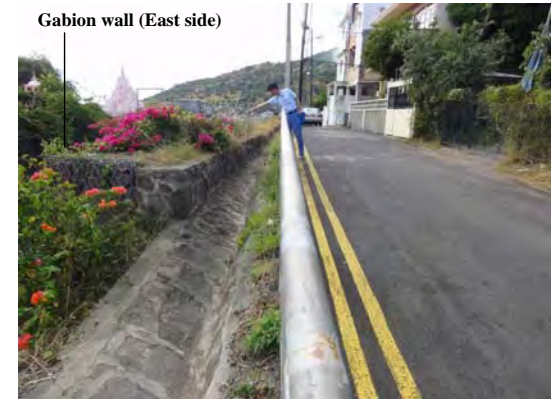
Ph-3 The upper part and the rear of the Gabion wall (East side)  
There is not the abnormality

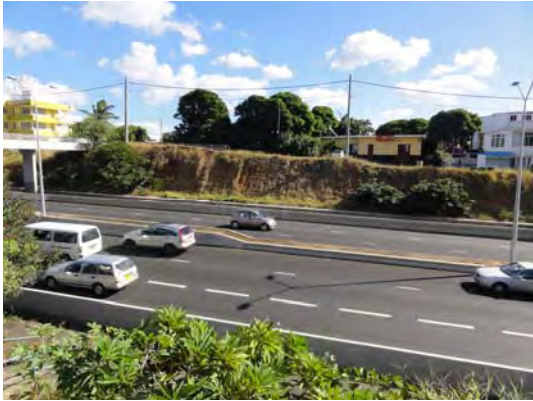
Ph-1 Full view of slope failure

The slope failure has been spotted along the cut-slope (5m height) at the roadside of highway. The surface of the cut-slope has been weathered, and it is eroded by rain.

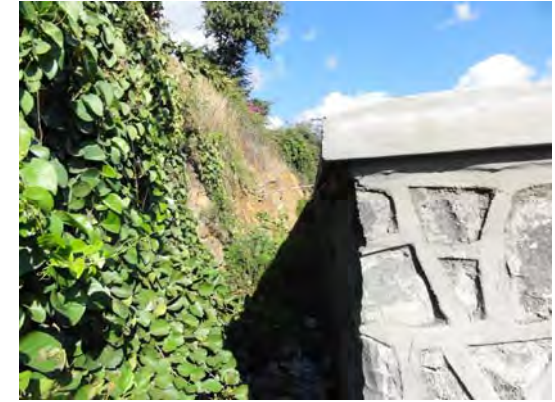
- ①The shallow slope failure has been occurred, and this slope has loose stones. It will be necessary to reconsider the retaining wall.
- ②The shallow slope failure has been occurred.
- ③The shallow slope failure has been occurred in this slope. Because the retaining wall keep back a rock, it is safe.

Ph-6 slope failure and retaining wall

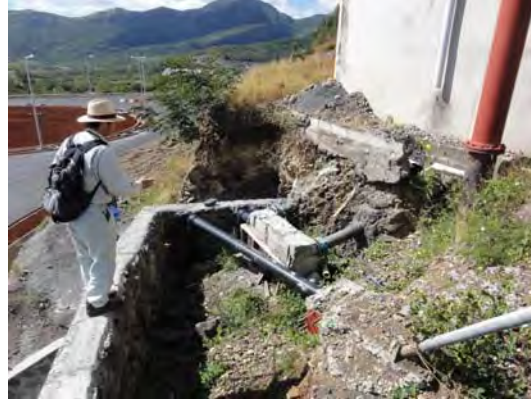
Insufficient drainage is causing erosion at the base of the water tank. Immediate remedial work is needed.

Ph-2 erosion of the groundwork

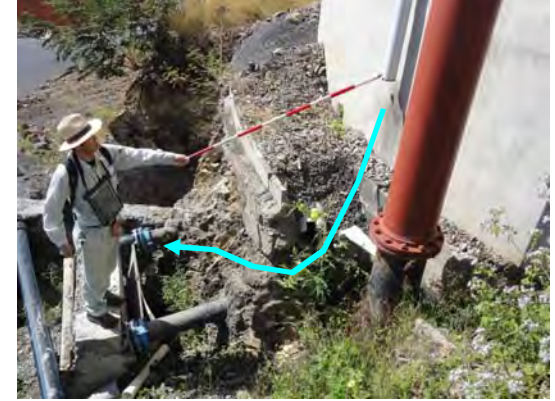
Ph-3 flow of surface water

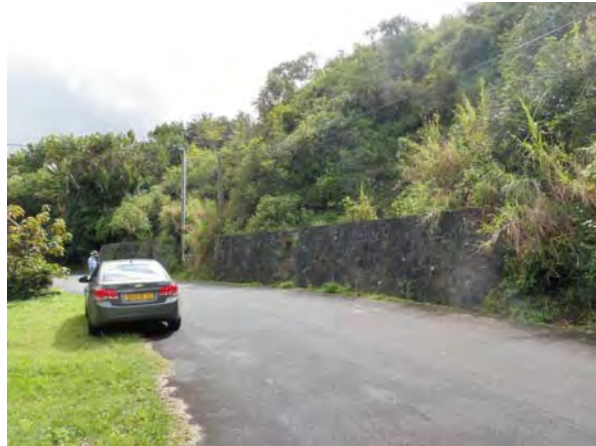
Ph-1 Full view (Retaining wall)

Retaining walls have been constructed as countermeasures where the slope failure has been confirmed. It is currently stable, although there were a few cracks spotted in the retaining walls which are believed to be due to substandard construction.

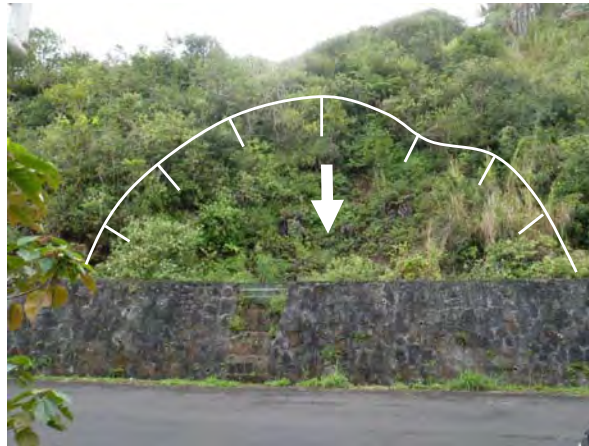
Ph-2 Trace of past slope failure

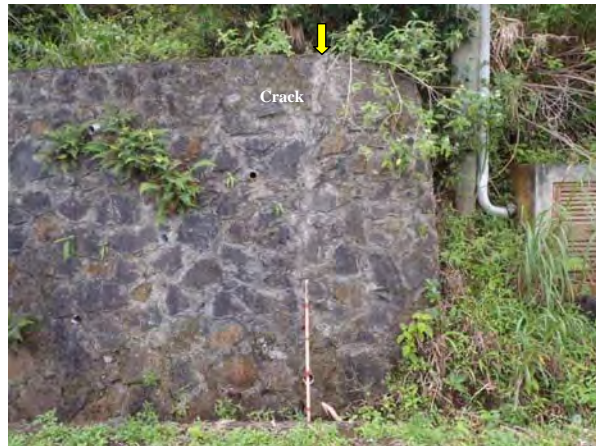
Ph-4 Cracks on retaining wall

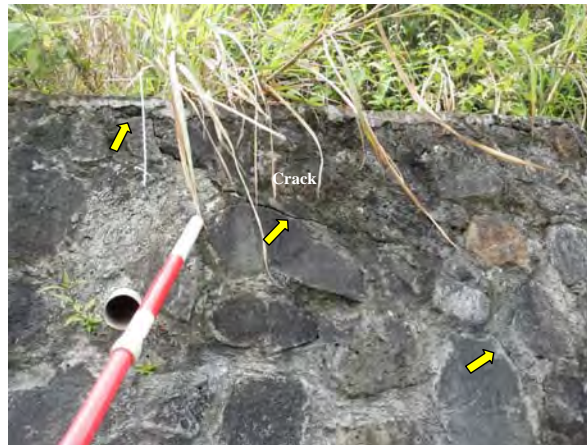
Ph-5 Cracks on retaining wall

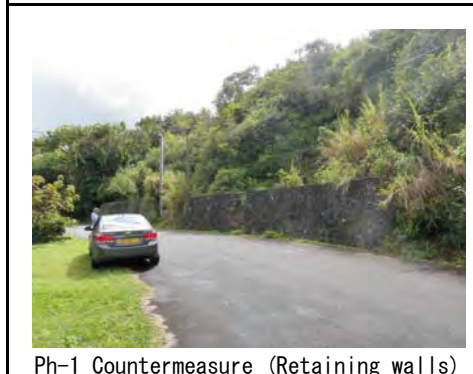
Ph-1 Countermeasure (Retaining walls)

[Description]  
The retaining walls was constructed as countermeasures where the slope failure has been confirmed. It is stable although there were a few cracks spotted within retaining walls which is believed to be the construction failure.  
It is not necessary to take a countermeasure immediately, but should be observed.

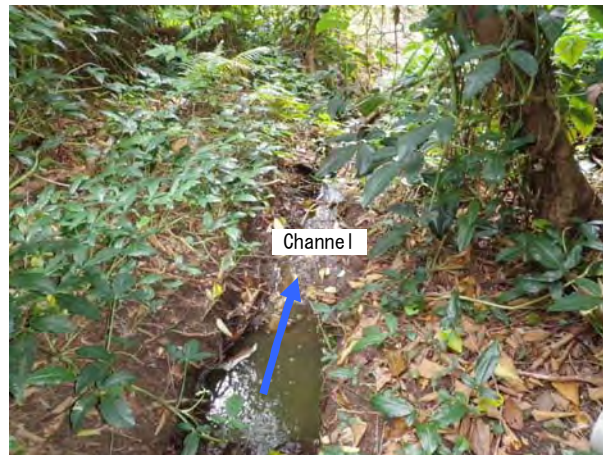
Ph-5 Waterway under slope

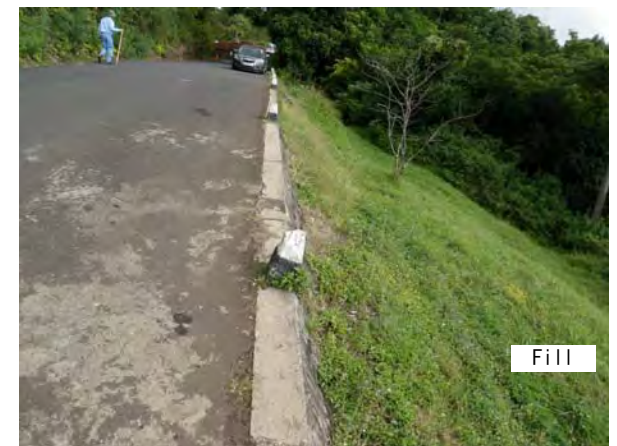
Cracks in the road shoulder have occurred due to a lack of bearing capacity .  
 The crack is located in the vicinity of the boundary of the cutting ground and the fill.  
 The subsidence of the road is 10-15cm.  
 The soil compaction is insufficient.  
 The fill material is soft.

Ph-6 Road constructed with fill

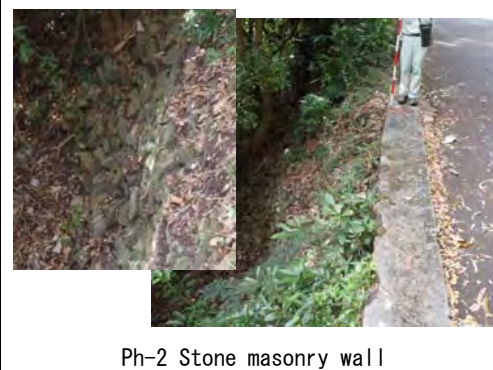
Ph-2 Stone masonry wall

[Description]  
 Deformation of the road has been confirmed at the cliff side of the road due to the lack of bearing capacity. The embankment of stone masonry wall and retaining wall are constructed but it is insufficient. Therefore, the re-construction of the retaining wall and stone masonry wall will be necessary in the near future.

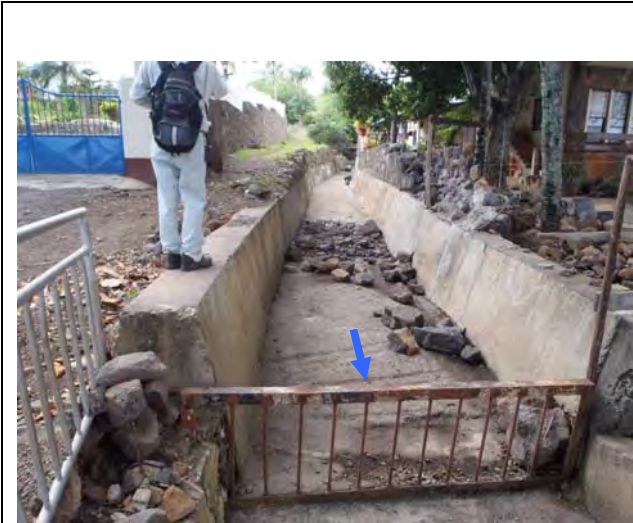
A debris flow has occurred in the past and a block wall has since been constructed. The water level rises considerably in the rainy season, soil and gravel might flow out on the road. Also, small surface failures have been observed frequently in this area.

Ph-1 Full view of the channel works

[Description]  
It is not enough though the valley shore erosion is prevented by channel works.  
There is a possibility that the stream begins to overflow from channel works in the rainy season. It is necessary to extend the upstream side channel works in the future.

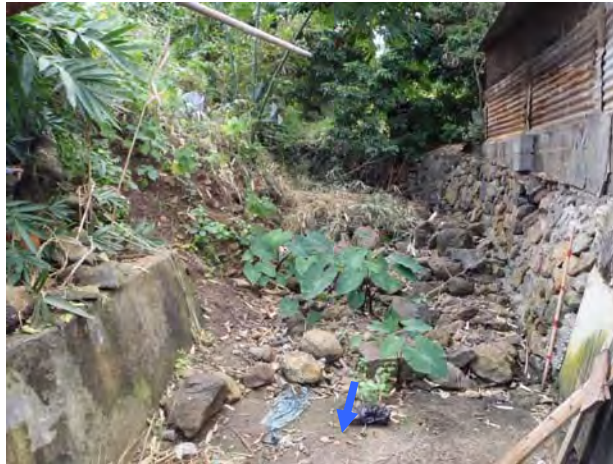
Ph-2 Unstable deposit in channel works

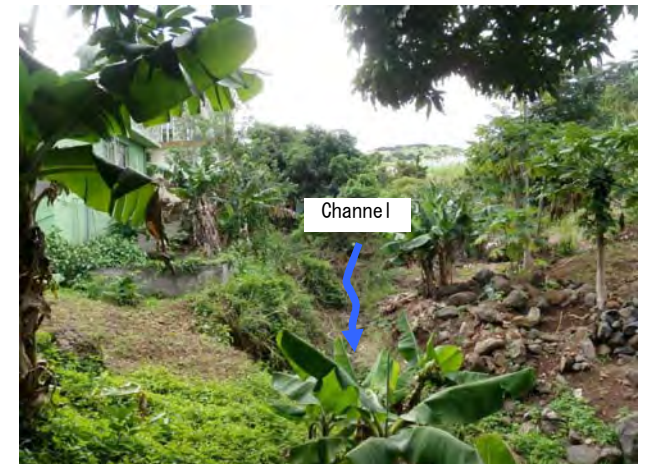
Ph-3 The upstream of channel works

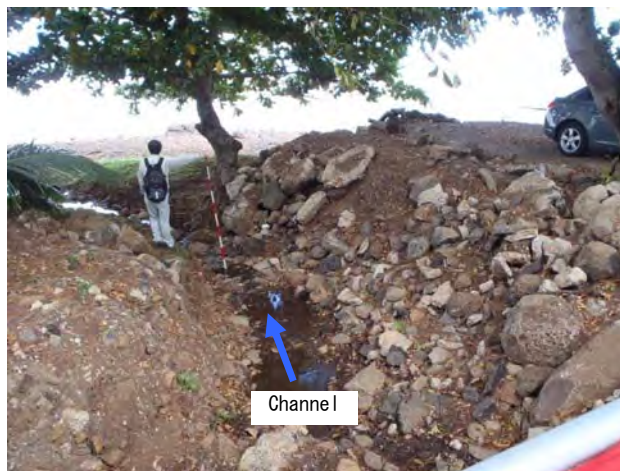
Ph-5 Discharged sediment at the mouth of stream

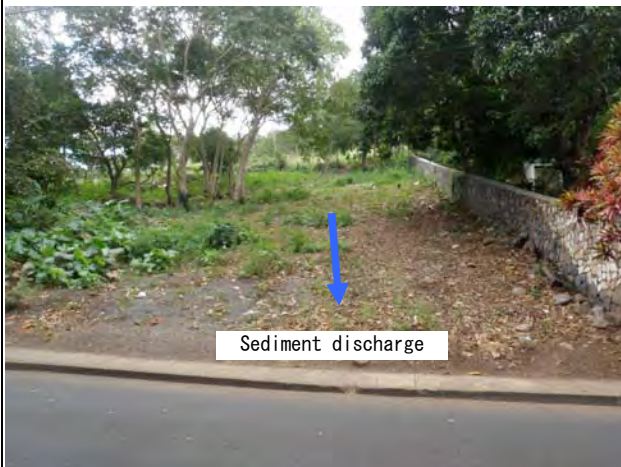
Ph-4 Slope where outflow of gravel and soil are expected

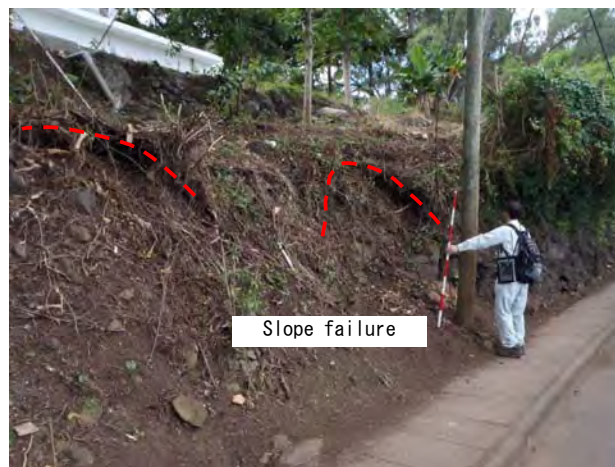
Ph-5 Surface collapse of slope

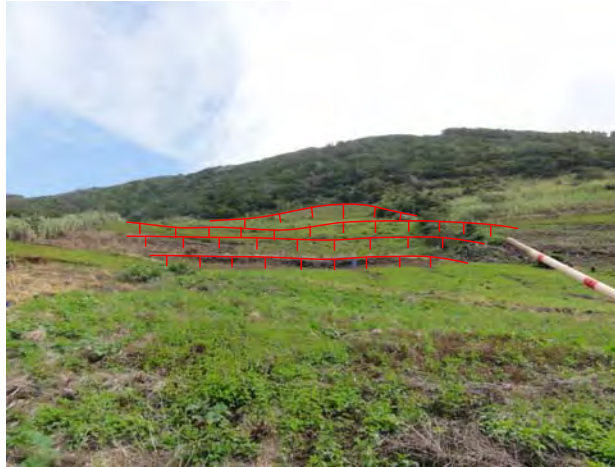
Ph-2 Scarps of the landslide upper part

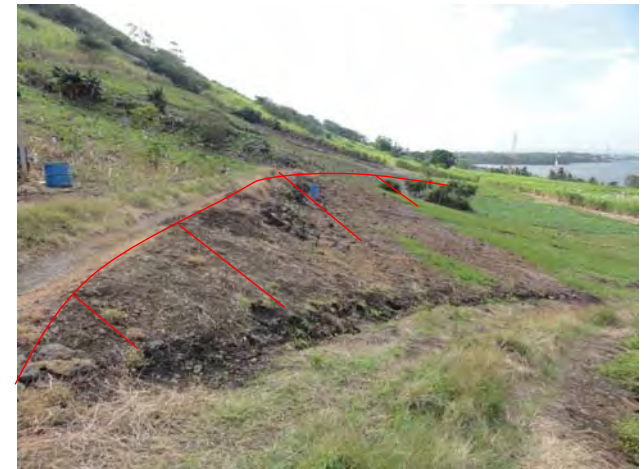
Ph-3 Scarps of the landslide upper part

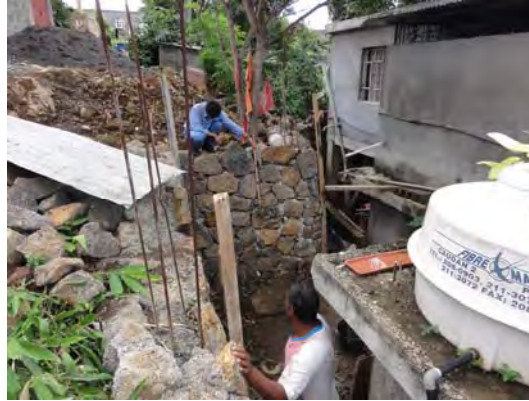
Ph-2 retaining wall

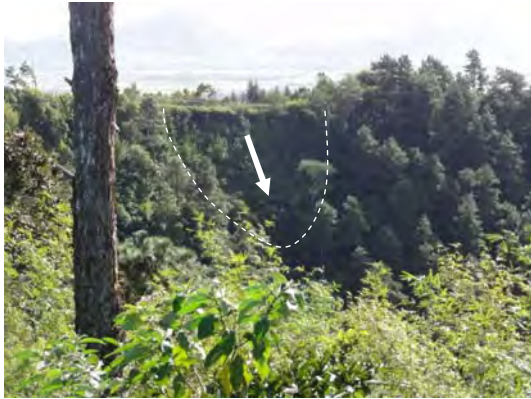
The slope failure in the crater of the volcano occurred during heavy rainfall in 2005.  
 B=35m, L=30m, D=2~3m

Ph-1 Full view of the slope failure

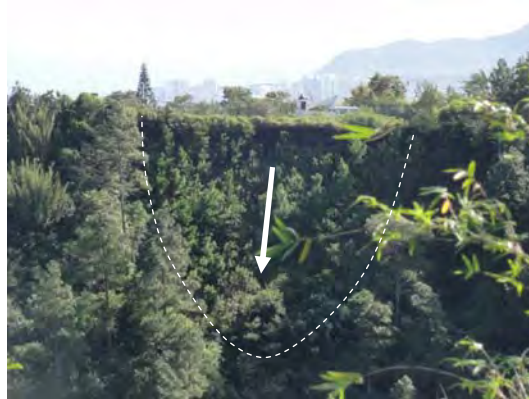
Ph-2 the slope failure  
B=35m, L=30m, D=2~3m

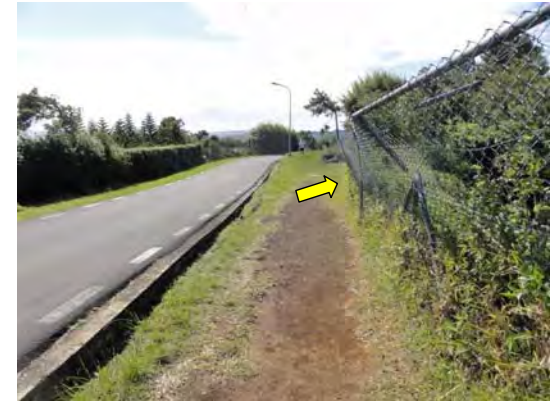
Ph-3 the fence in the back of slope failure  
It is damaged by slope failure

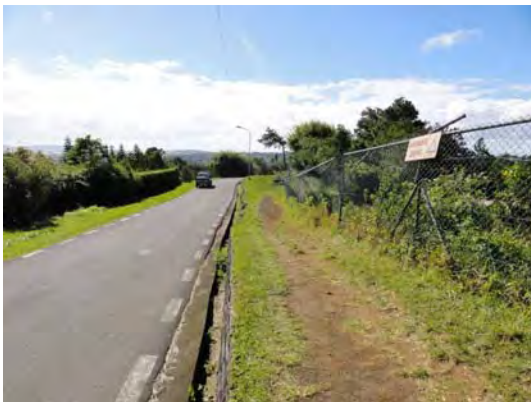
The possibility of slope failure on the rear side is low. However, the slope failure on both sides can be expected.

Ph-4 the back of the slope failure

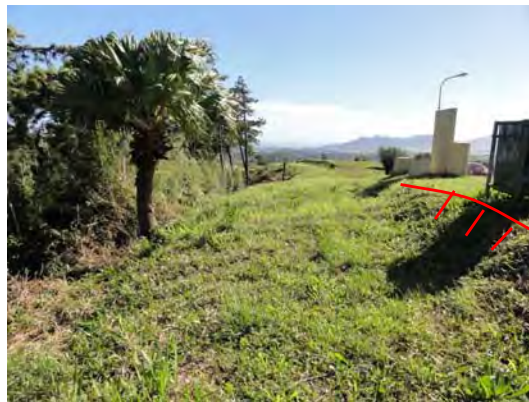
Also, the around area of the slope failure shows some characteristic as follows,  
 (1)Topography with the step continuously  
 (2)Some small slope failure

Ph-5 the around of the slope failure  
Topography with the Step continuously

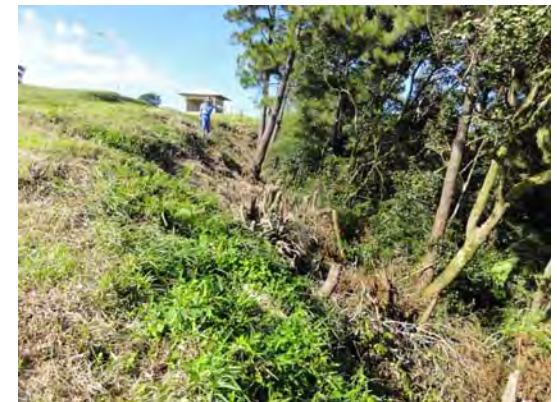
Ph-6 the around of the slope failure  
small slope failure

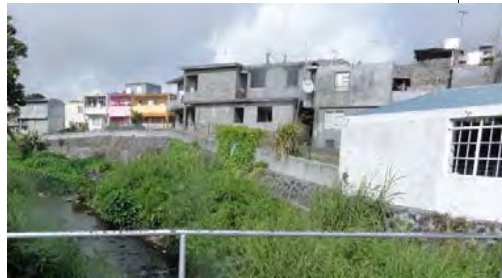
Stone masonry retaining wall (left bank)

[Description]  
The past damage is restored now.  
It is not necessary to carry out the countermeasures.

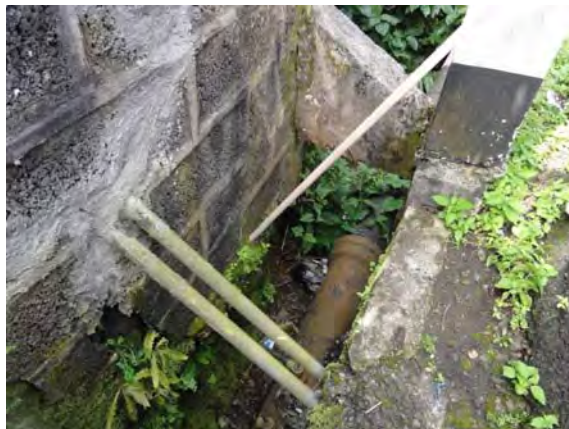
Ph-4 Eroded area  
The eroded depth is 50cm

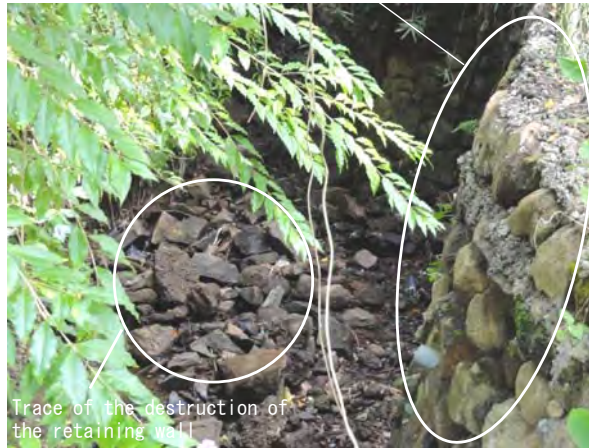
Ph-2 Trace of the destruction and the retaining wall

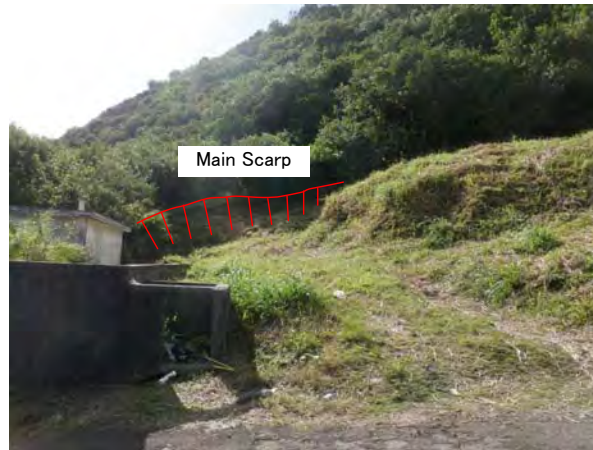
Ph-2 Collapse site

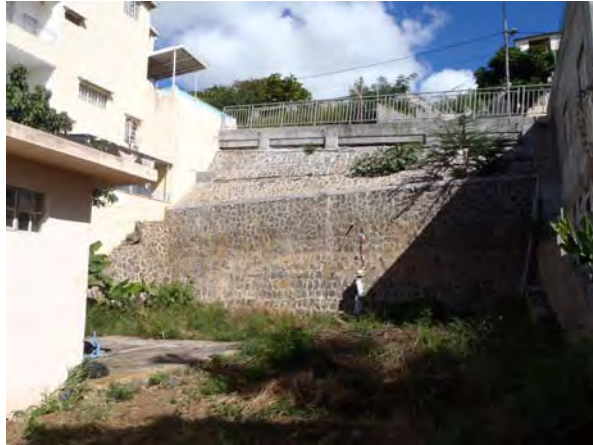
At this slope, slope failure occurred in 2010, and a road was destroyed. After a retaining wall was made as a countermeasure, large-scale slope failures have not been found. However, the stone blocks from on top of the retaining wall have fallen down. This is likely caused by the ground behind the retaining wall sinking due to lack of compaction of the backfilling soil. It is necessary to investigate it in detail.

Ph-1 Full view (Retaining wall)

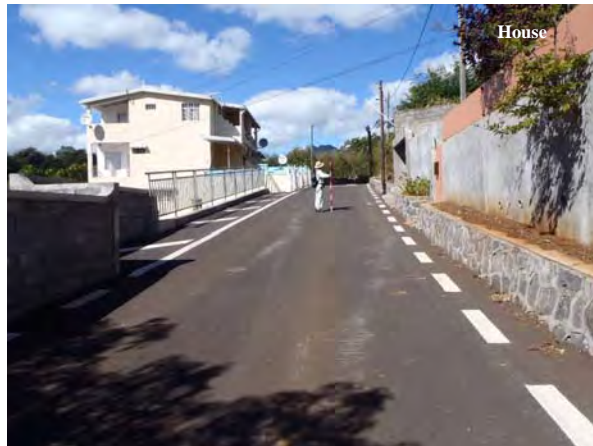
Ph-4 Full view (upper end of retaining wall)

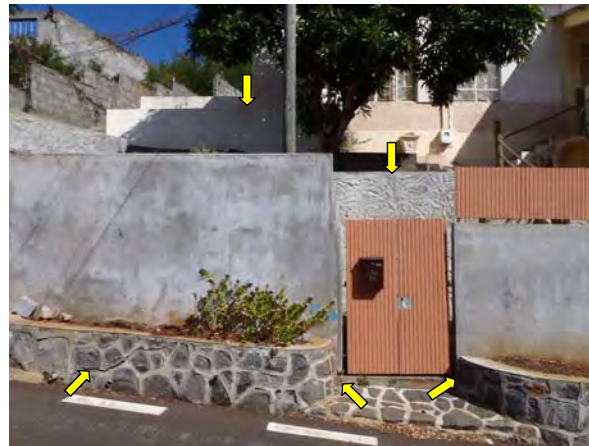
Ph-5 Damage on house

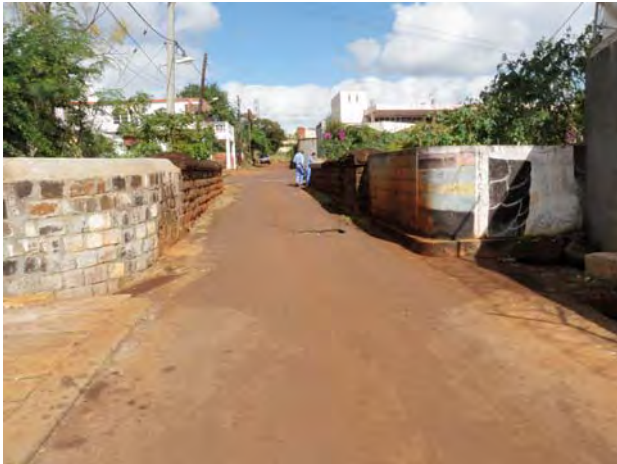
Ph-1 Full view of the bridge

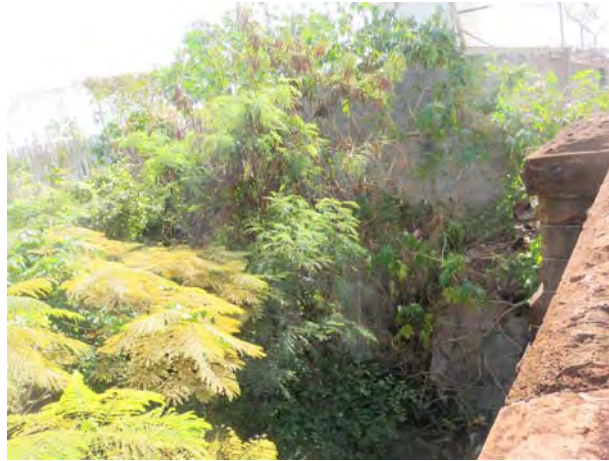
Ph-2 Bank erosion around bridge abutment

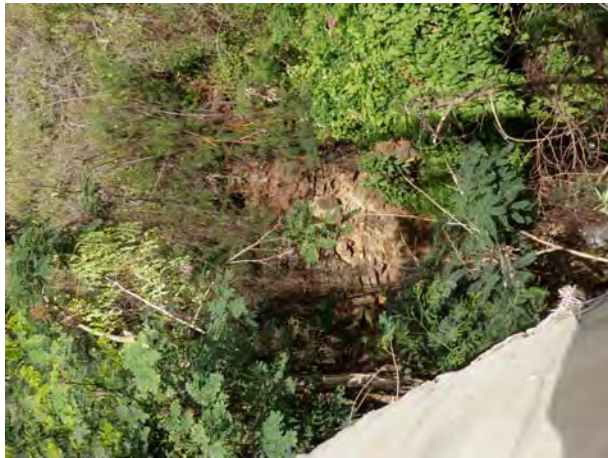
Ph-4 bank erosion
