## 8. Result of Aerial Photograph Interpretation

## Regular Check Sheet

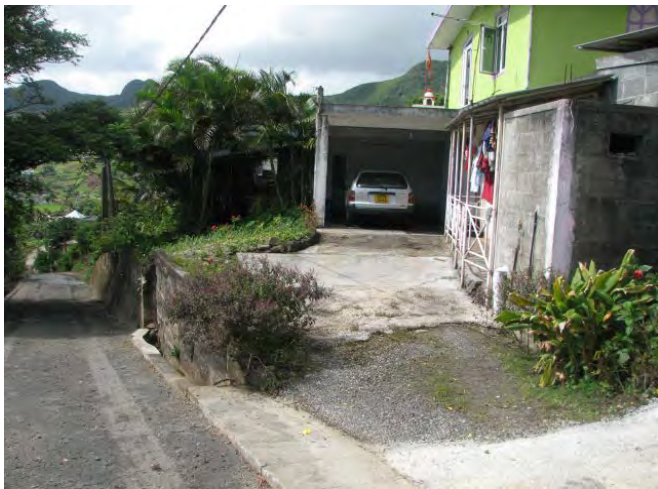
Full view of concrete block wall

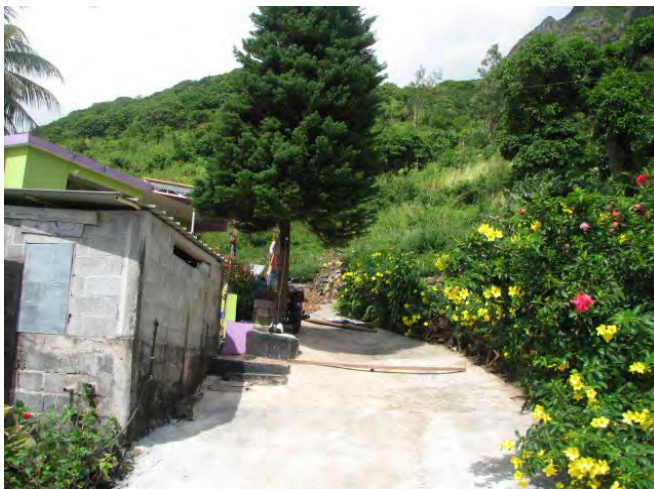
The course that the surface water flows through

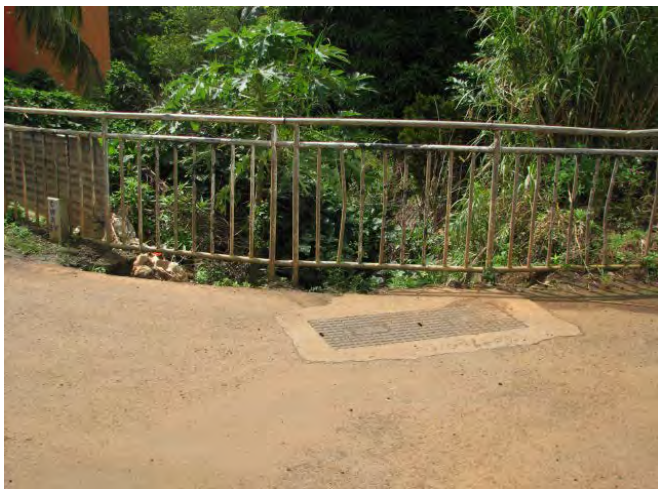
Full view of down stream

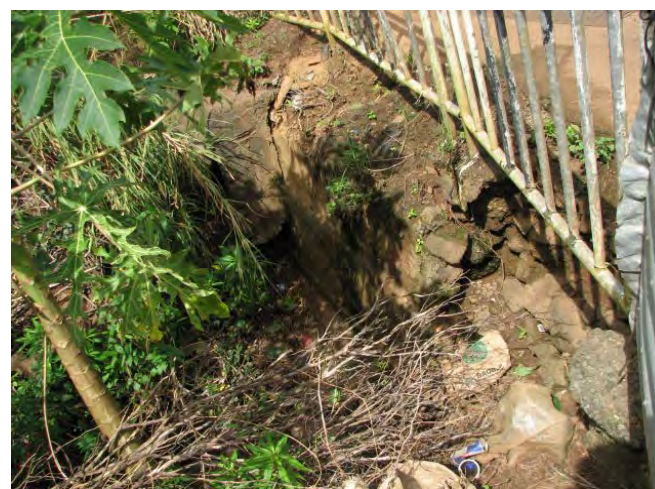
Outlet of downstream

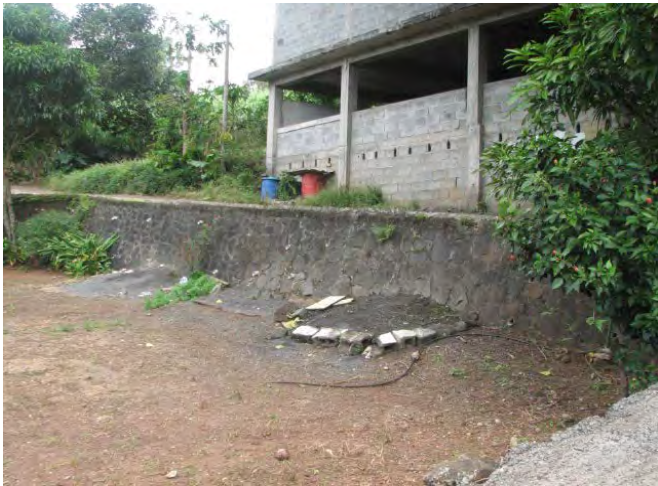
Full view of the retaining wall

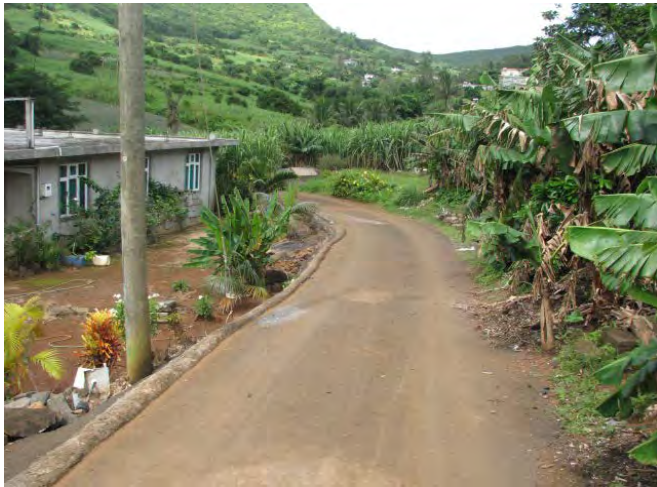
Full view of damage of retaining wall

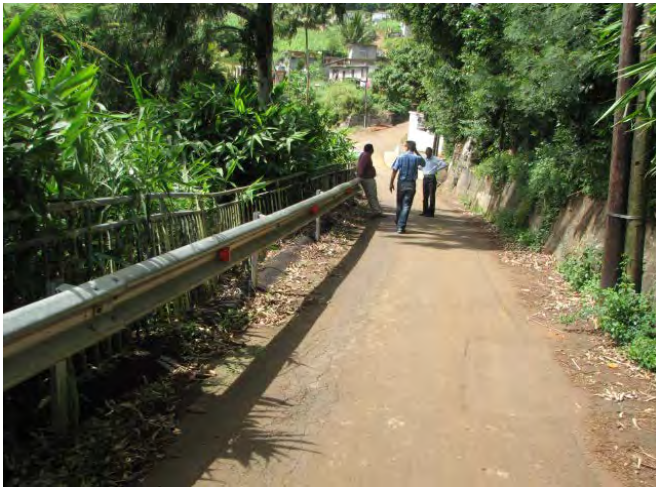
Full view of the road

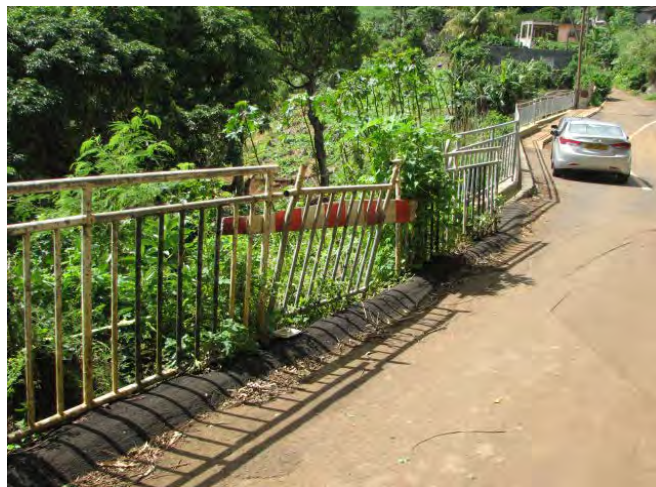
Repaired road of another site

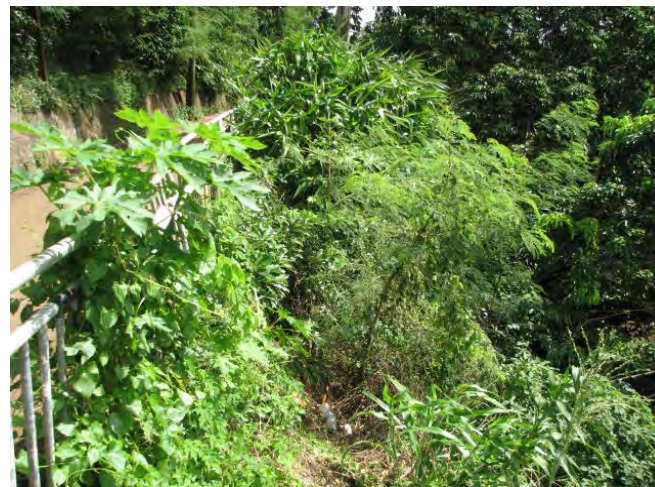
Cross section of the slope failure

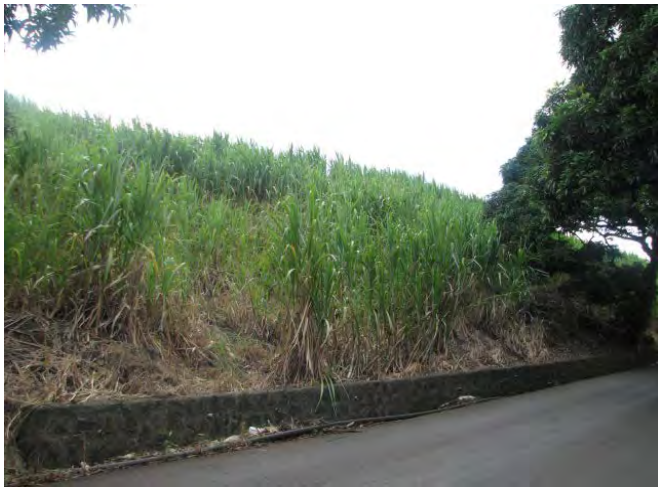
Full view of the slope

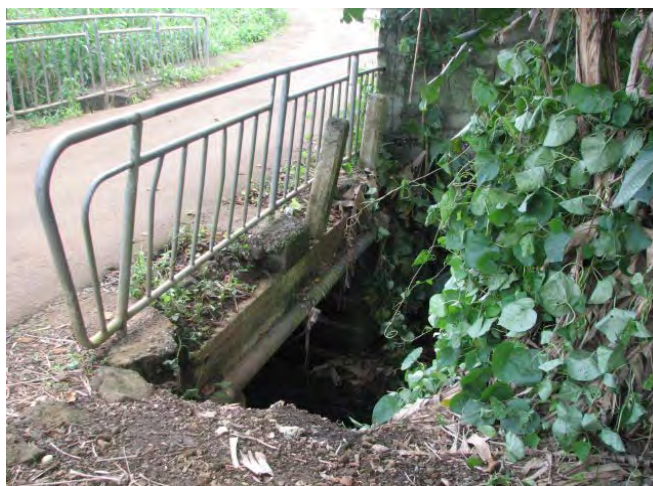
Eroded area at the upper side

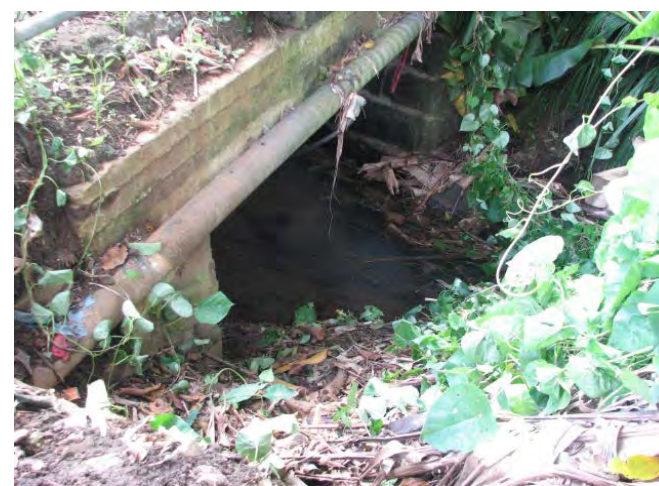
Inlet of box culvert

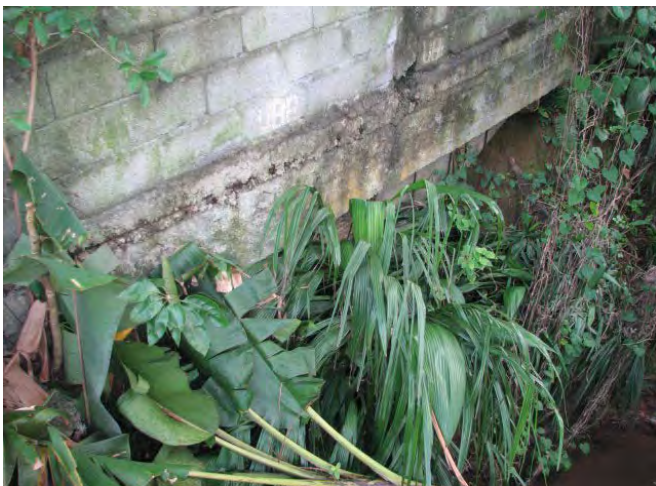
Outlet of box culvert

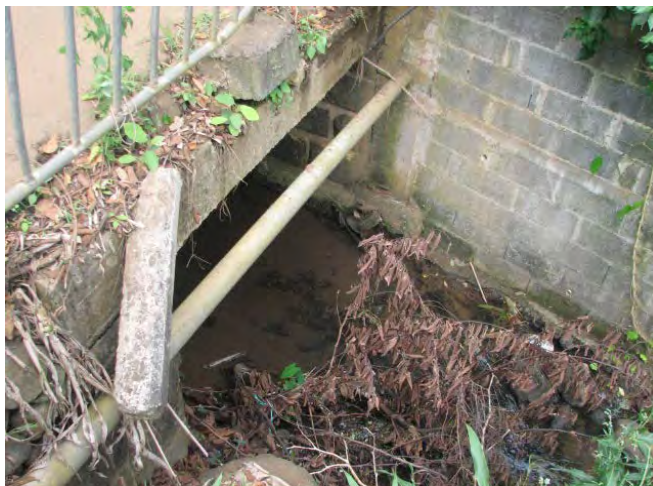
Outlet of box culvert

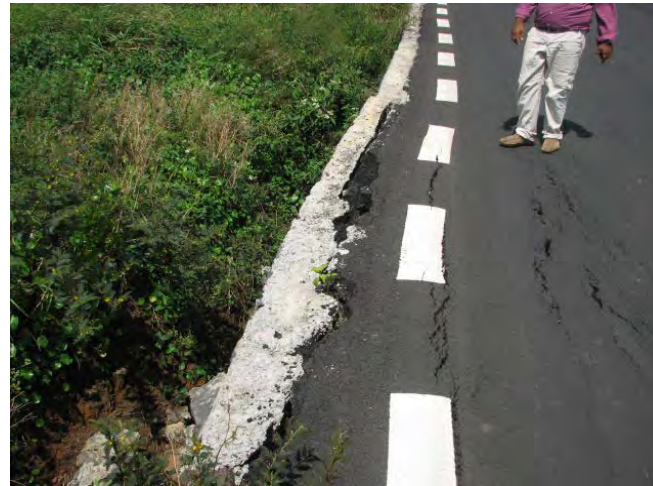
Deformation by erosion of foundation

Proposed action	Concrete ditched should be constructed along the road					
Purpose of action	to prevent further erosion of the road foundation.

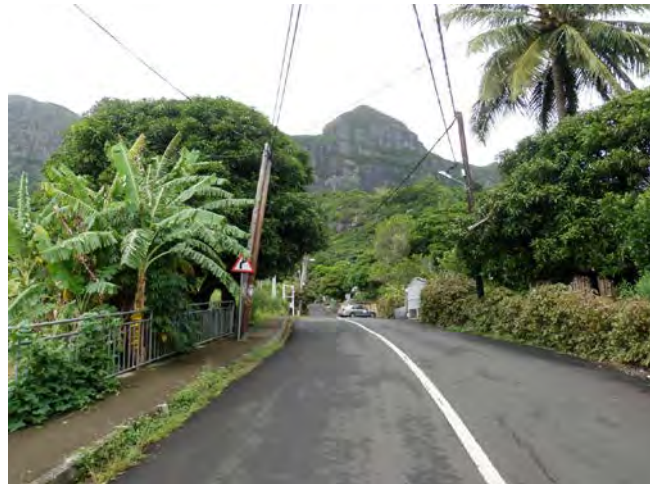
Incline of the telephone pole

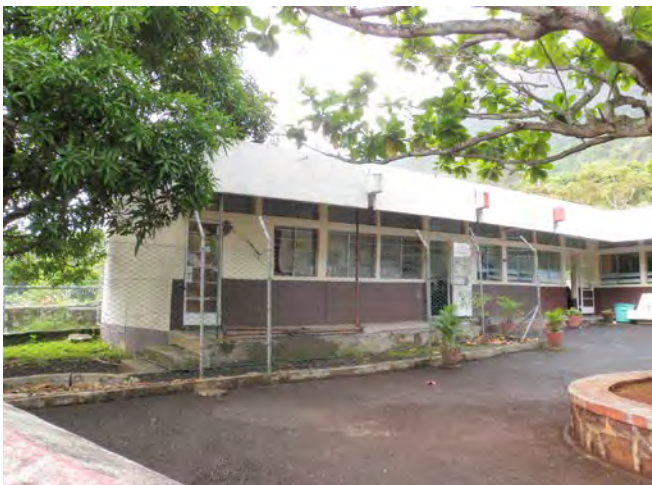
Heavy damage at school

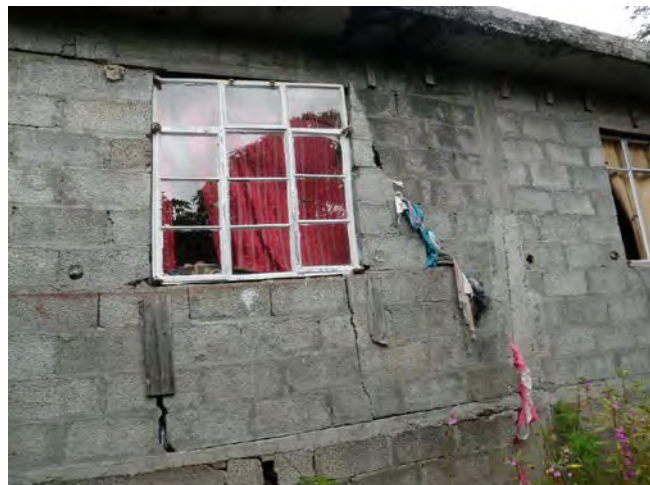
Heavy damage at houses

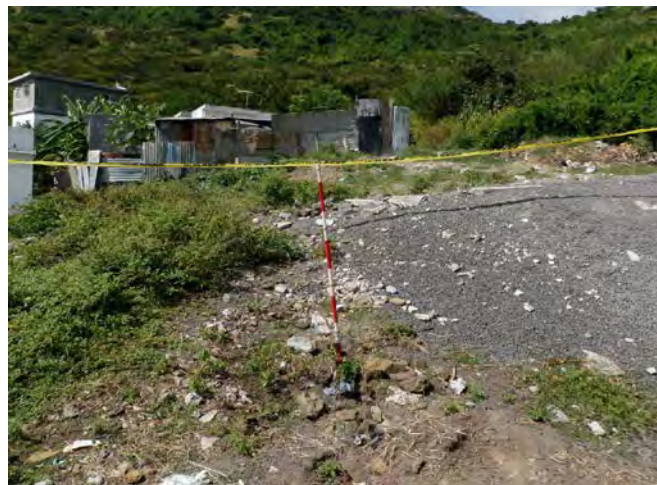
New cracks observed behind the house

Proposed action	Until the completion of countermeasures, monitoring and early warning system should be continuously implemented.						
Purpose of action

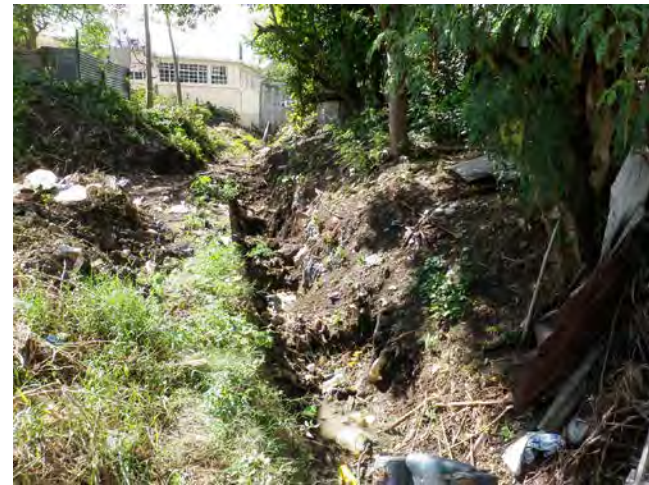
Toe of the landslide

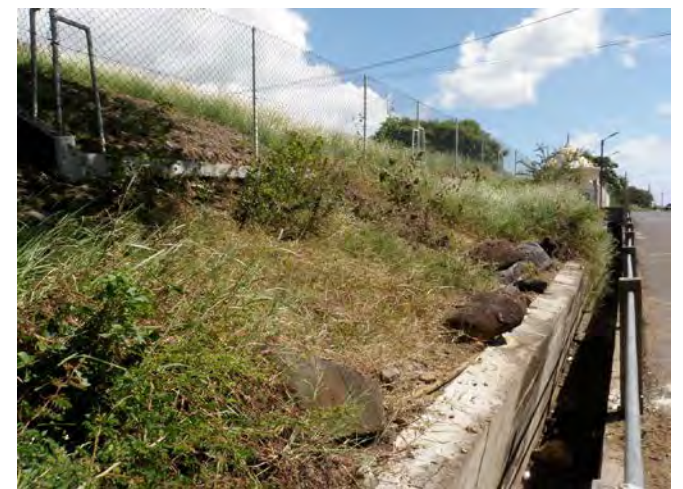
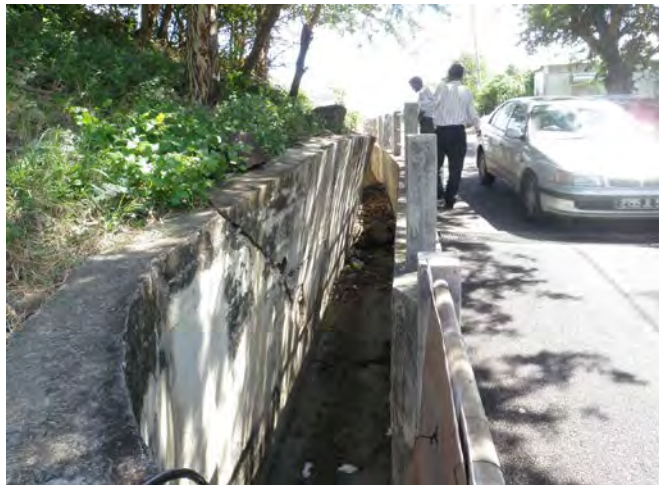
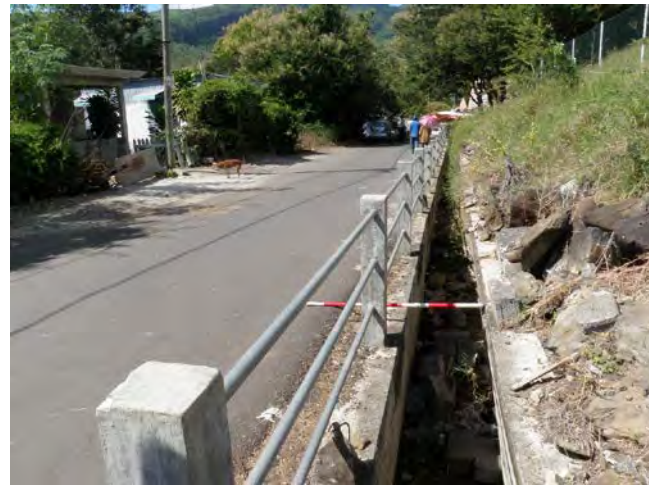
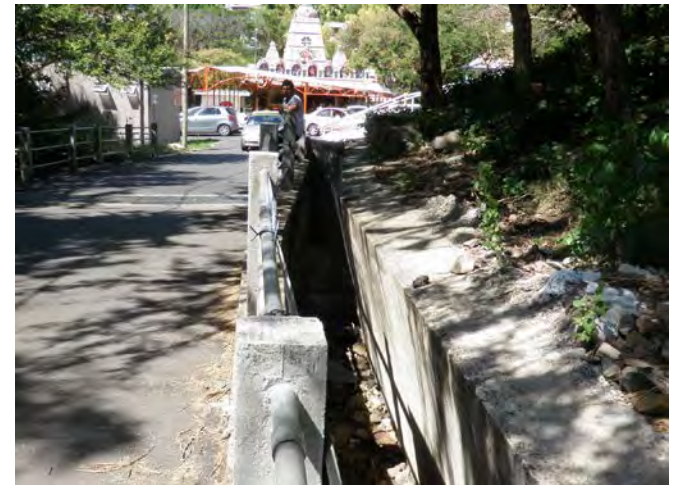
Inclined the retaining wall

Proposed action	Artificial structures (drainage, culvert, etc.) should be constructed in the future. The fill removal in the back of the ditch is also effective. It is preferable to construct the					
Purpose of action	To prevent overflow To reduce the earth load of the retaining wall

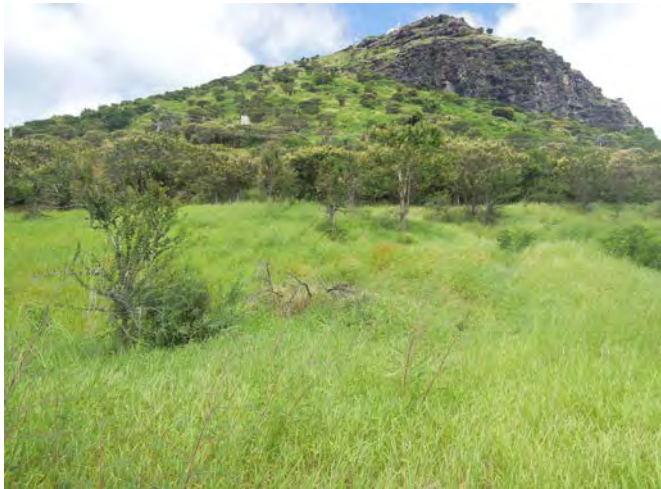
Upper slope of the landslide area.  
No notable cracks and displacement

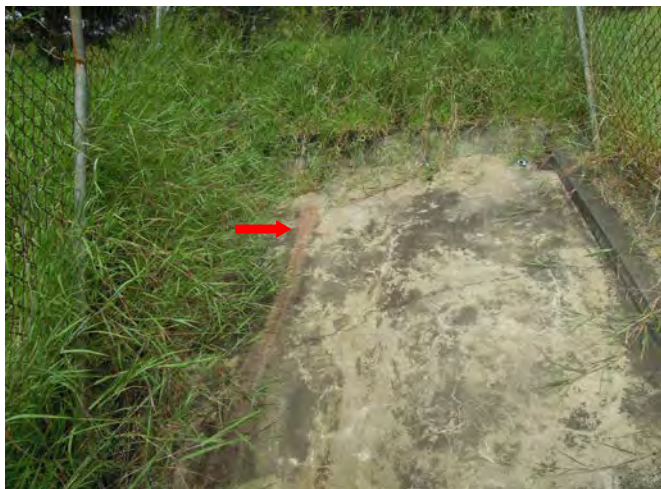
Horizontal drilling.  
The brown trace of water-flow was identified (red arrow)

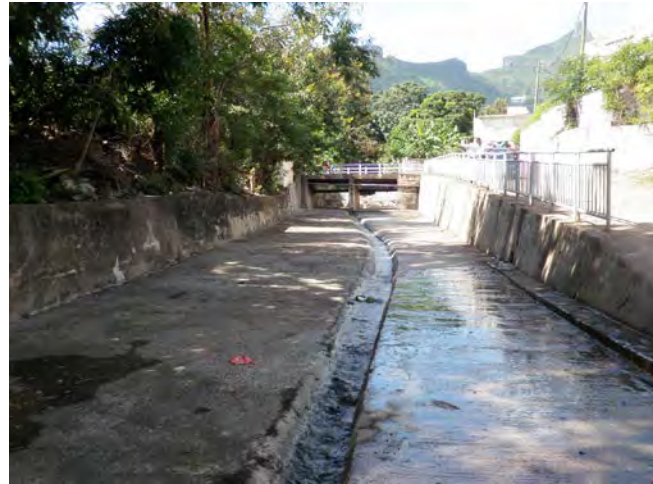
Full view of the channel (Upstream)

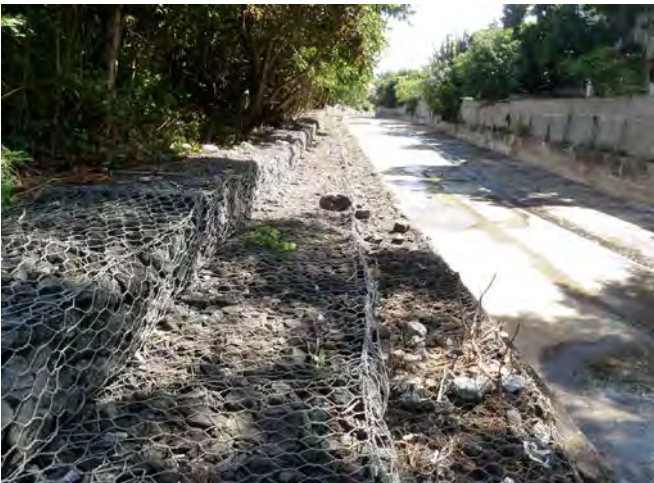
Management number	0101010101014	Disaster	Stream erosion	Area name	Pouce Stream	
Date	April 30, 2013					
Reporter's name	Yoji KASAHARA					
Landslide /Slope failure	New failure					
	Swell slope					
	New/enlarged step/cliff					
	New/enlarged crack on slope					
Rockfall	New rockfall					
	Enlarged crack on rock slope					
	Erosion of unstable rock					
Debris flow	Filling up of debris sediment					
	Overflow of debris on road					
	Clogged culvert					
	New failure on river slope					
Spring water	Depleted/decreased spring water					
	Increased spring water					
	New spring water					
	Turbid spring water					
House/road	New/enlarged step/settlement					
	New/enlarged crack					
Counter-measure	Damage/deformation					
	Clogged drainage					
	Overflowed drainage					
Other problem						
Condition	Damage is confirmed to the gabion. However, the function of the erosion prevention is secured.					
Proposed action

Some gabions have been damaged a little.

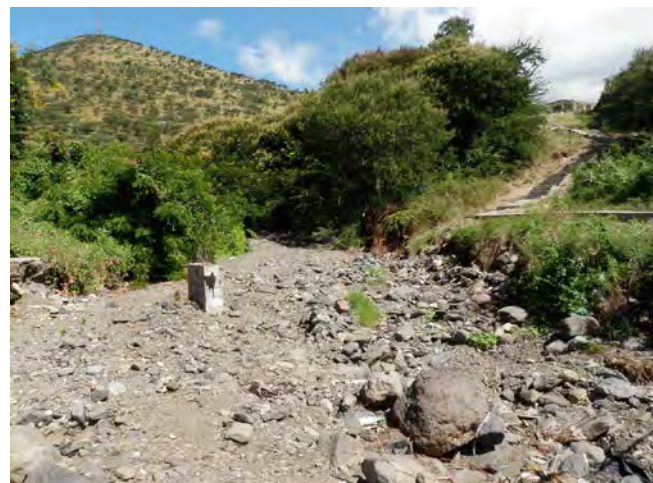
Debris flow occurred after the heavy rain.

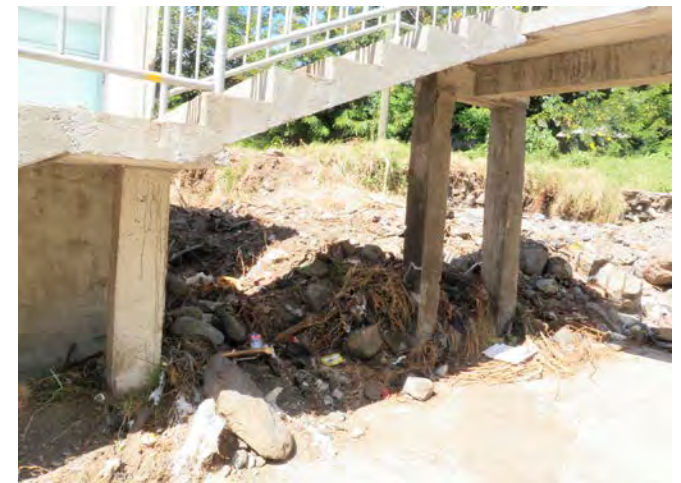
Deposited sand by debris flow

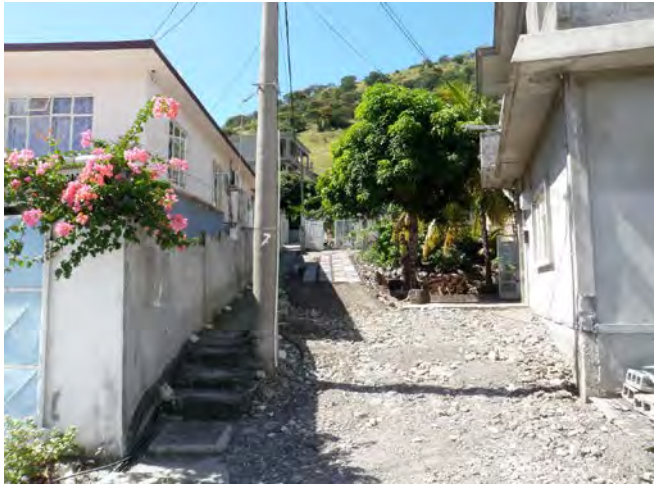
Management number	01010101010115	Disaster	Landslide	Area name	Old Moka Road, Camp Chapelon		
Date	April 29, 2013						
Reporter's name	Yoji KASAHARA						
Landslide /Slope failure	New failure						
	Swell slope						
	New/enlarged step/cliff						
	New/enlarged crack on slope						
Rockfall	New rockfall						
	Enlarged crack on rock slope						
	Erosion of unstable rock						
Debris flow	Filling up of debris sediment						
	Overflow of debris on road						
	Clogged culvert						
	New failure on river slope						
Spring water	Depleted/decreased spring water	decreased of spring water					
	Increased spring water						
	New spring water						
	Turbid spring water						
House/road	New/enlarged step/settlement						
	New/enlarged crack						
Counter-measure	Damage/deformation						
	Clogged drainage						
	Overflowed drainage						
Other problem							
Condition	No significant progress. However, the groundwater level is high in this area. Pushing the ditch out and cracks of house are confirmed.

Full view of the slope from road

Proposed action	Artificial structures (drainage, horizontal drainage, etc.) should be constructed on the house						
Purpose of action	To decrease the water level and prevent the deformation

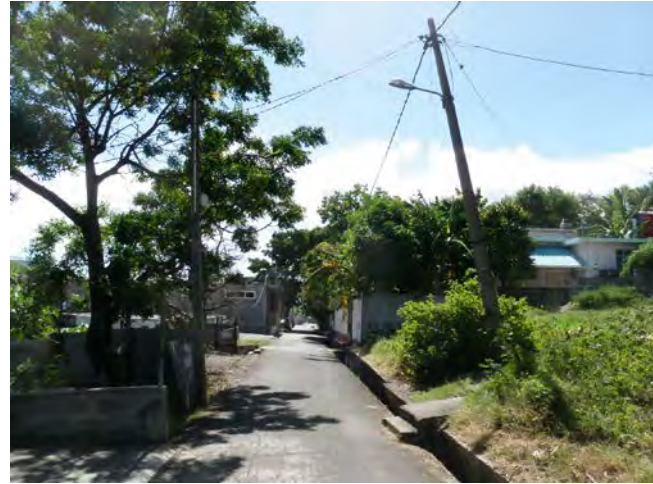
Incline of a telephone pole

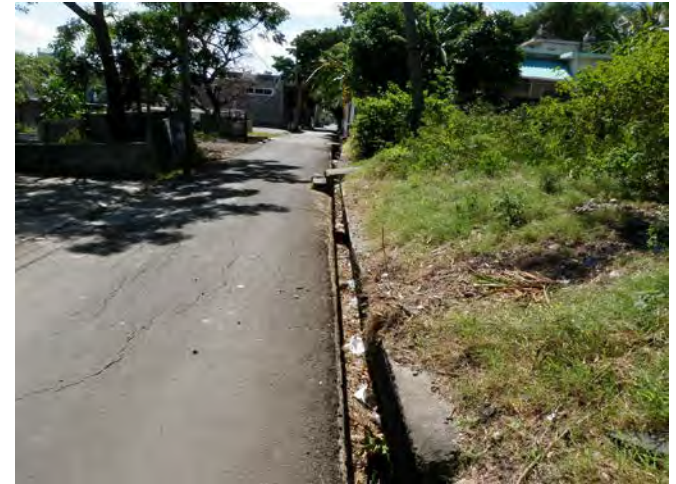
Retaining wall incline (Pushing of back out)

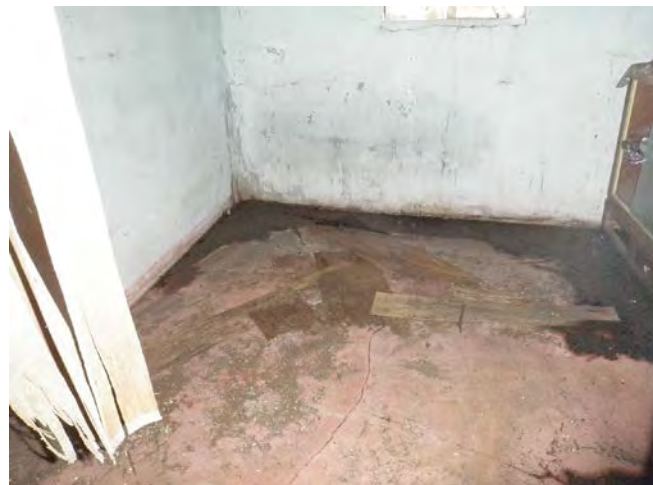
Spring water in corner of basement

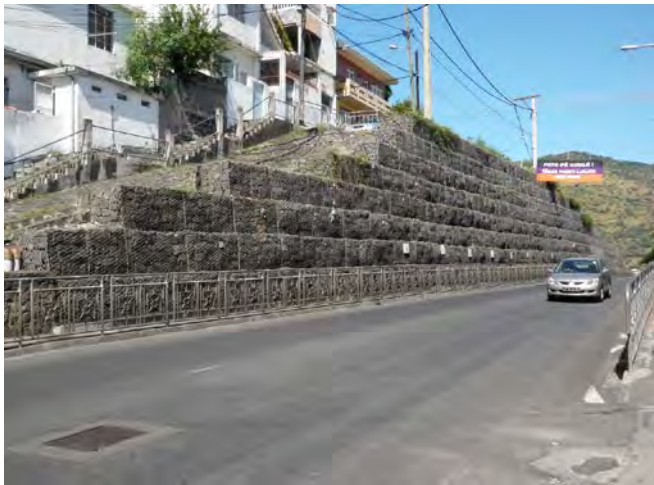
Full view of Gabion wall (East side)

Management number	010101010116	Disaster	Damage of wall	Area name	Boulevard Victria, Montague Coupe	
Date	April 30, 2013					
Reporter's name	Yoji KASAHARA					
Landslide /Slope failure	New failure					
	Swell slope					
	New/enlarged step/cliff					
	New/enlarged crack on slope					
Rockfall	New rockfall					
	Enlarged crack on rock slope					
	Erosion of unstable rock					
Debris flow	Filling up of debris sediment					
	Overflow of debris on road					
	Clogged culvert					
	New failure on river slope					
Spring water	Depleted/decreased spring water					
	Increased spring water					
	New spring water					
	Turbid spring water					
House/road	New/enlarged step/settlement					
	New/enlarged crack					
Counter-measure	Damage/deformation					
	Clogged drainage					
	Overflowed drainage					
Other problem						
Condition	No significant progress. However, the gabion has become unstable recently.					
Proposed action	It will be necessary to reinforce the gabion in the future. The fill removal in the back of the gabion is also effective.

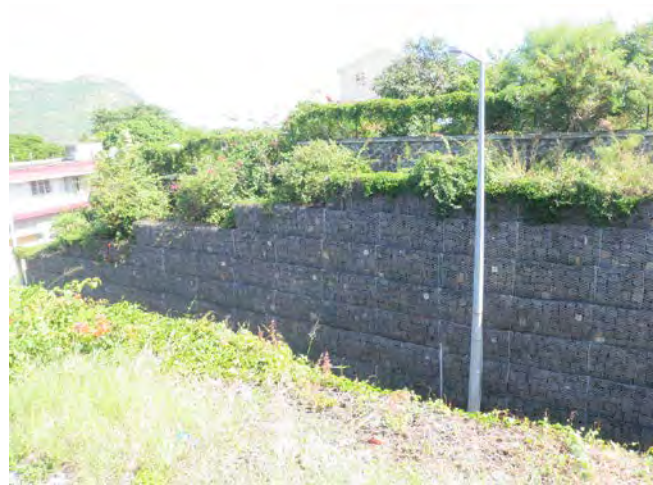
Full view of Gabion wall (West side)

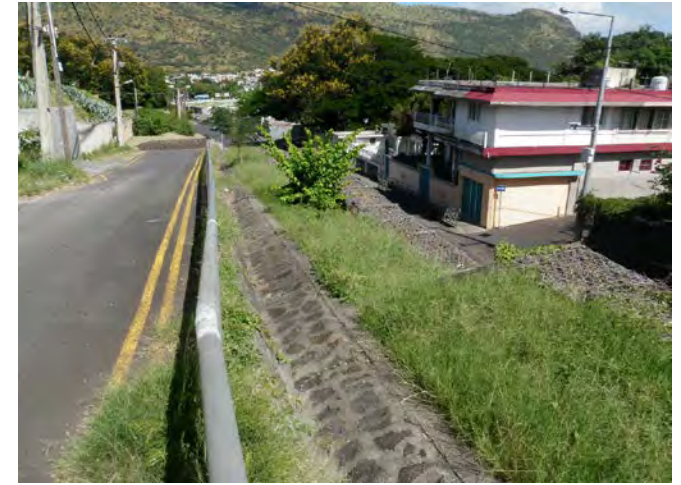
The upper part and the rear of the Gabion wall (East side)

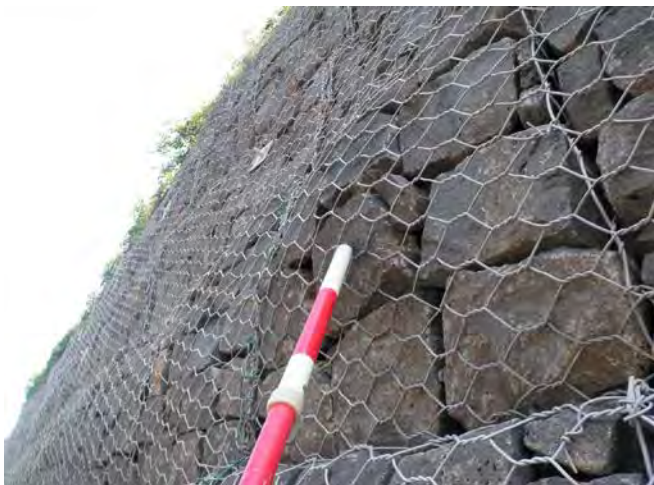
Pushing out is confirmed a little.

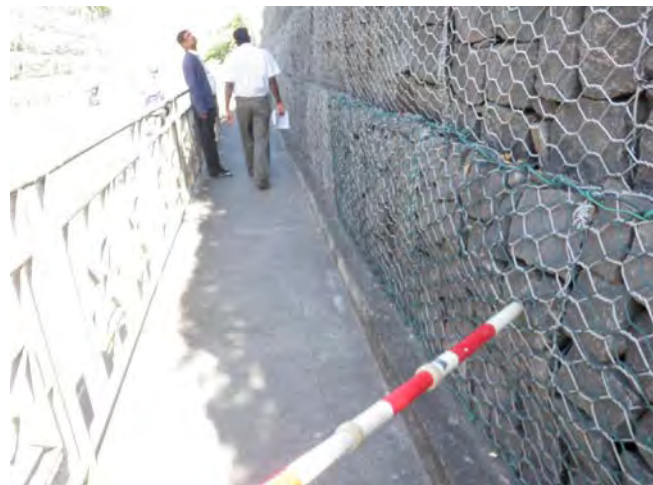
Gabion reinforced with rust prevention wire net

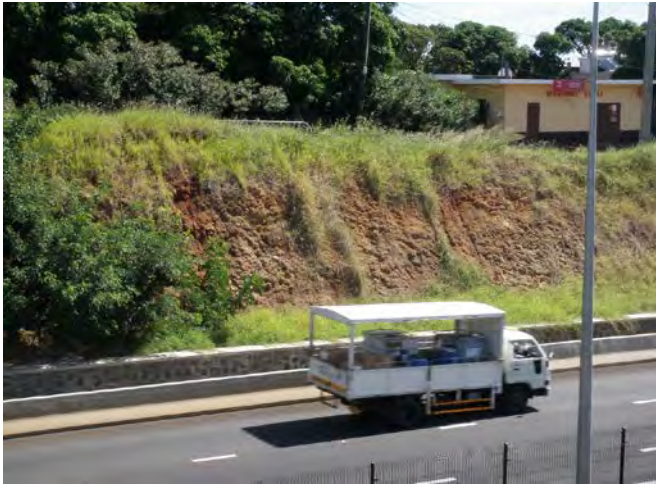
Other problem							
Condition	The slope around the bridge has small collapsed and sediment discharge was confirmed in the ditch.						
Proposed action	Artificial structures (drainage, ditch, etc.) should be constructed on the slope. It is necessary to green the slope .						
Purpose of action	To prevent further erosion of the slope.

Full view of the slope failure

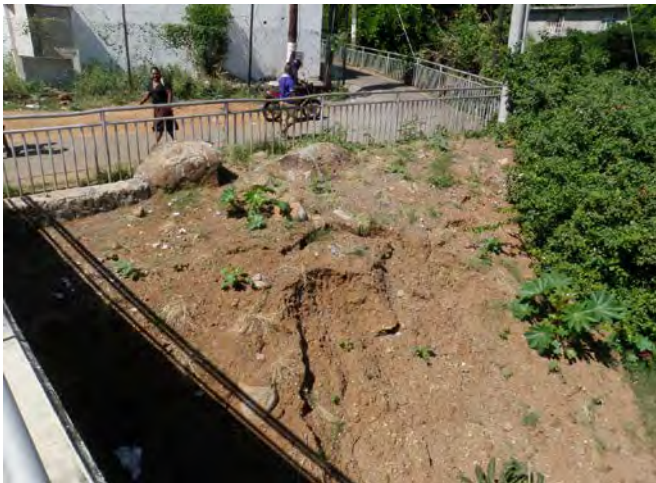
Full view of the slope failure( New failure)

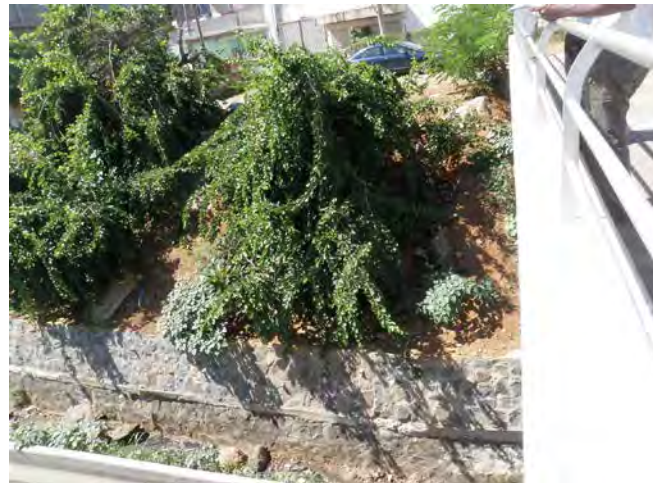
Falling rocks from the slope

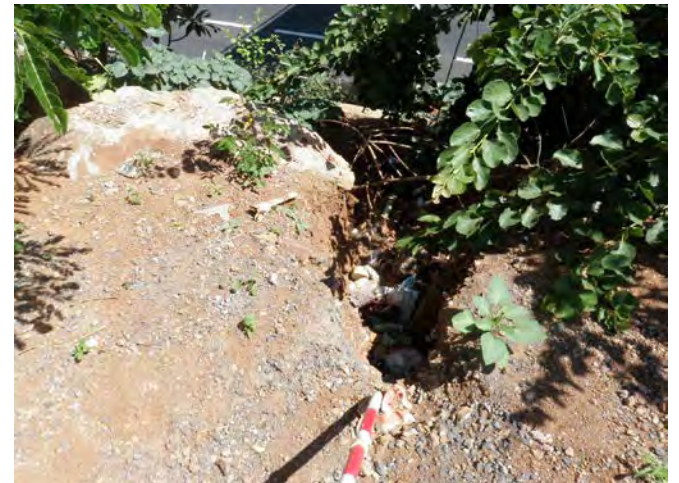
Top of trace of erosion

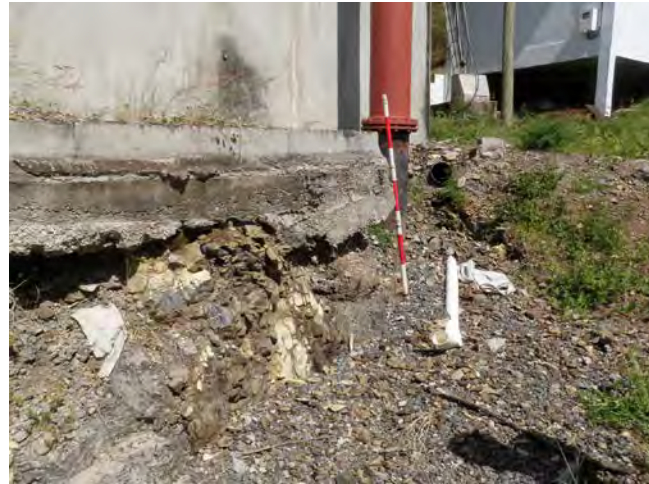
Erosion of the tank foundation

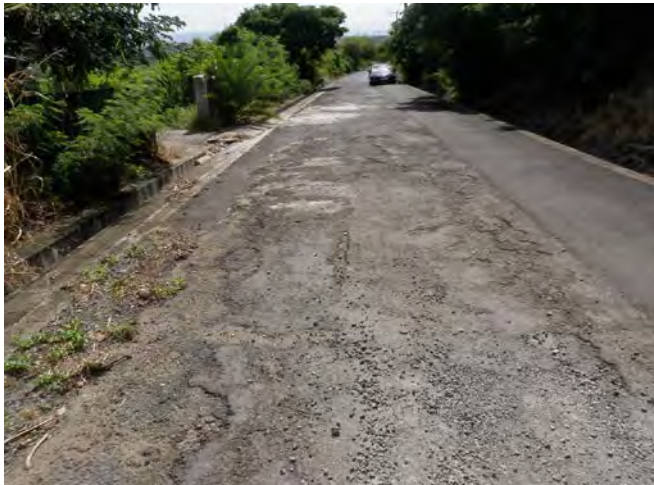
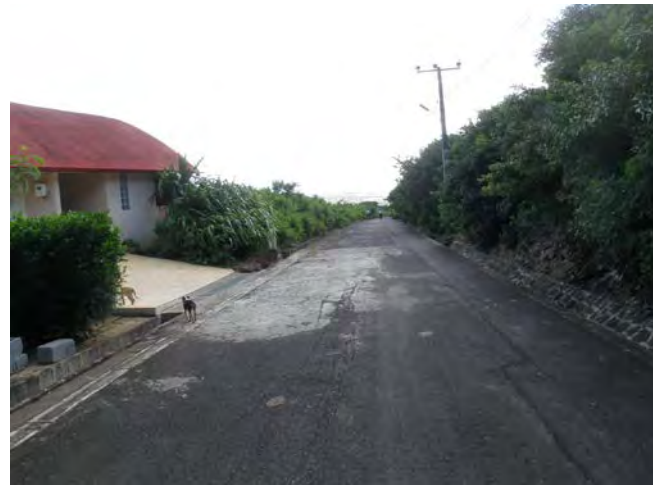
Condition	A lot of damages of the ditch are confirmed. The rockfall and the small collapse are confirmed.						
Proposed action	It is necessary to repair the ditch. In the future rockfall countermeasures should be constructed along the road.						
Purpose of action	To prevent rockfall and slope failure.

Cracks on the road

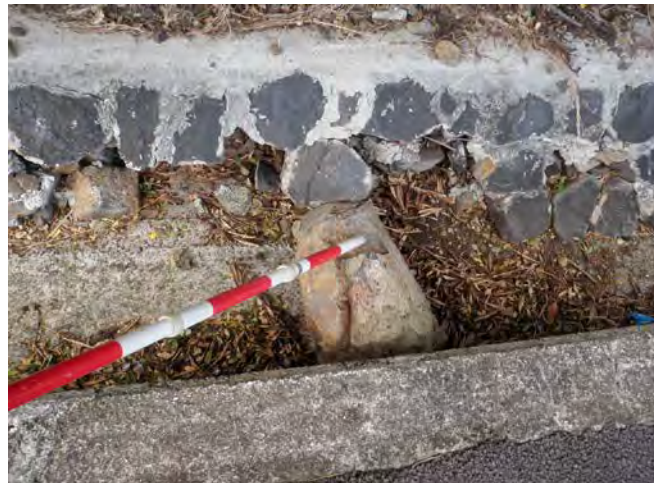
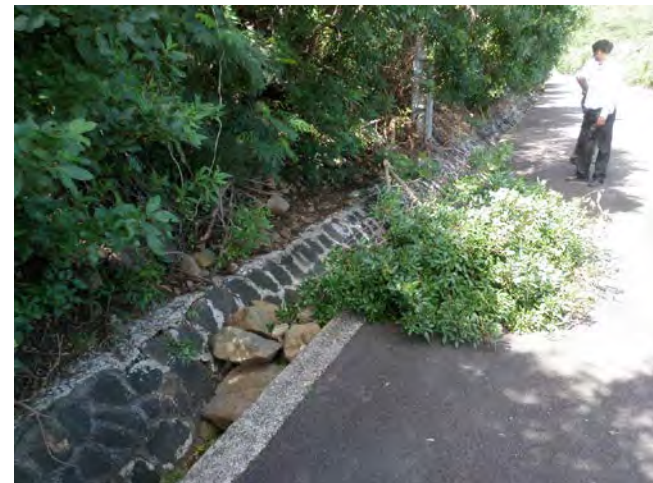
Rockfall from the mountain

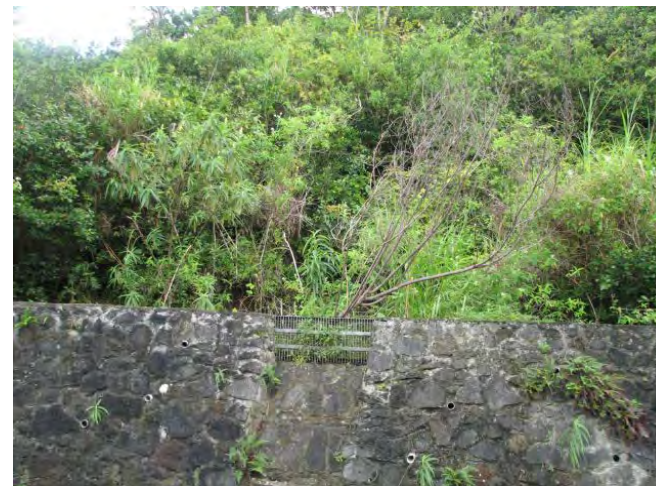
Trace of past slope failure

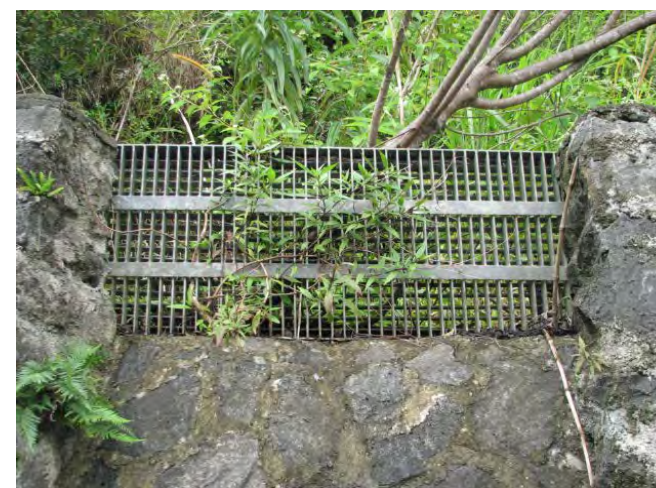
Outlet of surface water on the slope

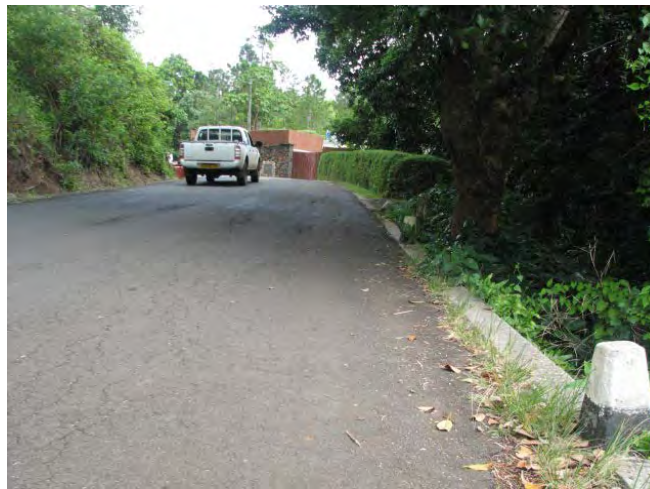
Crack on the road side

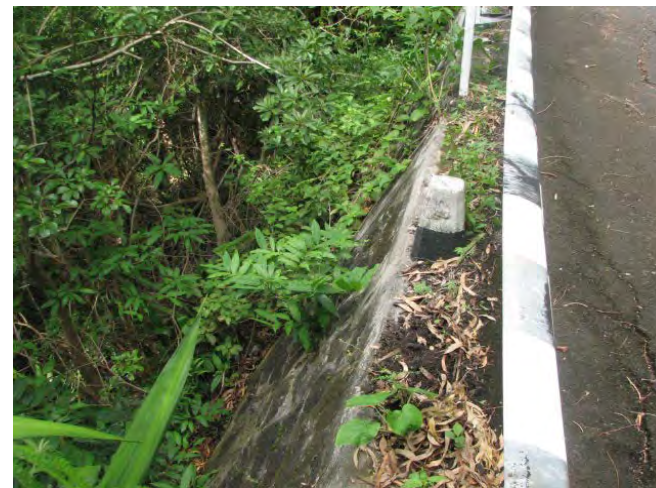
Retaining wall of the road along A-A' line

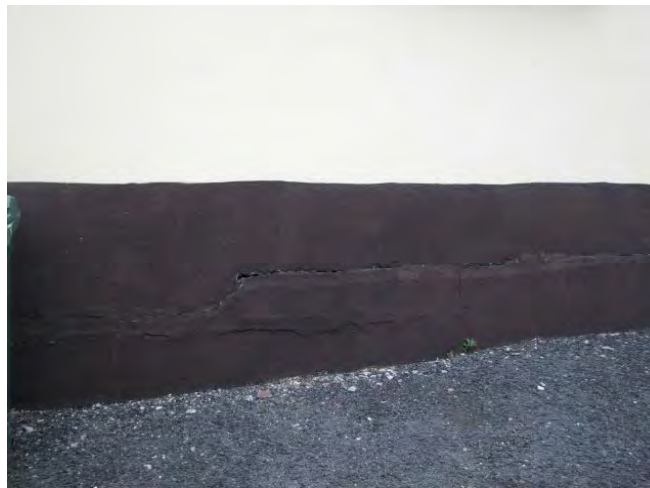
Management number	01010101010123	Disaster	Damage of house	Area name	Gremde Riviere Noire Village Hall		
Date	April 10, 2013						
Reporter's name	Takeshi KUWANO						
Landslide /Slope failure	New failure						
	Swell slope						
	New/enlarged step/cliff						
	New/enlarged crack on slope						
Rockfall	New rockfall						
	Enlarged crack on rock slope						
	Erosion of unstable rock						
Debris flow	Filling up of debris sediment						
	Overflow of debris on road						
	Clogged culvert						
	New failure on river slope						
Spring water	Depleted/decreased spring water						
	Increased spring water						
	New spring water						
	Turbid spring water						
House/road	New/enlarged step/settlement						
	New/enlarged crack						
Counter-measure	Damage/deformation						
	Clogged drainage						
	Overflowed drainage						
Other problem							
Condition	No significant progress. The cracks are caused by not landslide but lack of bearing capacity of the ground.

Cracks on wall

Proposed action	This area can be removed from the inspection sites after the discussion by related organization.						
Purpose of action

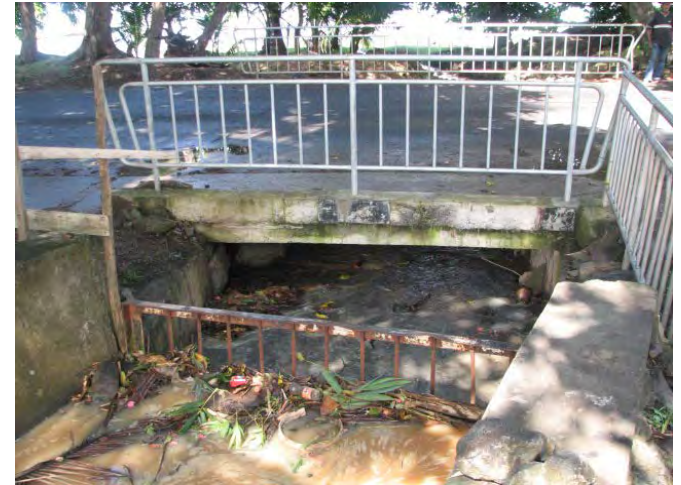
Management number	01010101010124	Disaster	Debris flow	Area name	Baie du Cap : (i) Near St Francois d'Assise Church		
Date	April 18, 2013						
Reporter's name	Takeshi KUWANO						
Landslide /Slope failure	New failure						
	Swell slope						
	New/enlarged step/cliff						
	New/enlarged crack on slope						
Rockfall	New rockfall						
	Enlarged crack on rock slope						
	Erosion of unstable rock						
Debris flow	Filling up of debris sediment	Small debris and garbage					
	Overflow of debris on road						
	Clogged culvert	Small debris and garbage					
	New failure on river slope						
Spring water	Depleted/decreased spring water						
	Increased spring water						
	New spring water						
	Turbid spring water						
House/road	New/enlarged step/settlement						
	New/enlarged crack						
Counter-measure	Damage/deformation						
	Clogged drainage						
	Overflowed drainage						
Other problem							
Condition	No significant progress. Small debris and garbage are stacked at the inlet of culvert.

Inlet of the box culvert  
Small debris and garbage are stacked

Proposed action	Regular maintenance (excavation of debris and garbage) should be conducted after rainy						
Purpose of action	To prevent the clog of culvert and overflow.

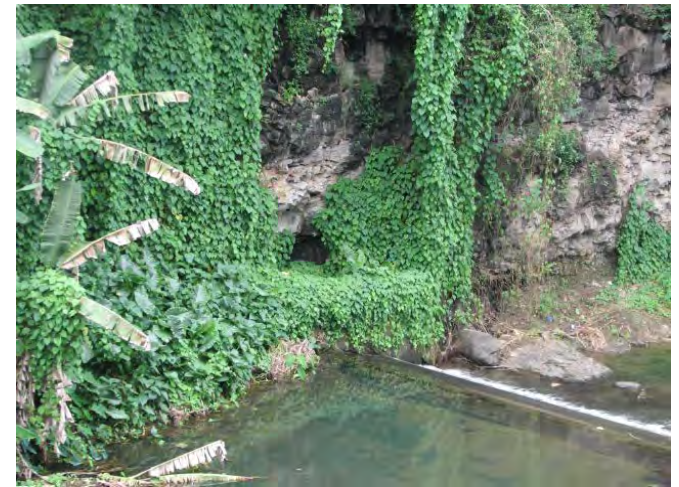
Management number	010101010101216	Disaster	Stream erosion	Area name	<i>Riviere des Anguilles, near the bridge</i>		
Date	April 12, 2013						
Reporter's name	Takeshi KUWANO						
Landslide /Slope failure	New failure						
	Swell slope						
	New/enlarged step/cliff						
	New/enlarged crack on slope						
Rockfall	New rockfall						
	Enlarged crack on rock slope						
	Erosion of unstable rock						
Debris flow	Filling up of debris sediment						
	Overflow of debris on road						
	Clogged culvert						
	New failure on river slope						
Spring water	Depleted/decreased spring water						
	Increased spring water						
	New spring water						
	Turbid spring water						
House/road	New/enlarged step/settlement						
	New/enlarged crack						
Counter-measure	Damage/deformation						
	Clogged drainage						
	Overflowed drainage						
Other problem							
Condition	Over the past several years, the erosion is slightly progressing so that the edge of the cliff has been approaching the houses.

Close view of the erosion at the bottom

Proposed action	Artificial structures (gabion, concrete walls etc.) should be constructed on the house side along the river						
Purpose of action	To prevent further erosion of the cliff.

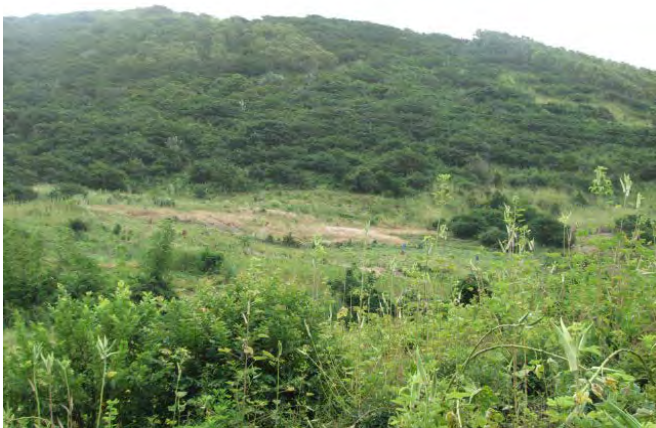
Management number	010101010101217	Disaster	Landslide	Area name	Quatre Soeurs, Marie Jeanne, Jhummah Streert, Old Grand Port		
Date	April 12, 2013						
Reporter's name	Takeshi KUWANO						
Landslide /Slope failure	New failure						
	Swell slope						
	New/enlarged step/cliff						
	New/enlarged crack on slope						
Rockfall	New rockfall						
	Enlarged crack on rock slope						
	Erosion of unstable rock						
Debris flow	Filling up of debris sediment						
	Overflow of debris on road						
	Clogged culvert						
	New failure on river slope						
Spring water	Depleted/decreased spring water						
	Increased spring water						
	New spring water						
	Turbid spring water						
House/ road	New/enlarged step/settlement						
	New/enlarged crack						
Counter- measure	Damage/deformation						
	Clogged drainage						
	Overflowed drainage						
Other problem							
Condition	As a pilot project site, monitoring is being conducted

Upperpart of the landslide

Proposed action	Until the completion of countermeasures, monitoring and early warning system should be continuously implemented.						
Purpose of action

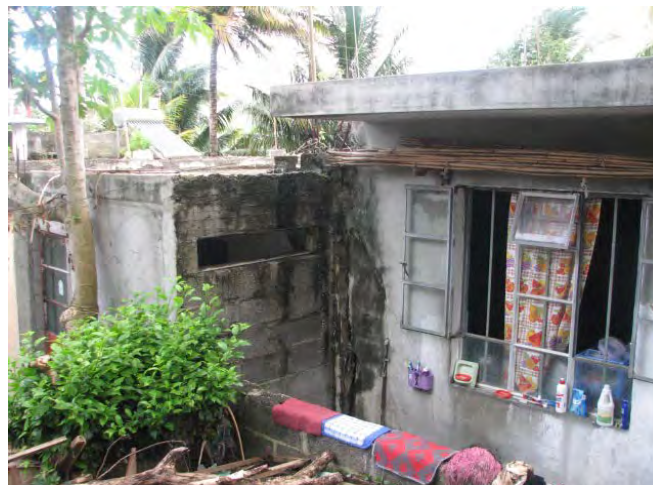
Heavy damages at houses

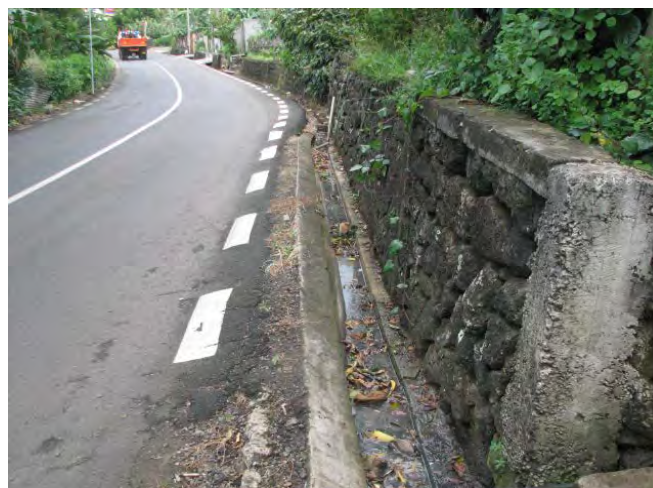
Deformed road side at the bottom of the lower landslide

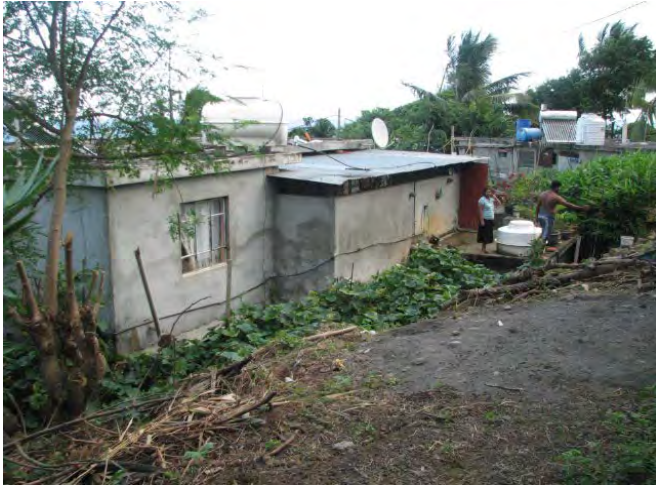
Full view of the slope and house

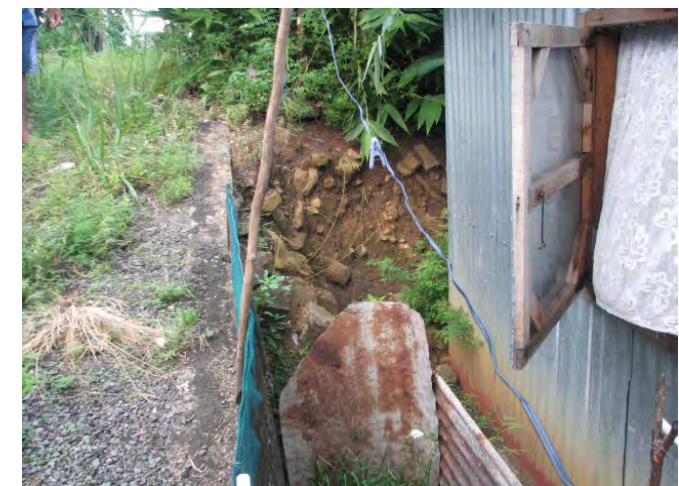
Small collapse next to the house

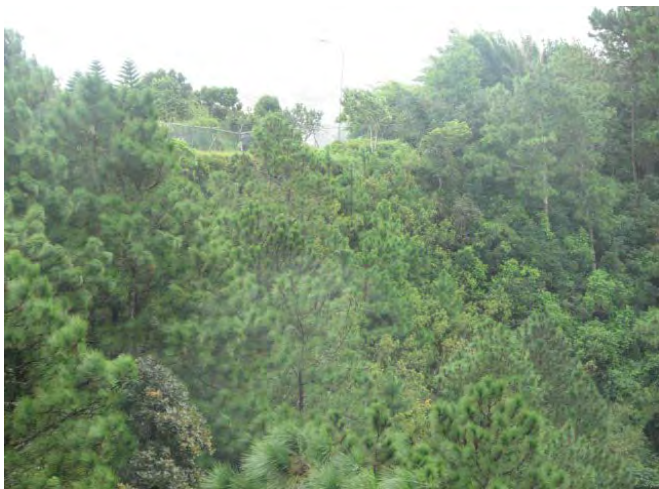
Full view of the slope failure

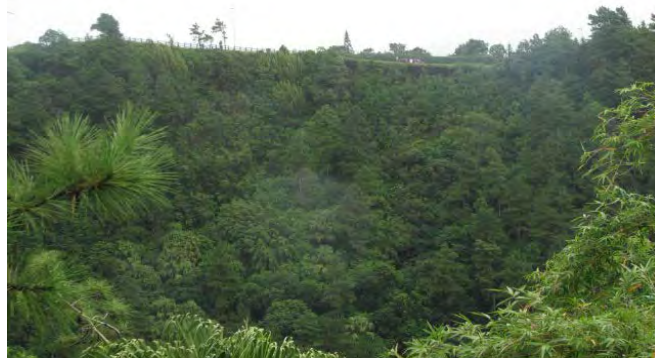
Full view of the slope failure  
Vegetation is getting recovery

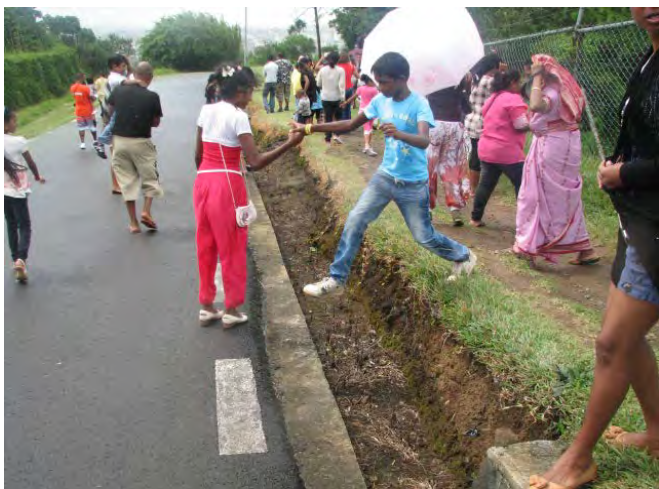
The back of the slope failure
