## 8. Result of Aerial Photograph Interpretation

## Regular Check Sheet

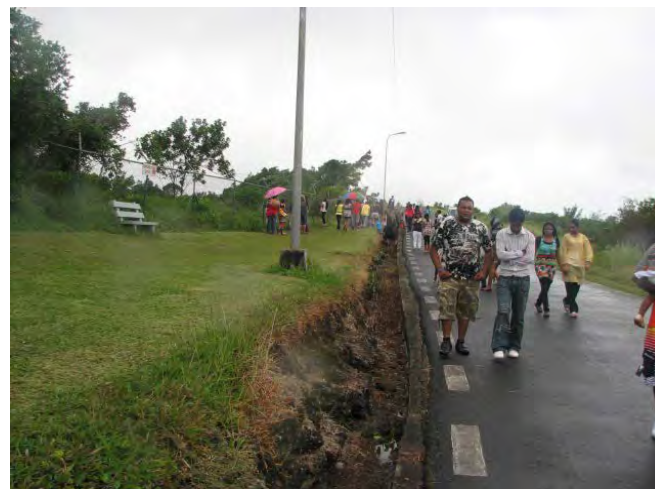
The back of the slope failure

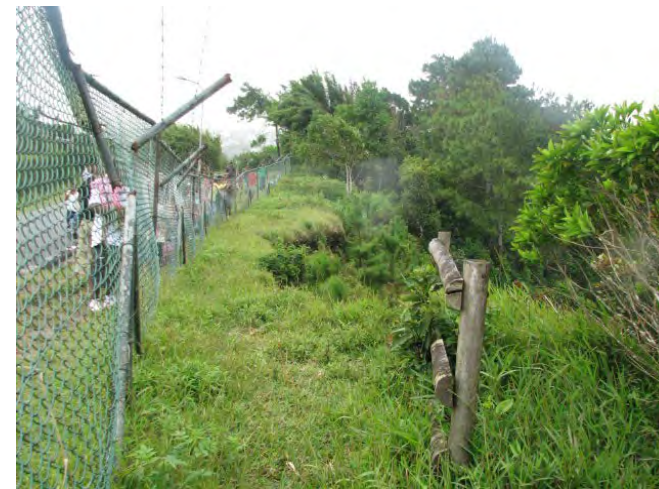
The top of the slope failure

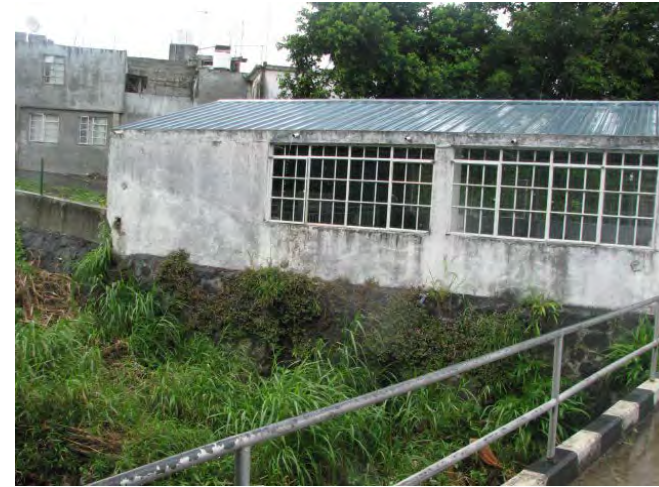
High water overflow at the bottom of the building

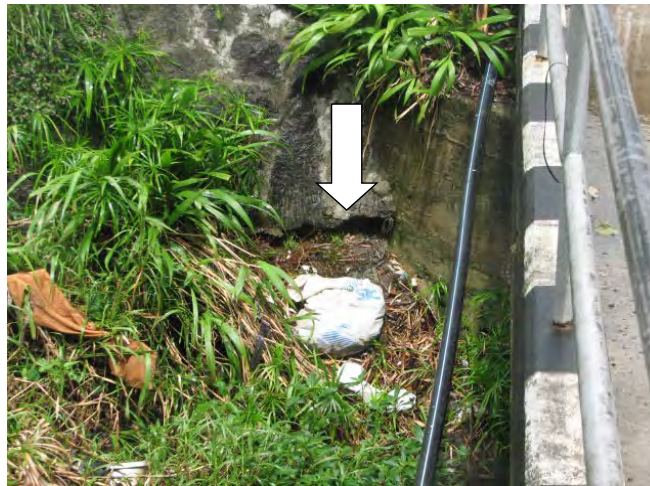
Erosion at the bottom of the building

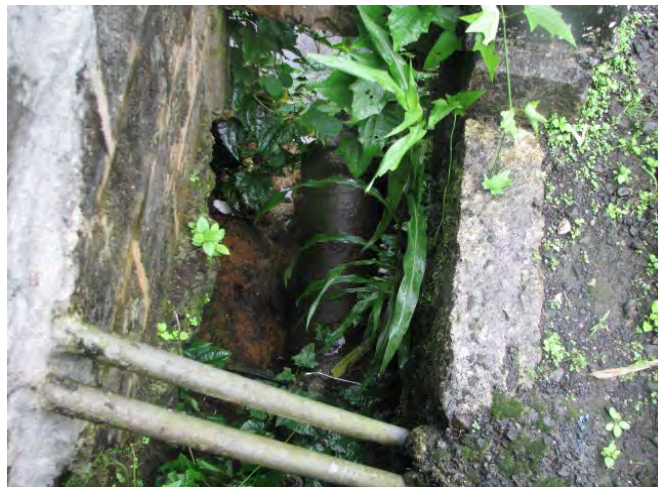
Eroded area  
the eroded depth is 50cm

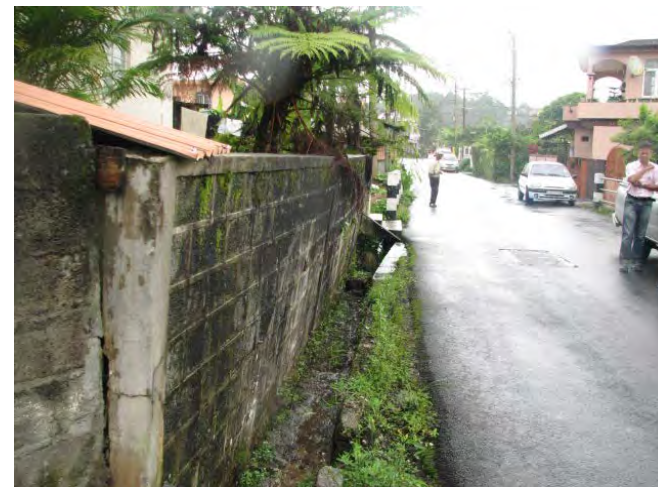
The inclined concrete block wall

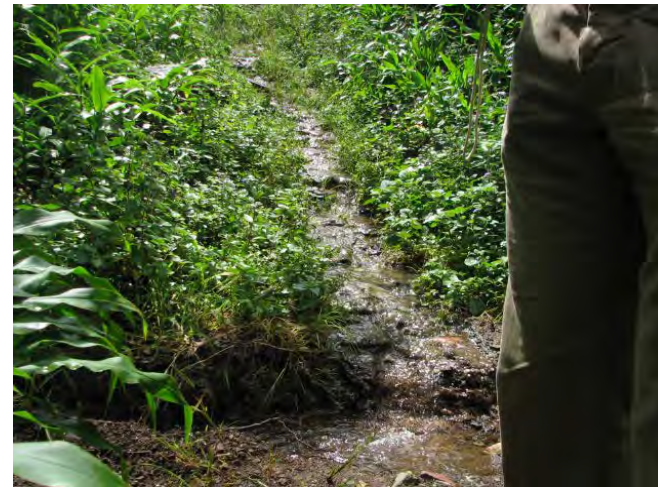
A road to the house  
much water flow away on the road.

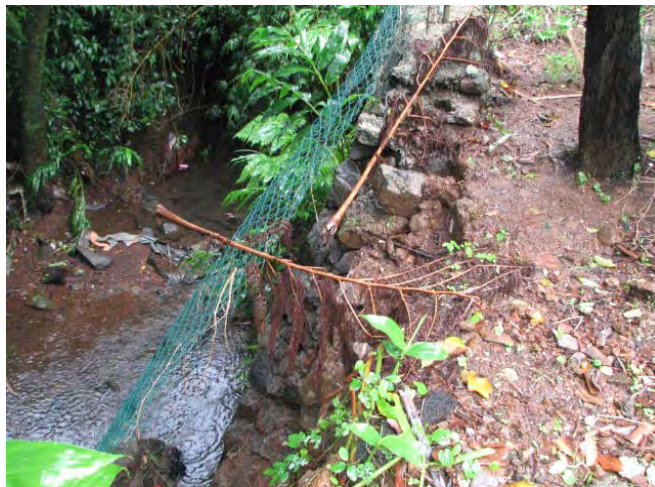
Close view of broken wall

Proposed action	The retaining wall should be repaired.						
Purpose of action	To avoid further collapse on house side.

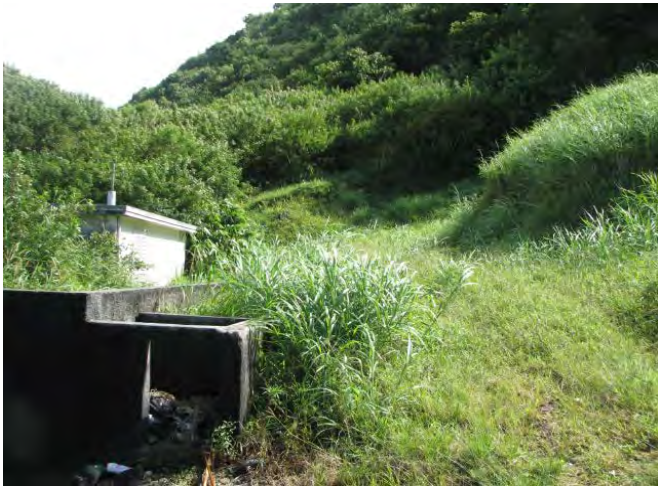
Full view of the collapse slope

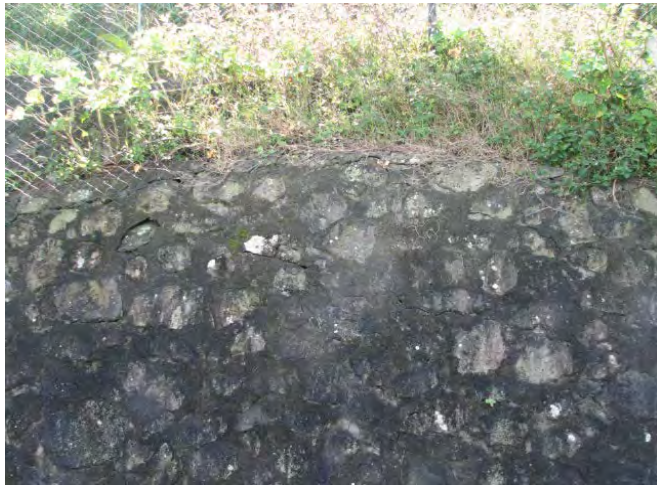
Crack of retaining wall

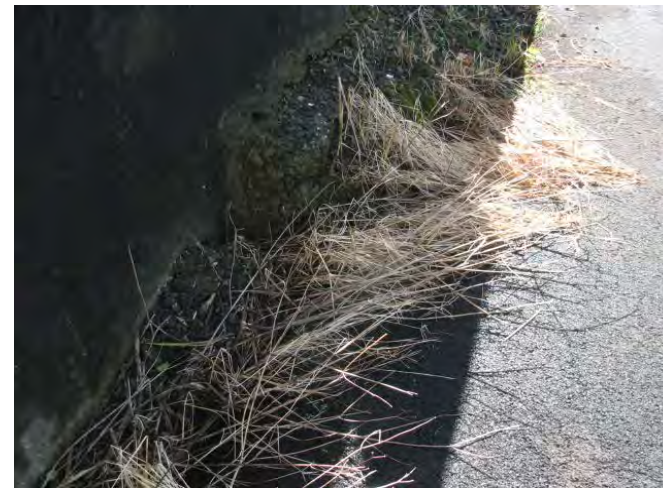
Spring water point (no water at the inspection)

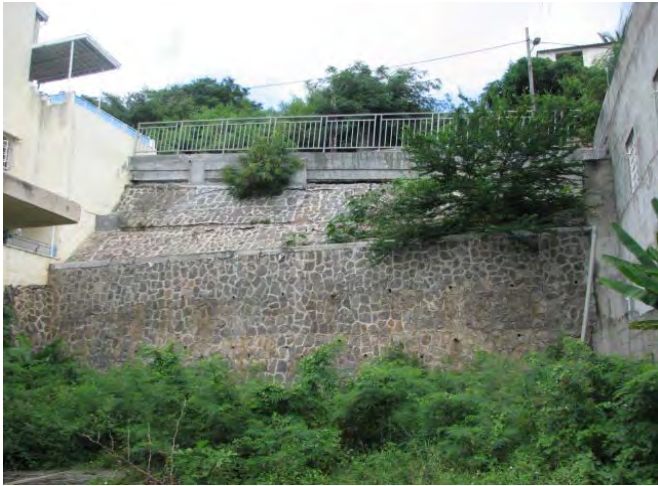
Full view (retaining wall)

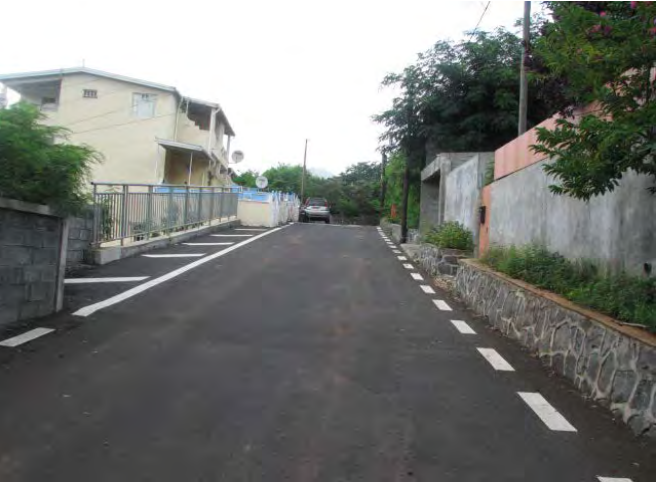
Full view (upper end of retaining wall)

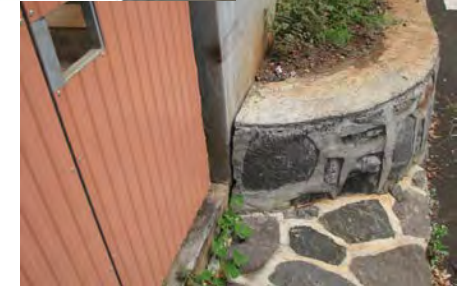
Cracks around the house

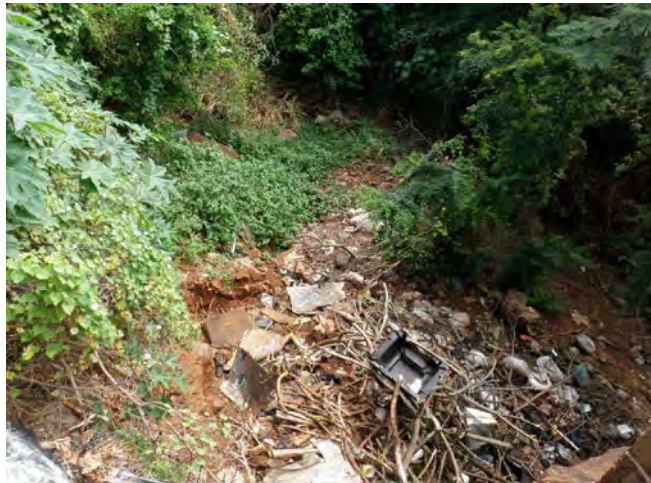
Bank erosion around bridge abutment

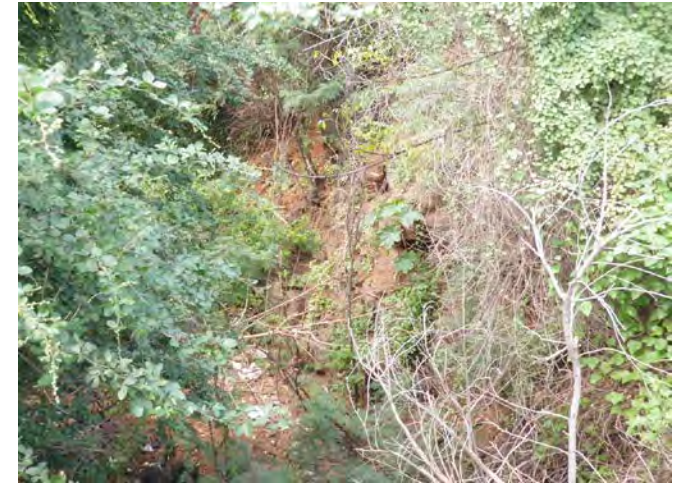
Bank erosion around bridge abutment

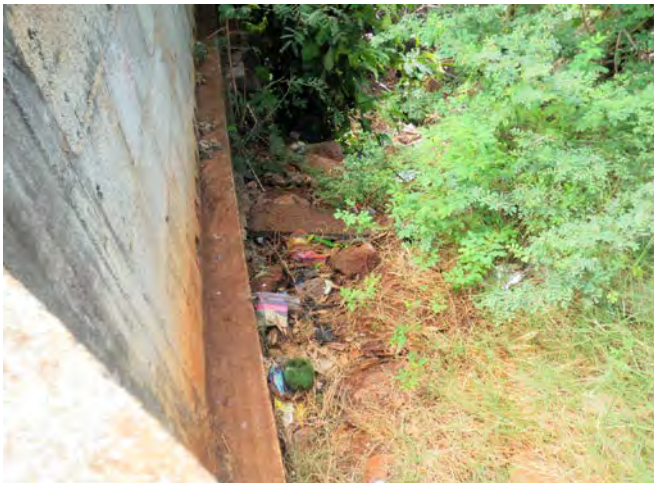
Erosion around structure

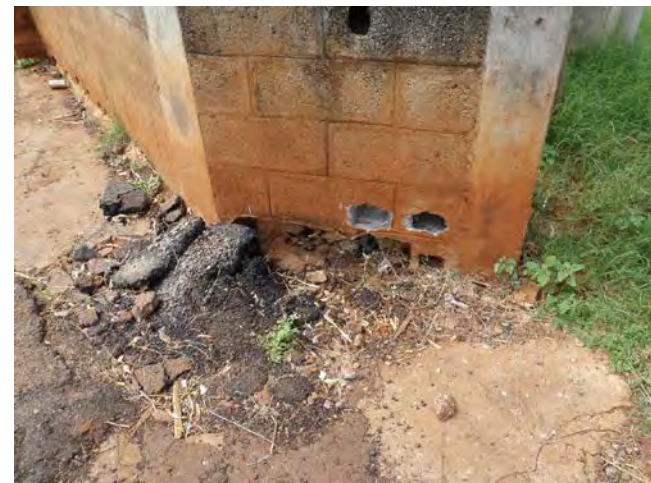
Grinding hole for drain.
