FOLLOW-UP COOPERATION STUDY REPORT
ON
THE PROJECT FOR IMPROVEMENT OF ROAD
MAINTENANCE EQUIPMENT
IN
THE FORMER YUGOSLAV REPUBLIC OF
MACEDONIA

JANUARY 2015

JAPAN INTERNATIONAL CORPORATION AGENCY

INGEROSEC CORPORATION

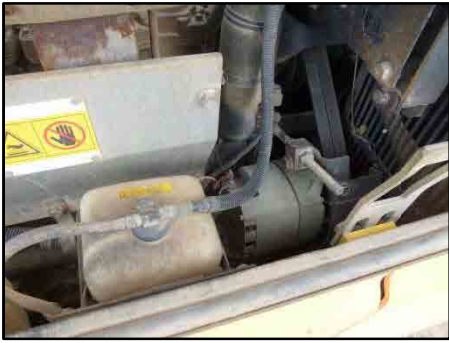
Locally purchased alternator
(Bulldozer)

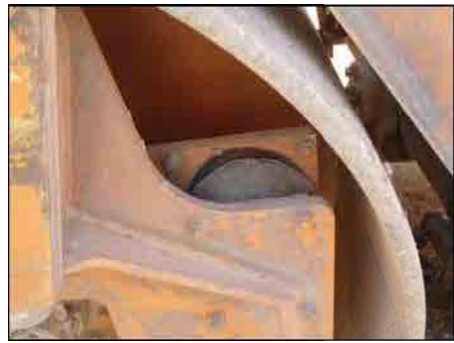
Vibration absorbing rubber of
10ton vibration roller

13	Vibration Roller (10ton)	Sakai SW750H	20209	Skopje	2666Hr	Good	Local made vibration absorbing rubber
14			20210	Veles	2622Hr	Good	Local made roller blade
15			20208	Stip	4002Hr	Working with some problem	①Air invasion to fuel line ②Pump for water sprinkler out of order
16			20211	Bitola	2880Hr	Good	Pump for water sprinkler out of order
17	Vibration Roller (4ton)	Sakai SW500	10111	Skopje	1541Hr	Good	Pump for water sprinkler out of order
18			10110	Veles	1599Hr	Good	
19			10108	Stip	1252Hr	Cannibalization	Rear Hydraulic motor out of order
20			10109	Bitola	1657Hr	Under repair	Vibratory motor out of order
21	Tire roller	Sakai TS200	23236	Skopje	2572Hr	Good	
22			23233	Veles	11661Hr	Good	
23			23234	Stip	3126Hr	Good	
24			23235	Bitola	3683Hr	Good	Diverted water sprinkler pump from 4ton roller 10109
25	Asphalt finisher	Niigata NFB60W	20138	Skopje	3198Hr	Good	①Large oil consumption ②Front tire worn out
26			20139	Veles	3415Hr	Good	①Output interface board trouble ②Front tire worn out

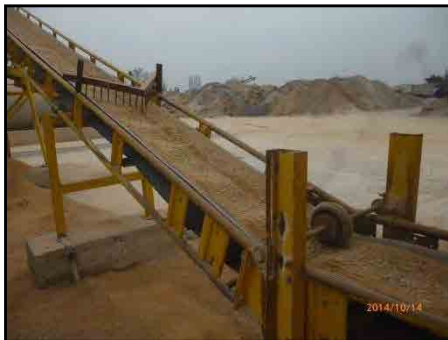
Bending spot of belt conveyor

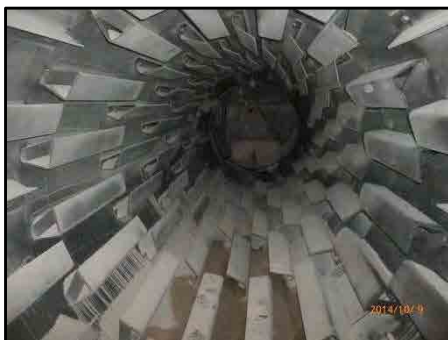
Good conditioned turbines of dryer burner

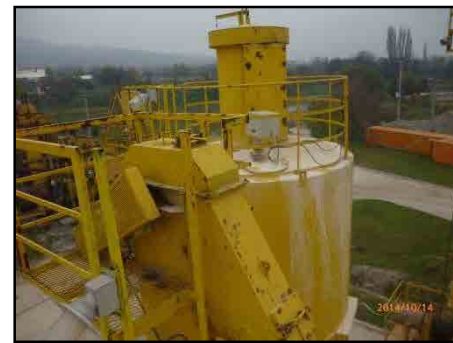
Locally installed sounding leveler at filler silo

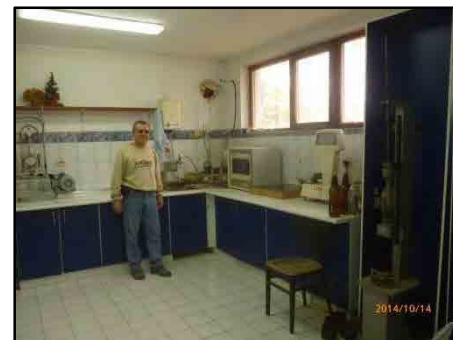
Asphalt mixture test room with old apparatus

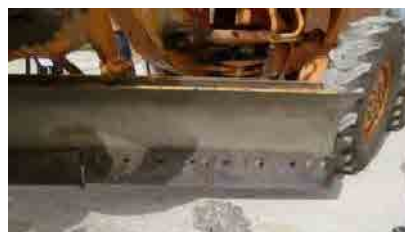
Photo3-3 Cutting edges made by Makedonijapat

4) When cutting edges, etc. for motor graders become worn, Makedonijapat uses parts it has made from steel, however, since these are not sharp and adversely impact excavation, it is desirable to use genuine parts.

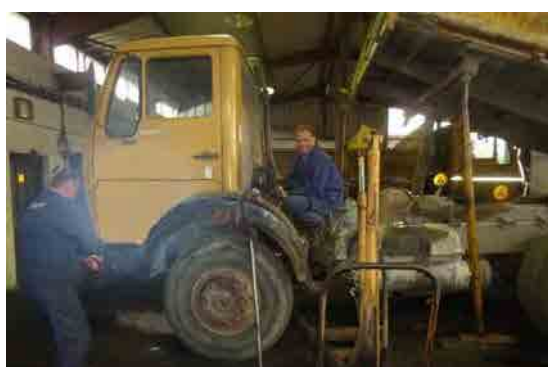
Photo 3-4 Transmission installation work (Bitola)

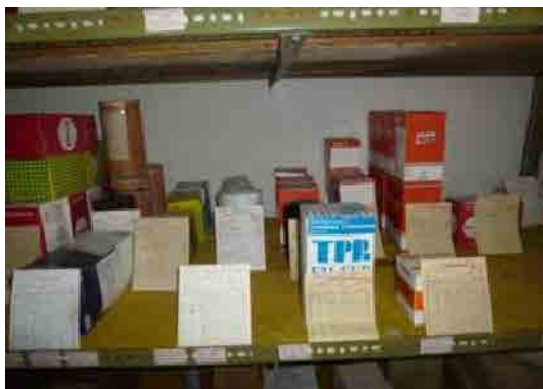
The Avtopat branch centrally manages the parts that were procured together with the equipment in the Grant Aid Project. However, improvements need to be made in terms of cooperation and information sharing with other branches concerning the control and distribution of these parts. For example, missed entries were seen in the cardex used for grasping parts quantities at Avtopat branch, control of storage locations wasn't functioning, and so on. Thus, parts control is not conducted at an appropriate level. In contrast, the Skopje and Bitola branches enter exact stock quantities on cardex and perform location control also.

Photo 3-6 Part stock condition (Skopje)

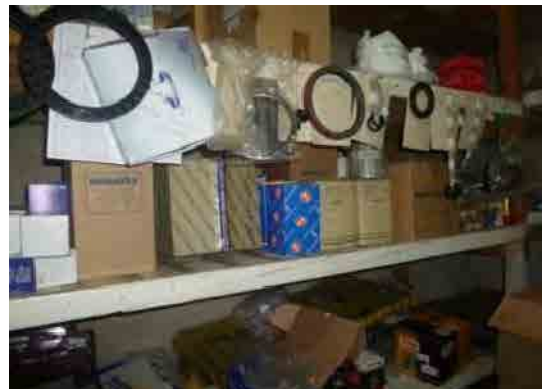
Photo 3-7 Part stock condition (Bitola)

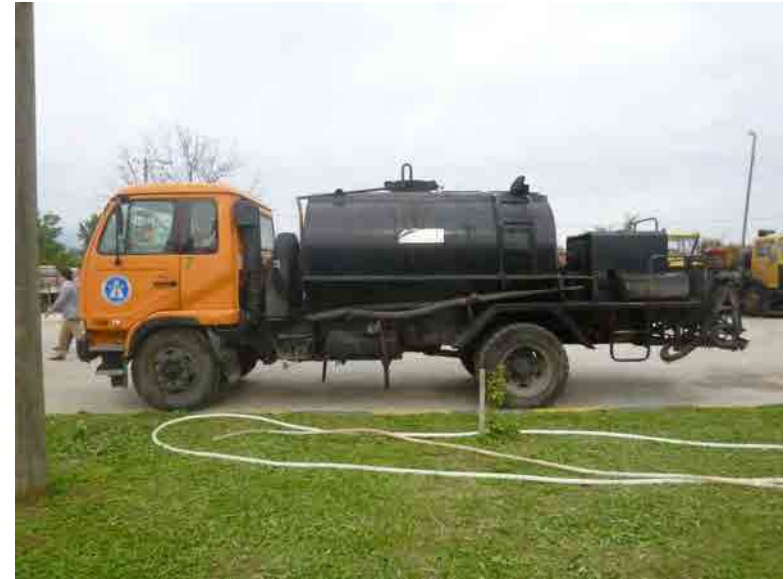
Type	: Asphalt distributor	Manufacturer	: Nissan Diesel (UD trucks)
Model	: LKC210D	Serial number	: LKC210D-00707
Branch	: Skopje branch	E/G serial number	: FE6-214790C
Check point	: Skopje branch		
Service meter/odd meter	:	49,602km	
Overall conditions	:	Good

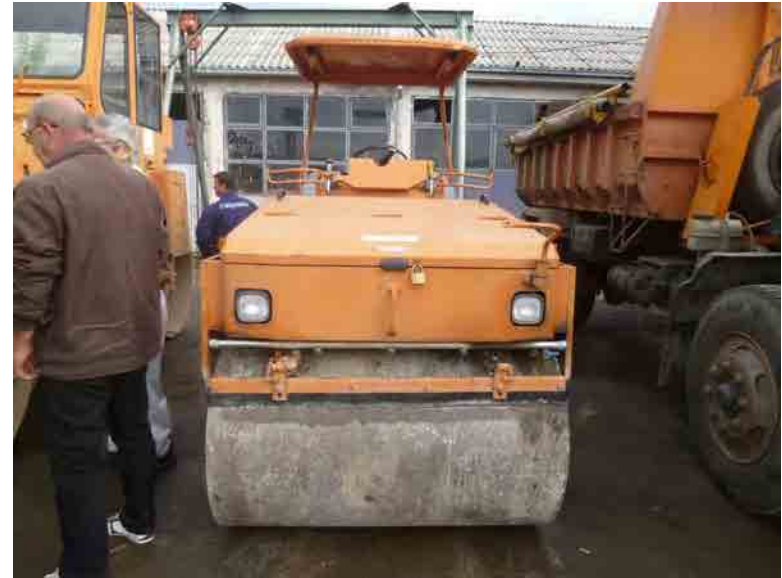
Type	: 4ton Vibratory roller	Manufacturer	: Sakai H. I.
Model	: SW500-1E	Serial number	: VSW18-10110
Branch	: Veles branch		
Check point	: Veles branch		
Service meter/odd meter	:	1,599Hr	
Overall conditions	:	Good

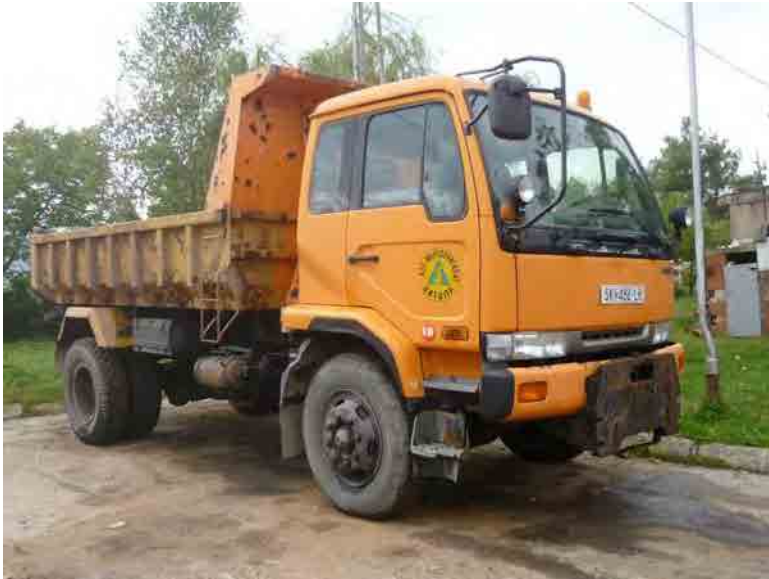
Type	: Dump truck	Manufacturer	: Nissan Diesel (UD trucks)
Model	: PKC212EHLB	Serial number	: PKC212E-00351
Branch	: Bitola branch	E/G serial number	: FE6-001379H
Check point	: Outskirts of Kichevo Paving work of route A2e (13.5m width x 850m length)		
Service meter/odd meter	:	246,244km	
Overall conditions	:	Fair	
1. There was oil leakage from below part of the engine, the engine oil pan perhaps. Welding works had been done twice, but still oil was leaked.			
2. The genuine wheel nuts were stolen, so stud bolts and nuts were changed.

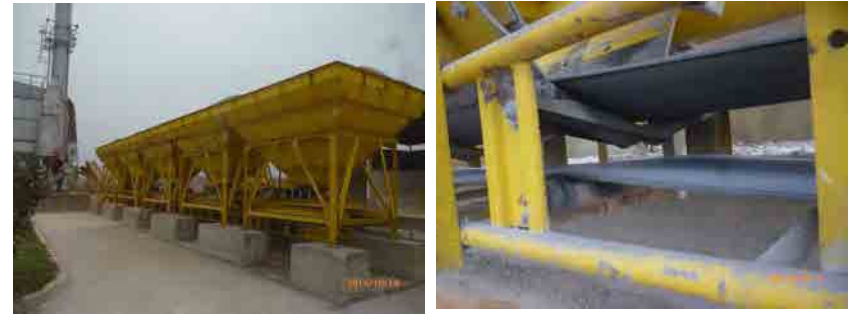
Cold bin, Belt feeder, Belt conveyor

1. Cold bin: The base was distorted by contacts of the wheel loader. Warning was issued to the manager.
2. Belt feeder: There are scratches and wear at the belt, which is to be changed when necessary.
3. Belt conveyor: There are scratches and wear at the belt, which is to be changed when necessary. Out of 72 carrier rollers 13 are stuck. Immediate replacement is required. At the bending corner, the pushing roller, F200, was replaced with a local one, but is to be replaced again with a genuine roller. Screen for removing large boulders was installed, which is said to be very effective.

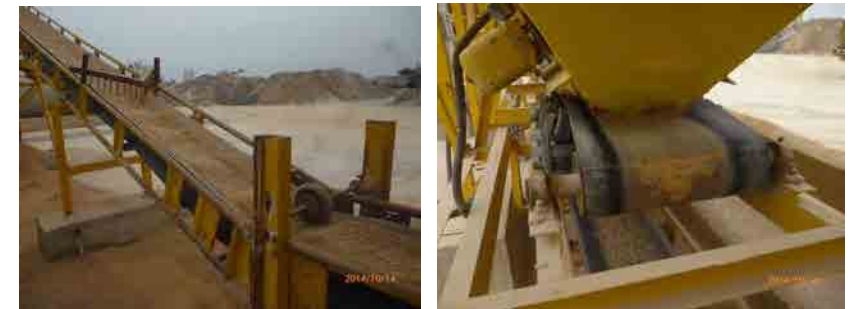
Pushing roller at the bending corner and large block removing device

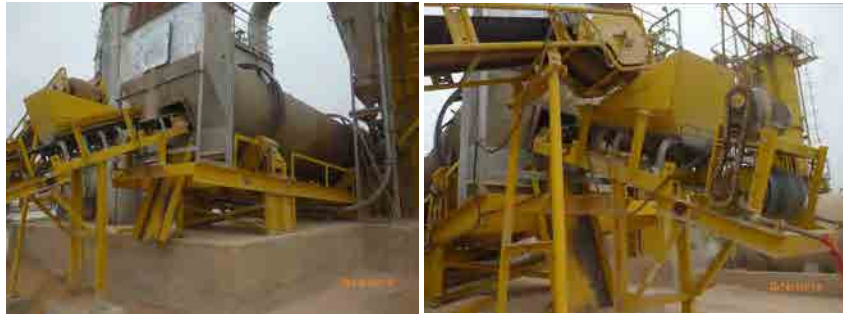
Cold aggregate conveyor, Dryer

- There are quite few damages at the dryer. The internal turbine is stout also.
The driving wheel has worn out slightly, but no problem at present. A spare is desirable.
A reduction gear rotates eccentrically. Further tightening is requested to the plant manager.
The thrust rollers and the ring tire are worn slightly, but no problem.
- The belt of cold aggregate conveyor was damaged and are planned to be replaced.
The chain cover is kept on having taken off. Asked the manager to attach it.

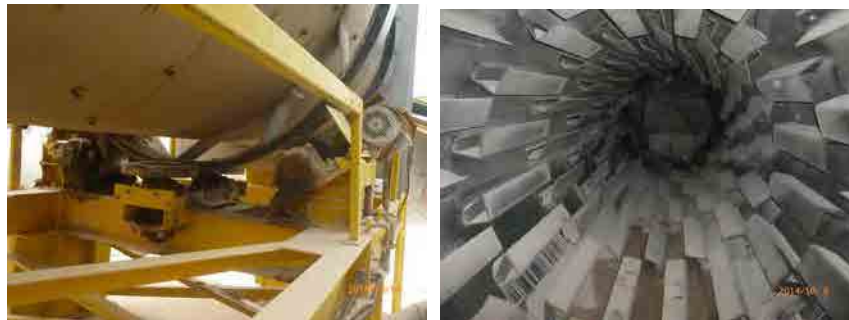
Dryer driving parts such as rollers

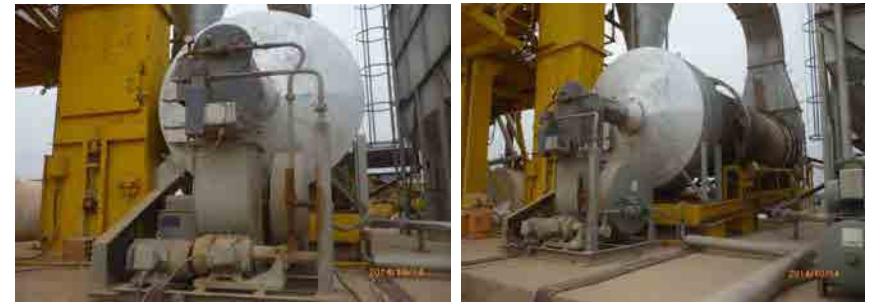
Front view of Dryer burner

- Flow meter does not work because of being damaged.
- Two fuel pressure gauges were broken. Secondary fuel pressure gauge of 2 mPa is installed.
Both gauges are required to be replaced with normal gauges of 5 mPa.
- Fuel pump makes large noise. The inner rotor is considered to be worn out.
The fuel pump is required to be replaced.
- The quality of fuel is said to be bad.

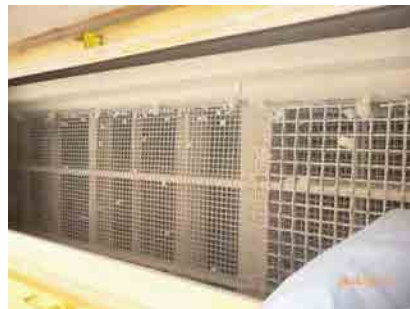
Screen of Vibrating sieve (still workable)

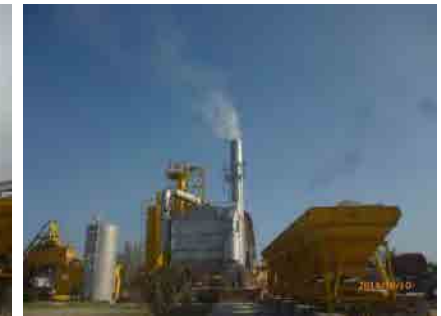
General view of dust collector (Part2), dust from the chimney

Plant name	Asphalt plant	Manufacturer	Tanaka Iron Works Co., Ltd.
Model	TAP-800, SB-60	Serial number	0106572
Production	Approximately 210,000tons (Accumulated)		
Unit name	Dust collector (Dry type dust collector, Bag filter, Dust recovery system)		
Status of unit	In operation with problems		
<p>1. Filters at the bag filter are torn and some dust is emitted from the chimney. The differential pressure is around 2000Pa, slightly large because of clogging. All filters are requested to be changed.</p>

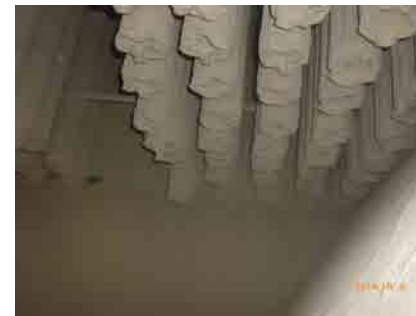
Inside bag filter (some torn filters)

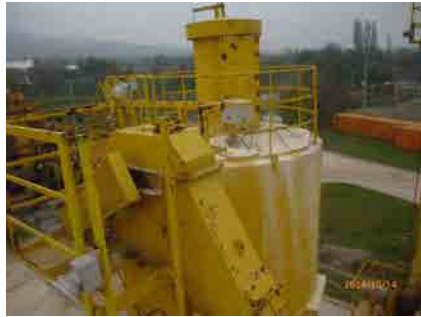
Top of filler silo, Upper part of filler elevator

Plant name	Asphalt plant	Manufacturer	Tanaka Iron Works Co., Ltd.
Model	TAP-800, SB-60	Serial number	0106572
Production	Approximately 210,000tons (Accumulated)		
Unit name	Filler feeding unit, Filler silo		
Status of unit	In operation with some minor problems		
<p>1. Filler may be leaked from mini bag at the top of filler silo. Filters may be not fixed or torn. No interference to asphalt production even checking is required.</p> <p>2. To measure the remained volume of filler silo, the leveler of empty and full position was attached position. originally. For convenience Japan-make sounding leveler was installed locally to detect the intermediate position.</p> <p>3. Filler feeding unit has no problem.</p>

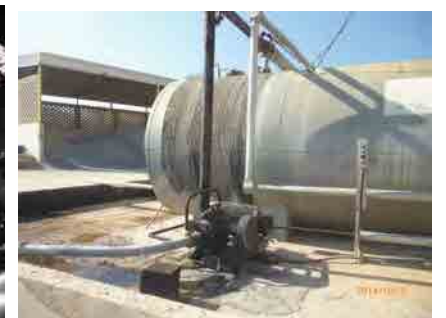
Locally replaced gear pump at the ground

Plant name	Asphalt plant	Manufacturer	Tanaka Iron Works Co., Ltd.
Model	TAP-800, SB-60	Serial number	0106572
Production	Approximately 210,000tons (Accumulated)		
Unit name	Asphalt supply system (Asphalt tank, hot oil heater, asphalt piping)		
Status of unit	In operation with minor problems.		
<p>1. Originally required time to warm asphalt tank was for 10hours, but is now for 25hours. Carbonized material is attached to heat piping at the asphalt plant, to be taken away in winter.</p> <p>2. Noise comes from the hot oil circulation pump. Bearing is to be checked. Coupling was replaced with China-make, which is cheaper but with shorter life than Japan-make.</p> <p>3. Gear pumps on the asphalt tank and at the ground were replaced locally.</p> <p>4. Piping connecting asphalt lorry and asphalt tank was clogged, so replaced locally.</p>

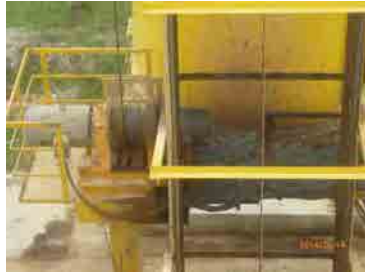
Spilled asphalt mixture is building up near the winch.

1. Skip is operating per batch of mixer.
2. Around 150kg of asphalt mixture is attached at the bucket of skip.
3. Brake of the winch operates almost without slippage.
The wires were replaced frequently. Local wire has different specifications and shorter life.
4. Asphalt mixture is building up near the winch and to be taken away immediately.

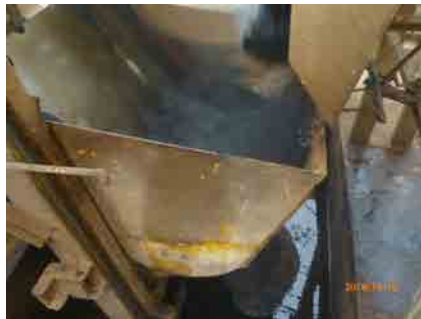
Asphalt mixture is just put in the bucket of Skip.

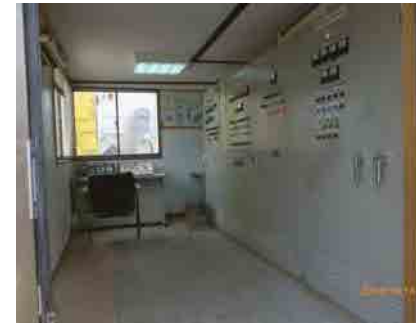
Control room inside

1. Many parts were struck by lightning.
The control panel, the inverter, the load cell and so on were damaged by lightning.
