# The Preparatory Survey for the Project for Enhancement of Safety in Apia Port

## Tug Boat Inspection Report T/B ATAFA

Augsut 2014

Oriental Consultants Co., Ltd.

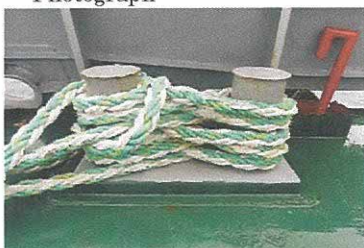
| No | LOCATION | NAME | SPECIFICATION | CONDITION | REMARK |
|---|---|---|---|---|---|
| 10 | Upper Deck<br>Aft | Bollard | 200A(Sch40) h : 550 | Good | |

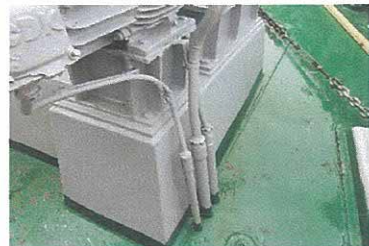
| No | LOCATION | NAME | SPECIFICATION | CONDITION | REMARK |
|---|---|---|---|---|---|
| 14 | Upper deck<br>Fore | Windlass base | Steel | Good | |

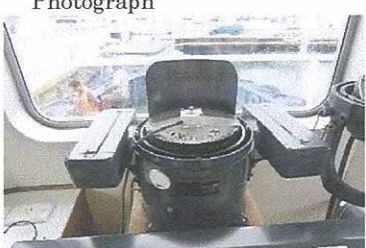
| No | LOCATION | NAME | SPECIFICATION | CONDITION | REMARK |
|---|---|---|---|---|---|
| 20 | Navigation bridge deck<br>Wheel house | Magnetic compass | DAIKO KEIKI<br>Type : T-150SLK<br>M. No. : 1498 | Good | |

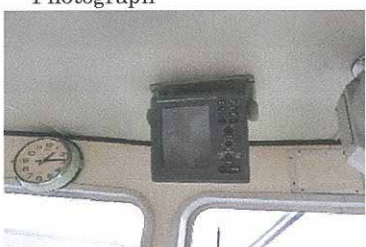
| No | LOCATION | NAME | SPECIFICATION | CONDITION | REMARK |
|---|---|---|---|---|---|
| 21 | Navigation bridge deck<br>Wheel house | Echosounder | FURUNO<br>Type : FE-700 | Good | |

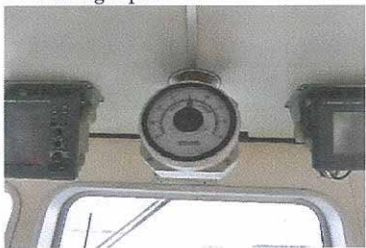
| No | LOCATION | NAME | SPECIFICATION | CONDITION | REMARK |
|---|---|---|---|---|---|
| 22 | Navigation bridge deck<br>Wheel house | Rudder angle indicator | KITAKO | Good | |

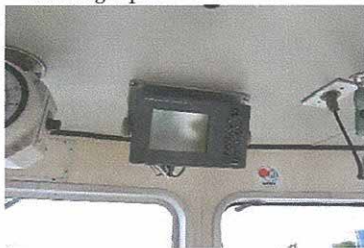
| No | LOCATION | NAME | SPECIFICATION | CONDITION | REMARK |
|---|---|---|---|---|---|
| 23 | Navigation bridge deck<br>Wheel house | GPS Navigation | FURUNO<br>Type : GP-80 | Good | |

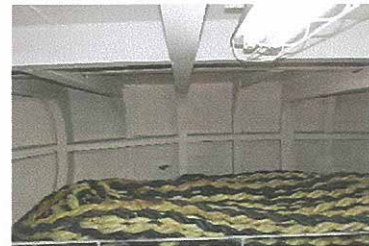
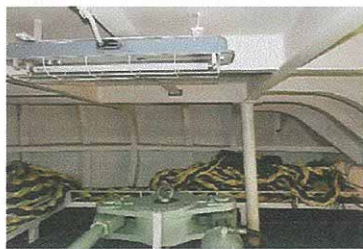
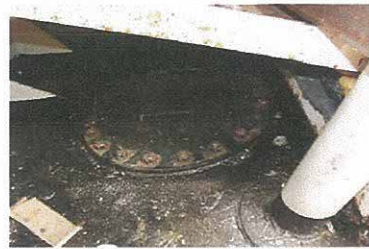
| No | LOCATION | NAME | SPECIFICATION | CONDITION | REMARK |
|---|---|---|---|---|---|
| 32 | Steering gear room | Side shell plate & Frame | | Good | |

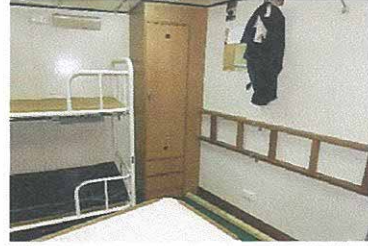
| No | LOCATION | NAME | SPECIFICATION | CONDITION | REMARK |
|---|---|---|---|---|---|
| 37 | Hold | C/Enginner room & Crew's room | | Good | |

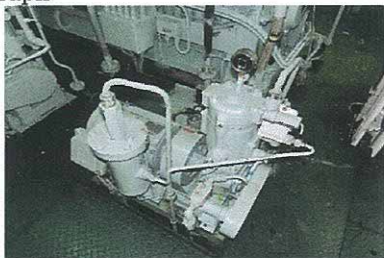
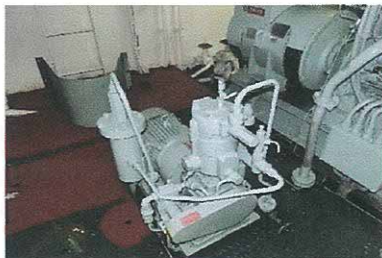
| N <sup>o</sup> | LOCATION | NAME | SPECIFICATION | CONDITION | REMARK |
|---|---|---|---|---|---|
| 45 | Engine room | Air compressor | MATSUBARA<br>Type : MS70R<br>Motor : ONISHI<br>Type : Sf-JR 5.5KW | Good | |

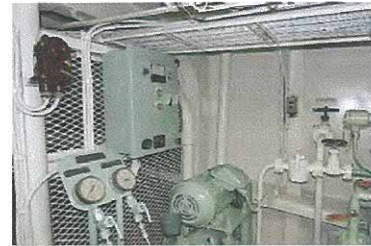
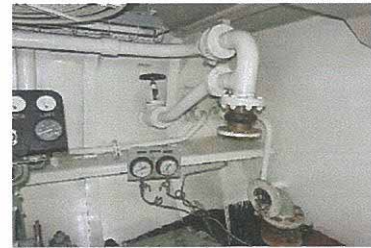
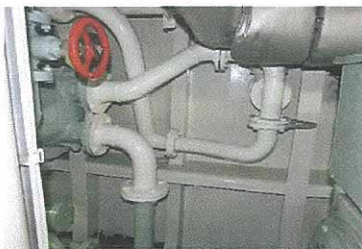
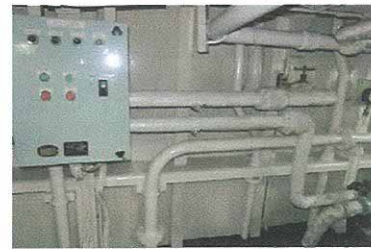
| No | LOCATION | NAME | SPECIFICATION | CONDITION | REMARK |
|---|---|---|---|---|---|
| 59 | Engine room | Side shell plate & Frame | | Good | |
