5.2.2.Detail Survey in Model Area  
a. Maps of Pilot Model District

## b. District Model Tanah Abvang Kec. Tanah Abang

REPORT OF EXISTING DRAINAGE SYSTEM

## 6. THE CONDITION OF DRAINAGE CHANNEL IN SURVEY AREA

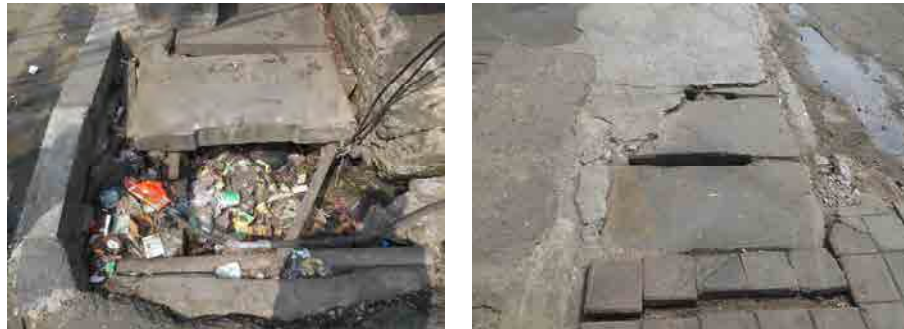
01. DETAIL OF JL. KH. MAS MANSYUR (TANAH ABANG AREA)

No.	Kelurahan	River Basin	Jalan	Structure					Condition		Remark
				Type	W Top / dia (m)	W Bottom (m)	H (m)	L (m)	Clogged	A	
									Failed	B	
									Subsidy	C	
1	TANAH ABANG	KALI KRUKUT	KH. MAS MANSYUR	□	1,00	1,00	1,20	510,00	Failed/Clogged	B/C	0,8
2	TANAH ABANG	KALI KRUKUT	KEBON PALA 1	□	0,65	0,65	1,10	295,00	Subsidy	B/C	0,3
3	TANAH ABANG	KALI KRUKUT	KEBON PALA 2	∩	0,60	0,40	0,75	350,00	Subsidy	B/C	0,1
4	TANAH ABANG	KALI KRUKUT	KEBON PALA 4	∩	0,70	0,60	0,60	190,00	-	C	0,1
5	TANAH ABANG	KALI KRUKUT	KEBON PALA 6	∩	0,60	0,40	0,45	320,00	-	C	0,15
6	TANAH ABANG	KALI KRUKUT	KEBON PALA 9	∩	1,00	0,60	0,70	685,00	Failed	B/C	0,2
7	TANAH ABANG	KALI KRUKUT	AWALUDIN 1	∩	1,00	0,60	0,60	315,00	Subsidy	B/C	0,15
8	TANAH ABANG	KALI KRUKUT	GG. MESS	∩	0,60	0,40	0,60	350,00	Failed	B/C	0,1
9	TANAH ABANG	KALI KRUKUT	GG. PORRA	∩	0,45	0,25	0,45	265,00	Subsidy	B/C	0,1
10	TANAH ABANG	KALI KRUKUT	GG. 01	∩	0,50	0,30	0,45	175,00	-	C	0,1

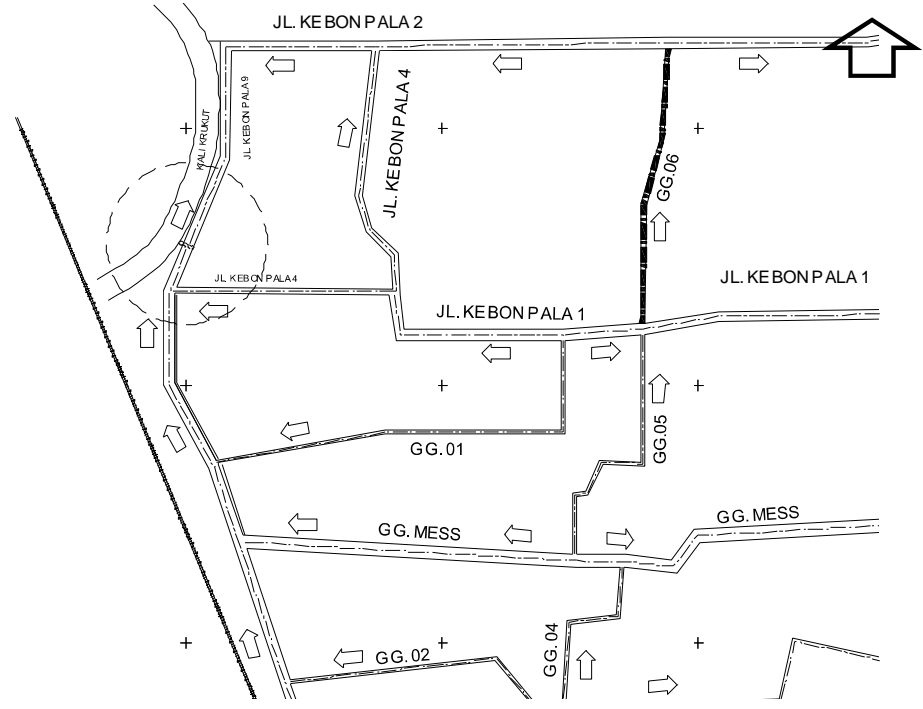
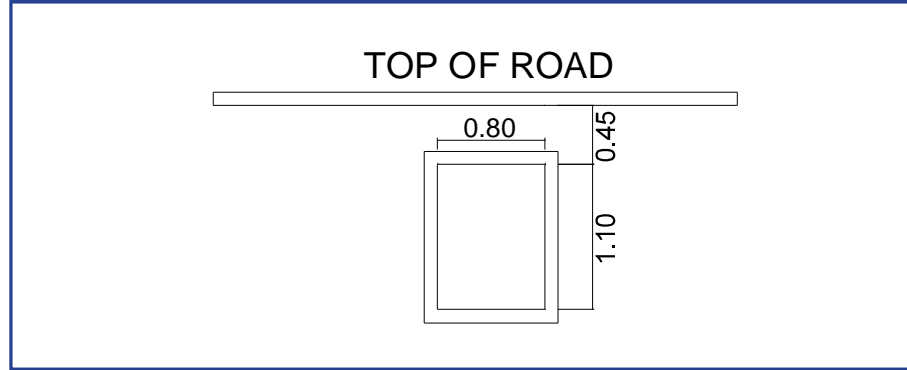
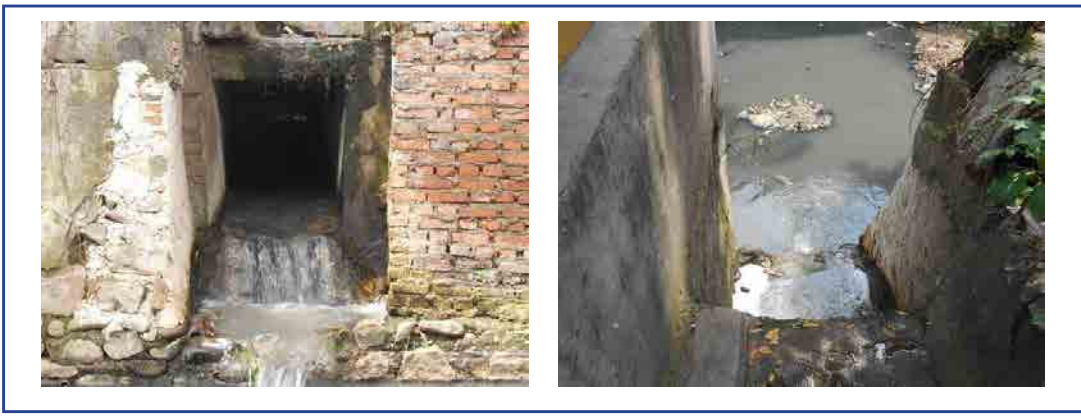
14. DETAIL OF GG. 05 (TANAH ABANG AREA)

POSITION  
 X= 700400.263 Y= 9313897.884

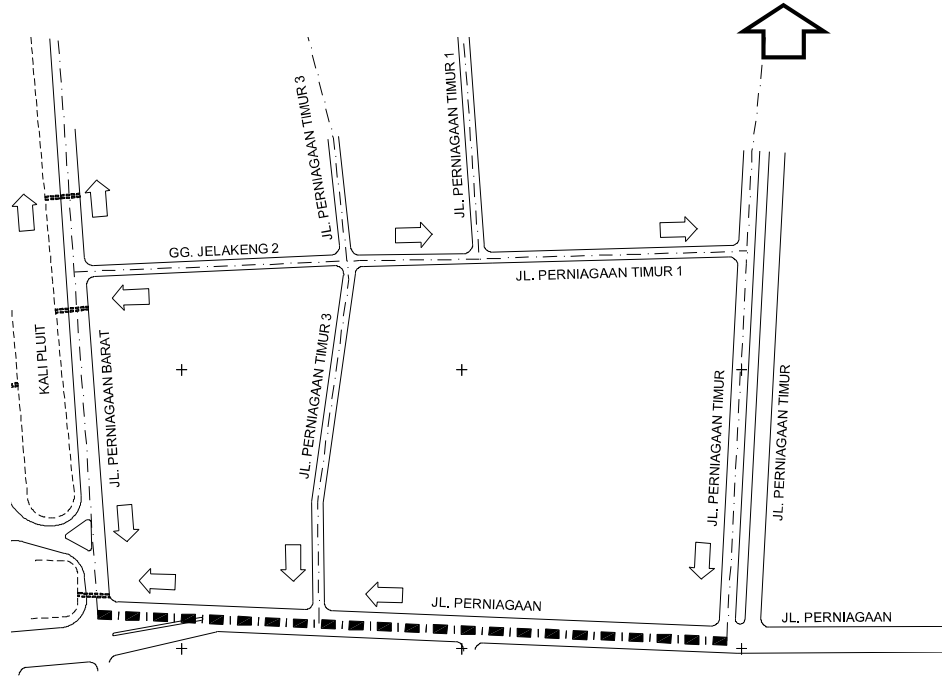
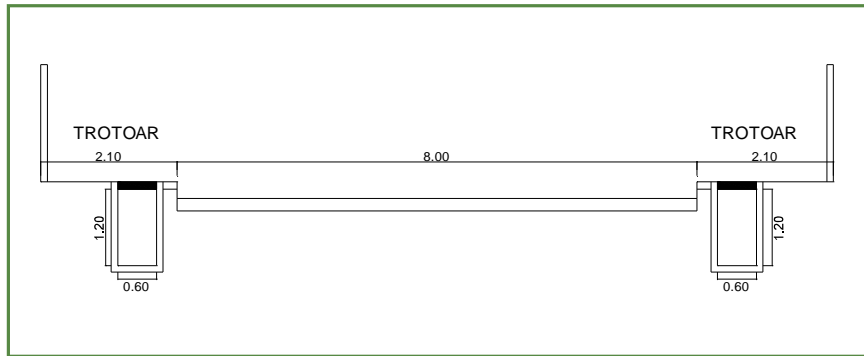
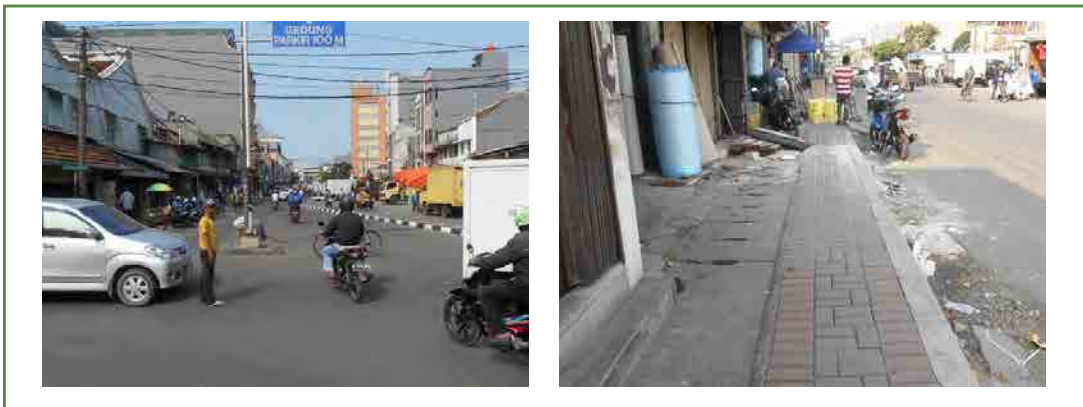
01. DETAIL OF JL. PERNIAGAAN (TAMBORA AREA-1)

Less water flows or no water flows can be found on JalanPerniagaan and Pengukiran. This is the indication that water flows not running properly, and clogging is a potential problem.

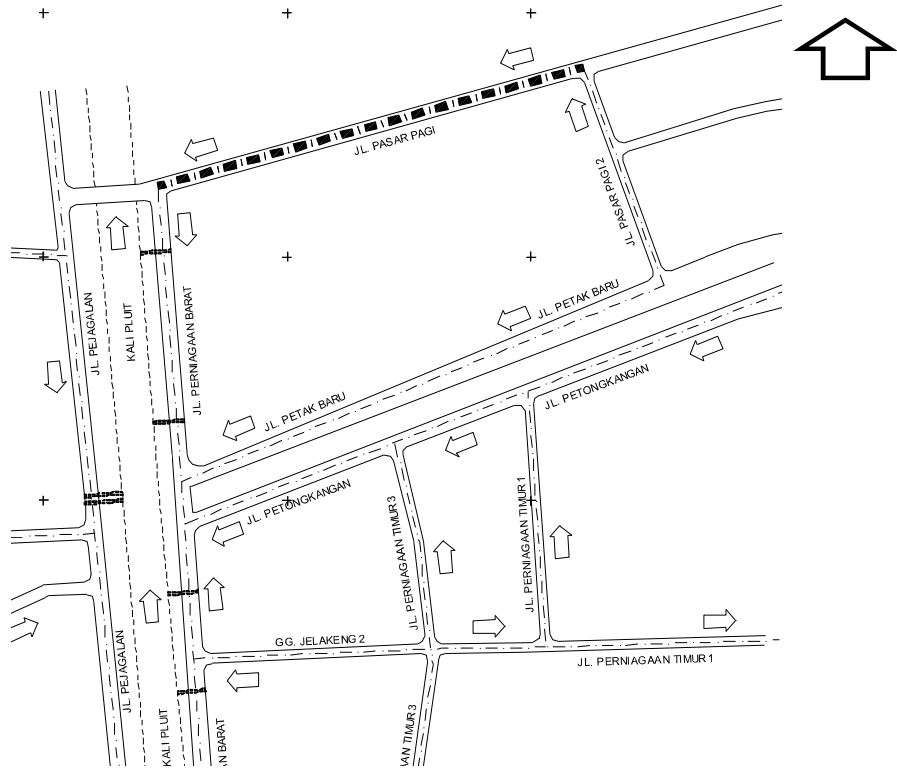
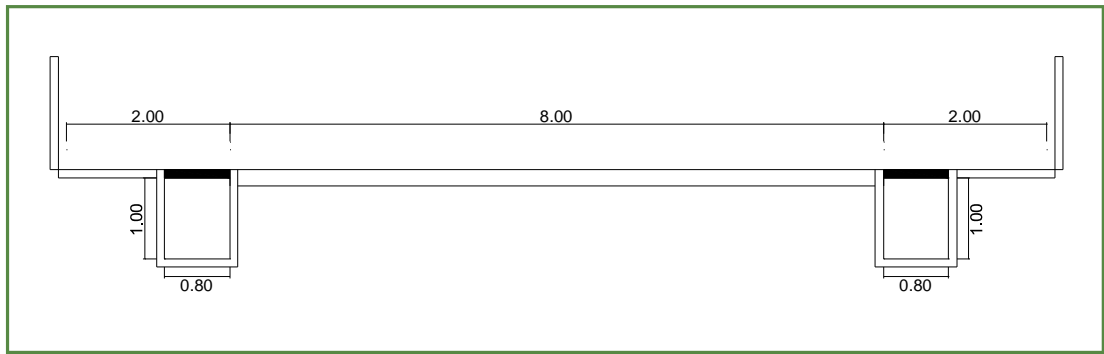
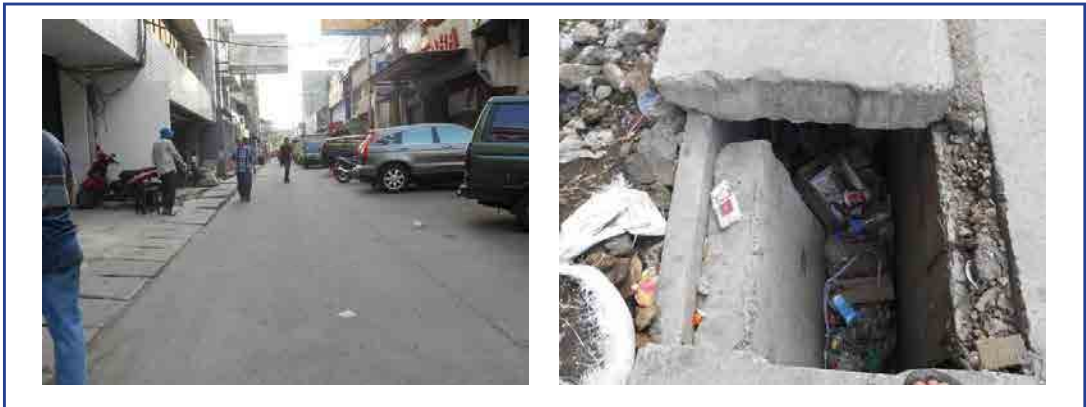
09. DETAIL OF JL. PASAR PAGI (TAMBORA AREA-1)

Sediments are very often happening on water tunnel, and it is sediment almost half of water channel depth. We can found higher sedimentation on Jalan Pasar Pagi, Pengukiran and Pejagalan. Other than channel depth sediment, they are a lot of waste on water surface. This condition is caused by less maintenance for water channel and not taking care of waste disposal.

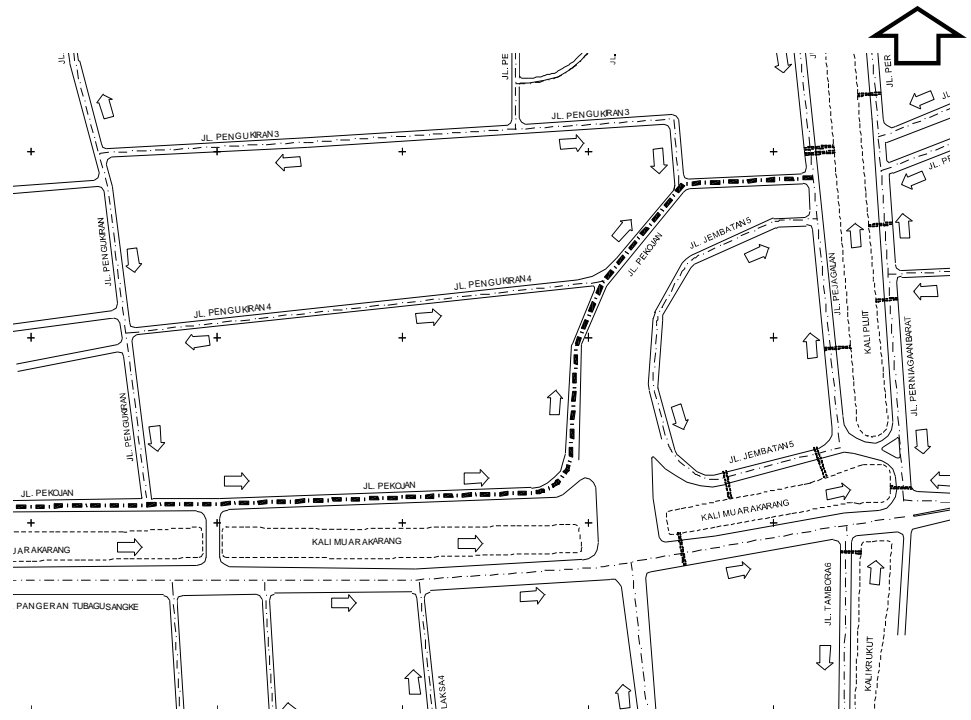
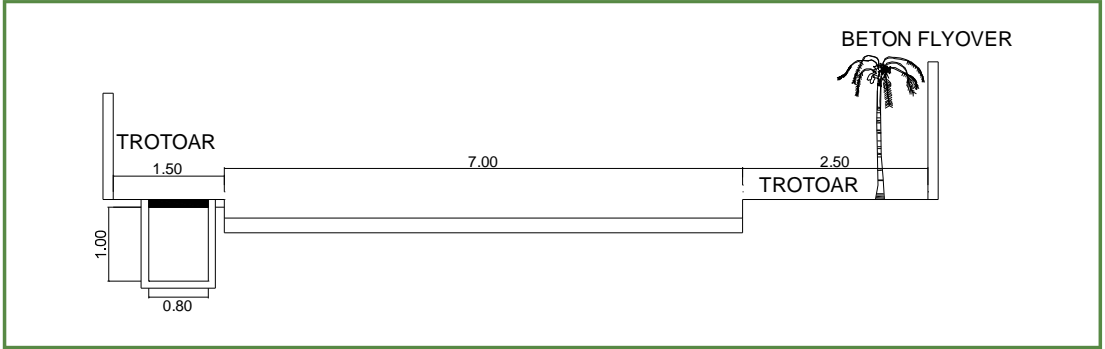
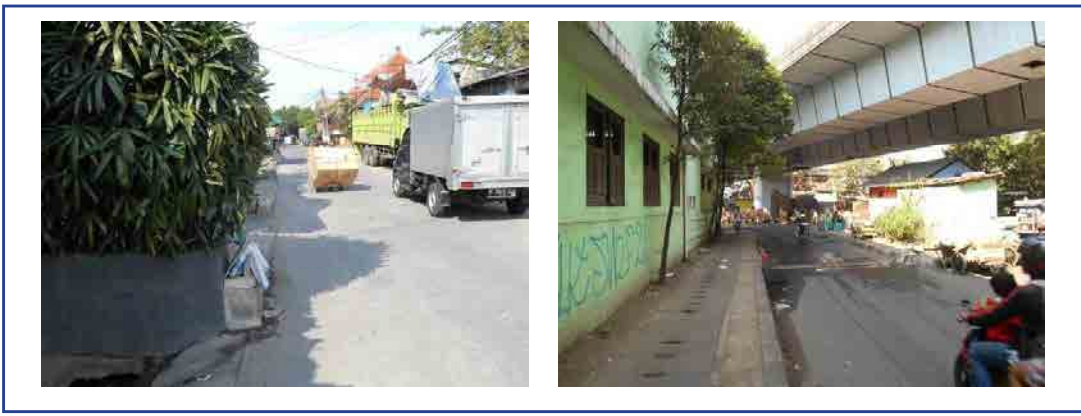
02. DETAIL OF JL. PEKOJAN (TAMBORA AREA-2)

The malfunction on the water closure is not very often happening on the resident area, it caused by the resident in this area is able to maintain/take care water closure. The problem on the water closure can be found on Jalan Pengukiran 3 (1 unit) and Jalan Pasar Pagi closure made by solid cemen that fell into the channel (it caused by the size of solid cement closure size not fit as same as Jalan Pekojan). The under channel malfunction/can not be seen or can not be found.

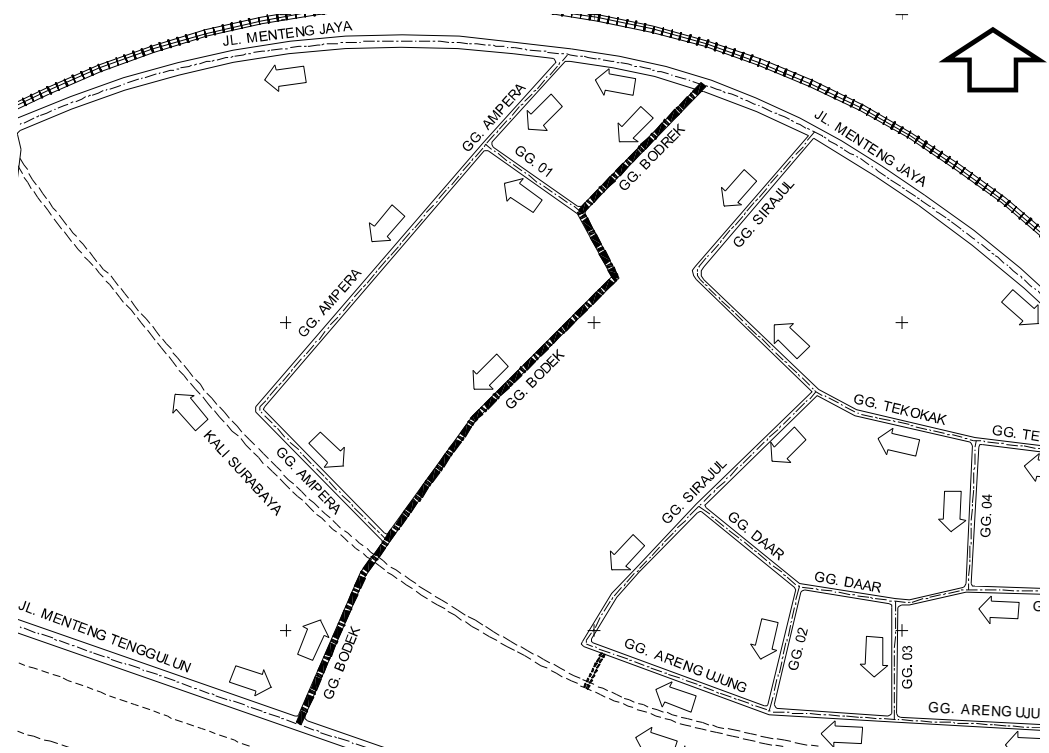
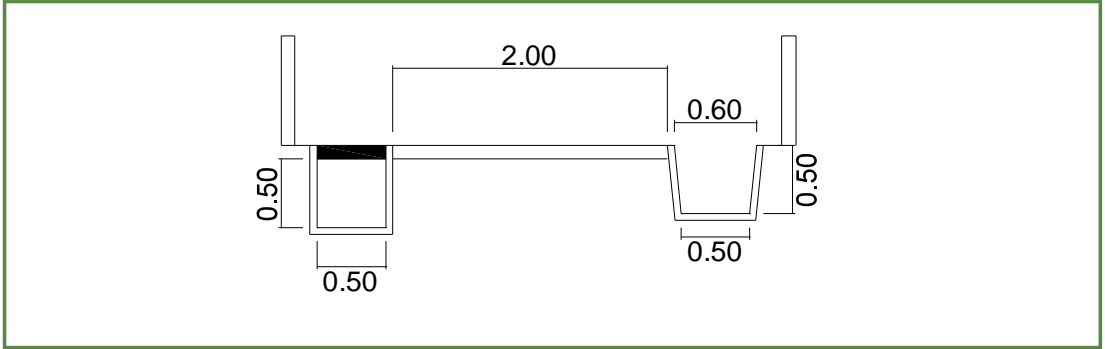
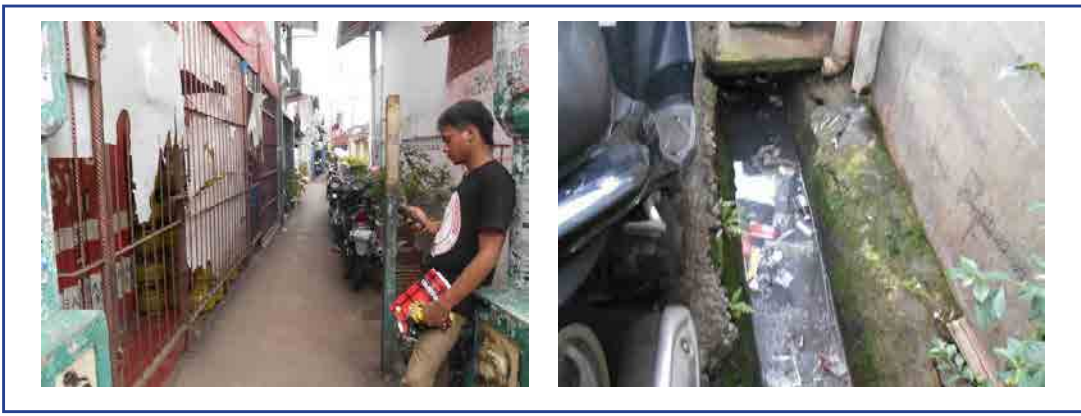
07. DETAIL OF GG. BODREK (MENTENG AREA 1)

0,60	0,50	0,50	230,00	Failed/Subsidy	B/C	0,2
7	MENTENG	KALISURABAYA	GG. BODREK

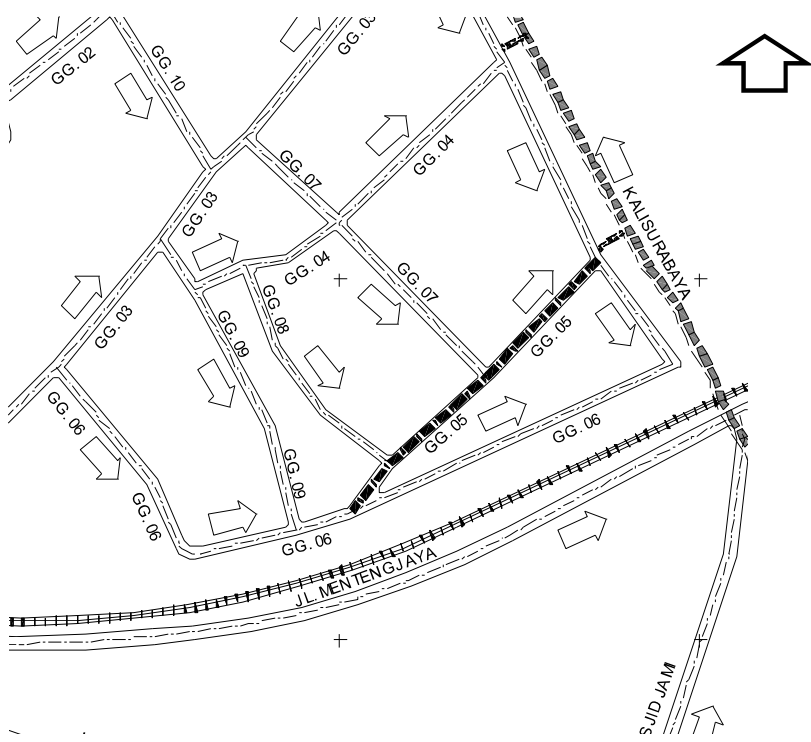
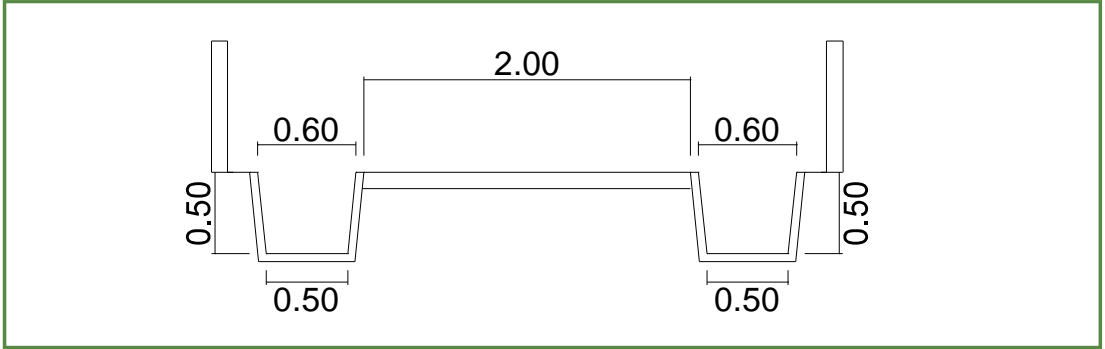
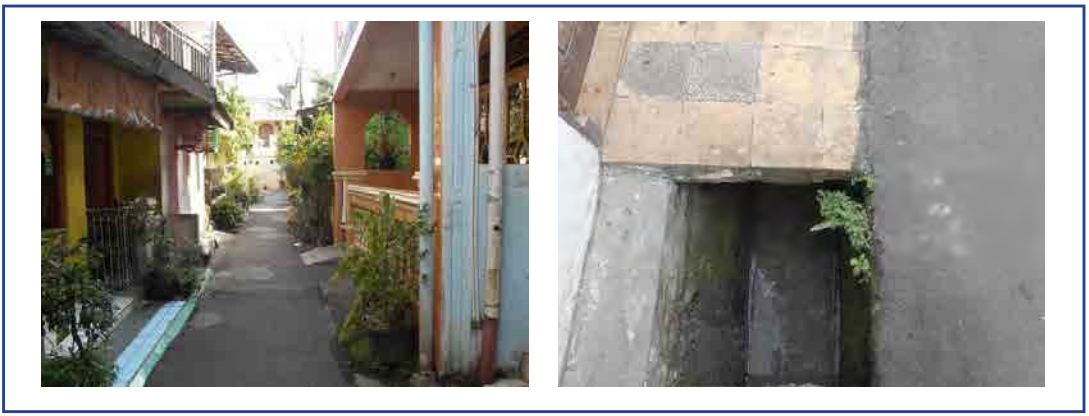
08. DETAIL OF GG. 05 (MENTENG AREA 2)

12	MENTENG	KALISURABAYA	GG. 09	∩	0,50	0,50	0,50	100,00	Failed	B/C	0,3
13	MENTENG	KALISURABAYA	GG. 10	□	0,50	0,50	0,50	65,00	-	C	0,2
14	MENTENG	KALISURABAYA	GG. 05	∩	0,50	0,40	0,50	50,00	Subsidy	B/C	0,2

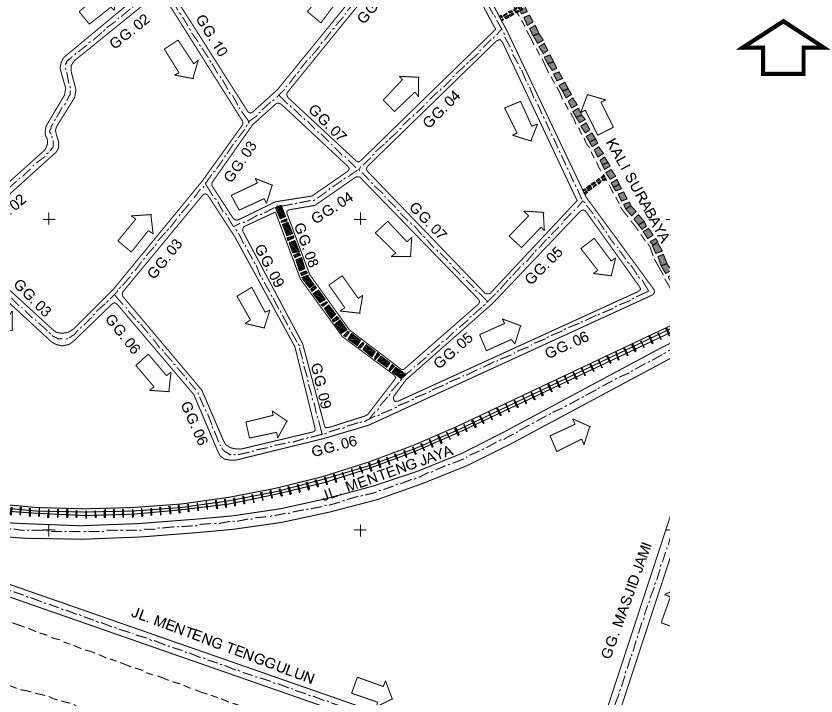
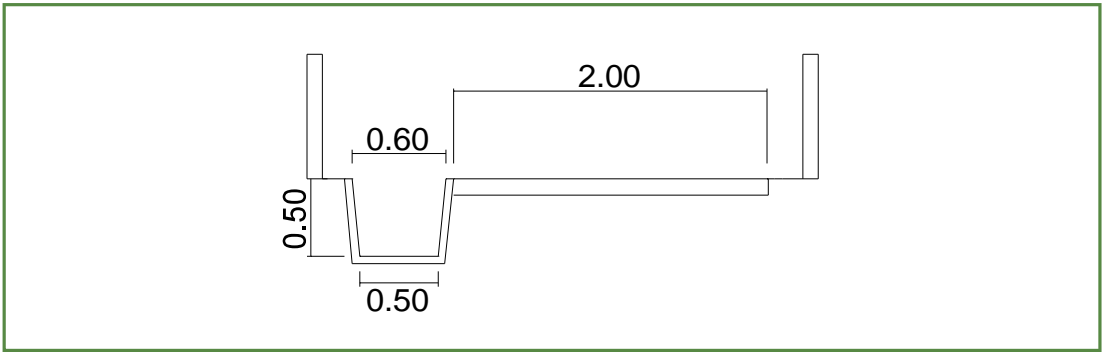
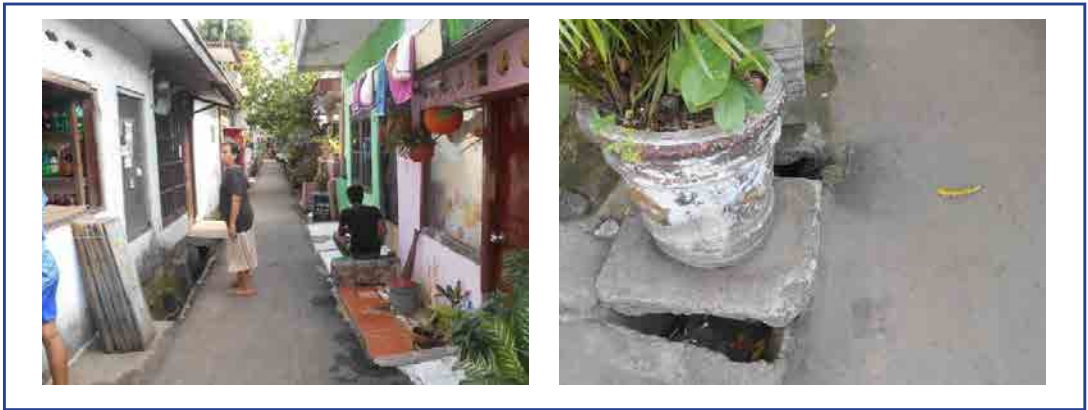
11. DETAIL OF GG. 08 (MENTENG AREA 2)

No.	Kelurahan	River Basin	Jalan	Structure					Condition		Remark
				Type	W Top / dia (m)	W Botto m (m)	H(m)	L(m)	Clogged	A	hf = Depth of flow
									Failed	B	(see encl. Photograph)
									Subsidy	C	
1	MENTENG	KALISURABAYA	SUKABUMI	□	1,00	1,00	0,90	170,00	Subsidy	B/C	0,7
2	MENTENG	KALISURABAYA	SINDANGLAYA	□	1,00	1,00	0,90	200,00	Subsidy	B/C	0,6
3	MENTENG	KALISURABAYA	MENTENG SUKABUMI	∩	0,60	0,50	0,50	235,00	Subsidy	B/C	0,15
4	MENTENG	KALISURABAYA	GG. 01	□	0,50	0,50	0,40	160,00	Subsidy	B/C	0,2
5	MENTENG	KALISURABAYA	GG. 02	□	0,50	0,50	0,40	265,00	Subsidy	B/C	0,2
6	MENTENG	KALISURABAYA	GG. 03	∩	0,60	0,50	0,50	245,00	-	C	0,2
7	MENTENG	KALISURABAYA	GG. 04	∩	0,60	0,50	0,50	110,00	-	C	0,2
8	MENTENG	KALISURABAYA	GG. 05	∩	0,60	0,50	0,50	100,00	-	C	0,15
9	MENTENG	KALISURABAYA	GG. 06	∩	0,60	0,50	0,50	215,00	-	C	0,15
10	MENTENG	KALISURABAYA	GG. 07	∩	0,50	0,40	0,50	100,00	Failed	B/C	0,2
11	MENTENG	KALISURABAYA	GG. 08	∩	0,60	0,50	0,50	75,00	Subsidy	B/C	0,2

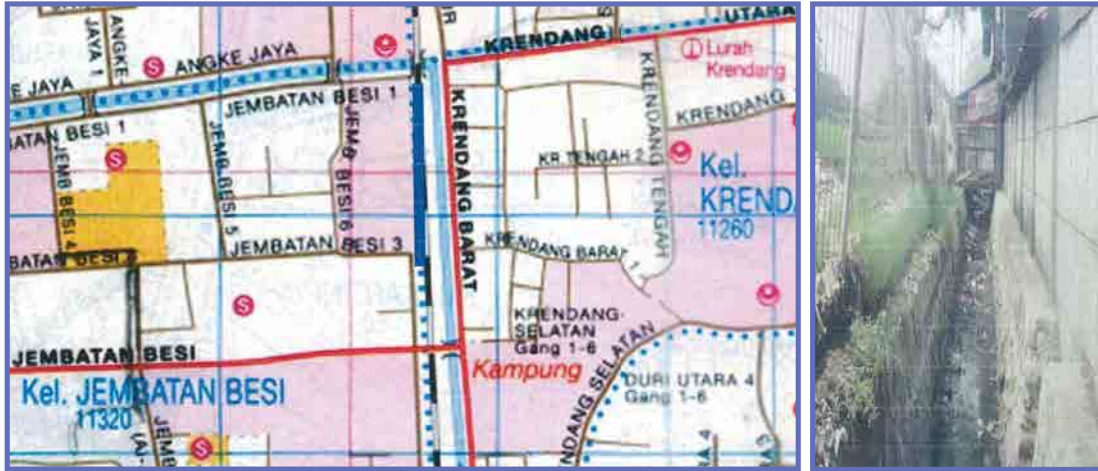
1. Nama Saluran	:	Saluran Phb. Kebon Sayur Sejajar Rel Duri Kel. Jembatan Besi
Panjang	:	255 m
Lebar Atas	:	1,00 m
Lebar Bawah	:	0,80 m
Kedalaman/Tinggi	:	1,00 m
Jenis Konstruksi	:	Batu kali
Kondisi Existing	:	Baik

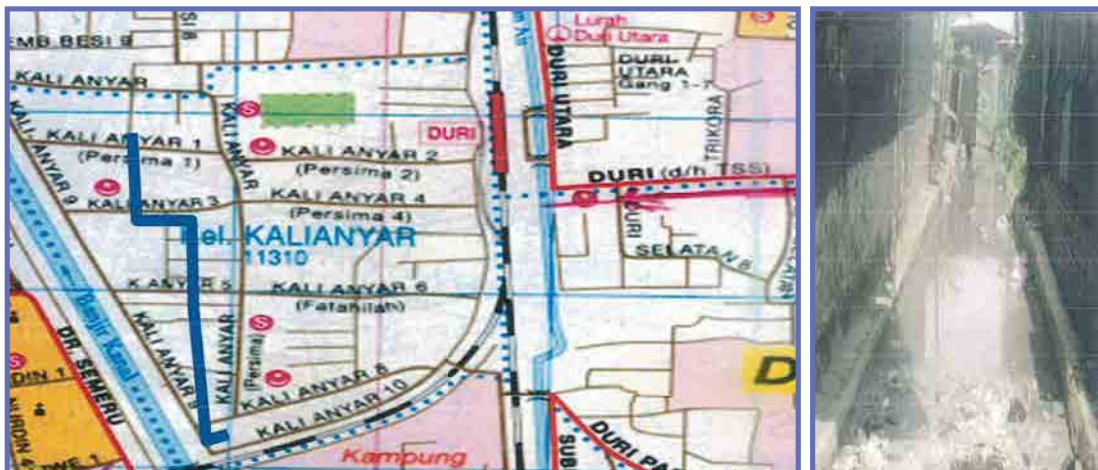
2. Nama Saluran	:	Saluran Phb. Kali Anyar Kel. Kali Anyar
Panjang	:	425 m
Lebar Atas	:	2,00 m
Lebar Bawah	:	1,50 m
Kedalaman/Tinggi	:	1,50 m
Jenis Konstruksi	:	Batu kali
Kondisi Existing	:	Baik

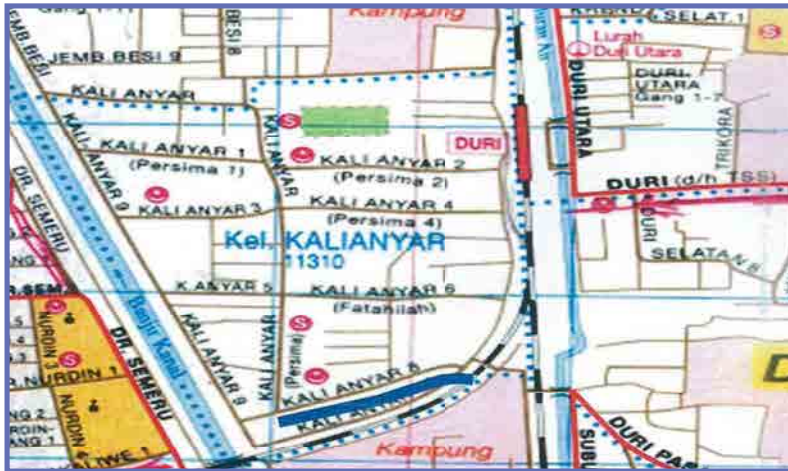
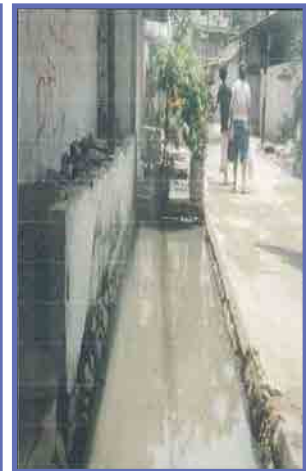
3.	Nama Saluran	:	Saluran Phb. Kali Anyar VIII Kel. Kali Anyar
	Panjang	:	425 m
	Lebar Atas	:	1,20 m
	Lebar Bawah	:	1,00 m
	Kedalaman/Tinggi	:	1,20 m
	Jenis Konstruksi	:	Batu kali
	Kondisi Existing	:	Baik

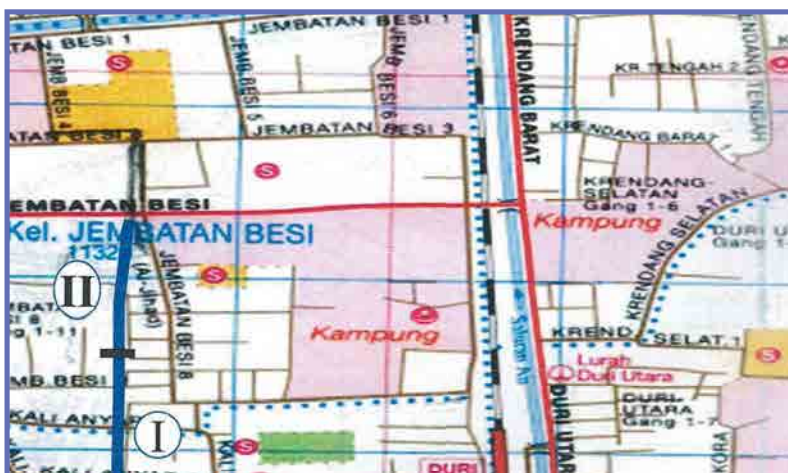
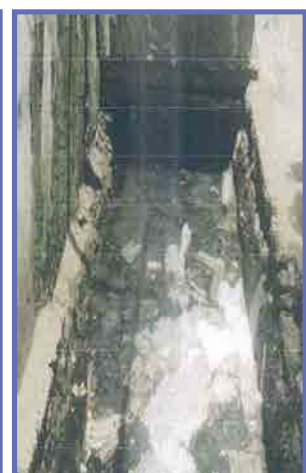
4.	Nama Saluran	:	Saluran Phb. Jembatan Besi VIII Kel. Jembatan Besi
			Segmen I                      Segmen II
	Panjang	:	124 m                      : 124 m
	Lebar Atas	:	1,00 m                      : 1,20 m
	Lebar Bawah	:	
	Kedalaman/Tinggi	:	1,00 m                      : 1,00 m
	Jenis Konstruksi	:	Beton                      : Beton
	Kondisi Existing	:

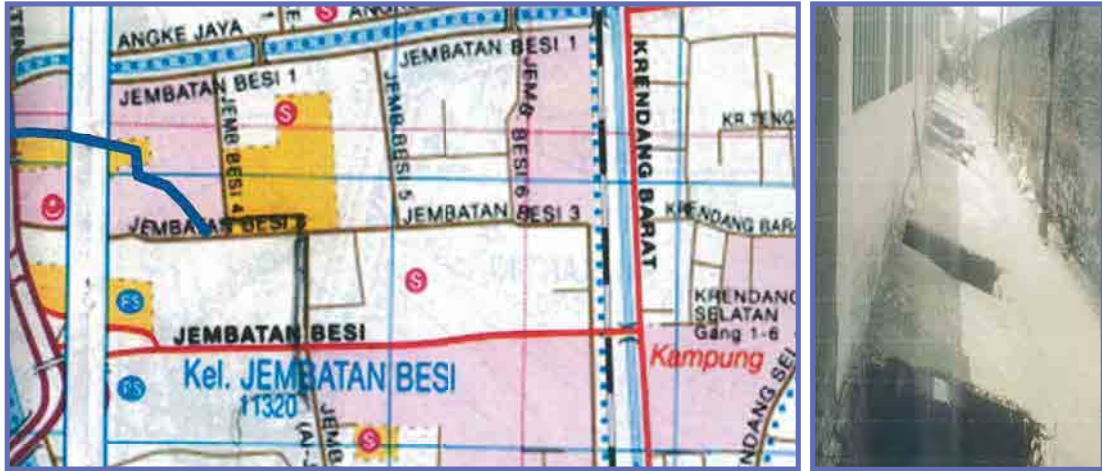
5. Nama Saluran	:	Saluran Phb. Liberty Kel. Jembatan Besi
Panjang	:	319 m
Lebar Atas	:	1,20 m
Lebar Bawah	:	1,00 m
Kedalaman/Tinggi	:	1,20 m
Jenis Konstruksi	:	Batu kali
Kondisi Existing	:	Baik

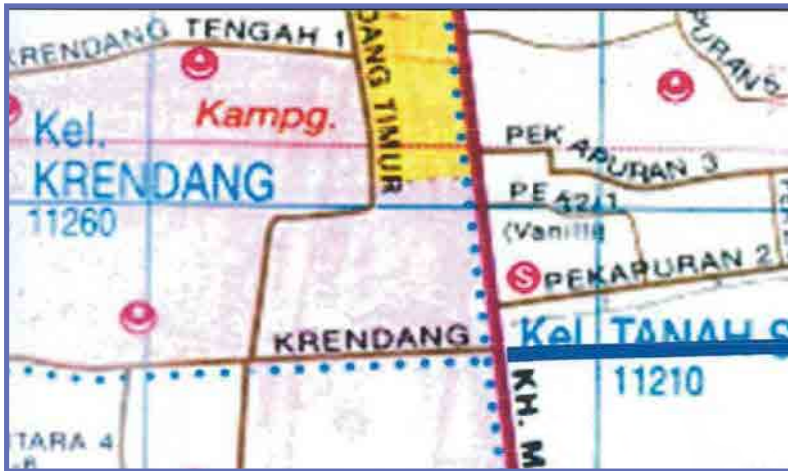
7.	Nama Saluran	:	Saluran Phb. Sang Si Kel. Tanah Sereal
	Panjang	:	565 m
	Lebar Atas	:	1,50 m
	Lebar Bawah	:	1,20 m
	Kedalaman/Tinggi	:	1,50 m
	Jenis Konstruksi	:	Batu kali
	Kondisi Existing	:	Baik

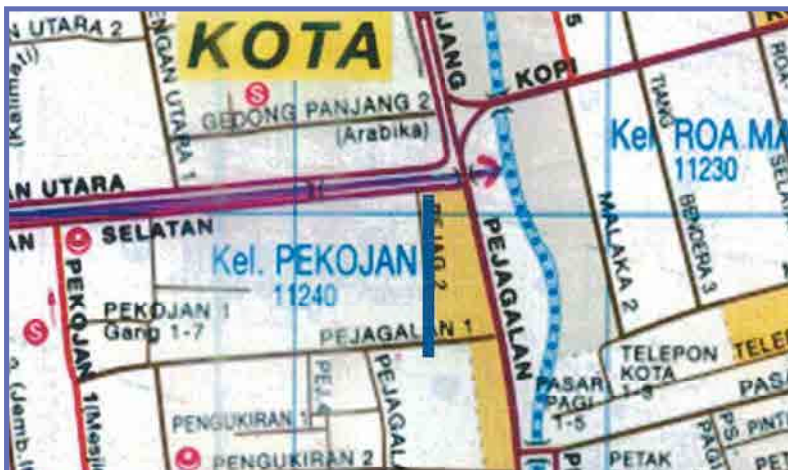
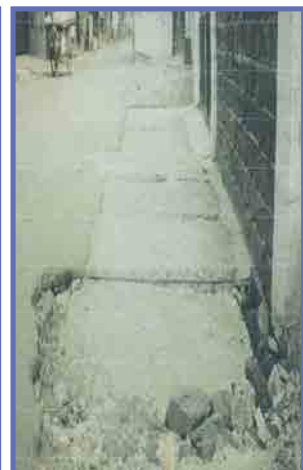
8.	Nama Saluran	:	Saluran Phb. Pejagalan II Kel. Pekojan
	Panjang	:	275 m
	Lebar Atas	:	1,20 m
	Lebar Bawah	:	
	Kedalaman/Tinggi	:	1,20 m
	Jenis Konstruksi	:	Beton
	Kondisi Existing	:	Tertutup

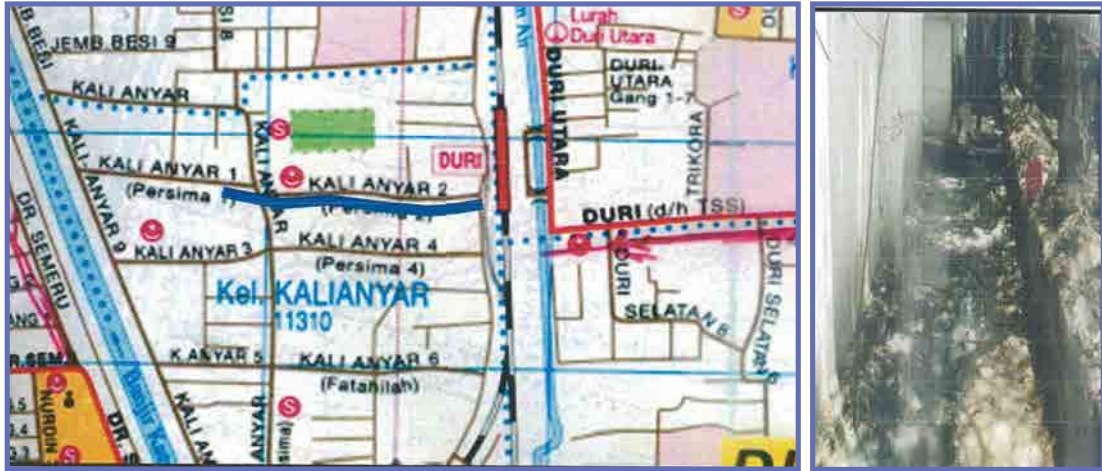
9. Nama Saluran	:	Saluran Phb. Kali Anyar I Kel. Kali Anyar
Panjang	:	452 m
Lebar Atas	:	2,00 m
Lebar Bawah	:	1,20 m
Kedalaman/Tinggi	:	1,20 m
Jenis Konstruksi	:	Batu kali
Kondisi Existing	:	Kurang baik

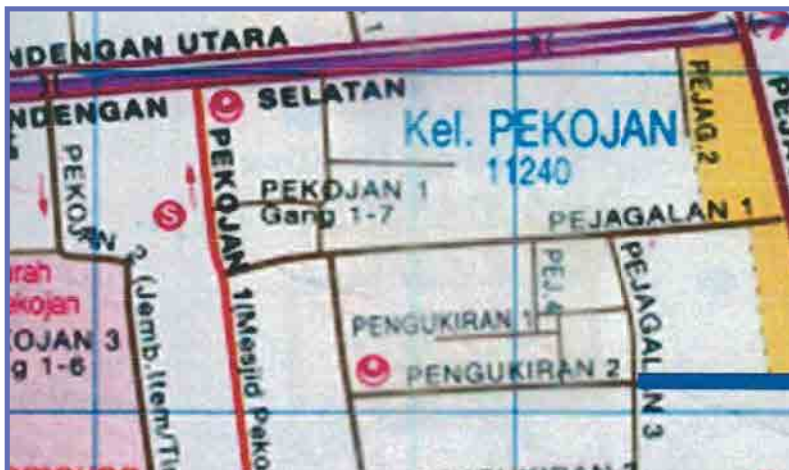
10. Nama Saluran	:	Saluran Phb. Pejagalan III Kel. Pekojan
Panjang	:	225 m
Lebar Atas	:	0,80 m
Lebar Bawah	:	0,80 m
Kedalaman/Tinggi	:	0,80 m
Jenis Konstruksi	:	Beton
Kondisi Existing	:	Baik

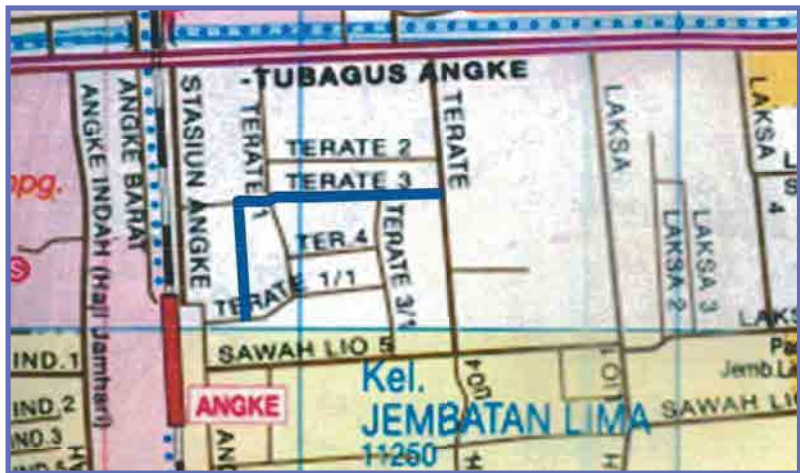
11. Nama Saluran	:	Saluran Phb. Teratai Dalam / Teratai III Kel. Jembatan Lima
Panjang	:	375 m
Lebar Atas	:	1,00 m
Lebar Bawah	:	0,80 m
Kedalaman/Tinggi	:	1,00 m
Jenis Konstruksi	:	Batu kali
Kondisi Existing	:	Baik

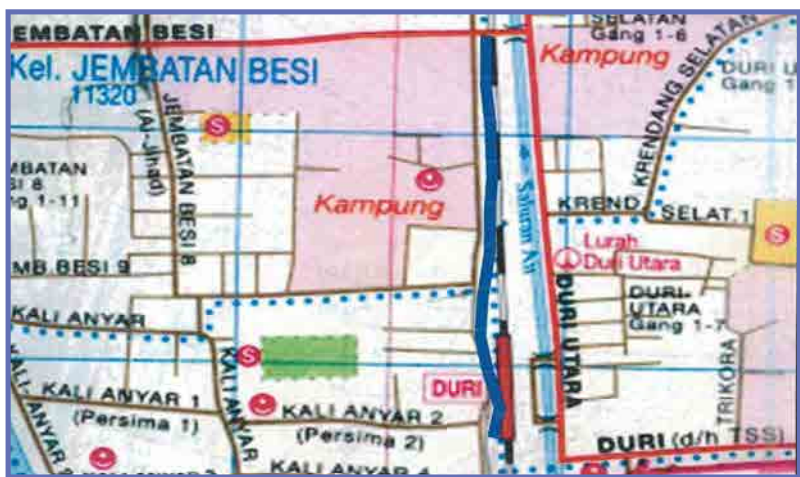
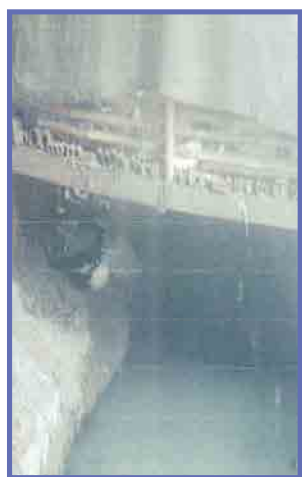
12. Nama Saluran	:	Saluran Phb. Duri Bangkit Kel. Jembatan Lima
Panjang	:	438 m
Lebar Atas	:	2,25 m
Lebar Bawah	:	2,00 m
Kedalaman/Tinggi	:	1,75 m
Jenis Konstruksi	:	Batu kali
Kondisi Existing	:	Baik

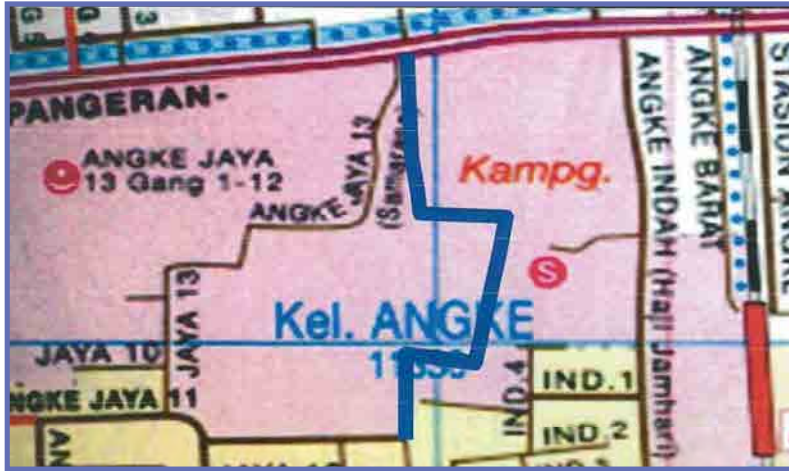
13. Nama Saluran	:	Saluran Phb. Sama Rasa Kel. Angke
Panjang	:	358 m
Lebar Atas	:	1,00 m
Lebar Bawah	:	0,80 m
Kedalaman/Tinggi	:	1,00 m
Jenis Konstruksi	:	Batu kali
Kondisi Existing	:	Baik

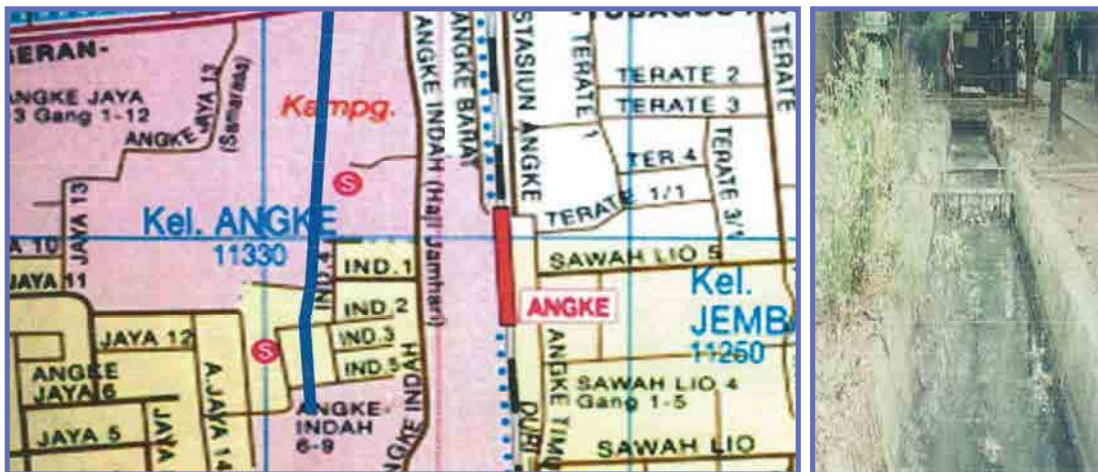
14. Nama Saluran	:	Saluran Phb. Kali Anyar Kel. Kali Anyar
Panjang	:	874 m
Lebar Atas	:	1,00 m
Lebar Bawah	:	0,80 m
Kedalaman/Tinggi	:	1,00 m
Jenis Konstruksi	:	Batu kali
Kondisi Existing	:	Baik

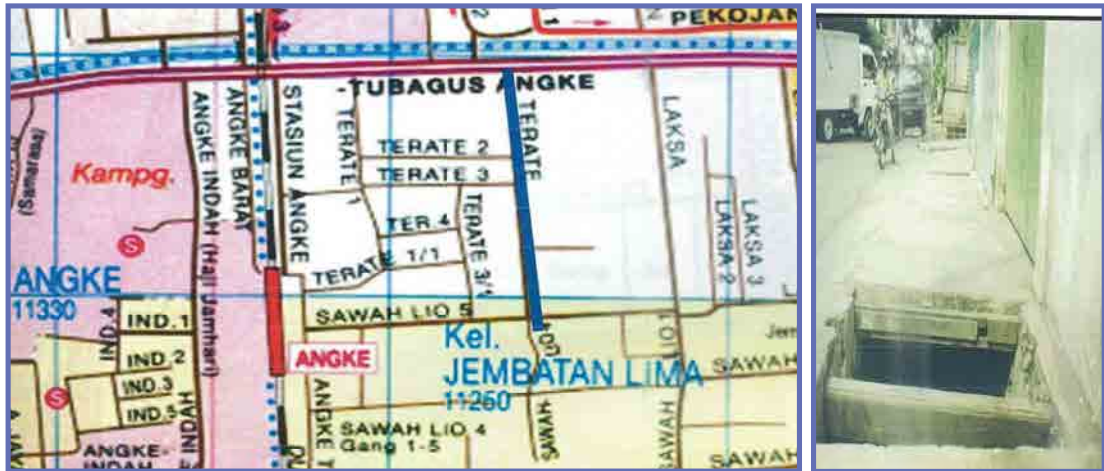
15. Nama Saluran	:	Saluran Phb. Teratai Kel. Jembatan Lima
Panjang	:	375 m
Lebar Atas	:	1,20 m
Lebar Bawah	:	1,00 m
Kedalaman/Tinggi	:	1,20 m
Jenis Konstruksi	:	Batu kali
Kondisi Existing	:	Baik

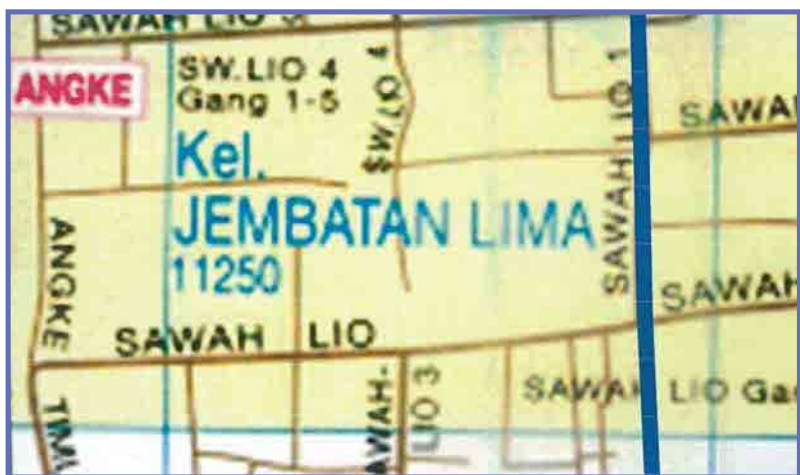
16. Nama Saluran	:	Saluran Phb. Sawah Lio Kel. Jembatan Lima
Panjang	:	375 m
Lebar Atas	:	1,50 m
Lebar Bawah	:	1,20 m
Kedalaman/Tinggi	:	1,50 m
Jenis Konstruksi	:	Batu kali
Kondisi Existing	:	Baik

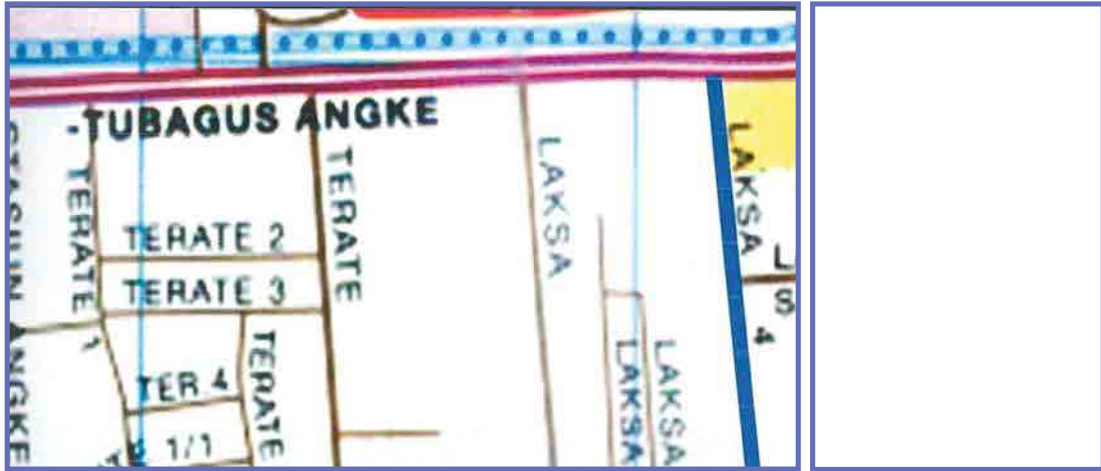
17. Nama Saluran	:	Saluran Phb. Laksa IV Kel. Jembatan Lima
Panjang	:	325 m
Lebar Atas	:	1,50 m
Lebar Bawah	:	1,20 m
Kedalaman/Tinggi	:	1,50 m
Jenis Konstruksi	:	Batu kali
Kondisi Existing	:	Baik

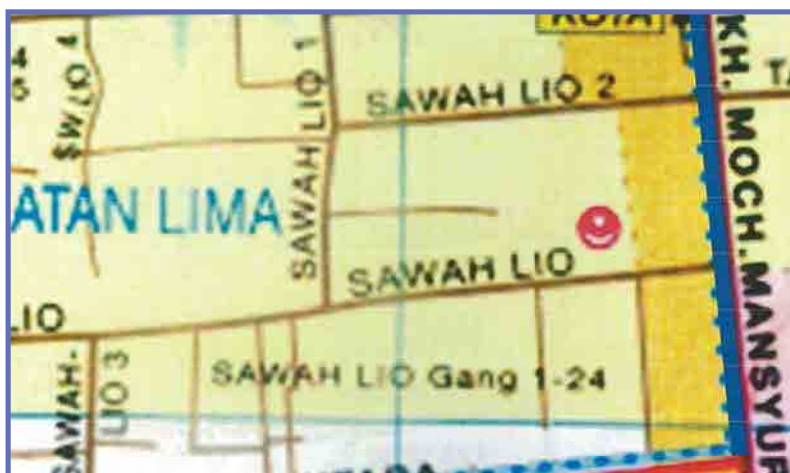
20. Nama Saluran	:	Saluran Phb. Mas Mansyur Kel. Jembatan Lima
Panjang	:	655 m
Lebar Atas	:	4,00 m
Lebar Bawah	:	3,50 m
Kedalaman/Tinggi	:	2,00 m
Jenis Konstruksi	:	Beton
Kondisi Existing	:	Baik

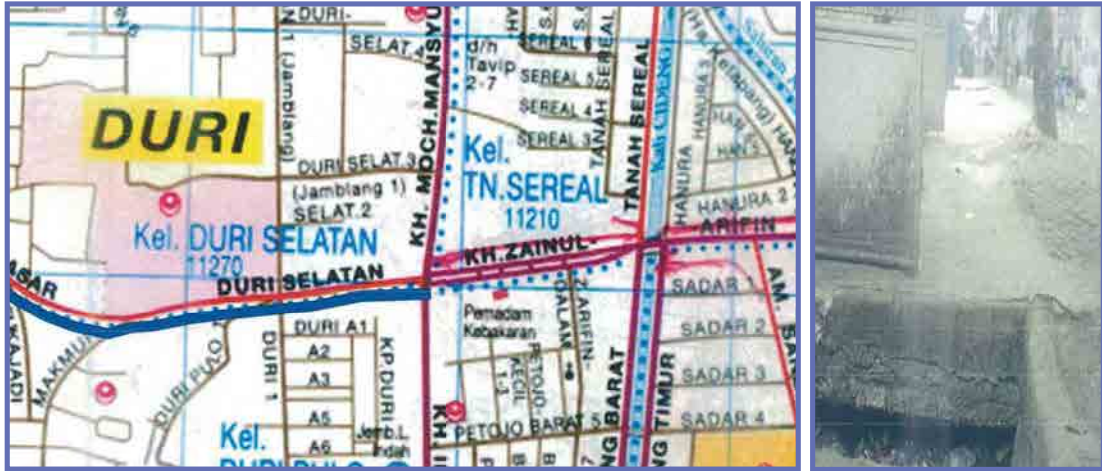
21. Nama Saluran	:	Saluran Phb. Duri Selatan Kel. Duri Selatan
Panjang	:	800 m
Lebar Atas	:	1,50 m
Lebar Bawah	:	1,20 m
Kedalaman/Tinggi	:	1,50 m
Jenis Konstruksi	:	Batu kali
Kondisi Existing	:	Baik

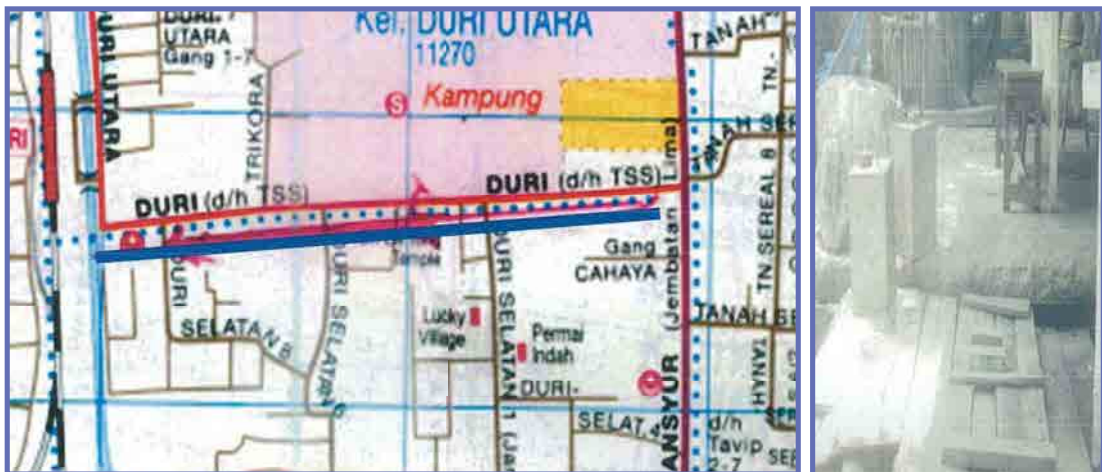
22. Nama Saluran	:	Saluran Phb. Duri (TSS) Kel. Duri Selatan
Panjang	:	685 m
Lebar Atas	:	1,50 m
Lebar Bawah	:	1,20 m
Kedalaman/Tinggi	:	1,50 m
Jenis Konstruksi	:	Batu kali
Kondisi Existing	:	Baik

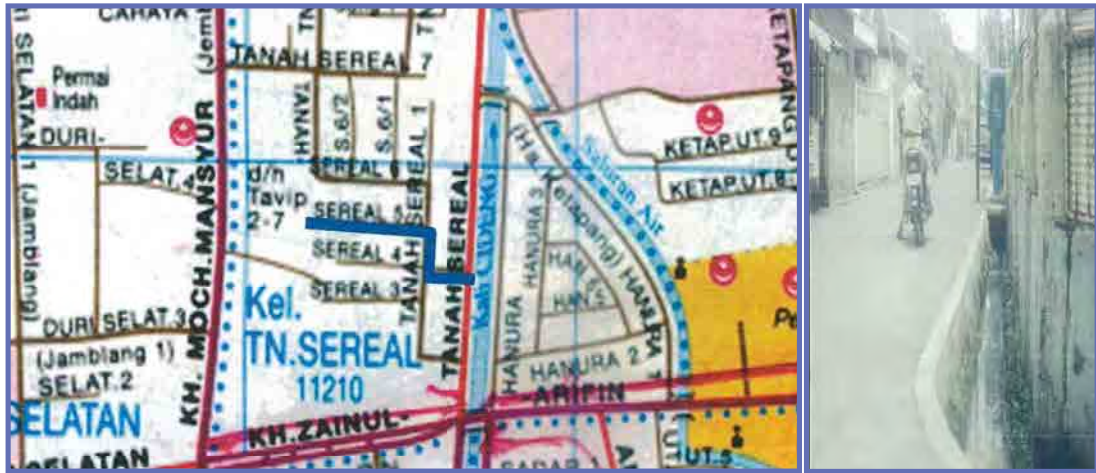
23. Nama Saluran	:	Saluran Phb. Tanah Sereal V Kel. Tanah Sereal
Panjang	:	380 m
Lebar Atas	:	1,00 m
Lebar Bawah	:	0,80 m
Kedalaman/Tinggi	:	1,00 m
Jenis Konstruksi	:	Batu kali
Kondisi Existing	:	Baik

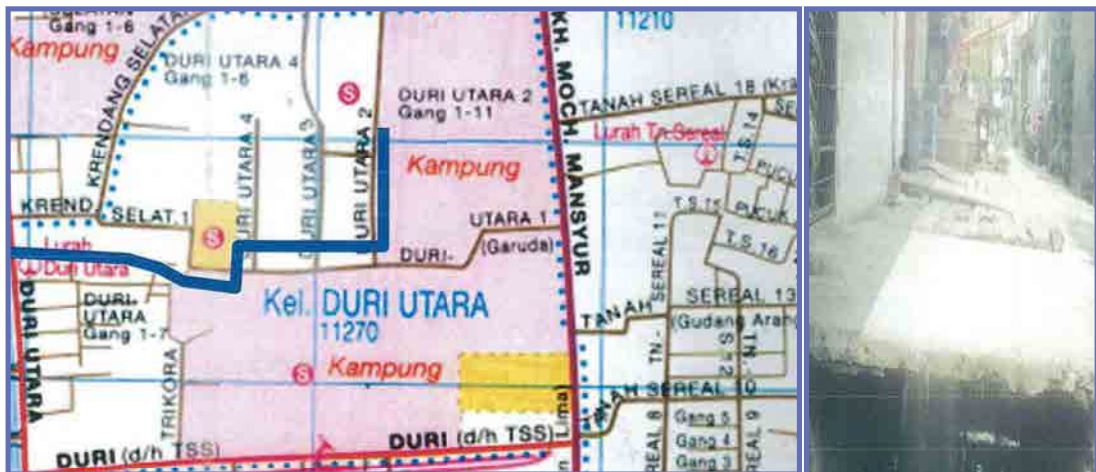
24. Nama Saluran	:	Saluran Phb. Lembayung Kel. Duri Utara
Panjang	:	657 m
Lebar Atas	:	1,50 m
Lebar Bawah	:	1,20 m
Kedalaman/Tinggi	:	1,50 m
Jenis Konstruksi	:	Batu kali
Kondisi Existing	:	Baik
