5.2.2.Detail Survey in Model Area  
a. Maps of Pilot Model District

## b. District Model Tanah Abvang Kec. Tanah Abang

REPORT OF EXISTING DRAINAGE SYSTEM

## 6. THE CONDITION OF DRAINAGE CHANNEL IN SURVEY AREA

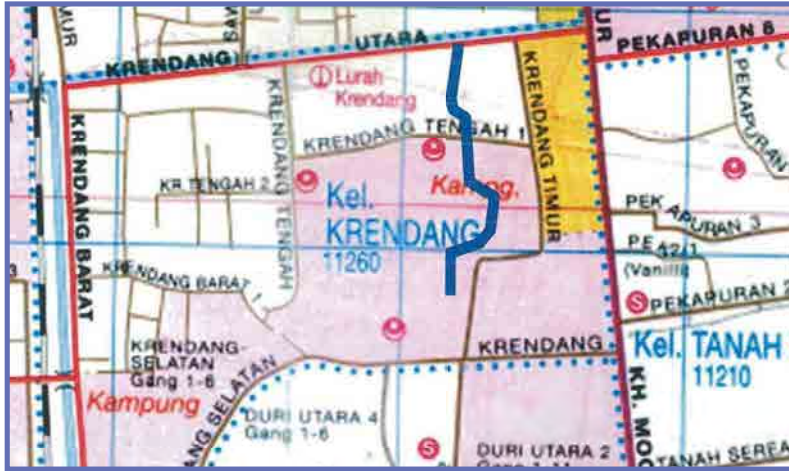
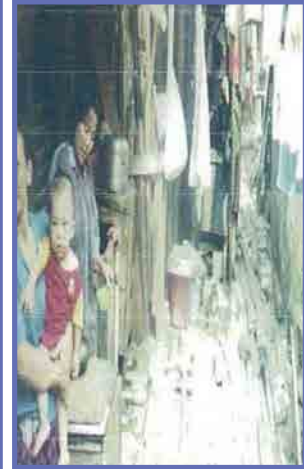
25. Nama Saluran	:	Saluran Phb. Krendang Kel. Krendang
Panjang	:	850 m
Lebar Atas	:	1,50 m
Lebar Bawah	:	1,20 m
Kedalaman/Tinggi	:	1,50 m
Jenis Konstruksi	:	Batu kali
Kondisi Existing	:	Baik

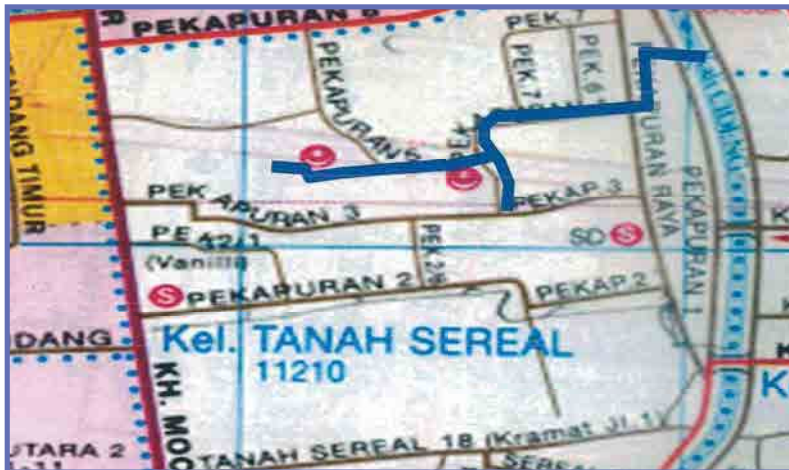
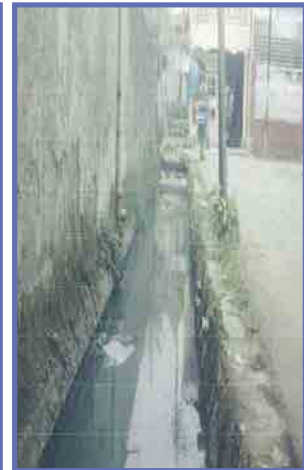
26. Nama Saluran	:	Saluran Phb. Pekapuran Kel. Tanah Sereal
Panjang	:	675 m
Lebar Atas	:	1,20 m
Lebar Bawah	:	1,00 m
Kedalaman/Tinggi	:	1,20 m
Jenis Konstruksi	:	Batu kali
Kondisi Existing	:	Baik

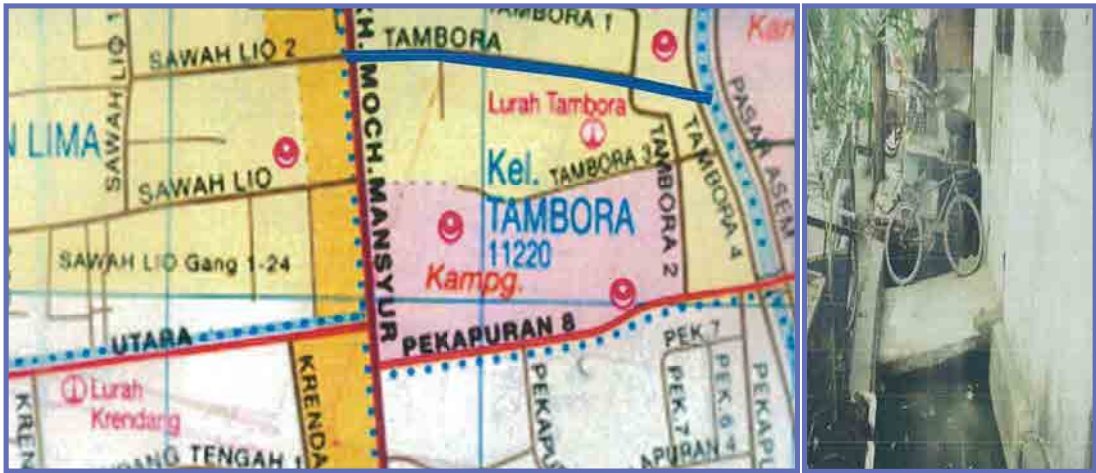
27. Nama Saluran	:	Saluran Phb. Tambora Kel. Tambora
Panjang	:	425 m
Lebar Atas	:	1,20 m
Lebar Bawah	:	
Kedalaman/Tinggi	:	1,20 m
Jenis Konstruksi	:	Beton
Kondisi Existing	:

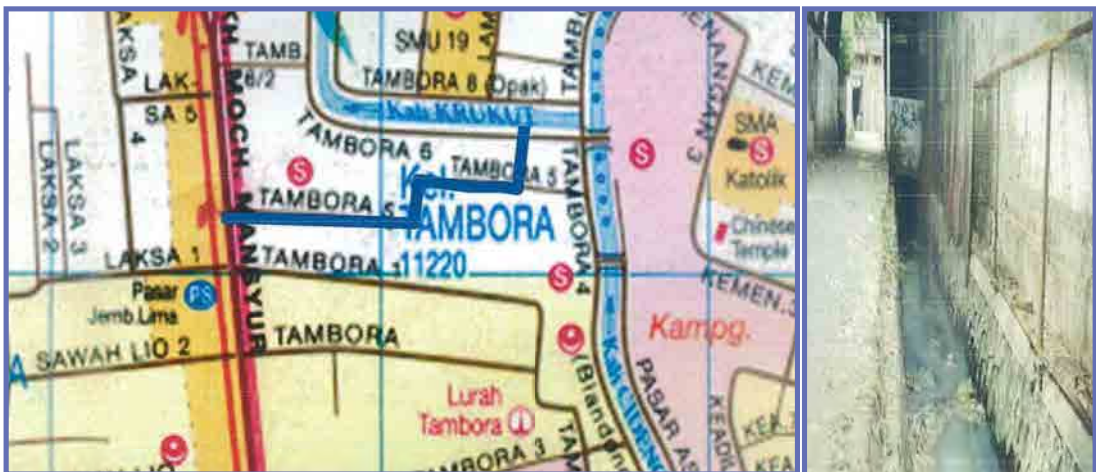
28. Nama Saluran	:	Saluran Phb. Tambora V Kel. Tambora
Panjang	:	365 m
Lebar Atas	:	1,20 m
Lebar Bawah	:	1,00 m
Kedalaman/Tinggi	:	1,20 m
Jenis Konstruksi	:	Batu kali
Kondisi Existing	:

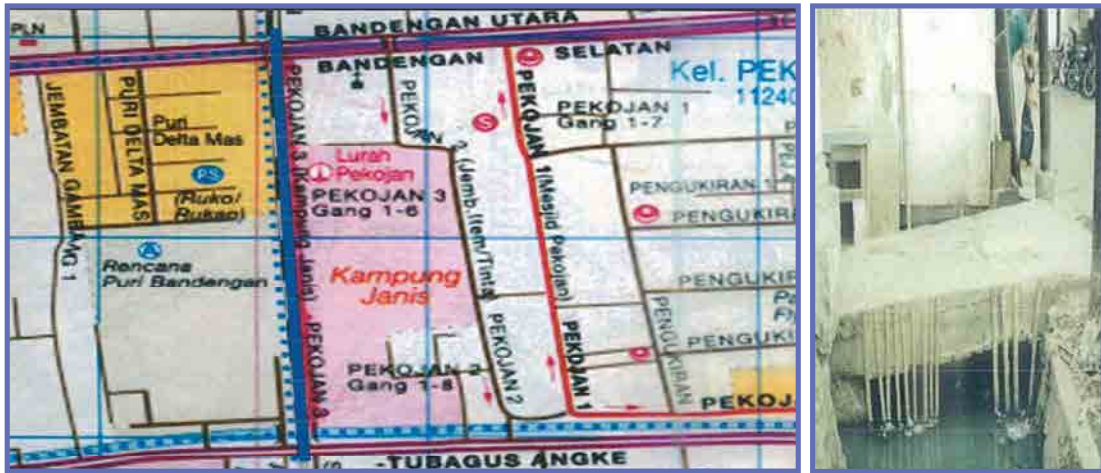
29. Nama Saluran	:	Saluran Phb. Kampung Janis/Pekojan III Kel. Pekojan
Panjang	:	570 m
Lebar Atas	:	1,50 m
Lebar Bawah	:	1,20 m
Kedalaman/Tinggi	:	1,50 m
Jenis Konstruksi	:	Batu kali
Kondisi Existing	:	Baik

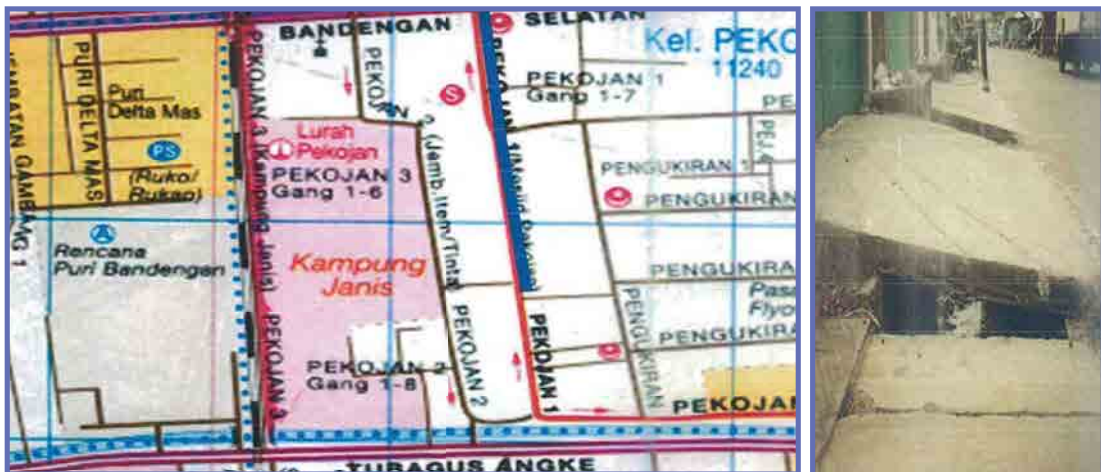
30. Nama Saluran	:	Saluran Phb. Pekojan I Kel. Pekojan
Panjang	:	225 m
Lebar Atas	:	1,00 m
Lebar Bawah	:	
Kedalaman/Tinggi	:	1,20 m
Jenis Konstruksi	:	Beton
Kondisi Existing	:	Baik

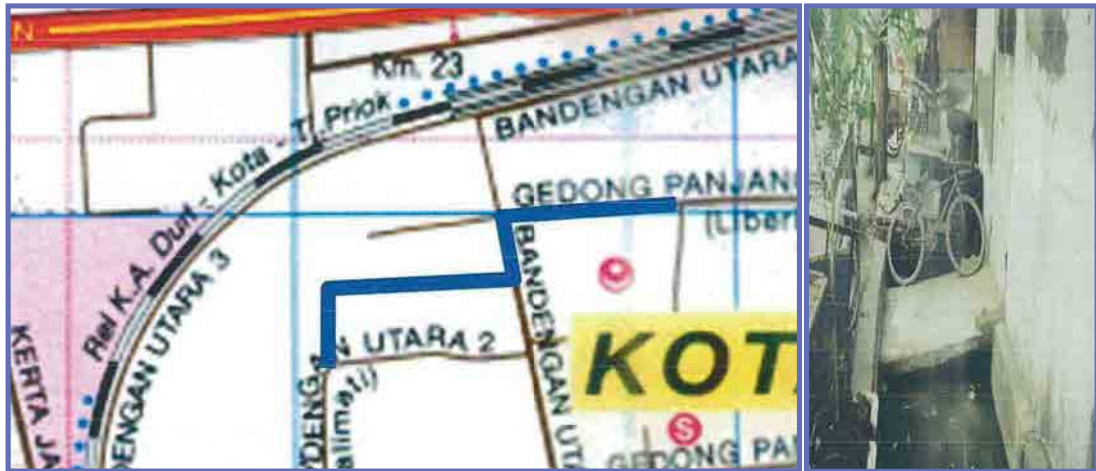
31. Nama Saluran	:	Saluran Phb. Gedong Panjang Kel. Pekojan
Panjang	:	225 m
Lebar Atas	:	1,00 m
Lebar Bawah	:	
Kedalaman/Tinggi	:	1,20 m
Jenis Konstruksi	:	Batu kali
Kondisi Existing	:	Baik

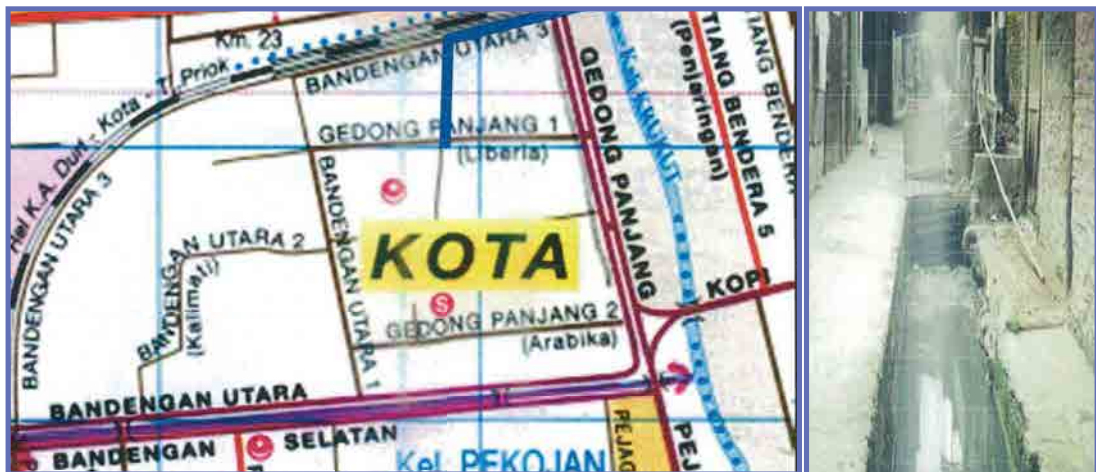
32. Nama Saluran	:	Saluran Phb. Gedong Panjang Kel. Pekojan
Panjang	:	575 m
Lebar Atas	:	1,20 m
Lebar Bawah	:	0,80 m
Kedalaman/Tinggi	:	1,20 m
Jenis Konstruksi	:	Batu kali
Kondisi Existing	:	Baik

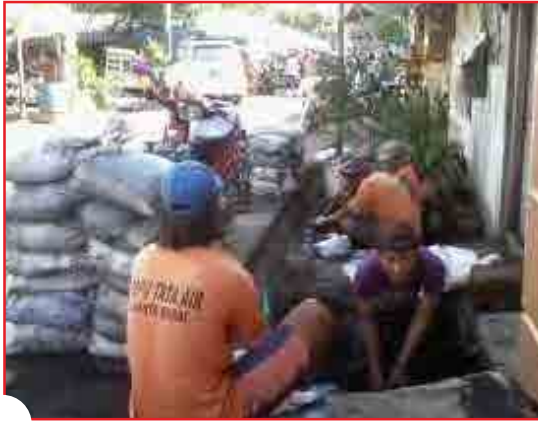
Excavation of sedimentation by man power at Jembatan Besi (Tambora)

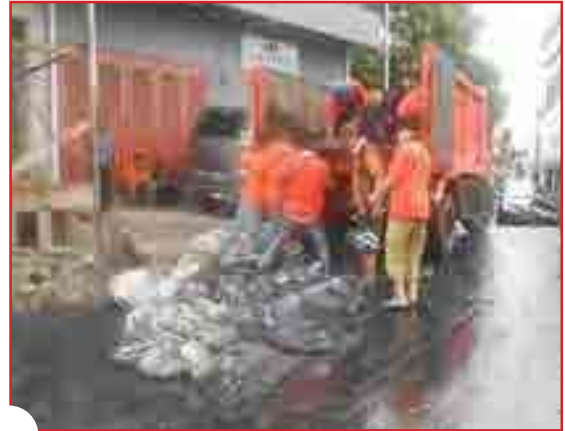
Taking sacks that contains sediment dredging up truck

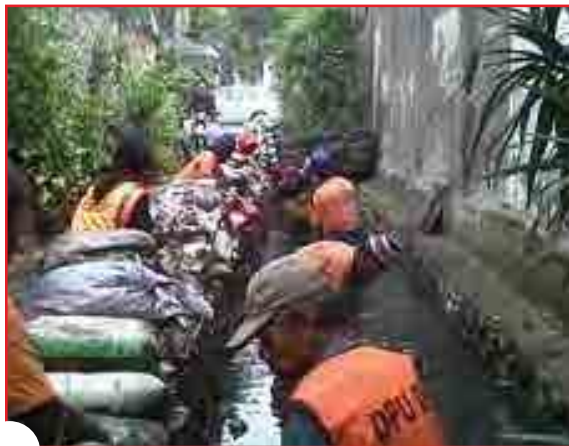
Excavation of sedimentation by man power at Saluran PHB Liberty (Tambora)

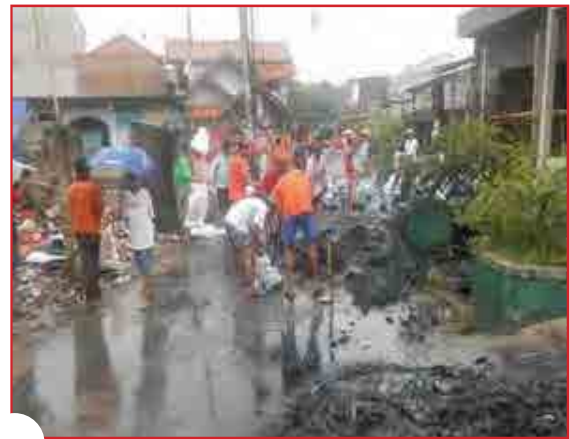
To put the land of sedimentation that has been dredged into the sacks by man power at PHB Klingkit, Rawa Buaya - Cengkareng

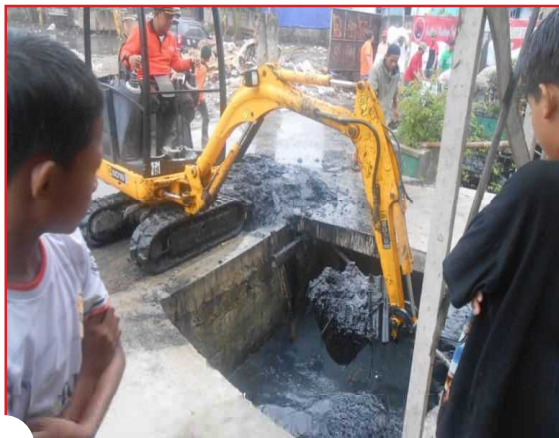
Excavation of sedimentation by mini bac khoe at PHB Klingkit Rawa Buaya - Cengkareng

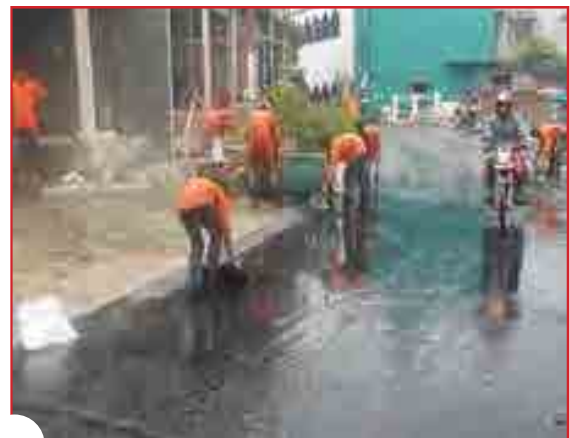
Road cleansing at PHB Klingkit, Rawa Buaya - Cengkareng

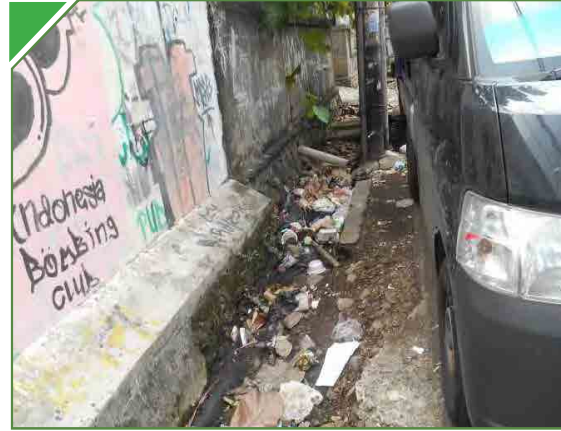
Clogging at Jl. Kebonpala 2

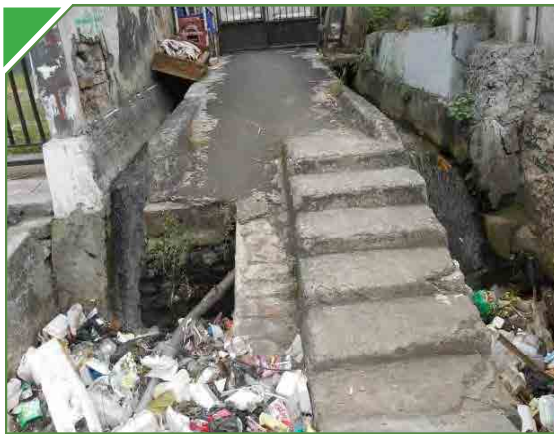
End of Jl. Kebonpala 9

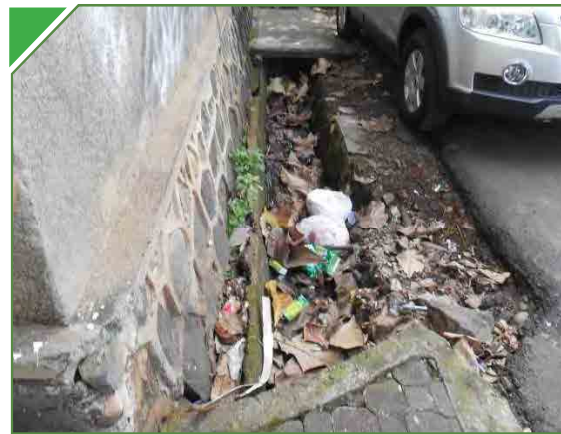
Clogging at Gg. Mas
