**THE PROJECT FOR CAPACITY  
DEVELOPMENT ON COASTAL  
PROTECTION AND REHABILITATION  
IN THE REPUBLIC OF MAURITIUS**

**FINAL REPORT**

**COASTAL CONSERVATION PLAN**

**(Volume 2)**

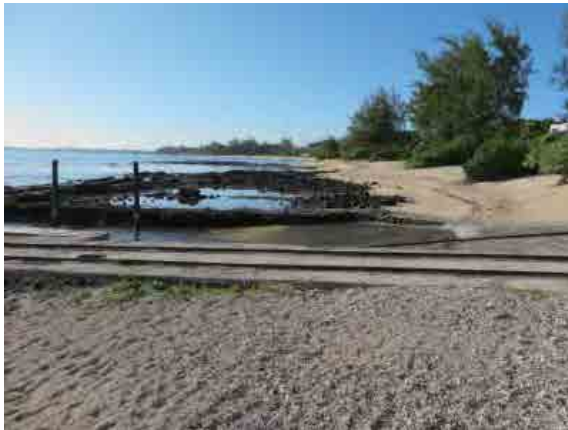
Point A (At the end of the slipway)

The littoral drift eastward is estimated from the west end toward the vicinity of the central part by the coastline changes of both sides of the ramp at the point A, and the coastlines shapes at the point B and C (refer to Figure 2.3.1). At the points B and C there are wide beaches. The beach sand is coarser compared with the sand of Mon Choisy and many coral gravel is scattered on the beach. The berm is high and the slope is steep from 1:5 to 1:7. The waves are estimated higher than those at Mon Choisy from such beach conditions. The beach is disappeared in front of the vertical revetments at the points D and E. At the point F near the eastern end, there are rock reefs, gravels and accumulation of gravels in the sand traps set by the lessees.

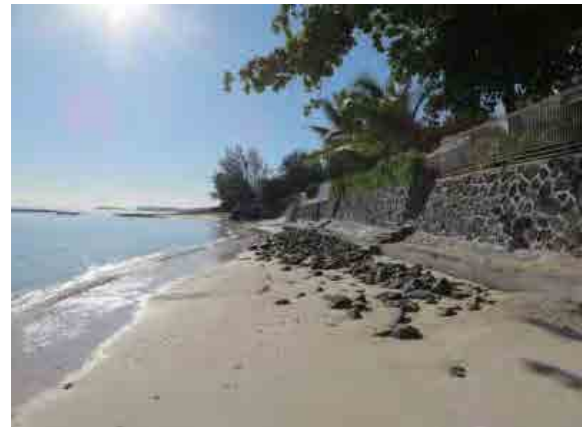
Point D (Eroded area, looking to the east)

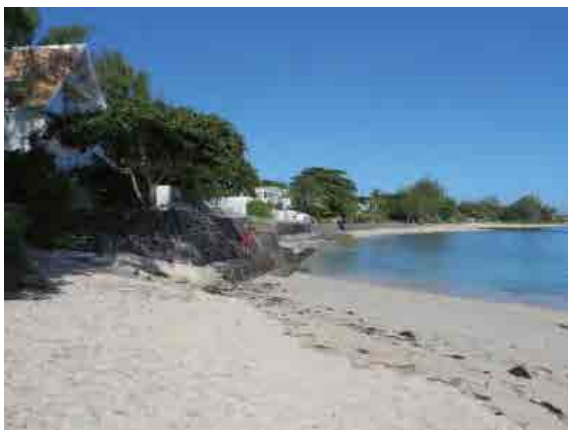
Point E (Eroded area, looking to the west)

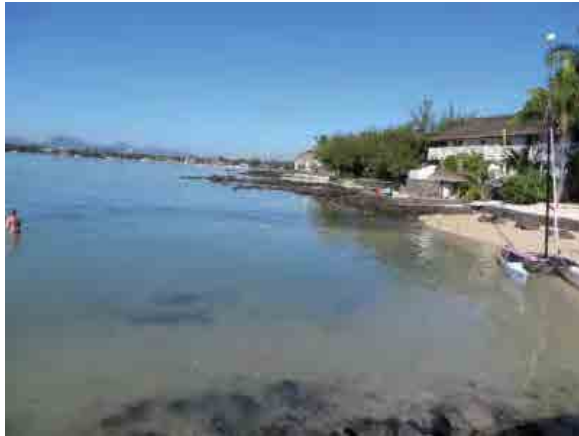
Point G (Small hotel)

The presence of southward littoral drift is clear from the entrance of Grand Baie (at the north) to the bottom of the bay (at the south) by the coastal condition at the east area (point G and H). At the northern end there are small hotels that established groynes by themselves to control the littoral drift to the south with the aim of ensuring a sandy beach in a limited range. The point I, was designated last year as a public beach, however, there is no sand beach in the front part so gabions were installed for land protection. MOESDDBM has already removed the gabions and gravels placed. At point J, is a residential area, there is no sandy beach and the coastal condition is the worst of these areas. And each lessee individually took measures such as small groynes and revetments which lead to the collapsing of littoral drift balance causing the adverse effect to the south. Point K, is 200 m before the southern end groyne and from this point the sand beach appears to form a curved coastline to the south groyne. Ahead from the Point L, which is the groyne at the southern end point, the sandy beach completely has disappeared, and it is the last groyne that is fully stopping the southward sand drift in this area.

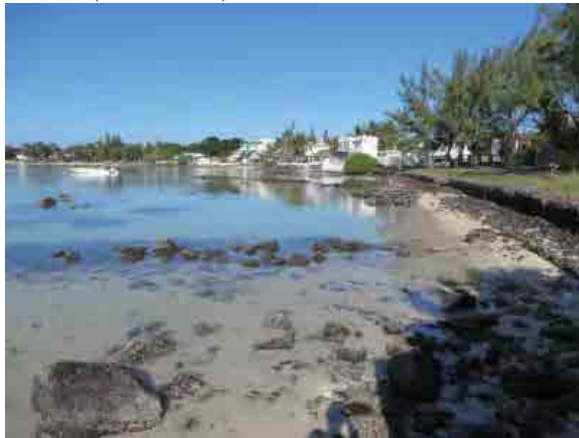
Point I (Public Beach)  
(Gabion was already removed in 2014)

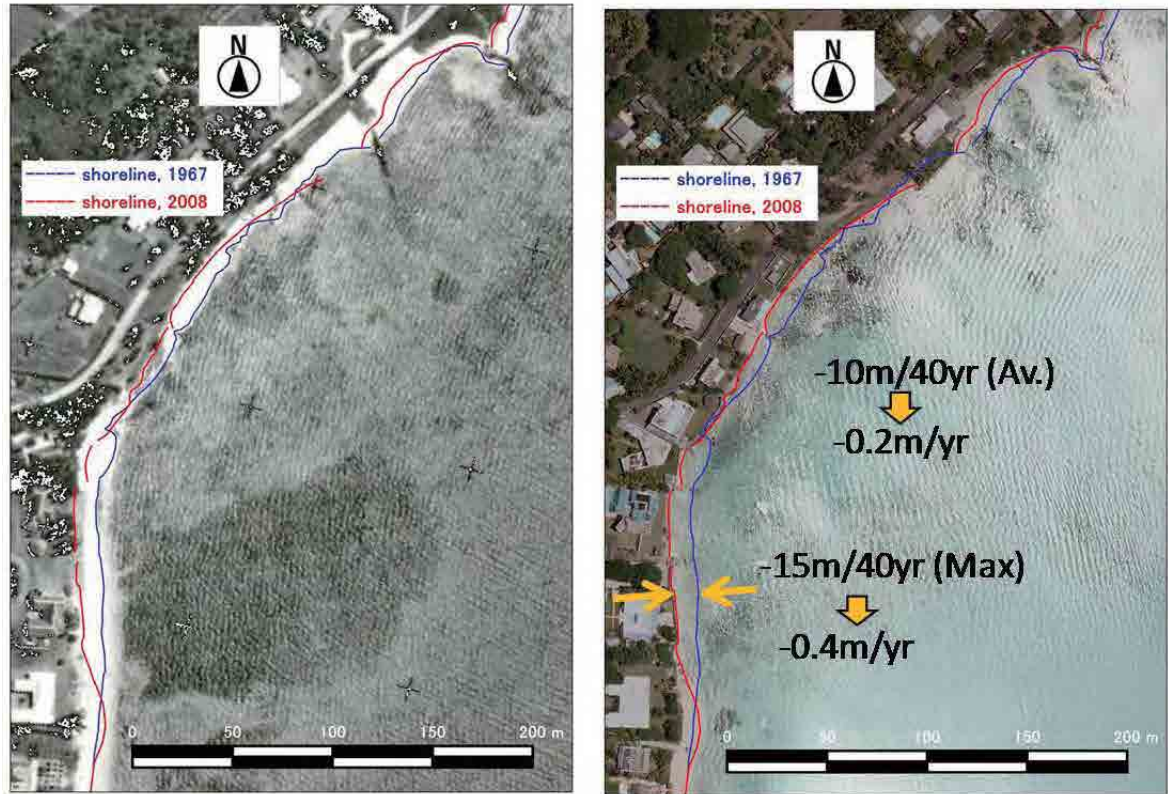
Figure 2.2.9 Comparison of Aerial Photo (Eroded east area), (left:1967, right:2008)

- The coast line has not changed at north rocky area, however, the middle of the curved part shows significant erosion. The most eroded area is sub cell No.6 as shown in Figure 2.2.10. The coastline eroded 15 m at the maximum of 0.4m/y within 45 years. Most of the beach here has already been eroded away and there has been almost no change over the last 10 years.
- The eroded area moves to the south and the sub cell No.7 has eroded over the last 10 years.
- The eroded volume was about 5,000 m<sup>3</sup> over 45 years at sub cell No.6 and the sediment loss of about 7,000 m<sup>3</sup> in the whole of east area was estimated from the changes of sediment budget in Figure 2.2.10.

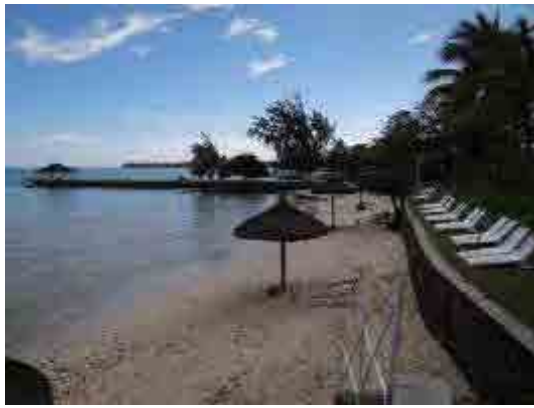
Point A (Groyne in front of the hotel at south area)

Figure 3.2.1 shows the location of photographs taken in January 2013, and each photograph is shown in Figure 3.2.2. The revetment and groynes were constructed during 1975 to 1991 at point A. The photos of the camping area located at northern side are shown in point B and C. The beach scarp with approximately 350m length was observed at the southern side of the public beach as shown in point D. The height of the scarp was roughly 2m. The scarp gradually disappeared toward the north and the sandy beach with mild slope exists at north side of the public beach as shown in point E. Point F shows the private beach of Club Med. According to the old aerial photograph, the vertical seawall in front of the hotel area was constructed during 1991 to 1997. The small groyne was constructed at north side of the seawall before 1967.

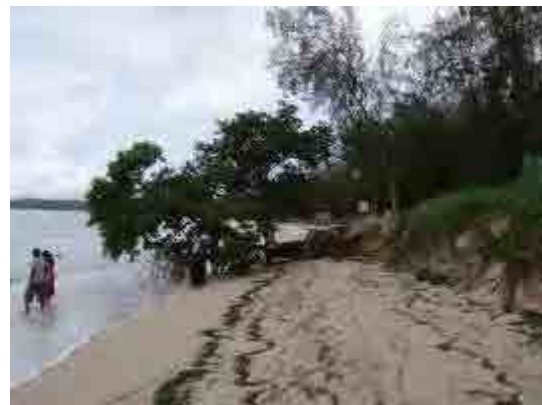
Point D (Scarp at south side of the public beach)

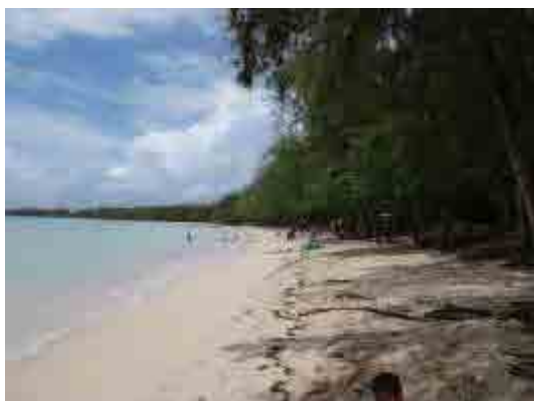
Point E (North side of the public beach)

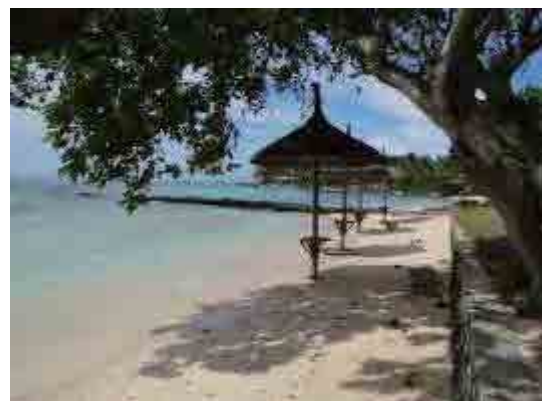
Point F (in front of Club Med)

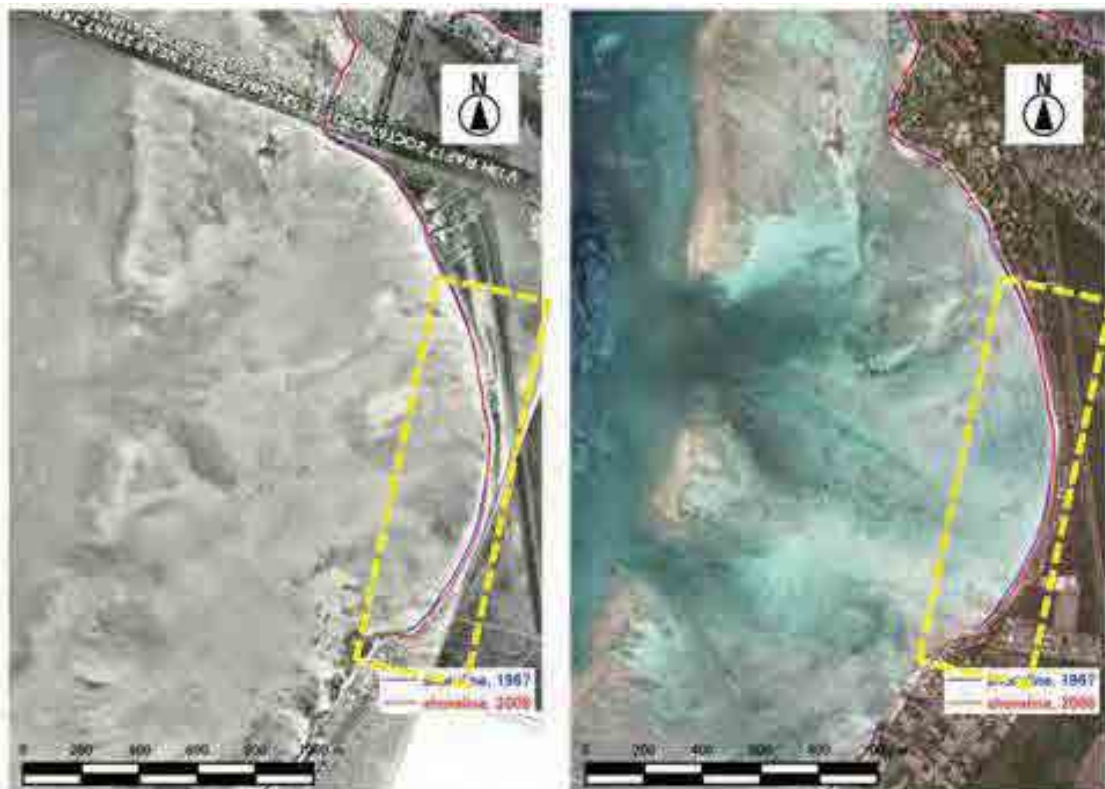
Figure 3.2.4 Comparison of Aerial Photo (Whole area), left:1967, right: 2008

Figure 3.2.4 shows vertical aerial and satellite photographs taken in 1975 and 2008 and Figure 3.2.5 shows an enlargement of the eroded area. The position of the shoreline in 1975 is described by a blue line and in 2008 by a red line. Figure 3.2.6 shows the sediment budget for six periods from 1967 to 2012. The volume was calculated from the result of area change. The value of 2.5m as the average height of sediment movement at coral beaches in Mauritius was assumed for calculating the volume from the area of change.

- The shoreline at south of the public beach ( sub cell No.7) was eroded 12m on average and 18m at the maximum within 45 years from 1967. The erosion seems to be continuing at present. The rate of erosion is 0.3m/y on average and 0.45m/yr at the maximum. The sediment budget at sub cell No.7 is about  $-20,000\text{m}^3$  (loss).
- Significant changes of shoreline cannot be observed at sub cell No.5. Also the sediment budget at sub cell No.6 is slight increased even though some changes were observed. The sand budget in total is  $-20,000\text{m}^3$  for 40 years and this beach is categorized as “totally eroded beach”.

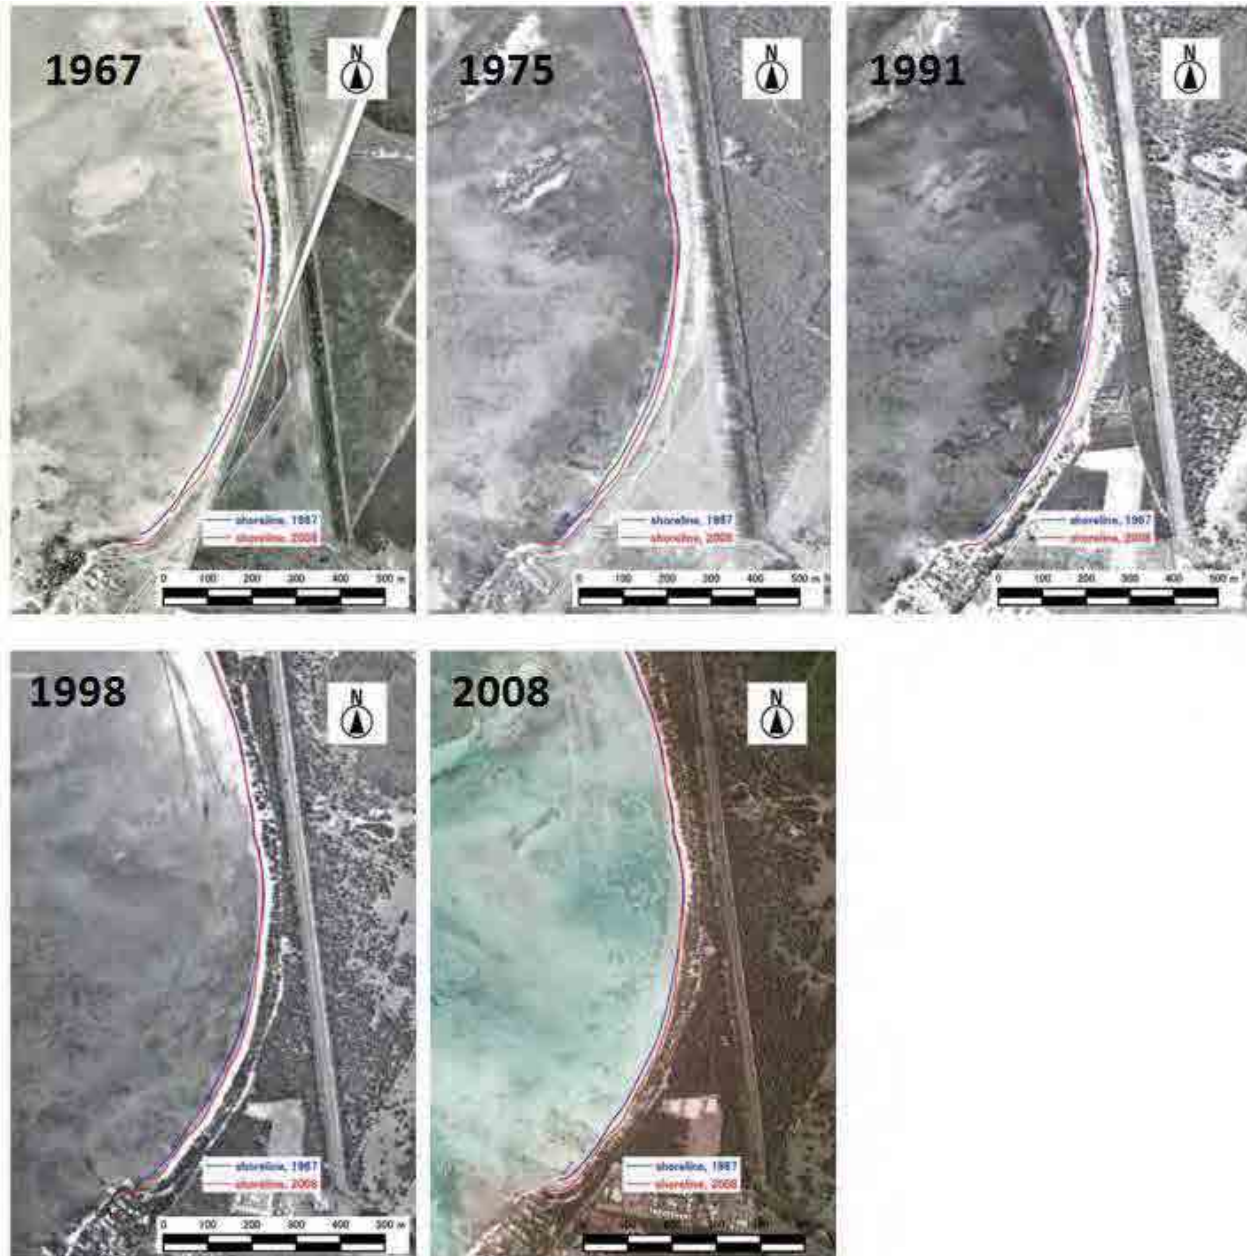
Figure 3.2.7 Change in Condition of Coral Reef from 1967 to 2008

Figure 3.2.7 shows the change in condition of coral reef from 1967 to 2008. It is identified that the light and shade pattern on coral reef decreased from 1998 to 2008. The shade part on the coral reef is identified as sea grass area based on the previous field observation.

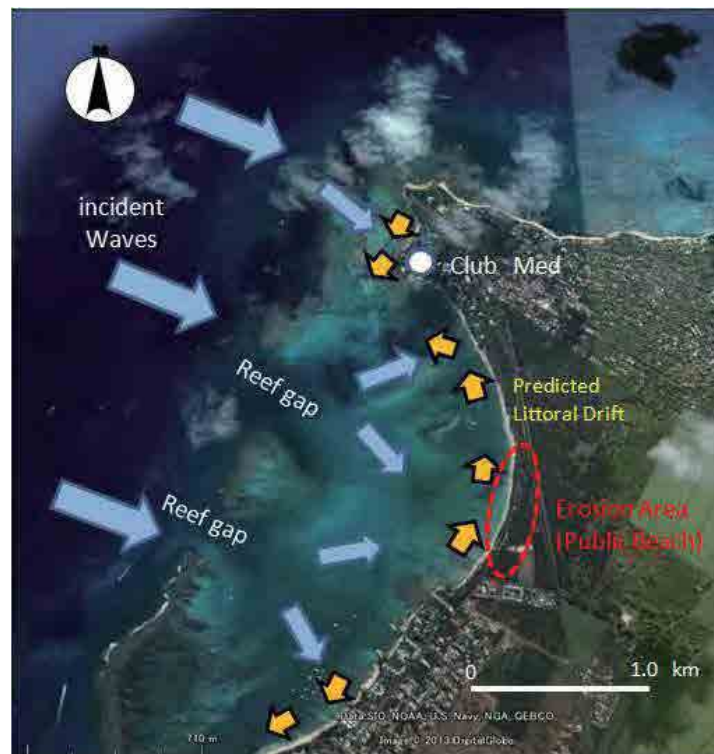
Figure 3.3.1 Wave and Littoral Drift Pattern at Mon Choisy

As the inclination of the foreshore in Mon Choisy is shown in Figure 3.3.1, the northward littoral drift was expected. The direction of sand movement was also estimated by the line pattern shown on the coral reef. The beach erosion at the south was identified based on the long term shoreline change. However beach accretion that might be expected to balance the sand loss due to erosion was not identified. The coastline at the north area (north of Club Med)

➤ There was no area of accretion identified in the north that corresponds to the erosion in the south. This means some quantity of the transported sand might be moved to the offshore through the reef gap.

➤ Two possibilities are thought for the potential sand source at Mon Choisy in the past as; 1) sand produced by corals on the reef, 2) sand inflow from south area. For 1), taking into account the current coral condition, it is not considered to be a source of sand. For 2), there was a possibility

to flow in from south area to the north before the construction of two groynes at the south part in 1975 to 1991. However, no sand inflow is now expected after the construction of these groynes. This means the sand inflow in current condition is too low.

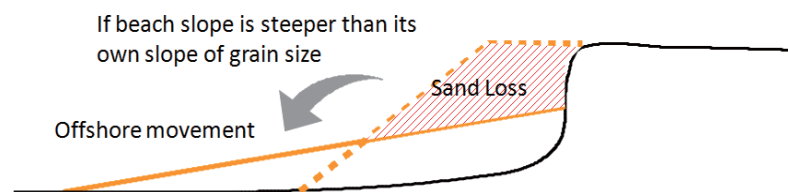
Figure 3.3.2 Offshore Sand Movement In Case of Employing of Fine Sand

According to the obtained information for the remedy to nourish sand with  $3,800\text{m}^3$ , which was undertaken by MOESDDBM in 2011, the excavated sand on land for hotel construction ( $3,200\text{m}^3$ ) and the land side sand ( $300\text{m}^3$ ) were employed as nourishment sand. This means the nourished sand has a possibility to be finer than existing sand on the shore. If the foreshore slope was steeper than the natural slope gradient that is stable for that grain size, some of the sand will be shifted toward offshore to keep its own slope as shown in Figure 3.3.2.

the south of the public beach. If the nourished sand is smaller than the existing ones, the sand moves offshore regardless of the longshore movement as presented in Figure 3.3.2. It is important to select proper sand size and corresponding beach slope for the onshore and offshore movement together with alongshore movement in the planning of nourishment. The nourished sand can be selected as courser than the existing ones for the stability of the beach though the principle is to use the same size as the existing beach. The selection of sand size has to consider the beach use because it affects the usability and amenity. Also it is strongly recommended not to use different colored sand on such tourism beaches formed by coral sand in order to keep the present image of coral beach as tourism area.

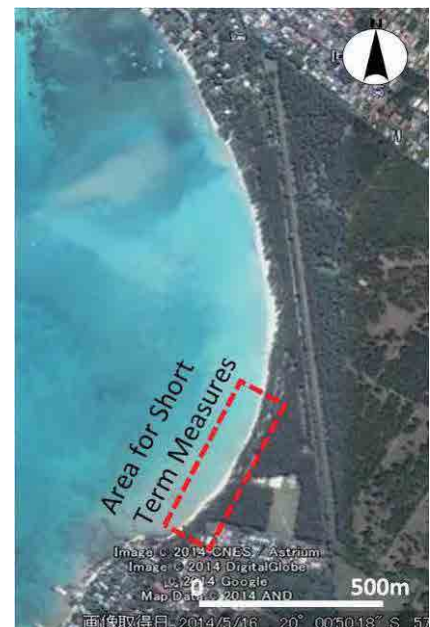
Figure 3.4.1 Area for Measures

- The target area for short term measures is a 450m-long section of the south part of the public beach as shown in Figure 3.4.1.
- Beach retreat at this area was estimated as 12m in average and 18m in maximum over 40 years based on long term shoreline change analysis. Also it seems that the retreat is continuing at present. If the beach width will be increased significantly, this will induce further unstable condition and sand discharge after the nourishment will be significant. Therefore, the target of short term measures is to keep the present position of the shoreline.

- From the above point of view, initial volume for the nourishment will be a sufficient amount so as to solve the existing beach scarp which is always observed at this area. As the result of continuous beach profile survey, it is assumed that the slope at scarp part is 1:5, average foreshore slope is 1:8 and berm height is 4.0m. Based on this assumption, the total volume for initial beach nourishment for 450m was estimated as 11,000m<sup>3</sup>.

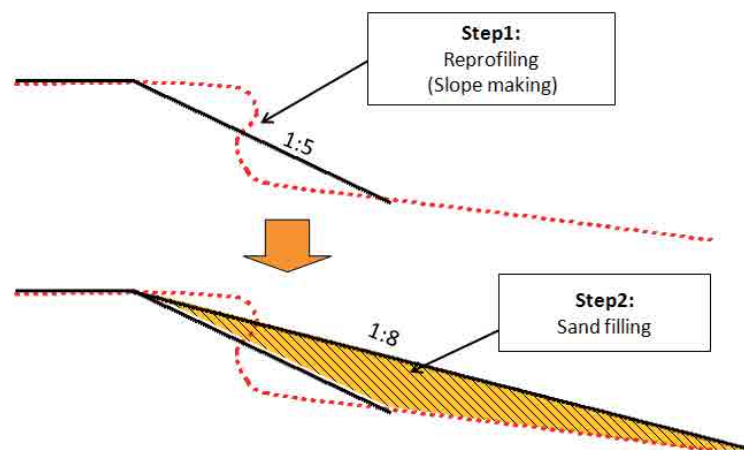
Figure 3.4.2 Measures of Beach Reprofiling and Nourishment

Recently there has been a more than 1.5m high beach scarp constantly present at the eroded area. It is hindering access by people wanting to use the beach. Sometimes it prevents recovering of natural beach by the onshore sediment movement (accretion) if the scarp is hard and vertical like a vertical revetment. Thus, it is better to undertake the beach reprofiling before nourishment in advance if the scarp has been already formed. The effect of beach reprofiling is not clear and needs to be evaluated from the monitoring results after reprofiling. The image of beach reprofiling and nourishment is shown in Figure 3.4.2.

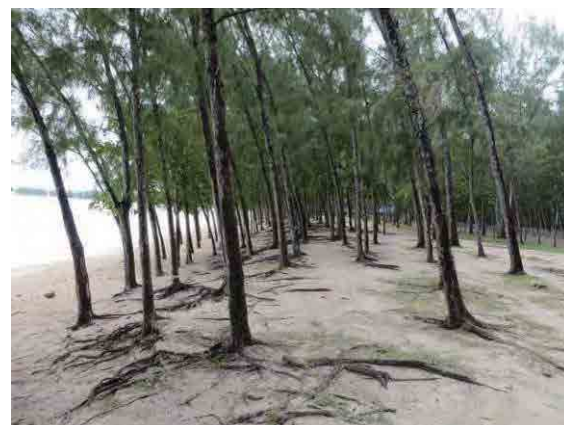
Figure 3.4.3 Trees at Foreshore

There are stumps of casuarinas trees at the beach cusp in the south eroded area as shown in Figure 3.4.3. The stumps work as a wall to prevent on-off sediment movement and the recovering of sand on the beach at calm period. The cutting or replanting of trees which cause trouble will contribute the stability of the beach.

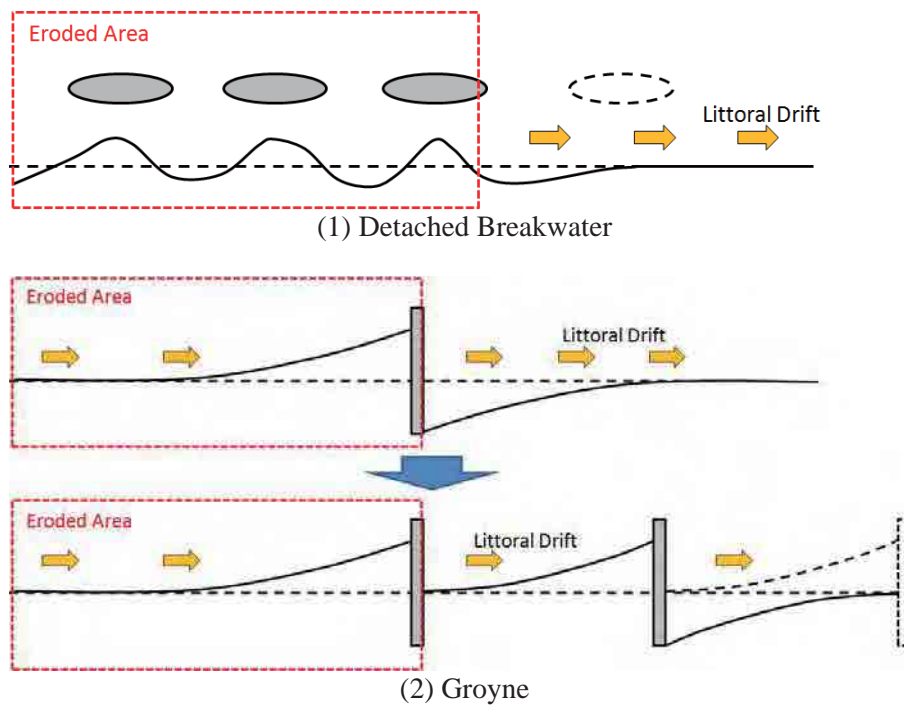
Figure 3.4.4 Impact of Structures to Down Drift Side

- Groynes, detached breakwaters or artificial reefs are effective at the eroded south area to stabilize the beach. However the total sand volume does not change basically as shown in Figure 3.4.4. The eroded area becomes stable and the down drift area will be eroded. Then it is necessary to make arrangement plan of structures to the whole sediment cell for the static stability.
- Once a structure is constructed, the impact will be caused at the north. Continuous construction of structures becomes necessary to solve the erosion. This brings the degradation of natural scenery and beach use.

Then the construction of structures should be avoided as much as possible.

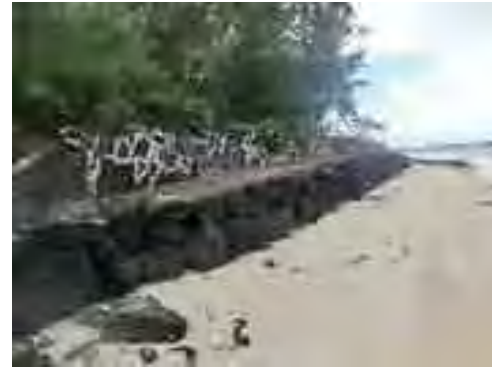
Photo B: Beach and Revetment in front of Lease Area at the East

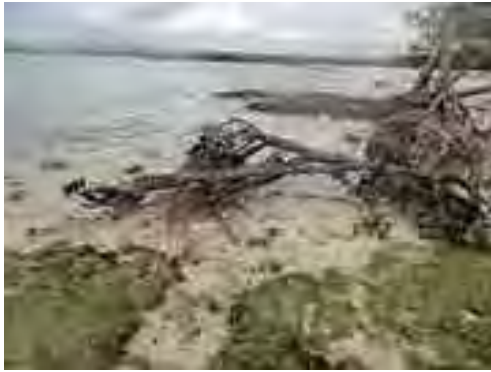
Photo C: Erosion and Damages of Mangrove

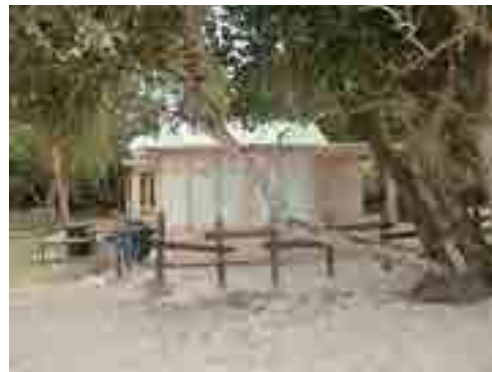
Photo D: Public Toilet

The public toilet is located at the sub cell No.4 and will be in danger if the trend continues. The beach scarp was seen after the cyclone of January 2014. The monitoring data by MOESDDBM shows the erosion in front of the public toilet and accretion at the bay bottom from November 2013 to January 2014.

From the effects of those measures the relocation of the public toilet can be done. The items and location of measures for the short term are shown in Figure 4.4.1.

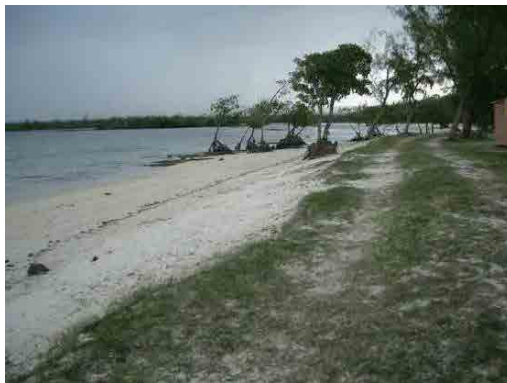
Photo E: Beach in front of the Public Toilet

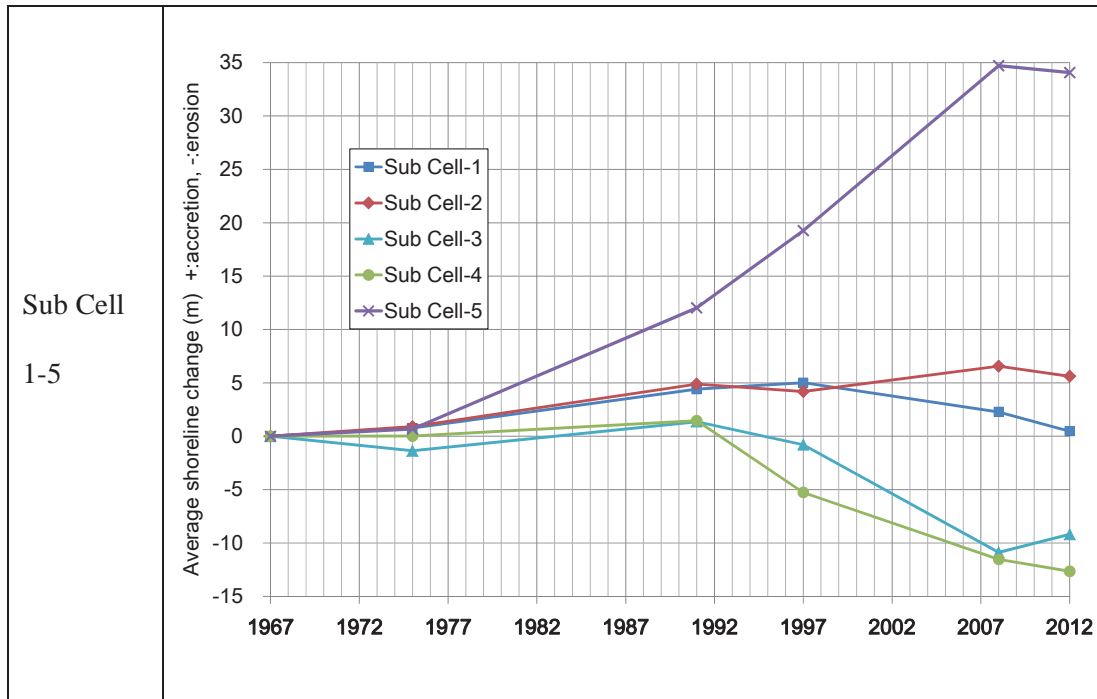
Figure 4.3.2 Shoreline Change at Bras d'Eau

The temporal change of shoreline is shown in Figure 4.3.2. At the sub cell No.5 the coastline is accreting 35m continuously as the rate of 0.8m/y within 45 years from 1967 to 2012. The increase is predominant in 1991 after. The accreted volume becomes more than 10,000m<sup>3</sup>. The other sub cells of No.3 and No.4 show the erosion of about 10m. After 1991 the erosion of No.3 and No.4 corresponds to the accretion of No.5. The sediment budget shows no large change.

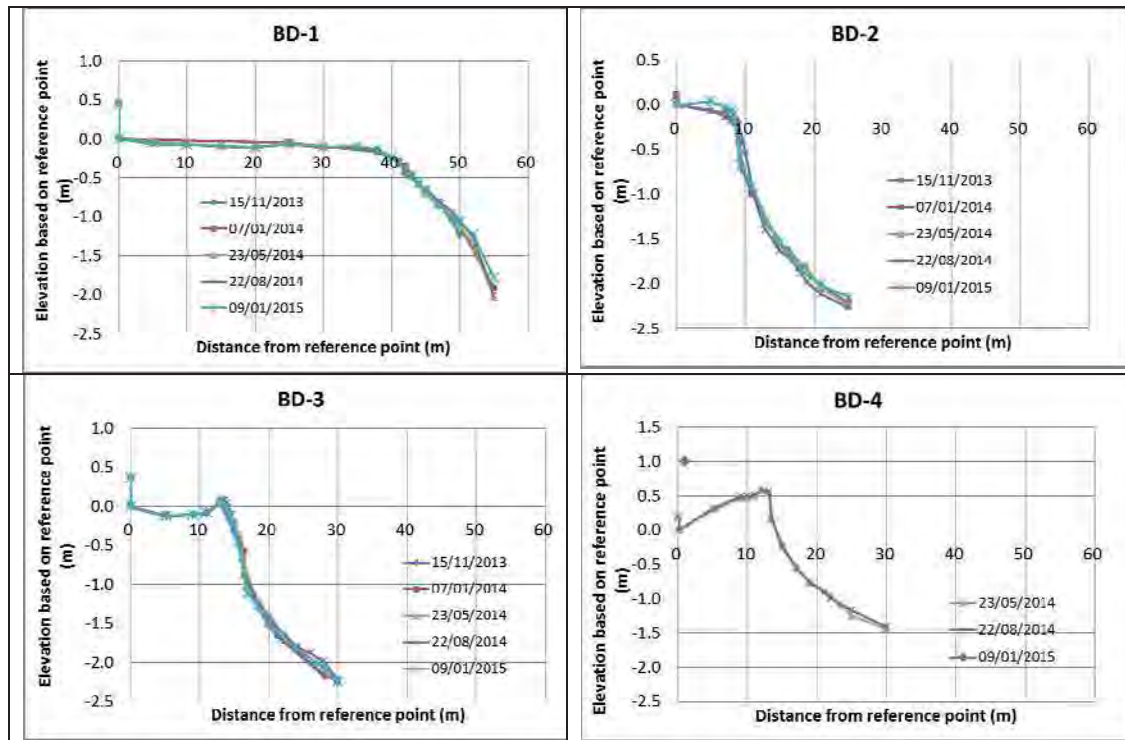
Figure 4.3.6 Beach Monitoring Results at Bras d'Eau

accretion after that and recovered at April 2015. At BD-3 the beach was eroded for long term but it is accreted during the monitoring period.

The changes seems to be related to the seasonal change of wave conditions and the changes of mangrove and seagrass in front of the beach. It is necessary to continue the monitoring because of the observation period is short to understand those changes.

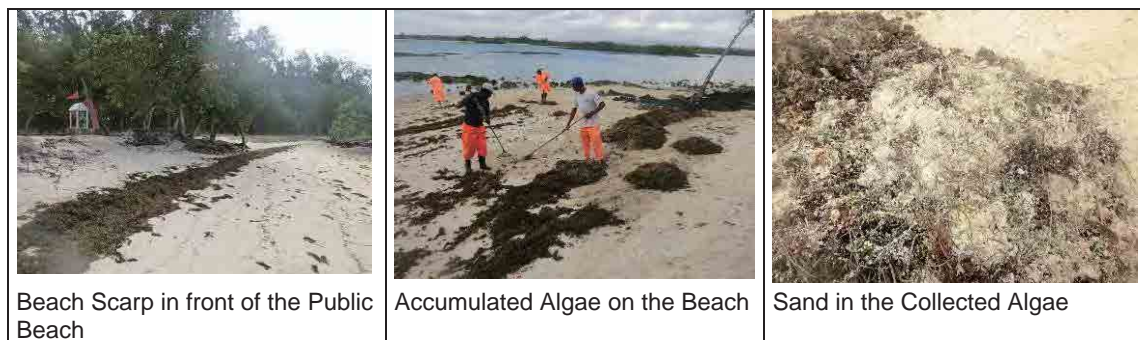
Scarps and fallen trees are seen at a part of the public beach and become an obstacle to the use of the beach. A lot of algae is drifted down to the beach and accumulated as shown in Figure 4.5.1. The algae is collected with sand and carried to the disposal site by Beach Authority. It seems that cleaning activity has affected the beach erosion slightly. However, there is the possibility that sand will be lost if it continues for long period.

Figure 4.5.1 Beach Scarp and Algae on the Beach at Bras d'Eau

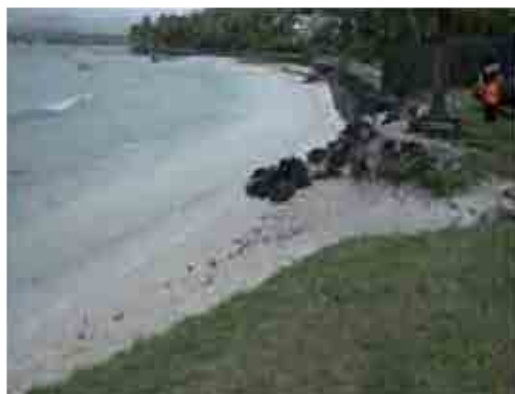
Photo A : Eroded Beach at the West of East Headland in June 2012

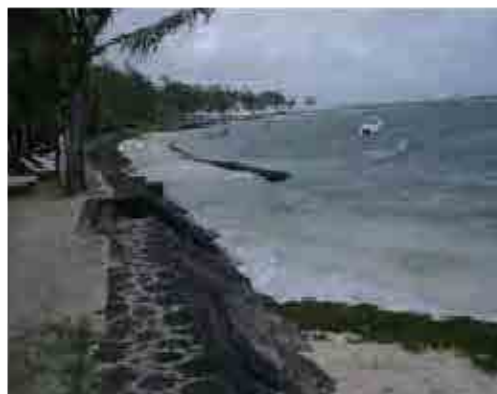
Photo B : Revetment and Detached Breakwater on front of the East Hotel in June 2012

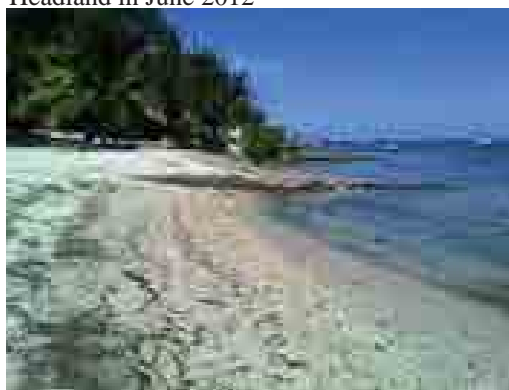
Photo C : Arrangement of Groynes

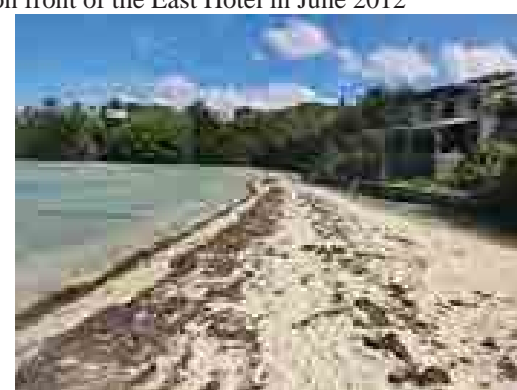
Photo D : Sand Accumulation at the West Beach

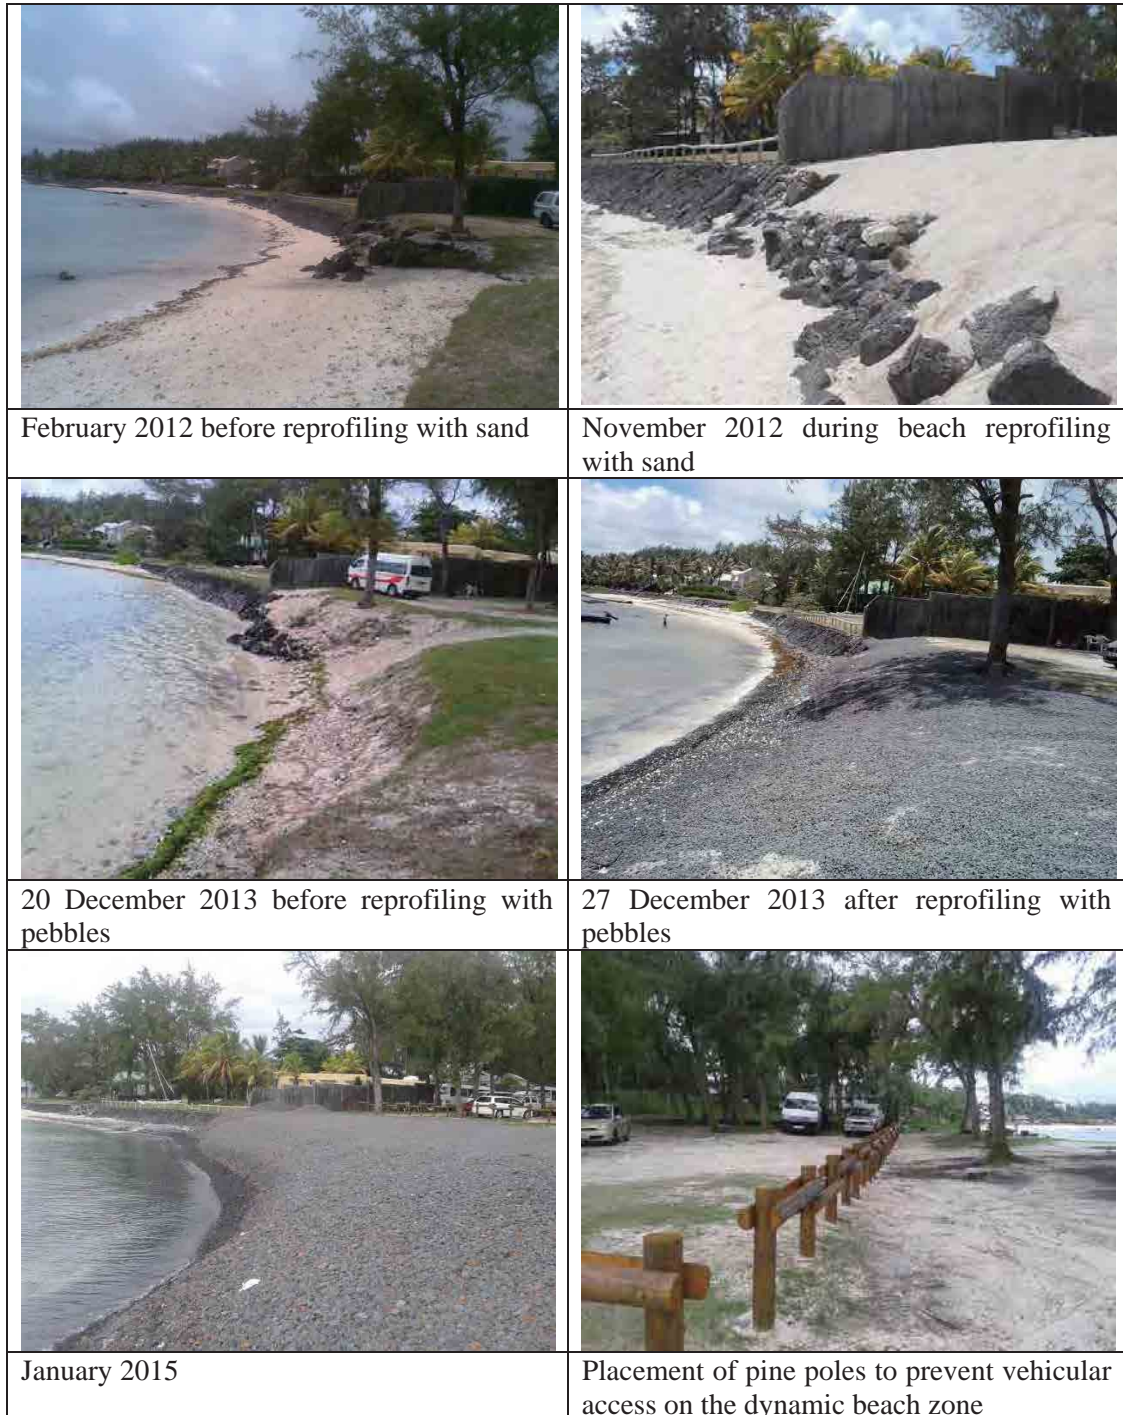
Figure 5.2.3 Beach Reprofiling at Public Beach

The MOESDDBM has carried out beach reprofiling at Trou d'Eau Douce, Quatre Cocos Vge in November 2012. However, during cyclone Dumile in January 2013, all the sand placed eroded away. Consequently the MOESDDBM placed small rock of diameter 15–25cm in November 2013. Following cyclone events of January and February 2014, it was found that the pebbles were still in place. The process is shown in Figure 5.2.3.

- The stretch of 50m as from the boundary wall of the public beach has been refurbished with pebbles at a height of 2m and width of 10m towards the sea (slope 1:5). Pebbles of 32-40mm diameter will be used which will be topped up with 15-25mm of pebbles.
- A wooden hand rail of 80m long as from public access has been built to restrict vehicular access across the public space. It was proposed that provision would be made for an access of approximately 2m in case of any emergency. It was also proposed that a signage for parking will be fixed near the wooden hand rail.

- Some 100 Bougainvillea, 30 Veloutier d' Argent, 30 Ste Marie and 15 Pongamia trees was planted in the area between the hand rail and the high water mark within the public space.
- Grasses would also be grown across the public space to stabilise the dune.

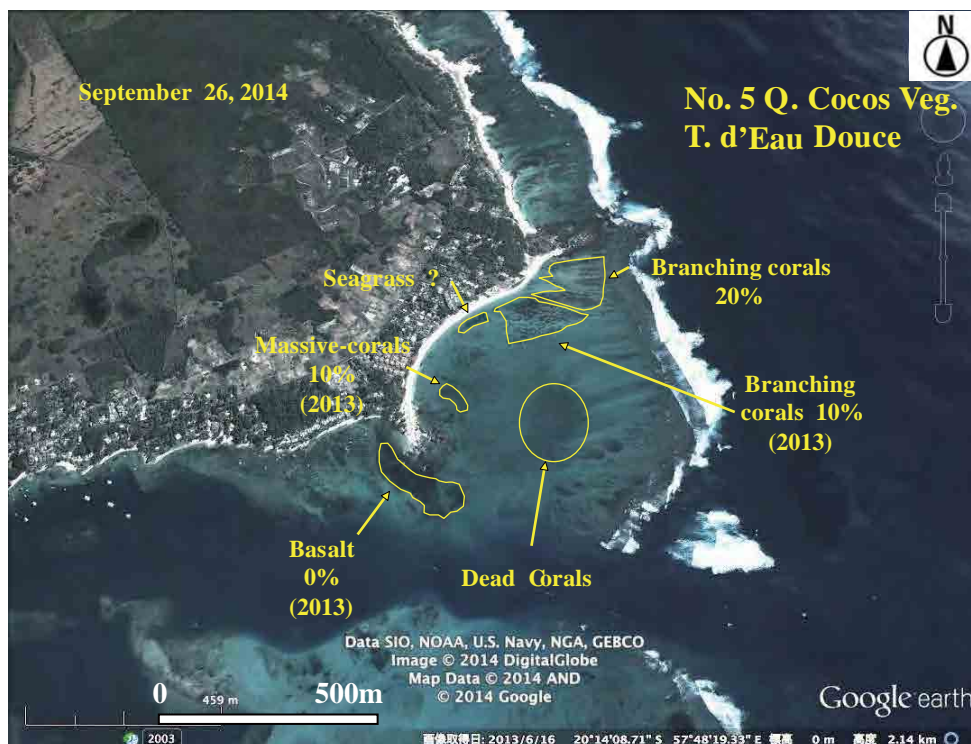
Figure 5.2.4 Coral Condition at Q. Cocos Vge Surveyed by Grass Boat

Living coral was not so abundant and its coverage was from 10 to 20 % as shown in Figure 5.2.4. However patch reefs dominated by branching *Acropora sp.* were seen at the north offshore of public beach. Surrounding areas of the patch reefs were covered by sand. Patch reefs covered same area also in the aerial photos taken in 1996. While, shore reefs dominated by massive corals were seen at the north offshore of public beach and its coverage of corals was only 10% with no juvenile *Acropora sp.*. Seagrass bed of *Halophila sp.* was observed in sandy bottom. *Padina sp.* was also observed on the skeleton of branching *Acropora sp.*. Transparency was 10 m and siltation was not seen. Skeleton of tabular and branching *Acropora sp.* accumulated at the central bottom of lagoon.

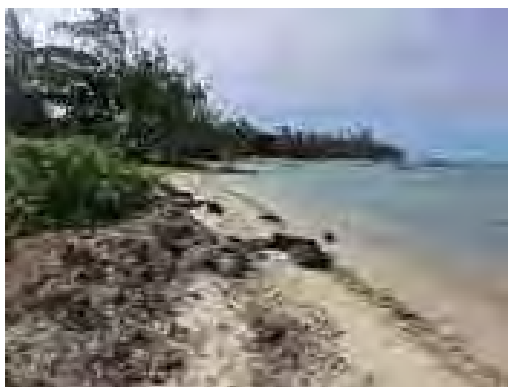
On a part of the beach sea algae and garbage are accumulated. Those seem to happen in front of the lease area in absence. (Figure 5.5.1)

Accumulated a lot of Sea Algae and Garbage,  
Possibly No Cleaning for a Long Term

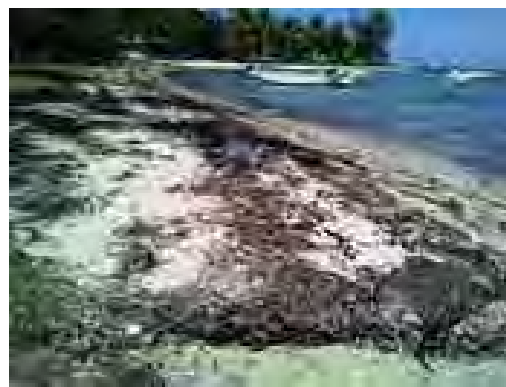
No Cleaning in front of Lease Area and  
Accumulation of Garbage on the Beach

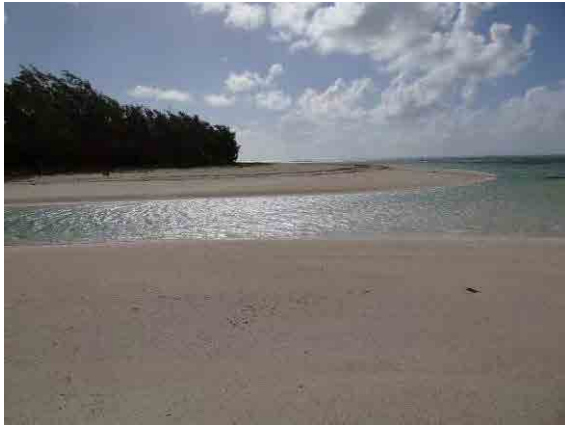
Point A shows the sea side and lagoon side from the channel. Since sand is deposited in the channel, most of the lagoon side in the channel becomes dry at low tide. In addition, the sedimentation area at the edge of channel is asymmetrical, and the coast shape in the north side edge looks like a tongue. On the other hand, the sedimentation area of the south side at the entrance to the channel is relatively small. A beach scarp is formed on the north side in the central part of the channel (Point B) while on the south side of the channel here there is significant sedimentation. Such asymmetric coastal formations (on either side of the channel) are a continuous tendency as confirmed from past aerial photos, which will be described later, as well as during the monitoring period in this study. It is thought that the prevailing direction of wave energy is from the south in this area judging from the fact that there has been a permanent beach scarp observed on the northern side of the channel. Sedimentation is occurring at a certain distance into the channel on the lagoon side after the wave energy has been dissipated in the channel.

Point A (View of the northern coast from the channel)

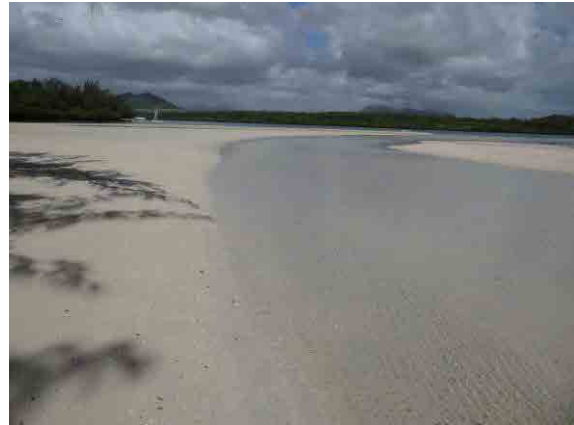
Point A (View of the lagoon side from the channel)

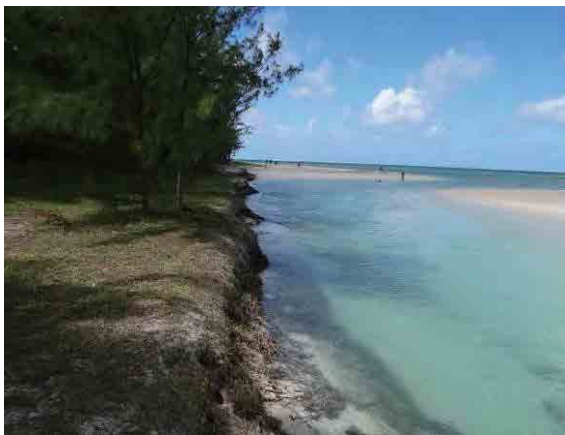
Point B (Beach scarp at center part of the channel)

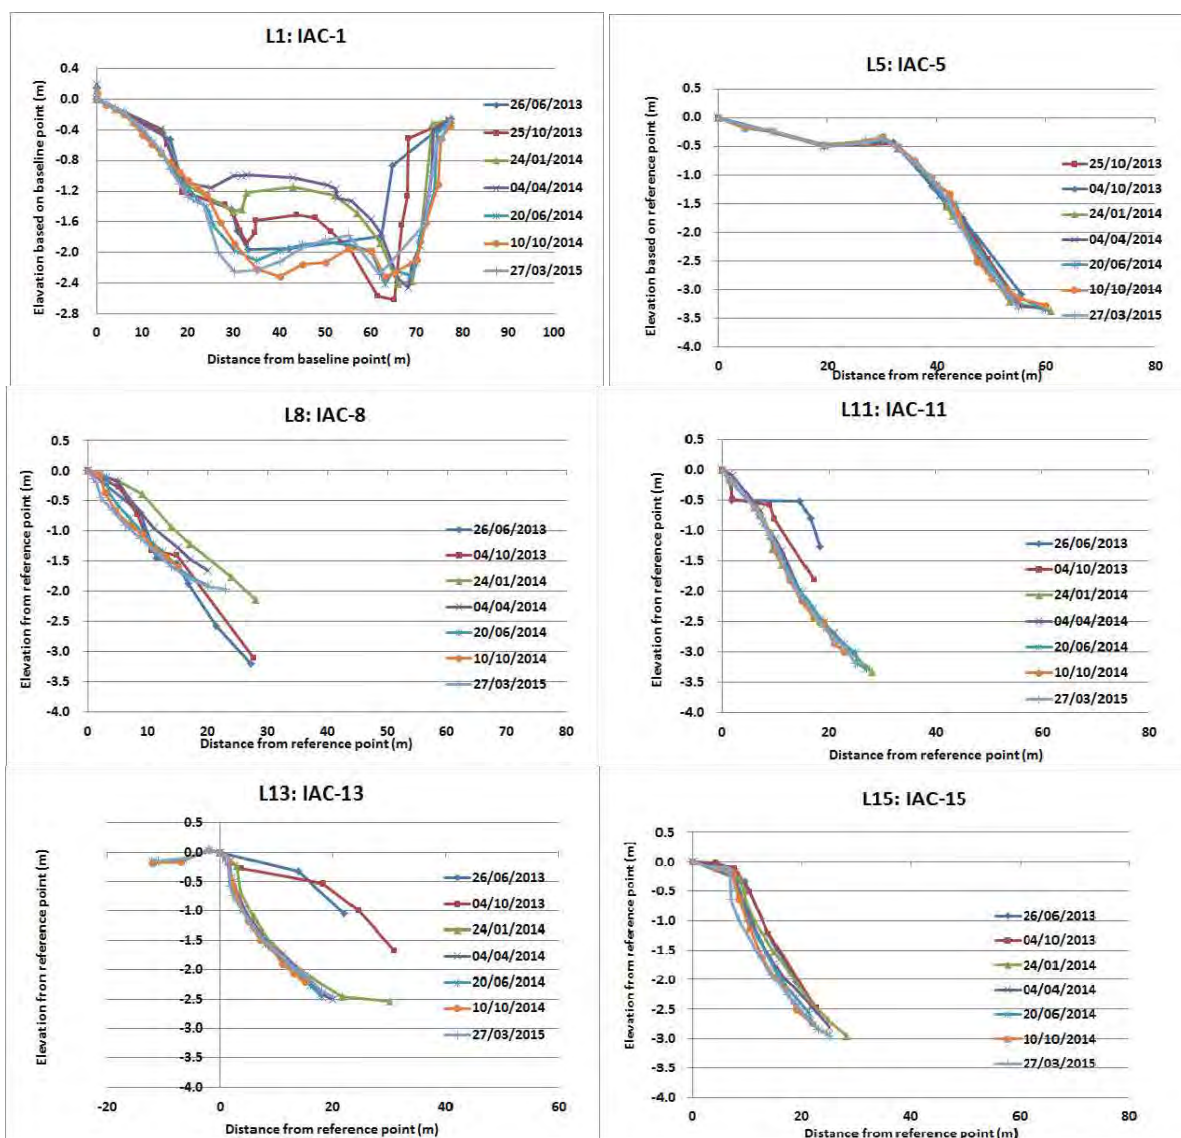
Figure 6.2.9 Result of Continuous Coast Monitoring at 6 Representative Cross Sections

- At L8 cross section near to the channel of Ile de l'Est, the coastline advanced around 5-7 m primarily from June 2013 to January 2014. But it has returned nearly to the original coastline position in October 2014.

- The dredged sand, which was carried out in October 2012, was placed at L11 and L13 cross sections located on the east side of Ilot Mangenie. The sand remained in this area until October 2013, but the coastline was eroded remarkably in January 2014. Then, big changes are not seen afterwards. It is thought that most of the deposited sand has already

- The sand dredged to clear a navigation channel, which was carried out in October 2012, was also deposited at the L15 cross section located in the north side of Ile de l'Est. This coastline is gradually eroded since June 2013, and it reached around 3-4 m by March 2015 and the erosion still continues until now.

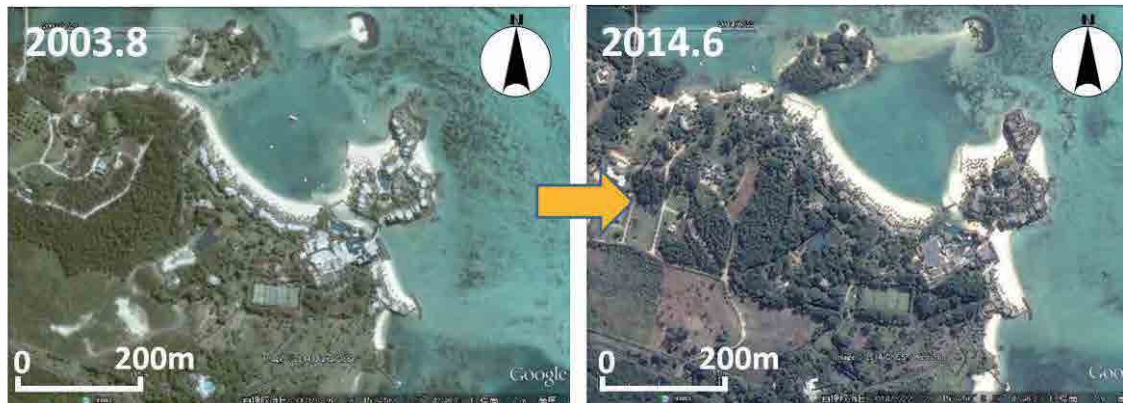
Figure 6.3.2 Closing of Channel at Touessrok Resort Hotel

The clogging by sedimentation is now significant in the channel which is behind the two existing islands and in front of the resort hotel located approximately 1 km north of Ilot Mangenie, as shown in Figure 6.3.2. JET has conducted the preliminary consultation to Touessrok Hotel and gave a suggestion to reduce the sedimentation at the channel.

Currently, the countermeasures against it are being prepared by the Hotel. In addition, the south side of the island was expanded with hotel development artificially. As a whole, the surrounding of this beach is in tendency of sedimentation shown in Figure 6.3.2, and this becomes a problem with respect to sightseeing.

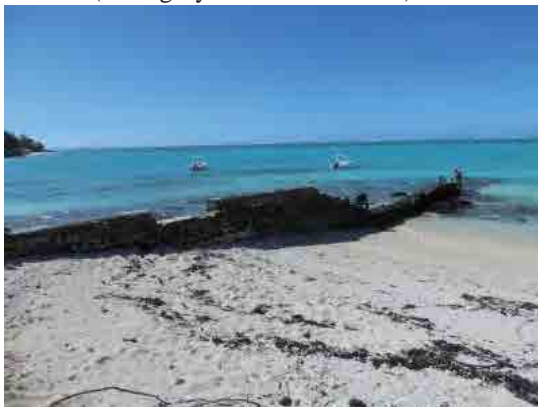
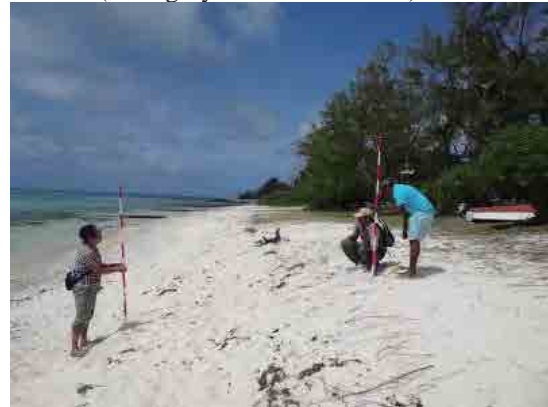
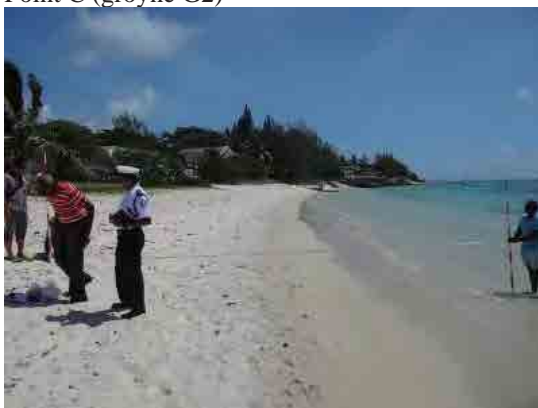
Point C (groyne G2)

- The monitoring results at L10 and L9 are those on the both sides of the G2 groyne (Point C in Figure 7.2.2), respectively. There is a different tendency found clearly between both sides of this groyne. At L10 on the south of G2, a notable deposition tendency is found in particular during the winter season from March to July 2014. On the other hand, an erosion tendency and the emergence of scarp are found during the same season at L9 on the north. Their seasonal variations have attained a range of about 2 to 3m. These phenomena closely correspond to the seasonal variation of wind direction, and suggest sand movement to the north during the winter season when a south-southeast wind blows strong.

- The L8 survey line is set to the north of the vertical revetment where a dry beach has completely disappeared, and a groyne has been constructed to the north of this line (near Point C in Figure 7.2.2). As in the case of L10, an about 2 to 3 m advance of coastline is found and an existence of littoral drift to the north is confirmed. It is foreseen that this coast will have an erosion tendency again during the period up to the coming summer season. This tendency could be confirmed through further continuous monitoring.
