**THE PROJECT FOR CAPACITY  
DEVELOPMENT ON COASTAL  
PROTECTION AND REHABILITATION  
IN THE REPUBLIC OF MAURITIUS**

**FINAL REPORT**

**COASTAL CONSERVATION PLAN**

**(Volume 2)**

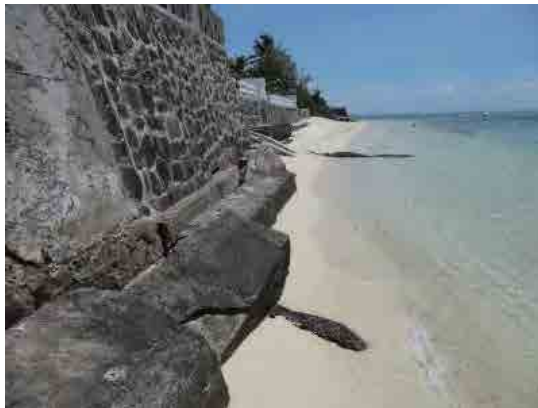
Point F

- Point F: The waves hit the revetment directly during the high tide and the dry beach is appeared slightly at low tide. The sandy beach width gradually extends from this point and the beach can be found in places where there are no concrete revetments.

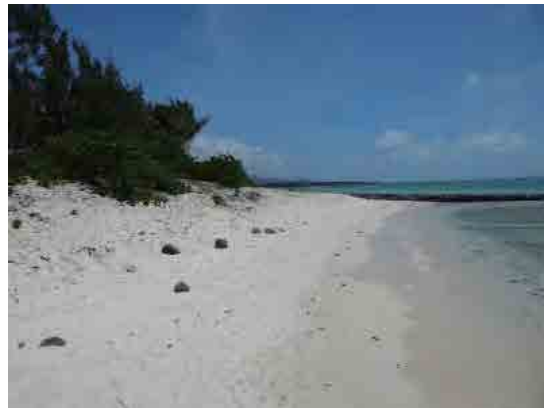
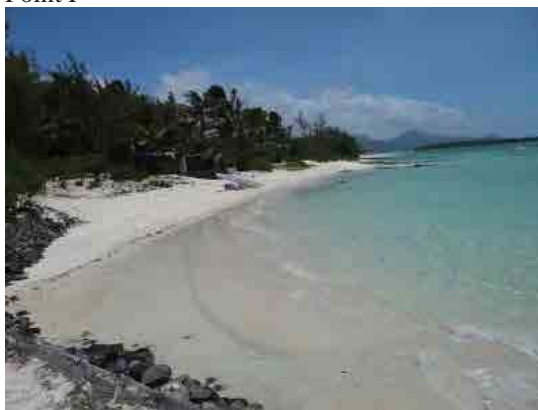
Point G (south of Groyne G3)

- Point G and H: The beach located at groyne G3 is accreted at the south and eroded at the north.
- Point I: In the vicinity of a small groyne 200 m north of groyne G3. The lessees are protecting their respective land by riprap and sand bags. The beach becomes wider for 1 km without groynes from this point.

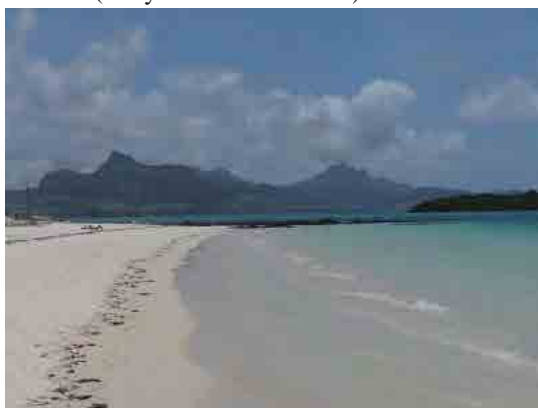
Point J (Looking at Groyne G4)

- Point J: It is located 100 m south of groyne G4 in the northern end where the beach is wide and has the gentle slope of 1:12 to 1:15.
- Point I: The north coastline was eroded significantly from the groyne at the north end. Rock reef becomes exposed in the north coast.

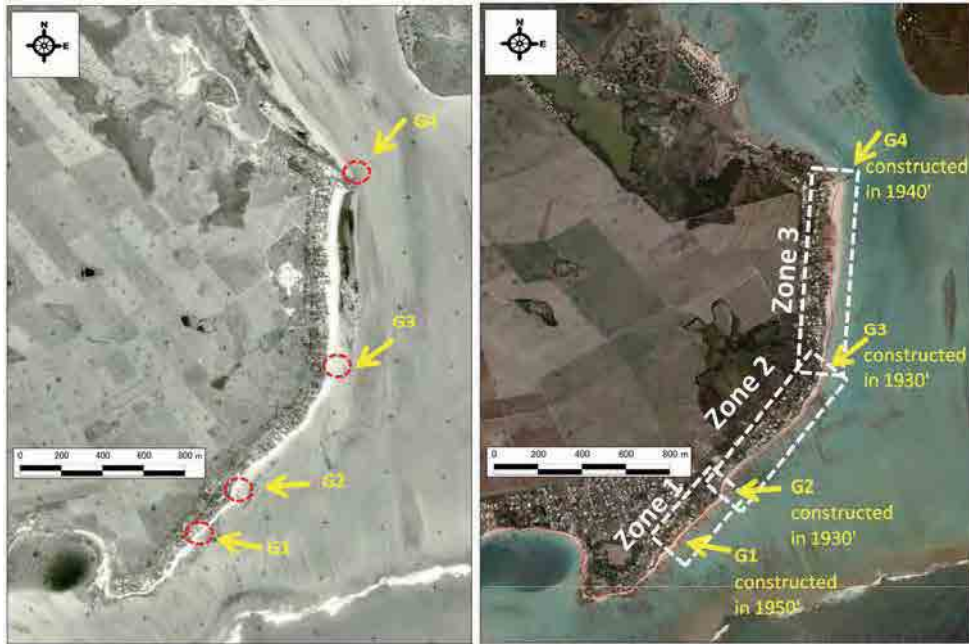
Figure 7.2.4 Comparison of Aerial Photos (left 1967, right 2008)

The main 4 groynes existed from 1967 as shown in the Figure. The groyne G1 was constructed in 1950s, G2 and G3 in 1930s and G4 in 1940s from interviews with residents who live for a long time in the area. There are old revetments and groynes constructed after cyclone Carol in 1960 and those types of structures were increasing after damage from several cyclones.

At the middle area of sub cell No.2 the beach was eroded from 1967 to 1997 and no changes after then. It is possible that the change of coastline cannot be read from the photo because there was no changes at the revetments which were constructed in many places. The ground level in front of the revetment at sub cell No.3 was lowering with the gradual loss of sand from the interviews with residents. At the sub cell No.4, the residents told that the erosion is continuous with the seasonal changes of sand.

The accumulation of sediment becomes  $20,000\text{m}^3$  within 40 years in a whole. The sand was mined at the north part of the reef from 1970s to 1990s and also from the beach and the sand dune behind the beach. The sand mining was banned by law after 2001 from the reef and beach. This action is and will continue to increase the sediment budget of this coastline.

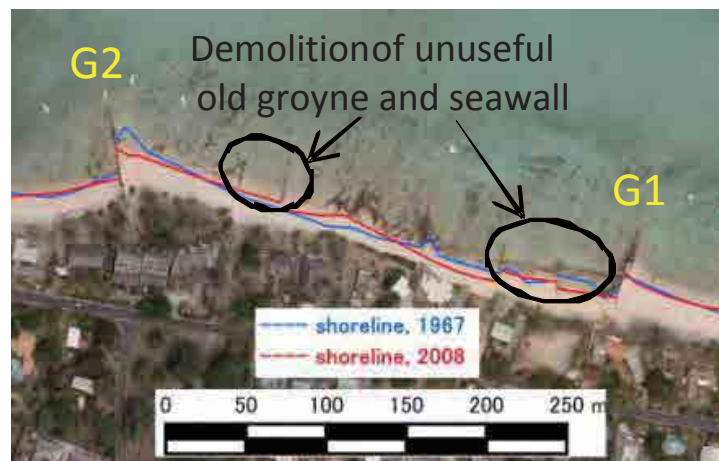
Figure 7.4.1 Plan of Coastal Conservation Measures in Zone 1

Zone 1 is about 330m long and located between existing groyne G1 and G2 at the south area. The zone forms a partly closed sediment cell of limited northward littoral drift by the groyne G2 made in 1930s and G1 made in 1950s as shown in Figure 7.4.1. The coastline changes were small within 45 years (1967-2012) and the beach is stable. The beach will be maintained its stable conditions with the existing groynes G1 and G2. Several groynes and low revetments were constructed after between groynes G1 and G2. The necessity of those groynes to control littoral drift is not observed judging from coastlines changes on both sides of the groynes. There is a possibility that low revetments are disturbing the supply of sand from the reef to beach. Then those groynes and revetments should be removed as unnecessary from the viewpoint of maintaining the beach use and landscape. The coastline changes after removing of those structures are estimated from the numerical coastline change model as shown in Figure 7.4.2. From the results there are expected to be no adverse effects of removal. It is desirable to remove the groynes gradually from the north to the south with monitoring.

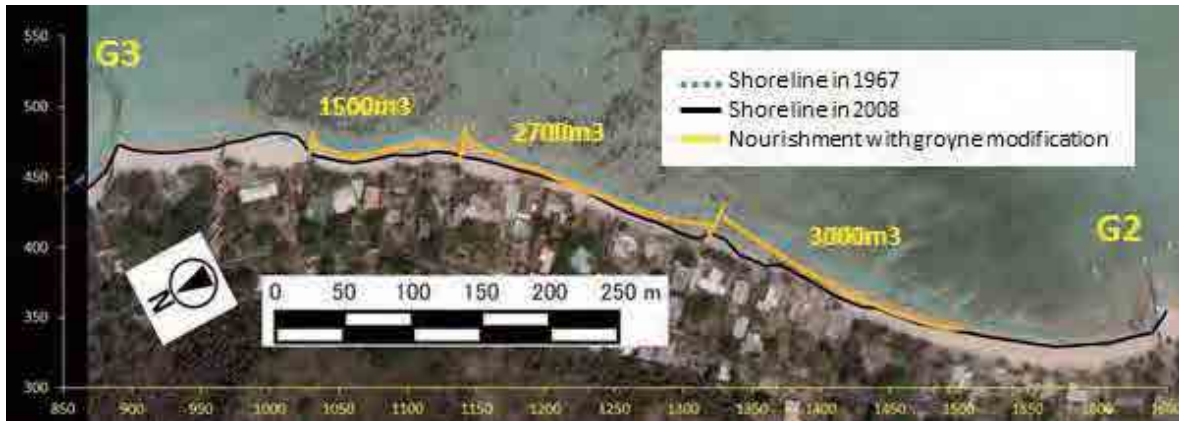
Figure 7.4.3 Plan of Coastal Conservation Measure in Zone 2

Zone 2 is about 760m and located between existing groyne G2 and G3 at the center area. The zone is the most problem area of the coast. The beach has eroded over a total length of 350m erosion is still in progress. Then the measures are to recover the beach by sand nourishment and to rearrange groynes by improvement, removing or construction for decreasing the loss of nourished sand to the north. The image of the measures is shown in Figure 7.4.3.

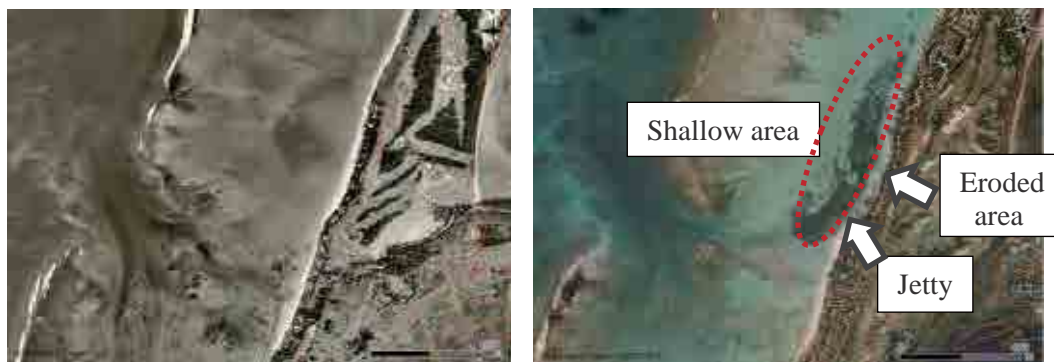
Figure 9.3.7 Beach Change at Le Morne north: left 1967 and right 2008

The beach was eroded at the north of the jetty as shown in Figure 9.3.7. Groynes were constructed and accumulated sand was bypassed for erosion measures. Shallows of seagrass are located parallel to the beach just offshore. At the area the current directs to the south offshore of the shallow and to the north between the shallow and the beach estimated from the trace of bed material. It suggests that there are some interactions between the shallow and the beach changes. The seagrass of shallow contributes to dissipate wave energy and to stabilize the beach. However the shifting of the shallow to the beach brings beach erosion because the longshore current keeps a certain distance between the shallow and the beach.

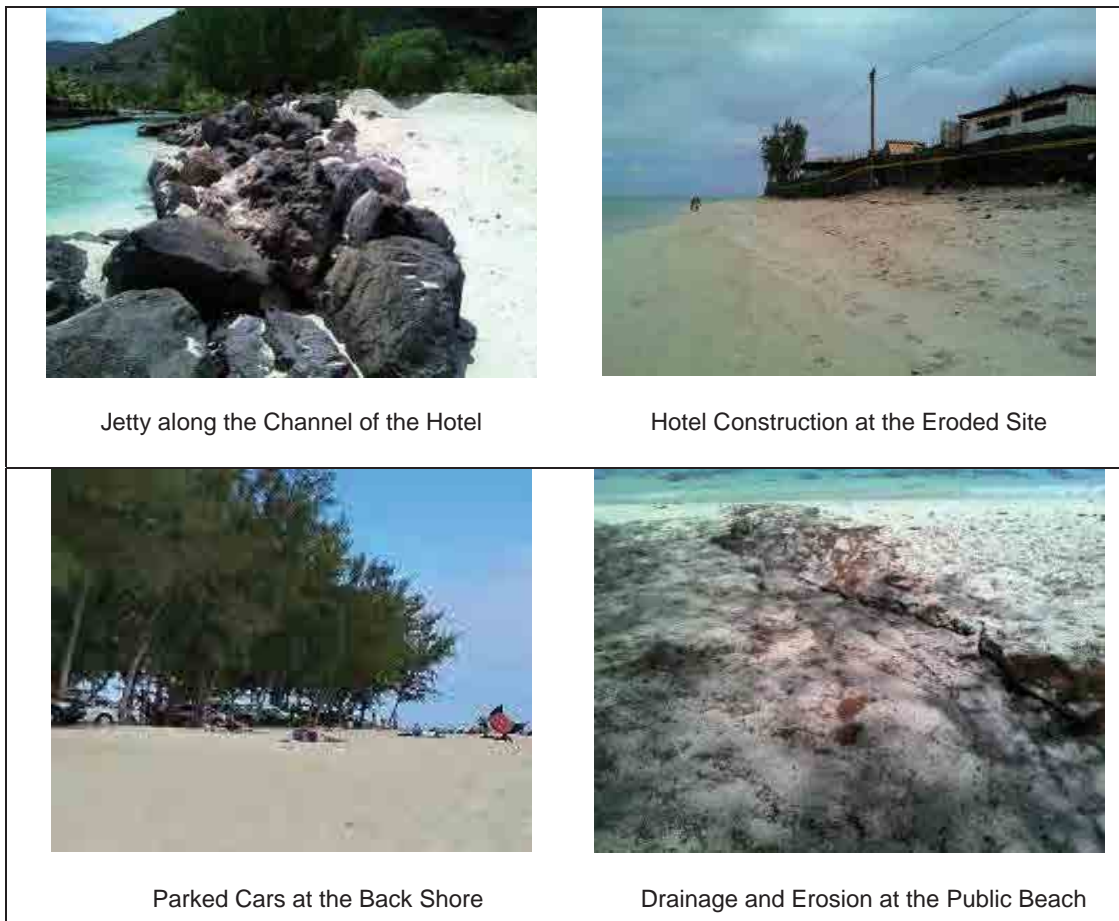
Figure 9.5.1 Problems of Beach Maintenance at Le Morne

There are several problems for the coast maintenance as shown in Figure 9.5.1. The dredging work is carried out for pleasure boats in the channel between hotels at least once a year. The dredged material is stocked on the beach. The erosion occurs in the north side of the channel.

Hotels already constructed. Many cars and motorcycles were parked on the backshore of the public beach because they could come and go freely at the coastal forest. But car parking issue was improved because car barriers were installed behind the beach during this study. On the other hand, cars are still parked on the backshore in the south side of the public beach. This activity has an influence on environment and utilization such as impacts on trees and marine organisms, car exhaust, reduction of utilization space and accidents to the beach users.

Rainwater drainage from landside washes away sandy beach locally.

Although car parking issue is gradually changing for the better after installation of car barriers in some beaches, but car and motorcycle parking issue are still seen at many public beach in Mauritius. It is recommended that parking space should be prepared in the whole Mauritius in a step-by-step manner considering various impacts.

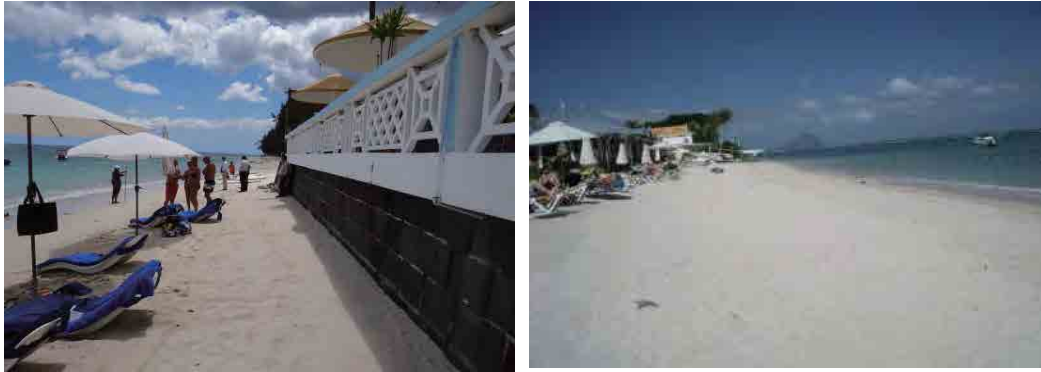
Figure 10.2.2 Coastal Condition at Flic en Flac: Left Revetment in front of Lease Area (Photo A), Right Beach Use (Photo B)

Mainly at the south hotels are located. A vertical revetment was constructed at the Gold Beach Hotel where the beach is narrow as shown in the Photo A of Figure 10.2.2. At the north wide beach is extended as shown in the Photo B. At the north a public beach, restaurants, shops and houses are located and hotels at the south.

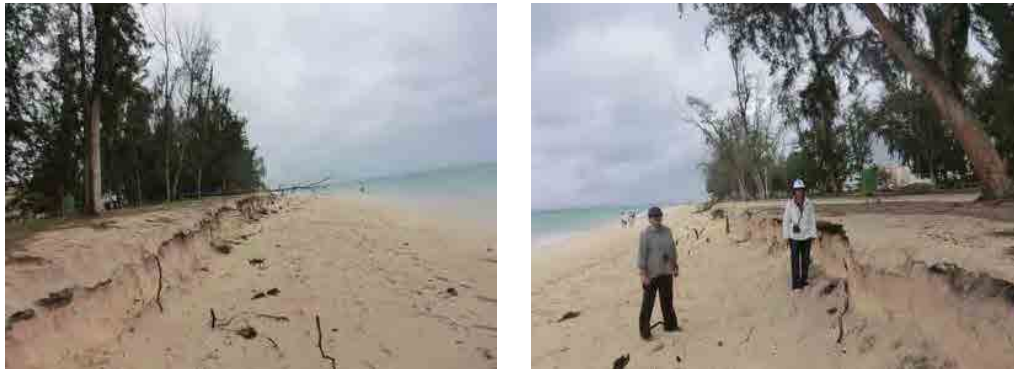
Figure 10.3.9 Beach Scarp at Flic en Flac Produced by Cyclone January 2013 (At Photo C of Figure 10.2.1)

The cyclone of January 2013 also caused beach scarp of 1m high as shown in Figure 10.3.9.

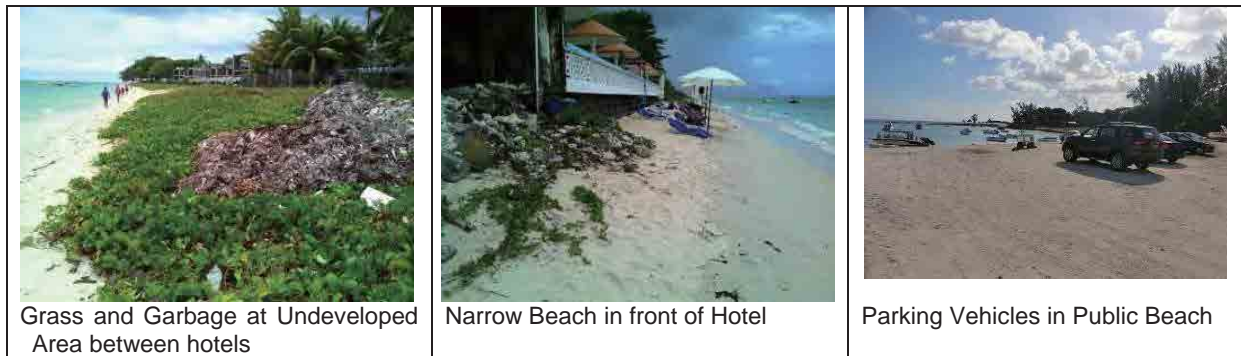
Figure 10.5.1 Beach Condition at Flic en Flac

Sandy beach hardly exists in front of the fence of the hotel. Gold Beach Hotel and Hilton Hotel face this issue. According to a manager of Gold Beach Hotel, the vertical revetment had already existed when owner purchased the existing hotel in 2004. It is assumed that the

revetment was built in 1970' to 1980'.

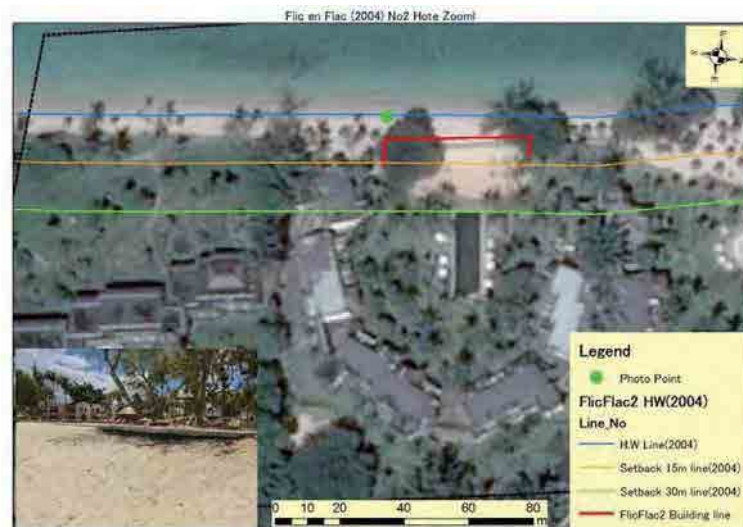
Figure 10.5.2 Position of Setback Line and Facility of Hotel (Flic en Flac-1)

The part of walkway with base exists in front of Hilton Hotel on the beach. This structure is not in aerial photographs until 2000 but it can be seen in a satellite photograph in 2004.

A line of HWM is put on the satellite photograph in 2004 and then from a line of HWM as starting point, lines with 15 m and 30 m from HWM are added on the land side. As the result, it proves that this structure is located between HWM and setback line with 15m. There is the possibility that this was constructed without observing setback rule. It is necessary to carry out demolition or relocation of this deck through discussion between hotel and related institutions because this structure will block continuous sediment transport in and around the hotel in future.

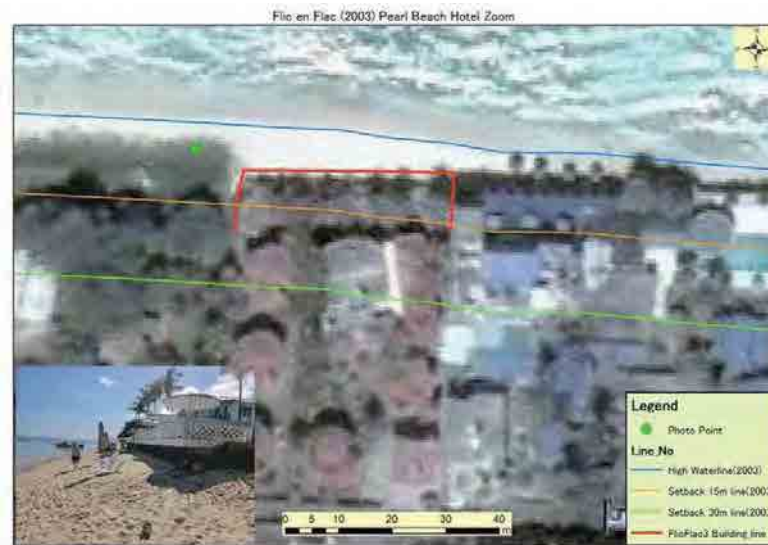
Figure 10.5.3 Position of Setback Line and Facility of Hotel (Flic en Flac-2)

The concrete deck exists in front of Gold Beach Hotel on this beach. This deck is located between HWL and setback line with 15m. In addition, a part of hotel facilities and swimming pool also are included in this area.

This deck was constructed following setback rule of 15 m which was in line with PPG at time of construction. It is to be noted that setback of 30 m came in 2004. It is necessary to carry out demolition or relocation of this deck through discussion between hotel and related institutions because this will block continuous sediment transport in and around the hotel in future.

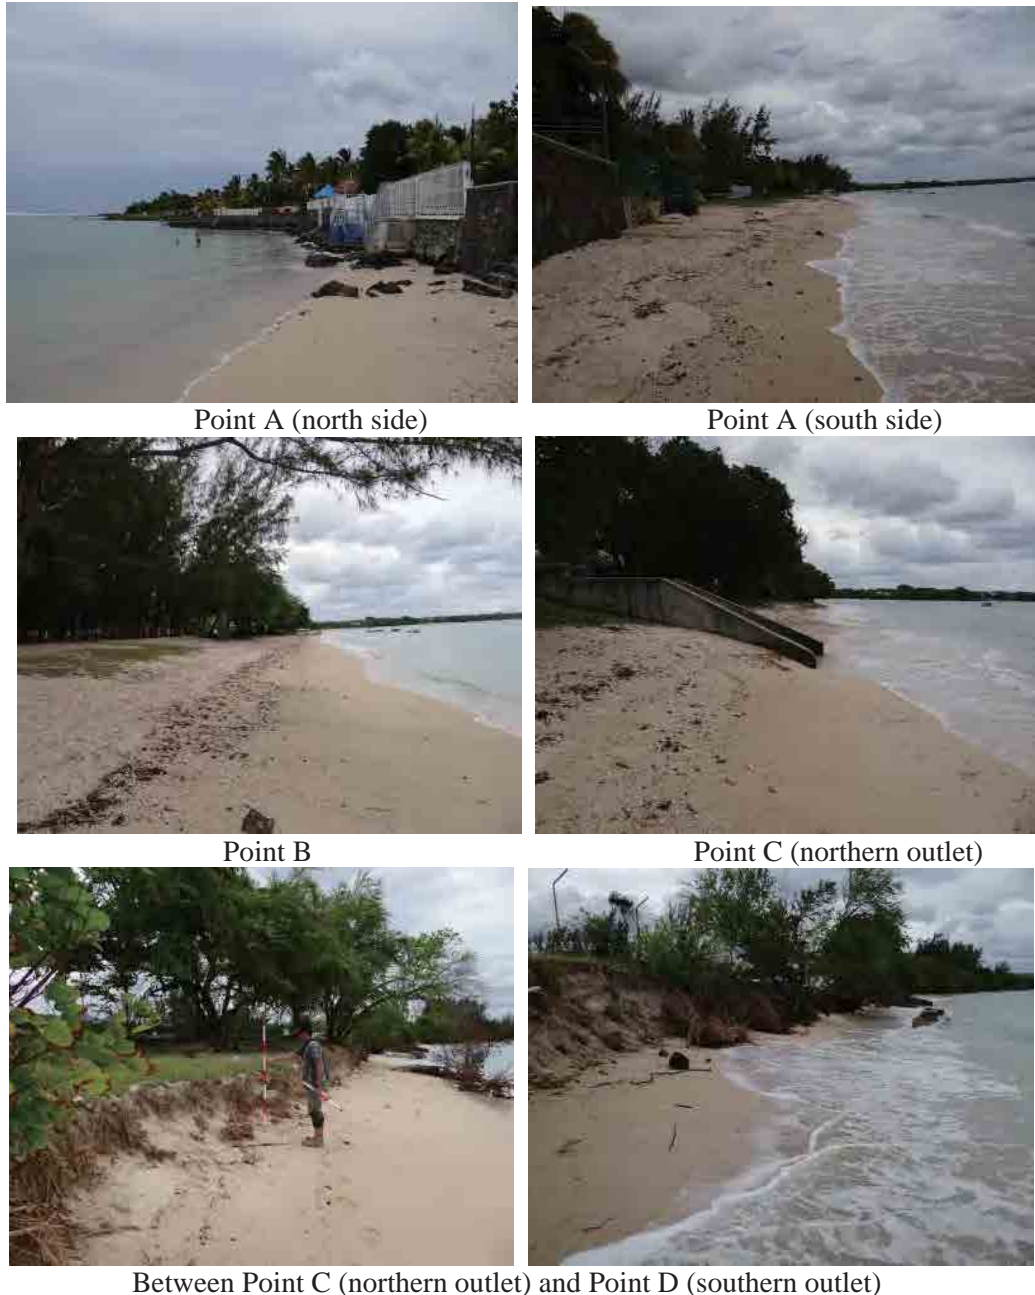
Figure 11.2.2 Beach Condition at Albion on January 2013 (1)

The photo of point A shows the beach condition at the northern residential and bungalow area. At the north from the point A, no sandy beach exists in front of the property. The coastal structures such as groynes and revetments were made to protect the property. From the interview and the past aerial photographs, it is confirmed the sandy beach existed previously. The photographs shows that the groynes and revetments were constructed from 1975 to 1991.

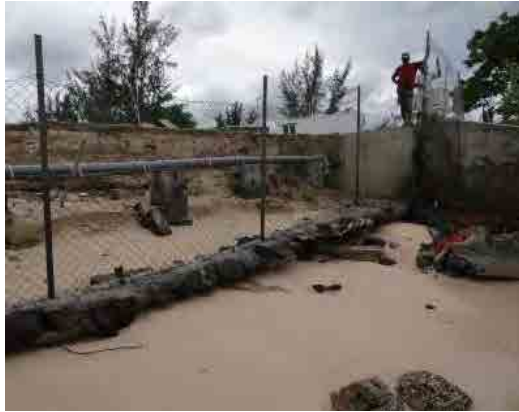
Point D (north side from the southern outlet)

The photo of point B shows the public beach at the central area. The sand beach is foreshore slope of 1:8.5 and seems to be stable without beach scarp. The beach erosion was identified from the south side of this northern outlet, and significant beach scarp was observed between point C and D as shown in Figure 11.2.2. The height of the beach scarp becomes higher gradually toward the south, and about 1.5m height at the north side of the southern outlet at Point D. Due to the serious beach erosion at this area, the underground pipe which was installed by AFRC has been already exposed. The height of beach scarp decreased toward the south from the point D. It was completely disappeared at the point E and sand beach with mild

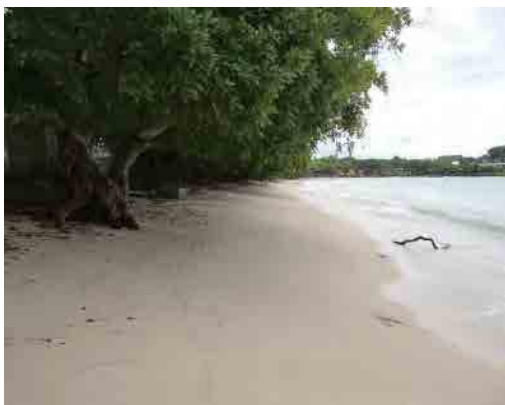
Point D (south side from the southern outlet)

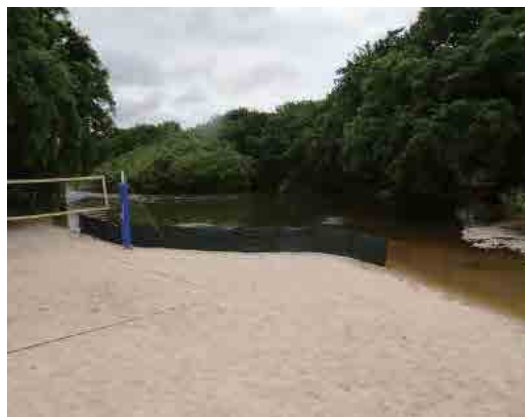
Point F

The point F is located in front of the reef gap. The local deformation of the beach due to existence of the reef gap was not observed. This area is utilized as private beach for the hotel which was constructed after 1997 in this area.

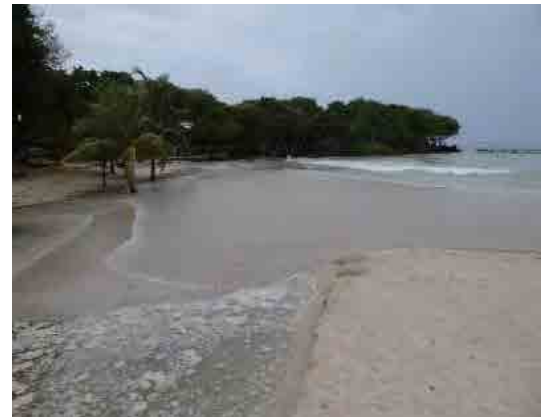
Point G (small freshwater pond)

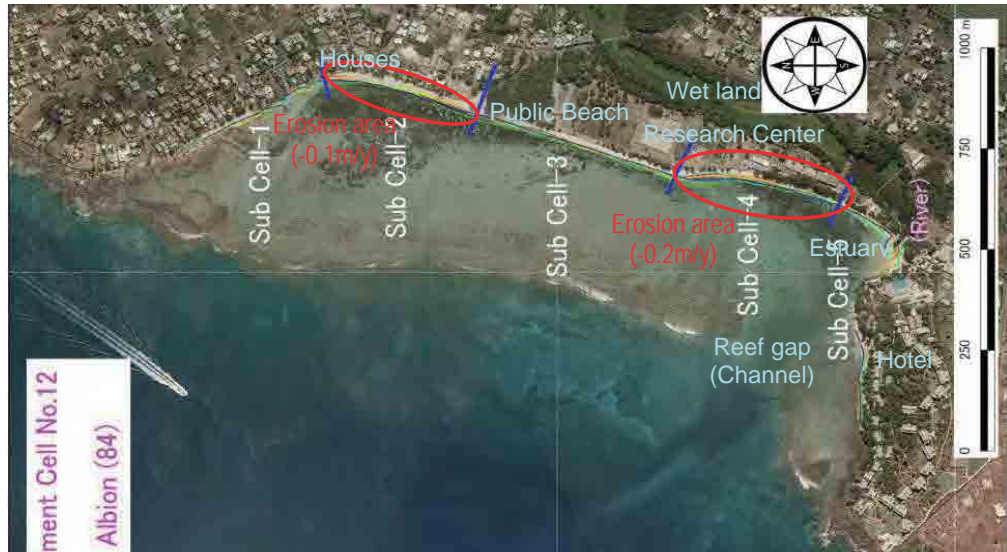
Figure 11.3.1 Study Area and Coastal Change at Albion

Figure 11.3.1 shows the study area and the coastal change at Albion. It is divided into 5 sub cells from No.1 at the north to No.5 at the south. For the long term the sub cell No.2 and No.4 were eroded, No.1 and No.3 were stable and No.5 shows large fluctuation.

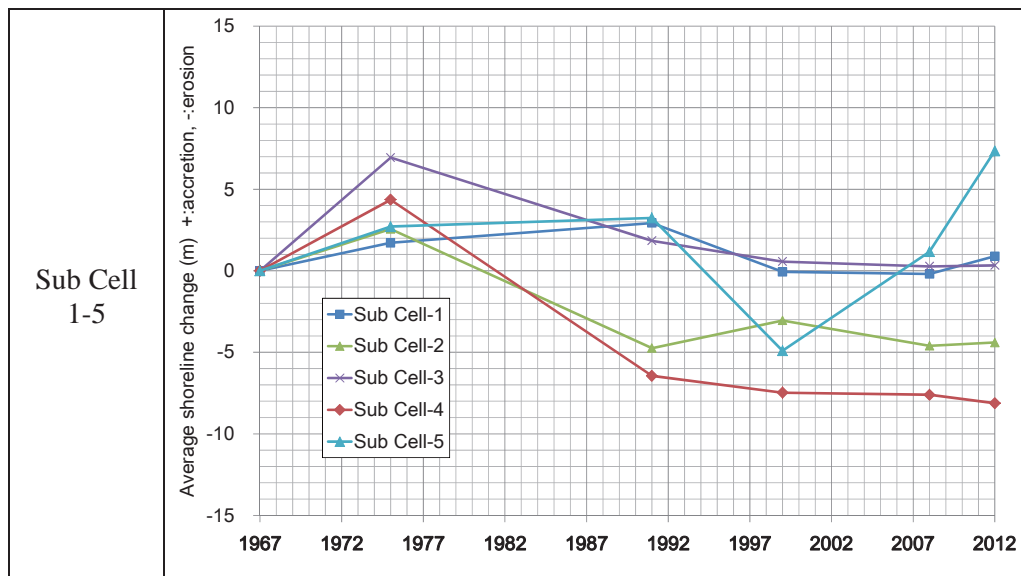
Figure 11.3.2 Shoreline Change at Albion

Temporal changes of shoreline are shown in Figure 11.3.2. The sub cell No.1 is stable, No.2, No.3 and No.4 was eroded from 1975 to 1991 with the maximum erosion of over 10m at No.4. At No.3 it was accreted from 1967 to 1975 and the erosion is not clear in long term. At No.5 it was eroded in 1999 and accreted in the after. The change is different from the other cells.

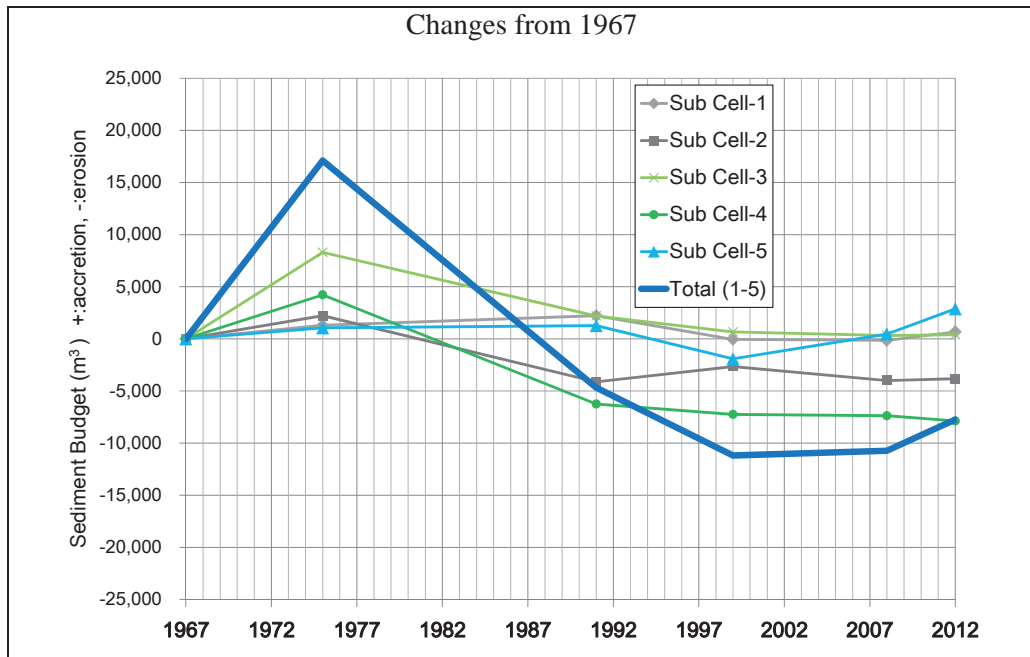
Figure 11.3.3 Sediment Budget at Albion (Sediment Cell No.12, Sub Cell-1-5)

The sediment budgets are shown in Figure 11.3.3. In total the accreted volume becomes 15,000m<sup>3</sup> from 1967 to 1975 and from 1975 to 1999 the eroded volume is 25,000 m<sup>3</sup>. After that the accreted volume is 3,000 m<sup>3</sup>. From 1967 to 2012 within 45 years the total becomes 8,000 m<sup>3</sup> of erosion and 200 m<sup>3</sup> a year in average.

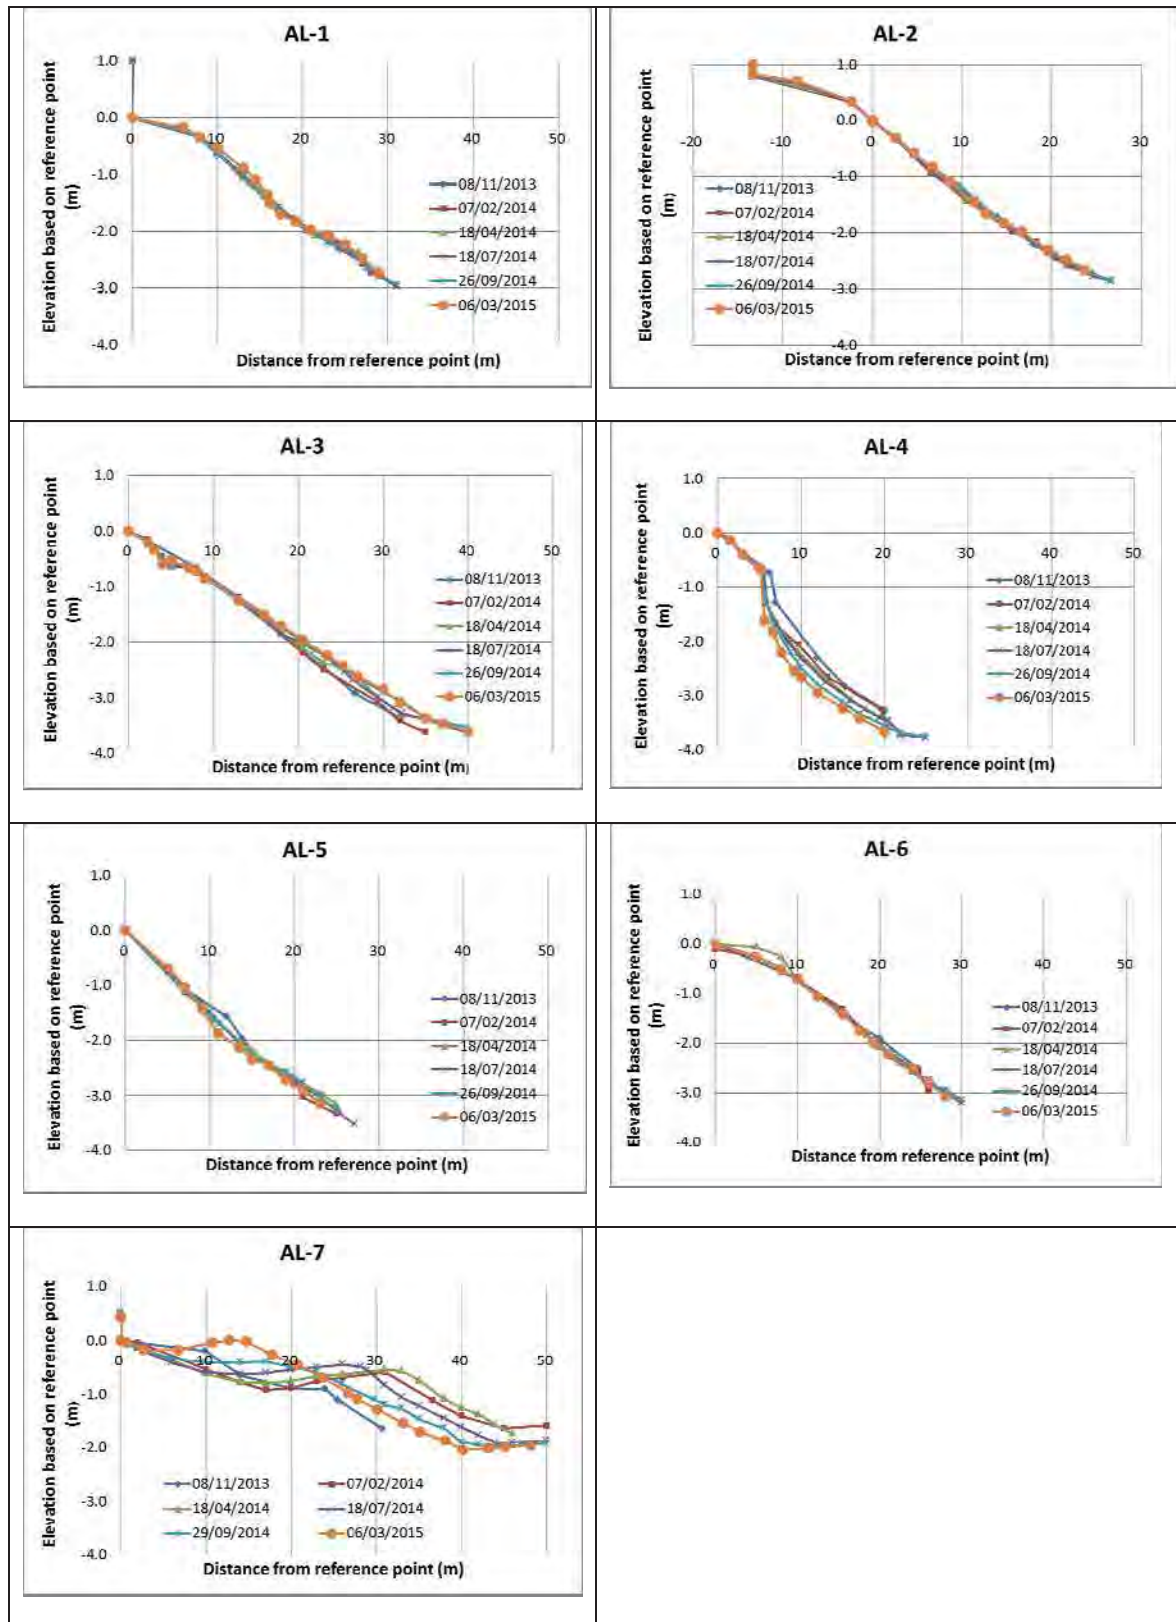
Figure 11.3.5 Beach Monitoring Results at Albion

The monitoring results of 6 times from November 2013 to March 2015 are shown in Figure 11.3.5. The transects from AL-1 to AL-2 are located in the eroded site of long term changes, at AL-3 is stable site, from AL-4 to AL-5 in the eroded site and from AL-6 to AL-7 in the accreted site. The profile at eroded site is steep. The elevation is relative height and not the ground level above MSL.

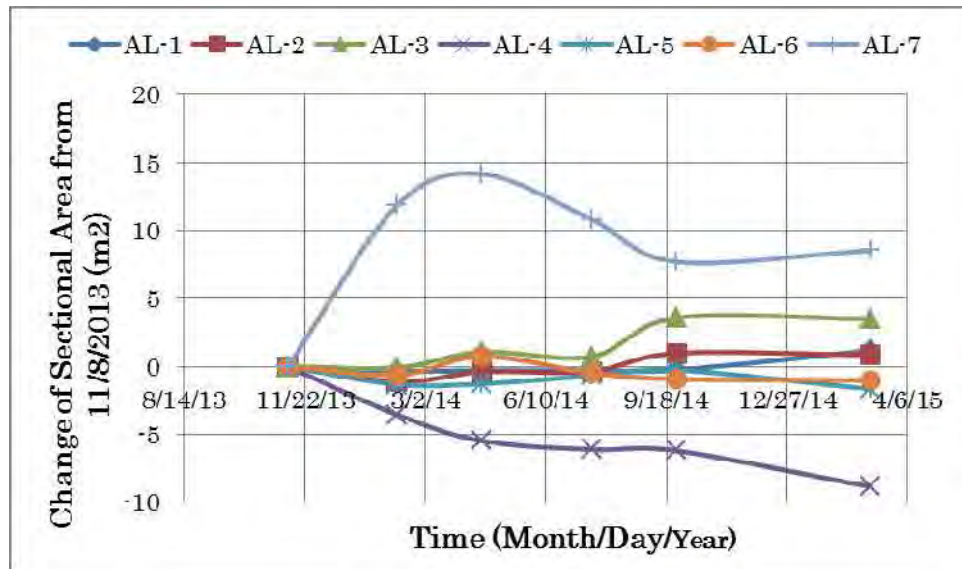
Figure 11.3.6 Temporal Changes of Sectional Area at Albion

The temporal changes of sectional area from the area at November 2013 as a baseline are shown in Figure 11.3.6. Here, the monitoring results are not always consistent with the long term change. Also the seasonal changes are relatively small. At the transects of AL-1 and

AL-2 the beach was eroded in long term. However it becomes stable or shows accretion recently. The beach of AL-4 located in front of AFRC was only eroded during the monitoring. The south beach of AL-7 located at the river mouth shows large changes with accreting trends as the same as long term changes.

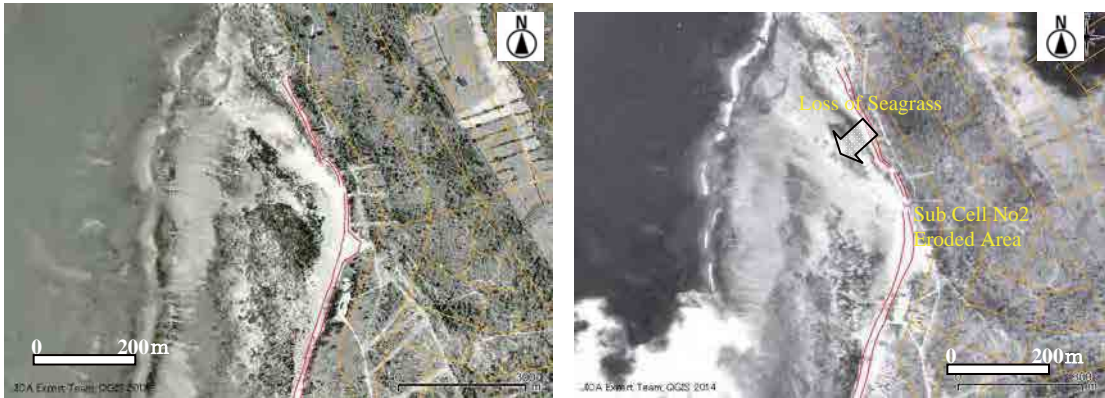
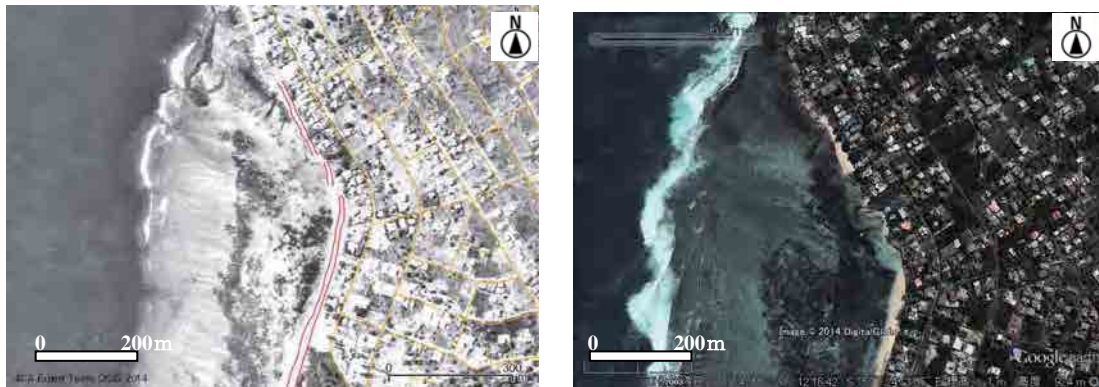
The main sources of beach sand seems to be the sand broken by high waves at the reef because the coral reef exists in front of the beach and the beach sand is made of coral. The reef conditions of sub cell No.2 are shown in Figure 11.3.7 from 1967 to 2013 at the time of erosion.

The photo of 1967 in Figure 11.3.7 shows wide shadows in front of the eroded area and it is estimated coral offshore and seagrass near the beach from the present conditions. In the photo of 1975 the shadows changed to white in some part where the sand covered the seagrass by the cyclone of Gervaise in 1975. The area corresponds to the eroded area of sub cell No.2. The erosion was caused by the disappeared seagrass which protected the beach. After 1991 the erosion did not progress and the seagrass recovered in the photo of 1991. In the satellite image of 2013 the seagrass in front of the beach was continuous but narrow compared to the south. A revetment was constructed at the eroded beach and protected beach erosion (refer to Figure 11.2.2). Though there is a possibility to prevent the recovering of the beach. At present the seagrass is extended its area.

Change of Seagrass : Left 1967, Right Loss of Seagrass after Cyclone 1975

Recovery of Seagrass : Left 1991, Right 2013年

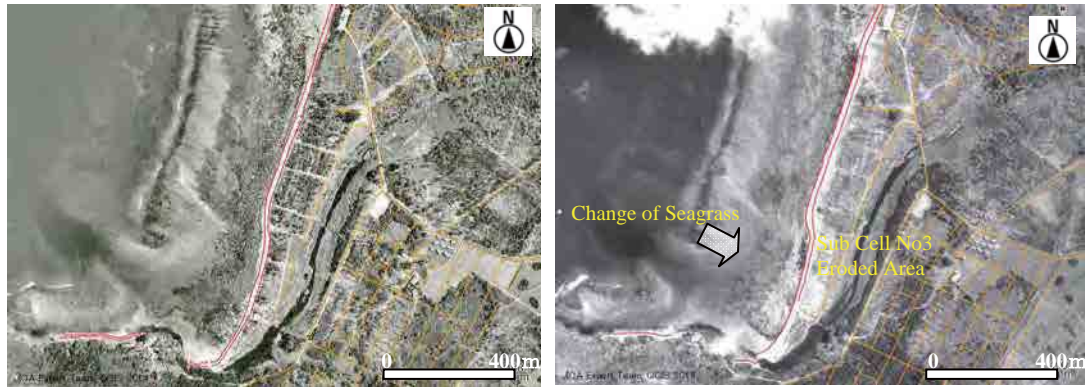
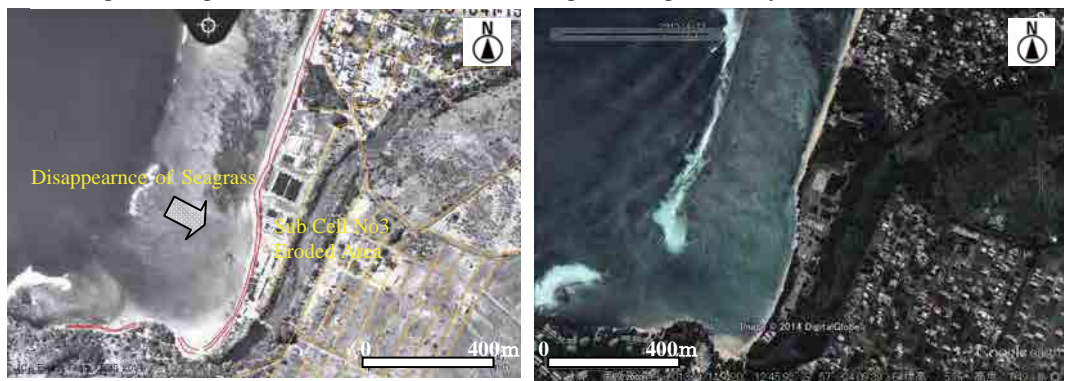
The reef conditions of sub cell No.4 are shown in Figure 11.3.8 from 1967 to 2013 at the time of erosion. The photo of 1967 shows wide seagrass in front of the beach. The seagrass existed but decreased in 1975 as shown in the photo of 1975. In 1991 the seagrass disappeared completely at the sub cell No.4 and the condition was continued in 2013.

The current pattern from the trace of bed shows the change of direction in front of the seagrass to offshore because of the seagrass in front of the beach in the photo of 1967. On the other hand the current from offshore reached to the beach and changed its direction to offshore through the channel as shown in the photo of 1991. The current in 1967 was prevented by the seagrass and in 1991 the current was reached to the beach. The change of current pattern caused the change of sediment transport. The loss of seagrass increased the wave and current action together with the rate of sediment transport and caused erosion.

Change of Seagrass : Left Condition at 1967, Right Change after Cyclone 1975

Change of Seagrass : Left Loss of Seagrass 1991, Right No Seagrass at 2013

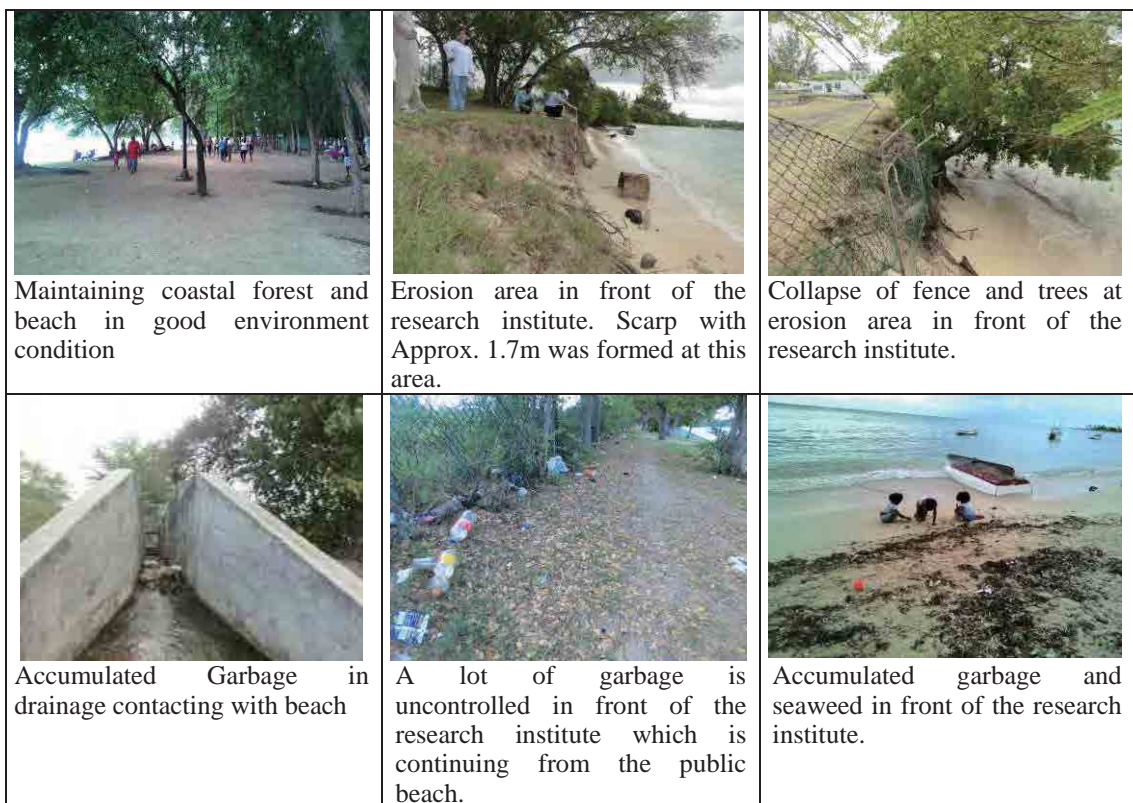
Figure 11.5.1 Beach Condition at Albion

People cannot pass through the beach because large scarp is formed in front of the research center. There are some possibilities that plantings and fence will fall down and flow out due to erosion.

Beach cleaning is carried out by the Beach Authority every day at the public beach. On the other hand, lots of garbage and driftage are left on the beach in front of the fishery research center. Garbage accumulates in ditch faced to the beach. It might be flowed out to the sea after the rain. Those conditions are shown in Figure 11.5.1.

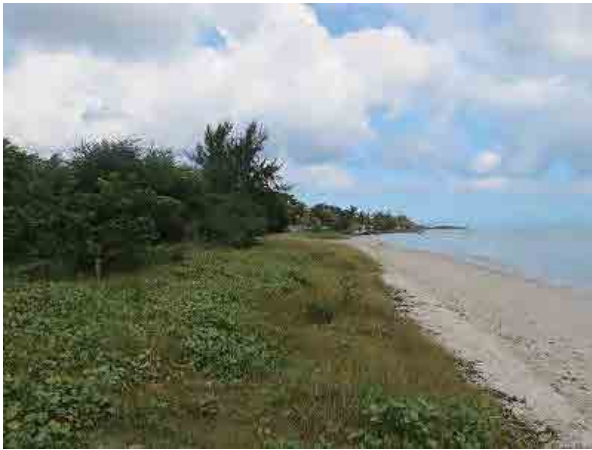
- Point A is approximately 600 m to the east side from the new revetment of the public beach. A wide sandy beach exists here, and vegetation is seen in the backshore.

Point A (Approx. 600m east from new revetment)

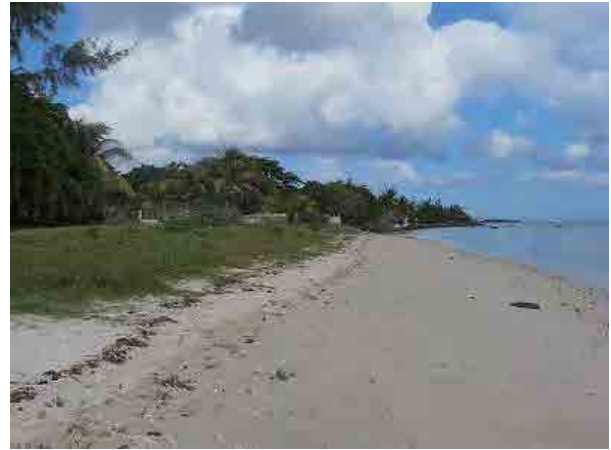
- Point B is approximately 250 m to the east of Point A. Beach width becomes narrow from this point, but the width of both foreshore and backshore still seems to be sufficient. Next point is Point C, and it can be seen in the far distance from this point.

Point B (Approx. 350m east from new revetment)

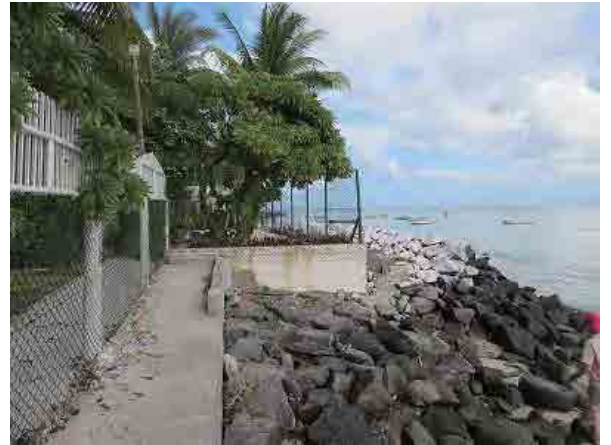
Point D (Boulder protection, approx. 100m east from new revetment)

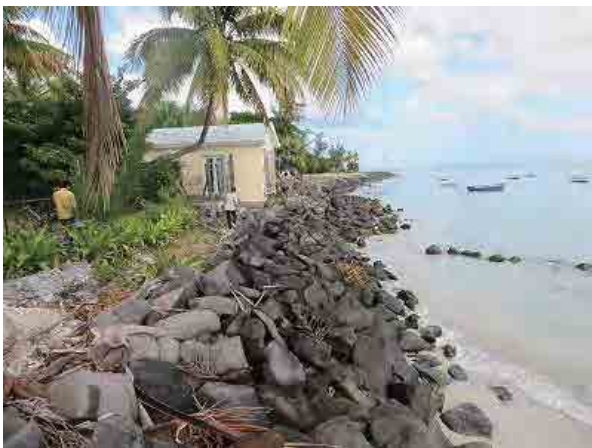
Point E (Boulder protection, approx. 100m east from new revetment)

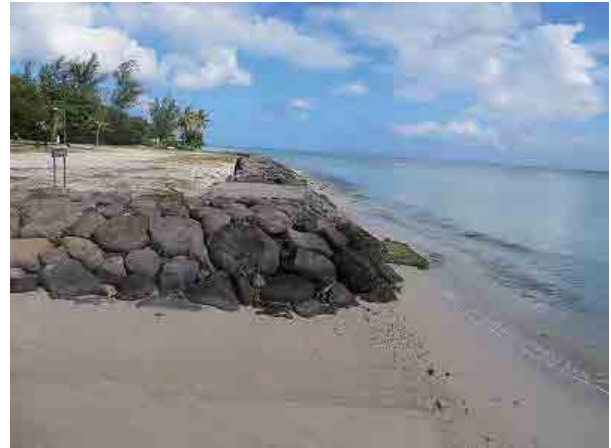
Point F (New revetment on public beach)

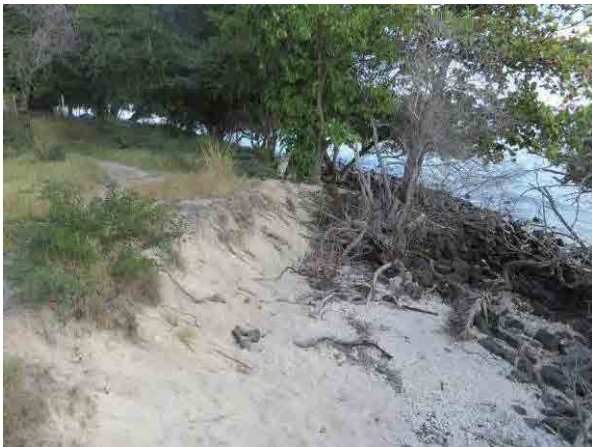
Point I (Approx. 200m west from point G)

- At Point I, which is approximately 100 m west from point H, it is found that the ground is greatly washed away and tree roots and stumps are exposed. There are rubble stones,

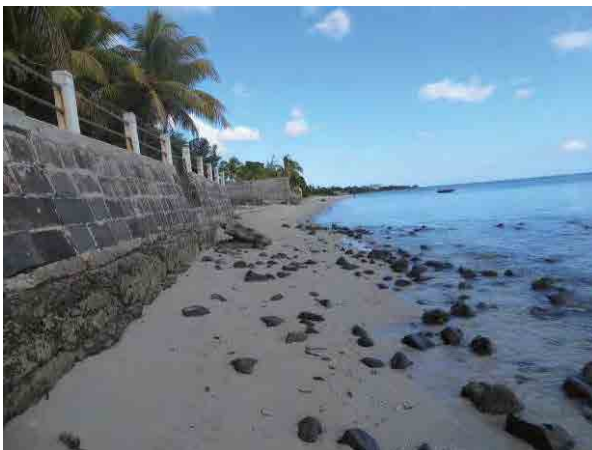
Point K (Approx. 150m west from point J)

- In point K which is approximately 150 m further to the west, the foundation of existing retaining-wall is exposed. It means that erosion still advances after the retaining-wall construction. And then, near point L, which is 150 m west point K, the sandy beach can be seen again. There are private homes and villas from point G to point K.

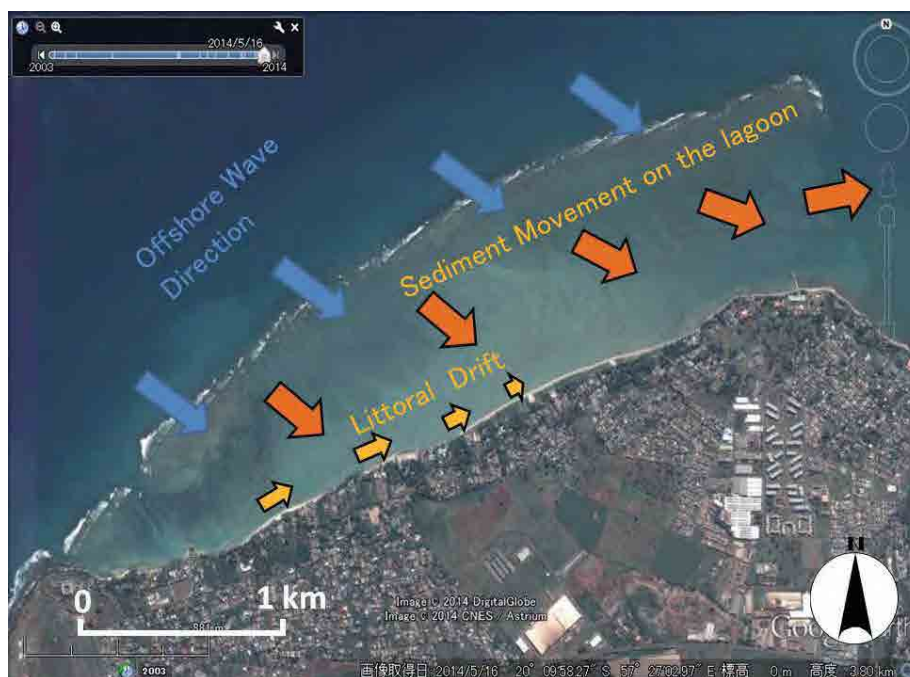
Figure 12.3.1 Wave and Littoral Drift Pattern at Pte. aux Sables

Figure 12.3.1 shows the incidence direction of the waves, the sand movement direction on the reefs and the littoral drift along the coast as estimated from the above-mentioned various approaches. It is thought that the sediment may move to the land side from the off-shore on the reef by the incidence of westerly waves in this coast. And then, it may gradually move to the east, as a whole, by the littoral drift facing east. The volume of drift sand as the whole coast is estimated to be 1,000 - 1,500 m<sup>3</sup>/year as the result of a long-term sediment budget (Figure 12.2.7). Since there is the difference in the drift sand volume locally, the erosion area and sedimentation area is seen in this coast.

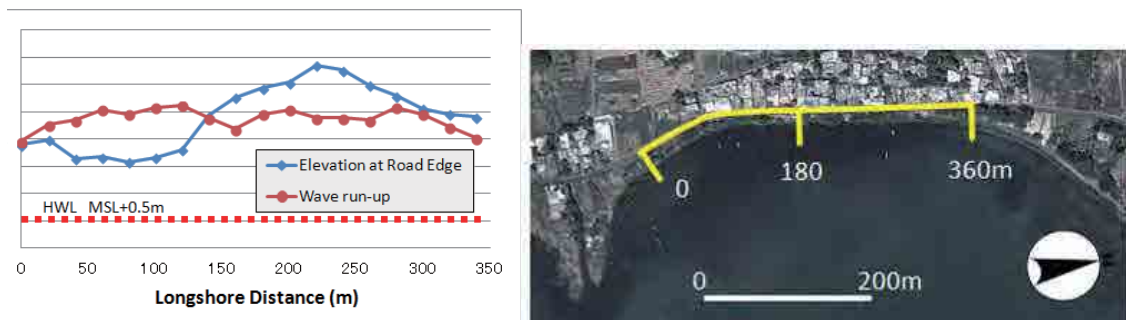
Figure 13.2.3 Coastal Road Elevation in the Area 'A'

Figure 13.2.3 shows current situation of the coast to clear that it would be a problem in the road traffic when sea level rise occurs in the future due to the climate change. Especially, the impact would appear in the section of the lower elevation of 1.5m comparing to the higher elevation section.
