**THE PROJECT FOR CAPACITY  
DEVELOPMENT ON COASTAL  
PROTECTION AND REHABILITATION  
IN THE REPUBLIC OF MAURITIUS**

**FINAL REPORT**

**COASTAL CONSERVATION PLAN**

**(Volume 2)**

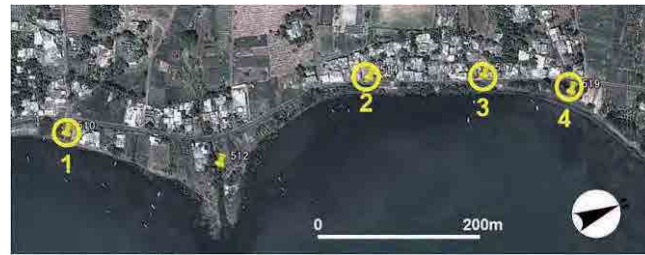
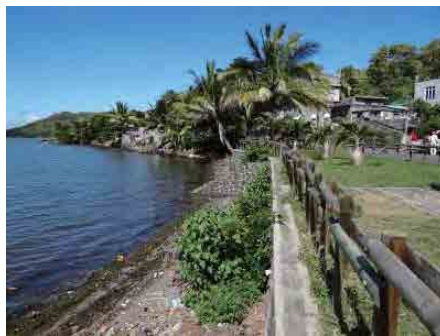
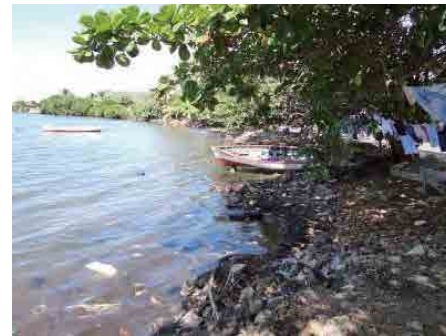
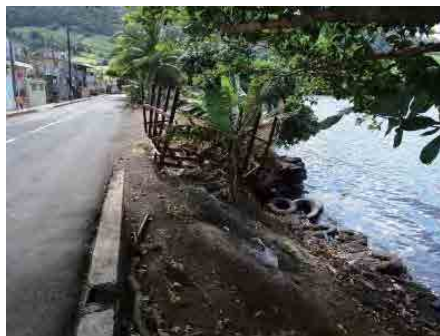
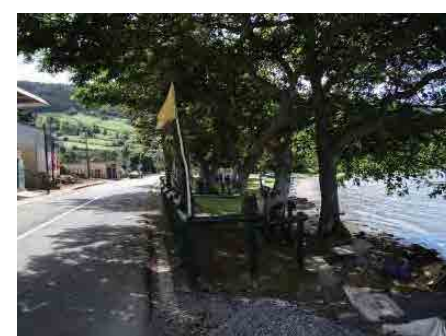
Figure 13.2.4 Current Situation of the Area 'A'

In the aspect of environment, shown as Figure 13.2.4, the problems of scattering garbage including littering from road side, deterioration of landscape value and having unpleasant odor can be notified in the beach. In the south estuary area effectiveness of plantation of mangrove has not been demonstrated because implementation of the activity has just started.

Location 1: Road elevation MSL+2.0m

Location 2: Road Elevation MSL+1.6m

Location 3: Road Elevation MSL+3.0m

Location 4: Road Elevation MSL+2.4m

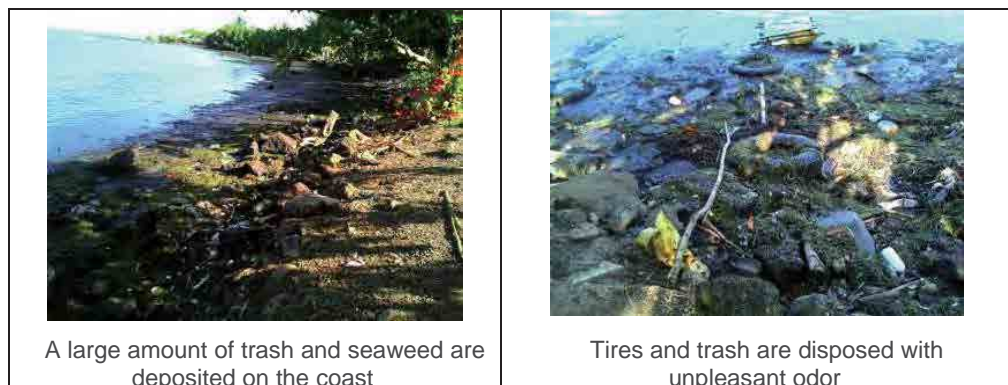
Figure 13.5.1 Coastal Situation before the Implementation

Before the implementation of the demonstration project, a large number of garbage, seaweed and tires were disposed with unpleasant odor in the projected beach. Beach environment was extremely deteriorated due to the littering addition to the decomposition and inflow of untreated gray water from housing as shown on Figure 13.5.1. These present health hazards.

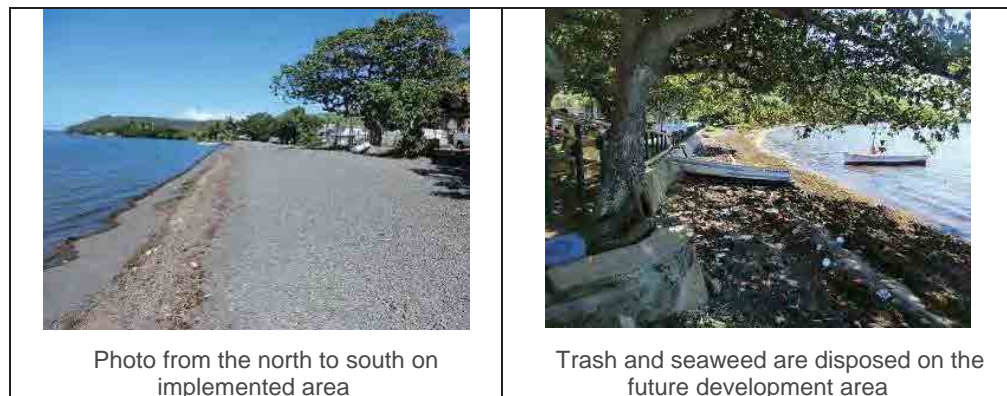
Figure 13.5.2 Coastal Situation after the Implementation

On the other hand, situation of the implemented area in June 2014 after the project, as shown on Figure 13.5.2, water quality, deposition of garbage and unpleasant odor have been significantly improved. It can be noted that voluntary clean-up activity on the beach by local residence is one

of the reasons for the improvement. Otherwise, in the non-implementation project area, deposition of garbage, seaweeds and water turbidity is still noticeable.

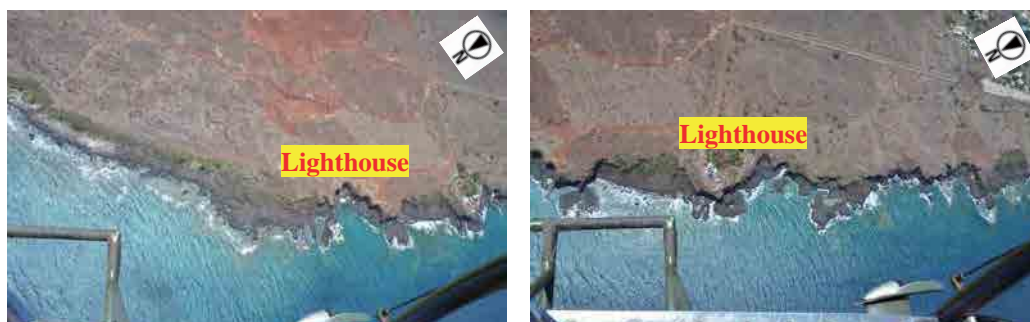
Figure 14.2.2 Aerial Photo of Albion Left : North, Right: South of Lighthouse

The aerial photo of the study area is shown in Figure 14.2.2 taken by a helicopter. The cliff was not eroded uniformly. The fluctuation is large and reached 30m in width. At the base collapsed rock is deposited 50m wide in its maximum. Future development is planned at the north of the light house.

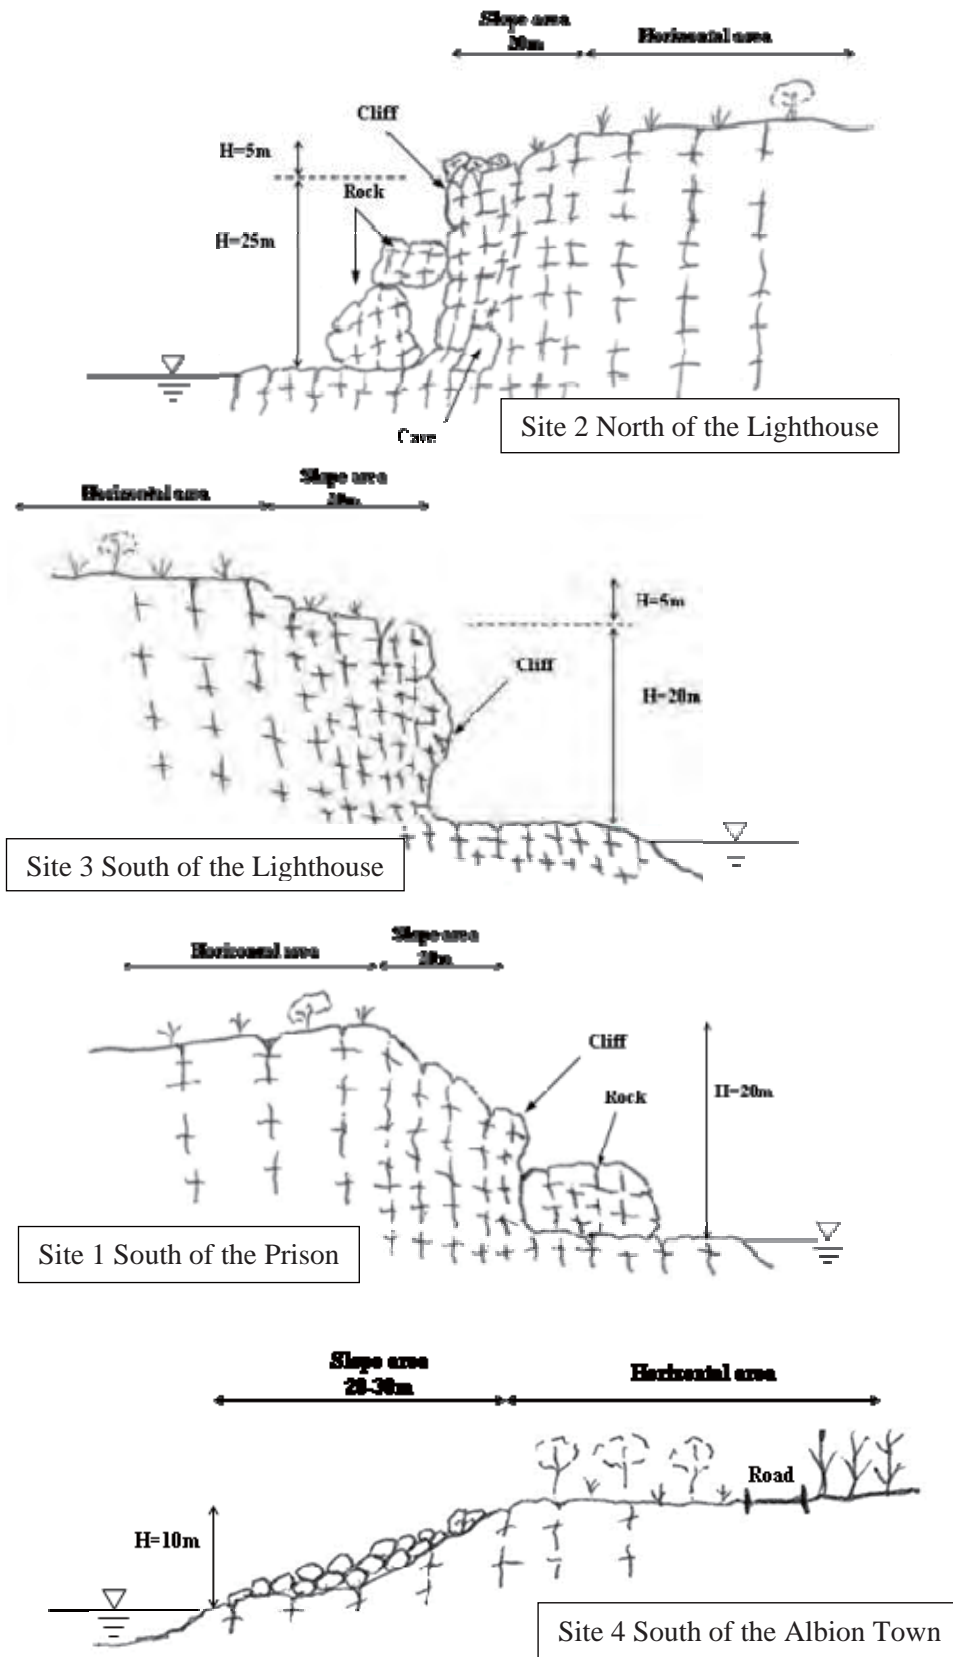
Figure 14.2.4 Sketch of Survey Points

The sketch of cliff is shown in Figure 14.2.4 and the results are as follows. Residential development has progressed in Albion area and the development is in progress. Geology of the coast is mainly composed of basalt and the terrain behind the coast is relatively flat and smooth. The coasts of Site 1 near the prison at Pte. aux Sables and Site 2 and Site 3 near the lighthouse at Pte. aux Caves are cliff of around 20 to 25m high with vertical slope. Basalt rock at the cliff surface is a pretty hard lithology itself and irregular cracks have developed in the vertical and horizontal directions with caves and overhang. The surface rock is seems to be weathering with topsoil. The bedrock is slightly larger and stable and the basalt rock has eroded away with gullies formed. There is a possibility that the rock of the upper portion collapse or fall down if the overhang progresses.

The coast of Site 4 at the south of Albion Town is about 10m high and covered by cobbles of 20 to 30m of width.

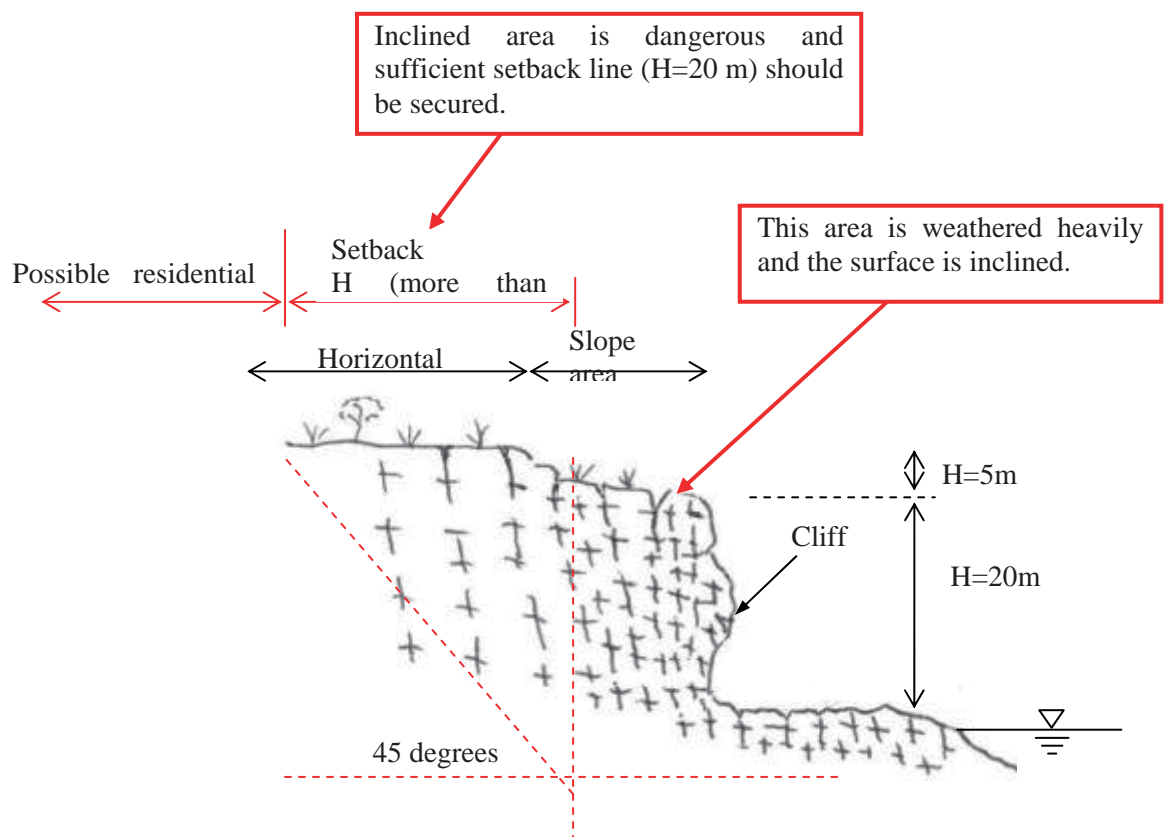
Figure 14.3.1 Image of the setback line (draft)

The setback line will be determined considering the estimation of cliff erosion speed, the life time of houses or structures, the slope area of the cliff and horizontal area. The most important is the slope area and it should be analysed based on the site inspection and aerial photos. From the preliminary site investigation, two areas can be taken as shown in Figure 14.3.1. The first is the slope area where the rock is weathered and the cave is formed. The second is the horizontal area where estimated from the slope stability.

analyze the existing conditions in details and then the final setback line will be determined. Figure 14.3.1 illustrates the image of the setback line.

Recommendations: use 5cm /yr as an example. Further investigations required for Mauritius, to define parameters required-to elaborate
