**The Project for
Improvement of Road Technology
in Disaster Affected Area in Myanmar**

**Technical Note on National Highway
& Expressway**

(Geometric Structure & Traffic Safety Facility)

June 2015

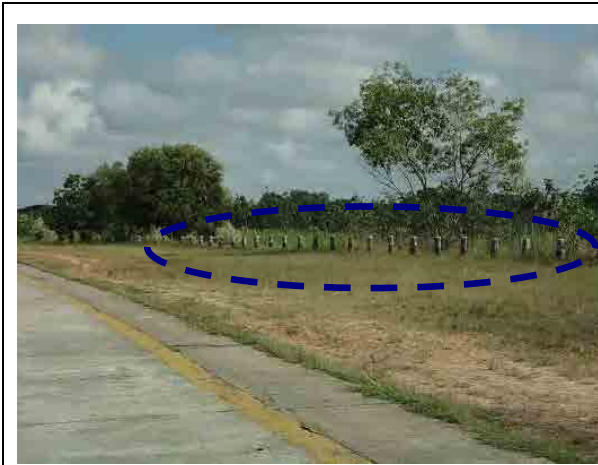
Ph.17 Risk of serious injury on passengers in case of colliding with concrete posts.

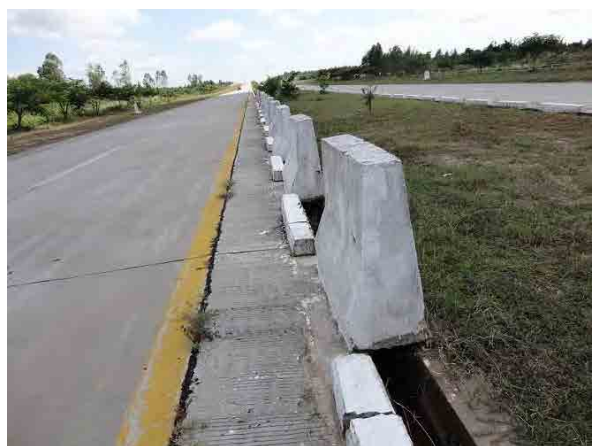
Ph.22 Parapet wall is located behind the curbs.

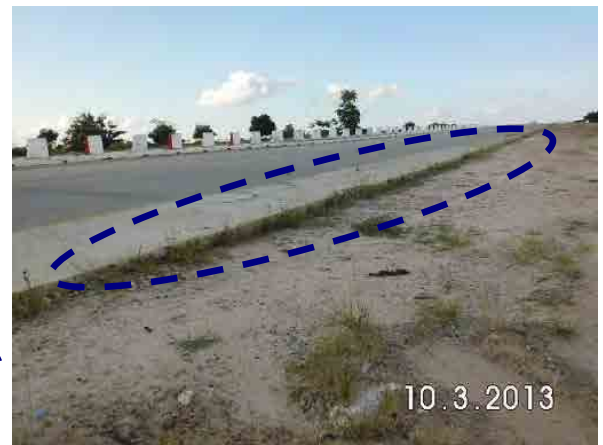
Ph.24 Gap occurred between shoulder and the outer area (photo from behind direction).

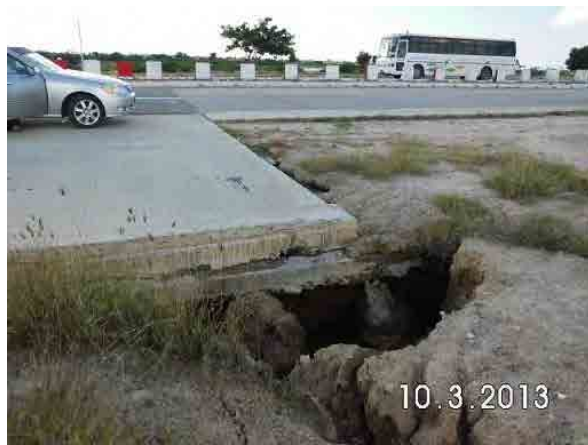
Ph.25 Large cavity under concrete slab. Potential risk of the collapse.

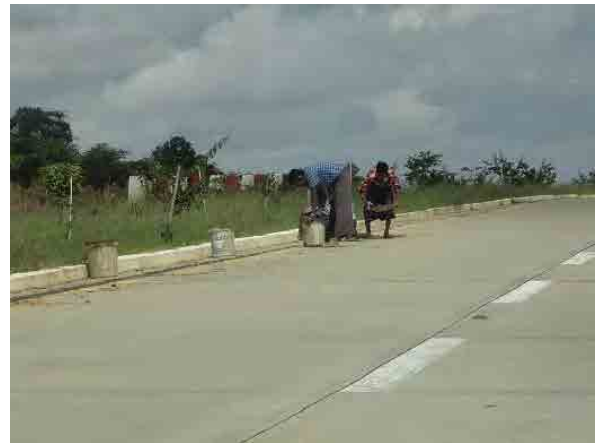
Ph.36 Injection of cement mortal into joint parts between each concrete slabs to prevent water penetration (good example).

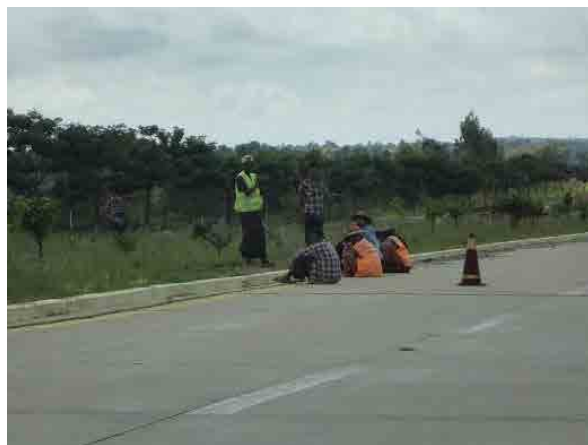
Ph.37 Workers took a rest within carriageway (prohibited work manner).

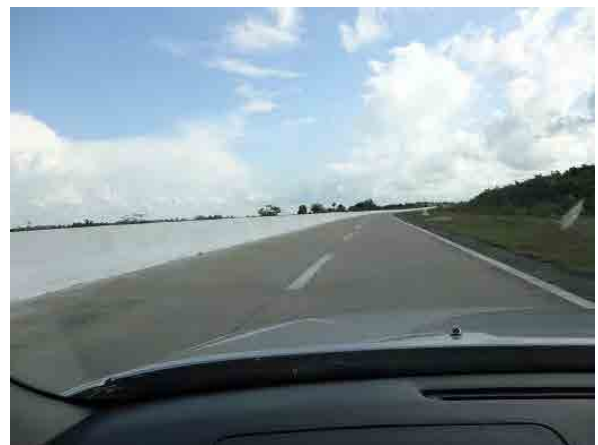
Ph.38 Continuous concrete wall on median strip side instead of concrete block (good example). Overrun will be prevented.

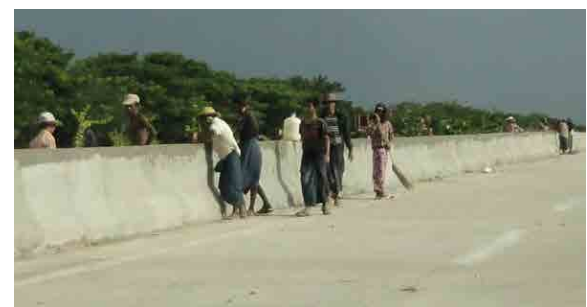
Ph.40 Workers took a rest within carriageway (prohibited work manner).

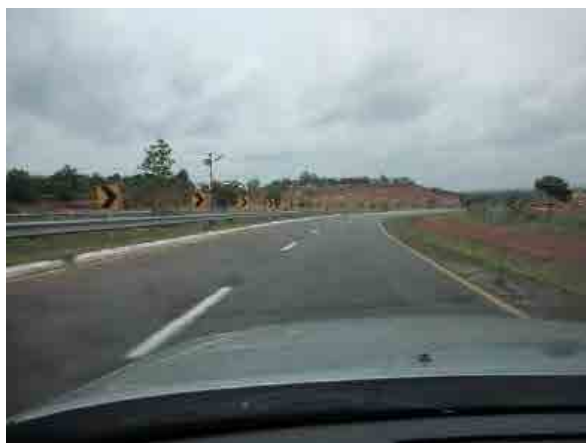
Ph.65 Traffic signs guide the driver's vision in the curve section (good example).

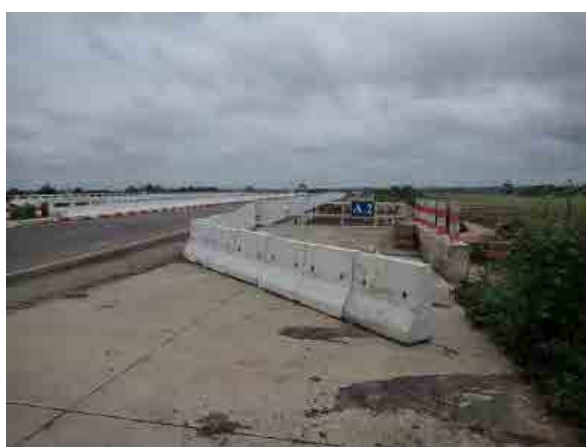
Ph.69 Place of the bus fall accident on May/2015 (198mile). Bridge construction site.

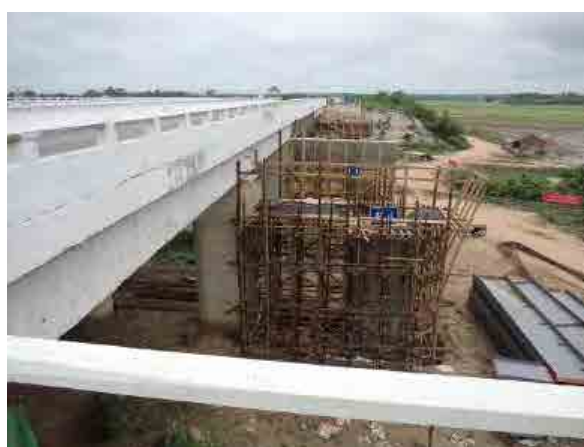
Ph.70 Place of the bus fall accident on May/2015 (198mile). Bridge widening work (2-lanes to 4-lanes) is in progress.

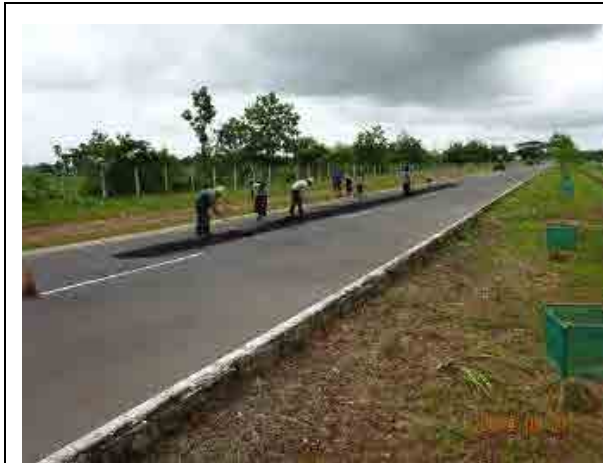
Ph.105 Repair work. Work area was clearly surrounded by the cones (good example).

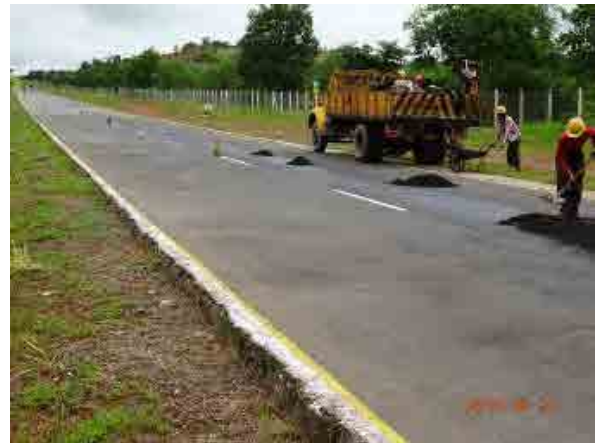
Ph.106 Repair work. Work area was clearly surrounded by the cones (good example).

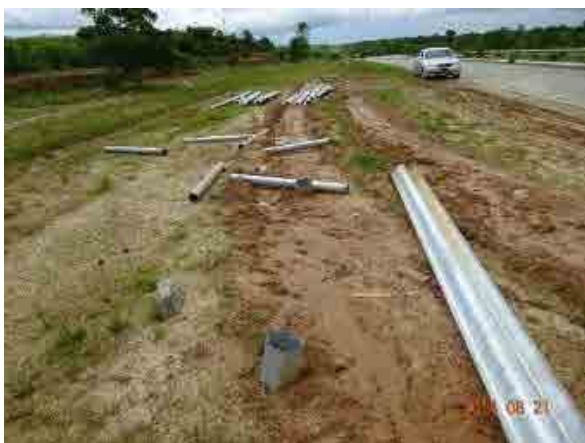
Ph.109 Work site of guardrail installation.

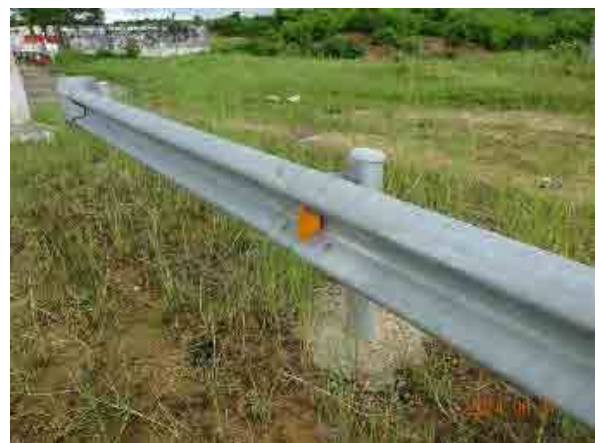
Ph.110 Work site of guardrail installation.

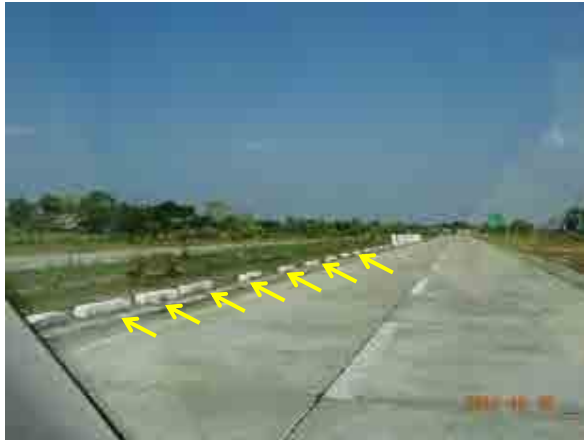
Ph.139 Concrete curb was set back to median strip side to secure shoulder width (good action).

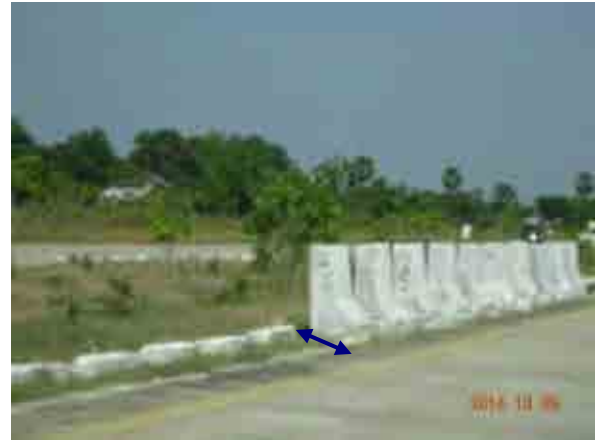
Ph.140 But concrete wall also should be set back.

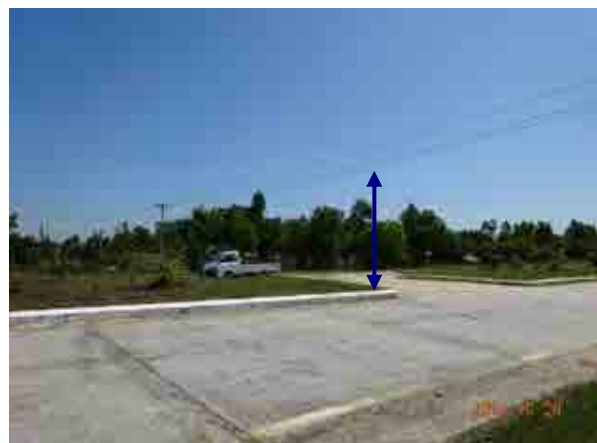
Ph.142 Electric wire seems too low.
