**PROJECT
FOR
IMPROVEMENT OF OPERATION AND
MAINTENANCE OF WATER SUPPLY AND
SEWERAGE SYSTEMS
IN
PARANA STATE, BRAZIL**

PROJECT COMPLETION REPORT

VOLUME II

Japan International Cooperation Agency (JICA)

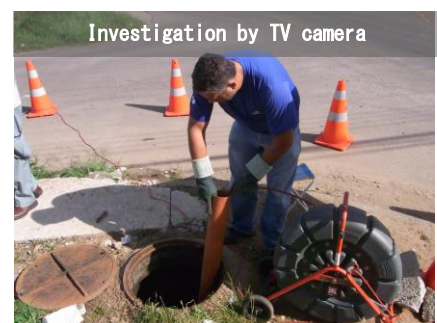
Because the insert method of this camera utilizes sewage flow, it is inserted and photographs after pipe cleaning without water stop usually. In case of our inspection the camera was inserted without finishing pipe cleaning and could not photograph because of submerge of it. In this case up flow of sewage pipe was stopped and longer distance was photographed than without stop.

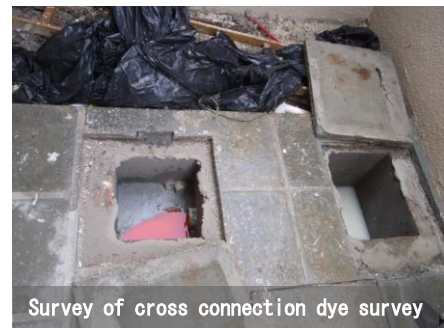
Survey of cross connection dye survey

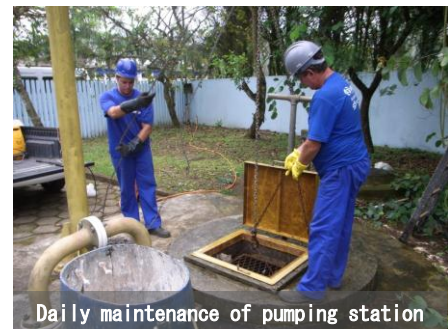
64 pumping stations of 103 stations in the target area are located in CMA. Out of these stations Piracuara Pumping Station in Atuba Sur watershed was inspected. In this station a mechanical trash screen has been removed by failure but other equipment is well operated. It has reserve tank and by-pass pipe to the river for support at the time of stopping. Pumping stations in CMA have by-pass pipe like this. While at large pumping stations flowmeter is installed and data is controlled well as for O/M, at smaller pumping stations it is not installed and data of operating time is checked every day or every few days. In this time at 6 pumping stations flowmeter is installed, and there is a plan to install it sequentially, installing it at 11 pumping stations (Atuba Sul basin : 3, CIC Xist basin : 5). Details of the result of investigation of pumping stations are shown at Activity 2-3 of Result 2.

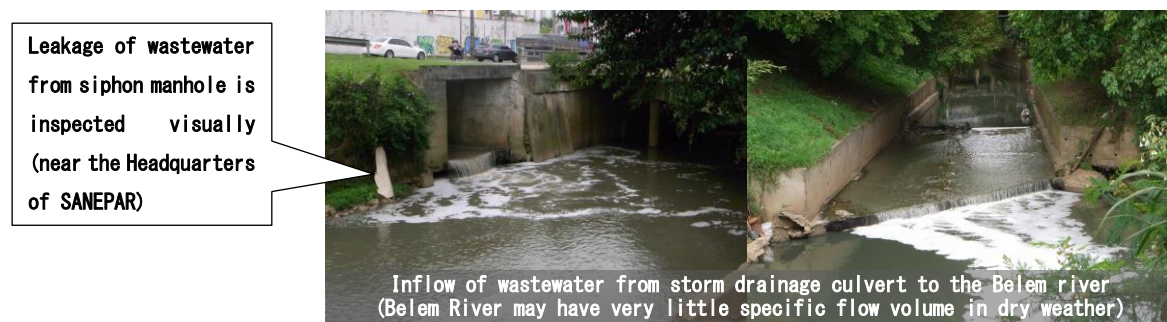
The overflow from sewage pipe network seems to occur also in dry weather. Especially in Belem basin, big amount of wastewater is discharged to the Belem river that flows from north to south of central area of the city and is covered in some area, and it causes remarkable water pollution. Major cause of SSO in dry weather is the leakage from manhole of blocked siphon at river cross sections and the discharge through previously installed discharge pipe (unidentified) in addition to cross connection. In CMA a lot of siphons are installed, and some of them are broken and ordered to be reconstructed. It needs detail investigation of siphons immediately. It is very difficult to clean up pipes of siphon structure when it is blocked by deposition of sand and dirt, and difficulty increases as time passes. Although siphon structure is designed of two lines basically, SANEPAR adopts single line except for some cases, and adopts bended siphon in which sand and dirt is easy to be deposited. These structures make the maintenance more difficult. From these facts to keep the basic function of sewage facility a fundamental countermeasure on broken siphon structure must be conducted base on the investigation of actual conditions.

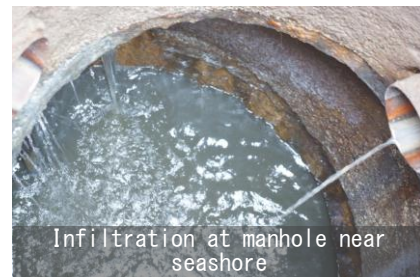
In coastal area in general sewage pipe is installed deeply and many pumping stations are installed because of flat geography (Out of 103 pumping stations in targeted area 39 stations are installed in coastal area). There is a problem of infiltration of ground water because of the high ground water level and soil quality with high permeability. Because infiltration is accompanied by intrusion of sand preventive cleaning of sewage pipe to remove deposited sand is conducted before tourist season when tourist population increases. Some trunk sewage pipe near the seashore intruded by much sand, and in some cases the road will be sunk after cleaning up sand and so there is a need for immediate action.

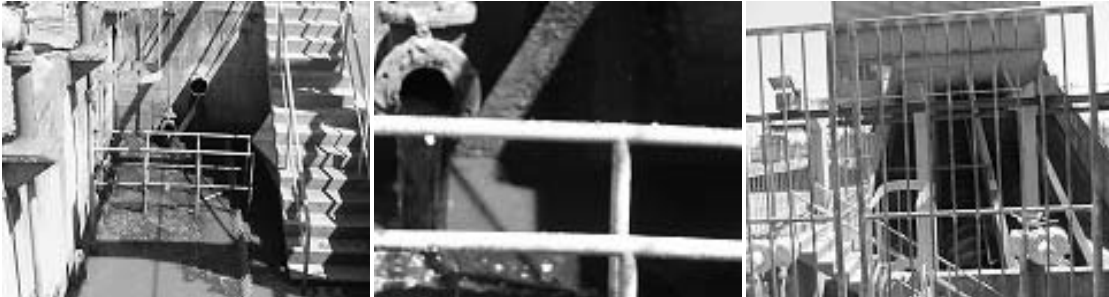
Influent: Depth of sewer main entering the plant seems to be 4m depth from the ground. Substantial

amount of screen debris is discovered (when sampling tube was got around by those debris). The JICA team noticed blackish wastewater 3m depth from the ground which flows into pump well. Three screw type main lifting pumps are installed. Normally, one unit is operated. Basically there is no need of control for pump operation. Normally one pump is operated while another one is added when increase of inflow. Mechanical screen (2 units).

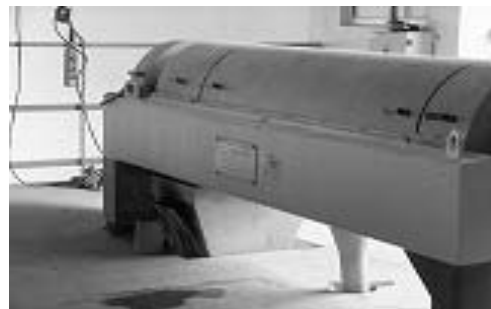
At the time of visit, dewatering has been stopped because of lack of space to store dewatered sludge which

follows dewatering. On the other hand, water content of

dewatered sludge is pretty high as a part of the dewatered sludge was remained.

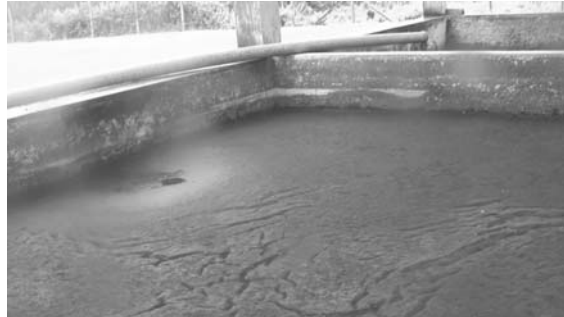
Sludge drying bed: All the sludge is withdrawn from UASB and dewatered and dried in sludge drying bed. License for agricultural use is already obtained. However, agriculture here does not have need for such materials, and sludge has not been used so far. At present, possibility use as land filling soil is being considered.

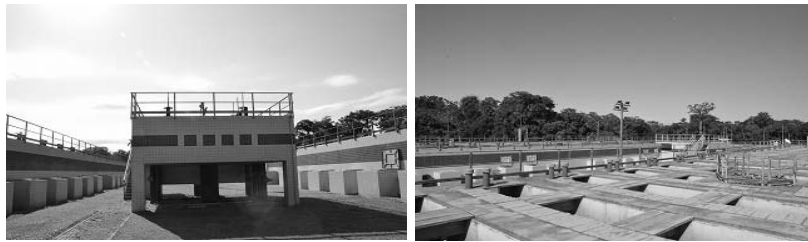
Influent: Raw sewage is received by pressure sewer from a pumping station. Screen if of two types; manual bar screen and mechanical one. Mechanical instruments have been wrong and settled grit has been removed by draining the chamber regularly.

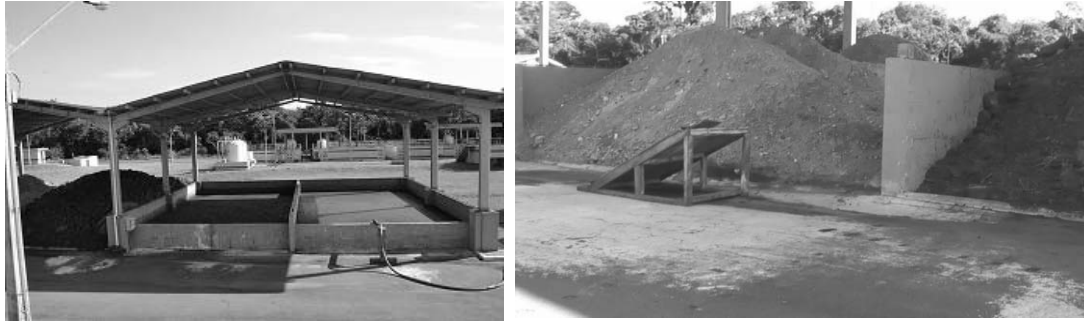
Sludge drying bed: More than 30 days are needed to make sludge dry. At present, construction of additional drying bed is planned. Like other treatment plants, final disposal of sludge has not established yet. Sludge is stored inside the plant site. After operation of DAF is started, sludge treatment and disposal of DAF have to be needed. At present, temporary pipe is laid out to sludge drying bed and DAF sludge is dewatered and dried there. Increasing sludge disposal will possibly be the problem in future.

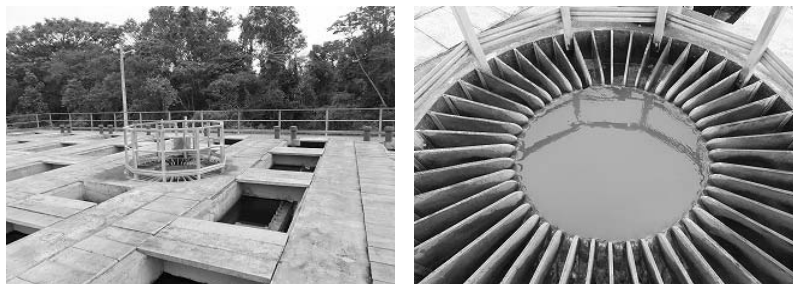
UASB: Volume of UASB is 1,000 m³, retention time is 8 hours. All the designs including other facilities are same as those of Guaraquecabe. UASB proves no remarkable floating scum and no sludge flock overflow and maintains relatively preferable treatment. No odor noticed from UASB. On the other hand, when sampling sludge from UASB, extraordinary

thickened sludge (apparently 10% of solid concentration) was drawn from the bottom of the tank.

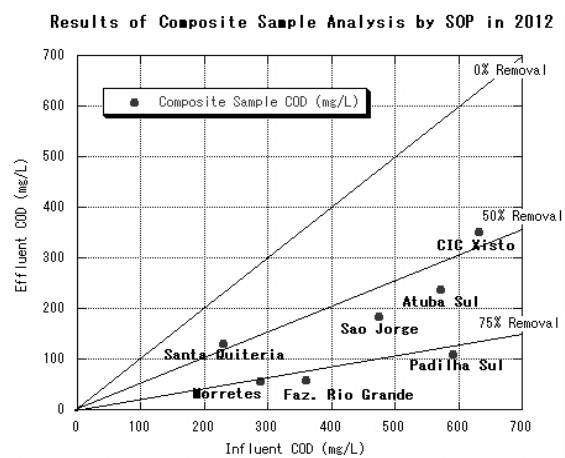
Fig. 3.3-5 COD removal

COD: Removal ratio of COD is lower than BOD ranging lower than 75%. Lower value of 50% was found. In addition to Morretes and Faz. Rio Grande which are relatively good performance, "Un-aerated Lagoon" of Padilha Sul indicate preferable performance too.

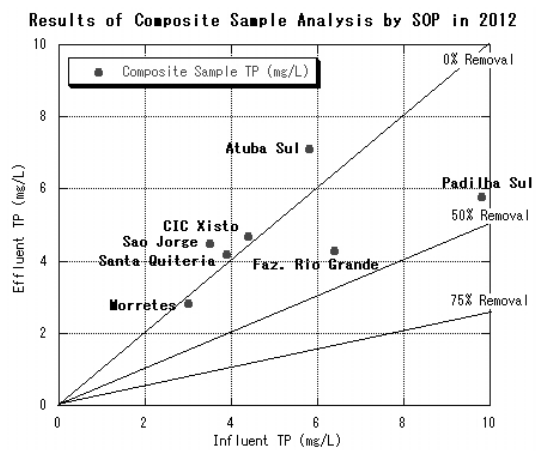
Fig. 3.3-8 T-P removal

T-P: As for phosphorus, except for some removal tendency for Faz. Rio Grande and Padilha Sul where lagoon is adopted, removal ratio seems insufficient too.

It should be noticed here that influent concentration of Padilha Sul is extremely higher than normal domestic sewage as T-N over 100mg/L, T-P over 10mg/L and it may be notified as some industrial wastewater is influencing the STP.
