連邦公共事業省

**ナイジェリア国  
コンクリートテスター（CTS）を  
用いた道路付帯コンクリート構造物の  
点検技術の普及・実証事業  
業務完了報告書**

平成 27 年 10 月

日東建設株式会社

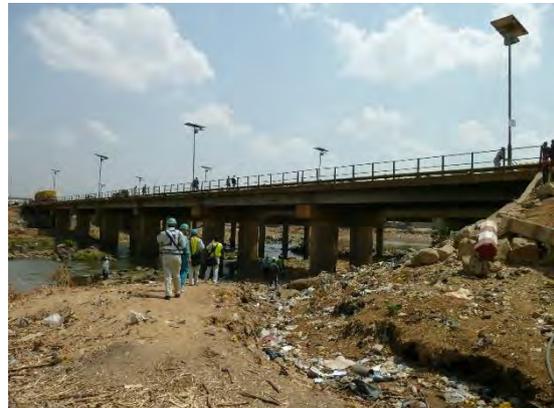
橋梁視察 (Usmandam Bridge : old)  
(2014年3月)

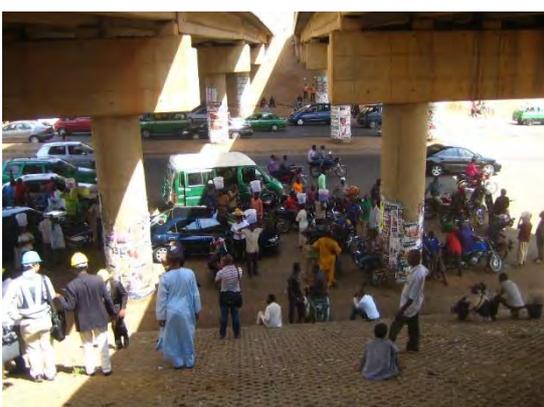
橋梁視察 (Nyanya Interchange Bridge)  
(2014年3月)

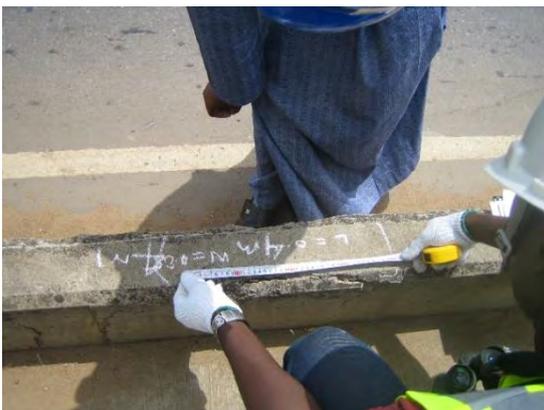
損傷箇所の測定  
(2014年6月)

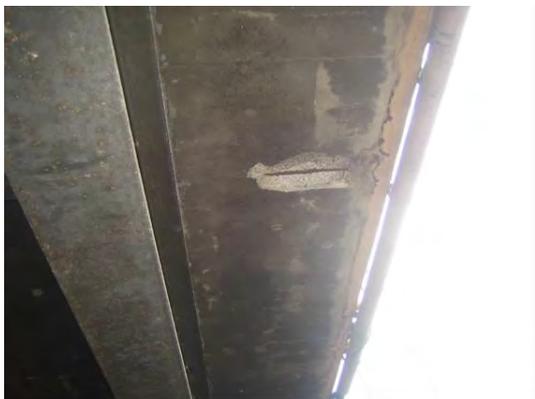
Usmandam Bridge (old) は、供用年が 1983 年（推定）であり、架橋されてから 30 年以上たっている。点検の結果、修繕された形跡は見られず、そのため床板の鉄筋の露出や橋梁添架管の損傷が見られた。また、高欄の欠落等も見られることから、早期に修繕工事を行うことで、道路利用者の安全確保、橋梁の寿命を少しでも延ばすことが出来ると考えられる。

図 3-7 床板鉄筋の露出（Usmandam Bridge(old)）

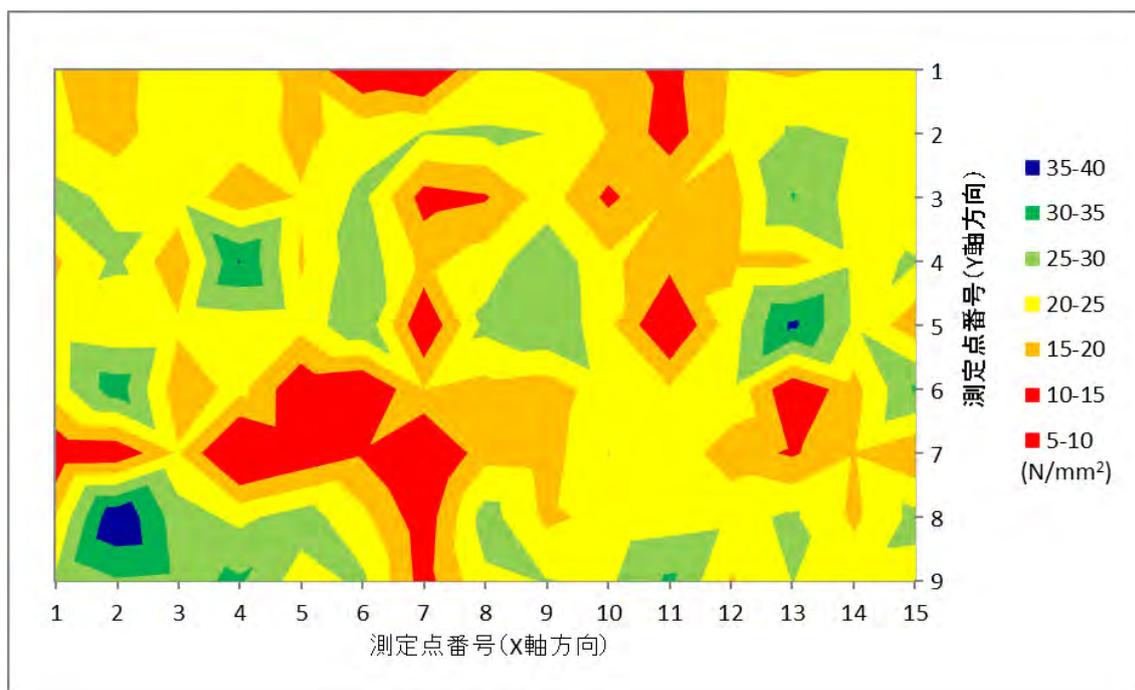
図 3-11 Zuba Flyover Bridge (Right / A2 橋台)のコンクリート強度分布

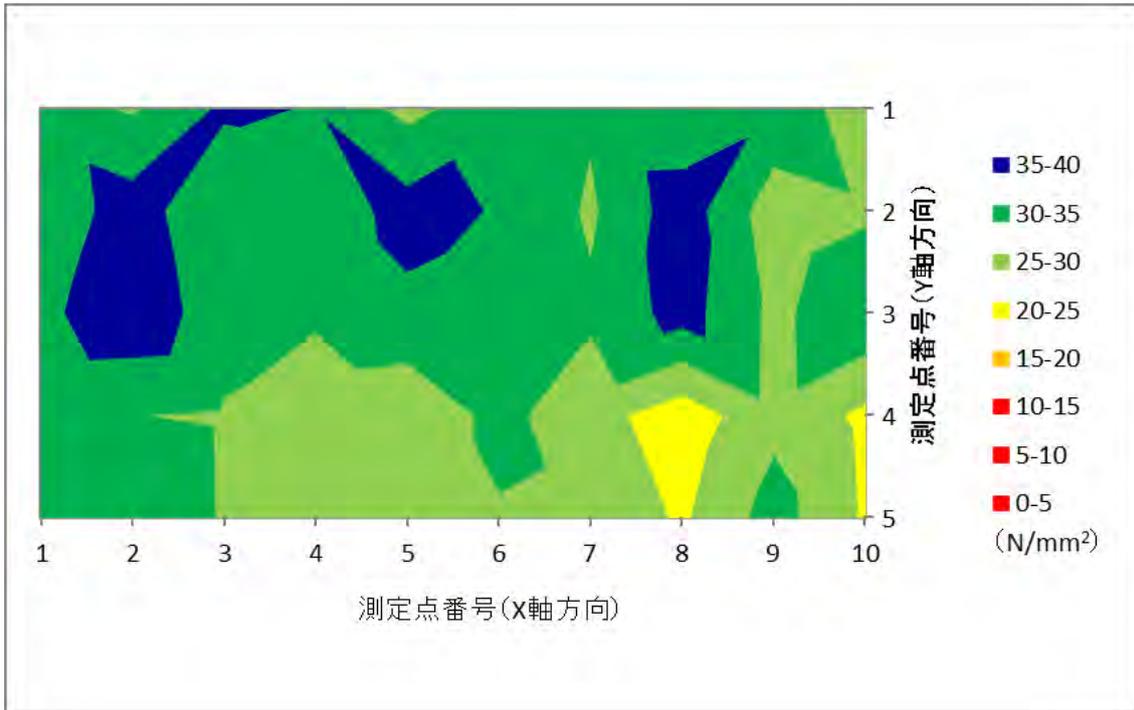
図 3-12 Karu Flyover Bridge (Light / P1 橋脚)のコンクリート強度の分布

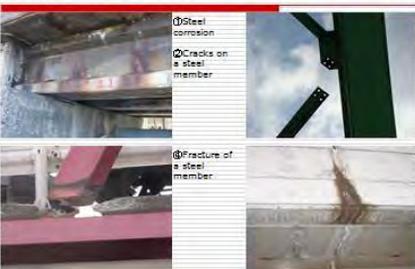
## Inspective defects 1

- ① Steel corrosion
- ② Cracks on a steel member
- ③ Fracture of a steel member
- ④ Bolt loss from steel members
- ⑤ Cracks, water leak, and free lime development on a concrete bridge

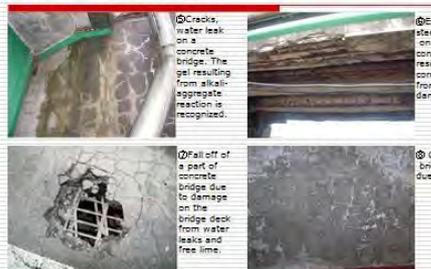
## Inspective defects 2

- ⑥ Cracks, water leak on a concrete bridge. The gel resulting from alkali-aggregate reaction is recognized.
- ⑦ Exposure of steel member on a concrete bridge resulting from corrosion of steel from chloride damage.
- ⑧ Fall off of a part of concrete bridge due to damage on the bridge deck from water leaks and free lime.
- ⑨ Cracks on the bridge deck due to free lime.

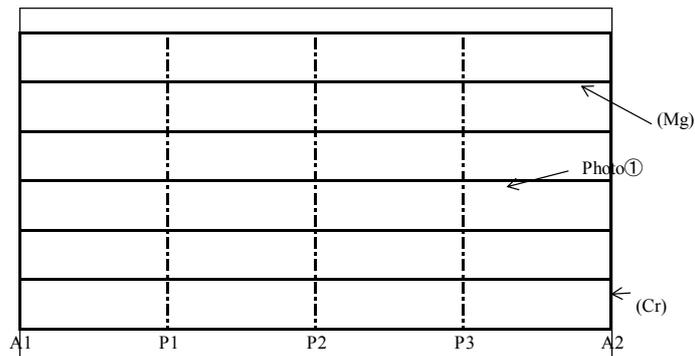
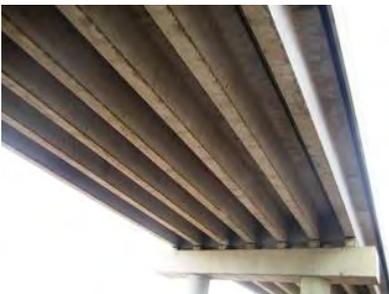
■Gwagwalada Lokaja Flyover Bridge (Left) : 損傷記録表 1

橋梁ID			
橋梁名		Gwagwalada Lokaja Flyover Bridge (Left)	
No.	1	点検実施日	2014/6/4
対象部材	主桁・横桁・床版		
損傷の種類	-		
判定結果	-		
応急措置	実施	実施内容	-
	未実施	できなかった理由	-
		実施予定時期	-
		実施予定内容	-

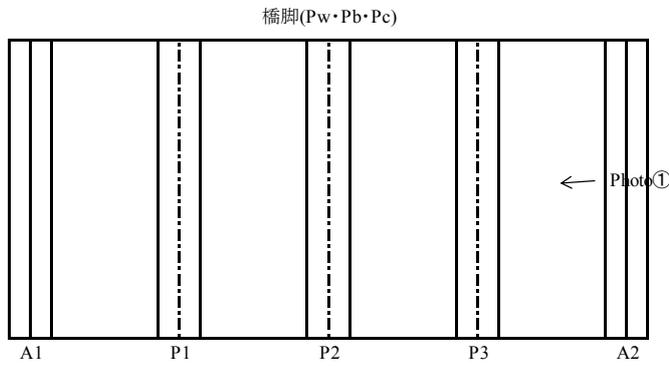
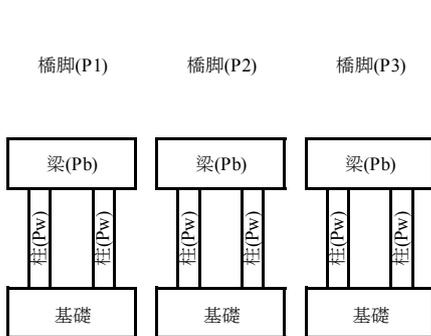
## ■Gwagwalada Lokaja Flyover Bridge (Right) : 損傷記録表 6

No.	6			点検実施日	2014/6/4
対象部材	橋脚				
損傷の種類	-				
判定結果	-				
応急措置	実施	実施内容	-		
	未実施	できなかった理由	-		
		実施予定時期	-		
		実施予定内容	-

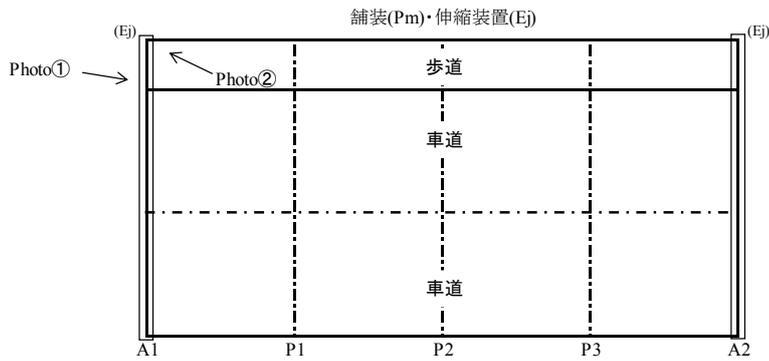
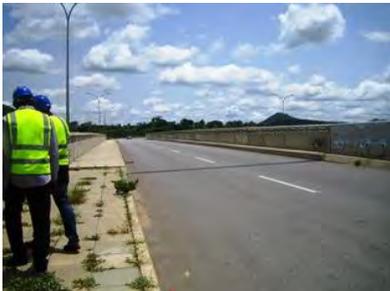
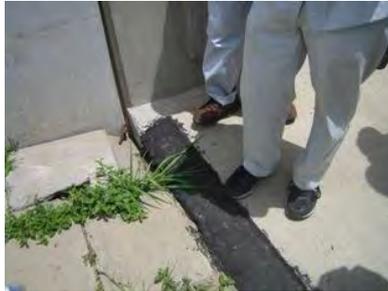
No.		4		橋梁ID			
				橋梁名		Giri Interchange Bridge (Right)	
				点検実施日		2014/6/4	
対象部材		舗装・伸縮装置					
損傷の種類		-					
判定結果		-					
応急措置	実施	実施内容	-				
	未実施	できなかった理由	-				
		実施予定時期	-				
		実施予定内容	-

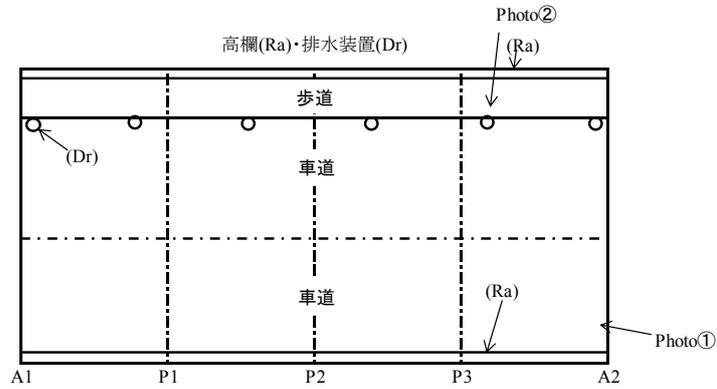
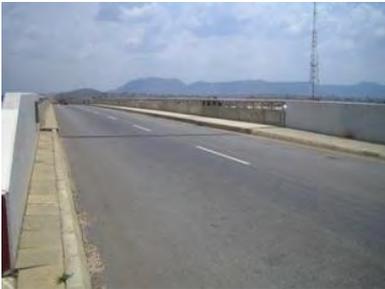
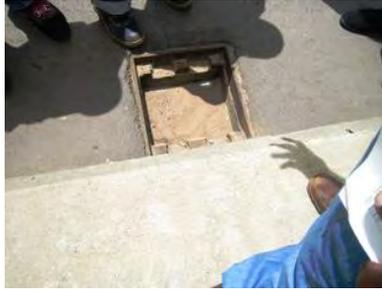
No.		5		橋梁ID	
				橋梁名	Giri Interchange Bridge (Right)
				点検実施日	2014/6/4
対象部材		高欄・排水装置			
損傷の種類		-			
判定結果		-			
応急措置	実施	実施内容	-		
	未実施	できなかった理由	-		
		実施予定時期	-		
		実施予定内容	-

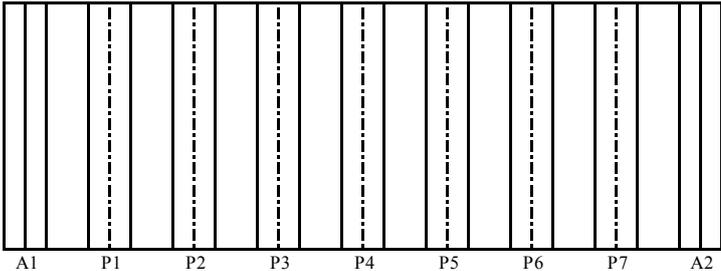
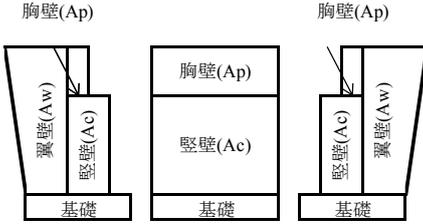
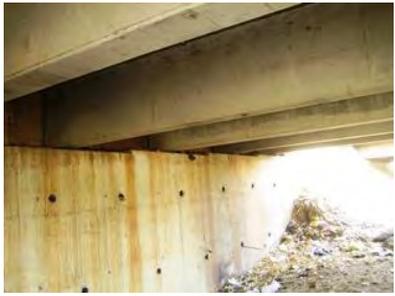
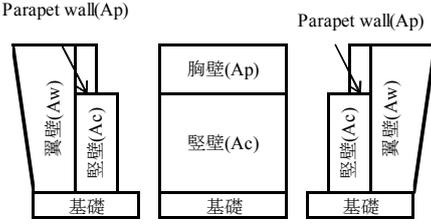
<b>橋梁ID</b>	
		<b>橋梁名</b>	Usmandam Bridge(New) (Left)
<b>No.</b>	3	<b>点検実施日</b>	2014/6/5
<b>対象部材</b>		橋台	
<b>損傷の種類</b>		-	
<b>判定結果</b>		-	
<b>応急措置</b>	実施	<b>実施内容</b>	-
	未実施	できなかった理由	-
		実施予定時期	-
		実施予定内容	-

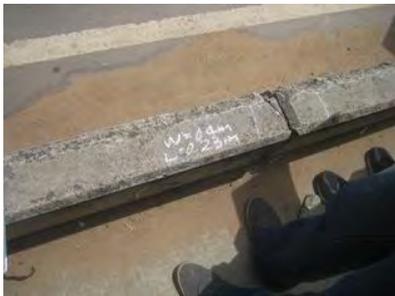
Photo②

No.	5	点検実施日	2014/6/6
対象部材	縁石		
損傷の種類	欠損		
判定結果	D		
応急措置	実施	実施内容	—
	未実施	できなかった理由	当面の緊急性は低い
		実施予定時期	2016年度
		実施予定内容	設計図を確認し、対策の必要性を検討

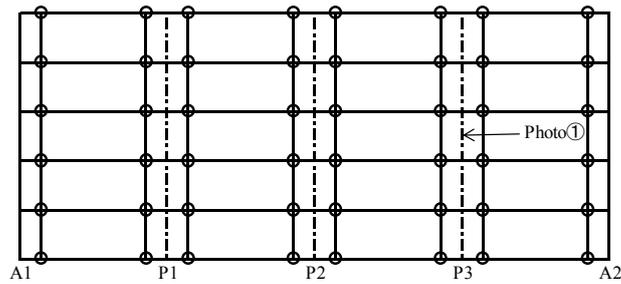
支承(Bh)

No.		2		橋梁ID	
対象部材		支承		橋梁名	Zuba Flyover Bridge (Right)
損傷の種類		-		点検実施日	2014/6/6
判定結果		-			
応急措置	実施	実施内容	-		
	未実施	できなかった理由	-		
		実施予定時期	-		
		実施予定内容	-

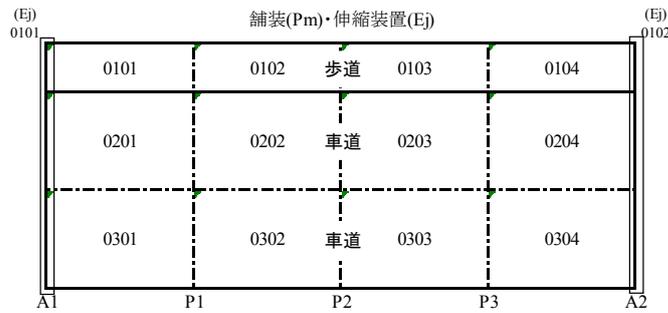
No.	4	点検実施日	2014/6/9
対象部材	舗装・伸縮装置		
損傷の種類			
判定結果			
応急措置	実施	実施内容	
	未実施	できなかった理由	
		実施予定時期	
		実施予定内容
