Minutes of Meeting on the Draft Final Report of Data Collection Survey on Disaster-resilient Feeder Ports and Logistics Network in the Republic of the Philippines

1-1-1 Major Condition of the Structure and Damages in Leyte Area

3. Results of Site Survey

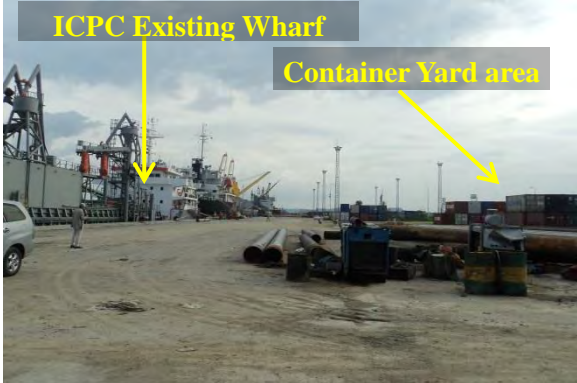
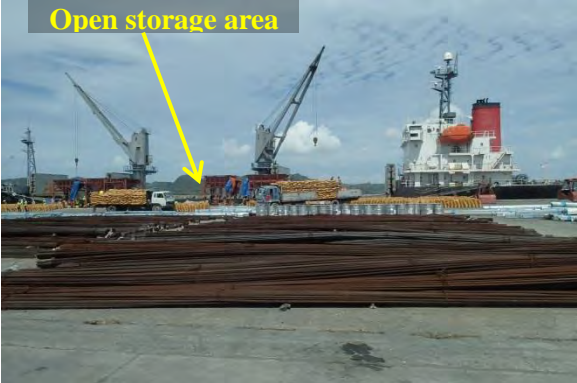
<p>Open storage area</p>
<p>Figure No.2 Existing ICPC Wharf</p>	<p>Figure No.3 ICPC open storage Area.</p>

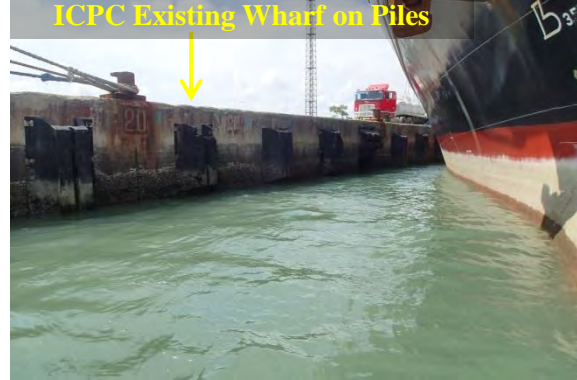
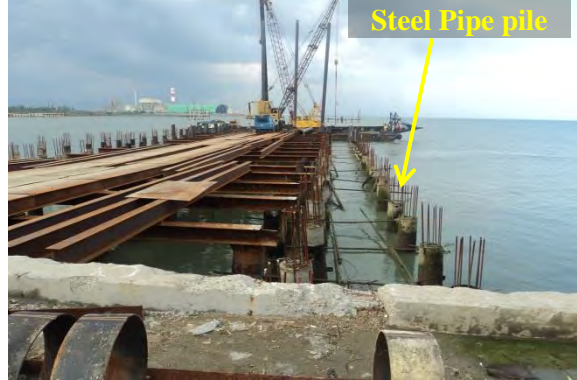
<p>Steel Pipe pile</p>
<p>Figure No.4 ICPC existing wharf.</p>	<p>Figure No.5 Ongoing Piling works for wharf extension.</p>

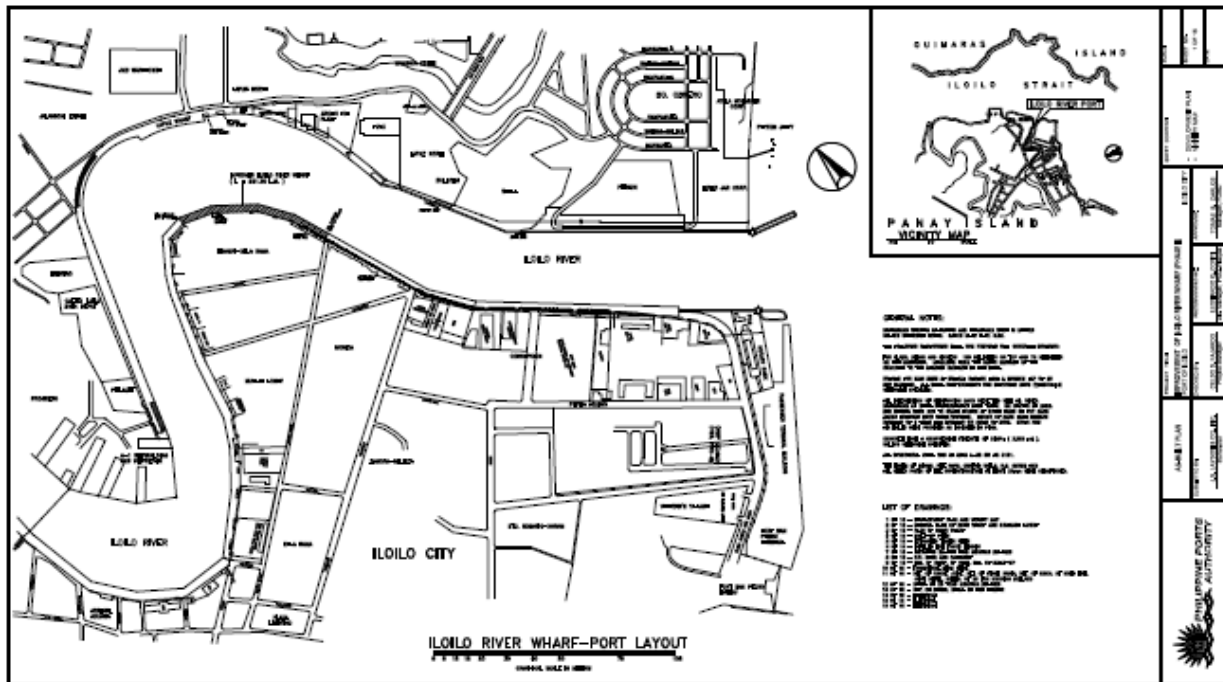
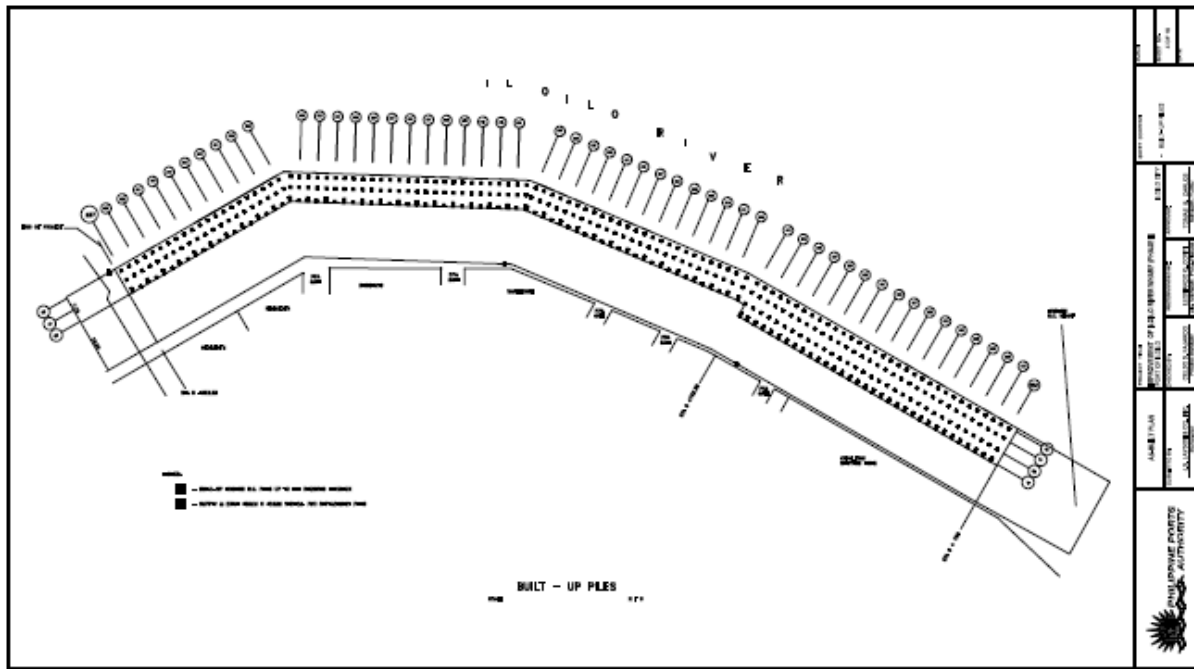
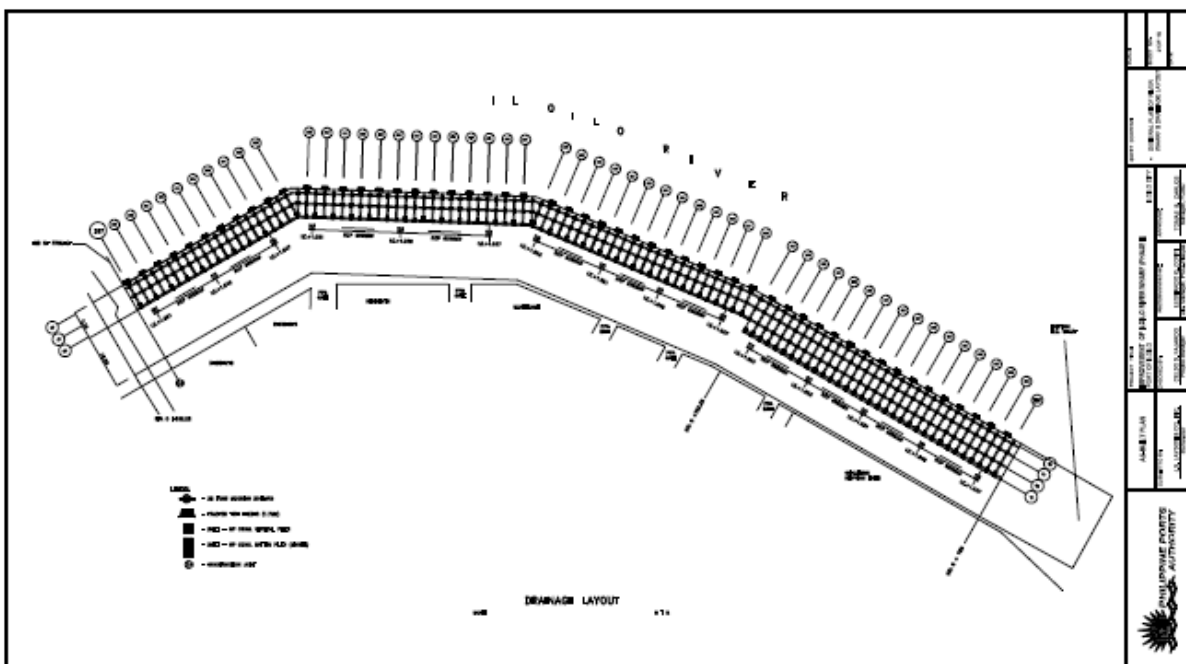
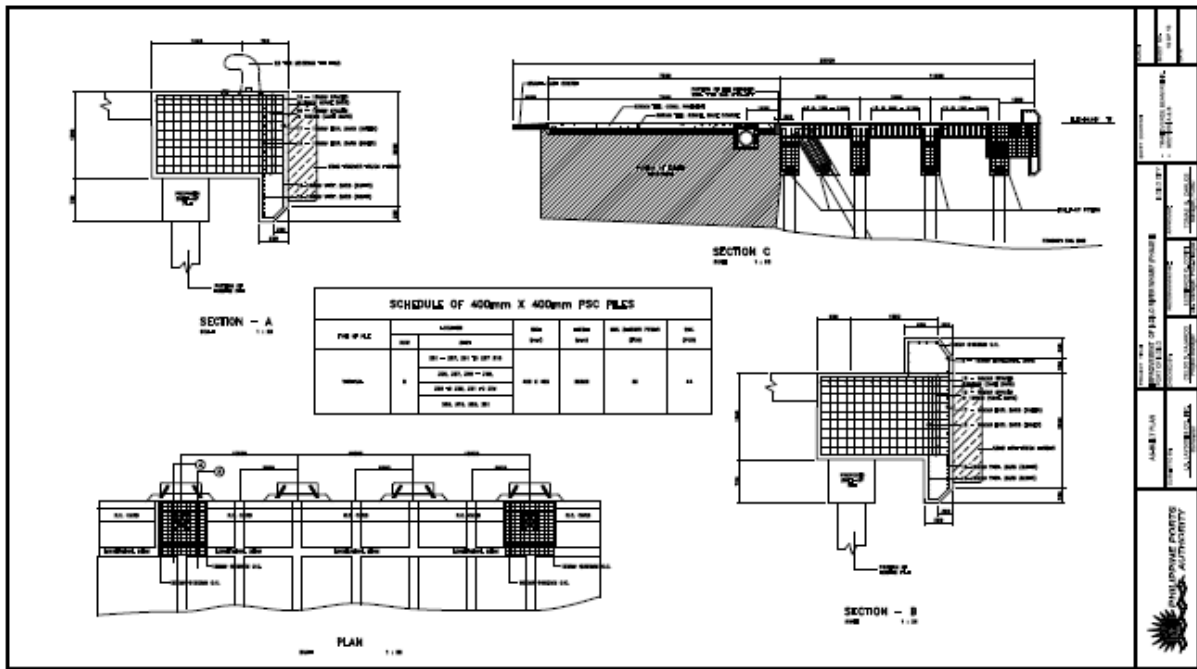
Figure No.1-a

Port Layout of Iloilo River wharf

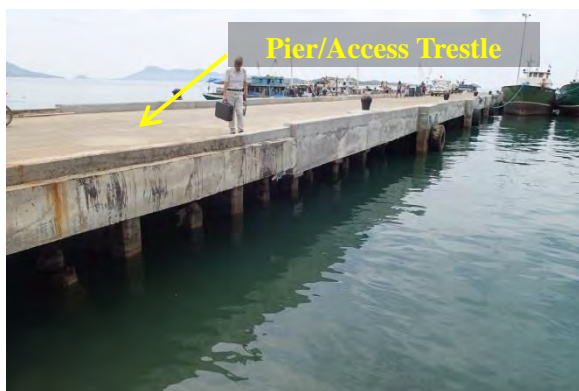
Figure No.6
Newly Rehabilitated Pier/Trestle.

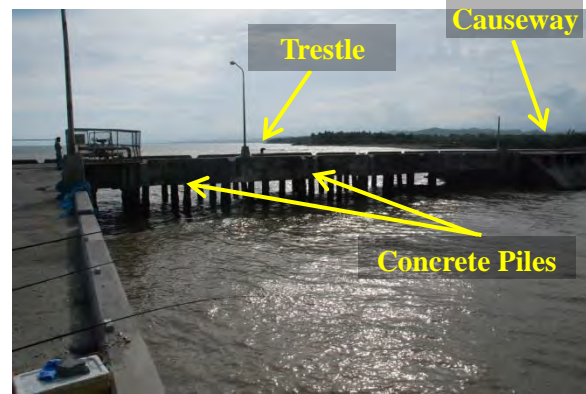
Figure No.5
Existing Causeway and RC Trestle.

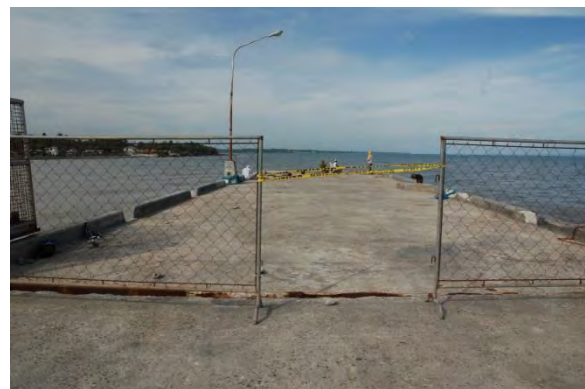
Figure No.7
Existing RC Wharf.

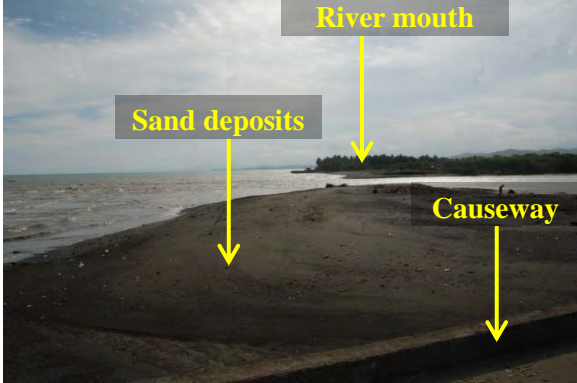
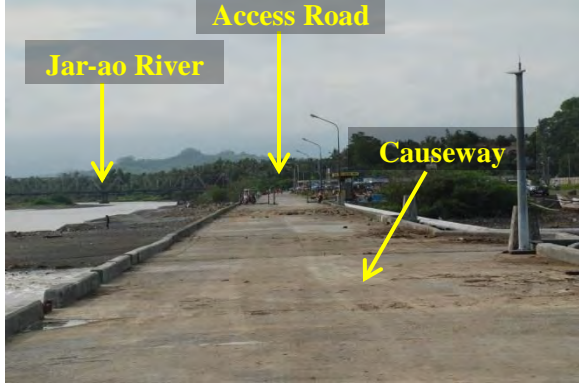
<p align="center">Figure No.16</p> <p>Sand deposits at the river mouth of Jar-ao river.</p>	<p align="center">Figure No.17</p> <p>Figure shows Jar-ao river and the access road to the port.</p>

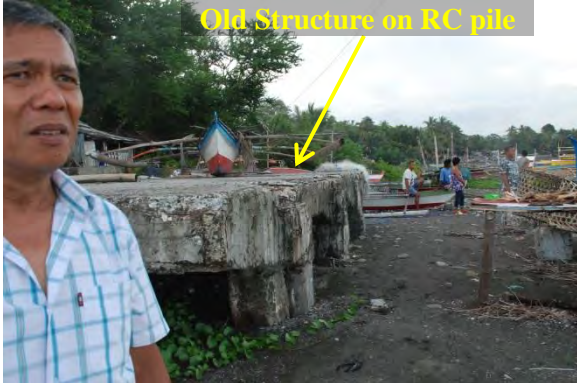
<p align="center">Figure No.2</p> <p>According to LGU Miag-ao the structure was constructed by DPWH during Pres. Marcos time and was suspended after 1986 EDSA revolution.</p>	<p align="center">Figure No.3</p> <p>Existing Concrete structure on RC pile.</p>

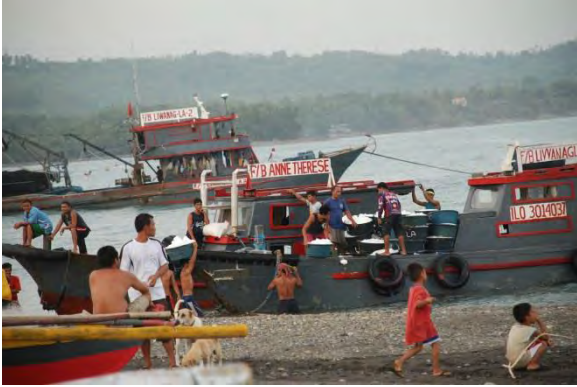
<p align="center">Figure No.4</p> <p>Fishing Vessel loading crushed ice at Miag-ao port.</p>	<p align="center">Figure No.5</p> <p>Beach area at the right side of Maig-ao port.</p>

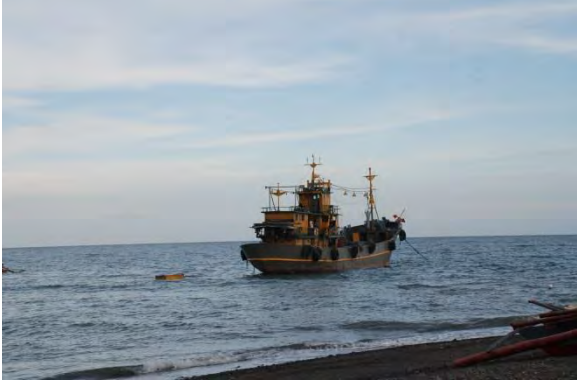
<p align="center">Figure No.6</p> <p>Vessel anchored at harbor area of Miag-ao port.</p>	<p align="center">Figure No.7</p> <p>Anchored Fishing Vessels.</p>
