3.2. Bohol Province

3.2.1. Tagbilaran

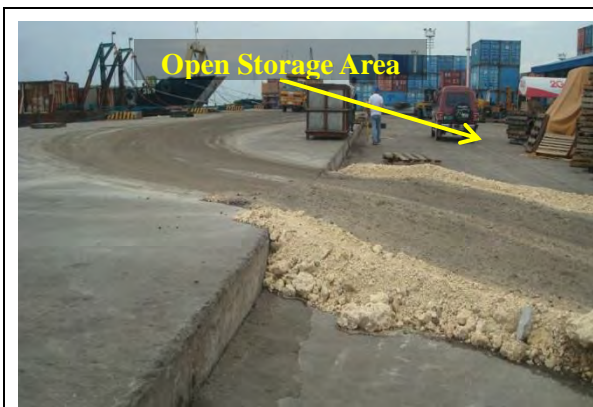
Figure No.2
Concrete Pavement at Open storage area settled after the OCT 2013, 7.2 magnitude EQ.

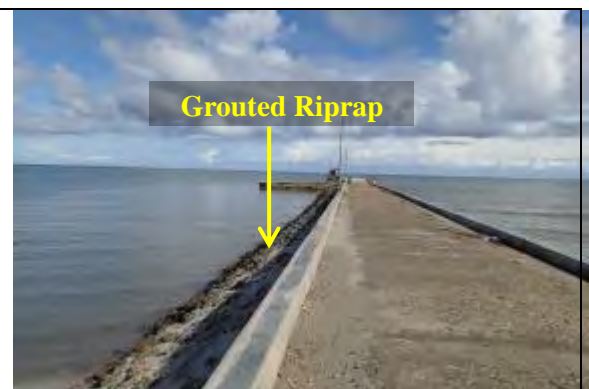
Figure No. 3
Existing Causeway with grouted riprap bulkhead.

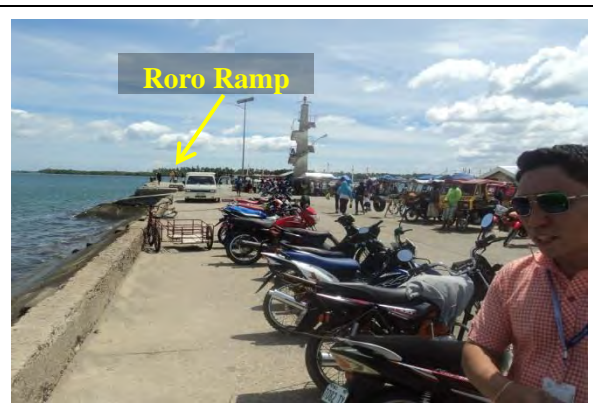
Figure No.3
Damaged causeway pavement caused by OCT 2013 EQ. Causeway is submerged during high tide.

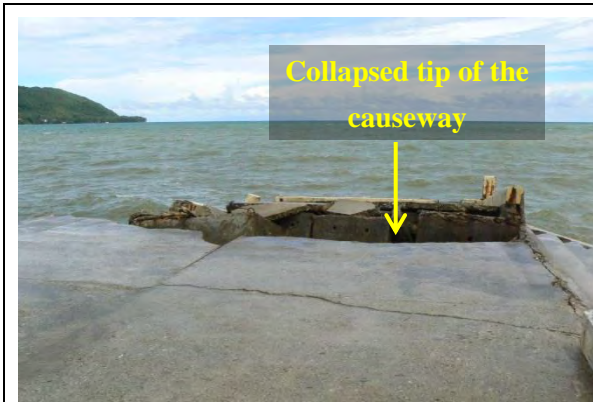
Figure No.4
Collapsed portion of the Causeway due wave action.

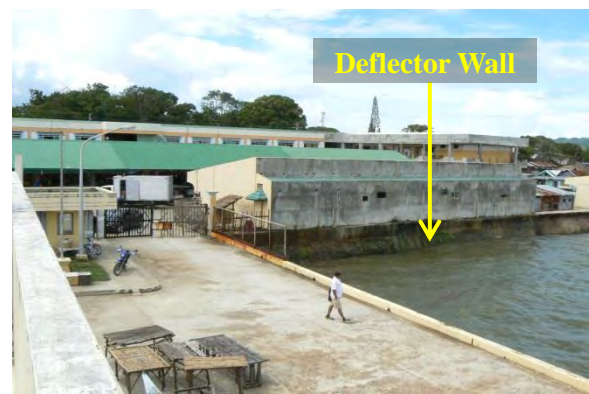
Figure No. 7
Wave Deflector wall.

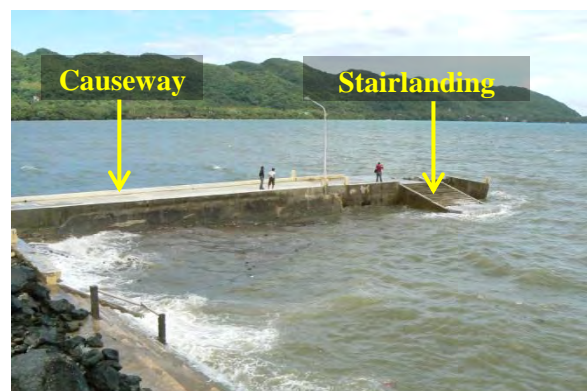
Figure No. 9
Existing Causeway with Stairlanding

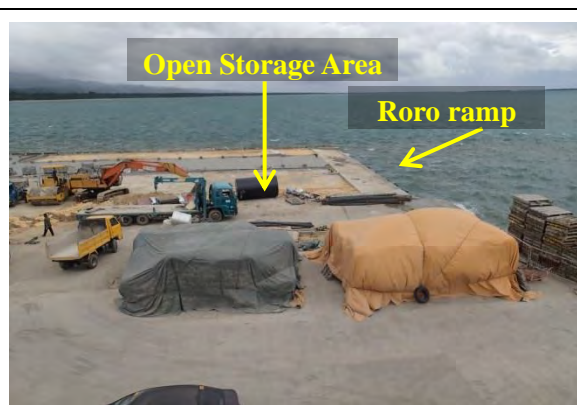
Figure No.3
Open Storage area and the new Roro ramp.

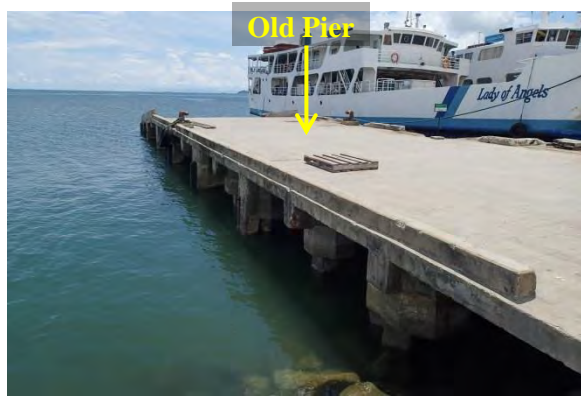
Figure No.2
Left side of the old RC Pier

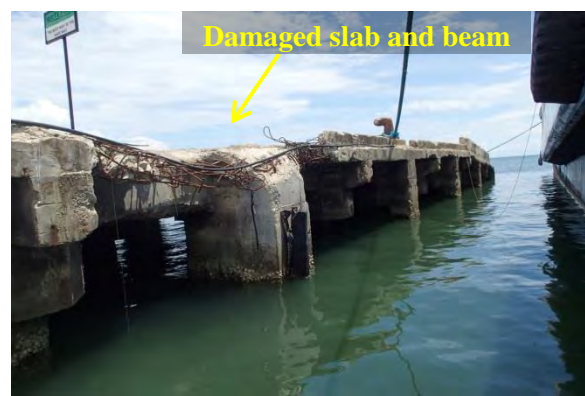
Figure No.3
Right Side of the old RC Pier

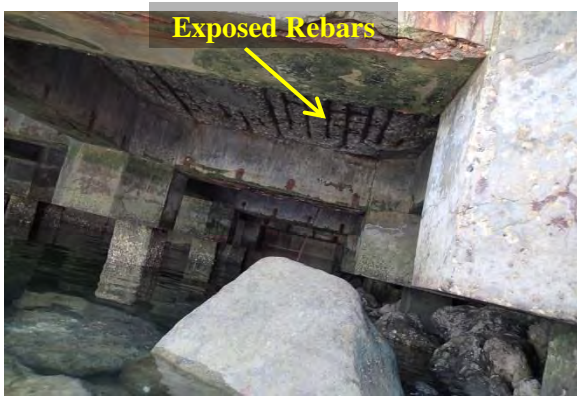
Figure No.4
Under deck slab and beam of the old RC Pier.

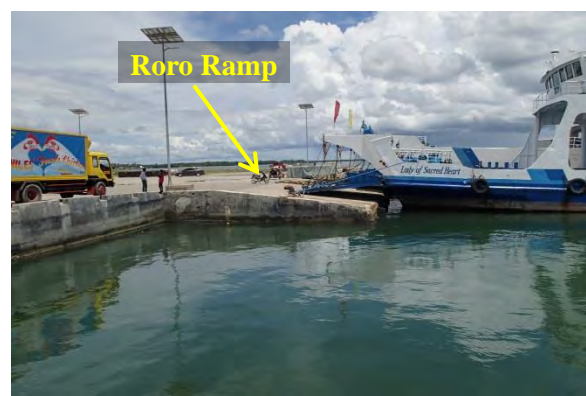
Figure No.5
Roro ramp adjacent to the old RC pier.

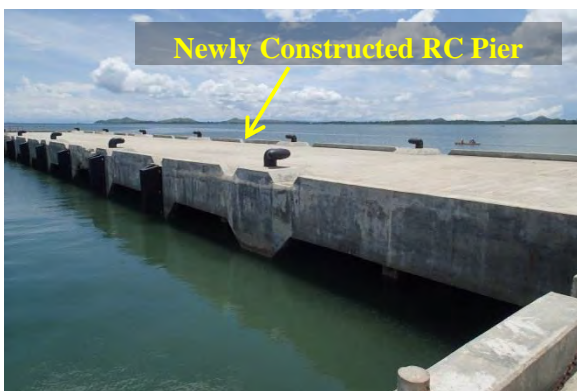
Figure No.6
Left side of the new RC Pier.

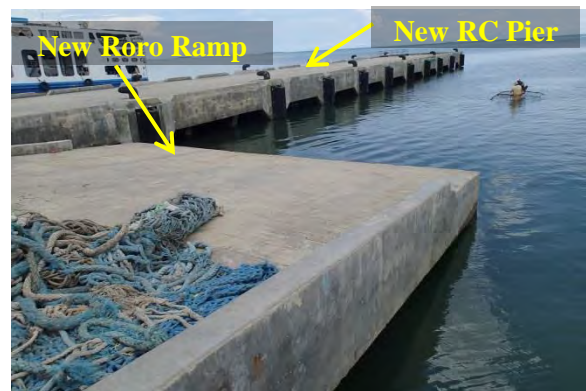
Figure No.7
Right side of the new RC Pier.

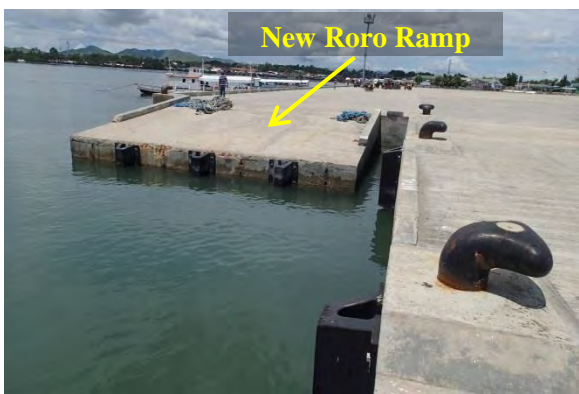
Figure No.8
New Roro ramp.

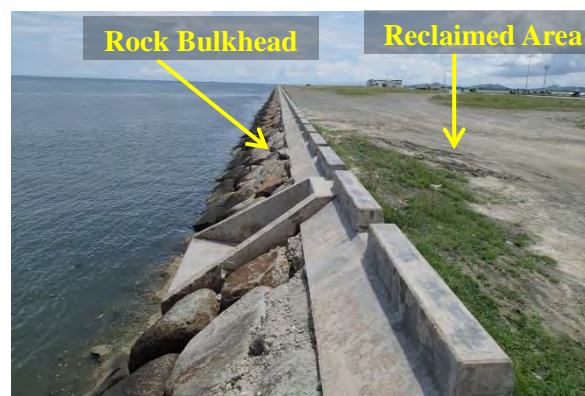
Figure No.11
Rock Bulkhead at reclaimed area

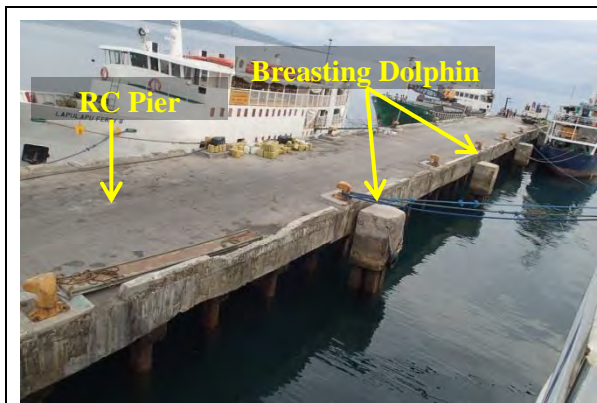
Figure No.2
The figure shows the Northwest (NW)/ right side of RC Pier

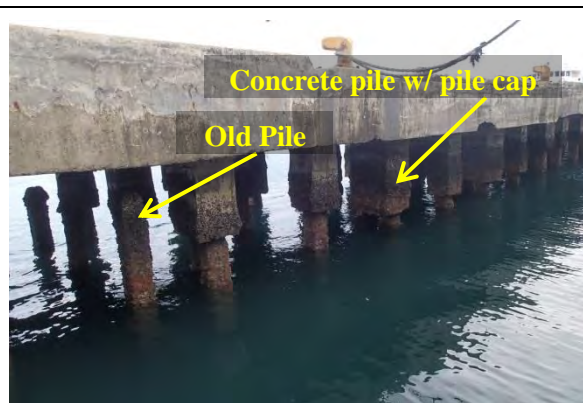
Figure No.3
Right Side of the existing pier.

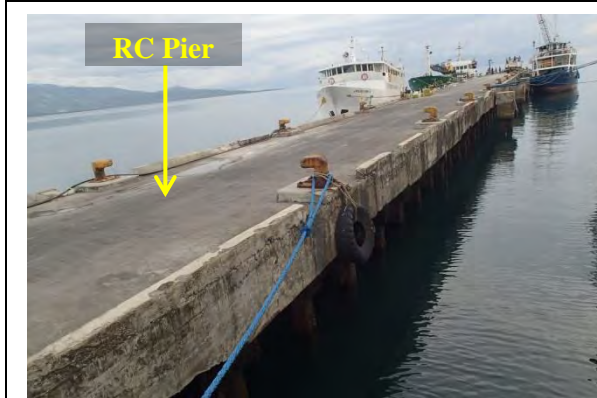
Figure No.4
The RoRo berth area.

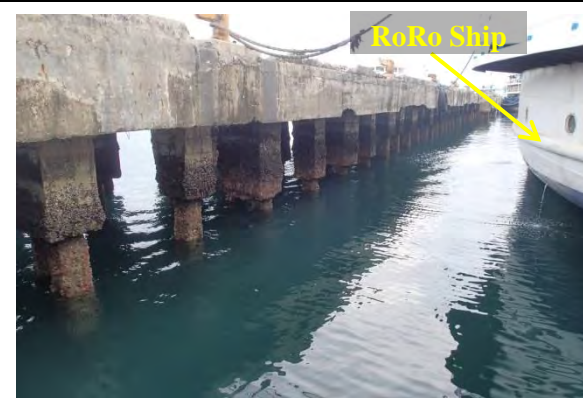
Figure No.5
The concrete pile of RC pier near the RoRo ramp.

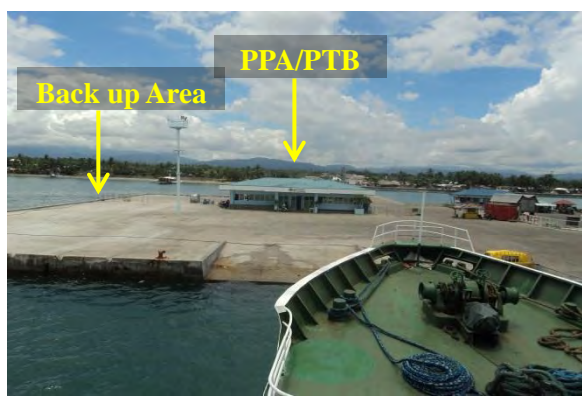
Figure No.2
Port back-up area at the NW side.

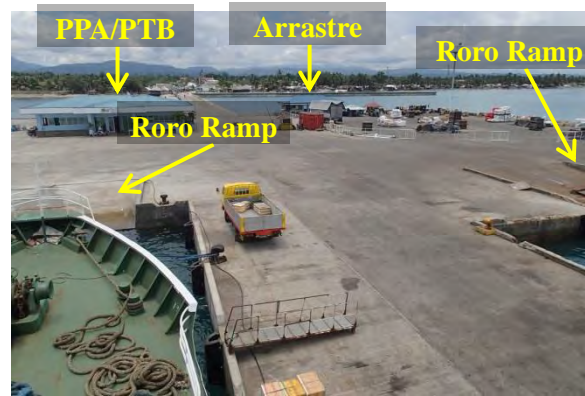
Figure No.3
Port Back-up area at the SE side.

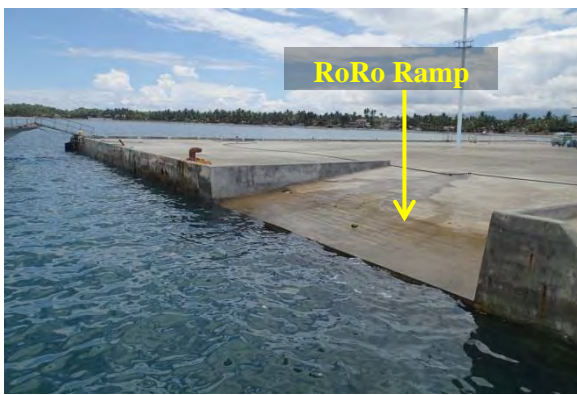
Figure No.4
The RoRo ramp at the west side of the port during high tide.

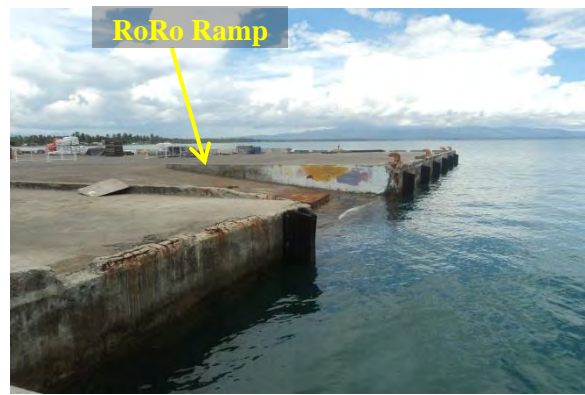
Figure No.5
The RoRo ramp at the east side of the port during high tide.

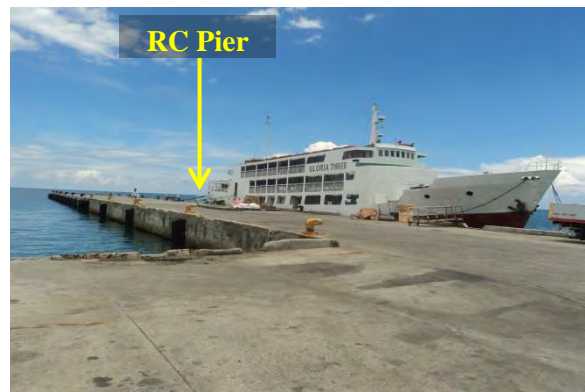
Figure No.7
Existing RC Pier

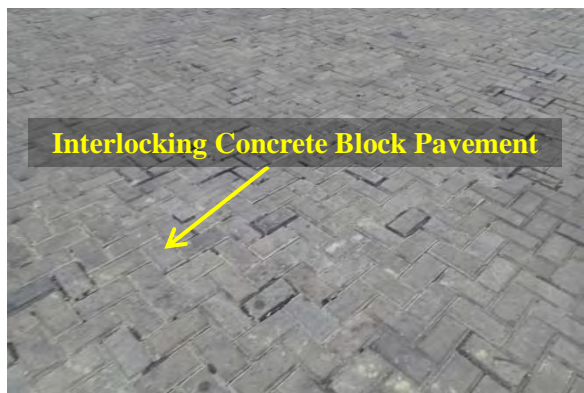
Figure No.10
ILB Pavement used at open storage area.
