**The Project  
for  
Rehabilitation of Yangon Port  
and  
Main Inland Water Transport  
in  
The Republic of The Union of Myanmar  
(Follow-Up)

Final Report**

February 2016

Nippon Koei Co., Ltd. (NK)

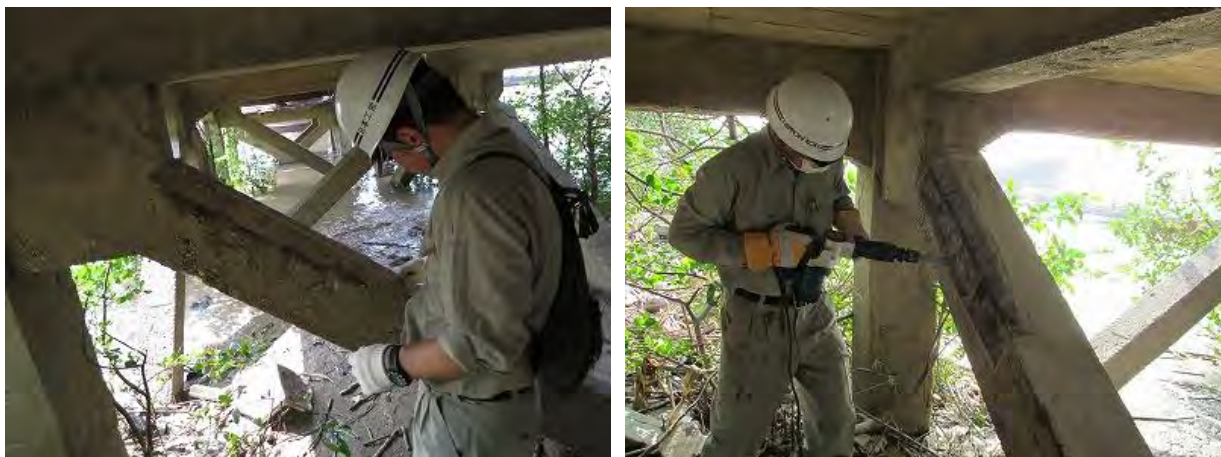
**Photo 3.21 Condition of Deteriorated Jetty and Demonstration of Chipping**

Cracks and rebar exposure occurred due to rebar corrosion at some beams at the Wadan Jetty 6. The Expert selected this jetty as a suitable site for the on-site training because the deterioration by rebar corrosion is popular in Yangon port.

The Expert removed the concrete covering and the rusted rebar, painted it with anti-rust paint, added a new rebar, and refilled new mortar. Time was limited to show how to repair the RC Beam during the training. Therefore, the Expert showed the repair process and explained the important points about the repair of the RC beam.
