**DATA COLLECTION SURVEY REPORT
FOR
IMPROVEMENT OF NAVIGATION
CHANNEL OF YANGON PORT
IN THE REPUBLIC OF THE UNION OF
MYANMAR**

FINAL REPORT

**CURRENT SITUATION OF
RIVERBANK EROSION OF YANGON RIVER**

MARCH 2016

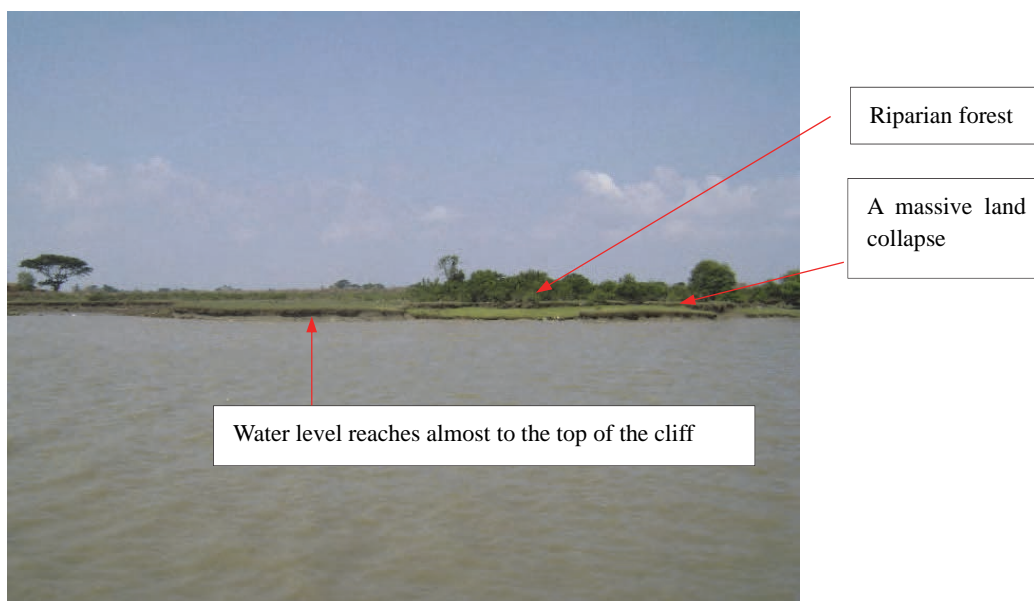
Figure 3-9: A Part of the Right Bank in High Tide (A distant view)

Although Figures 3-1~3-8 were taken in low tide, the above Figure 3-9 was in high tide and it shows that the water level is very close to the top of the cliff. It can be said that the impression of the Yangon River is very different between low tide and high tide. On the right side of the above picture, evidence of a mass land collapse can be seen.

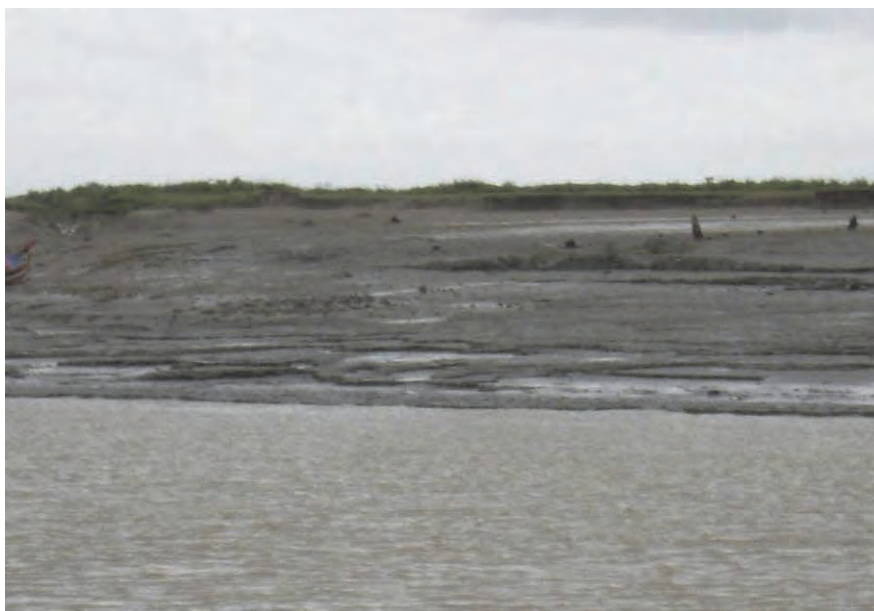
Figure 3-10: Part of the Seaside Line near the River Mouth on the Right Bank Side

The above Figure 3-10 shows a part of the seaside line near the river mouth on the right bank side and it shows a natural, stable, gentle slope. In contrast to the gentle slopes along the river, there is no riparian forest behind this slope.

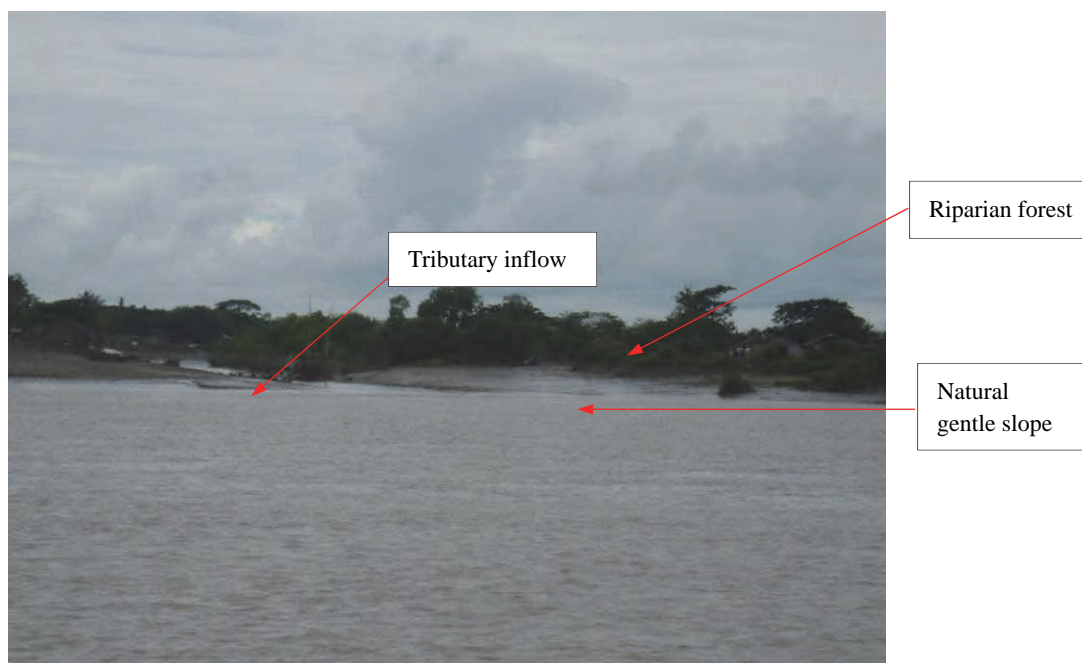
Figure 3-11: A Tributary Inflow at the Right Bank

The next figure shows the location of tributary inflow along the right bank. The natural gentle slope can be seen on both ends of the inflow, and riparian forest can be seen behind the gentle slope.

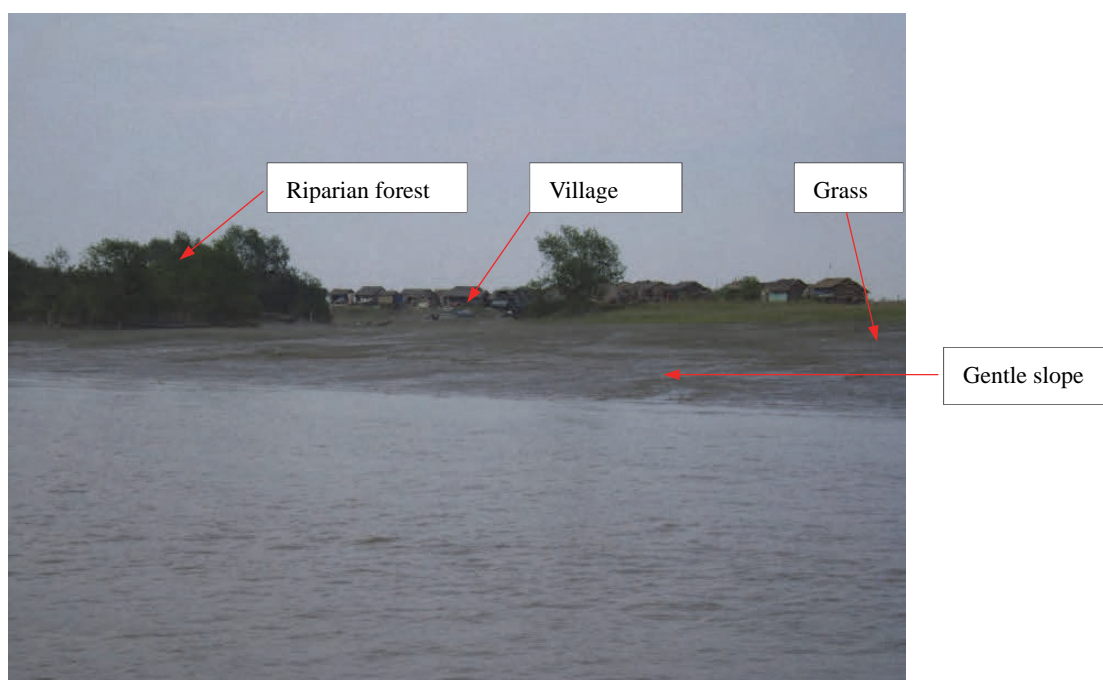
Figure 3-12: A Stable Gentle Slope on the Downstream Side of the Thilawa Area

The next figure shows a tributary inflow on the left bank near a village located downstream of the Thilawa Area. The riparian forest exists on both riverbanks of the tributary. Only gentle slopes can be seen and there is no cliff near here.

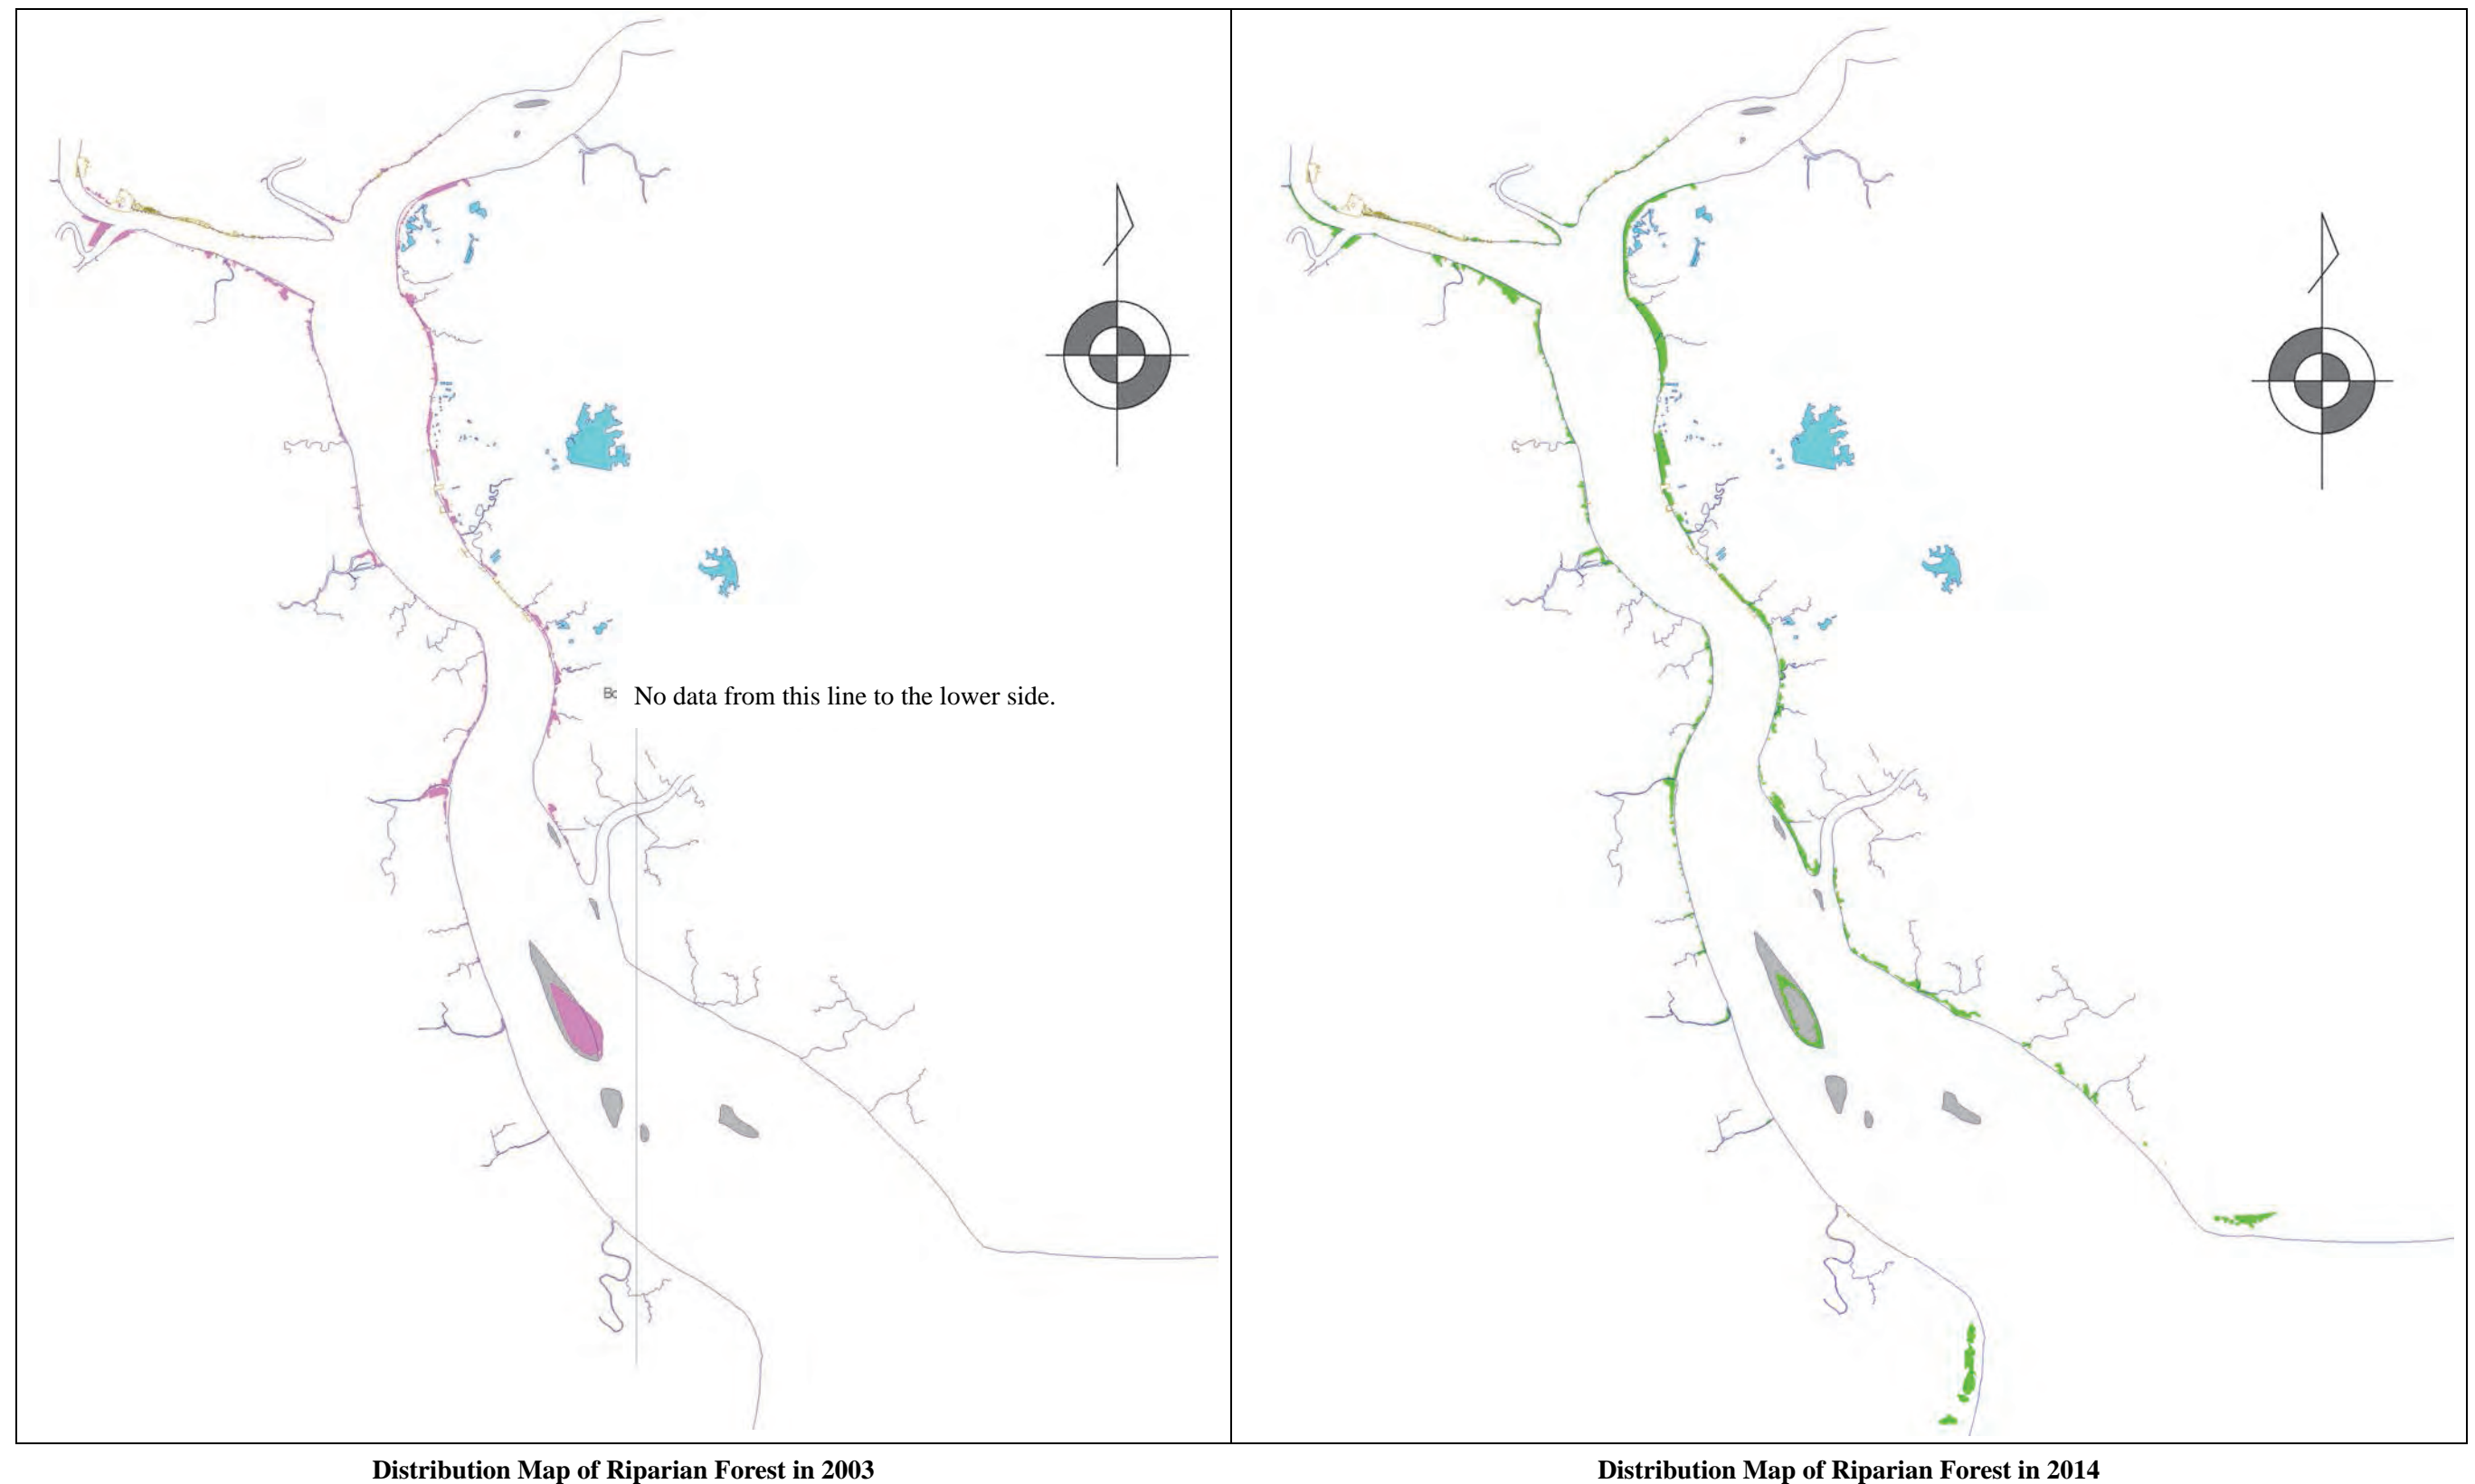
Figure 4-2: The Distribution Map of Riparian Forest in 2003 and 2014

As clearly shown in the above tables, there is no riparian forest along the right bank of the lower Thilawa Area where can be seen the cliff type bank continuously, in other words, where riverbank erosion has happened. As for the left bank, although the coverage ratio of riparian forest is slightly increasing at the block from 20 to 30 km, basically the coverage ratio of the riparian forest along both banks decreases as it gets closer to the river mouth. On the other hand, the riparian forest along the middle bank remains up to now and no large change can be seen.

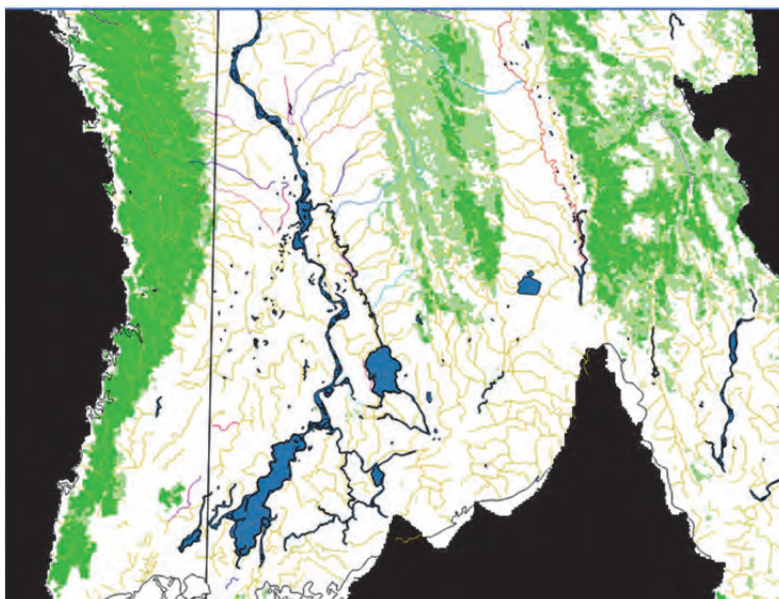
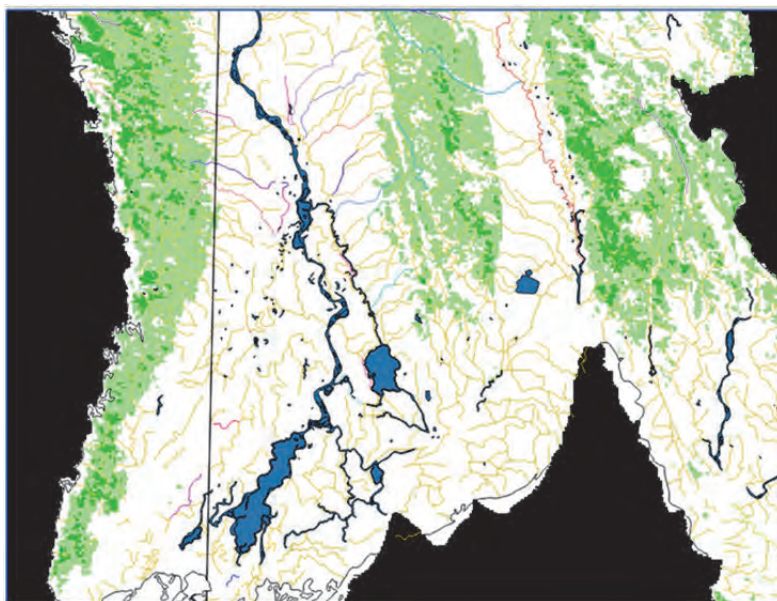
The following satellite images are from the SPOT satellite (the Centre national d'études spatiales: CNES satellite from France) showing the condition of natural forest in the year 2000 and 2010. The green colour shows the area of the forest, the darker green indicates denser forest and the brighter green means thinner forest. Deep forest was widespread in 2003 but by 2010 it was lost in most of the area and thin and small forests are spotted and distributed. The result shows that natural forest in Myanmar is being rapidly damaged and the trend would be continue or increase in 2015.

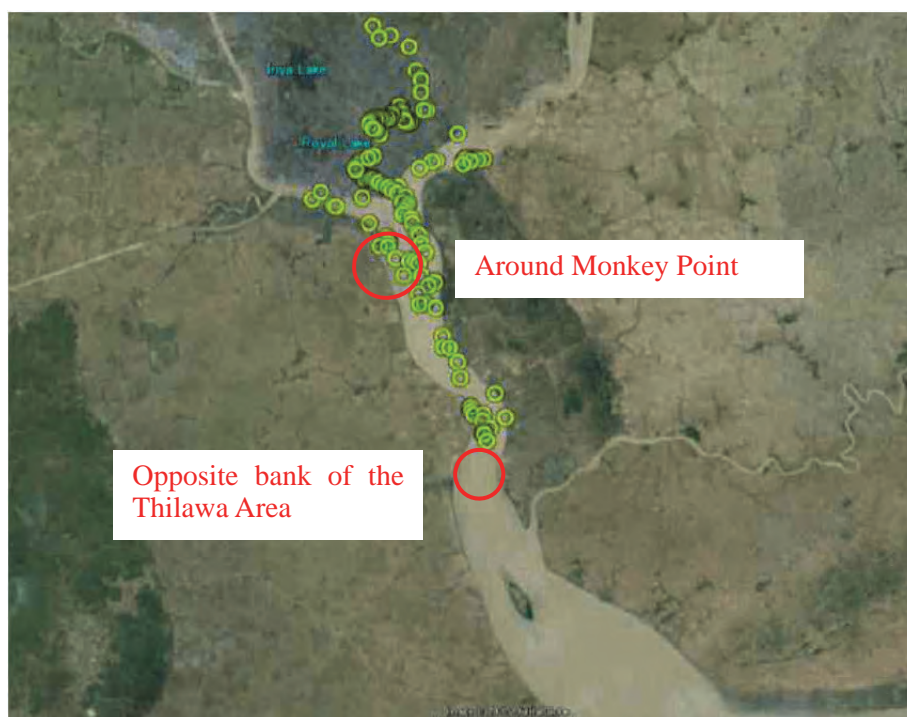
Figure 4-5: The Work Vessels Mining the Construction Sand (April, 2015)

Many sand mining activities can be seen in the objective Study area of the Yangon River. The extracted sand is used for the purpose of mixing concrete and for land reclamation material. The detailed report is done in the main report of the Study. The following satellite image shows the condition of work vessels mining the sand.

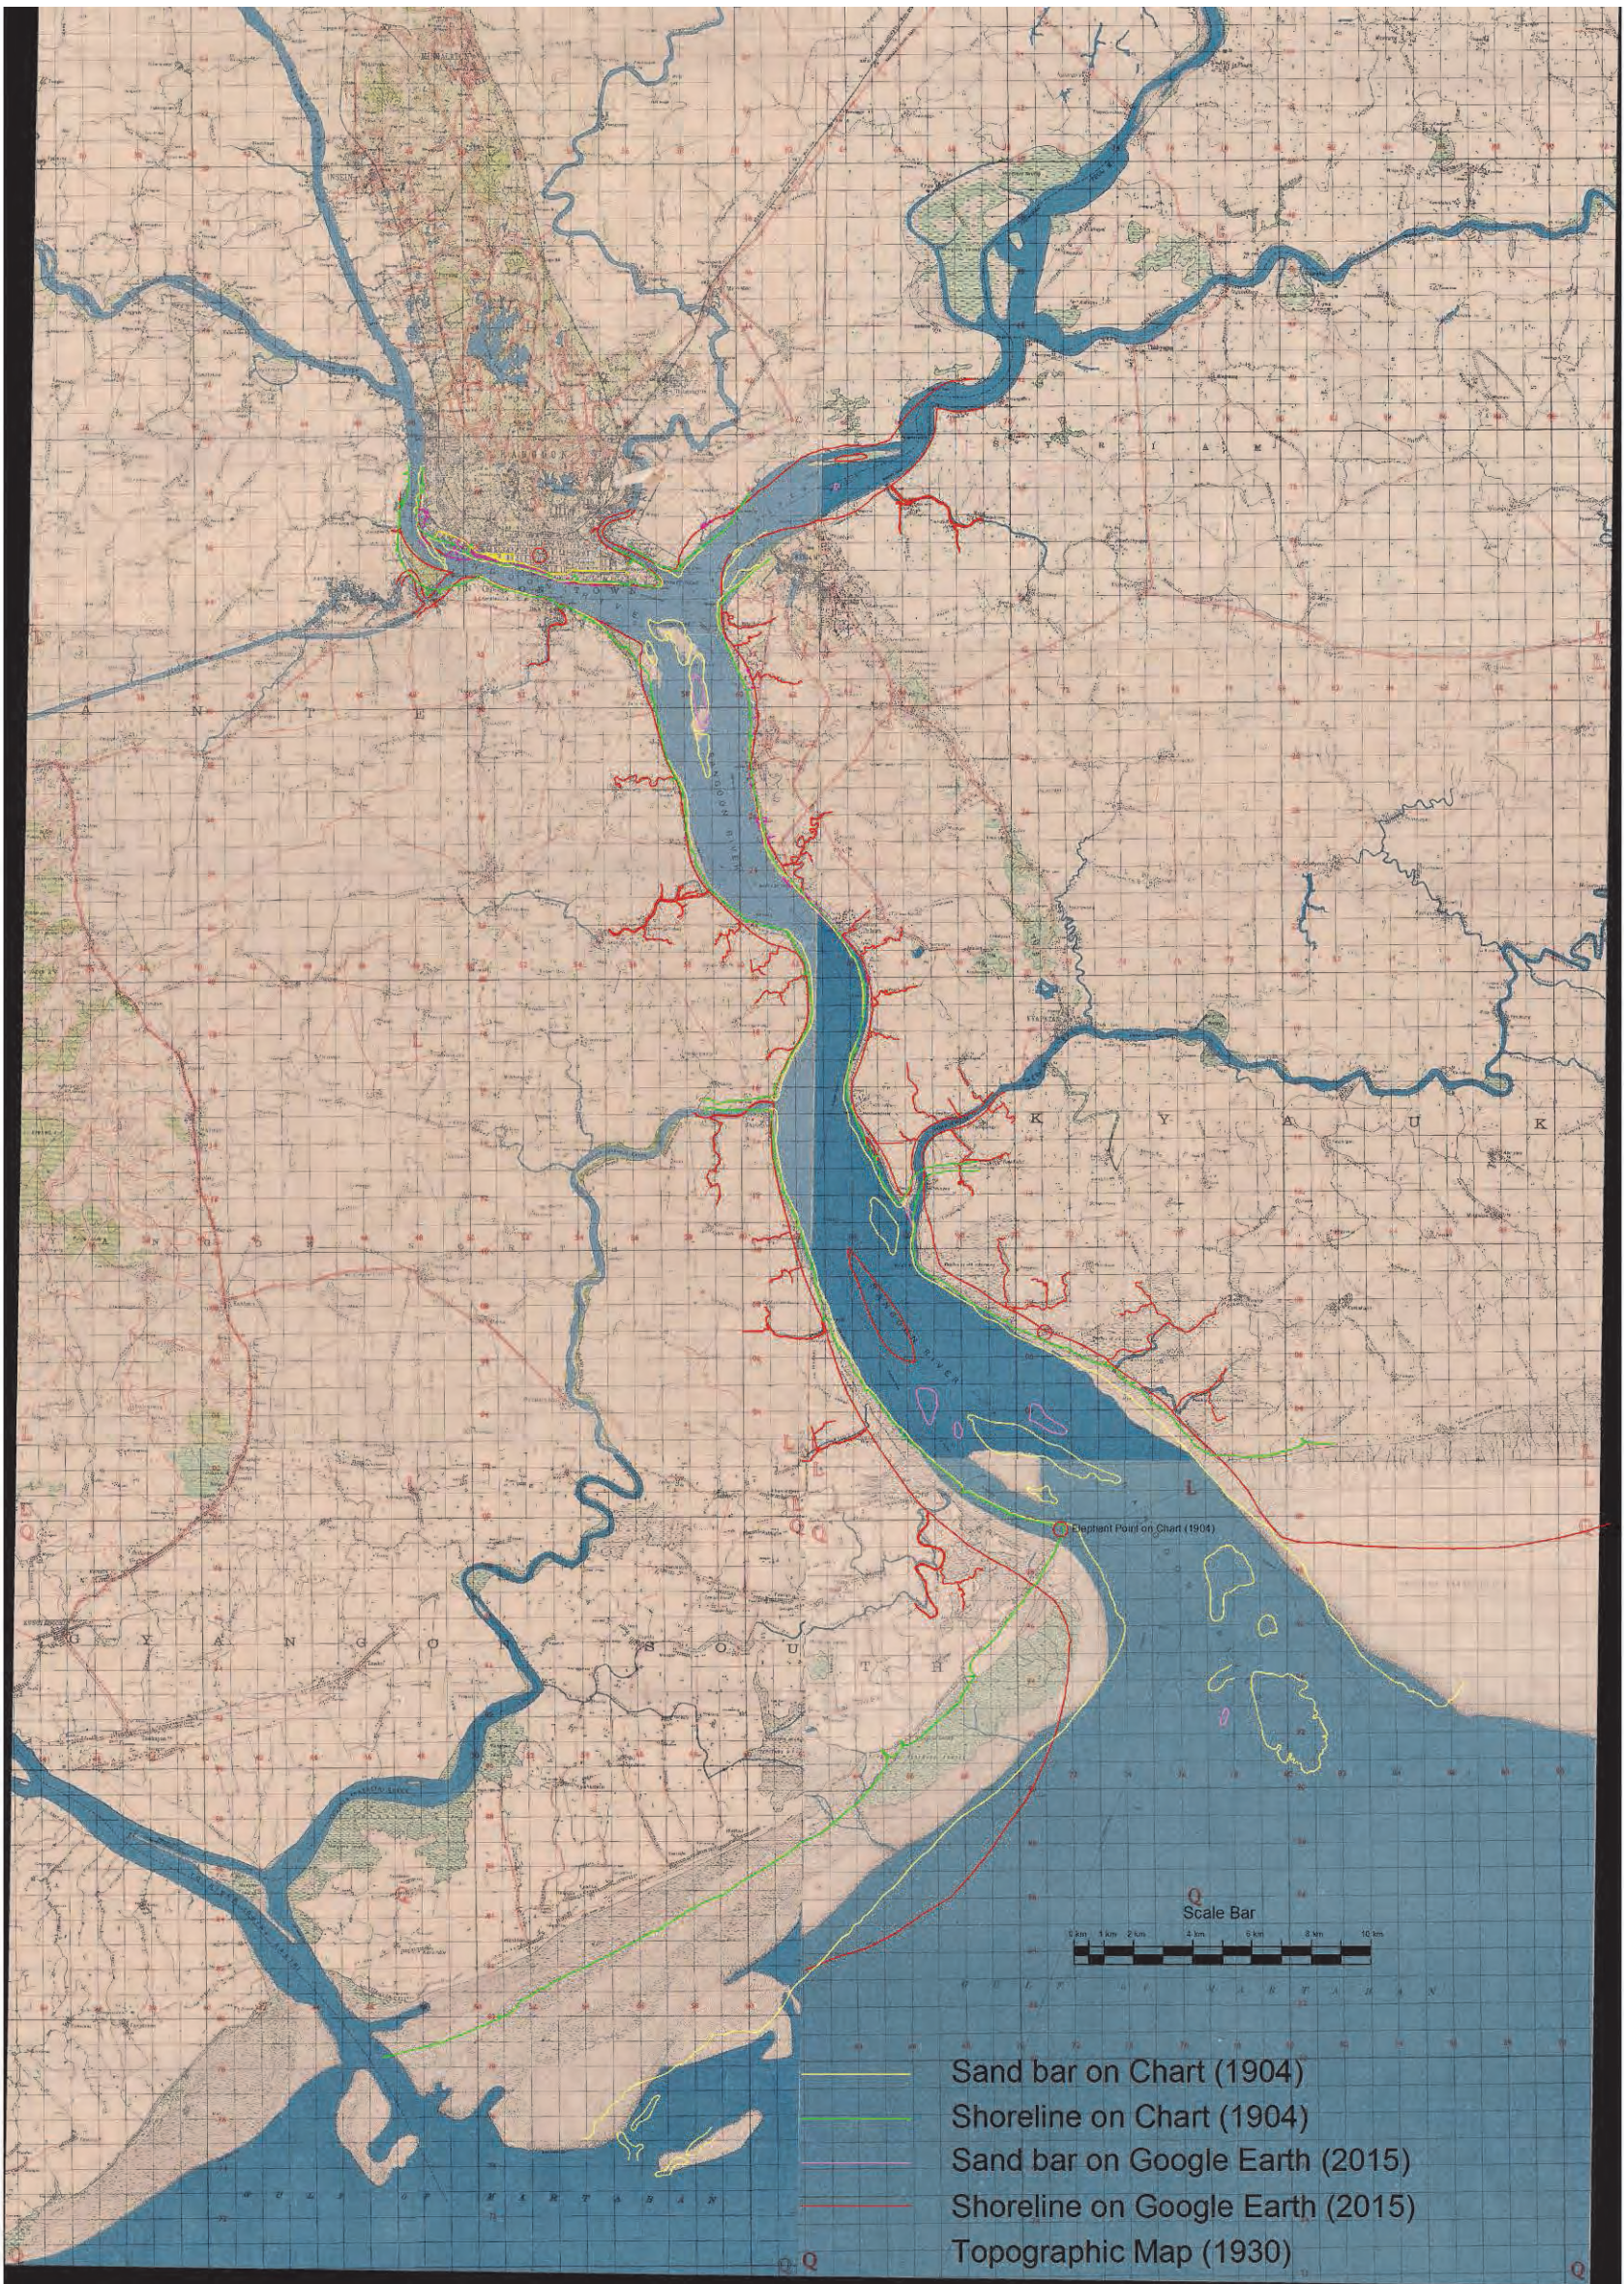
Figure 5-5: Brief Comparison of Riverbank Lines among 1904 Marine Chart, 1930 Map and 2015 Satellite Image

In this Study, a report for the examination of the Yangon River issued in 1976 by the United Nations Development Programme^{*1} (hereafter: UN Report) was also collected. Considering the UN Report and the brief comparison of the riverbank line in Figure 5-5, the features of the change on the riverbank lines of the Yangon River would be regarded as follows:

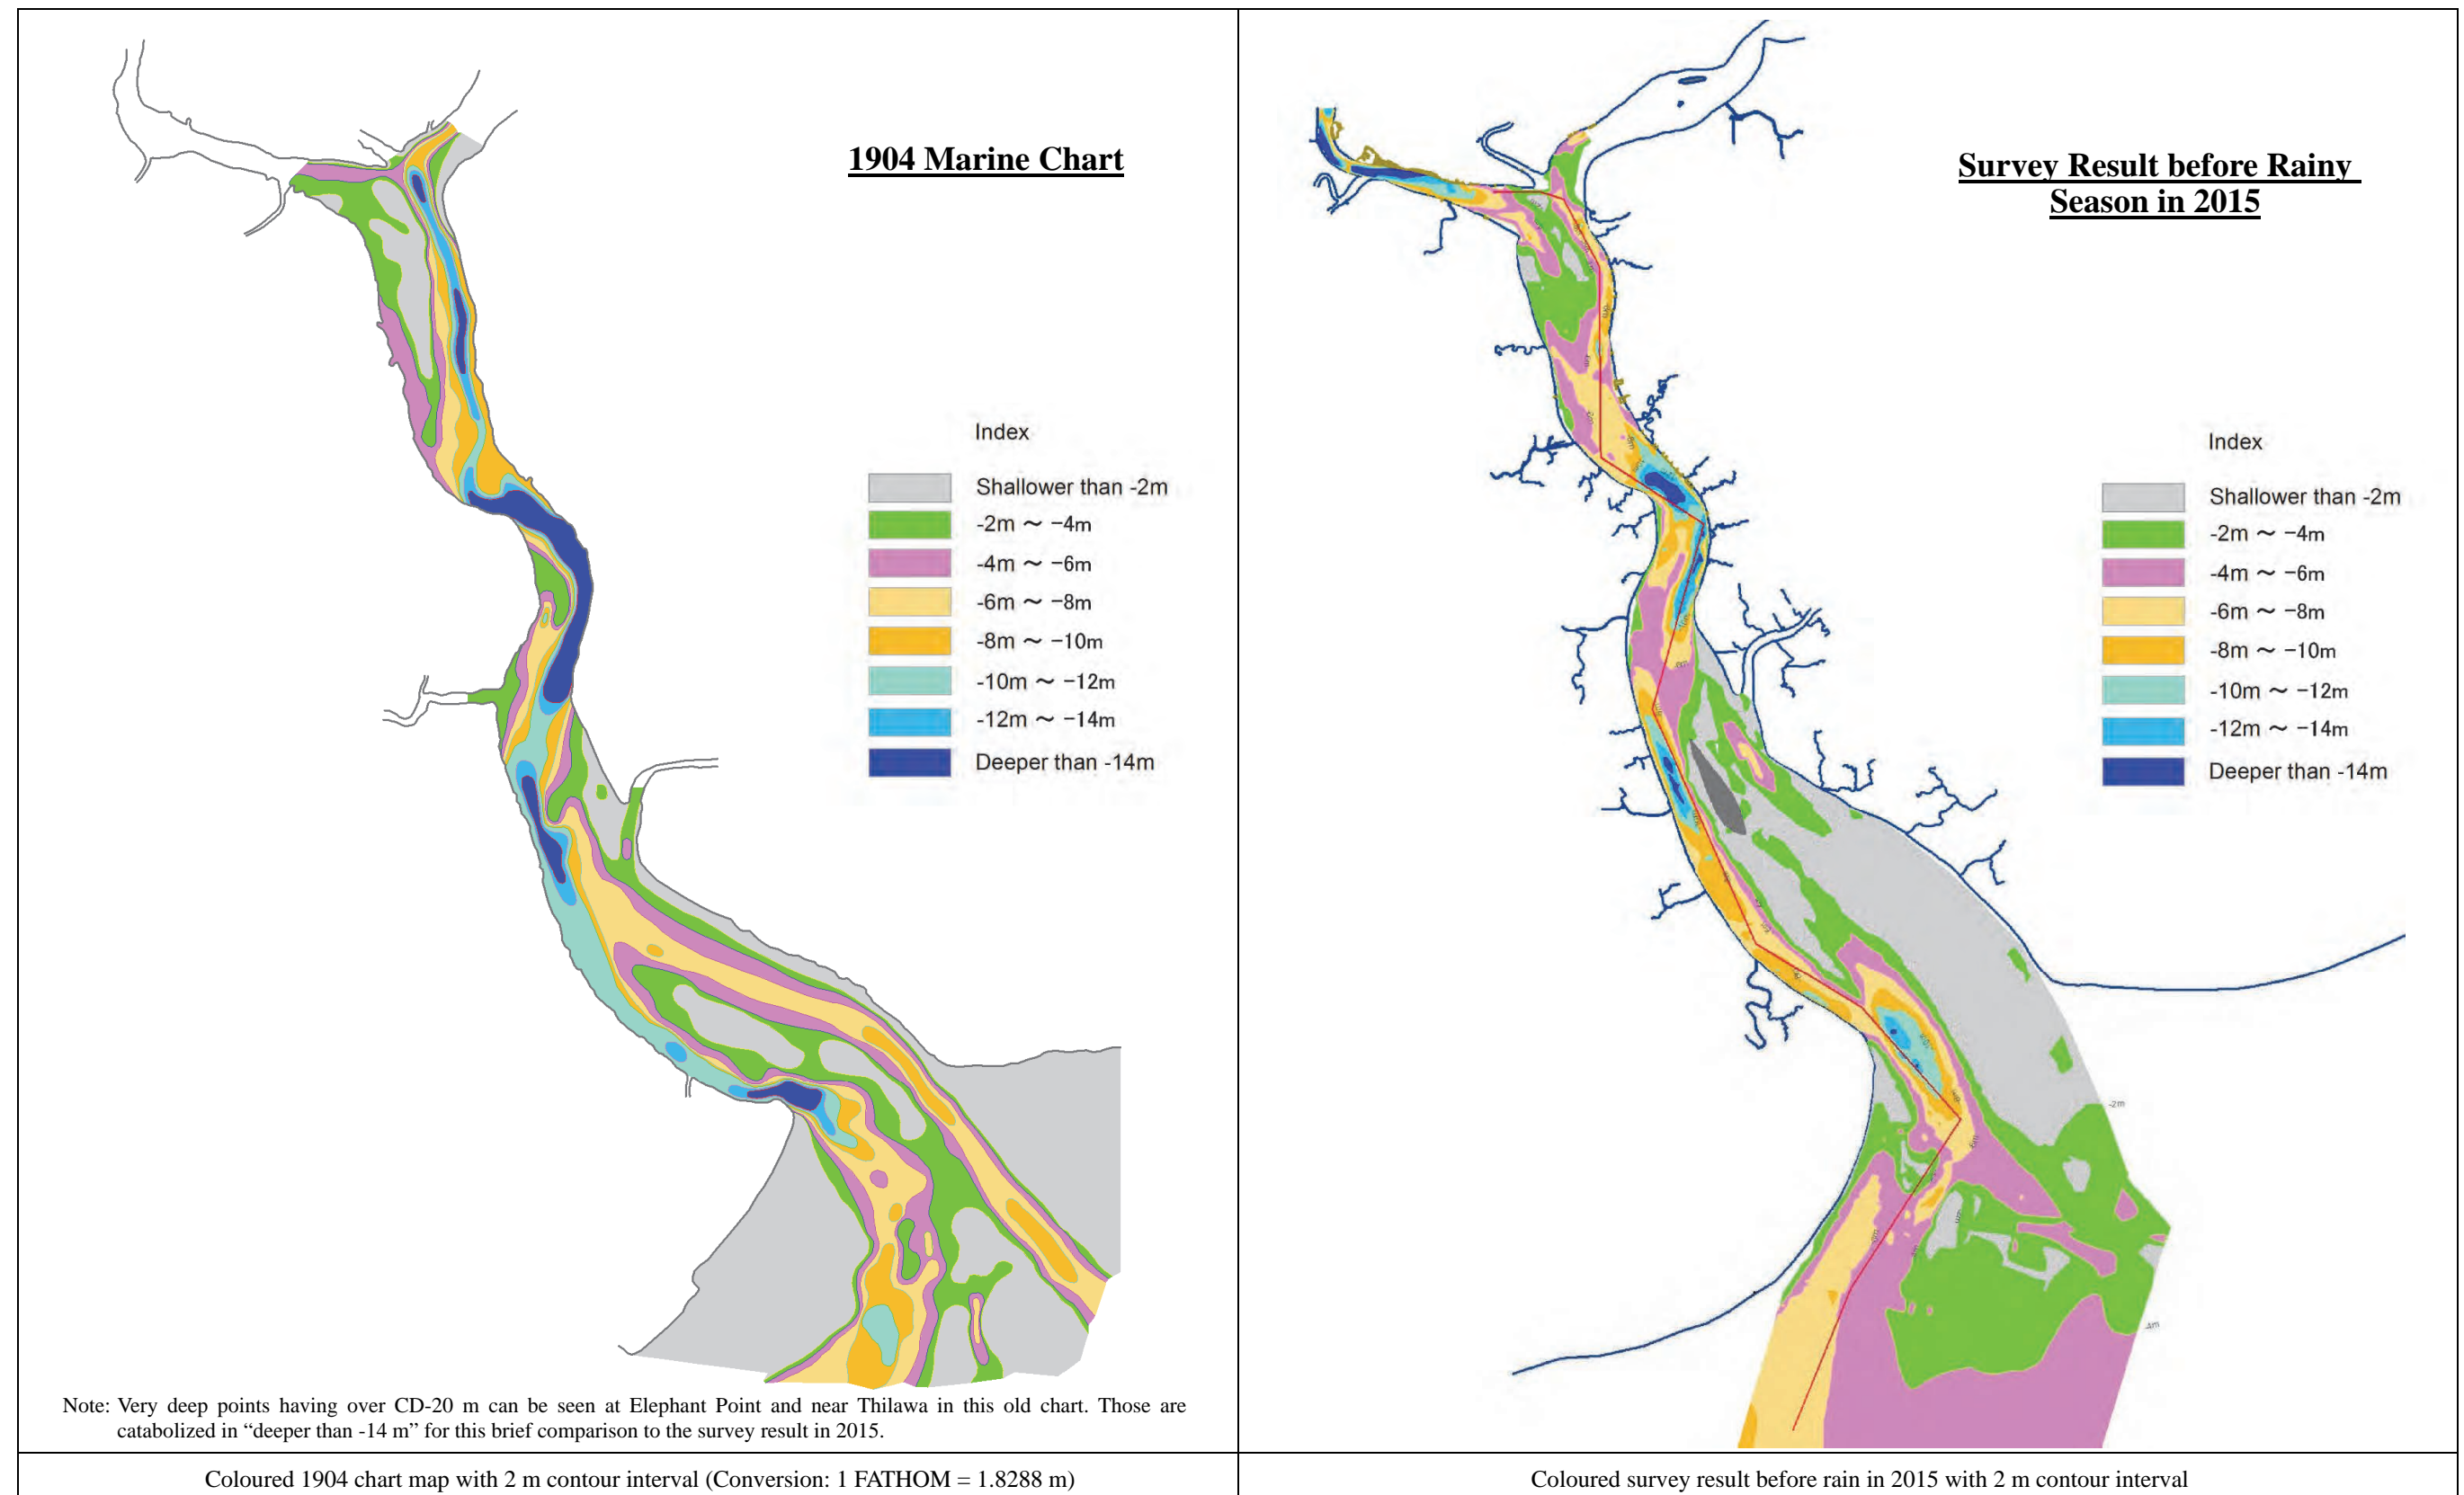
Figure 5-6: Brief River Depth Comparison between 1904 and 2015

The depth of the access channel from Monkey Point to Elephant Point surveyed in 2015 is generally kept at CD -6 m in both survey results before / after the rainy seasons. On the other hand, it can be seen that the depth in the same area in 1904 was CD-10 m according to the marine chart. Also, the area called the east channel is presently very shallow, within CD-2 m, but it was kept at least CD-6 m in 1904 and it is almost the same depth as the present west channel. Considering these facts, it can be said that the access channel of the Yangon River is getting shallower compared to the depth in 1904.

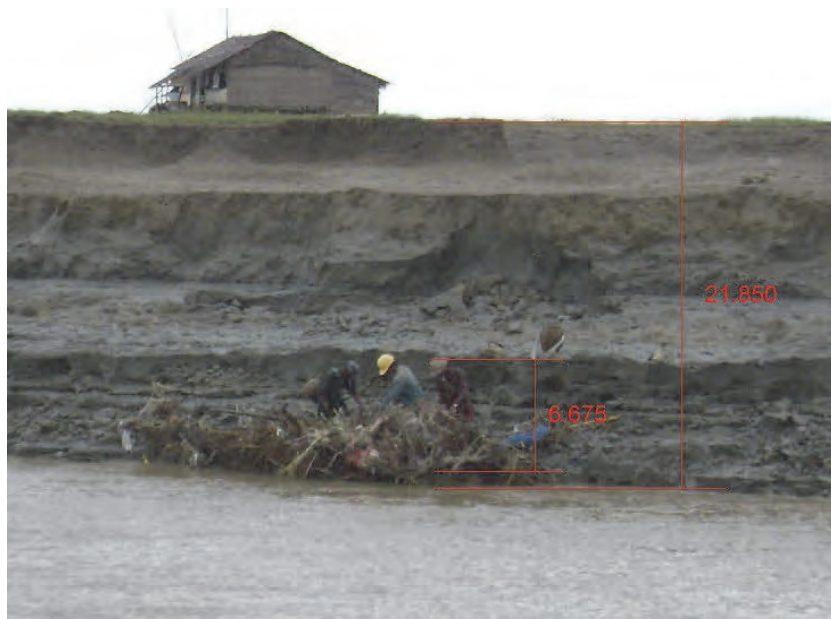
Figure 6-1: A Sample of Height Estimation by AutoCAD (Reference No. 4.2.1)
(The above picture was taken during low tide, September 5, 2015)

The following sample was taken 15 km upstream of the right river mouth. A man's height was set as 165 cm as mentioned above, and the cliff height was estimated. At the same time, other height information shown in the background like a house was used for the estimation as well.

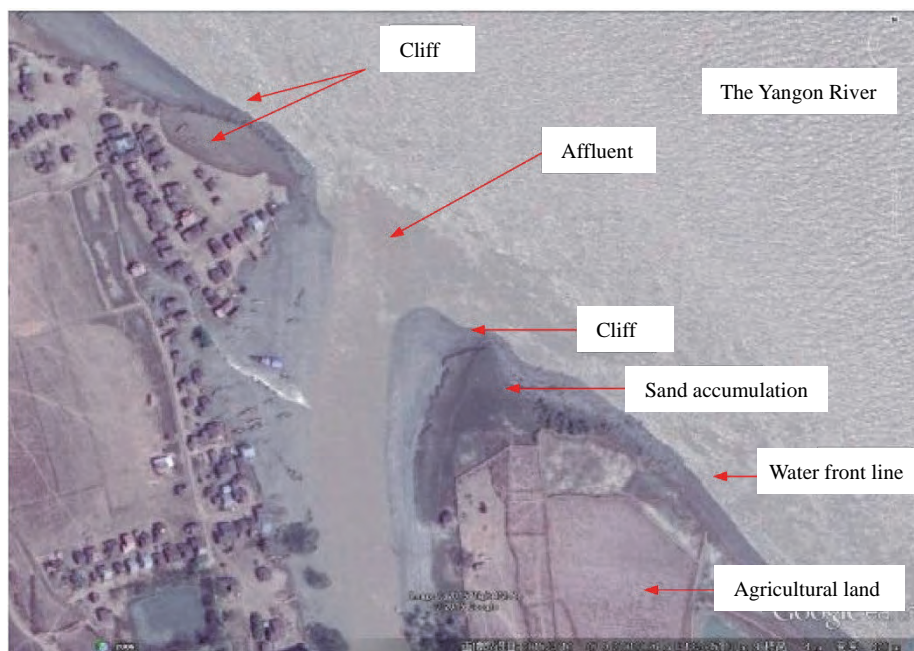
Attachment Figure 1-2: A Satellite Image of the Right Bank in Lower Tide

The following image shows a part of the right riverbank of the Yangon River near the river mouth as well but in a different part from the above location. In the centre of the image, there is an affluent. Both banks of the affluent have no cliff but the gentle-sloped banks can be seen. On the other hand, the riverbank of the Yangon River has a cliff type with one and / or two steps in the middle. This affluent has no major riparian forest but basically all other affluents have forest along both riverbanks.

There is no clear ridge in the agricultural land so it is used for paddy fields. In the tributary estuary, a sloped riverbank can be seen along the downstream side and it shows a part of darker gray coloured and which is probably caused by wetness from river water, so the picture was likely taken in lower tide.

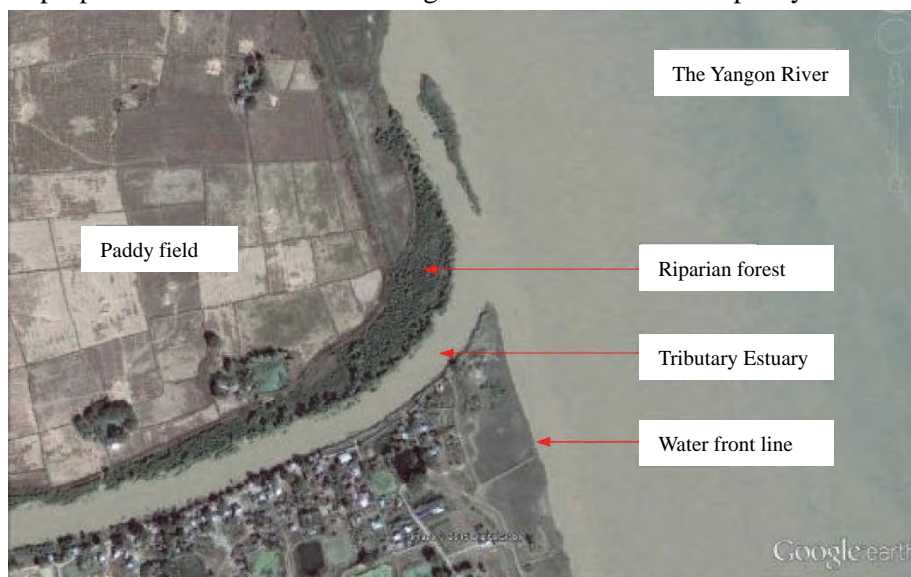
Attachment Figure 1-3: A Satellite image of the Right Bank in Higher Tide

The following image shows a different tributary estuary and it was taken in higher tide. The river water is not clean so it makes it difficult to identify the shape of the riverbank. As for the upper side of the riverbank, a riparian forest can be seen. The farther left side is used for agricultural purposes but there is no clear ridge so it would be used for paddy fields.

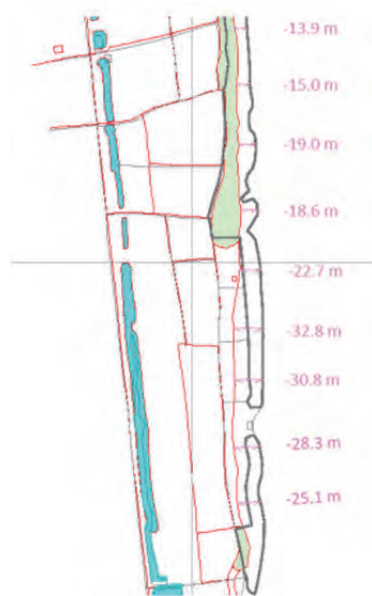
Attachment Figure 2-3: Secular Change at Point C (Section 4~12)

The Point C is located in the relatively long straightened right bank with about 4 km. 2 satellite images, on November 25, 2003 and December 31, 2014, were selected from Google Earth. The line of the cliff top edge, roads, houses and boundaries of agricultural area and so on were traced from these images. Also, secular change of the area of the riparian forest was traced.

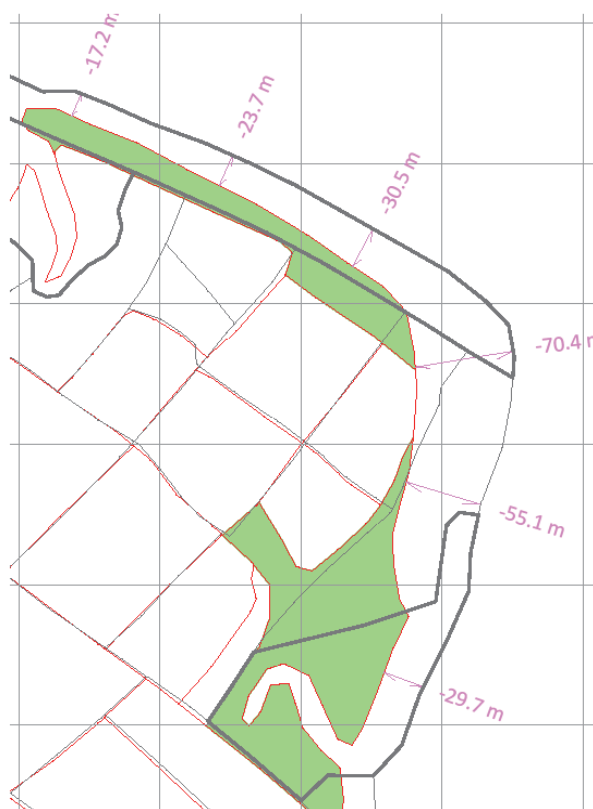
Point D is located at the sharp bend of the right bank where it is almost the opposite bank of the Thilawa Area. Two satellite images, from November 25, 2003 and April 10, 2015, were selected from Google Earth. The line of the cliff top edge, roads, and the riparian forest areas were traced.

As per the results of the above calculation, the secular change of the riverbank line at Point D is in the erosional trend and the amount is 2.8 m/year on average.

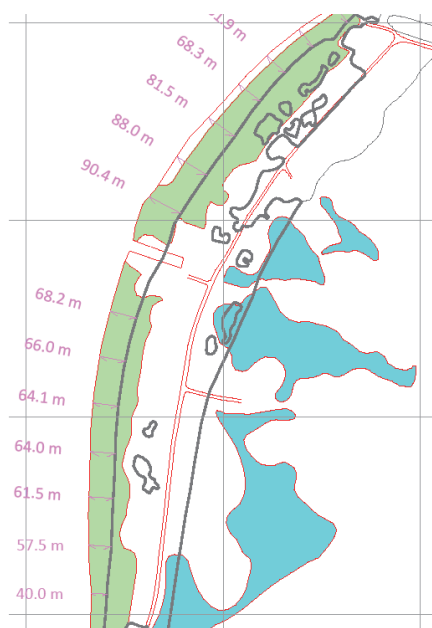
Point E is located on the left bank of the lower side of the junction point between the Yangon River and the Bago River. The satellite images, from November 25, 2003 and April 10, 2015, were selected from Google Earth. The line of the cliff top edge, roads, houses, ponds, riparian forest areas and boundaries of agricultural areas were traced from these images.

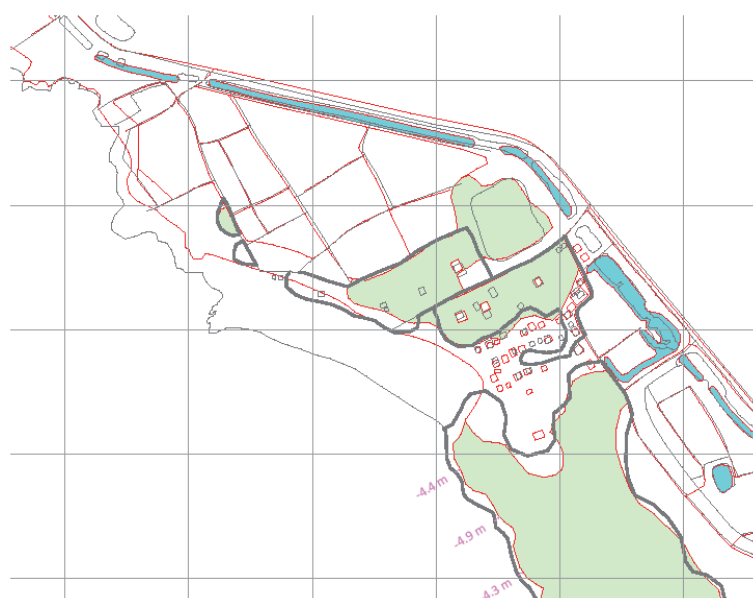
Point H is located on the left bank near the river mouth of the Yangon River. The images, from February 10, 2010 and March 10, 2015, were selected from Google Earth. The line of the cliff top edge, roads, houses, riparian forests, and boundaries of agricultural areas were traced from these images.

As per the results of the above calculations, both cases with/without riparian forest were in an erosional trend. In the case with the forest, the amount is 1.2 m/year on average and in the case without the forest, the amount is 7.3 m/year on average.

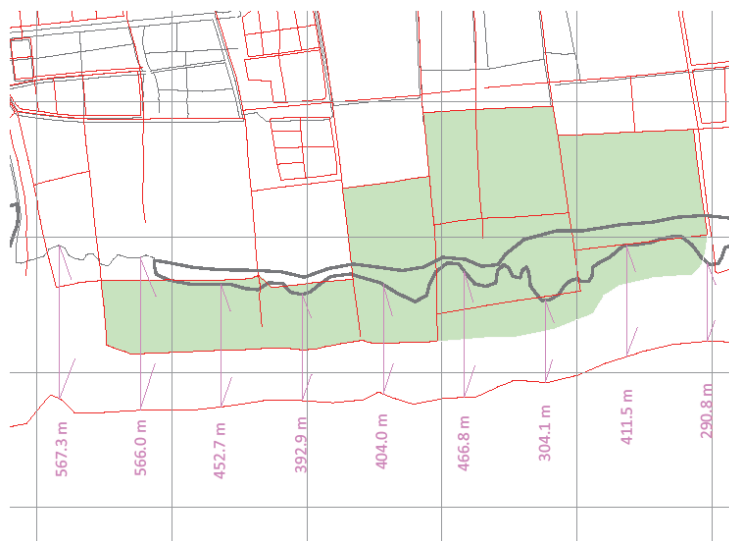
Point I is located on the eastern shore line. The images, from April 20, 2002 and November 20, 2014, were selected from Google Earth. The line of the cliff top edge, roads, riparian forests, and boundaries of fish ponds were traced from these images.

As per the results of the above calculations, Point I was in an accumulation trend as mentioned before, and the amount is 30.2 m/year on average.

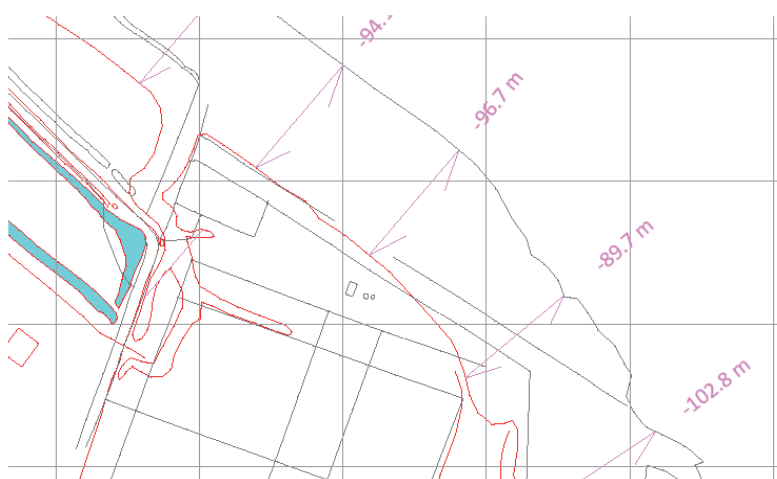
Point J is located at a little downstream of Elephant Point. Two images, from February 10, 2010, and February 10, 2014, were taken from Google Earth but the interval of the two was shorter compared to the other points. Google Earth has not many good quality images. The line of the cliff top edge, roads, and boundaries of agricultural area were traced from these images.

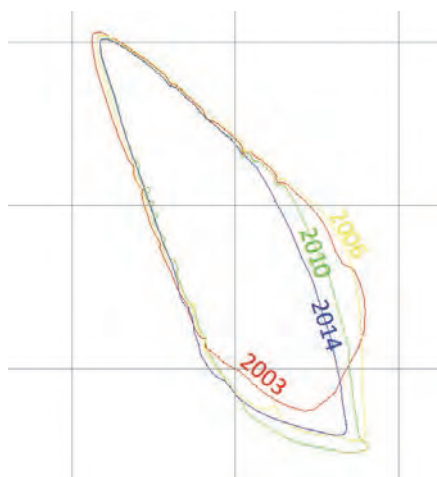
Attachment Figure 2-11: Secular Change at the Middle Bank

There is a middle bank on the downstream side of the Yangon River. Three images, from November 25, 2003, March 23, 2010, and February 13, 2014, were selected from Google Earth. The lines of roads, and riparian forests were traced from these images.
