THE PREPARATORY SURVEY
ON
THE PROJECT FOR RECONSTRUCTION ON
NIPPON CAUSEWAY ON TARAWA
TO ADAPT CLIMATE CHANGE
IN
REPUBLIC OF KIRIBATI

FINAL REPORT

JAPAN INTERNATIONAL COOPERATION AGENCY

CTI ENGINEERING INTERNATIONAL CO., LTD.
IDES INC.

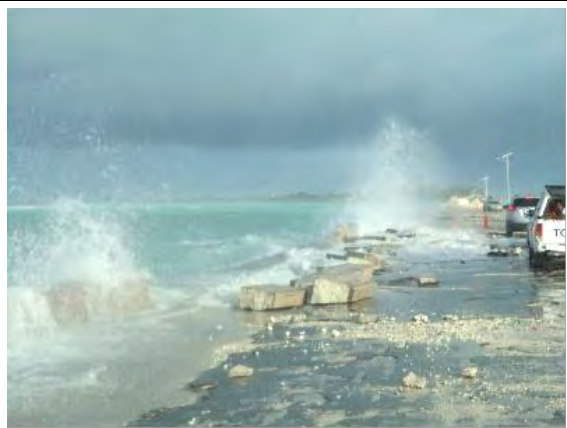
Table 2.2.1-23 Presumed Overtopping Rate at Damage

To verify the above calculation and its appropriateness, the overtopping rate at the time of the damage is assumed on the basis of the site photo, and compared with the result of the calculation. Before and after 12th of March 2015 the cyclone Pam caused damage to the causeway, the overtopping rate of 0.0016~0.080(m³/m/wave) is presumed at the time on the site photo shown in Table 2.2.1-23. Referring to the calculation in Table 2.2.1-22, the overtopping rate of 0.0078(m³/m/s) or 0.073(m³/m/wave) using the wave period of 9.3s is obtained under the present parapet height (+4.54m), and therefore the result of the calculation seems reasonable comparing the above assumed rate at the damage.

Appearance of Overtopping	Overtopping Rate in one Wave (2πQ/(HoL _A))
	Splash (water mass)	< 10 ⁻⁴
	Splash, Jumping water (large water mass) Part of wave body over	10 ⁻⁴ - 5x10 ⁻³
	Wave body continuously over	5x10 ⁻³ - 10 ⁻²
	Entire wave over	>10 ⁻²
	Source: Akira TAKADA "Wave Run Up and Overtopping"	
Photo at the damage on 12 th of March 2015	The overtopping rate of 10 ⁻⁴ ~5x10 ⁻³ (2 π Q/(HoL _A)) is obtained from the above Table, and Q=0.0016~0.080(m ³ /m/wave) is presumed using the wave height of 0.8m and the period of 9 sec.

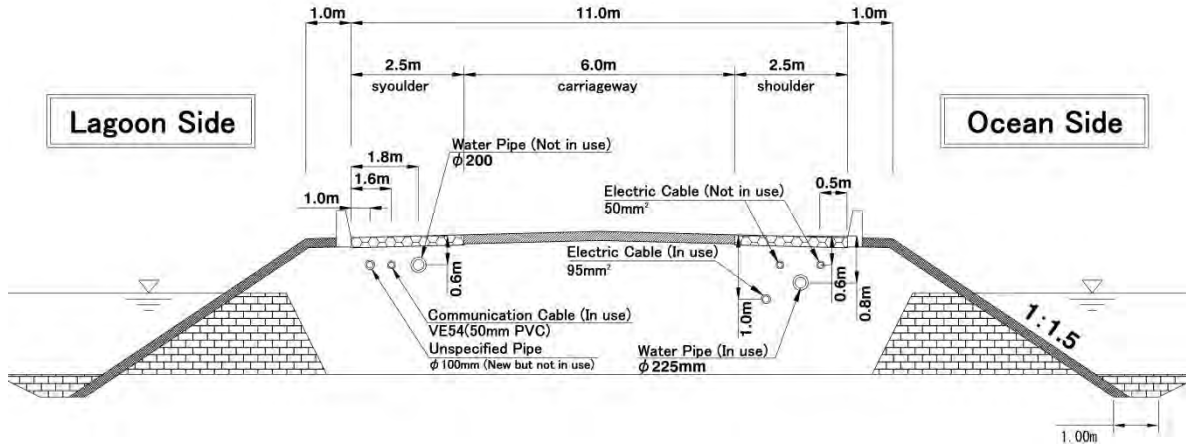
Figure 2.2.1-12 Typical Cross Section of Utilities

- Water pipes, communication cables and electric cables are buried under the shoulder.
- So far, decrease in the strength of soil cement associated with excavation of the shoulder for utilities maintenance and water leak of water pipe have affected on the structure of Nippon Causeway. (refer to Figure 2.2.1-12)
- To prevent them, utilities shall be installed in separate utility boxes.
- Relocated section is shown in Figure 2.2.1-13.

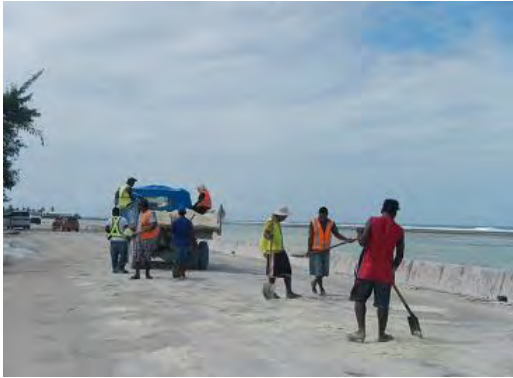
Filling while walking with a dump truck

The procedure of filling is through spreading of sand in pot holes, level by foot, and then compaction by a vehicle. It shall be effective for a while, but gradually come off and wash away by rainfalls. Hence, it is merely a short term countermeasure.

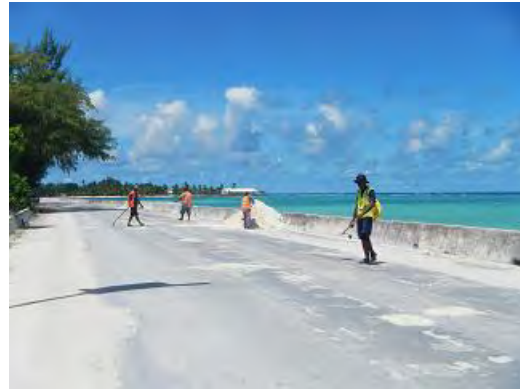
Filling pot holes by workers

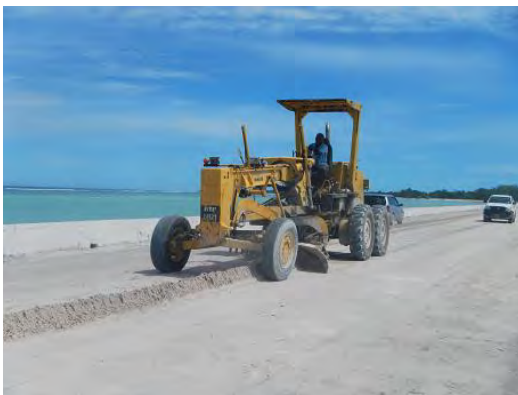
Scraping and filling by motor grader

In Betio side from the bridge, the MPWU's mortar grader is directly scraping the asphalt pavement for leveling and filling pot holes due to poor pavement condition.

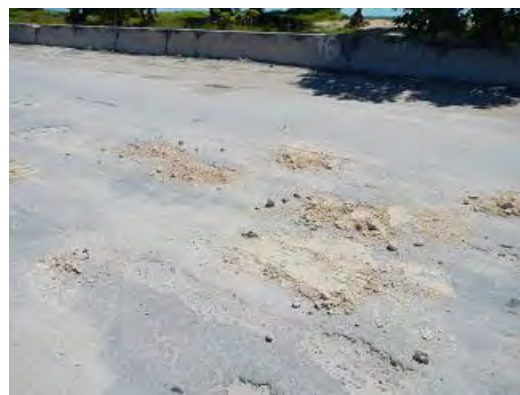
Natural compaction by vehicles

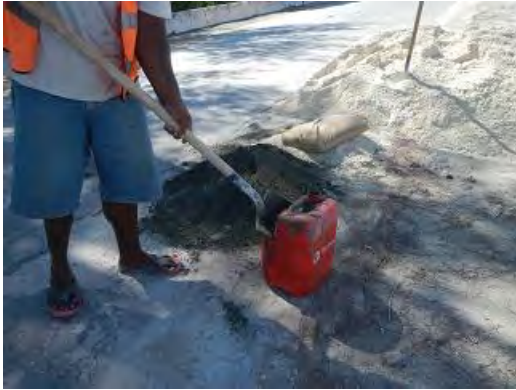
Mortar mixture

Mortar was made from cement and sand mixture with seawater and applied to a crack surface manually. Mixture ratio was not good and cement content was low. Neither V-cut at the crack nor pushing mortar inside of the crack was applied.

A technical transfer was conducted at the first field survey by providing simple manuals for mortal mixture procedure and crack repair (see Figure 2.2.1-14).

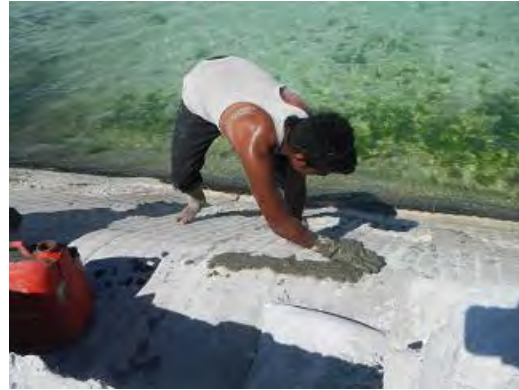
Mortar application

There were many places that applied mortars were peeling off due to improper work and lack of quality control concept.

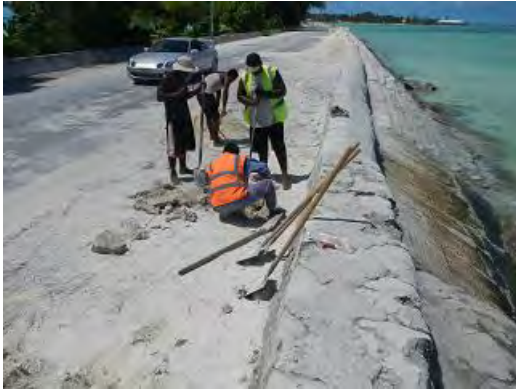
Trial excavation

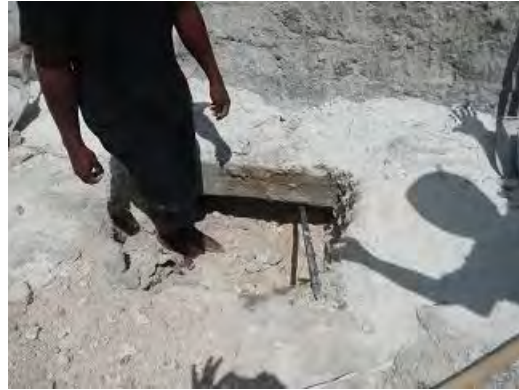
Large cavity under seawall

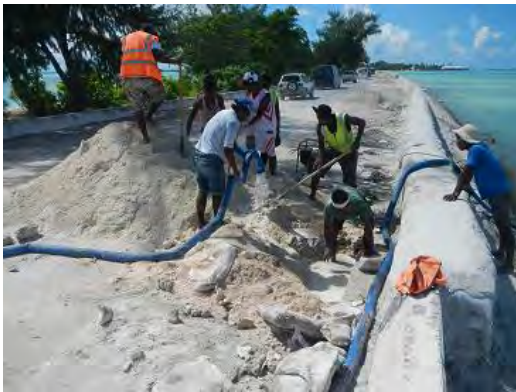
Hydraulic filling

7Kw small generator and 2" water pump were utilized for hydraulic filling. The filling was properly conducted, but the cracks caused for cavity were not repaired. Hence, sand may be wash off again from the cracks.

It was instructed that hydraulic filling should be conducted during high tide to evade using water pump but in case the filling sand is washed off from the cracks, mark the location and repair the cracks during the next low tide.

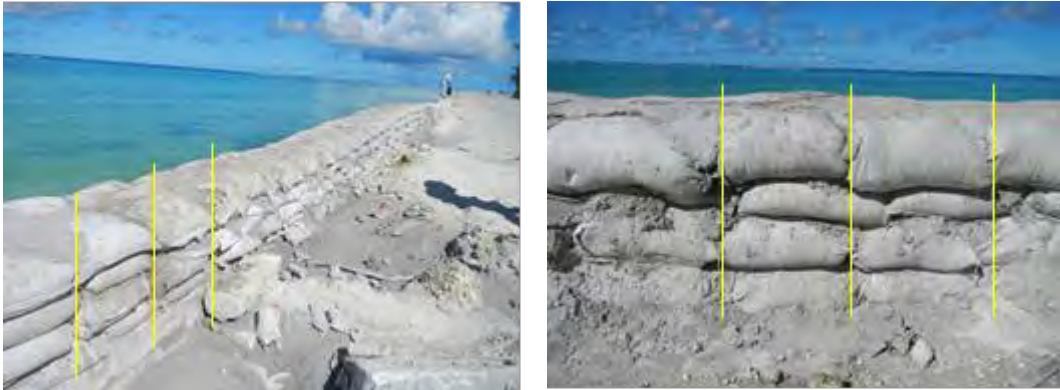
Sandbags are piled in one column (not alternately piled)

Sandbag piling for seawall was rather messy. Usually sandbags are piled alternately to get the strength, but it was observed that there were some locations that sandbags are piled in just one column.

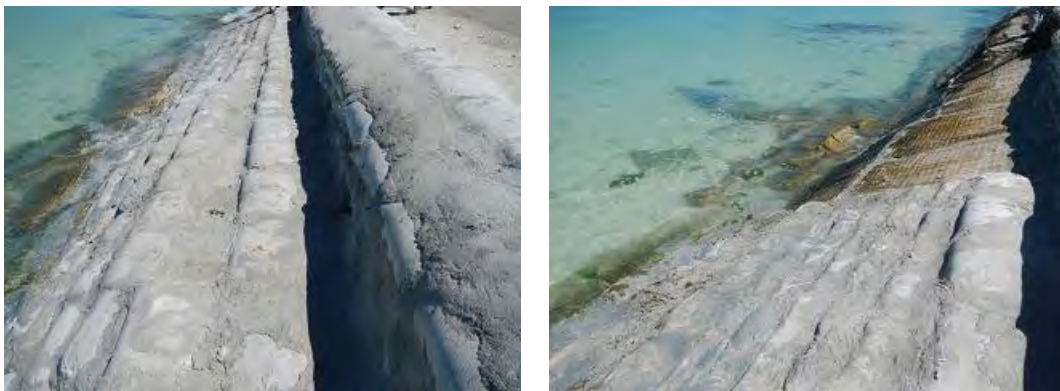
Repair of slopes

Many sandbags piled for slope protection are torn apart or worn due to UV and waves.

However, they were made of mortar and relatively robust and no sandbags with cracks were observed during low tide inspection.
