**Ministry of Works, Transport and Communications
Reli Assets Holding Company
United Republic of Tanzania**

**Preparatory Survey on
Flood Protection Measures for
Central Railway Line
in the United Republic of Tanzania**

**Final Report
Volume 1: Main Text**

July 2016

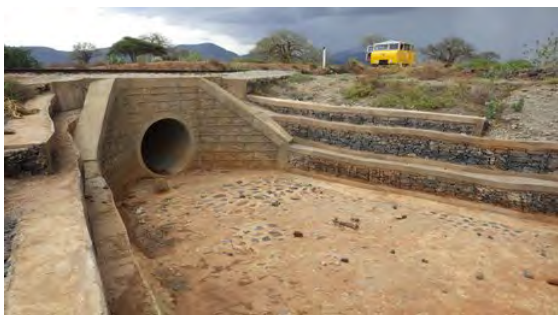
Figure 3.13: Box Culvert (Km 359)

Culverts frequently become clogged with sand carried by running water (Figure 3.13 above). When a culvert becomes clogged, running water crossing under the track stops, causing overflows and/or backwater flows. When running water hits an embankment slope, the embankment will be eroded, causing a higher possibility of embankment destruction, to be mentioned below. Moreover, backwater around a culvert causes water penetration into the embankment, reducing its strength.

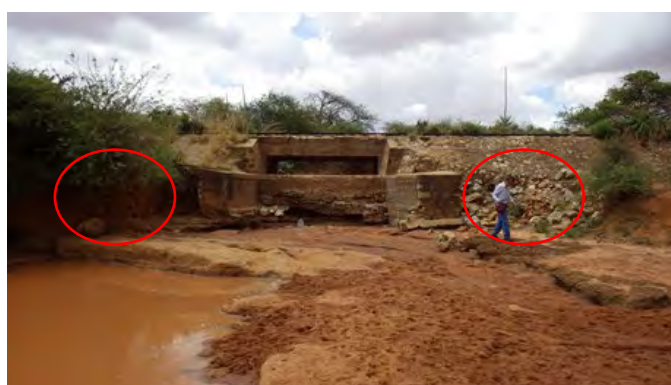
Figure 3.16: Embankment Erosion by Running Water (Km 410)

If an embankment supporting a track is destroyed, railway operations will be stopped for a long period. In the site survey, the Study Team found several places where the risk of embankment destruction is high due to erosion from running water. In many places, running water hits embankment slopes beside culverts and bridges (Source: JICA Study Team Figure 3.16). Embankment destruction may possibly occur at those places in the future.

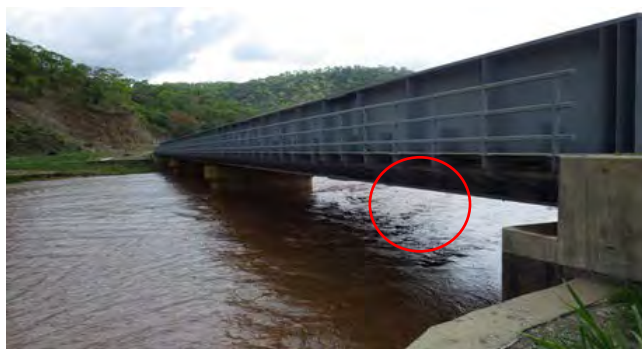
Figure 3.17: Danger Point of the Bridge Destruction (Km 293)

Figure 3.17 shows a small clearance between the river water level and the soffit of the bridge girder, and this presents a possibility of the bridge being washed away when water levels rise. It is necessary to confirm the height of under the girder, and high water marks will be verified in the course of future investigations.

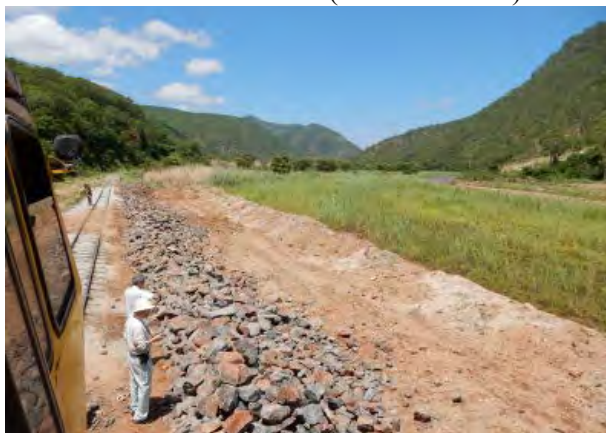
Km 315

The erosion of the riverbank was very close to the track.

In early December 2014, to prepare for the protection against the coming rainy season, the track was re-routed toward the mountain side (max. 18 m diversion).

On 18 December 2014, the trial run was conducted successfully.

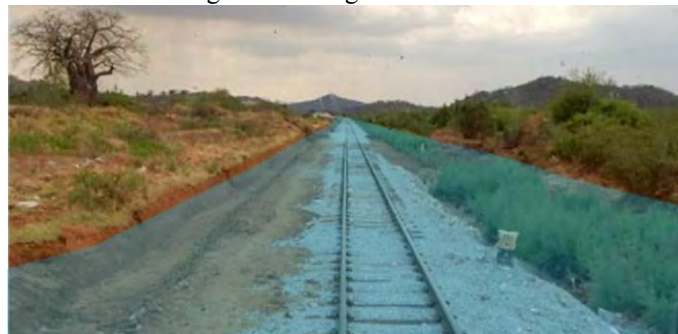
An Example of at Km 363 (toward Gulwe)

· Image of submergence of the track

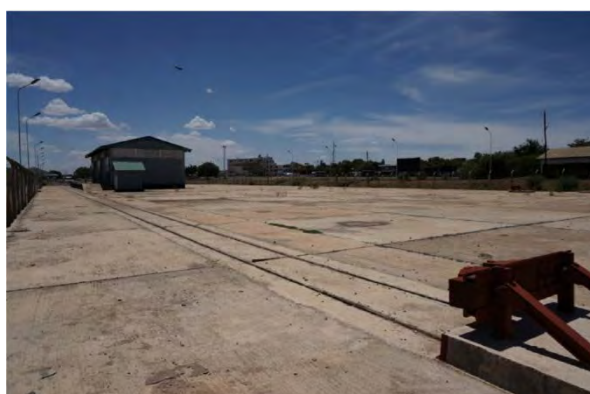
Figure 3.21: Shinyanga Inland Container Depot, 2013

Shinyanga ICD has completed construction, but has basically no activity due to the low capacity of TRL. The original rationale for construction for this ICD was to containerize cotton/cotton cake for export, as Shinyanga is a major cotton production area. However, as later described in Chapter 4 (Traffic Demand Forecast), TRL has completely lost this business, and Shinyanga sits idle. The Government of Tanzania is working with Chinese investors to drastically grow industries in this area; many of them are cotton-related but not all of them, so there is potential for future use of the ICD.

RAHCO is still in the process of inviting tenders for leasing this ICD. Two of the five container reach stackers donated by the BTC to RAHCO were intended to go to this ICD, but they are still in Dar es Salaam, and there is an open invitation for bidders for their leasing. At present, there is a low probability that they will actually end up at Shinyanga in the near future, since there is no demand there for their use. (More private ICDs are opening in Dar es Salaam, and it is more likely that they will end up there.) Figure 3.21, from a METI Study Team site visit, demonstrates the lack of activity at Shinyanga ICD in October 2013:

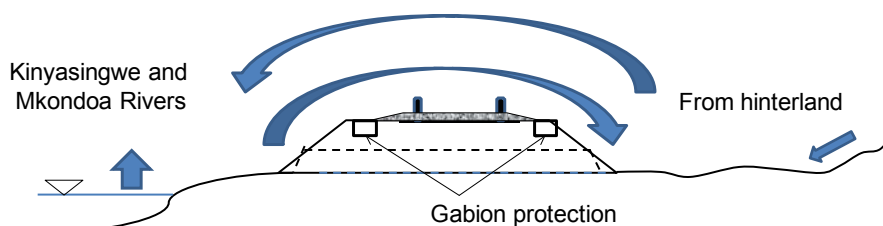
Figure 5.8: Overtopping of Floodwaters above Track Embankment

There is also the possibility of overtopping occurring from two directions: the river side and the inland side, as shown in Figure 5.8:

These high-risk areas of overtopping are identified and summarized based on the experiences of recent floods as well as the current conditions confirmed through site reconnaissance, as tabulated in Table 5.7. During the incoming rainy season, daily monitoring and preventive measures, if necessary, shall be conducted by the TRL's Gangmen and/or River Gang in particular at those sections.

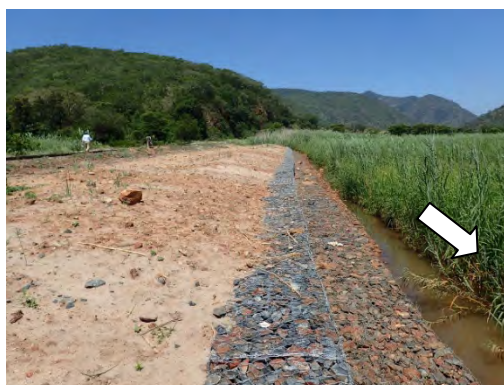
**Figure 5.10: Completed Revetment
by Gabion at Km 302**

This site was heavily eroded and the embankment was totally washed away by the flood in March 2014. Then, TRL provided riverbank protection by gabion, completing in February 2015.

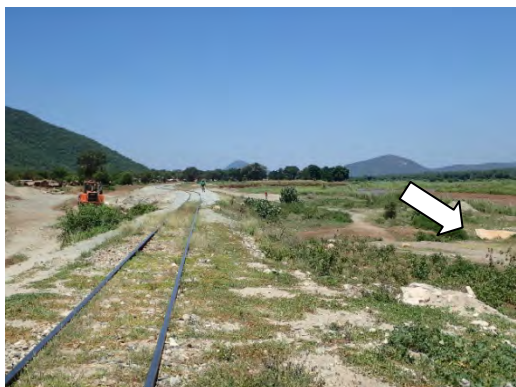
Figure 5.11: Completed Shifting of Railway Alignment at Km 315

This site has been considered as the most dangerous site for bank erosion, because in August 2014 only a few meters are left between the existing track alignment and the shoulder of riverbank. Then, in October 2014 TRL started restoration works, including shifting the railway alignment toward the mountainside at maximum 20 m. Shifting of the rail has been completed. On the other hand, the revetment by gabion boxes (upper portion) has been suspended in the middle of this section in February 2015. It is reported that the budget for restoration works has run out and a resumption of work is pending, waiting on a release of funds to complete the remaining section. Construction works of a new box culvert located at Km 316.5 have been completed.

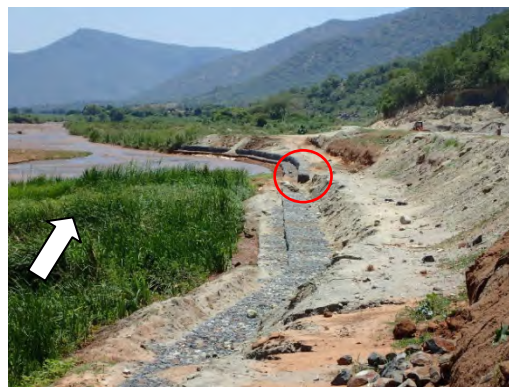
Figure 5.12: Suspension of Installation Works of Gabion

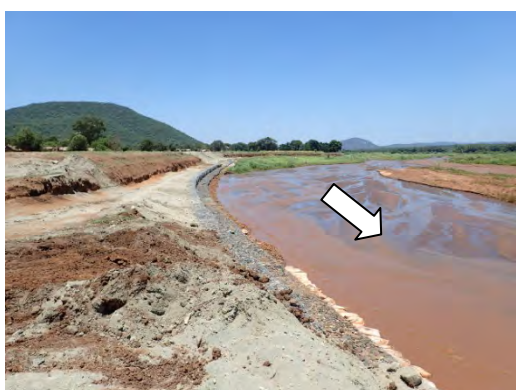
Figure 5.13: Completed Feature of Revetment Works by Gabion Boxes (Lower Level)

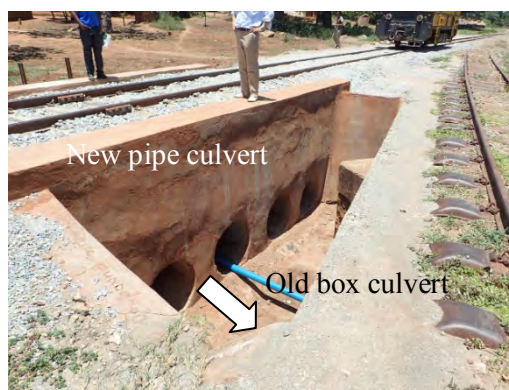
Figure 5.14: New Pipe Culvert (4 Pipe Culverts) at u/s Side of the Old Box Culvert (2 Barrels, Rectangular)

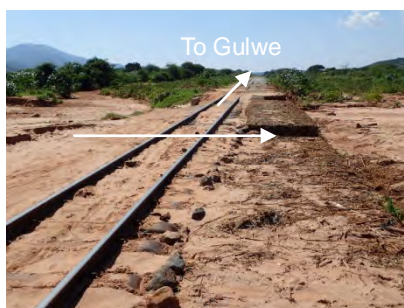
Figure 5.17:
Near CL 349.8B
(buried)

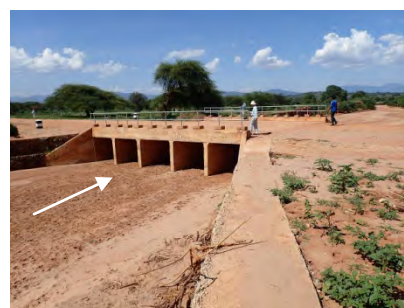
Figure 5.18:
New Box Culvert
Constructed
by TANROADS

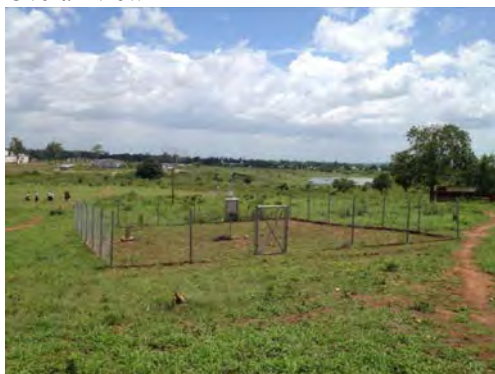
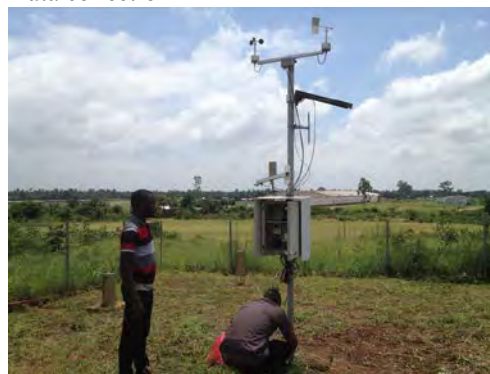
Figure 6.2: Kutukutu Automatic Weather Station

Automatic rainfall data has not been recorded
due to a connection error between the gauge
and the data logger in the control panel.

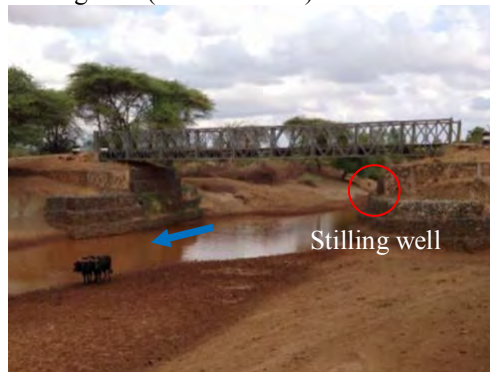
Figure 6.6: Kongwa Water Level Gauging Station (1GD16)

Stilling well (not functional)

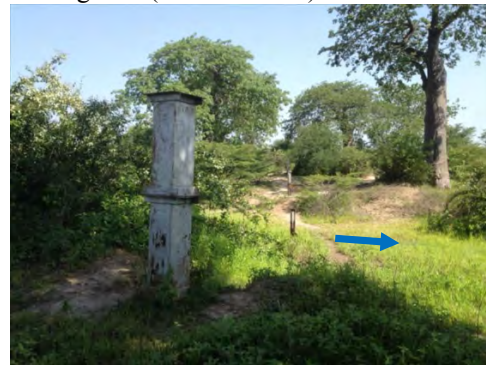
Figure 6.8: Chihanga Water Level Gauging Station (LKIC)

Stilling well (not functional)

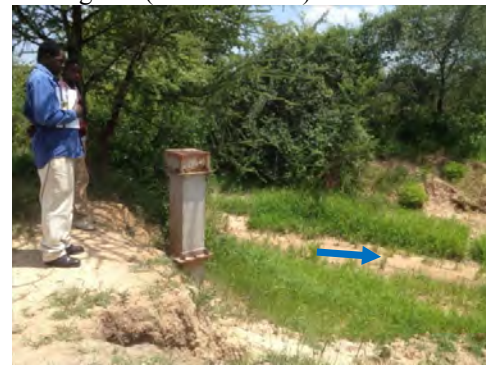
Stilling well(not functional)

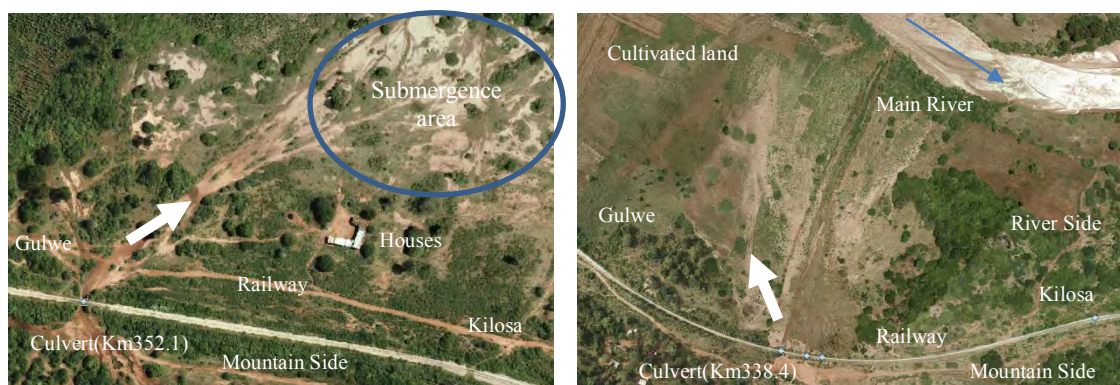
Figure 6.44: Culvert without Drainage Way

Figure 6.44 shows examples of culverts without drainage ways. These culverts are usually far from the river. Downstream of these culverts, an area of land is submerged during floods.

Therefore, in order to protect housing and cultivated lands from floods, if the location of the culvert is expected to result in a high discharge of flow from the mountain-side, it is recommended to orient the channel from the culvert toward the main river.

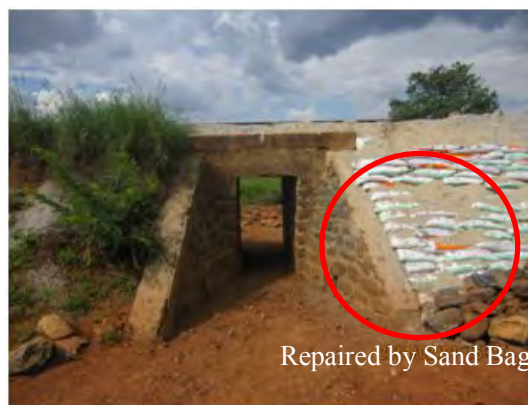
Figure 6.46: Example of Culvert Intake

Figure 6.46 shows an example of an intake wall for a waterway culvert, constructed of concrete and masonry. During the site survey, it was found that some culverts had serious damages around the intake. Therefore, it is necessary not only to increase the capacity of culverts, but also to place backfill materials behind the walls of the intakes of culverts.
